An Evaluation of Potential Effects on Old-Growth Redwoods
from Implementation of the Richardson Grove Operational
Improvement Project

August 14, 2015

Dennis Yniguez
Registered Consulting Arborist
Dennis@TreeDecisions.com
510-649-9291

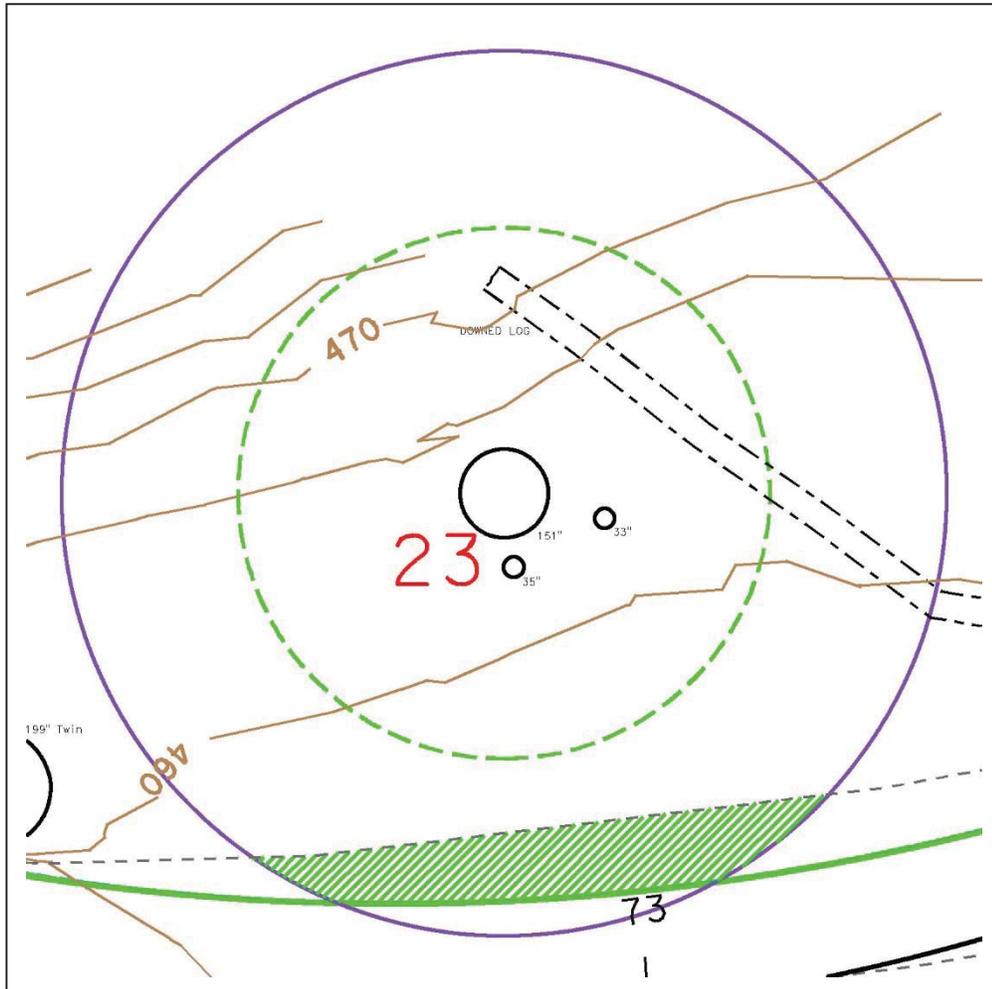
Description: Tree #23, 151 inches DBH (depicted in Attachment A, Sheet 6).

Evaluation: Effect of root zone disturbance is extremely minor and there would be no decline in foliage density or tree health.

Details of Work: The road would be moved up to 10 feet away from the tree. Where pavement would be removed, road materials would be replaced with gravel at the road edge and native soils and duff beyond. The top layer of roadway would be ground off and replaced with new asphalt.

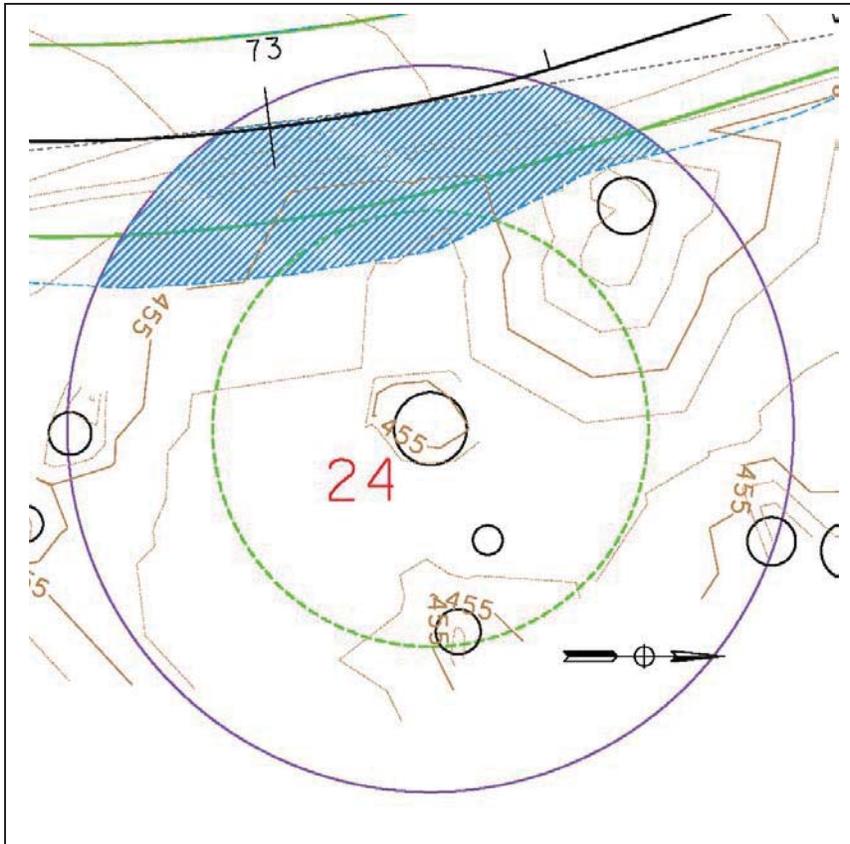
Description: Tree #24, 152 inches DBH (depicted in Attachment A, Sheet 6). Tree has two trunks.

Evaluation: Effect of root zone disturbance is very slight and there would be no decline in foliage density or tree health.

Details of Work: The road would be widened up to 17 feet toward the tree. Where road would be widened, soil and old road materials would be dug out and replaced with new road materials. New soils would be placed to construct embankment (average depth greater than 36 inches). The top layer of roadway would be ground off and replaced with new asphalt.

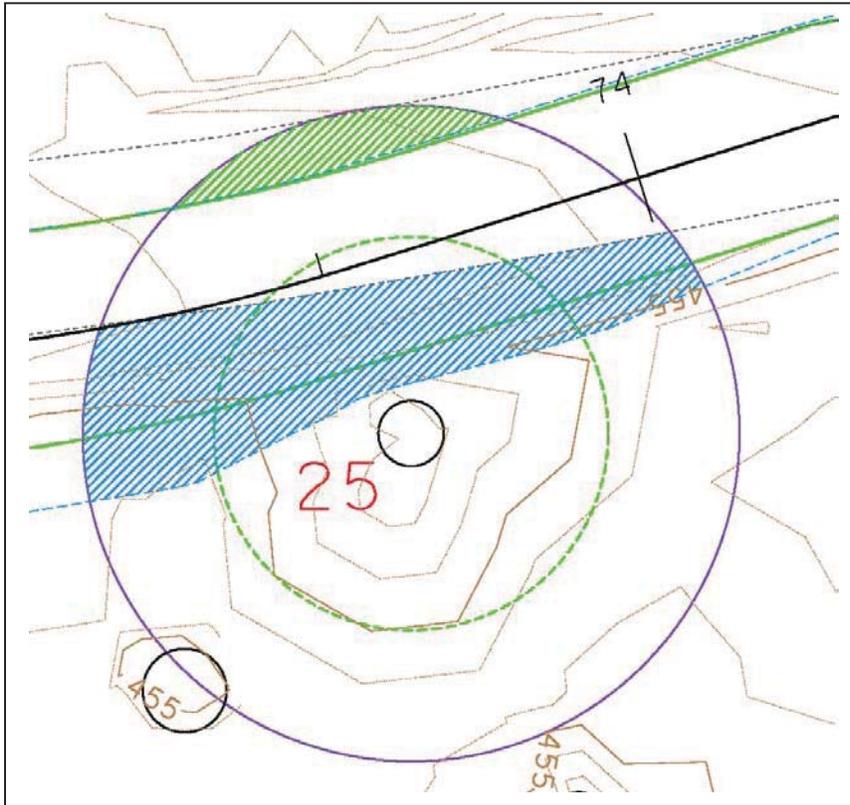
Description: Tree #25, 119 inches DBH (depicted in Attachment A, Sheet 6).

Evaluation: Effect of root zone disturbance may be a short-term visible reduction in foliage density that is still well within the adaptive capabilities of the tree.

Details of Work: The road would be widened up to 17 feet toward the tree; across the road it would be narrowed by up to 9 feet. Where road would be widened, soil and old road materials would be dug out and replaced with new materials. New soils would be placed to construct embankment (average depth greater than 36 inches). Where pavement would be removed, road materials would be replaced with gravel at the road edge, and native soils and duff beyond. The top layer of roadway would be ground off and replaced with new asphalt.

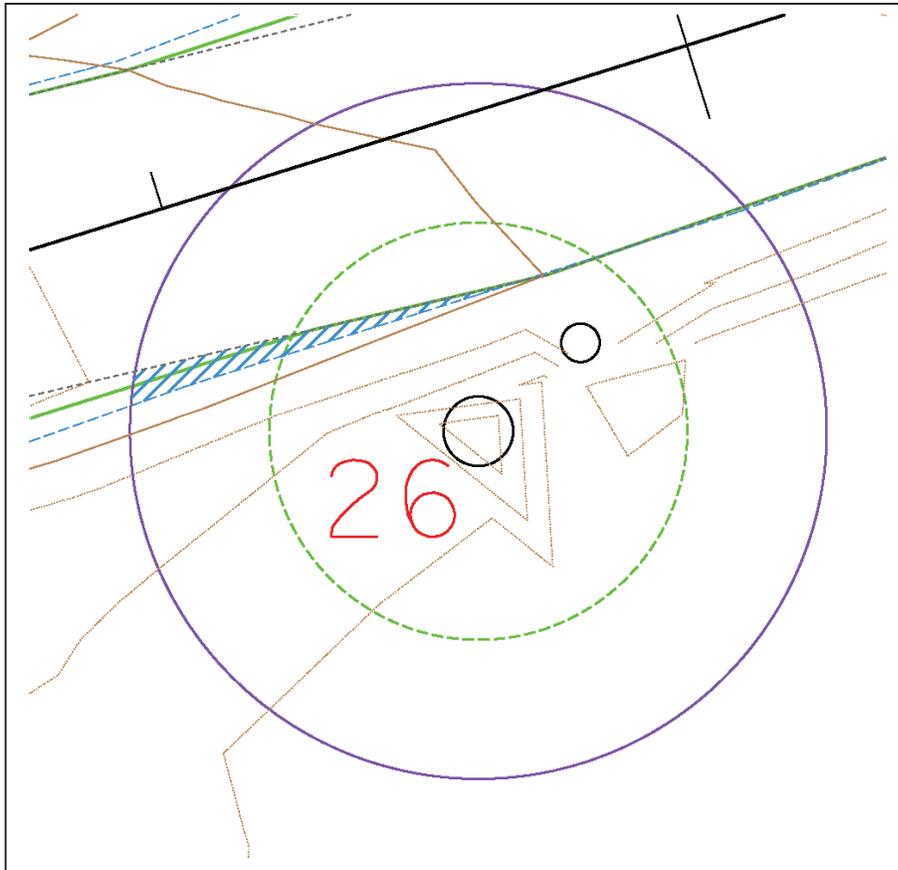
Description: Tree #26, 76 inches DBH (depicted in Attachment A, Sheet 6). Tree has a large basal scar that is callusing over.

Evaluation: Effect of root zone disturbance is very slight and there would be no decline in foliage density or tree health.

Details of Work: The road would be widened up to 2 feet toward the tree. New soils would be placed to construct embankment (average depth 1-2 inches). The top layer of roadway would be ground off and replaced with new asphalt.

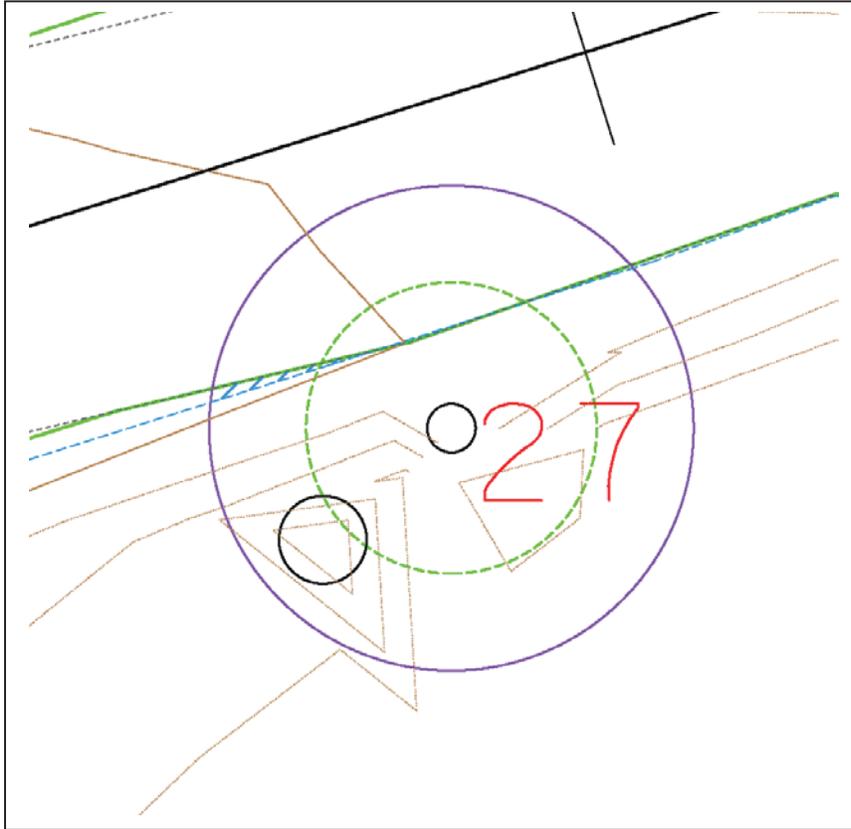
Description: Tree #27, 43 inches DBH (depicted in Attachment A, Sheet 6). Tree is adjacent to road and appears to have been struck by vehicles.

Evaluation: Effect of root zone disturbance is extremely minor and there would be no decline in foliage density or tree health.

Details of Work: New soils would be placed to construct embankment (average depth 1-2 inches). The top layer of roadway would be ground off and replaced with new asphalt.

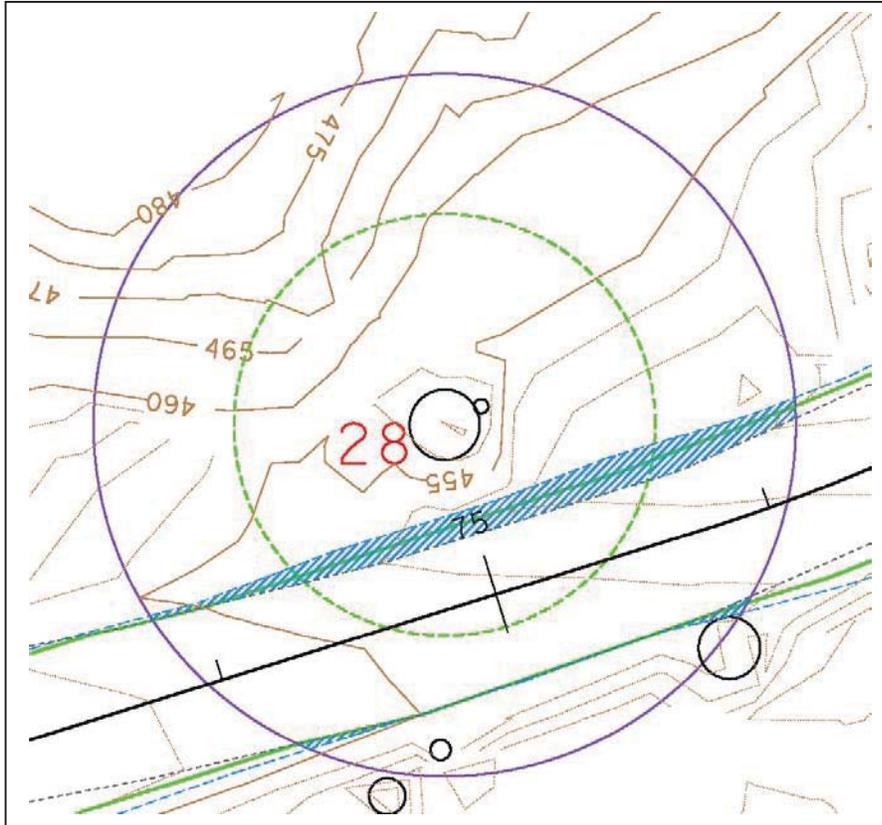
Description: Tree #28, 147 inches DBH (depicted in Attachment A, Sheet 7). Tree has two trunks with a large basal hollow, and is growing on a mound of earth above the road.

Evaluation: Effect of root zone disturbance is very slight and there would be no decline in foliage density or tree health.

Details of Work: The road would be widened up to 3 feet toward the tree. Where road would be widened, soil and old road materials would be dug out and replaced with new road materials. New soils would be placed to construct embankment (average depth 6 to 18 inches). The top layer of roadway would be ground off and replaced with new asphalt.

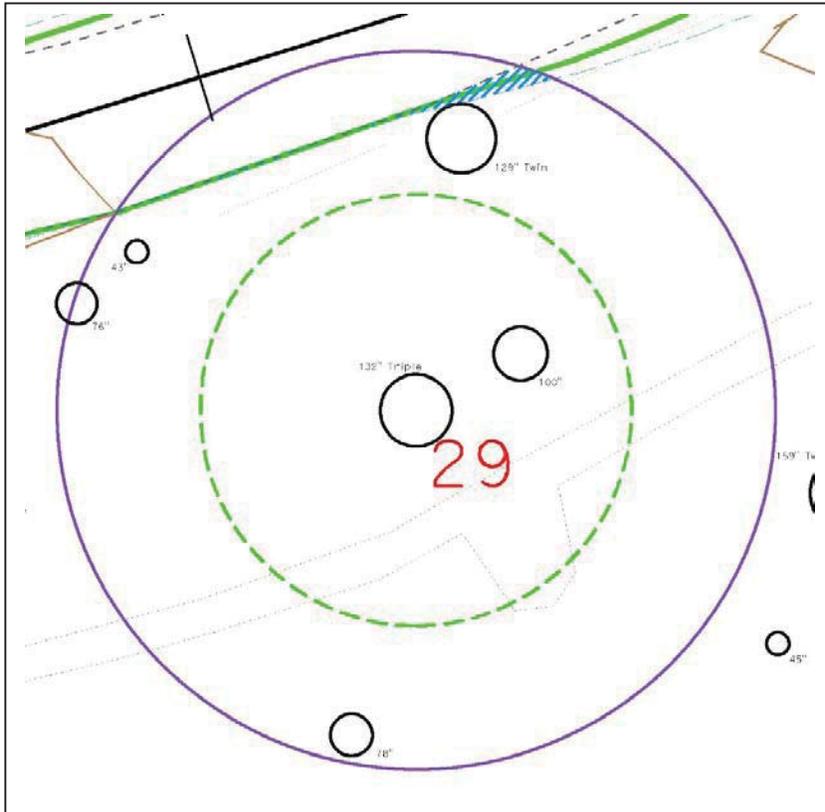
Description: Tree #29, 132 inches DBH (depicted in Attachment A, Sheet 7). Tree has three trunks.

Evaluation: Effect of root zone disturbance is extremely minor and there would be no decline in foliage density or tree health.

Details of Work: The road would be widened less than 2 feet toward the tree. Where the road would be widened, soil and old road materials would be dug out and replaced with new road materials. New soils would be placed to construct embankment (average depth 6 to 18 inches). The top layer of roadway would be ground off and replaced with new asphalt.

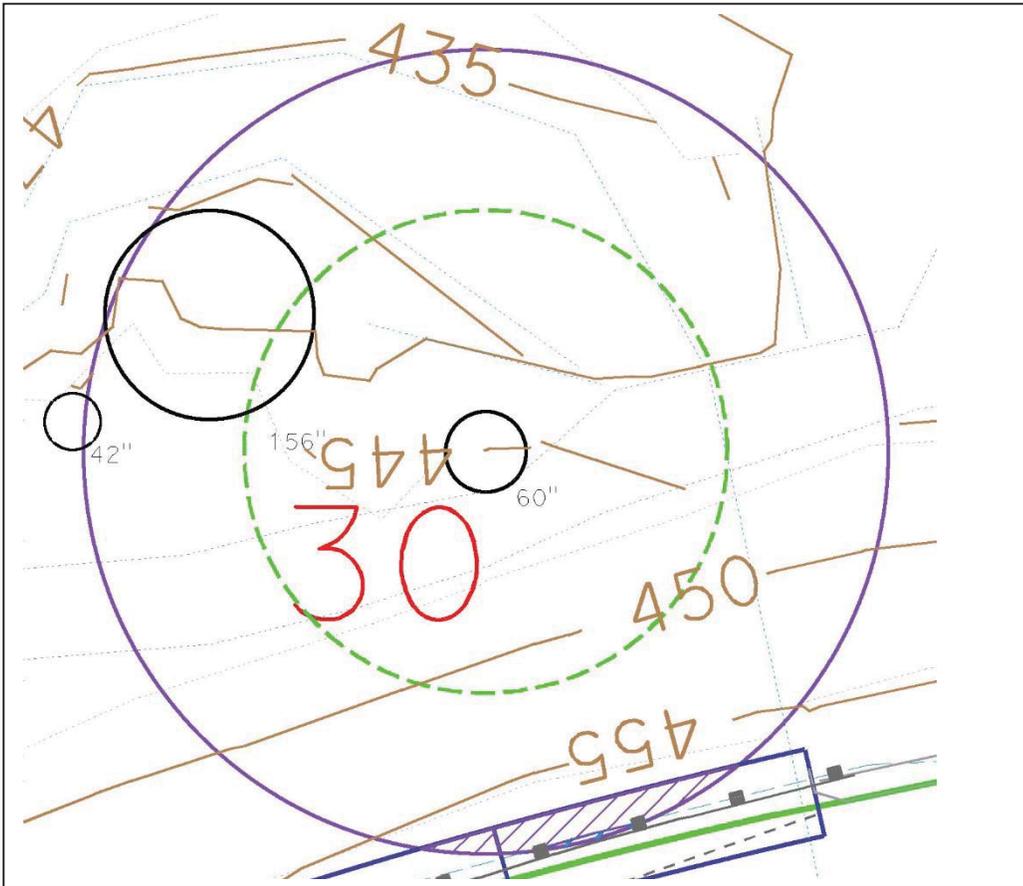
Description: Tree #30, 60 inches DBH (depicted in Attachment A, sheet 10). On slope below bridge.

Evaluation: Effect of root zone disturbance is slight and there would be no decline in foliage density or tree health.

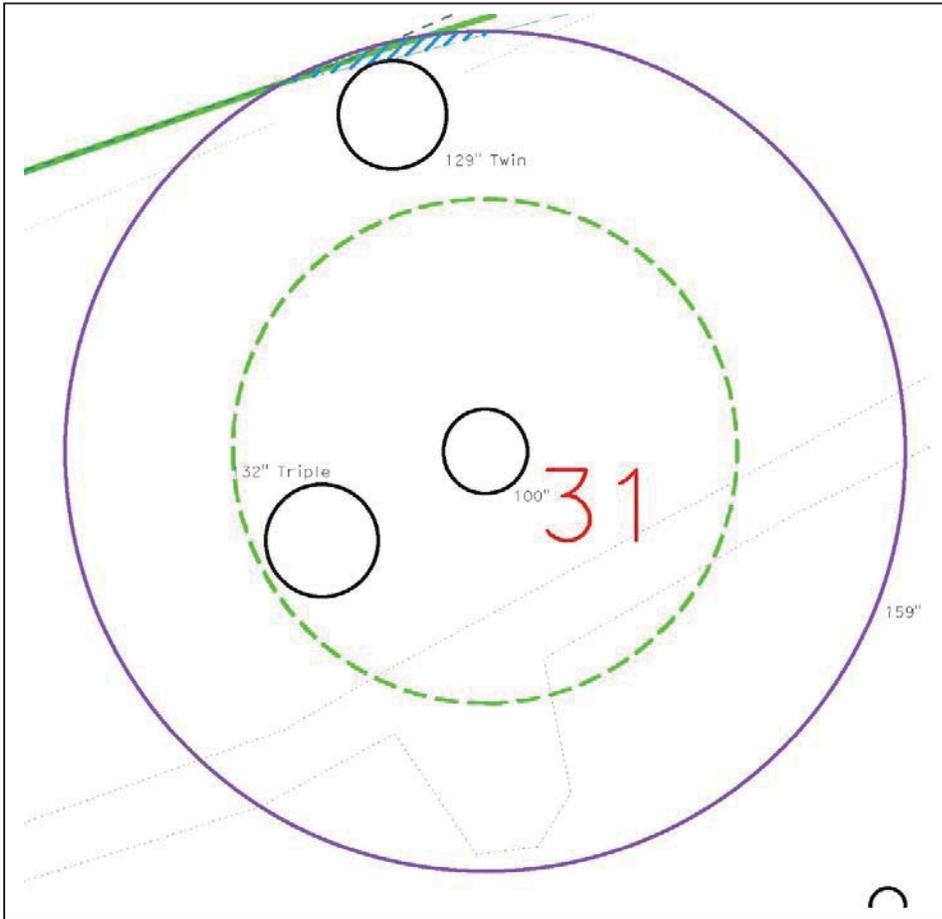
Description: Tree #31, 100 inches DBH (depicted in Attachment A, Sheet 7).

Details of Work: The road would be widened less than 1 foot toward the tree. Where the road would be widened, soil and old road materials would be dug out and replaced with new road materials. New soils would be placed to construct embankment outside of structural root zone (average depth 6 to 18 inches).

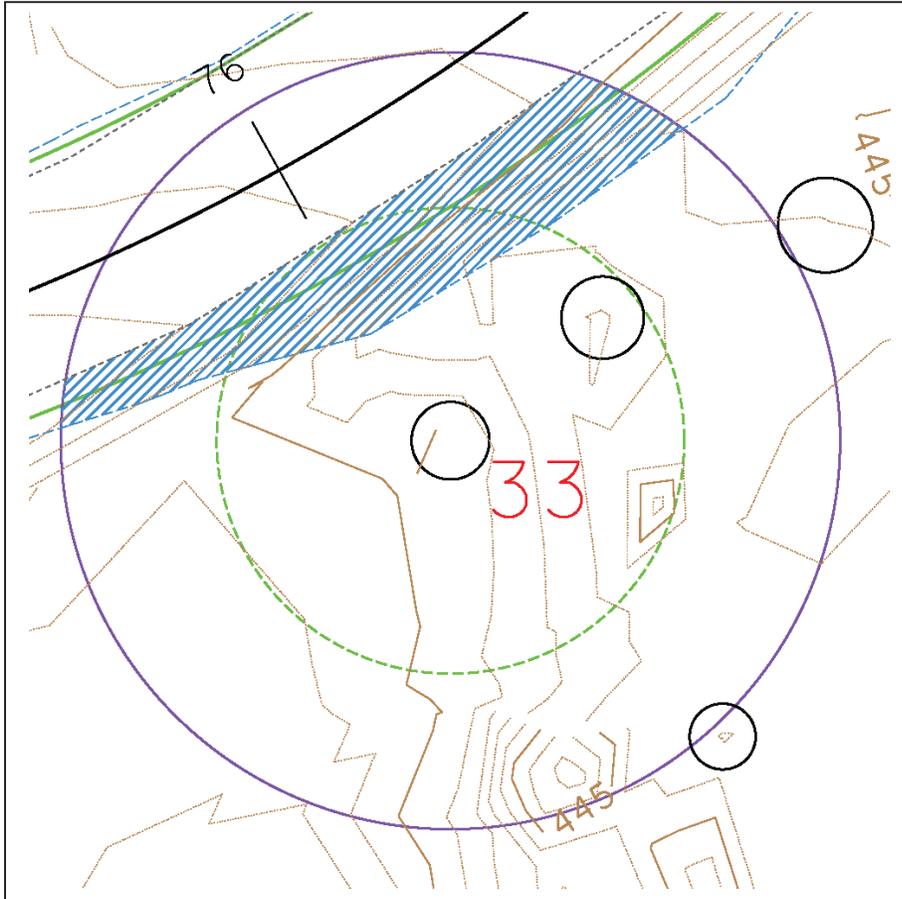
Description: Tree #33, 118 inches DBH (depicted in Attachment A, Sheet 7).

Evaluation: Effect of root zone disturbance is slight and there would be no decline in foliage density or tree health.

Details of Work: The road would be widened up to 6 feet toward the tree. Where road would be widened, soil and old road materials would be dug out and replaced with new road materials. New soils would be placed to construct embankment (average depth 18 to 36 inches). The top layer of roadway would be ground off and replaced with new asphalt.

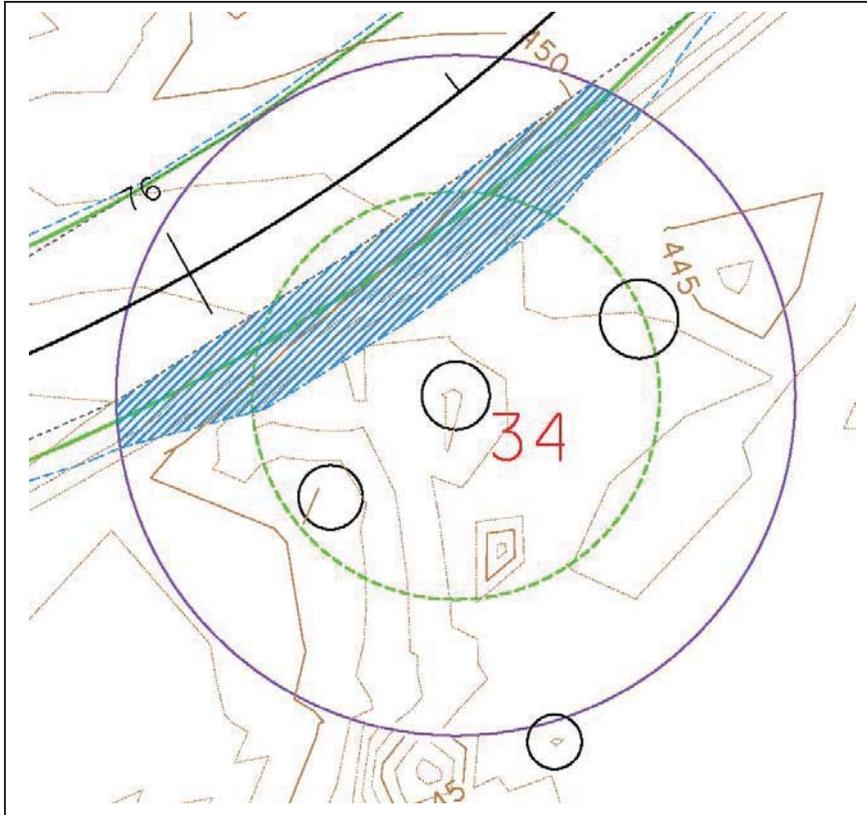
Description: Tree #34, 125 inches DBH (depicted in Attachment A, Sheet 7).

Evaluation: Effect of root zone disturbance is slight and there would be no decline in foliage density or tree health.

Details of Work: The road would be widened up to 5 feet toward the tree. Where road would be widened, soil and old road materials would be dug out and replaced with new road materials. New soils would be placed to construct embankment (average depth greater than 36 inches). The top layer of roadway would be ground off and replaced with new asphalt.

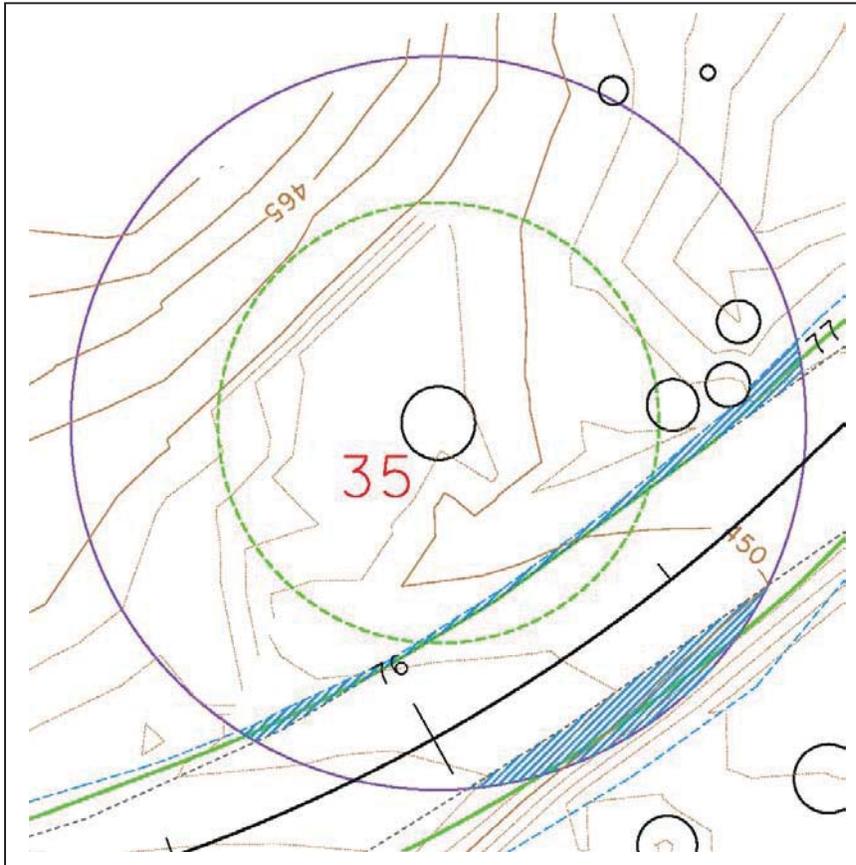
Description: Tree #35, 154 inches DBH (depicted in Attachment A, Sheet 7). Tree has a full crown and a fire scar on one side of trunk.

Evaluation: Effect of root zone disturbance is slight and there would be no decline in foliage density or tree health.

Details of Work: The road would be widened up to 2 feet toward the tree; across the road it would be widened up to 6 feet. Where road would be widened, soil and old road materials would be dug out and replaced with new road materials. New soils would be placed to construct embankment (average depth 6 to 18 inches). The top layer of roadway would be ground off and replaced with new asphalt.

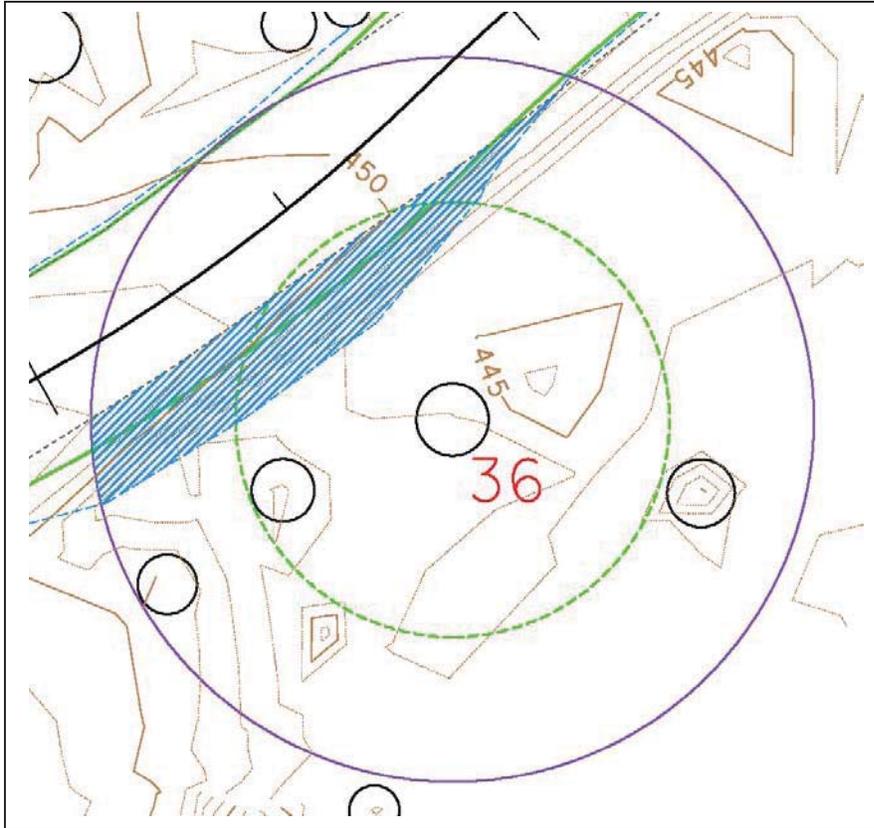
Description: Tree #36, 144 inches DBH (depicted in Attachment A, Sheet 7).

Evaluation: Effect of root zone disturbance is slight and there would be no decline in foliage density or tree health.

Details of Work: The road would be widened up to 5 feet toward the tree. Where road would be widened, soil and old road materials would be dug out and replaced with new road materials. New soils would be placed to construct embankment (average depth greater than 36 inches). The top layer of roadway would be ground off and replaced with new asphalt.

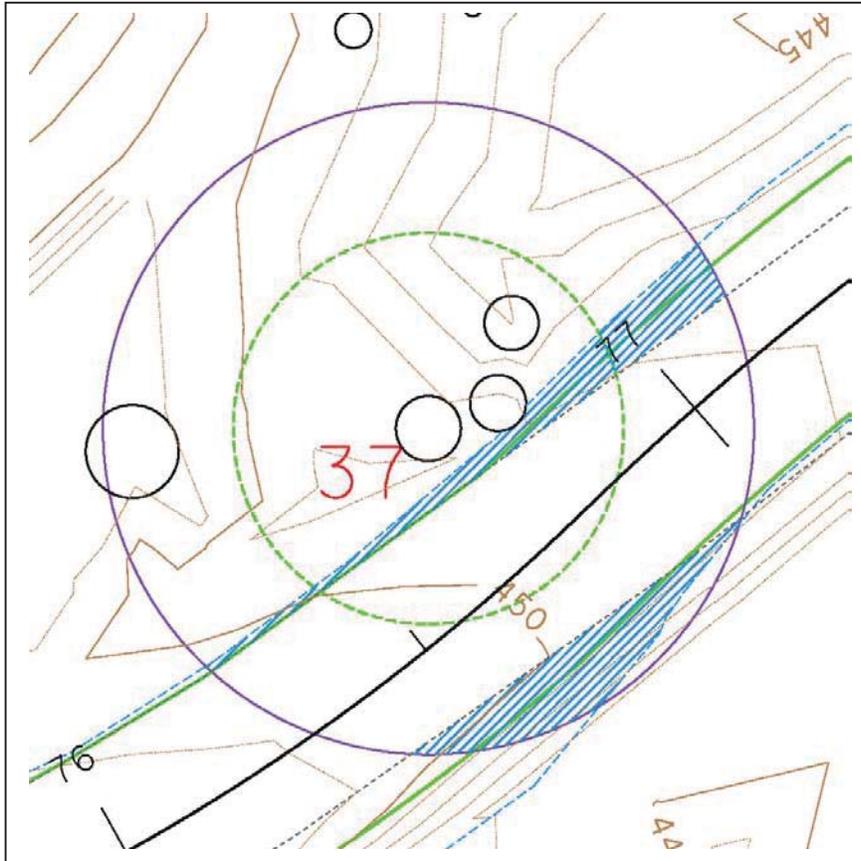
Description: Tree #37, 108 inches DBH (depicted in Attachment A, Sheet 7).

Evaluation: Effect of root zone disturbance may be a short-term visible reduction in foliage density that is still well within the adaptive capabilities of the tree.

Details of Work: The road would be widened up to 5 feet toward the tree; across the road it would be widened up to 5 feet. Where road would be widened, soil and old road materials would be dug out and replaced with new road materials. New soils would be placed to construct embankment (average depth 6 to 18 inches). The top layer of roadway would be ground off and replaced with new asphalt.

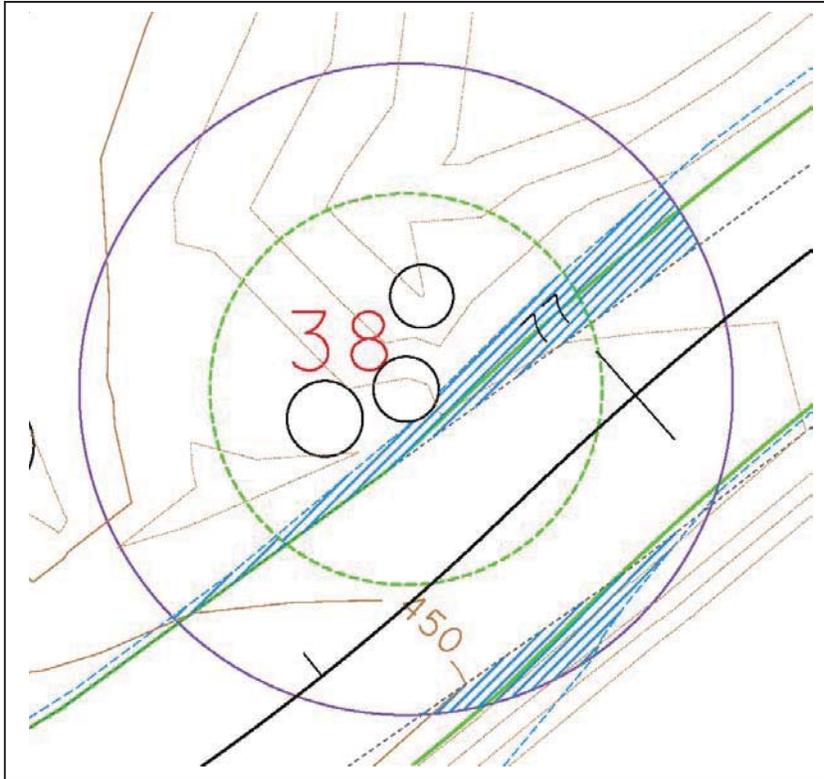
Description: Tree #38, 94 inches DBH (depicted in Attachment A, Sheet 7).

Evaluation: Effect of root zone disturbance may be a short-term visible reduction in foliage density that is still well within the adaptive capabilities of the tree.

Details of Work: The road would be widened up to 5 feet toward the tree; across the road it would be widened up to 4 feet. Where road would be widened, soil and old road materials would be dug out and replaced with new road materials. New soils would be placed to construct embankment (average depth 6 to 18 inches). The top layer of roadway would be ground off and replaced with new asphalt.

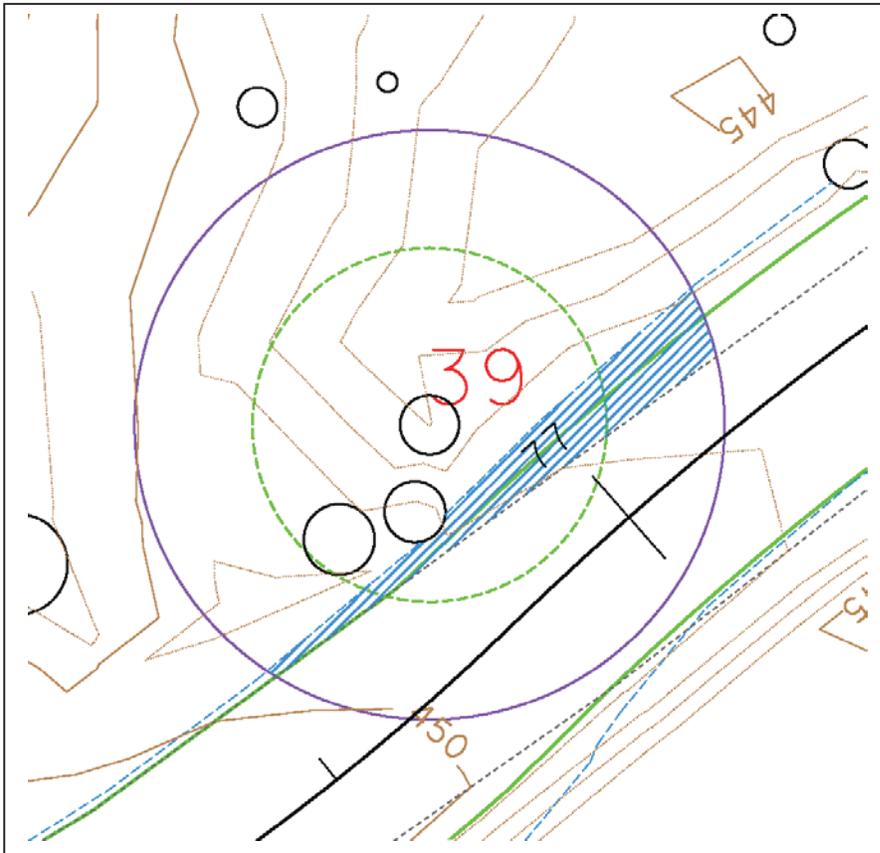
Description: Tree #39, 90 inches DBH (depicted in Attachment A, Sheet 7).

Evaluation: Effect of root zone disturbance is slight and there would be no decline in foliage density or tree health.

Details of Work: The road would be widened up to 5 feet toward the tree. Where road would be widened, soil and old road materials would be dug out and replaced with new road materials. New soils would be placed to construct embankment (average depth 6 to 18 inches). The top layer of roadway would be ground off and replaced with new asphalt.

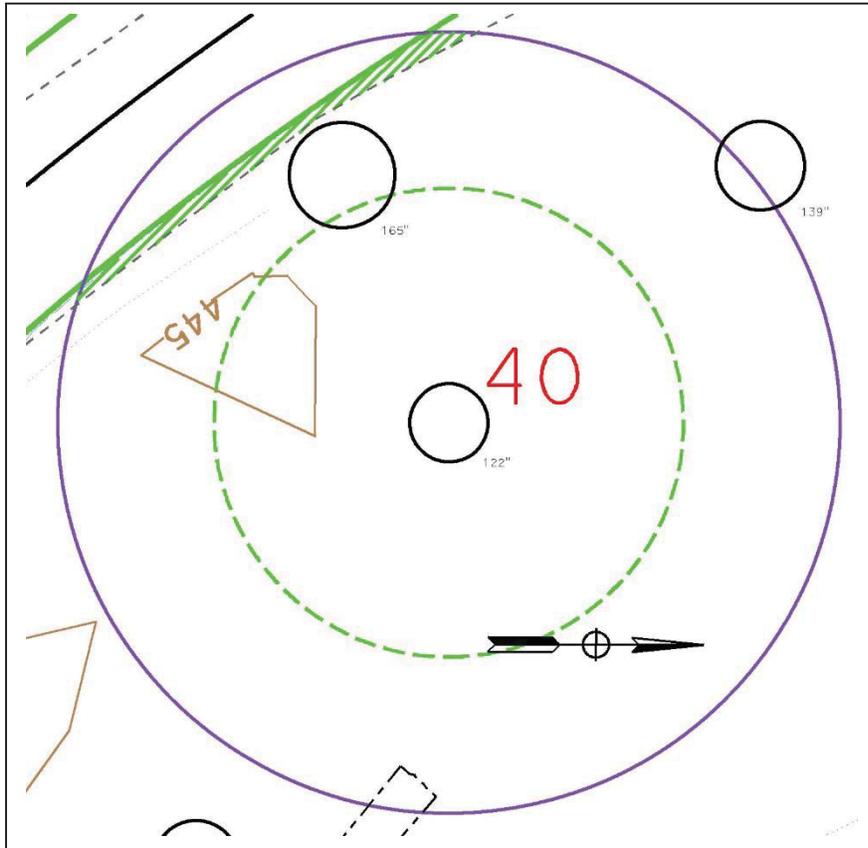
Description: Tree #40, 122 inches DBH (depicted in Attachment A, Sheet 7).

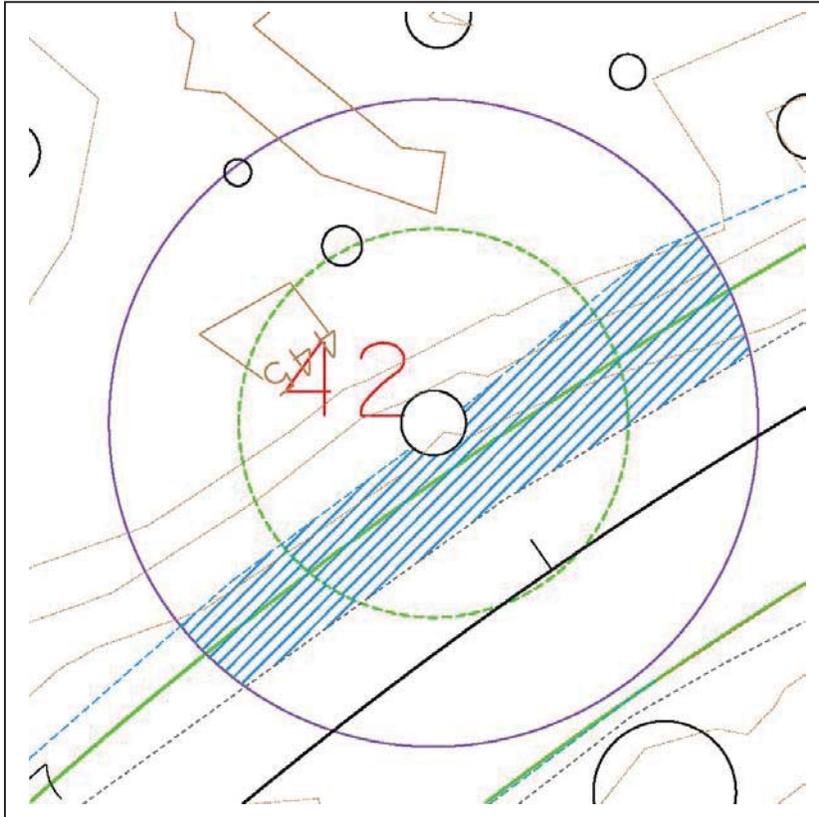
Description: Tree #42, 75 inches DBH (depicted in Attachment A, Sheet 7).

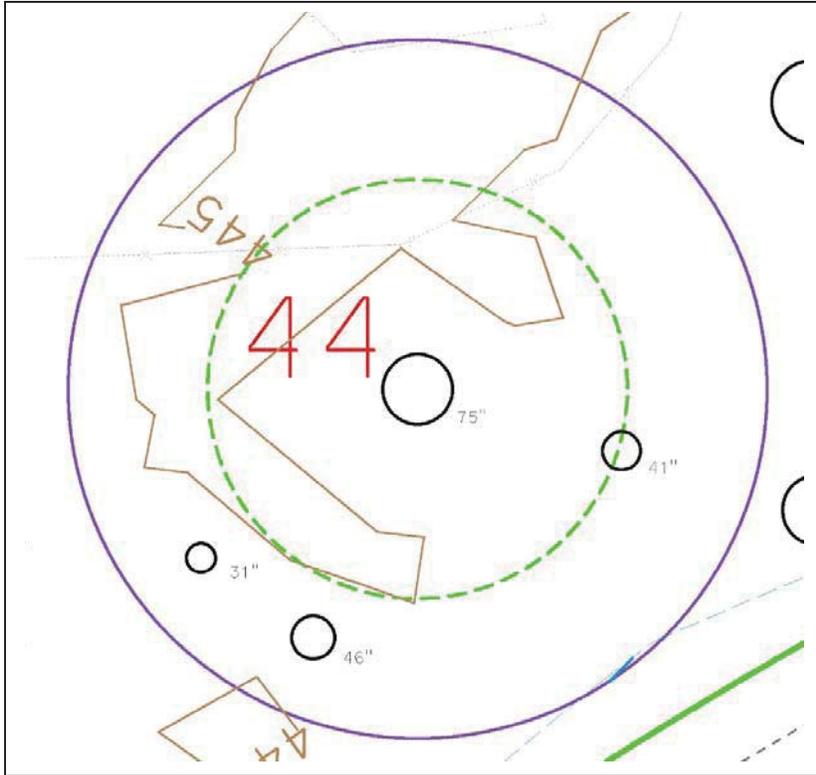
Description: Tree #44, 75 inches DBH (depicted in Attachment A, Sheet 8).

Evaluation: Root zone disturbance would have no effect on tree health.

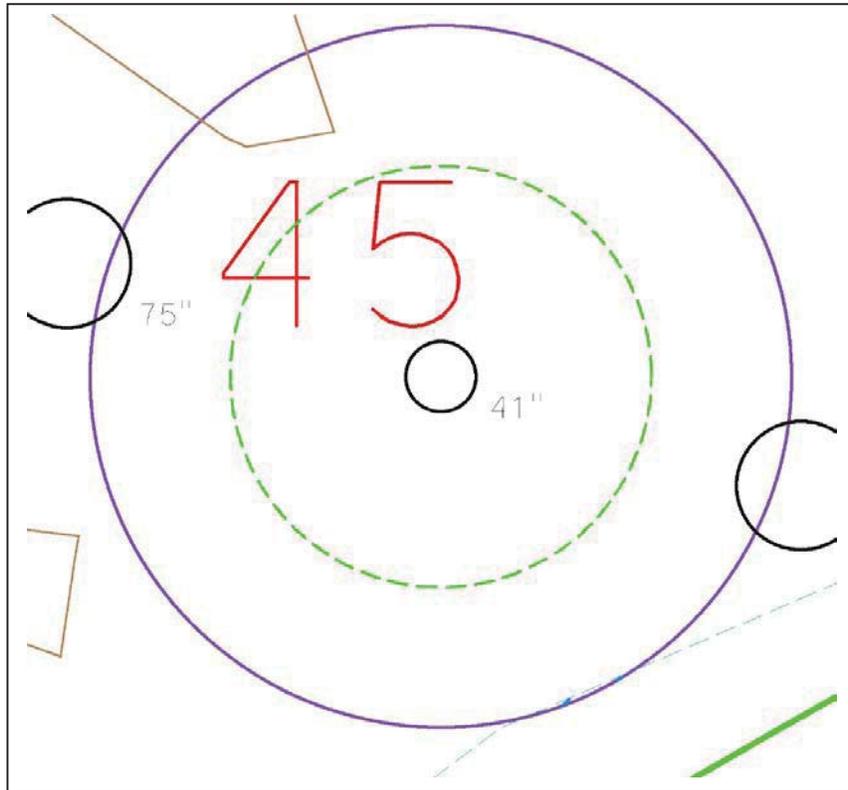
Description: Tree #45, 41 inches DBH (depicted in Attachment A, Sheet 8).

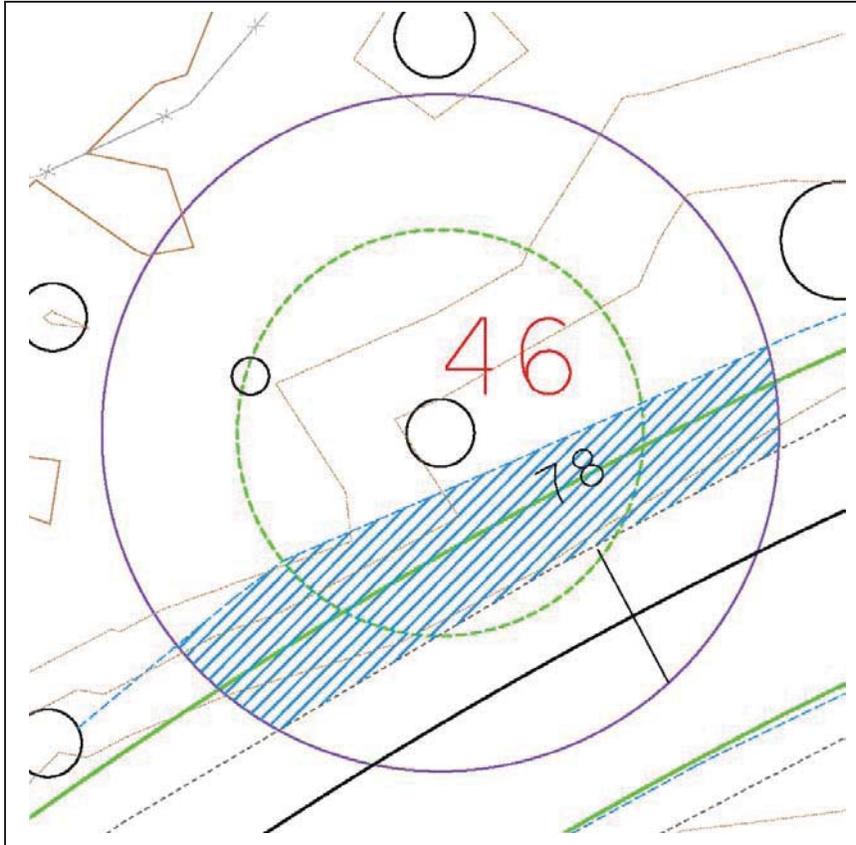
Description: Tree #46, 75 inches DBH (depicted in Attachment A, Sheet 8). (Listed as Tree #46 in Table 9 and #34 in Table 10 of Final EA.)

Evaluation: Effect of root zone disturbance may be a short-term visible reduction in foliage density that is still well within the adaptive capabilities of the tree.

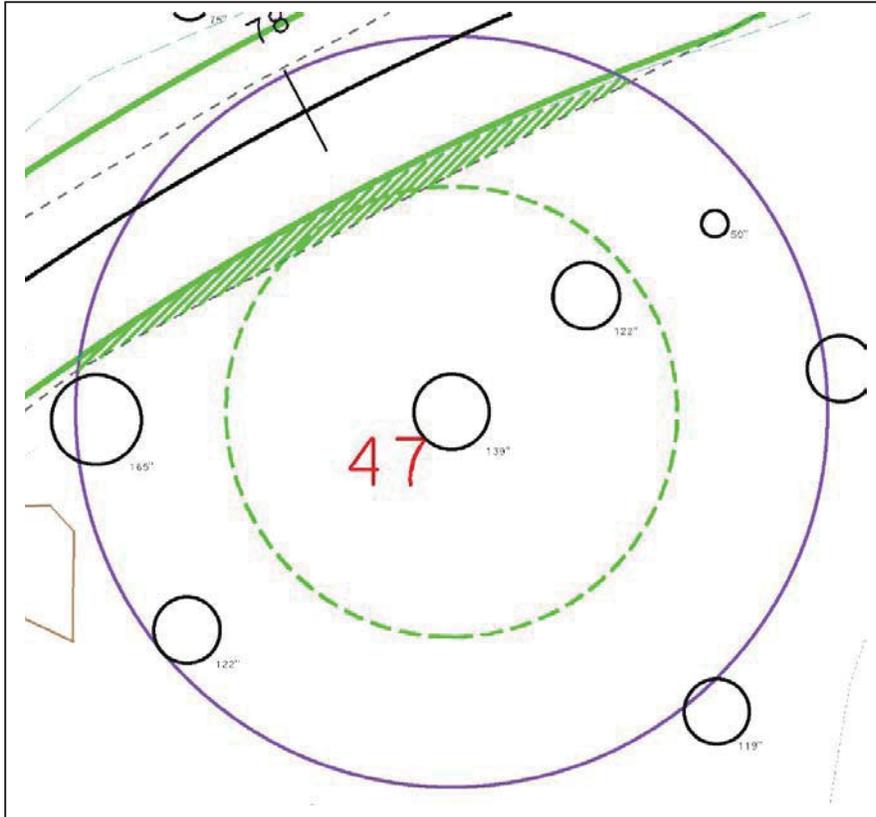
Description: Tree #47, 139 inches DBH (depicted in Attachment A, Sheet 7).

Evaluation: Effect of root zone disturbance is extremely minor and there would be no decline in foliage density or tree health.

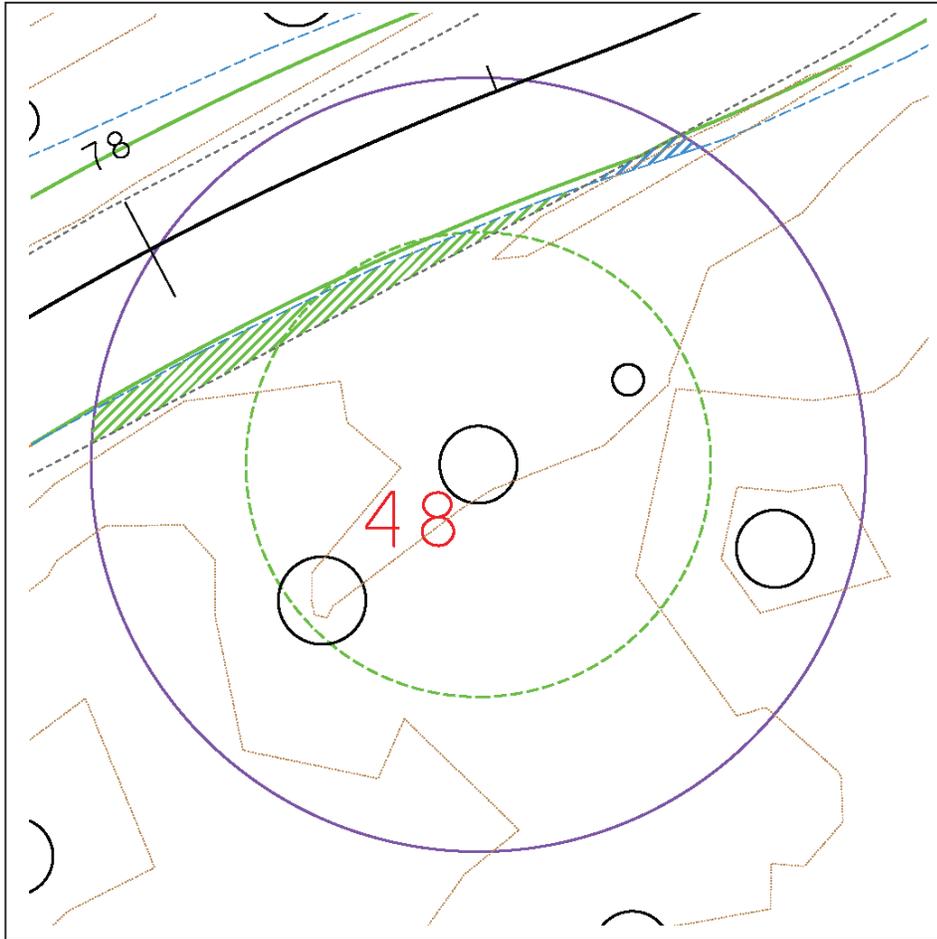
Description: Tree #48, 122 inches DBH (depicted in Attachment A, Sheet 8).

Evaluation: Effect of root zone disturbance is extremely minor and there would be no decline in foliage density or tree health.

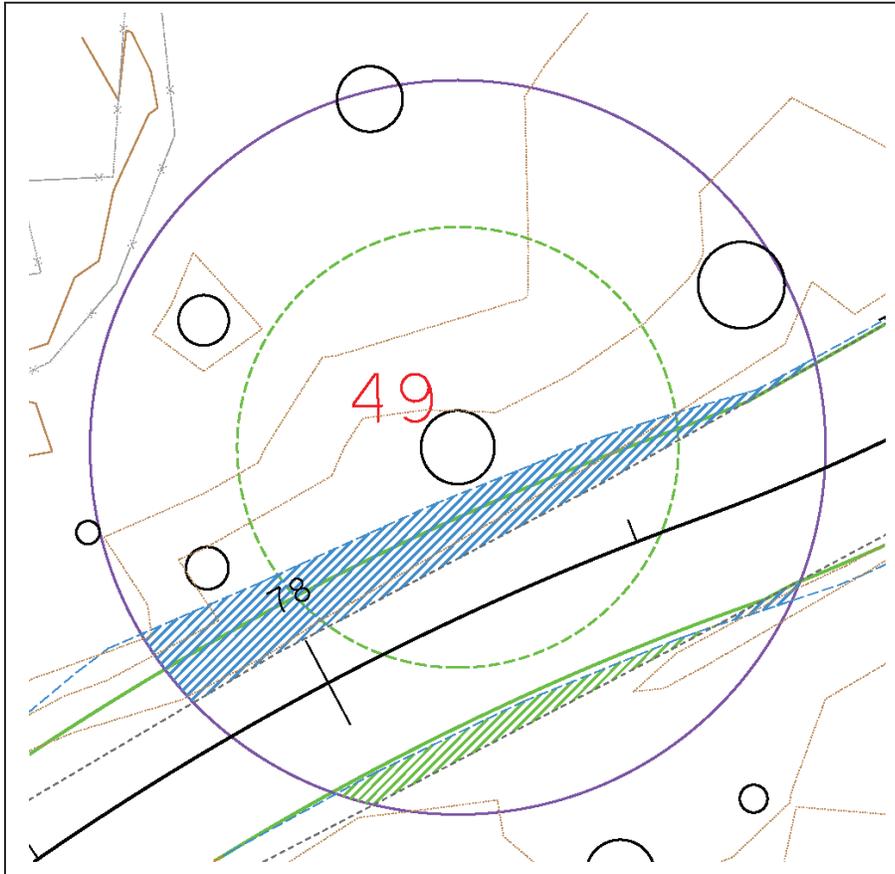
Description: Tree #49, 130 inches DBH (depicted in Attachment A, Sheet 8).

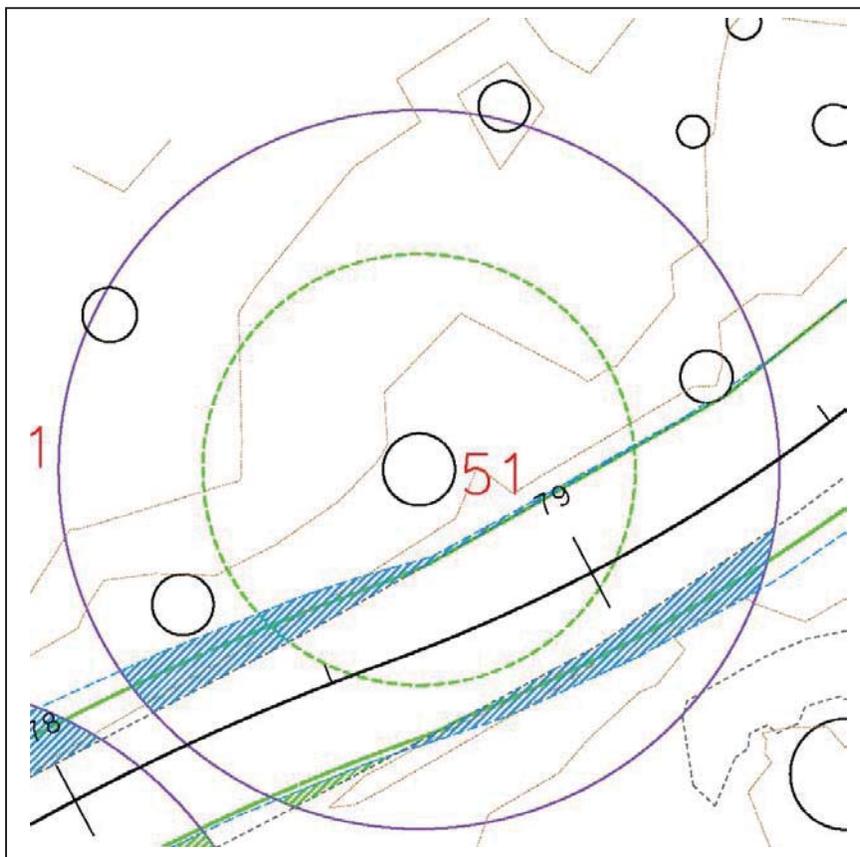
Description: Tree #51, 153 inches DBH (depicted in Attachment A, Sheet 8). Tree has a cavity with fire scar, though not extensive. Area around the tree had historically been used for vehicle parking.

Evaluation: Effect of root zone disturbance is slight and there would be no decline in foliage density or tree health.

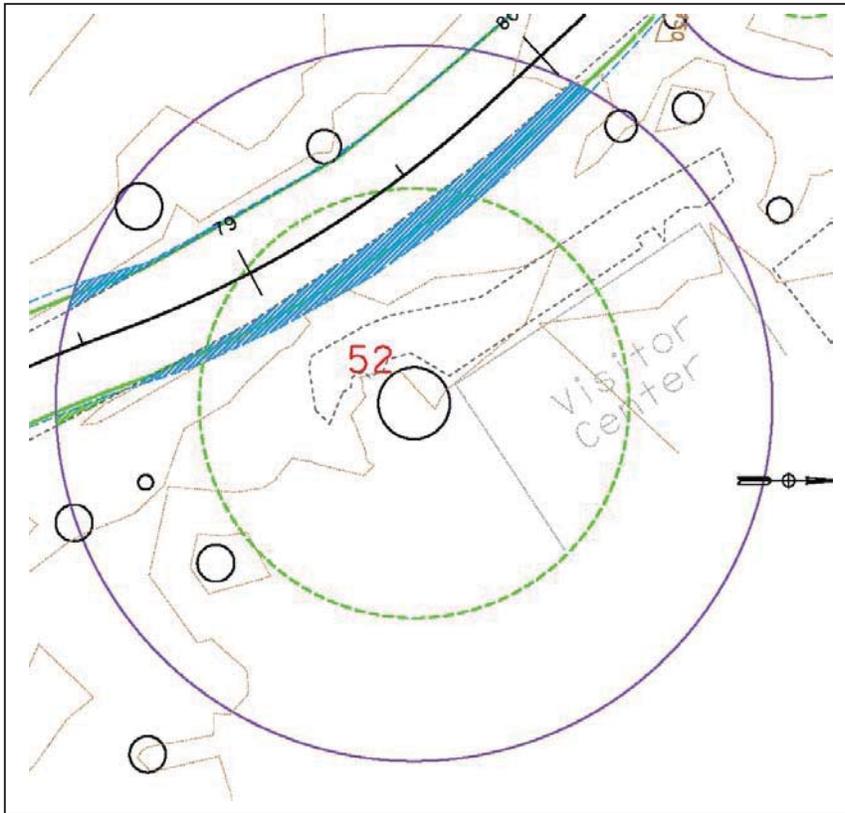
Description: Tree #52, 236 inches DBH (depicted in Attachment A, Sheet 8). Tree has two trunks. It is next to the park Visitor Center and is known as the “bat” tree. The ground around the trunk and through the hollow of the tree is completely paved.

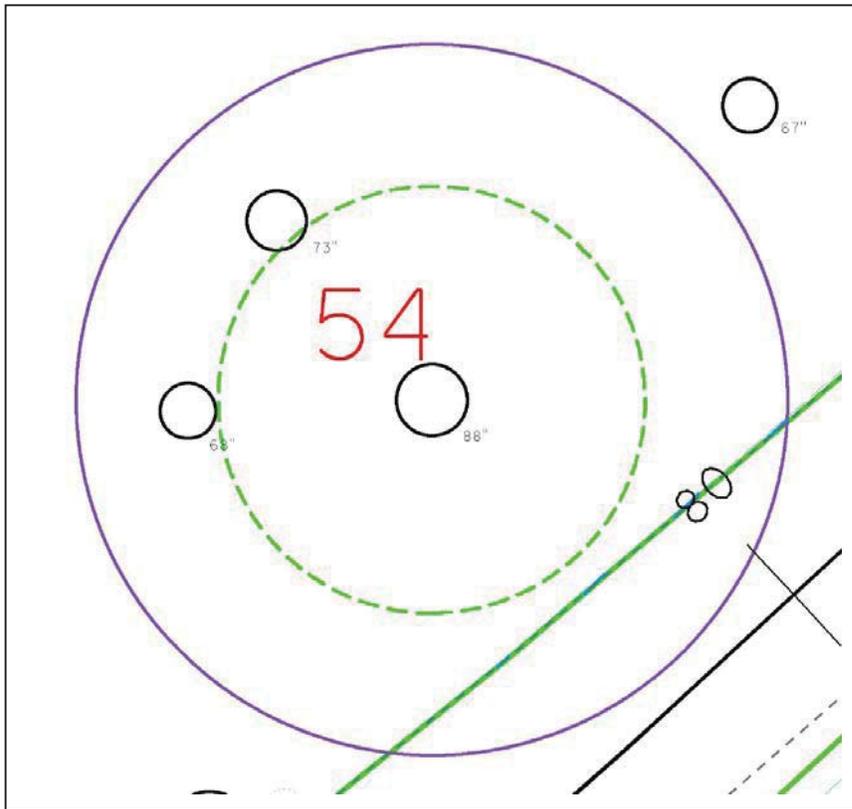
Description: Tree #54, 88 inches DBH (depicted in Attachment A, Sheet 8).

Evaluation: Effect of root zone disturbance is very slight and there would be no decline in foliage density or tree health.
