An Evaluation of Potential Effects on Old-Growth Redwoods
from Implementation of the Richardson Grove Operational
Improvement Project

August 14, 2015

Dennis Yniguez
Registered Consulting Arborist
Dennis@TreeDecisions.com
510-649-9291

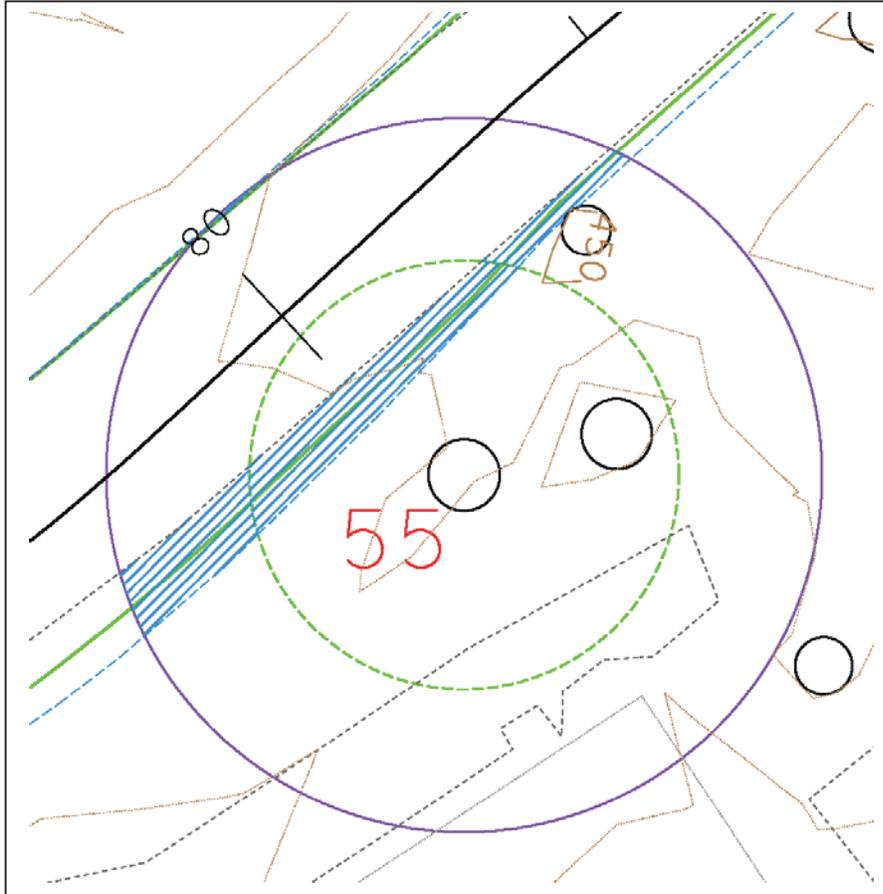
Description: Tree #55, 104 inches DBH (depicted in Attachment A, Sheet 8).

Evaluation: Effect of root zone disturbance may be a short-term visible reduction in foliage density that is still well within the adaptive capabilities of the tree.

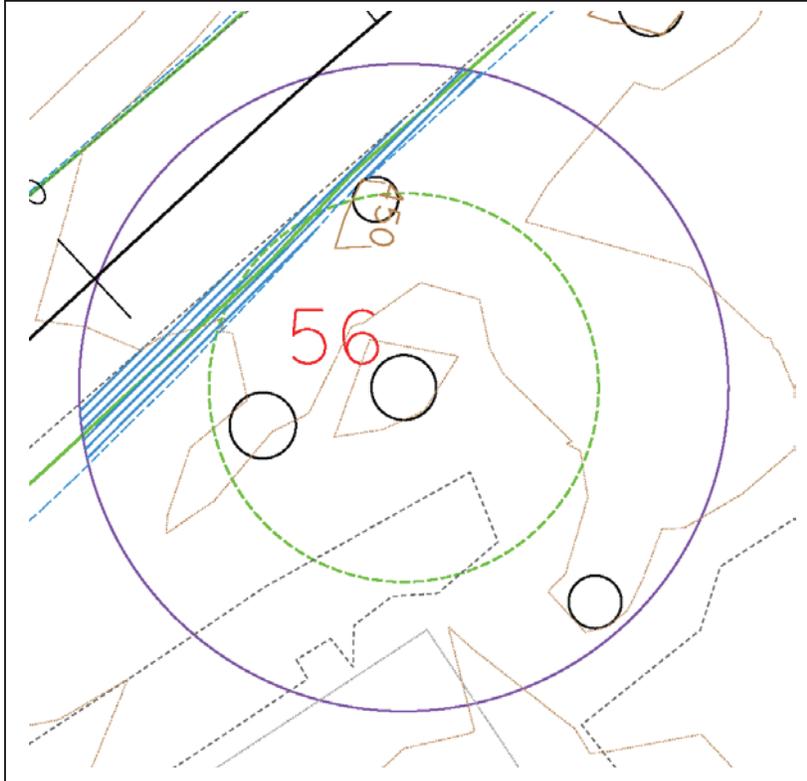
Description: Tree #56, 102 inches DBH (depicted in Attachment A, Sheet 8). Tree is by the large park entrance sign at the Visitor Center.

Evaluation: Effect of root zone disturbance is slight and there would be no decline in foliage density or tree health.

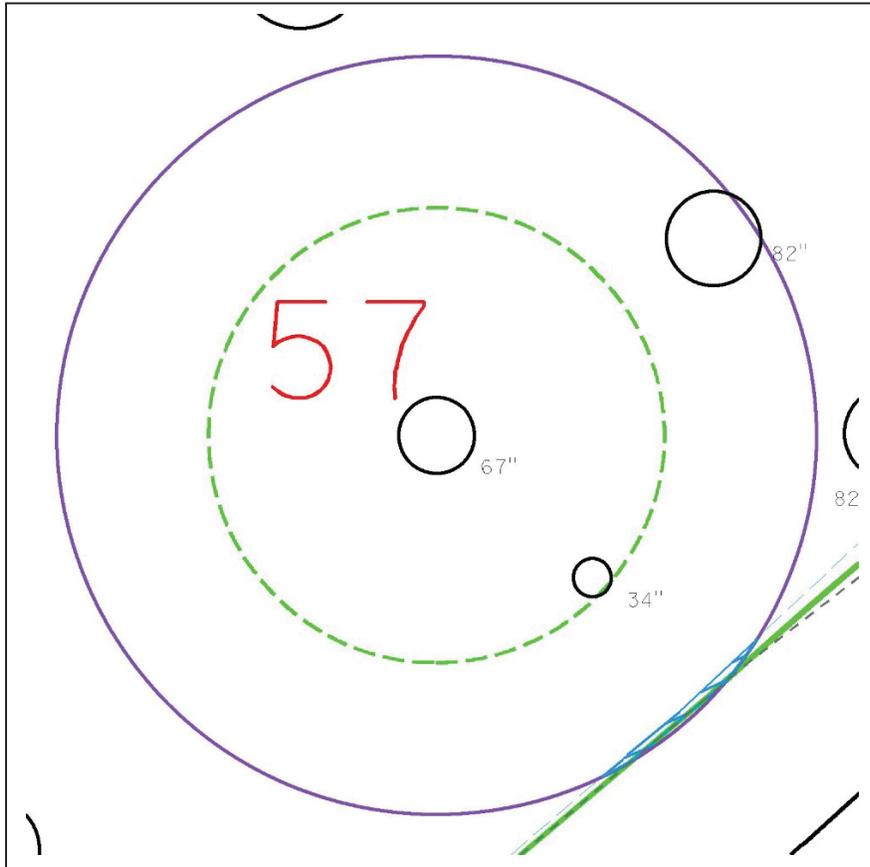
Description: Tree #57, 67 inches DBH (depicted in Attachment A, Sheet 8). Tree is away from road.

Evaluation: Effect of root zone disturbance is extremely minor and there would be no decline in foliage density or tree health.

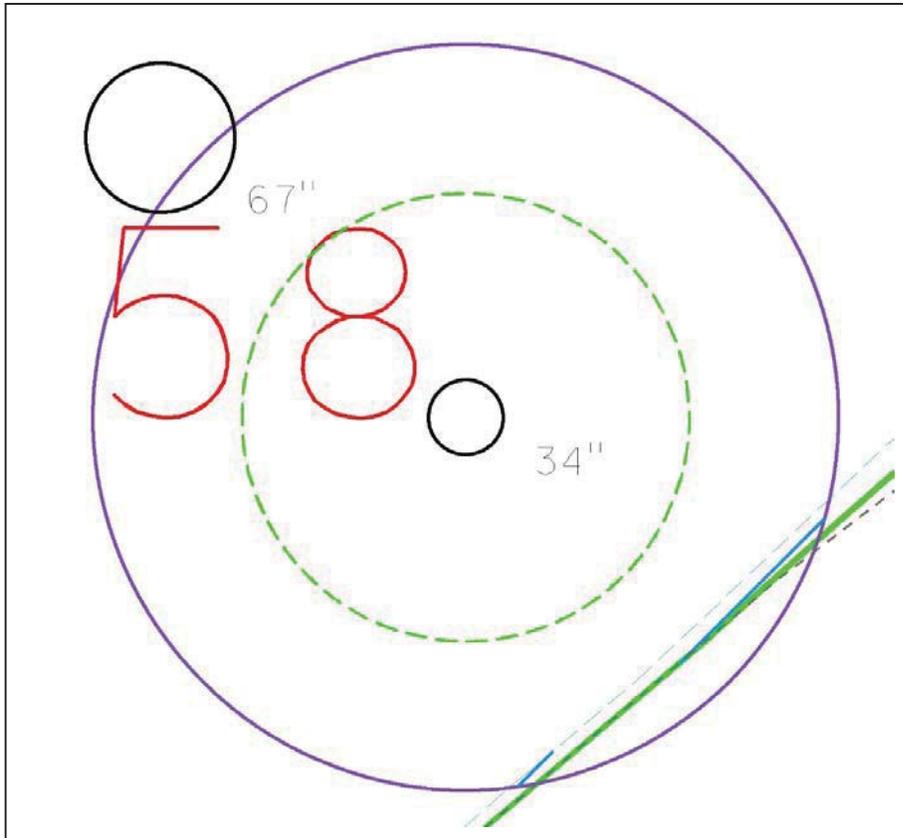
Description: Tree #58, 34 inches DBH (depicted in Attachment A, Sheet 8). This is a small tree near the road.

Evaluation: Effect of root zone disturbance is very slight and there would be no decline in foliage density or tree health.

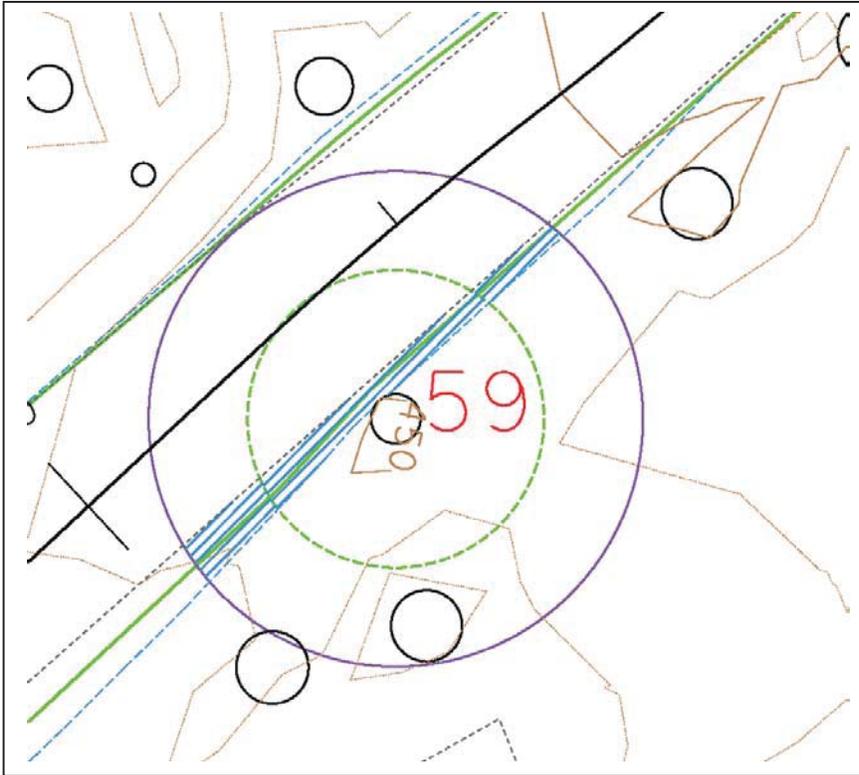
Description: Tree #59, 72 inches DBH (depicted in Attachment A, Sheet 8). There is vehicle parking behind tree.

Evaluation: Effect of root zone disturbance may be a short-term visible reduction in foliage density that is still well within the adaptive capabilities of the tree.

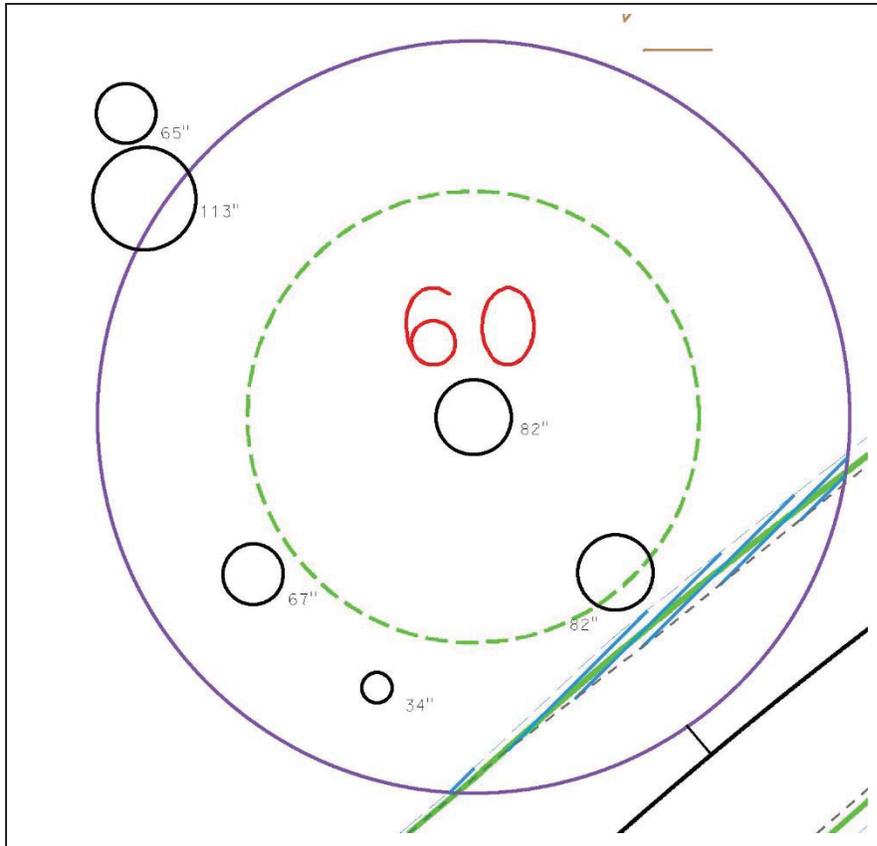
Description: Tree #60, 82 inches DBH (depicted in Attachment A, Sheet 9).

Evaluation: Effect of root zone disturbance is extremely minor and there would be no decline in foliage density or tree health.

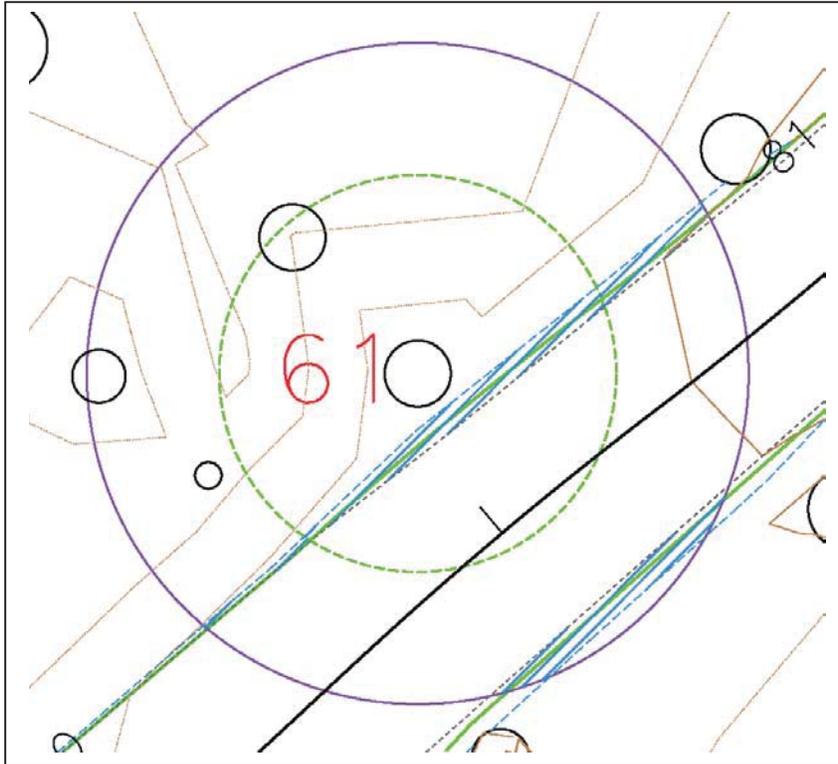
Description: Tree #61, 82 inches DBH (depicted in Attachment A, Sheet 8).

Evaluation: Effect of root zone disturbance may be a short-term visible reduction in foliage density that is still well within the adaptive capabilities of the tree.

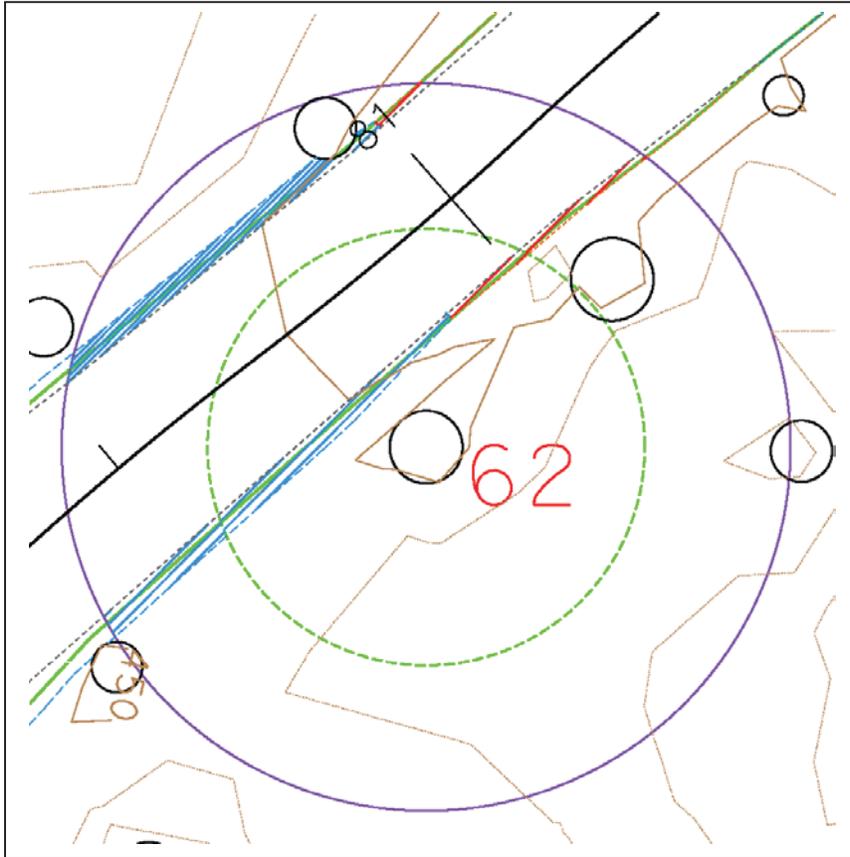
Description: Tree #62, 94 inches DBH (depicted in Attachment A, Sheet 9). Tree was apparently struck by a vehicle and has formed a substantial callus roll at the wound edges.

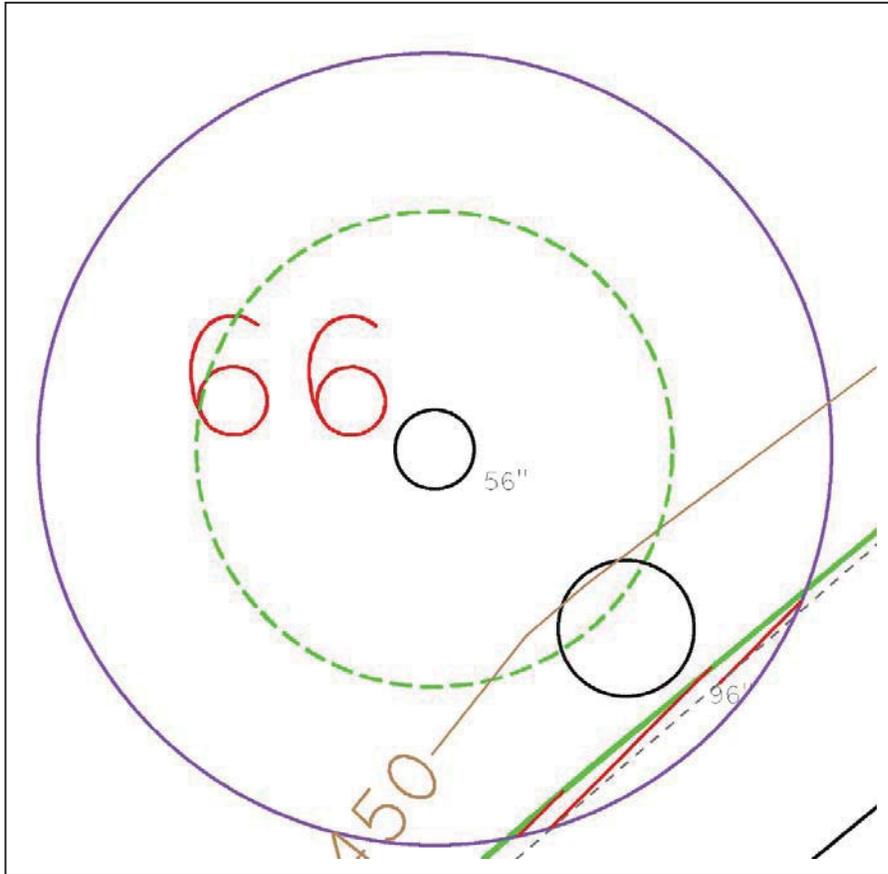
Description: Tree #66, 56 inches DBH (depicted in Attachment A, Sheet 9). Tree is farther away from road, behind tree 68.

Evaluation: Effect of root zone disturbance is extremely minor and there would be no decline in foliage density or tree health.

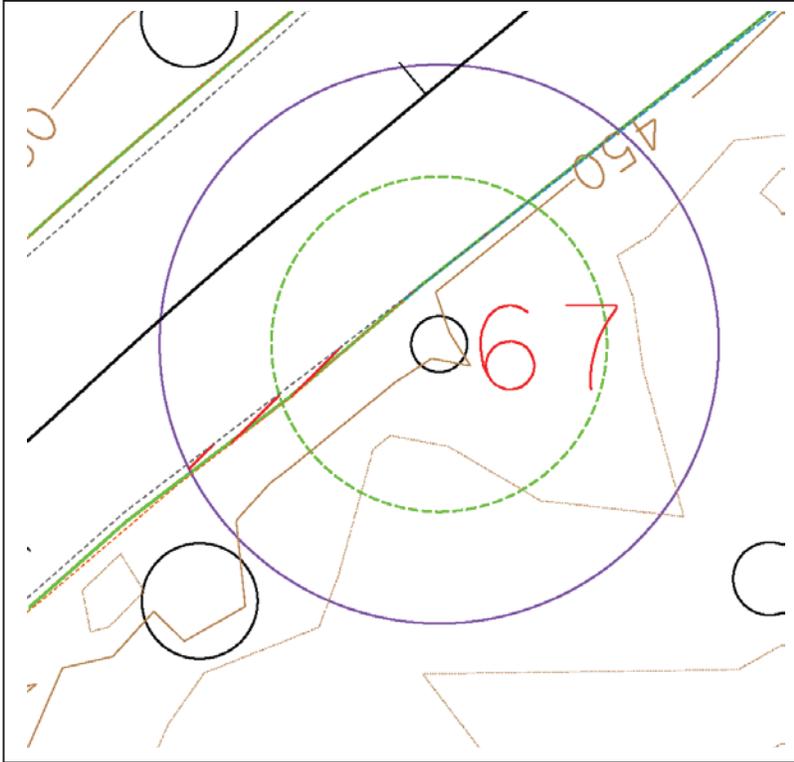
Description: Tree #67, 57 inches DBH (depicted in Attachment A, Sheet 9). Tree appears to have been struck by a vehicle, or perhaps cut to accommodate road, and injury has callused over.

Evaluation: Effect of root zone disturbance may be a short-term visible reduction in foliage density that is still well within the adaptive capabilities of the tree.

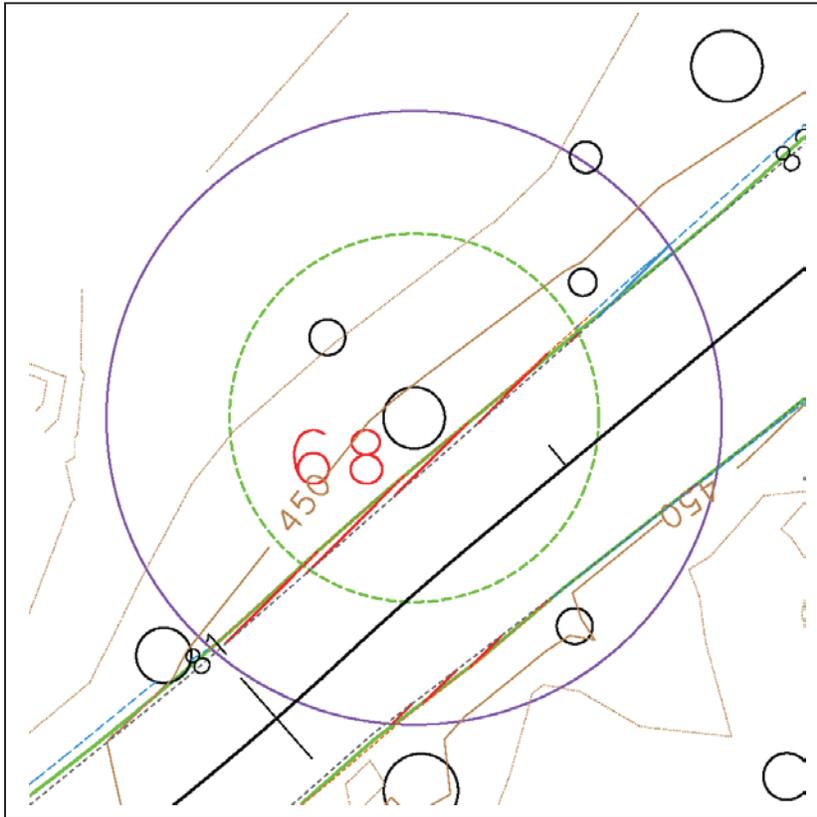
Description: Tree #68, 96 inches DBH (depicted in Attachment A, Sheet 9). Trunk of tree appears to have been struck repeatedly by vehicles.

Evaluation: Effect of root zone disturbance may be a short-term visible reduction in foliage density that is still well within the adaptive capabilities of the tree.

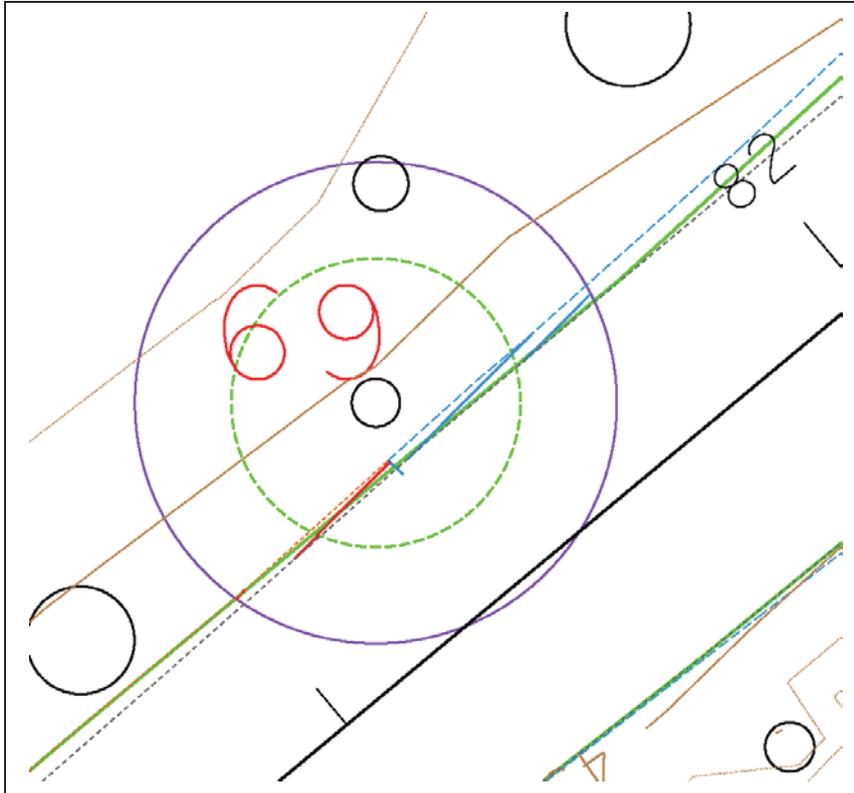
Description: Tree #69, 43 inches DBH (depicted in Attachment A, Sheet 9).

Evaluation: Effect of root zone disturbance may be a short-term visible reduction in foliage density that is still well within the adaptive capabilities of the tree.

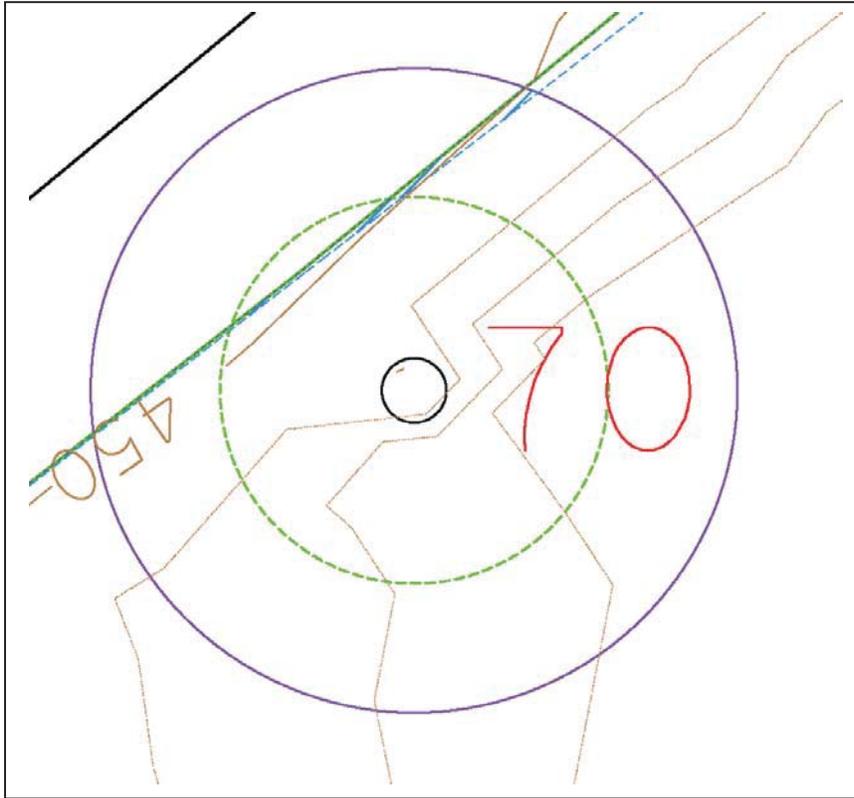
Description: Tree #70, 44 inches DBH (depicted in Attachment A, Sheet 9).

Evaluation: Effect of root zone disturbance is slight and there would be no decline in foliage density or tree health.

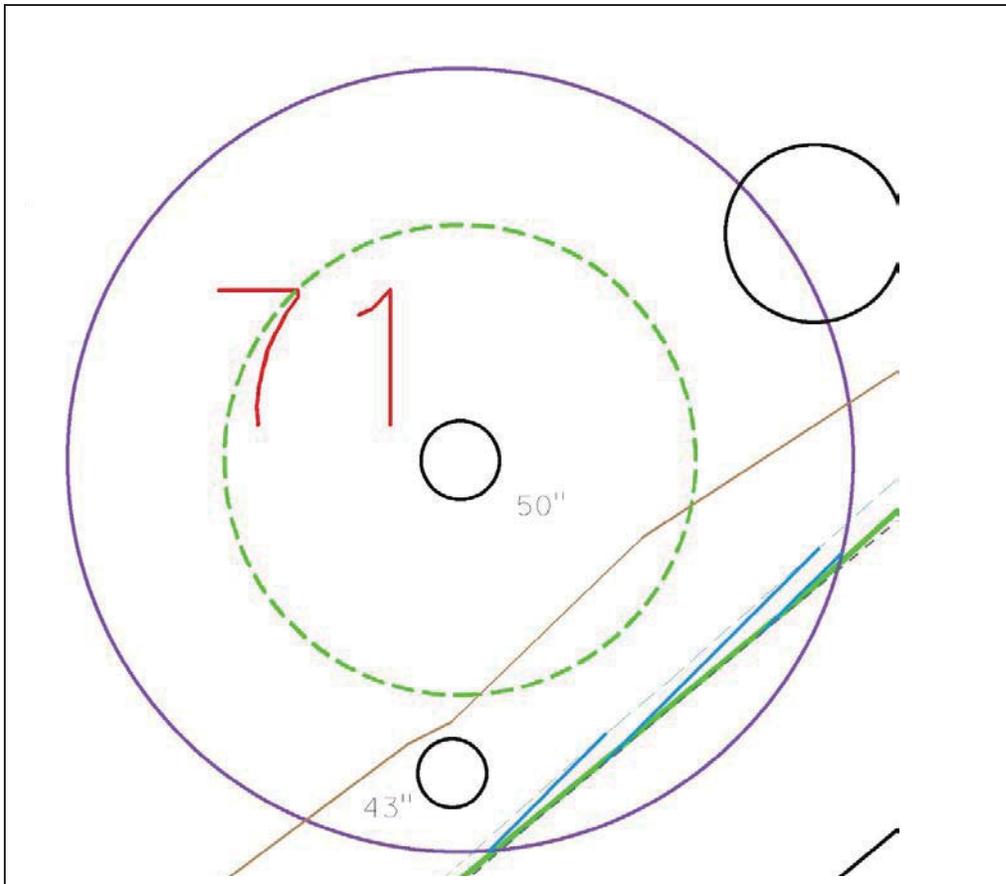
Description: Tree #71, 50 inches DBH (depicted in Attachment A, Sheet 9).

Evaluation: Effect of root zone disturbance is extremely minor and there would be no decline in foliage density or tree health.

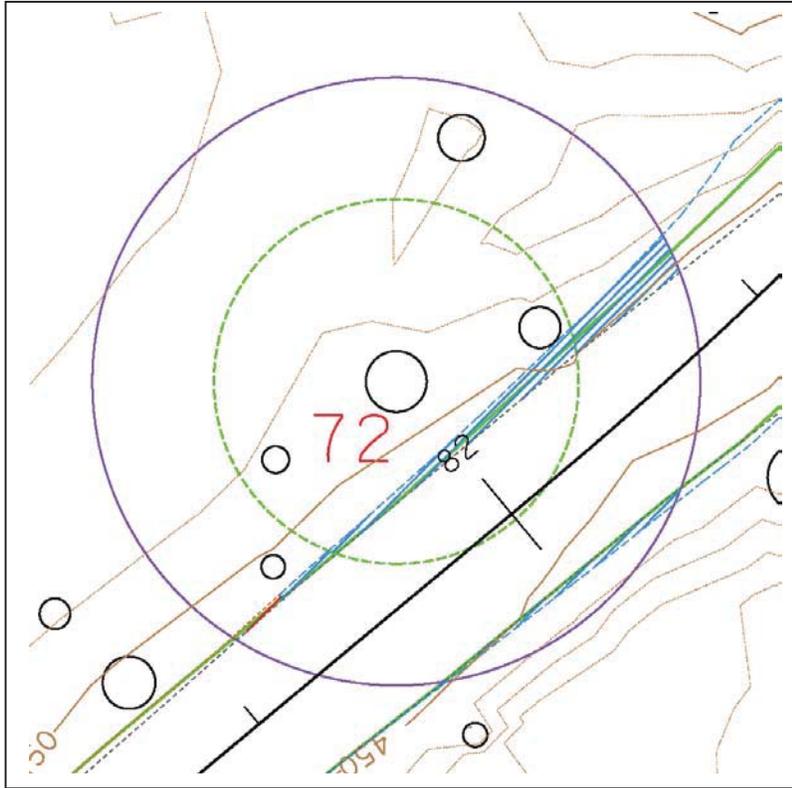
Description: Tree #72, 112 inches DBH (depicted in Attachment A, Sheet 9).

Evaluation: Effect of root zone disturbance is slight and there would be no decline in foliage density or tree health.

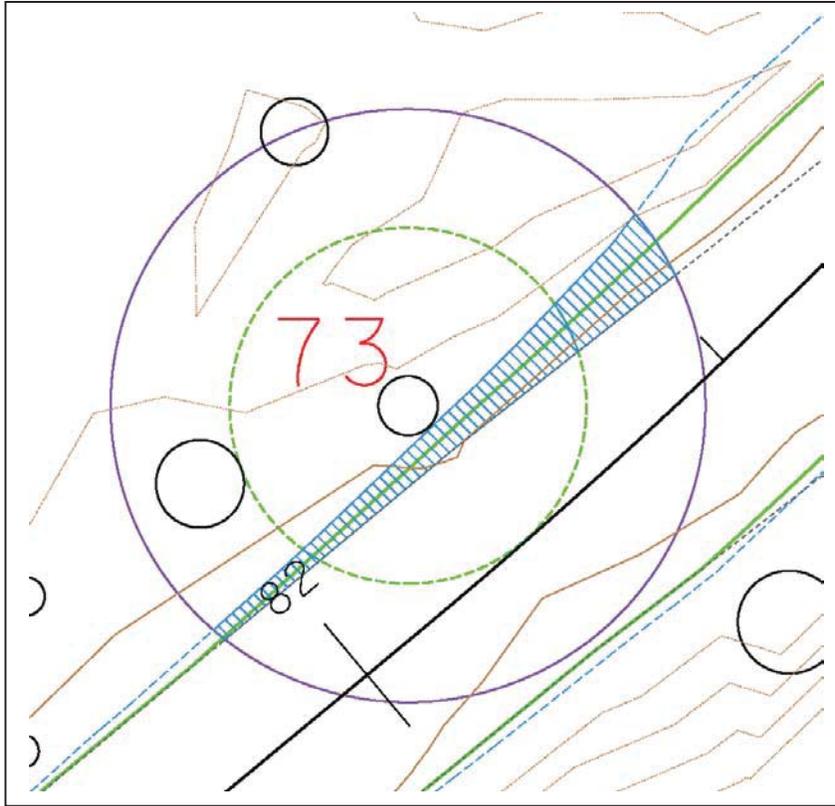
Description: Tree #73, 76 inches DBH (depicted in Attachment A, Sheet 9). Tree base appears to have been struck by a vehicle.

Evaluation: Effect of root zone disturbance may be a reduction in root health sufficient to cause lasting visible dieback of wood in the uppermost crown; tree survival is not threatened.

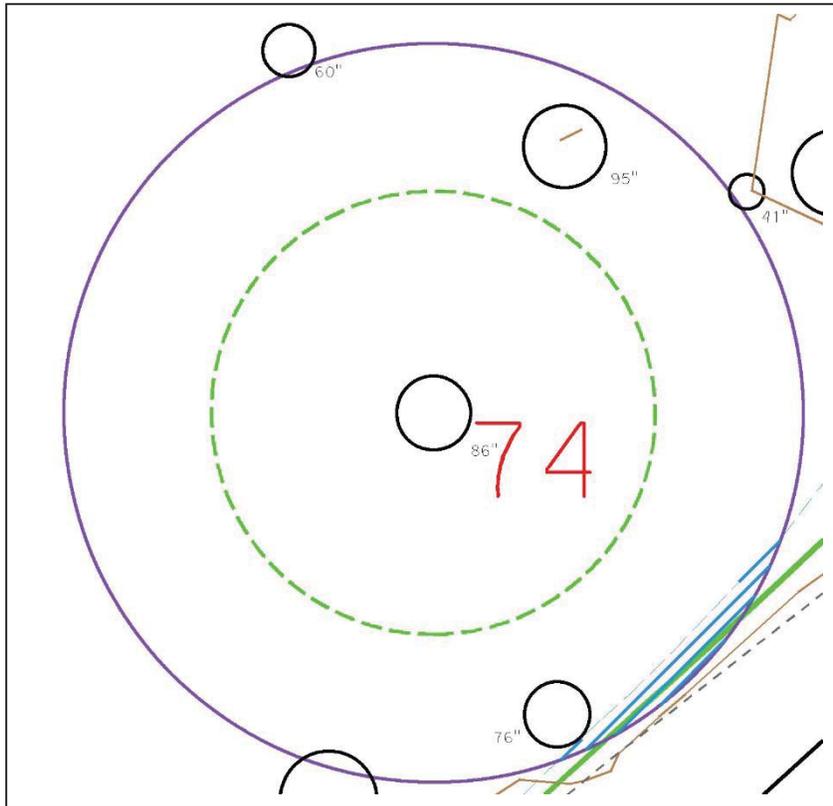
Description: Tree #74, 86 inches DBH (depicted in Attachment A, Sheet 9).

Evaluation: Effect of root zone disturbance is extremely minor and there would be no decline in foliage density or tree health.

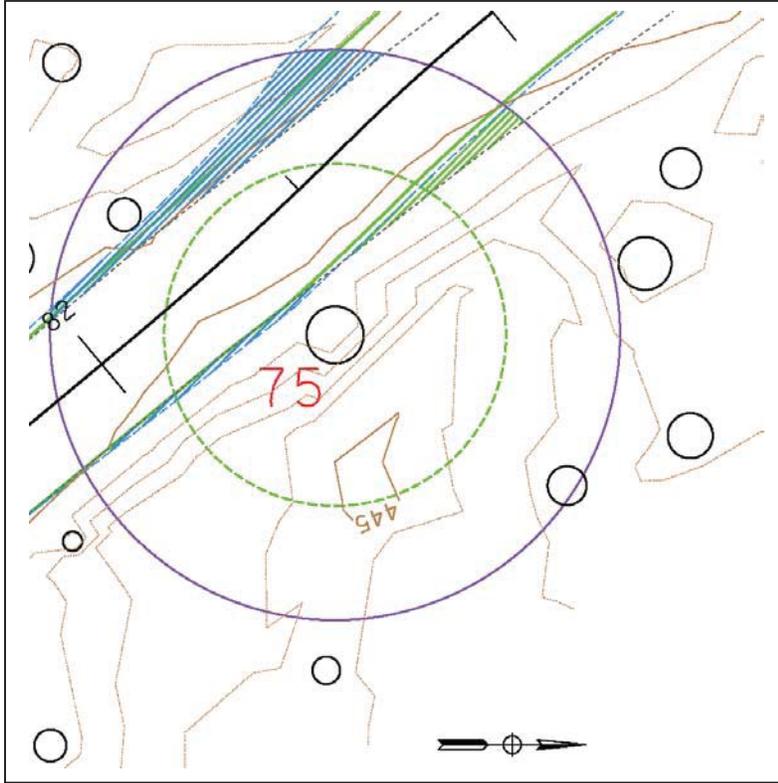
Description: Tree #75, 132 inches DBH (depicted in Attachment A, Sheet 9).

Evaluation: Effect of root zone disturbance is slight and there would be no decline in foliage density or tree health.

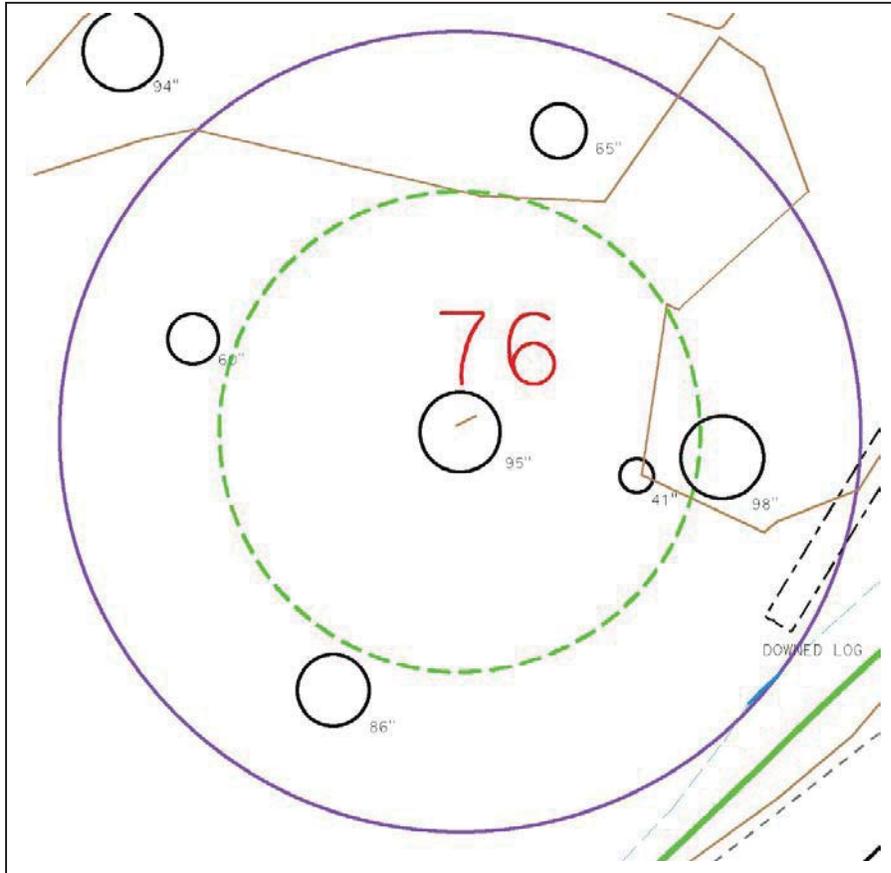
Description: Tree #76, 95 inches DBH (depicted in Attachment A, Sheet 9).

Evaluation: Root zone disturbance would have no effect on tree health.

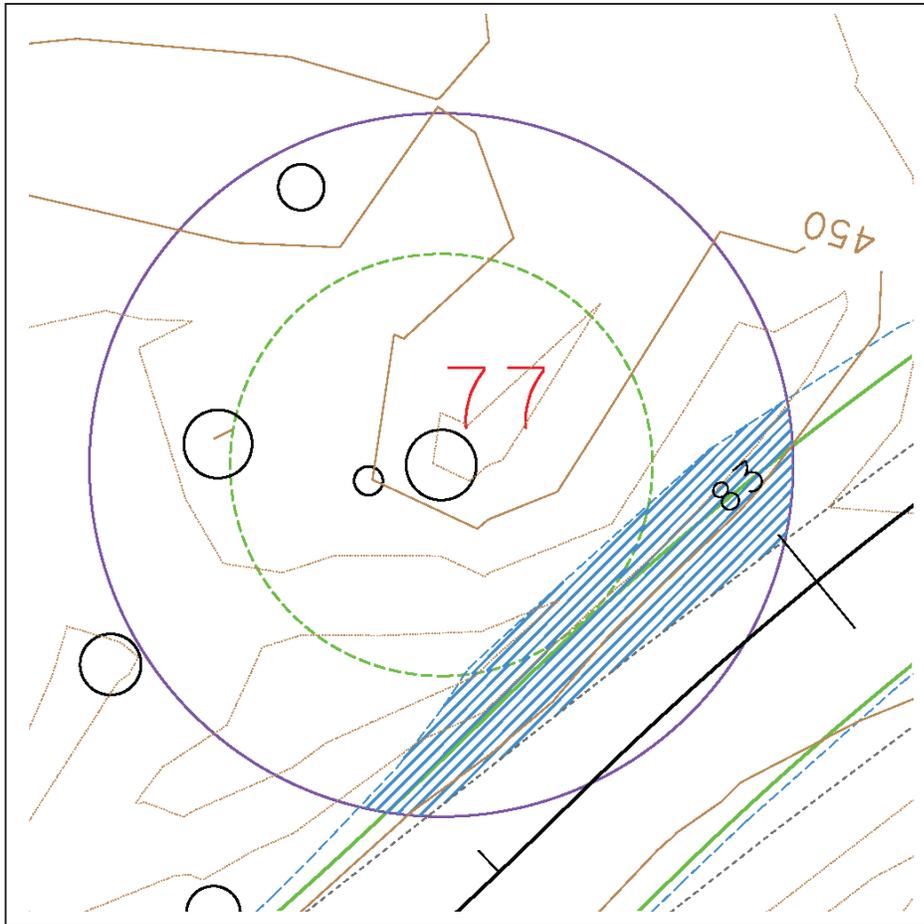
Description: Tree #77, 98 inches DBH (depicted in Attachment A, Sheet 9).

Evaluation: Effect of root zone disturbance is slight and there would be no decline in foliage density or tree health.

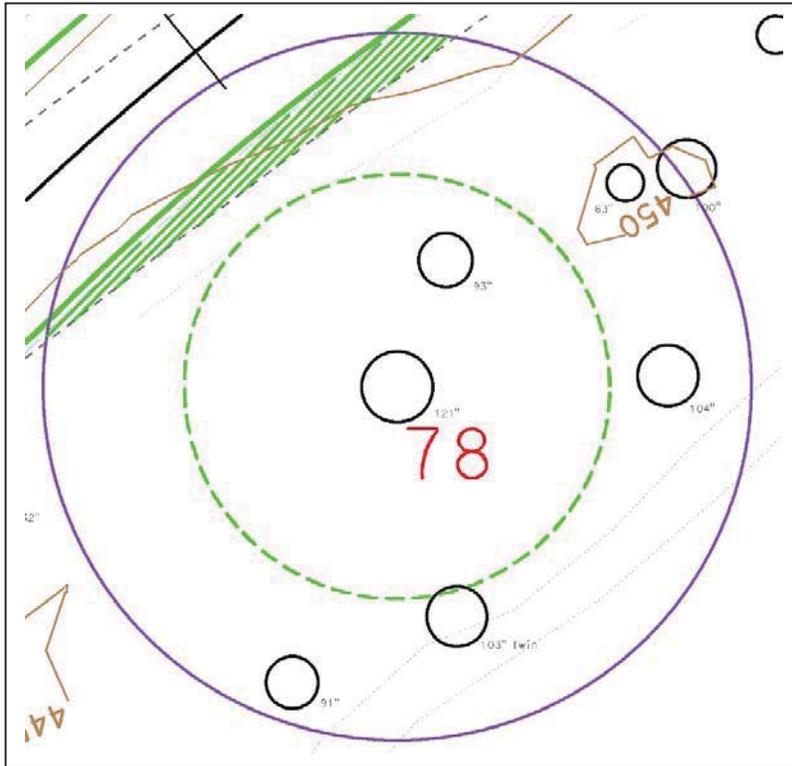
Description: Tree #78, 121 inches DBH (depicted in Attachment A, Sheet 9).

Evaluation: Effect of root zone disturbance is extremely minor and there would be no decline in foliage density or tree health.

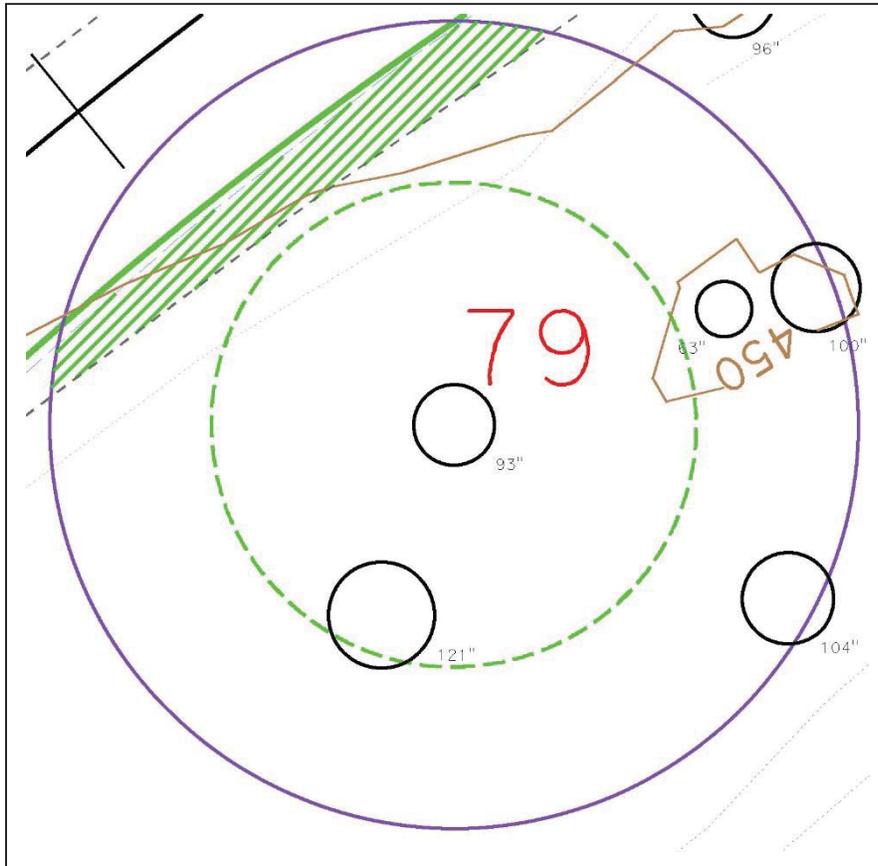
Description: Tree #79, 93 inches DBH (depicted in Attachment A, Sheet 9).

Evaluation: Effect of root zone disturbance is extremely minor and there would be no decline in foliage density or tree health.

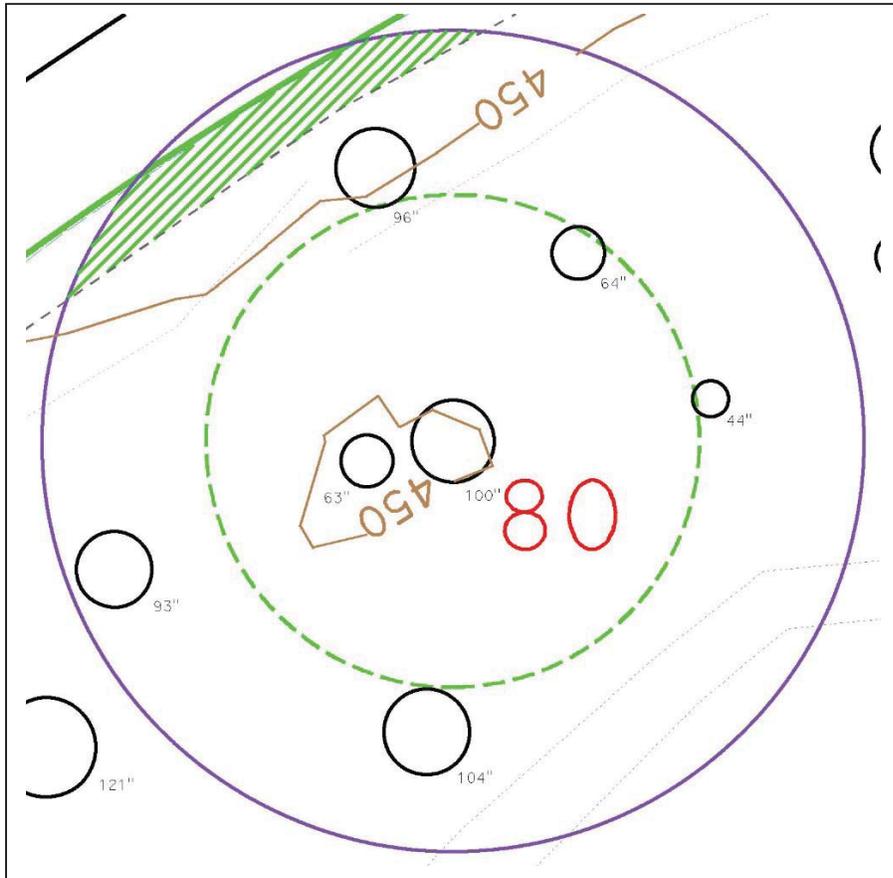
Description: Tree #80, 100 inches DBH (depicted in Attachment A, Sheet 9).

Evaluation: Effect of root zone disturbance is extremely minor and there would be no decline in foliage density or tree health.

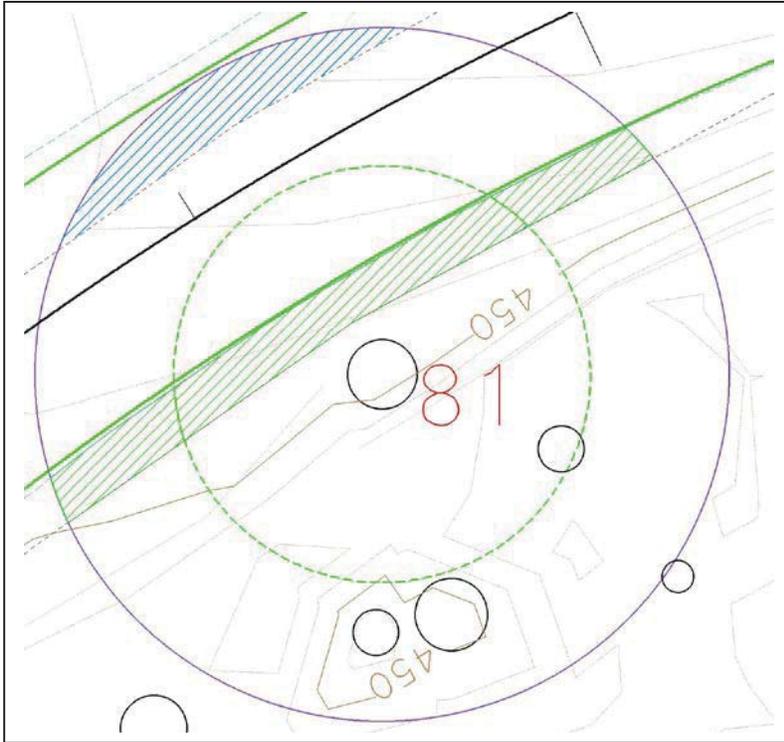
Description: Tree #81, 96 inches DBH (depicted in Attachment A, Sheet 10).

Evaluation: Effect of root zone disturbance is slight and there would be no decline in foliage density or tree health.

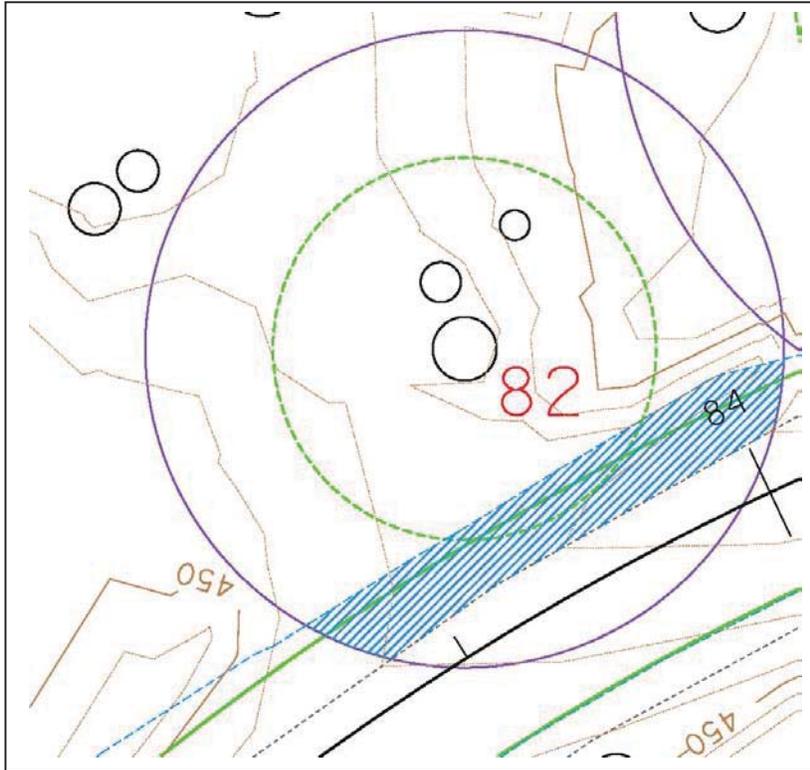
Description: Tree #82, 112 inches DBH (depicted in Attachment A, Sheet 10).

Evaluation: Effect of root zone disturbance is slight and there would be no decline in foliage density or tree health.

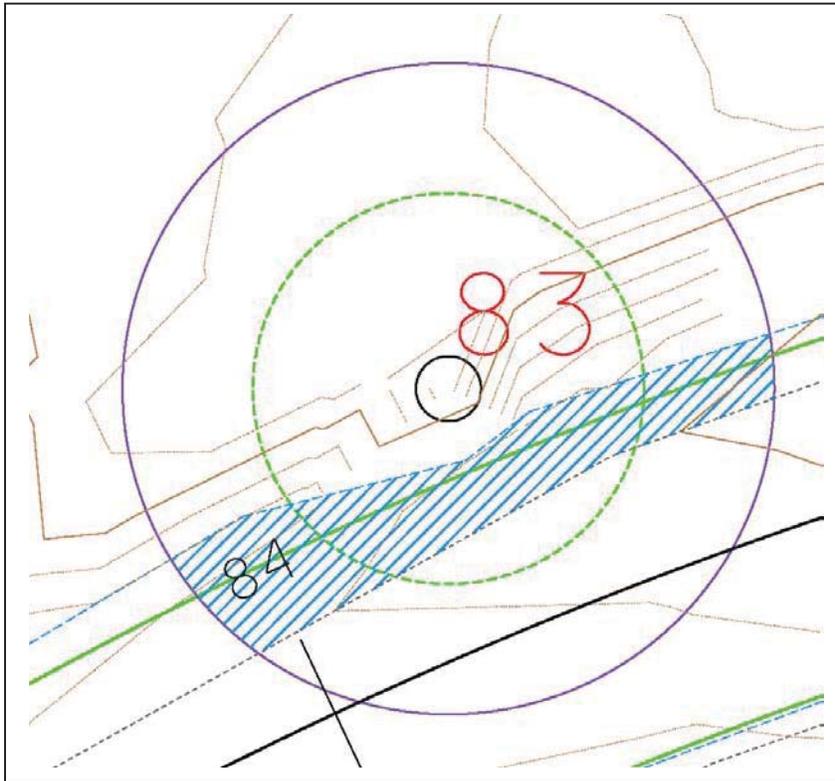
Description: Tree #83, 67 inches DBH (depicted in Attachment A, Sheet 10). Tree is growing in embankment.

Evaluation: Effect of root zone disturbance is slight and there would be no decline in foliage density or tree health.

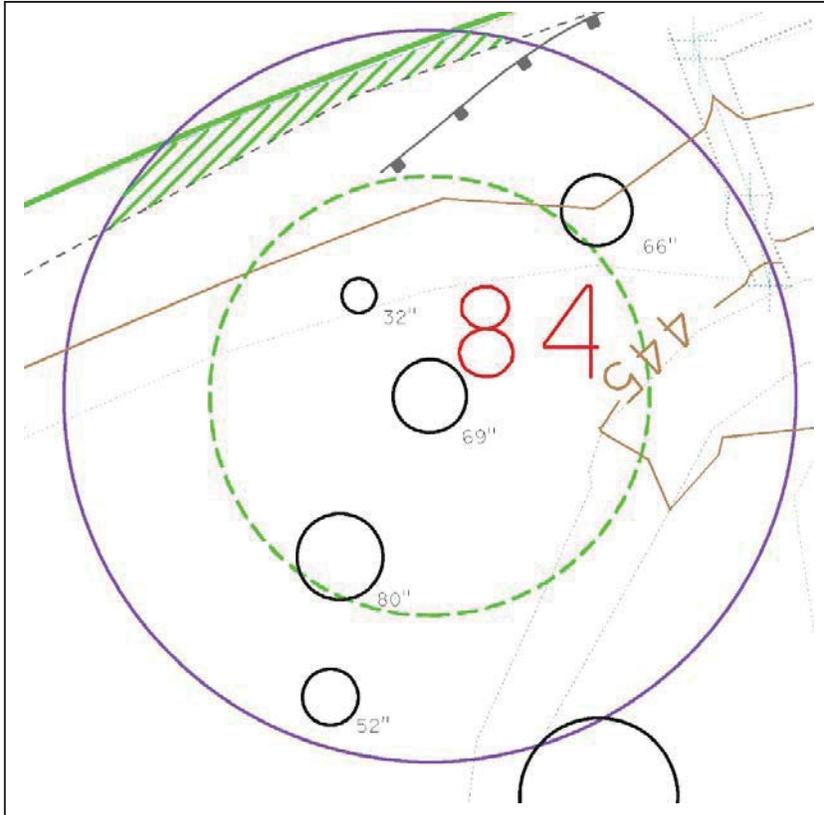
Description: Tree #84, 69 inches DBH (depicted in Attachment A, Sheet 10).

Evaluation: Effect of root zone disturbance is extremely minor and there would be no decline in foliage density or tree health.

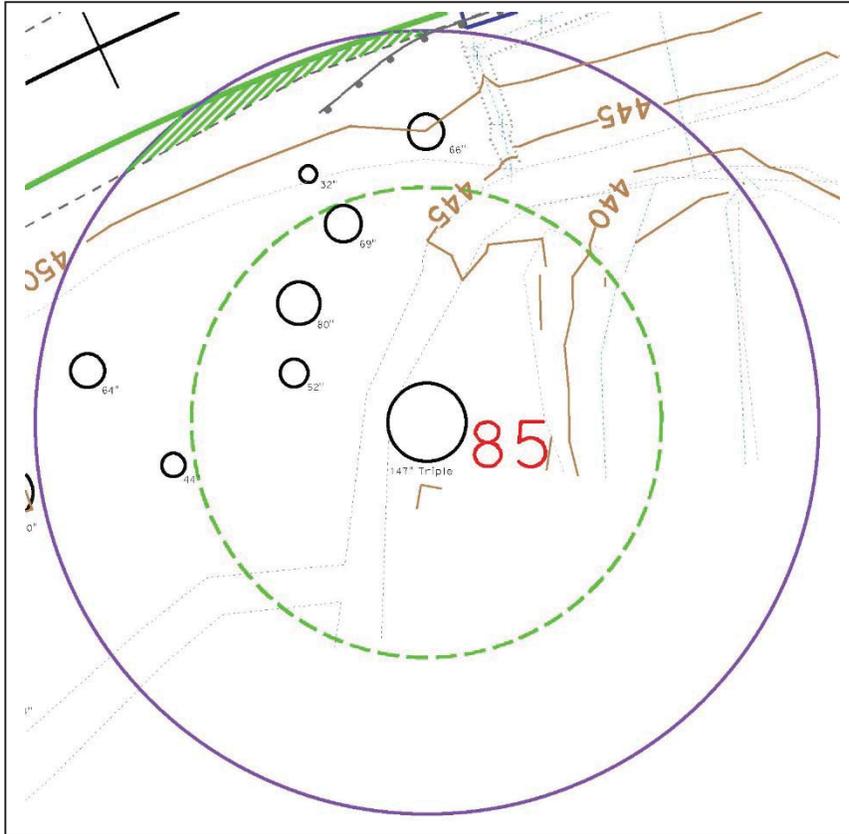
Description: Tree #85, 147 inches DBH (depicted in Attachment A, Sheet 10). Tree has three trunks.

Evaluation: Effect of root zone disturbance is extremely minor and there would be no decline in foliage density or tree health.

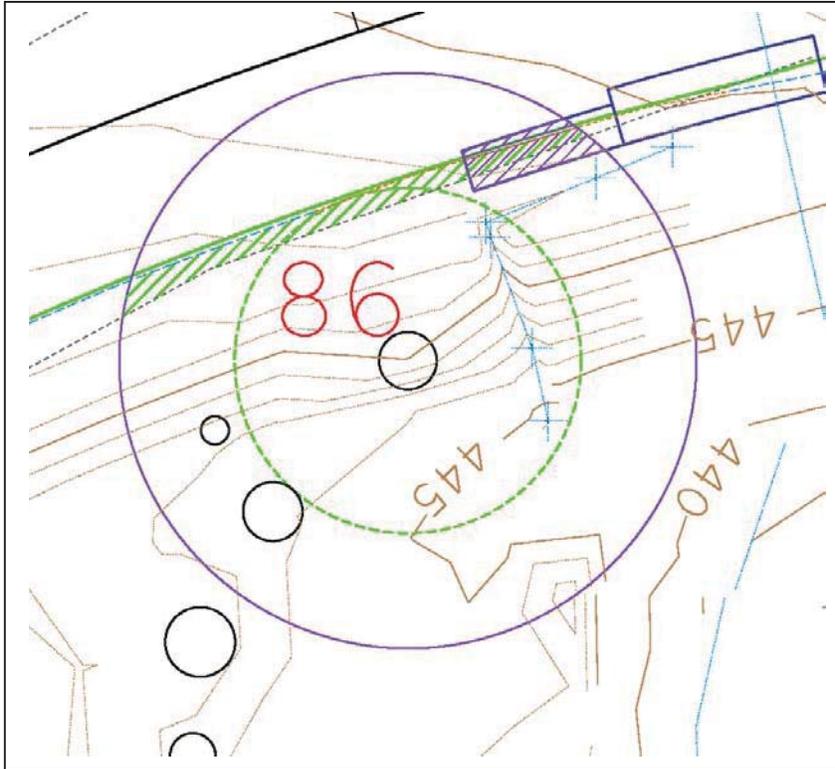
Description: Tree #86, 66 inches DBH (depicted in Attachment A, Sheet 10).

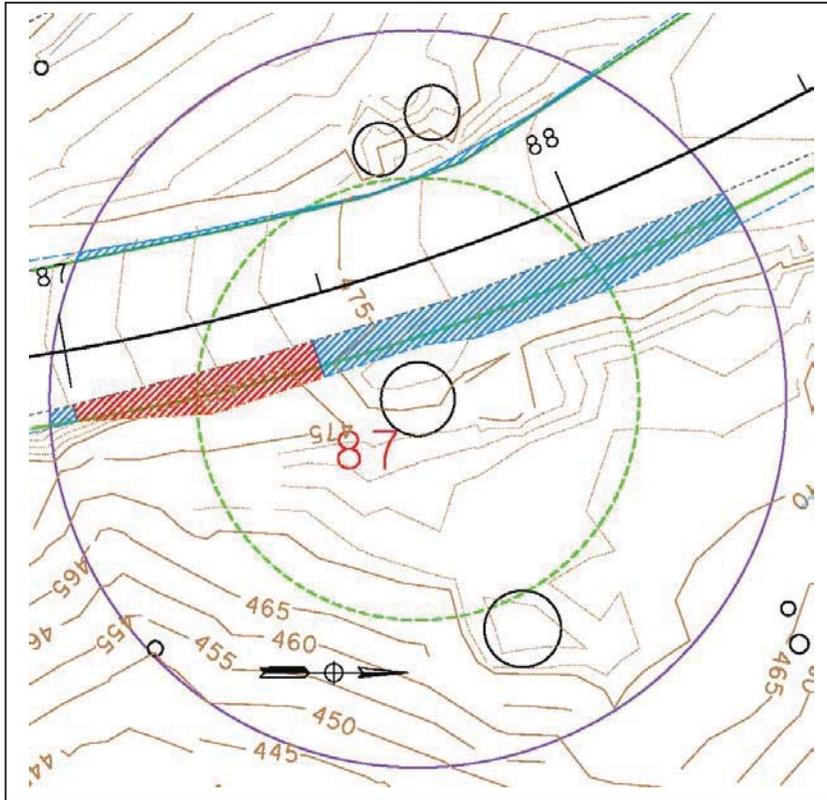
Description: Tree #87, 168 inches DBH (depicted in Attachment A, Sheet 11). Tree has two trunks.

Evaluation: Effect of root zone disturbance may be a short-term visible reduction in foliage density that is still well within the adaptive capabilities of the tree.
