An Evaluation of Potential Effects on Old-Growth Redwoods
from Implementation of the Richardson Grove Operational
Improvement Project

August 14, 2015

Dennis Yniguez
Registered Consulting Arborist
Dennis@TreeDecisions.com
510-649-9291

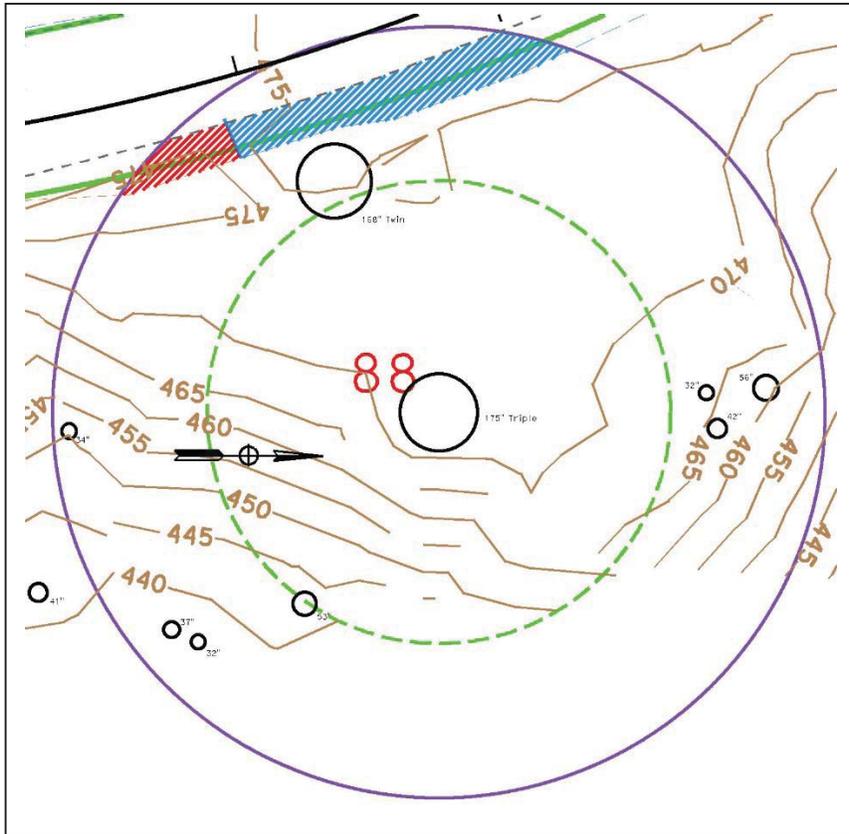
Description: Tree #88, 175 inches DBH (depicted in Attachment A, Sheet 11). Tree has three trunks.

Evaluation: Effect of root zone disturbance is extremely minor and there would be no decline in foliage density or tree health.

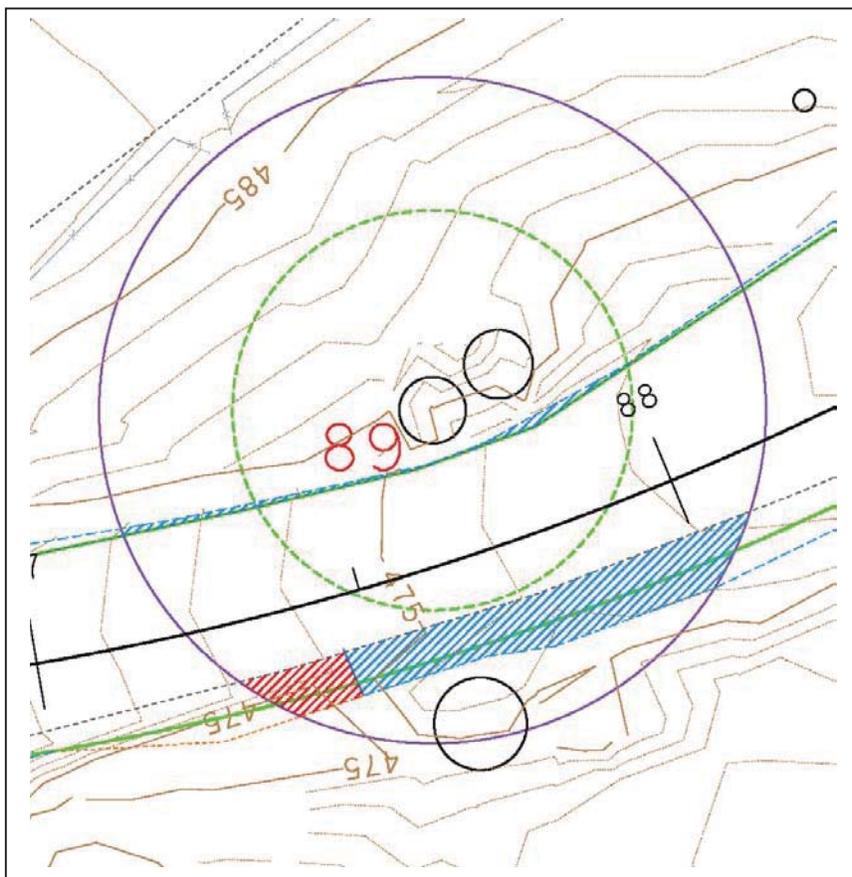
Description: Tree #89, 121 inches DBH (depicted in Attachment A, Sheet 11). Tree and adjacent Tree #90 may have developed from a single base that is now hollowed by a fire cavity. Several large buttress roots facing the road were severed decades ago during highway construction. The uppermost top of tree is dead (“spike” top) but has vigorous crown below.

Evaluation: Effect of root zone disturbance is very slight and there would be no decline in foliage density or tree health.

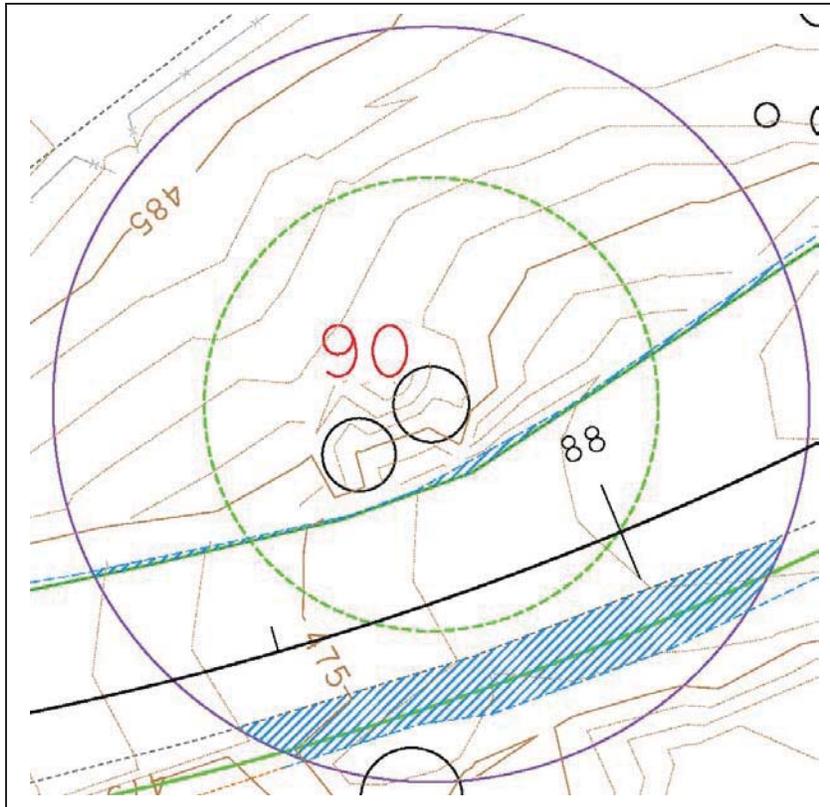
Description: Tree #90, 125 inches DBH (depicted in Attachment A, Sheet 11). Tree has two trunks. This tree and adjacent Tree #89 may have developed from a single base that is now hollowed by a fire cavity. Several large buttress roots facing the road were severed decades ago during highway construction. The tree now has a dead remnant "spike top" but maintains an apparently vigorous crown.

Evaluation: Effect of root zone disturbance is very slight and there would be no decline in foliage density or tree health.

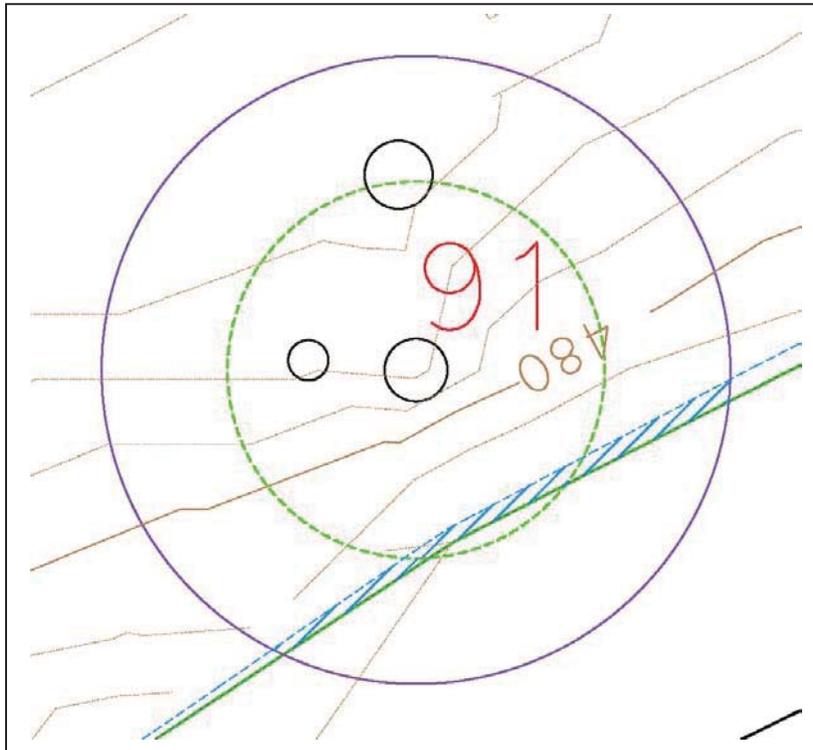
Description: Tree #91, 62 inches DBH (depicted in Attachment A, Sheet 11). Tree is away from roadway.

Evaluation: Effect of root zone disturbance is extremely minor and there would be no decline in foliage density or tree health.

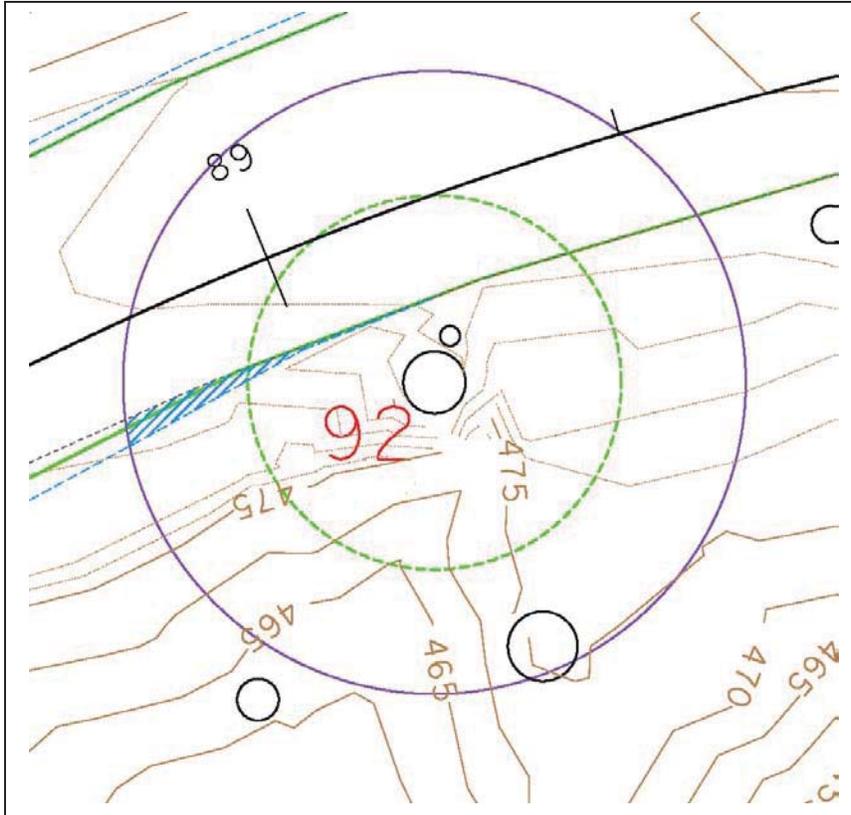
Description: Tree #92, 100 inches DBH (depicted in Attachment A, Sheet 11). Tree has two trunks. A fire scar extends from base of tree up to about 20 feet.

Evaluation: Effect of root zone disturbance is very slight and there would be no decline in foliage density or tree health.

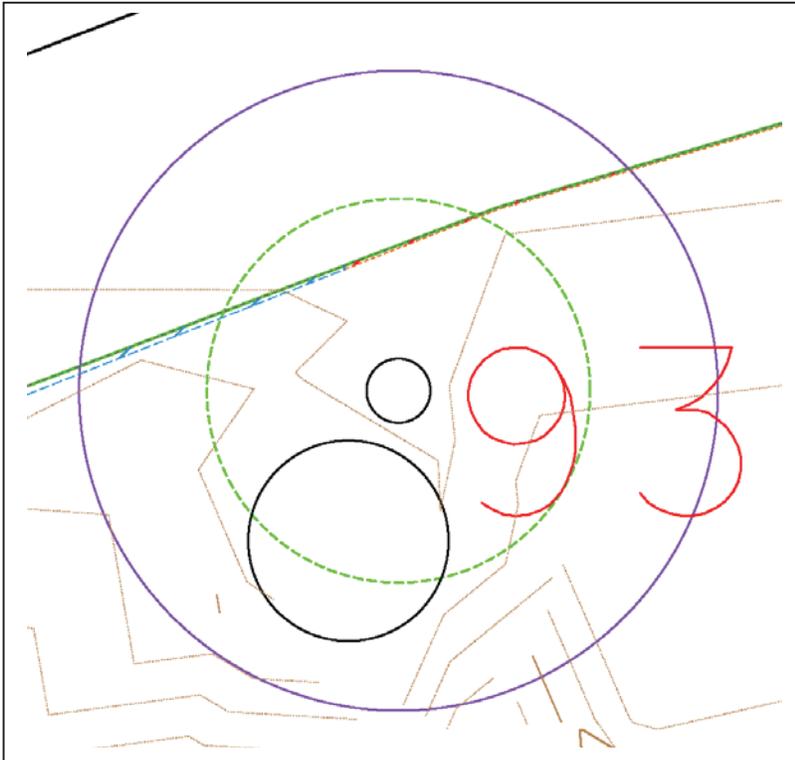
Description: Tree #93, 32 inches DBH (depicted in Attachment A, Sheet 11).

Evaluation: Effect of root zone disturbance is extremely minor and there would be no decline in foliage density or tree health.

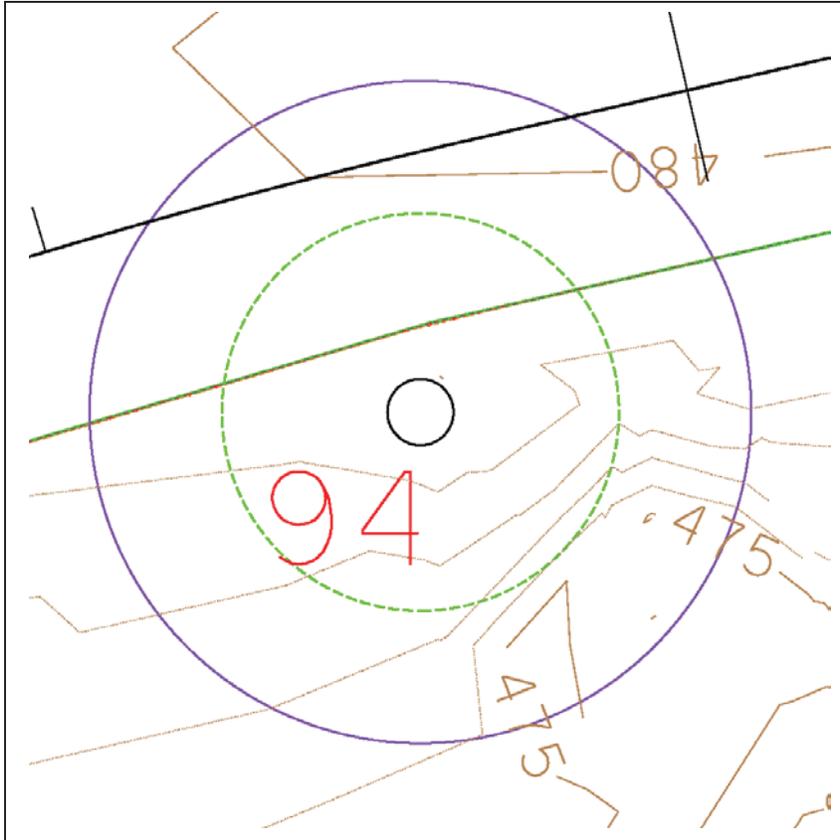
Description: Tree #94, 61 inches DBH (depicted in Attachment A, Sheet 12). Trunk has numerous dead branches on one side; tree may have been suppressed by an adjacent, now-fallen tree.

Evaluation: Effect of root zone disturbance is extremely minor and there would be no decline in foliage density or tree health.

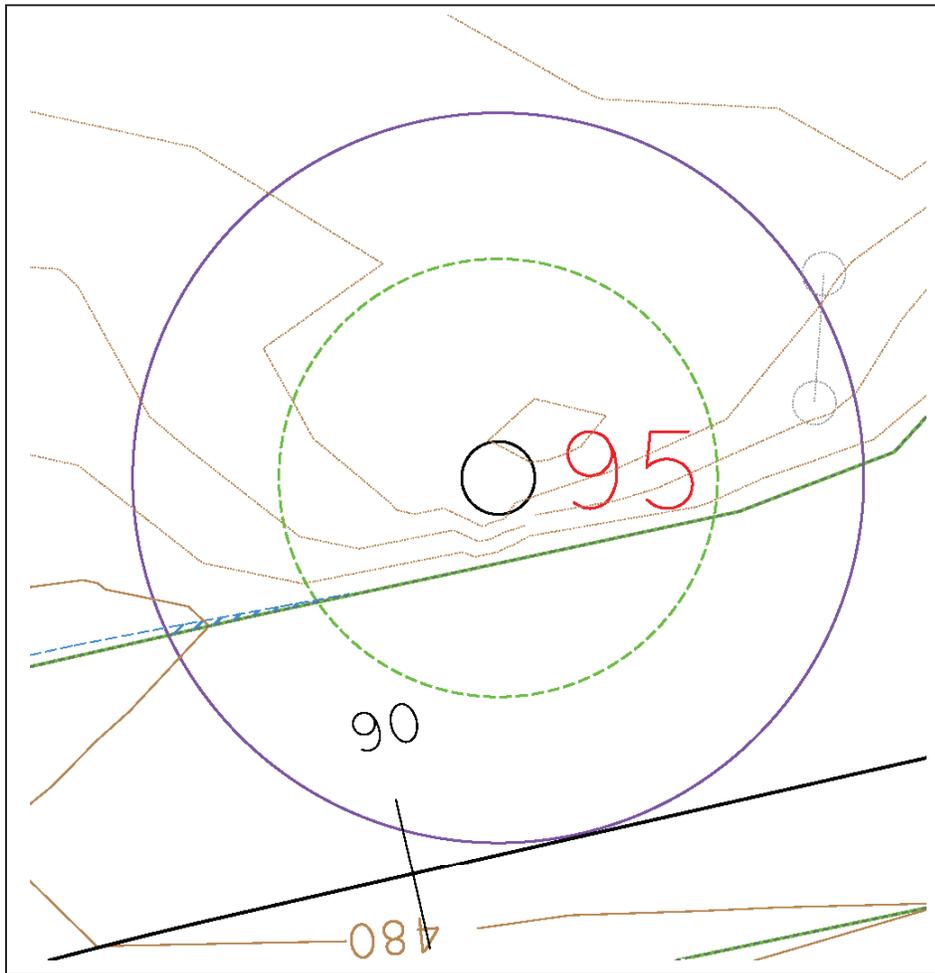
Description: Tree #95, 80 inches DBH (depicted in Attachment A, Sheet 12).

Evaluation: Effect of root zone disturbance is extremely minor and there would be no decline in foliage density or tree health.

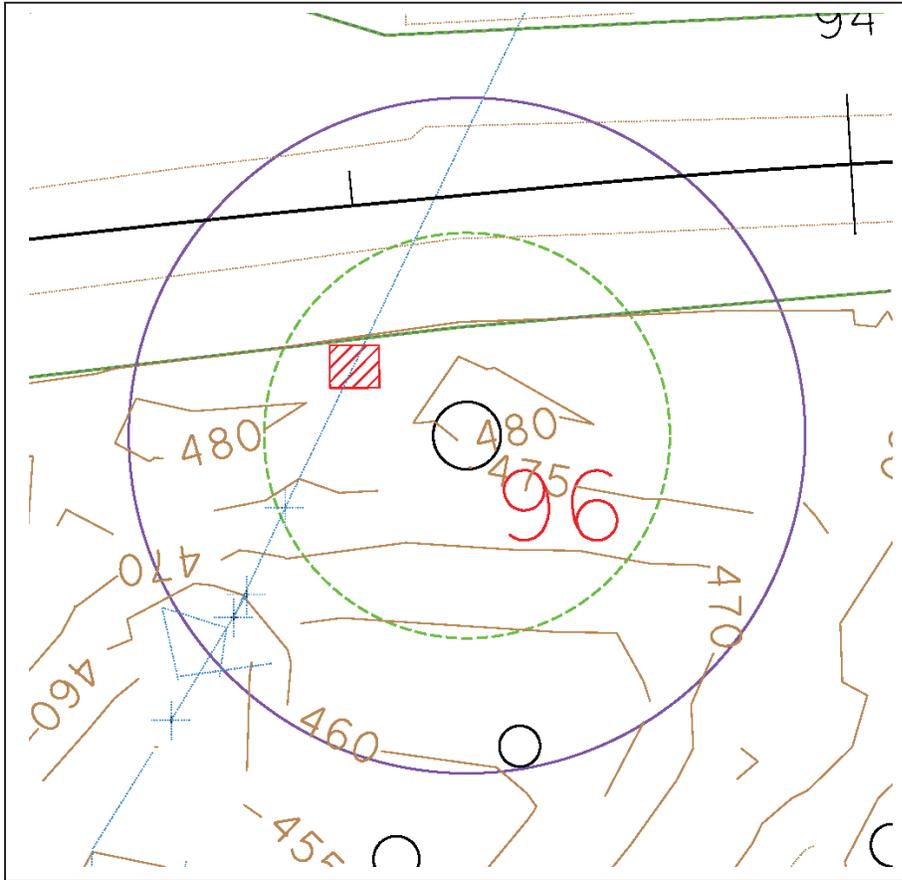
Description: Tree #96, 81 inches DBH (depicted in Attachment A, Sheet 13).

Evaluation: Effect of root zone disturbance is very slight and there would be no decline in foliage density or tree health.

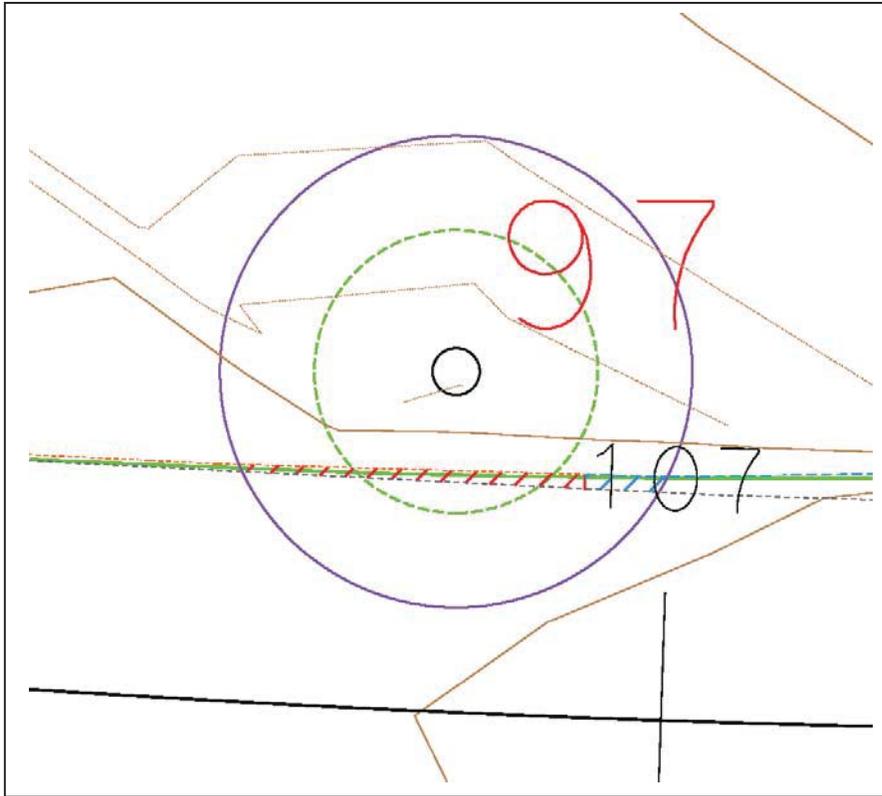
Description: Tree #97, 32 inches DBH (depicted in Attachment A, Sheet 18). Tree has a cavity at the base, on side opposite road.

Evaluation: Effect of root zone disturbance is slight and there would be no decline in foliage density or tree health.

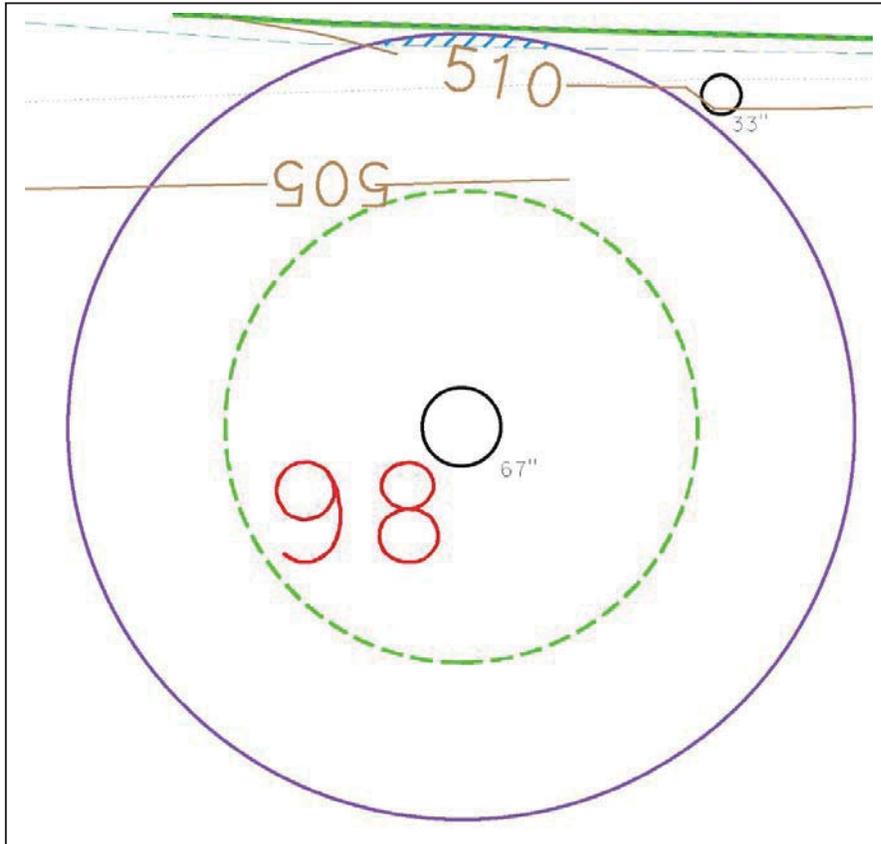
Description: Tree #98, 67 inches DBH (depicted in Attachment A, Sheet 18).

Evaluation: Effect of root zone disturbance is extremely minor and there would be no decline in foliage density or tree health.

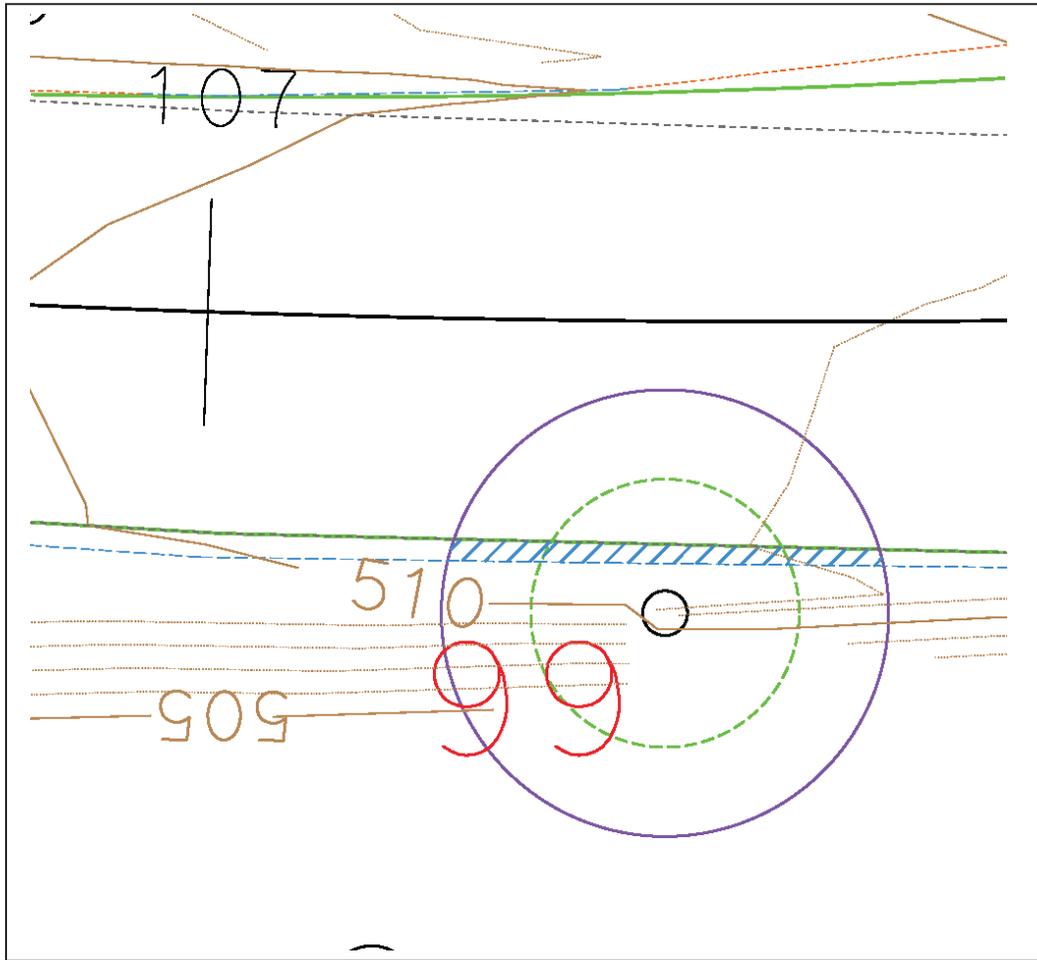
Description: Tree #99, 33 inches DBH (depicted in Attachment A, Sheet 18).

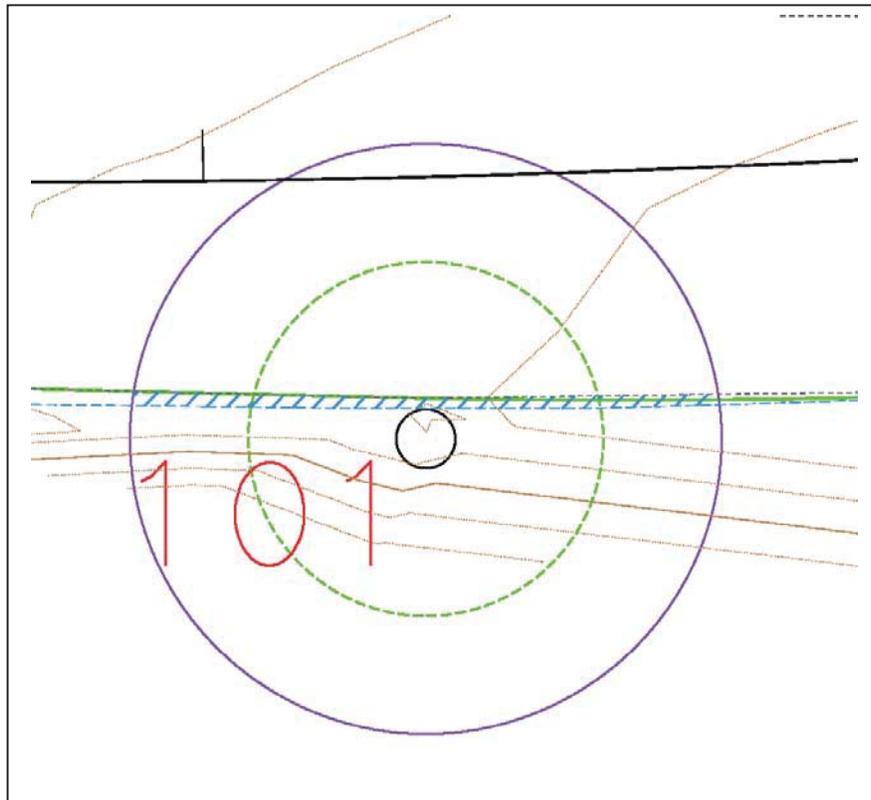
Description: Tree #101, 48 inches DBH (depicted in Attachment A, Sheet 18).

Evaluation: Effect of root zone disturbance is very slight and there would be no decline in foliage density or tree health.

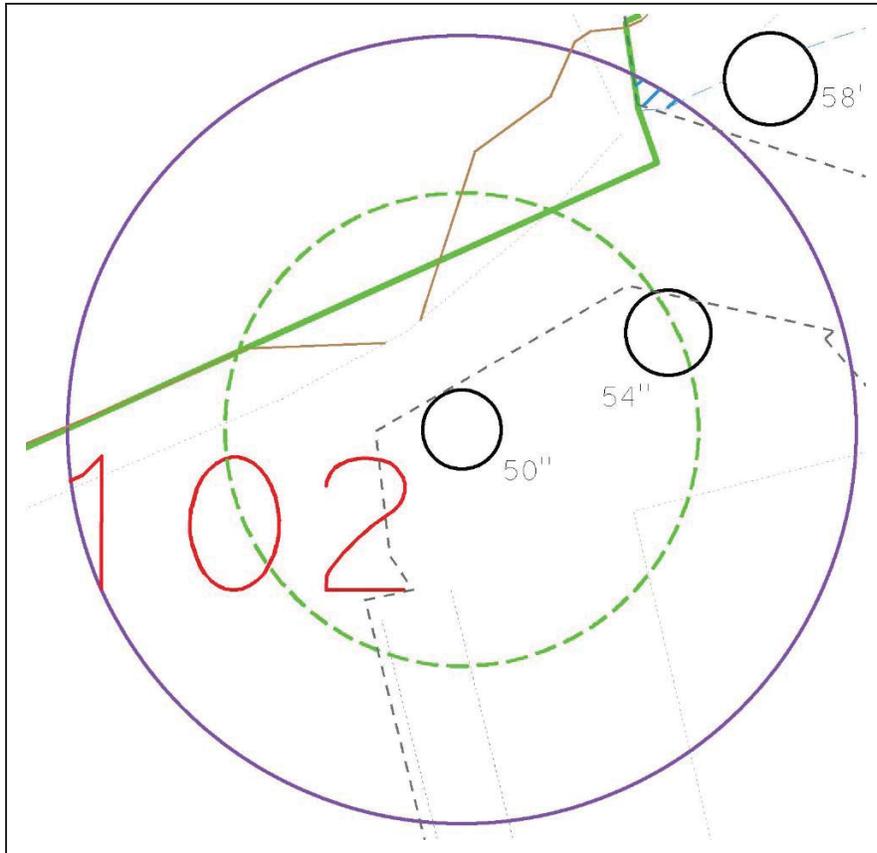
Description: Tree #102, 50 inches DBH (depicted in Attachment A, Sheet 19). This tree is adjacent to Tree #103, away from the road.

Evaluation: Effect of root zone disturbance is extremely minor and there would be no decline in foliage density or tree health.

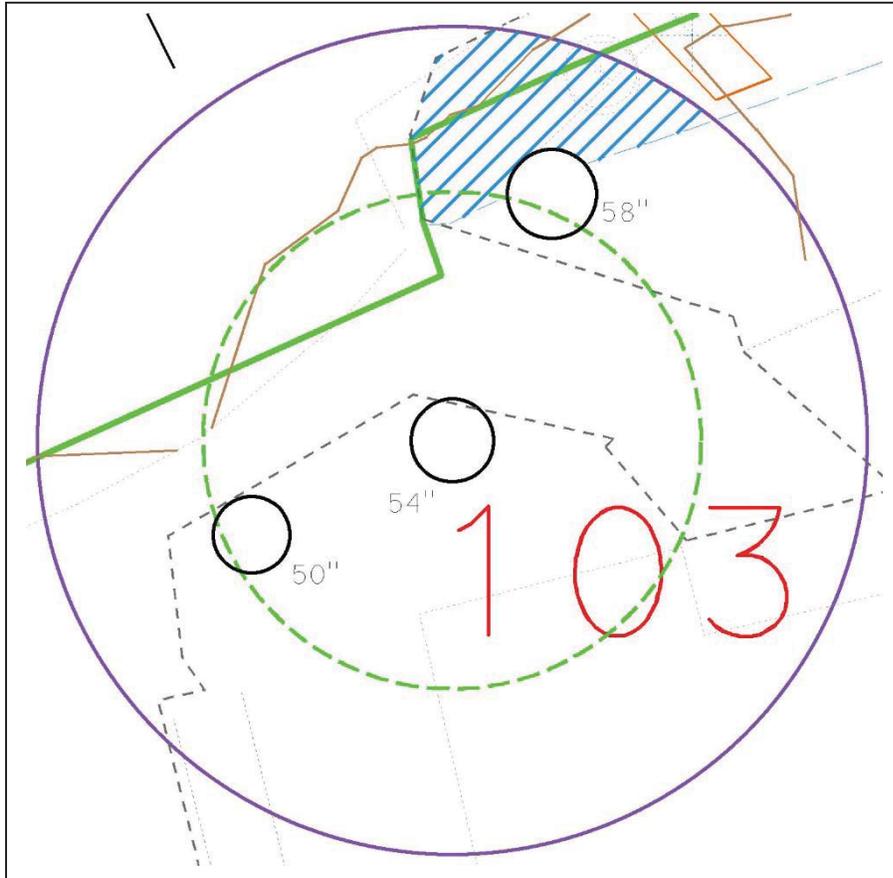
Description: Tree #103, 54 inches DBH (depicted in Attachment A, Sheet 19). Tree is growing in an island of soil in front of a building.

Evaluation: Effect of root zone disturbance is very slight and there would be no decline in foliage density or tree health.

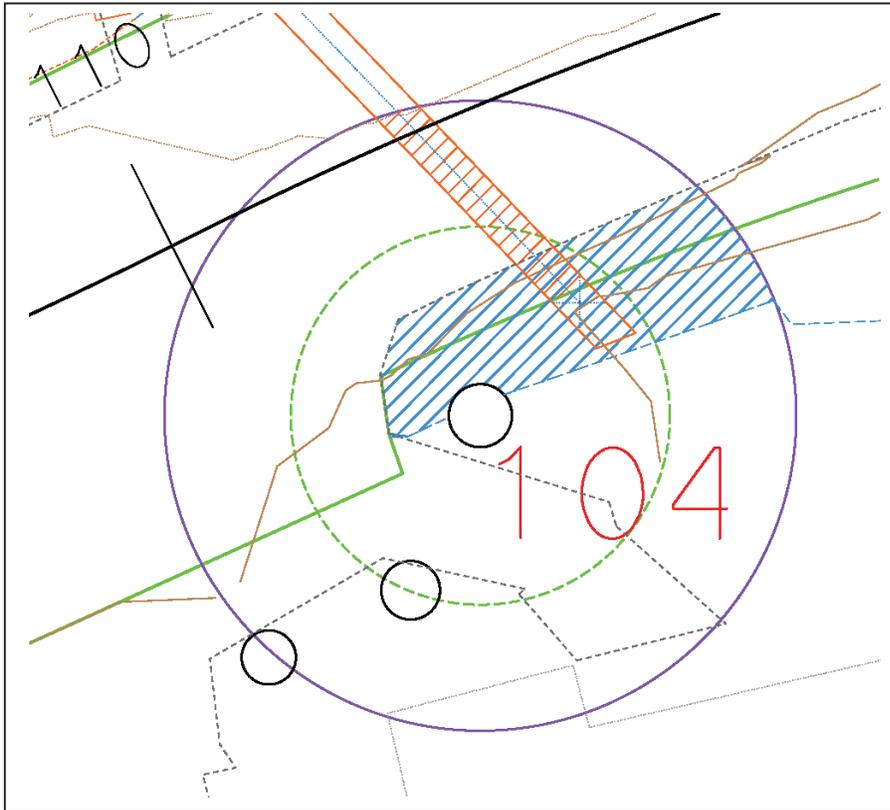
Description: Tree #104, 58 inches DBH (depicted in Attachment A, Sheet 19).

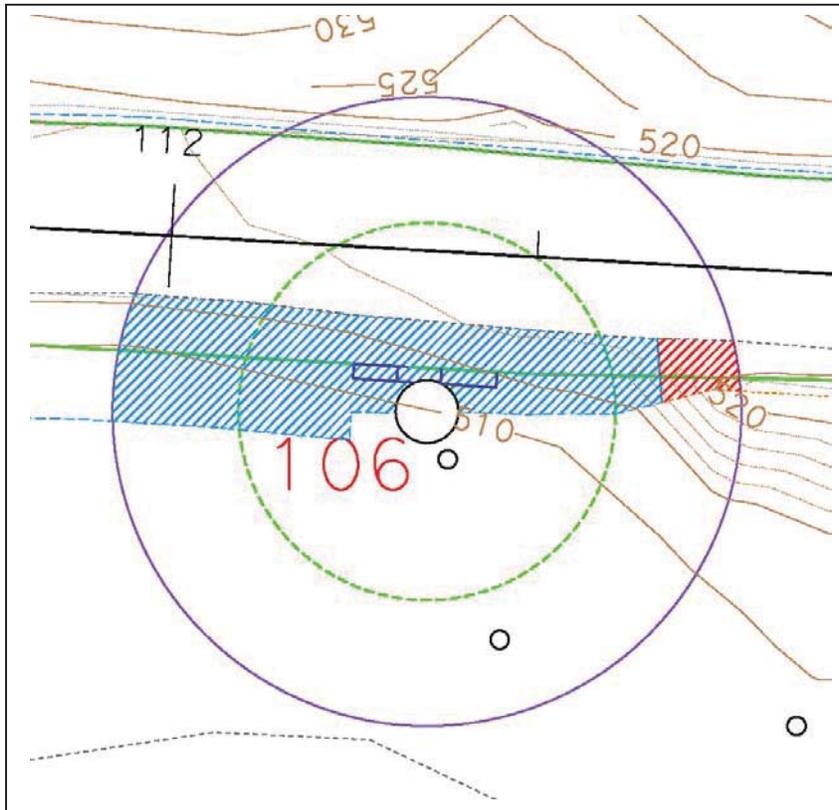
Description: Tree #106, 103 inches DBH (depicted in Attachment A, Sheet 19). Tree has two trunks. It is established at roadway height at least 10 feet above downslope buttress flare.

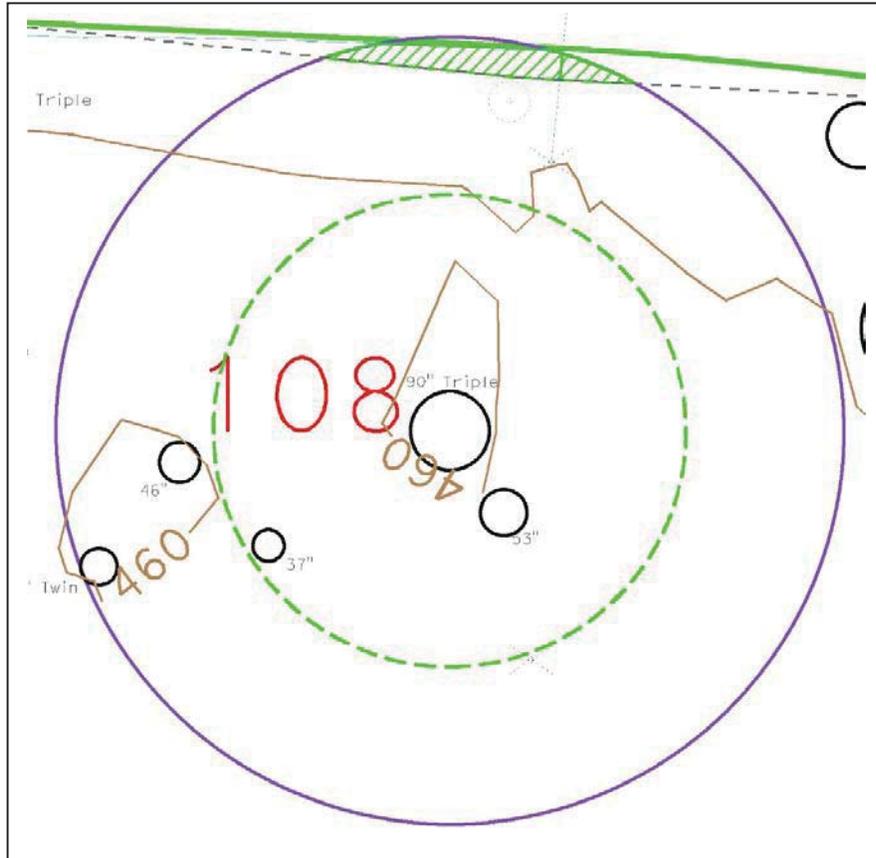
Description: Tree #108, 90 inches DBH (depicted in Attachment A, Sheet 5). Tree has three trunks.

Evaluation: Root zone disturbance would have no effect on tree health.

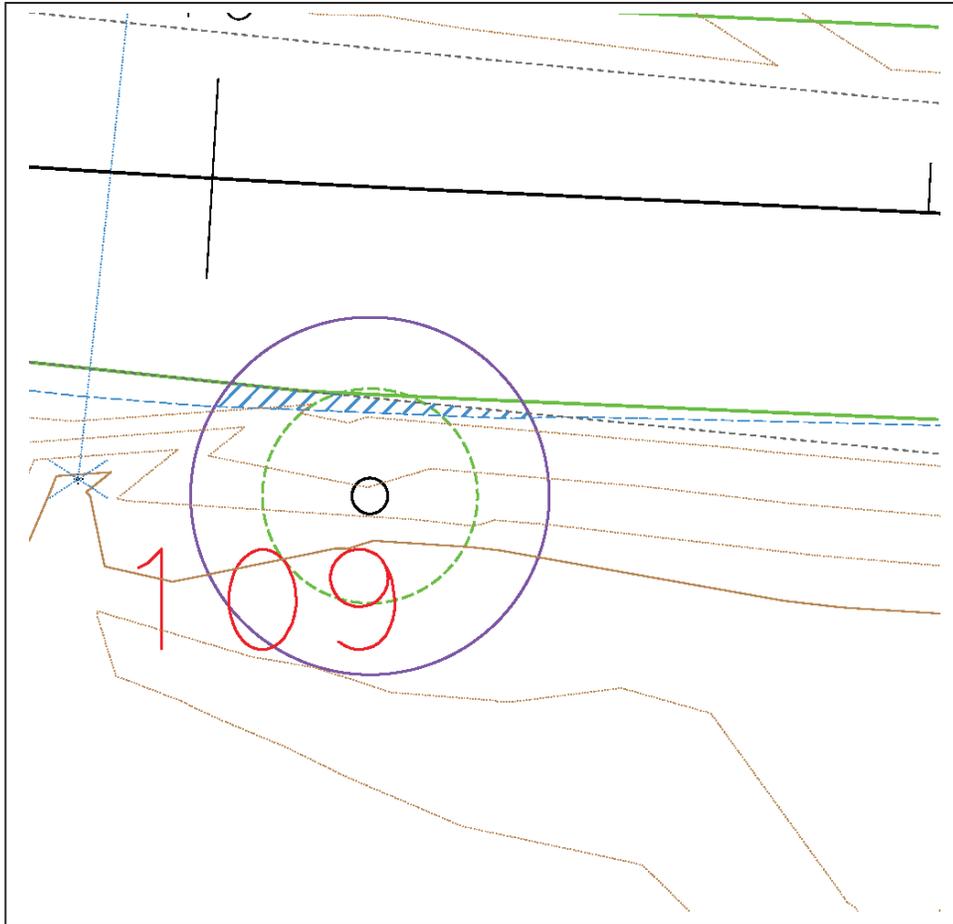
Description: Tree #109, 30 inches DBH (depicted in Attachment A, Sheet 5). Tree has three trunks.

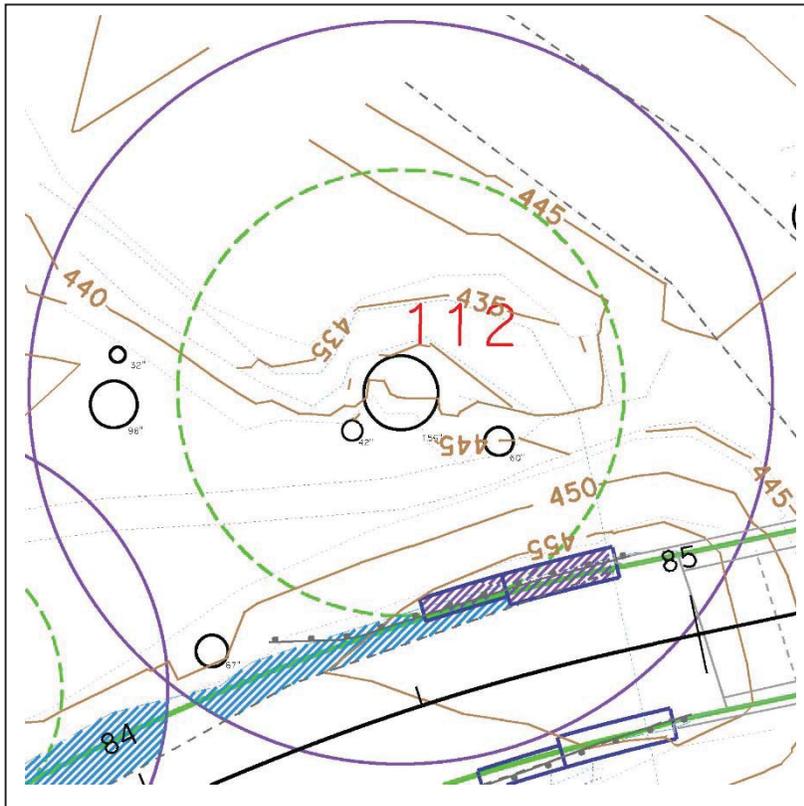
Description: Tree #112, 156 inches DBH (depicted in Attachment A, Sheet 10). Tree is growing in the bank of Durphy Creek; some exposed roots are scoured by soil and rock movement on the creek side.

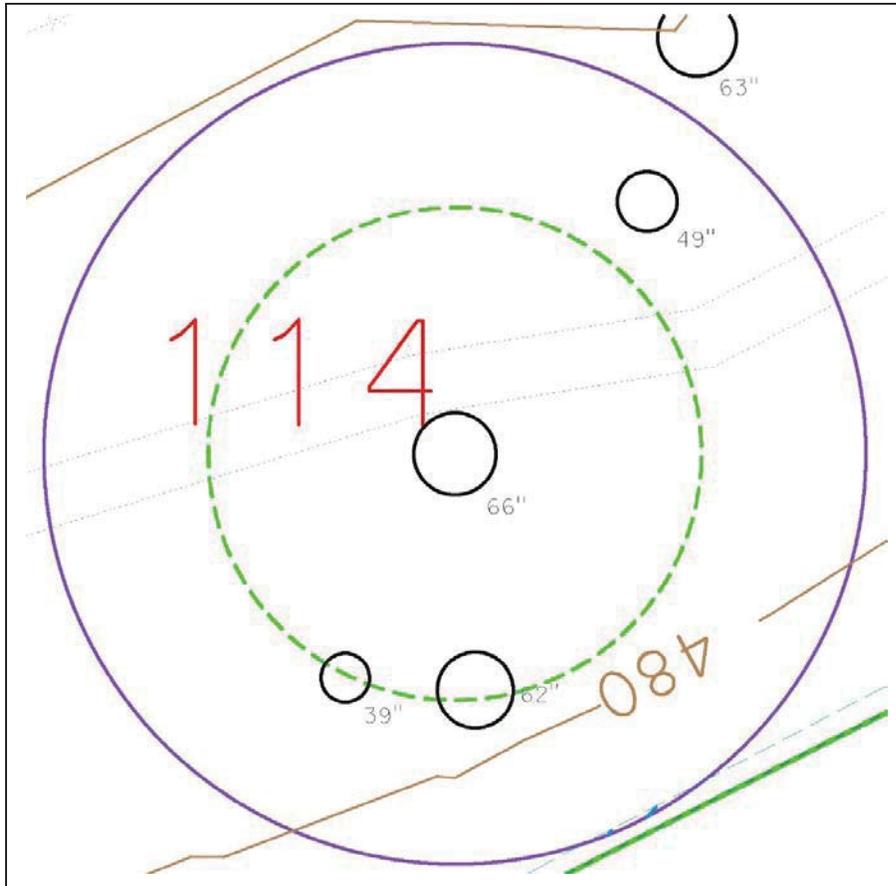
Description: Tree #114, 66 inches DBH (depicted in Attachment A, Sheet 11). Tree is well off roadway.

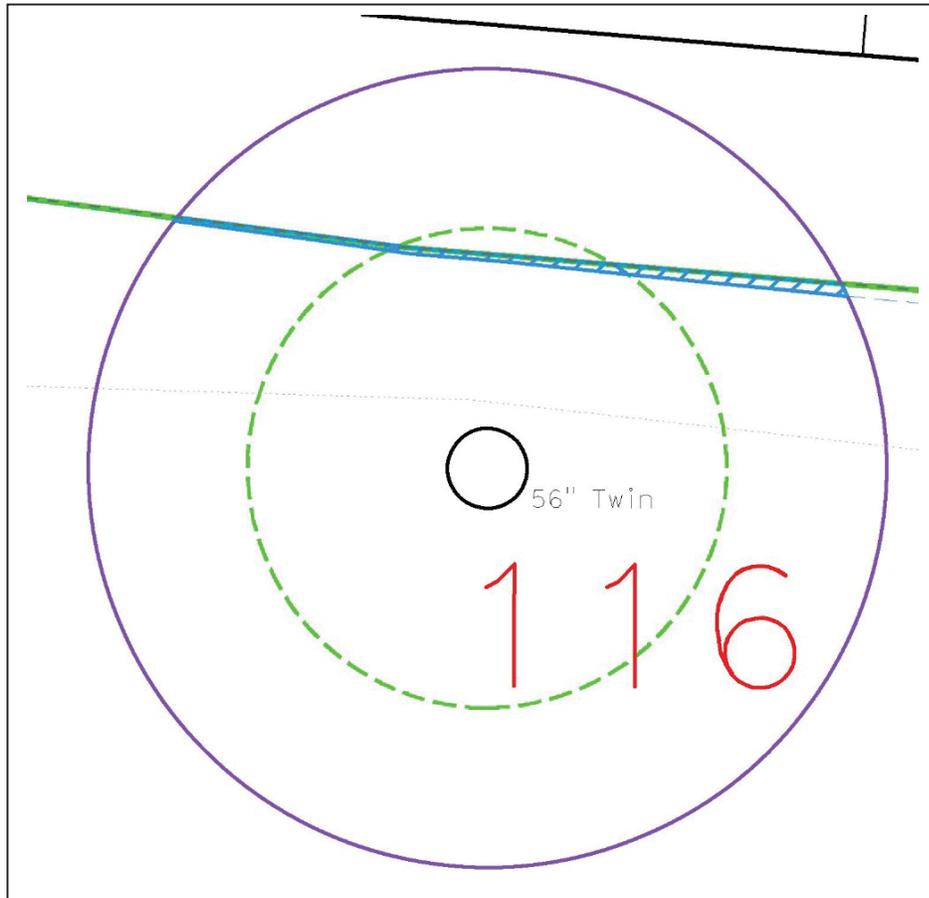
Description: Tree #116, 56 inches DBH (depicted in Attachment A, Sheet 17). Tree has two trunks.

Evaluation: Effect of root zone disturbance is extremely minor and there would be no decline in foliage density or tree health.

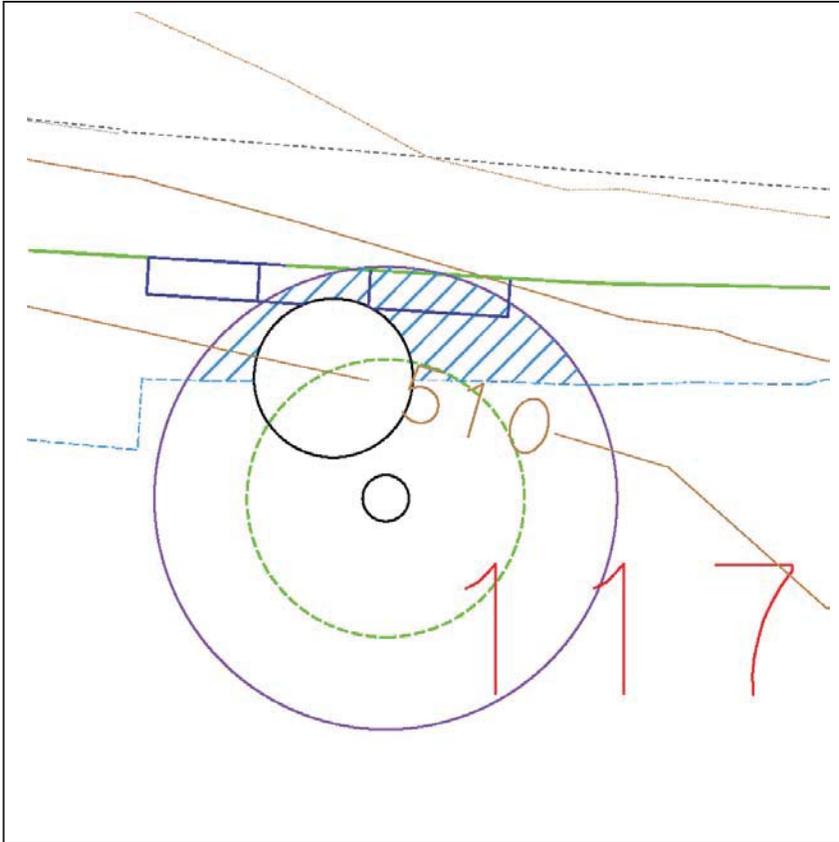
Description: Tree #117, 30 inches DBH (depicted in Attachment A, Sheet 19). Trunk of tree is partially buried against bank.

Evaluation: Effect of root zone disturbance is very slight and there would be no decline in foliage density or tree health.

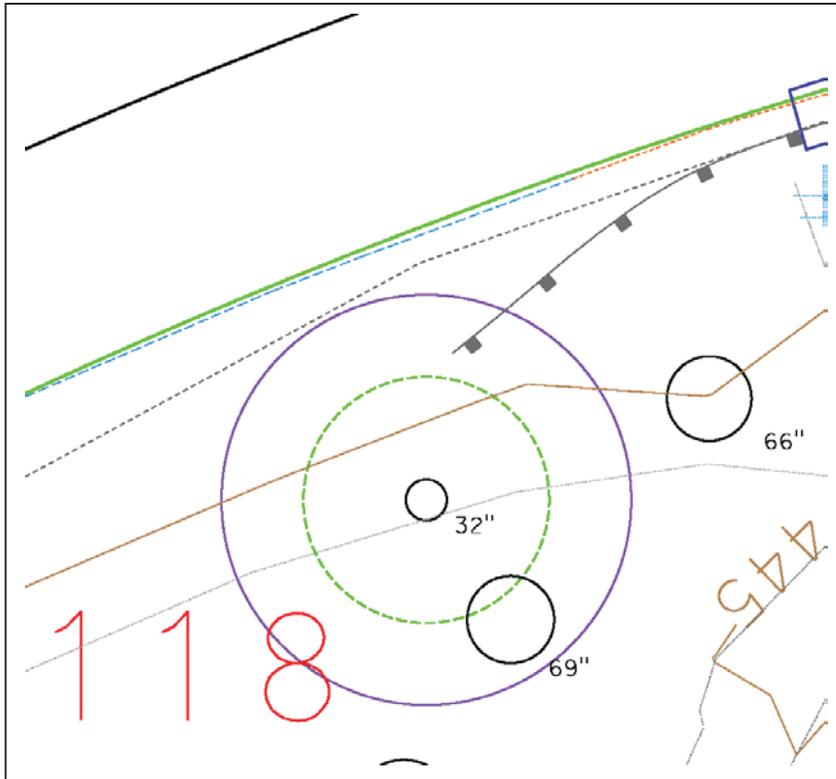
Description: Tree #118, 32 inches DBH (depicted in Attachment A, Sheet 10).

Evaluation: Effect of root zone disturbance is extremely minor and there would be no decline in foliage density or tree health.

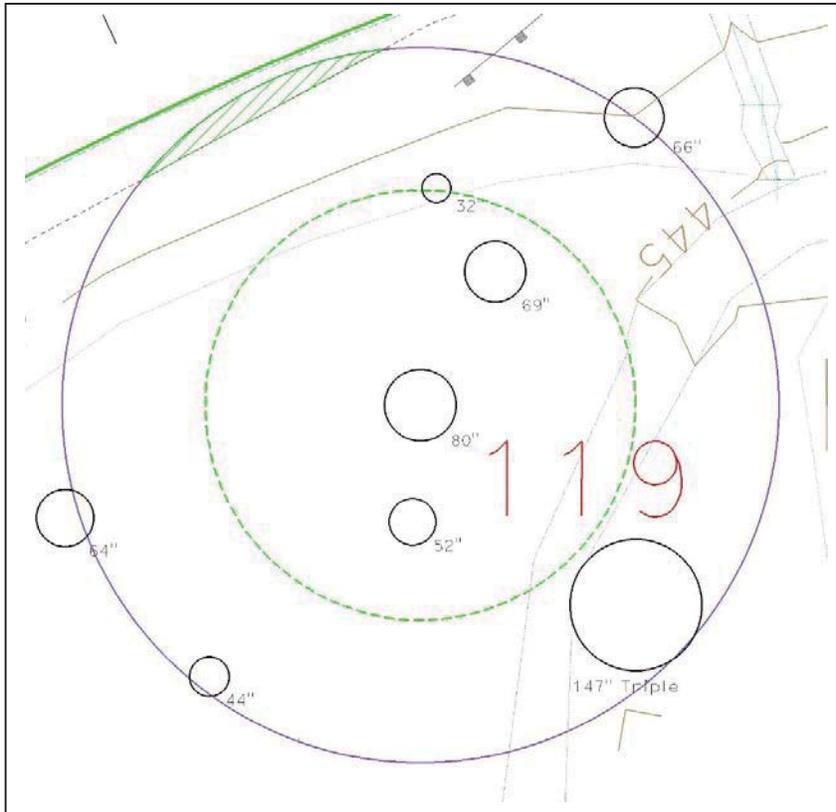
Description: Tree #119, 80 inches DBH (depicted in Attachment A, Sheet 10).

Evaluation: Effect of root zone disturbance is extremely minor and there would be no decline in foliage density or tree health.
