## **Tree Preservation Assessment**

State Route 82 El Camino Real Roadway Renewal Project San Mateo County, CA

PREPARED BY: HortScience | Bartlett Consulting 325 Ray St. Pleasanton, CA 94566

November 2021

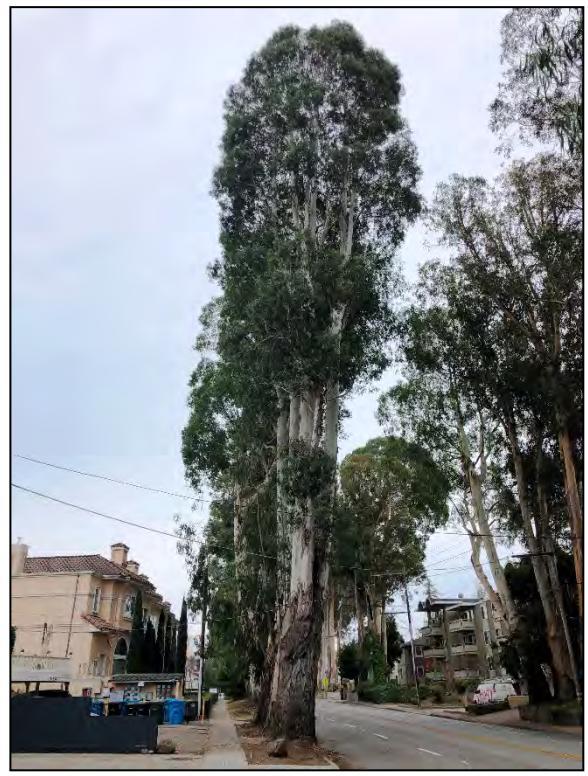
**Photo 9** (L): Looking north at manna gum #437. Although the tree had been topped and reduced, it was in good condition, with better form and structure than those in fair condition.

**Photo 10** (R): Looking southwest at blue gum #243. It was in poor condition, with a very sparse crown and moderate dieback of twigs and branches throughout the crown.
