Subject: DESIGN INFORMATION BULLETIN (DIB) 83-05

DESIGN INFORMATION BULLETIN No. 83 - 05
CALTRANS SUPPLEMENT TO FHWA CULVERT
REPAIR PRACTICES MANUAL

Department of Transportation
Division of Design
Office of Hydraulics and Stormwater Design

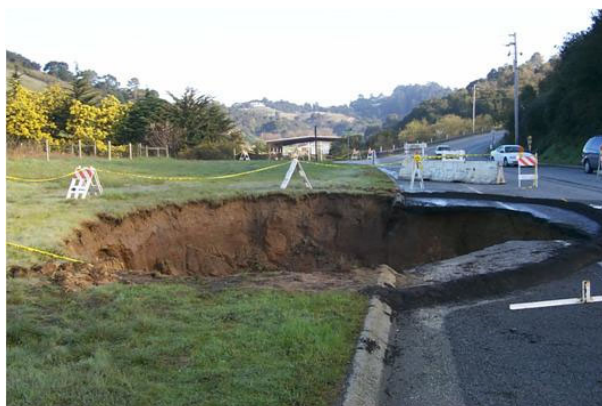
A variety of external loads and changing soil conditions may cause joints to open allowing backfill infiltration and water exfiltration, however, this is unlikely if the proper bands are used. Key factors in the inspection of joints are indications of backfill infiltration and water exfiltration causing erosion of surrounding soil resulting in surface holes or pavement deflections. See Index 11.1.1.

Sink Hole Damage (Location Unknown)

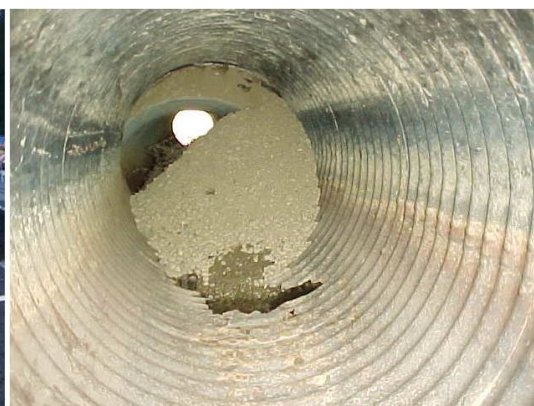
Loss of Backfill Fines

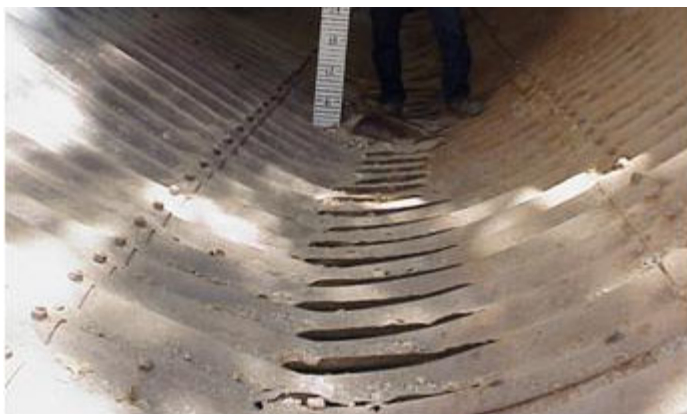
One of the most common problems with corrugated metal culverts is deterioration of the invert, usually due to a combination of corrosion and abrasion once the galvanizing layer has been worn away. It is for this reason that corrugated steel culverts are frequently coated with an asphaltic or other type of protective coating. However, in HDM Table 855.2C, with the exception of polyethylene (CSSRP), towards the upper end of the flow velocity range for moderate abrasion, these coatings are generally ineffective and alternative invert materials are recommended. See HDM Index 855.2 Abrasion, and Indices 2.1.2.1, 2.1.2.2, and 2.1.2.3, for corrosion and abrasion influences that must be included in any estimation of service life. If these influences have been overlooked or inadequately addressed during the original design, eventually the coatings are abraded or broken away, and corrosion that attacks the bare steel is accelerated by abrasion that constantly removes the somewhat protective oxide layer formed by corrosion.

Worn Invert on Leading Edge (To Flow) of Corrugations Caused by Abrasion

Since a corrugated metal pipe is classified as a flexible structure that requires interaction with soil for stability, loss of the invert may result in severe distortion and collapse of the culvert (see Index 11.1.1).

Thus, repairs for severely deteriorated inverts in large diameter metal culverts must include:

- Structural repairs that restore the structural capacity of the culvert to resist circumferential thrust loads
- Re-establishing the connection between the soil and the pipe by filling voids immediately on the backside of culverts with low strength pressure grout mix. This will tend to crack rather than build an undesirable 'block'. Refer to Index 6.1.2 and page B-135 of [FHWA Culvert Repair Practices Manual Volume 2](#), for procedures for grouting voids behind and under culverts.

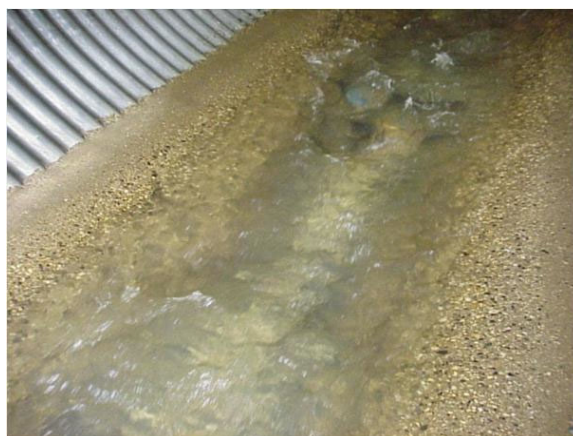
For extremely abrasive conditions (i.e., Level 6 in HDM Tables 855.2A and 855.2F) alternative materials are recommended to reduce the significant paving thickness required for concrete to achieve a 50-year maintenance free service life. HDM Table 855.2F provides guidance on minimum material thickness to achieve a 50-year maintenance free service life. See photo below for an example of abrasion level 6 where insufficient concrete

invert paving thickness was placed. Per HDM Table 855.2F, abrasion levels 5 and 6 require over 12 inches of concrete to achieve a 50-year maintenance free service life, however, 3-5 inches of calcium aluminate abrasion resistant concrete (or mortar) is equivalent. For composite sections, a "raked" finish is preferred to provide a good mechanical bond area for calcium aluminate concrete to mechanically key into the concrete. See photo. When applied directly to the invert, WWM should be tack welded to the host pipe for improved bonding.

(Above) Example of Insufficient Concrete Invert Paving Design Thickness for Abrasion Level 6

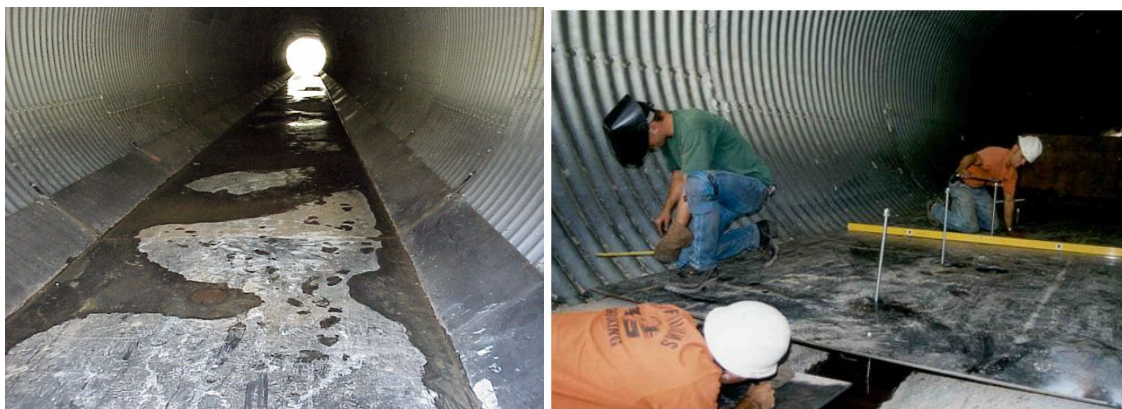
Finished 0.375-inch Thick Steel Plate Invert

Workers Placing Steel Plates (See Detail Below)

In locations with severe abrasion (see Index 2.1.2.3) a viable option to invert paving with concrete may be to armor plate the invert with steel plates (thickness between 0.25 inch and 0.50 inch). See HDM Table 855.2F. This method is used in large diameter pipes that can accommodate a reduction in waterway area. The smooth, wide invert spreads wear over a greater area and is less of an impediment to flow than corrugated metal. It is important to securely attach steel armor plates to the host pipe. See 03-Nev-49 pictures below of 0.375 inch thick steel armor plate example at Shady Creek that replaced a concrete invert lining.

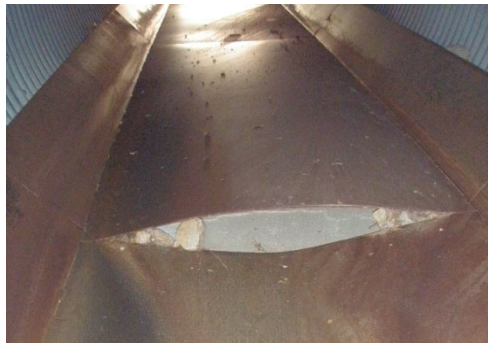
Example Steel Armor Plating Detail. To prevent piping under the steel plate, it is important to provide end treatment details – particularly at the upstream end. See details below and post-construction photo of 120 inch SPP on Sbd 330 where end treatment was not part of the design.

Insufficient Anchorage with No End Treatment

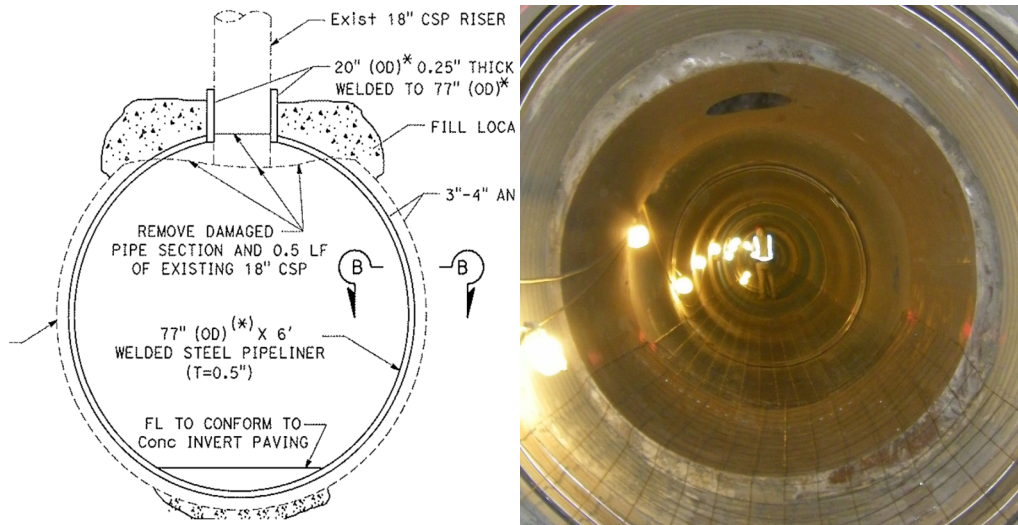
12-ORA-261-PM 3.74

Localized Repair to 84-inch CMP in Vicinity of 18-inch Riser

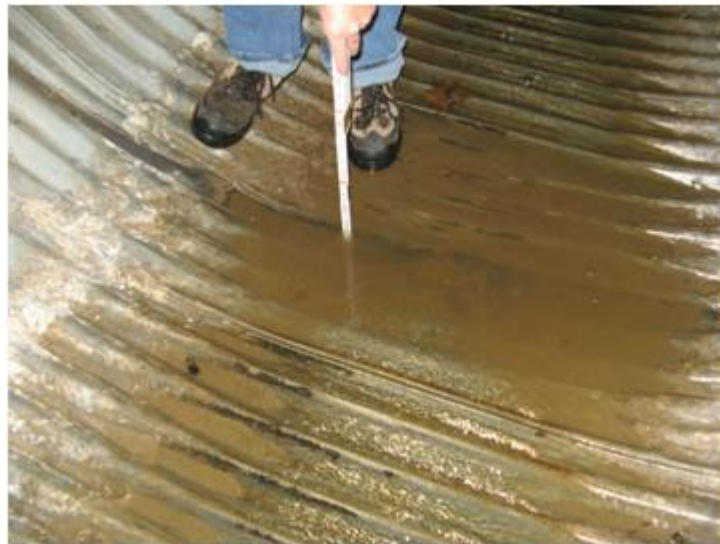
Backfill Fines Infiltrating Through CMP Joint

When the pipe is located beneath the ground water level, consideration must be given to the possibility of loss of side support through soil migration (the conveying by groundwater of finer particle soils into void spaces of coarser soils). Generally, migration can occur where the void spaces in the pipe backfill are sufficiently large enough to allow the intrusion of eroded fines from the trench sidewalls. For migration to occur, the in-situ soil must be erodible, and there must be a flow path for the water. Normally, erodible soils are fine sands and silts and special clays. This situation is exacerbated where a significant gradient exists in the ground water from the outside of the trench towards the inside, i.e.,

As a remedial measure for such anticipated conditions, depending on the amount of shape distortion, cementitious grouting, or a combination of expansion rings (refer to previous discussion for sealing culvert joints with expansion ring gaskets or repair sleeves under Index 5.1.1.1.3.2), and Slurry Cement pressure grouted backfill in lieu of Structure Backfill, or a combination of Structure Backfill with Filter Fabric (only if external access is feasible) is recommended. See Index 6.1.2. Grouting Voids in Soil Envelope. Also see appendices B-26 and B-34, [FHWA Culvert Repair Practices Manual Volume 2](#) for procedures for sealing culvert joints and repair at a distorted section.

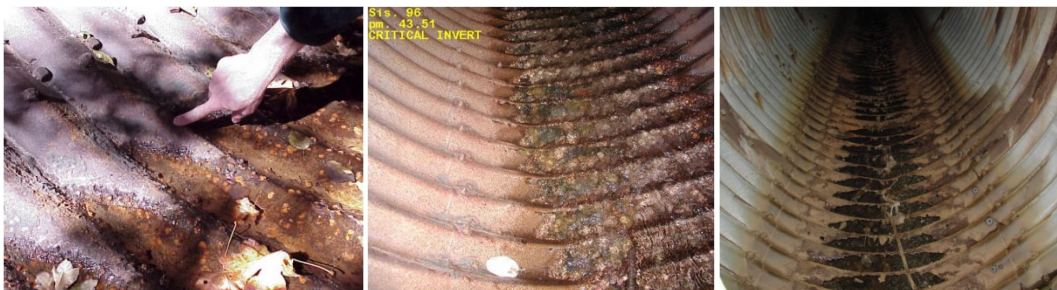
Corroded inverts in metal pipe will visually appear much differently than those worn by abrasion. Corrosion will first manifest itself inside the culvert as rust with nodules and pitting. See first photo below. The first perforations may appear in a much wider area related to the flow-line compared to when abrasion is the primary wear factor. For example, in the middle photo below, the first perforations are occurring on either side at the outer edge of the darker wear zone. The wear pattern of a severely corroded CMP invert will appear to have rough edges and often has strands of metal remaining at 6 o'clock. See third photo below.

Progressively Corroded CMP Inverts

The dark, stained, wear zone present in most worn metal pipes usually indicates the limit of exposed steel where the galvanizing layer has worn away. Even in nonabrasive flows, most galvanizing exposed to frequent flow generally lasts a maximum of 10 years.

Corrosion on the backside may be present if rust stains inside the pipe are present around joints and seams outside (i.e., above) the general flow zone. See third photo above.

Contact the Corrosion Technology Branch within DES for a detailed investigation.

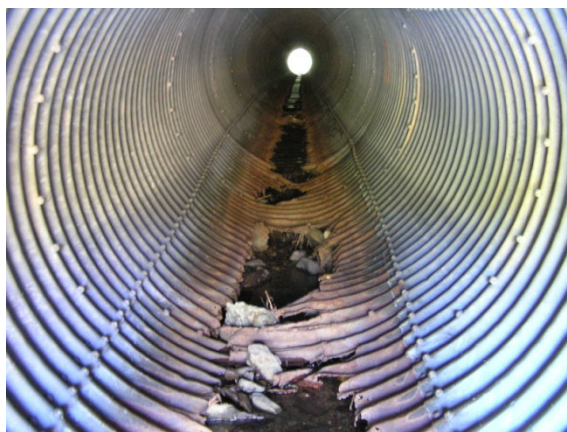
The overall condition of the culvert should be assessed, as well as the soil-pipe conditions that caused the deformation to occur (e.g., corrosion, abrasion, poor compaction, open joints, etc...). Symmetrical deflection of the crown may be indicative of problems with support of the bottom of the culvert or insufficient backfill/cover over the top of the culvert. Unsymmetrical deformation of the top of the culvert may be the result of loss of soil support on one side of the bottom (potentially from problems due to infiltration, infiltration and piping at joint(s) or perforated invert) or improper compaction of the backfill on one side of the culvert. Thus the shape may not be symmetrical for either the entire length of the culvert or individual sections of it. Therefore, the conditions that caused the deformation must be assessed and the rehabilitation plan must include correcting the underlying problem. See Appendix B-34, [FHWA Culvert Repair Practices Manual Volume 2](#), for procedures for repair at a distorted section.

Shape Distortion Caused by Backfill Soil Loss

The decision to repair (re-compact embedment material, grout voids, repair joints or line invert) versus replace the culvert by trenching and cover or by other trenchless methods such as jacking or pipe-ramming, is dependent in part on the structural integrity of the culvert. If the culvert must be replaced, the decision to replace by trench and cover versus other trenchless methods will be influenced by cost, the need to maintain traffic during

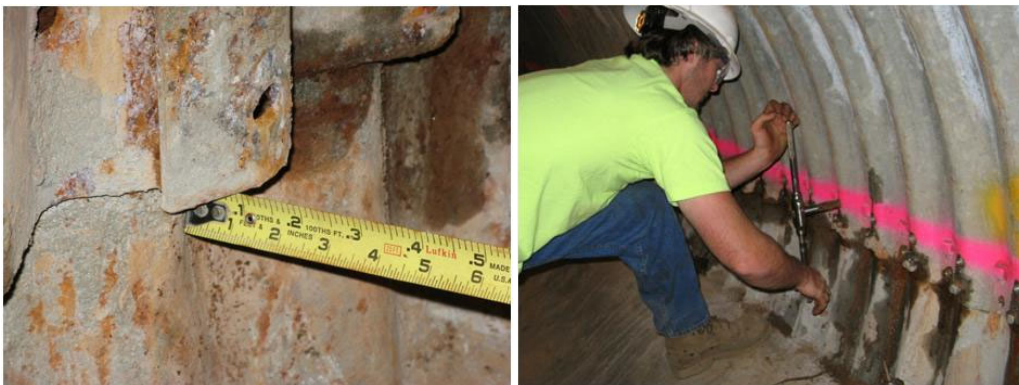
The longitudinal seams of structural steel plate culverts are subject to displacement and cracking due to incorrect assembly of the plates and differential soil pressures or most commonly, if there is instability in the backfill caused by infiltration.

Longitudinal or transverse seams in structural plate assemblies may deteriorate due to sheared or corroded connector bolts, lost or corroded nuts, or plate tears.

Repairs are made by splicing, re-bolting (see pictures below) or welding with reinforcing steel to the inside corrugation valleys at the location of seam distress. See Appendix B-38, [FHWA Culvert Repair Practices Manual Volume 2](#).

Whatever repair is made must be structurally sufficient to accommodate the load thrust, which will be present in the shell of the conduit. Contact Underground Structures within DES for all structural repair recommendations.

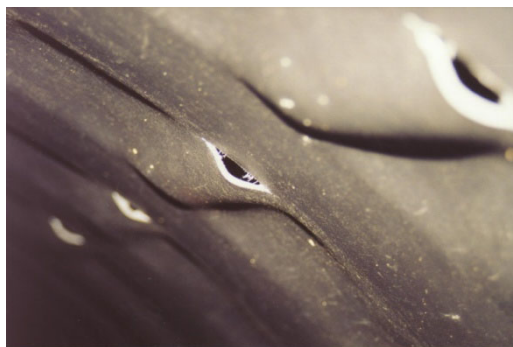
Other issues that are unique to plastic include oxidation, stress cracking and problems associated with exposure to ultraviolet rays at the ends and being flammable. Cracks in high-density polyethylene (HDPE) pipes are most typically going to occur at a seam. In reference to HDPE, it is worth noting that since it is a relatively new culvert product, both the material qualities and physical design are undergoing continuous change. Pipe made today has a different profile, different corrugation (annular instead of helical or spiral) and is made with revised resin compounds as the industry upgrades its products. Given that our standards for placement have been relatively constant, we are more likely to see cracking and other problems in older pipes.

Splitting of 60 inch Diameter Pipe. This Pipe was Installed in 1996 by Another State

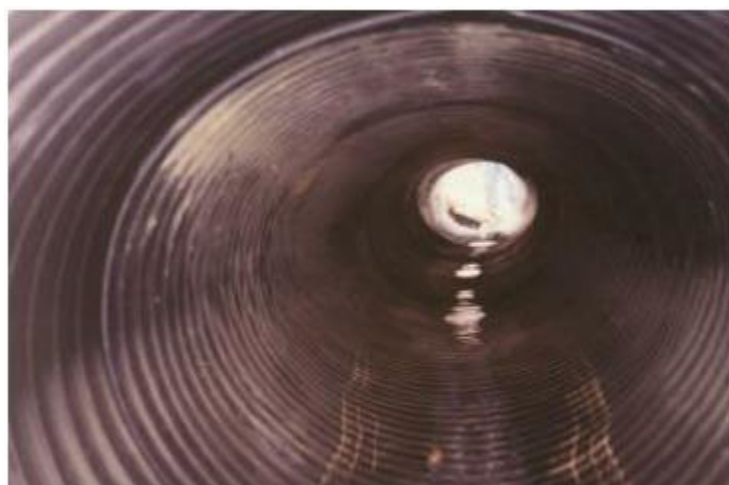
Profile of pipe: Note wall buckling and obvious oval shape. This 42 inch diameter pipe was installed in 1994. The pipe is 82 feet long and has a maximum cover of about 10

feet. Separations of the joints ranged from 1 to 3 inches. Rippling of the sidewalls is apparent throughout the length of the pipe (see below).

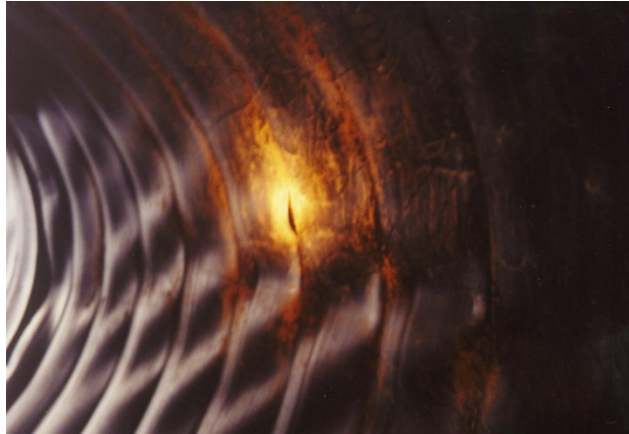
Small Crack and Wall Rippling

Compared to other pipe materials, plastic may have a higher potential for damage from improper handling, and a higher potential for damage from improper backfilling procedures including wall cracks, excessive deflection, bulges, joint separation, excessive joint overlap caused by longitudinal expansion and wall rippling and buckling.

Some of the problems that have been outlined for plastic pipe may be monitored, such as deflection (see Index 5.1.2.2.4). However, pipes with excessive deflection will need to be replaced or lined with a rigid material that is capable of supporting all ground and traffic loads. See Index 11.1.1.

Depending on the problem, excluding excessive deflection, other possible choices for repair not discussed in the previously referenced indices include, lining with cured in place pipe, machine wound PVC or replacement. See Index 6.1 and 9.1. If lining plastic pipe with cured in place pipe, UV curing must be specified in lieu of any heat curing methods which may cause damage to the host pipe. See Index 6.1.3.2.

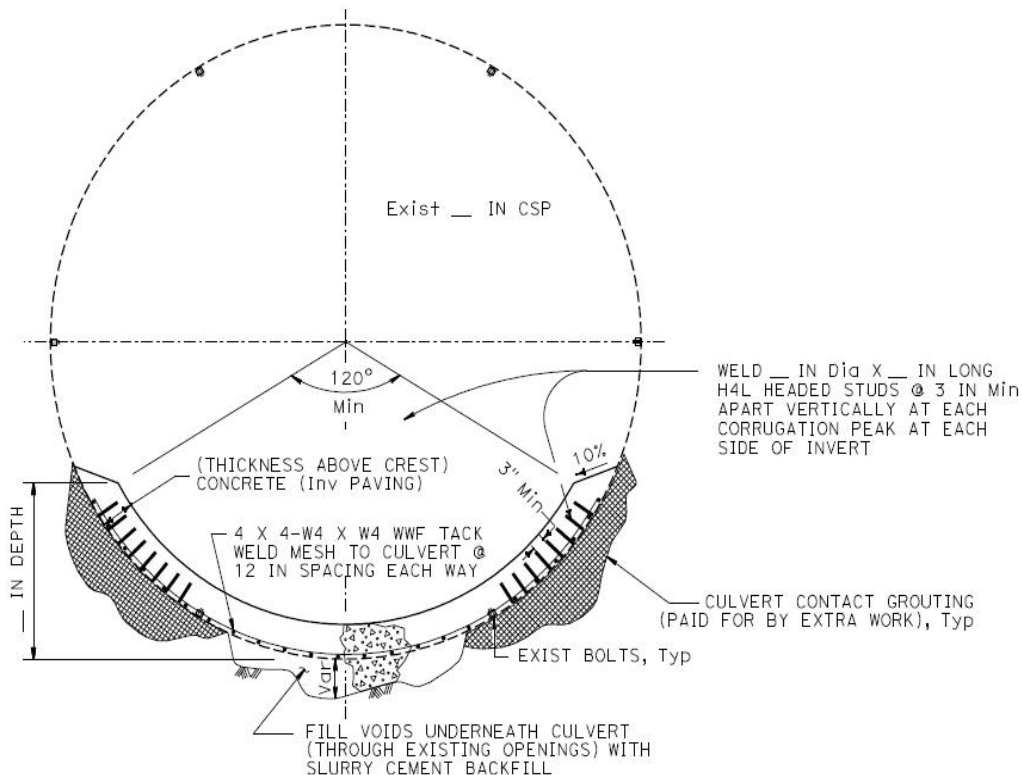
Large diameter (human entry) pipe repairs for voids below the invert and in the backfill. See pipe photo under Index 5.1.2.2.4. for example prior to repairs.

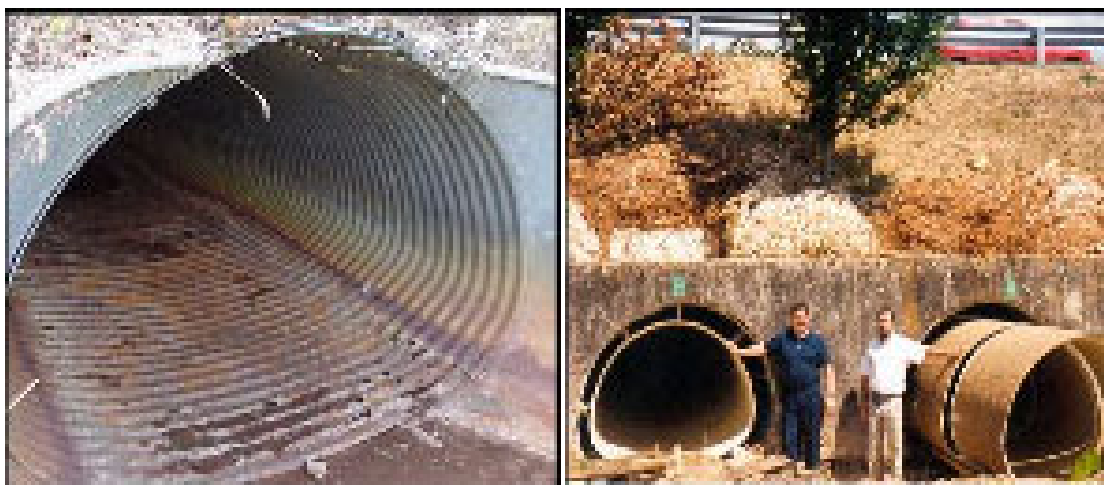
Existing Multi-Plate Arch Before Lining

After Lining with FRP

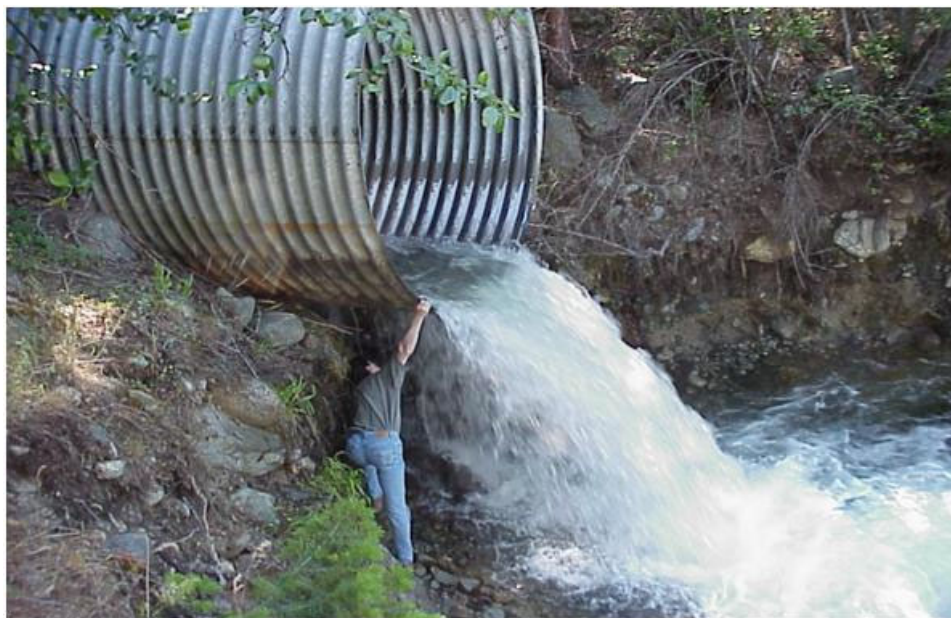
The modification of an existing culvert to facilitate the movement of fish to spawn can introduce several problems in the operation of an installation. Culverts are generally designed to operate under inlet control, which can be detrimental to fish passage. See the picture below for an example where the outlet scour hole created a jump too high for fish passage.

If a culvert is modified to operate under outlet control, or modifications are made to the barrel, there may be a decrease in efficiency, and related increase in water depth and sedimentation. Refer to [FHWA Culvert Repair Practices Manual Volume 1](#), pages 3-58 to 3-61, 5-39 to 5-50 and Volume 2, Appendix B-23, for a discussion on fish passage and fish passage devices. Developed in conformance with both state ([California Department of Fish and Wildlife](#)) and Federal ([NOAA Fisheries Service, Southwest Region](#)) criteria, "Fish Passage Design for Road Crossings" provides worksheets, flow charts, design examples and other design aids to assist the designer in achieving permit achievable projects;

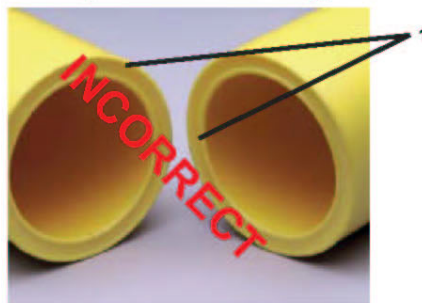
Figure 2 Unacceptable Concave Melt Appearance

A concave melt surface is unacceptable; it indicates pressure during heating. (See Figure 2). Do not continue. Allow the component ends to cool and start over at Step 1.

1. Unacceptable concave melt appearance.

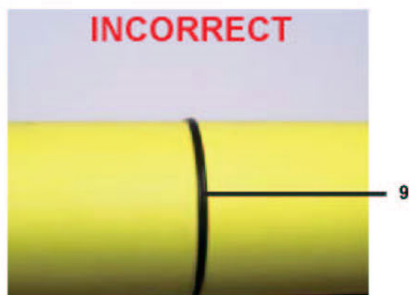
9. Insufficient heat time; melt bead too small

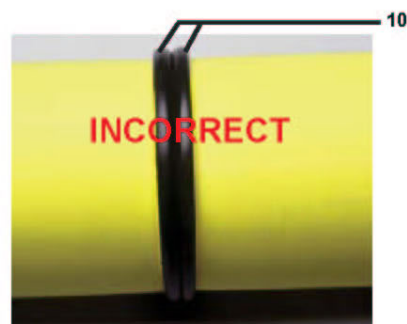
10. Excessive heat time or pressure applied during heating; melt bead too large

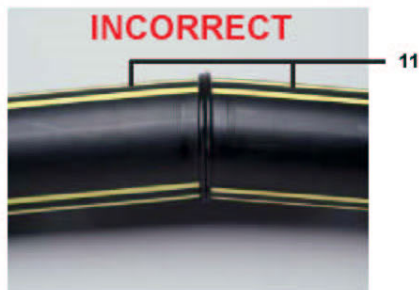
11. Pipe angled into fusion unit

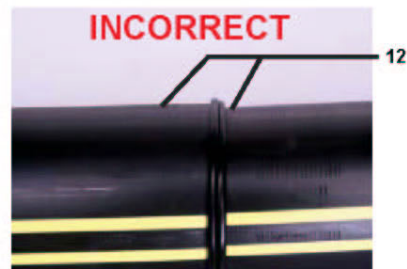
12. Improper "High-Low" alignment

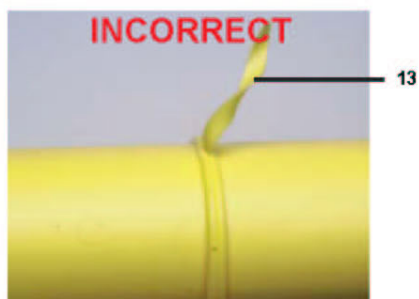
13. Incomplete face off or failure to remove faced off ribbons

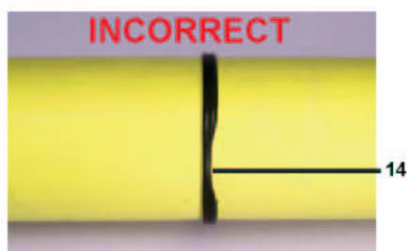
14. Incomplete face off

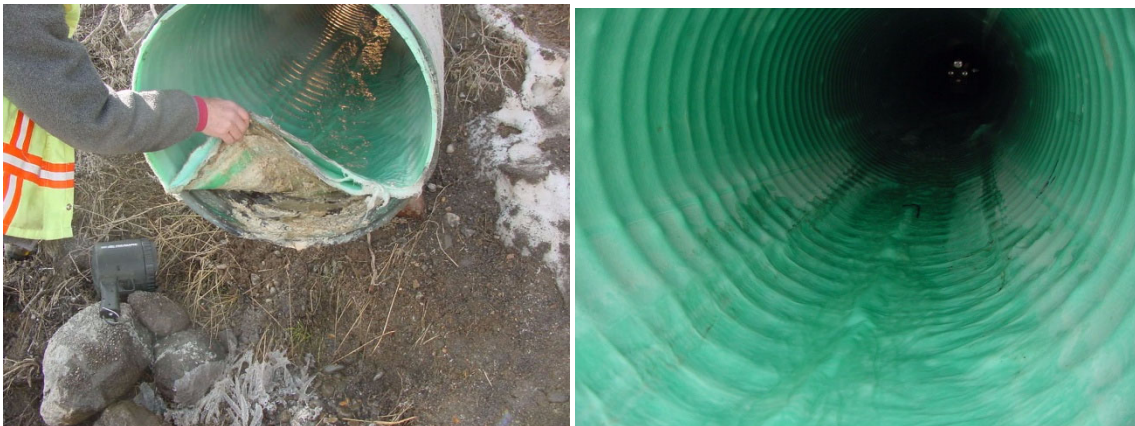
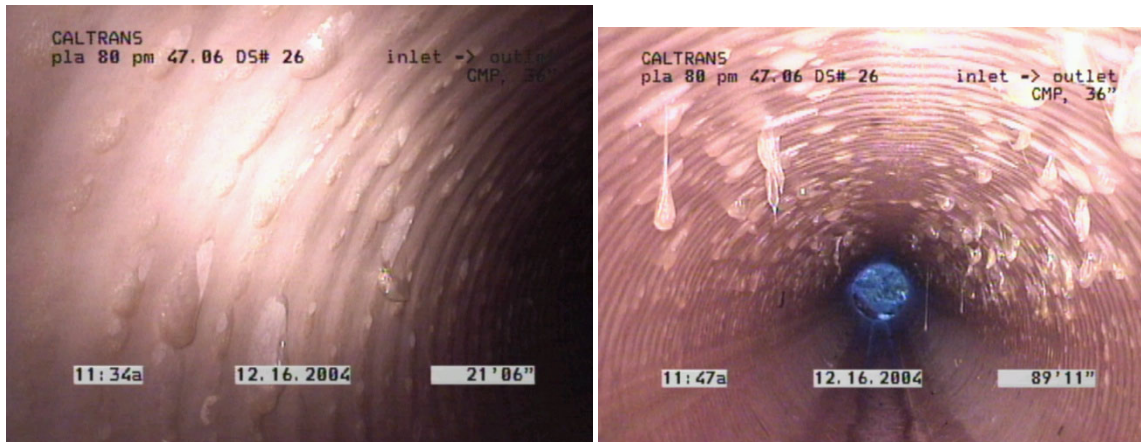
Examples of Delamination, Bubbling and Rippling in Lined CMP Host Pipes

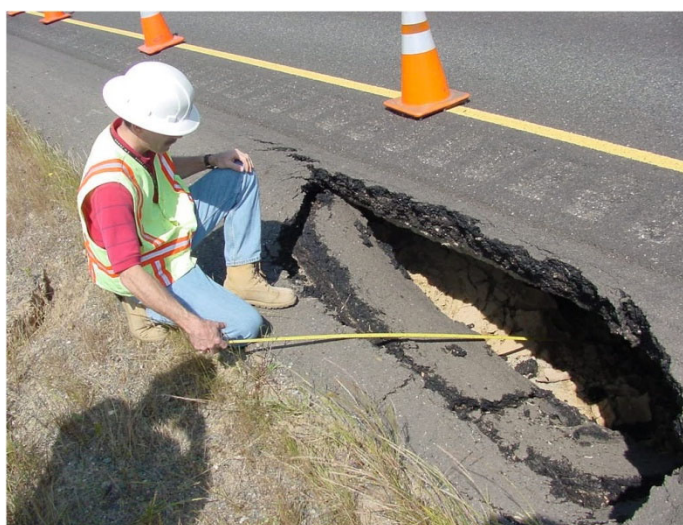
In June 2003, a sinkhole was identified by maintenance adjacent to the number one lane of the westbound traveled way on Highway 50 in El Dorado County at Post Mile 14.0 just east of El Dorado Road Overcrossing (Br. No 25-76) in the vicinity of a 96 inch Structural Steel Plate Pipe (SSPP). This section of Highway 50 was constructed 35 years prior. The 820 foot long SSPP was constructed as a cross drain for Indian Creek which was realigned from its original location to the east and uphill. A 230 foot long 36-inch diameter bitumen coated CMP connects into the SSPP at the center in the median and a 56 foot long 18-inch diameter CMP connects into the SSPP approximately 150 feet from the outlet. Both pipes collect drainage from the north side of the freeway and outlet into the SSPP.

Measuring the Sinkhole

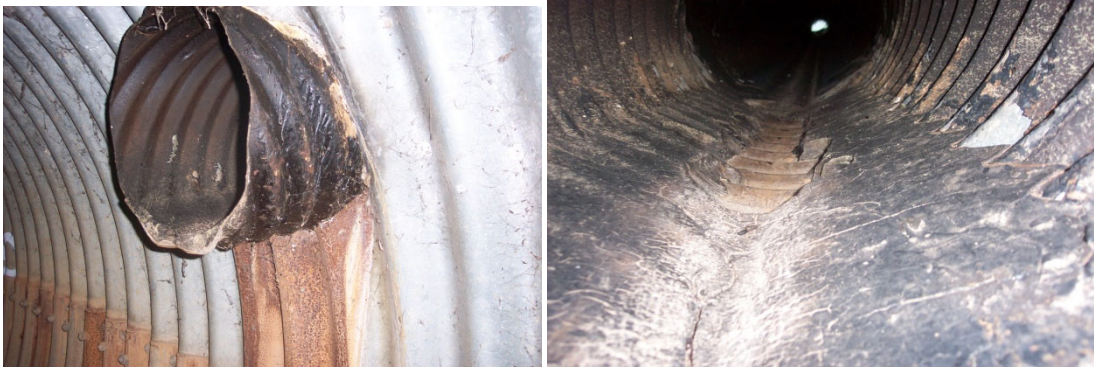
36 Inch Bitumen Coated CMP Tie-In. Note rust stain below from perforated invert. Perforations in invert to 36 inch CMP allowed water to leak behind 96 inch culvert

An 32 inch plastic slip liner was also included into the contract to rehabilitate the 230 foot long, 36 inch diameter, and bitumen coated CMP connecting into the SSPP at the center in the median.

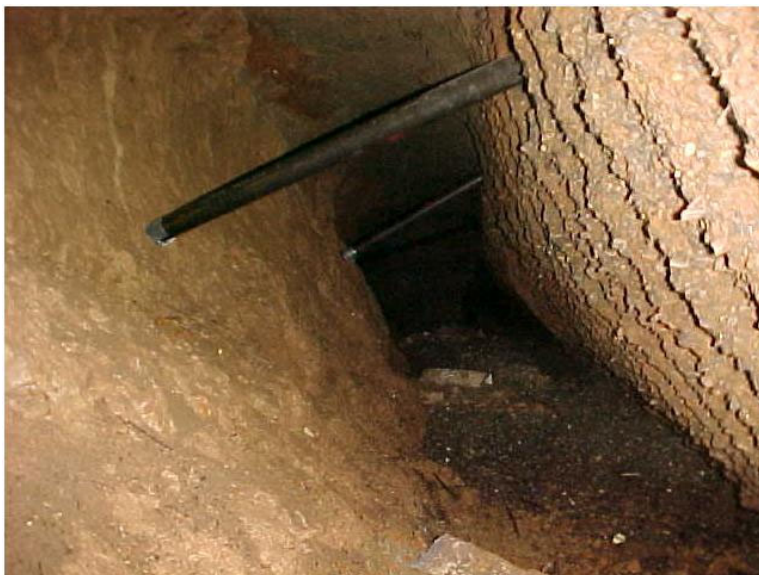
Probing revealed the presence of a large, long void in the backfill between the sinkhole beginning near the midpoint and ending approximately 620 feet from the inlet at the 4

Large, Long Void That Was Located By Probing. Note corroded back side of culvert on right side of picture.

o'clock position. After shotcreting was completed it was decided to core some additional ports and fill the large void with a 3-sack sand slurry prior to contact grouting work previously described. In addition, the long void that was found through probing extended to the surface near the original sinkhole and was also filled with slurry placed from the surface. See below.

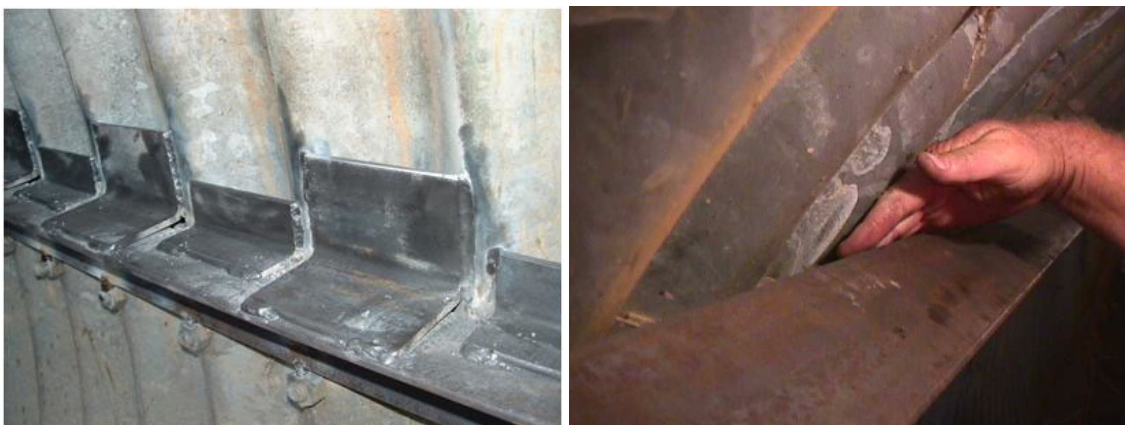
- Thrust transfer design was labor intensive and vertical angle iron design needed modifying in the field to make better contact with pipe (see pictures above); the original design did not work for the field conditions because the deformed host pipe resulted in several areas of poor contact with the longitudinal angle iron (see picture with hand). Therefore, it is incumbent for the designer to make sure their design will meet field conditions.

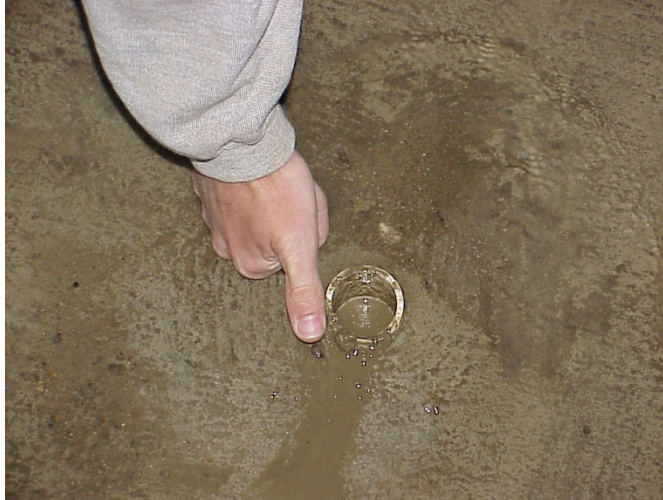
- Design changes made in field by Construction without communication to other units: 3- sack sand slurry in lieu of contact grout design used to fill largest void and decision to introduce “weepholes” in invert that were not shown on the plans (see pictures on following page):

PVC Pipe “Weep” Placed in Rock Below Invert. Later, larger weeps were “cored” in addition in addition to these.

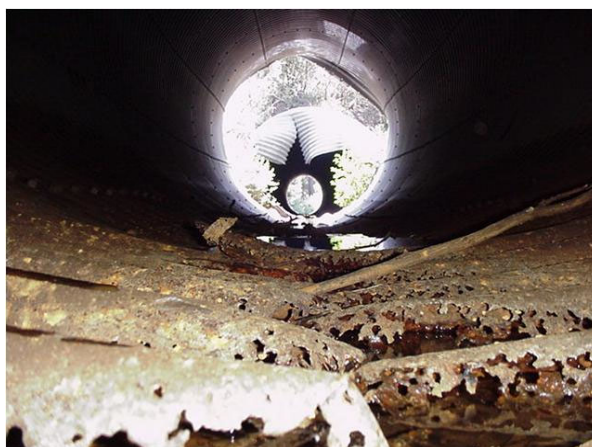
Corroded and Overlapping Invert. Note oval shape of pipe

Due to the deterioration of the invert plate and the subsequent loss of hoop strength, these culverts were deforming at the invert as revealed by a wide variation in cord length measurements (eastbound: 0-15 inches, westbound 0-13 inches) between the edges of the two plates (one edge on either side of the bottom or invert plate) that overlap the invert plate. The loss of chord length represented the amount of deformation in the bottom of the culvert due to external pressures that were no longer resisted by the hoop strength of the culvert at the invert.

Over the years the bottom of the culvert had deteriorated - possibly due to corrosion from de-icing salts placed on the roadway above during winter. Once the pipe had perforated, stream flows could then pass beneath the pipe carrying away soil fines (either within the stream flow or by moving outward into the voids of the courser graded surrounding highway fill material). The as-built plans indicated the freeway fill was constructed with 'shot rock' consisting of larger diameter material than the finer grained and potentially erodible backfill adjacent to the pipes.

The original plan by Maintenance Engineering was to place a reinforced concrete invert lining in each of the culverts with no thrust connection. However, District Hydraulics expressed concerns that the loss of hoop strength may continue to allow these pipes to collapse even farther, therefore, a structural stiffening system was considered in the invert to regain the lost hoop strength.

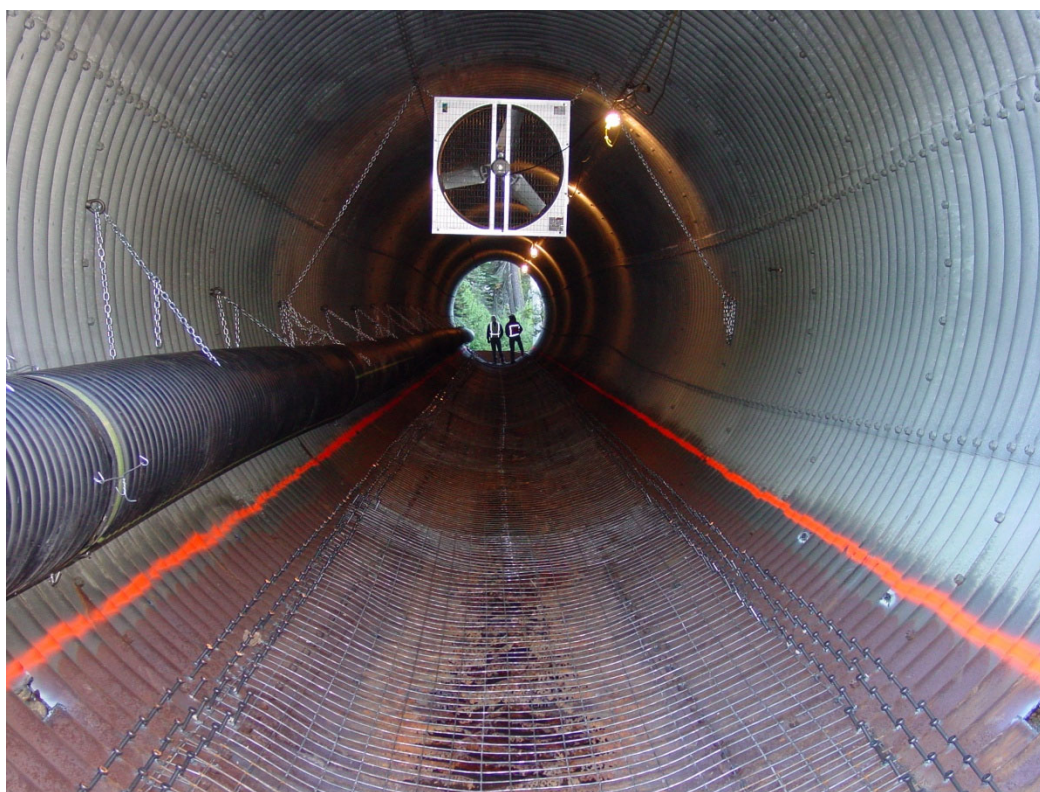
Eastbound Pipe Prior to Concrete Placement with Temporary HDPE By-Pass, WWM and Nelson Studs

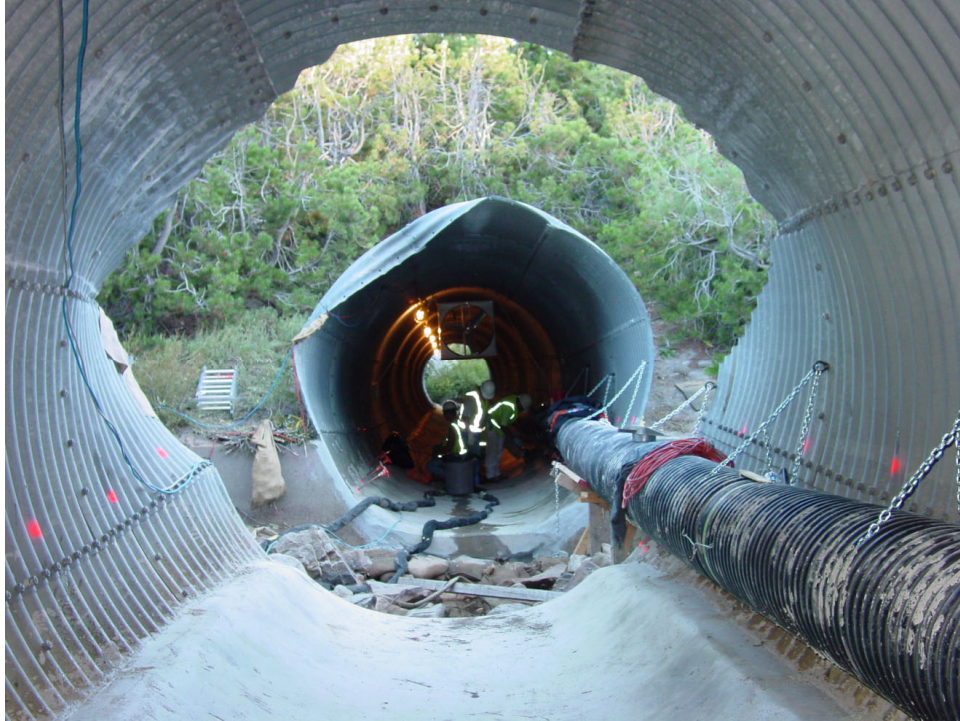
The concrete design for the invert included a 4000 psi compressive strength and 3/8 inch aggregate along with air entraining for the freeze-thaw conditions. The 4-inch thick minor concrete invert lining was limited to the lower quadrant of the culvert (i.e., 90 degrees coverage from the 4:30 to 7:30 clock positions).

The voids directly below the invert were filled with the same concrete.

View of Both Pipes After Concrete Invert Paving

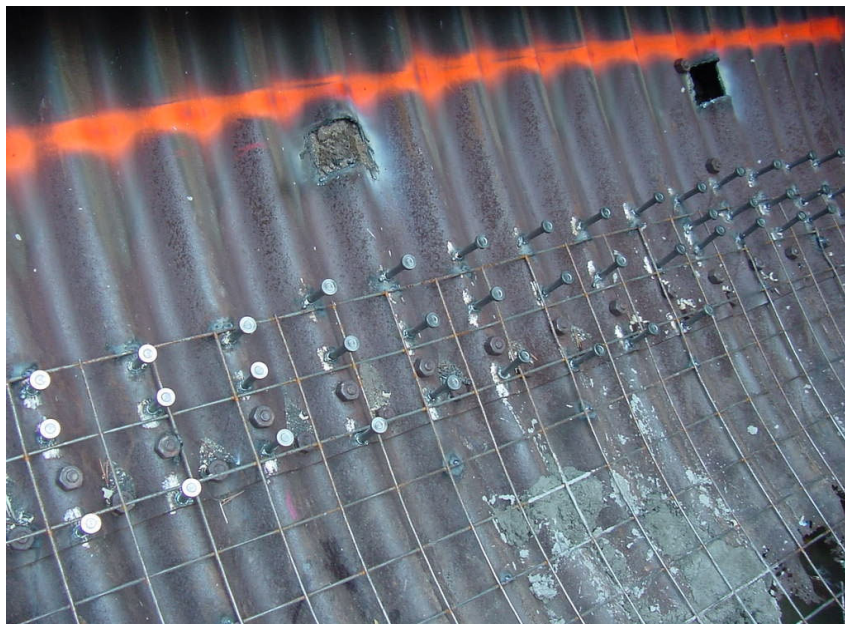
Before paving the invert, coupons were cut into the culvert wall in order to probe for voids. Most of the voids found were below the springline, however, a significant void was discovered near the outlet of the eastbound pipe above the springline at the 10 o' clock position. In both pipes the most significant voids were found at the inlet.

Coupons Cut in Sidewall of Culvert for Probing and Grouting

A decision was made to use polyurethane foam grout rather than cementitious grout to fill the voids behind the culvert. The decision to use polyurethane grout was based primarily on the fact that an agreement with the cementitious grouting contractor regarding Force Account rates could not be reached. Furthermore, the District already had a Maintenance service contract with a company called Uretek for slab jacking and had some success with the material for jacking operations (including this site in January 2003). Although the foam has been used in PCC slab raising work for several years on many California State Highways, there were concerns that the Uretek foam may have environmental impacts and durability issues, since it had not been used for this type of application. The Resident Engineer explained the environmental concerns with cementitious grout migrating into the creek during placement and stated that Uretek had provided data showing the foam to be inert and that it would not leach into the creek. This material is supposed to be inert in a live stream environment and will not absorb water. When first placed, high-density polyurethane rigid closed cell hydro-insensitive grout is supposed to form a mechanical seal by expanding twelve times its liquid volume in 8-12 seconds.

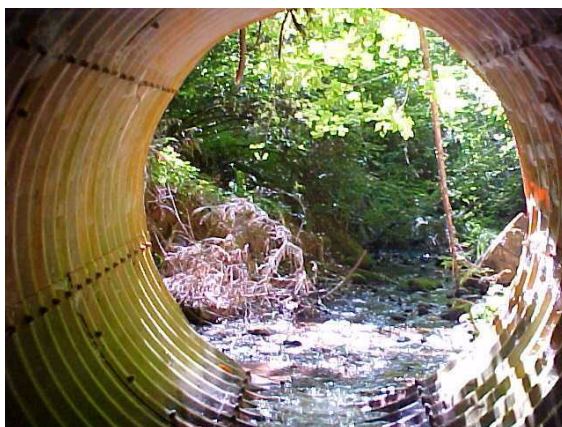
Inlet of Original Pipe

Inside the culvert, corrosion, a perforated invert (up to 0.5 inch perforations) and missing nuts and bolts from the steel plating were observed as a result of the corrosion. Also, the bolt pattern of the steel plates were originally constructed “in-line” with each adjacent plate instead of being offset, which might have contributed to structural weakness.

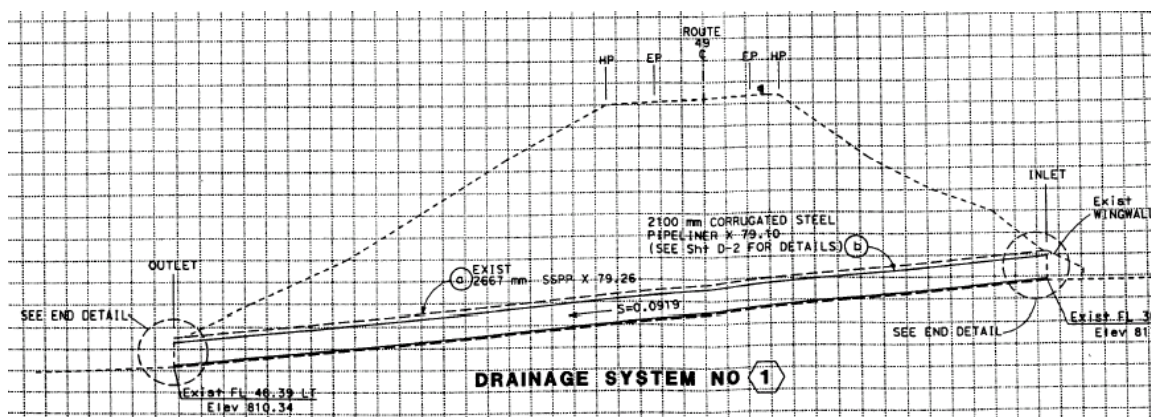
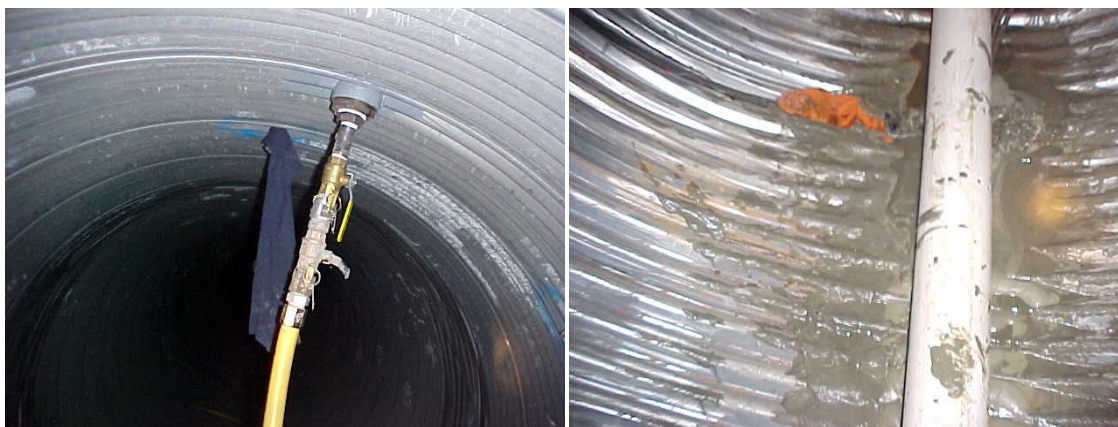
The resulting hydrostatic pressure at the downstream end from continuous grouting of the annular space between the existing culvert and the 84-inch CSP liner placed inside caused the liner to float and buckle with grout leaking out of the liner's joints which had been specified as watertight with gaskets. The grouting operation was immediately stopped and a Contract Change Order (CCO) was developed.

Grouting Through Grout Port in Soffit of Liner

Grout from Leaking Joints in Invert

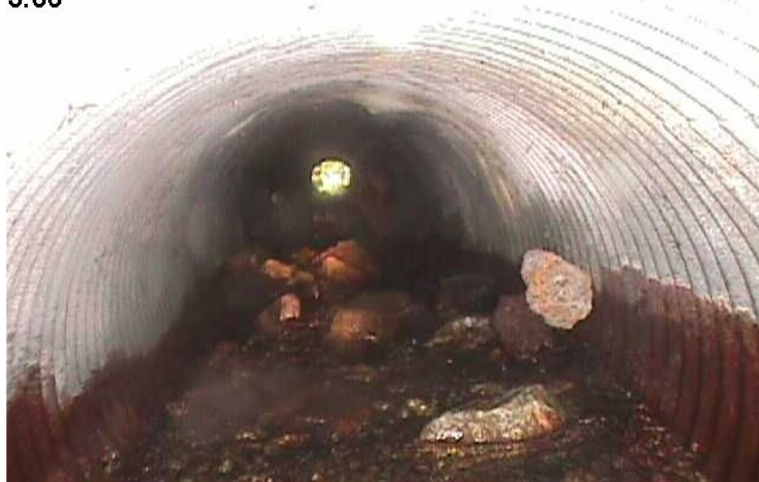
Video Inspection Photo

Originally installed in 1974, a 10 gage CMP has a maximum cover of approximately 50 feet, and a slope of 12.3%. Inspection photos taken in 2004 indicate a stained invert but no perforations. The culvert barrel shape and joints were deemed “in good condition”. In 2007 a video inspection was performed, and the inspection report indicated:

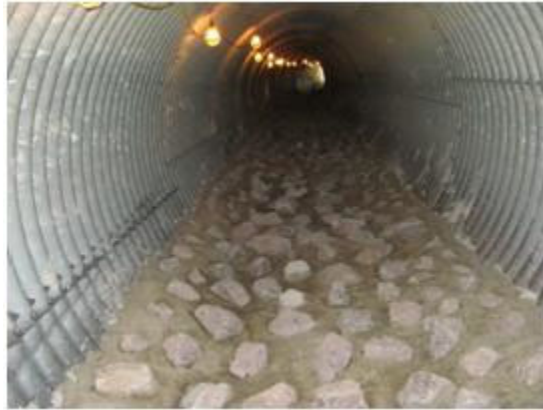
Abrasive Channel Materials and Worn Invert

Worn Invert (Abrasion) Before and After Repairs

In this case there was enough available headwater elevation at the site to accommodate a concrete invert lining thickness of up to 15 inches and concreted rock slope protection with Class II rock for the concreted rock grading from Section 72-3 of the Standard Specifications because it compared well with the maximum bedload size (see photos).

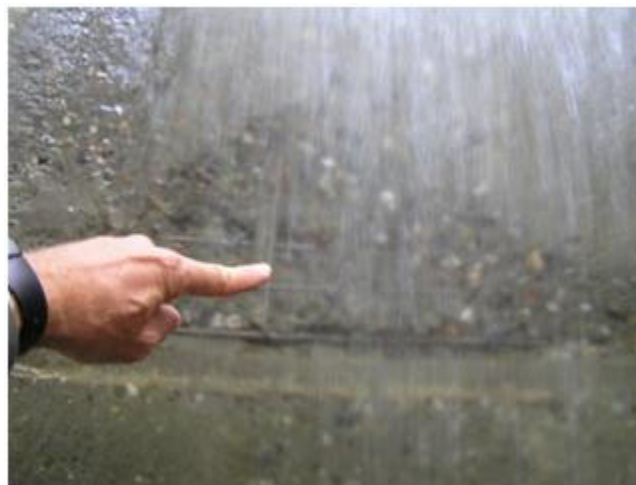
By 2011 the new pipe barrel was prematurely experiencing excessive invert wear and some of the steel reinforcement was exposed immediately downstream of the last joint. Therefore the RCP had already reached the end of its 'maintenance free' service life after just 5 years and the concrete had worn at least an inch and was in need of repairs. See photo below.

Exposed Steel Reinforcement

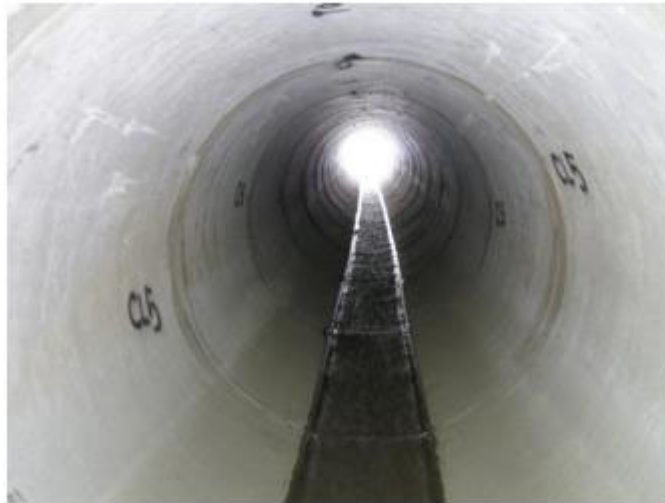
For the existing RCP (see photo below), the estimated wear rate of the 1-inch concrete cover was a simple calculation based on 5 years until first exposure of the steel reinforcement. The estimated wear of the concrete is 1-inch/5 years or 200 mils/year (0.2 in/year).

Existing 84 inch RCP Replacement at 5 years

From HDM Tables 855.2D and 855.2A, 1.9 mils/year anticipated wear for the steel indicates the abrasion level was 5 and RCP is generally not recommended. Therefore, to provide the required 50 year service life for repairs to the RCP invert, the following options were recommended:
