DESIGN INFORMATION BULLETIN NO. 83 - 04  
CALTRANS SUPPLEMENT TO FHWA CULVERT REPAIR  
PRACTICES MANUAL

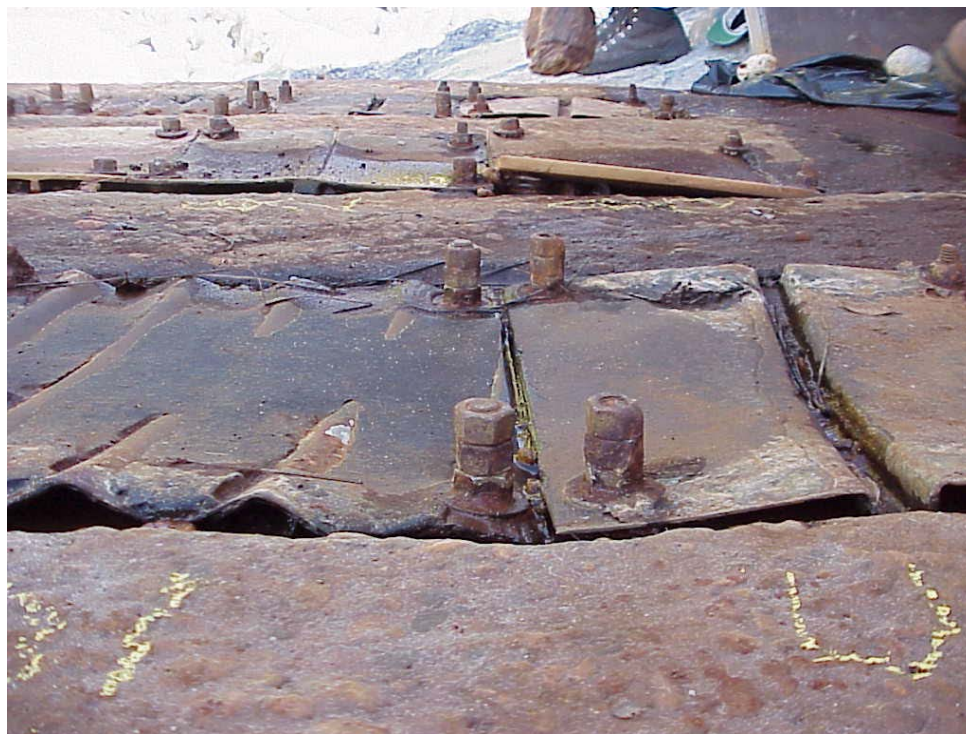
**Various Culvert Material Test Panels Shown Above After 1 Year Of Wear At Site With Moderate To Severe Abrasion (Velocities Generally Exceed 10 ft/s, See Table Next Page). Note: the significant wear to abrasive resistant protective coatings, which, would typically not be recommended under these conditions (see table next page). The bed load material composed of 90% quartz sand. Also note the wear on the leading edges (right) of the steel nuts.**

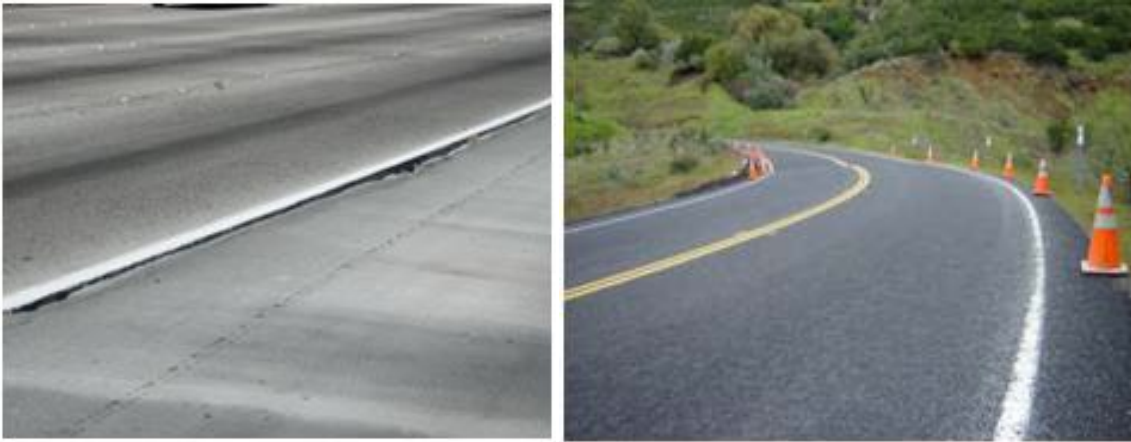
- a) Evaluate the roadway for cracks or depressions:

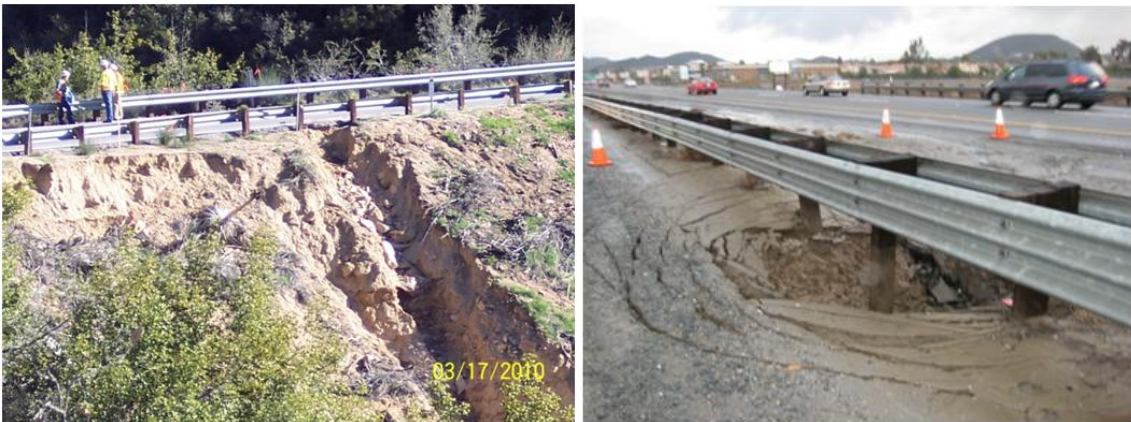
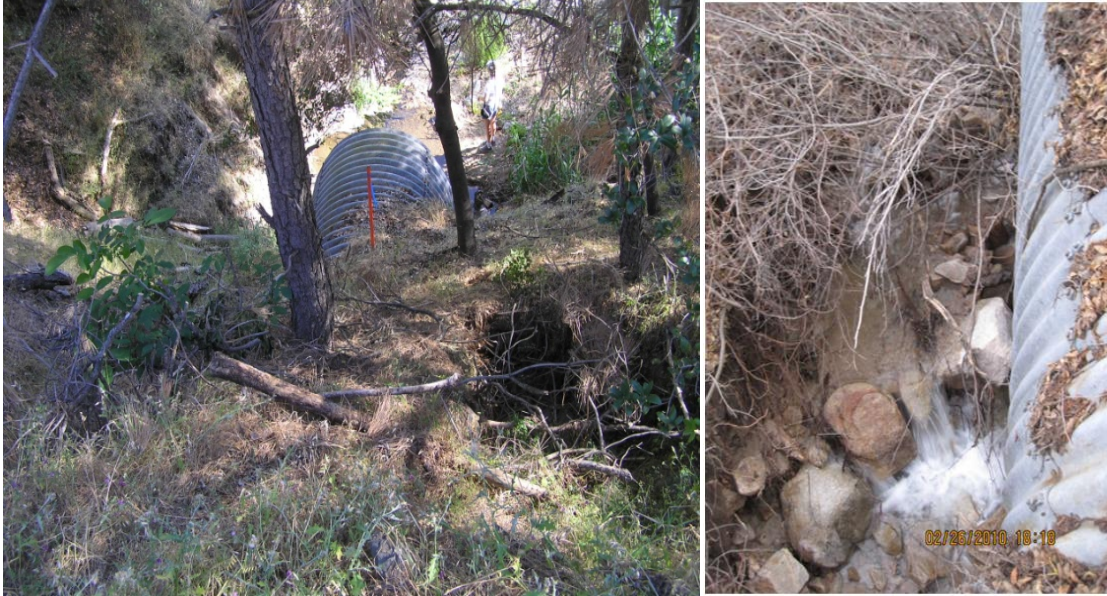
- b) Evaluate the embankment and median for depressions, sinkholes, scour or piping:

Further investigations by Geotechnical Design may be needed. Refer to Index 7.1.6.3 for coordinating with Geotechnical Design.

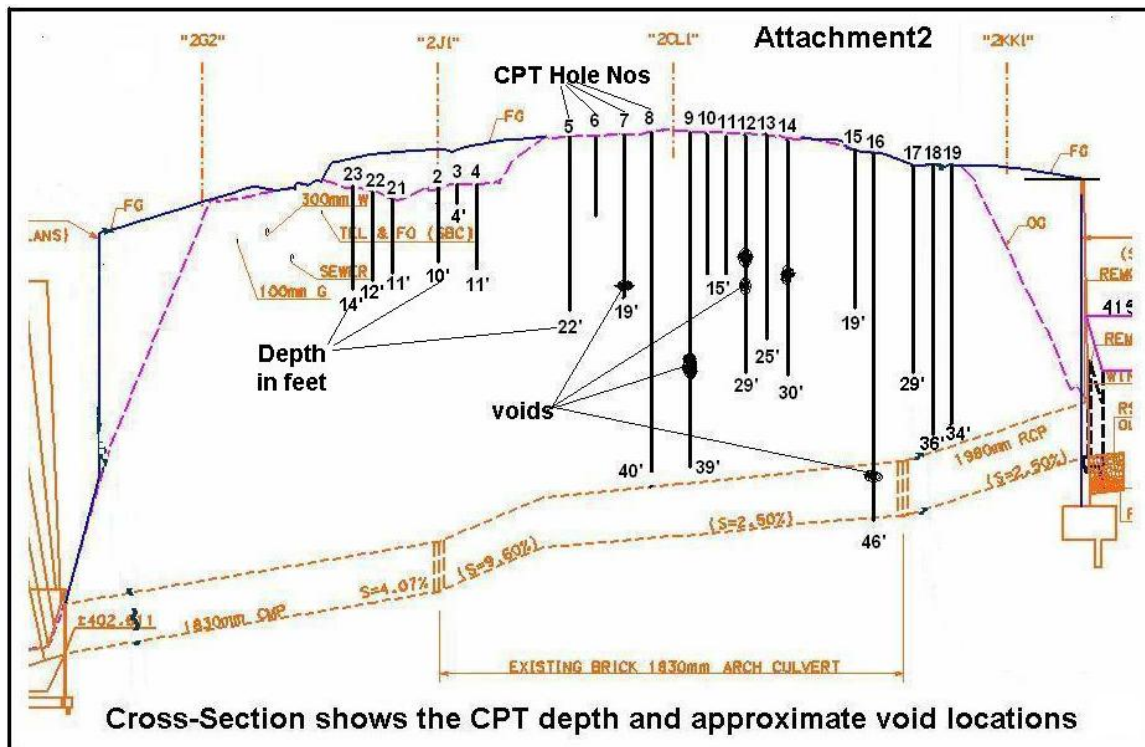
When the water table is higher than the culvert invert, water may seep into the culvert between storms. Infiltration can occur during flood events by suction from pressure differentials in inlet control culverts. If voids in the backfill are discovered during the field review, the most likely cause of soil loss is the migration of soil fines from infiltration - either through a worn invert or leaking joints. It is important to investigate the full extent of the voids. In human entry culverts this may simply involve performing hammer soundings (if metal pipe) along with a thorough evaluation of the roadway and the embankment for cracks, depressions, sinkholes, scour or piping. In non-human entry culverts that are inspected by camera, if symptoms such as a worn invert or open joints are present, the same thorough evaluation of the roadway and the embankment must be performed. However, if the full extent of the voids or their cause (e.g. groundwater) is still unknown, further investigations by Geotechnical Services may be needed. See below.

#### **Void Detection in the Roadway Prism by Geotechnical Services with Cone Penetrometer**

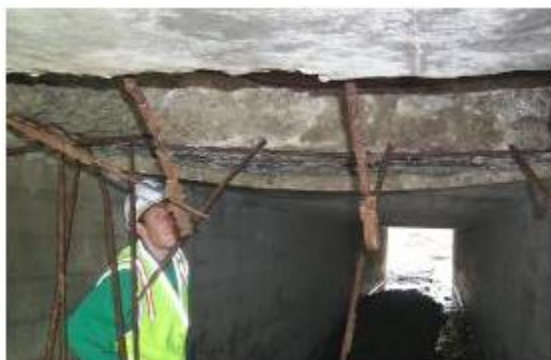
**Failed Crown in Reinforced Concrete Box Culvert**

Precast concrete culverts may sustain damage in their crown section due to the depth of cover being too shallow to adequately support and distribute vehicle live loads. The result may be cracking, spalling and distortion in the crown area. Some information on procedures that may be used to repair such problems is provided in Appendix B-37 of FHWA Culvert Repair Practices Manual Volume 2. For severe cases of crown deterioration (see photo), replacement may be necessary.

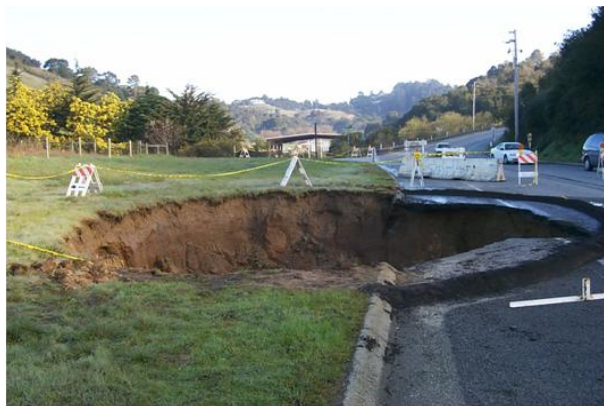
A variety of external loads and changing soil conditions may cause joints to open allowing backfill infiltration and water exfiltration, however, this is unlikely if the proper bands are used. Key factors in the inspection of joints are indications of backfill infiltration and water exfiltration causing erosion of surrounding soil resulting in surface holes or pavement deflections. See Index 11.1.1.

**Sink Hole Damage (Location Unknown)**

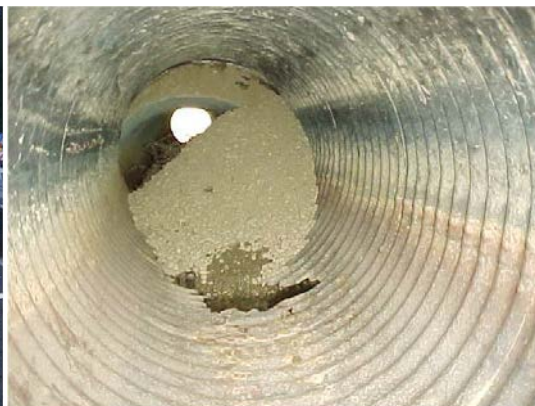
**Loss of Backfill Fines**

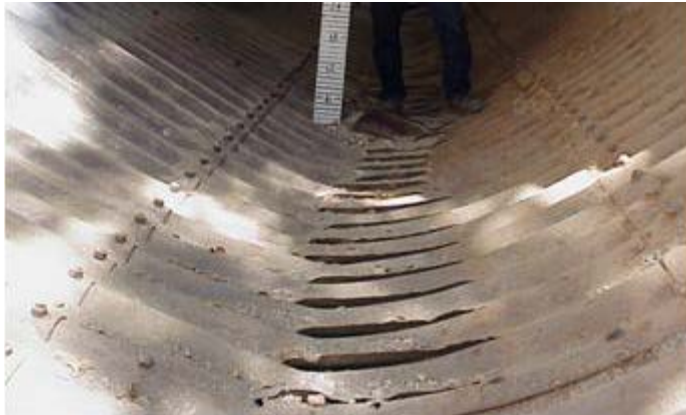
**Worn Invert on Leading Edge (To Flow) of Corrugations Caused by Abrasion**

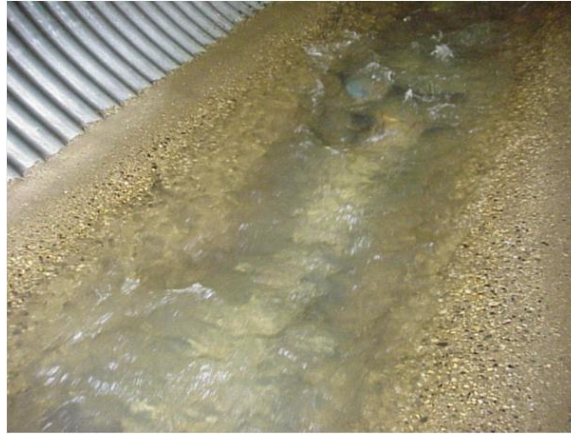
**(Above) Example of Insufficient Concrete Invert Paving Design Thickness for Abrasion Level 6**

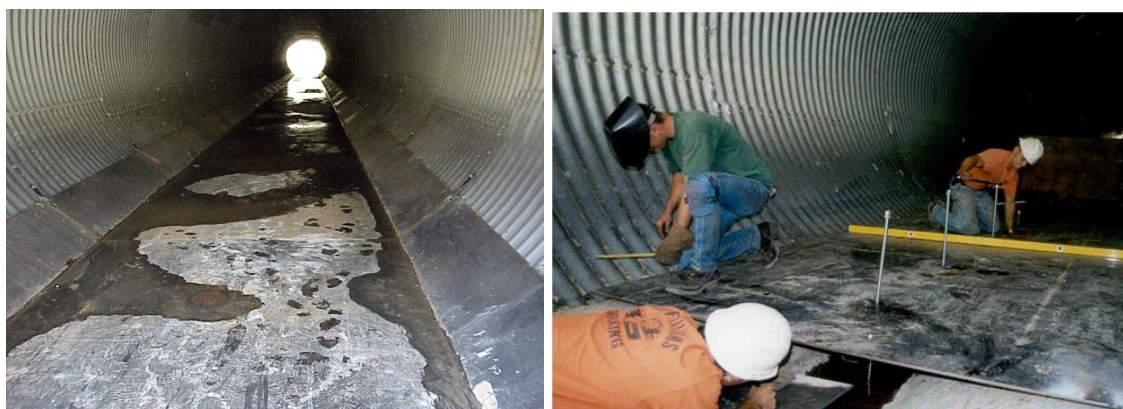
**Finished 0.375-inch Thick Steel Plate Invert**

**Workers Placing Steel Plates (See Detail Below)**

In locations with severe abrasion (see Index 2.1.2.3) a viable option to invert paving with concrete may be to armor plate the invert with steel plates (thickness between 0.25 inch and 0.50 inch). See HDM Table 855.2F. This method is used in large diameter pipes that can accommodate a reduction in waterway area. The smooth, wide invert spreads wear over a greater area and is less of an impediment to flow than corrugated metal. It is important to securely attach steel armor plates to the host pipe. See 03-Nev-49 pictures below of 0.375 inch thick steel armor plate example at Shady Creek that replaced a concrete invert lining.

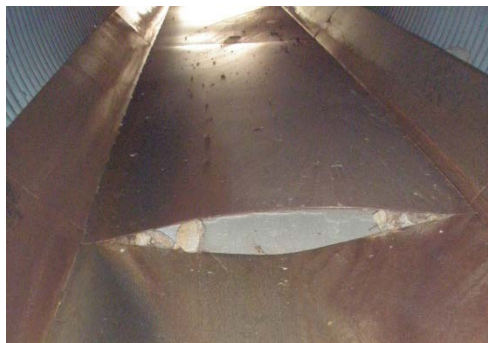
**Insufficient Anchorage with No End Treatment**

**Example Steel Armor Plating Detail. To prevent piping under the steel plate, it is important to provide end treatment details – particularly at the upstream end. See details below and post-construction photo of 120 inch SPP on Sbd 330 where end treatment was not part of the design.**

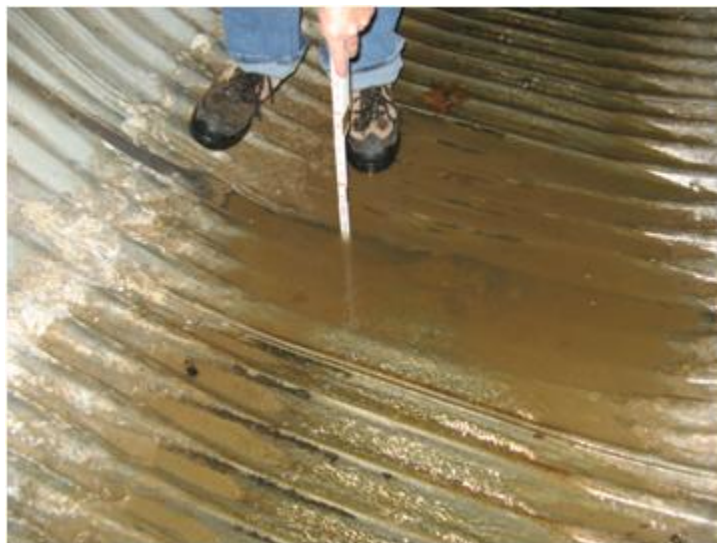
**Backfill Fines Infiltrating Through CMP Joint**

When the pipe is located beneath the ground water level, consideration must be given to the possibility of loss of side support through soil migration (the conveying by groundwater of finer particle soils into void spaces of coarser soils). Generally, migration can occur where the void spaces in the pipe backfill are sufficiently large enough to allow the intrusion of eroded fines from the trench sidewalls. For migration to occur, the in-situ soil must be erodible, and there must be a flow path for the water. Normally, erodible soils are fine sands and silts and special clays. This situation is exacerbated where a significant gradient exists in the ground water from the outside of the trench towards the inside, i.e., the trench must act as a drain, and/or the pipe joints are not watertight (see Highway Design Manual 854.1(2) – Joint Performance – Watertight Joint).

As a remedial measure for such anticipated conditions, depending on the amount of shape distortion, cementitious grouting, or a combination of expansion rings (refer to previous discussion for sealing culvert joints with expansion ring gaskets or repair sleeves under Index 5.1.1.1.3.2), and Slurry Cement pressure grouted backfill in lieu of Structure Backfill, or a combination of Structure Backfill with Filter Fabric (only if external access is feasible) is recommended. See Index 6.1.2. Grouting Voids in Soil Envelope. Also see appendices B-26 and B-34, FHWA Culvert Repair Practices Manual Volume 2 for procedures for sealing culvert joints and repair at a distorted section.

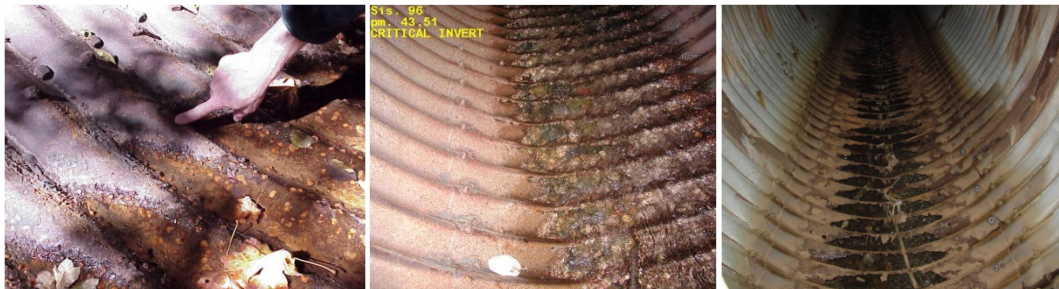
Corroded inverts in metal pipe will visually appear much differently than those worn by abrasion. Corrosion will first manifest itself inside the culvert as rust with nodules and pitting. See first photo below. The first perforations may appear in a much wider area related to the flow-line compared to when abrasion is the primary wear factor. For example, in the middle photo below, the first perforations are occurring on either side at the outer edge of the darker wear zone. The wear pattern of a severely corroded CMP invert will appear to have rough edges and often has strands of metal remaining at 6 o'clock. See third photo below.

#### **Progressively Corroded CMP Inverts**

The dark, stained, wear zone present in most worn metal pipes usually indicates the limit of exposed steel where the galvanizing layer has worn away. Even in nonabrasive flows, most galvanizing exposed to frequent flow generally lasts a maximum of 10 years.

Corrosion on the backside may be present if rust stains inside the pipe are present around joints and seams outside (i.e., above) the general flow zone. See third photo above.

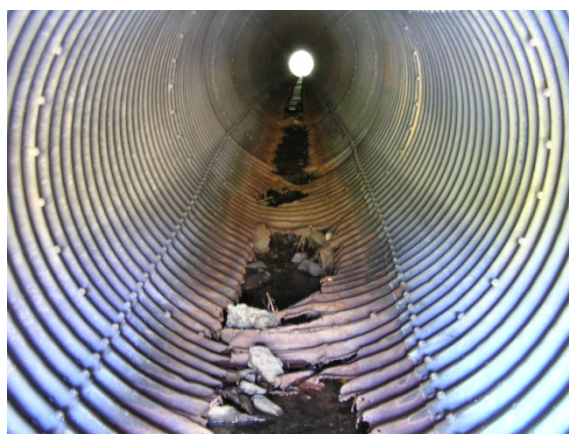
The overall condition of the culvert should be assessed, as well as the soil-pipe conditions that caused the deformation to occur (e.g., corrosion, abrasion, poor compaction, open joints, etc...). Symmetrical deflection of the crown may be indicative of problems with support of the bottom of the culvert or insufficient backfill/cover over the top of the culvert. Unsymmetrical deformation of the top of the culvert may be the result of loss of soil support on one side of the bottom (potentially from problems due to infiltration, infiltration and piping at joint(s) or perforated invert) or improper compaction of the backfill on one side of the culvert. Thus the shape may not be symmetrical for either the entire length of the culvert or individual sections of it. Therefore, the conditions that caused the deformation must be assessed and the rehabilitation plan must include correcting the underlying problem. See Appendix B-34, FHWA Culvert Repair Practices Manual Volume 2, for procedures for repair at a distorted section.

**Shape Distortion Caused by Backfill Soil Loss**

The decision to repair (re-compact embedment material, grout voids, repair joints or line invert) versus replace the culvert by trenching and cover or by other trenchless methods such as jacking or pipe-ramming, is dependent in part on the structural integrity of the culvert. If the culvert must be replaced, the decision to replace by trench and cover versus other trenchless methods will be influenced by cost, the need to maintain traffic during

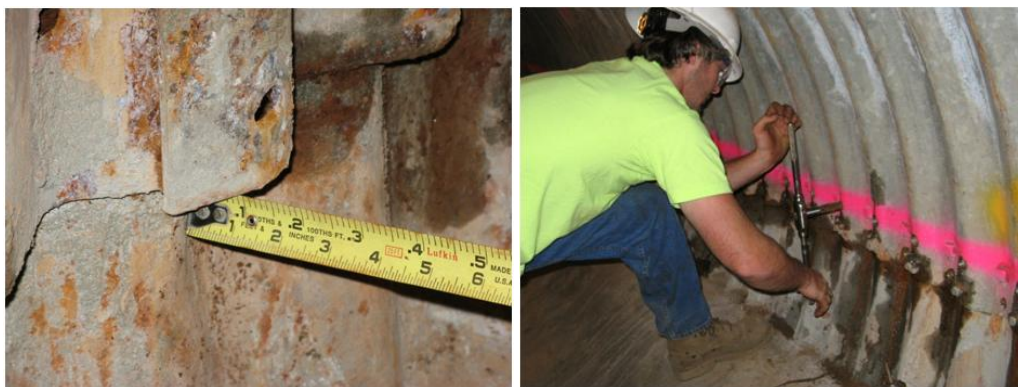
The longitudinal seams of structural steel plate culverts are subject to displacement and cracking due to incorrect assembly of the plates and differential soil pressures or most commonly, if there is instability in the backfill caused by infiltration.

Repairs are made by splicing, re-bolting (see pictures below) or welding with reinforcing steel to the inside corrugation valleys at the location of seam distress. See Appendix B-38, FHWA Culvert Repair Practices Manual Volume 2.

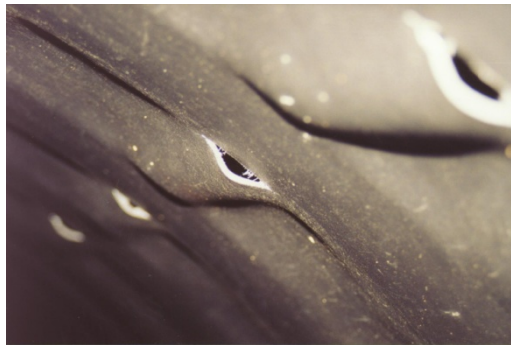
**Splitting of 60 inch Diameter Pipe. This Pipe was Installed in 1996 by Another State**

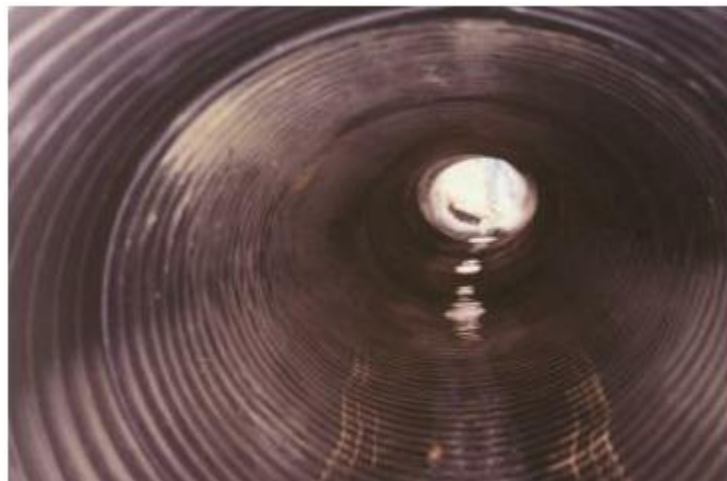
Profile of pipe: Note wall buckling and obvious oval shape. This 42 inch diameter pipe was installed in 1994. The pipe is 82 feet long and has a maximum cover of about 10 feet. Separations of the joints ranged from 1 to 3 inches. Rippling of the sidewalls is apparent throughout the length of the pipe (see below).

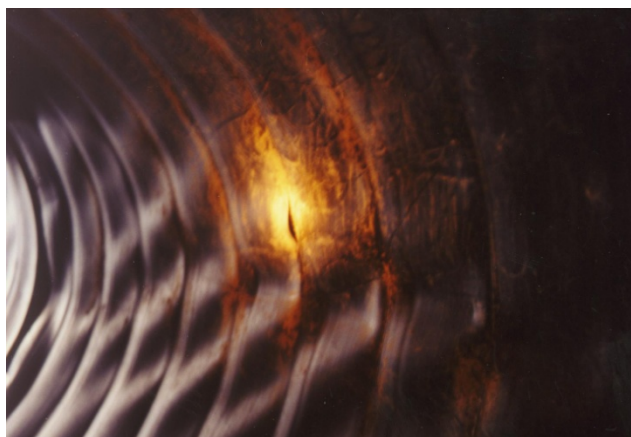
**Small Crack and Wall Rippling**

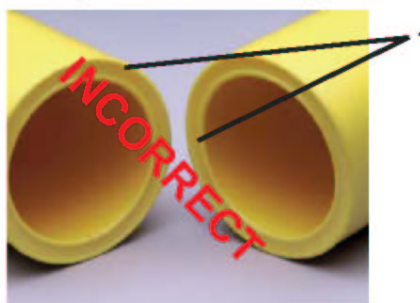
**Figure 2 Unacceptable Concave Melt Appearance**

*A concave melt surface is unacceptable; it indicates pressure during heating. (See Figure 2). Do not continue. Allow the component ends to cool and start over at Step 1.*

**1. Unacceptable concave melt appearance.**

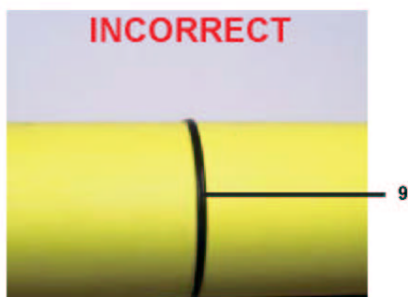
9. Insufficient heat time; melt bead too small

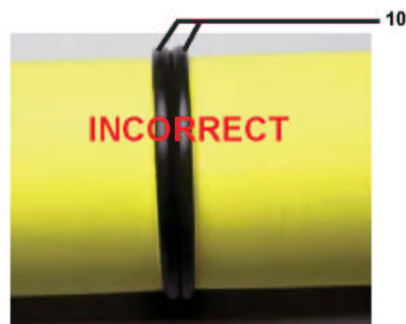
10. Excessive heat time or pressure applied during heating; melt bead too large

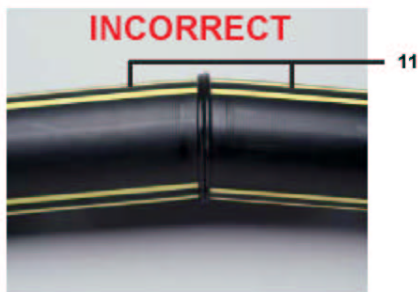
11. Pipe angled into fusion unit

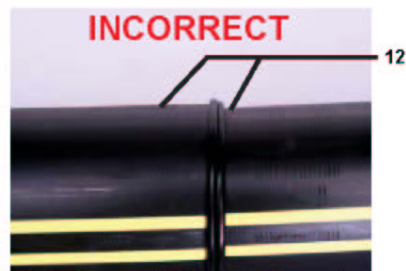
12. Improper "High-Low" alignment

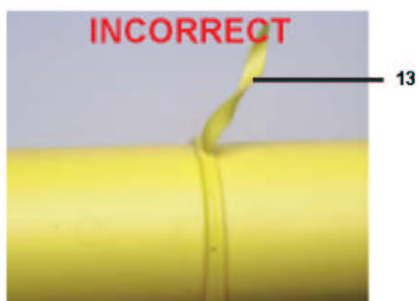
13. Incomplete face off or failure to remove faced off ribbons

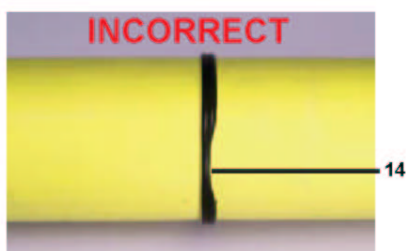
14. Incomplete face off

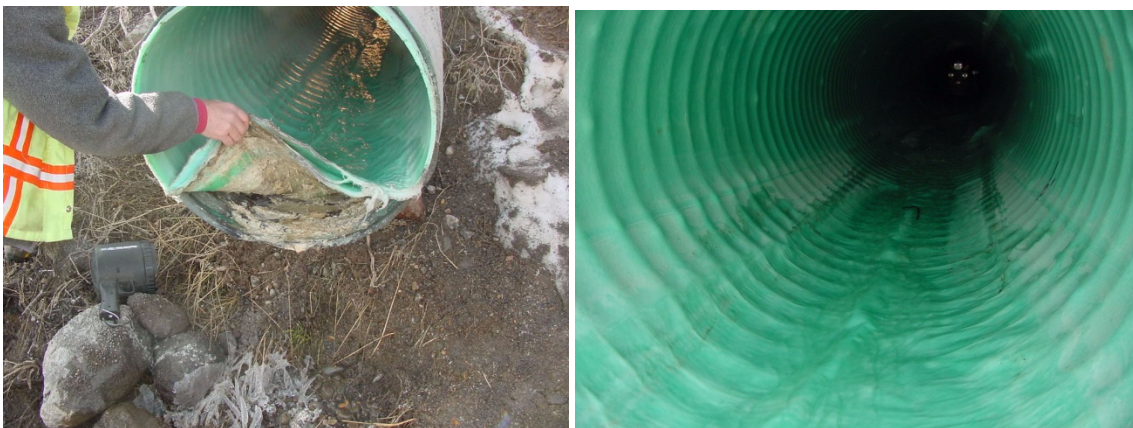
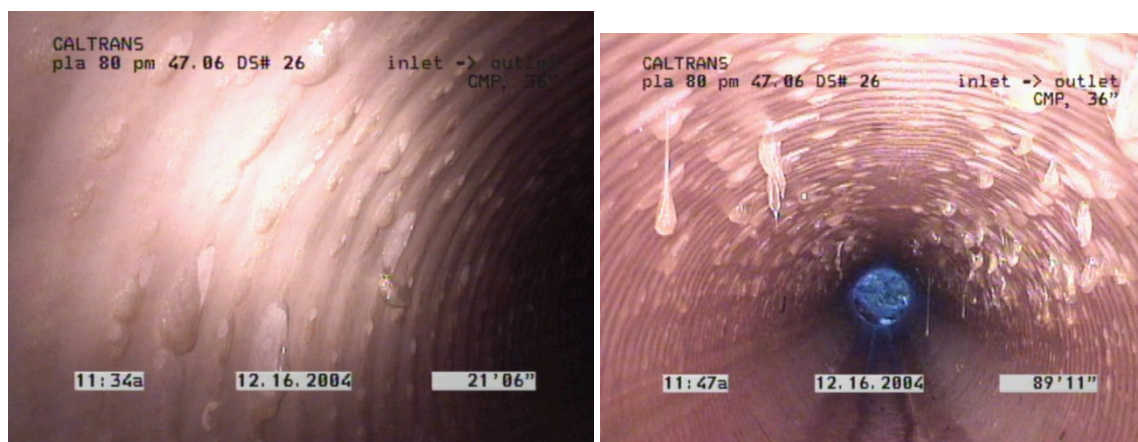
**Examples of Delamination, Bubbling and Rippling in Lined CMP Host Pipes**

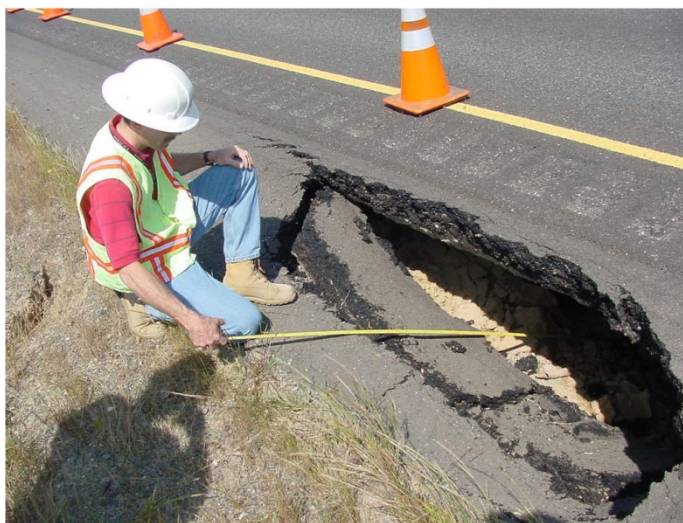
#### Measuring the Sinkhole

In June 2003, a sinkhole was identified by maintenance adjacent to the number one lane of the westbound traveled way on Highway 50 in El Dorado County at Post Mile 14.0 just east of El Dorado Road Overcrossing (Br. No 25-76) in the vicinity of a 96 inch Structural Steel Plate Pipe (SSPP). This section of Highway 50 was constructed 35 years prior. The 820 foot long SSPP was constructed as a cross drain for Indian Creek which was realigned from its original location to the east and uphill. A 230 foot long 36-inch diameter bitumen coated CMP connects into the SSPP at the center in the median and a 56 foot long 18-inch diameter CMP connects into the SSPP approximately 150 feet from the outlet. Both pipes collect drainage from the north side of the freeway and outlet into the SSPP.

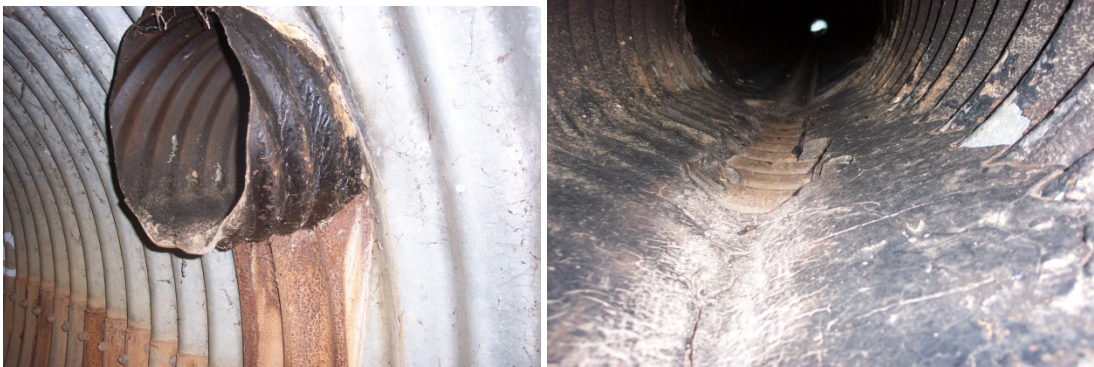
**36 Inch Bitumen Coated CMP Tie-In. Note rust stain below from perforated invert. Perforations in invert to 36 inch CMP allowed water to leak behind 96 inch culvert**

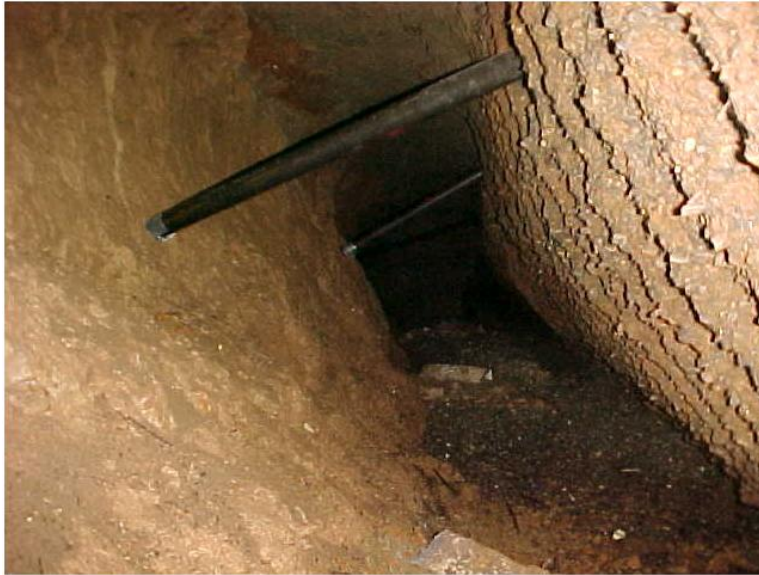
Probing revealed the presence of a large, long void in the backfill between the sinkhole beginning near the midpoint and ending approximately 620 feet from the inlet at the 4

**Large, Long Void That Was Located By Probing. Note corroded back side of culvert on right side of picture.**

o'clock position. After shotcreting was completed it was decided to core some additional ports and fill the large void with a 3-sack sand slurry prior to contact grouting work previously described. In addition, the long void that was found through probing extended to the surface near the original sinkhole and was also filled with slurry placed from the surface. See below.

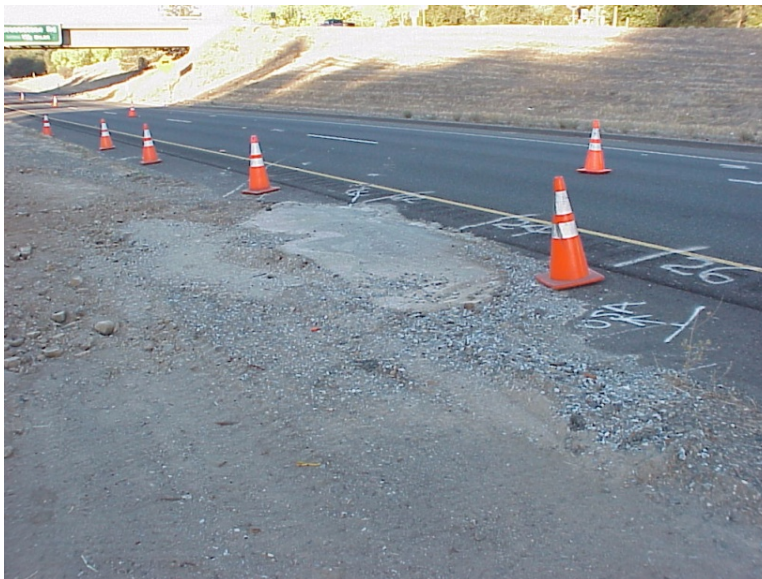
**Freshly Placed Slurry where Void Migrated to Surface**

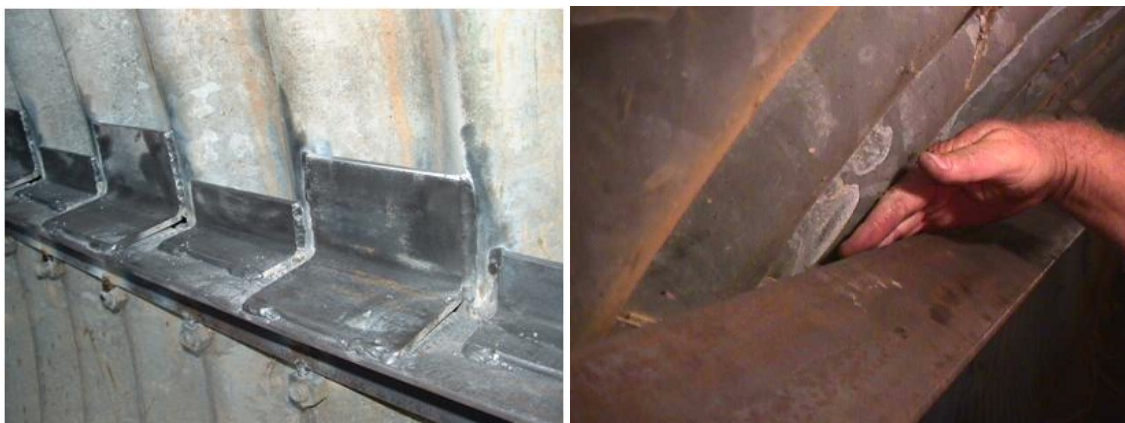
- Thrust transfer design was labor intensive and vertical angle iron design needed modifying in the field to make better contact with pipe (see pictures above); the original design did not work for the field conditions because the deformed host pipe resulted in several areas of poor contact with the longitudinal angle iron (see picture with hand). Therefore, it is incumbent for the designer to make sure their design will meet field conditions.

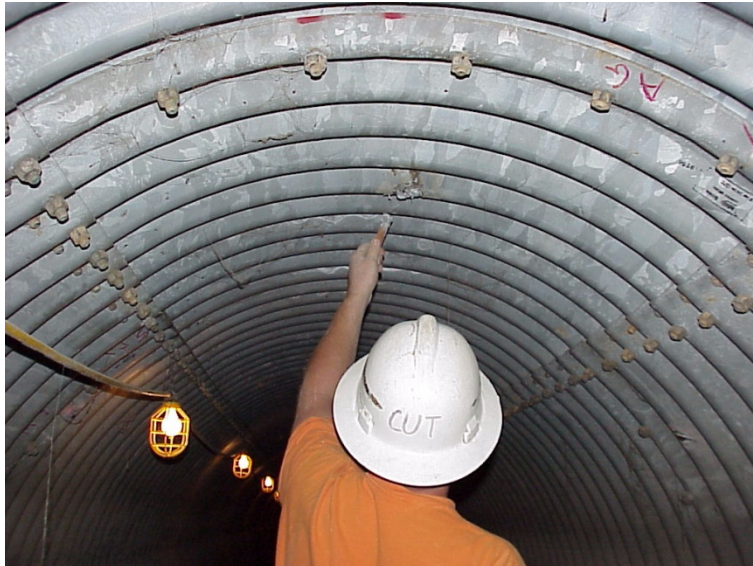
- Repairs from CPT testing damage should be included in contract (see picture next page):

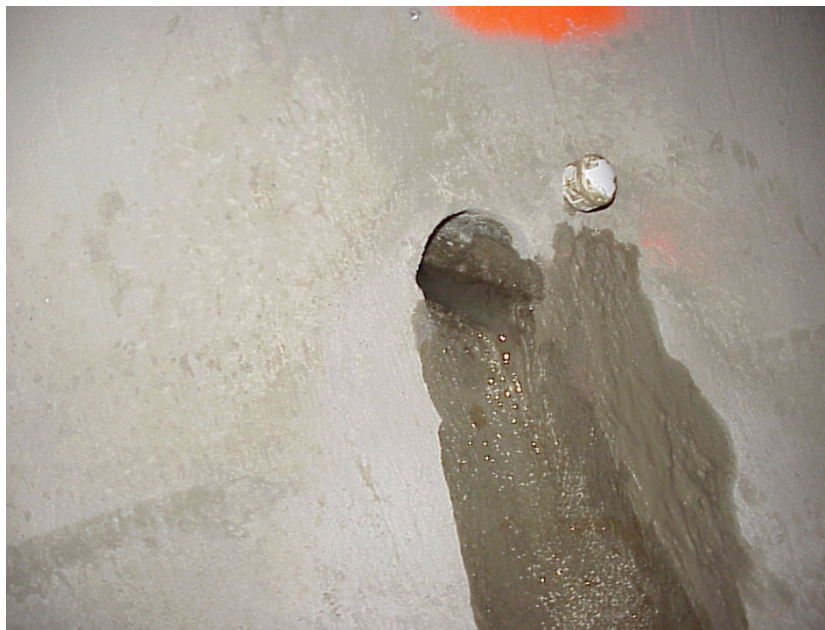
- Design changes made in field by Construction without communication to other units: 3- sack sand slurry in lieu of contact grout design used to fill largest void and decision to introduce “weepholes” in invert that were not shown on the plans (see pictures on following page):

**“Cored” Grout Hole in Shotcrete Used to Fill Large Void with 3-Sack Sand Slurry Leaking Groundwater During Contact Grouting. Note capped contact grout port.**

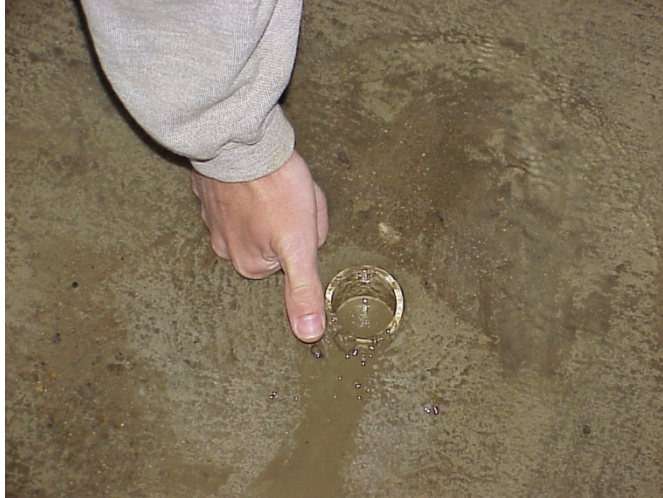
**PVC Pipe “Weep” Placed in Rock Below Invert. Later, larger weeps were “cored” in addition in addition to these.**

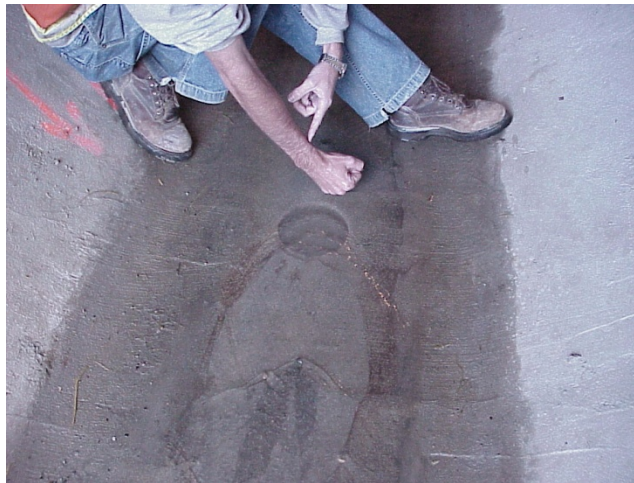
**Cored Weep in Shotcrete Invert**

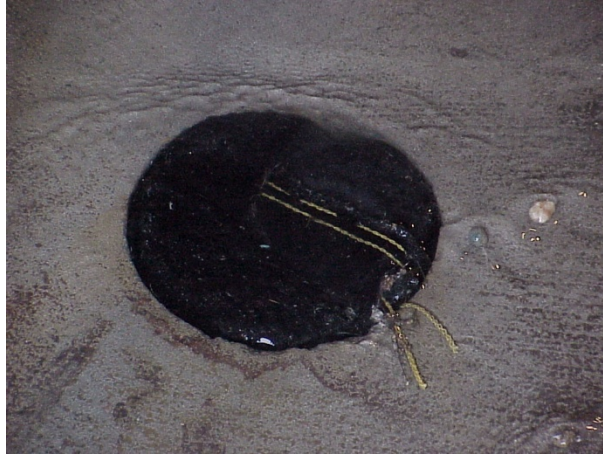
**Installed Gravel Filter Bag in Invert Weep**

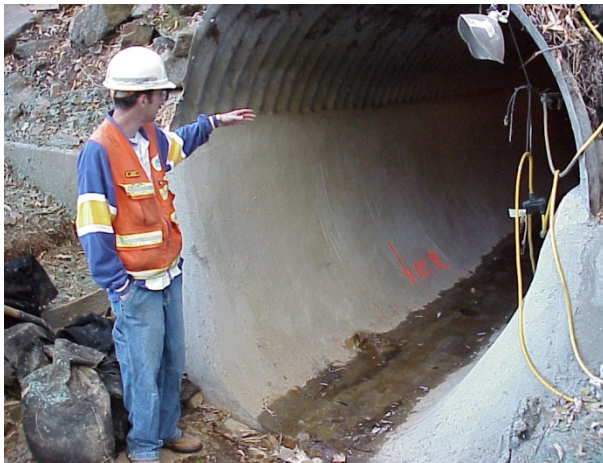
**Outlet of 96-inch Pipe After Repair**

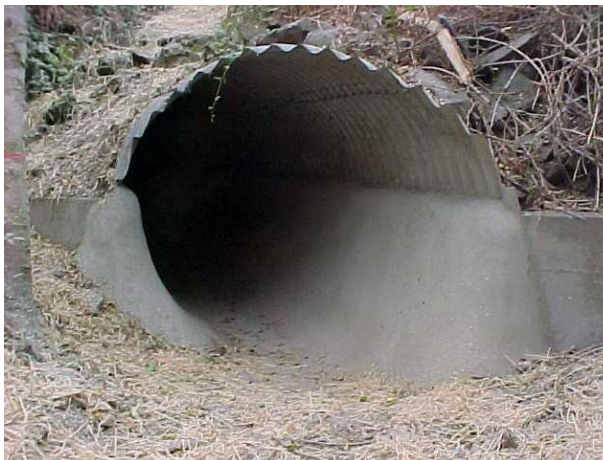
**Inlet of 96-Inch Pipe After Repair**

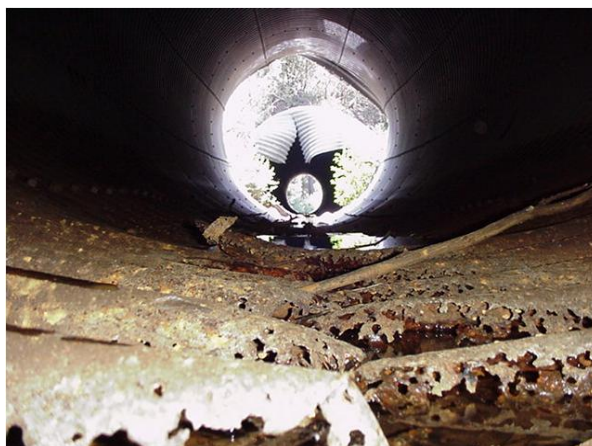
**Corroded and Overlapping Invert. Note oval shape of pipe**

Due to the deterioration of the invert plate and the subsequent loss of hoop strength, these culverts were deforming at the invert as revealed by a wide variation in cord length measurements (eastbound: 0-15 inches, westbound 0-13 inches) between the edges of the two plates (one edge on either side of the bottom or invert plate) that overlap the invert plate. The loss of chord length represented the amount of deformation in the bottom of the culvert due to external pressures that were no longer resisted by the hoop strength of the culvert at the invert.

Over the years the bottom of the culvert had deteriorated - possibly due to corrosion from de-icing salts placed on the roadway above during winter. Once the pipe had perforated, stream flows could then pass beneath the pipe carrying away soil fines (either within the stream flow or by moving outward into the voids of the courser graded surrounding highway fill material). The as-built plans indicated the freeway fill was constructed with 'shot rock' consisting of larger diameter material than the finer grained and potentially erodible backfill adjacent to the pipes.

As the fine material from beneath the pipe was evacuated, fill from the midline of the pipe could then settle down to fill the void left by the lower evacuated material. Surrounding and surface fill material would then begin to settle into the voids left by the fill that used to surround the midline of the pipe. The structural section beneath the PCC slabs began to fail and settle in and fill the voids of the settled fill material. The PCC slabs were left bridging the void left by the failed structural section. Ultimately, the slabs began to settle unevenly and created the surface dip.

It was concluded that corrosion was far more problematic than abrasion as a contributor to the invert perforation. Invariably, the corrugation valleys were what was perforated and not the corrugation crests. In addition, while there was some wear apparent on the connecting nuts/bolts that were in the invert, the extent of upstream side wear was very slight - again indicating that while there is/was enough abrasion to remove the zinc coating, it was not severe and some chemical action is attacking the steel.

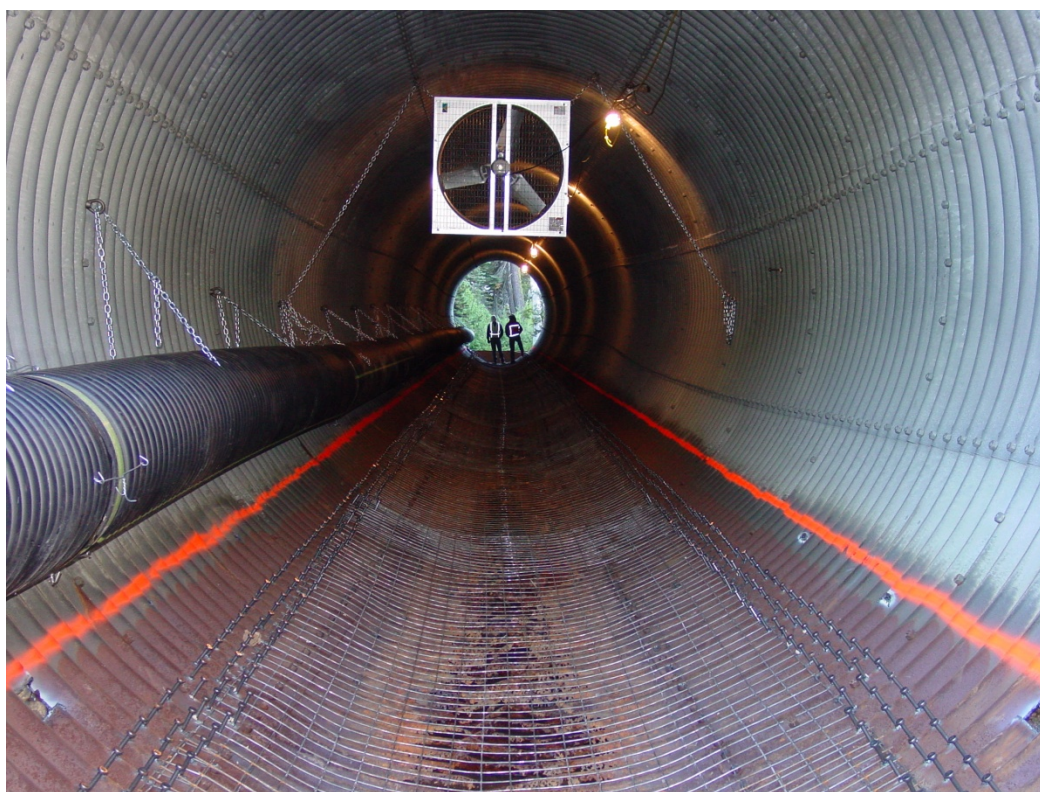
### **Eastbound Pipe Prior to Concrete Placement with Temporary HDPE By-Pass, WWM and Nelson Studs**

The original plan by Maintenance Engineering was to place a reinforced concrete invert lining in each of the culverts with no thrust connection. However, District Hydraulics expressed concerns that the loss of hoop strength may continue to allow these pipes to collapse even farther, therefore, a structural stiffening system was considered in the invert to regain the lost hoop strength.

Observations were made that the Route 80 culverts have severe out-of-plane sidewalls due to invert buckling and overlapping. Due to the undulations in the culvert invert and walls, the pre-fabricated longitudinal Bearing Angles would have to be cut into many shorter lengths in order to obtain a flush fit with the culvert walls. Also the corrugation spacing varies between the original 6" o/c to 5" o/c due to the culvert invert/wall undulations. This would prevent shop punching of holes in the longitudinal support angles due to varying spacing requirements. Consequently, a simpler repair method employing only Nelson Studs for locations with severe out-of-plane sidewalls was requested. While not as desirable as Alternatives I or II, Alternative III entails the following:

- 1) This procedure does not employ longitudinal Bearing Angles.
- 2) This repair method should only be used for culvert repairs where sidewalls are still in excellent structural condition.
- 3) Nelson Studs are used as shear anchors to transfer culvert wall thrust into the new concrete invert slab.
- 4) Weld (3) 1/2" dia. x 3-1/8" long H4L Headed Nelson Studs, spaced 3" apart vertically, at each corrugation peak (6" o/c). Nelson Studs to be attached to only non-corroded portions of culvert wall.
- 5) Tack weld 4" x 4" – 6" x 6" WWF mesh to bottom 90 degrees of culvert invert at 12" o/c ea way, in order to provide composite action.
- 6) Pour 4" thick (minimum thickness above crest) concrete invert slab ( $f'_c = 4000$  psi) to cover Nelson Studs.
- 7) Concrete lining to cover lower 90-degree internal angle. Slope top portions of concrete to provide for drainage.

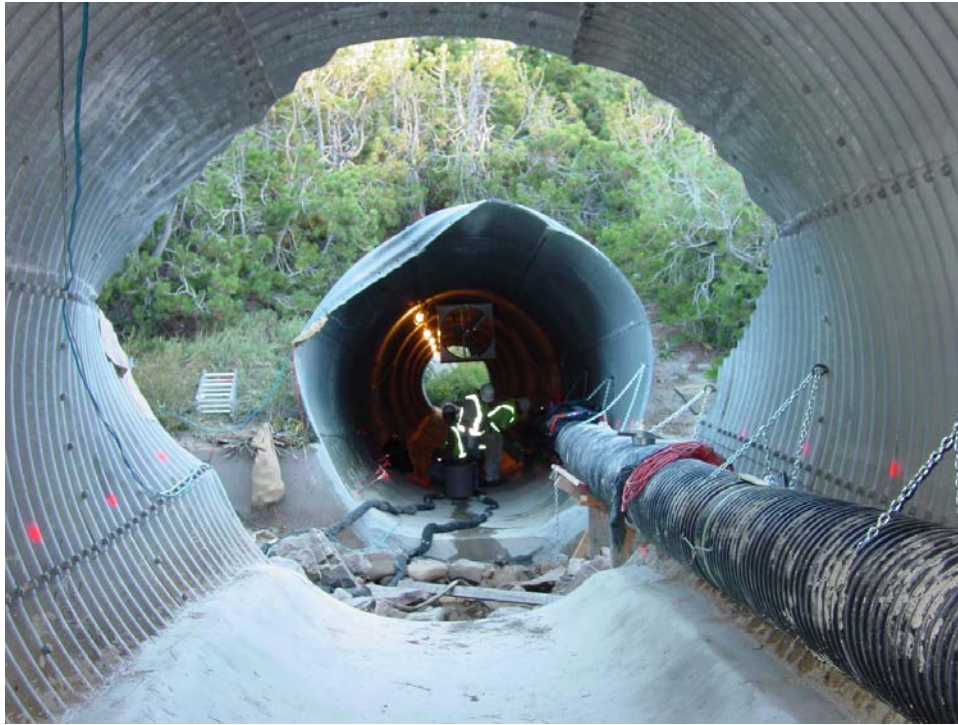
**View of Both Pipes After Concrete Invert Paving**

The concrete design for the invert included a 4000 psi compressive strength and 3/8 inch aggregate along with air entraining for the freeze-thaw conditions. The 4-inch thick minor concrete invert lining was limited to the lower quadrant of the culvert (i.e., 90 degrees coverage from the 4:30 to 7:30 clock positions).

The voids directly below the invert were filled with the same concrete.

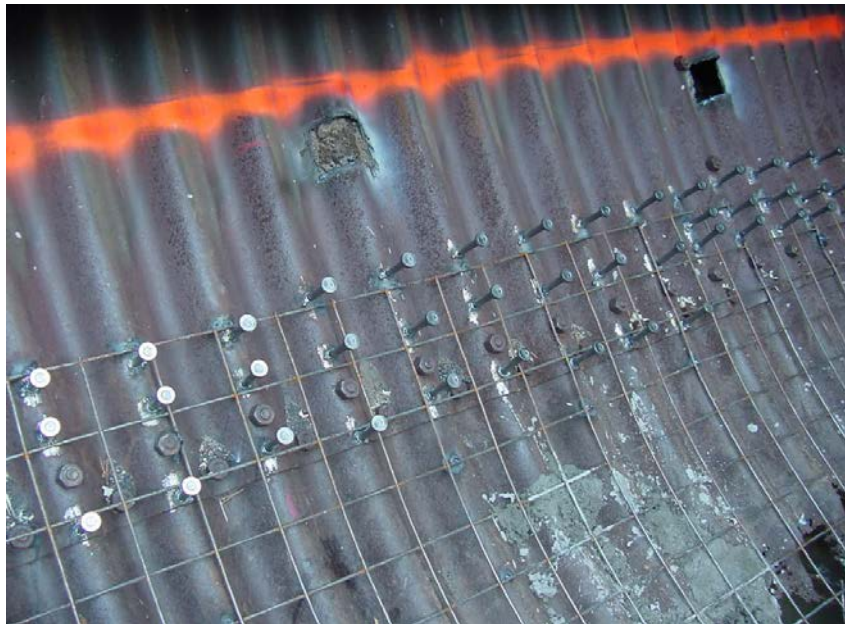
Before paving the invert, coupons were cut into the culvert wall in order to probe for voids. Most of the voids found were below the springline, however, a significant void was discovered near the outlet of the eastbound pipe above the springline at the 10 o'clock position. In both pipes the most significant voids were found at the inlet.

**Coupons Cut in Sidewall of Culvert for Probing and Grouting**

A decision was made to use polyurethane foam grout rather than cementitious grout to fill the voids behind the culvert. The decision to use polyurethane grout was based primarily on the fact that an agreement with the cementitious grouting contractor regarding Force Account rates could not be reached. Furthermore, the District already had a Maintenance service contract with a company called Uretek for slab jacking and had some success with the material for jacking operations (including this site in January 2003). Although the foam has been used in PCC slab raising work for several years on many California State Highways, there were concerns that the Uretek foam may have environmental impacts and durability issues, since it had not been used for this type of application. The Resident Engineer explained the environmental concerns with cementitious grout migrating into the creek during placement and stated that Uretek had provided data showing the foam to be inert and that it would not leach into the creek. This material is supposed to be inert in a live stream environment and will not absorb water. When first placed, high-density polyurethane rigid closed cell hydro-insensitive grout is supposed to form a mechanical seal by expanding twelve times its liquid volume in 8-12 seconds.

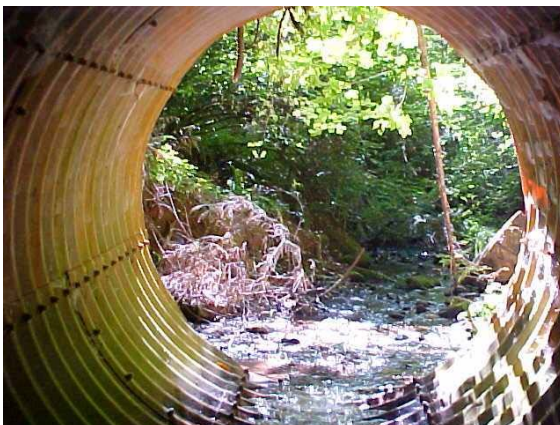
Inside the culvert, corrosion, a perforated invert (up to 0.5 inch perforations) and missing nuts and bolts from the steel plating were observed as a result of the corrosion. Also, the bolt pattern of the steel plates were originally constructed “in-line” with each adjacent plate instead of being offset, which might have contributed to structural weakness.

**Inlet of Original Pipe**

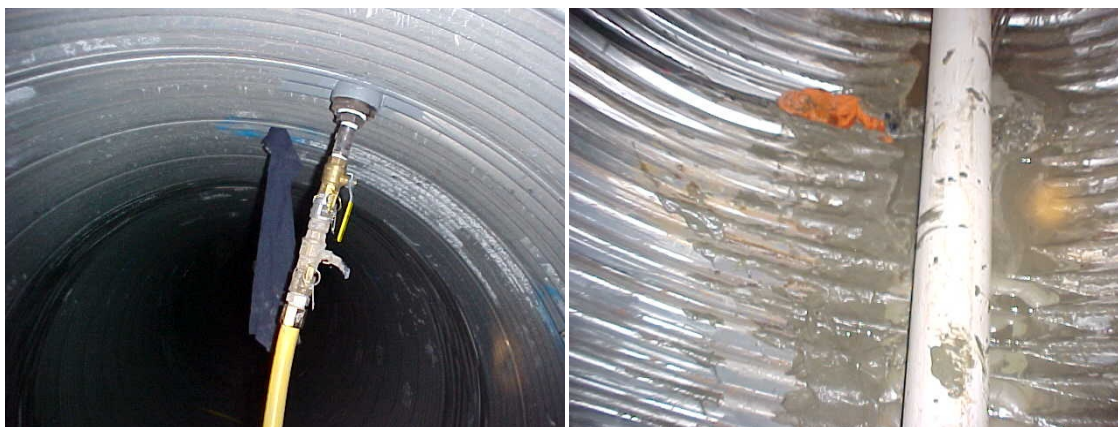
The resulting hydrostatic pressure at the downstream end from continuous grouting of the annular space between the existing culvert and the 84-inch CSP liner placed inside caused the liner to float and buckle with grout leaking out of the liner's joints which had been specified as watertight with gaskets. The grouting operation was immediately stopped and a Contract Change Order (CCO) was developed.

#### Grout from Leaking Joints in Invert

Particular attention to the contractor's grouting plan for long, large diameter, flexible liners is needed for pipes on a steep grade where there is a potential for significant hydrostatic pressure. Both the specified gasketed water tight joints and method for continuous grouting needed modifying in the field to welded joints and grouting in separate lifts.
