DESIGN INFORMATION BULLETIN NO. 83 - 04  
CALTRANS SUPPLEMENT TO FHWA CULVERT REPAIR  
PRACTICES MANUAL

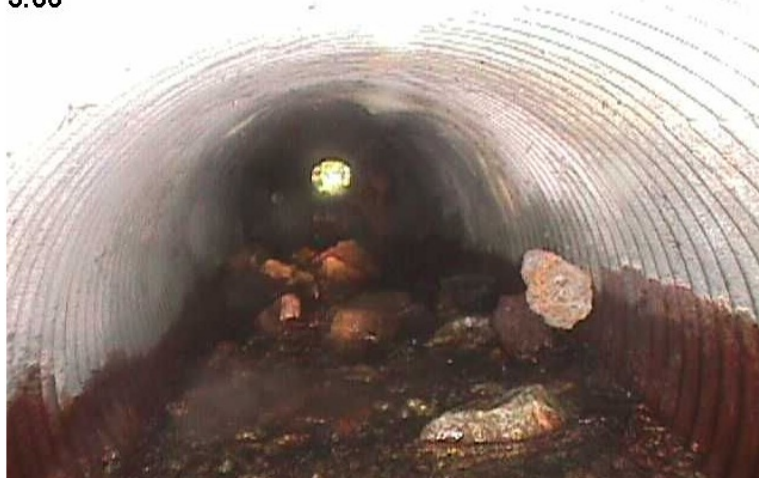
**Video Inspection Photo**

Originally installed in 1974, a 10 gage CMP has a maximum cover of approximately 50 feet, and a slope of 12.3%. Inspection photos taken in 2004 indicate a stained invert but no perforations. The culvert barrel shape and joints were deemed “in good condition”. In 2007 a video inspection was performed and the inspection report indicated:

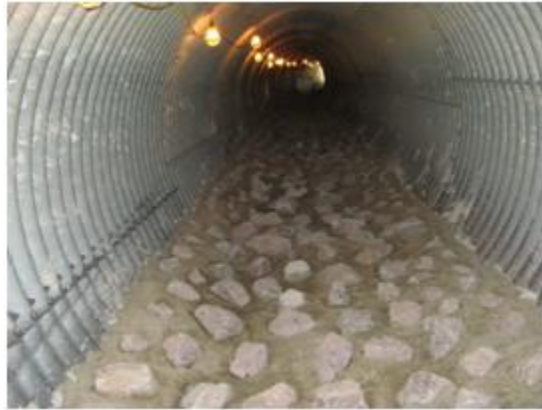
#### **Worn Invert (Abrasion) Before and After Repairs**

In this case there was enough available headwater elevation at the site to accommodate a concrete invert lining thickness of up to 15 inches and concreted rock slope protection with 'facing' selected for the concreted rock grading from Section 72 of the Standard Specifications because it compared well with the maximum bedload size (see photos).

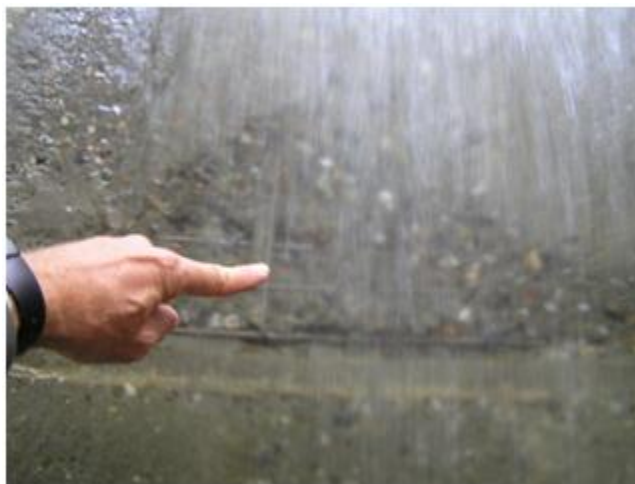
By 2011 the new pipe barrel was prematurely experiencing excessive invert wear and some of the steel reinforcement was exposed immediately downstream of the last joint. Therefore the RCP had already reached the end of its 'maintenance free' service life after just 5 years and the concrete had worn at least an inch and was in need of repairs. See photo below.

**Exposed Steel Reinforcement**

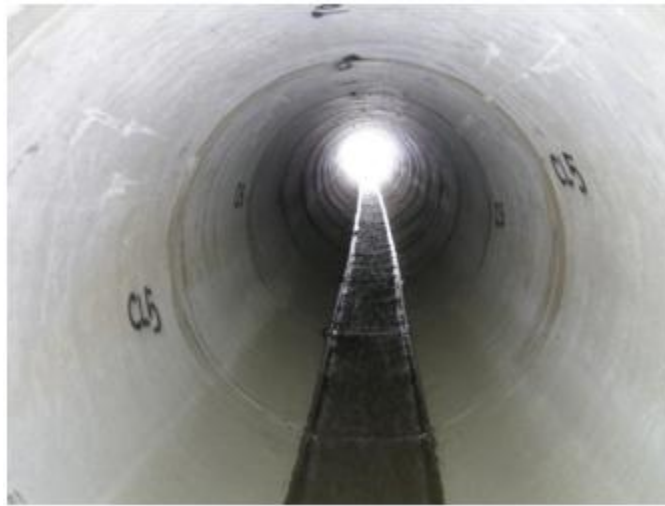
For the existing RCP (see photo below), the estimated wear rate of the 1-inch concrete cover was a simple calculation based on 5 years until first exposure of the steel reinforcement. The estimated wear of the concrete is 1-inch/5 years or 200 mils/year (0.2 in/year).

#### **Existing 84 inch RCP Replacement at 5 years**

From HDM Tables 855.2D and 855.2A, 1.9 mils/year anticipated wear for the steel indicates the abrasion level was 5 and RCP is generally not recommended. Therefore, to provide the required 50 year service life for repairs to the RCP invert, the following options were recommended:
