# CALIFORNIA BRIDGE ENGINEERS SEMINAR

Presentation 4 - Innovative Independent Quality Assurance for Fracture-Critical Bridge Members

# Innovative Independent Quality Assurance for Fracture-Critical Bridge Members

Maged Armanuse, Office Chief  
Office of Quality Assurance and Source Inspection  
Division of Engineering Services

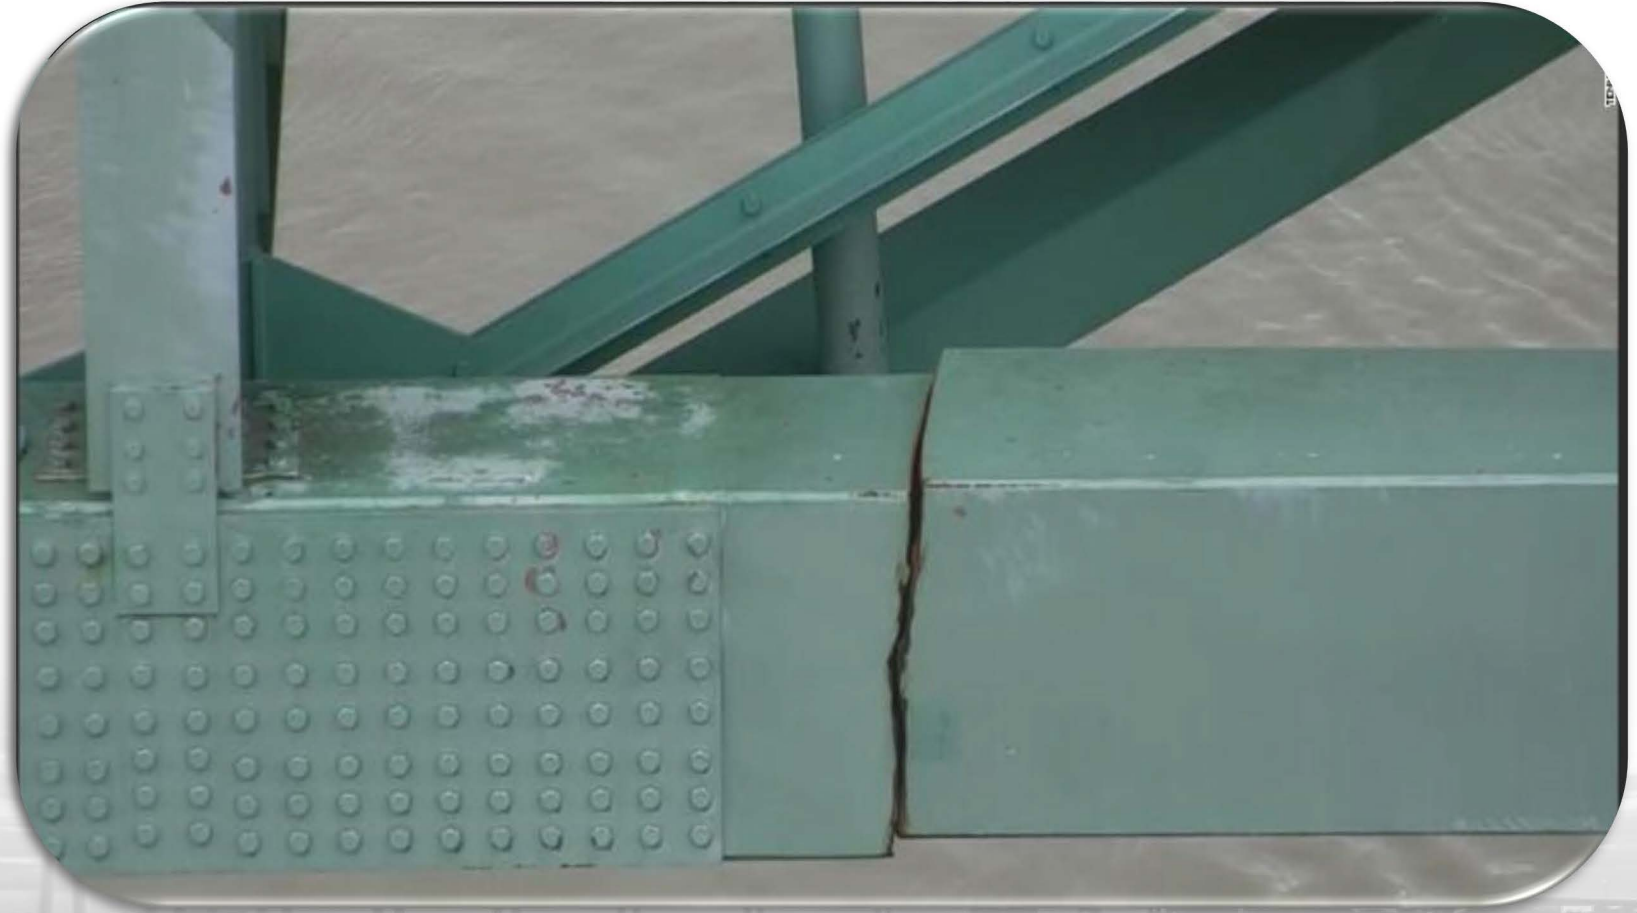
# Cracks are found

Hernando de Soto  
Bridge (built 1973)

I-40, Mississippi River  
Tennessee

Root Cause

Hydrogen Cracking

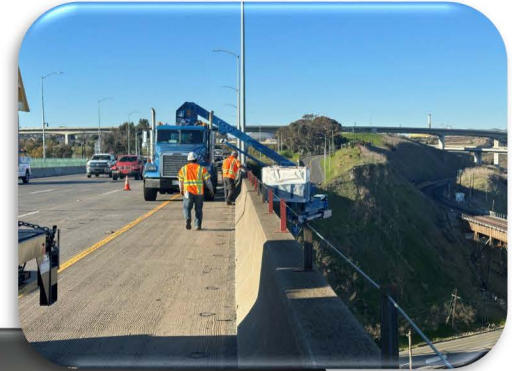
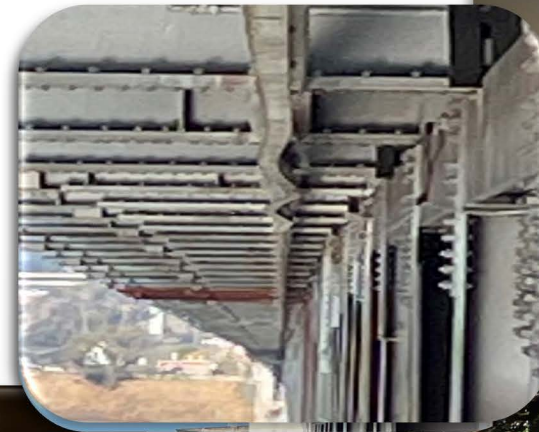
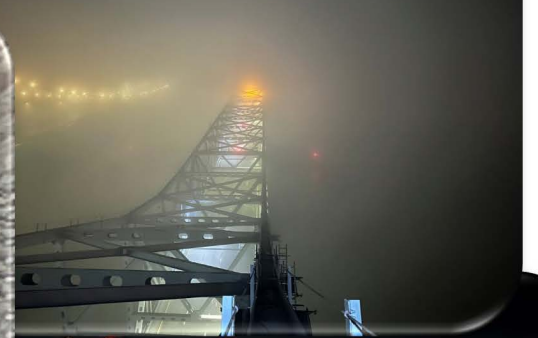
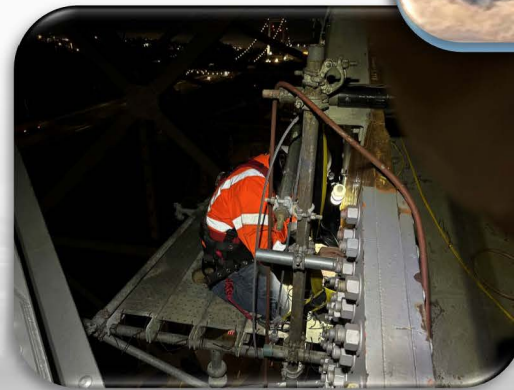
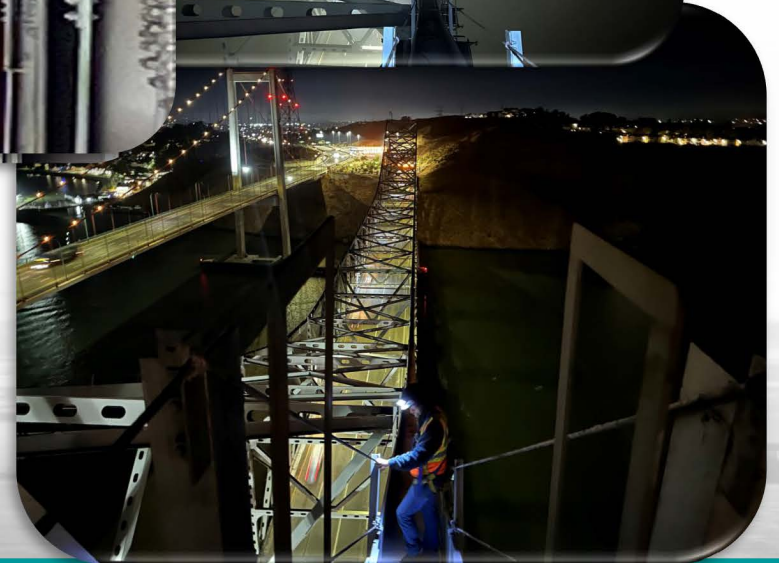
# Challenges: Inaccessible welds

On Benicia-Martinez - Over 100 initially Inaccessible welds

Addressed:

- Custom solutions to each of the four scenarios

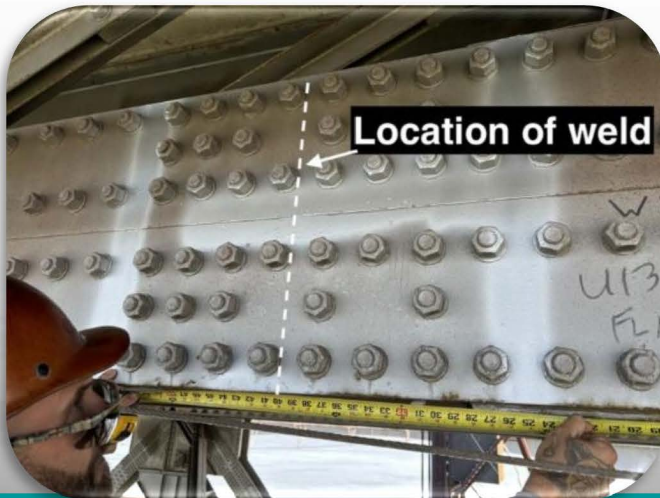
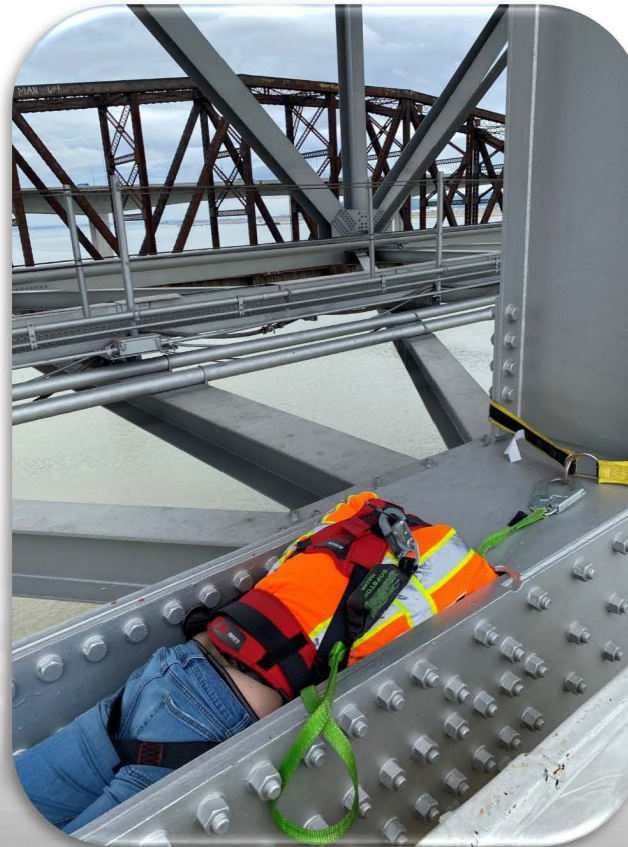
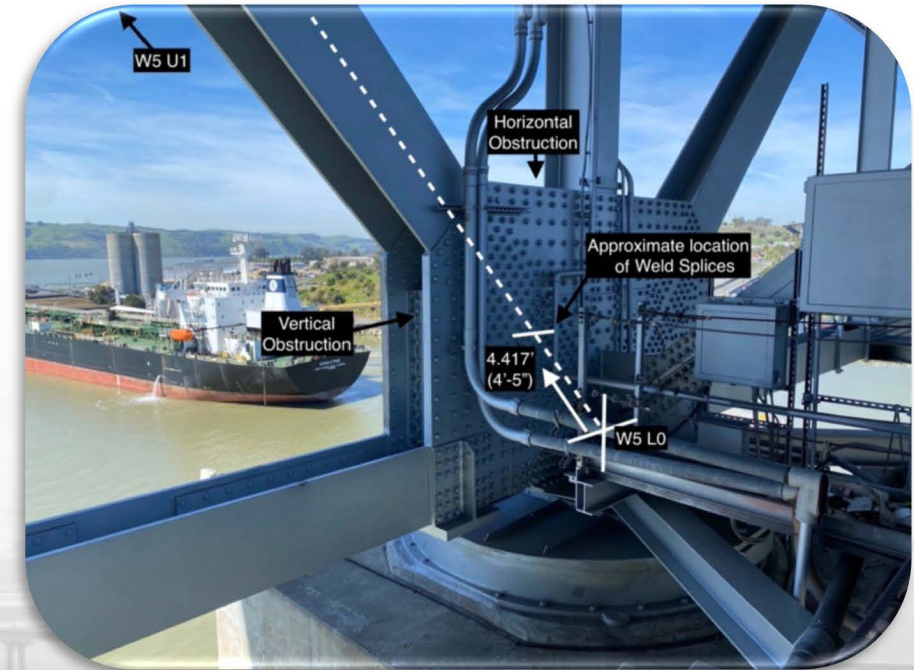
# Challenges: Identifying welds through thick paint

- **Issue:** Weld locations obscured by paint
- **Solution:** Eddy Current confirmed weld location through thick paint systems.
  - Eliminated the need for large-scale paint removal
  - Reduced preparation time.
  - Reliable foundation for subsequent UT examinations.
