Roadway Departure Technical Brief No. 1

Maintenance of Traffic Barrier Systems

California Local Roads

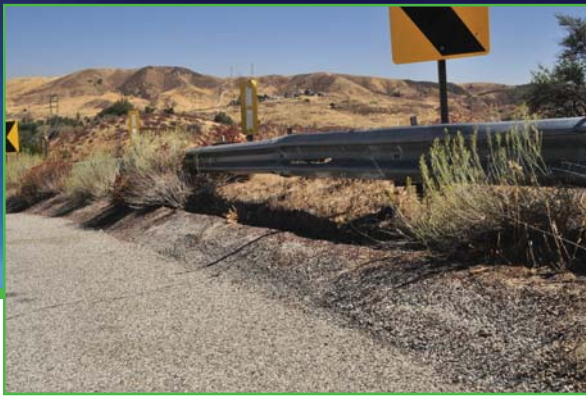
- Vertical tears in the W-beam (**Photograph A**) that extend to the top or bottom of the rail greatly reduce the capacity of the rail and create areas of high stress concentrations, both of which can cause the rail to tear completely through and allow vehicular penetration upon impact. Non-manufactured holes (e.g., those caused by crash damage, lug nut damage, or corrosion) in the rail element that intersect the top or bottom edges of the W-beam should also be considered a priority repair condition.
- Rail flattening (**Photograph B**) with or without post deflection, increases the chances that an impacting vehicle will overturn upon contact and may increase the deflection distance. Any flattened panel that increases the W-beam section width to more than 18 inches (normal height is 12 inches) should be replaced.
