**DEVELOPMENT OF STAKING CONFIGURATIONS
FOR K-RAIL**

1. REPORT NO. FHWA/CA/MI-2006/21	2. GOVERNMENT ACCESSION NO.	3. RECIPIENT'S CATALOG NO.	
4. TITLE AND SUBTITLE DEVELOPMENT OF STAKING CONFIGURATIONS FOR K-RAIL		5. REPORT DATE December 2008

16. ABSTRACT Full-scale crash testing was conducted on various staking configurations for pre-cast concrete barrier (California K-rail). The staking configurations tested were developed in effort to optimize cost and worker safety. Testing was conducted in accordance with NCHRP Report 350. The tested barriers consisted of twelve or thirteen concrete segments, each 6045 mm (20 ft) in length. The segments were placed on 125-mm (5-in) AC pavement and connected together with 31.8 x 660 - mm (1.25 x-26 in) pins. Each segment was secured to the ground using 25 x 610-mm (24-in) stakes either uncapped or capped. The tests were performed at the Caltrans Dynamic Test Facility in West Sacramento, California. A total of six crash tests were conducted under Report 350 Test Level 3-11. Two testing groups were established: K-rail as a median barrier and K-rail adjacent to an excavation. Each group was tested under three staking configurations. One test fro

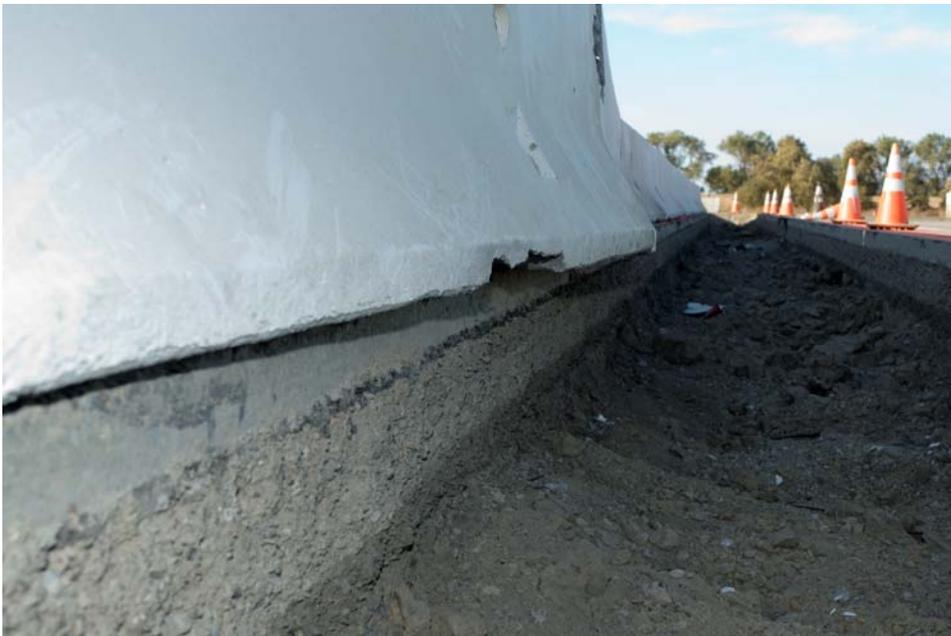
Figure 2-65. Test 675 - Barrier over Excavation

Test 675, with capped stakes placed in every stake hole on the traffic-side of the K-rail but none on the excavation side, resulted in minimal lateral deflation and good vehicle redirection. There was no damage to the pavement. The review by the Committee resulted in the assessment that the 280 mm (11 in) of overlap into the excavation was acceptable. The structural adequacy of configuration 675 is acceptable.

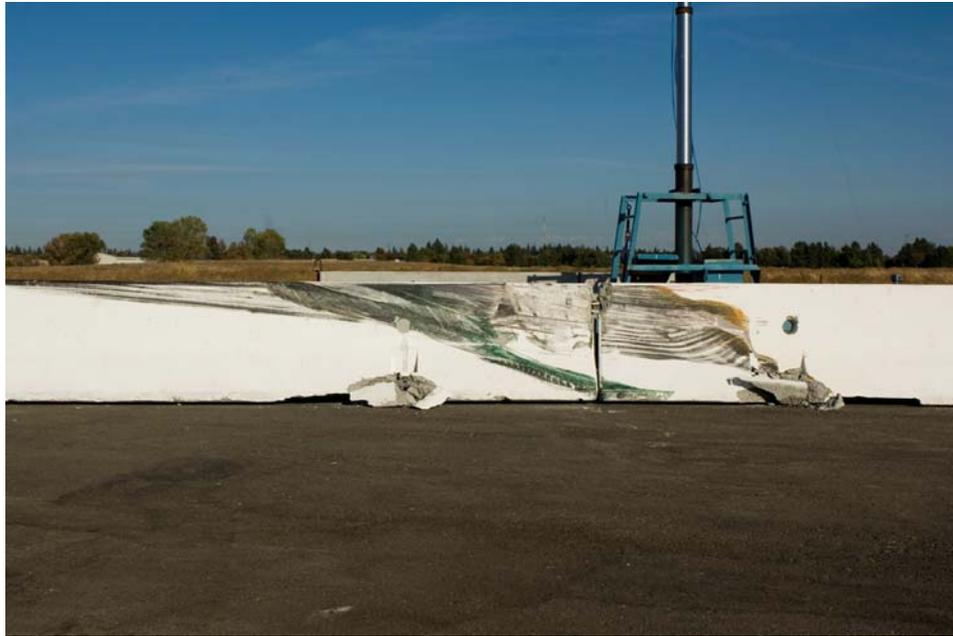
Figure 2-66. Test 675 - Impact Point Post-Impact

The pin and loop connection between sections 5 & 6 (nearest to the impact point) and 6 & 7 bent and caused spalling at the joint. The slots located in the upstream end of Section 5 and downstream end of Section 6 had spalling. Sections 5 and 6 had scuffmarks on the surface from the impact. The barriers' maximum lateral static displacement was 350 mm (13.8 in) and the maximum lateral dynamic displacement was 350 mm (13.8 in) at the toe. The barrier extended over the excavation by approximately 280 mm (11.0 in). Static measurements were taken with a tape measure, and dynamic measurements were obtained via film analysis.

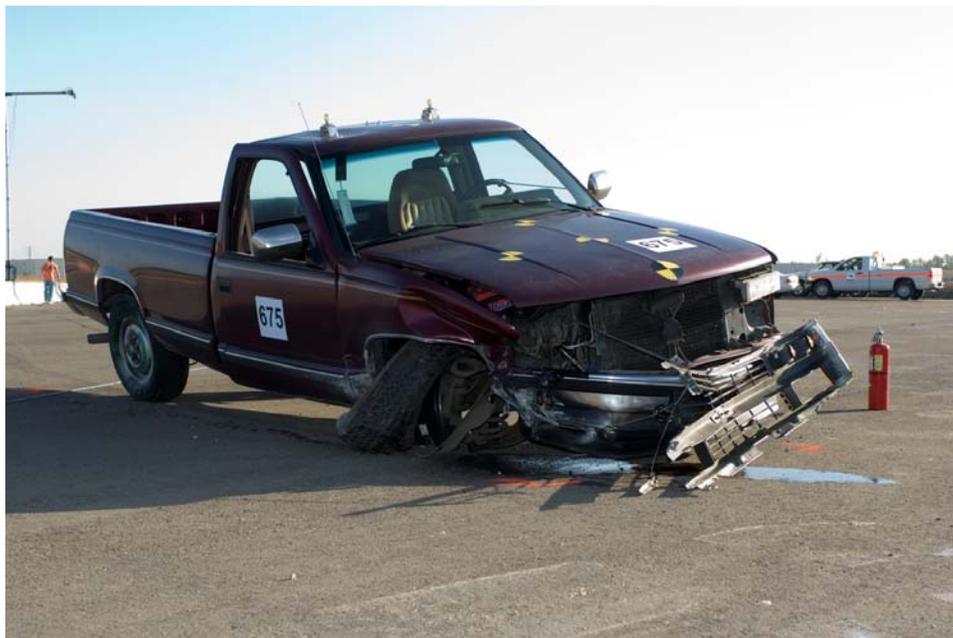
Figure 2-70. Test 675 - Front-right View of Vehicle Post-Impact

The impact damaged the right front corner of the vehicle. The right front quarter panel and bumper were crushed. The tire slipped off the rim. The suspension and steering assemblies were damaged. The tie rod sheered off the spindle. The hub guidance assembly was slightly damaged.

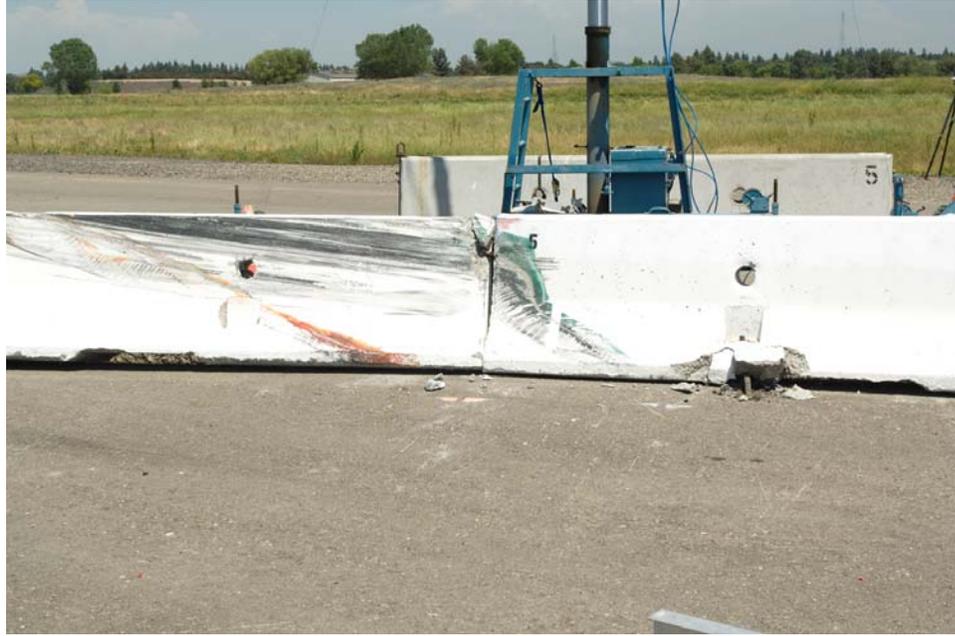
Figure 2-78. Test 676 - Impact Point Post-Impact

The pin and loop connections between sections 5 & 6 (nearest to the impact point) and 6 & 7 were bent and caused spalling at the joint. Section 5 had spalling at the stake location. Sections 5 and 6 had scuffmarks from the impact. Sections 9 through 12 had minor scuffing on the top, which occurred when the vehicle rode on top of the barrier.

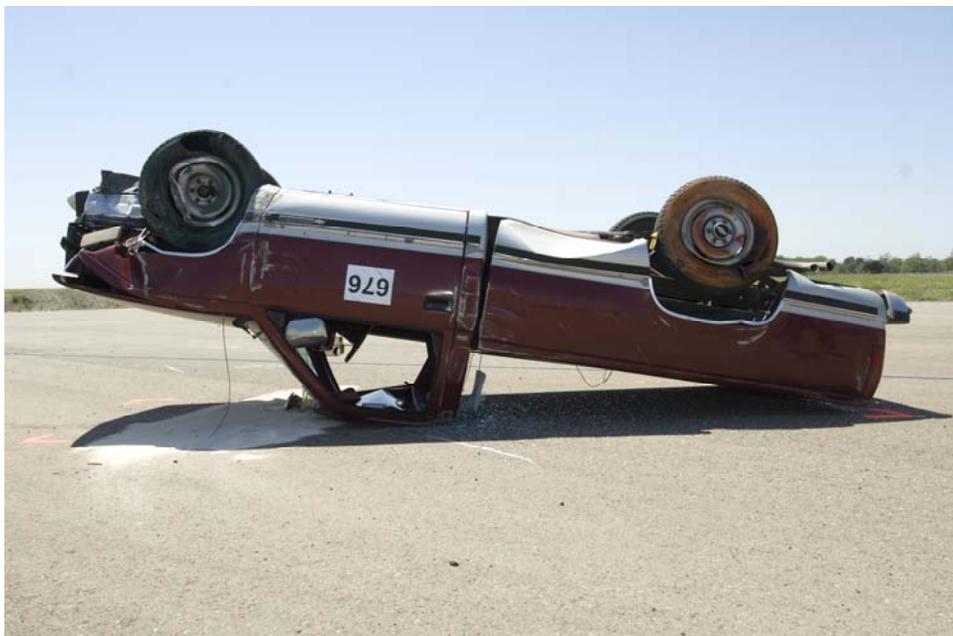
Figure 2-81. Test 676 - Vehicle Post-Impact Side View

The initial impact damaged the right front corner of the vehicle. The right front quarter panel and bumper were crushed inwards. The right front tire and right side rims were damaged. The right body panel was crushed when the vehicle rode on top of the barrier. The windshield was damaged during the rollover, but remained in place. The rear window shattered.

Test 676, with a single capped stake on the downstream traffic side of each K-rail, resulted in excessive barrier movement and a rollover of the test vehicle. This test was a clear failure of the Structural Adequacy criteria.
