1. REPORT NUMBER  FHWA/CA10-0515	2. GOVERNMENT ASSOCIATION NUMBER	3. RECIPIENT'S CATALOG NUMBER
4. TITLE AND SUBTITLE  DEVELOPMENT OF WEED CONTROL BARRIER BENEATH METAL BEAM GUARDRAIL	5. REPORT DATE  January 2011

7. AUTHOR  David Whitesel, John Jewell, Robert Meline	8. PERFORMING ORGANIZATION REPORT NO.  FHWA/CA10-0515	
9. PERFORMING ORGANIZATION NAME AND ADDRESS  Roadside Safety Research Group California Department of Transportation 5900 Folsom Blvd. Sacramento, CA. 95819	10. WORK UNIT NUMBER  FHWA/CA10-0515

# **DEVELOPMENT OF WEED CONTROL BARRIER BENEATH METAL BEAM GUARDRAIL**

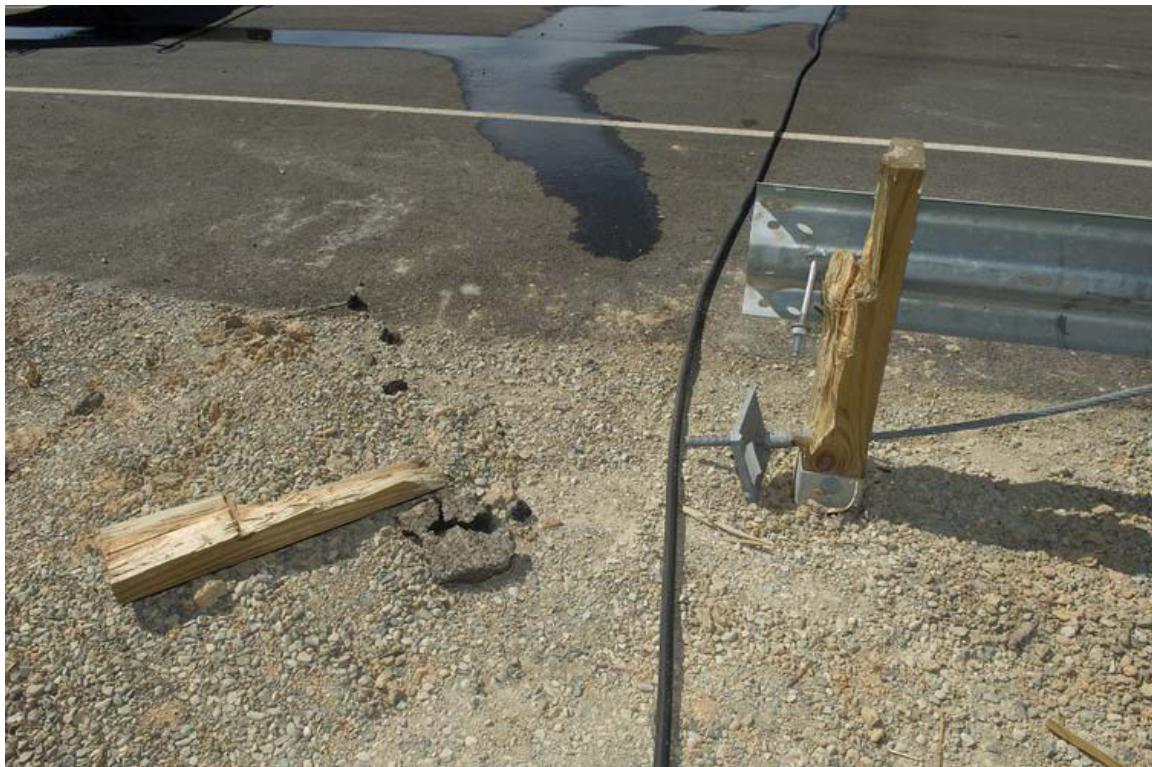
Figure 2-22 – Downstream SFT after Test 658

The main damage was the rupture of the w-beam rail. Secondly, the upstream SFT deflected toward the impact point, likely because the soil surrounding the metal tube was not adequately compacted. The rail stretched upstream of the impact point and compressed downstream of the impact point, as evidenced by movement of as much as  $\frac{1}{4}$  inch at the lap splices. Every post twisted counterclockwise, possibly also because of the inadequate anchoring of the upstream end treatment. As the rail shifted laterally (in the downstream direction), the wood post at the downstream SFT fractured (see Figure 2-22). Several blockouts also fractured during impact and were thrown from the point of impact toward the field. The blockout nearest the point of impact appeared to fracture upon impact, possibly before the post was able to rotate. Thus the reaction point of the rail would not have been raised, possibly contributing to the system failure. At the rupture point, the bottom of the w-beam element appears to have failed in shear due to contact with the top of the post at that location while the upper portion appears to have failed in tension.

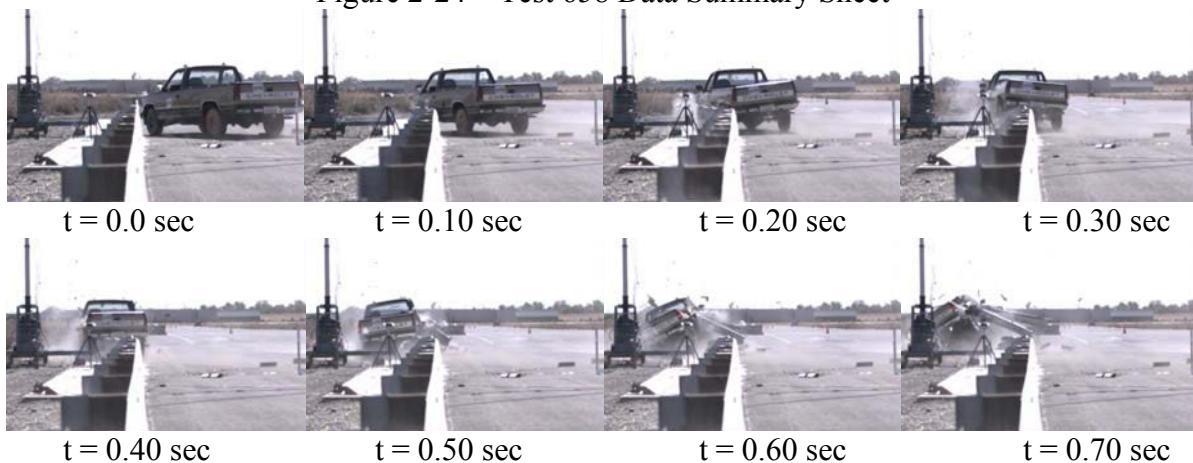
Figure 2-24 – Test 658 Data Summary Sheet

**Barrier Damage:** The W-beam ruptured, allowing the vehicle to penetrate beyond the guardrail.

The vehicle was extensively damaged from the w-beam rail rupture and subsequent vehicle rollover. No further analysis of vehicle damage was performed.

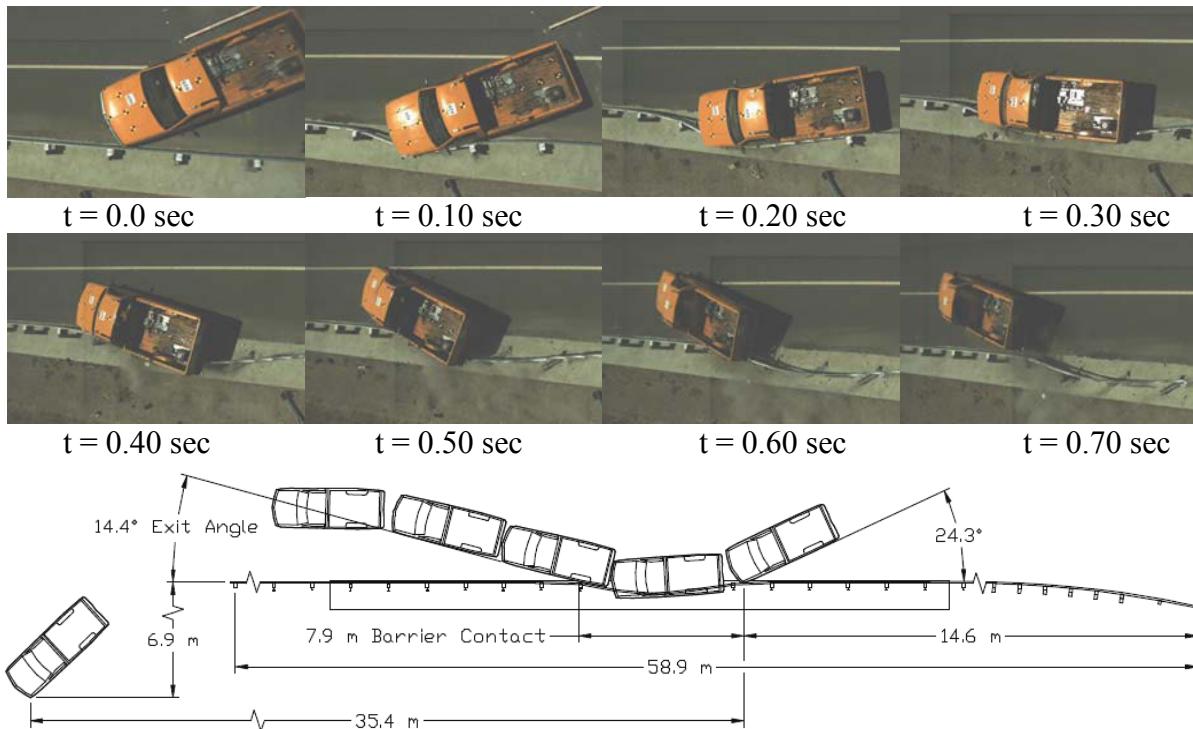
Figure 2-42 – Test 659 Data Summary Sheet

**Barrier Damage:** Permanent deflection at posts 19-23, with the CRMCrete in the leave-out area broken out as expected. Posts 20-22 yielded and were bent over. The W-Beam rail was deflected and deformed but intact. Maximum dynamic deflection was estimated at 40 inches (1016 mm). Maximum permanent deflection of the rail was 1.9 feet (579 mm) at approximately 14.2 feet (4.33 m) downstream of impact.

There was mild to moderate damage to the entire left side of the vehicle. The left portion of the front bumper and left front fender were pushed rearward. The left front tire and wheel assembly were detached from the vehicle. There was minor denting of the left door, left side of the bed, and left rear fender. The maximum passenger compartment deformation was one inch, between the motor panel and the rear of the occupant compartment.
