Concrete Overlay on Asphalt Pilot Project at Woodland SR 113: Construction

Angel Mateos, John Harvey, Miguel Angel Millan, Rongzong Wu, Fabian Paniagua, Jessica Cisneros, and Julio Paniagua

Partnered Pavement Research Center (PPRC) Project Number 3.39 (DRISI Task 3201): Implementation and Field Performance Evaluation of Concrete Overlay on Asphalt

1. REPORT NUMBER UCPRC-RR-2020-01	2. GOVERNMENT ASS NUMBER	OCIATION	3. RECIPIENT'S CATALOG NUMBER	
4. TITLE AND SUBTITLE Concrete Overlay on Asphalt Pilot Project	at Woodland SR 113: Co	nstruction	5. REPORT PUBLICATION DATE July 2021

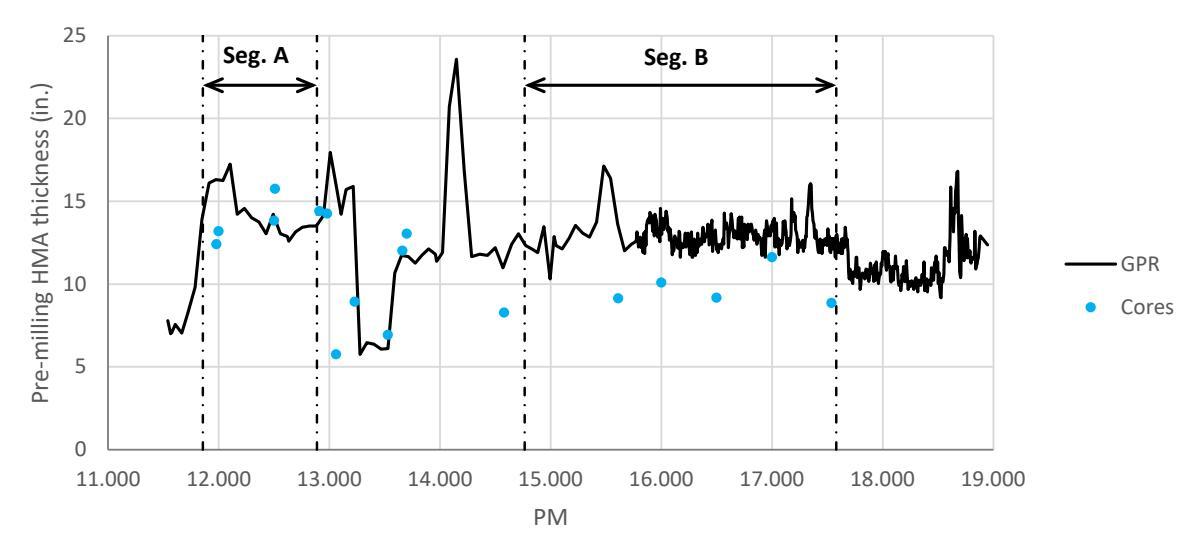
Figure 2.4: Asphalt thickness before milling.

Based on the data collected in a 2011 Caltrans ground-penetrating radar (GPR) evaluation, the existing pavement's asphalt thickness roughly varied between 13 and 16 in. along Segment A and between 12 and 14 in. along Segment B (Figure 2.4). While cores extracted in 2017 during the COA project's design phase confirmed the GPR measurements in Segment A, they also showed that the actual asphalt thickness along Segment B was roughly 9 to 11 in., somewhat less than the GPR measurements (Figure 2.4). The difference between the two thickness measurements may be attributable to one or more sources. Among them are GPR signal processing errors, moisture that affected the asphalt's dielectric constant, or the presence of an asphaltic material that was in the pavement during the GPR survey but which was destroyed during the coring process. Determining the actual source or sources of the difference would require more research. But whatever the reason, the difference in measurement emphasizes how important it is for an agency to conduct a thorough site investigation of an existing pavement before choosing a rehabilitation type and developing a design for that pavement. And this is true not just for COA: it applies to any rehabilitation project.

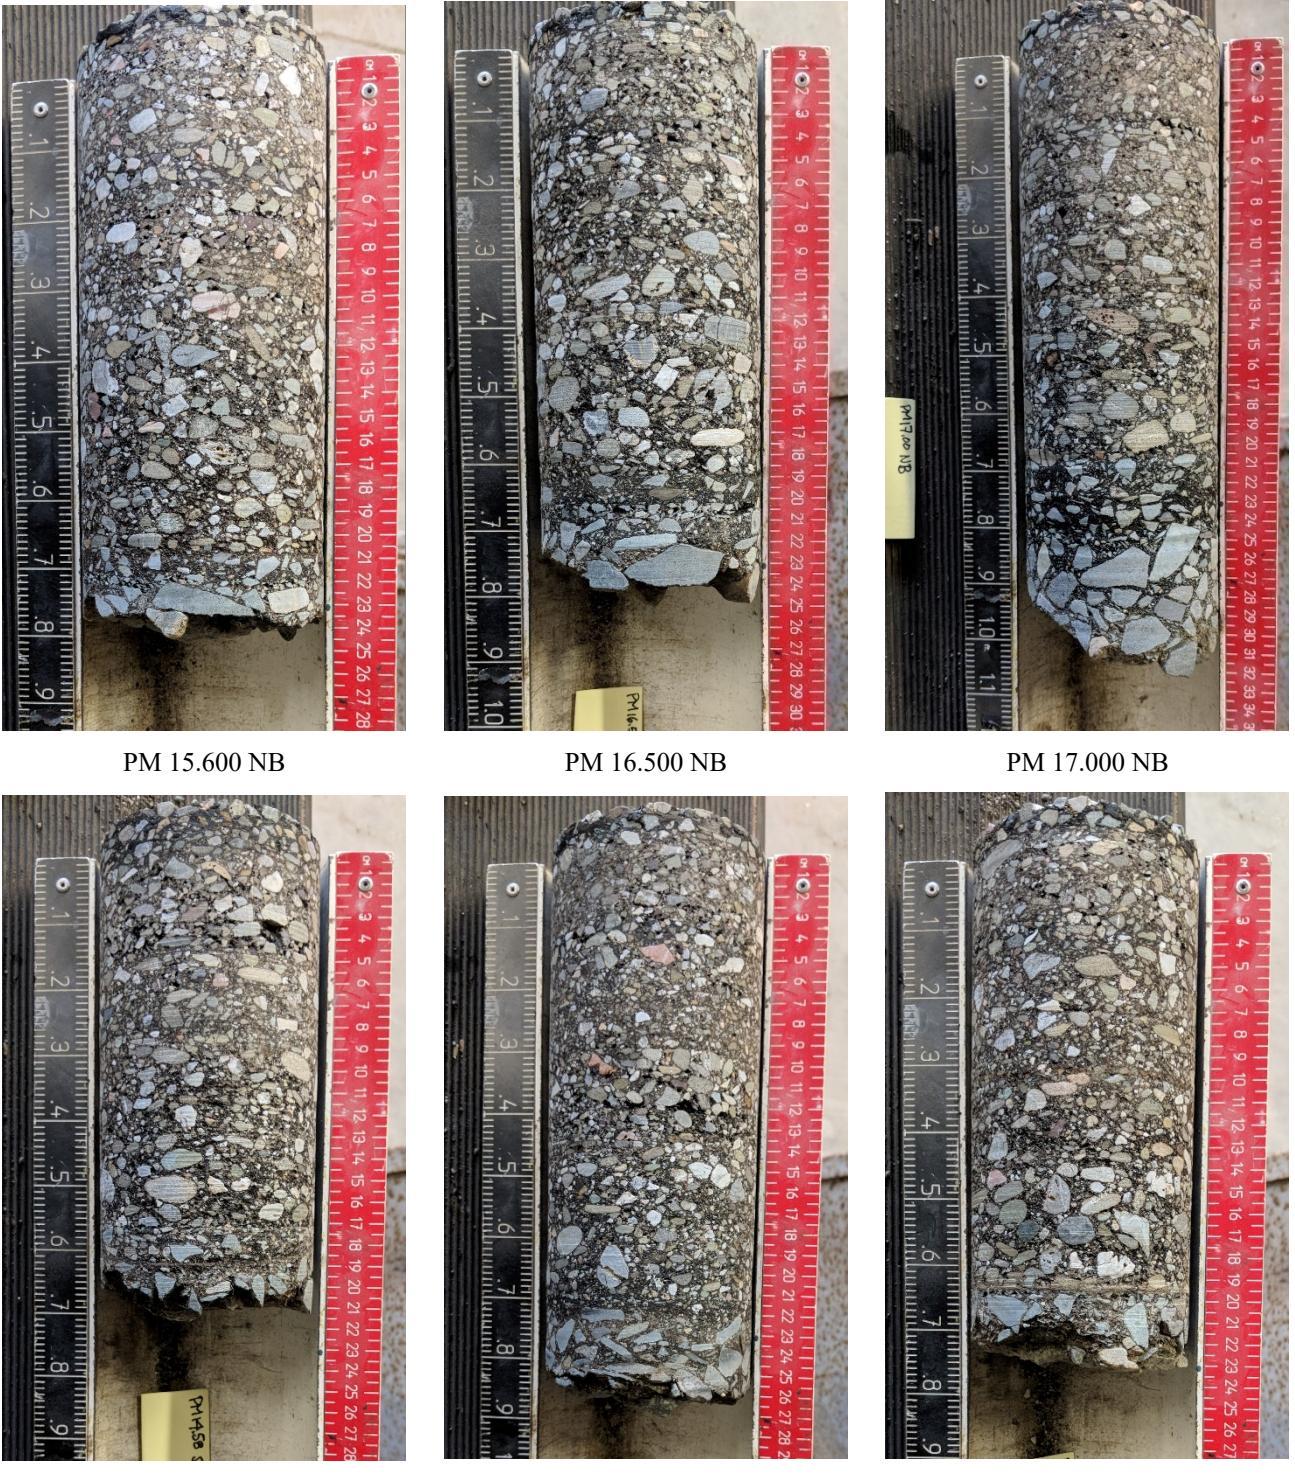
All the cores were extracted from spots in or between the wheelpaths. None were extracted at cracked locations or shoulders. The Segment A cores did show frequent delamination and some moisture damage (Figure 2.5) to the asphalt, but the Segment B cores showed the asphalt to be in good condition (Figure 2.6). A second set of cores was extracted from both segments on top of asphalt cracks. These cores showed that cracking had affected the full depth of the asphalt layer and that moisture had produced considerable damage in the lower asphalt lifts (Figure 2.7).

Figure 2.6 Cores extracted from uncracked areas of the right wheelpath: Segment B.

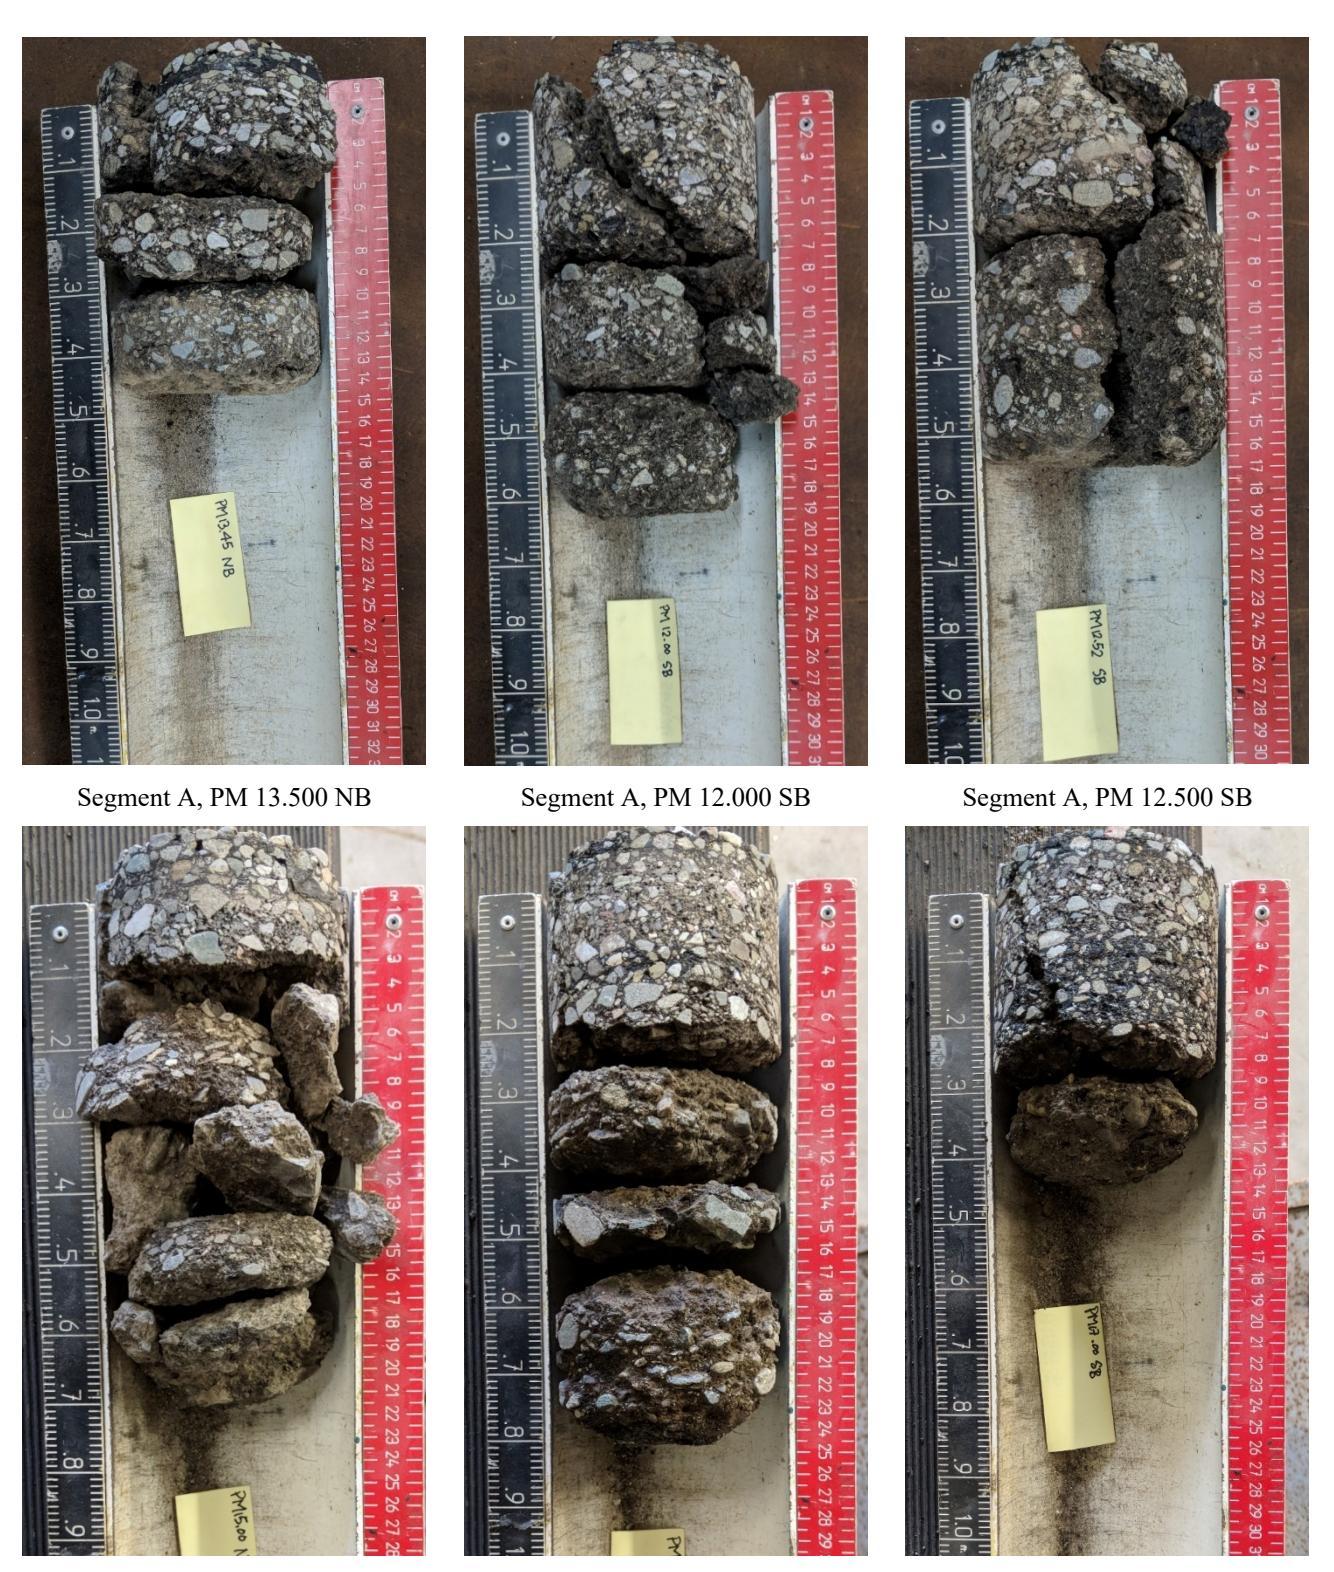
Segment B, PM 15.000 NBSegment B, PM 17.600 NBSegment B, PM 17.000 SBNote: Black/left ruler units are tenths of a foot (not inches); red/right ruler units are centimeters (cm).Figure 2.7: Cores extracted from cracked locations in the right wheelpath.

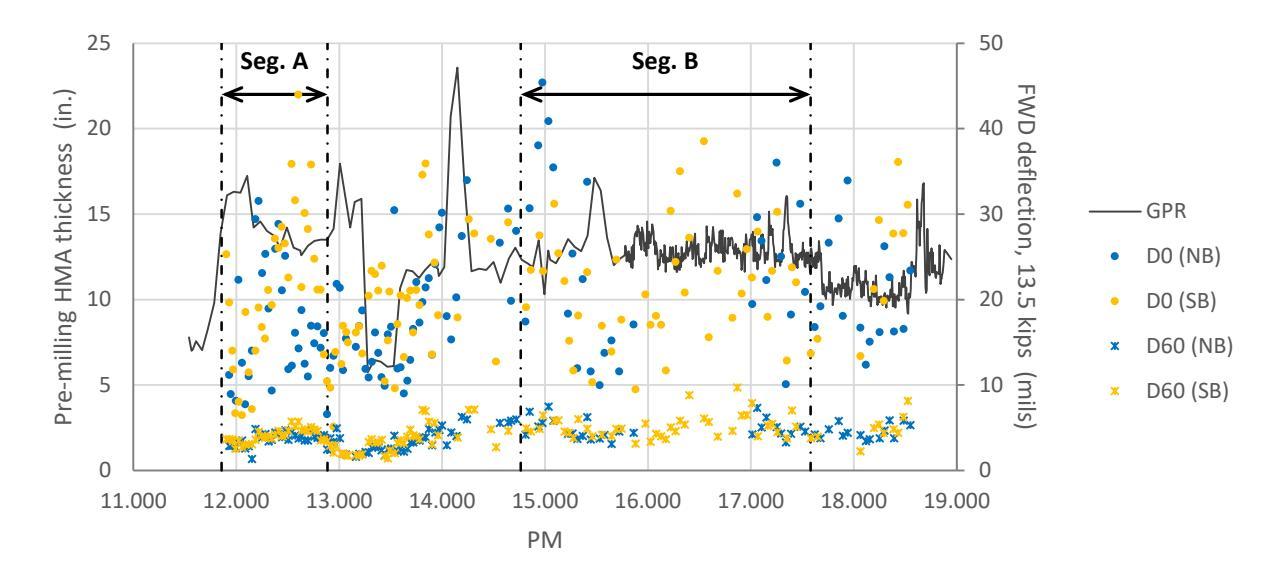
The existing asphalt pavement between PM 11.800 and PM 14.000 was evaluated with the FWD on March 30, 2017, and the pavement between PM 14.000 and PM 18.000 was evaluated on October 26, 2017. The evaluations revealed a highly variable bearing capacity, as evidenced by the variability in deflections shown in Figure 2.8. Based on these FWD results, the backcalculated asphalt stiffness varied from around 100,000 to 1.5 million psi, but with no clear pattern related to post mile or asphalt temperature (asphalt temperature varied between 57 and 71°F during the FWD evaluations). The lower limit of the backcalculated stiffness, 100,000 psi, corresponded to an asphalt layer in poor structural condition, while the upper limit, 1.5 million psi, corresponded to an asphalt layer in good structural condition. Subgrade backcalculated stiffness was relatively low, with values ranging from 5,000 to 15,000 psi (Figure 2.9).

*Note:* D0 and D60 are deflections at, respectively, 0 and 60 in. from the center of the loading plate. Figure 2.8: Deflections measured under FWD loading.

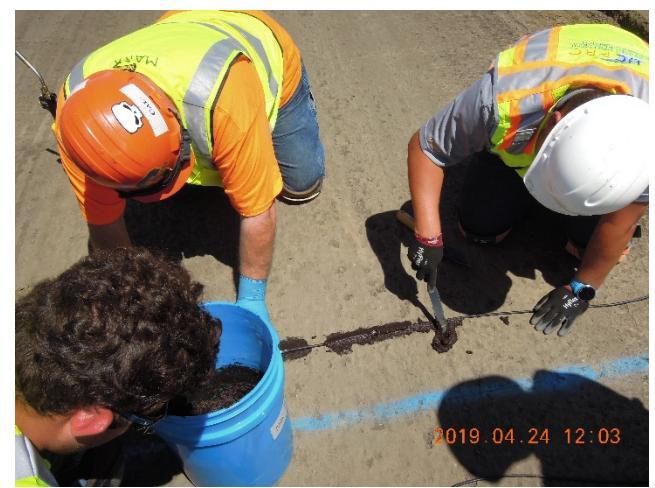
The asphalt strain gauges were placed on top of the milled old HMA at IPs A21 and A22. Sand-cold mix asphalt (SA) was used to fix the strain gauge cables to the old HMA surface and to prepare a bed for the strain gauges (Figure 3.8, top left and top right). In addition to fixing the gauges to the milled old HMA surface, the SA bed prevented the uneven milled surface from punching through the gauges during the RHMA-G compaction. The gauges and cables were covered with hot RHMA-G right before the asphalt paver arrived at their location (Figure 3.8, bottom right). The goal of this operation was to prevent the gauges from moving during the extension of the RHMA-G overlay.

Fixing strain gauge cable with sand-cold mix asphalt

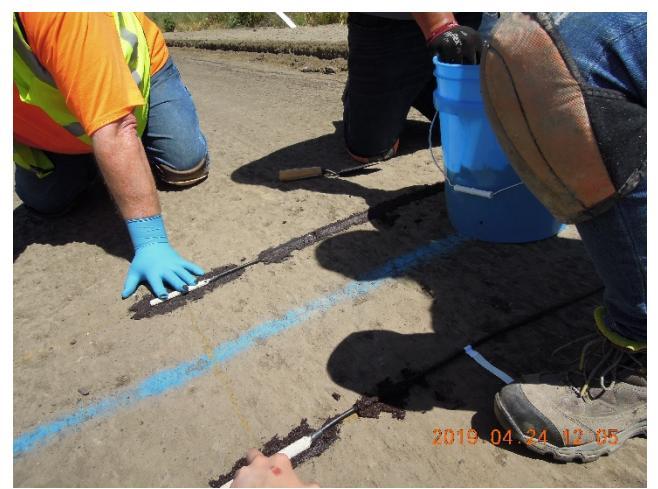
Strain gauges placed on SA bed (to prevent the milled surface from punching through the gauge during the RHMA-G compaction)

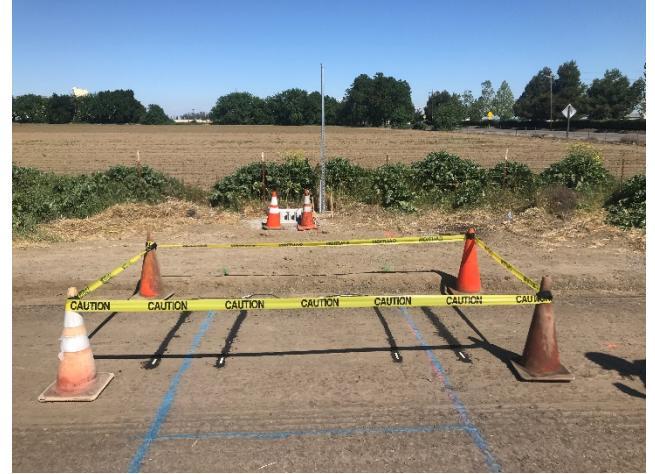
Strain gauge and cable protection until RHMA-G placement

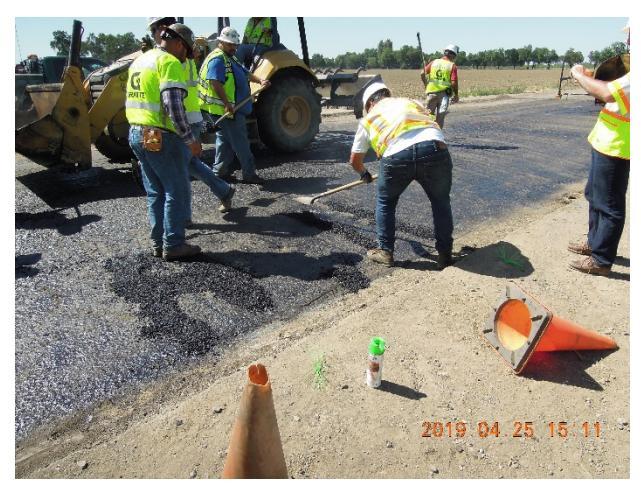
Hot RHMA-G placed over the strain gauges and cables right before the RHMA-G extension

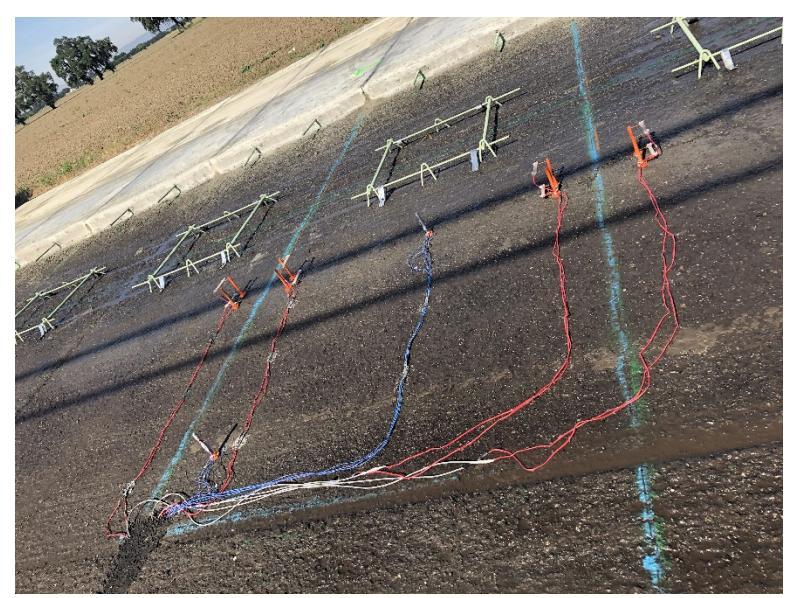
All sensors fixed to rods or chairs, zip ties tips and sensor labels cut, cables fixed with epoxy to the asphalt base.

### Figure 3.12: Instrumented point A32, right before concrete overlay placement.

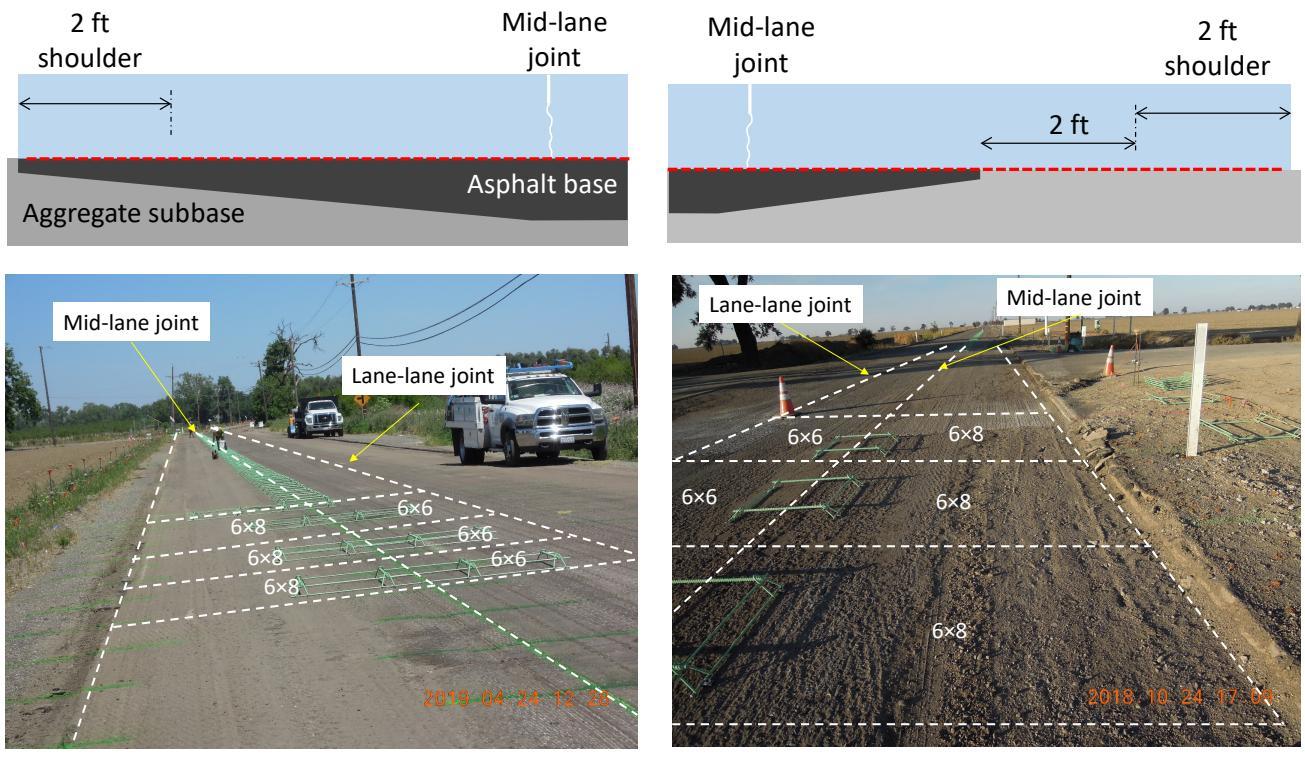
A visual survey was conducted to quantify the condition of the milled asphalt base at the shoulder edge of the roadway. In this survey, a rating between -2 and +2 was assigned to each 100 ft. long roadway segment. A -2 rating refers to a scenario where an insufficient asphalt base width ends about 2 ft. inside the lane-shoulder line while a +2 rating refers to a scenario where the asphalt base extends 2 ft. into the shoulder, as shown in Figure 4.6. A +2 rating was also assigned to segments where the shoulder had been paved with asphalt (Figure 4.5) after milling. The results of the visual survey are shown in Figure 4.7.

+2 Rating: 100% of the exterior slab (6×8 ft.) would rest on the asphalt base

-2 Rating: Roughly 50% of the exterior slab (6×8 ft.) would rest on the asphalt base; the rest would rest on the aggregate subbase

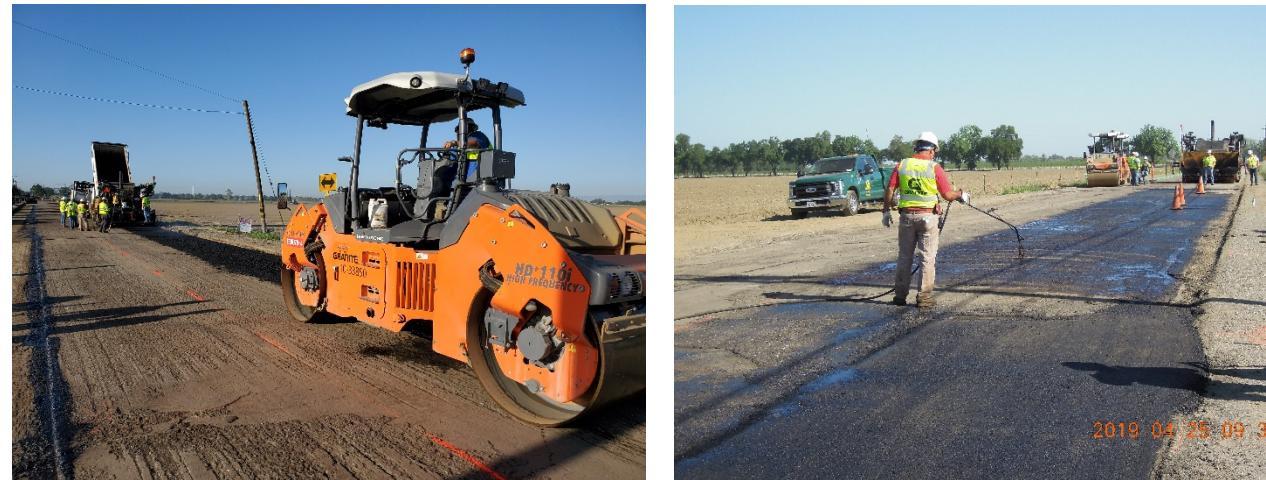
### Figure 4.8: Preparations for asphalt paving.

Pre-paving work included patching the areas with insufficient or missing asphalt base at the shoulder edge of the roadway and applying a tack coat on the milled old HMA (Figure 4.8). During the placement and compaction of the RHMA-G overlay, the air temperature was approximately 80 to 90°F, the sky was clear (Figure 4.9), and the wind speed was low (< 7 mph). The asphalt temperature during the rolling wheel compaction varied between 300°F, at the beginning of the breakdown compaction, to 200°F, at the end of the compaction process, meeting the specifications in Section 39. After the RHMA-G construction, a set of nine cores was extracted. The average air void content of the cores was 7.5% based on the saturated surface-dry method (AASHTO T 166), with individual values varying from 4% to 10%. This variation percentage is relatively high, but it is similar to the variation observed in the same asphalt mix type in overlays with similar thicknesses. The upper limit of the variation range was slightly above the 9% maximum prescribed in Section 39. The larger the air void content of the asphalt mix, the lower the stiffness and the greater the moisture susceptibility will be. The RHMA-G thickness varied from 1.2 to 1.8 in., with an average value of 1.5 in.

Patching areas with insufficient or missing asphalt base at the shoulder edge of the roadway

Tack coat application

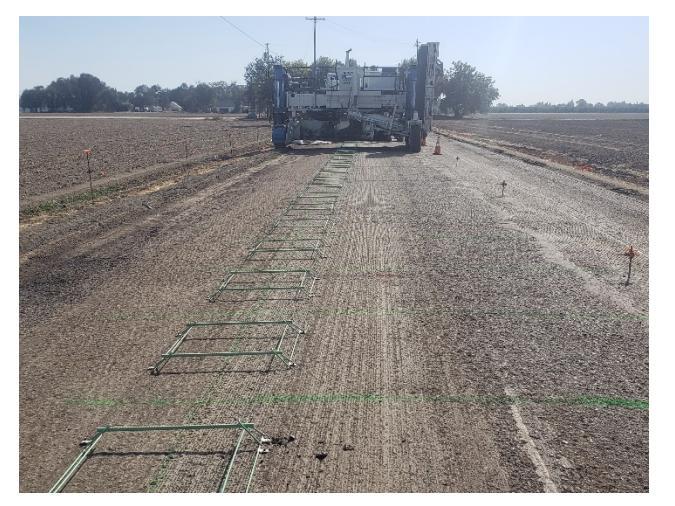
Compliant tie bar baskets

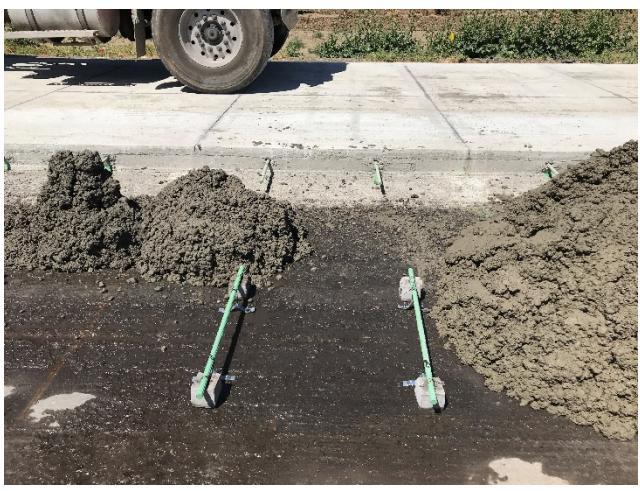
Tie bar baskets were used for the midlane longitudinal joint, as shown in Figure 4.13, except for a small portion in the northbound lane around PM 12.655, where a noncompliant handmade system was used. The tie bars of the longitudinal joint between lanes were inserted manually into the plastic concrete, as shown in Figure 4.14. This technique, which is not one of the options prescribed in Caltrans Standard Specifications, Section 40 yields little control of the tie bar position and allows air pockets to form in the concrete around the manually inserted tie bar.

Handmade system used on a small portion of the project, northbound lane around PM 12.655

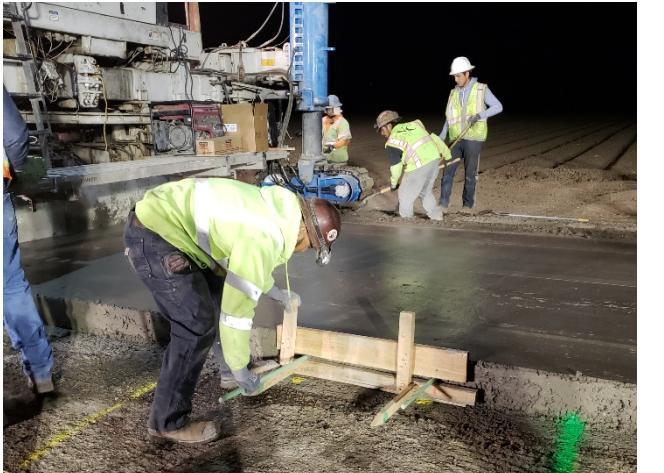
Manual insertion of tie bars in the plastic concrete

*Note:* Manual insertion of the tie bars in the plastic concrete is not one of the options prescribed in Caltrans Standard Specifications, Section 40.

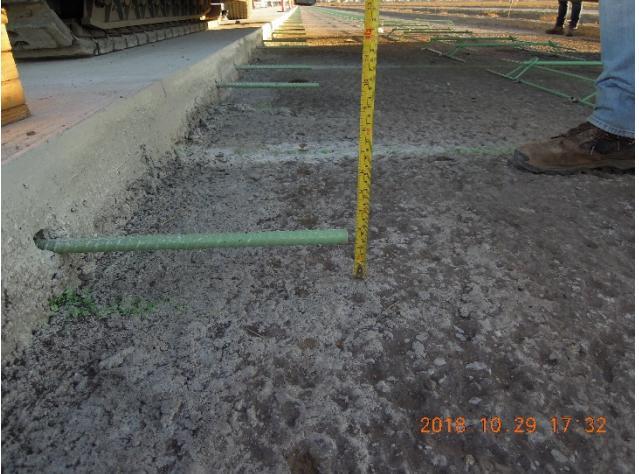
Figure 4.14: Manual insertion of tie bars in the plastic concrete.

Air pocket around the manually inserted tie bar

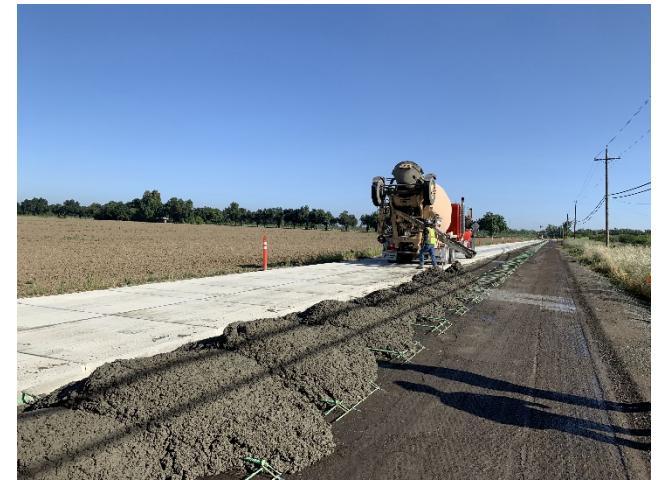
Figure 4.15: Asphalt surface moisture conditioning.

Before placement of the concrete overlay, the asphalt surface was wet conditioned by a truck that sprayed water on it. Overall, the asphalt surface was adequately wet conditioned; it was wet but free of standing water, approximating a saturated surface-dry condition (Figure 4.15, left). At some spots, however, the asphalt surface dried before the concrete was placed (Figure 4.15, right) and it would have been beneficial to have sprayed these spots with water manually. At other locations, the irregularity of the milled asphalt surface caused water ponds to form at the shoulder edge of the roadway (Figure 4.15, right). This standing water may have had a negative effect on the concrete poured at these locations.

Asphalt surface is adequately wet conditioned: uniformly moist but free of standing or flowing water

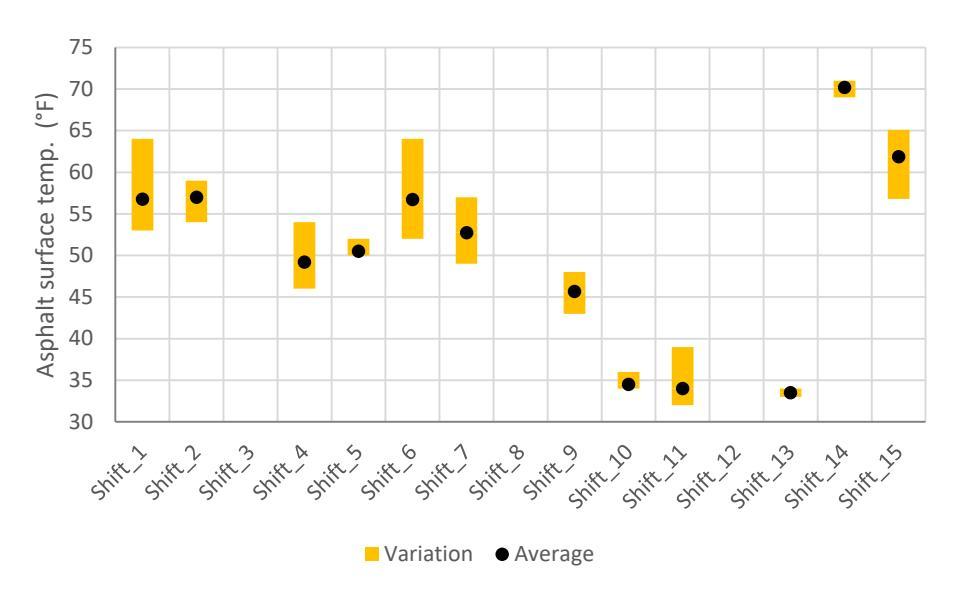
#### Figure 4.21: Asphalt surface temperature variation during concrete paving.

During the concrete paving, the asphalt surface temperature ranged from the low 30s to the low 70s Fahrenheit (Figure 4.21). The asphalt surface temperatures were much lower than the 120°F limit prescribed by the project special provisions. The asphalt surface temperature was particularly low during paving Shifts 10 through 13, due to the low air temperatures on those days and during the nighttime paving. Even though neither the Caltrans Standard Specifications nor the project special provisions prescribed a minimum asphalt surface temperature during concrete paving, it would still have been desirable for the temperature to not drop below 50°F. This 50°F minimum agrees with the Caltrans Standard Specifications, Section 90 requirement that "immediately before placing the concrete, the temperature of the mixed concrete must be from 50 to 90°F." The temperature of the plastic concrete was also measured during the construction of the overlay, with the results shown in Figure 4.22. Some measurements were below 50°F, but these were taken between the side-belt spreader and the paver, not immediately before placing the concrete.

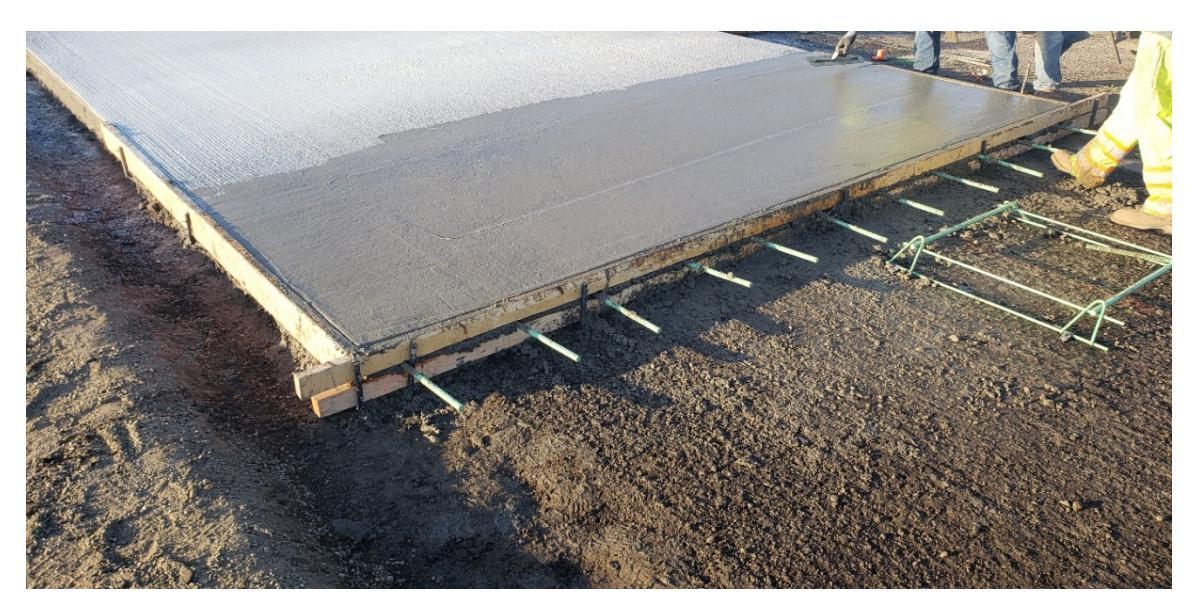
Figure 4.24: Installation of tie bars instead of dowels at a transverse joint (end of paving Shift 1).

Some of the transverse construction joints (beginning/end on paving shifts) were built incorrectly. Specifically, at the first construction joint (Section B, northbound direction, between paving Shifts 1 and 2), tie bars rather than dowels had been installed (Figure 4.24). After learning of the issue, the resident engineer instructed the contractor to use dowels at the transverse construction joints. Even though this was done, in some cases lubricant was applied either poorly or not at all. As a result, some of these joints may have locked.

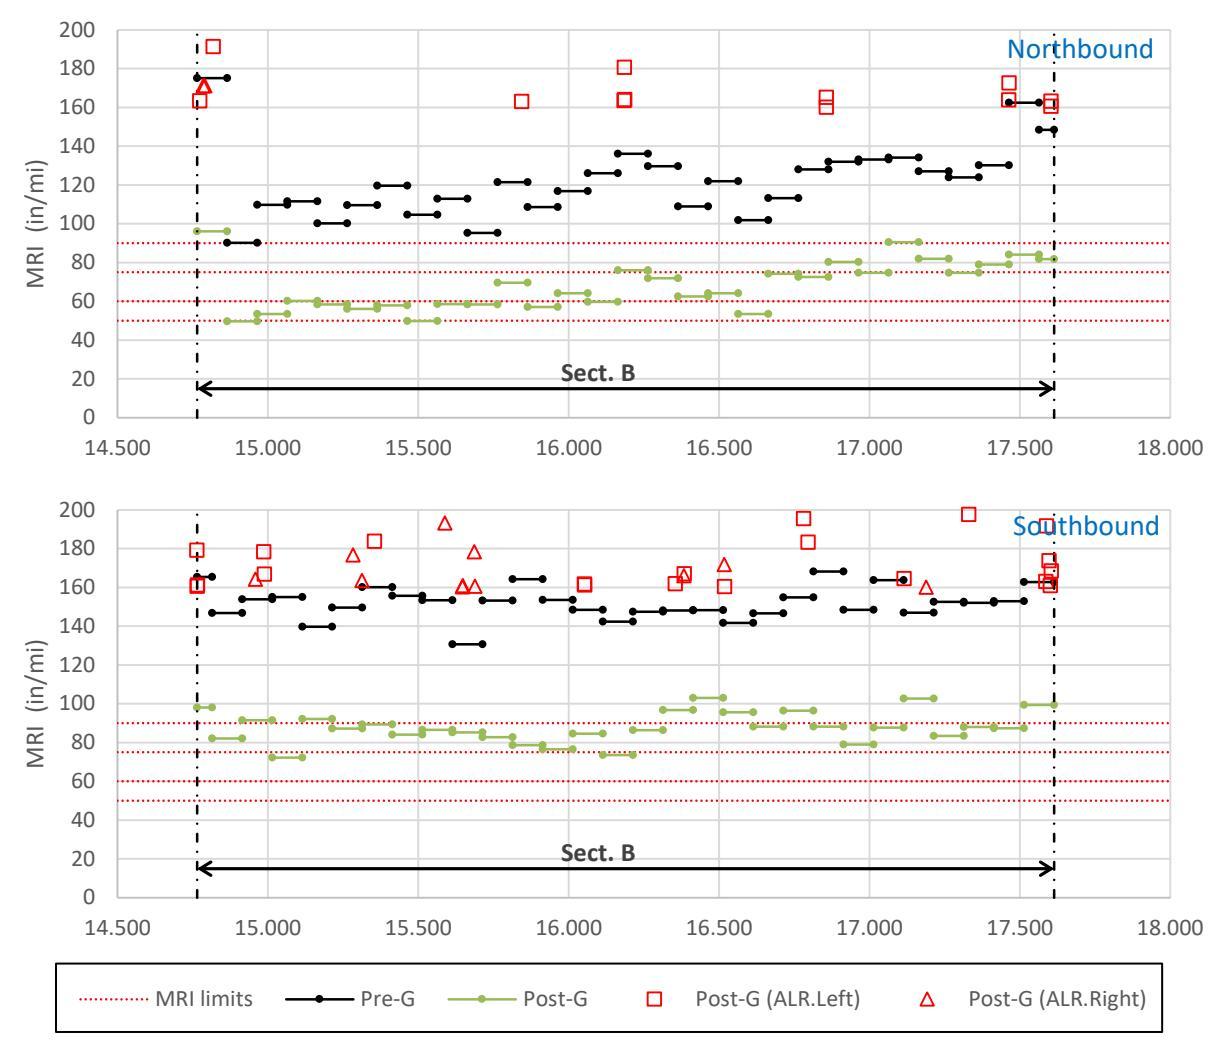
Figure 4.30: Longitudinal smoothness: Segment B.

The postconstruction longitudinal smoothness of the concrete overlay was relatively poor, as shown by the Pre-G (pre-grinding—i.e., before grinding) series in Figure 4.30 and Figure 4.31. The 0.1 mi. mean roughness index (MRI) varied from 70 to 175 in./mi., which was considerably higher than the 60 in./mi. upper limit prescribed by Section 40 of the 2015 Caltrans Standards Specifications that apply to this project. The MRI limits series in Figure 4.30 and Figure 4.31 are based on the 2019 Caltrans smoothness specifications, Table 67.5 (JPCP reconstruction). This table includes payment disincentives for MRIs between 75 and 90 and mandatory grinding when MRI exceeds 90 in./mi. Even though these specifications are not applicable to this project, an evaluation of the concrete overlay pre- and post-grinding smoothness followed by a comparison of those against the new Caltrans specifications was regarded as an interesting exercise. It revealed that the entire project would have required mandatory grinding since the MRI exceeded 90 in./mi at all the 0.1 mi. segments.

Based on the Post-G (post-grinding) series results shown in Figure 4.30 and Figure 4.31, few of the 0.1 mi. segments (around 14% of the project length) passed the 60 in./mi. requirement, but most of them (around 82% of the project length) would have passed the 90 in./mi. requirement.

Figure 4.30 and Figure 4.31 also show the areas of localized roughness present after the grinding operation; the roughness of these areas was categorized according to the 2019 Caltrans smoothness specifications (160 in./mi. limit). As shown in the figures, a considerable number of areas of localized roughness (ALRs) still existed after the grinding operation.

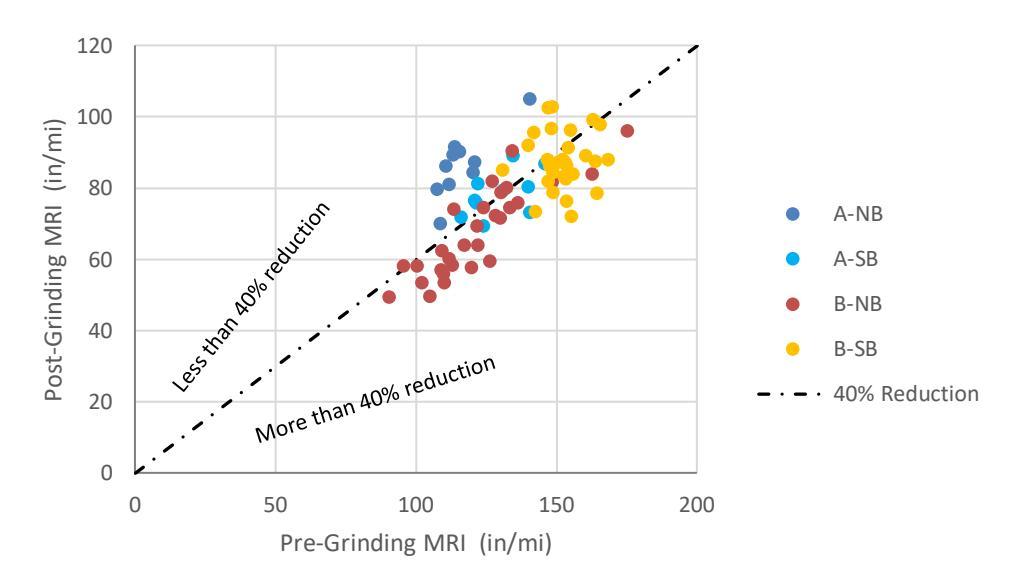
Figure 4.33: MRI improvement due to grinding.

To try to meet Caltrans smoothness specifications, the complete project was subjected to grinding (blanket grinding). The appearance of the post-grinding surface can be seen in Figure 4.32. Grinding operations took place in April 2019 on Segment B and in the second half of May 2019 on Segment A. Overall, the grinding resulted in a 40% MRI improvement, although the improvement for individual 0.1 mi. segments varied from 19% to 53% (Figure 4.33).
