1. REPORT NUMBER FHWA/CA/MI-2006/22	2. GOVERNMENT ASSOCIATION NUMBER	3. RECIPIENT'S CATALOG NUMBER
4. TITLE AND SUBTITLE CRASH TESTING OF VARIOUS ROADSIDE HARDWARE		5. REPORT DATE December 2006

CRASH TESTING OF VARIOUS ROADSIDE HARDWARE

DEPARTMENT OF TRANSPORTATION
DIVISION OF RESEARCH AND INNOVATION
OFFICE OF MATERIALS AND INFRASTRUCTURE

Research Performed by Roadside Safety Research Group

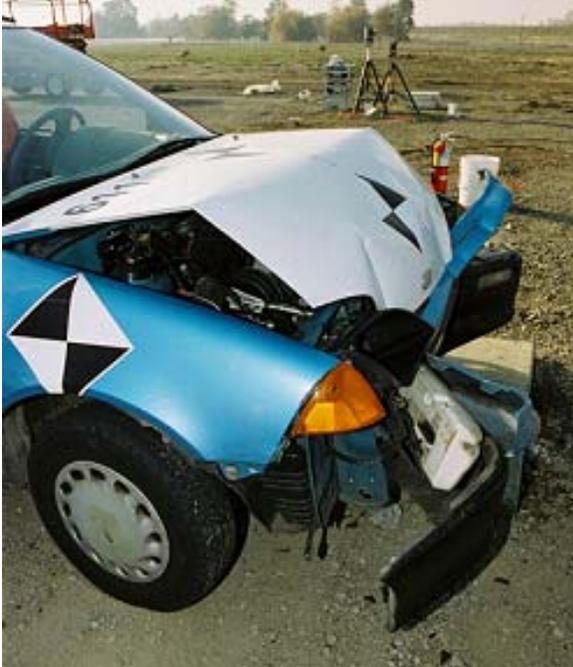
Figure 2-9. Test Vehicle After Test 611

The entire front of the vehicle was moderately damaged in the initial impact with the 334C controller cabinet and would not have been operable afterwards. The hood, bumper, headlamp area, grille, both front fenders, and suspension components were all affected. The radiator was ruptured and pushed back far enough that it made contact with the exhaust manifold of the transverse-mounted engine.

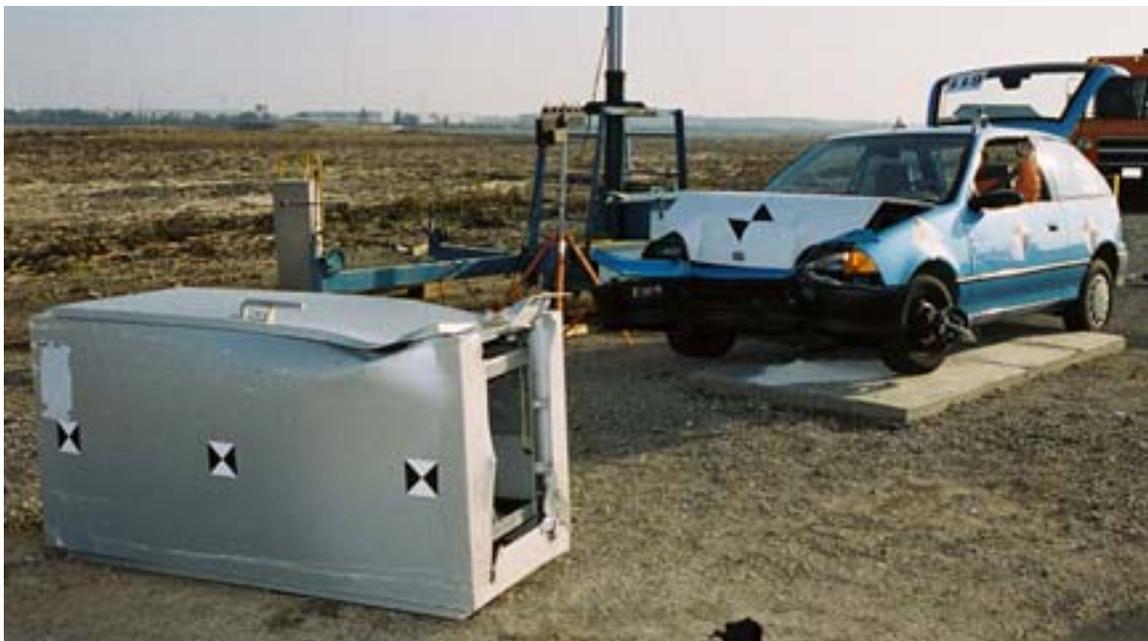
Figure 2-12. Controller Cabinet Test Article and Vehicle After Test 611

The damage to the test article was extensive and would require complete replacement of the cabinet. It is not known if the electronic components installed in the rack inside the cabinet would have been serviceable after the impact because non-operating units were used to simulate the weight and placement of functioning units. The cast-in-place anchor bolts were bent and damaged enough that their re-use would be questionable. There was significant spalling of the concrete pedestal on the down-stream side as a consequence of the anchor bolts being pushed rearward. The bottom of the cabinet was torn where the anchor bolts pulled through.

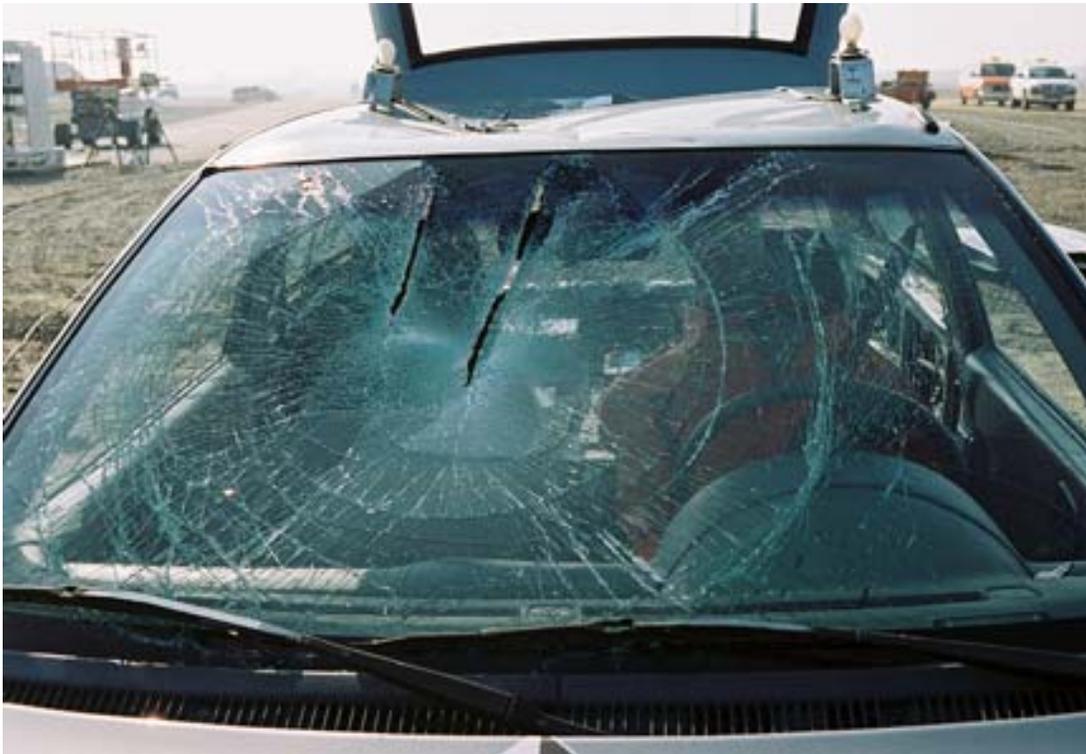
Figure 2-17. Test Vehicle After Test 613

The entire front of the vehicle was moderately damaged in the initial impact with the chain control sign and was drivable but not legally operable afterwards. The hood, bumper, and grille were all affected. The bottom signs penetrated the windshield approximately 50-75 mm (2.0-3.0 in) (Figure 2-21). The roof's maximum deformation was approximately 50 mm (2.0 in). The windshield penetration and roof deformation were minor enough that there would have been no significant risk of injury to vehicle occupants.

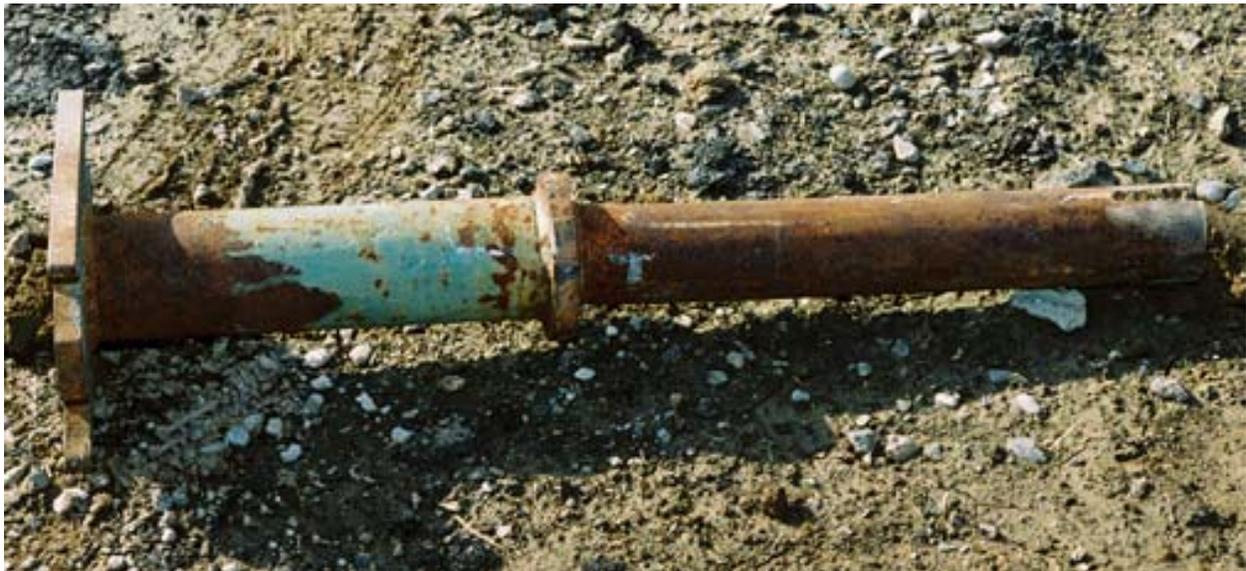
Figure 2-19. Breakaway Base From Test Article After Test 613

Although the sign panels were somewhat deformed, the entire post assembly could be reset on the undisturbed base and remain functional until it is deemed necessary to either replace or repair the panels.

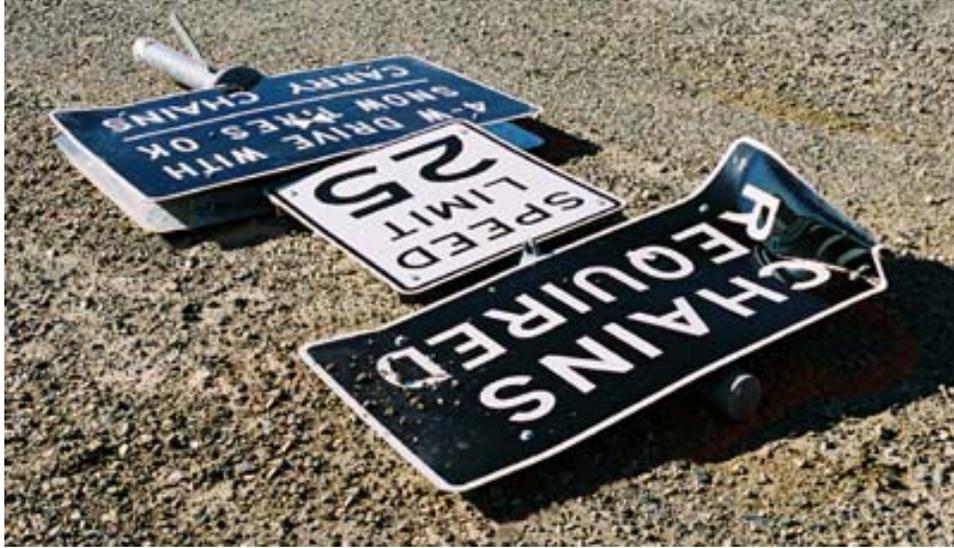
Figure 2-29. Test Article After Test 614

Article Damage: All signs were slightly damaged but reusable. The steel post and base were not damaged and could be immediately reused.

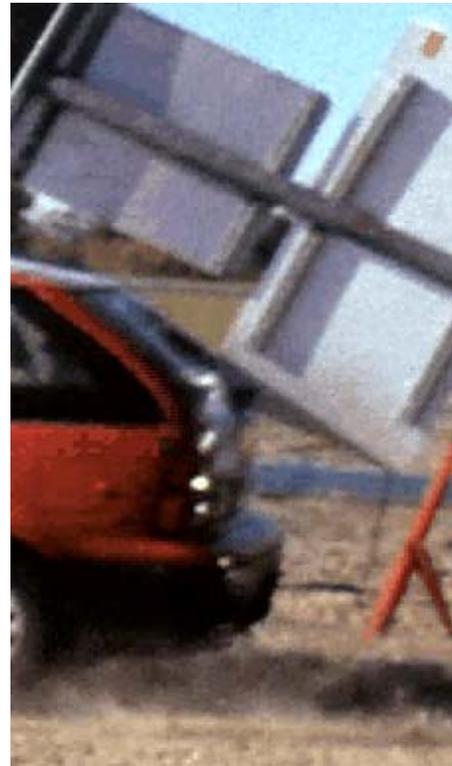
Figure 2-32. Chain Control Sign Penetration into Rear Window – Test 614

The entire front of the vehicle was slightly damaged in the initial impact with the chain control sign and was drivable, but not legally operable afterwards. The hood, bumper, and grille were all affected. The bottom signs did not penetrate through the windshield, but deformed it inward approximately 50-75 mm (2.0-3.0 in) (Figure 2-31). The roof's maximum deformation was approximately 38 mm (1.5 in) at the front-center. The rear window was penetrated near the bottom-center approximately 20 mm (0.79 in) by the top sign panel (Figure 2-32). The roof deformation and the sign penetration of the windshield and rear window were minor and would have presented no significant risk to vehicle occupants.

The longitudinal occupant impact velocity was 2.70 m/s (8.86 ft/s), which was below the allowable maximum of 5 m/s (16.4 ft/s) specified in NCHRP Report 350. The longitudinal and lateral occupant ridedown accelerations, $-2.75 g$ and $5.21 g$, respectively, were below the allowed maximum of $20 g$. Test results are summarized in Table 2-4 on page 52.

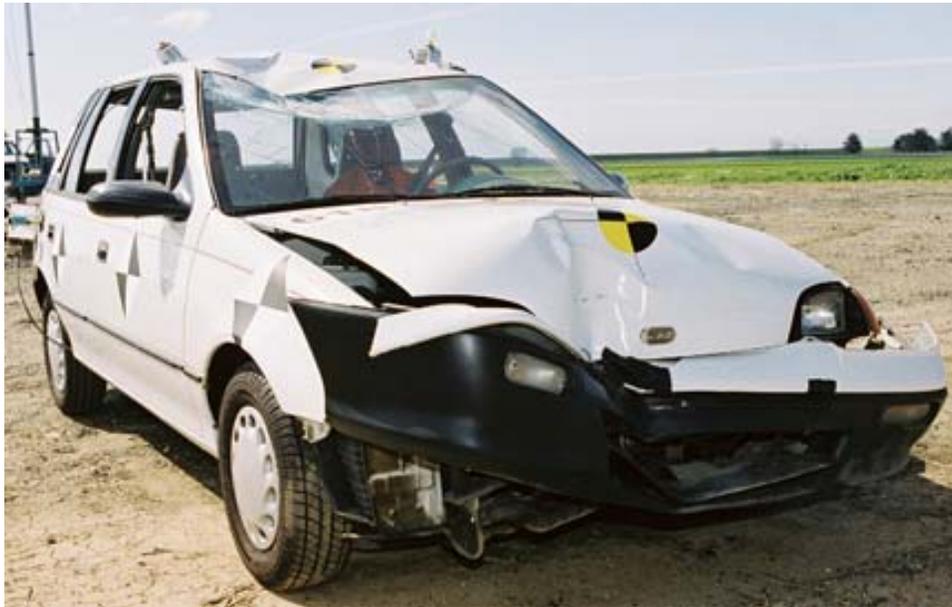
Figure 2-37. Test Vehicle After Test 618

The entire front of the vehicle was moderately damaged in the initial impact with the test article. The vehicle was drivable, but not legally operable after the impact. The hood, bumper, and grille were all affected. The front windshield was damaged along the roofline but was not penetrated. The greatest roof deformation was centered at the top of the windshield and was found to be approximately 90 mm (3.5 in). The extent of the deformation inside the passenger compartment is evident by comparing Figure 2-41 with Figure 2-42. Because of the location of this deformation, there would have been no significant risk to vehicle occupants.

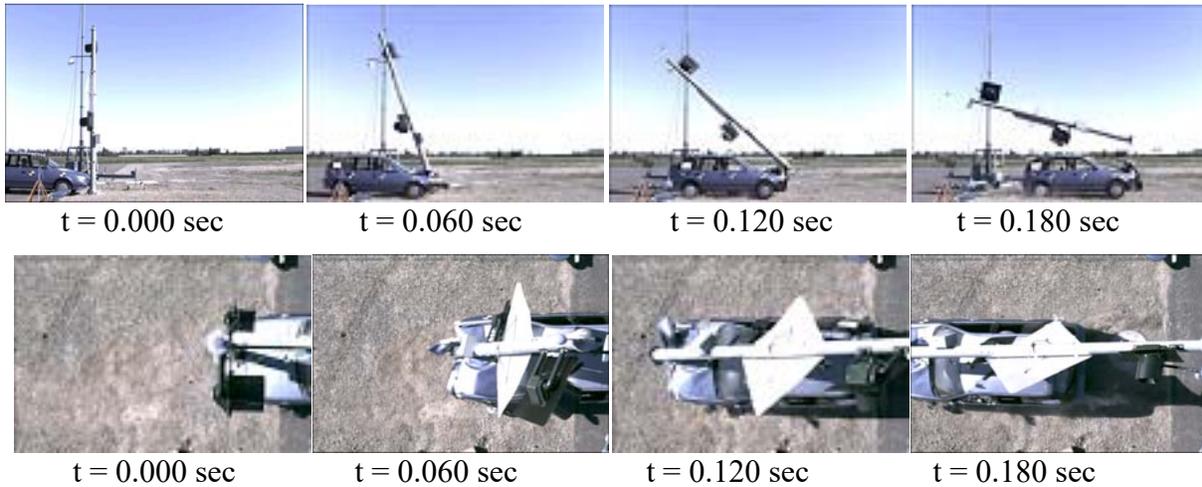
Figure 2-52. Impact Sequence and Diagram for Test 616

Article Damage: The assembly could be field-repaired by placing new components on the undamaged pole and re-erecting it on site.

The entire front of the vehicle was significantly damaged in the initial impact with the warning sign with flashing beacons and was inoperable afterwards. The hood, bumper, headlamp area, grille, both front fenders, and suspension components were all affected. The test article did not penetrate through the windshield or roof. The radiator was ruptured and pushed back far enough that it made contact with the exhaust manifold of the transverse-mounted engine.

The sign panels were somewhat deformed, the flashing beacons were damaged beyond repair, and the light fixture had broken away from the pole. The entire post assembly could be repaired in the field and reset on the undisturbed base or removed to a shop location for repair.

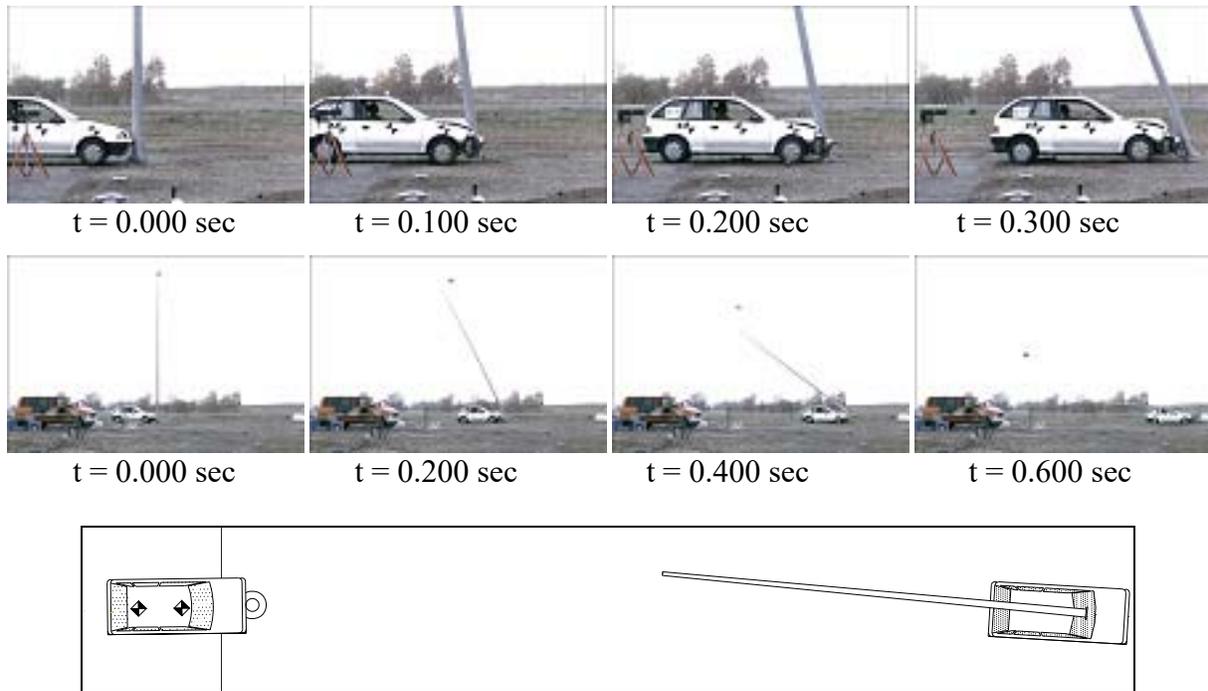
Figure 2-63. Impact Sequence and Diagram for Test 617

Article Damage: The assembly could be field-repaired by placing new components on the undamaged pole and re-erecting it on site.

The entire front of the vehicle was moderately damaged in the initial impact with the light standard and the vehicle was inoperable afterwards. The roof, hood, bumper, headlamp area, grille, both front fenders, and suspension components were all affected. The entire length and width of the roof was deformed by the secondary impact and presented risk to occupants. The roof's maximum deformation was approximately 64 mm (2.5 in) and was centered at the top of the windshield. The radiator was ruptured and pushed back far enough that it made contact with the exhaust manifold of the transverse-mounted engine.

The light standard was not damaged and could be reused. The pole-top mounted luminaire was completely destroyed. It could be field-replaced and the entire assembly could be reset on the undisturbed base.

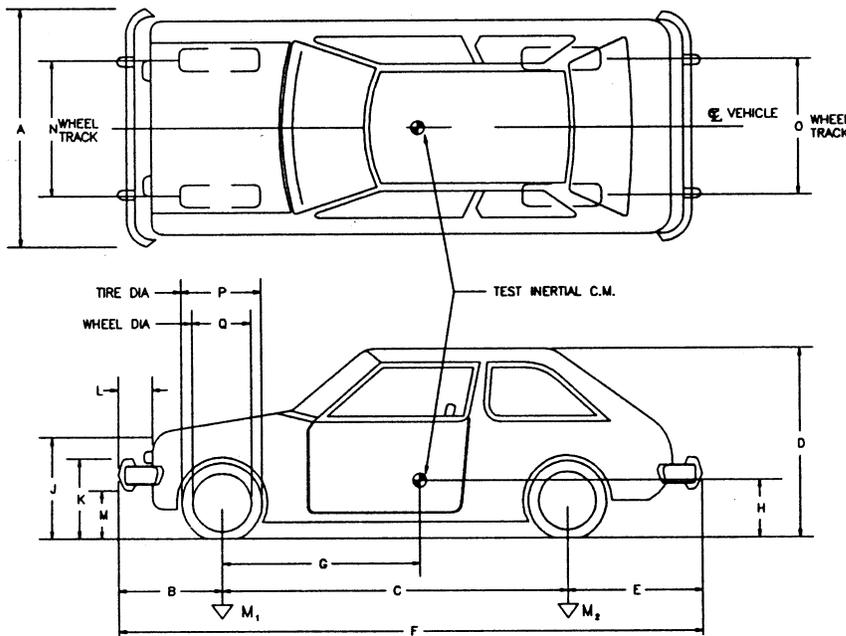
DESCRIBE ANY DAMAGE TO VEHICLE PRIOR TO TEST: Side-swipe along driver's door – documented with pictures.
Front bumper was pushed rearward 19mm from a previous minor impact.

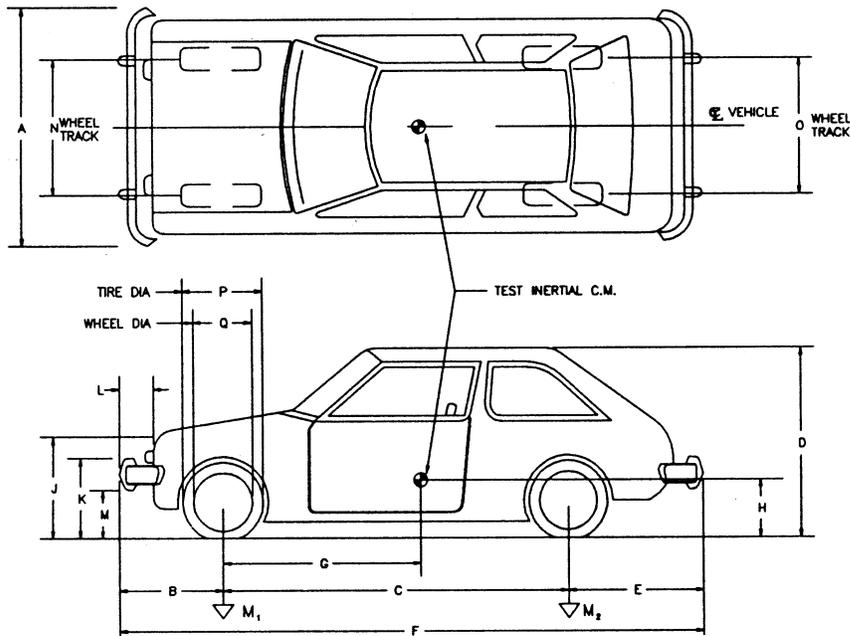
DATE: 19 NOV 2002 TEST NO: 613 VIN NO: 2C1MR2468R6747557 MAKE: Geo
 MODEL: Metro YEAR: 1994 ODOMETER: 144,557 mph TIRE SIZE: 155R12
 TIRE INFLATION PRESSURE: LF 32 RF 32 LR 32 RR 32
 MASS DISTRIBUTION (kg) LF 221.5 RF 217.2 LR 146.5 RR 139.7
 DESCRIBE ANY DAMAGE TO VEHICLE PRIOR TO TEST: small dent on hood – front and centered

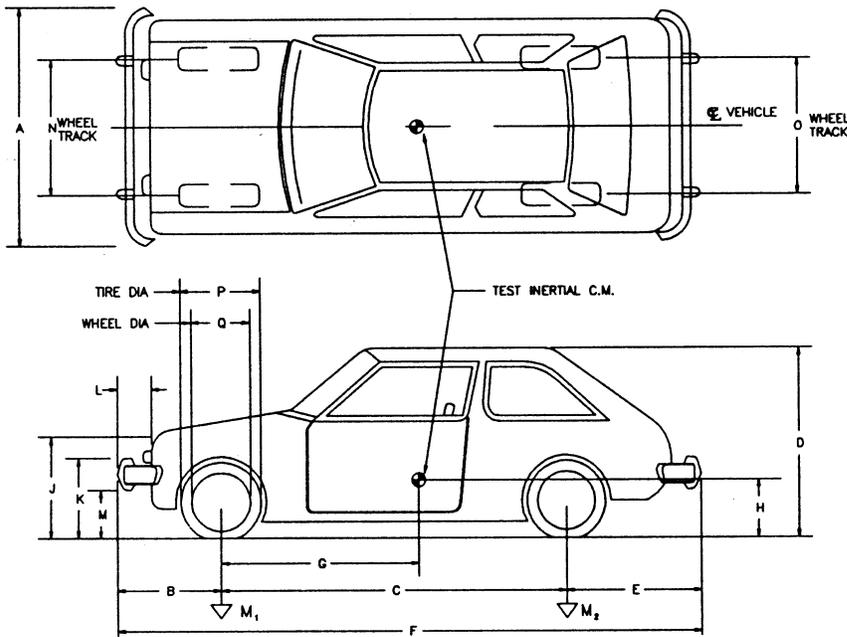
DESCRIBE ANY DAMAGE TO VEHICLE PRIOR TO TEST: small dent in driver's door, 50 mm long, 1.5 mm deep. Passenger door window molding was missing which resulted in a loose window condition – irrelevant to testing.
