1. REPORT NUMBER CA19-3106	2. GOVERNMENT ASSOCIATION NUMBER	3. RECIPIENT'S CATALOG NUMBER
4. TITLE AND SUBTITLE Encasement Research: Effective Utility Encasement Criteria and Methods		5. REPORT DATE 07/08/2019
7. AUTHOR Shailesh Chandra and Hung Nguyen		6. PERFORMING ORGANIZATION CODE
9. PERFORMING ORGANIZATION NAME AND ADDRESS California State University, Long Beach Research Foundation Long Beach, CA 90840		8. PERFORMING ORGANIZATION REPORT NO.
12. SPONSORING AGENCY AND ADDRESS California Department of Transportation Division of Research, Innovation, and System Information 1727 30th Street, MS-83, Sacramento, CA 95816		10. WORK UNIT NUMBER
13. TYPE OF REPORT AND PERIOD COVERED Final Report		11. CONTRACT OR GRANT NUMBER 65A0664
14. SPONSORING AGENCY CODE		15. SUPPLEMENTARY NOTES

Encasement Research: Effective Utility Encasement Criteria and Methods

California Department of Transportation

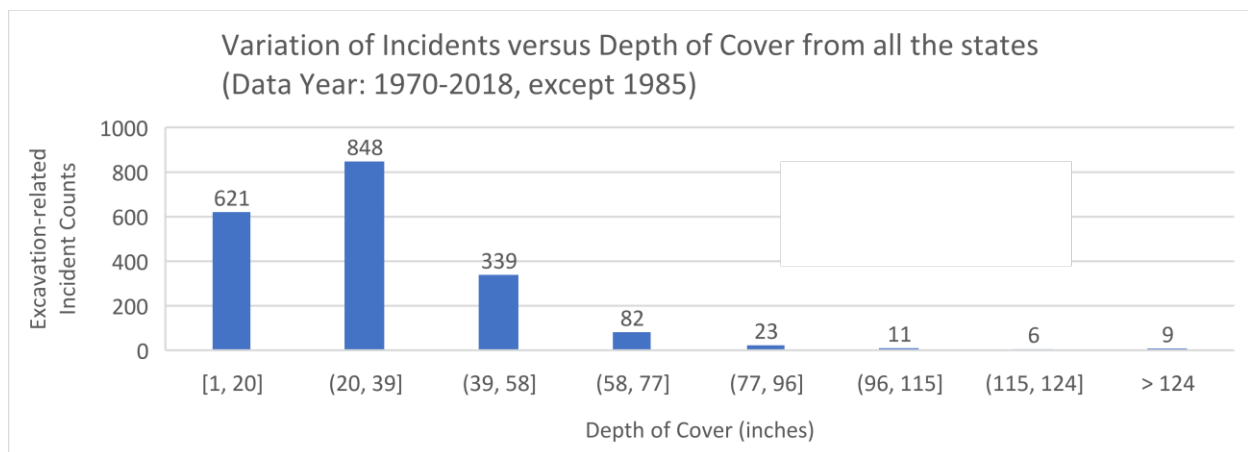
Figure 2: Distribution of incidents for depth of cover for Gas Transmission pipelines from all the states

The charts in Figs. 1 – 6 show counts of incidents with respect to various depth of cover at which the incidents have occurred for various pipeline systems. It is evident from these charts that majority of excavation-related incidents occurred at depths of cover between 20” to 37” in California and in all the states of the nation. Note that these observations have been made based on historical data obtained and analyzed from incidents reported on PHMSA between 1970 -2018 for gas transmission pipelines and between 2010-2018 for gas distribution pipelines.

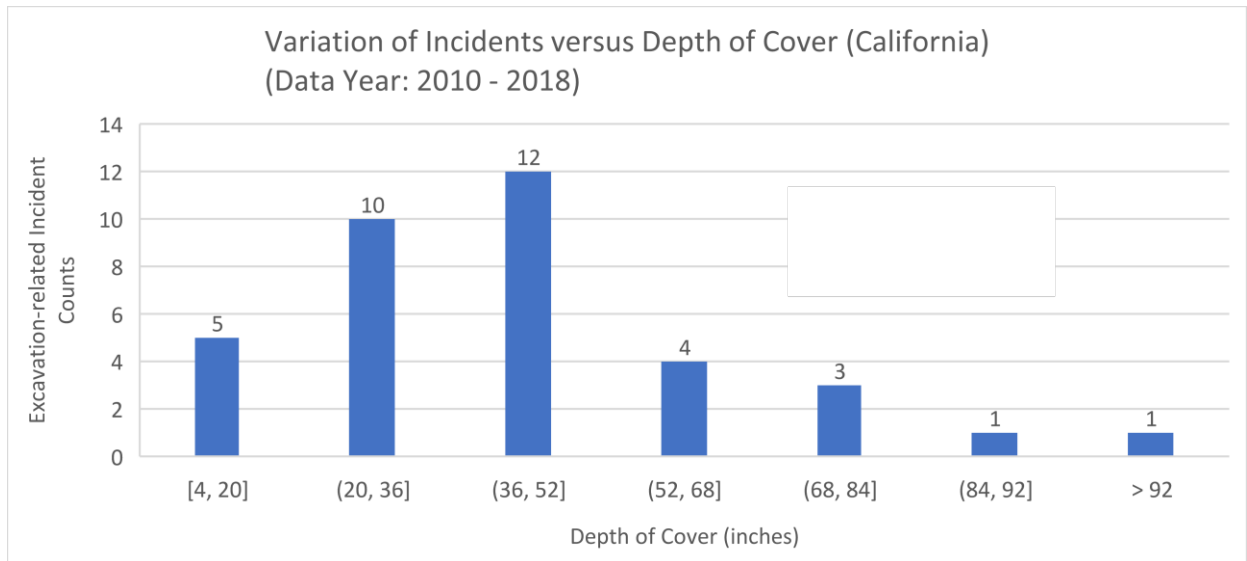
Figure 3: Distribution of incidents for depth of cover for Gas Distribution pipelines in California

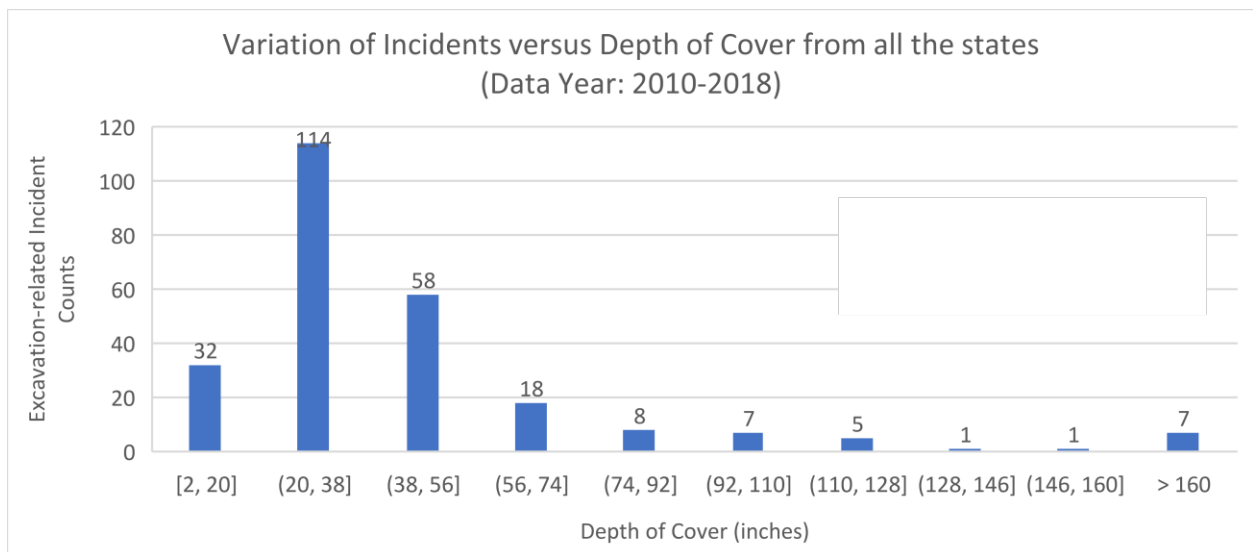
Figure 4: Distribution of incidents for depth of cover for Gas Distribution pipelines from all the states

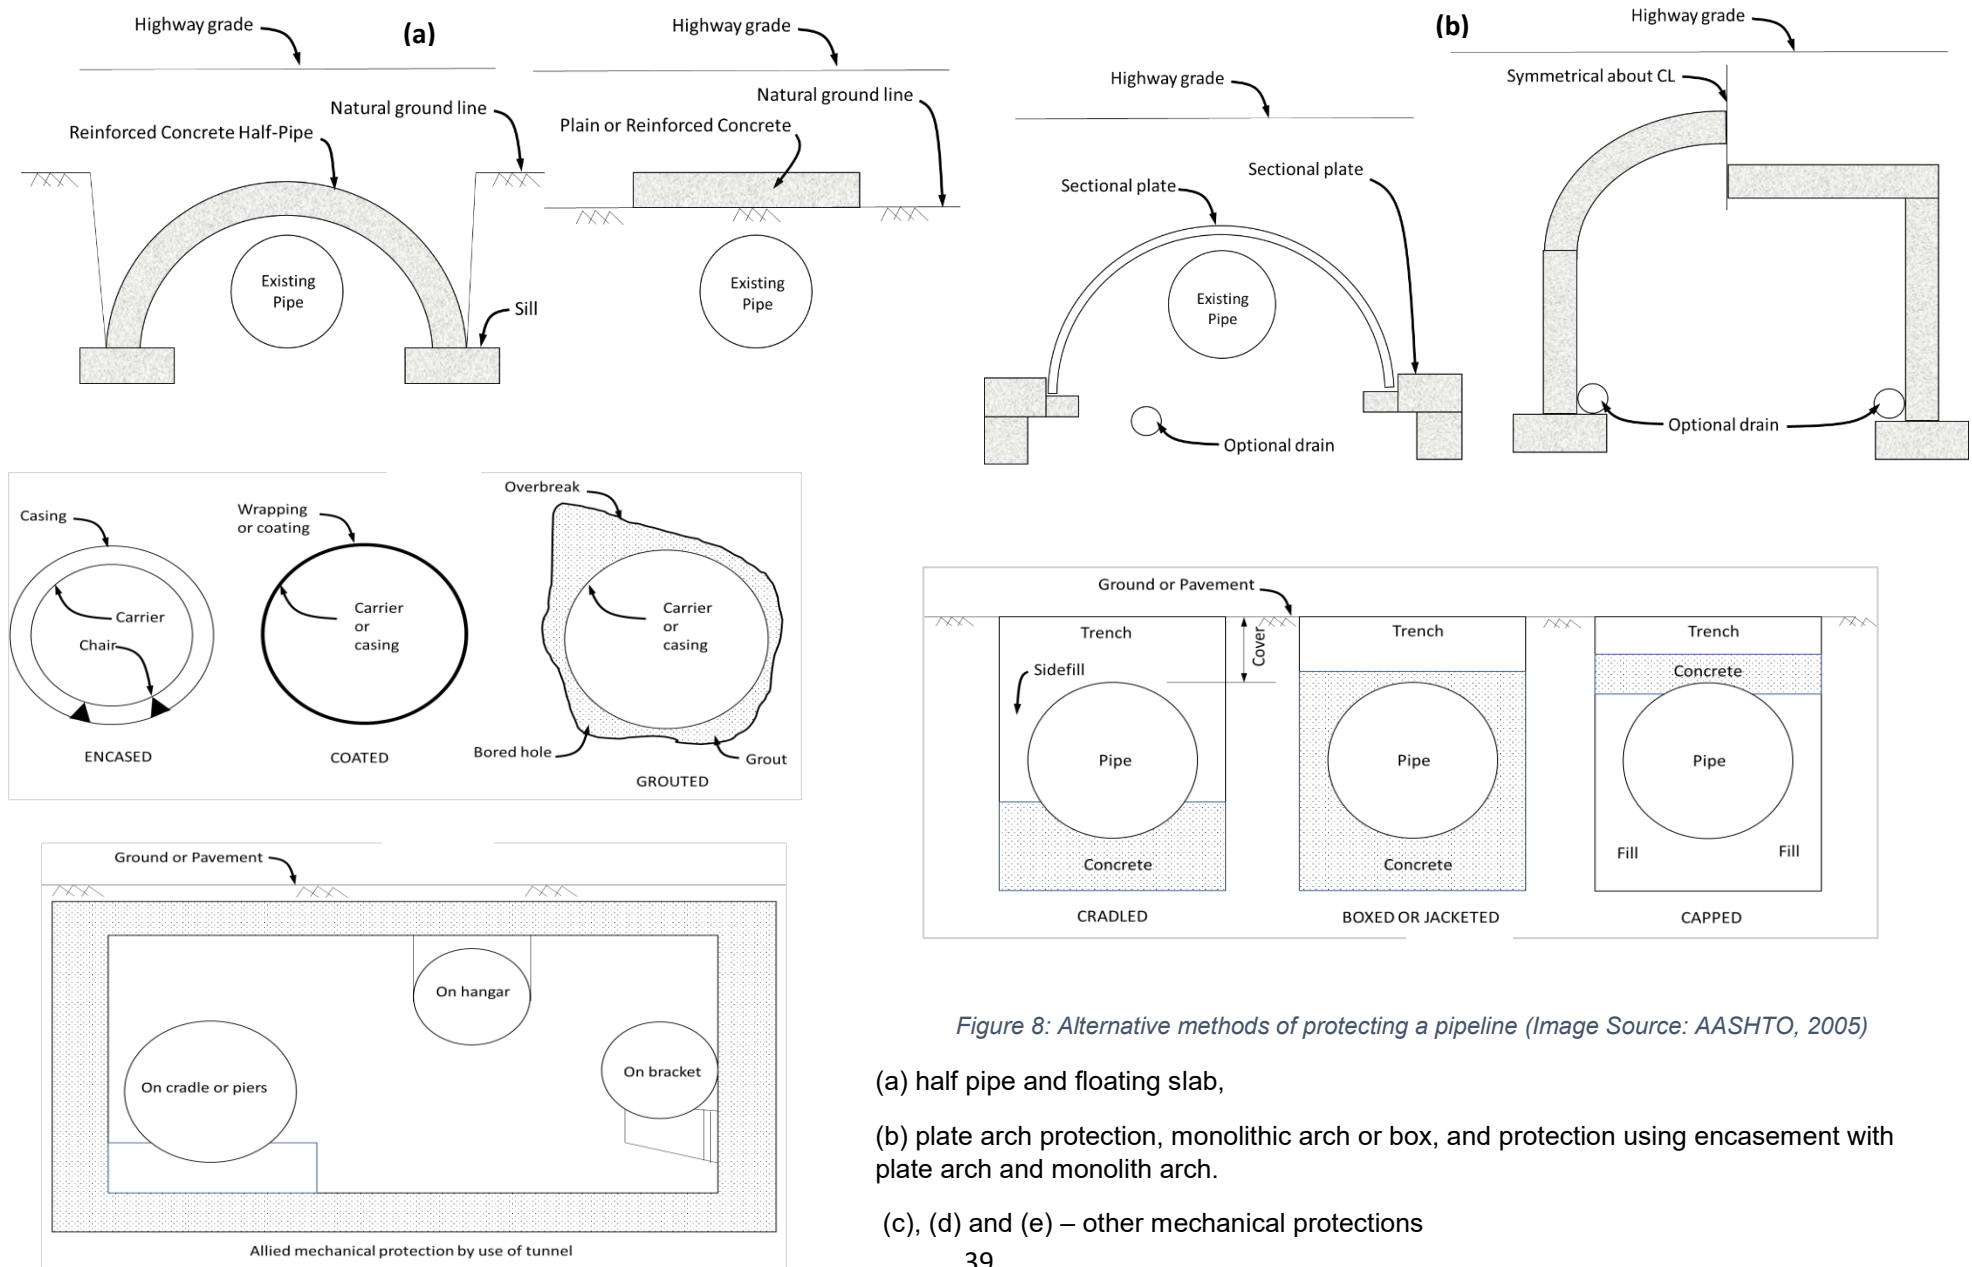
Figure 8: Alternative methods of protecting a pipeline (Image Source: AASHTO, 2005)

(a) half pipe and floating slab,

There are alternatives to casing a pipeline which often ensure the same level of protection to the carrier pipe and eliminates most of the cons listed above. For example, a single box-culvert-like structure can be used (see Fig. 8). In specific, protection to the carrier can be ensured using encasement with half pipe and floating slab, plate arch protection, monolithic arch or box, and protection using encasement with plate arch and monolith arch or other types of mechanical protection for underground utility crossings as shown in Fig. 8.

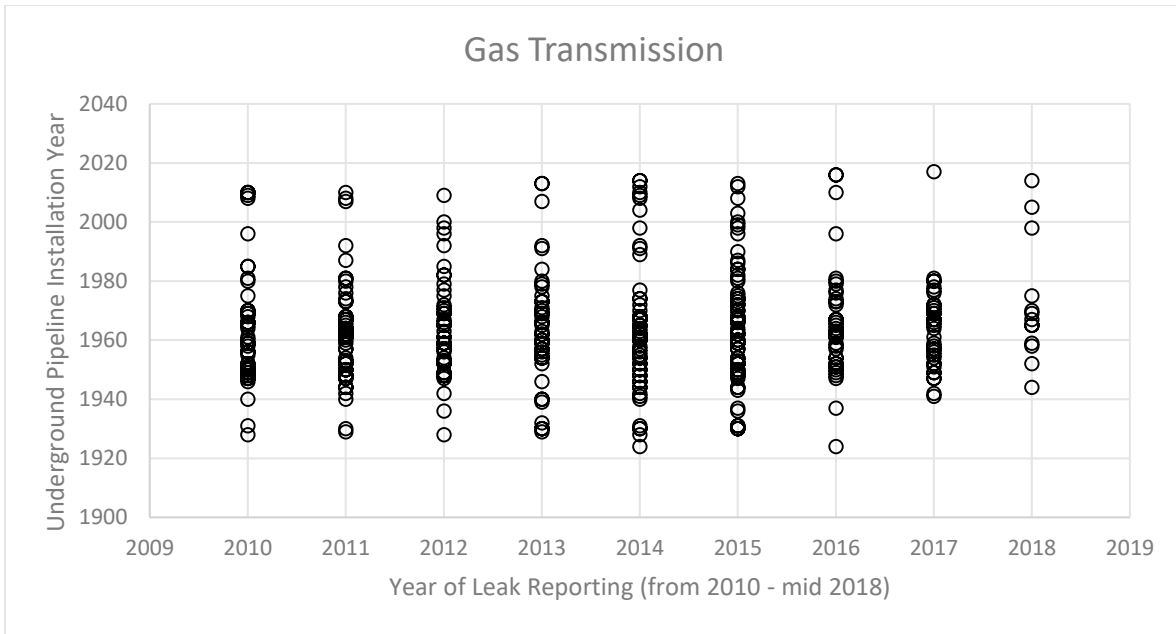
Figure 9: Cumulative variation in number of underground/under soil gas transmission pipeline leaks with respect to their installation year in all the states (Source: PHMSA, 2018)

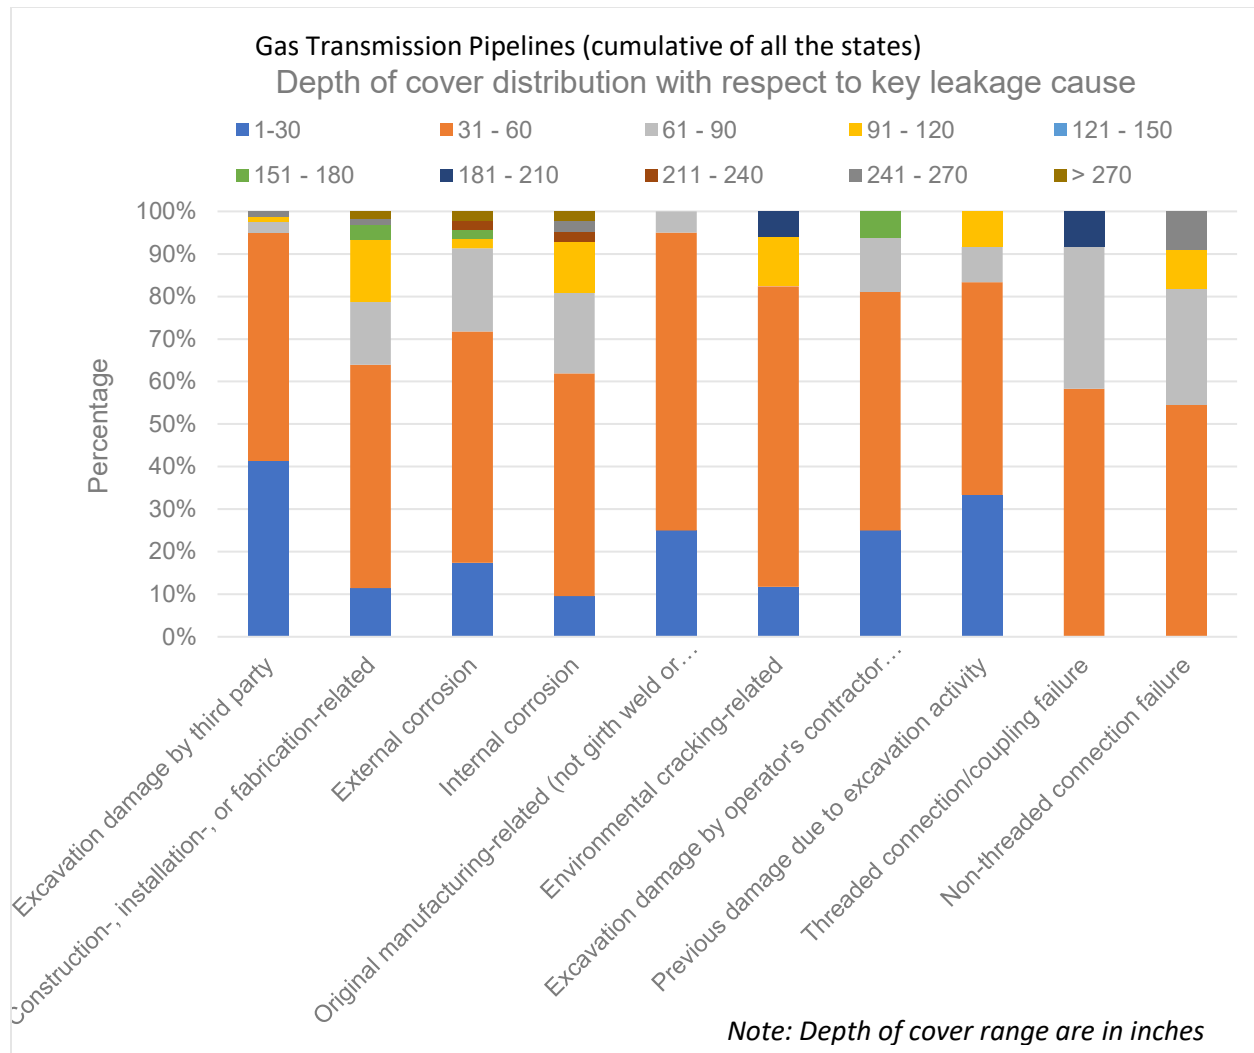
Figure 15: Year 2010 to 2018 percentage distribution of depth of cover versus leakage causes for Gas Transmission pipelines from all the states.

The chart in Fig. 15 and Fig. 16 shows the respective percentage distribution of underground gas transmission and distribution pipeline leakage causes with respect to the depth of cover. The data used has been used for pipeline incidents that occurred between 2010 to 2018. The distribution has been divided with respect to the following depth of cover (in inches) categories: 1-30, 31 – 60, 61 – 90, 91 – 120, 121 – 150, 151 – 180, 181 – 210, 211 – 240, 241 – 270 and greater than 270 inches. The two charts show the percentage of leakages has been highest for the range of 31 to 60 inches of depth of cover. Within California, depth of cover less than 60 inches has the highest probability of showing leakage due to excavation (see Fig. 17 and 18).

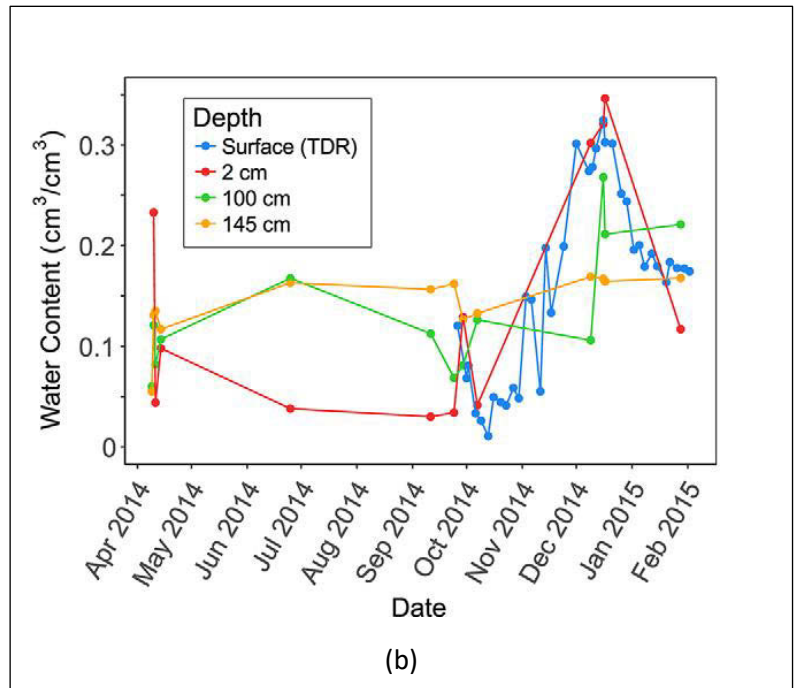
Figure 23: (a) Precipitation events at the site, and (b) Volumetric soil water content measured at the site

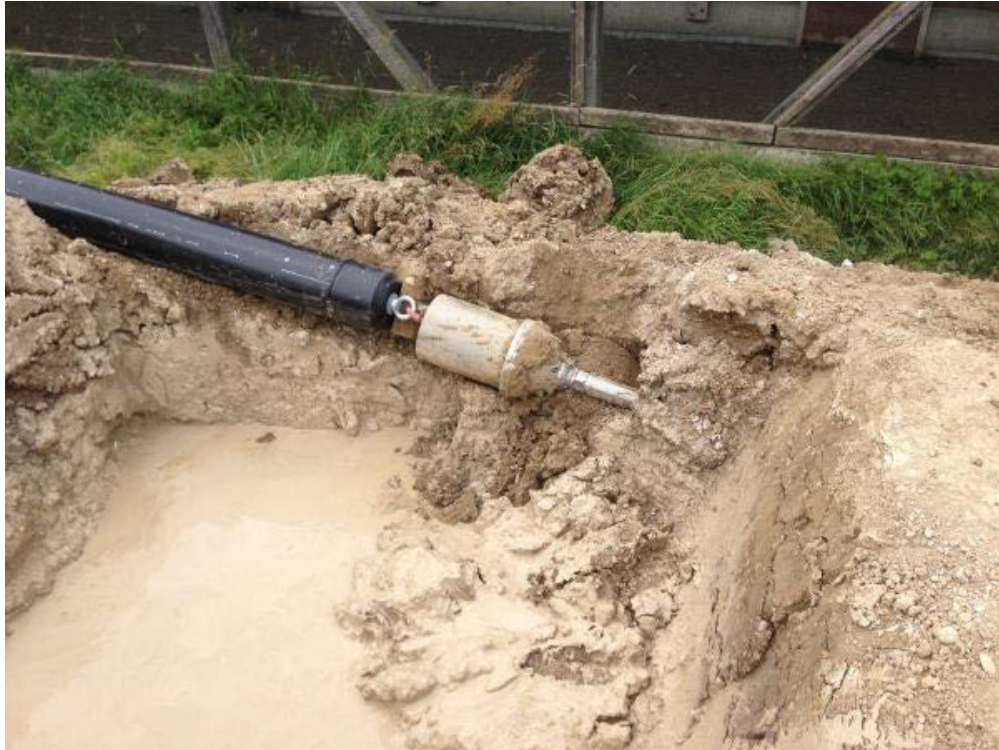
Figure 31: Pipe pulling (Source: Terra, Trenchless Technologies, 2018)

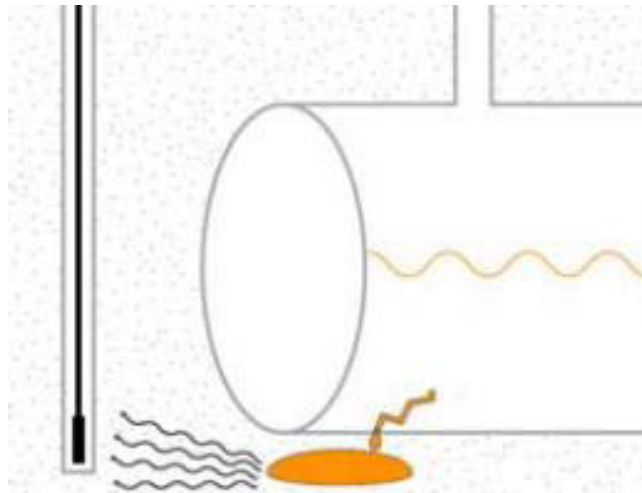
Figure 35: Vapor monitoring

Vapor monitoring: The vapor monitoring measures either the product fumes in the soil around the UST or special tracer chemicals added to the UST, which escape in order to check for a leak. This also has monitoring wells.
