VISUAL IMPACT ASSESSMENT

El Camino Real Roadway Renewal Project

February 24, 2021

California Department of Transportation
04-SM-82
PM 12.3 to 15.8
0416000142 – EA 0K810

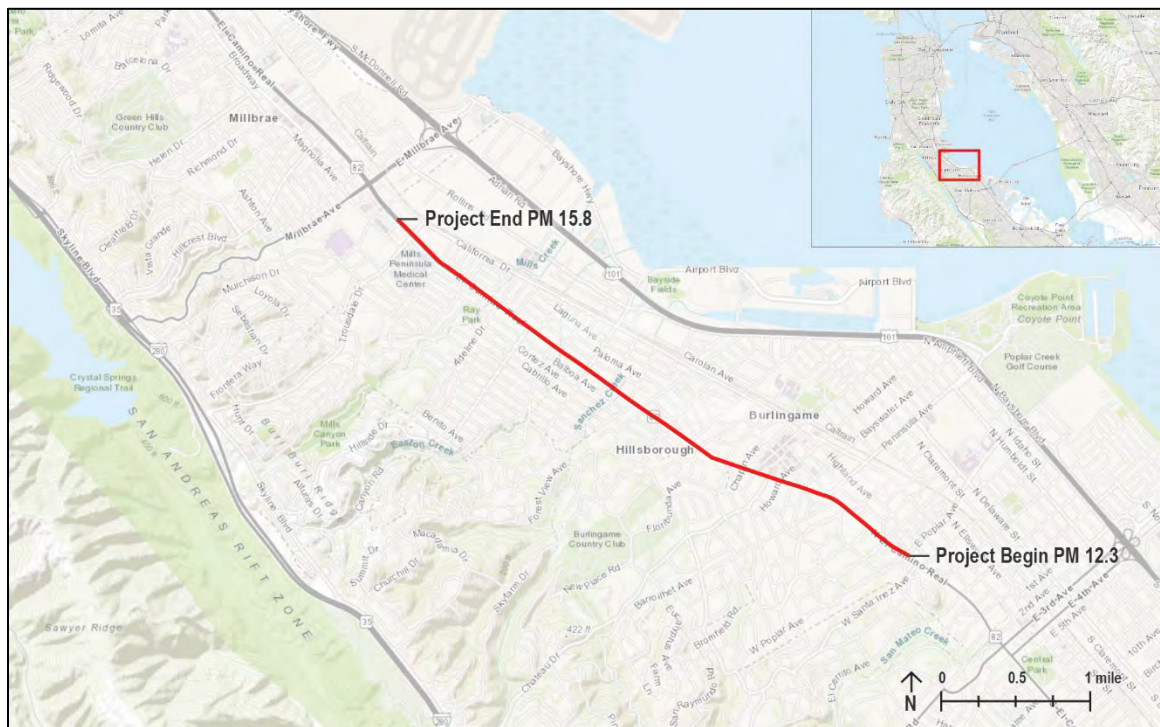
FIGURE 1: PROJECT AREA—The project area consists of a 3.6-mile segment of California State Route 82 in the cities of Millbrae, Burlingame, Hillsborough and San Mateo.

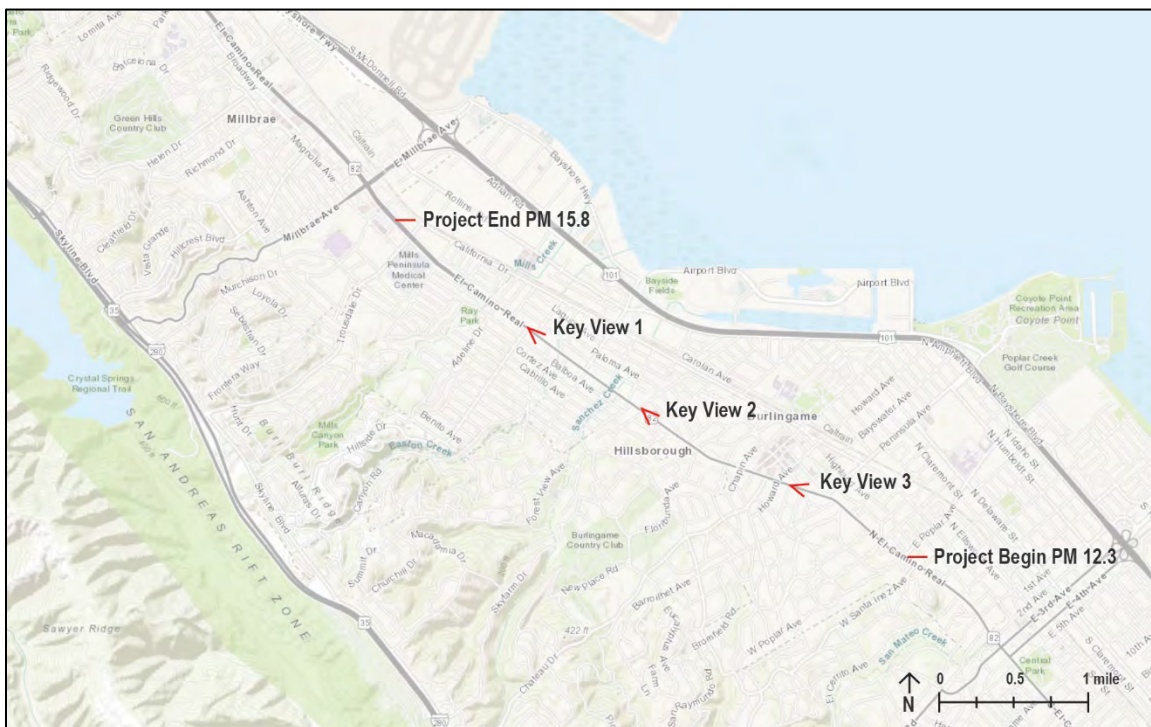
Figure 2: This map delineates the key views that will be used to assess visual impacts that may be caused by the proposed project.

- Key View 1 – From south of the Hillside Drive Intersection with El Camino Real looking south on El Camino Real.
- Key View 2 – From south of the Forest View Avenue Intersection with El Camino Real looking south on El Camino Real.
- Key View 3 – From south of the Carol Avenue Intersection with El Camino Real looking south on El Camino Real.

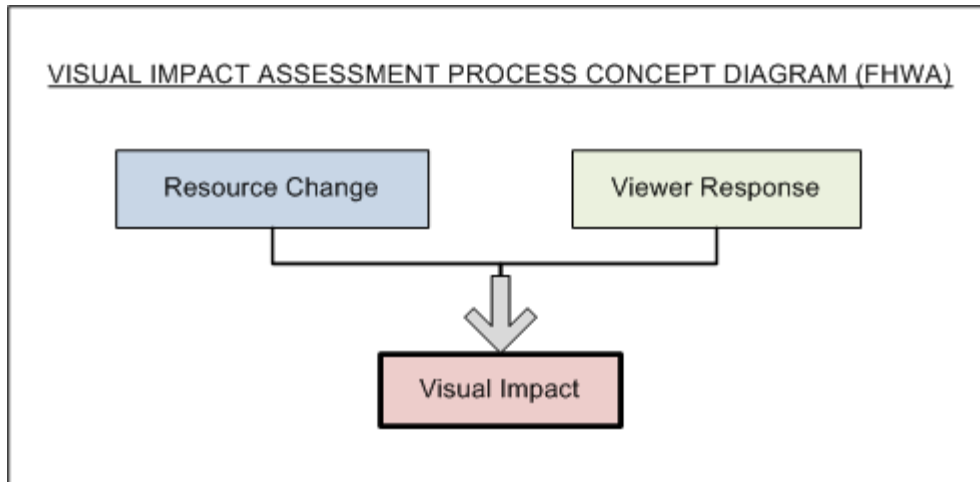
Visual impacts are determined by assessing changes to the visual resources and predicting viewer response to those changes. These impacts can be beneficial or detrimental. Cumulative impacts and temporary impacts due to the contractor’s operations are also considered. A generalized visual impact assessment process is illustrated in the following diagram:

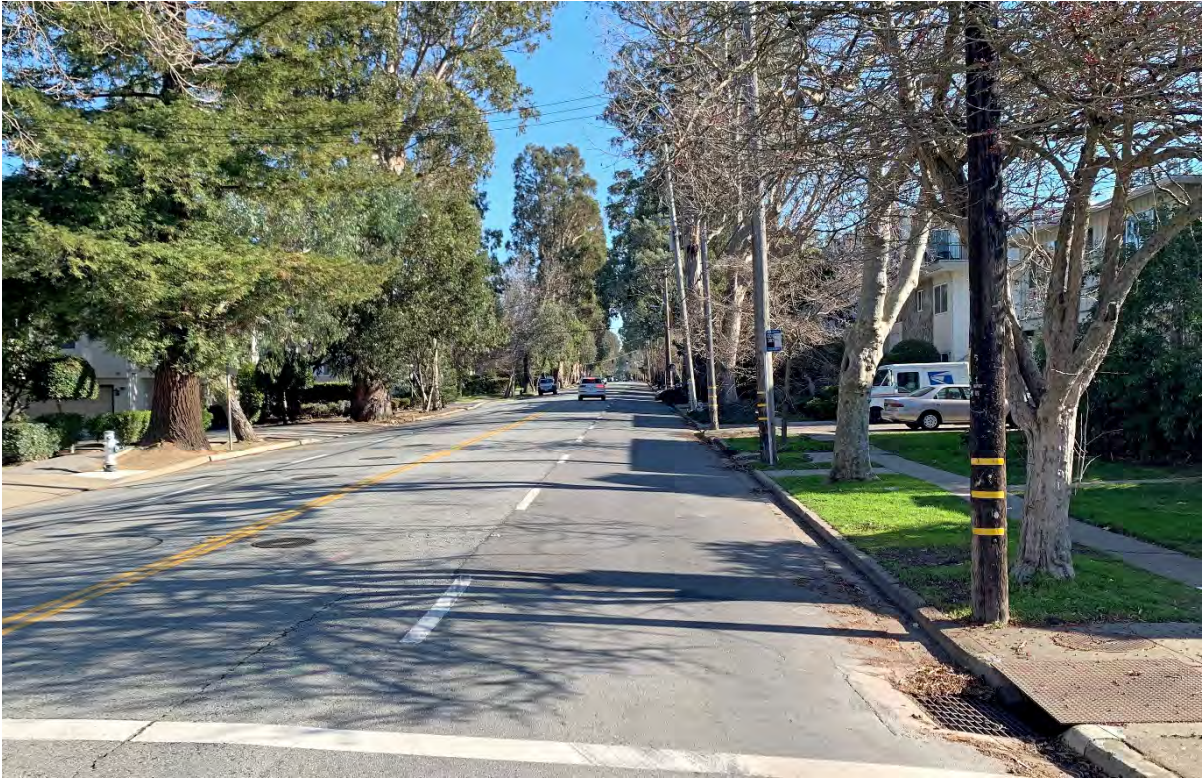
KV-1 Existing Condition

Key View 1 demonstrates the diversity of the tree-lined character of this portion of El Camino Real. There are a variety of tree species and forms in this Key View with both moderate-sized Sycamores in the foreground and taller evergreens and Eucalyptus in the middle and background. The visual mass of the trees creates a feeling of enclosure and their canopy dominates long views. Both the regular spacing of trees and continuous canopy add to the unity of the visual setting, while also providing a visual screen between adjacent buildings and the roadway environment. Overhead utilities and utility poles are hidden within the mass tree trunks and canopy. While not immediately obvious, the poor condition of the sidewalks and roadway surface slightly detract from the visual quality.

The Existing Condition can also be used to represent the No Build Alternative. In the near future, it is likely the older larger Eucalyptus in the middle and background would be removed and replaced with Elm trees. Since there is a variety of trees of different ages and sizes in this key view, removal of these individual trees will be only moderately apparent.

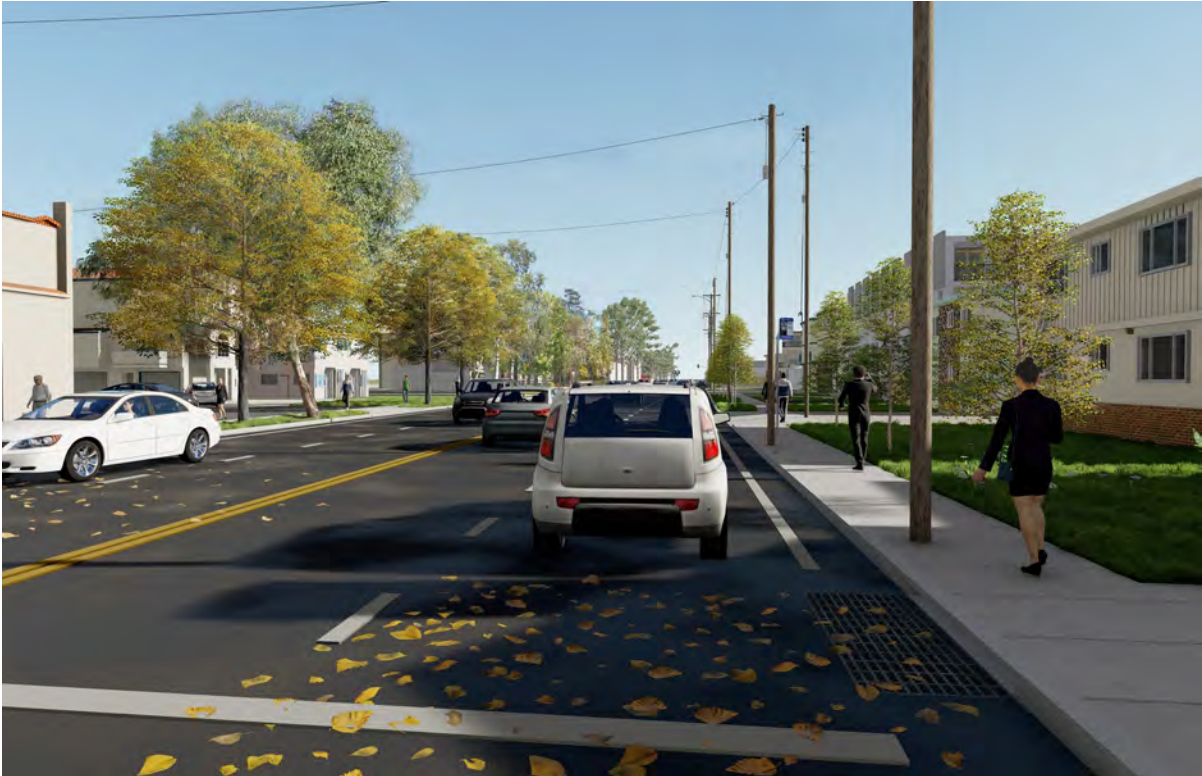
KV-1 Proposed Condition – Alternative 1

In this alternative, most of the trees in the Key View would require removal in order to replace drainage infrastructure along the southbound side of El Camino Real and to reconstruct driveways on the northbound side. The loss of these trees changes the visual setting notably, dramatically altering the tree-lined character and cohesiveness of the view. While the existing roadway configuration and width is retained, the view becomes more open and the intimate feeling is diminished without the double rows of large trees and their enclosing canopy in the foreground. Utility lines and poles are more visible revealing visual clutter. New street trees help to restore the visual character and quality of the existing condition. However, their much smaller scale post-construction and reduced number does not reestablish the same visual quality as the existing condition with its uniform mature tree canopy. Current restrictions on tree planting adjacent to utility poles and underneath power lines limit the number of replacement trees and their mature size along the southbound side of the street. Since trees cannot be planted within 10 feet of a pole, and trees underneath power lines must not reach a height over 25' at maturity, the visual character and quality would be permanently changed. By locating the sidewalk at the curb near the intersection as seen on the southbound side of the street, corner sight distance is maintained, and tree planting is maximized. Beyond the required area of clear sight distance, the sidewalk meanders back to its current location behind the planting strip to provide a buffer between pedestrians and traffic. New street surfaces and sidewalks improve visual quality to some degree. The overall level of resource change is moderate-high to high post construction and moderate-high 20 years after construction.

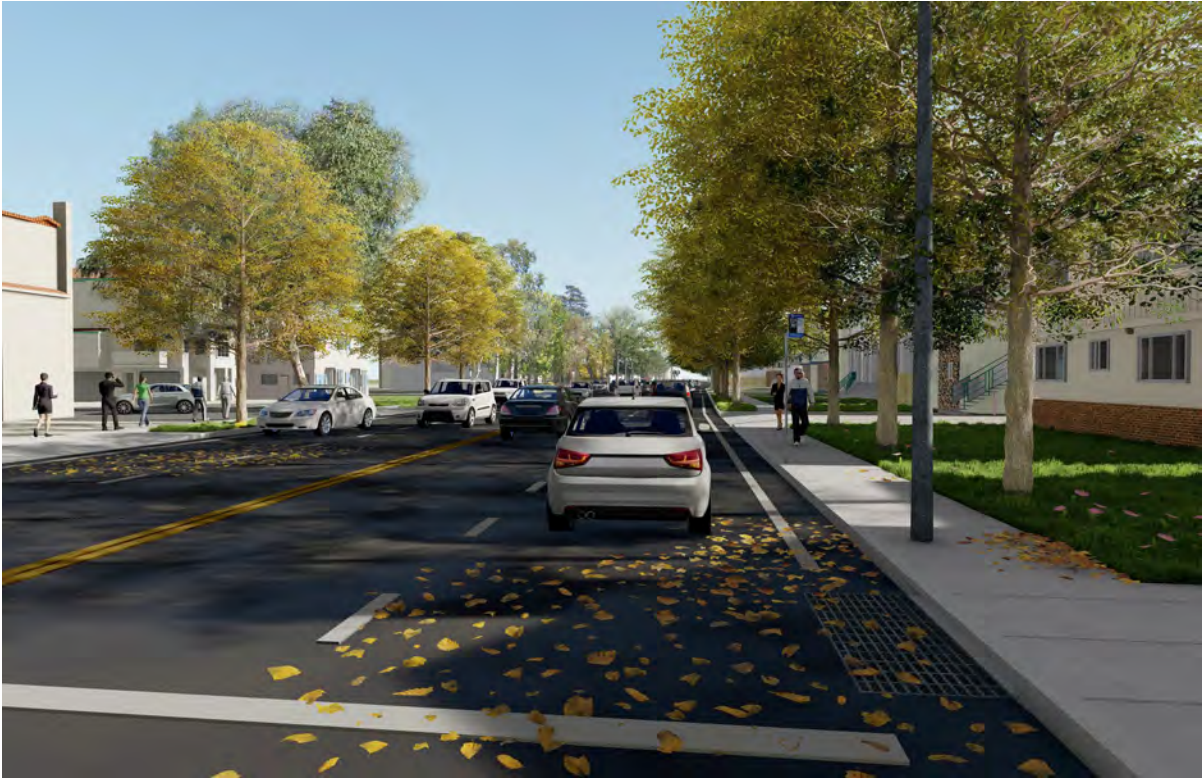
KV-1 Proposed Condition – Alternative 2

Alternative 2 results in similar changes to the visual environment as Alternative 1 due to the loss of trees. The view is more open than the existing condition and the intimate feeling is diminished without the large trees and enclosing canopy. Unlike Alternative 1, this alternative would remove utility poles and relocate the utility lines underground. The undergrounding of overhead utilities in this view both improve unity and allow more space for replacement tree planting. New street trees help to restore the tree-lined character and cohesiveness of the view. While immediately post-construction the new trees' much smaller scale results in lower visual quality, over time the replacement trees would reach a stature matching current conditions. This alternative also allows more trees to be replanted without the power pole restrictions. New street surfaces and sidewalks improve visual quality to some degree. The overall level of resource change is moderate-high post-construction and moderate-low 20 years after construction.

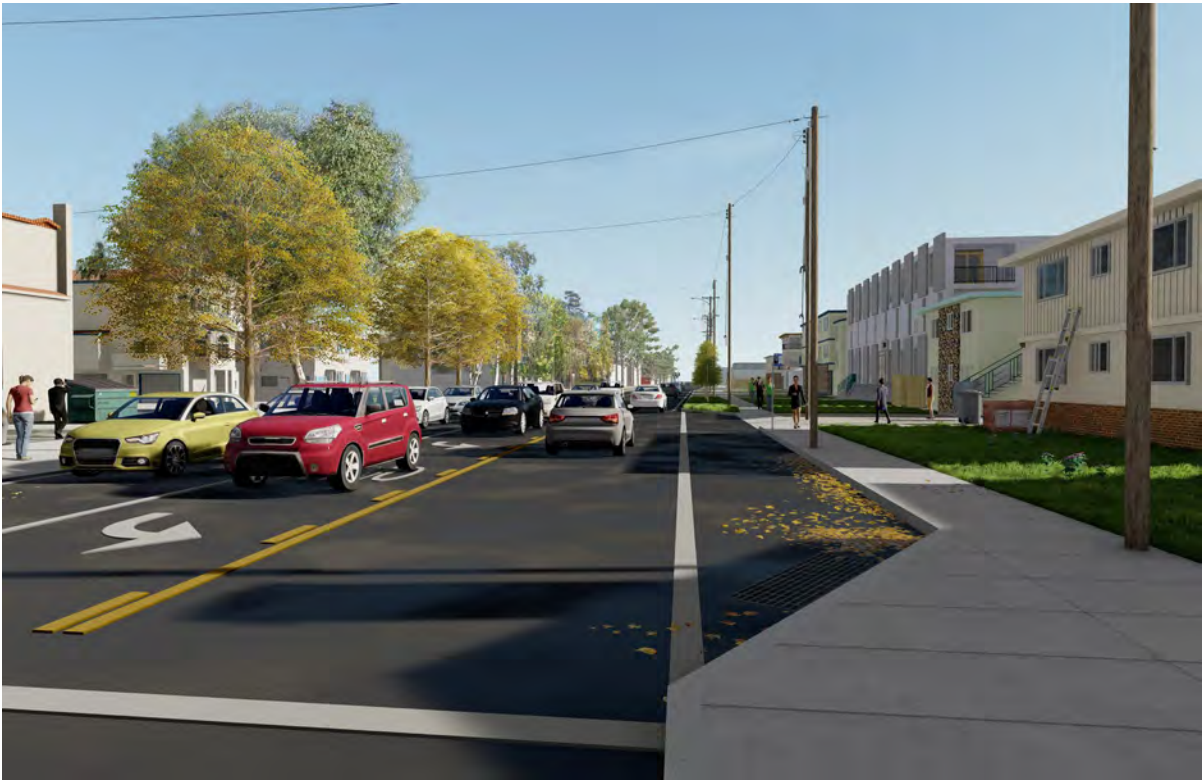
KV-1 Proposed Condition – Alternative 3

Alternative 3 results in the same loss of trees as Alternatives 1 and 2. Here too, the view is more open than the existing condition and the intimate feeling is diminished without the large trees and enclosing canopy. Unlike Alternatives 1 and 2, this alternative changes the roadway lane configuration from two travel lanes in each direction with shoulders to one travel lane in each direction with a 2-foot shoulder and a continuous center left turn lane. The curb line is moved three feet into the existing roadway to the edge of the new shoulder.

Unlike Alternatives 1 and 2, a new bus pull-out would be constructed on southbound El Camino at an existing bus stop and is visible in the foreground of this key view. The bus pull-out widens the roadway cross-section along its 150-foot length. There is insufficient right of way to plant trees adjacent to the bus pullout, creating a break in the line of trees. Construction of the bus pull-out results in fewer replacement trees in this key view. Along northbound El Camino and beyond the bus pull-out in the southbound direction, there is enhanced green space from the widened planting strip. The shoulder and wider planted buffer along with new street and sidewalk surfaces improve visual quality over existing conditions. The newly planted street trees help to restore the tree-lined character, though they will not achieve a mature stature for many years. The newly planted trees on the southbound side will be of a smaller stature, even at maturity, to avoid conflicts with overhead utilities. Fewer in number and smaller in size, the replacement trees on the southbound side no longer provide a visual screen between adjacent buildings and the roadway environment. The overall level of resource change is moderate-high to high post construction and moderate-high 20 years after construction.

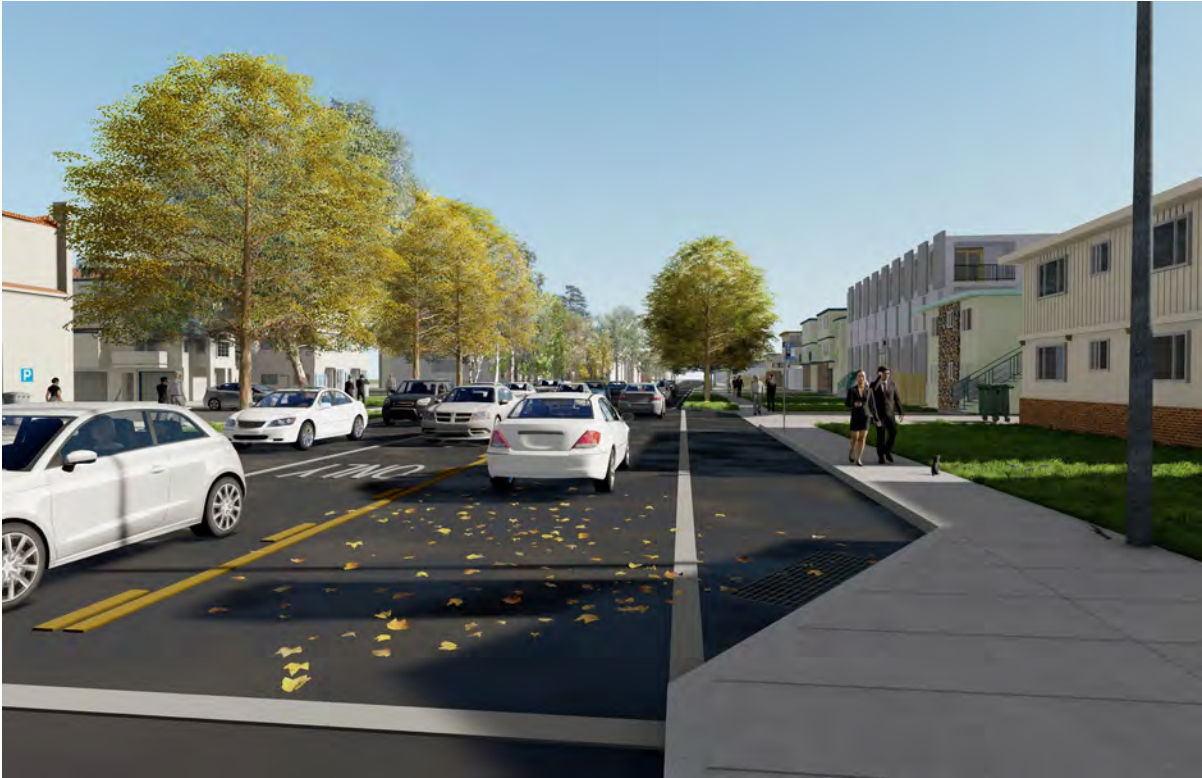
KV-1 Proposed Condition – Alternative 4

Alternative 4 results in the same loss of trees as the other alternatives. Consequently, the view is more open than the existing condition and the intimate feeling is diminished without the large trees and enclosing canopy. As in Alternative 3, this alternative changes the roadway lane configuration, shifts the curb line towards the center of the roadway and adds a bus pull-out. Like Alternative 3, the roadway cross-section is widened at the bus pull-out precluding replacement tree planting in this area and creating a break in the line of trees. In areas other than the bus pull-out, there is enhanced green space from the widened planting strip.

Unlike Alternative 3, this alternative would relocate the utility lines and poles underground. As in Alternative 2, the undergrounding of overhead utilities in this view both reduce visual clutter and allow more space for replacement tree planting. New street trees help to restore the tree-lined character and cohesiveness of the view. While post-construction the new trees' much smaller scale results in lower visual quality, over time the replacement trees would reach a stature matching current conditions. This alternative also allows more and larger trees to be replanted without the power pole restrictions within the widened planting area. This makes the canopy restoration notably better in Alternative 4 than in Alternative 3. New street surfaces and sidewalks improve visual quality to some degree. The overall level of resource change is moderate-high post-construction and moderate 20 years after construction.

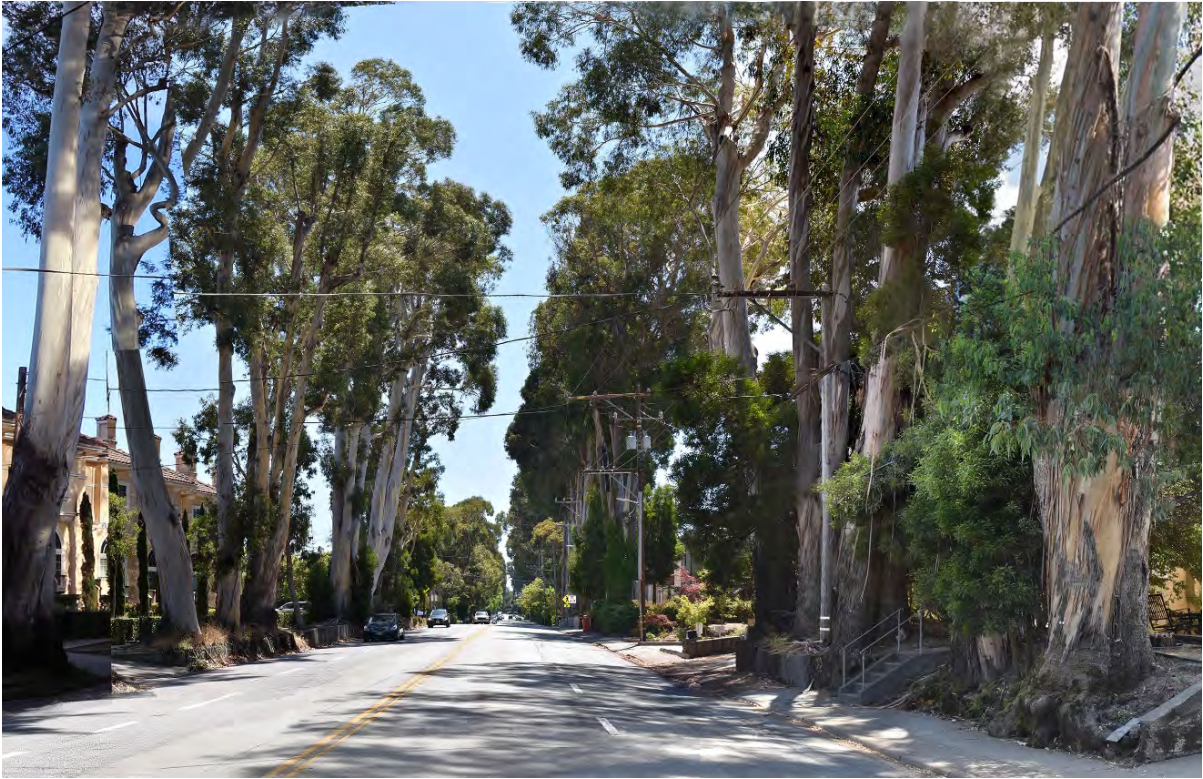
KV-2 Existing Condition

Key View 2 demonstrates the tree-lined character of this portion of El Camino Real, and the prominence of the century-old Eucalyptus trees in the visual experience of this highway. The visual mass of the extremely large Eucalyptus trees creates a feeling of enclosure, limits the view of the sky, masks the visual clutter of overhead utilities and provides a visual screen between adjacent buildings and the roadway environment. Both the tight spacing of trees and continuous canopy enhance vividness and unity, tying the visual setting together and creating a strong sense of cohesiveness. While not immediately obvious, the poor condition of the sidewalks, roadway surface and retaining walls slightly detract from the visual quality.

The Existing Condition can also be used to represent the No Build Alternative. The gradual loss of these cherished trees is less poignant than larger scale removal. However, given the advanced age and generally compromised health of the Eucalyptus trees in this view, the need for removal is reasonably anticipated in the foreseeable future. Replacement Elms would be planted as existing trees require removal.

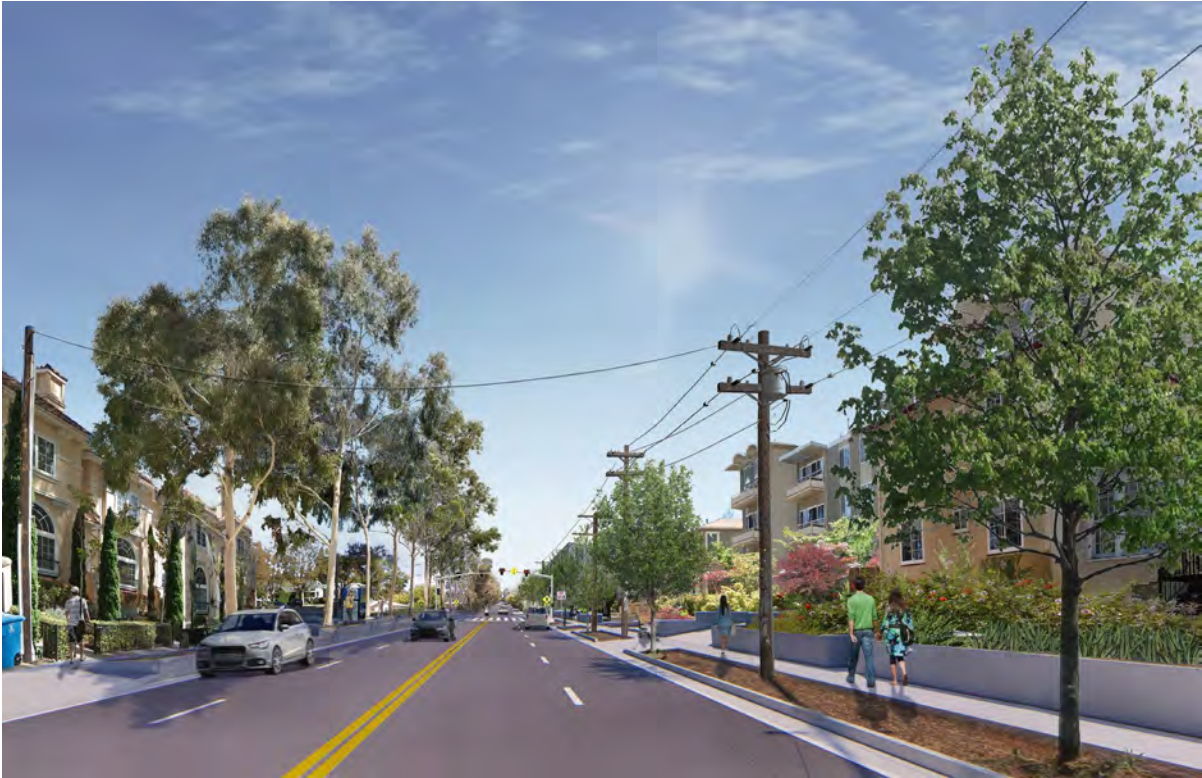
KV-2 Proposed Condition – Alternative 1

In this Alternative, most of the trees within the key view will require removal in order to replace retaining walls that will be disturbed from road and sidewalk construction along both sides of El Camino Real. The loss of trees changes the visual setting dramatically. While the existing roadway configuration and width is retained, the view becomes more open and the intimate feeling for highway users, and privacy enjoyed by highway neighbors is diminished without the large trees and enclosing canopy. Utility lines and poles are more visible revealing visual clutter. A new Pedestrian Hybrid Beacon is also visible in the distance at the Palm Drive pedestrian crossing. New street trees help to restore the tree-lined character and cohesiveness of the view. However, their much smaller scale post-construction and reduced number does not have the same visual quality as the existing condition with its rows of towering, mature trees. One positive outcome of having to replace all the trees in this key view is that the replacement street trees can be relocated in between the roadway and sidewalk creating a buffer from traffic for pedestrians.

As noted for Key View 1, current restrictions on tree planting adjacent to utility poles and underneath power lines limit the number of replacement trees as well as their mature size along the southbound side of the street. This greatly reduces the visual character and quality from the existing condition post-construction. While Eucalyptus varieties or other tall tree species may be planted on the northbound side, these would not be feasible for the southbound side. Even over time the stature of the replacement trees on the southbound side of the road would never approach that of the existing Eucalyptus trees. New street surfaces, sidewalks and retaining walls improve visual quality to some degree. The overall level of resource change is high post construction. 20 years after construction the replacement trees would reduce the level of resource change to moderate-high as their canopies increase in size and begin to enclose the street.

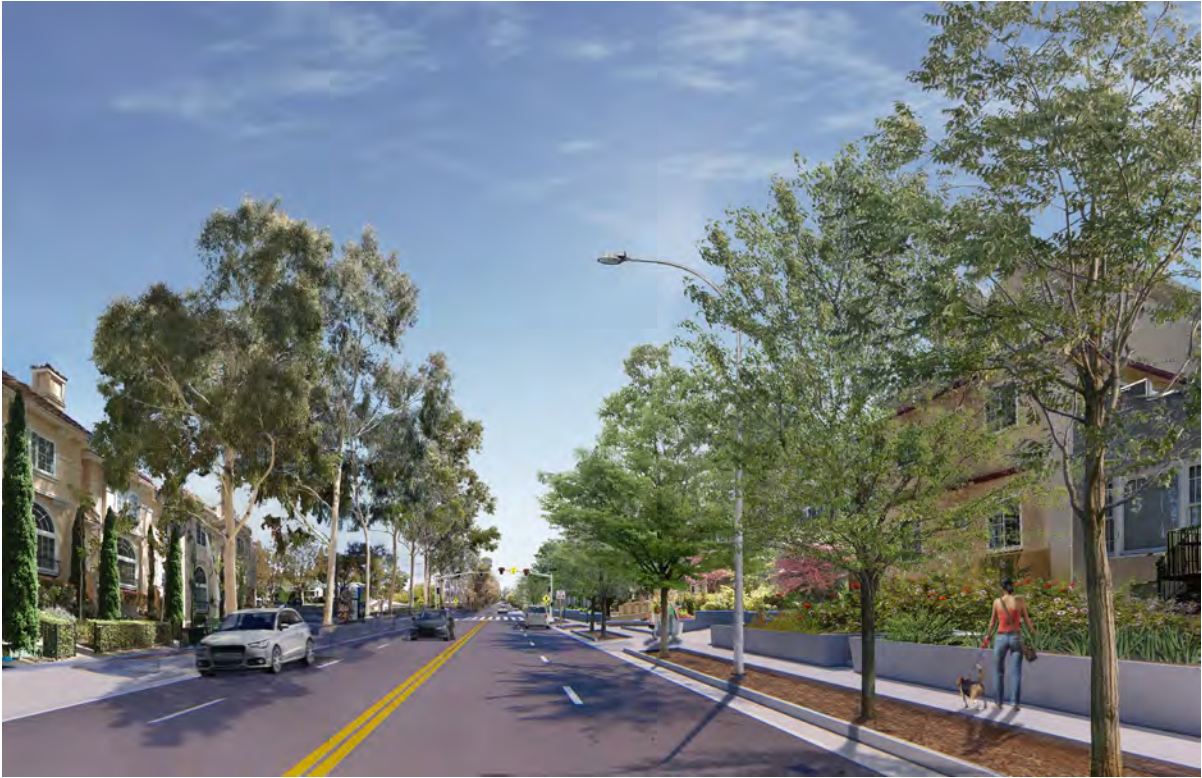
KV-2 Proposed Condition – Alternative 2

This Alternative includes the same improvements as Alternative 1, and the associated effects to visual character and quality described above are the same. Unlike Alternative 1, this alternative would relocate the utility lines and poles underground. The undergrounding of overhead utilities in this view both reduces visual clutter and allows for the planting of larger replacement trees. Without power pole restrictions, more trees can also be planted. New street trees in similar numbers help to restore the tree-lined character and cohesiveness of the view. This key view shows Eucalyptus species on the northbound side, and Elm and other varieties on the southbound side. The Elms, with their smaller trunk size, would provide greater visibility for driveway users, and allow for a greater number of replacement trees to be installed in the planted buffer. Elms and other species would have different visual qualities from the current and replacement Eucalyptus but would still contribute to the visual quality of the roadway. While post-construction the new trees' much smaller scale results in lower visual quality, over time the replacement trees would bring visual quality closer to current conditions. New street surfaces, sidewalks and retaining walls improve visual quality to some degree. The overall level of resource change is high post construction. 20 years after construction the replacement trees would reduce the level of resource change to moderate as their canopies increase in size and begin to enclose the street and create a screen between adjacent buildings and the roadway environment.

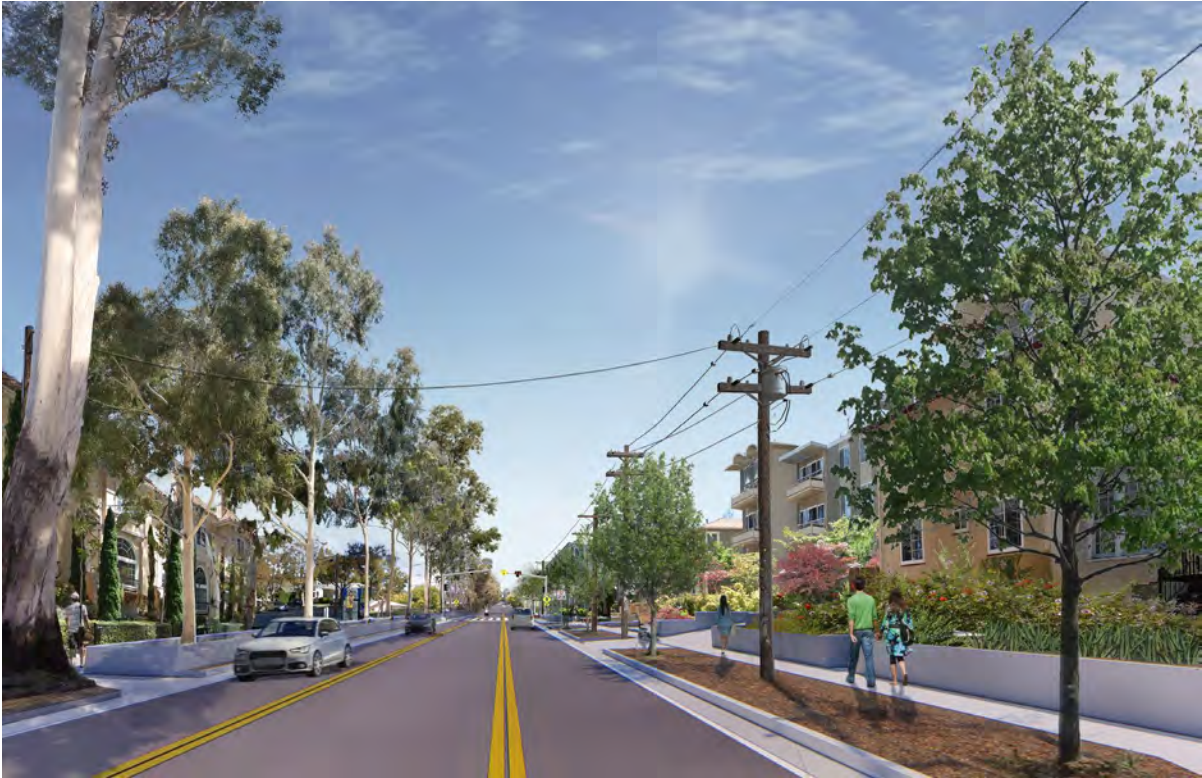
KV-2 Proposed Condition – Alternative 3

In this key view, Alternative 3 has nearly the same tree loss as Alternatives 1 and 2, apart from one large Eucalyptus preserved in the foreground. This results in a more open view than the existing condition and a diminished sense of intimacy and privacy without the large trees and their enclosing canopy. Unlike Alternatives 1 and 2, this alternative changes the roadway lane configuration and cross-section from two travel lanes in each direction with shoulders to one travel lane in each direction with 2-foot shoulders and a continuous center left-turn lane. The curb line is moved three feet into the existing roadway to the edge of the new shoulder allowing for a widened and relocated planted buffer between the roadway and sidewalk. The widened planting strip increases the unpaved surfaces in the view, and along with new street and sidewalk surfaces, improves visual quality over existing conditions. The newly planted street trees help to restore the tree-lined character, though they will not achieve a mature stature for many years. The overall level of resource change is moderate-high to high post construction and moderate-high 20 years after construction.

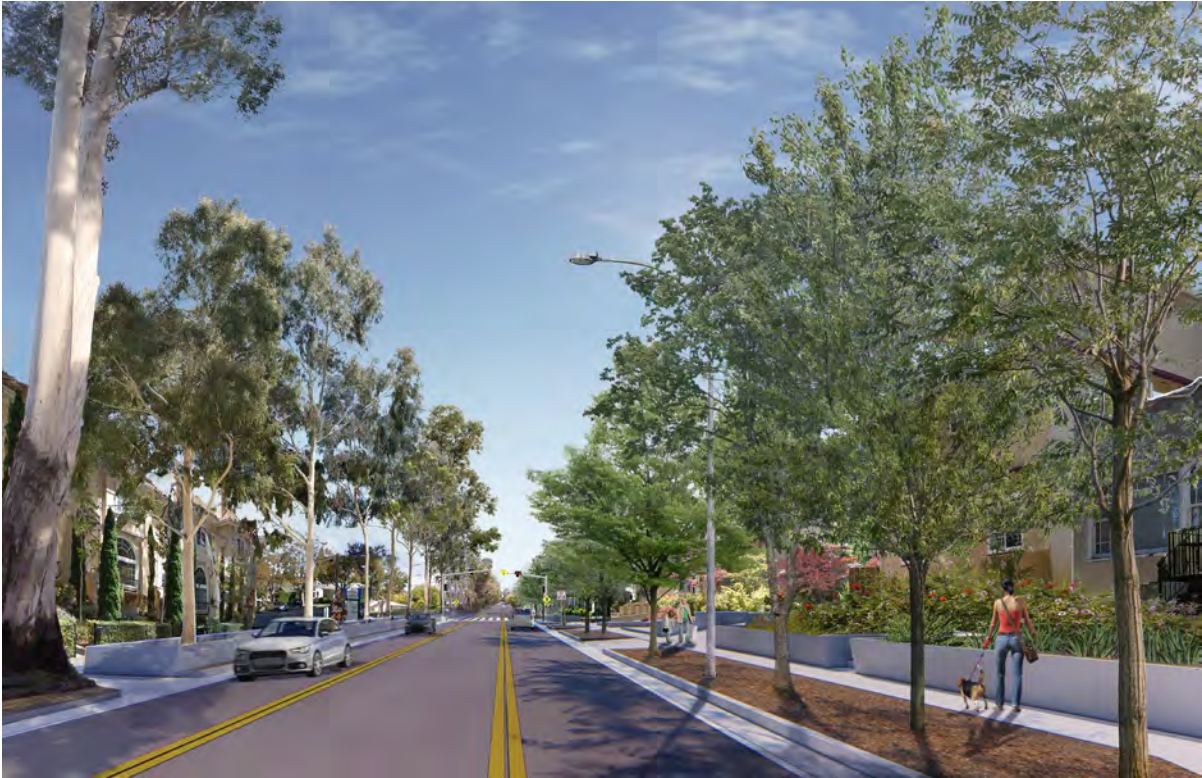
KV-2 Proposed Condition – Alternative 4

This Alternative includes the same improvements as Alternative 3, and the associated affects to visual character and quality described above are the same. Unlike Alternative 3, this alternative would relocate the utility lines and poles underground. The undergrounding of overhead utilities in this view both reduces visual clutter and allows more space for replacement planting of large-statured trees, as in Alternative 2. New street streets in similar scale and number help to restore the tree-lined character and cohesiveness of the view. As in the other Alternatives, a variety of tree species would likely be selected. While post-construction, the new trees' much smaller scale results in lower visual quality, over time the replacement trees would bring visual quality closer to current conditions. New street surfaces, sidewalks and retaining walls improve visual quality to some degree, along with the widened planted buffer between the roadway and sidewalk. The overall level of resource change is high post construction. 20 years after construction the replacement trees would reduce the level of resource change to moderate-low as their canopies increase in size and begin to enclose the street.

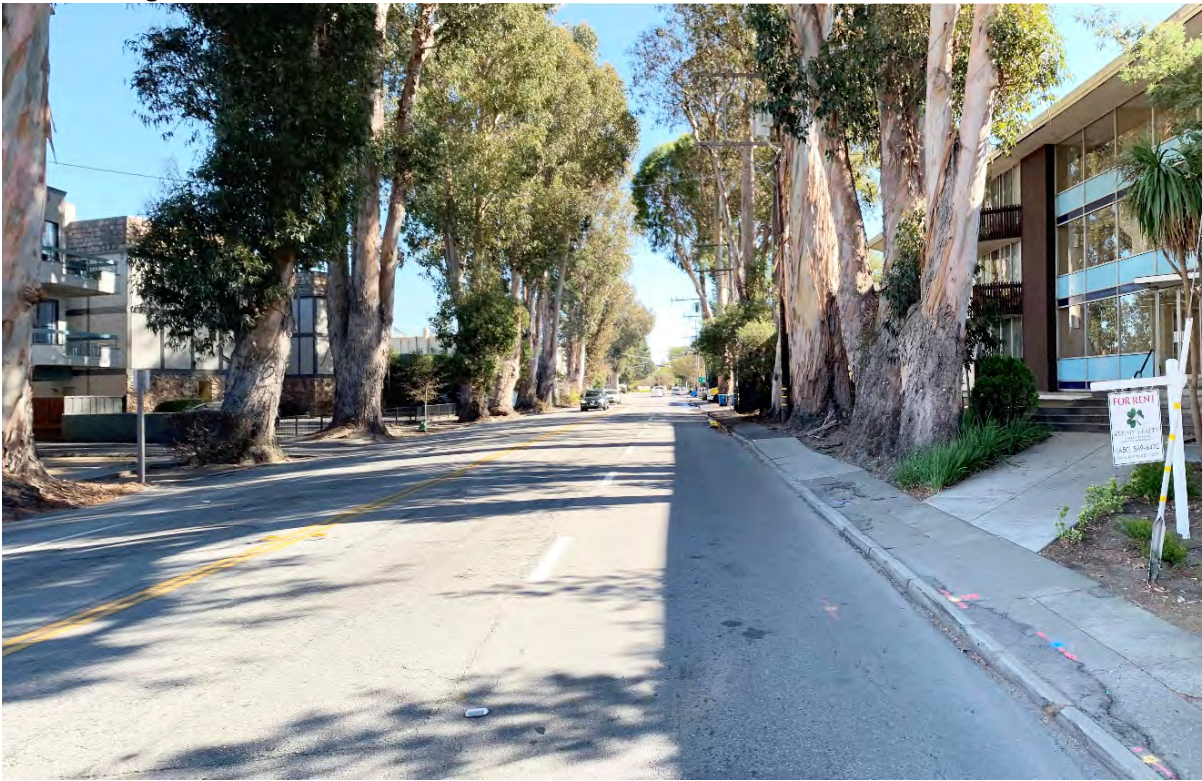
KV-3 Existing Condition

Like Key View 2, Key View 3 demonstrates the tree-lined character of El Camino Real, and the prominence of the century-old Eucalyptus trees in the visual experience. Even adjacent to the relatively larger two to three-story multi-family residential buildings in this view, the trees remain dominant. The visual mass of the extremely large Eucalyptus trees creates a feeling of enclosure and screens development in long views. Both the close spacing of trees and continuous canopy enhance vividness and unity, tying the visual setting together and creating a strong sense of cohesiveness. While not immediately obvious, the poor condition of the sidewalks and roadway surface slightly detract from the visual quality.

The Existing Condition can also be used to represent the No Build Alternative. The gradual loss of these cherished trees is less poignant than larger scale removal. However, given the advanced age and generally compromised health of the Eucalyptus trees in this view, the need for removal is reasonably anticipated in the foreseeable future. Removed trees would be replaced with Elm trees and would not achieve the same stature as the current Eucalyptus, even at maturity.

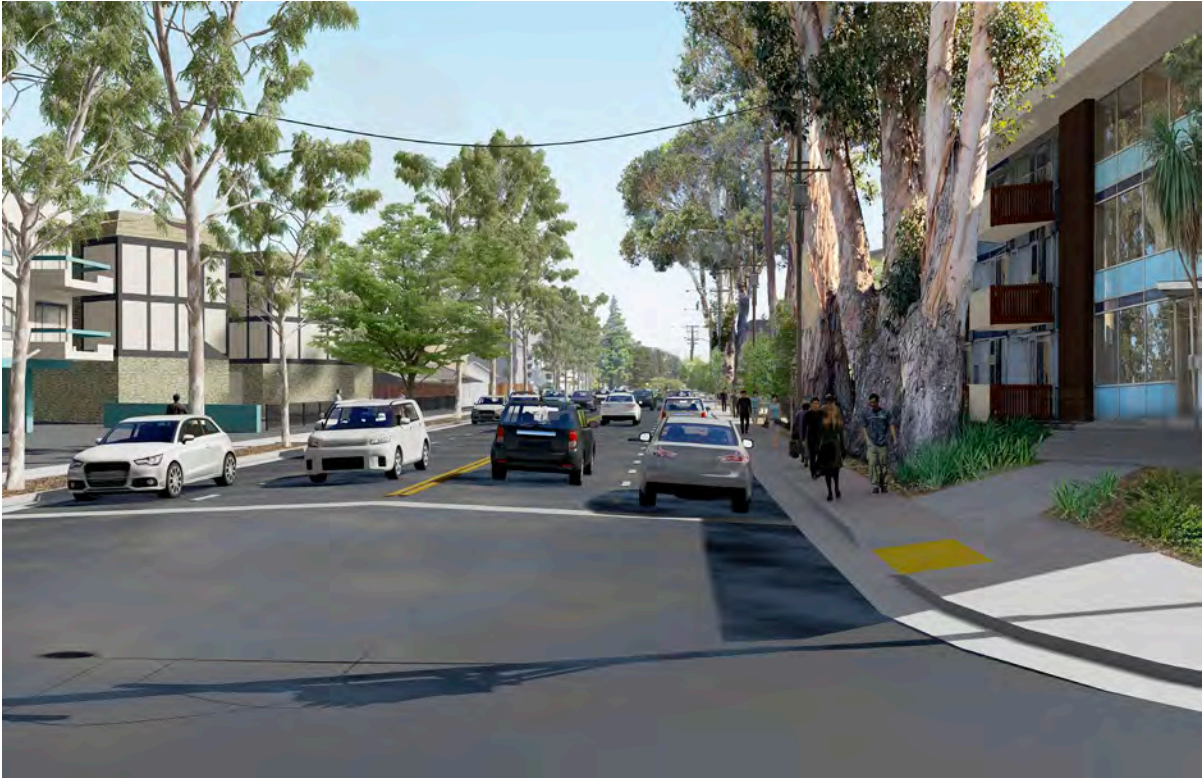
KV-3 Proposed Condition – Alternative 1

In this alternative, many trees visible in the Key View primarily along the northbound side of El Camino Real will require removal in order to replace sidewalks, driveways, and curb and gutter. While the existing roadway configuration and width is retained, the view becomes more open and the intimate feeling is diminished without the large trees and their enclosing and screening canopy. This is more pronounced in this key view due to the larger scale of the buildings and the greater setback to the front of the buildings along northbound El Camino Real. The retention of some large, mature trees along the southbound side of El Camino Real helps to maintain a degree of character and quality, and utility lines and poles remain mostly hidden in their canopy. New street trees help to further restore the tree-lined character and cohesiveness of the view. However, their much smaller scale post-construction and reduced number for sight distance requirements does not have the same visual quality as the existing condition, with its double rows of towering, mature trees. New street surfaces and sidewalks would improve visual quality to some degree. Over time as the older preserved trees near the end of their lifespan and require replacement, the visual presence of overhead utility lines and poles would become more dominant. Replacement trees on southbound El Camino Real would be limited in size and number due to utility restrictions. The overall level of resource change is moderate-high to high post construction. 20 years after construction the level of resource change would still be considered moderate-high.

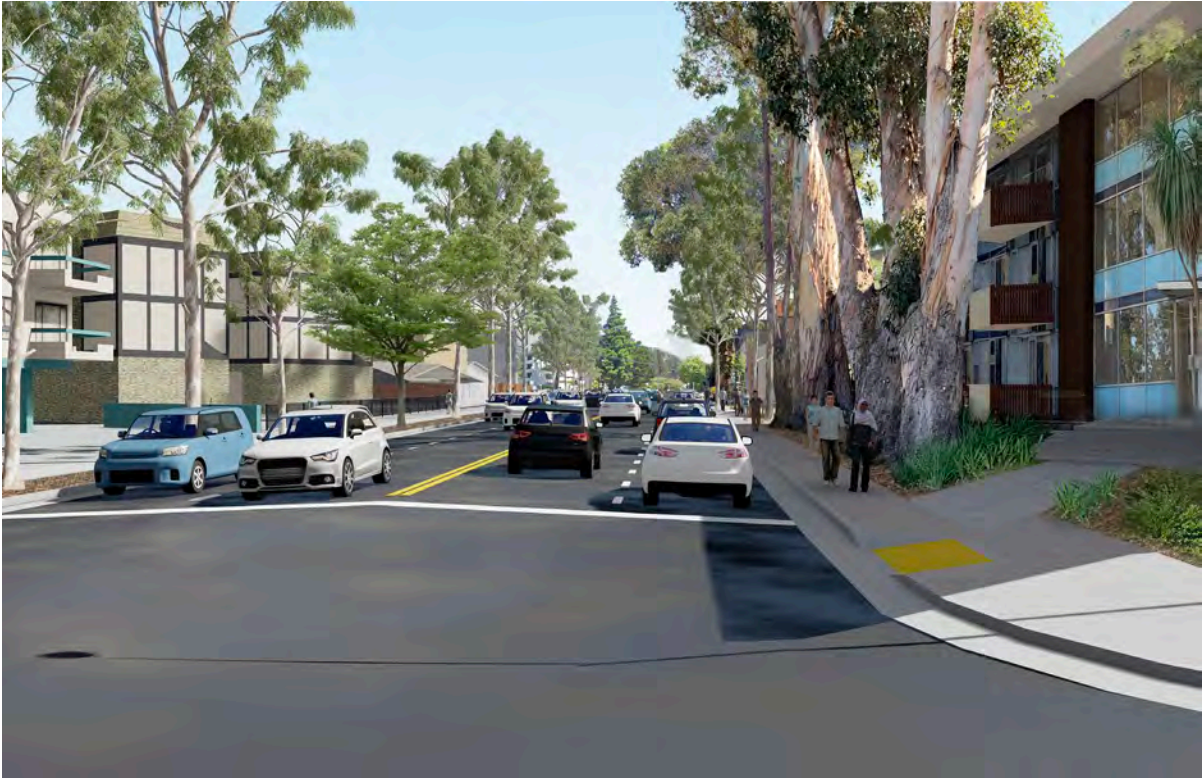
KV-3 Proposed Condition – Alternative 2

This alternative includes the same improvements as Alternative 1, and the associated affects to visual character and quality described above are the same in this key view. Unlike Alternative 1, this alternative would relocate the utility lines and poles underground. In the near-term this has a nominal effect on visual character and quality since the overhead utilities are largely hidden in the canopies of the retained trees. New street streets in similar numbers help to restore the tree-lined character and cohesiveness of the view. Post-construction the new trees' much smaller scale results in lower visual quality. However, the replacement tree species would reach a large stature at maturity, which would bring visual quality closer to current conditions as the trees grow. Additionally, without the restrictions of overhead utilities, these large-statured species could continue to be replanted in the future when the older trees need to be removed. New street surfaces and sidewalks improve visual quality somewhat. The overall level of resource change is moderate-high to high post construction. Twenty years after construction the replacement trees would reduce the level of resource change to moderate as their canopies increase in size and begin to enclose the street.

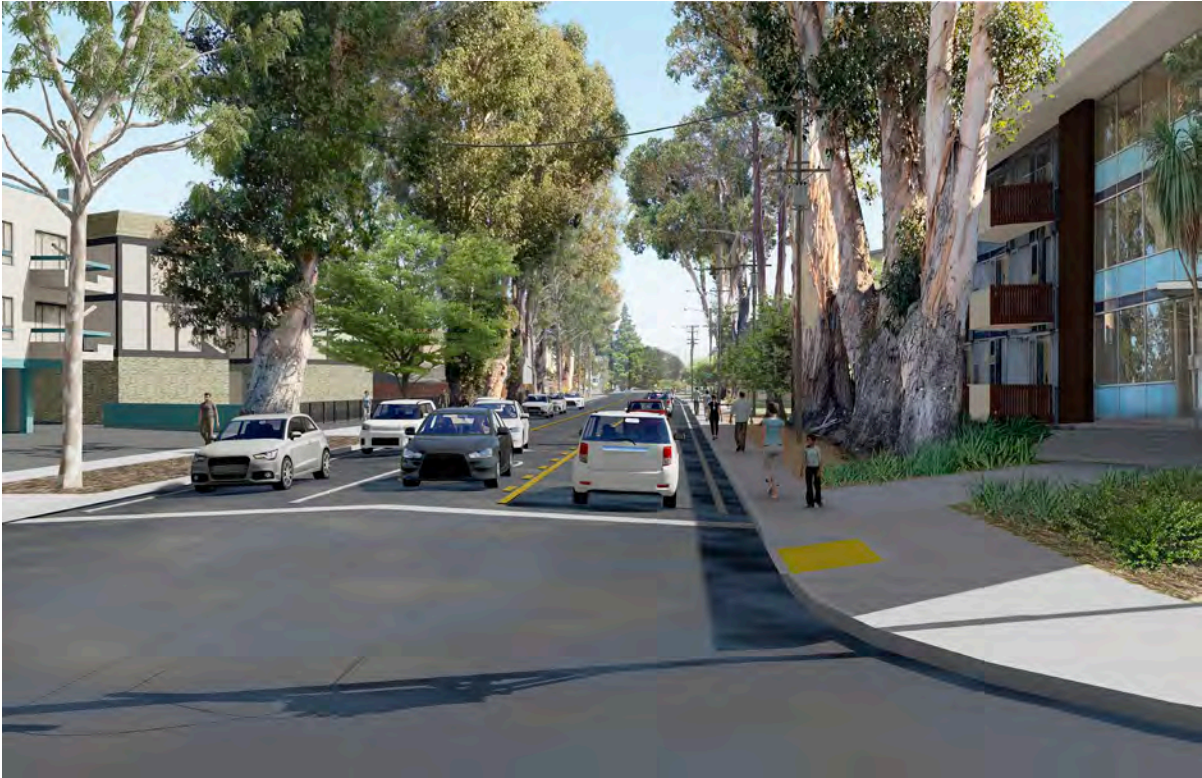
KV-3 Proposed Condition – Alternative 3

Unlike Alternatives 1 and 2, Alternative 3 retains many trees along the northbound side of the street due to the relocation of the curb and gutter three feet into the existing roadway. The roadway is reconfigured from two travel lanes in each direction with shoulders to one travel lane in each direction with 2-foot shoulders and a continuous center left-turn lane. The shifted curb line allows for a widened planting area, which serves as a buffer between the roadway and sidewalk on the northbound side of the street. The retention of large, mature Eucalyptus trees along both sides of El Camino Real help to maintain character and quality, as well as the sense of enclosure and intimacy. As in Alternative 1, the utility lines and poles remain mostly hidden in tree canopy. New street trees help to restore the tree-lined character and cohesiveness of the view. However, their much smaller scale post-construction does not have the same visual quality as the existing condition with its more continuous, double rows of towering, mature trees. Additionally, the overhead utility lines and poles on the southbound side of the street limit the size and number of replacement trees. Over time as the older preserved trees near the end of their lifespan and require replacement, the visual presence of overhead utility lines and poles would become more dominant and small species of trees would replace them, resulting in a further degradation of visual quality on the southbound side. New street surfaces and sidewalks would improve visual quality to some degree. The overall level of resource change is moderate to moderate-high post construction. 20 years after construction the replacement trees would reduce the level of resource change to moderate.
