VISUAL IMPACT ASSESSMENT

El Camino Real Roadway Renewal Project

February 24, 2021

California Department of Transportation
04-SM-82
PM 12.3 to 15.8
0416000142 – EA 0K810

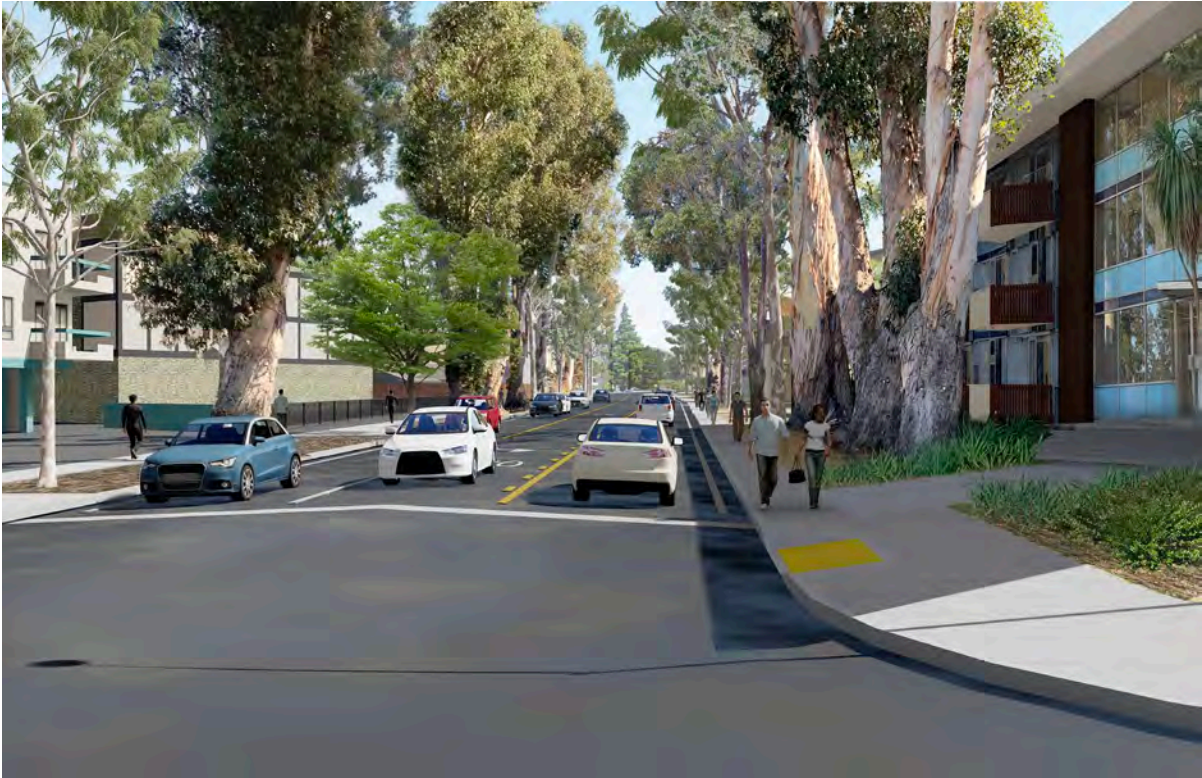
KV-3 Proposed Condition – Alternative 4

This alternative includes the same improvements as Alternative 3, and the associated affects to visual character and quality described above are the same in this key view. Unlike Alternative 3, this alternative would relocate the utility lines and poles underground. In the near-term this has a nominal effect on visual character and quality since the overhead utilities are largely hidden in the canopies of the retained trees. Over time as these older trees near the end of their lifespan and require replacement, the absence of this infrastructure would result in less visual clutter. New street streets in similar numbers help to restore the tree-lined character and cohesiveness of the view. While post-construction the new trees' much smaller scale results in lower visual quality, the replacement trees would bring visual quality closer to current conditions as they mature. Additionally, without the restrictions of overhead utilities, trees of larger mature size could be replanted in the future when the older trees need to be removed. New street surfaces and sidewalks improve visual quality somewhat. The overall level of resource change is moderate post construction. 20 years after construction the replacement trees would reduce the level of resource change to low as the replacement trees reach a mature stature.

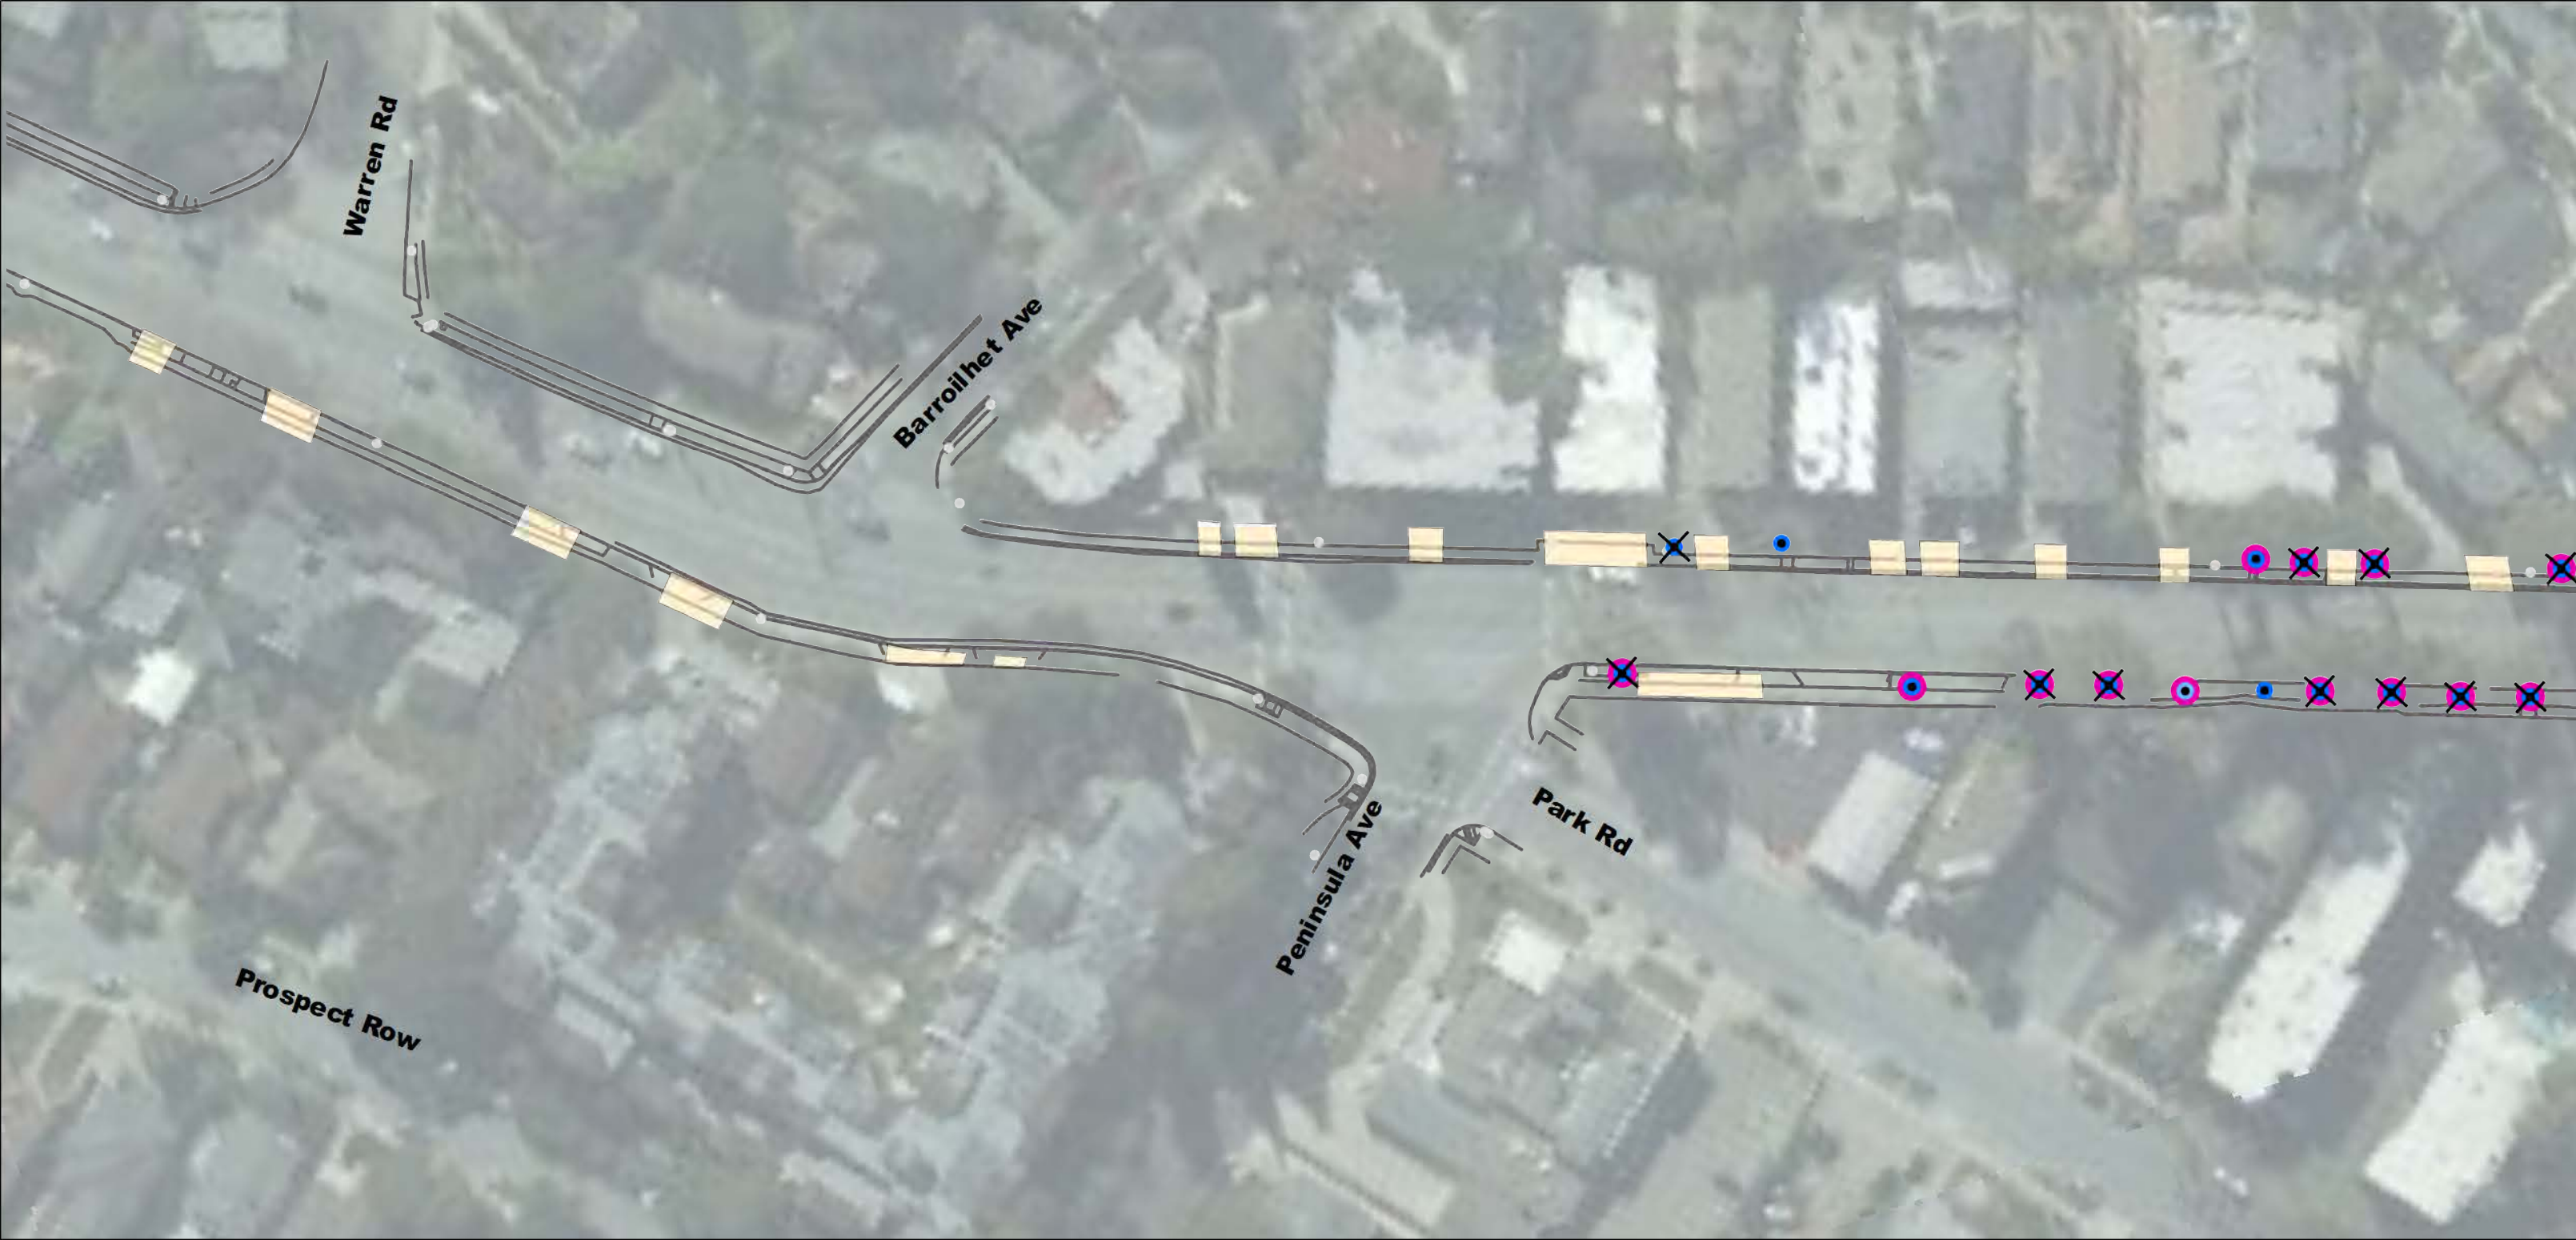
Potential Removal & Retention of Existing Trees - Alternative 1 & 2

Note: Based on Preliminary Layout Plans for the purposes of evaluating environmental impacts.

Critical to the assessment of the resource change anticipated under these project alternatives is an understanding of the scope of tree removal required for this project. For the purposes of this analysis, tree removals were carefully considered with the preliminary data available. Field surveys of existing trees were conducted to determine general condition of trees and their likely resilience to anticipated construction impacts. Through analysis of both tree health and construction impacts of the various design alternatives, preliminary assessments of anticipated tree removals were generated. Maps of these anticipated

removals are included as an appendix to this Visual Impact Assessment. It should be noted that additional arborist reviews may prompt a revision of this visual impact assessment.

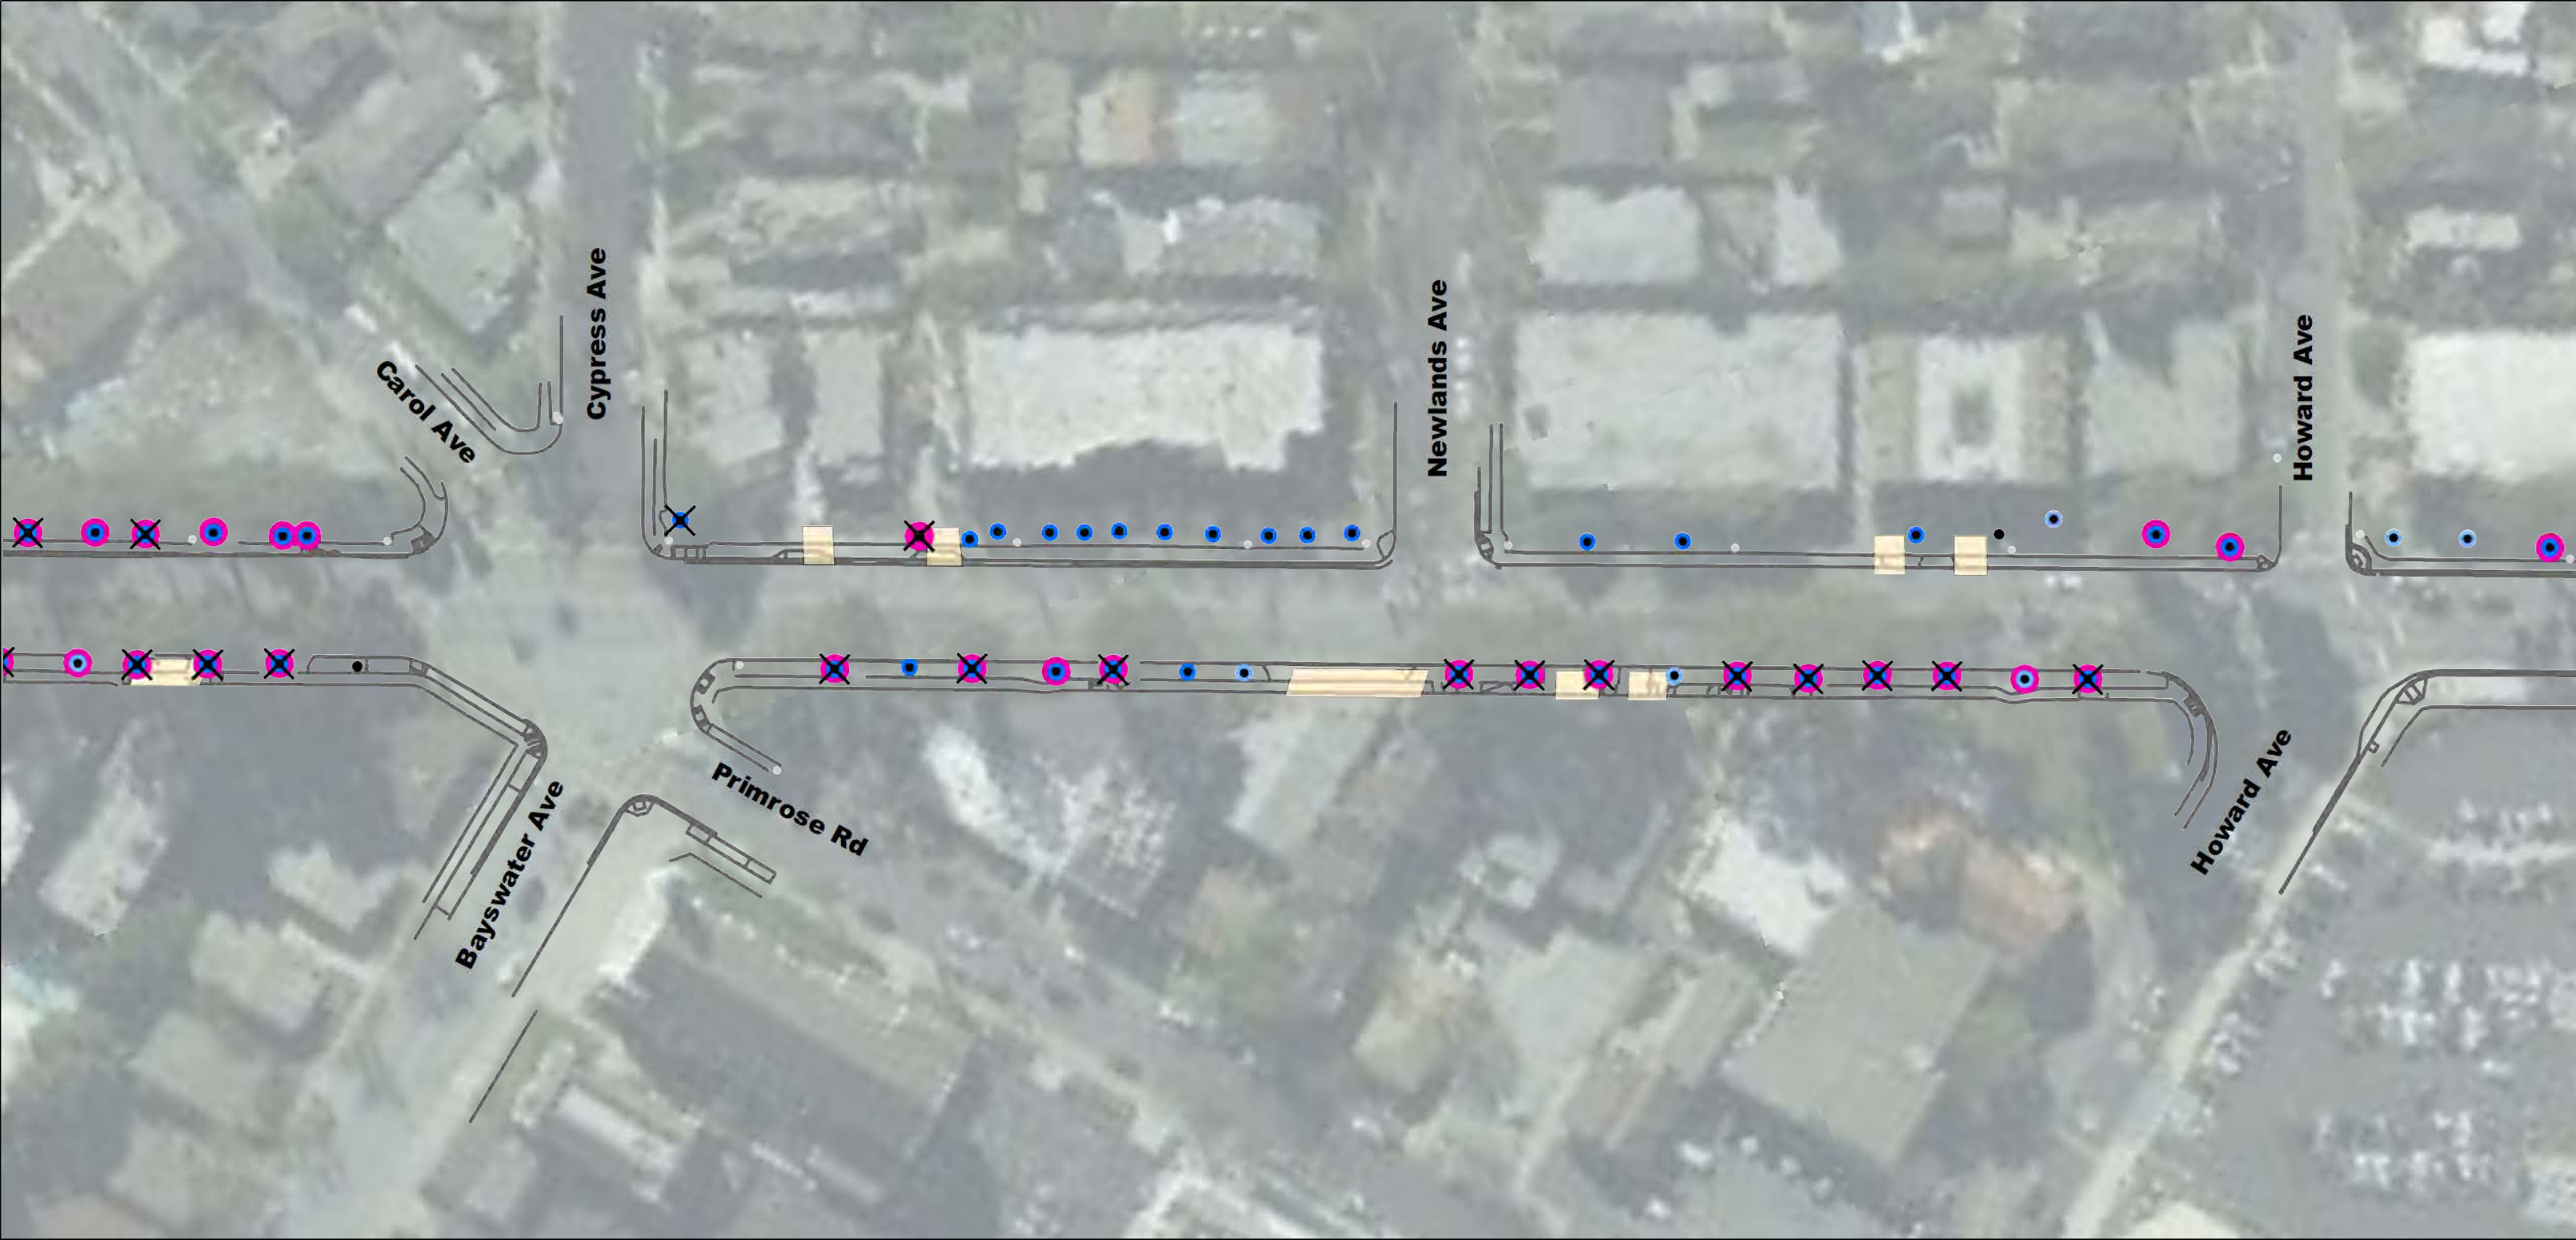
Potential Removal & Retention of Existing Trees - Alternative 1 & 2

Note: Based on Preliminary Layout Plans for the purposes of evaluating environmental impacts.

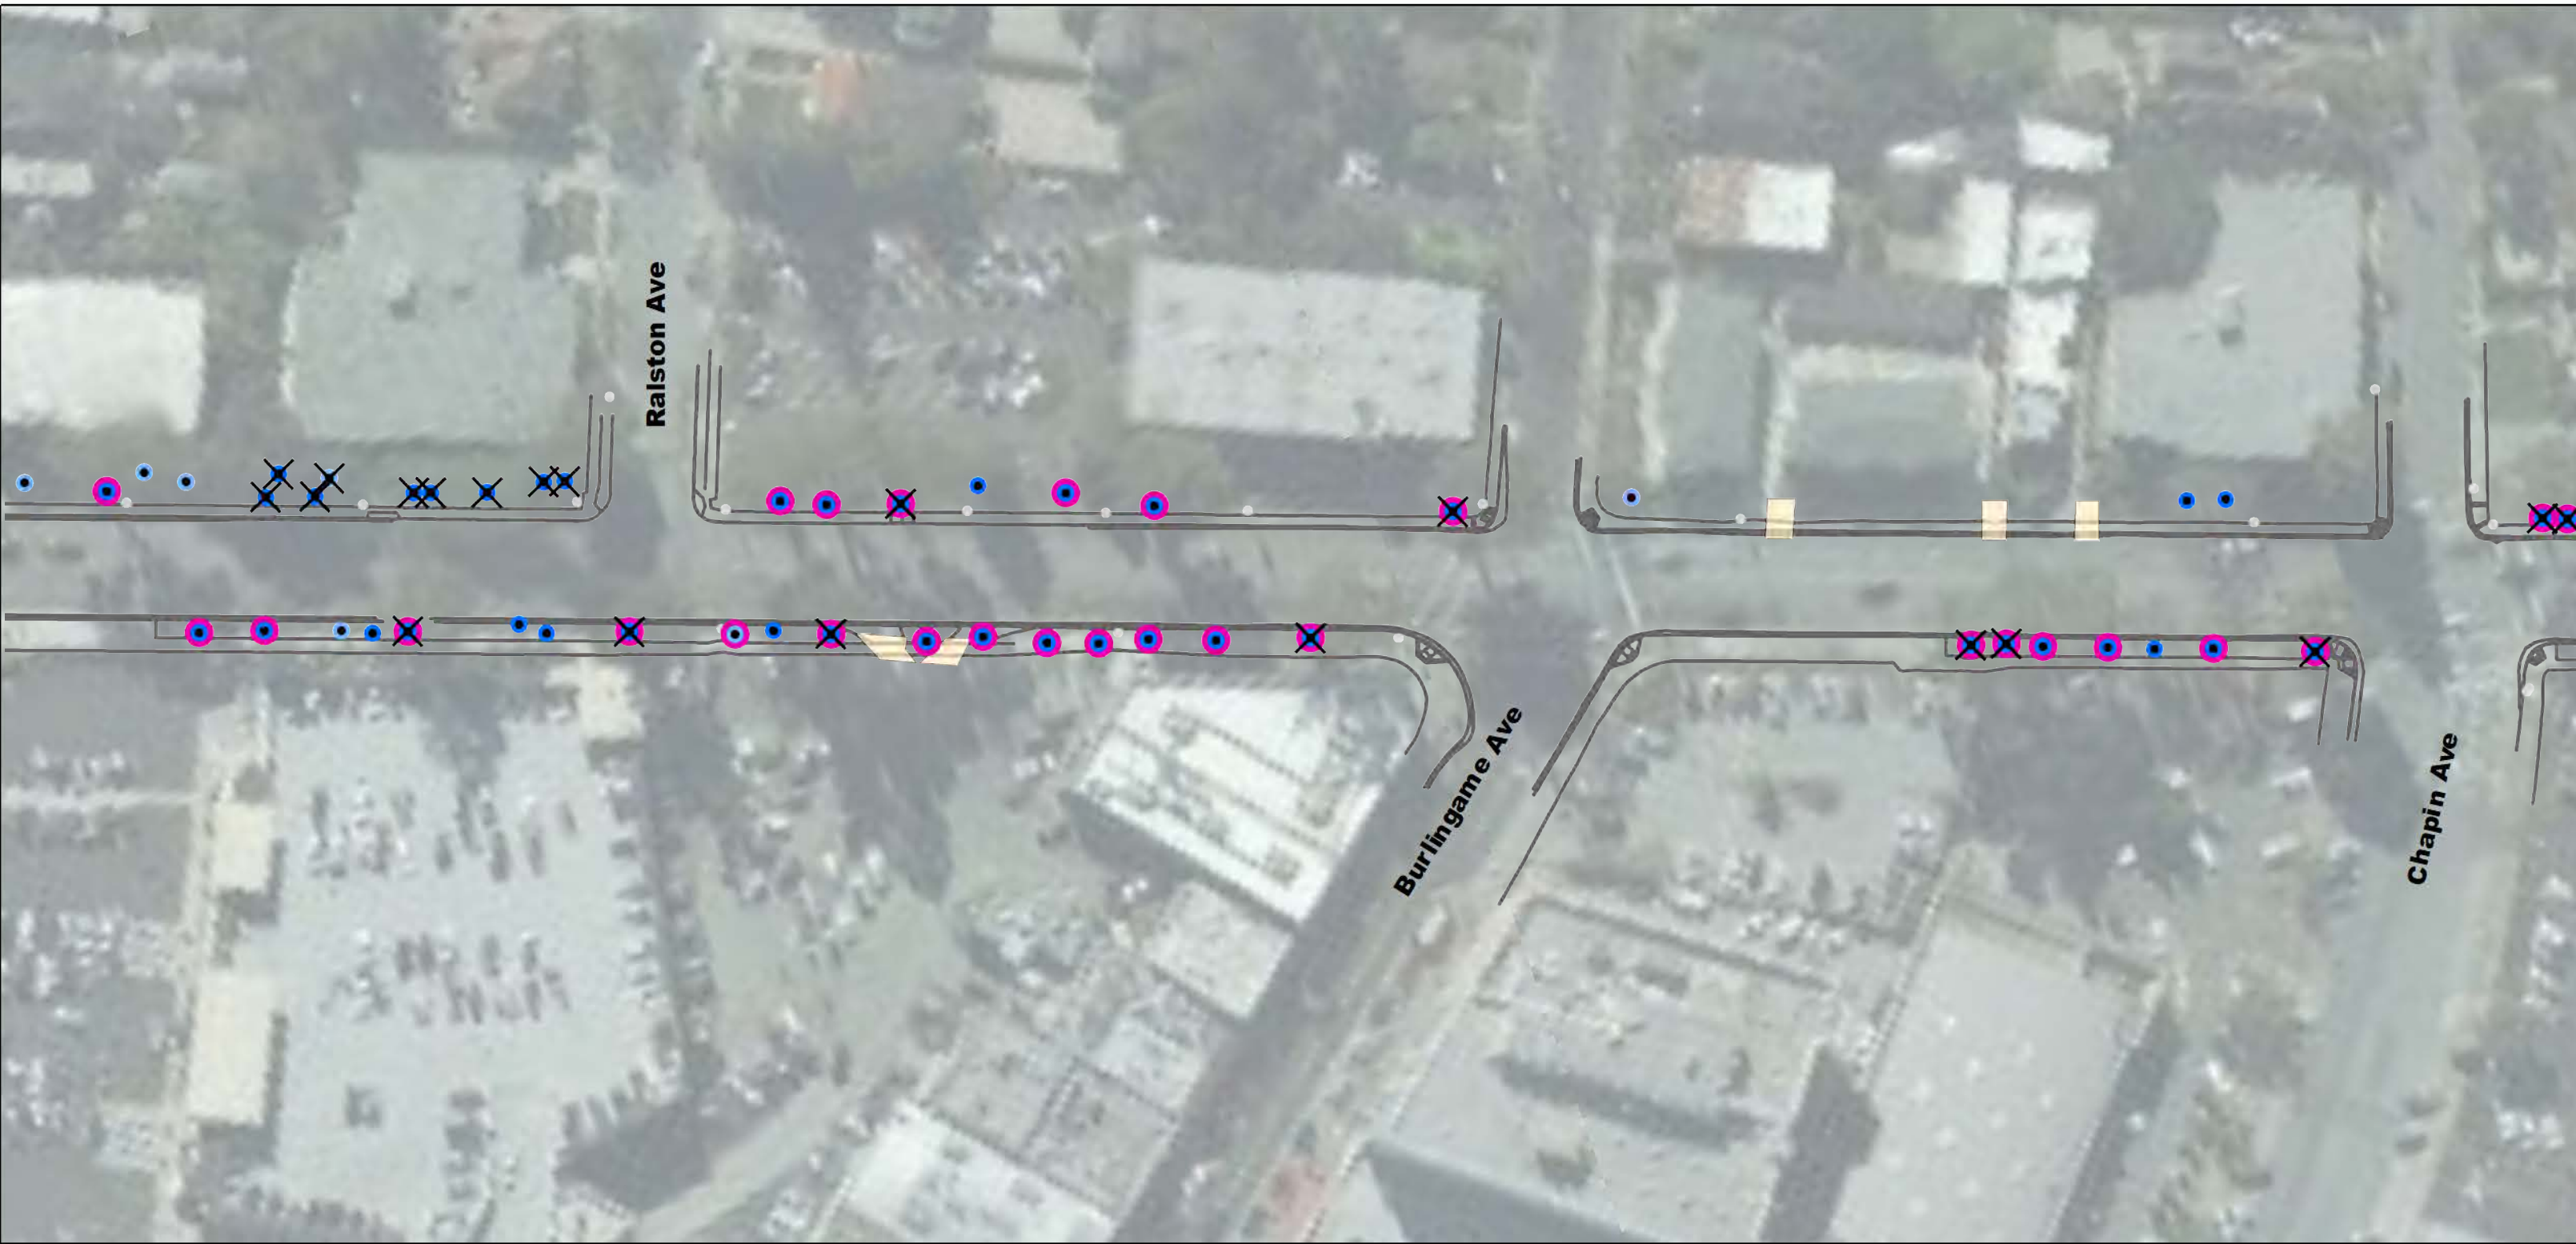
Potential Removal & Retention of Existing Trees - Alternative 1 & 2

Note: Based on Preliminary Layout Plans for the purposes of evaluating environmental impacts.

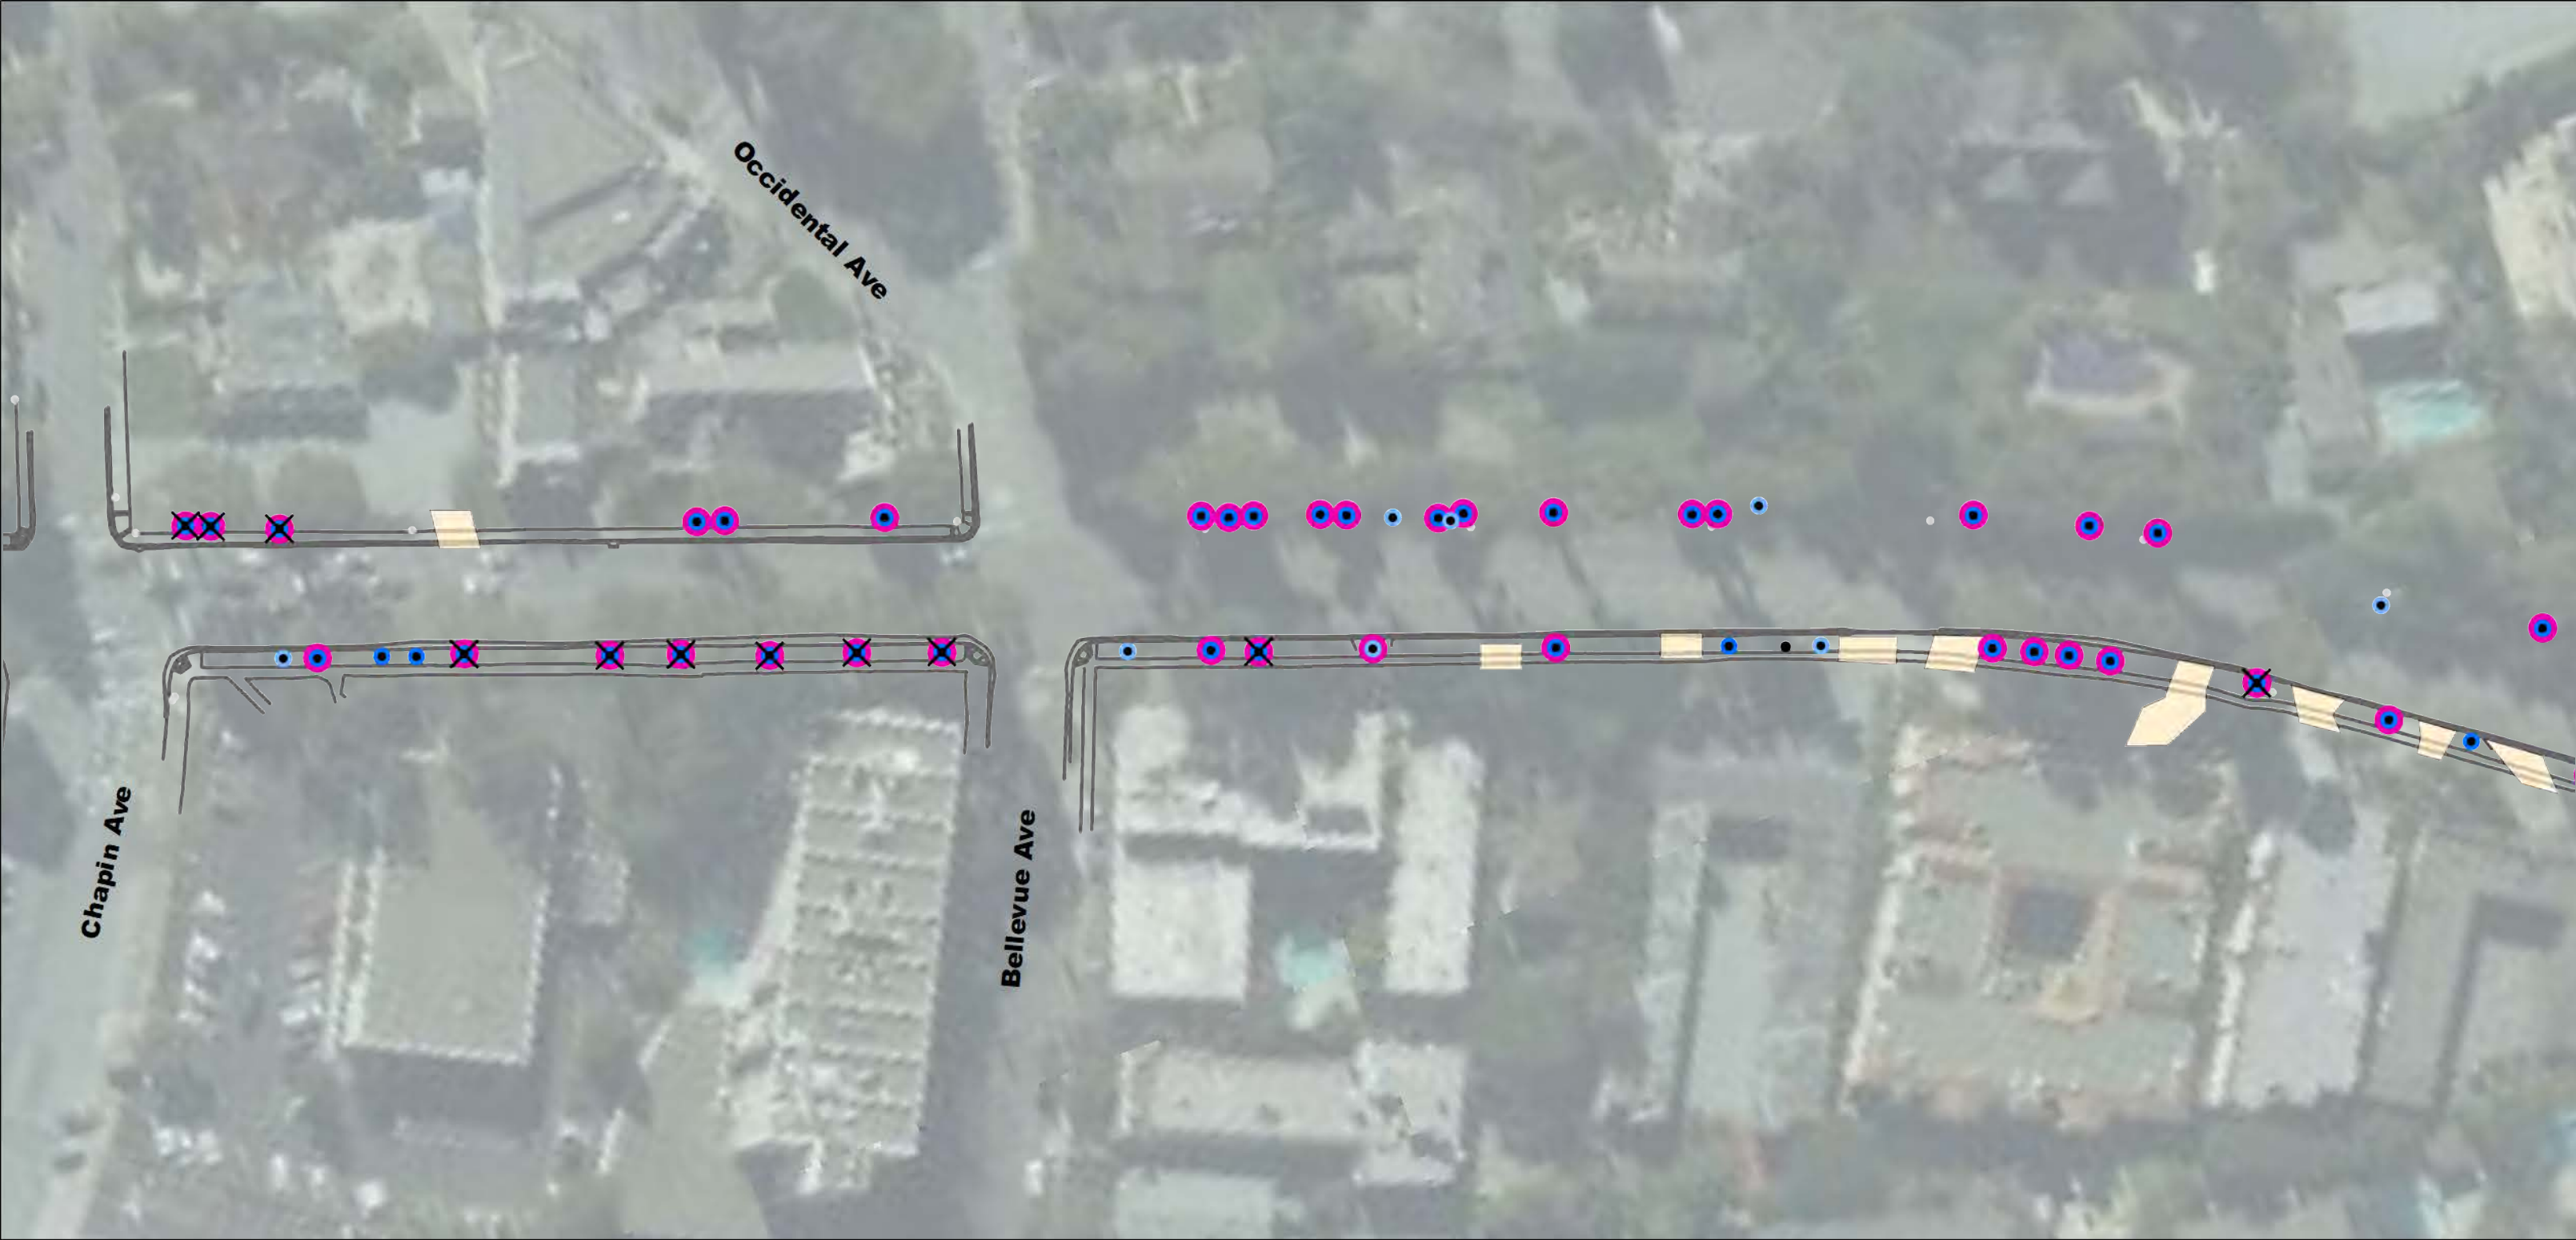
Potential Removal & Retention of Existing Trees - Alternative 1 & 2

Note: Based on Preliminary Layout Plans for the purposes of evaluating environmental impacts.

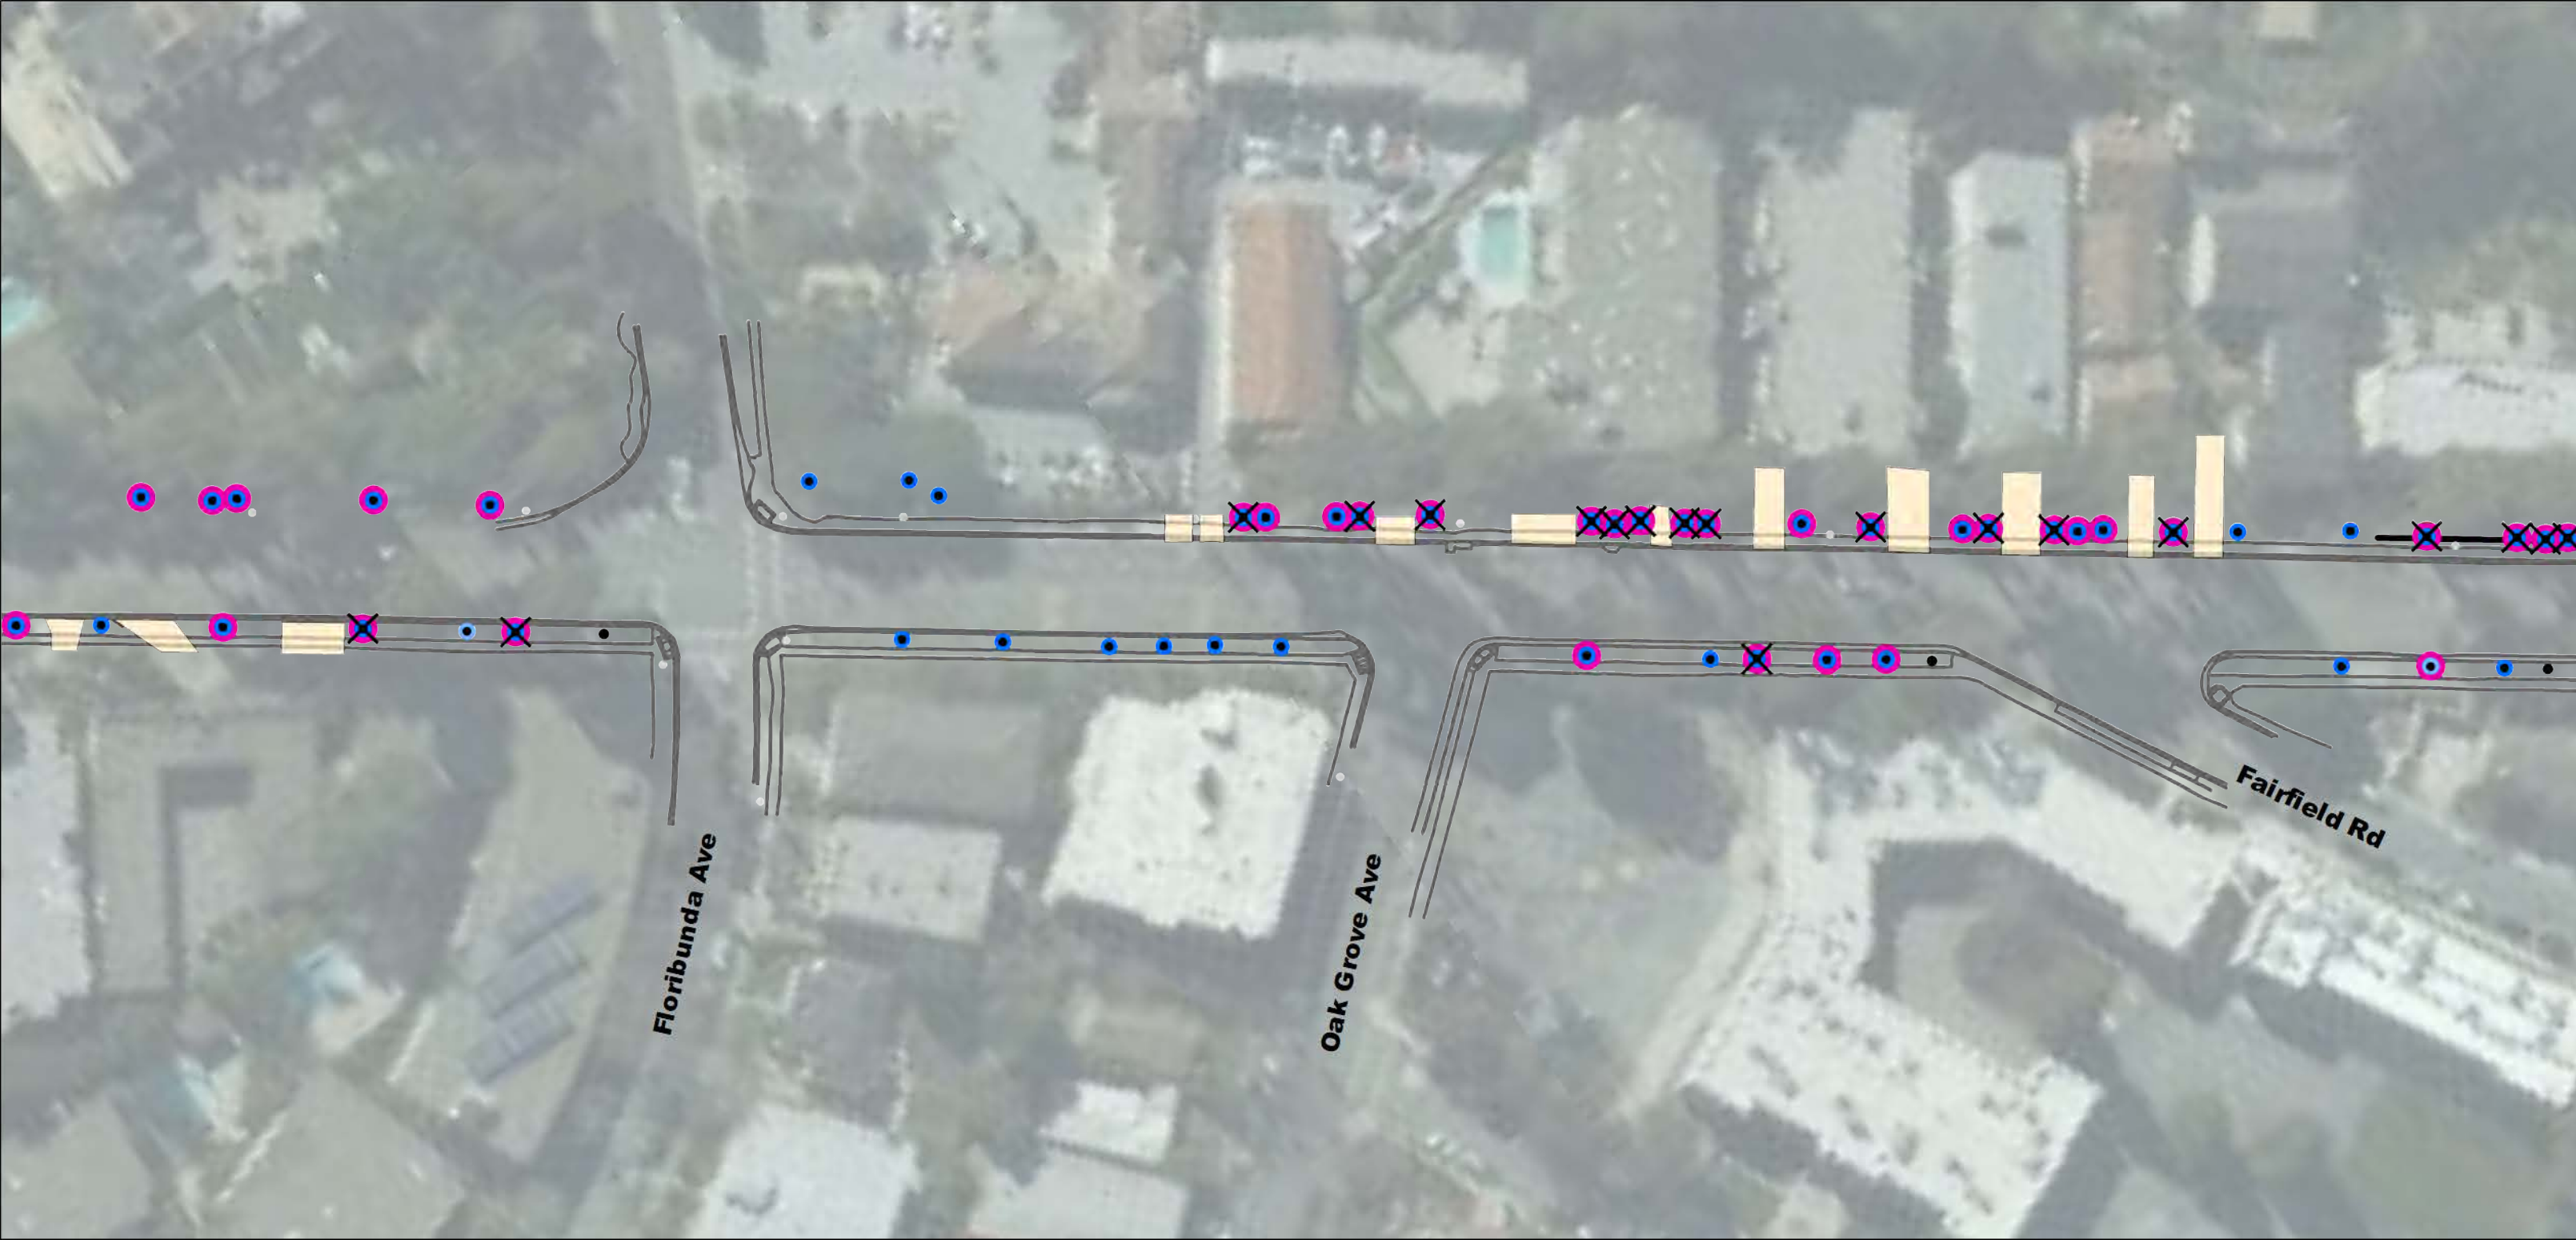
Potential Removal & Retention of Existing Trees - Alternative 1 & 2

Note: Based on Preliminary Layout Plans for the purposes of evaluating environmental impacts.

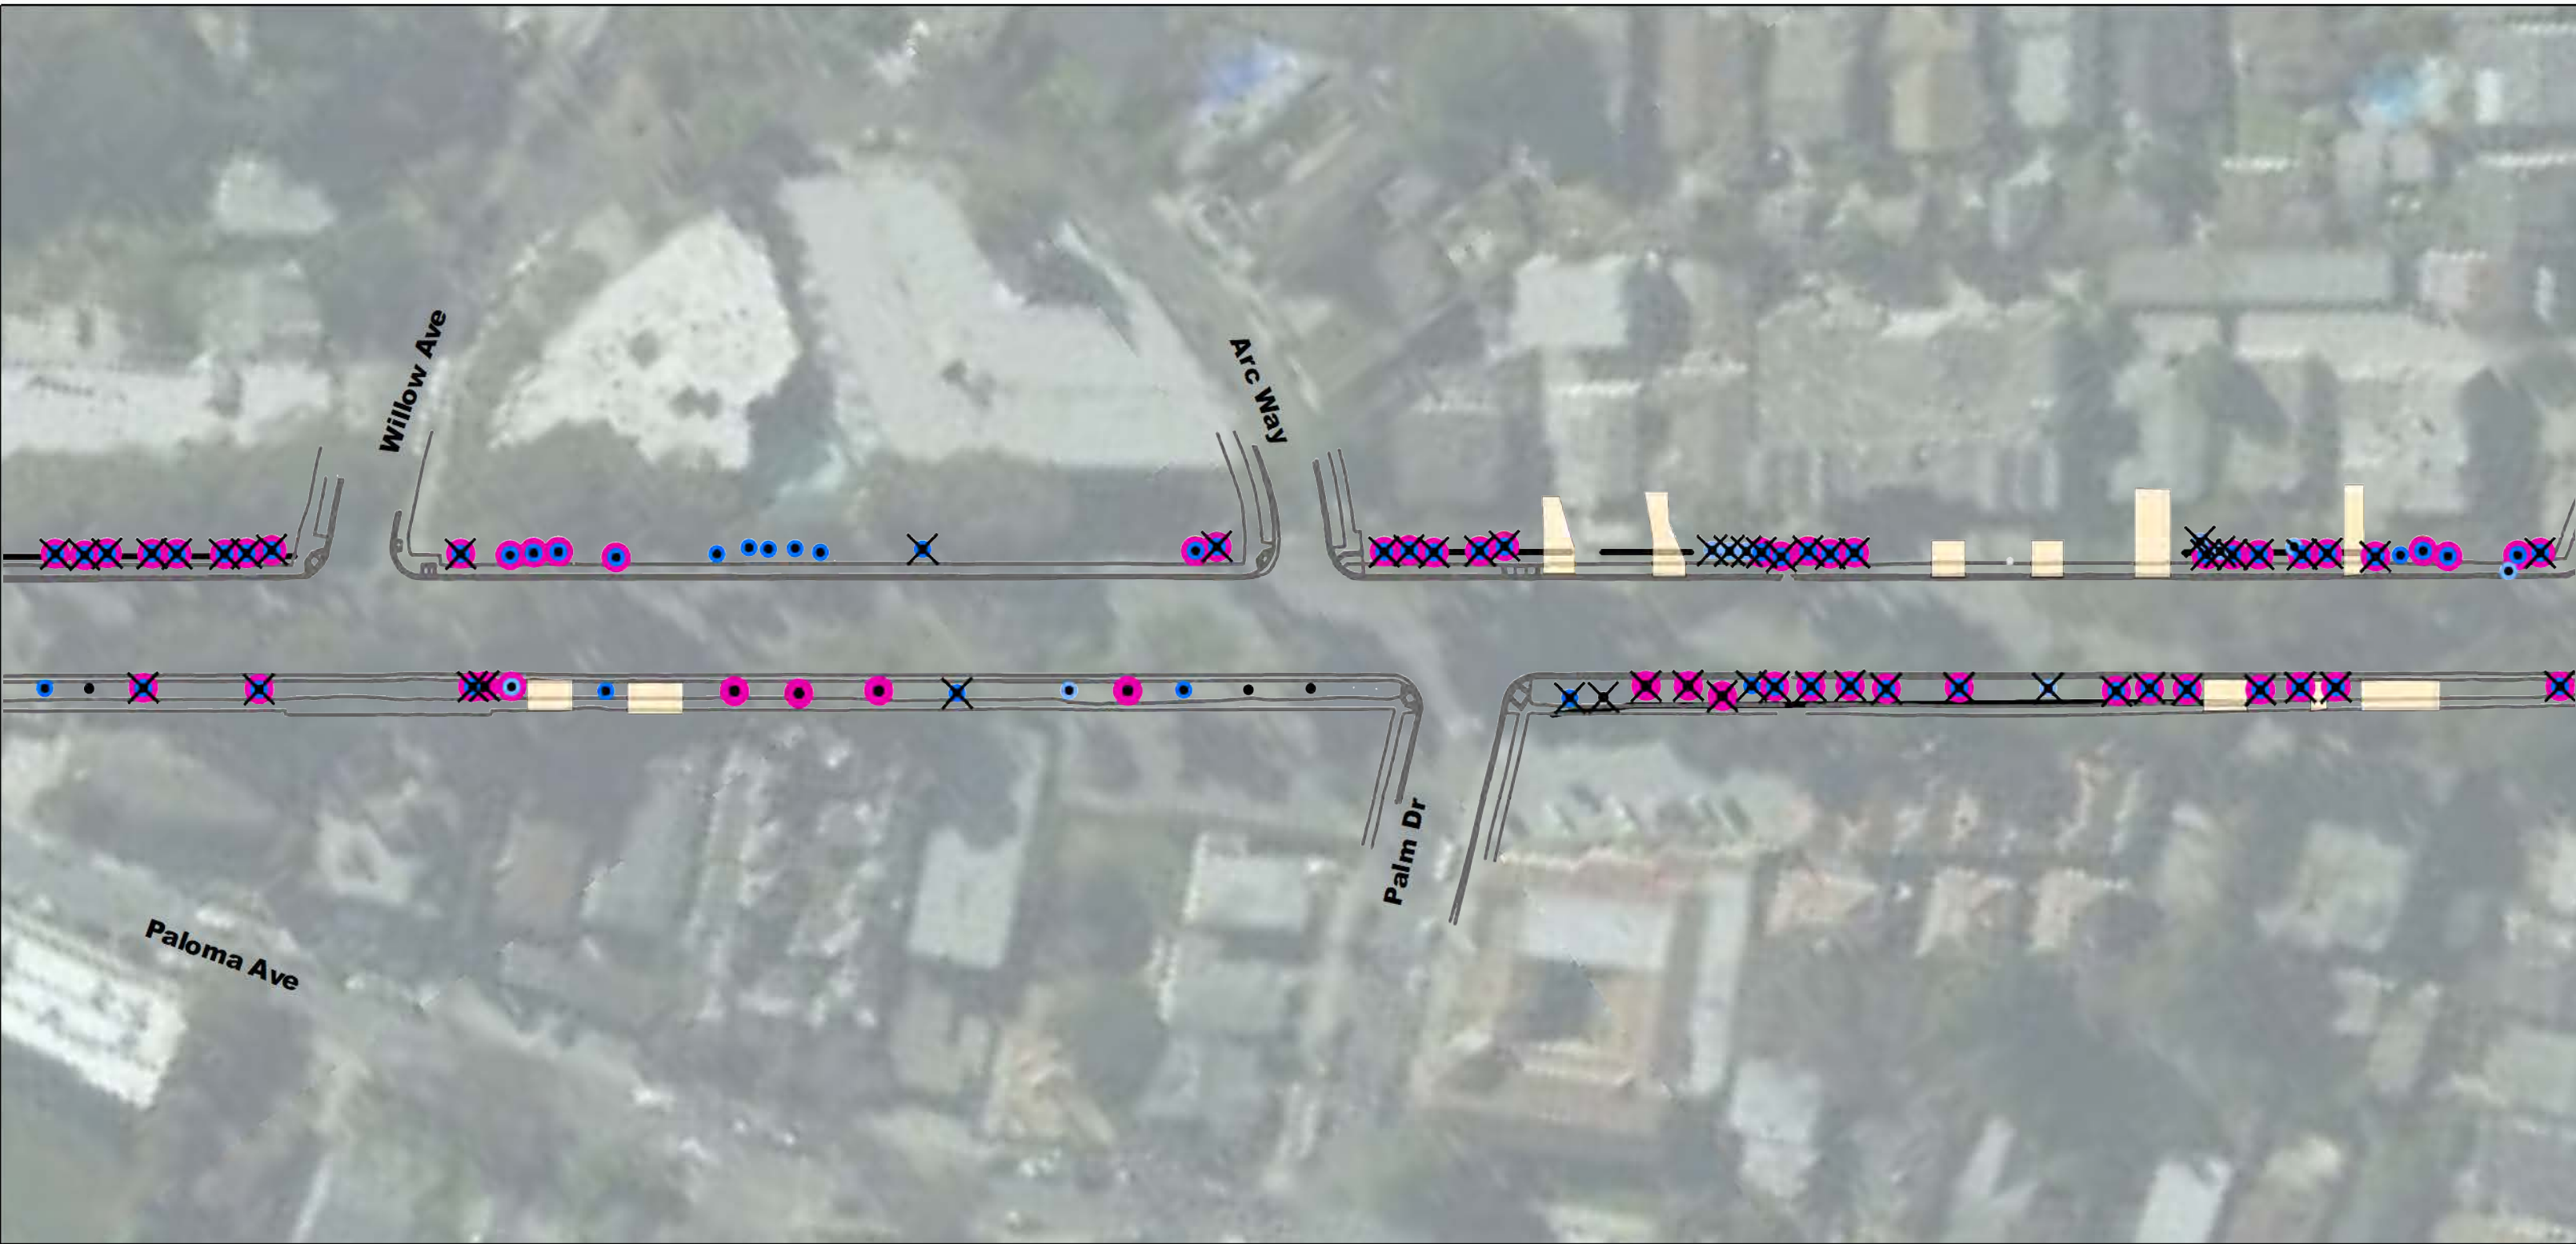
Potential Removal & Retention of Existing Trees - Alternative 1 & 2

Note: Based on Preliminary Layout Plans for the purposes of evaluating environmental impacts.
