VISUAL IMPACT ASSESSMENT

El Camino Real Roadway Renewal Project

February 24, 2021

California Department of Transportation
04-SM-82
PM 12.3 to 15.8
0416000142 – EA 0K810

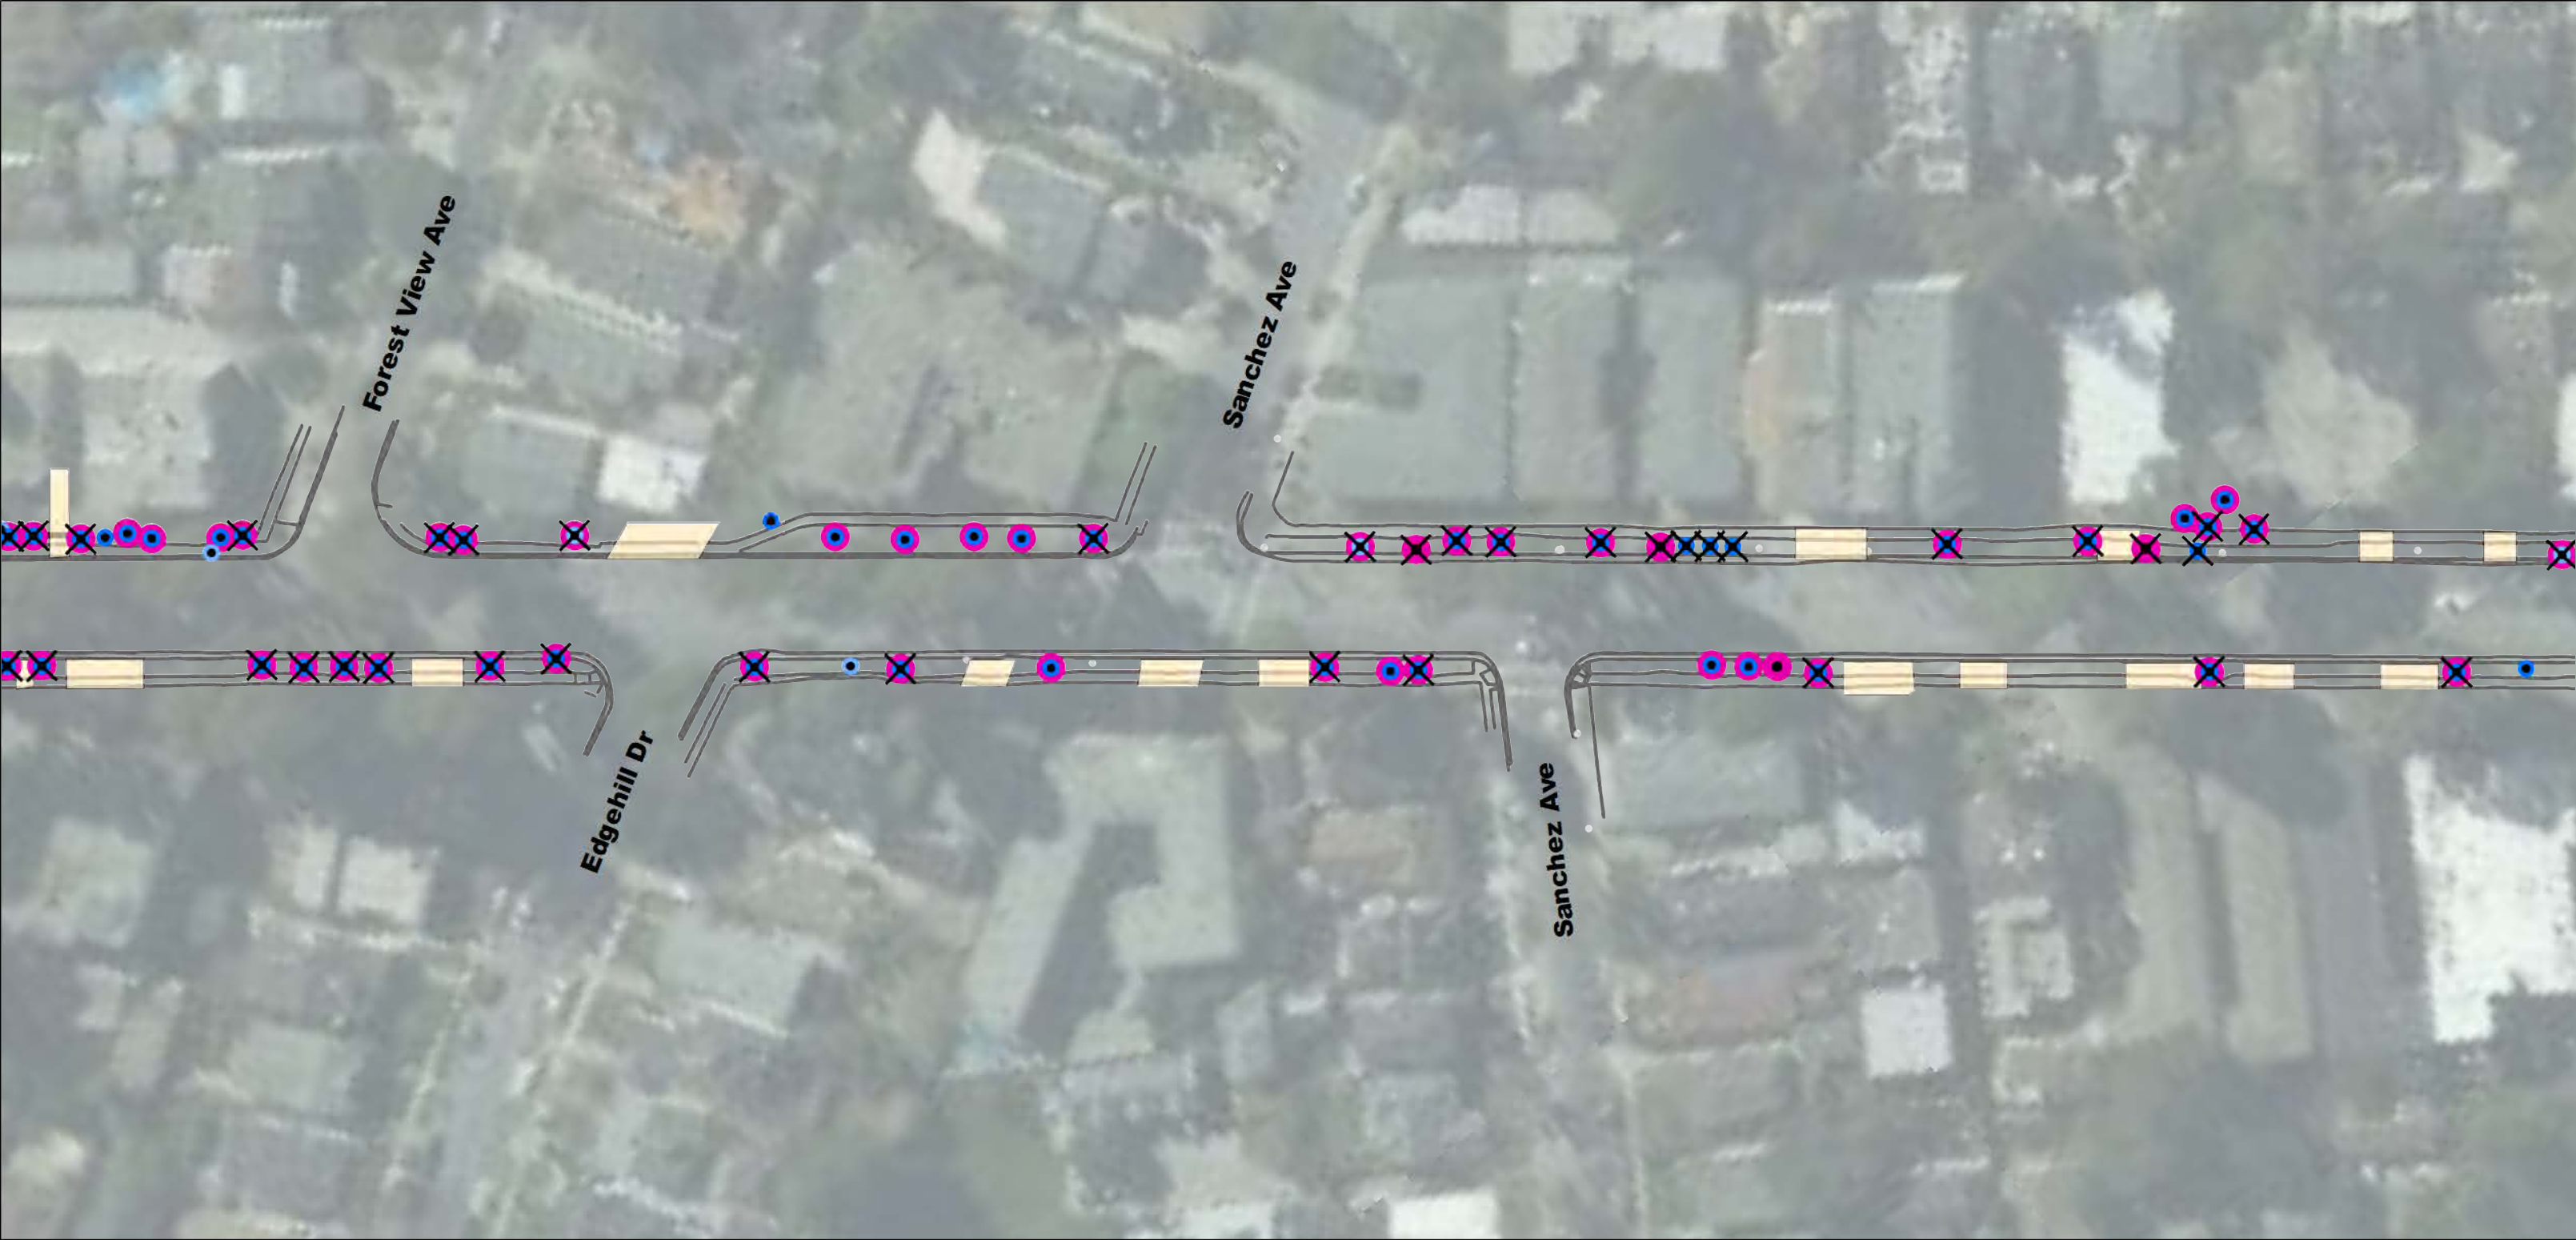
Potential Removal & Retention of Existing Trees - Alternative 1 & 2

Note: Based on Preliminary Layout Plans for the purposes of evaluating environmental impacts.

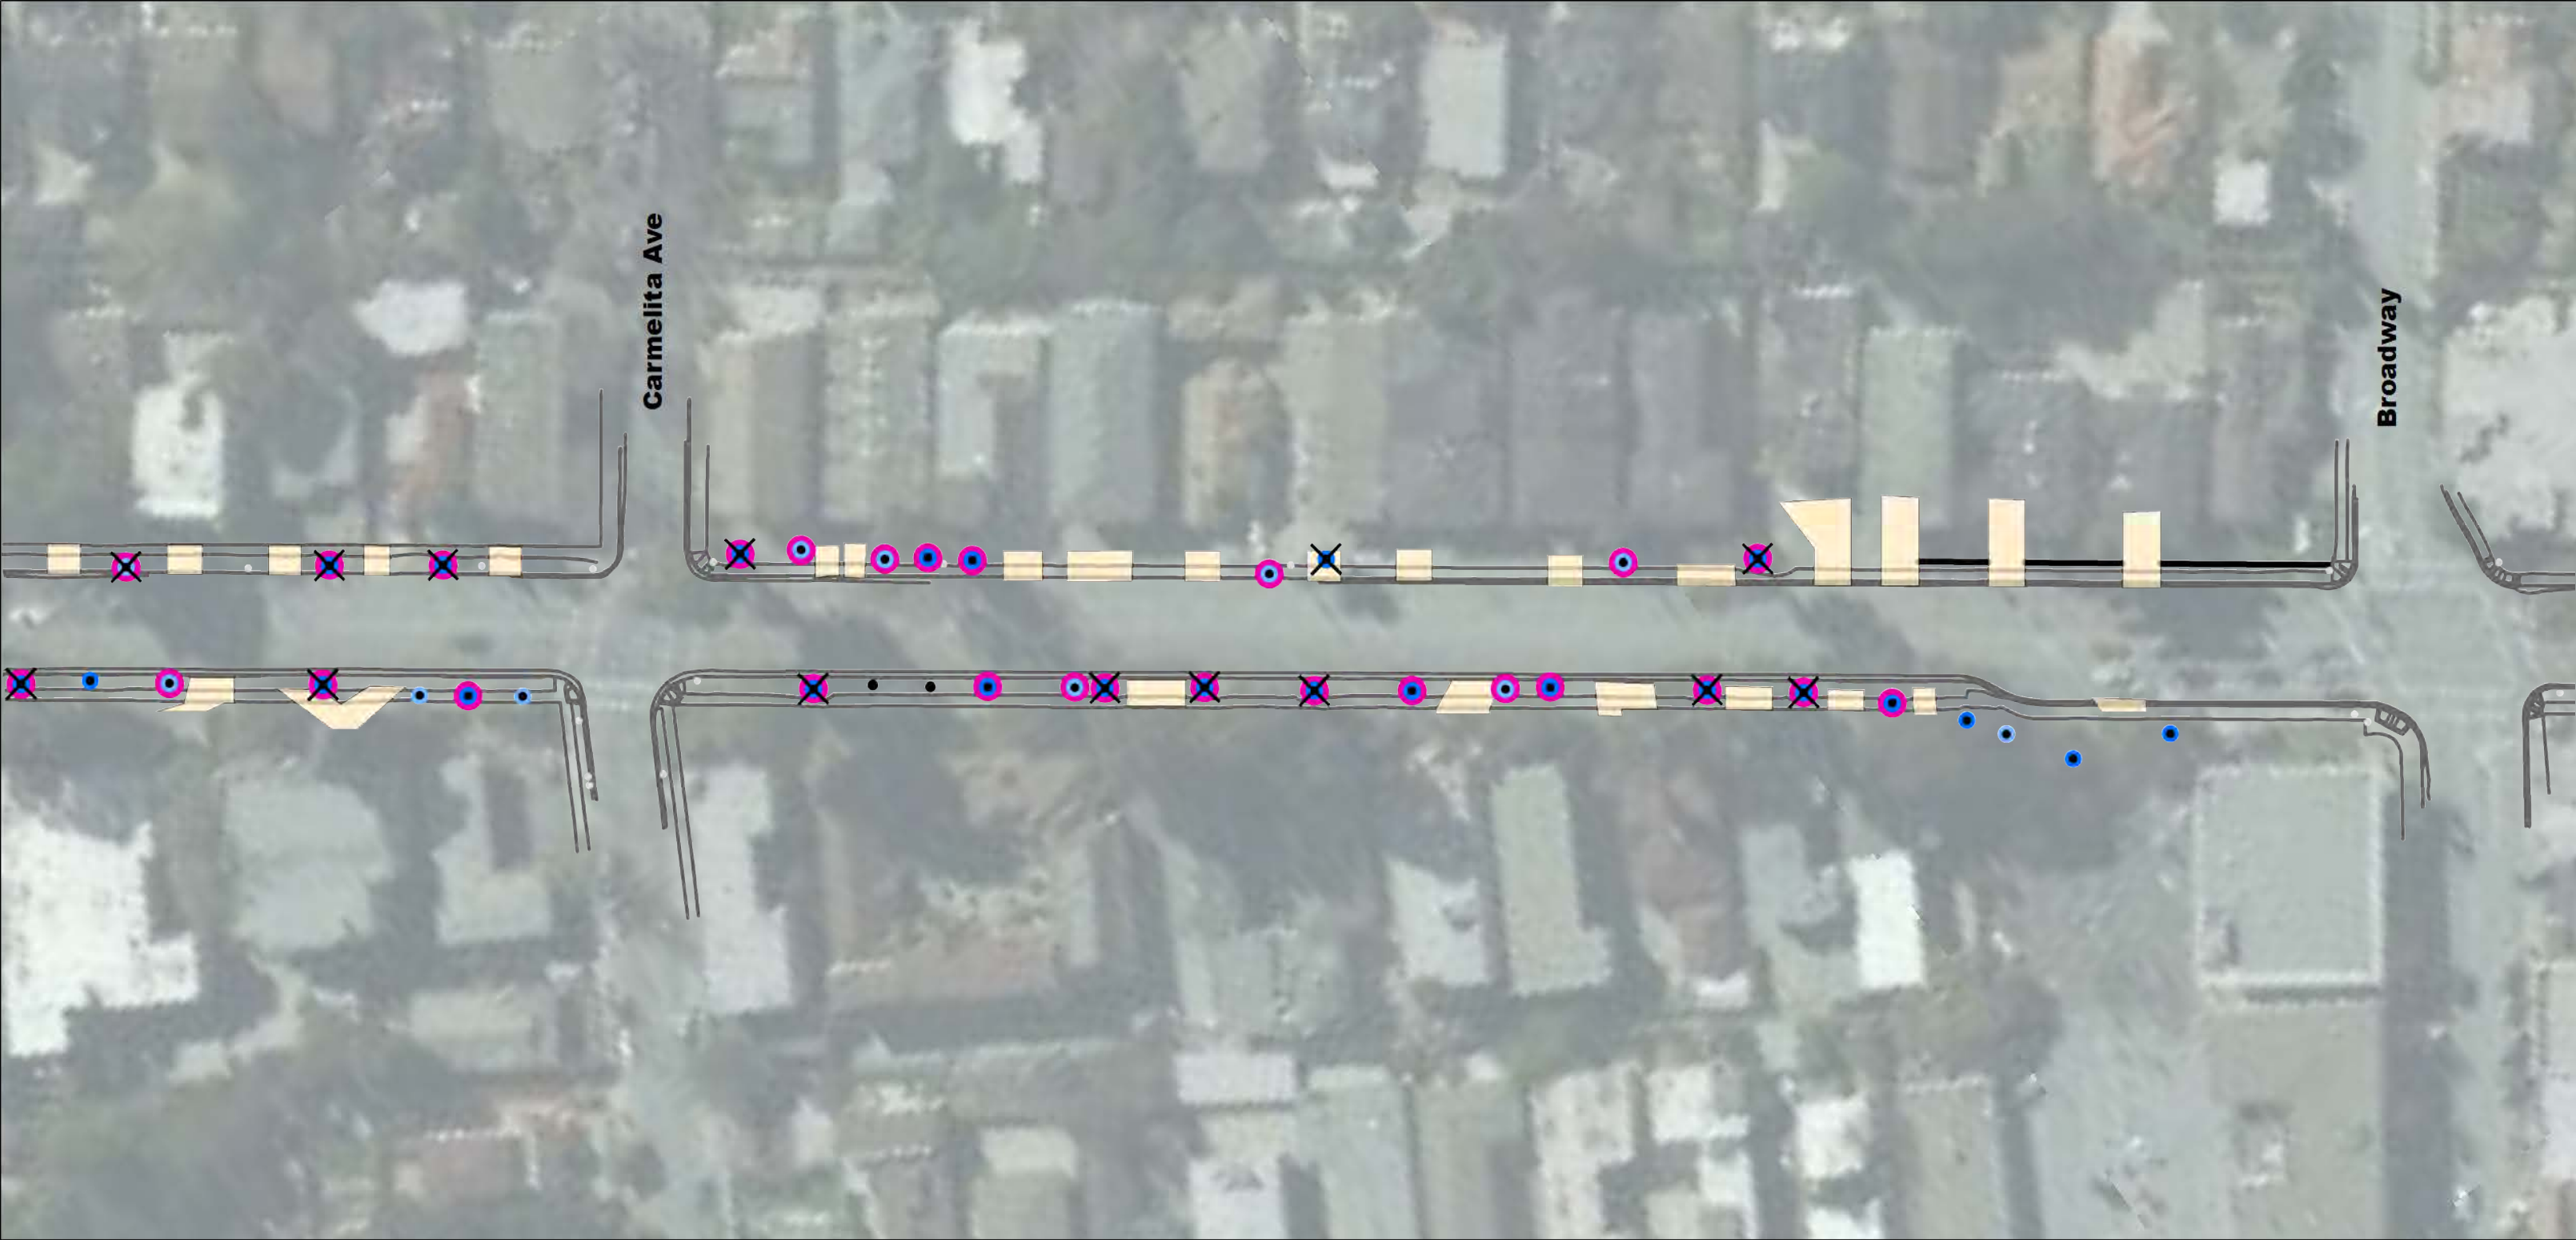
Potential Removal & Retention of Existing Trees - Alternative 1 & 2

Note: Based on Preliminary Layout Plans for the purposes of evaluating environmental impacts.

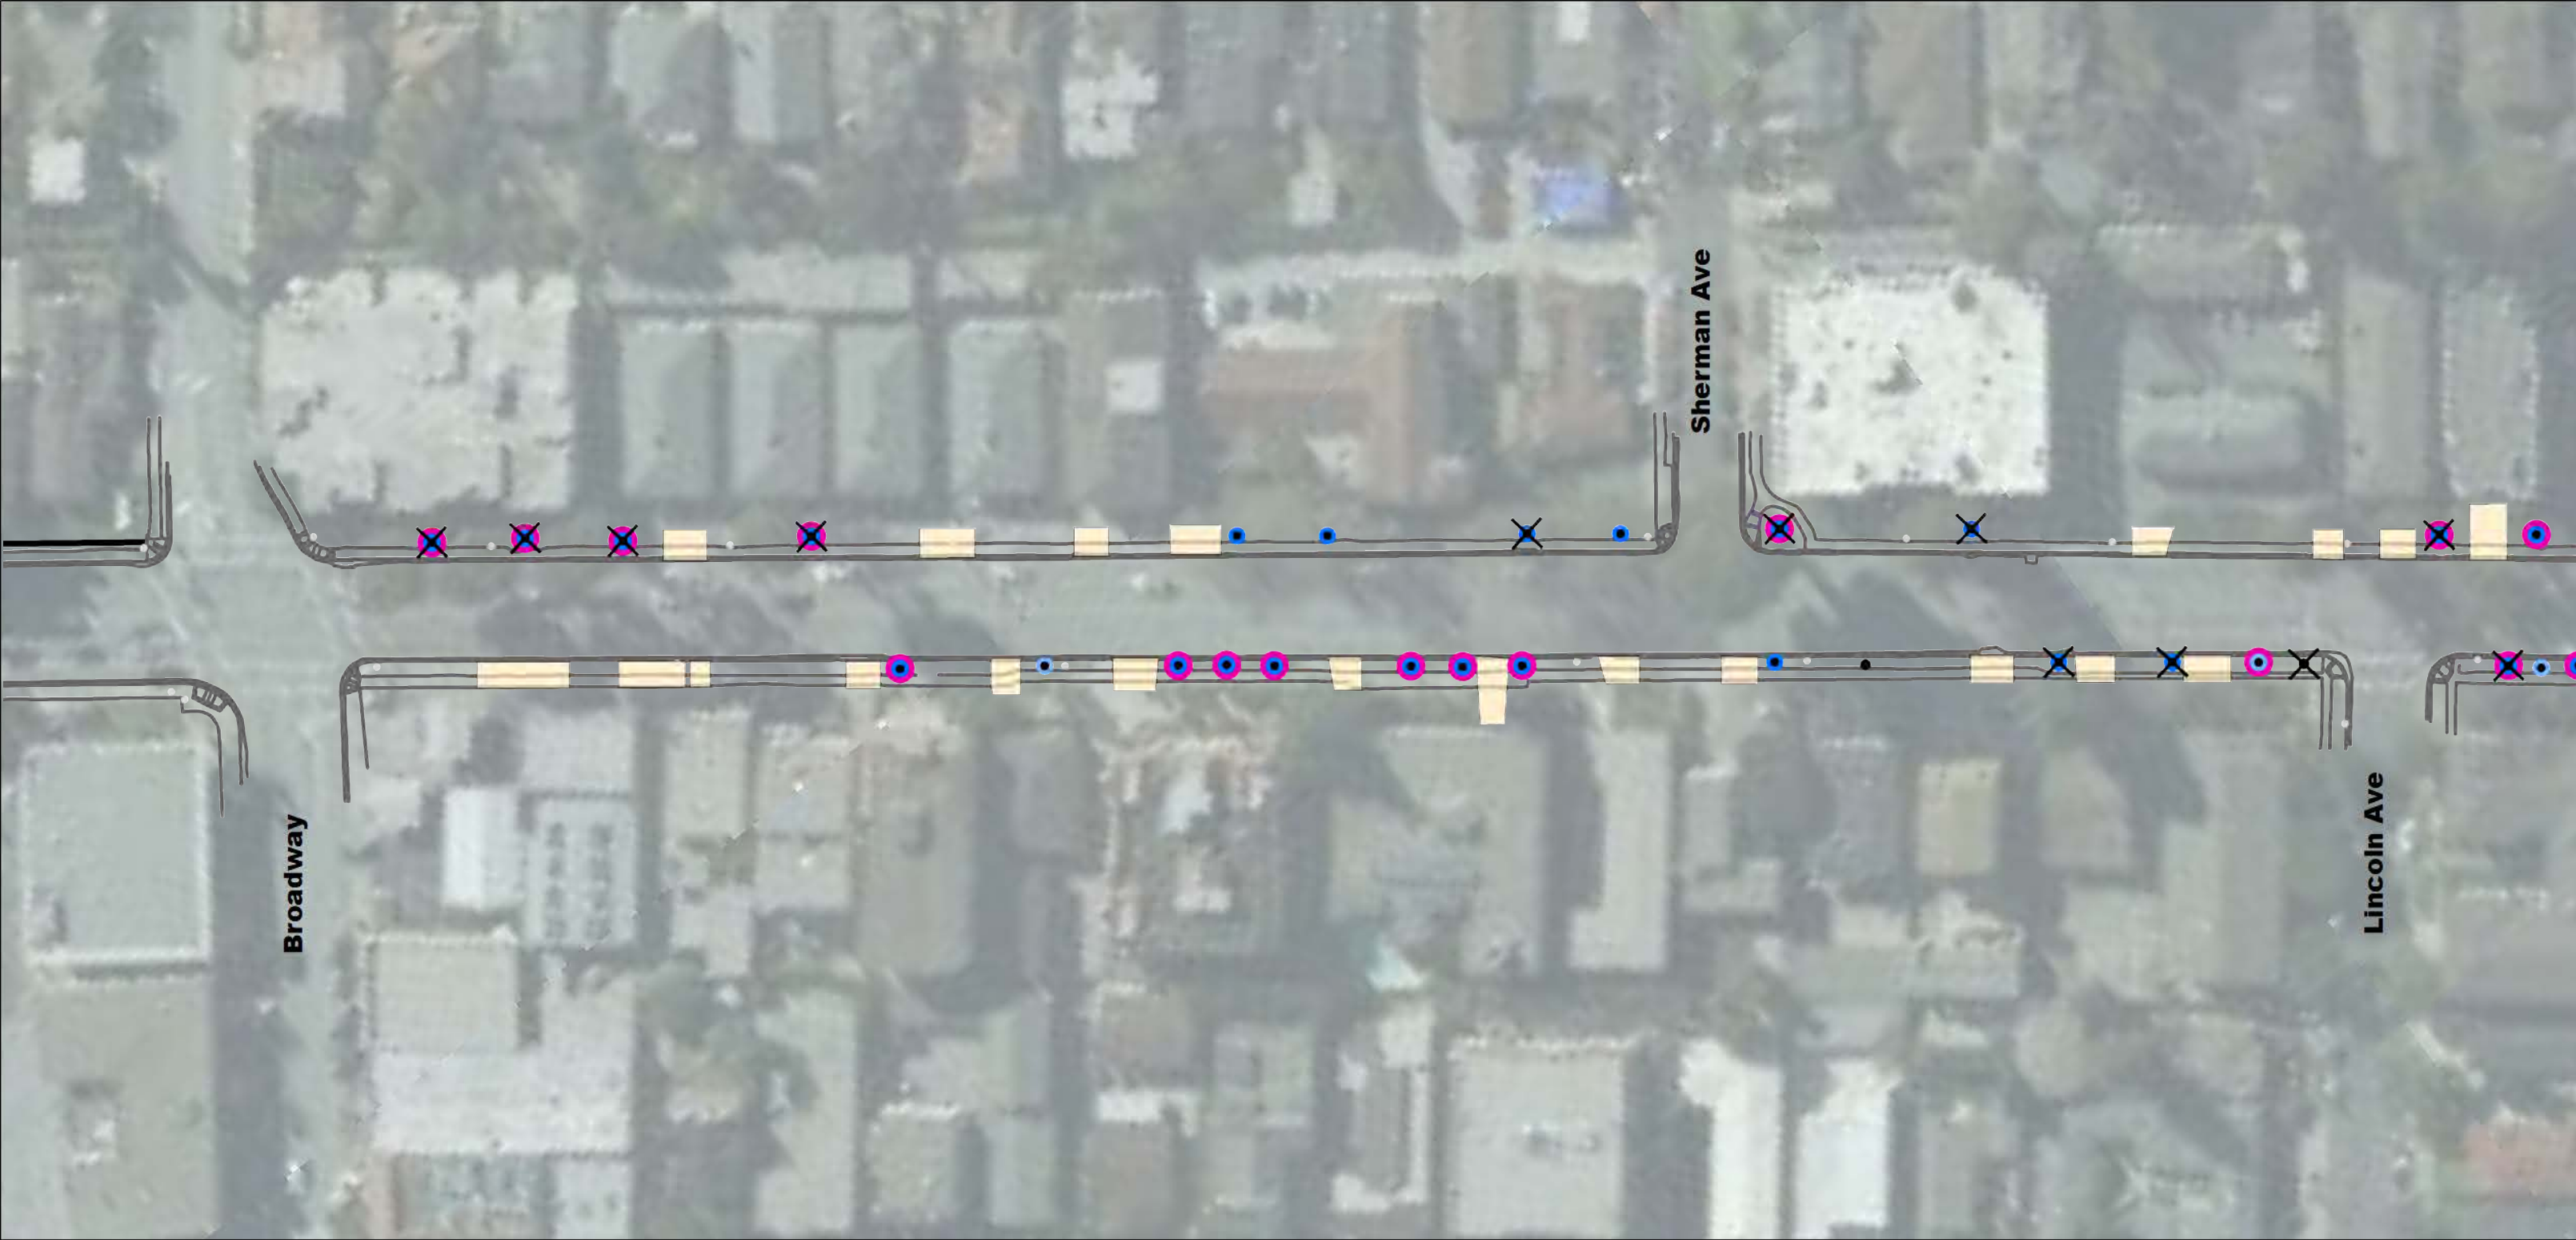
Potential Removal & Retention of Existing Trees - Alternative 1 & 2

Note: Based on Preliminary Layout Plans for the purposes of evaluating environmental impacts.

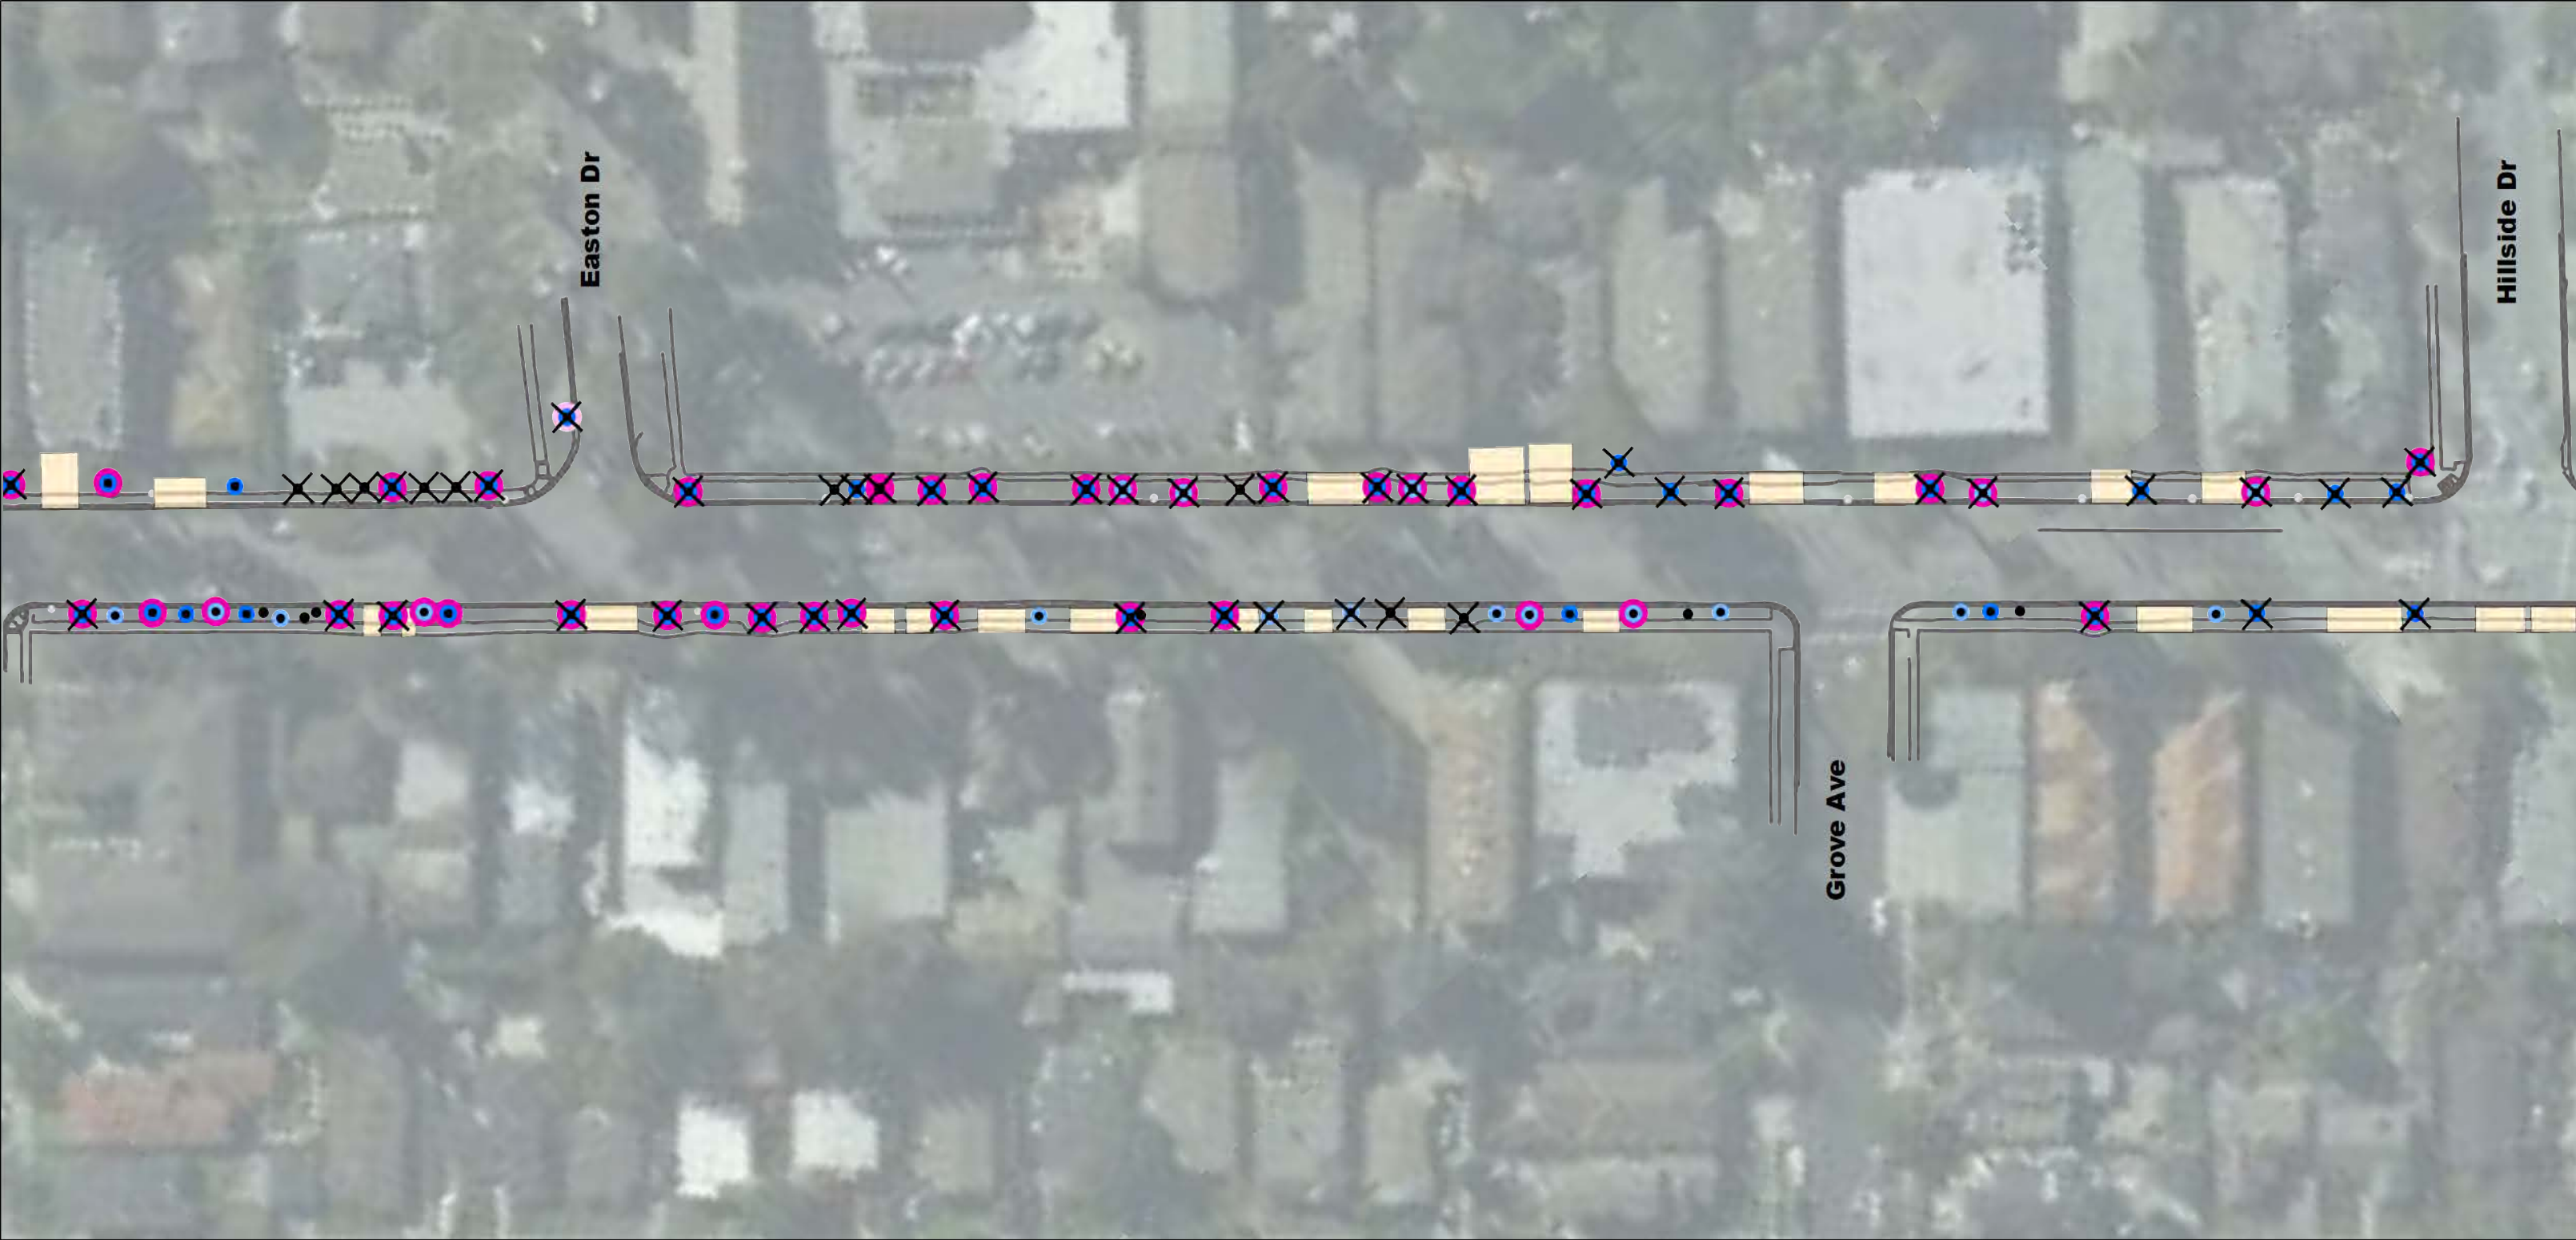
Potential Removal & Retention of Existing Trees - Alternative 1 & 2

Note: Based on Preliminary Layout Plans for the purposes of evaluating environmental impacts.

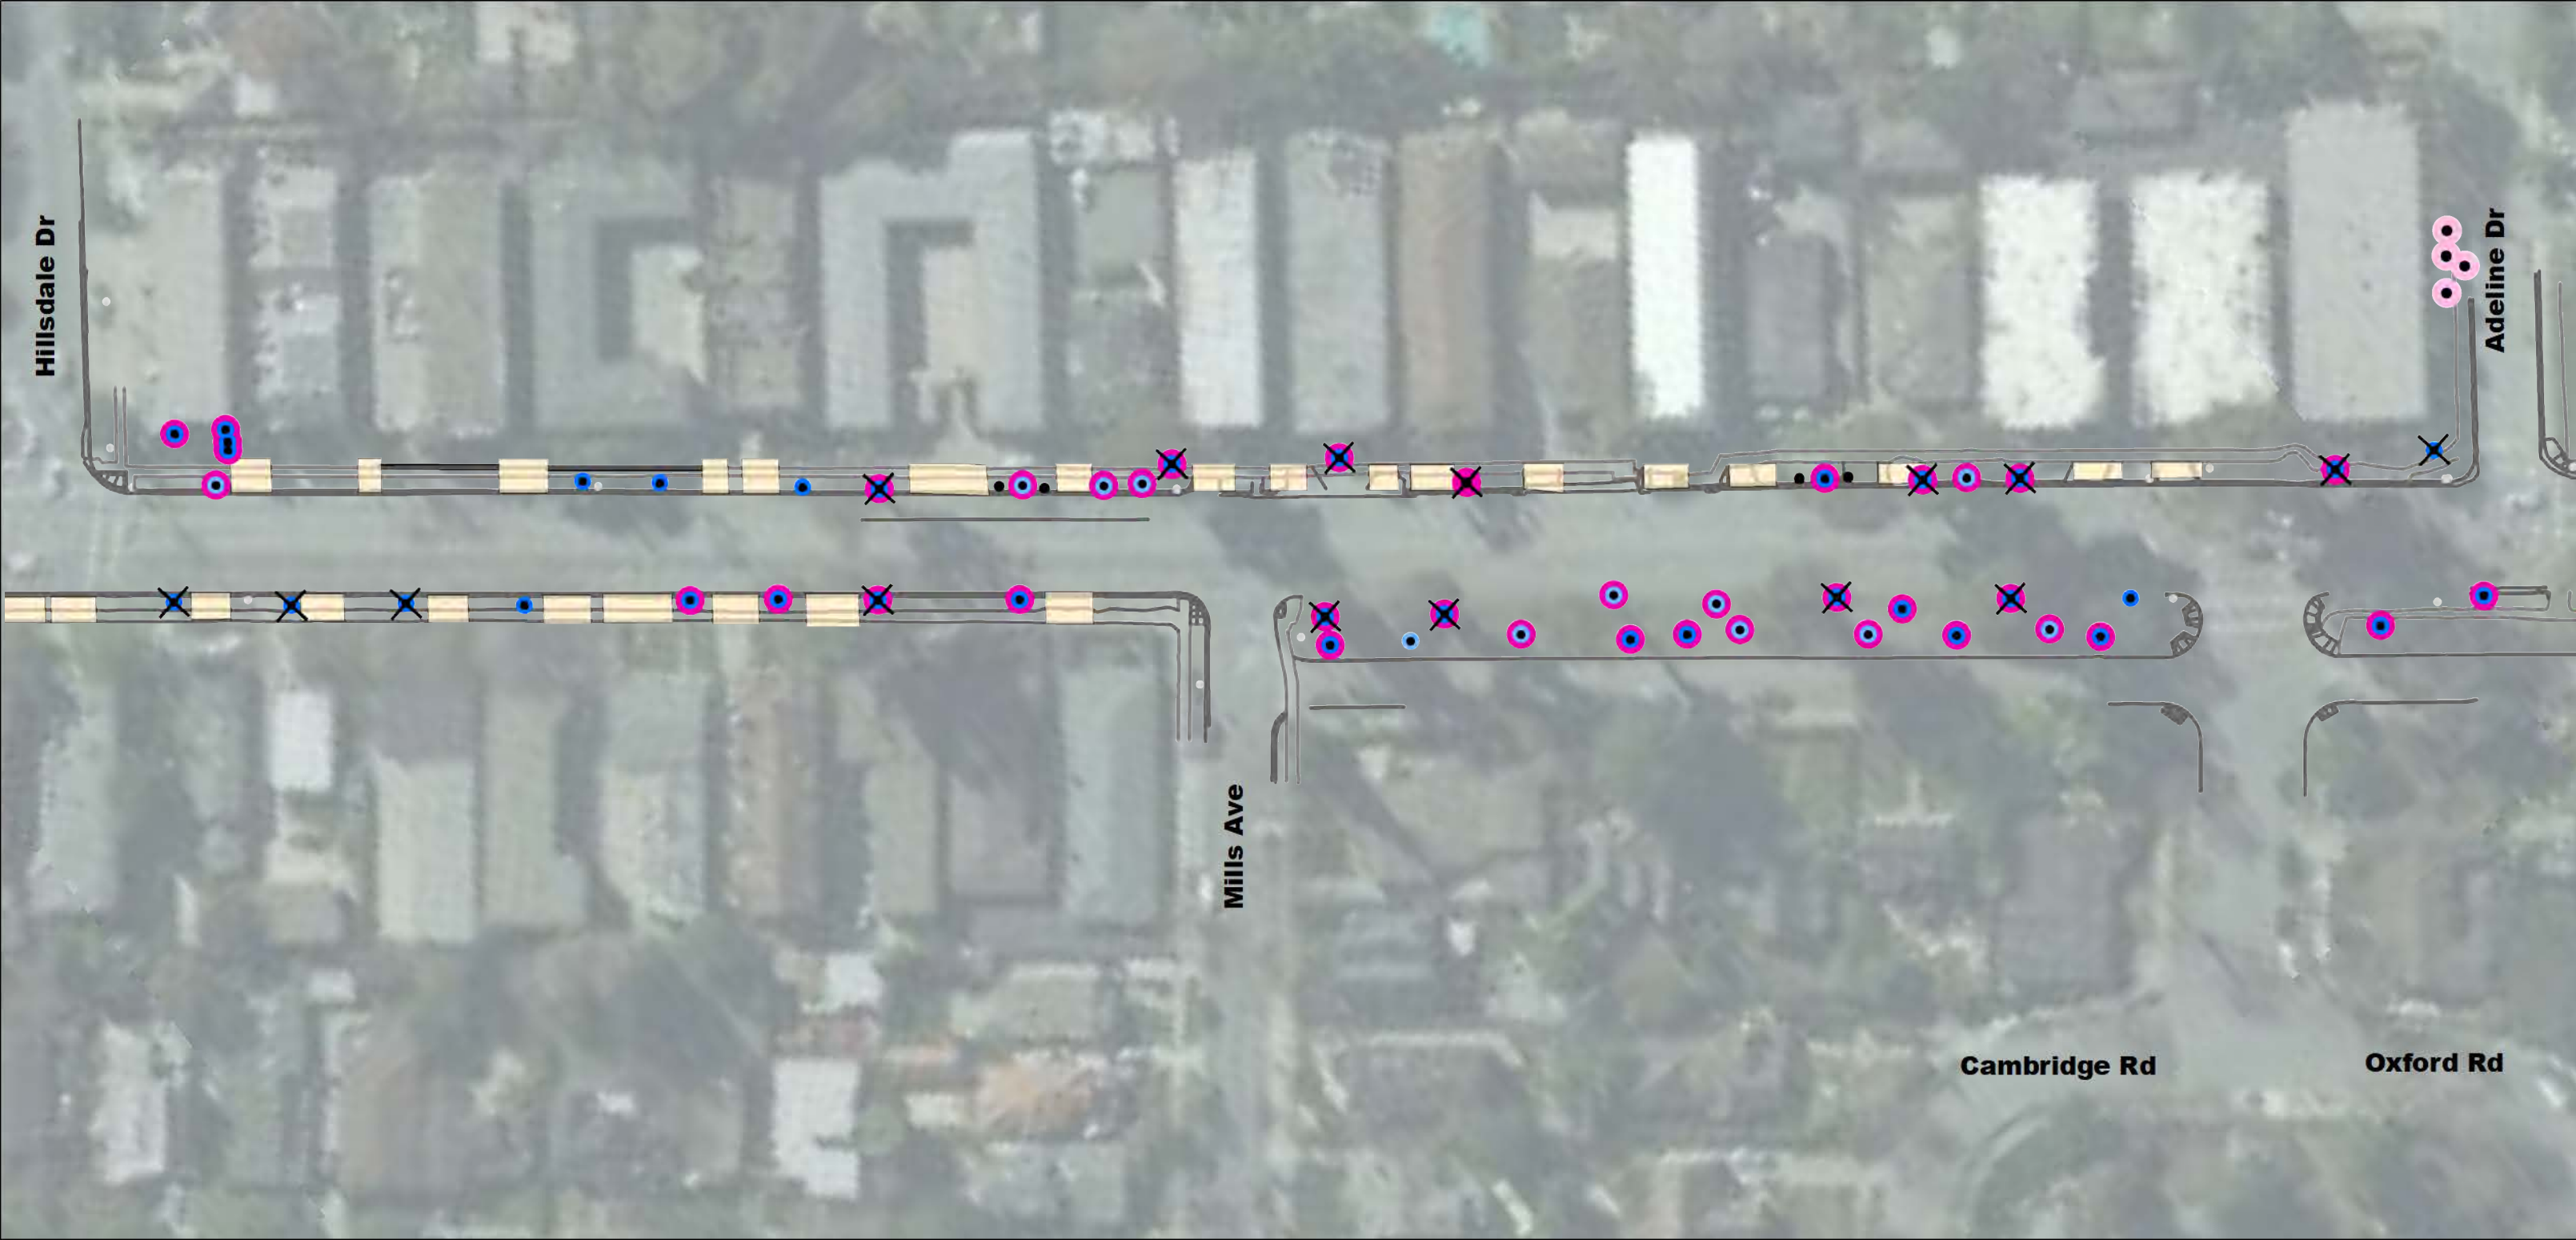
Potential Removal & Retention of Existing Trees - Alternative 1 & 2

Note: Based on Preliminary Layout Plans for the purposes of evaluating environmental impacts.

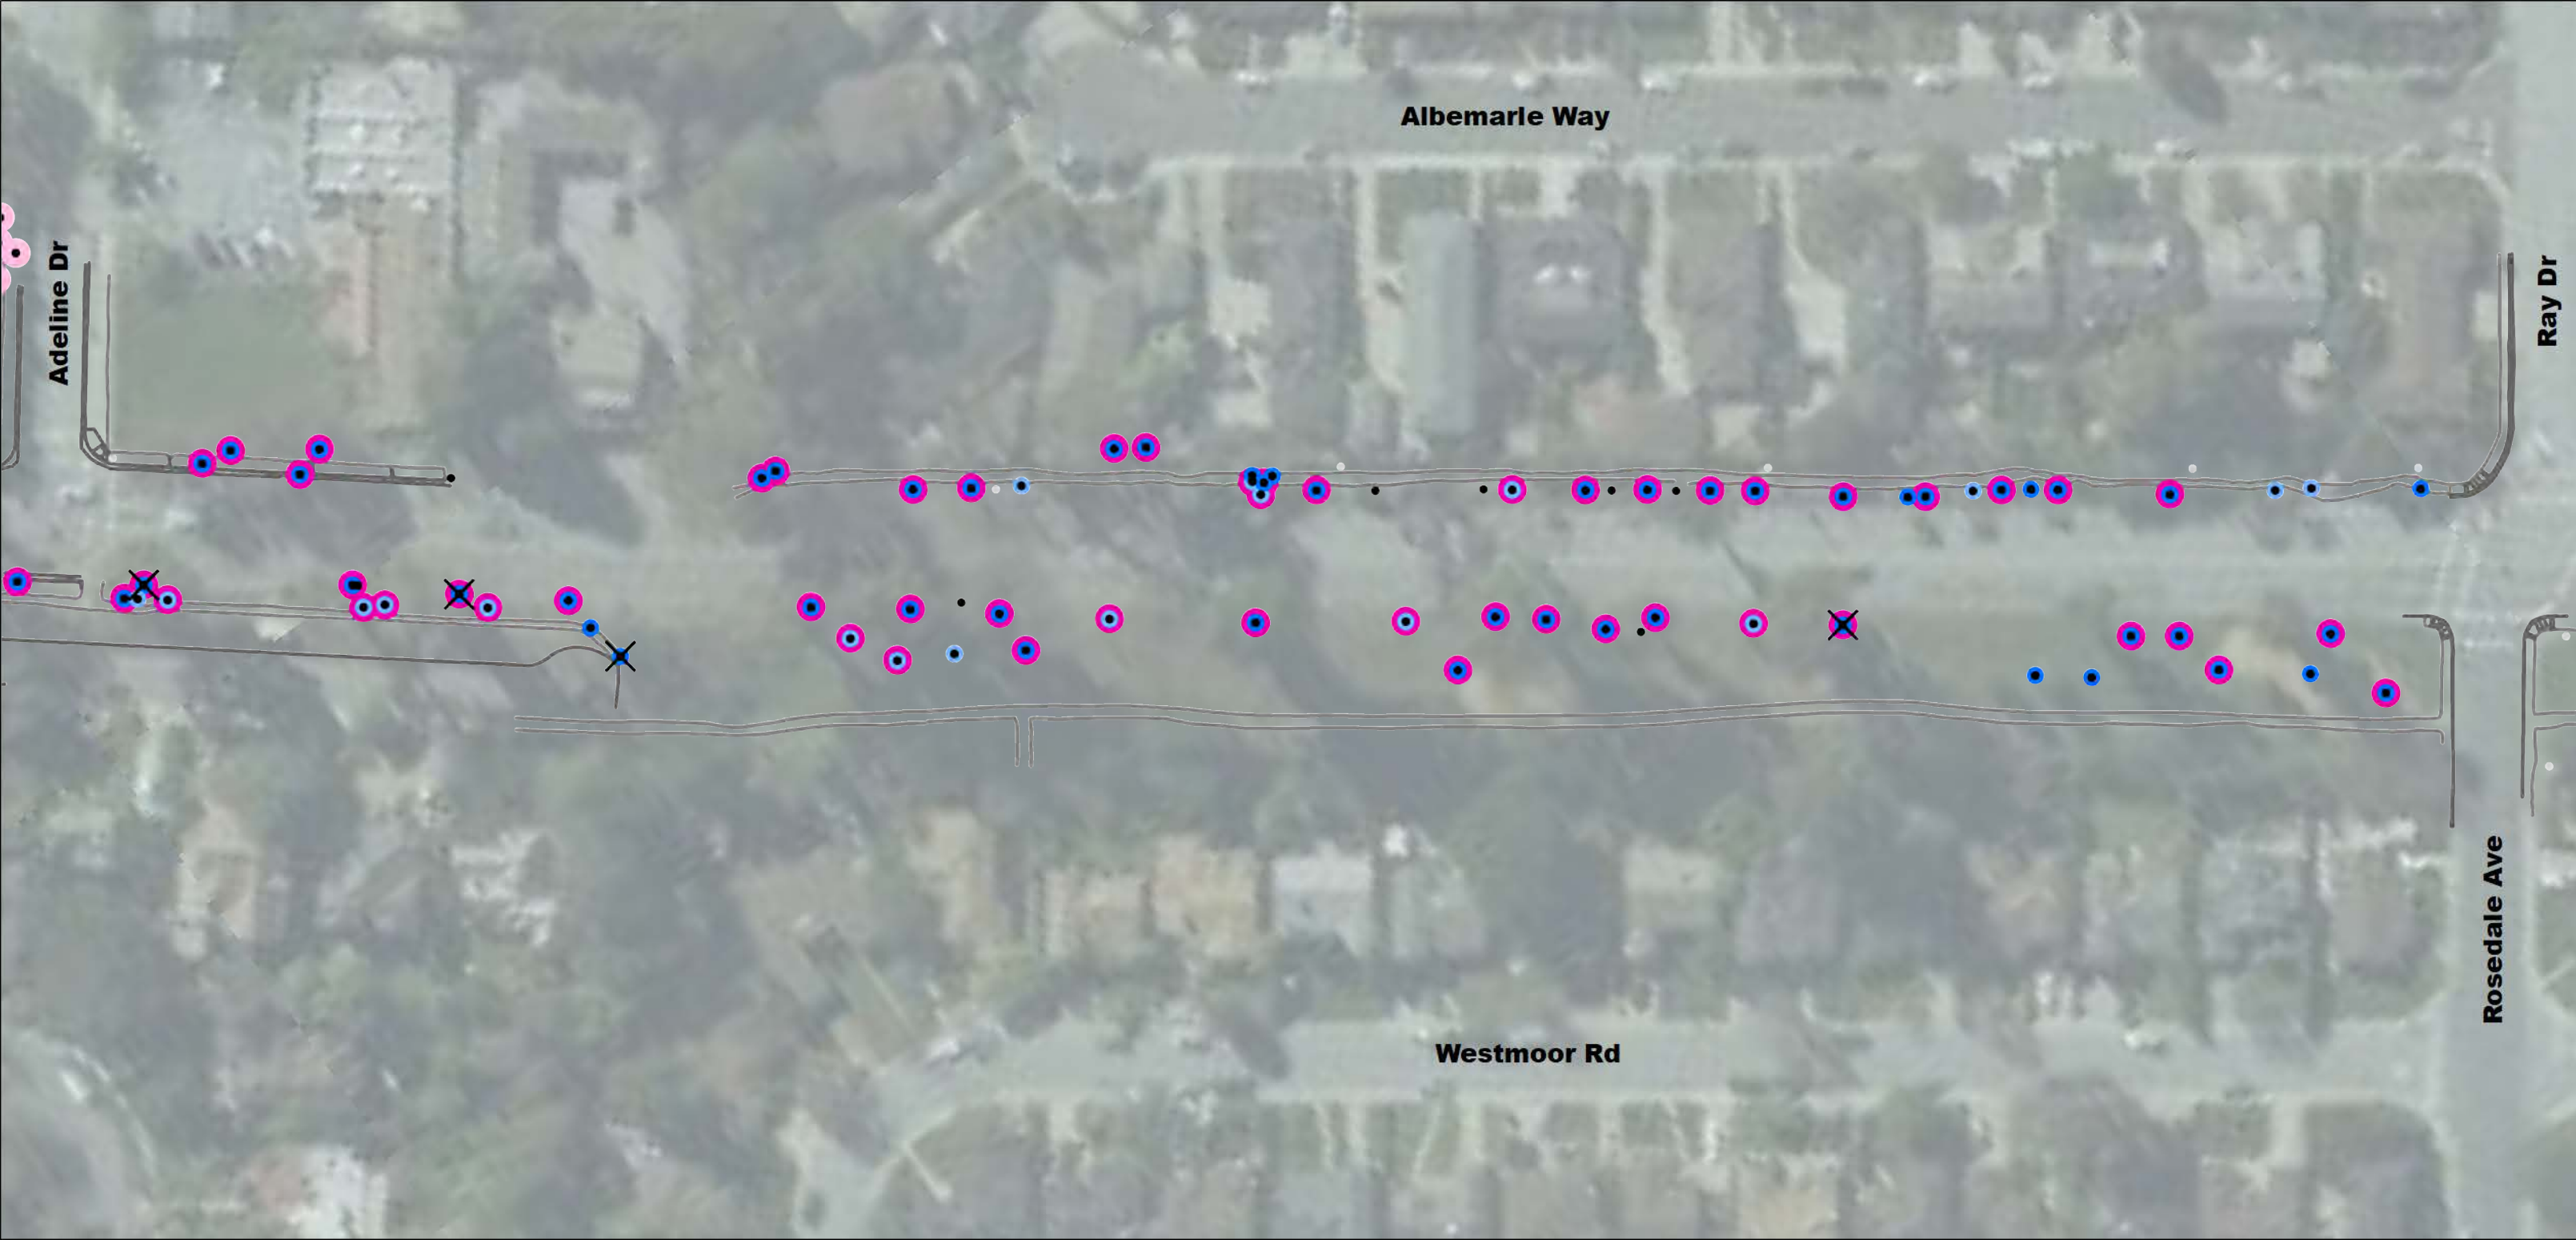
Potential Removal & Retention of Existing Trees - Alternative 1 & 2

Note: Based on Preliminary Layout Plans for the purposes of evaluating environmental impacts.

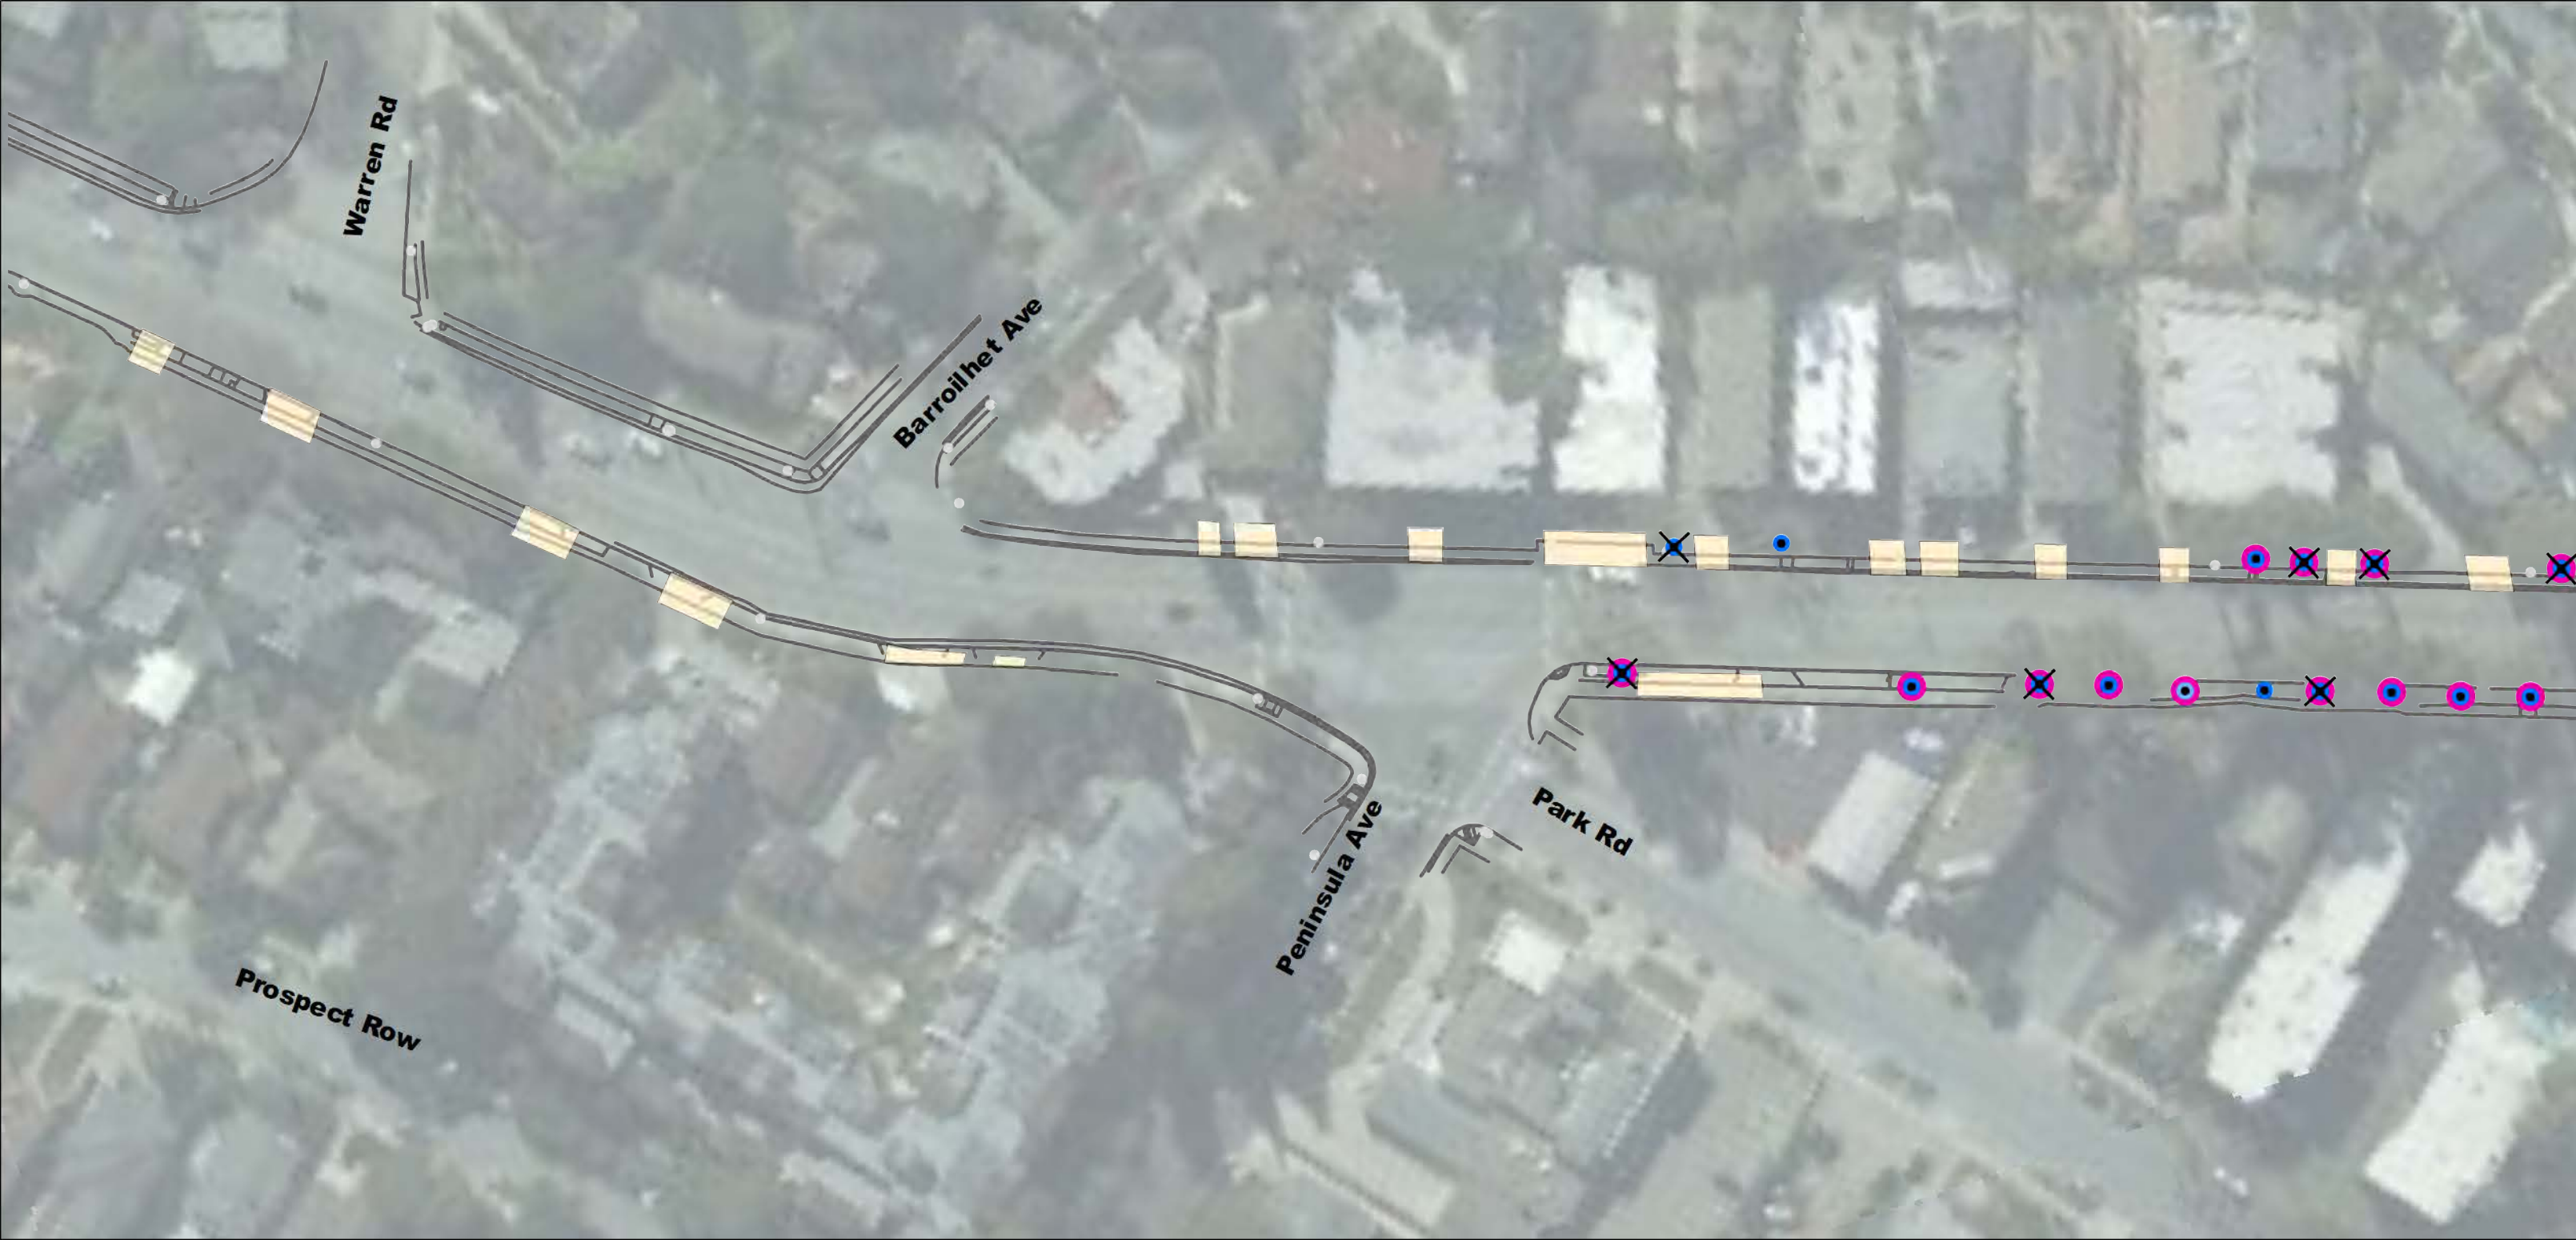
Potential Removal & Retention of Existing Trees - Alternative 3 & 4

Note: Based on Preliminary Layout Plans for the purposes of evaluating environmental impacts.
