VISUAL IMPACT ASSESSMENT

El Camino Real Roadway Renewal Project

February 24, 2021

California Department of Transportation
04-SM-82
PM 12.3 to 15.8
0416000142 – EA 0K810

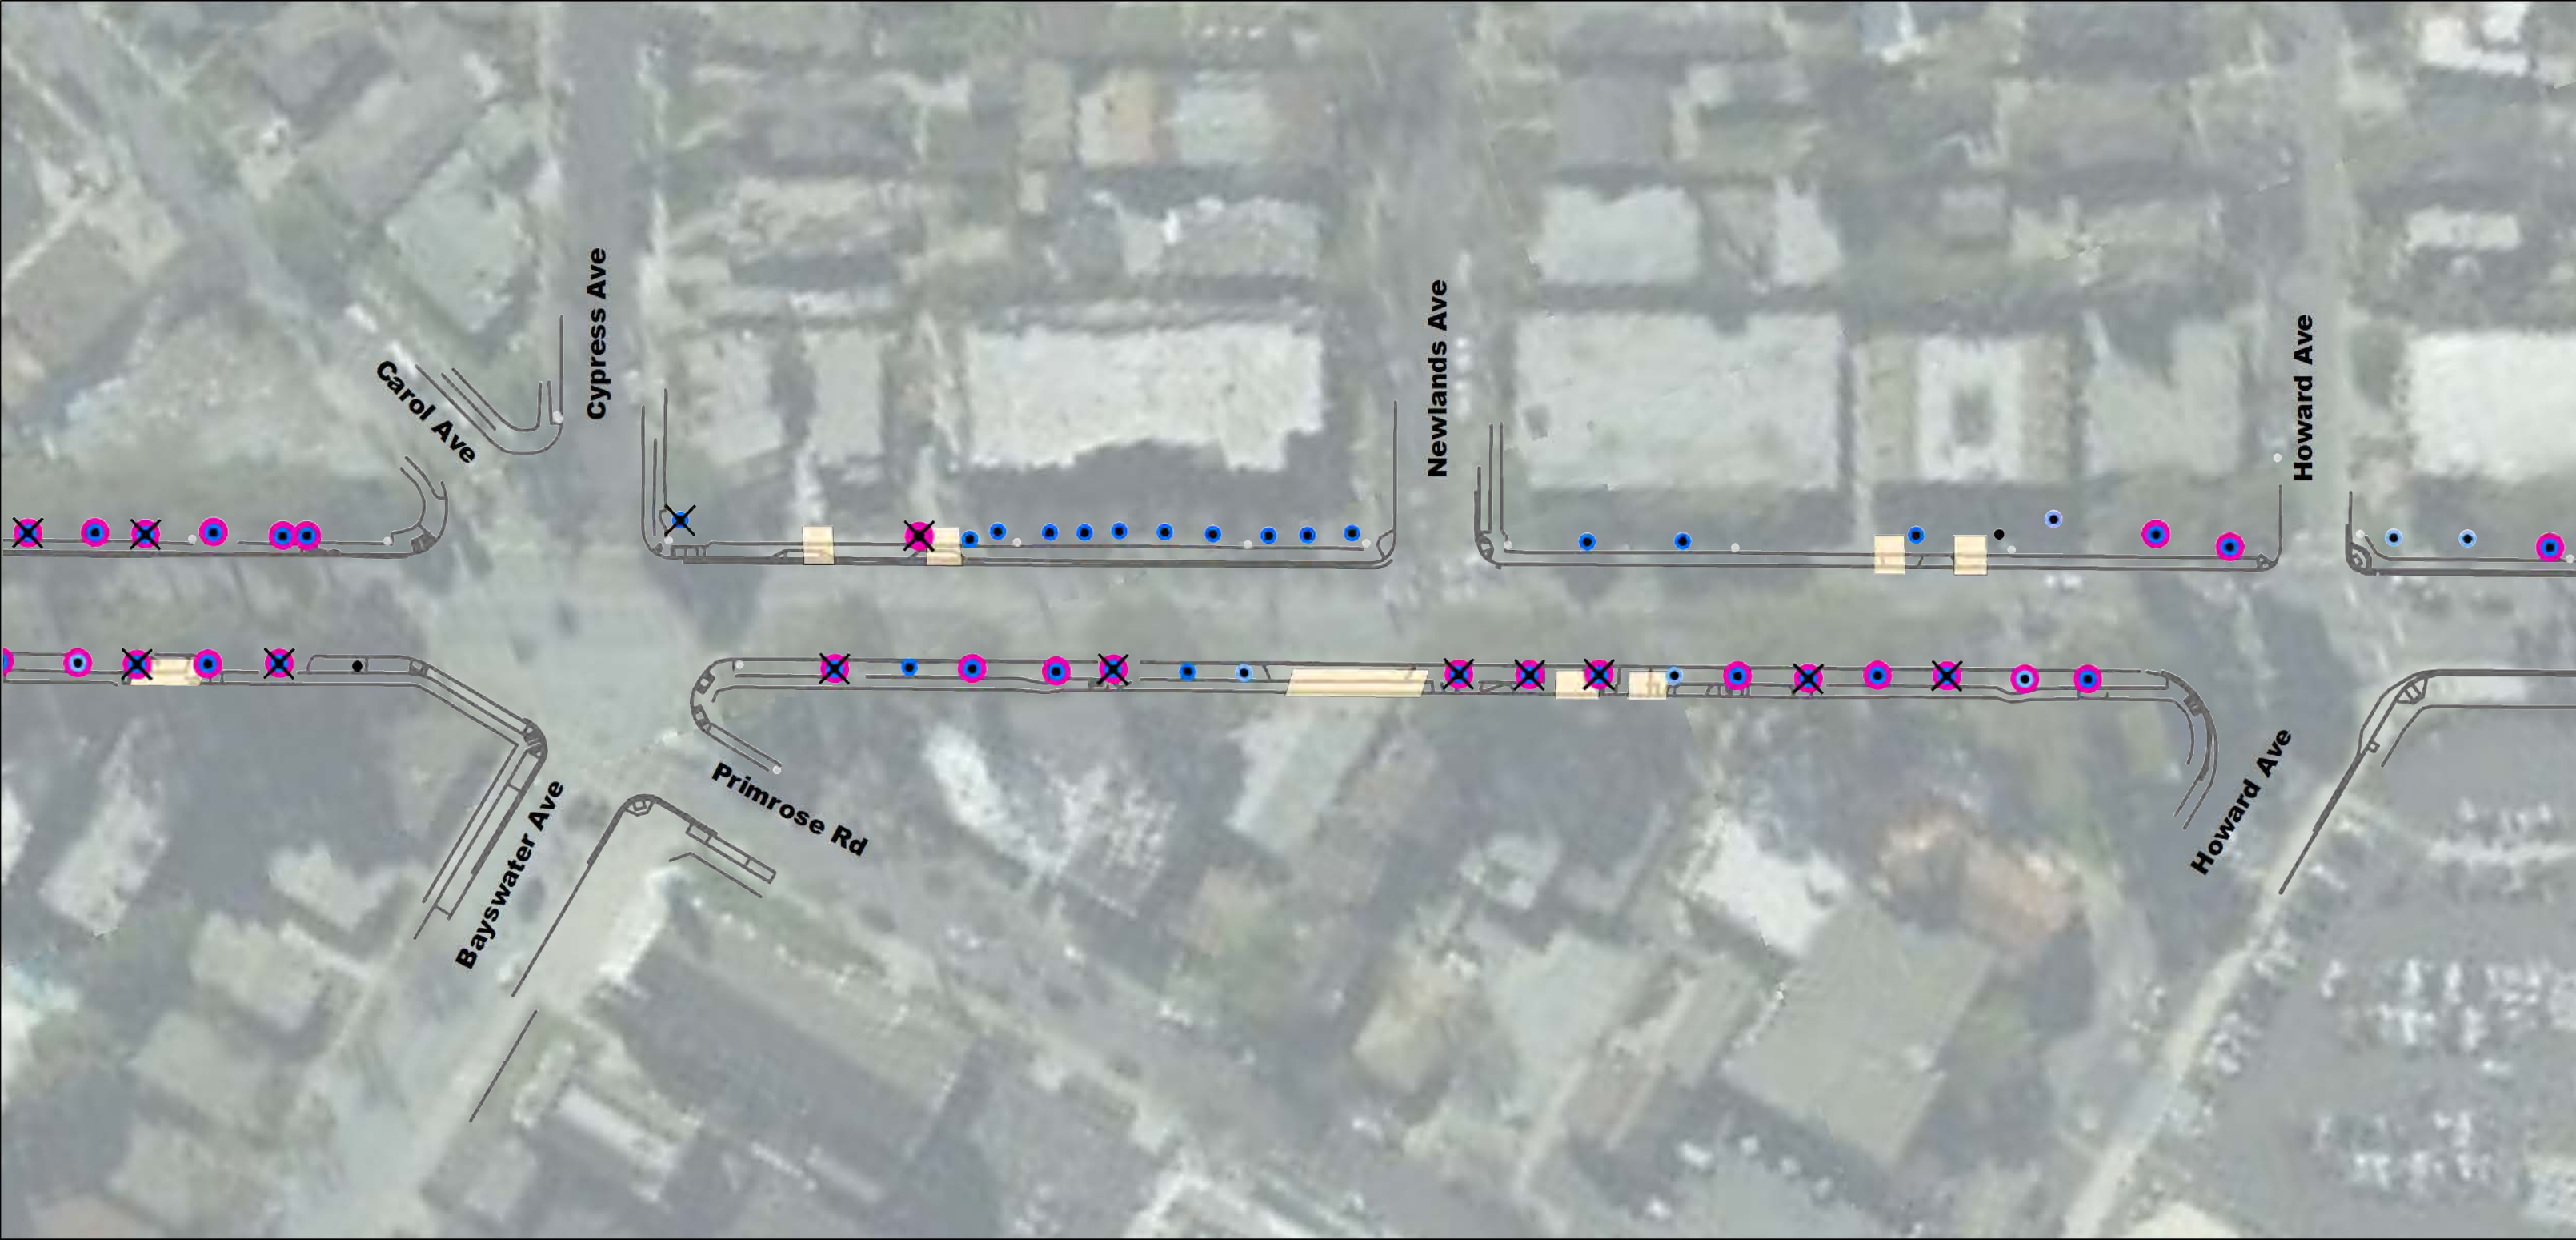
Potential Removal & Retention of Existing Trees - Alternative 3 & 4

Note: Based on Preliminary Layout Plans for the purposes of evaluating environmental impacts.

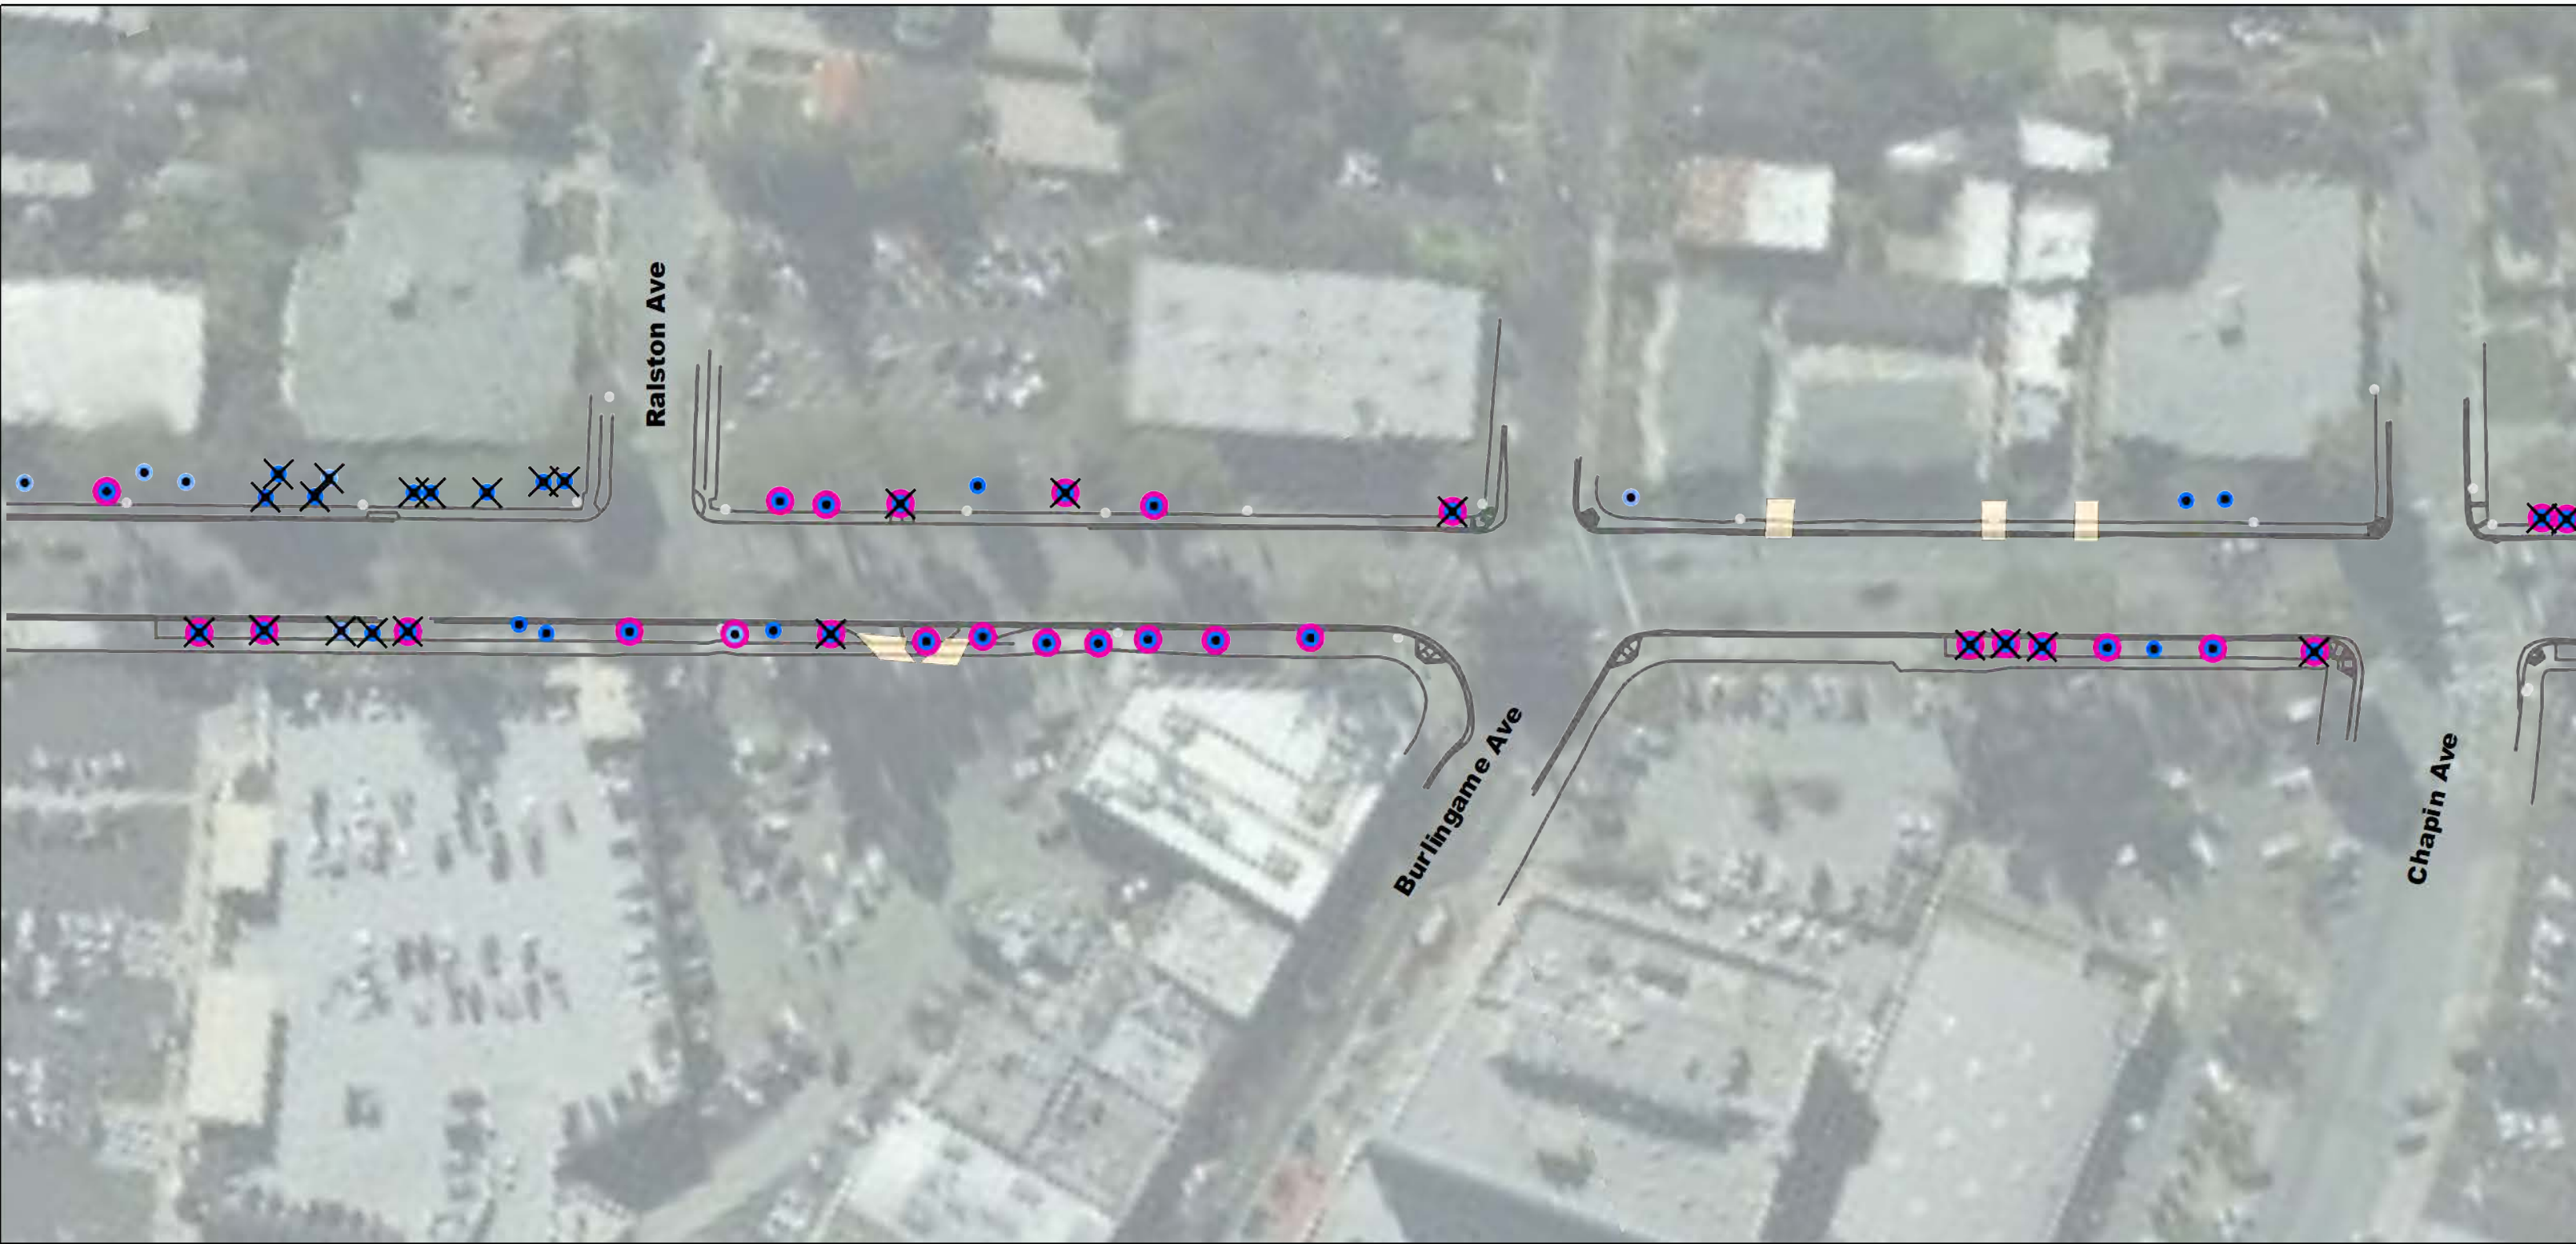
Potential Removal & Retention of Existing Trees - Alternative 3 & 4

Note: Based on Preliminary Layout Plans for the purposes of evaluating environmental impacts.

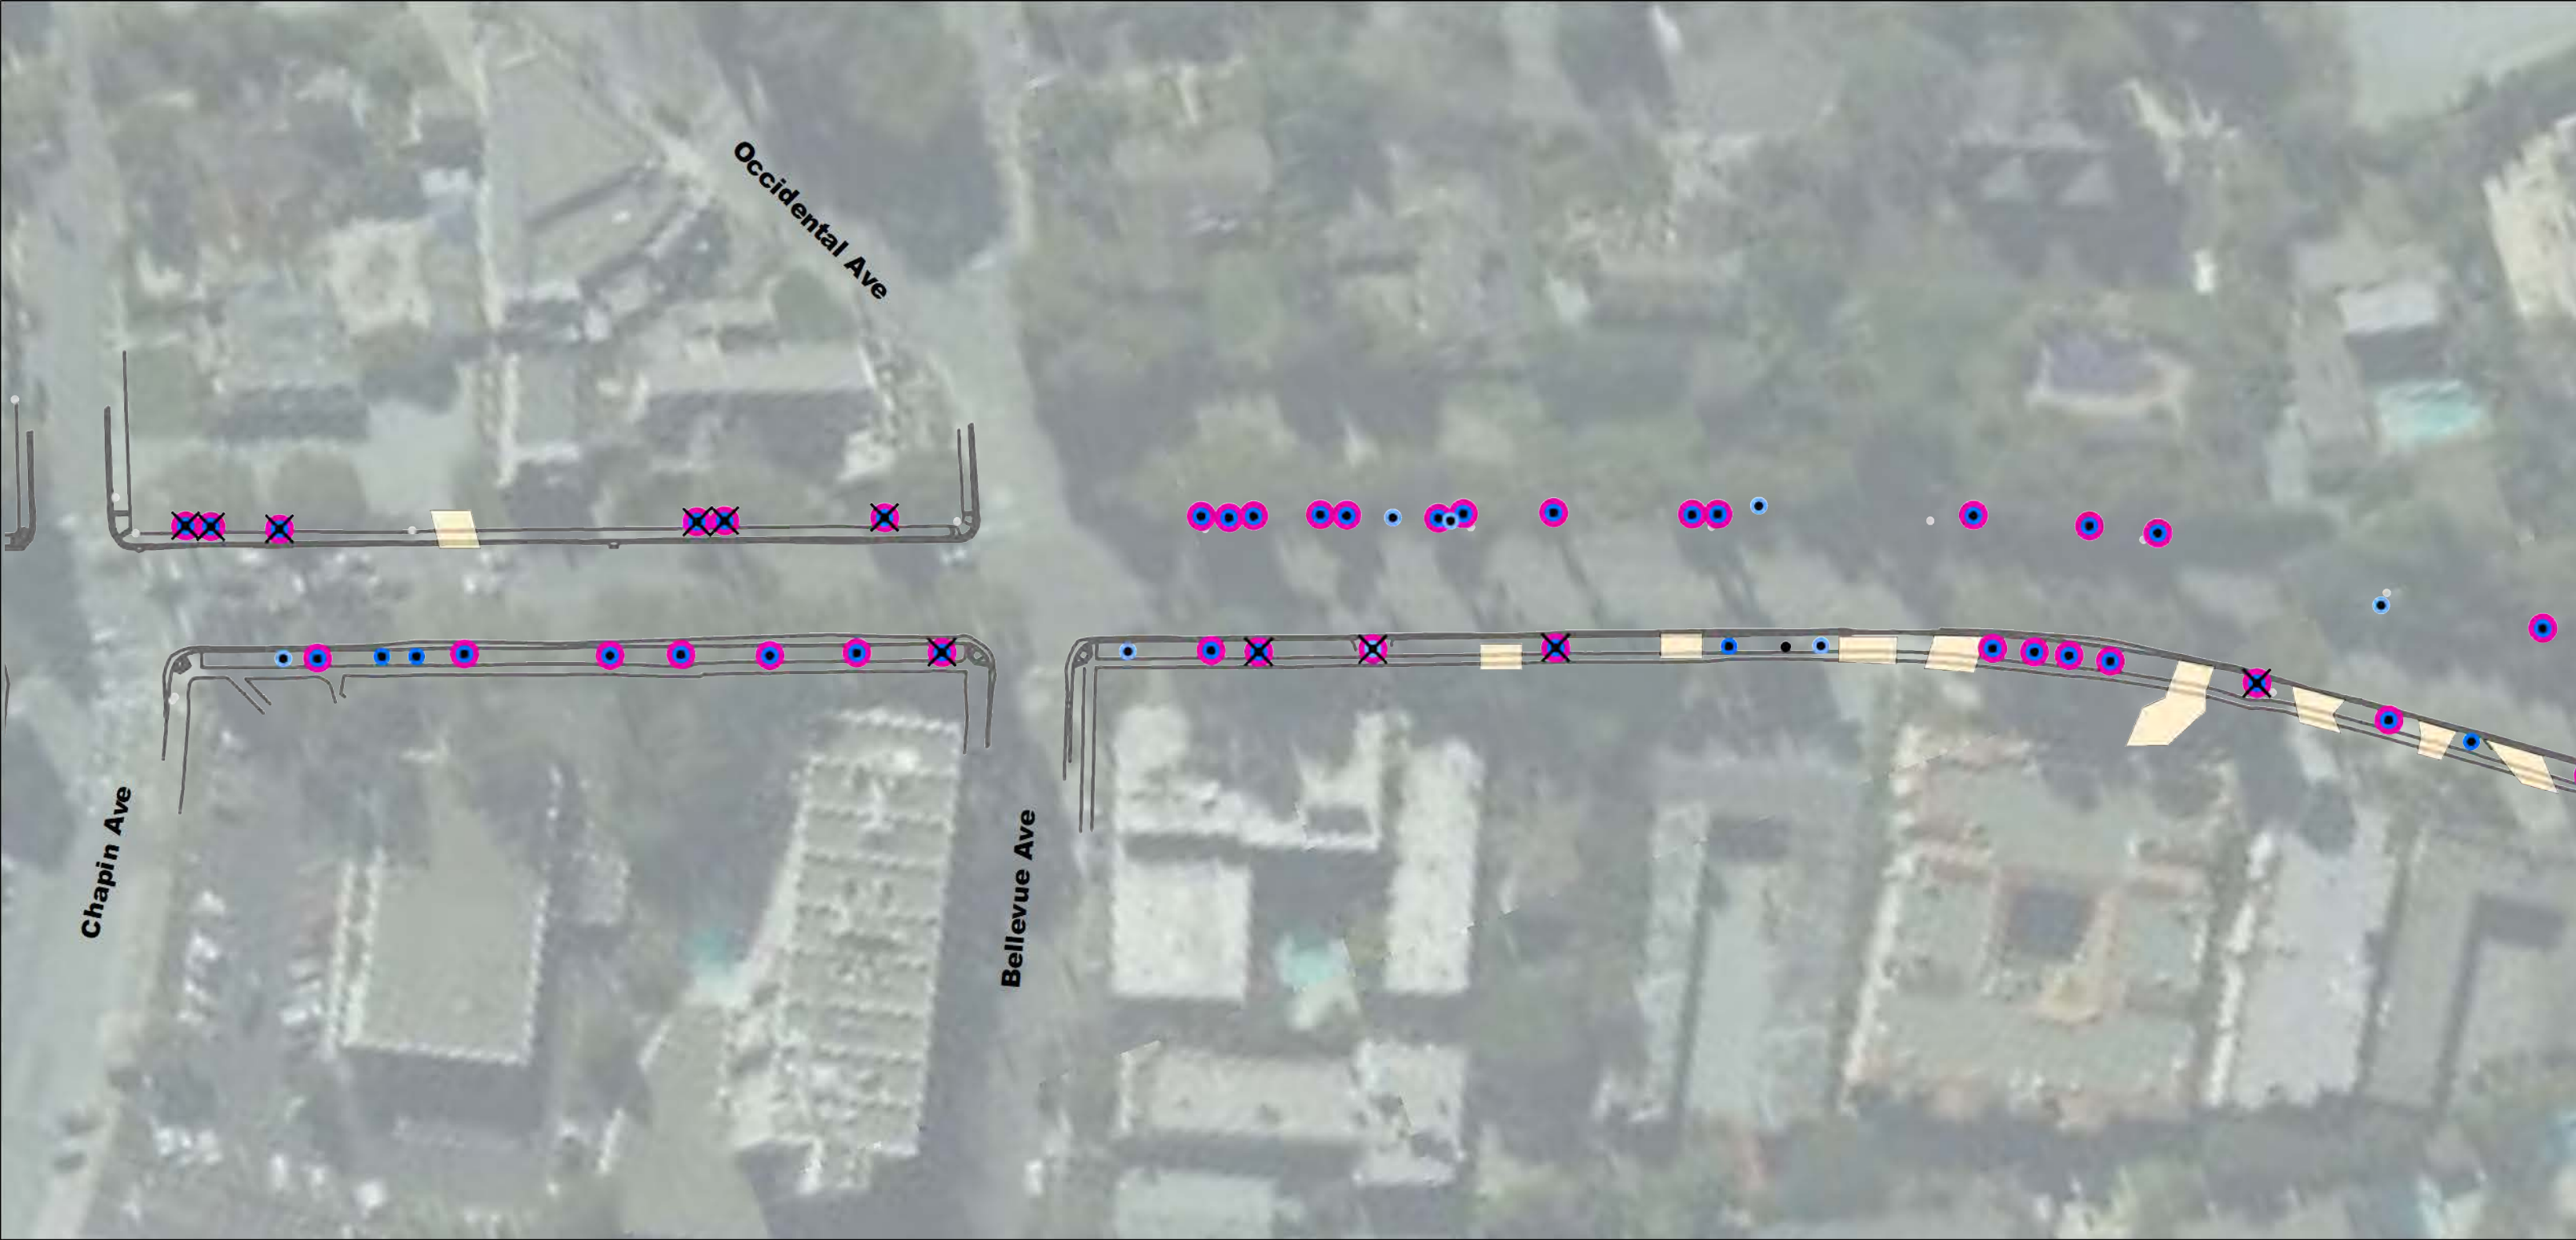
Potential Removal & Retention of Existing Trees - Alternative 3 & 4

Note: Based on Preliminary Layout Plans for the purposes of evaluating environmental impacts.

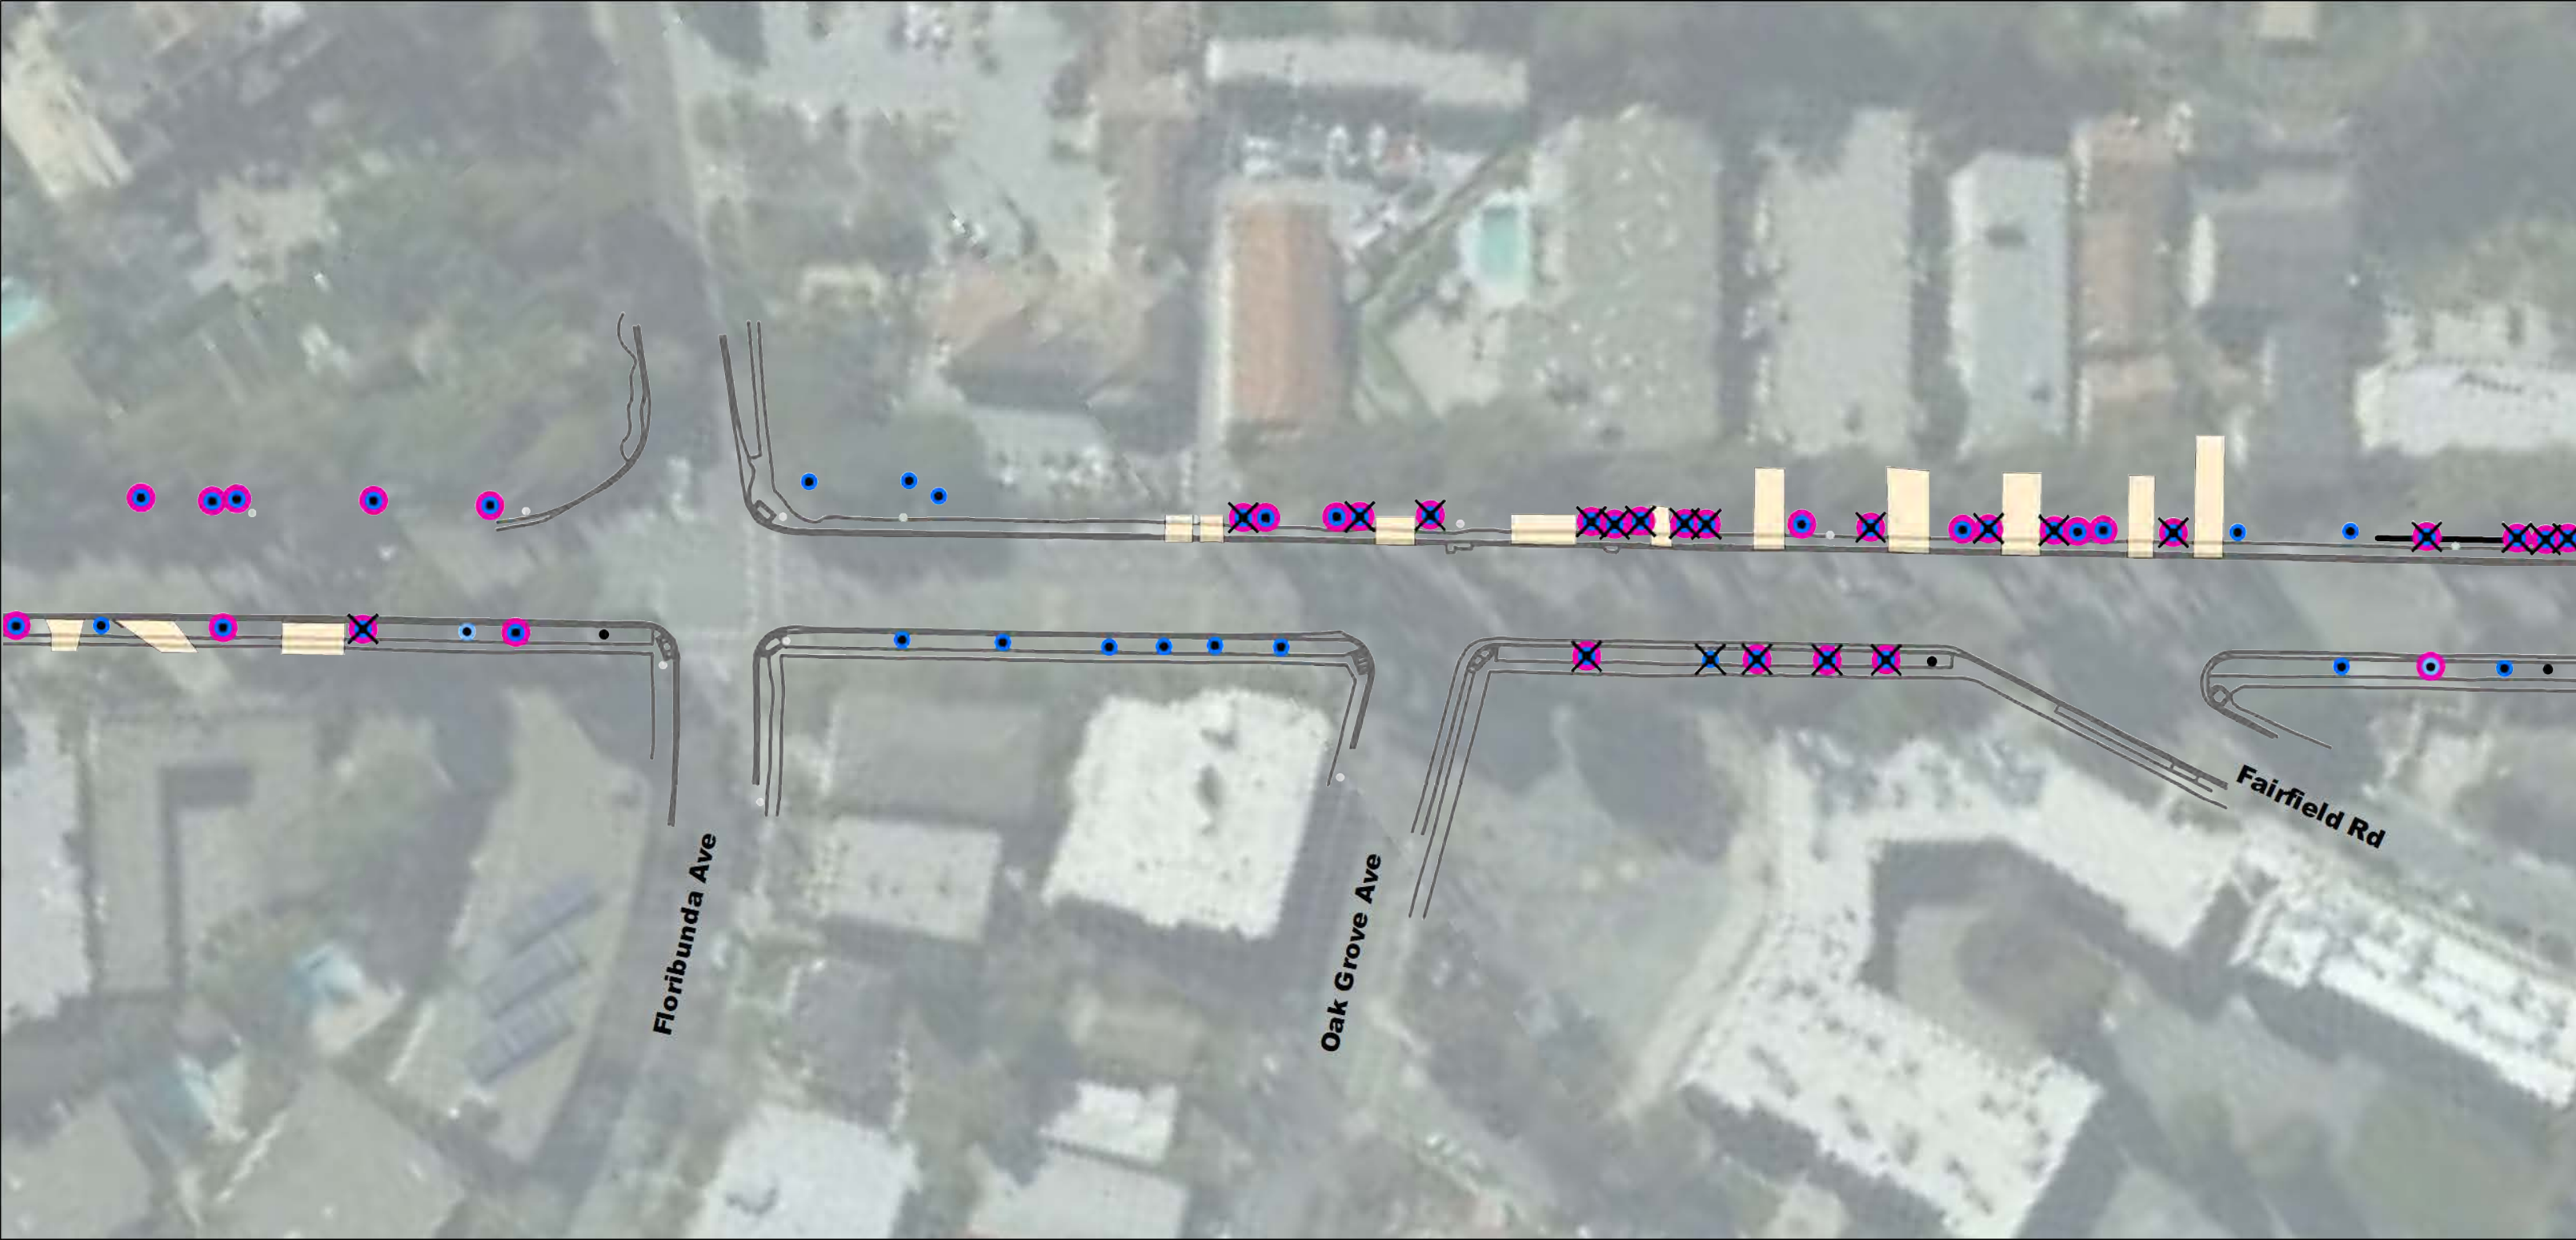
Potential Removal & Retention of Existing Trees - Alternative 3 & 4

Note: Based on Preliminary Layout Plans for the purposes of evaluating environmental impacts.

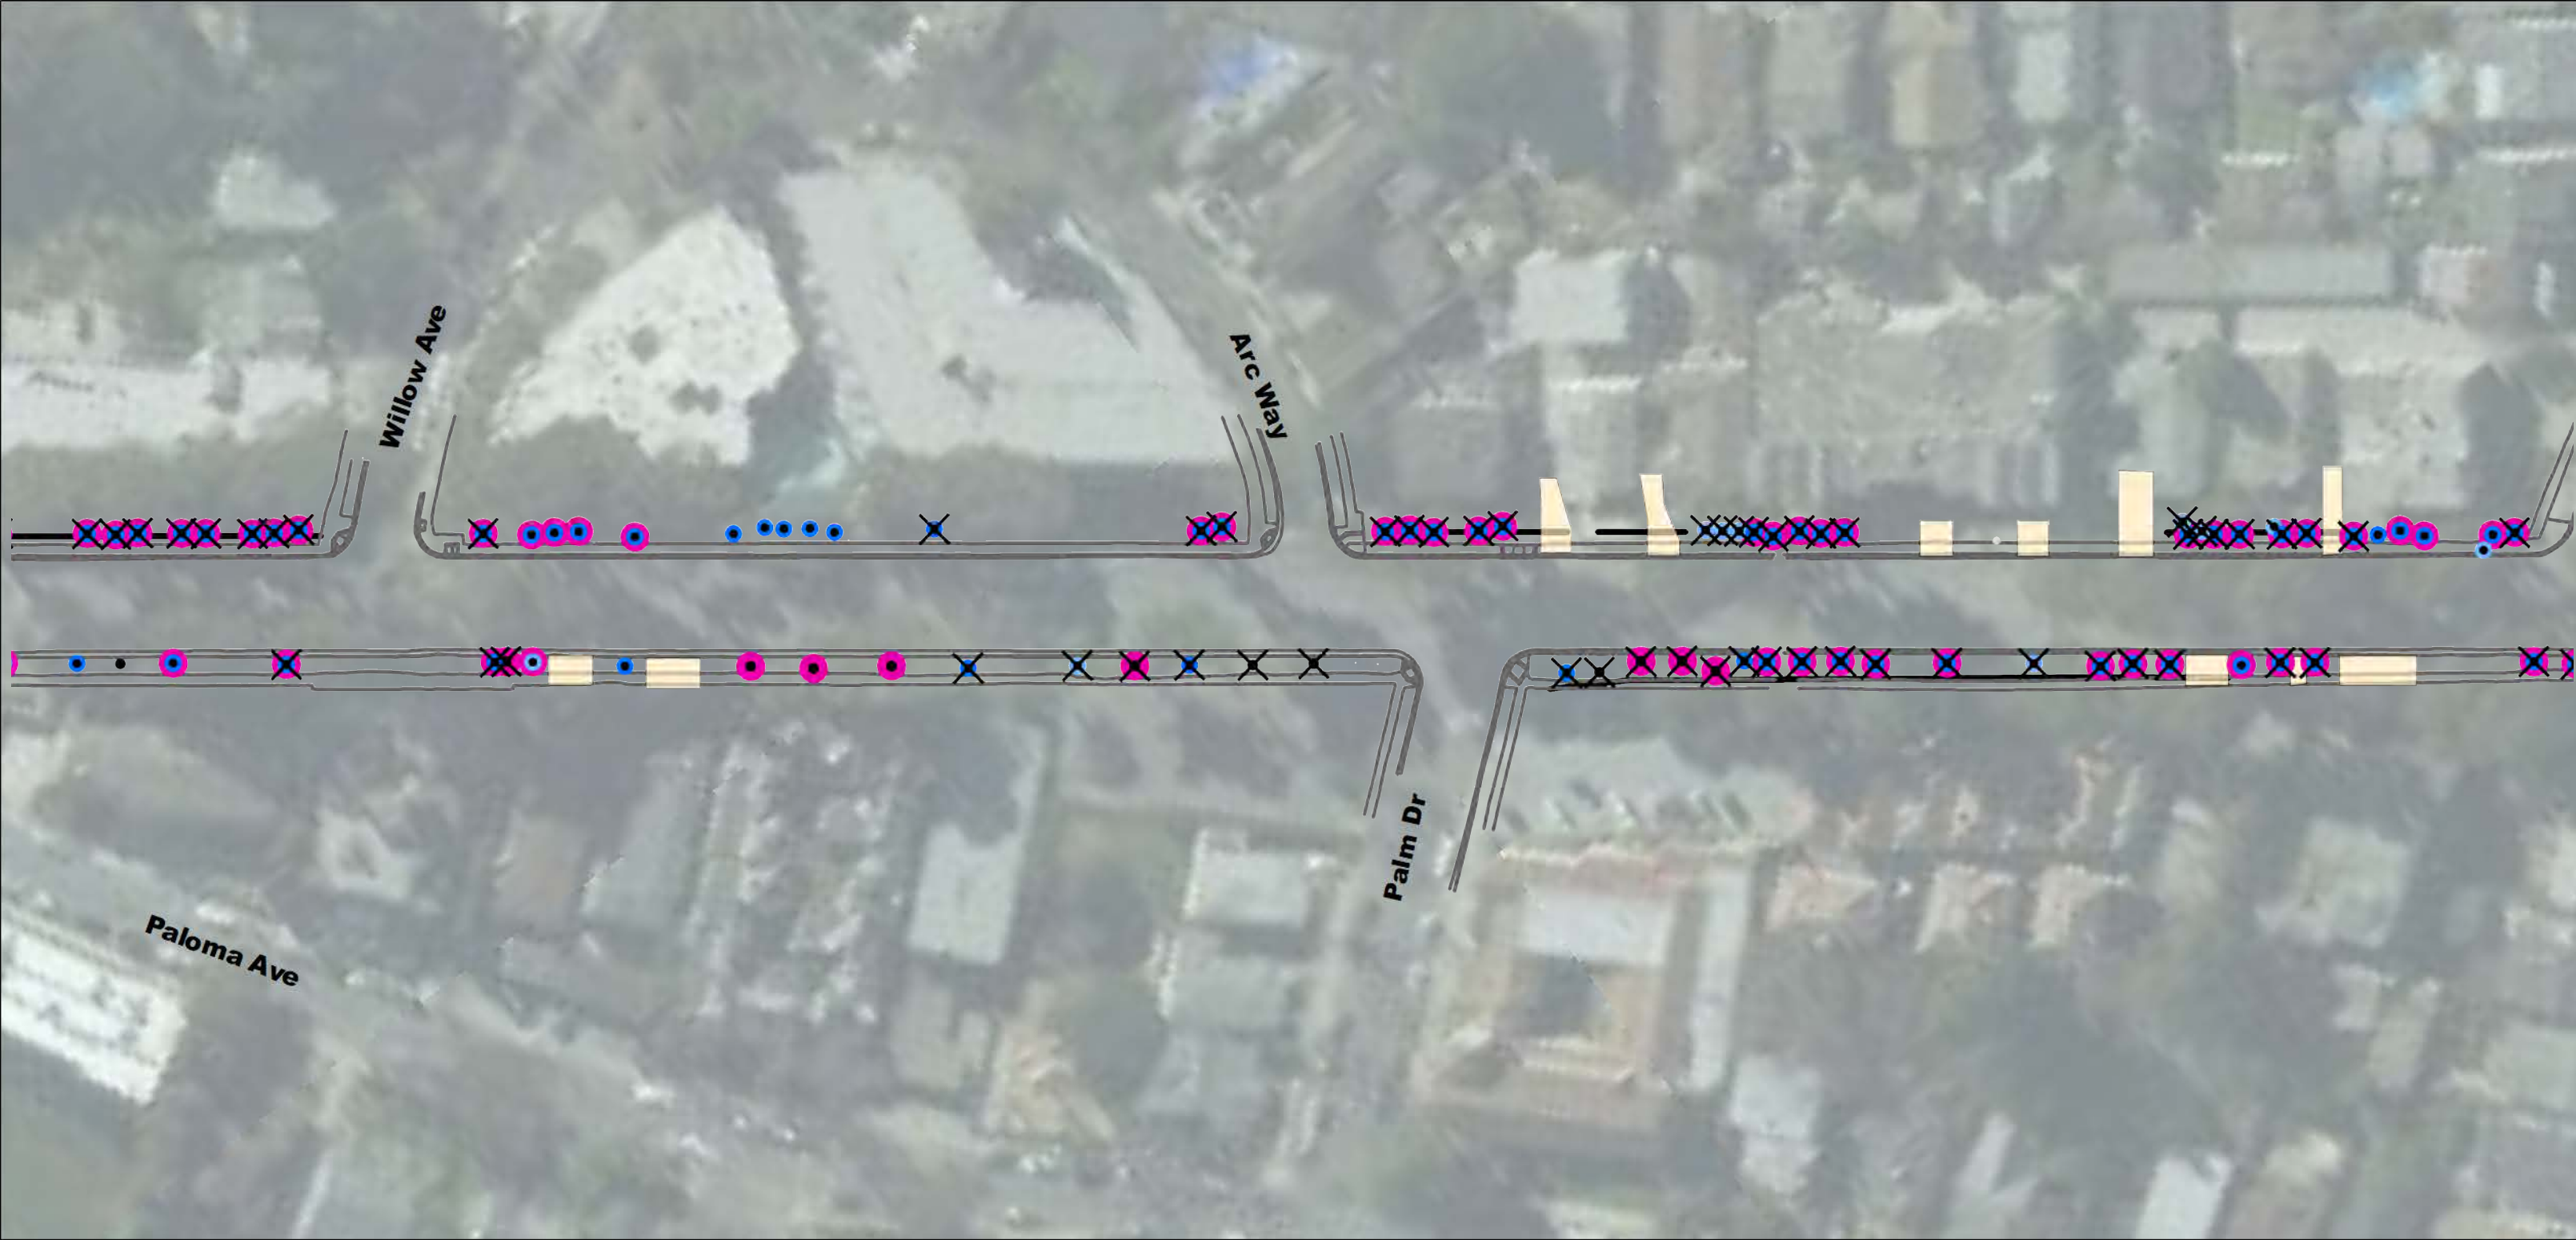
Potential Removal & Retention of Existing Trees - Alternative 3 & 4

Note: Based on Preliminary Layout Plans for the purposes of evaluating environmental impacts.

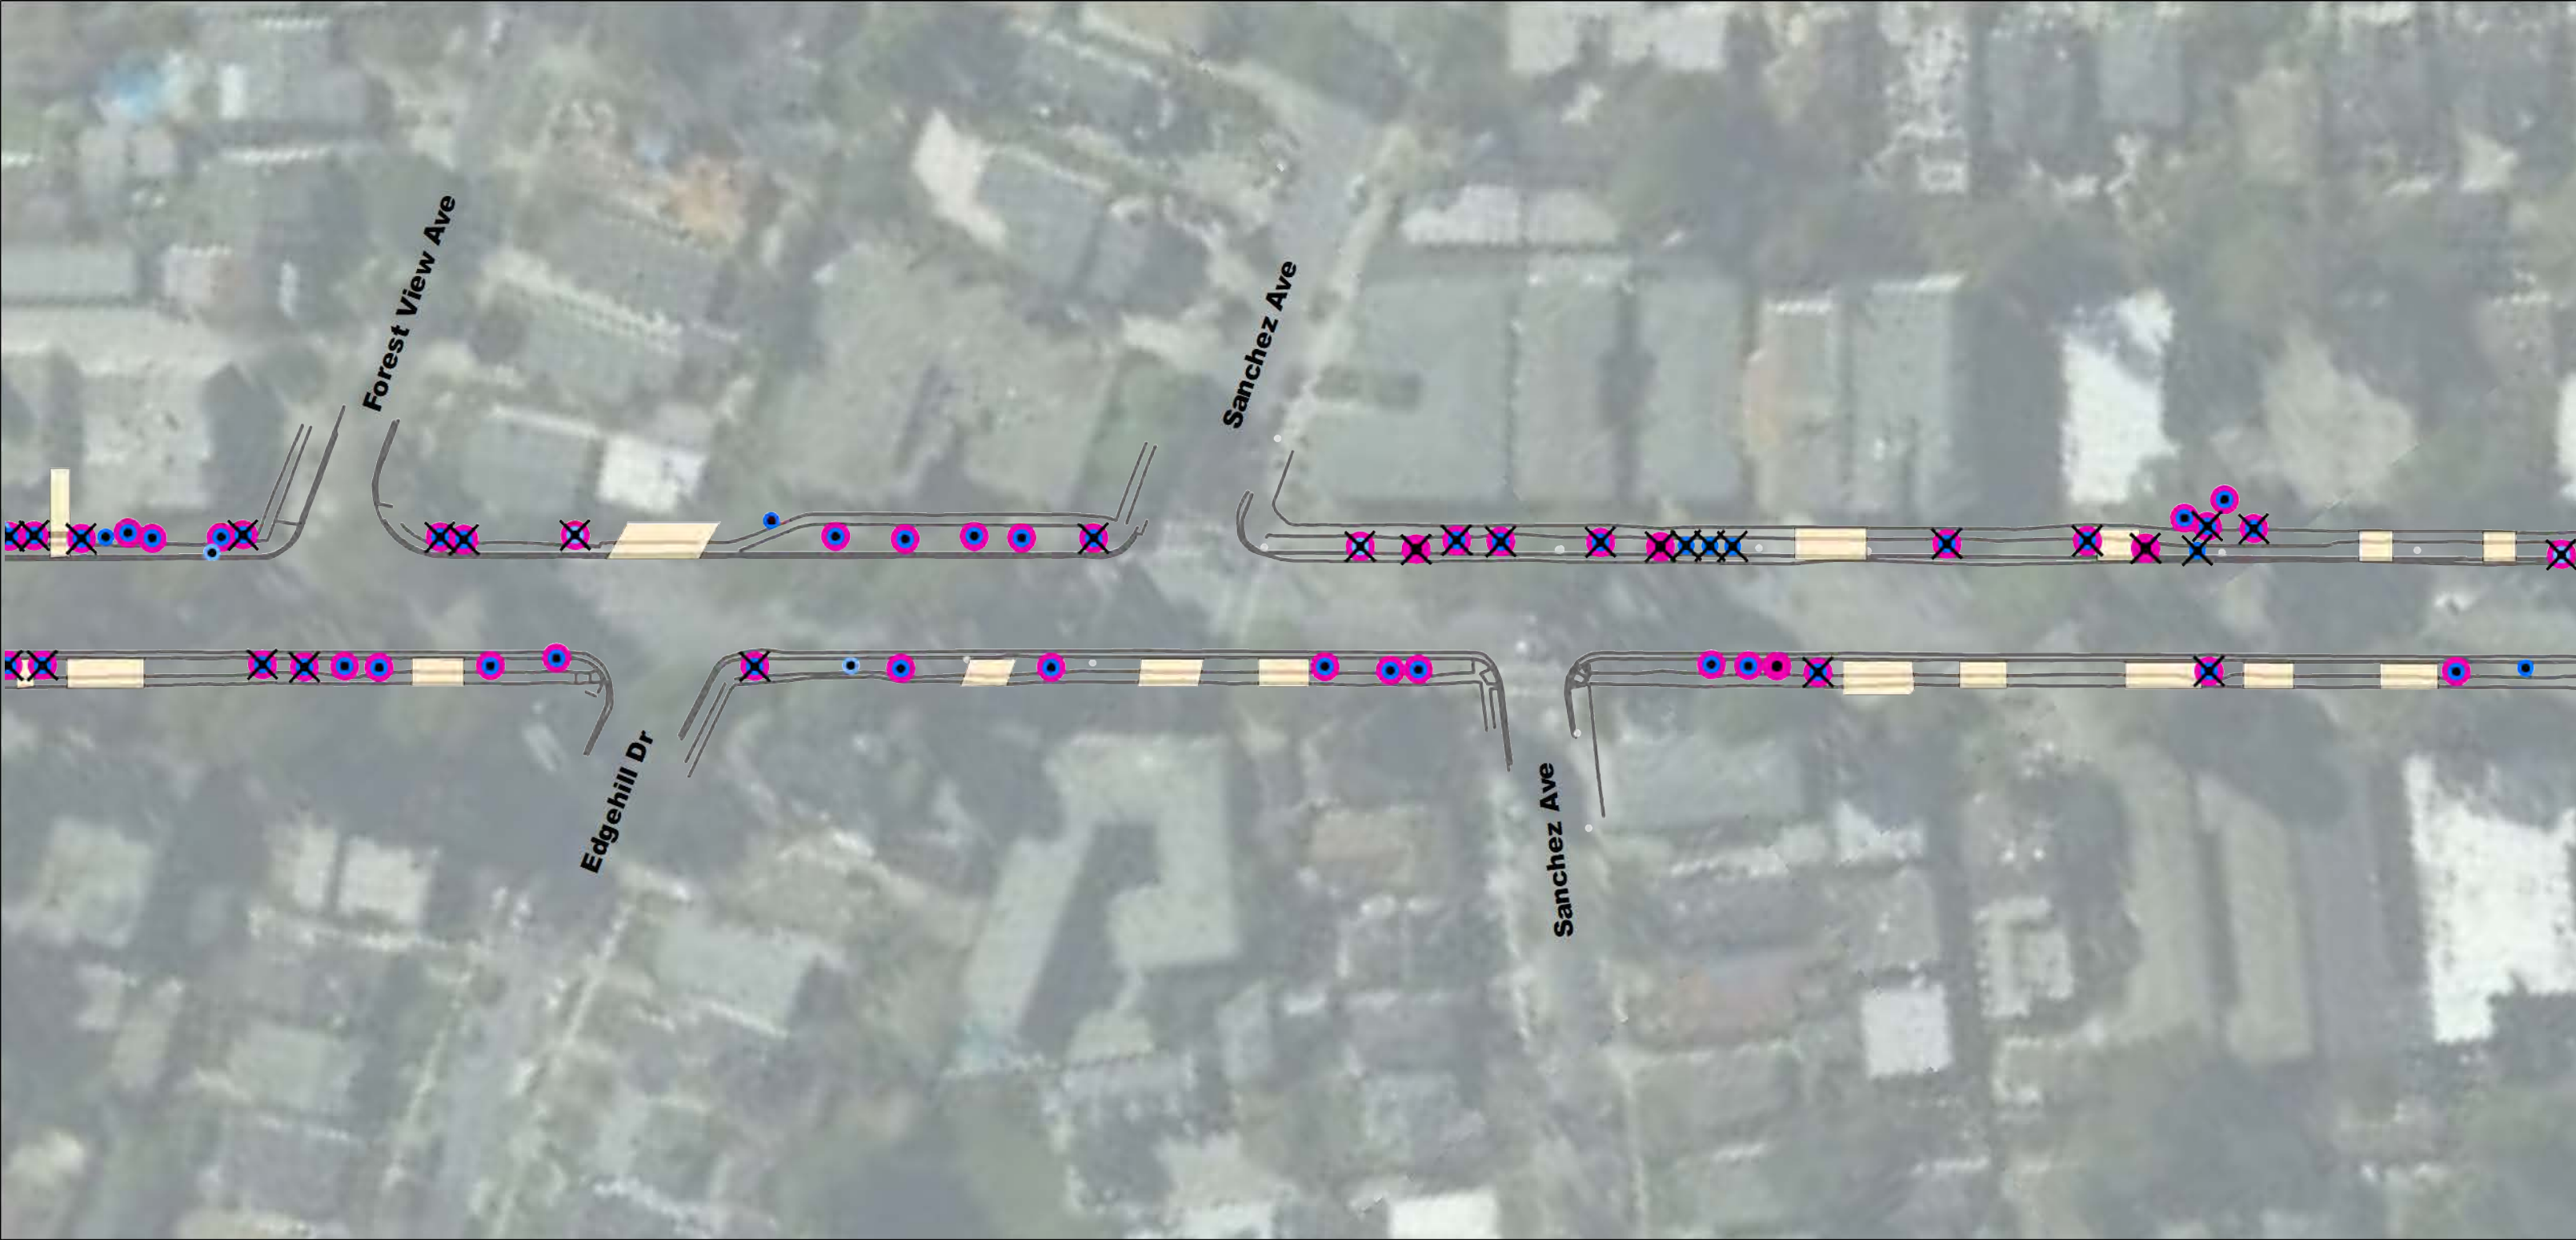
Potential Removal & Retention of Existing Trees - Alternative 3 & 4

Note: Based on Preliminary Layout Plans for the purposes of evaluating environmental impacts.

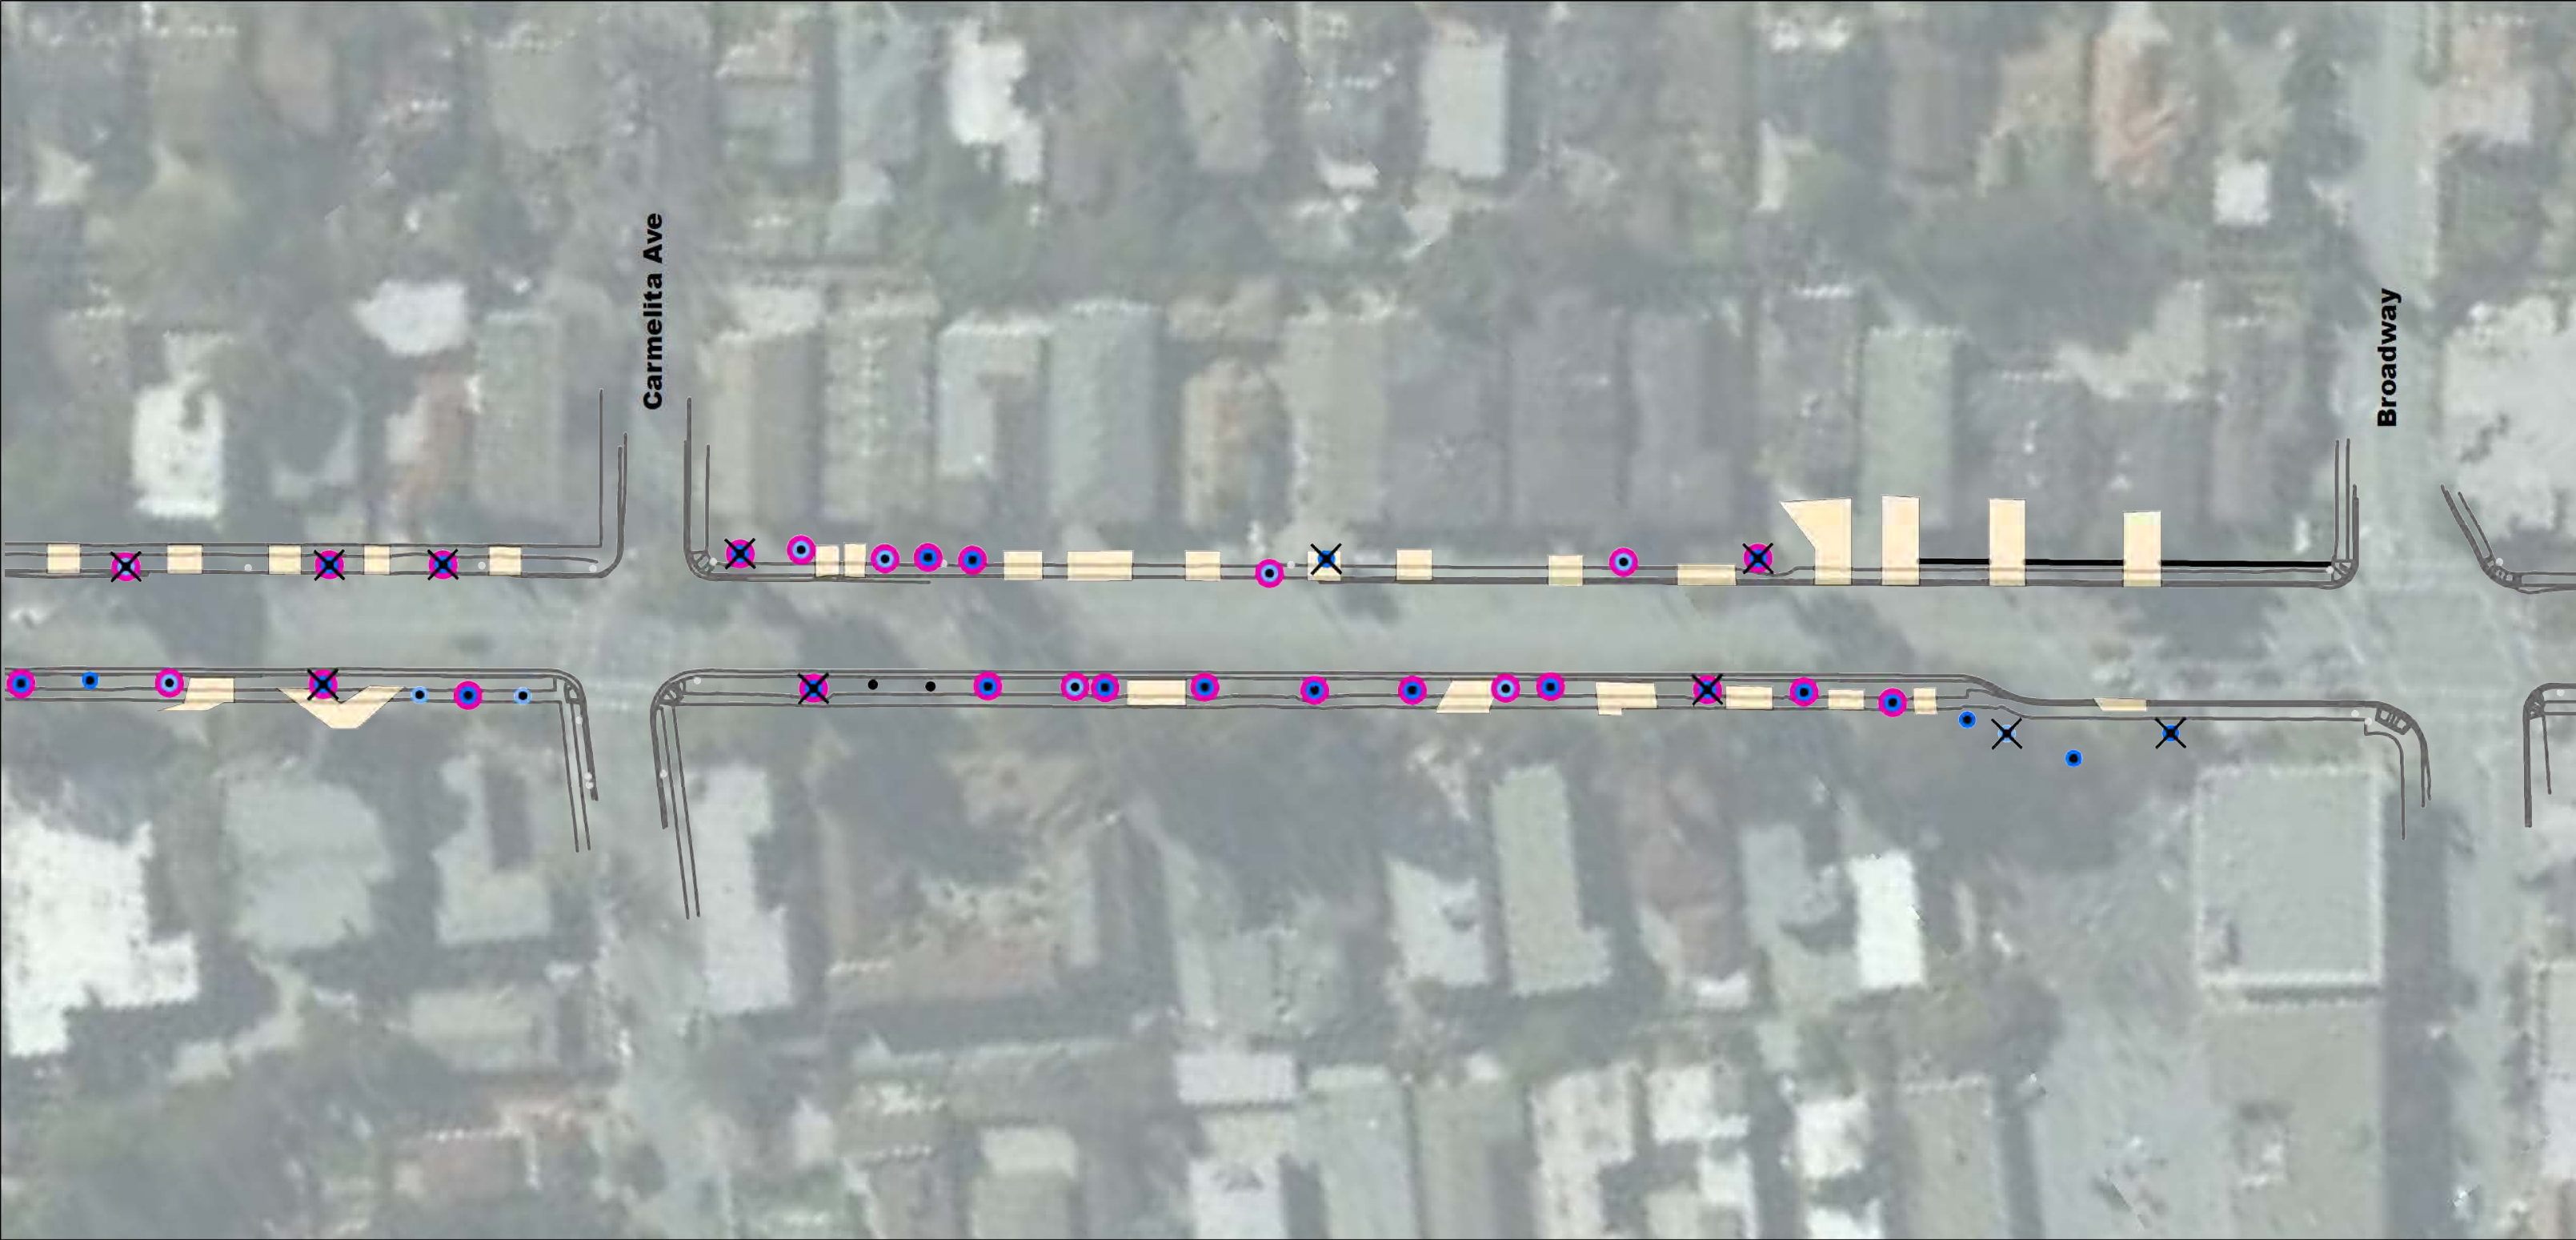
Potential Removal & Retention of Existing Trees - Alternative 3 & 4

Note: Based on Preliminary Layout Plans for the purposes of evaluating environmental impacts.
