VISUAL IMPACT ASSESSMENT

El Camino Real Roadway Renewal Project

February 24, 2021

California Department of Transportation
04-SM-82
PM 12.3 to 15.8
0416000142 – EA 0K810

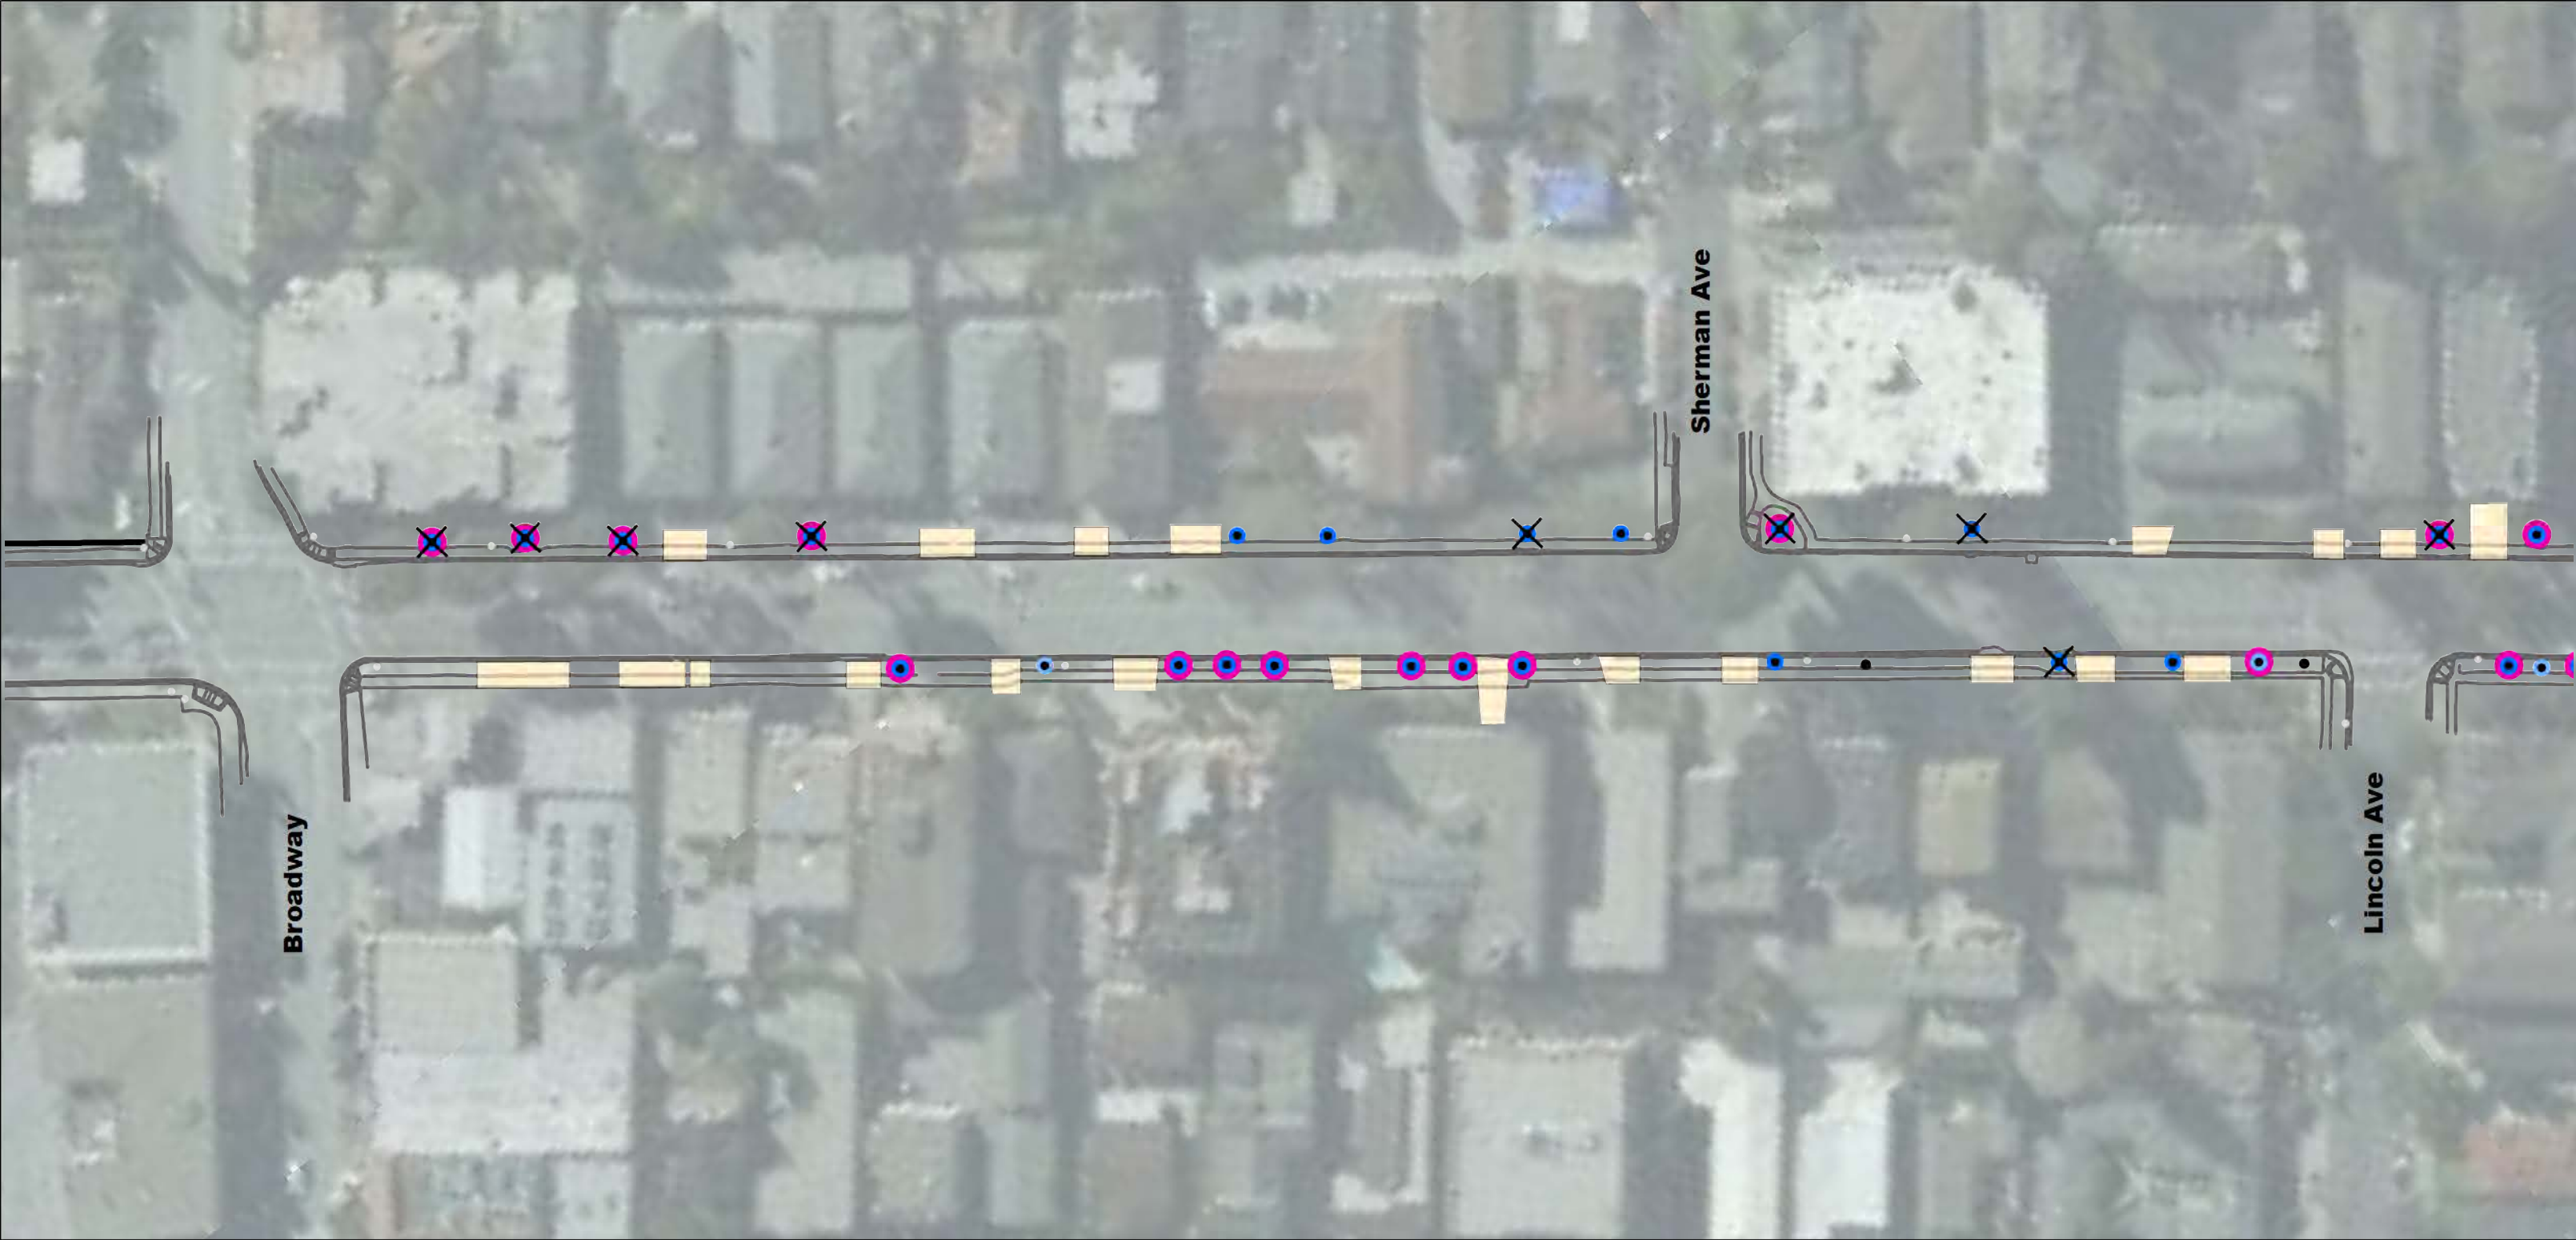
Potential Removal & Retention of Existing Trees - Alternative 3 & 4

Note: Based on Preliminary Layout Plans for the purposes of evaluating environmental impacts.

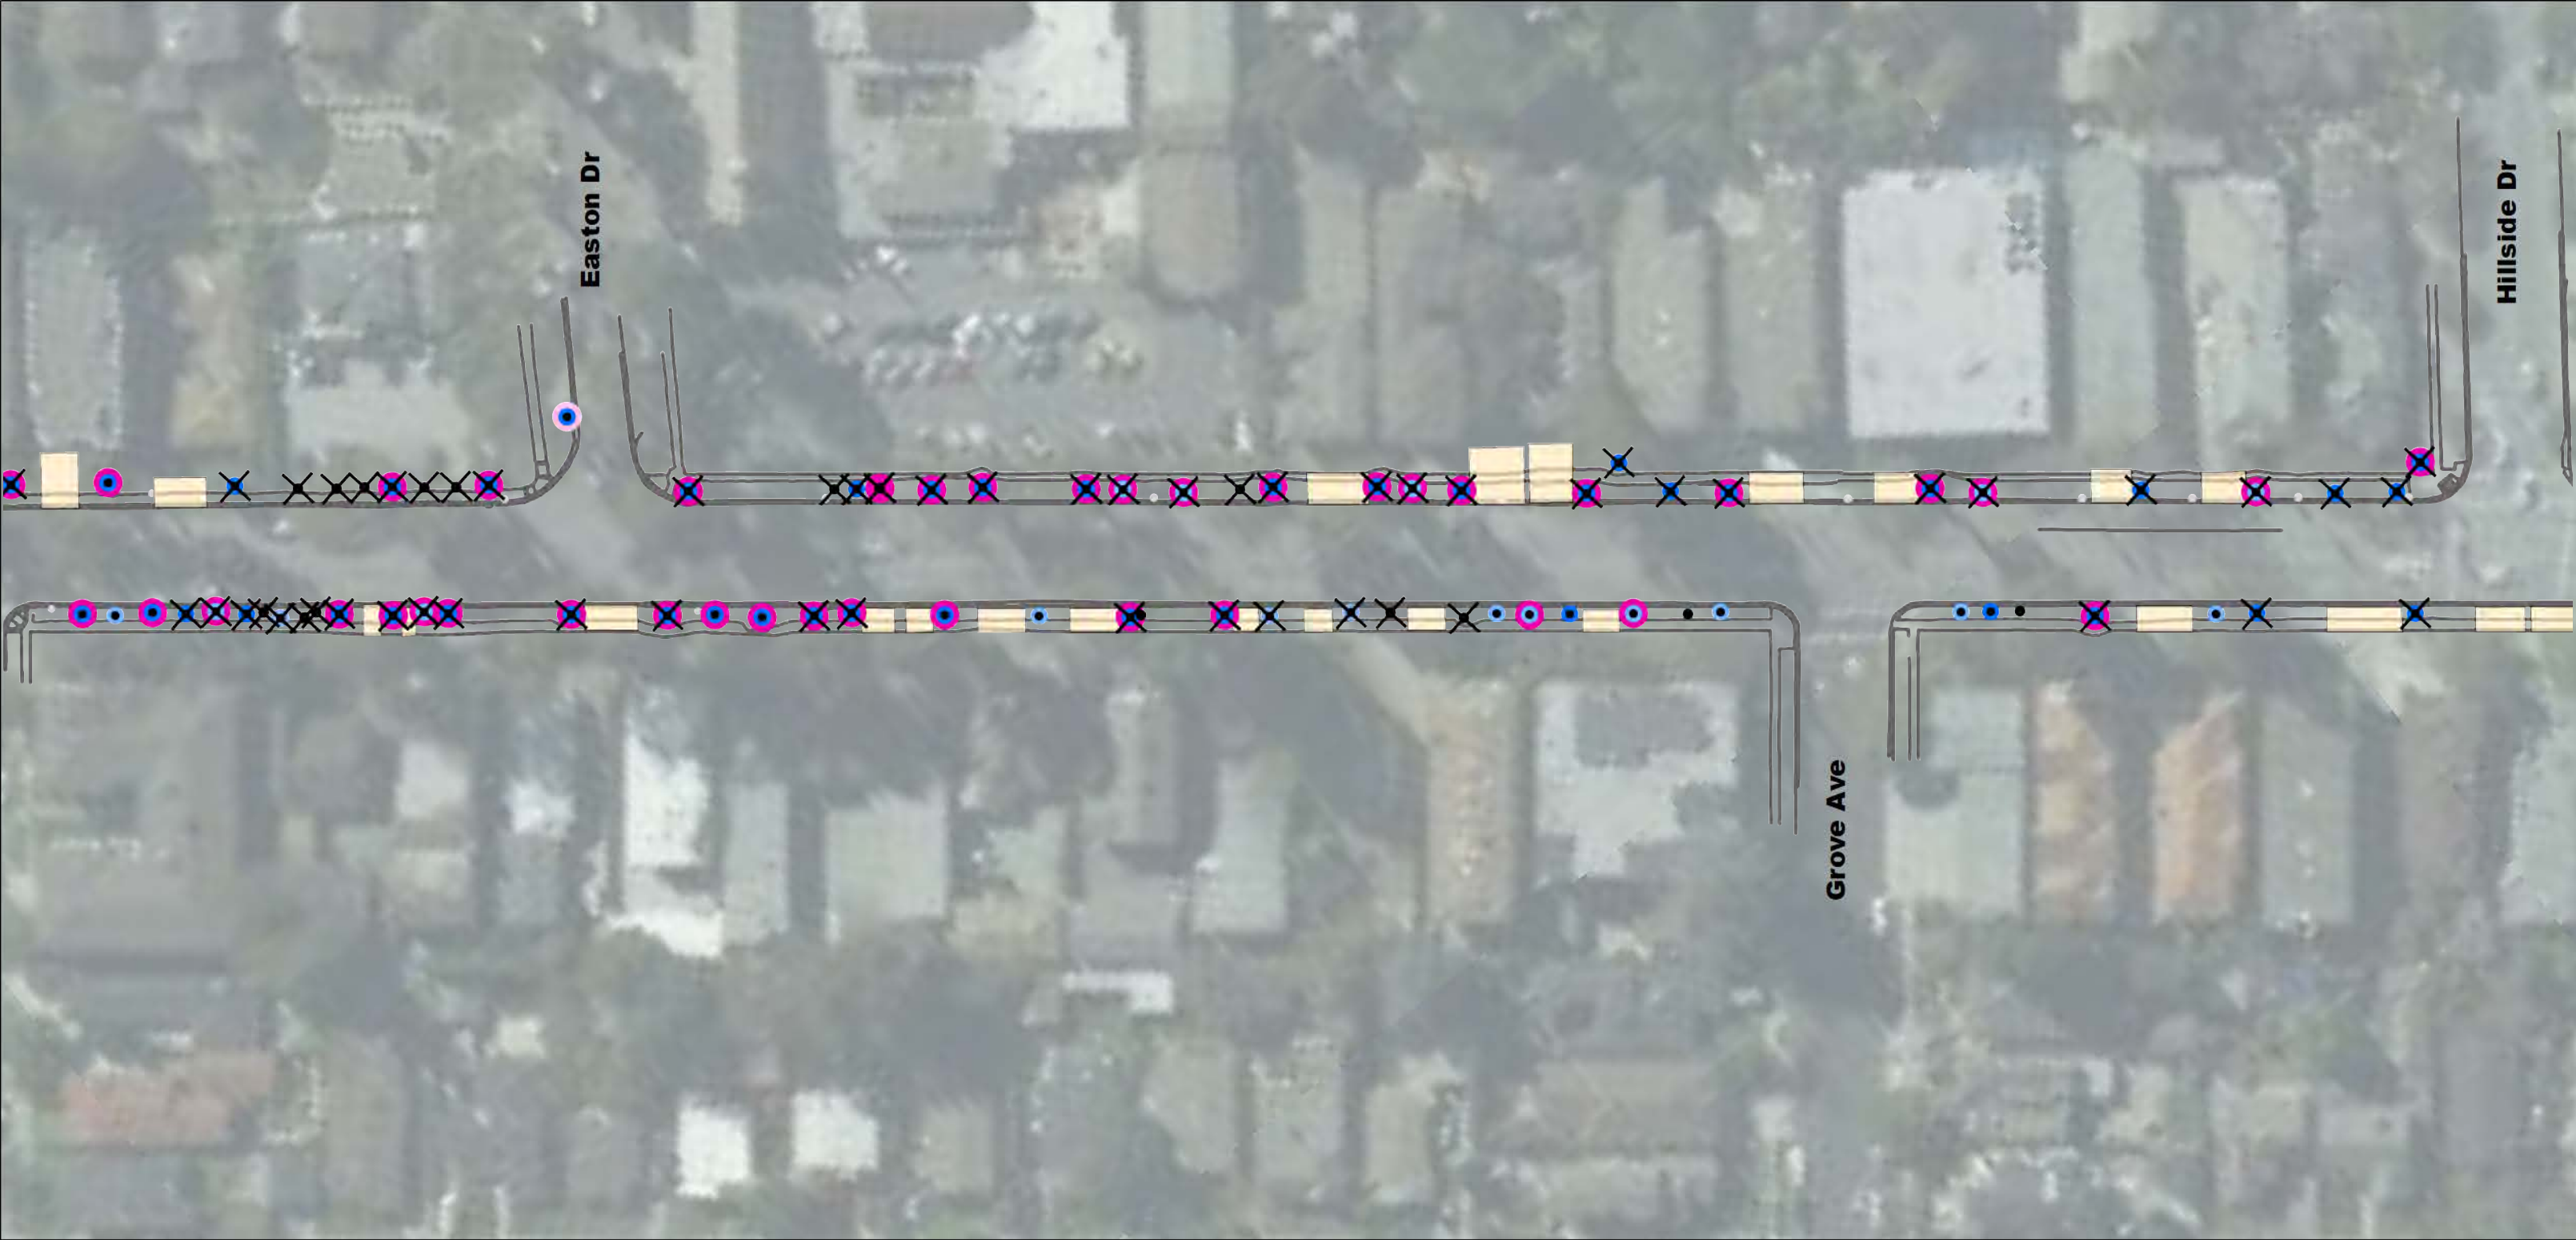
Potential Removal & Retention of Existing Trees - Alternative 3 & 4

Note: Based on Preliminary Layout Plans for the purposes of evaluating environmental impacts.

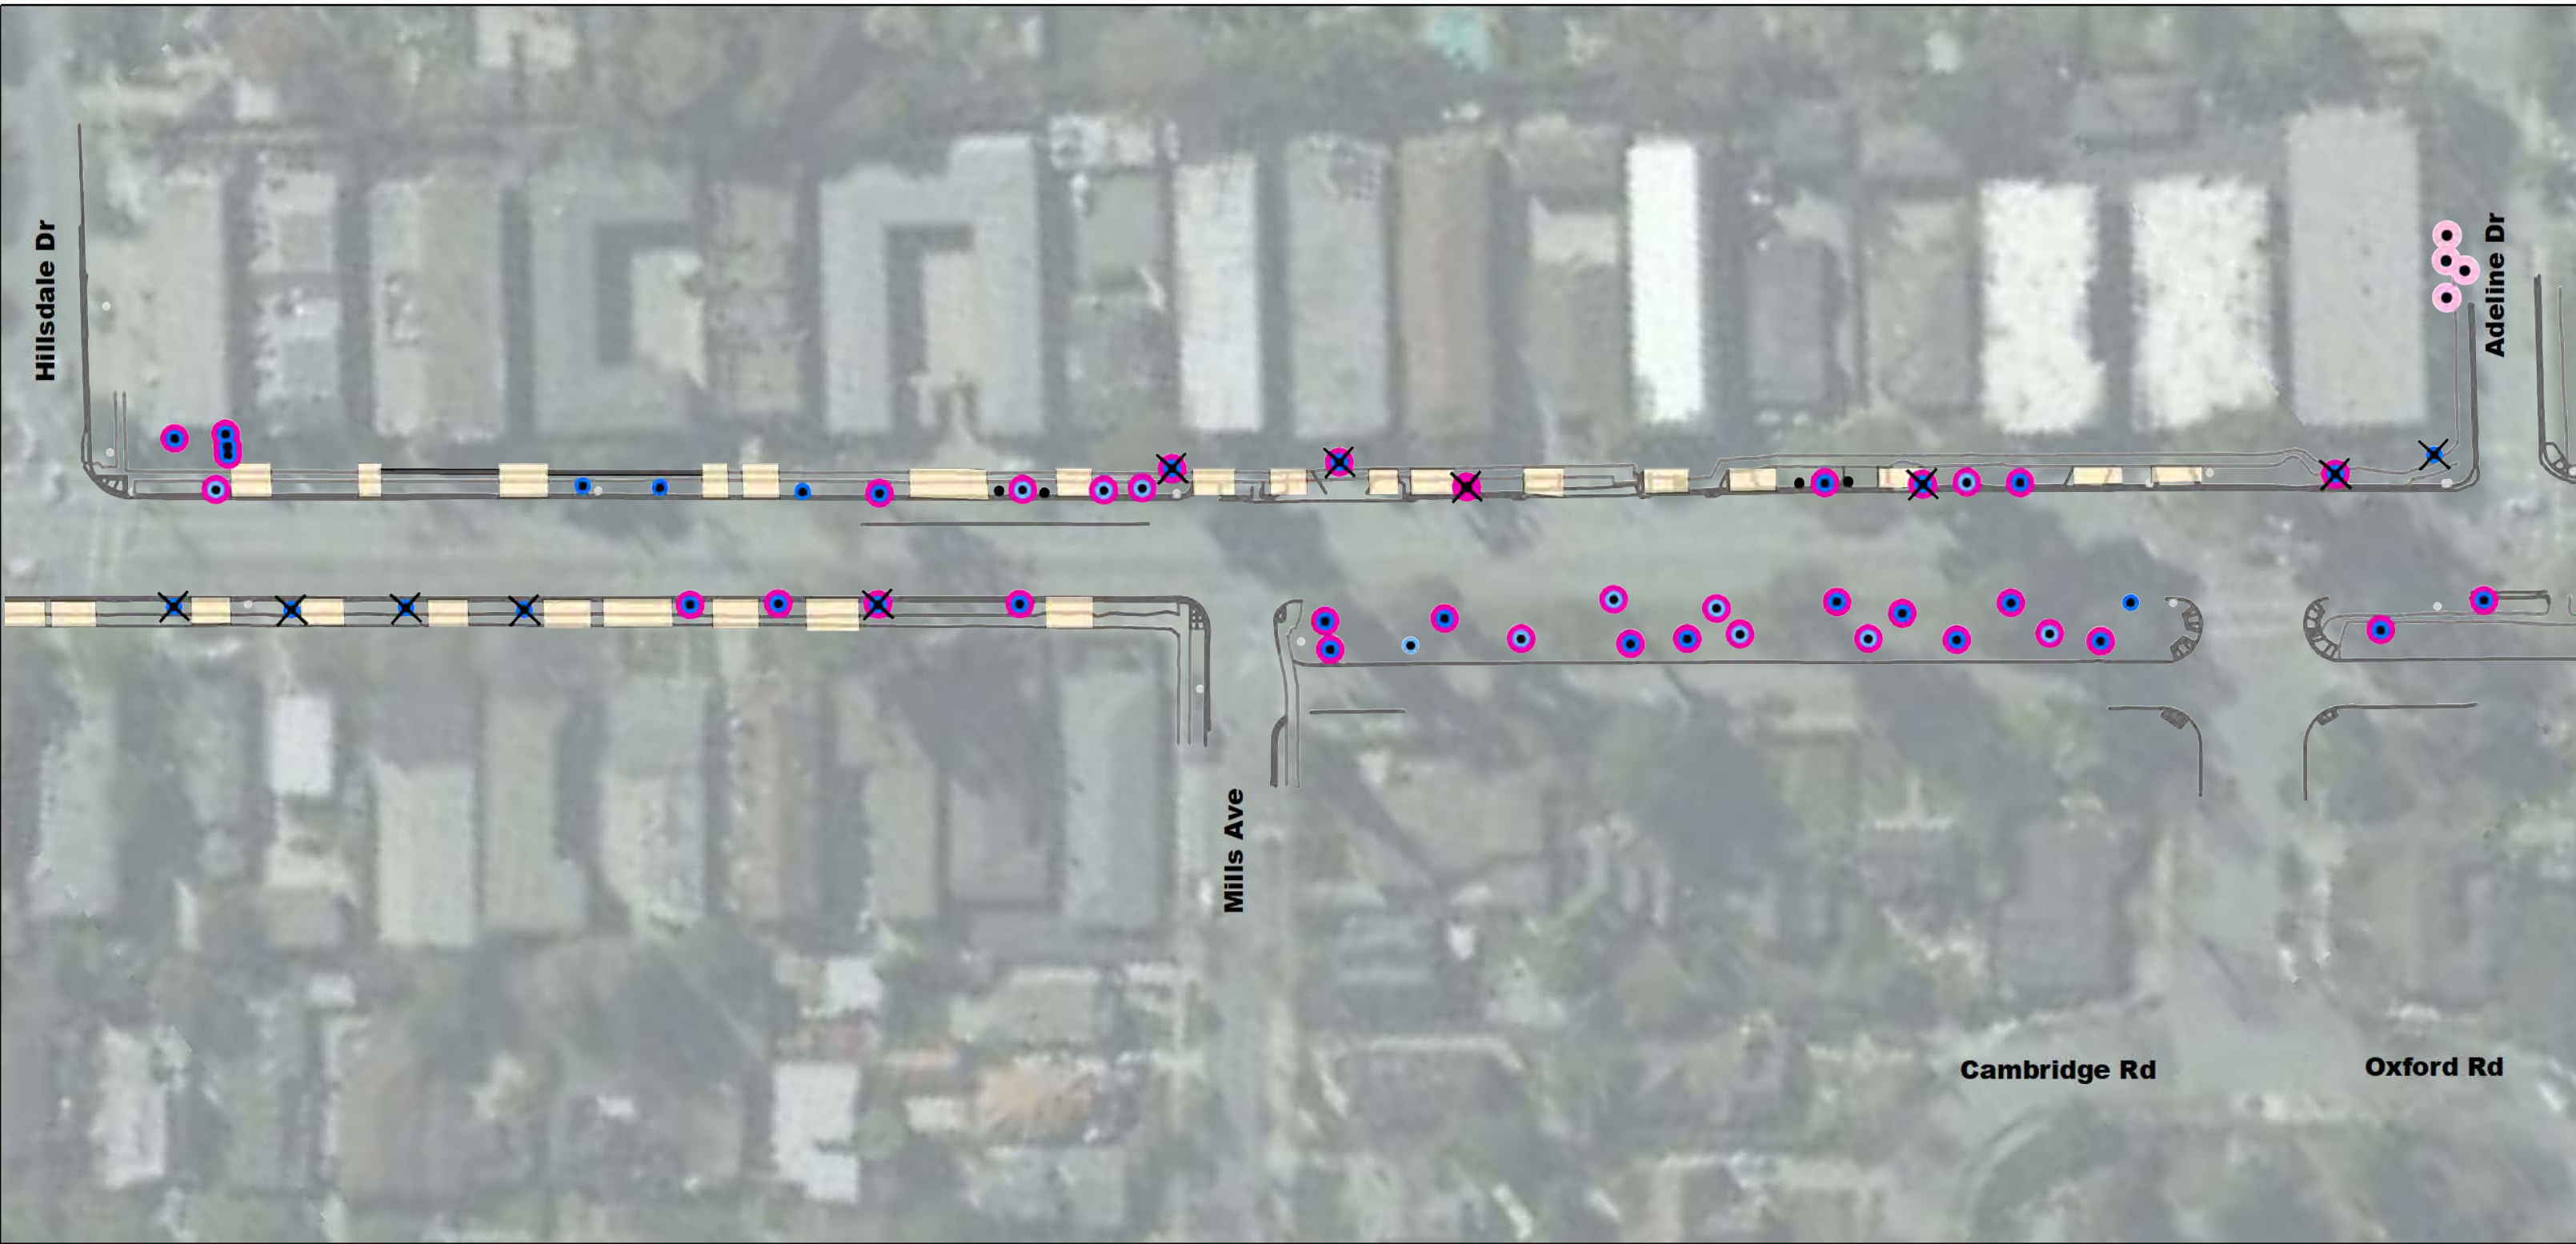
Potential Removal & Retention of Existing Trees - Alternative 3 & 4

Note: Based on Preliminary Layout Plans for the purposes of evaluating environmental impacts.

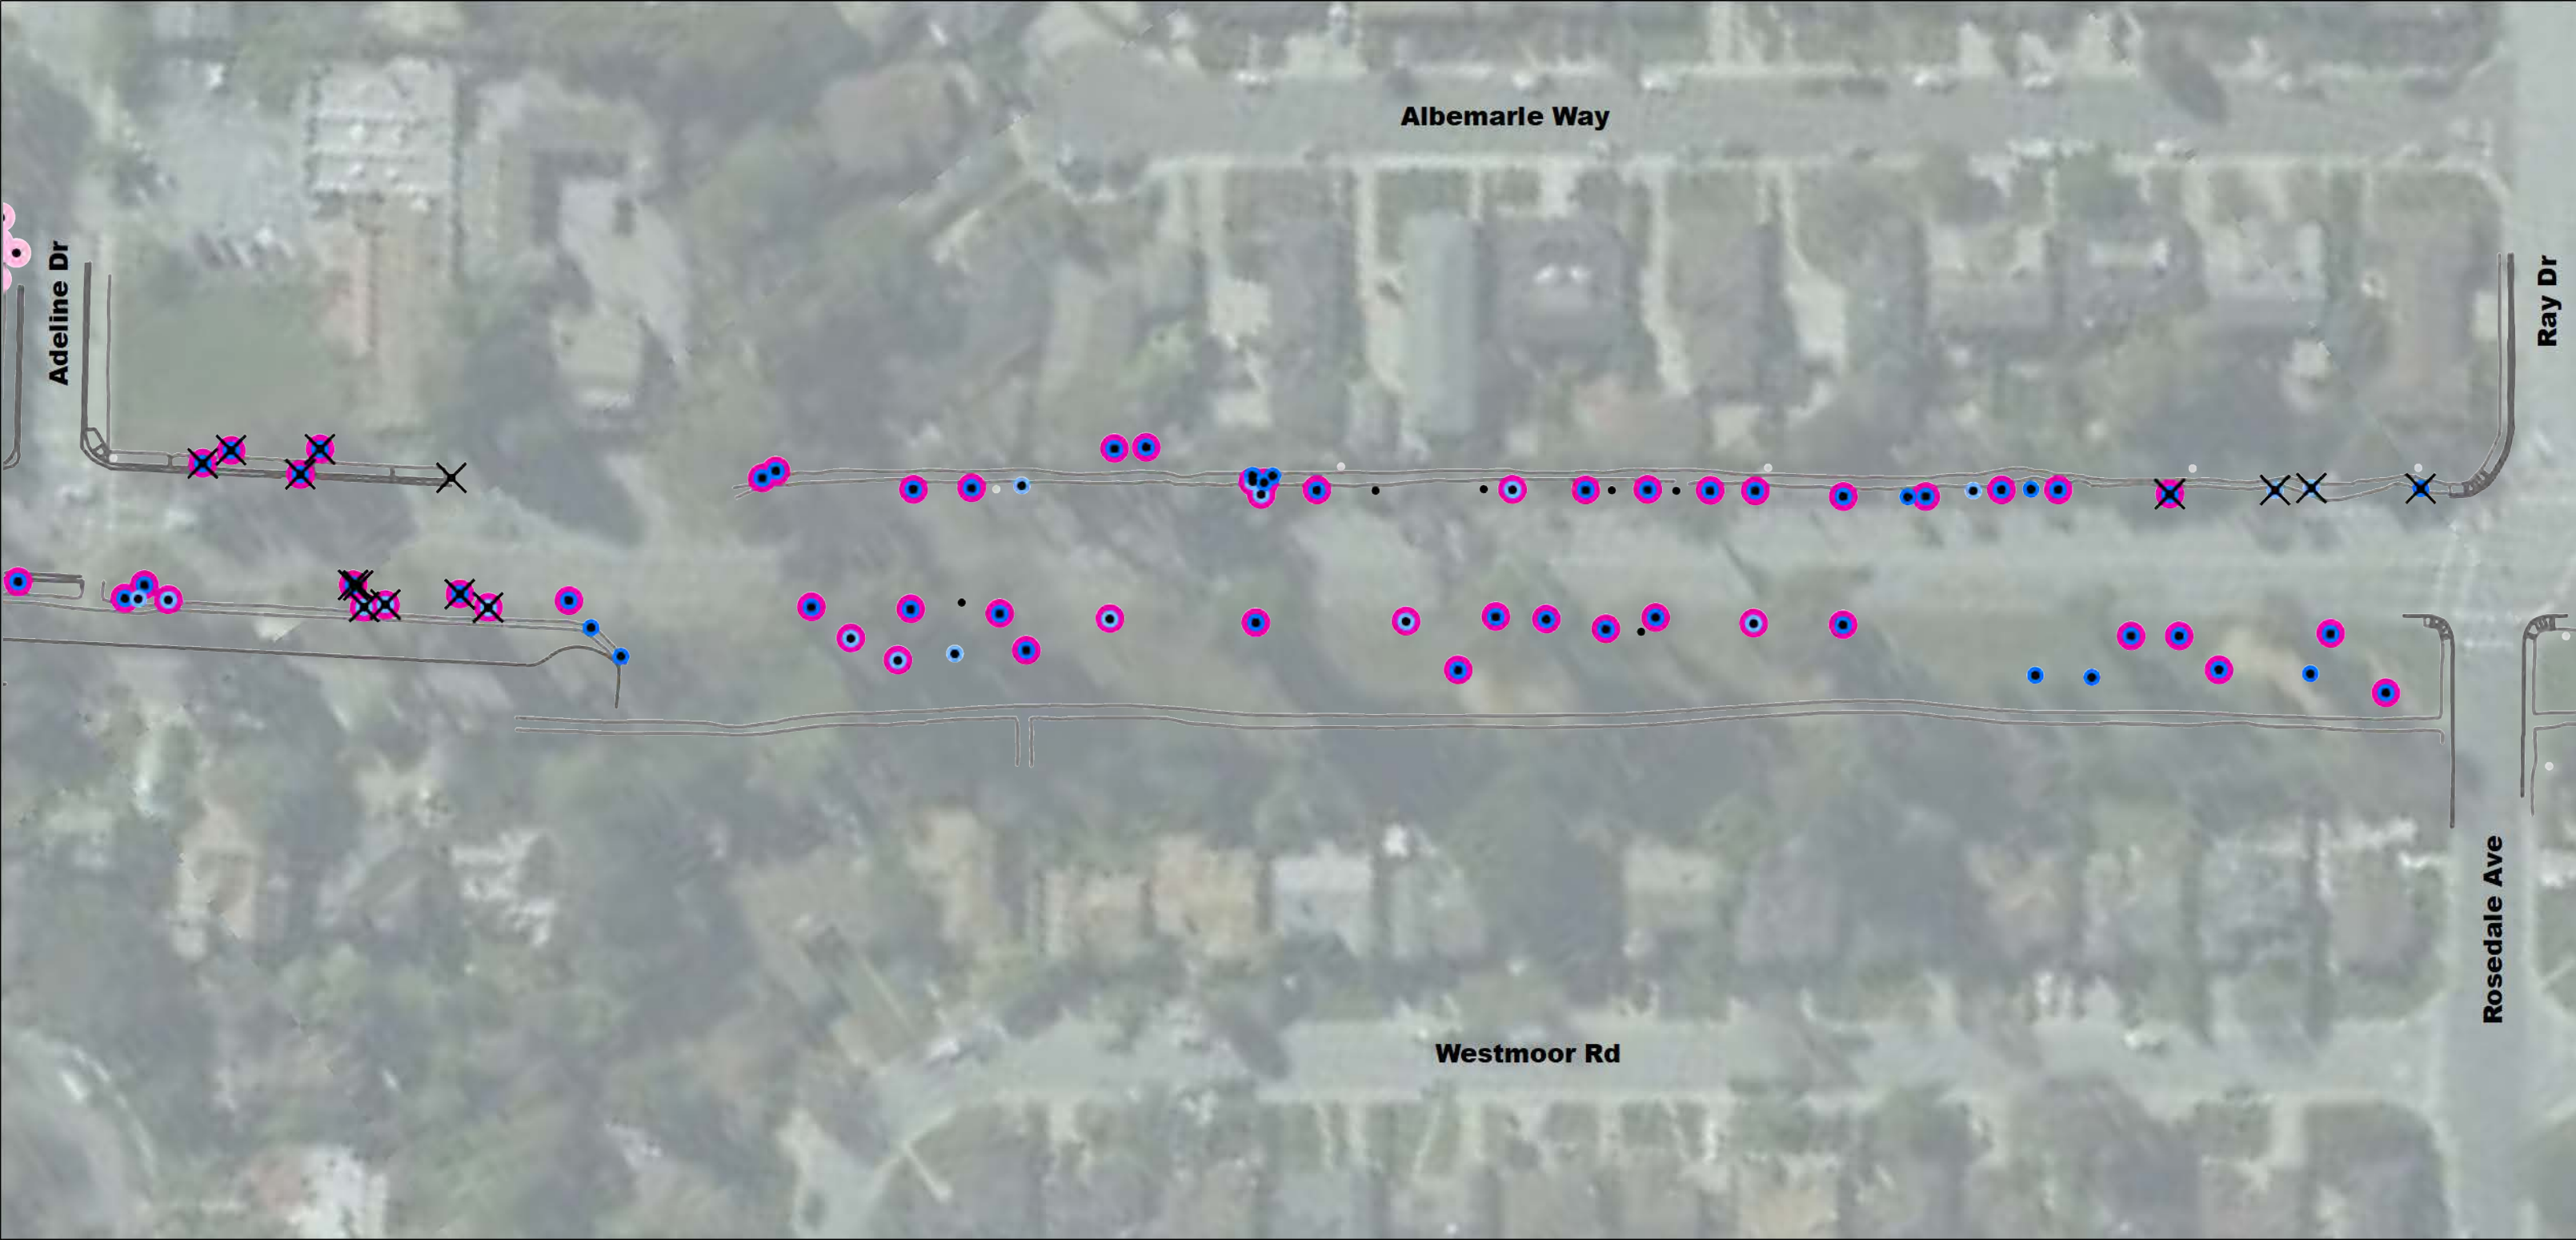
Potential Removal & Retention of Existing Trees - Alternative 3 & 4

Note: Based on Preliminary Layout Plans for the purposes of evaluating environmental impacts.
