Caltrans Hydromodification Requirements Guidance Storm Water Best Management Practices Rapid Assessment of Stream Crossings Higher Level Stream Stability Analysis

### CTSW-OT-14-314.05

February 2015

California Department of Transportation Division of Environmental Analysis, Storm Water Program 1120 N Street Sacramento, California 95814

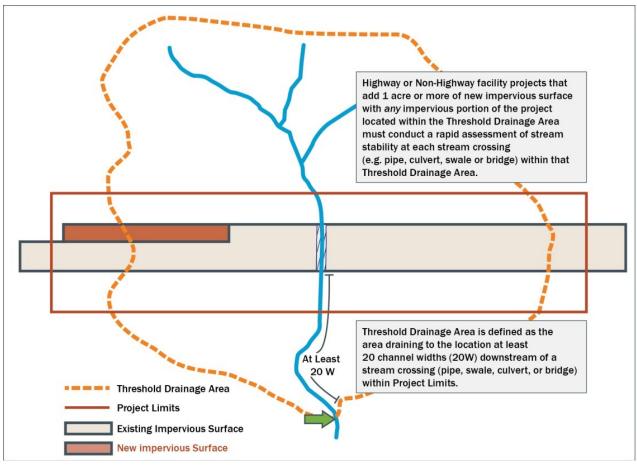
#### Figure 1. Definition of Threshold Drainage Area (TDA) The TDA is delineated with a dashed line. The TDA drains to the point marked with the green arrow.

The TDA is delineated with a dashed line. The TDA drains to the point marked with the green arrow. The TDA drainage network is shown in blue, with the stream crossing (culvert) shown as a straight purple line

The next step is to determine whether at least part of the new impervious surface lies within a threshold drainage area (TDA). The TDA is a key concept underlying the procedure outlined in this manual. The permit text (Provision E.2.d.3).c) and should be consulted for details. The permit defines the TDA as the area draining to a location at least 20 channel widths downstream of a stream crossing (Figure 1).

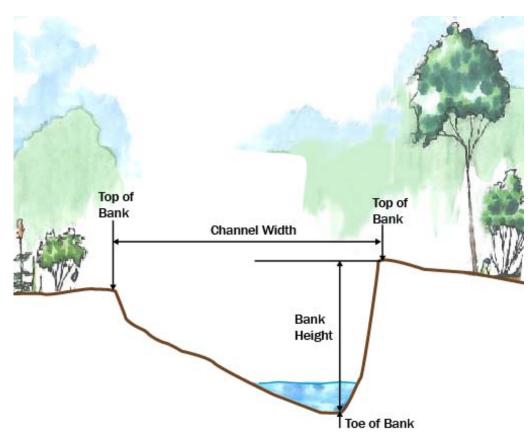
Figure 2. Definition of Top Bank and Other Channel Features

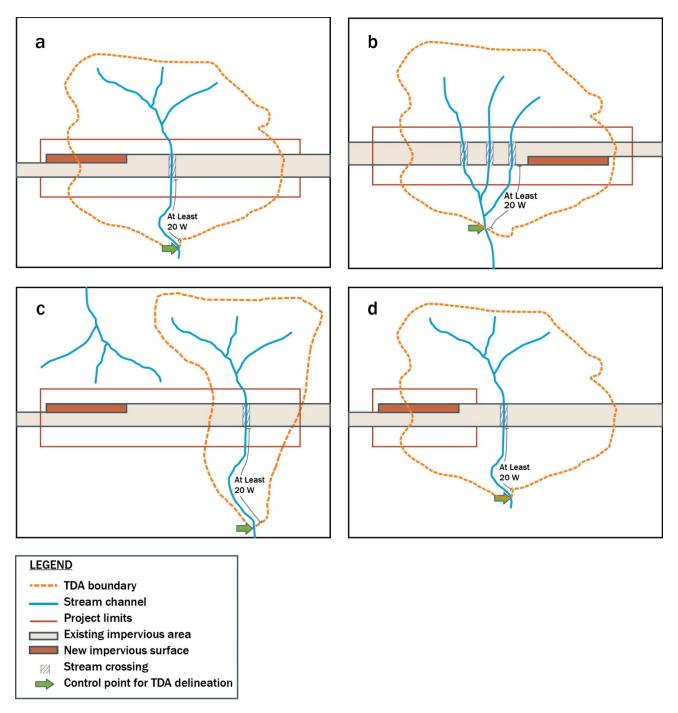
#### Figure 3. RSA Requirements

Schematics illustrating Projects Involving 1 Acre or More of Net New impervious Area That Do (a and b) and Do Not (c and d) Require an RSA. (a) > 1 acre of new impervious area within TDA, RSA required; (b) Several TDAs that are tributary to a larger one, and > 1 acre new impervious area within largest TDA, RSA required; (c) New impervious area entirely outside TDA, RSA not required; (d) Project does not contain any stream crossings, RSA not required. See text for more detail.

Figure 3 provides some example TDA delineations.

- Figure 3a shows a project that contains a stream crossing and new impervious surface. Even though only part of the project and only part of the new impervious surface is within the TDA, if the impervious area ≥ 1 acre, an RSA will be required. Furthermore, if the new impervious surface were comprised of several small parcels with total surface area ≥ 1 acre, an RSA would be required.

- Figure 3b shows a project with multiple stream crossings, but all TDAs are contained within a single TDA when the watershed is delineated using the most downstream 20W control point. In this case the entire new impervious surface is within the TDA, although the project limits extend outside the TDA. If net new impervious area ≥ 1 acre, an RSA is required.

- Figure 3c provides an example of a project that contains a stream crossing, but the entire new impervious surface lies outside the TDA delineated from a point 20W downstream from the crossing. No RSA is required.

- Figure 3d depicts a project that does not contain a stream crossing within the project limits. No RSA is required.

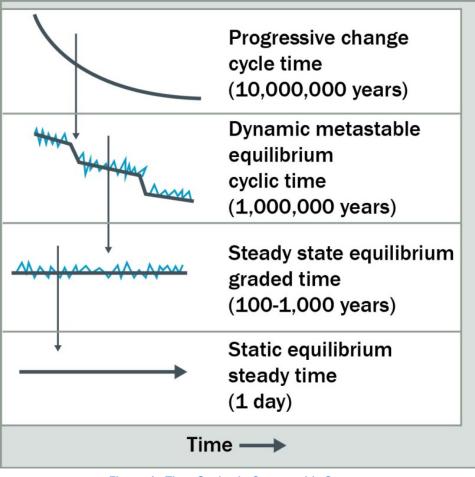
Figure 4. Time Scales in Geomorphic Systems (Boyer and Shields 2007)

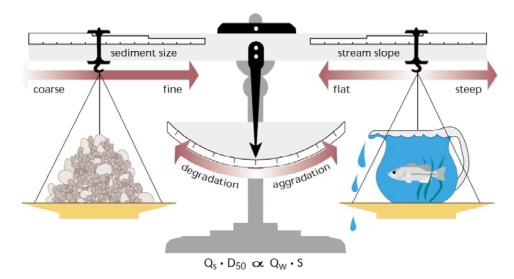
Figure 5. Schematic Illustrating Lane's Relation

In Alluvial Channels that are free to adjust their boundaries through erosion and sedimentation, changes in any of the four quantities in the relation will produce adjustments in the other three to maintain equilibrium (Federal Interagency Stream Restoration Working Group 1998)

Although complex models and considerable professional judgment is needed for precise prediction of fluvial response to hydromodification at a given site, Lane's relation is very useful for understanding how and why channels behave as they do (Figure 5). This simple relation is a key tool for rapid stability assessments (Lagasse et al. 2012). Lane's relation (Lane 1955) states that the driving and resisting forces in a fluvial system respond to each other to create a balance. The driving forces may be expressed as the product of water discharge and channel slope, and the resisting forces as the product of sediment discharge and sediment size. Mathematically, the Lane relation is

Note that the relation is a proportion (~), not an equation (=). The relationship holds only for fully alluvial channels that are free to erode their boundaries in response to changes in inputs. The Lane relation has often been illustrated by sketches similar to the one in Figure 5. Increasing either water discharge or slope (left side) will trigger increased sediment discharge or bed sediment coarsening (right side), or both. This relation can be useful for predicting the types of adjustment that will occur in a fluvial system and for explaining previous or ongoing channel responses. However, it cannot be used to quantify the magnitude or speed of the response, since it is only a relation and not an equation.

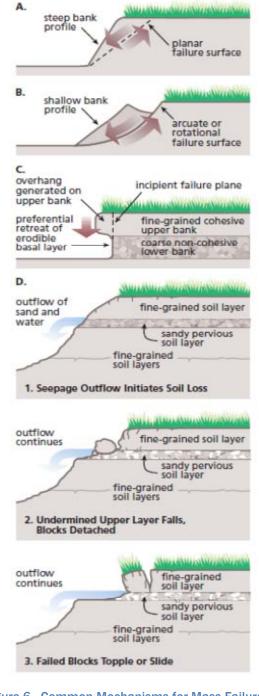
Figure 6. Common Mechanisms for Mass Failure of Streambanks (FISRWG 1998)

In contrast to the bank erosion described by the previous indicator, mass wasting or bank failure is indicated by the removal of large blocks of material from the bank face (Figure 6 and Figure 24). Mass wasting may occur when portions of the bank are undercut by toe erosion, when banks become so high and steep that they slump or slide, or when subterranean erosion by shallow groundwater works in concert with other processes to weaken a large section of bank that then slumps, caves, or slides. Banks experiencing mass wasting are typically high and steep and composed at least in part of cohesive soils; also, failure blocks are often present along the toe of bank. These failure blocks gradually disintegrate through cycles of wetting and drying, and the resulting smaller particles are removed by high flows. Leaning or fallen trees along the bank are often indicative of mass wasting; in some cases failure blocks may rotate back toward the bank as they fall, causing trees to lean away from rather than toward the channel. Sandy banks do not produce failure blocks, but can experience mass wasting as shallow, planar slides of material when bank toes are undercut. Mass wasting can be a rapid process. Usually banks subject to mass wasting have tension cracks along the top bank that run parallel to the channel 1–3 ft from the bank face. Because mass failures do not occur

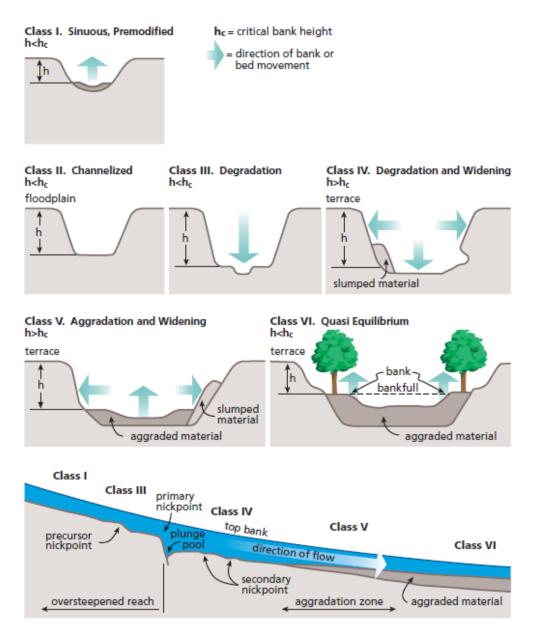
Figure 7. Schematic of Conceptual Channel Evolution Model (FISRWG 1998) Model from Schumm et al. (1984), and Simon (1989)

Patterns of erosion associated with channel incision seem to follow a sequence of steps that have been described in a conceptual channel evolution model (CEM), shown in Figure 7. There are several versions of the CEM, but the one presented here is representative. The long profile at the bottom of Figure 7 is typical of the changes that may be observed as one moves from place to place along an actively incising stream; the smaller cross-sectional drawings are typical for each class or stage, but also depict the sequence of changes that occur at a fixed location as time passes. First, natural or "premodified" channels will be sinuous, with more or less stable banks, and may even be slightly aggradational (Class or Stage I). Recent work published by Cluer and Thorne (2012) suggests that CEM Class I is preceded by a braided or anastomosing stage (multiple channels divided by bars and vegetated islands). Other recent research has modified the standard CEM for streams characteristic of southern California, including transitions from single-thread to multithread and braided evolutionary endpoints (Hawley et al. 2012). Straightening (channelization) places a channel in Class II, but this stage often triggers vertical adjustment in the form of general bed lowering or the formation of steps or waterfalls in the bed (known as knickpoints or headcuts), which migrate upstream (Class III). Unless prevented by some erosionresistant material in the bed (e.g., boulders, concrete, bedrock) or by a structure such as a dam, weir, or culvert, the headcut will continue to move upstream until the watershed is so small and flows are so low that the stream no longer has sufficient power to erode the bed (stream power = QS, the left side of the Lane relation). If the headcut deepens the channel enough to force banks to exceed a critical bank height, hc, for geotechnical stability, extremely rapid channel widening via mass failure results, defined as Class IV. Bank failure may be exacerbated in some ecoregions because channel incision may lower the water table along the stream which causes adverse impacts on riparian vegetation. Class IV channels often exhibit erosion of both banks. When channels become so wide that they cannot transport the sediment load from upstream, vertical processes shift from degradation to aggradation, even though some bank erosion may continue (Class V). When deposited bars become high enough to support woody vegetation, a new channel within the enlarged, incised channel, and a Class VI form may be identified. Recent research suggests that this CEM should be expanded to include a form that often develops after Class VI that is braided (Cluer and Thorne 2013).

The CEM is idealized. Actual fluvial systems may shift among Classes III, IV, and V repeatedly as pulses of sediment pass downstream and series of headcuts moves upstream. Nevertheless, it is quite important to note that instability can rapidly progress upstream in an incising system. A reach that has remained stable for many years can suddenly deepen and widen several fold, when a migrating headcut passes through.

The most common cause of artificial entrenchment is channel incision (downcutting) in response to hydromodifications associated with development. Incision indicators are consistent with the CEM (Figure 7) and include the following (Castro 2003):

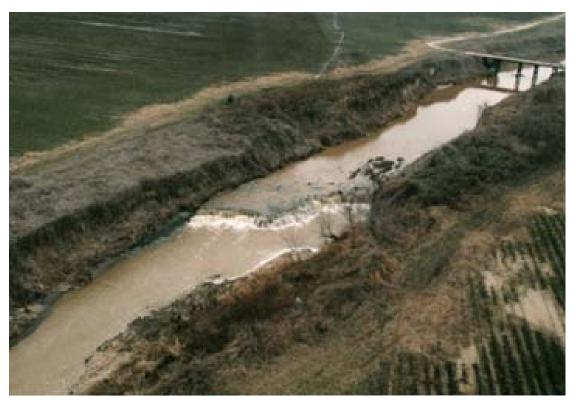
Figure 8. Headcut in Consolidated Cohesive Bed Approaching County Road Bridge Big Creek, MS, 1997

Headcuts pose a particularly serious hazard to highway infrastructure (Figure 8). For example, in 1995, a railroad bridge near Kingman, Arizona, collapsed as a passenger train passed over it, injuring more than 150 people. The bridge collapse was caused by upstream migration of a headcut following heavy rains and the failure of a downstream check dam (Johnson 2006). Sediments and large wood brought into channels (particularly Classes III and IV) as a result of incision are deposited downstream in Class V and VI reaches. Accelerated deposition can fill a channel, forcing flows over the banks and damaging or destroying roadways or embankments. Excessive amounts of large wood can also lodge on bridge piers or block entrances to pipes and culverts. Even dynamically stable channels can threaten highway rights-of-way when upstream meanders migrate toward them (Figure 9). A fuller description of the implications of stream channel instability for highway structures is provided by Lagasse et al. (2012). The FHWA publication, *A Field Guide for Bridge Inspectors* (FHWA 2009) is a handy, well-illustrated pocket guide with checklists for assessing symptoms of instability. Caltrans guidance is available for culvert inspections also (Caltrans 2008).

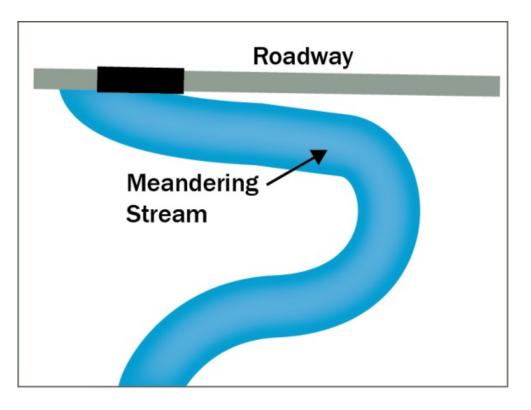
**Figure 9. Meander Threatening a Roadway** Most rapid erosion along a bend occurs on the concave bank just downstream of the bend apex.

More rapid transmission of precipitation through the drainage network results in higher peak discharges and resultant increases in stream power (the left side of Lane's relation). Unstable channels may threaten stream crossings by eroding embankments or approaches, undermining piers, or destroying culvert foundations. As channels shift, the flow path of floodwaters may be directed at an unfavorable angle to structural piers and abutments. Piers originally founded in overbank floodplain areas can become main channel piers due to channel migration. Footings and foundations may be exposed and undermined by local scour or channel degradation. Concave banklines (outsides of meanders) typically migrate downvalley, and may impinge on approach embankments or abutments (Figure 9).

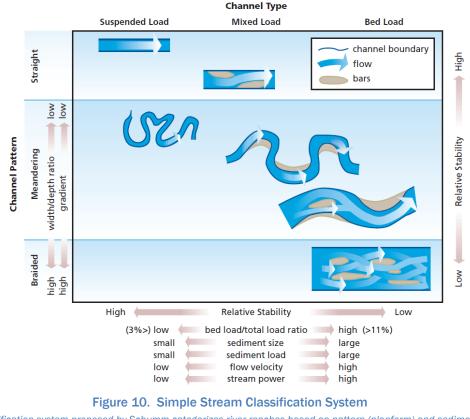
The classification system proposed by Schumm categorizes river reaches based on pattern (planform) and sediment load. Stability varies based on these characteristics. From FISRWG (1998).

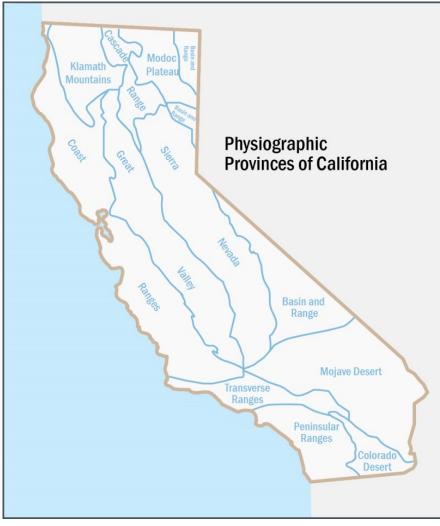
Figure 11. Physiographic Subregions of California From California Geological Survey (2002).

This subregion includes the Sections labeled "Cascade Range" and "Sierra Nevada" in Figure 11.

This subregion includes the Sections labeled "Modoc Plateau," "Basin and Range," and "Transverse Ranges" in Figure 11.

The Pacific Coastal subregion in California is characterized by a wide variety of channel types that include arroyos and alluvial fans. These stream types tend to be unstable both laterally and vertically. Human alterations of stream channels in this region are widespread and have changed erosion and deposition patterns. Streams may be ephemeral, intermittent, or perennial. Sections in this region include those labeled "Klamath Mountains," "Great Valley," and "Coast Ranges" in Figure 11.

This subregion includes the sections labeled "Peninsular Ranges," "Mojave Desert," and "Colorado Desert," in Figure 11.

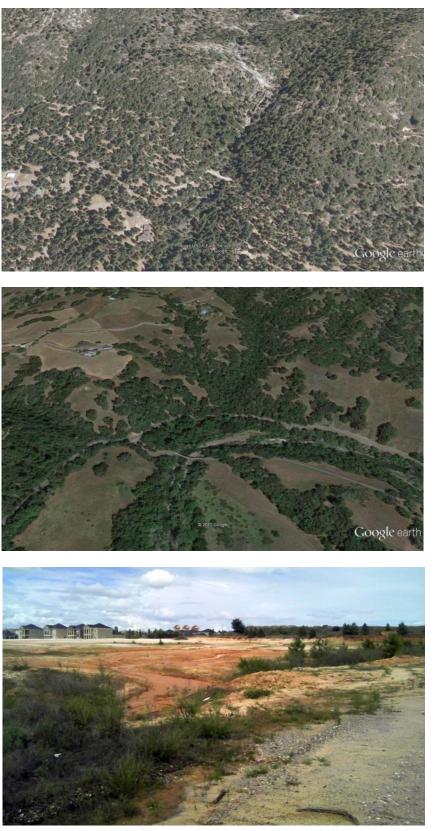
Figure 12. Watershed Examples From top: excellent, good to fair, and poor watershed and floodplain conditions

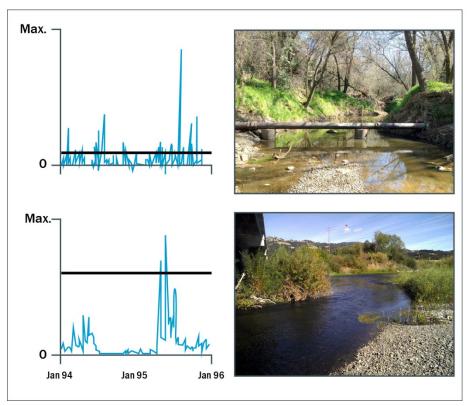
#### Figure 13. Flow Characteristic Examples

Flashy discharge hydrograph from incised channel in urban area (Top Plot), and hydrograph of perennial stream draining natural area fed by snowmelt, with no flashy behavior (Bottom Plot). Horizontal lines indicate discharge levels that transport the most sediment. Photos to the right of each plot illustrate typical conditions for flashy and stable-flow channels, but are not from the same locations as the hydrographs.

The second indicator is a measure of stream flow variability when viewed across a year or longer period (Figure 13). Hydromodification tends to reduce the percentage of stream flow that is contributed by shallow groundwater and increase the amount of direct runoff. Accordingly, ephemeral, flashy (rapid rise and fall) hydrographs are given higher (less stable) ratings. Since the field inspection portion of the RSA is typically a one-time event at baseflow, this indicator is best assessed using actual gage data, obtained as described in the section below on Level 2 analysis. In the absence of such data, flow characteristics may be roughly assessed based on the appearance of the channel and its environs when the field inspection is conducted. Channels with stable, perennial flows and no flashy behavior (Table 6) tend to have well-defined, densely vegetated banks.

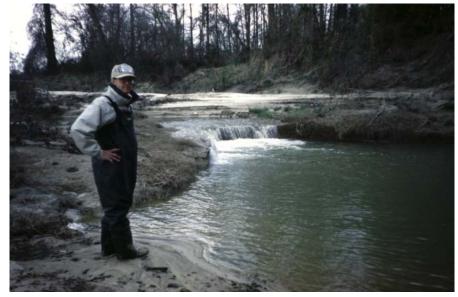
Figure 16. Headcut Formed in Cohesive Streambed

Headcuts—vertical drops or offsets in the channel bed, "waterfalls" at baseflow. Also called knickpoints, a headcut formation is most obvious in streams with cohesive beds and banks (Figure 16) because headcuts remain fairly vertical as they progress upstream, and are thus readily visible. In sand or gravel-bedded rivers, discrete headcuts do not form, and regions of active downcutting may extend over hundreds or thousands of feet ("knickzones").

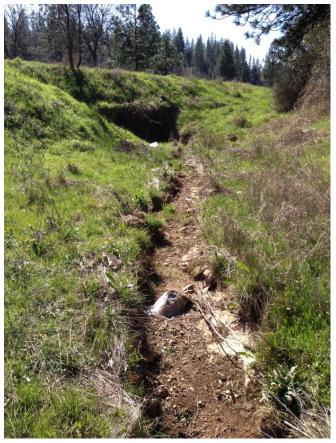
Figure 17. Channel Entrenchment Examples Top: Deeply incised channel with cohesive banks and lacking any sediments in channel bed. Bottom: Non-incised channel with berms or floodplains several times as wide as the channel on both sides. No signs of undercutting infrastructure or oversteepened banks.

No bars or sediment deposits— erosion of the channel bed down to bedrock or other resistant soil layer. Sometimes banks on both sides of the channel will be near vertical, raw, and eroding (Figure 17).

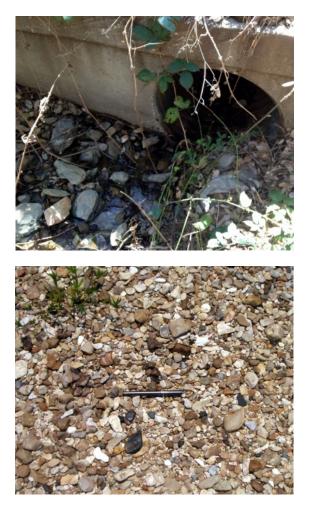
**Figure 18. Examples of Bed Material Top:** Excellent bed material. Large gravel and cobble, tightly packed. **Middle:** Good bed material. Writing pen in center for scale. Bed is covered with 10–30 mm (0.4 – 1.2 in.) gravel at this point, but sand appears elsewhere along the cross section (outside the photo). Sediments are only slightly imbricated (overlapped and packed). **Bottom:** Poor bed material. Coins for scale. 90% sand, D<sub>50</sub> ~ .20 mm.

The fifth indicator, bed material, is based on the size of bed sediments and how tightly they are consolidated or interlocked (Figure 18). Table 6 uses the variable Fs, or the fraction of the bed composed of sand, as a key discriminant for this indicator. Strictly speaking, if sandsized sediment is present on the bed in mixture with other sizes, a sample must be collected and subjected to sieve analysis to generate reliable estimates of Fs. However, for the purposes of an RSA, a simple visual estimate of the fraction of bed surface that is sand is adequate. The engineer should examine the channel from the top bank where it affords an unobstructed view of the bed, or from near the channel centerline, to make this estimate. Each estimate should apply to a given cross section, and an overall average should be determined based on at least 10 cross sections placed at constant spacing along the >40W-long representative reach.

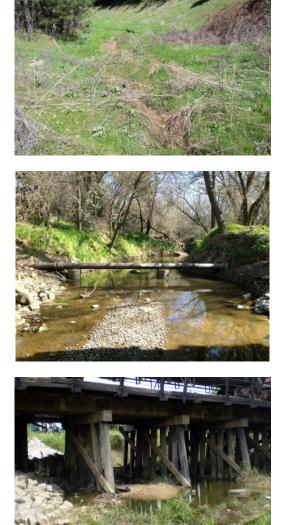
Figure 20. Examples of Obstructions Top: Excellent condition for obstruction. Small amounts of vegetation and one piece of metal debris in approach channel to culvert. Middle: Good obstruction. Pipeline crossing (with concrete piers) is only major obstruction in reach, but local deposition and scour caused by obstruction are evident. Bottom: Poor obstruction condition. Railroad bridge crosses channel at an angle so that pile bents are oriented at an angle to approach flow, collecting debris and trash and impacting entire reach. Riprap bank protection and vegetation add minor obstruction. Sediment accumulation downstream from obstruction is evident.

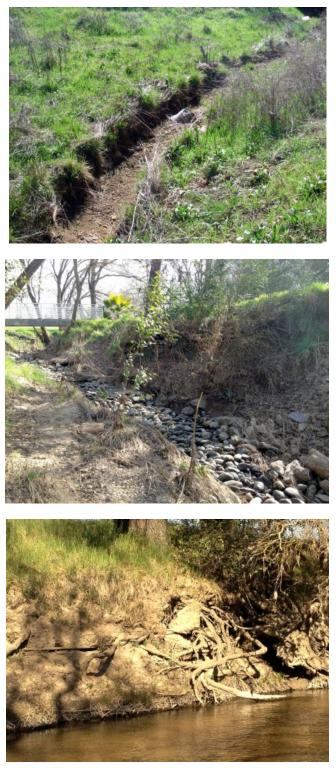
Figure 21. Examples of Bank Slope Angle

Top: Excellent score. Average bank slope is 5H:1V, cohesive soils, bank heights ~ 6 ft.

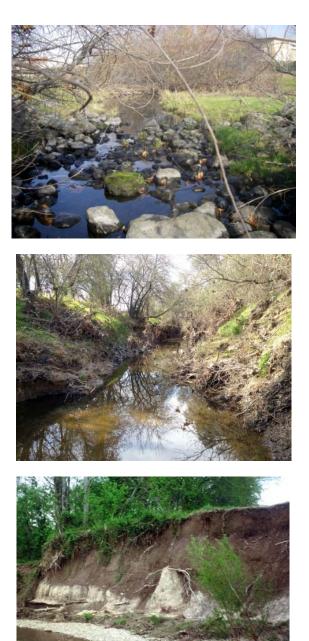
Figure 22. Bank Protection Example

**Top:** Good score for vegetative or engineered bank protection indicator due to bank stability, partial coverage of banks by woody species, and partial protection of bank with stone. **Middle:** Fair bank protection. Small band of woody vegetation at top of bank. Trees leaning over channel, root exposures, some riprap at toe of left bank. **Bottom:** Poor bank protection. Very little woody vegetation along banks, no structural lining or armor.

Stable, well-protected banks are less susceptible to erosion due to hydromodification than those already exhibiting signs of stress. Bank protection may consist of artificial structures, such as riprap revetment, or a band of dense, healthy riparian vegetation (Figure 22). Excellent scores are reserved for sites with either (1) both banks protected by intact revetment or lining (asphalt or concrete) or (2) both banks heavily vegetated with erect, mature hardwoods. Departures from these conditions warrant higher numerical scores (Table 6). Scores for this indicator should be determined by examining at least 10 cross sections placed at constant spacing along the >40W-long reach. If vegetation is present, attention should be paid to signs of distress, such as exposure of roots and the orientation of trunks with respect to vertical. Higher scores are assigned to softwoods, coniferous species, and monocultures. In similar fashion, higher scores should be assigned to banks with damaged revetment or other damaged countermeasures. Refer to Example 4 in Appendix B for a case where an overall score of 7.7 was assigned to an urban channel without any engineered bank protection, but a thin but fairly dense band of trees growing at the top of both banks.

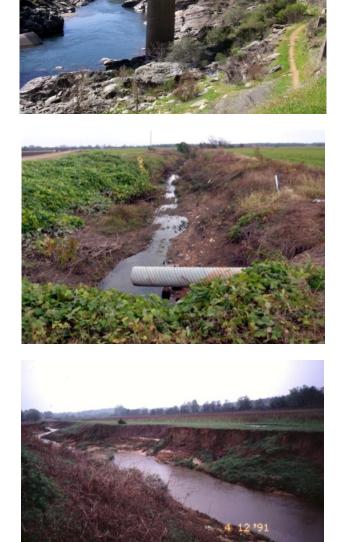
Figure 23. Bank Erosion Examples Top: Excellent score. Bank erosion limited to insignificant footpath along upper bank due to bedrock and boulders along lower bank. Middle: Good score. Raw area is prominent on right bank, but there are no undercut roots, and much of the bank is well vegetated with herbaceous species. Bottom: Poor score. Almost continuous exposed soil and cuts along both banks.

Bank erosion is rated based on its extent along the reach and its severity (Figure 23). Streambank erosion is a natural process, and alluvial channels will exhibit raw (unvegetated) banks in certain locations, especially at elevations below normal baseflow and on the outside of bends. However, when bank condition is assessed for an entire >40W-long reach, stable channels that receive Excellent ratings for bank erosion will exhibit only small areas of active erosion. Poor ratings are associated with near-continuous raw banks, both in a streamwise direction and up and down the bank at a given cross section. Bank vegetation can be a strong indicator of rapid erosion, the engineer should look for undercut root mats and sod. Especially notable are local zones of distress, such

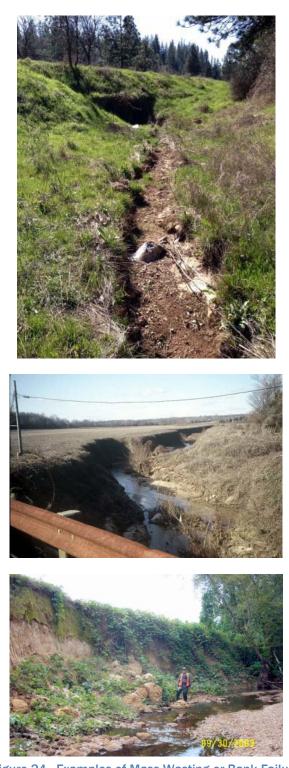
Figure 24. Examples of Mass Wasting or Bank Failure Top: Excellent score. Low, well-vegetated banks with no evidence of mass failure. Middle: Fair score. Evidence of frequent and significant mass wasting. Channel width irregular, scalloping of left bank. Presence of bank vegetation slightly reduces score. Bottom: Poor score for mass wasting indicator. High banks with recent failure blocks at toe, regular bank slumping, irregular channel width (not visible from this photo point).

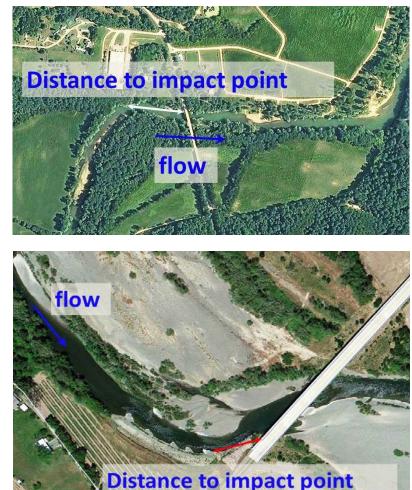
Figure 25. Stream Crossing Alignment with Flow Examples Distance to impact point is measured starting at the upstream end of crossing and moving upstream to the point of greatest erosional stress on the bank of the first bend. **Top:** This site would receive an excellent score for this indicator, because the impact point is more than 150 ft upstream of the bridge, and the approach channel is only slightly out of line with the bridge opening. **Bottom:** Poor score for alignment. Crossing is extremely skewed to flow and impact point is quite close to bridge (~100 ft from closest bridge opening). Score is reduced slightly by presence of countermeasures (rock vanes) intended to improve flow alignment.

Most stream channels are not straight, and flow forces on banks are typically greatest just downstream of the apex of a bend, at a point that coincides with the intersection of flow lines or the channel centerline at the bend entrance and the bankline (Figure 25). This point is called the meander impact\_point, and often corresponds with a zone of rapid bank migration. Meander migration typically occurs in a downvalley direction, so the proximity of upstream impact points to stream crossings is of concern in the RSA. Rapidly migrating bends can impinge on embankments or approaches to bridges or culverts. Tight bends upstream of crossings will produce poor alignments, such that flow must turn sharply to pass through the crossing. Ideally, flow should be aligned so that high-flow vectors pass directly through the bridge or culvert with no redirection or deflection required. The examples presented in Appendix B generated low scores when upstream impact point locations were considered. However, Example 2 presented a complex case of stream channel flow alignment: "although the top bank alignment upstream from the bridge was well aligned, there was a small gully that joined the main channel immediately upstream from the bridge that made a sharp angle with the main channel and a large bar at the confluence of the two channels.

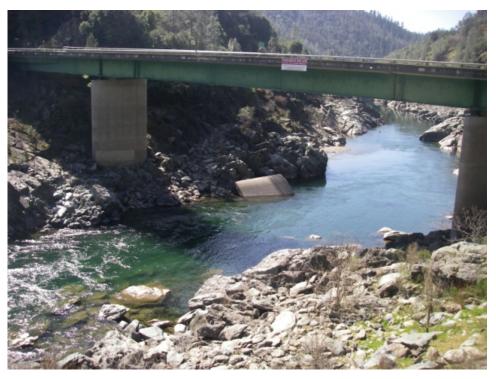
Figure B1.1. Placer-49, PM 0.2. Bridge over North Fork American River.

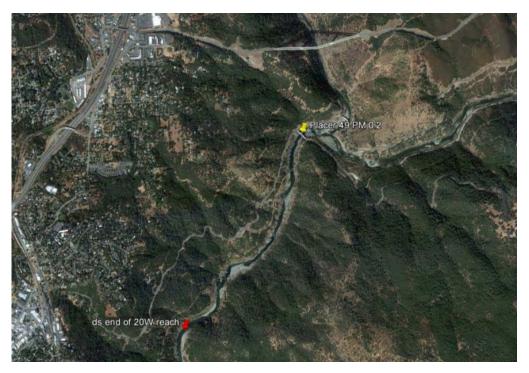
Figure B1.3. Location of point for delineation of threshold drainage area.

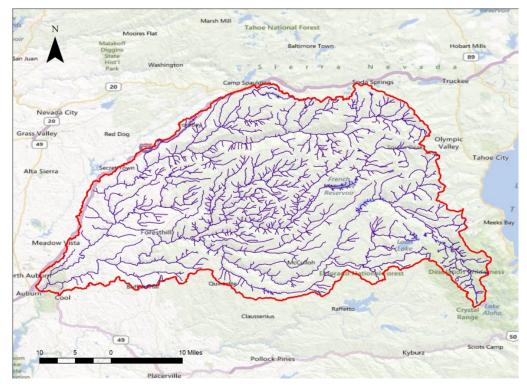
Figure B1.4. Threshold drainage area, Example 1.

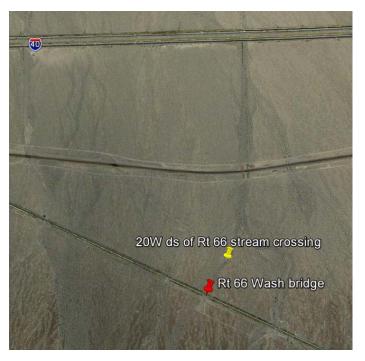
Figure B2.3. Location of point for delineation of threshold drainage area.

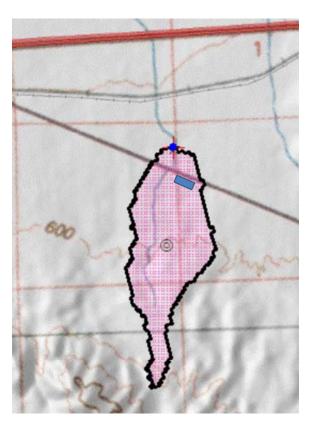
Figure B2.4. Threshold drainage area, Example 2. Gray rectangle indicates new impervious area.

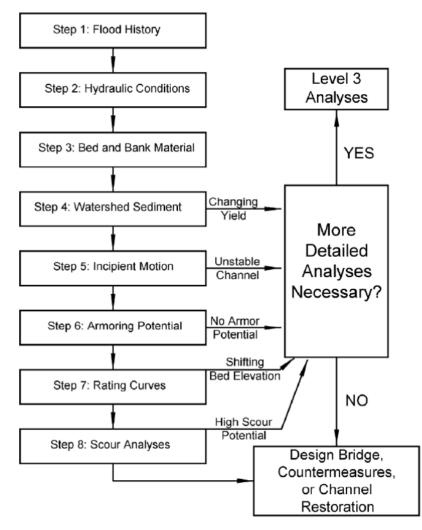
Figure B2.11. Flow chart for Level 2: Basic Engineering Analysis. From Lagasse et al. (2012)

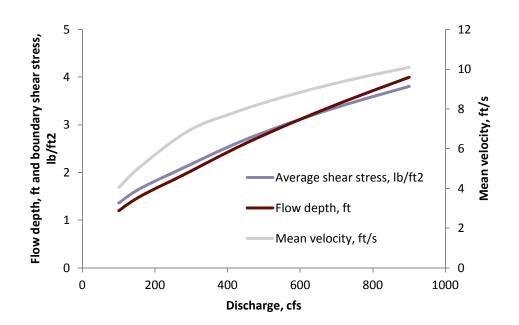
Figure B2.12. Hydraulic characteristics of representative reach, Route 66 Wash near Ludlow, based on assumption of uniform flow.

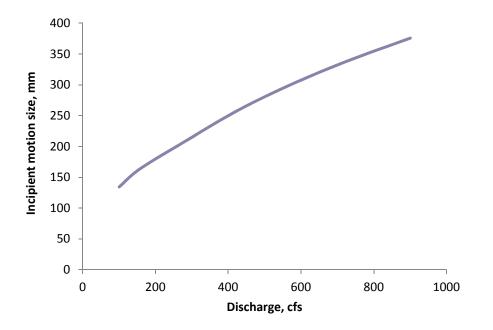
Figure B2.13. Incipient motion size for representative reach, Route 66 Wash near Ludlow.

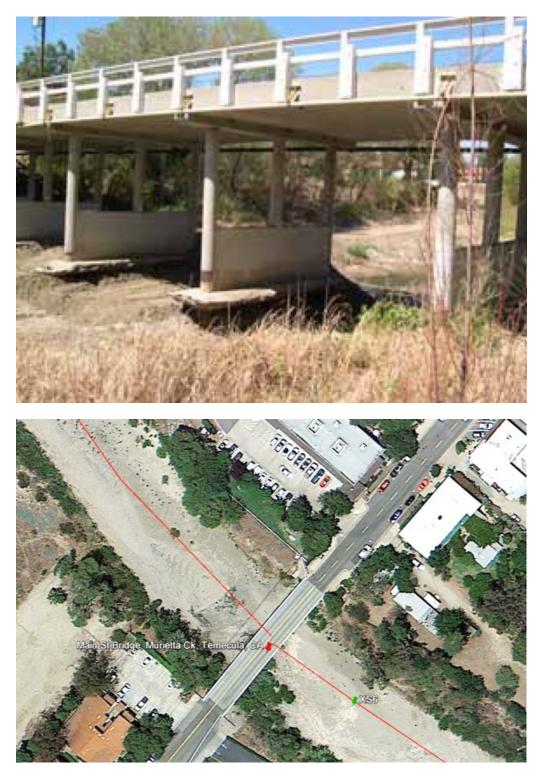
Figure B3.1. Ground level (top) and aerial (bottom) views of Main Street Bridge over Murietta Creek at Temecula, CA.

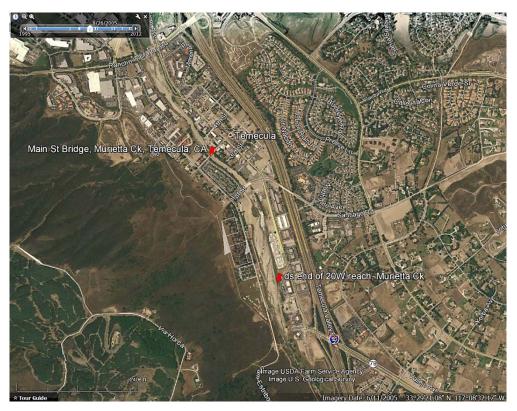
Figure B3.3. Location of point for delineation of threshold drainage area.

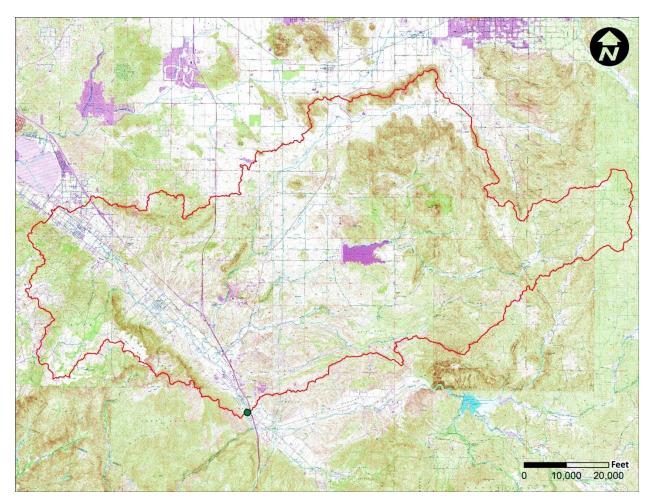
Figure B3.4. Threshold drainage area, Example 3.

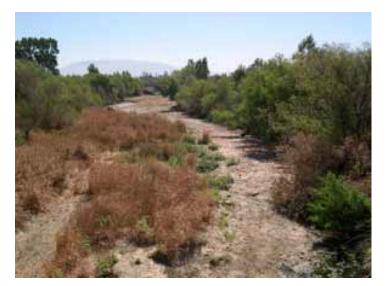
Figure B3.7. View from Main Street bridge facing downstream showing heavily vegetated alternate bars.

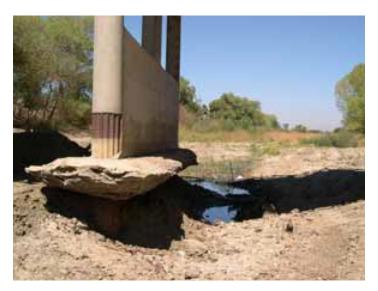
Figure B3.8. Main Street bridge showing exposure of bridge pier foundation due to bed lowering.

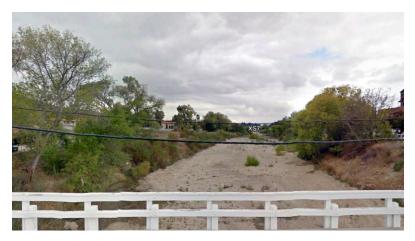
Figure B3.9. View upstream from the Main Street bridge showing typical bed material. Also see Figure B3.1.

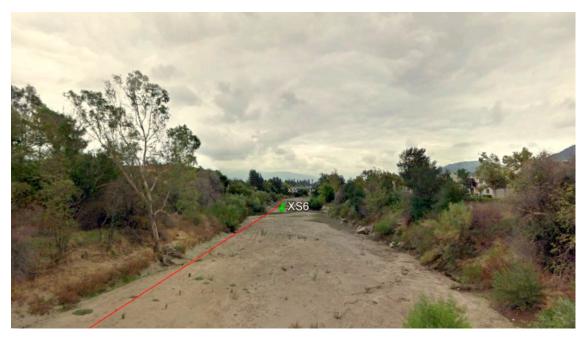
Figure B3.10. View downstream from Main Street bridge.

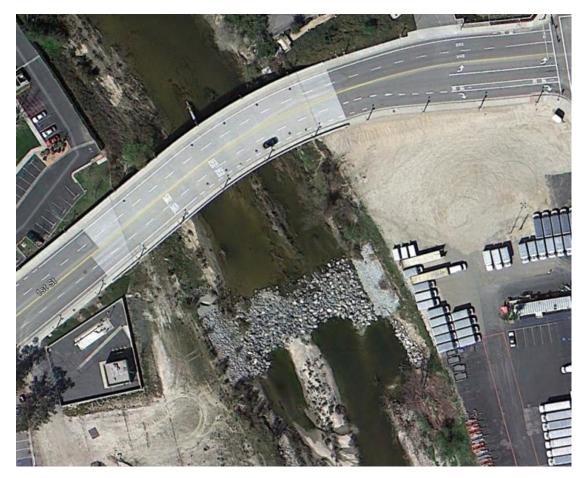
Figure B3.11. Aerial view (2011) of grade control structure constructed downstream from 1st Street Bridge.

In the case of this site, a riprap grade control structure was installed downstream from the 1<sup>st</sup> Street bridge ca. 2004 (Figure B3.11). Presentation of design criteria for grade controls is beyond the scope of this document. However, properly designed grade controls placed downstream from bridges can be effective countermeasures against failure due to undermining by erosion. Evidently the Murietta Creek grade control structure crest elevation was set high enough to protect both the 1<sup>st</sup> Street and the Main Street bridges, prompting sediment deposition at both locations that filled the areas around the exposed pier footings. Long term evolution of the channel of Murietta Creek will continue to be influenced by development and changes in watershed land cover, and a major flood control project is planned for this reach, also.

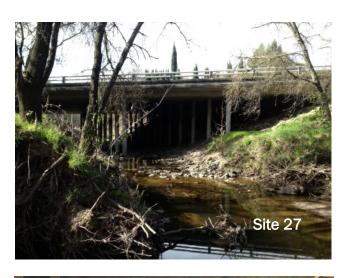
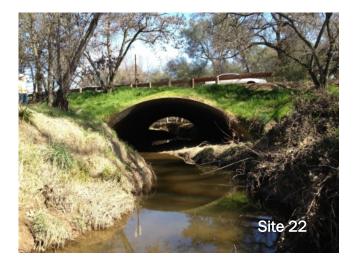
Figure B4.2. Ground level views of existing crossings of Arcade Creek, Citrus Heights, CA, at the three sites included in the project for Example 4.

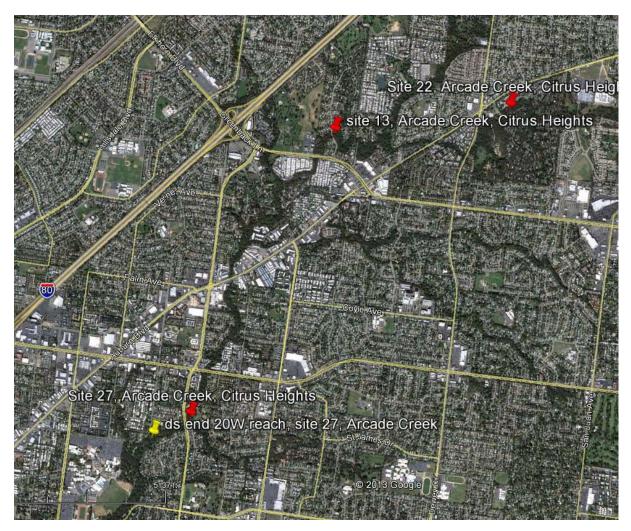
Figure B4.3. Yellow icon shows location of point for delineation of threshold drainage area at 20 channel widths (20W) downstream from site 27. Arcade Creek is shown by the forested corridor that runs from northeast to southwest.

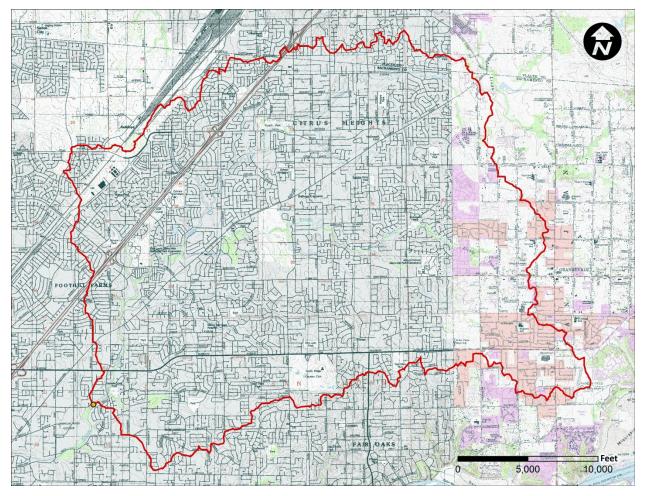
Figure B4.4. Threshold drainage area, Example 4.

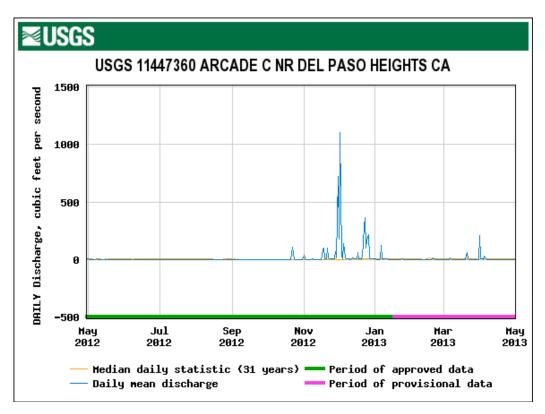
Figure B4.6. Daily mean discharge for USGS gaging station downstream from TDA. From <u>http://nwis.waterdata.usgs.gov/nwis/inventory/?site\_no=11447360</u>.

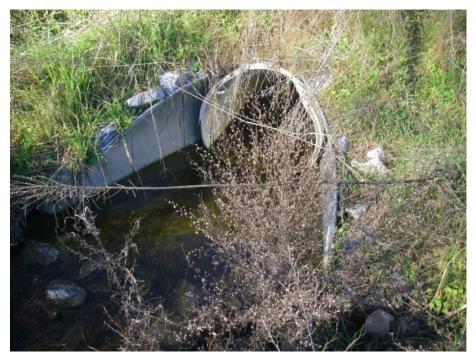
Figure B5.1. Flared outlet for Example 5 culvert.

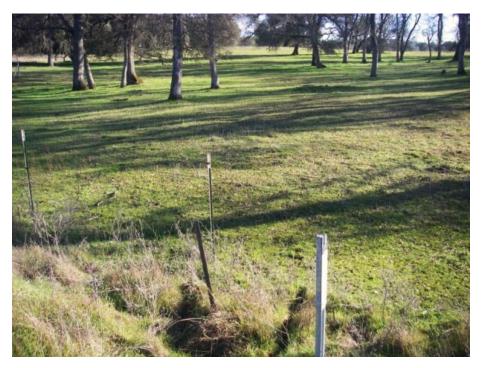
Figure B5.2. Area upstream of culvert inlet for Example 5.
