1. REPORT NUMBER CA 13-2180	2. GOVERNMENT ASSOCIATION NUMBER	3. RECIPIENT'S CATALOG NUMBER
4. TITLE AND SUBTITLE Post-Earthquake Bridge Damage Mitigation - Post-Earthquake Damage Repair of Various Reinforced Concrete Bridge Components		5. REPORT DATE June, 2013

6. PERFORMING ORGANIZATION CODE UNR/
7. AUTHOR(S) Amarjeet Saini and M. Saiid Saiidi		8. PERFORMING ORGANIZATION REPORT NO. UNR/CA13-0371
9. PERFORMING ORGANIZATION NAME AND ADDRESS Department of Civil and Environmental Engineering University of Nevada, Reno Reno, Nevada 89557-0152		10. WORK UNIT NUMBER

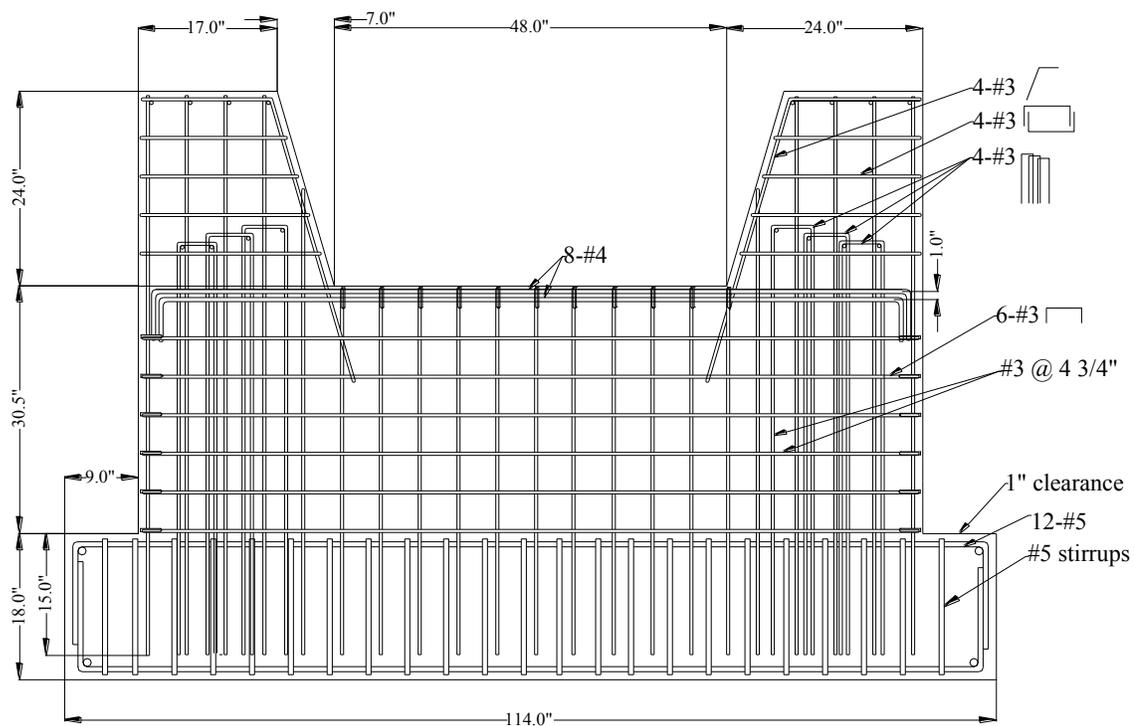
Figure 3-1. Elevation view of reinforcement layout of shear key test unit 4A

The repair of shear keys under DS2 is illustrated through an example in this section. The objective of the repair for shear keys under DS2 is to restore shear strength loss of 20% of concrete component without changing the mode of failure. The shear key test unit 4A (Figure 3-1) was used as a benchmark with original shear capacity of 334.9 kips [1489.7 kN]. The material properties were presented in Section 3.4.

To help clarify the example, test unit 4A (Figure 3-1) is used to identify different types of reinforcement in typical existing abutment and shear key connection region.

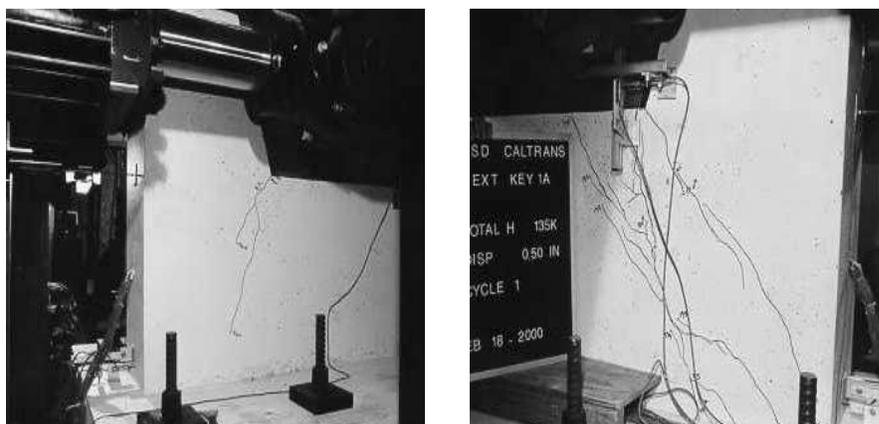
Figure 3-2. Damage state 2

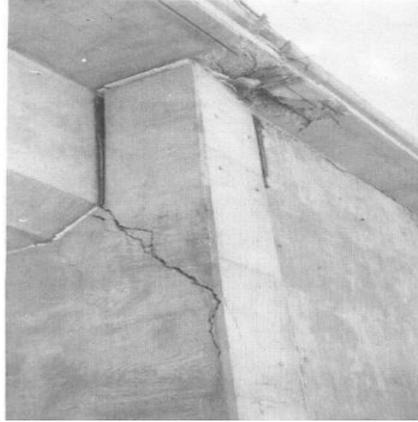
Figure 3-3. Damage state 5

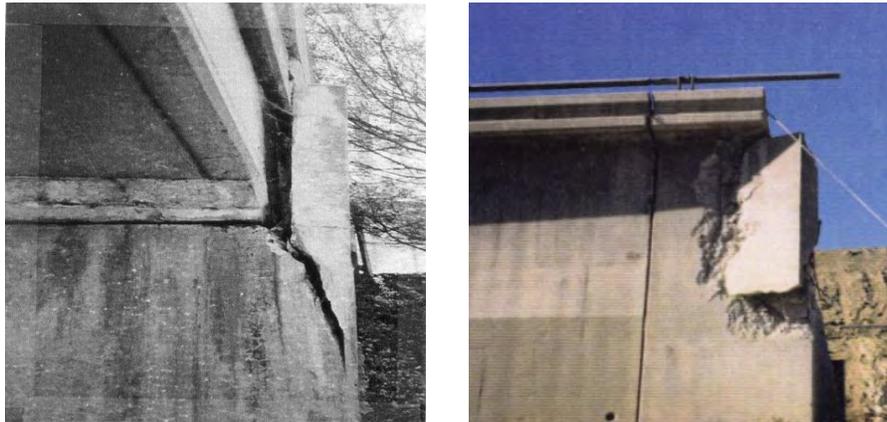
Figure 3-4. Damage state 6

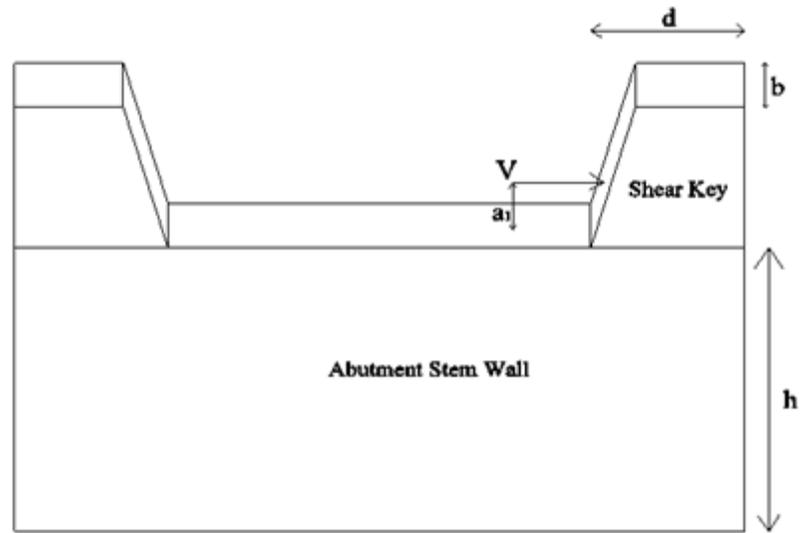
Figure 3-5. 3D view of shear key

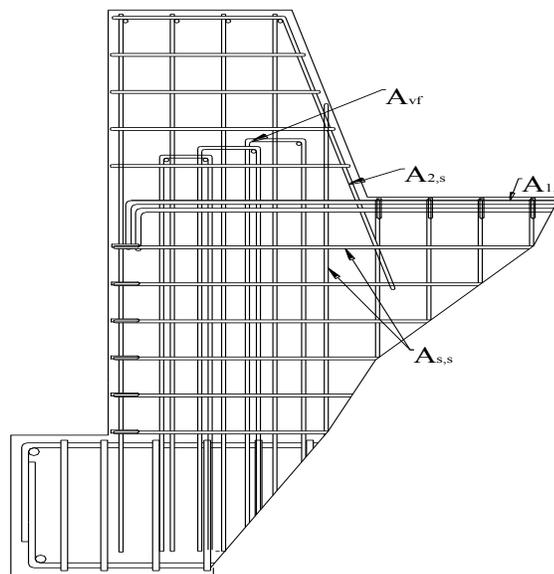
Figure 3-6. Shear key reinforcement location layout

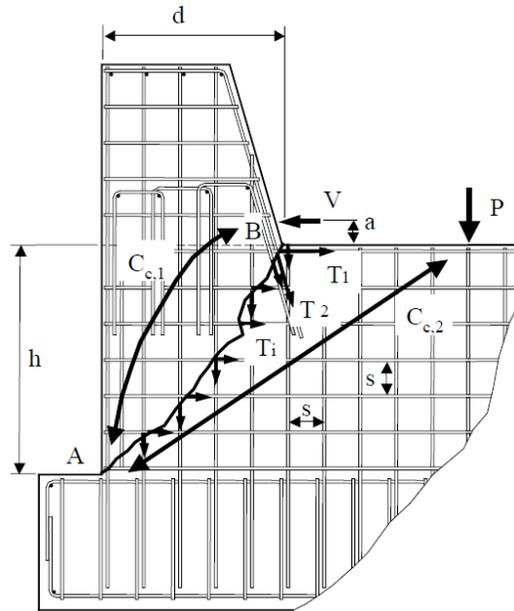
Figure 3-7. Exterior shear keys, strut-and-tie model (Megally et al. 2001)

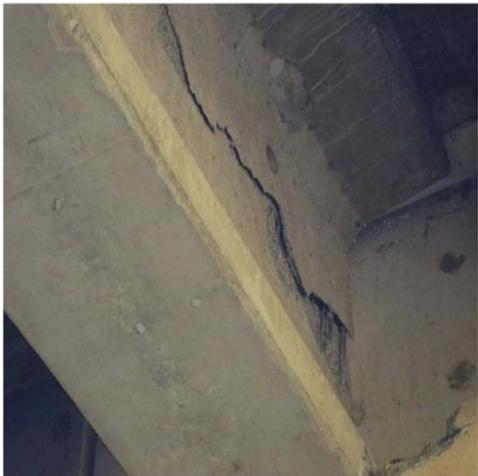
Figure 4-3. Damage state 3

P/S girders under DS3 exhibit extensive spalling of cover concrete. Figure 4-3 shows an example of P/S girder under DS3.

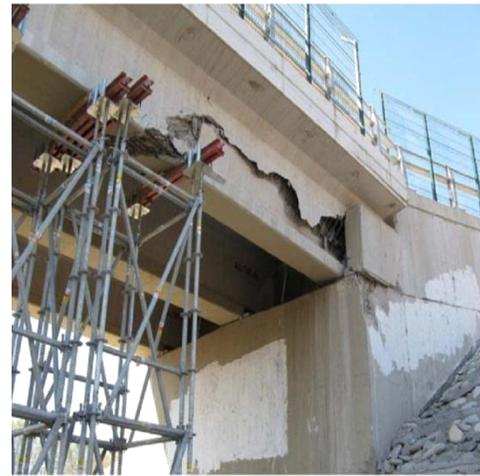
Figure 4-4. Damage state 4

This damage state consists of extensive spalling of cover concrete and visible longitudinal bars. Figure 4-4 shows an example of P/S girders under DS4.

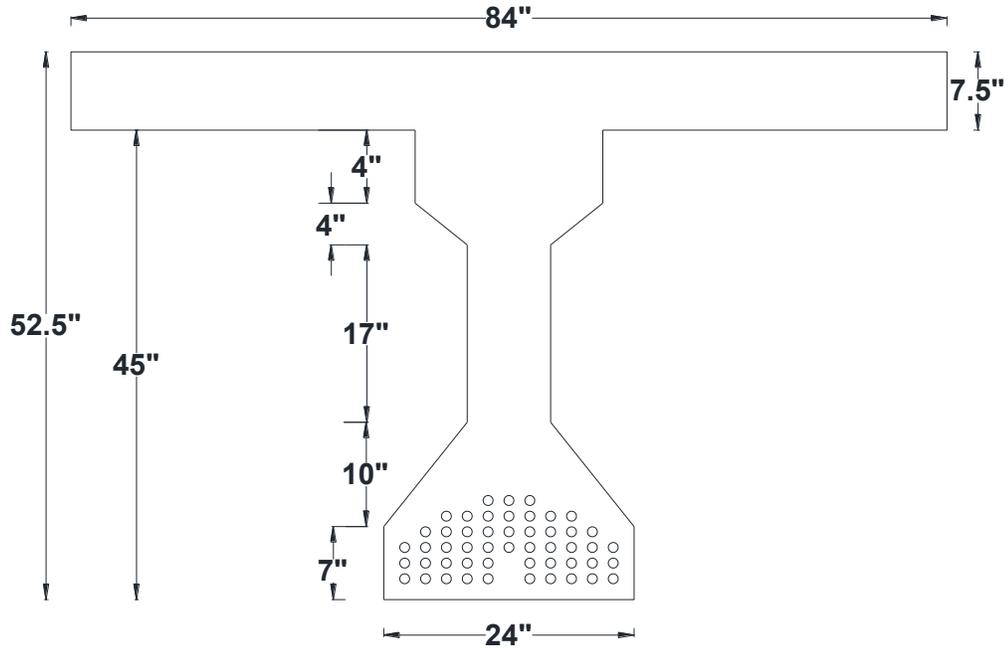
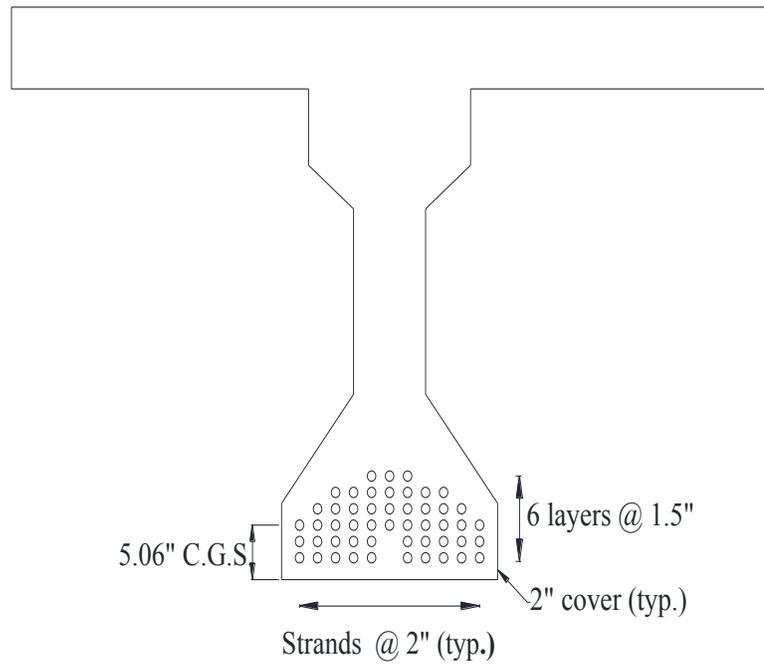
Figure 4-5. Prototype I girder cross section

Figure 4-6. Prestressing strands detail

To develop a repair method, a prototype P/S I-girder section was used in this study. Girder cross section details are shown in Figure 4-5 and Figure 4-6. Section geometric and material properties are presented in Table 4-1. Prototype girder geometric and material properties. Prestressing steel material properties are compiled in Table 4-2. For ease of developing a repair design it was assumed that, the given girder is a simply

The repair of P/S girders under DS2 and DS3 is illustrated through an example in this section. The objective of the repair of P/S girders under DS2 and 3 is to restore section flexural capacity loss of 10%. The prototype P/S girder shown in Figure 4-5 and Figure 4-6. Prestressing strands detail were used as bench mark. The original moment capacity of the section is 4510 k-ft [6134 kN-m]. The moment capacity after 10% loss is equal to 4048 k-ft [5505 kN-m].

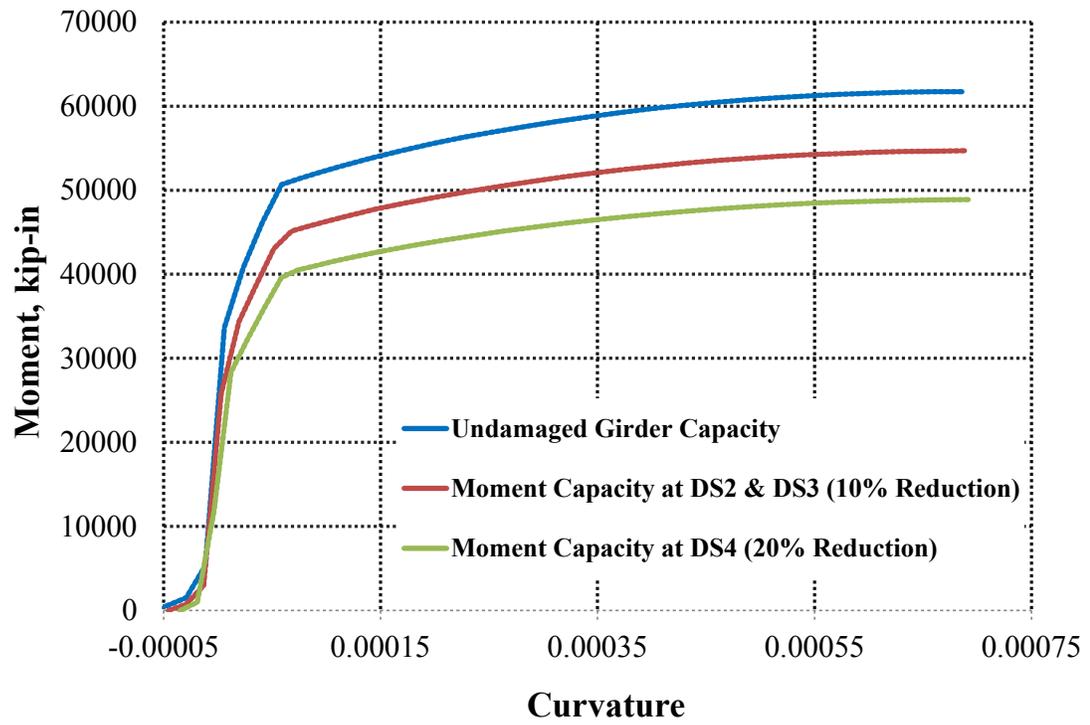
Figure 4-7. Moment-curvature of I girder section at various damage states

supported interior girder. To determine the nominal moment capacity of I-girder, program Xtract was used to obtain the moment-curvature relationship. Effective yield moment was used as a nominal moment capacity of the section. Figure 4-7 shows the moment-curvature plot of the girder section at various DS's.

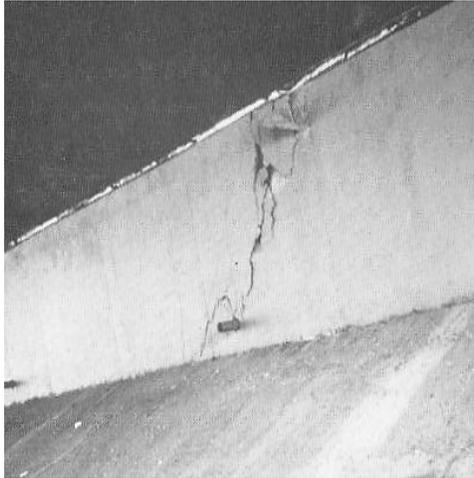
Figure 5-1. Damage state 2

This damage state corresponds to minor spalling of the cover concrete. Figure 5-1 shows an example of DS2.

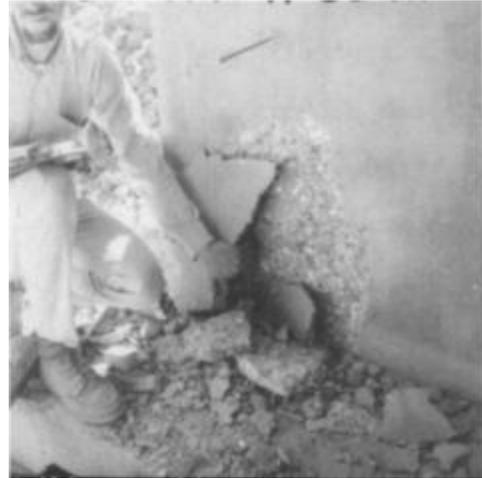
Figure 5-2. Damage state 3

Abutments under DS3 exhibit extensive spalling of cover concrete. Figure 5-2 shows an example of abutments under DS3.

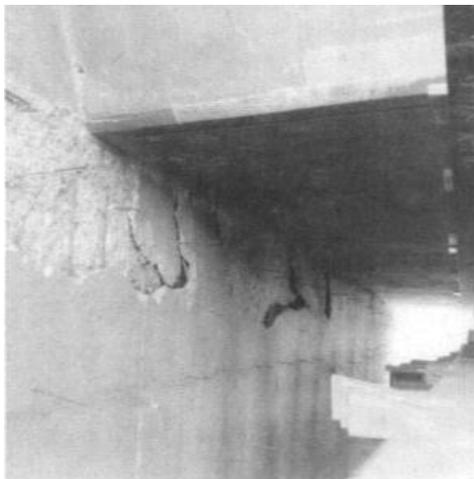
Figure 5-3. Damage state 4

This damage state consists of extensive spalling of cover concrete and visible reinforcing bars. Figure 5-3 shows an example of abutments under DS4.

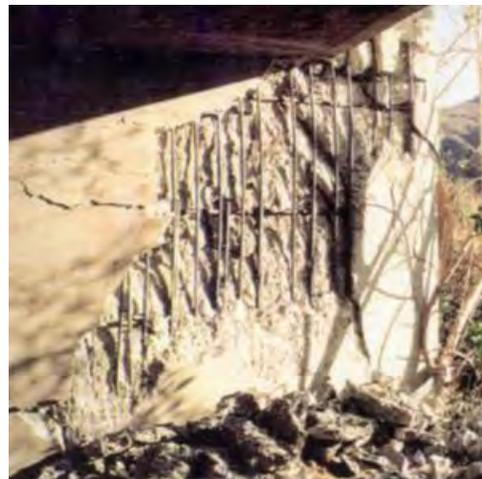
Figure 5-4. Damage state 6

This damage state corresponds to fractured bars and failure of abutments. Figure 5-4 shows abutments under damage state DS6.

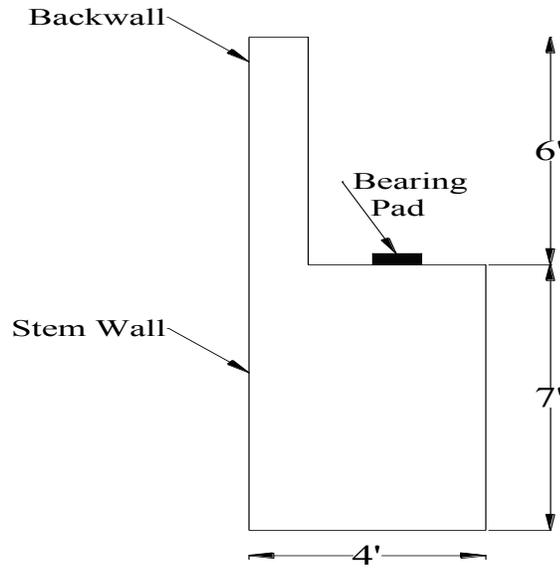
Figure 5-5. Side view of bridge abutment (seat type)

The repair of abutment stem wall under DS3/DS4 is illustrated through an example in this section. The objective of the repair for abutments under DS3/DS4 is to restore shear strength loss of 50% of concrete component. The abutment shown in Figure 5-5 was used as bench mark with original shear capacity of 6109 kips [27174 kN]). In calculating A_{cv} , the entire l_w was conservatively used. If damage is localized, the designer may use a shorter length not to be less than $1.5 \times h_w$. The material properties of abutment stem wall are presented in Table 5-1.

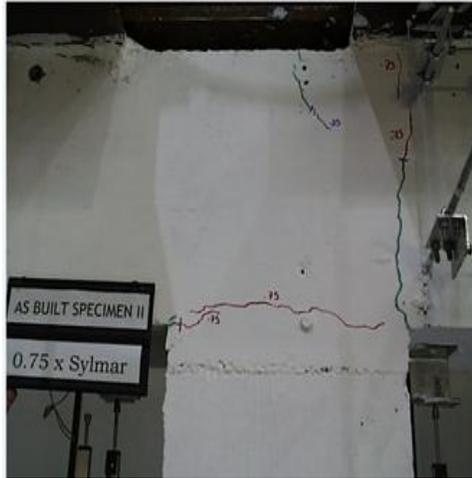
Figure 6-1. Damage state 1

This DS corresponds to minor flexural cracks at column-joint and/or beam-joint interface. Figure 6-1 shows an example of DS1.

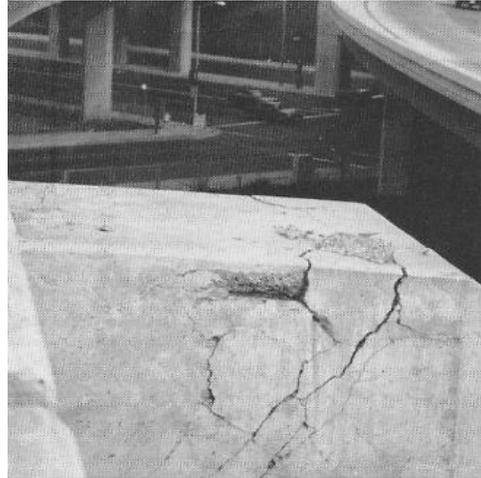
Figure 6-2. Damage state 2

This DS corresponds to shear cracking and/or minor spalling of the cover concrete. Figure 6-2 shows an example of DS2.

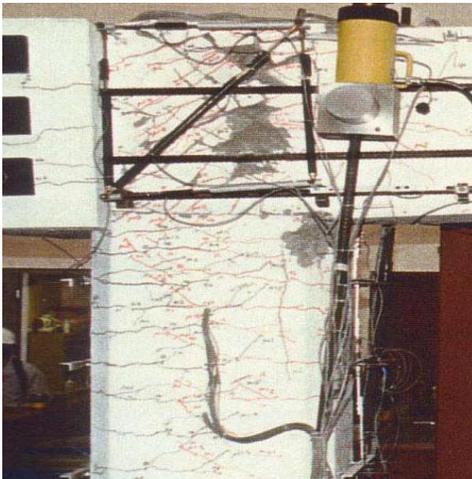
Figure 6-3. Damage state 3

Joints under DS3 exhibit extensive spalling of cover concrete. Figure 6-3 shows an example of joints under DS3.

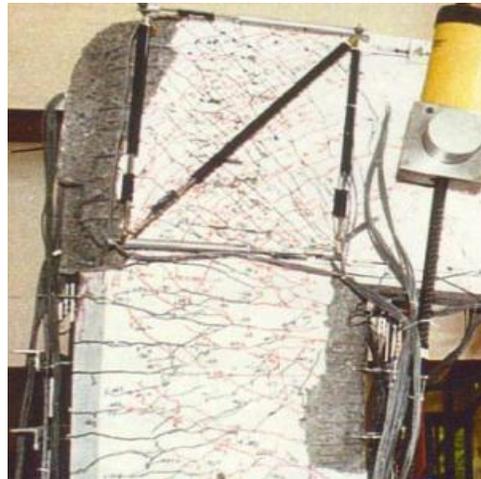
Figure 6-4. Damage state 4

This DS consists of extensive spalling of cover concrete and visible bars. Figure 6-4 shows an example of joints under DS4.

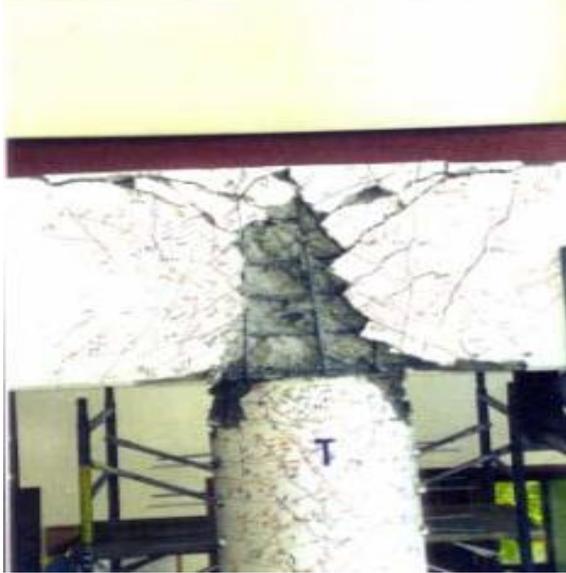
Figure 6-5. Damage state 6

This DS corresponds to the core concrete crushing and/or bar fracture. Figure 6-5 shows an example of joints under DS6.

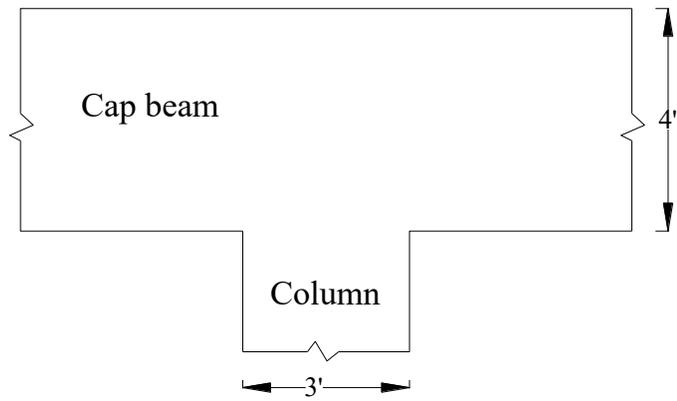
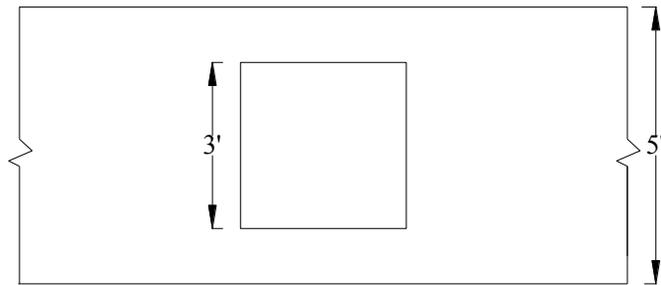
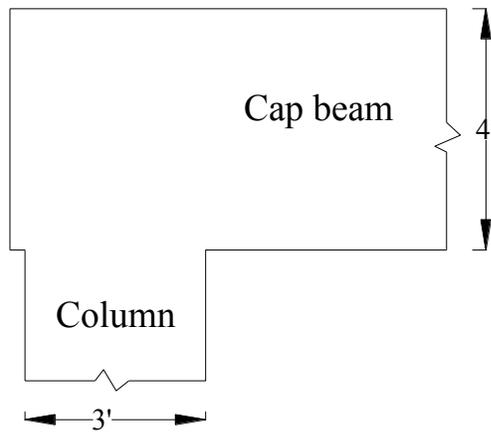
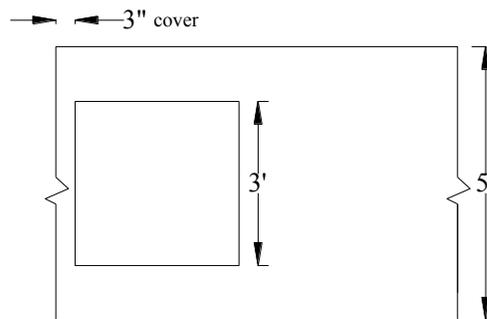
Figure 6-6. Elevation view of undamaged T joint

Figure 6-7. Plan view of undamaged T joint

Figure 6-8. Elevation view of undamaged knee Joint

Figure 6-9. Plan view of undamaged knee joint

To demonstrate a repair design, rectangular beam-column configuration was used as a benchmark. The joints shown in Figure 6-6 to Figure 6-9 were used to determine the shear strength of T and knee joint. The nominal joint shear strength (V_{jn}) was calculated using Eq. 6-1 (ACI 352 R-02).

The repair of RC bridge joints under DS2 is illustrated through an example in this section. The objective of the repair for joints under DS2 is to restore shear strength loss of 30%. The joints shown in Figure 6-6 to Figure 6-9 were used to illustrate the method. The original shear strength of T and knee joint was calculated as 1100 kips [4893 kN] and 733 [3261 kN], respectively. The expected compressive strength of concrete was assumed to be 5 ksi [34.5 Mpa].

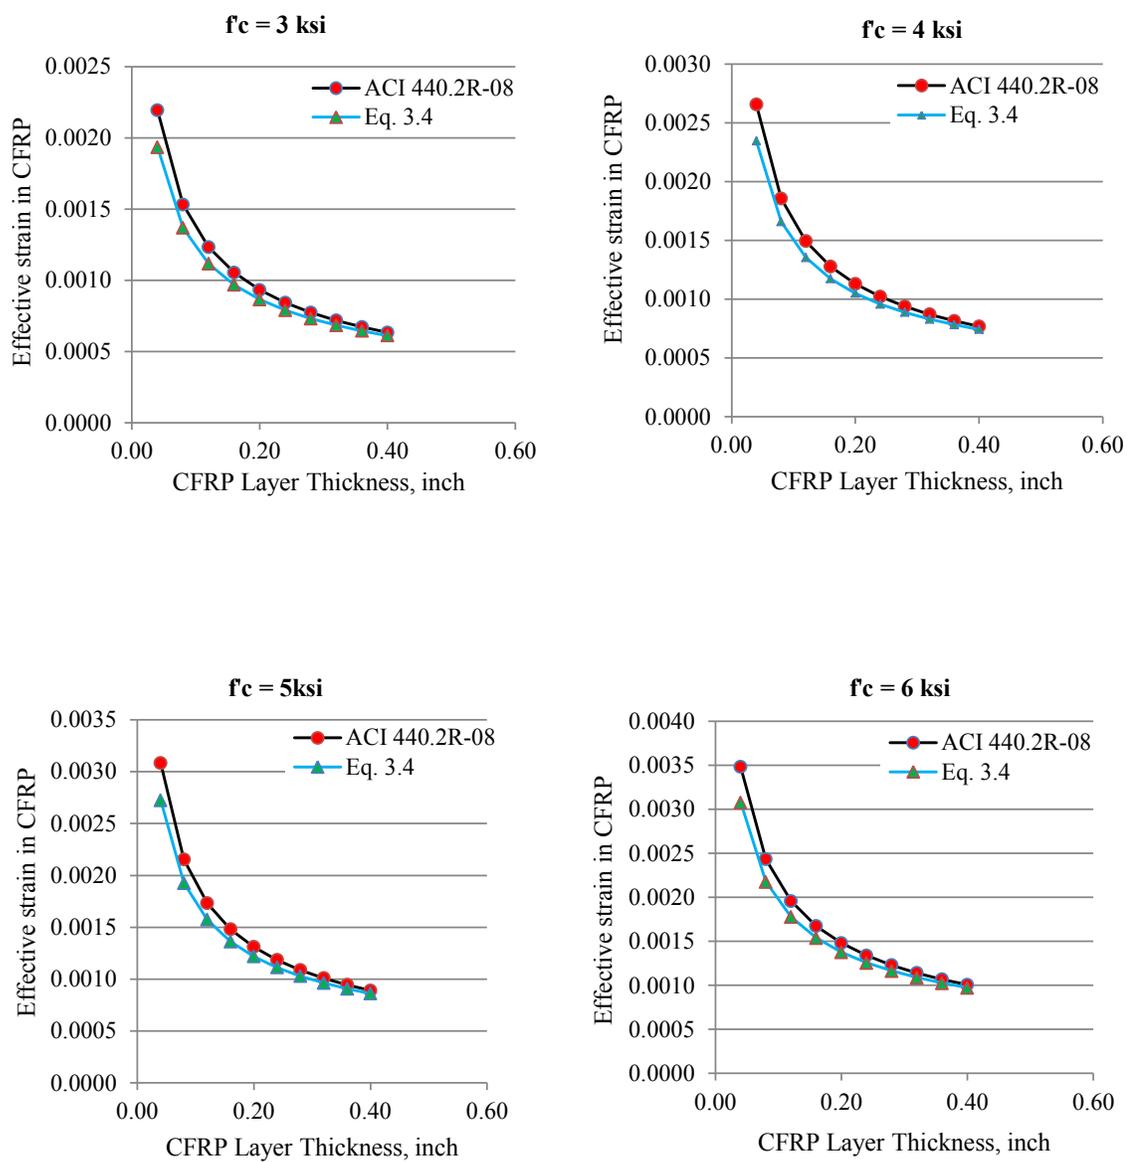
Figure A- 1. Effective strain in CFRP vs thickness for tensile modulus of 10000 ksi

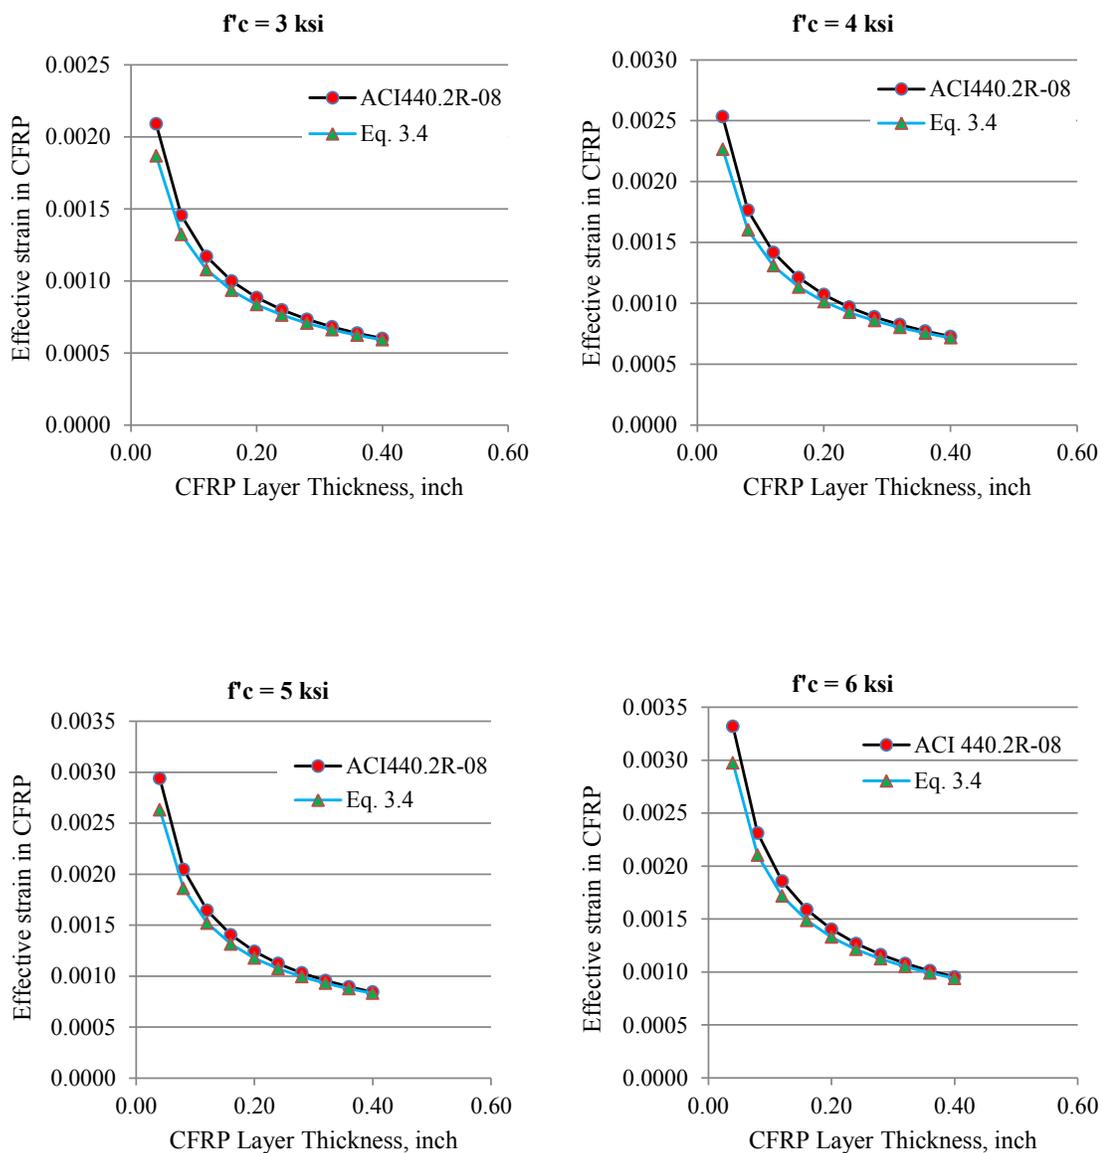
Figure A- 2. Effective strain in CFRP vs thickness for tensile modulus of 11000 ksi

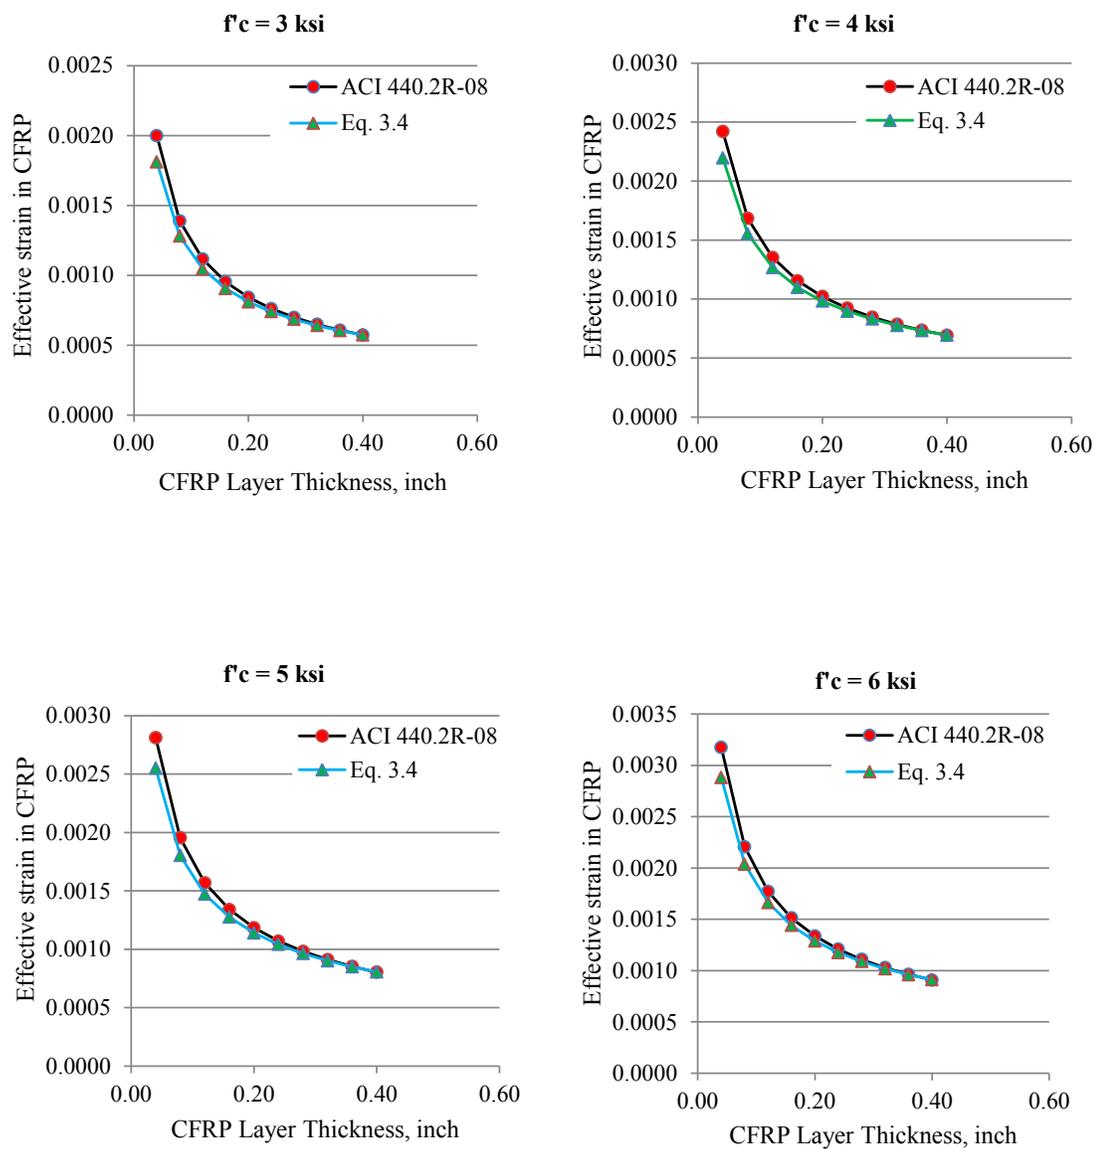
Figure A- 3. Effective strain in CFRP vs thickness for tensile modulus of 12000 ksi

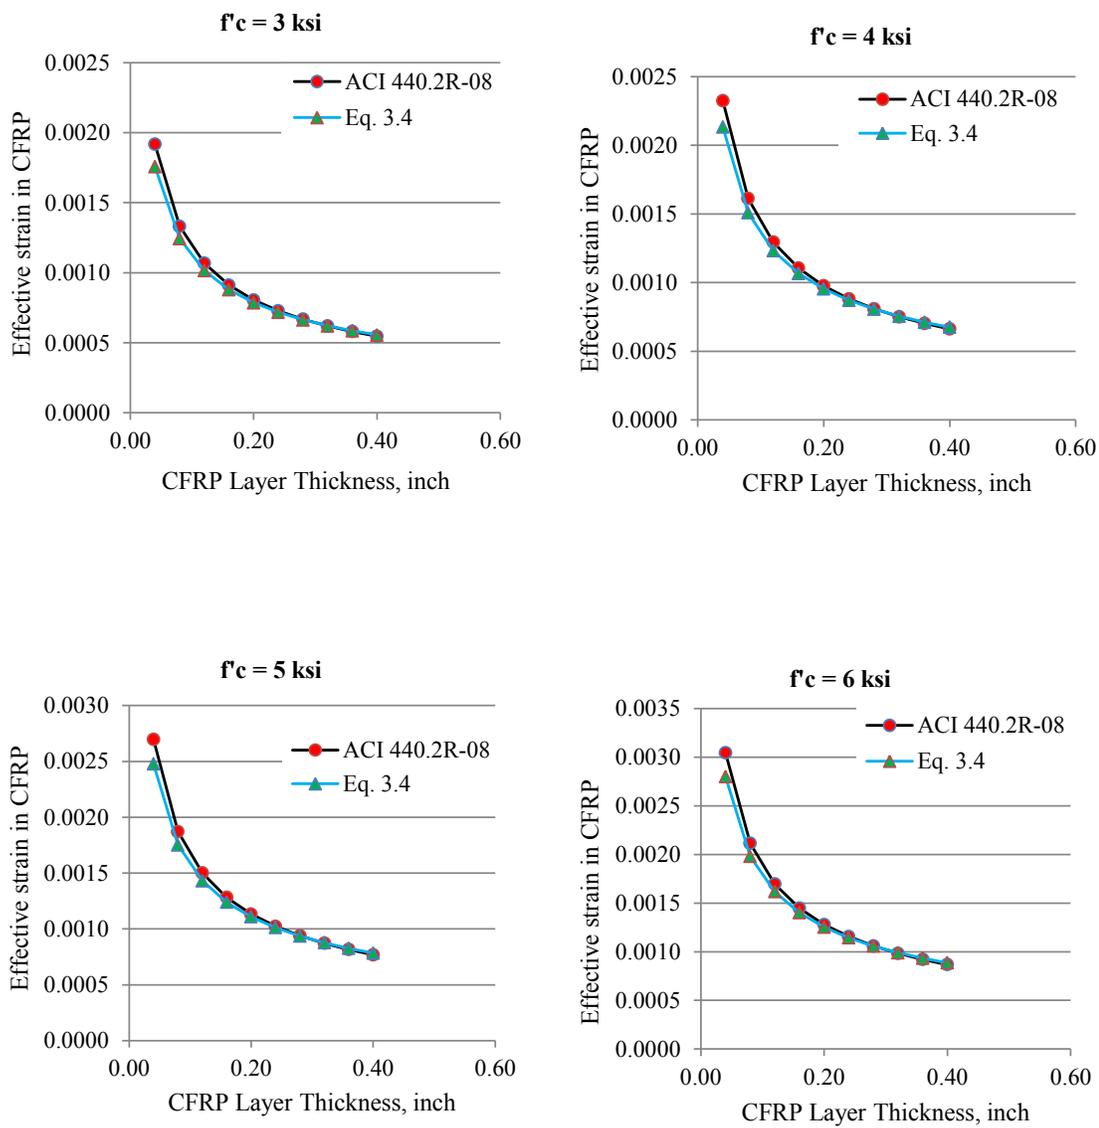
Figure A- 4. Effective strain in CFRP vs thickness for tensile modulus of 13000 ksi

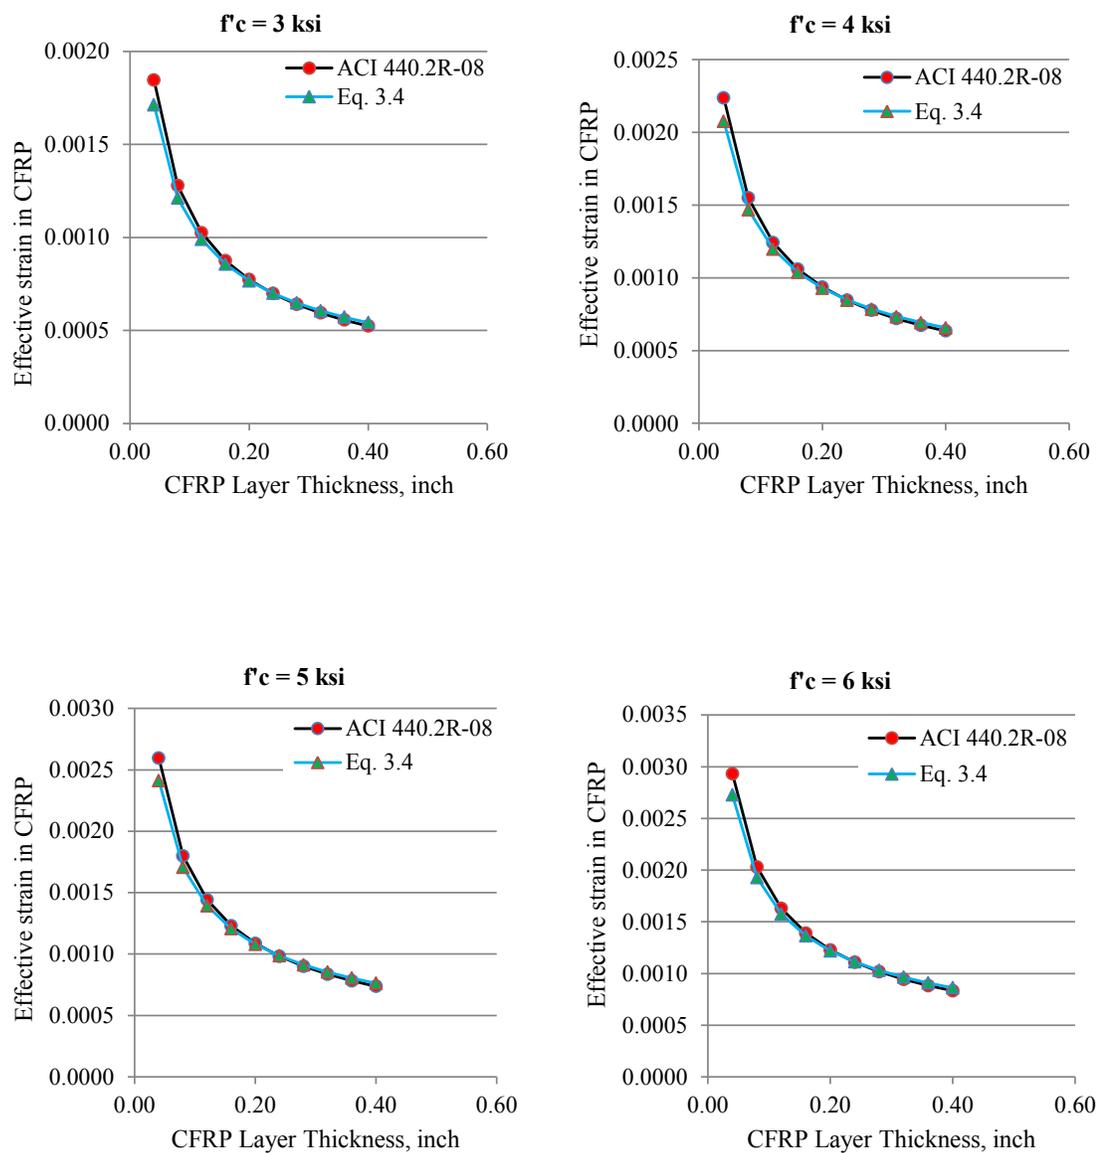
Figure A- 5. Effective strain in CFRP vs thickness for tensile modulus of 14000 ksi

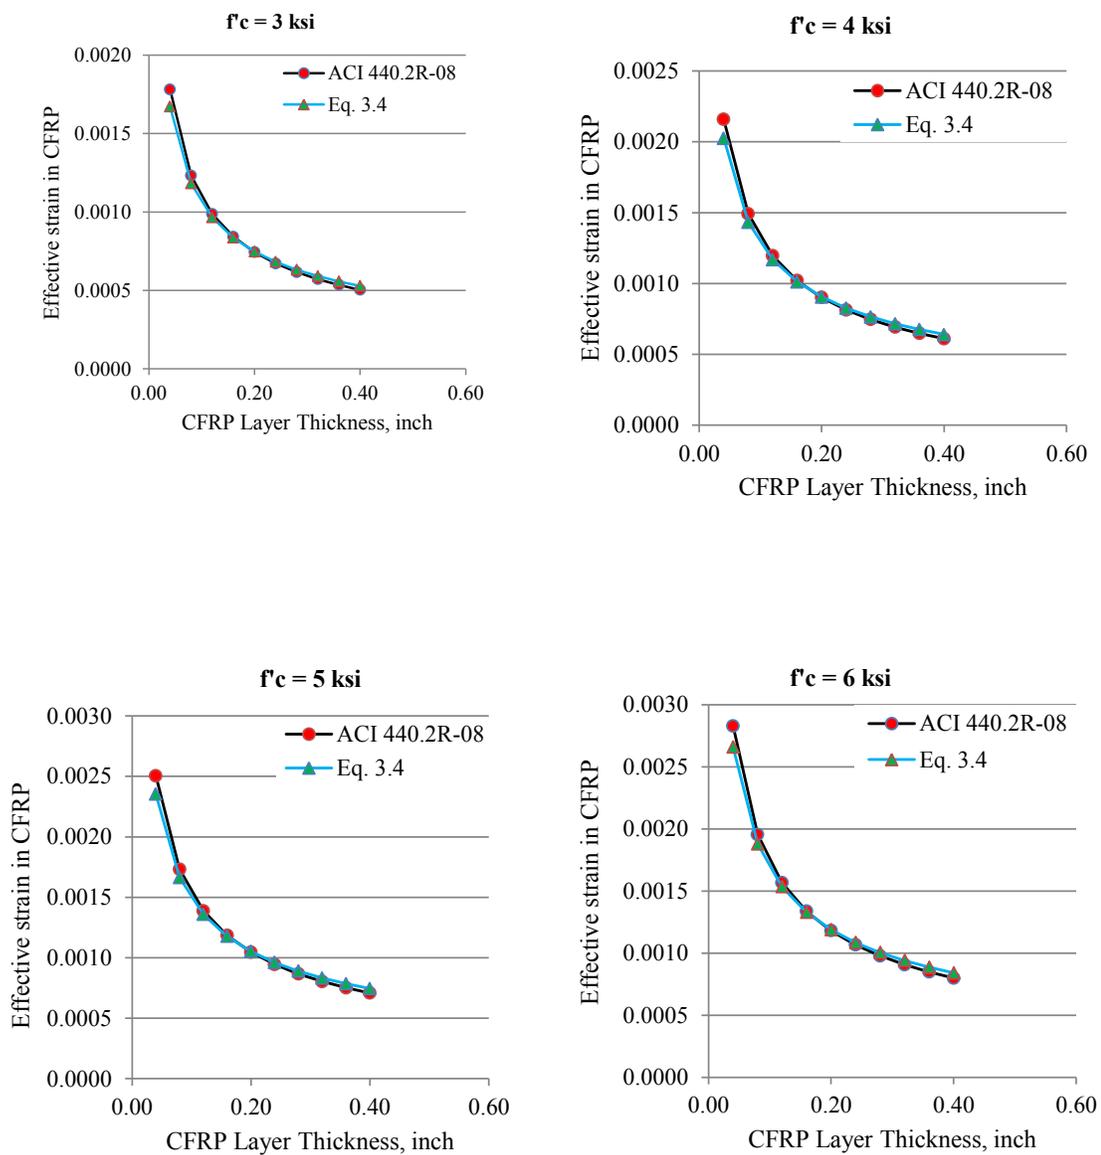
Figure A- 6. Effective strain in CFRP vs thickness for tensile modulus of 15000 ksi

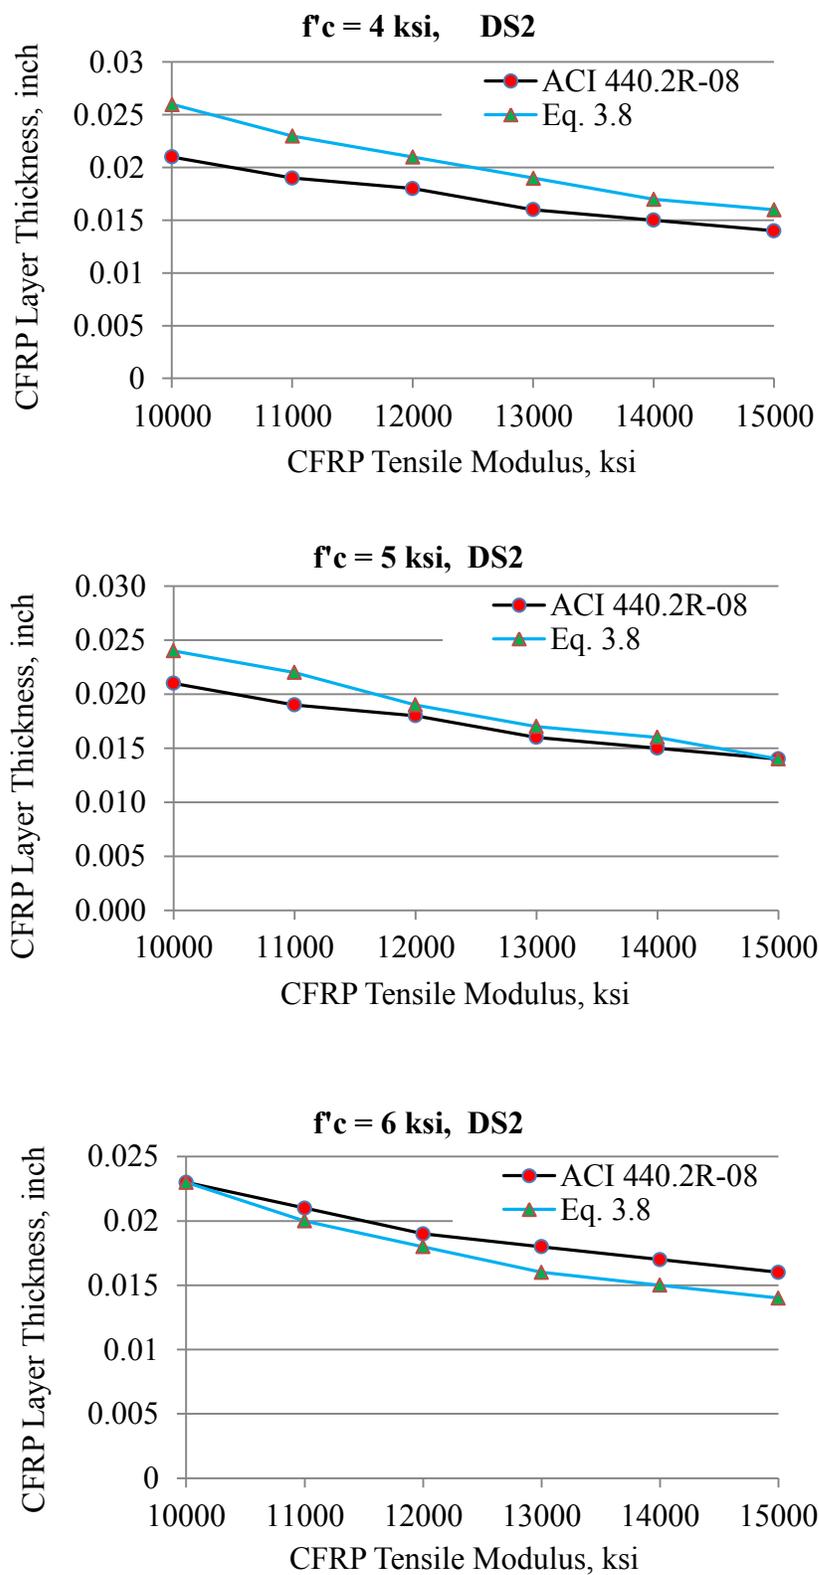
Figure A- 7. Required CFRP thickness for shear keys under DS2.

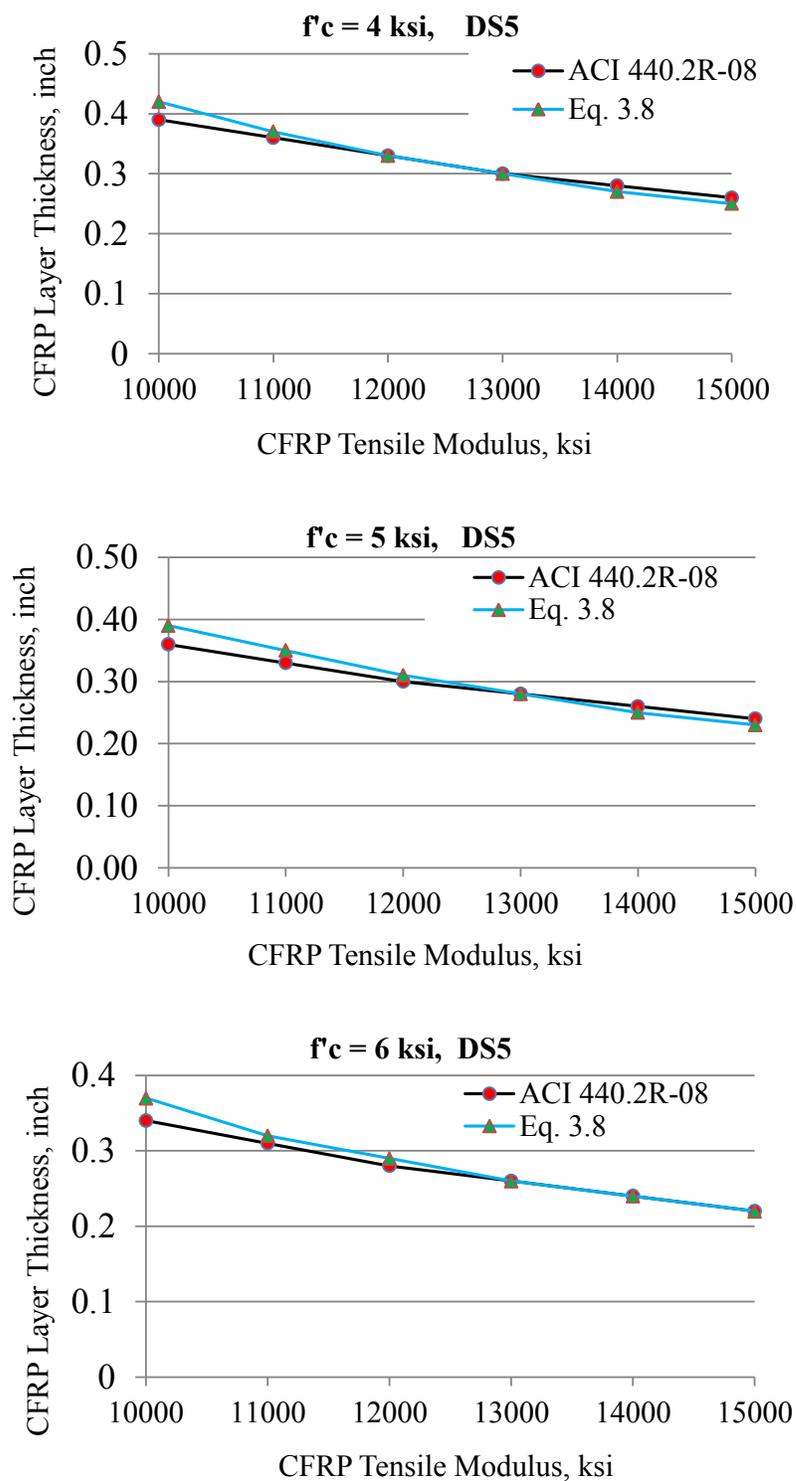
Figure A- 8. Required CFRP thickness for shear keys under DS5.

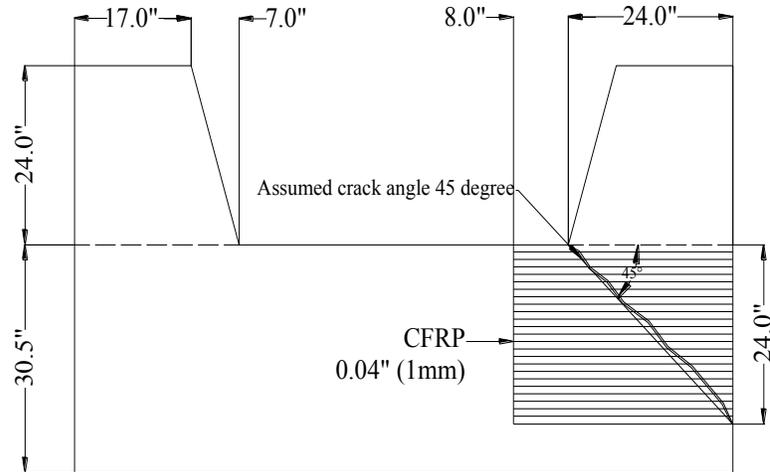
Figure B1- 1. Shear key repair design for DS2 (front view)

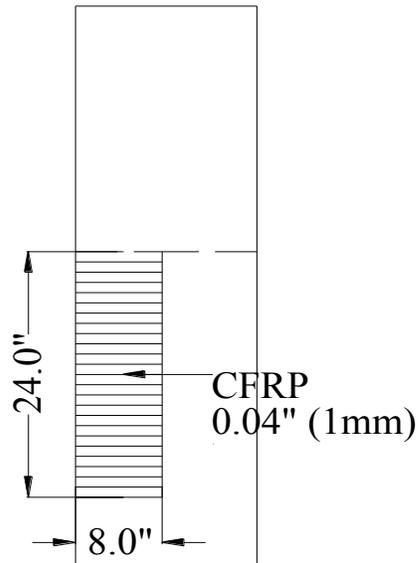
Figure B1- 2. Side view of repair for DS2

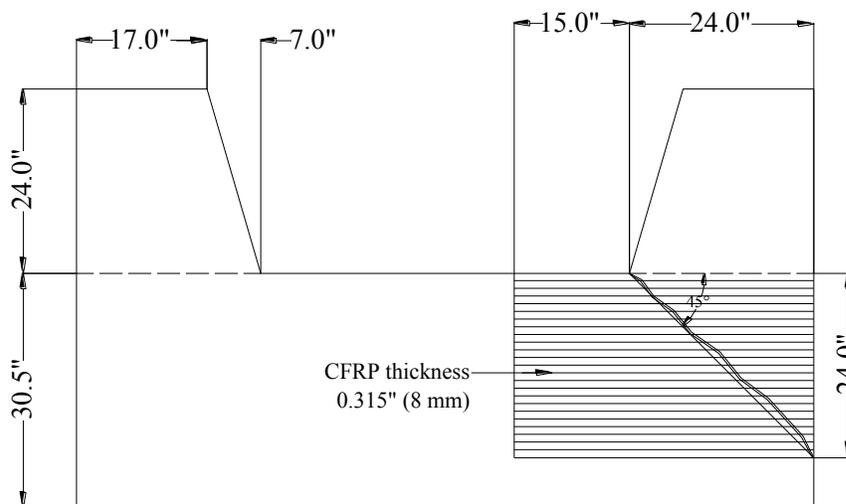
Figure B1- 3. Shear keys repair design for DS5 (front view)

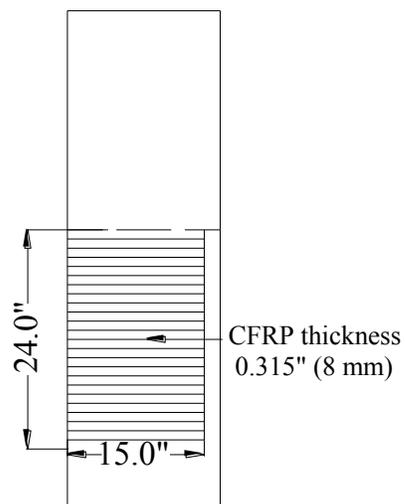
Figure B1- 4. Shear keys repair design for DS5 (side view)

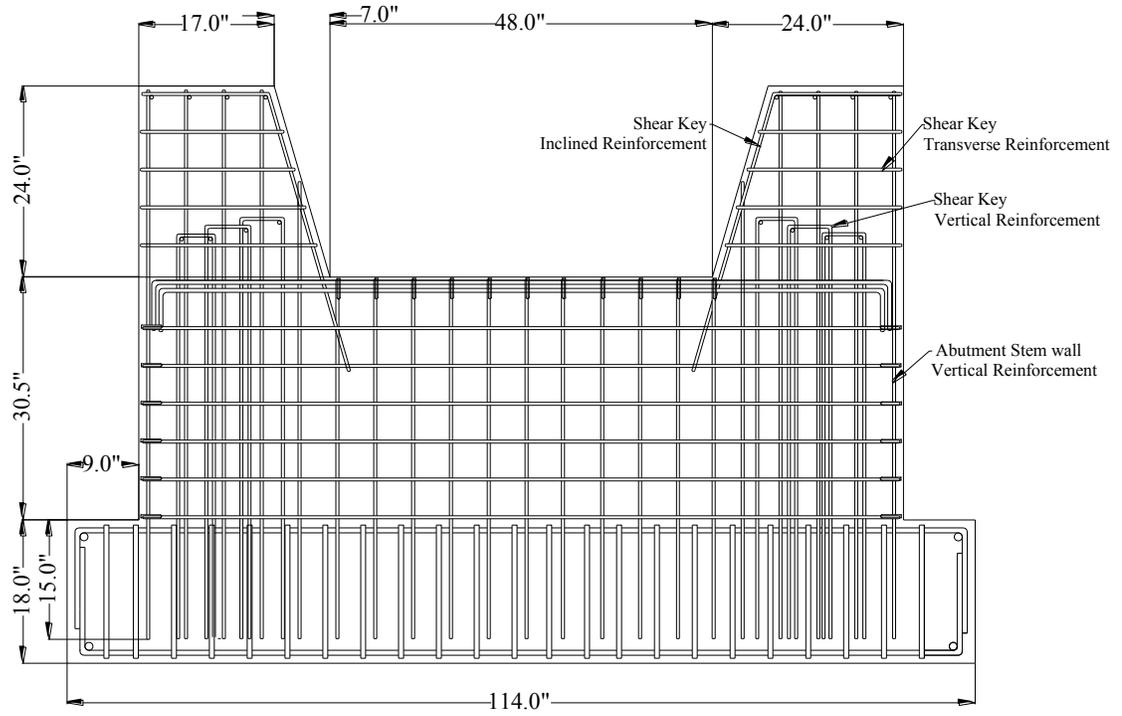
Figure B1- 5. Elevation view of reinforcement layout

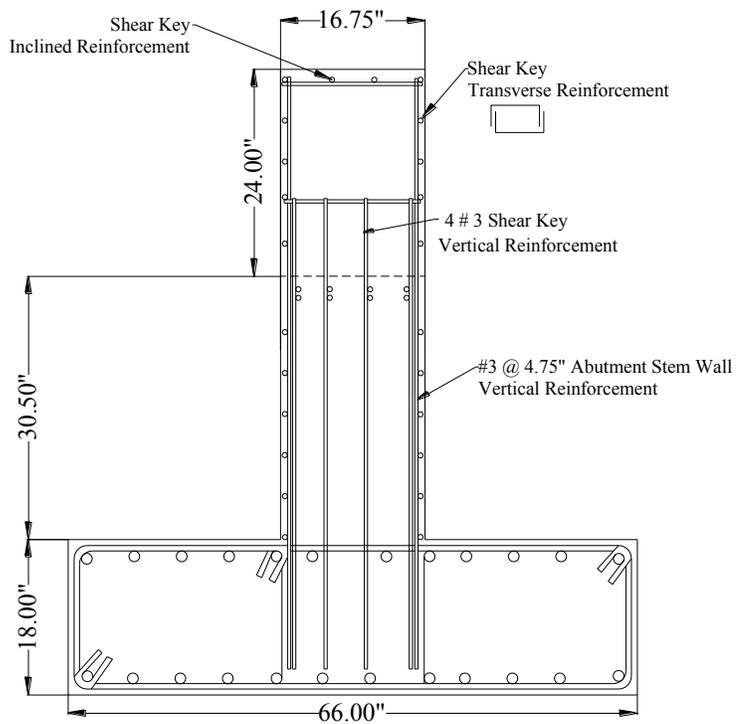
Figure B1- 6. Side view of shear key reinforcement layout
