1. REPORT NUMBER CA 13-2180	2. GOVERNMENT ASSOCIATION NUMBER	3. RECIPIENT'S CATALOG NUMBER
4. TITLE AND SUBTITLE Post-Earthquake Bridge Damage Mitigation - Post-Earthquake Damage Repair of Various Reinforced Concrete Bridge Components		5. REPORT DATE June, 2013

6. PERFORMING ORGANIZATION CODE UNR/
7. AUTHOR(S) Amarjeet Saini and M. Saiid Saiidi		8. PERFORMING ORGANIZATION REPORT NO. UNR/CA13-0371
9. PERFORMING ORGANIZATION NAME AND ADDRESS Department of Civil and Environmental Engineering University of Nevada, Reno Reno, Nevada 89557-0152		10. WORK UNIT NUMBER

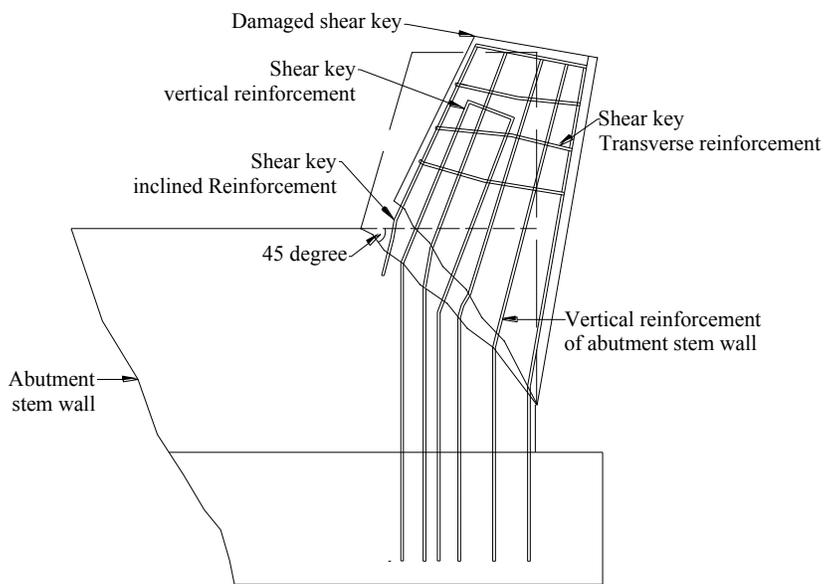
Figure B1- 7. Failure of shear key

For this example, shear key is designed for a capacity of 200 kips [890 kN]. The expected yield strength of steel is 68 ksi [302.5 MPa]. The following procedure is recommended to repair shear keys at DS6 (Figure B1- 7):

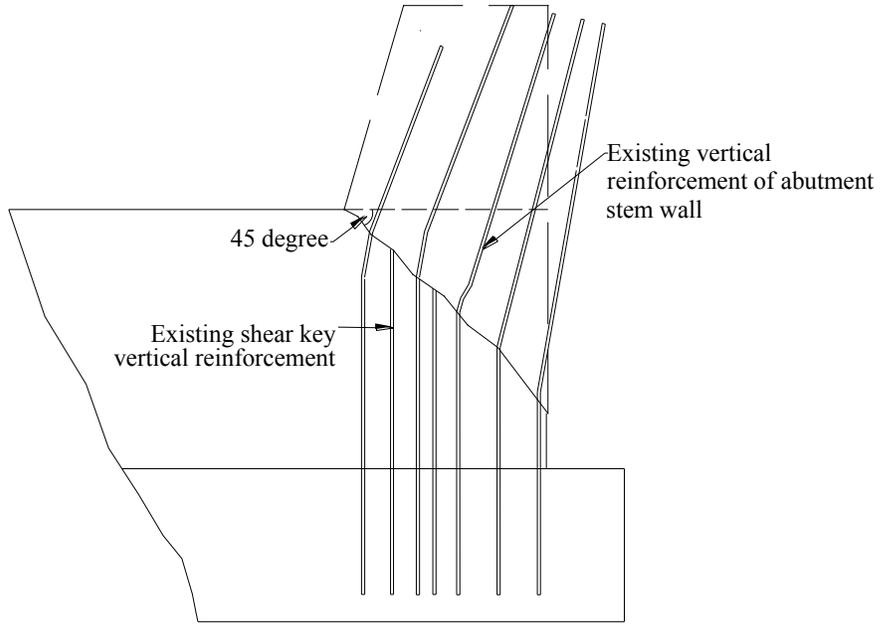
Figure B1- 8. Removal of shear key transverse and inclined reinforcement

Step 2. Remove the existing shear key transverse and inclined reinforcement but keep the abutment stem wall vertical reinforcement (Figure B1- 8). Cut all the vertical reinforcement crossing the shear key-abutment stem wall interface above 45 degree failure plane (Figure B1- 8)

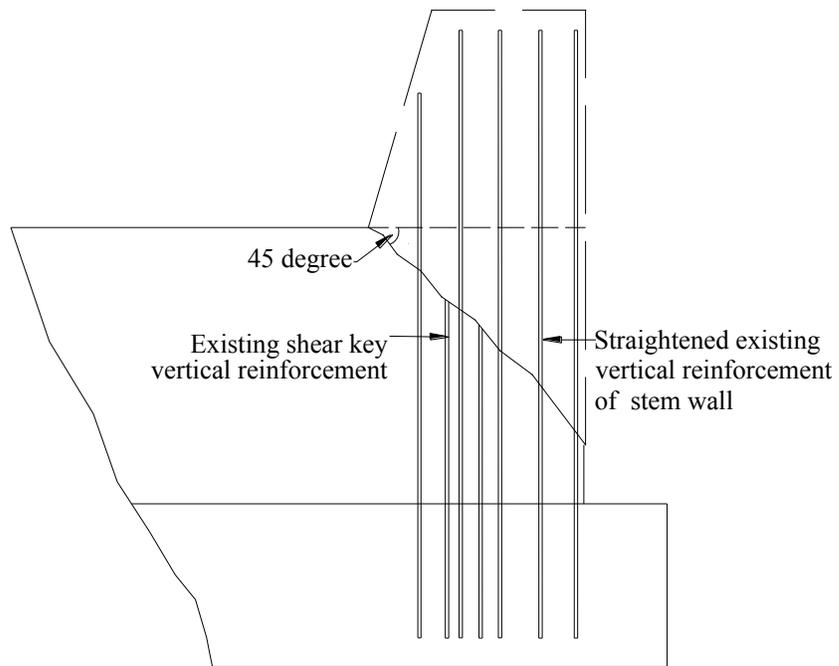
Figure B1- 9. Straightened existing stem wall vertical reinforcement

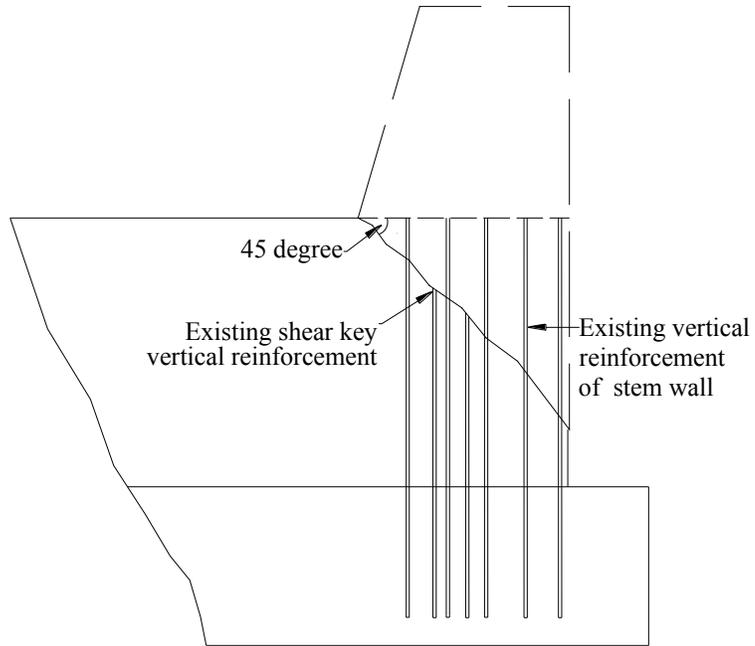
Figure B1- 10. Cut off existing stem wall vertical reinforcement and terminate at shear key-stem wall interface

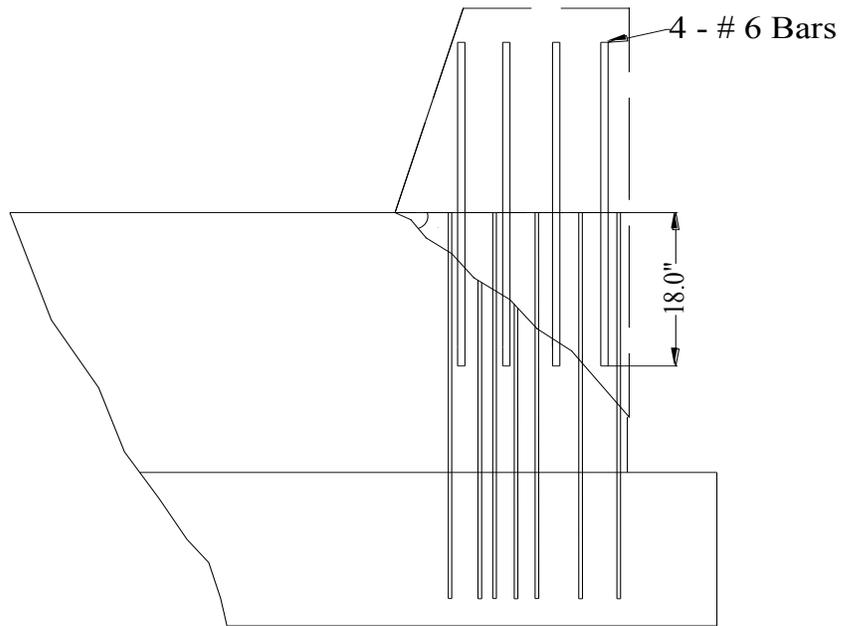
Figure B1- 11. Installation of new vertical bars

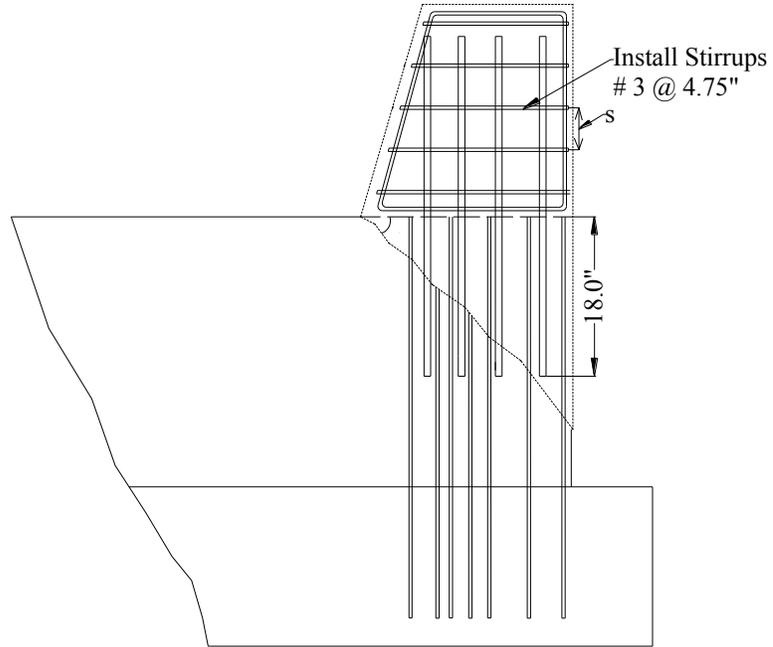
Figure B1- 12. Installation of stirrups (front view)

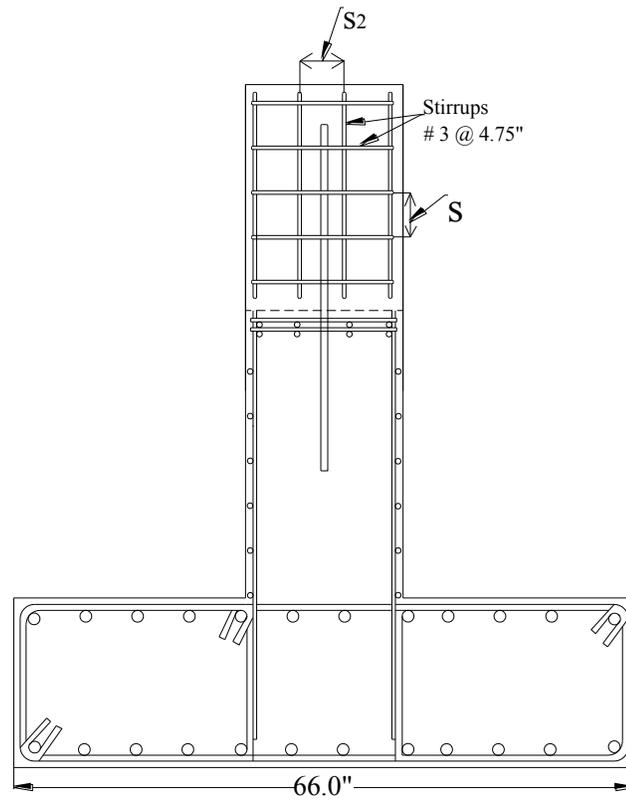
Figure B1- 13. Installation of stirrups (side view)

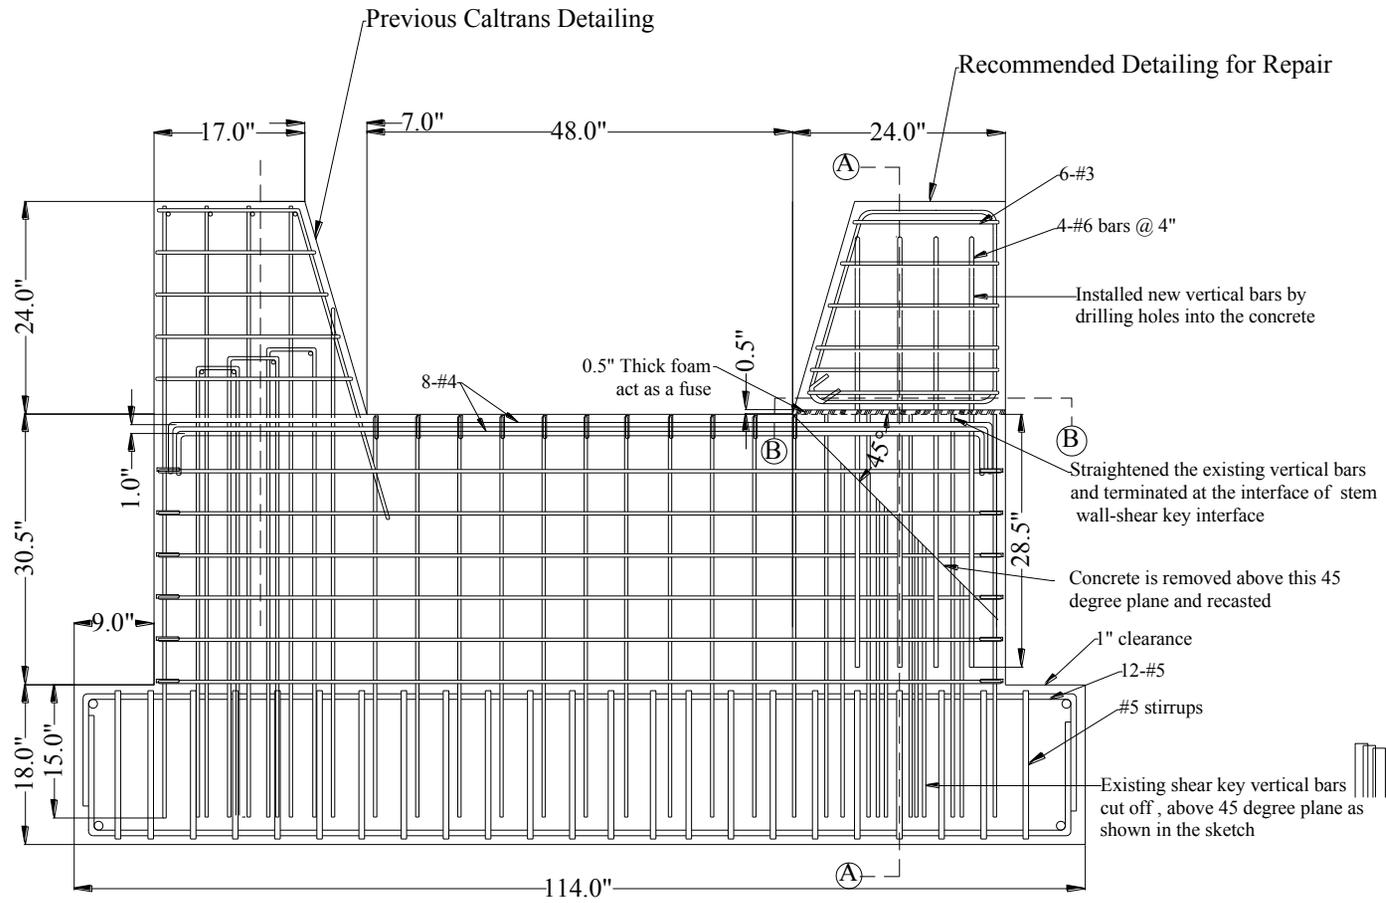
Figure B1- 14. Elevation view of a shear key repair for DS6

Figure B1- 14, Figure B1- 15, and Figure B1- 17 show the elevation, cross section, and side view of the repaired shear key for DS6, respectively. Figure B1- 16 shows the side view of the shear key vertical reinforcement.

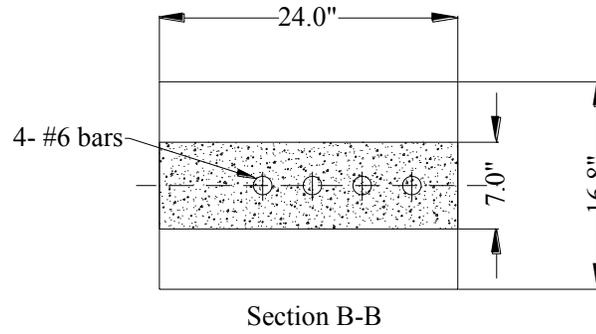
Figure B1- 15. Cross section of repaired shear key for DS6

Step 7. Provide a smooth construction joint at shear key-abutment stem wall interface to develop a weak plane so a shear friction coefficient of 0.4 can be used. For this example, the width (throat thickness) and depth of the shear key at construction joint is 7 and 24 in, respectively. The minimum 7 in [178 mm] throat thickness is recommended to have sufficient plastic moment capacity of the section so that, the shear key would not fail in flexure before sliding occurs.

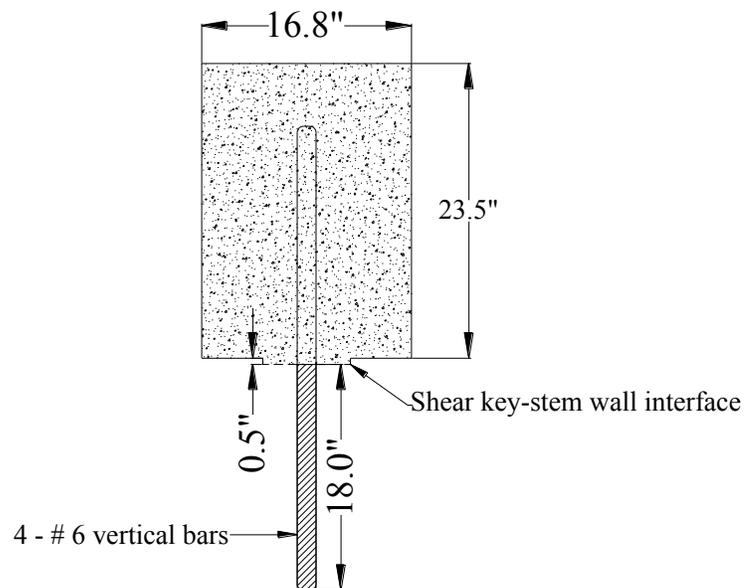
Figure B1- 16. Side view of shear key vertical reinforcement

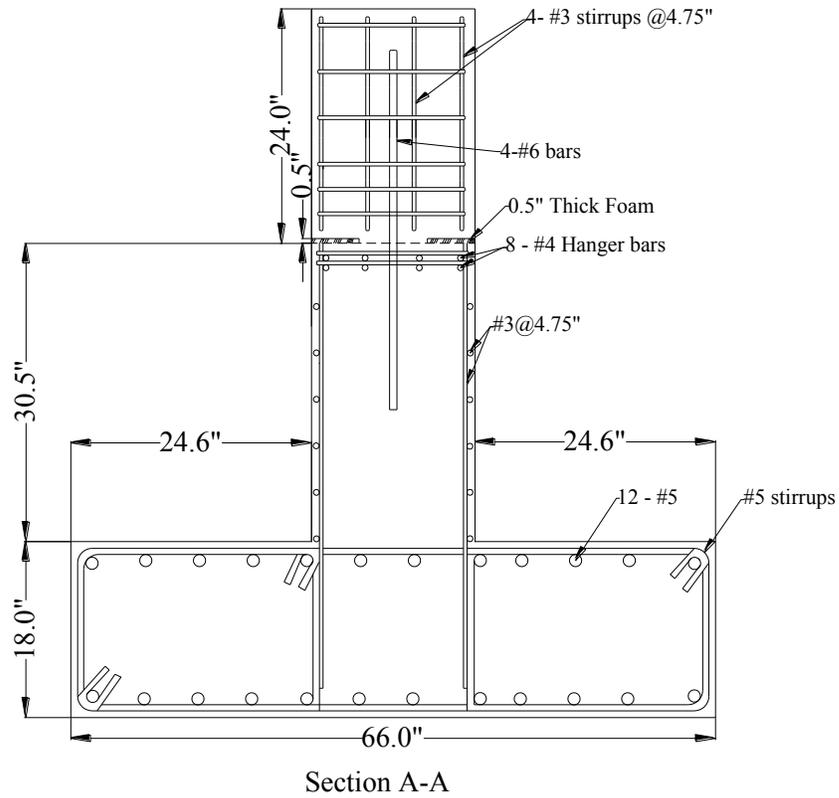
Figure B1- 17. Side view of shear key repair for DS6

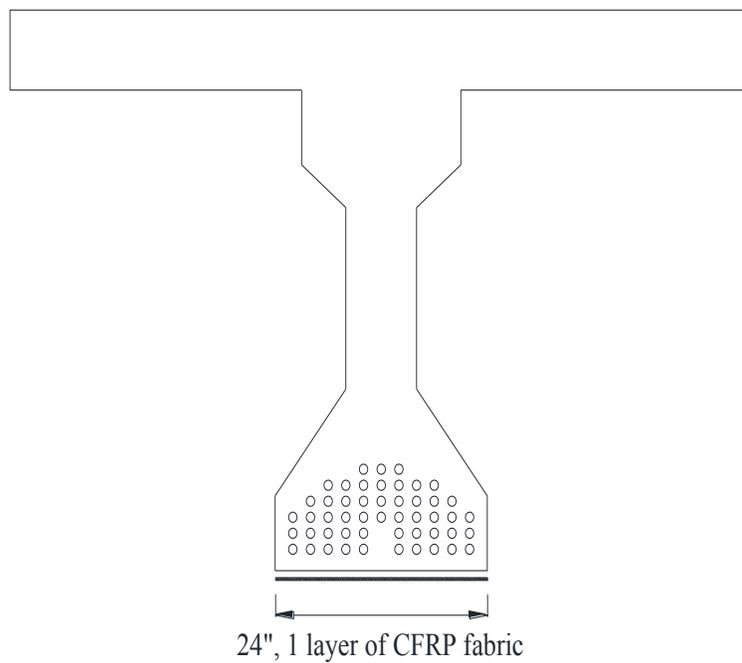
Figure B2- 1. P/S girder repair under DS2 and DS3

The material properties of unidirectional CFRP fabrics used are shown in Table 3-1. The required CFRP thickness and number of CFRP layers were calculated using the procedure recommended in section 4.6 of this report. The required CFRP thickness and area to restore 10% moment strength loss are 0.04 in. [1 mm] and 0.96 in² [619.4 mm²], respectively. The total capacity of the repaired P/S girder is 4555 k-ft [6195 kN-m] compared to the original girder capacity of 4510 k-ft [6134 kN-m]. Other parameters are compiled in Table B2- 1. Table B2- 1, shows the repaired P/S girder cross section under DS2 and 3.

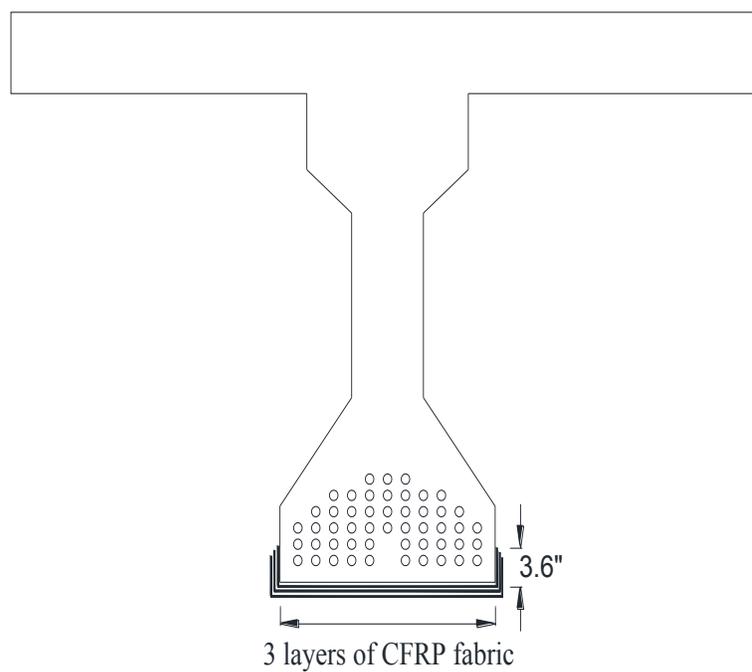
Figure B2- 2. P/S girder repair under DS4

The CFRP material properties used in repair of DS4 are the same as that used in DS2 and DS3. Unidirectional CFRP fibers are used in the longitudinal direction of the girder to repair P/S girders under DS4. The required CFRP thickness to make up 20% loss of flexural strength is 0.12 in. [3mm] (3 layers). The flexural strength provided with this design is 4318 k-ft [5873 kN-m] compared to the target strength of 4510 k-ft [6134 kN-m] which is 96% of the target capacity. To make up for the rest 4%, it is recommended to bend the CFRP around the girder soffit corners for at least half the bottom flange depth (U wrap). The flexural strength provided by this design is 4485 k-ft [6100 kN-m], which is approximately equal to the target strength of 4510 k-ft [6134 kN-m]. Other parameters are presented in Table B2- 1. Figure B2- 2 shows the P/S girder repair at DS4.

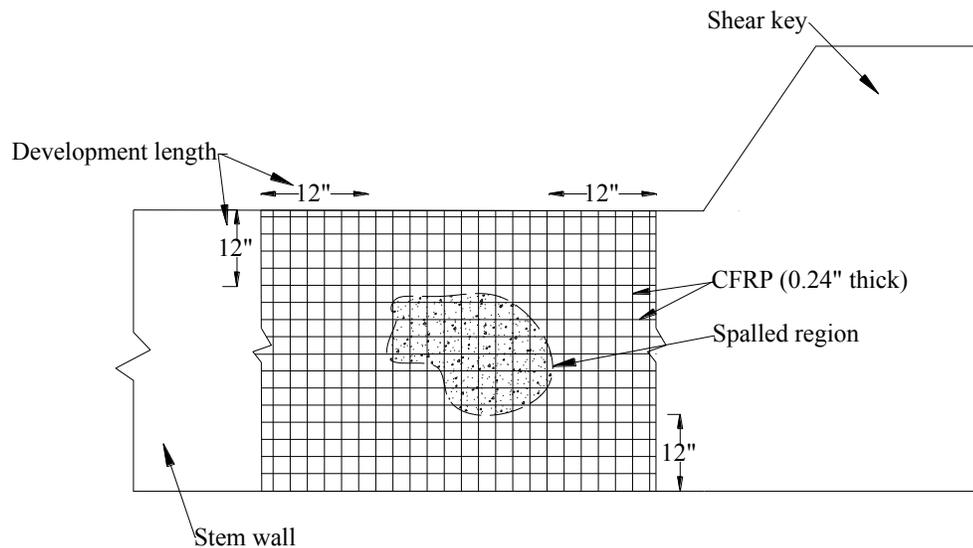
Figure B3- 1. Repair of abutment wall under DS3 and DS4

The repair of abutment stem wall under DS3/DS4 is illustrated through an example in this section. The objective of the repair for abutments under DS3/DS4 is to restore shear strength loss of 50% of concrete component. The abutment shown in Figure 5-5 was used as bench mark with original shear capacity of 6109 kips [27174 kN]). In calculating A_{cv} , the entire l_w was conservatively used. If damage is localized, the designer may use a shorter length not to be less than $1.5 \times h_w$. The material properties of abutment stem wall are presented in Table 5-1.

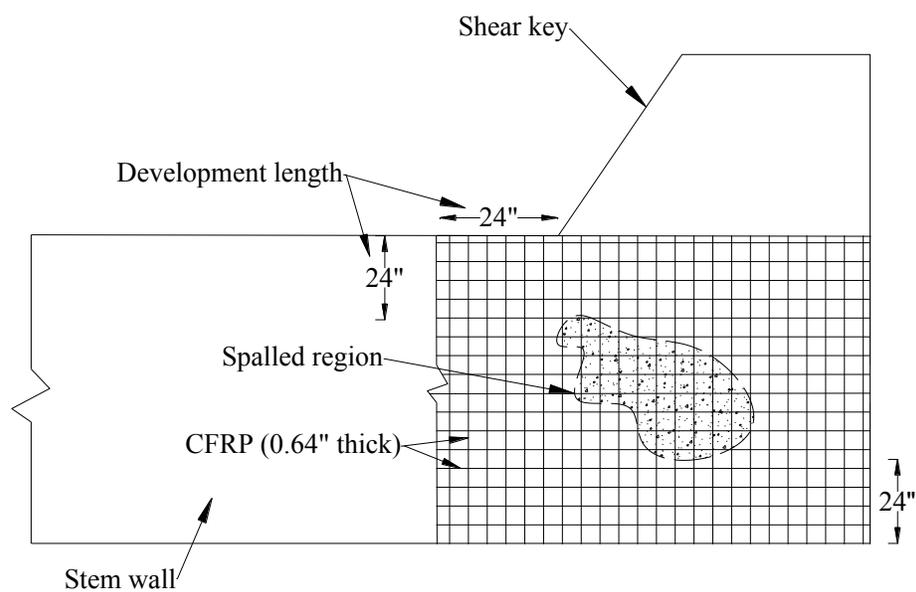
Figure B3- 2. Repair of abutment wall under DS6

CFRP fibers were used in the horizontal or vertical directions to repair abutments with DS6. The required CFRP thickness to restore shear strength loss at DS6 is determined by utilizing Eq. 5-2 and 3-8. In this example, the entire l_w was conservatively used to calculate A_{cv} . If damage is localized, the designer may use a shorter length not to be less than $1.5xh_w$. The required CFRP thickness presented in Table B3- 1 for DS6 are based on the assumed shear strength loss of 80%, which is 4887 kips [21738 kN]. The required CFRP thickness was determined to be 0.62 in [15.5 mm]. Sixteen layers with a total thickness of 0.64 in [16 mm] are provided in each horizontal and vertical direction. Figure B3- 2 shows the repair of abutment stem wall for DS6.

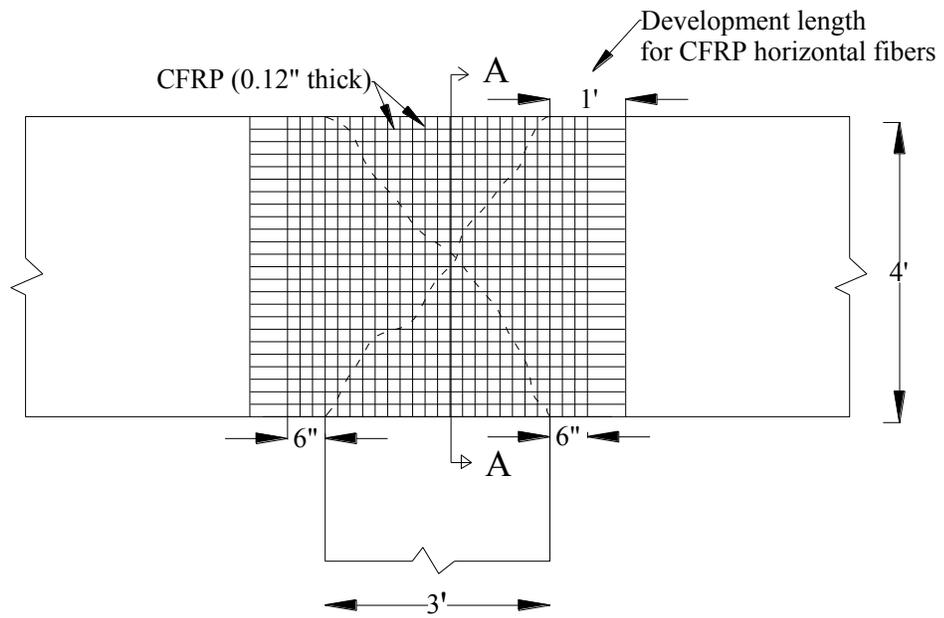
Figure B4- 1. Elevation view of T joints repair under DS2

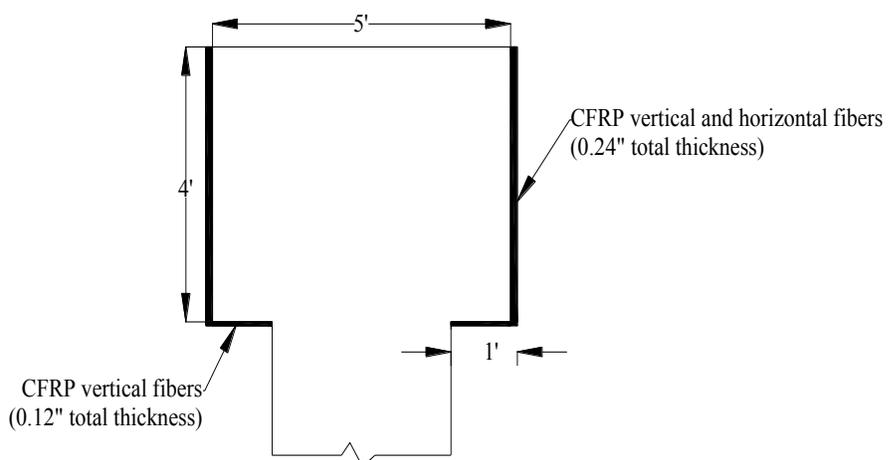
Figure B4- 2. Section A-A of T joints repair under DS2

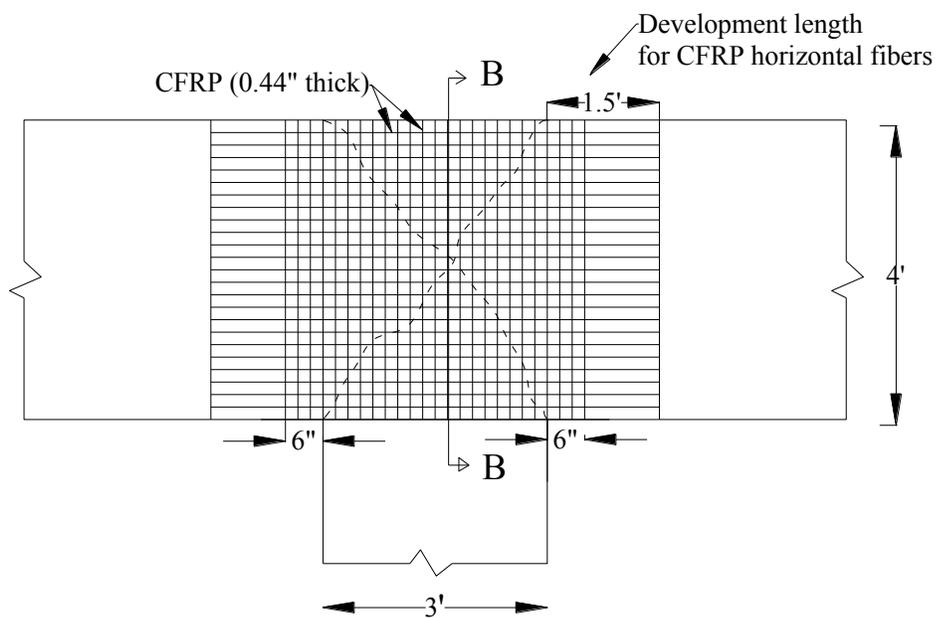
Figure B4- 3. Elevation view of T joints repair under DS3 and DS4

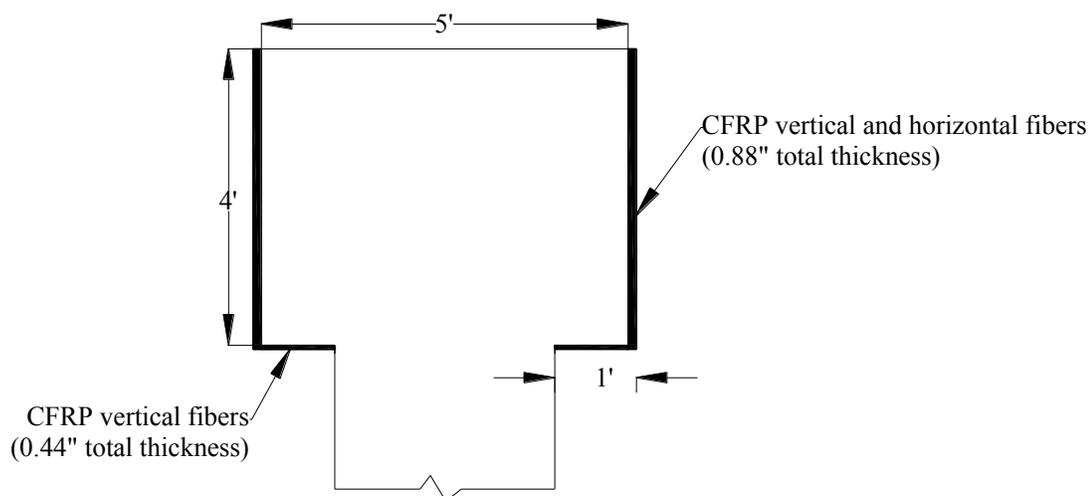
Figure B4- 4. Section B-B of T joints repair under DS3 and DS4

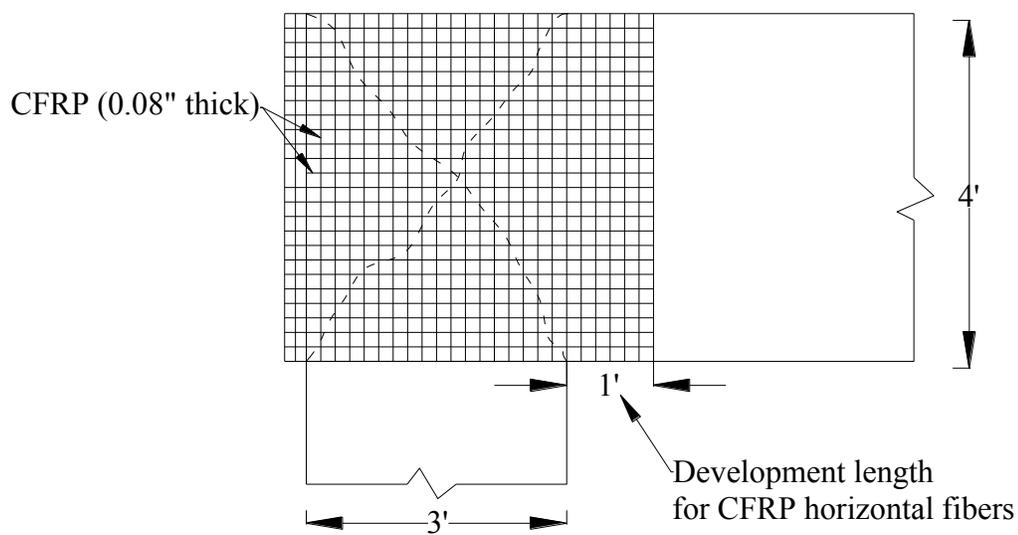
Figure B4- 5. Elevation view of knee joints repair under DS2

wrap with a total thickness of 0.08 in [2mm] are provided in each direction of the knee joint. Figure B4- 5, Figure B4- 6, and Figure B4- 7 show the elevation, side, and plan view of the repair for knee joints under DS2, respectively.

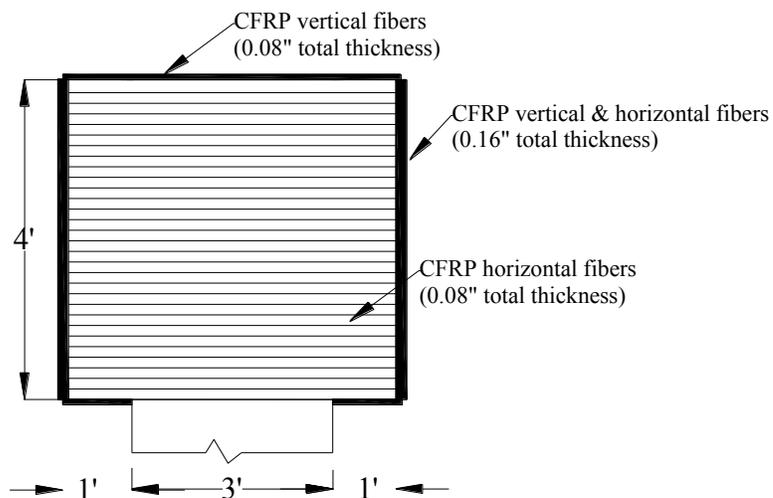
Figure B4- 6. Side view of knee joints repair under DS2

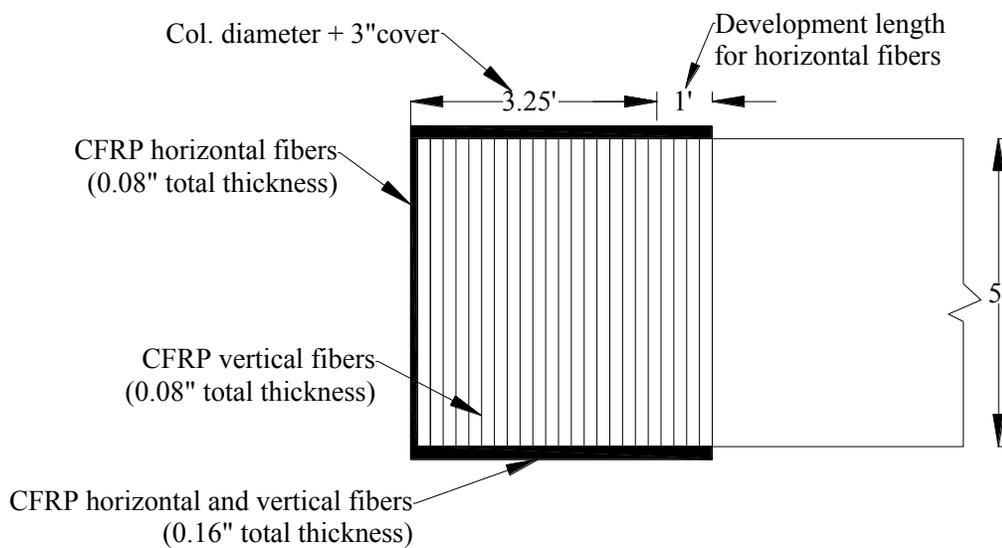
Figure B4- 7. Plan view of knee joints repair under DS2

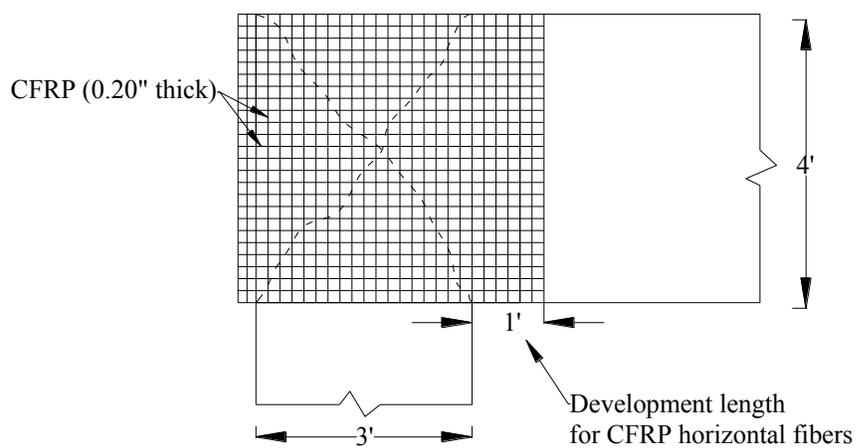
Figure B4- 8. Elevation view of knee joints repair under DS3 and DS4

The objective of repair of joints under DS3 and DS4 was to restore shear strength loss of 60%. The CFRP material used in repair of DS3 and DS4 was the same as that used in DS2. Unidirectional CFRP fabrics were used with fibers in the horizontal or vertical directions to repair joints with DS3 and DS4. The required CFRP thickness to restore shear strength loss at DS3 and DS4 was determined by utilizing Eq. 3-8. The required CFRP thickness presented in Table B4- 1 for T-joints under DS3 and DS4 is based on the assumed shear strength loss of 60%, which is 660 kips [2936 kN]. The required CFRP thickness was determined to be 0.44 in [11 mm] in each direction (horizontal or vertical) on each side of the cap beam. Eleven layers with a total thickness of 0.44 in [11 mm] are provided in each direction. Figure B4- 3 and Figure B4- 4 show the elevation and section view of the repair of T-joints under DS3 and DS4, respectively. The same repair procedure used for T-joints was applied to determine the required CFRP thickness for knee joints under DS3 and DS4. The required CFRP thickness presented in Table B4- 2 for knee joints under DS3 and DS4 is based on the assumed shear strength loss of 60%, which is 440 kips [1957 kN]. The required CFRP thickness for knee joints under DS3 and DS4 was determined to be 0.20 in [5 mm] in each direction. Five layers of U-wrap with a total thickness of 0.20 in [5 mm] are installed in each direction. Figure

B4- 8, Figure B4- 9, and Figure B4- 10 show the elevation, side, and plan view of the repaired knee joints under DS3 and DS4, respectively.

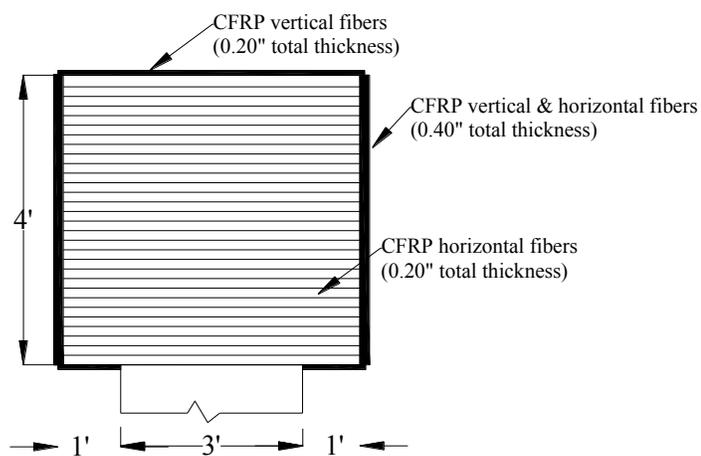
Figure B4- 9. Side view of knee joint repair under DS3 and DS4

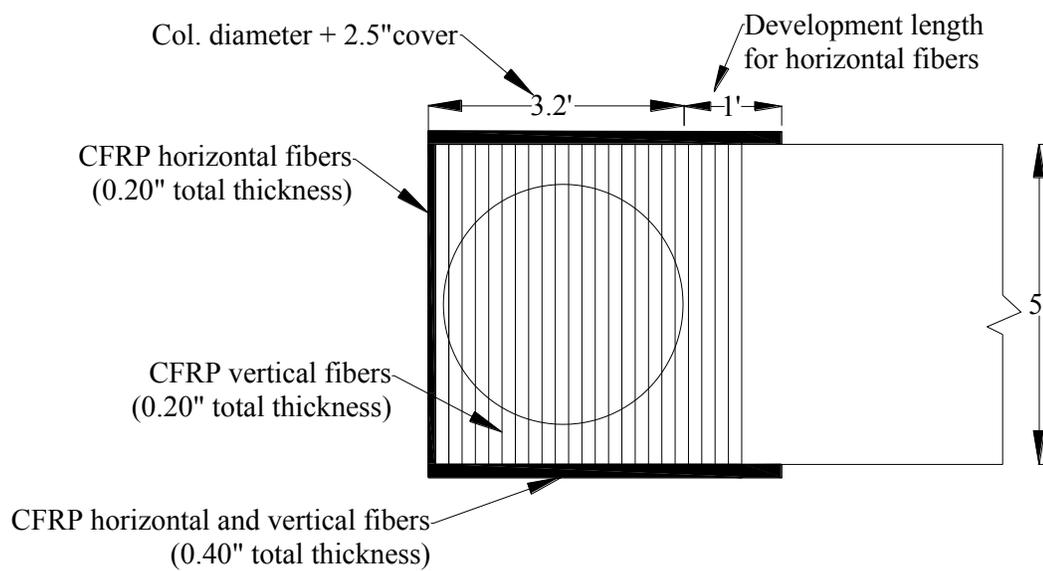
Figure B4- 10. Plan view of knee Joint repair under DS3 and DS4
