1. REPORT NUMBER CA12-1200 A	2. GOVERNMENT ASSOCIATION NUMBER	3. RECIPIENT'S CATALOG NUMBER
4. TITLE AND SUBTITLE Quieter Pavement Research: Concrete Pavement Tire Noise	5. REPORT DATE 05/30/2011

6. PERFORMING ORGANIZATION CODE
7. AUTHOR John T. Harvey and Erwin Kohler	8. PERFORMING ORGANIZATION REPORT NO. UCPRC-RR-2010-03	
9. PERFORMING ORGANIZATION NAME AND ADDRESS University of California, Davis & Berkeley Partnered Pavement Research Center 1353 S. 46th Street, Bldg. 452 Richmond, CA 94804	10. WORK UNIT NUMBER

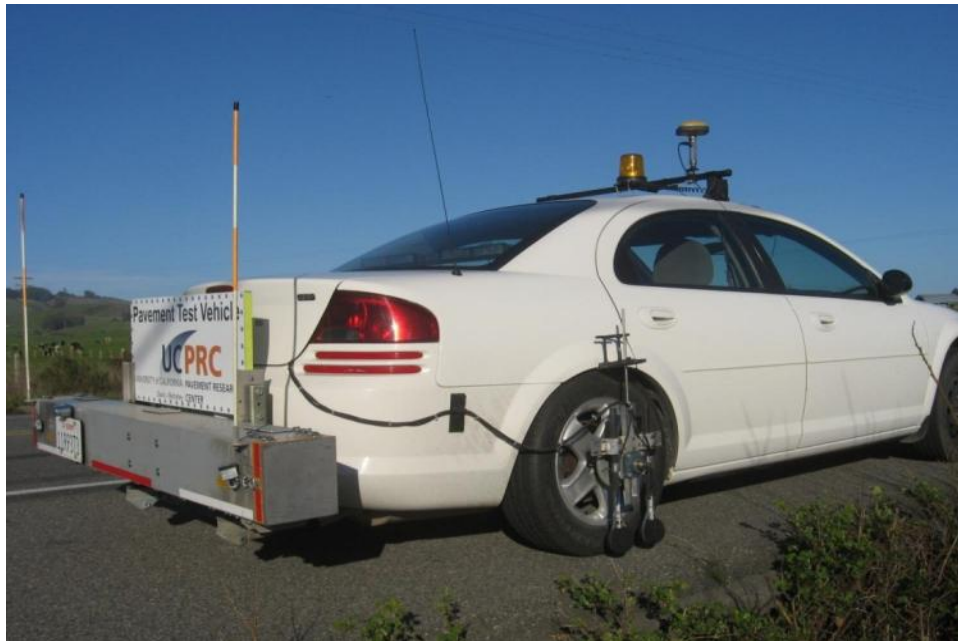
Figure 2.1: Instrumented vehicle with on-board sound intensity probes and an inertial profilometer.

In addition to the use of the OBSI method to measure tire/pavement noise, an inertial profilometer was used to measure International Roughness Index (IRI) and Mean Profile Depth (MPD), and visual observations were made of the surface texture type and condition of each test section. The measured IRI values and texture observations were collected at the same fixed short intervals used for OBSI measurement. The instrumented vehicle used in this project is shown in Figure 2.1.

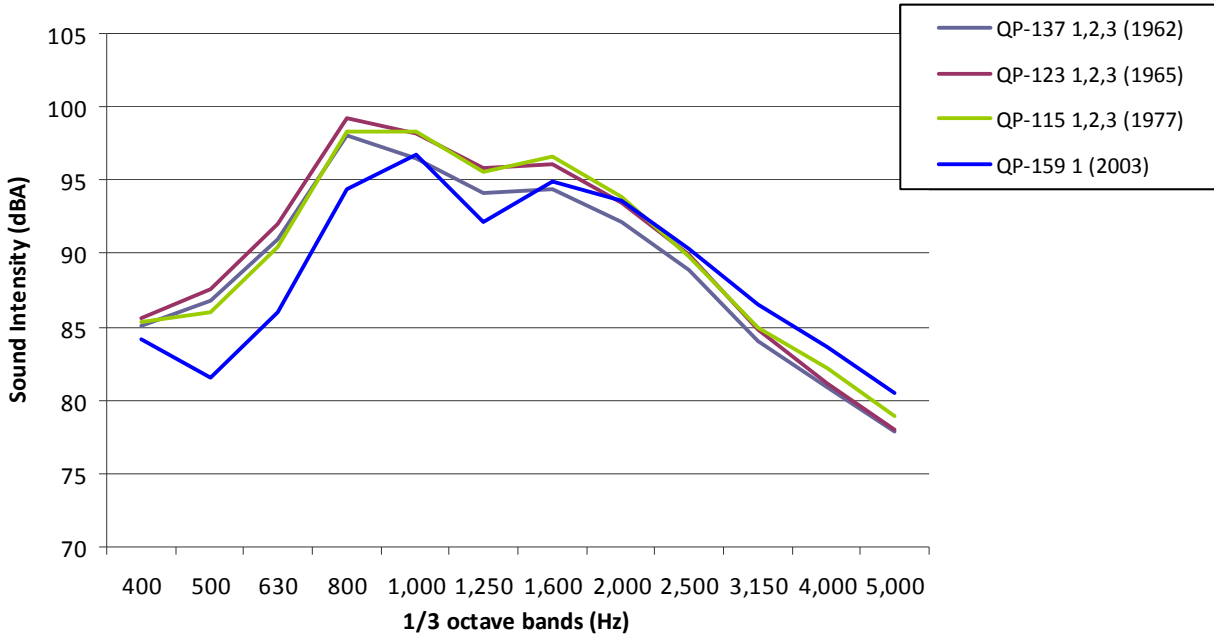
Figure 3.1: OBSI spectral content for burlap drag sections, texture *aged*.

There were no sections with burlap drag texture in the *new* texture category. The texture *aged* and texture *worn out* sections are shown in Figure 3.1 and Figure 3.2 respectively. A comparison of the average spectral content for the conditions is shown in Figure 3.3. For one-third octave band frequencies below 1,600 Hz, the spectra for the sections with the texture *worn out* have greater sound intensity levels than for *aged* texture sections.

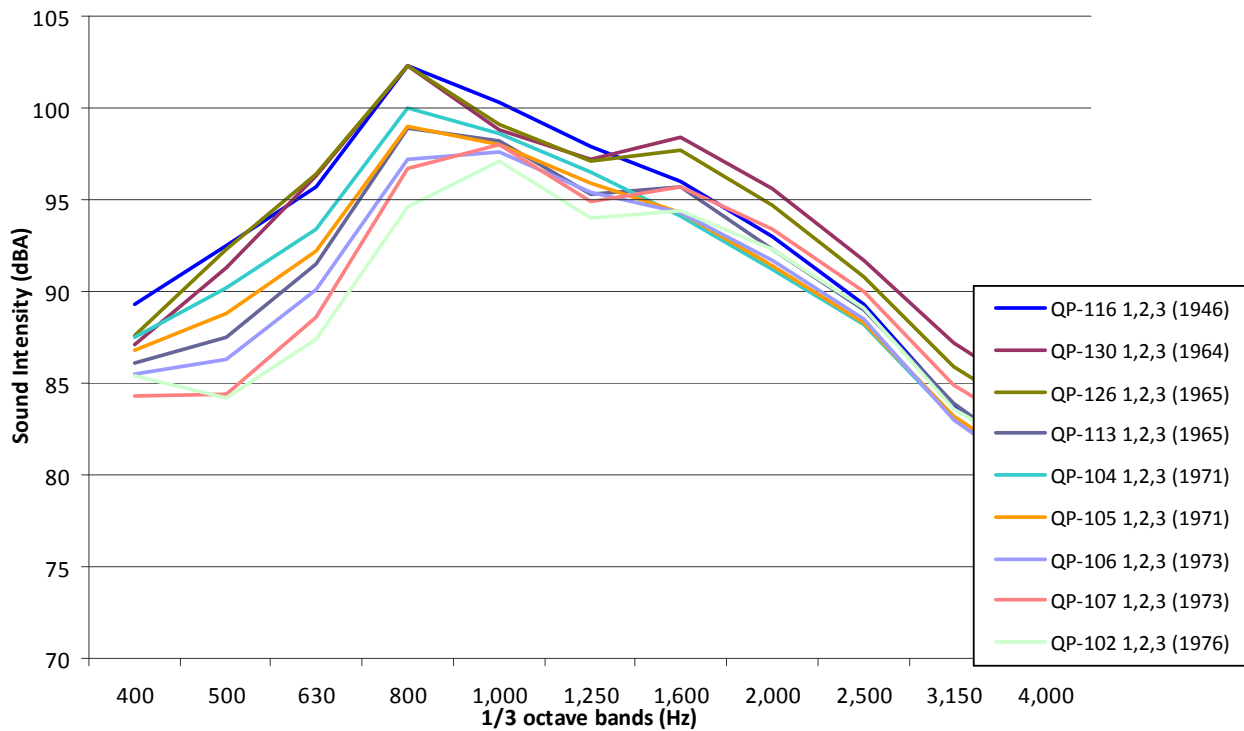
Figure 3.2: OBSI spectral content for burlap drag sections, texture *worn out*.

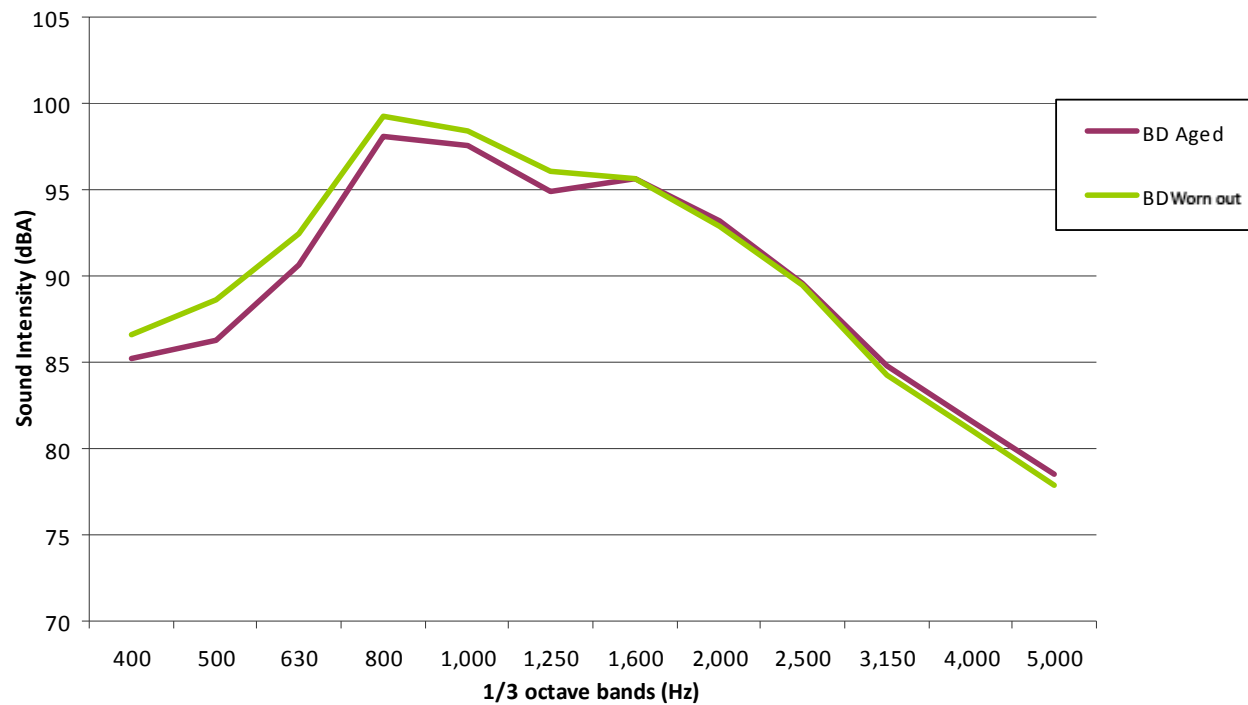
Figure 3.3: Comparison of average OBSI spectral content for burlap drag sections with texture in different conditions.

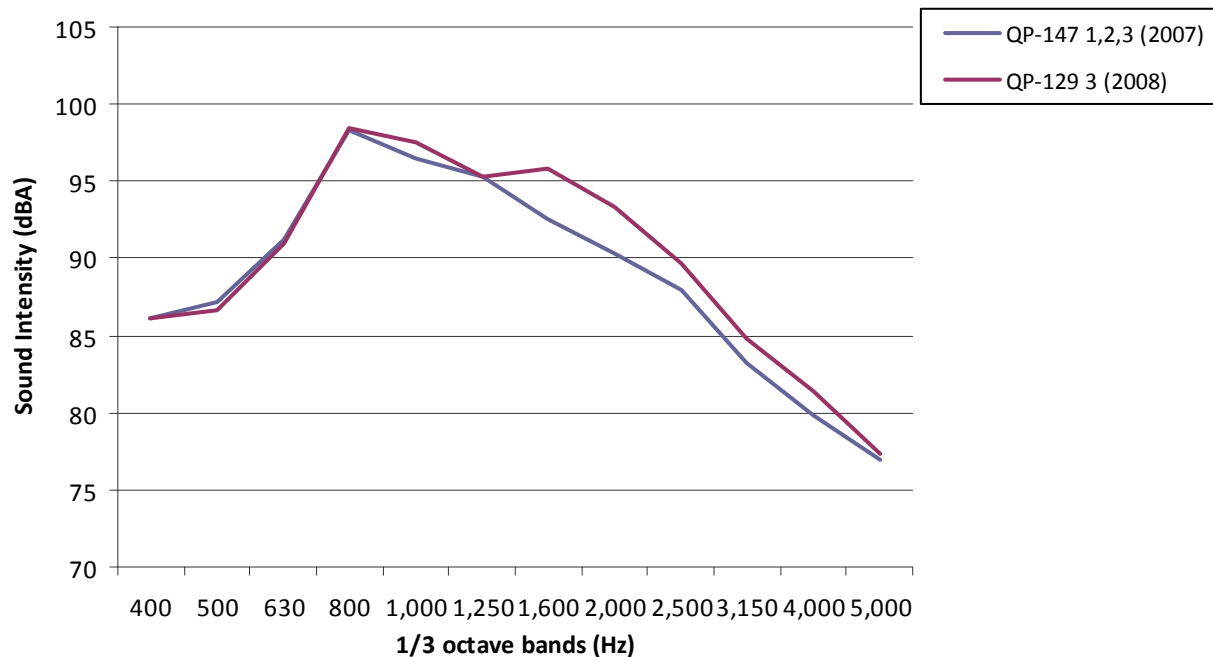
Figure 3.4: OBSI spectral content for diamond ground sections, texture *new*.

There were no diamond ground sections in the texture *worn out* category. The *new* texture and *aged* texture sections are shown in Figure 3.4 and Figure 3.5 respectively. A comparison of the average spectral content for the two texture conditions is shown in Figure 3.6. The comparison shows almost no difference between the *new* and the *aged* textures, on average. Differences within each texture condition category are greater than differences between the average spectra for each category.

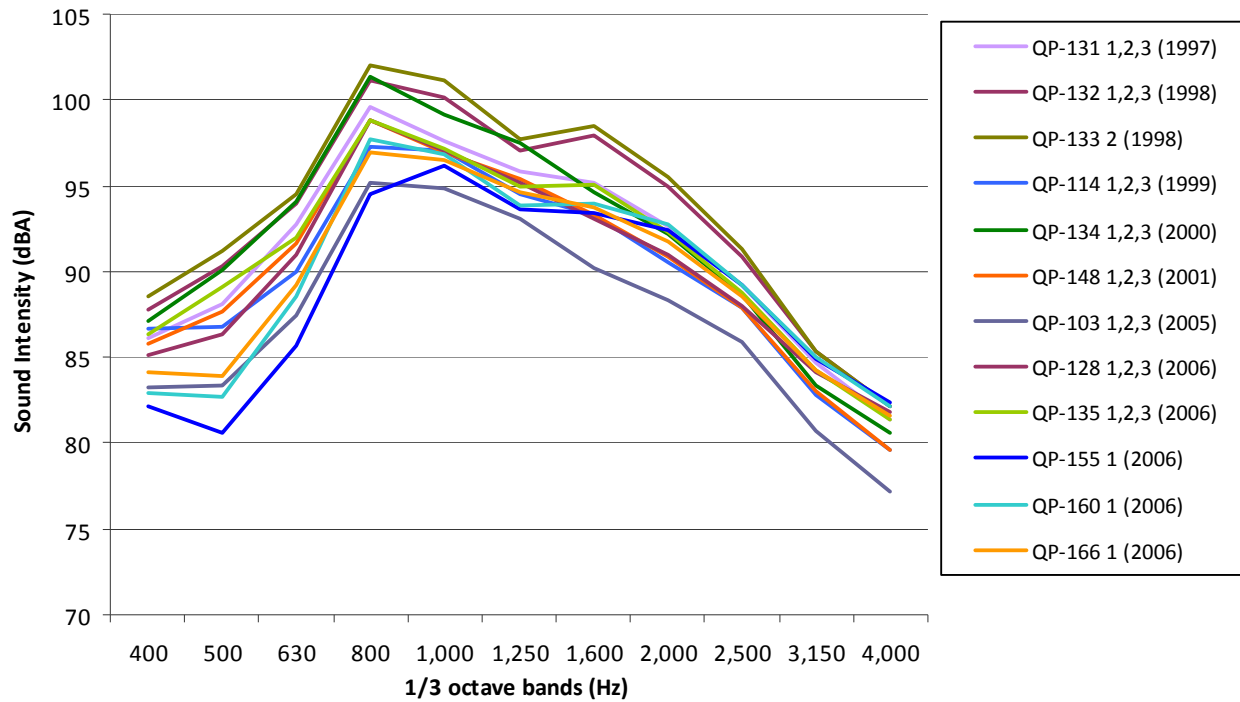
Figure 3.5: OBSI spectral content for diamond ground sections, texture *aged*.

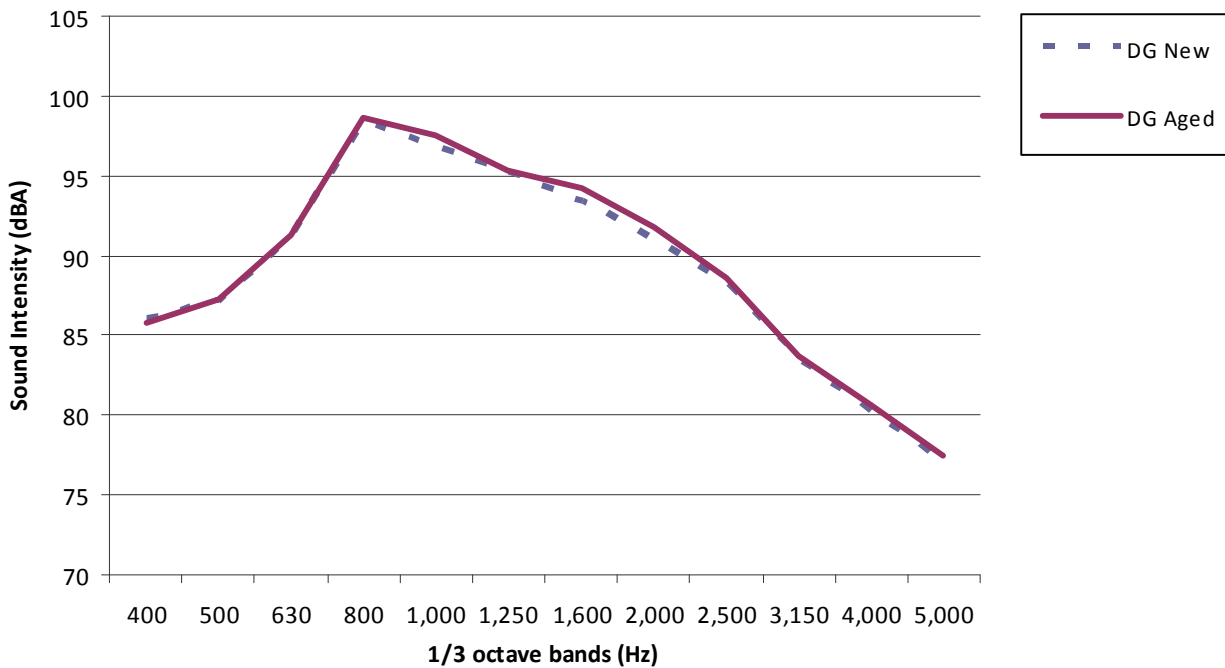
Figure 3.6: Comparison of OBSI spectral content for diamond ground sections with texture in different conditions.

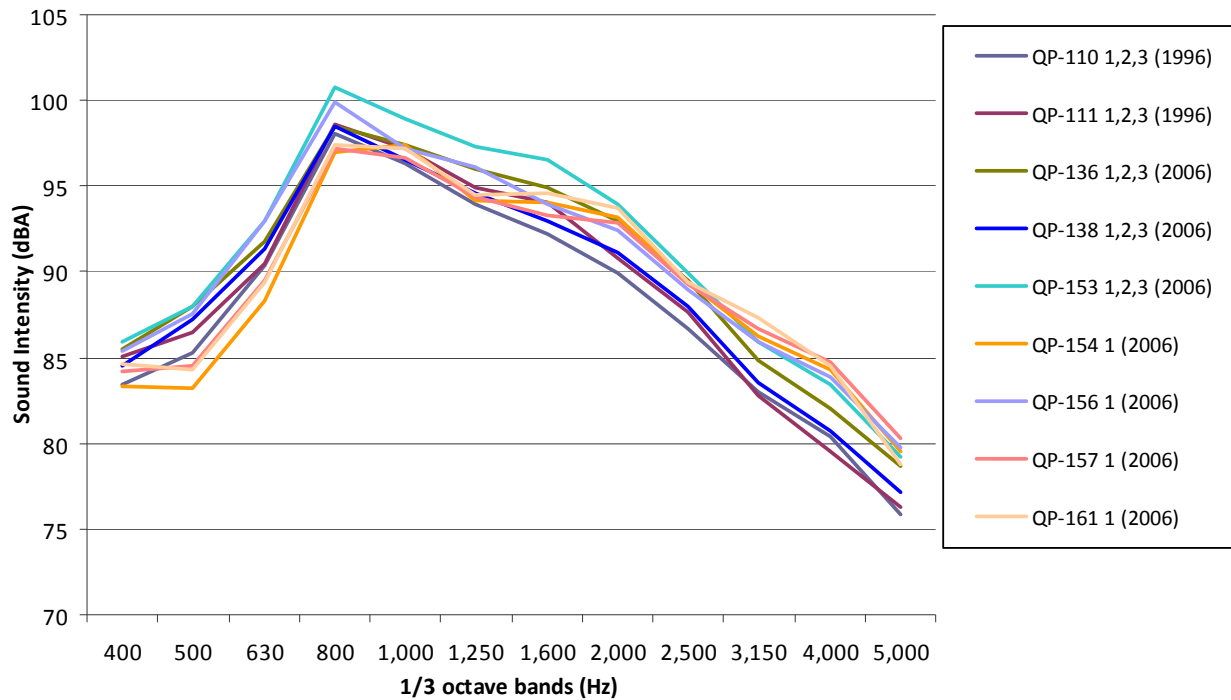
Figure 3.7: OBSI spectral content for diamond grooved sections, texture *aged*.

All diamond grooved sections fall in the *aged* texture category, so comparison against other conditions is not possible. Figure 3.7 shows the results at each site, while Figure 3.8 presents the average of all sites. There is a range of 4 to 5 dB(A) for every frequency within the *aged* texture category. The older sections, built in 1996, appear to have lower OBSI levels for frequencies of 2,000 Hz and higher frequencies, and to have OBSI levels in the middle of the range of the other sections built in 2006 for frequencies below 2,000 Hz.

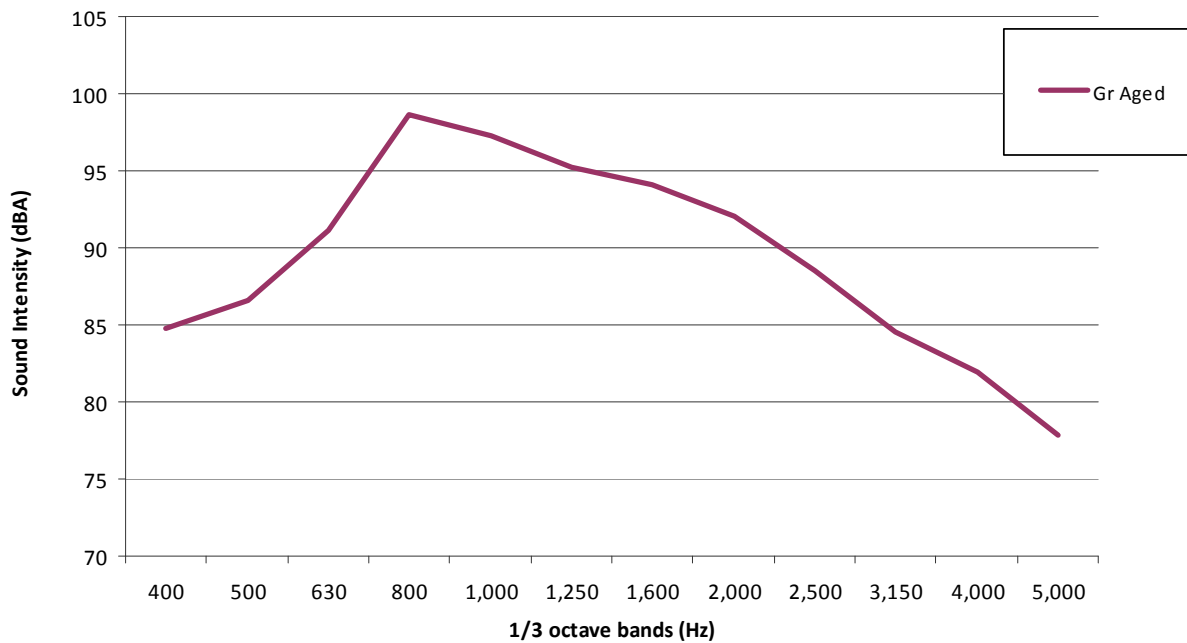
Figure 3.8: Average of OBSI spectral content for diamond grooved sections.

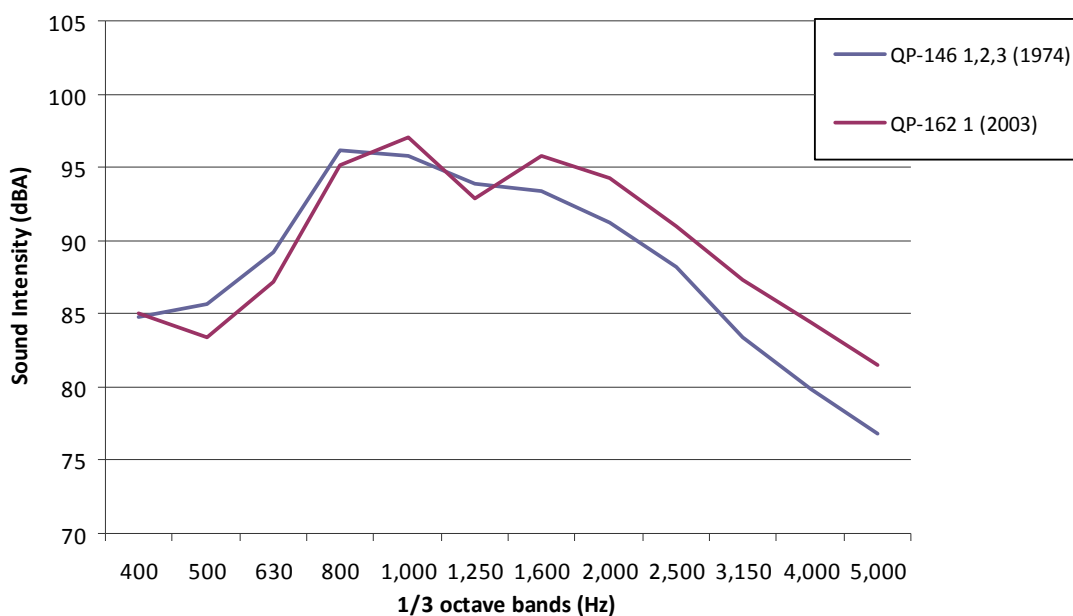
Figure 3.9: OBSI spectral content for longitudinally broomed sections, texture *aged*.

There were no sections with longitudinally broomed texture in the *new* texture category. The texture *aged* and texture *worn out* sections are shown in Figure 3.9 and Figure 3.10 respectively. A comparison of the average spectral content for the two texture conditions is shown in Figure 3.11. It can be seen that there is not much difference between the two texture conditions. Differences within each texture condition category are greater than the differences between the average spectra for each category.

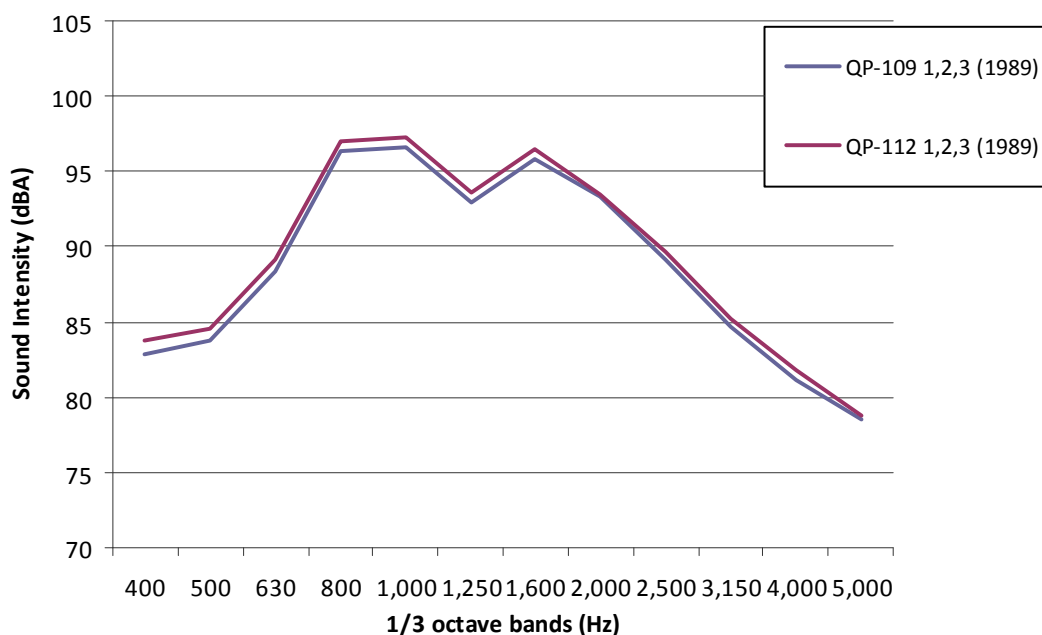
Figure 3.10: OBSI spectral content for longitudinally broomed sections, texture *worn out*.

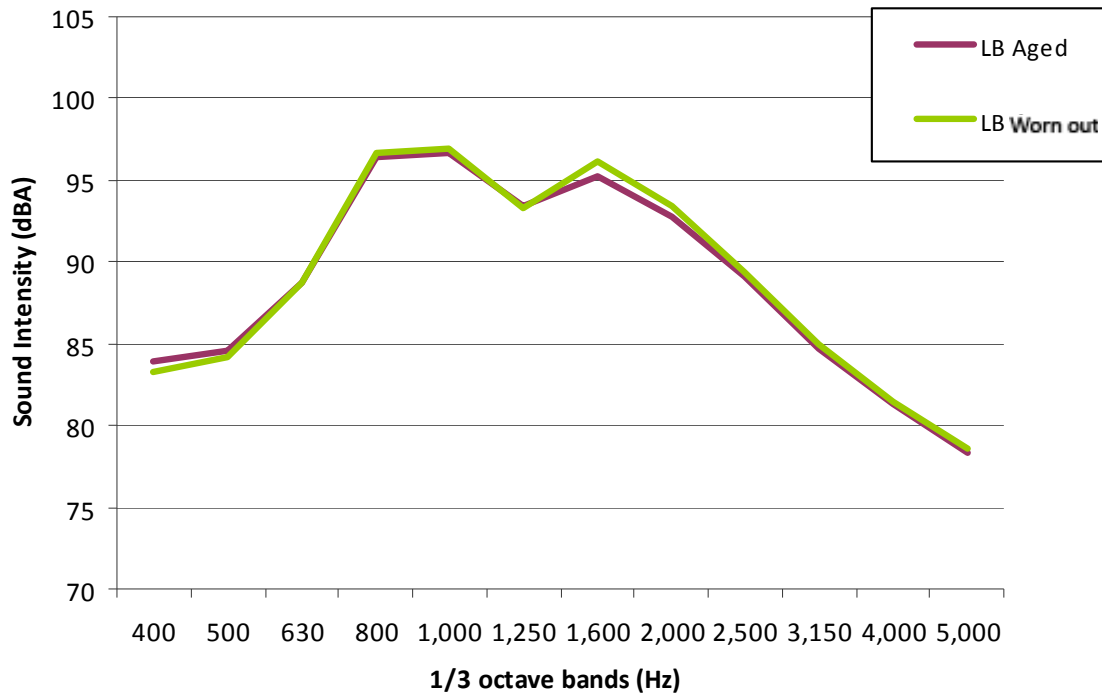
Figure 3.11: Comparison of OBSI spectral content for longitudinally broomed sections with texture in different conditions.

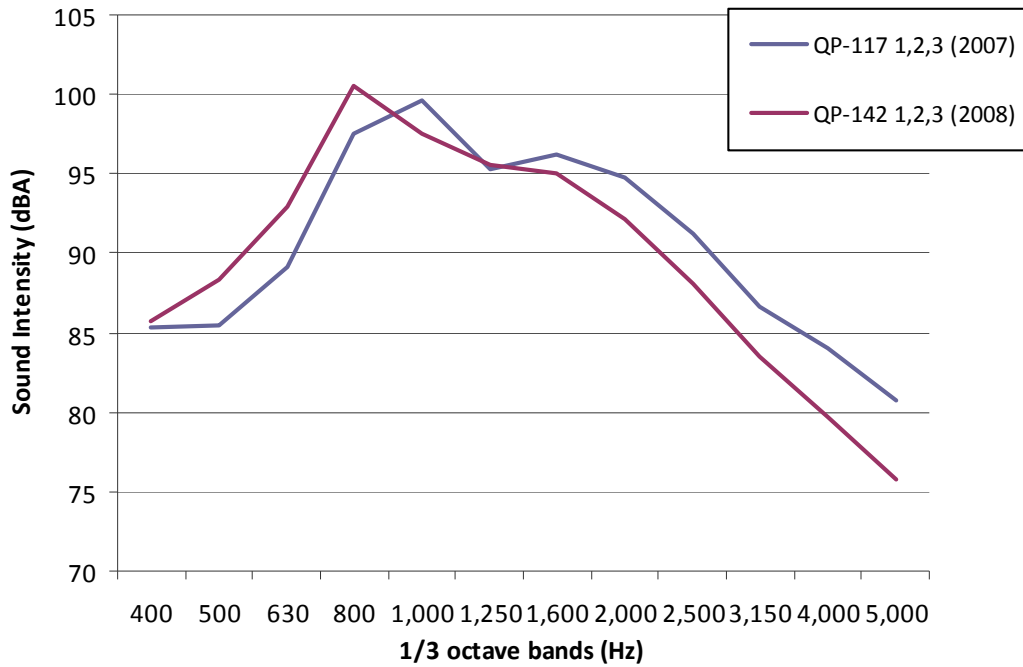
Figure 3.12: OBSI spectral content for longitudinally tined sections, texture *new*.

This is the only texture type with sections found in the three texture conditions. Sections with longitudinally tined texture in the texture *new*, texture *aged*, and texture *worn out* categories are presented in Figure 3.12, Figure 3.13, and Figure 3.14 respectively. The second year results from Section 142 were excluded from the analysis because of extensive damage to the pavement surface caused by truck chain wear. A comparison of the average spectral content for the conditions is shown in Figure 3.15. The average spectra for the three conditions are very similar, with the primary differences being that the OBSI level for the very low frequencies increases after the first year, and that OBSI increases some for the 1,250 Hz frequency as the texture ages. Differences within each texture condition category are greater than differences between the average spectra for each category.

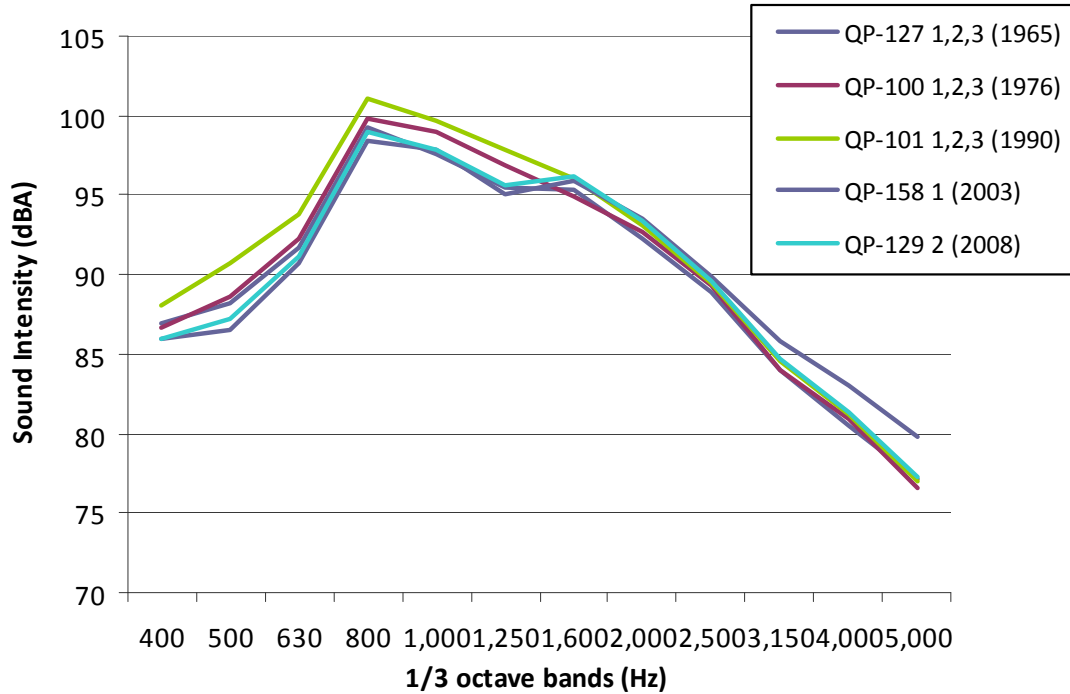
Figure 3.13: OBSI spectral content for longitudinally tined sections, texture *aged*.

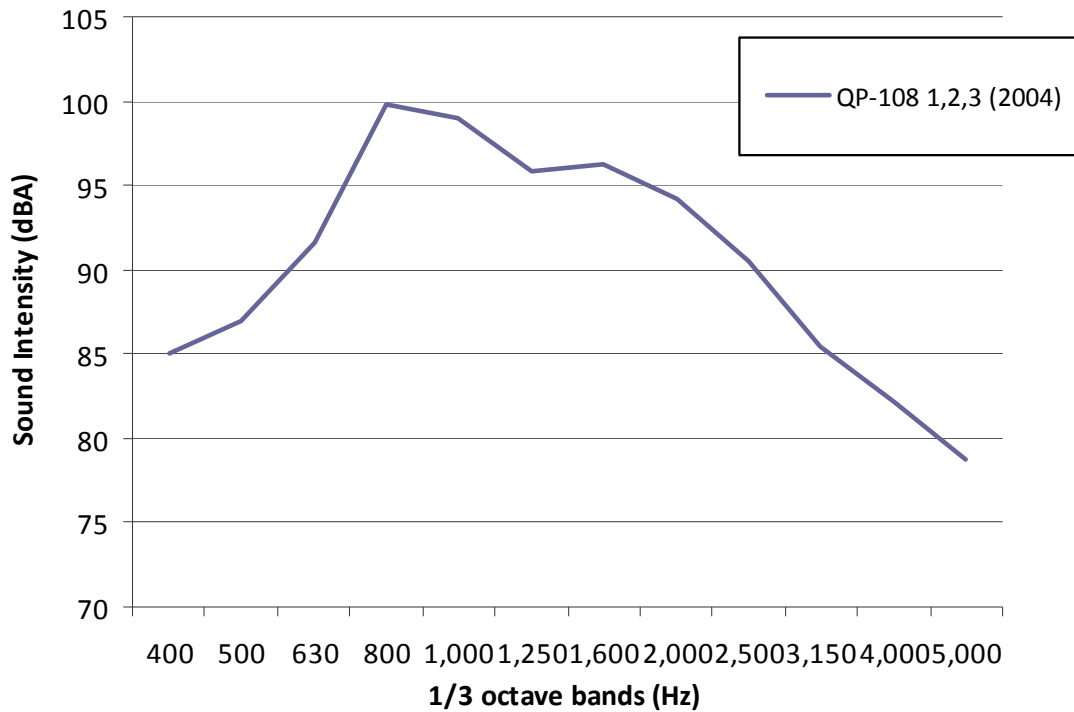
Figure 3.14: OBSI spectral content for longitudinally timed sections, texture *worn out*.

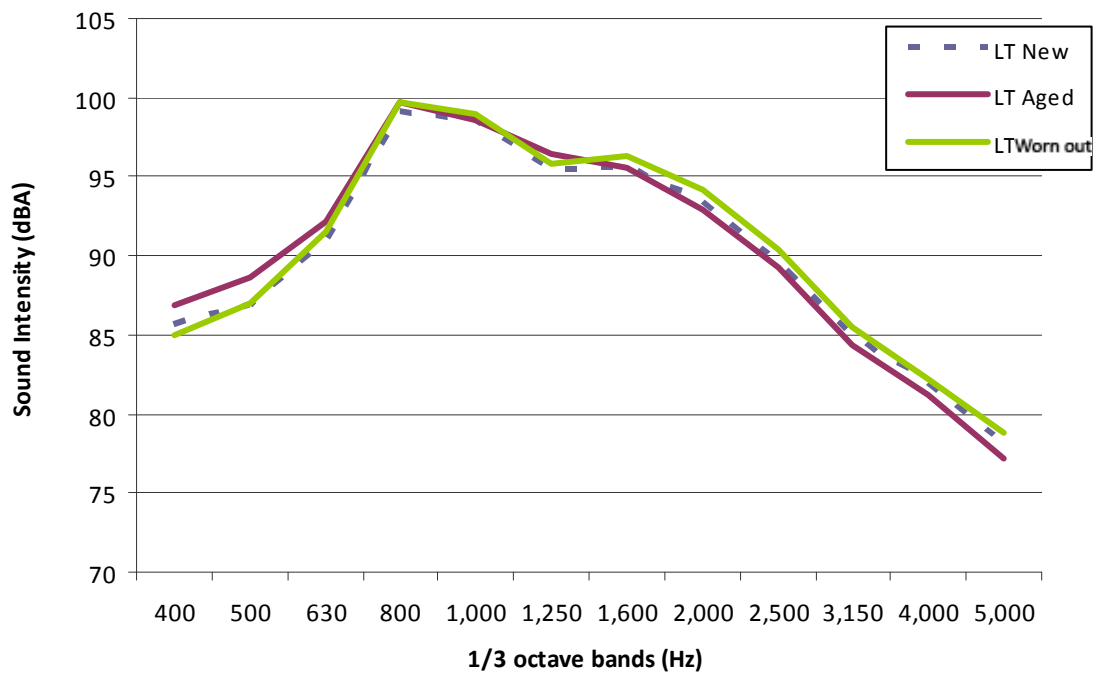
Figure 3.15: Comparison of OBSI spectral content for longitudinally timed sections with texture in different conditions.

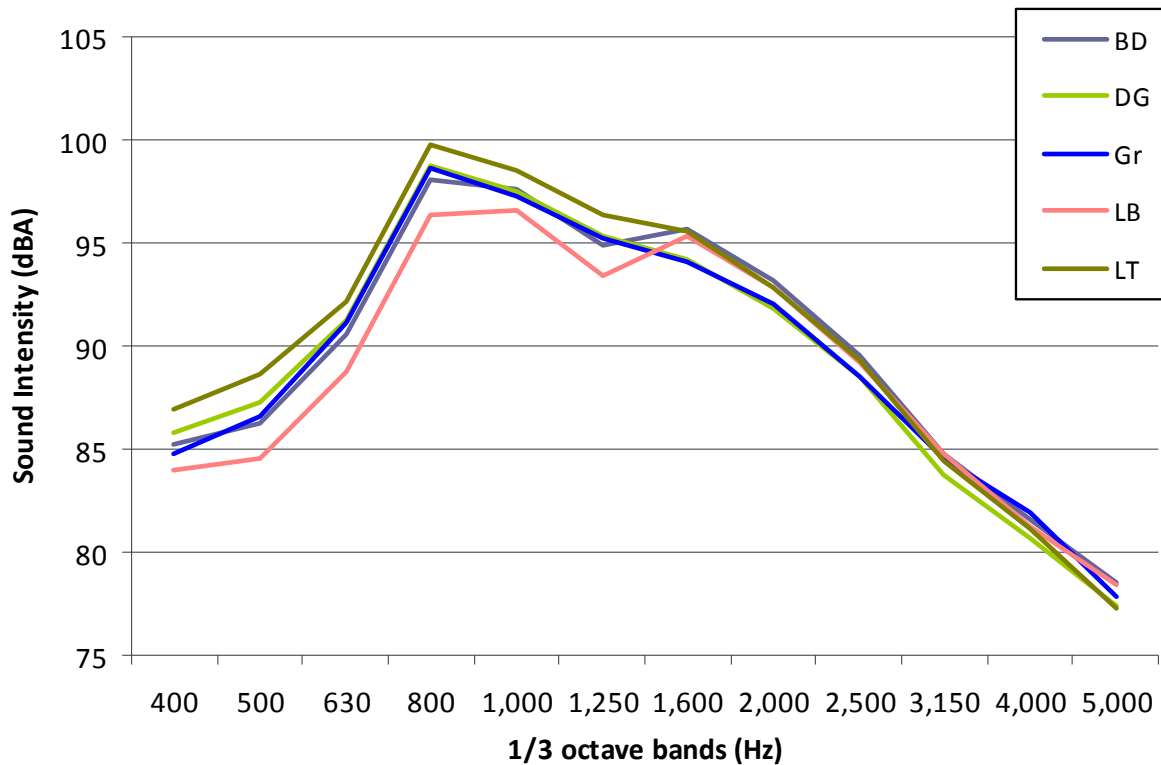
Figure 3.16: Comparison of OBSI spectral content of sections with different texture types, average of all sections of a texture type.

(Note: BD = burlap drag, DG=diamond ground, Gr=diamond grooved, LB=longitudinally broomed, LT=longitudinally tined.)

To begin the examination of the noise characteristics of concrete pavement surface textures in more detail, Figure 3.16 presents the one-third octave sound intensity levels, using the average for each texture type and including textures of all three conditions. The longitudinally broomed texture has markedly lower levels at frequencies below 1,250 Hz. The other surface types are difficult to distinguish from each other in terms of average OBSI spectra. Given that once the texture of a surface has disappeared, it is no longer considered to be designed, and it is more appropriate to consider only those sections with *aged* texture, as presented in Figure 3.17.

The average spectra for all texture types and conditions was shown previously in Figure 3.16. The minimum and maximum spectra values for the one-third octaves are shown for all sections with aged texture in Figure 3.19 and Figure 3.20, respectively.

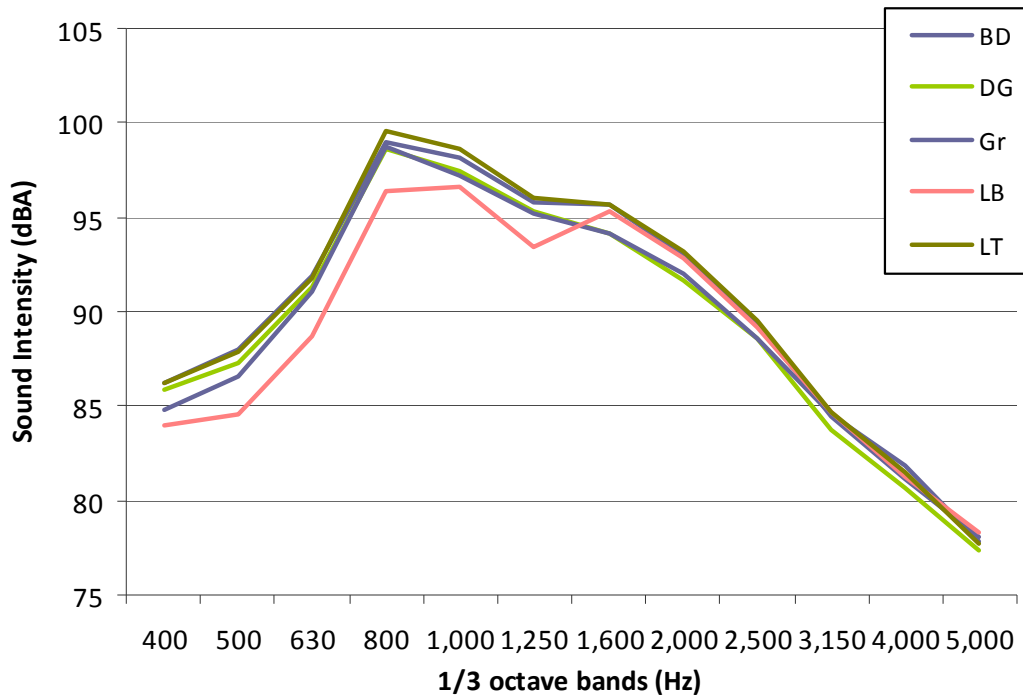
Figure 3.17: Comparison of OBSI spectral content of sections with different texture types, average of sections with texture aged.
(Note: BD = burlap drag, DG=diamond ground, Gr=diamond grooved, LB=longitudinally broomed, LT=longitudinally tined.)

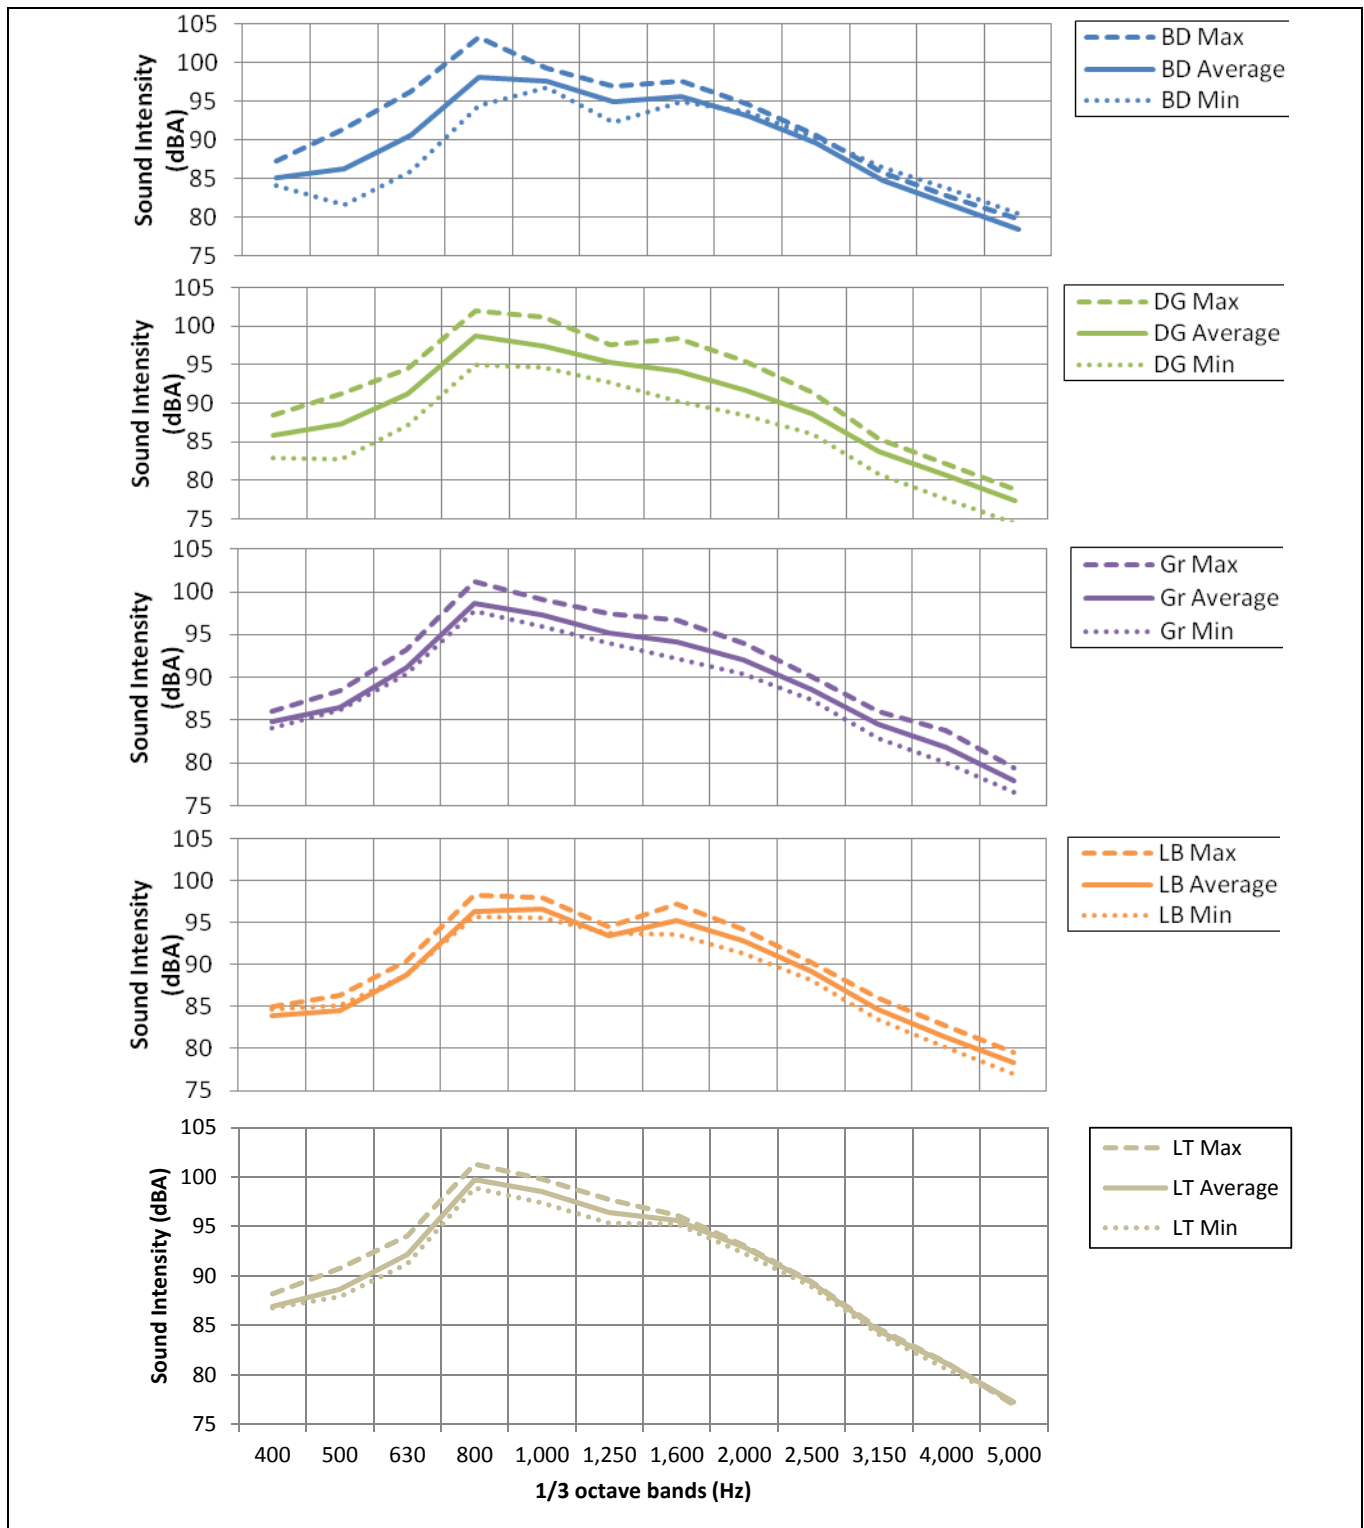
Figure 3.18: Comparison of OBSI spectral content of sections of different texture type (only texture *aged*).

Because an average spectrum is just a mathematical construction of a fictitious average section, it is convenient to include in the plots the actual spectra for the sections with the highest and lowest OBSI (of the *aged* texture category). This is presented in Figure 3.18.

The results of Figure 3.18 are presented again in Table 3.1, along with the average overall OBSI for the *aged* texture category for each texture type.

Between DG and BD the analysis is as follows: the Max spectra and the Average spectra are similar for the two texture types. At 1,250 Hz, the BD is lower than at the adjacent 1 kHz and 1.6 kHz frequency bands. Below 800 Hz the Min spectra are similar for BD and DG. At 1,000 Hz the BD texture minimum noise level is higher than the DG, but they are similar again at 1,250 Hz. Above 1,600 Hz the BD texture minimum spectrum is similar to the average levels, whereas the Min DG spectrum remains considerably lower than the average spectrum.

The mechanism that increases the loudness of BD texture occurs at low frequencies because above 1,600 Hz the Min, the Average, and the Max spectra are all similar. The mechanism that increases the loudness of DG texture involves the entire spectrum.

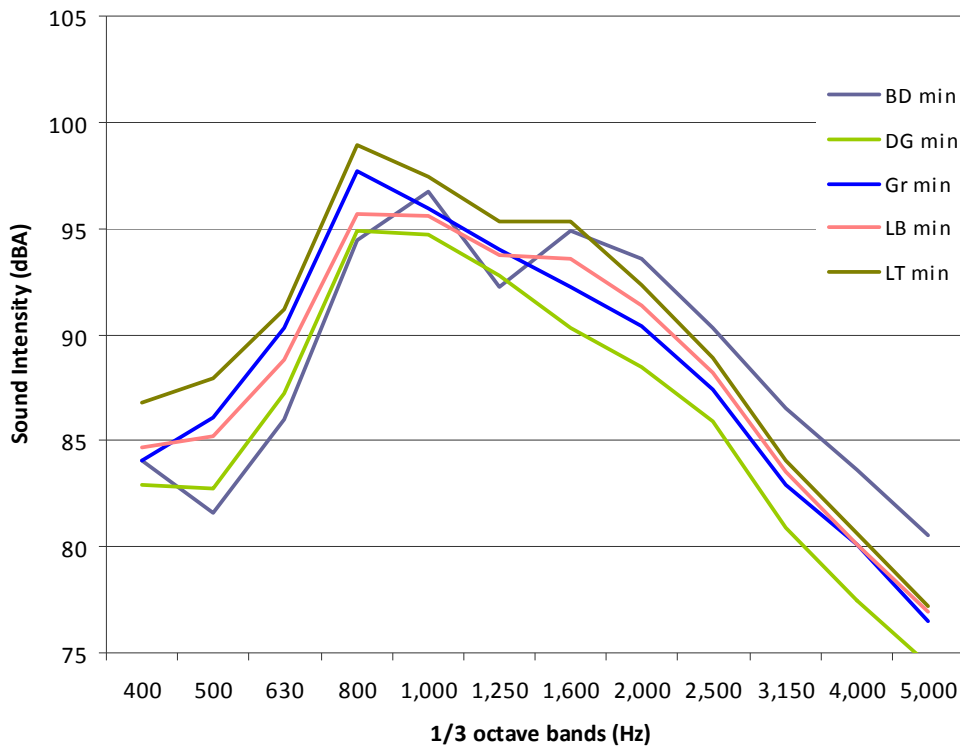
Figure 3.19: Comparison of OBSI spectral content of sections with different texture types, minimum of sections with *aged* texture.

(Note: BD = burlap drag, DG=diamond ground, Gr=diamond grooved, LB=longitudinally broomed, LT=longitudinally tined.)

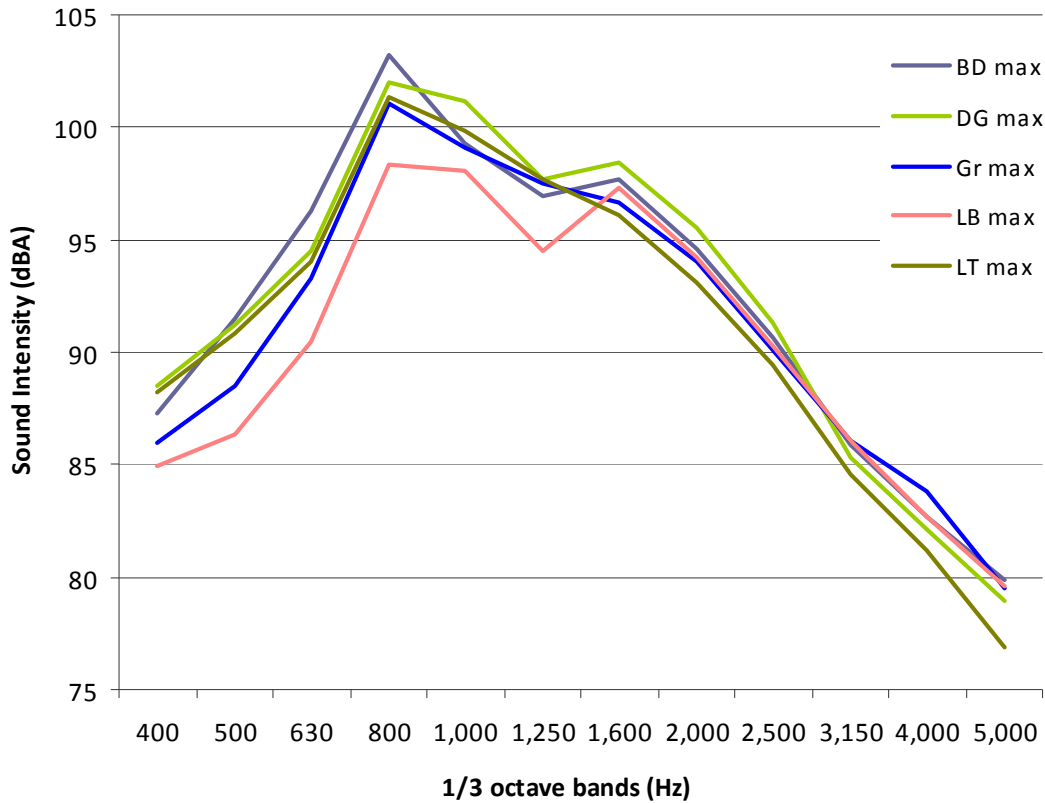
Figure 3.20: Comparison of OBSI spectral content of sections with different texture types, maximum of sections with texture *aged*.
 (Note: BD = burlap drag, DG=diamond ground, Gr=diamond grooved, LB=longitudinally broomed, LT=longitudinally tined.)

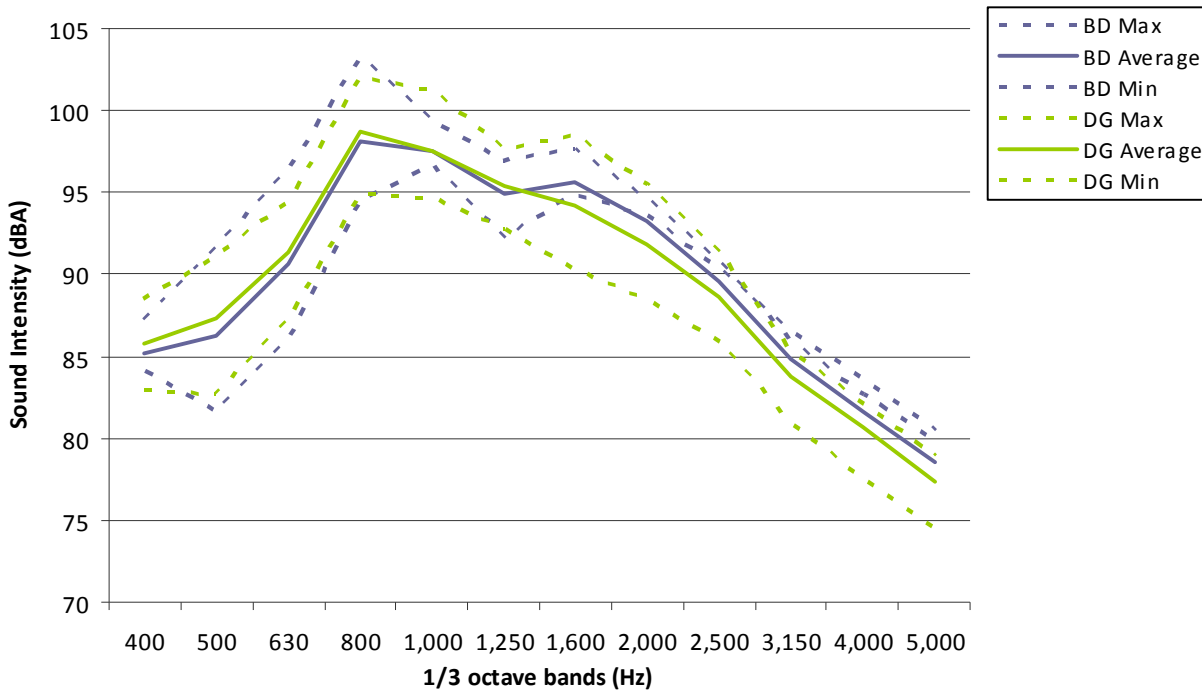
Figure 3.21: Comparison of OBSI spectral content of diamond ground (DG) and burlap drag (BD), texture *aged* sections.

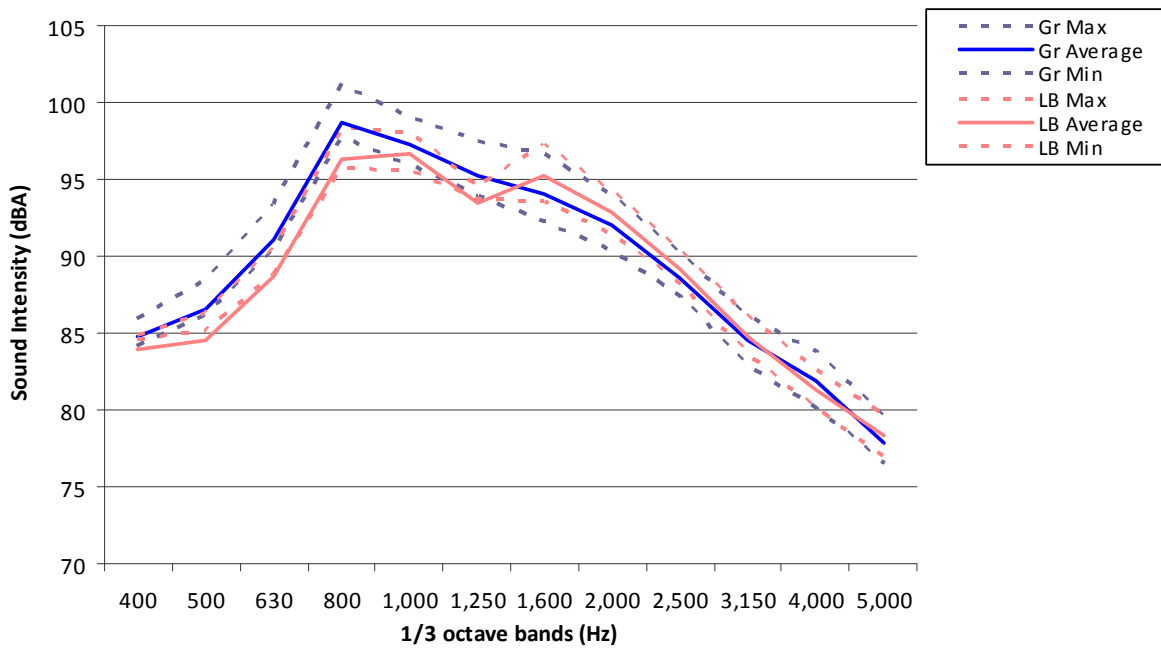
Figure 3.22: Comparison of OBSI spectral content of longitudinally broomed (LB) and diamond grooved (Gr), texture *aged* sections.

Between LB and Gr the analysis is as follows: The Max spectrum is higher for Gr than LB below 1,600 Hz. The Average spectrum is higher for Gr than LB below 1,250 Hz. The LB Average spectrum shows intensities at 800 Hz and 1,000 Hz very similar to those for Gr. The Min LB spectrum is lower than the Average LB spectrum only at the 1,600 and 2,000 Hz bands. The Max and Average LB spectra show markedly lower intensities at 800, 1,000, and 1,250 Hz compared to the Gr spectra, which are the primary contributors to overall sound intensity.

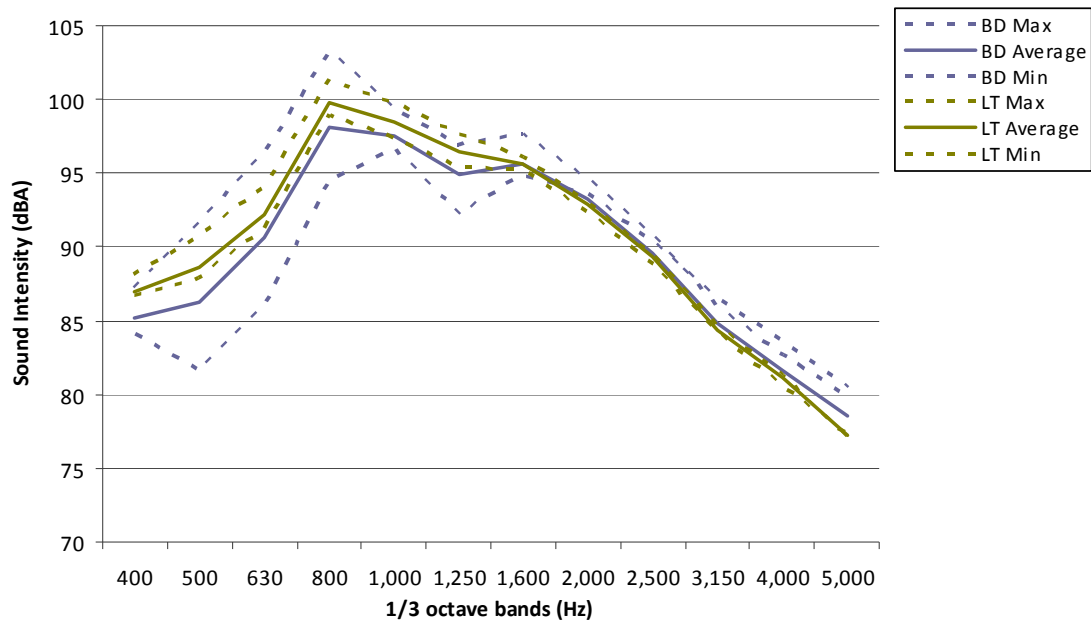
Figure 3.23: Comparison of OBSI spectral content of longitudinally timed (LT) and burlap drag (BD) sections.

Between LT and BD the analysis is as follows: The LT spectrum is very similar for the Max, the Average, and the Min curves for both textures at frequencies higher than 1,600 Hz, with the differences in the low frequencies. In these low frequencies the BD texture is quieter than the LT texture for the Average and the Min curves.
