1. REPORT NUMBER CA12-1200 A	2. GOVERNMENT ASSOCIATION NUMBER	3. RECIPIENT'S CATALOG NUMBER
4. TITLE AND SUBTITLE Quieter Pavement Research: Concrete Pavement Tire Noise	5. REPORT DATE 05/30/2011

6. PERFORMING ORGANIZATION CODE
7. AUTHOR John T. Harvey and Erwin Kohler	8. PERFORMING ORGANIZATION REPORT NO. UCPRC-RR-2010-03	
9. PERFORMING ORGANIZATION NAME AND ADDRESS University of California, Davis & Berkeley Partnered Pavement Research Center 1353 S. 46th Street, Bldg. 452 Richmond, CA 94804	10. WORK UNIT NUMBER

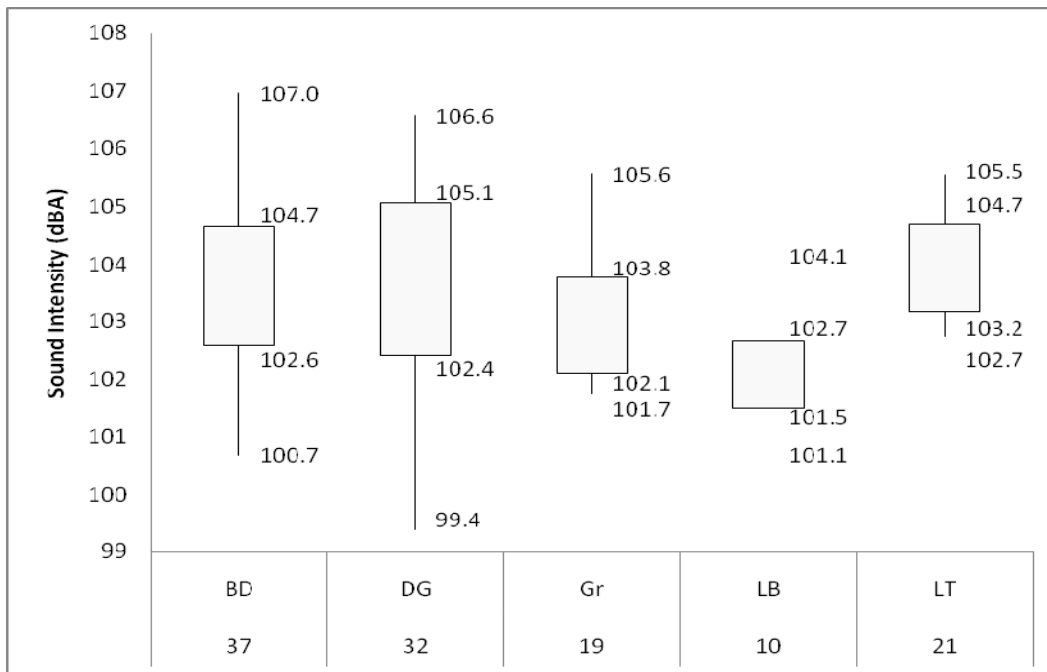
Figure 3.24: Box plots of OBSI results by texture type, Year 1.

(Notes: BD = burlap drag, DG=diamond ground, Gr=diamond grooved, LB=longitudinally broomed, LT=longitudinally tined; number of observations in sample shown below texture type.)

The box plots in Figure 3.24 through Figure 3.26 show the OBSI level by texture type respectively for the data set corresponding to Year 1, Year 2, and the combined Year 1 and Year 2 data. The values shown in the box plots are the minimum and the maximum, and the 1st and 3rd quartiles.

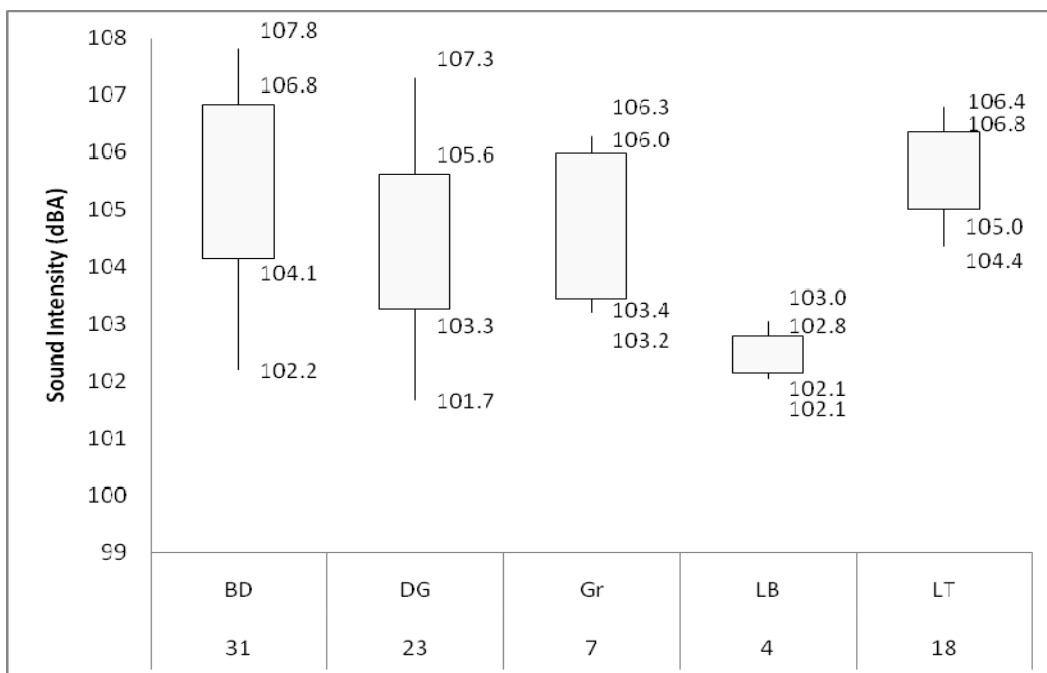
Figure 3.25: Box plots of OBSI results by texture type, Year 2.

(Notes: BD = burlap drag, DG=diamond ground, Gr=diamond grooved, LB=longitudinally broomed, LT=longitudinally tined; number of observations in sample shown below texture type.)

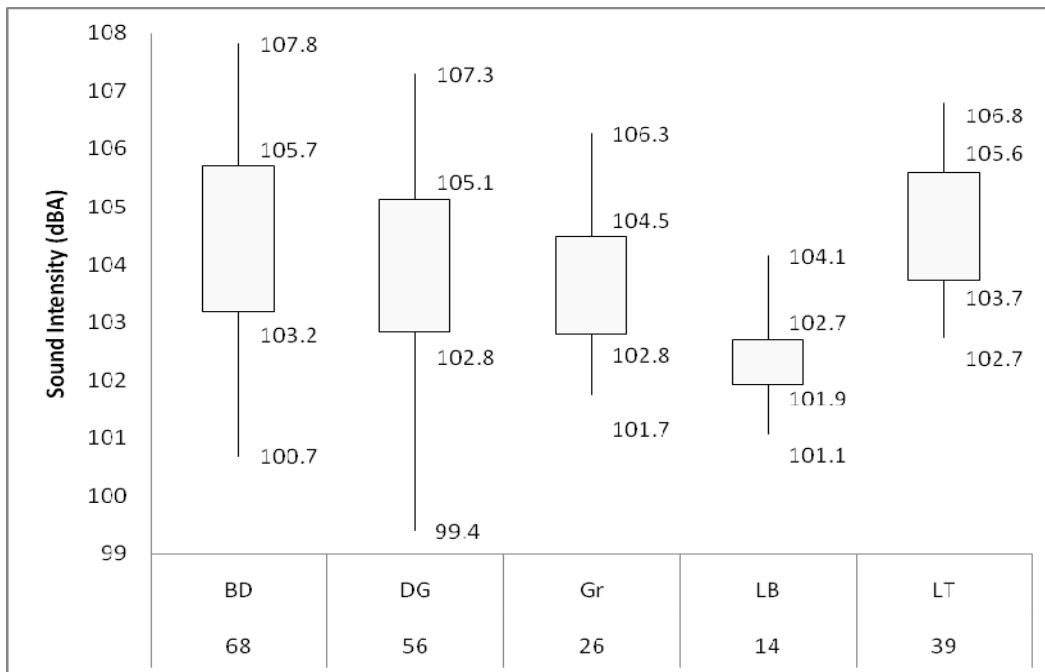
Figure 3.26: Box plots of OBSI results by texture type, Years 1 and 2 combined.
 (Notes: BD = burlap drag, DG=diamond ground, Gr=diamond grooved, LB=longitudinally broomed, LT=longitudinally tined; number of observations in sample shown below texture type.)

The quietest texture type, when considering the mean of the OBSI results of all sections with the same nominal surface type with all texture conditions (*new, aged and worn out*) and combining Year 1 and Year 2 data, was found to be the longitudinally broomed (LB), although this conclusion must be treated with some caution because of the smaller sample size for this texture type. The longitudinally broomed group presented a mean OBSI level of 102.3 dB(A) based on 14 measurements obtained by combining the two years of results on 10 sections located at four different sites (Table 2.5). Next, the diamond grooved and diamond ground texture types showed values similar to each other in terms of mean OBSI level—103.6 and 103.8 dB(A), respectively—and are therefore ranked as the second quietest. The value for diamond ground sections is the result of 56 measurements on 32 sections located at 14 sites, and for diamond grooved it is the result of 26 measurements on 19 sections located at 9 different sites. Burlap drag and longitudinally tined surfaces had mean OBSI levels of 104.5 and 104.8 dB(A), respectively. There were 42 measurements on 21 longitudinally tined sections located at eight different sites, and 68 measurements for burlap drag on 37 sections at 13 sites.

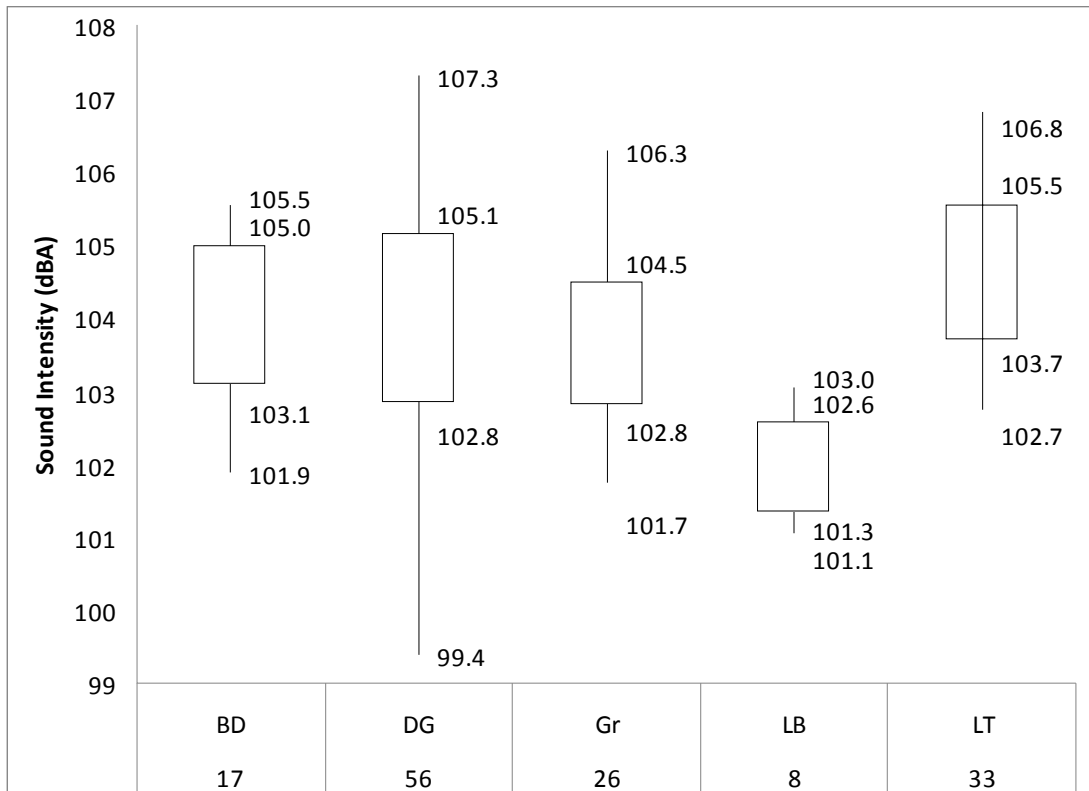
Figure 3.27: Box plots of overall OBSI results by texture type, Years 1 and 2 combined, only sections with *new* and *aged* textures (sections with texture *worn out* are excluded).
(Notes: BD = burlap drag, DG=diamond ground, Gr=diamond grooved, LB=longitudinally broomed, LT=longitudinally tined; number of observations in sample shown below texture type.)

Figure 3.27 is similar to Figure 3.26 but only showing sections with *new* and *aged* textures.

Figure 3.27 shows a box plot of overall OBSI for each texture type for the *new* and *aged* textures, with those sections with *worn out* textures removed. Figure 3.28 shows the normal distribution curves of OBSI results by texture type, all sections. Figure 3.29 shows the normal distribution curves of OBSI results by texture for the *new* and *aged* textures, with the *worn out* textures removed.

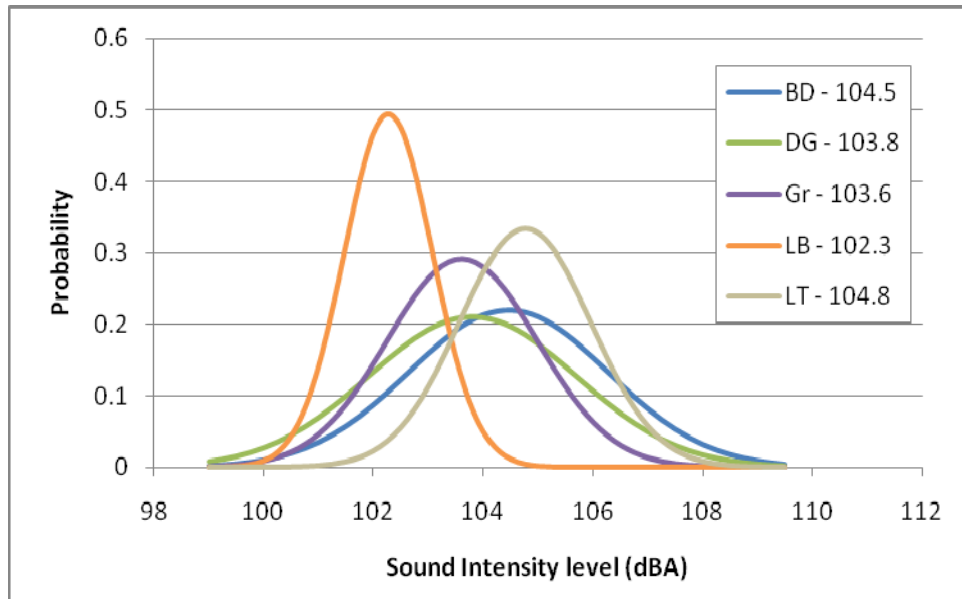
Figure 3.28: Normal distribution curves of OBSI results by texture type, all sections.
(Notes: BD=burlap drag, DG=diamond ground, Gr=diamond grooved, LB=longitudinally broomed, LT=longitudinally tined; sample sizes for LB and Gr are smaller than for other textures.)

Table 3.3 for the combined data from Year 1 and Year 2, and for each texture type. The resulting charts are presented in Figure 3.28 including all sections and in Figure 3.29 excluding sections with the texture *worn out* condition. The legend includes the mean OBSI level in dB(A) next to the texture-type abbreviation.

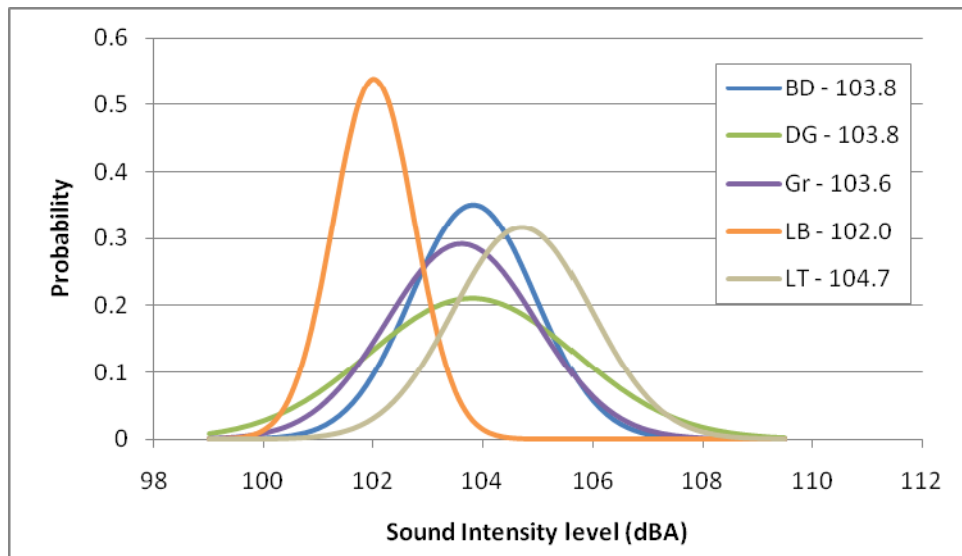
Figure 3.29: Normal distribution curves of OBSI results by texture type, only *new* and *aged* texture.
(Note: Sample sizes for LB and BD are smaller than for other textures.)

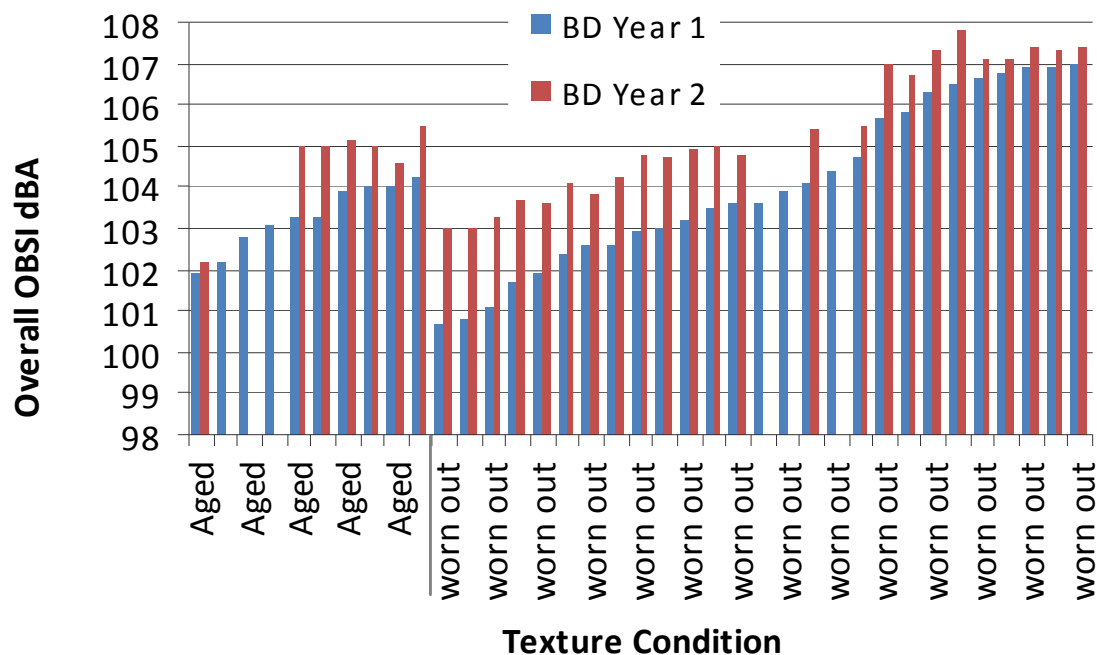
Figure 3.30: Year 1 and Year 2 OBSI values for all burlap drag sections.

Figure 3.30 shows OBSI results for the burlap drag sections. The vast majority of the burlap drag sections were built in the 1960s and 1970s. The only “young” section, which was about six years old at the time of testing, is QP-159.1 at the Mojave Bypass. The oldest sections, which were 62 years old, are on Interstate 80 in Solano County (QP-116.1, QP-116.2, and QP-116.3). Older sections have higher OBSI levels. Figure 3.31 shows all texture conditions for the burlap drag sections plotted versus the number of years since they were last surfaced, including all Year 1 and Year 2 measurements.

Figure E.4: Compare with Figure 3.30: Burlap drag Year 1 and Year 2 results for all texture conditions (*new, aged, worn out*).

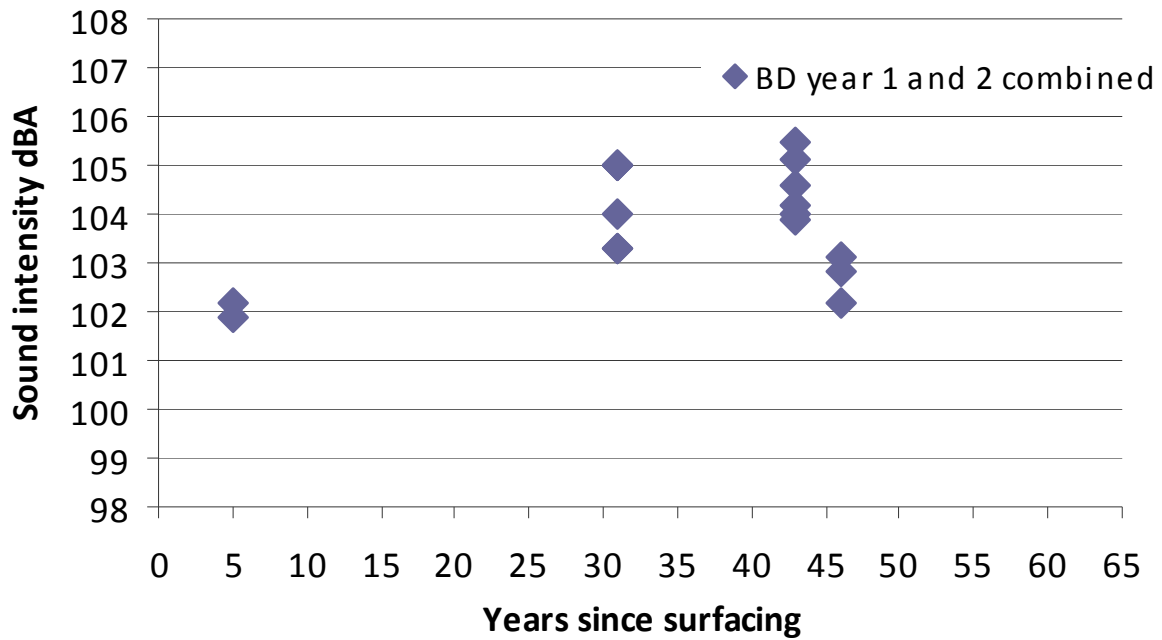
Figure 3.31: Year 1 and Year 2 OBSI values for all burlap drag sections versus years since last surfacing.

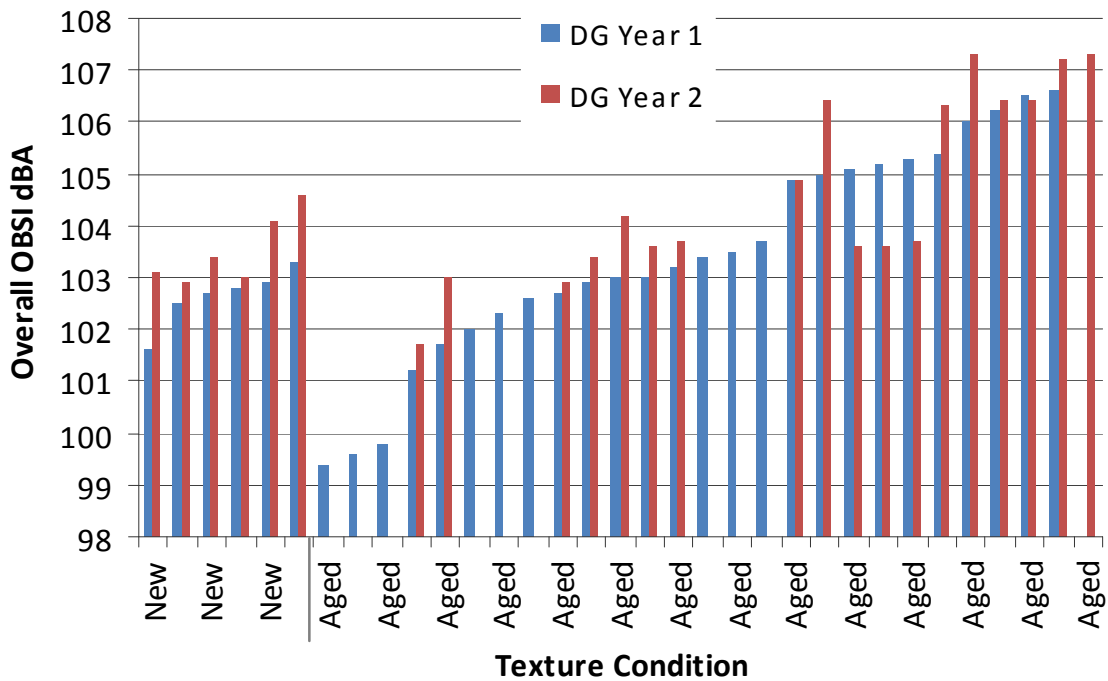
Figure 3.32: Year 1 and Year 2 OBSI values for all diamond ground sections.

Figure 3.32 shows OBSI results for the diamond ground sections. The oldest sections evaluated were 11 years old at the time of testing. It seems again that older sections have higher OBSI levels. Figure 3.33 shows all texture conditions for the diamond ground sections plotted versus the number of years since they were last surfaced, including all Year 1 and Year 2 measurements.

Figure E.5: Compare with Figure 3.32: Diamond ground Year 1 and Year 2 results for all texture conditions (*new, aged, and worn out*).

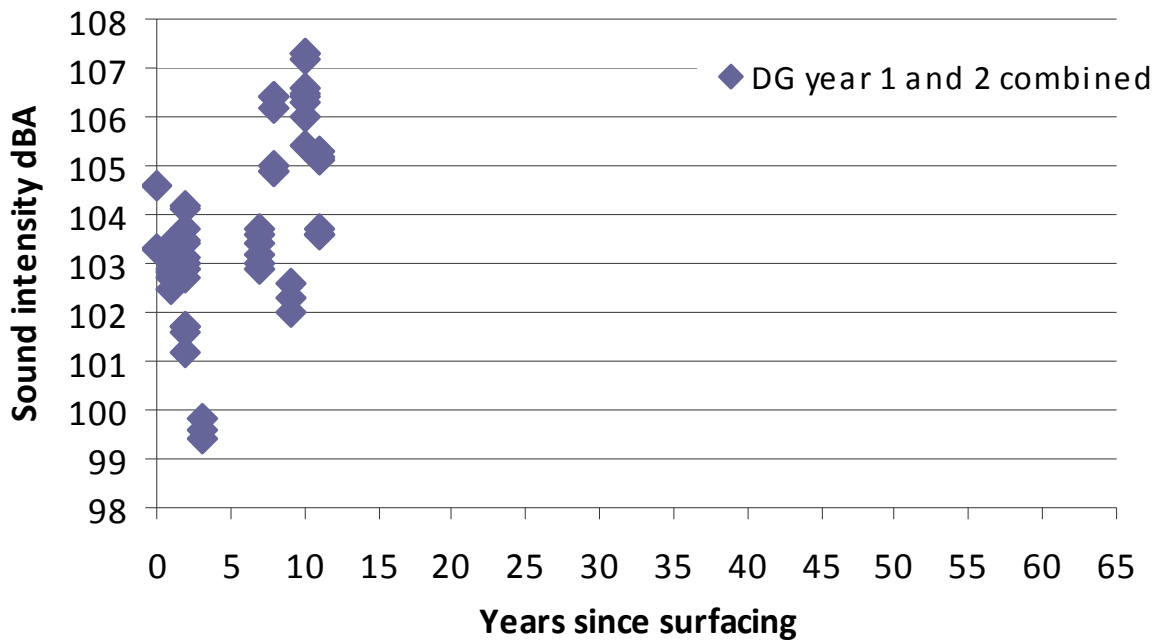
Figure 3.33: Year 1 and Year 2 OBSI values for all diamond ground sections versus years since last surfacing.

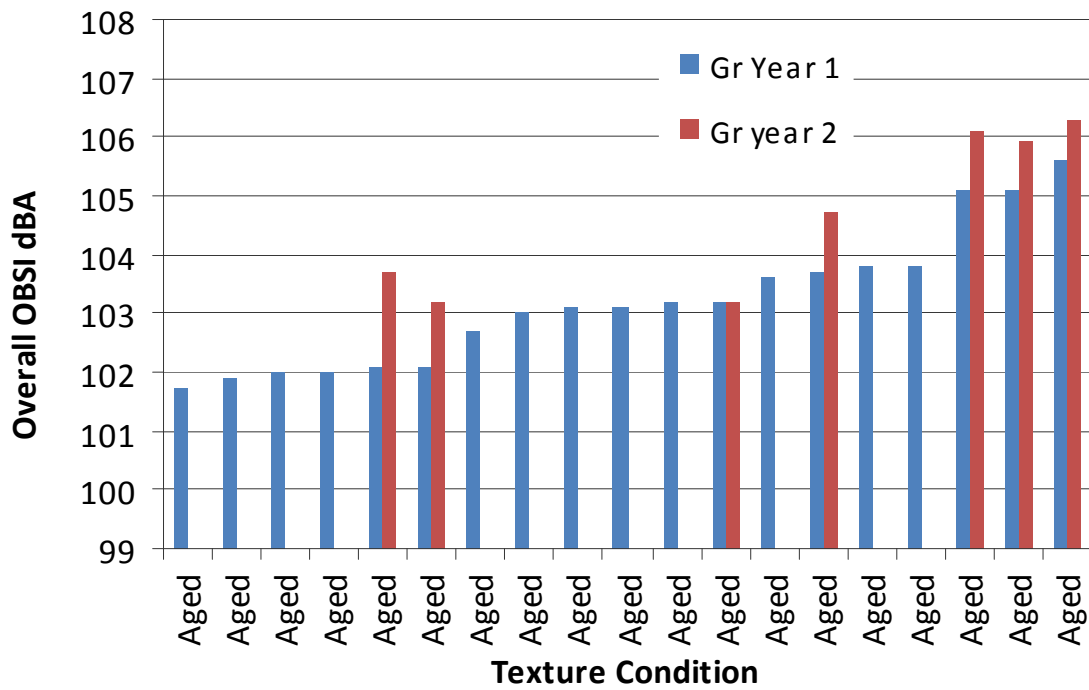
Figure 3.34: Year 1 and Year 2 OBSI values for all diamond grooved sections.

Figure 3.34 shows OBSI results for the diamond grooved sections. Although some of the pavements on US 101 in Sonoma County were built in 1962 (QP-136 and QP-138), records indicate that the sections were diamond grooved in 2006. Older sections were about 12 years old after grooving, and were located on Interstate 80 in Nevada County (QP-110 and QP-111). It is not possible to observe a trend in OBSI level over time with the available data. Figure 3.35 shows all texture conditions for the diamond grooved sections plotted versus the number of years since they were last surfaced, including all Year 1 and Year 2 measurements.

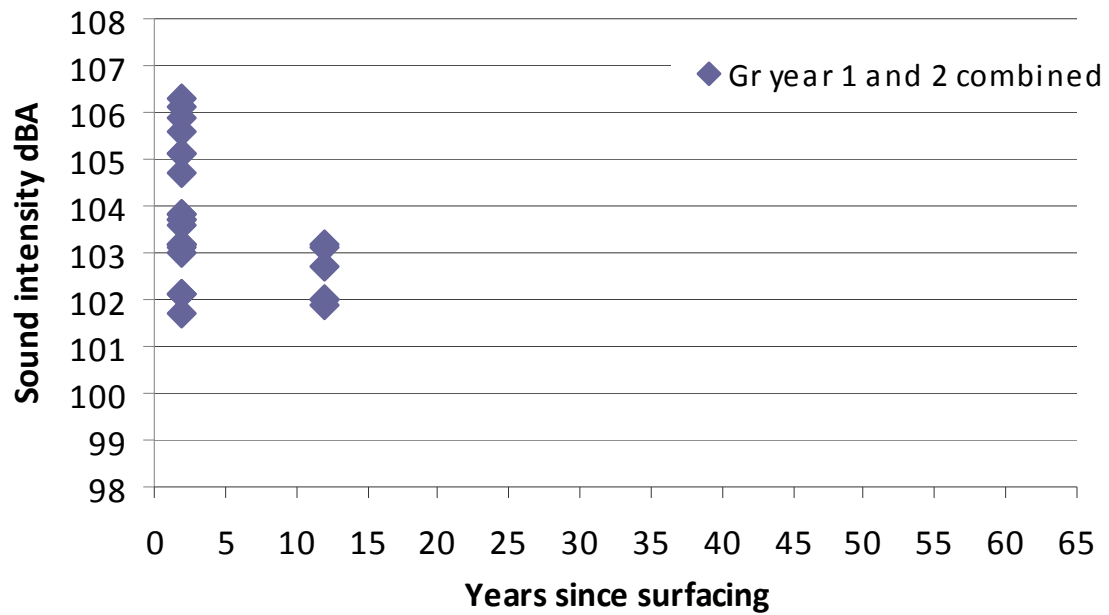
Figure 3.35: Year 1 and Year 2 OBSI values for all diamond grooved sections versus years since last surfacing.

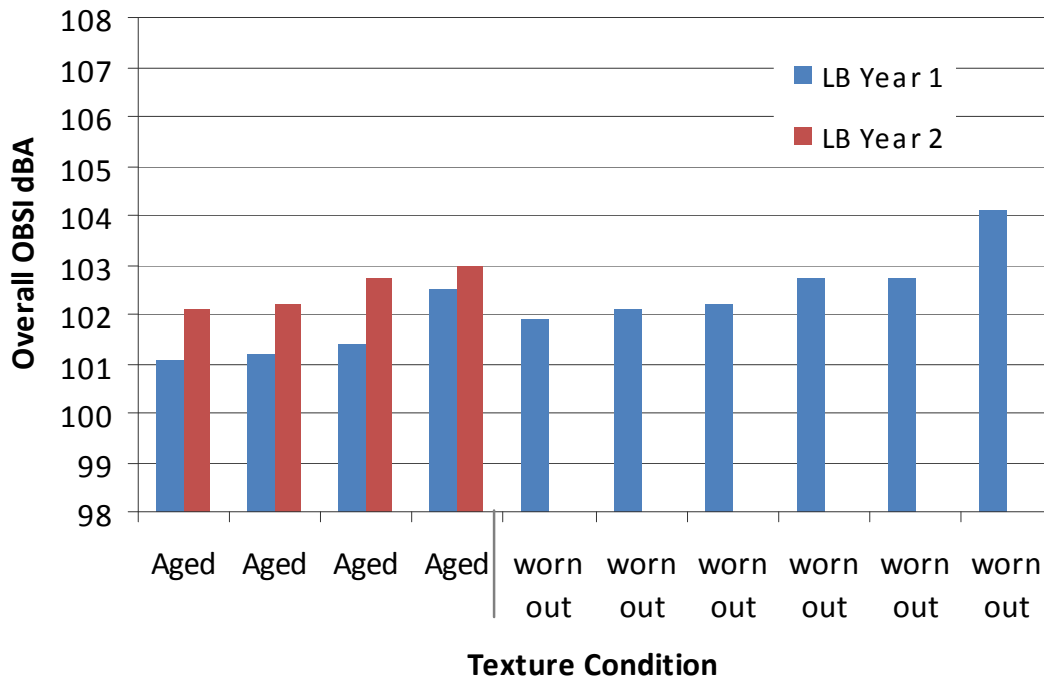
Figure 3.36: Year 1 and Year 2 OBSI values for all longitudinally broomed sections.

Figure 3.36 shows OBSI results for the longitudinally broomed sections. The six-year old section is at the Mojave Bypass on State Route 58. The 19-year old sections are on Interstate 80 in Nevada County (QP-109 and QP-112), but were overlaid with asphalt between Year 1 and Year 2. The 34-year-old sections are on Interstate 280 in San Mateo County (QP-146). From the limited available data, it seems that OBSI levels on this type of surface texture do not increase much over time. Figure 3.37 shows all texture conditions for the longitudinally broomed sections plotted versus the number of years since they were last surfaced, including all Year 1 and Year 2 measurements.

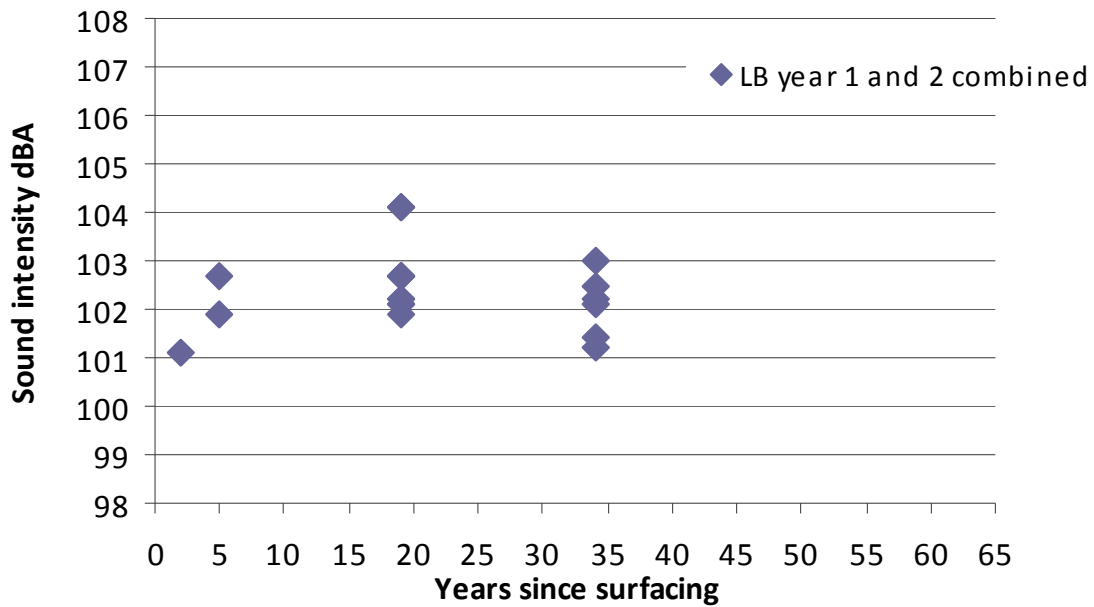
Figure 3.37: Year 1 and Year 2 OBSI values for all longitudinally broomed sections versus years since last surfacing.

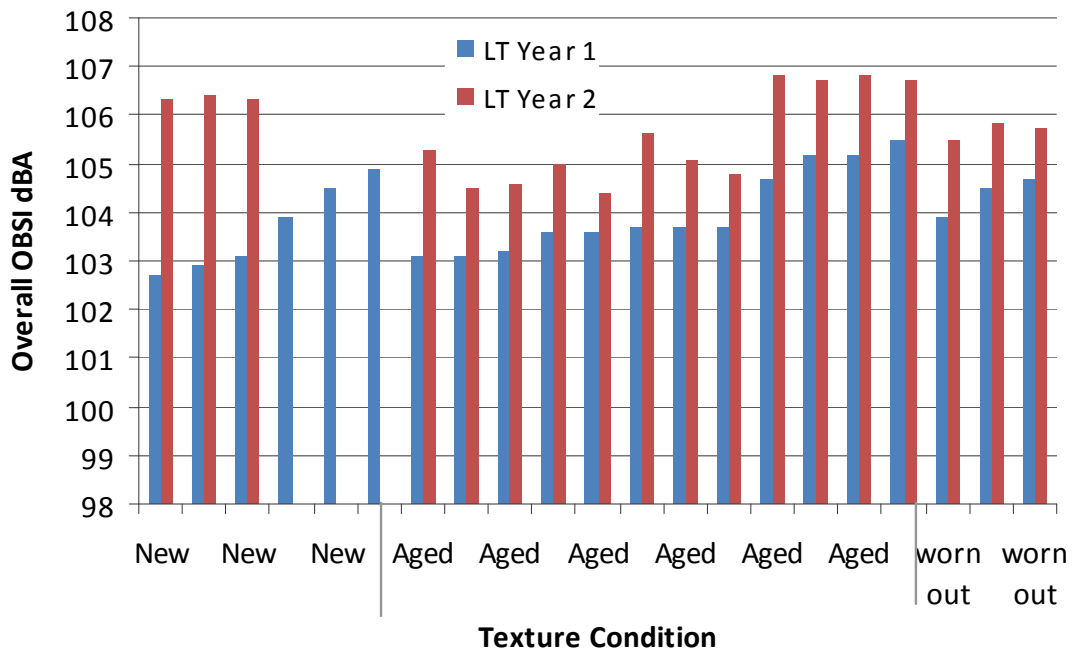
Figure 3.38: Year 1 and Year 2 OBSI values for all longitudinally tined sections.

Figure 3.38 shows OBSI results for the longitudinally tined sections. The OBSI levels remain mostly between 103 and 107 dB(A), even for sections that are over 30 and 40 years old. Figure 3.39 shows all texture conditions for the longitudinally tined sections plotted versus the number of years since they were last surfaced, including all Year 1 and Year 2 measurements.

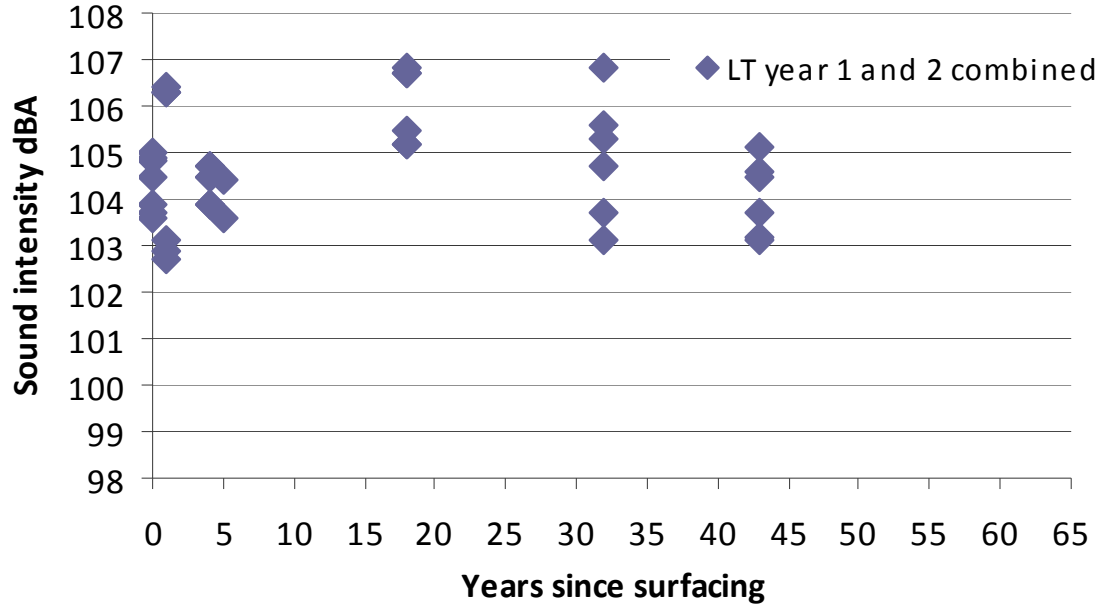
Figure 3.39: Year 1 and Year 2 OBSI values for all longitudinally tined sections versus years since last surfacing.

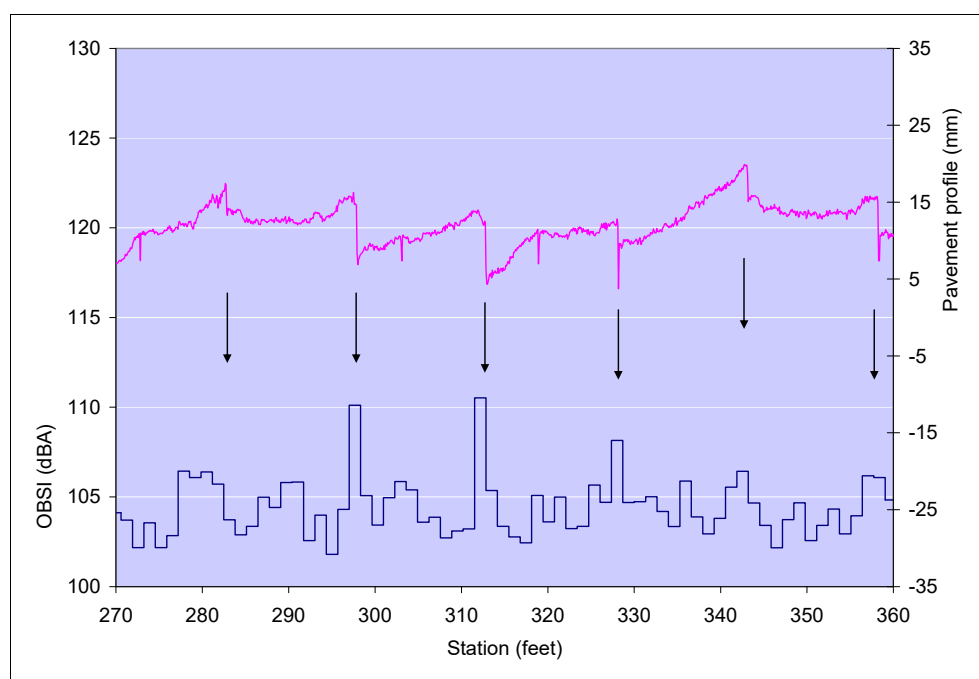
Figure 3.40: Noise level spikes and correspondence to joint faulting.

slap caused by the joint groove, faulting and overbanded sealant. An example of that initial analysis is shown in Figure 3.40 for a faulted jointed concrete pavement on I-80 near Davis, CA, with the pavement profile measured with a high-speed laser in the right wheelpath shown above and OBSI in 15-ms intervals shown below. The example shows a maximum spike of about 8 dB(A) at the third joint from the left (joints indicated by arrows in the figure), where the fault height is approximately 9 mm (0.36 inches). The effects of faulting and joint groove cross-sectional area are not separated at that joint. Analysis of these results was extremely labor-intensive and there was insufficient funding in the project to fully analyze and consider these effects in the results, or to automate the analysis.

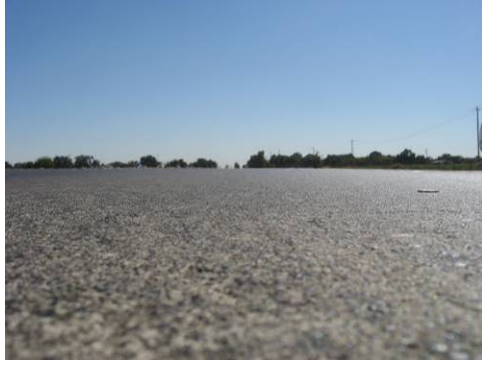
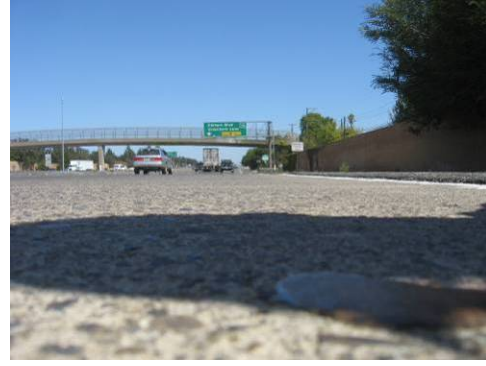
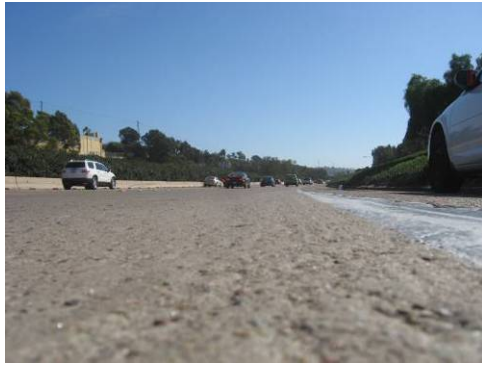
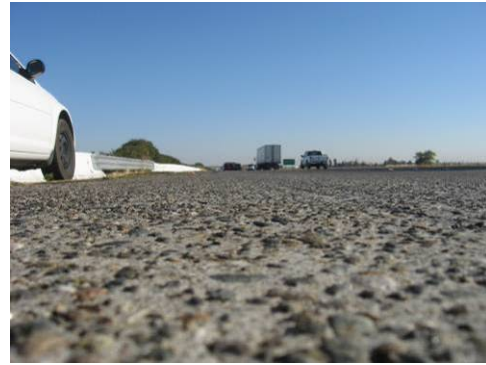
QP-102.2 (103.0 dB[A])

QP-107.3 (103.7 dB[A])

QP-130.1 (107.3 dB[A])

QP-116.1 (107.8 dB[A])

Figure 4.1: Example photographs of burlap drag surfaces and their OBSI levels.

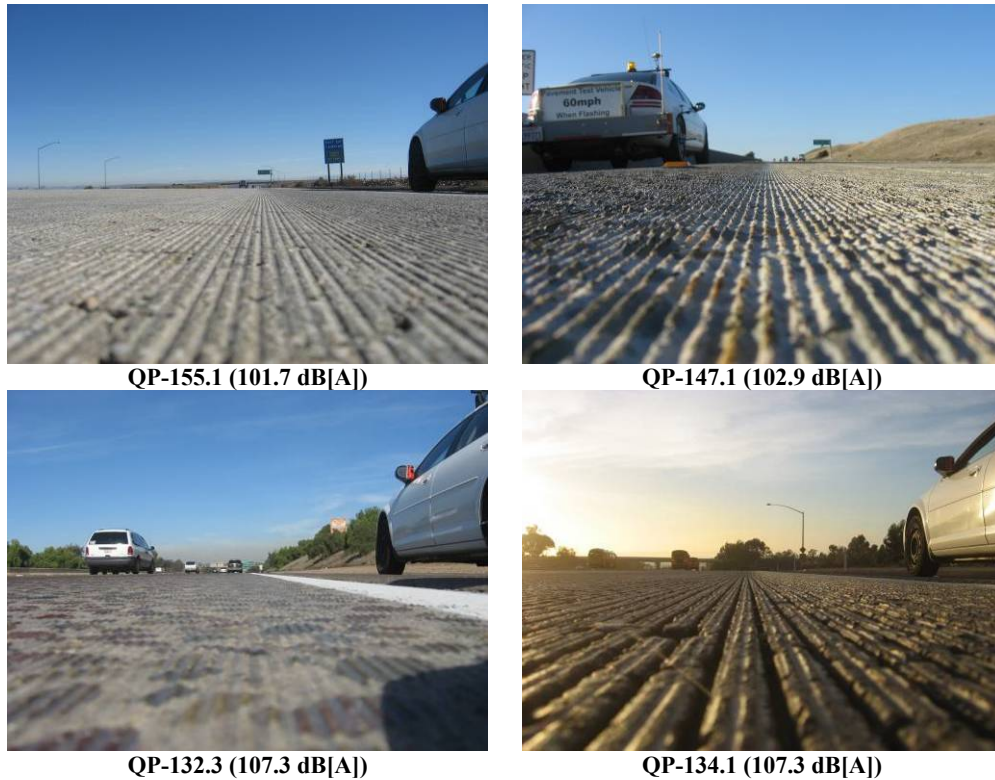
Figure 4.2: Example photographs of diamond ground surfaces and their OBSI levels.

Diamond grinding is a technique commonly used in California to correct texture and profile. Older diamond-ground sections included in this study were about 11 years old. A summary of the information for diamond grinding is presented in Table 4.2. Texture depth (macrotexture) is a possible reason for the variability in OBSI levels, in this case measured as the height of the fins left in the concrete between the diamond grinding blades. Photographs of example diamond ground surfaces are shown in Figure 4.2.

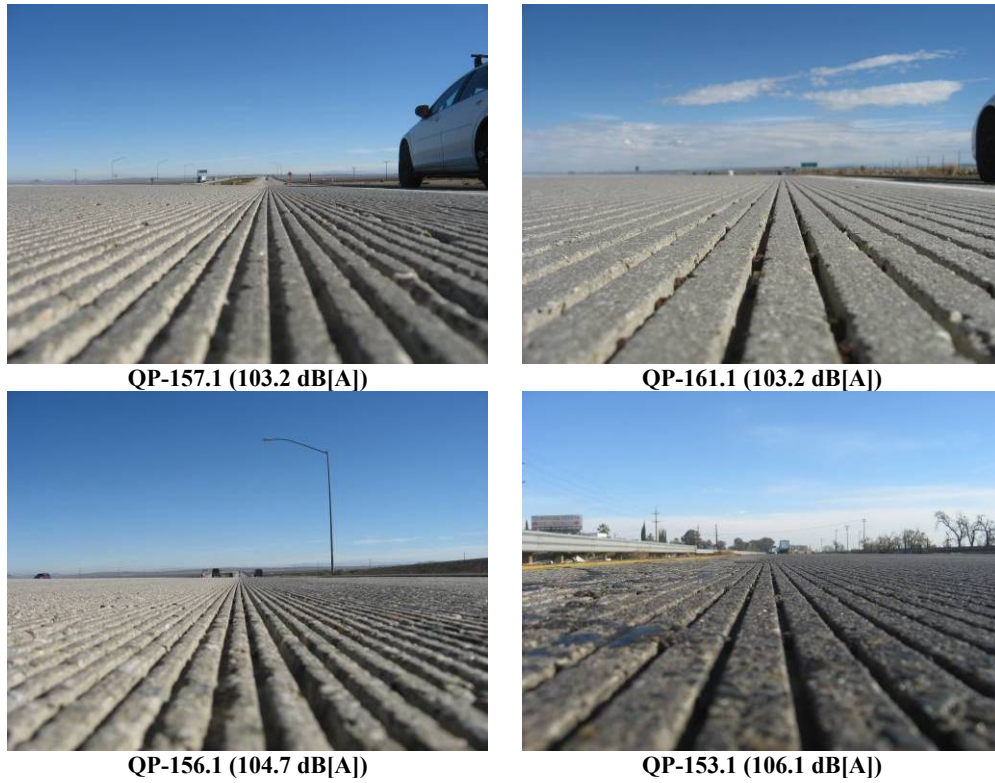
Figure 4.3: Example photographs of diamond grooved surfaces and their OBSI levels.

Prior to this testing, it was uncertain whether diamond grooving without diamond grinding had an effect on noise level because the grooves leave most of the contact area between the tire and the pavement unchanged, and therefore diamond grooving might not be as effective as diamond grinding for reducing the noise level on existing concrete pavements. However, based on this study's results for 19 diamond grooved sections and 32 diamond ground sections (7 and 24 sections in Year 2, respectively), the two techniques appear to yield similar OBSI levels. Comparison of Figure 3.33 (diamond ground) and Figure 3.35 (diamond grooved) shows that experiment samples of both texture types have similar ages, with less than 15 years since their last resurfacing. It can also be seen from Table 2.1 that the DG and Gr sample sections are distributed across both passenger car and truck lanes and in both dry and wet parts of state, except for the very wet North Coast region. A summary of the information for diamond grooved sections is presented in Table 4.3. Photographs of example diamond grooved surfaces are shown in Figure 4.3.

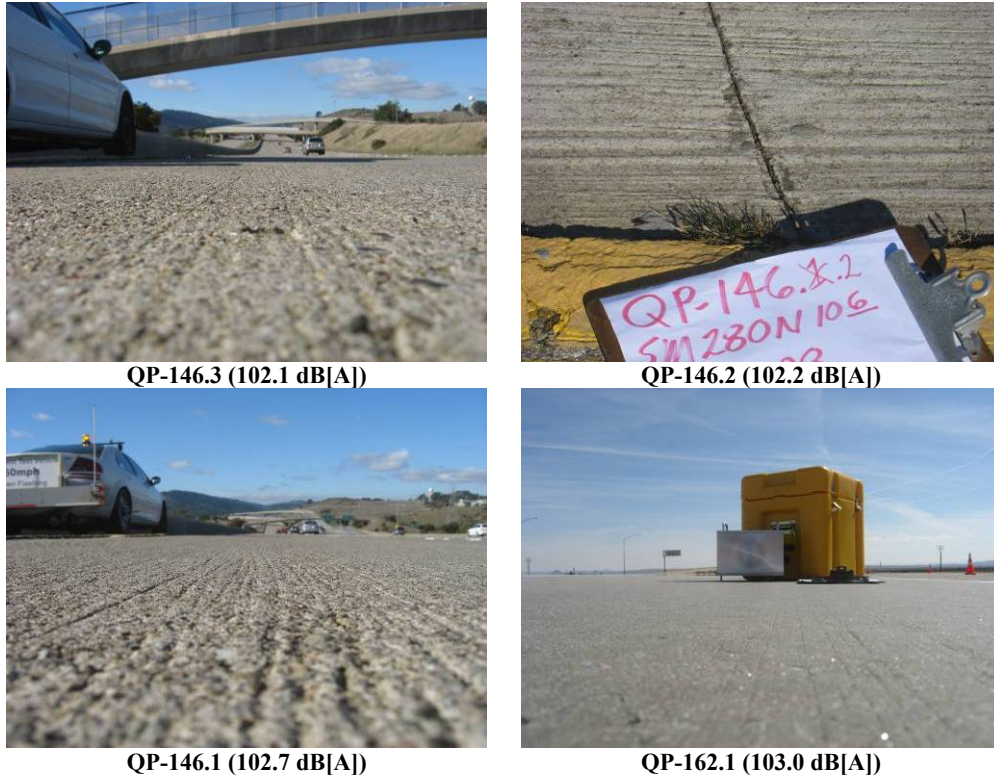
Figure 4.4: Example photographs of longitudinally broomed surfaces and their OBSI levels.

Longitudinally broomed pavement surface texture is uncommon on California highways. The difference between longitudinally broomed and burlap drag surface textures is only clear on surfaces that are not *worn out* (i.e., texture has not been worn off by traffic) and still show the striations caused by the texturing tool. The difference between the two techniques is less apparent in the case of *worn out* surfaces. In this study, the presence of striations of more than 1 or 2 mm depth (as evaluated subjectively from photographs) was considered reason to label a texture as longitudinally broomed. If only shallower striations or none were observed, then the section was labeled as having a burlap drag texture type. This resulted in a low number of longitudinally broomed sections, and affected the balance of the experimental factorial, complicating the interpretation of results. From a practical point of view, longitudinal brooming could be considered equivalent to a “heavy drag” texture. A summary of the information for longitudinally broomed sections is presented in Table 4.4. Photographs of example longitudinally broomed surfaces are shown in Figure 4.4.

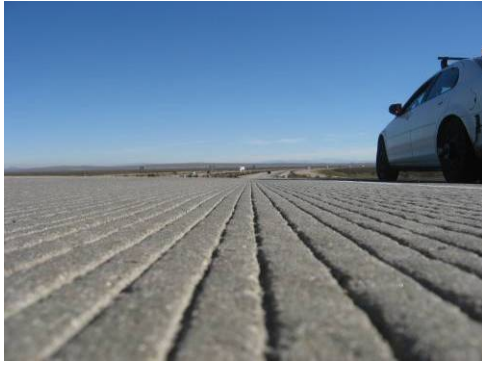
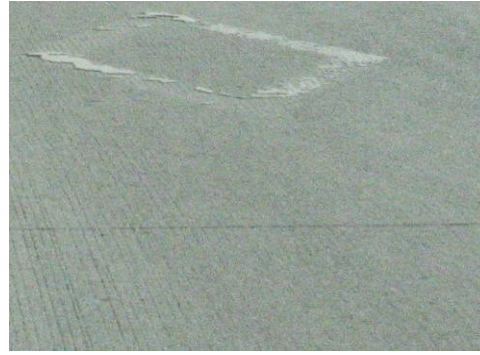
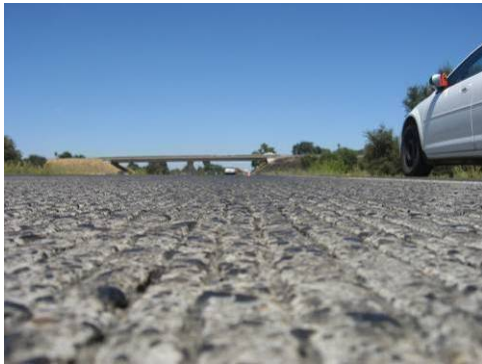
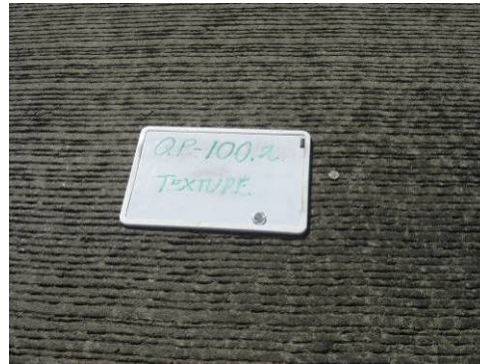
QP-158.1 (104.4 dB[A])

QP-127.3 (104.5 dB[A])

QP-101.1 (106.7 dB[A])

QP-100.2 (106.8 dB[A])

Figure 4.5: Example photographs of longitudinally tined surfaces and their OBSI levels.

Longitudinal tining is the texture type most commonly found on California highways. Sections tested in the study ranged in surface age from several months to 42 years. The interquartile range reveals that 50 percent of the sections of this texture type are expected to fall between 103.7 and 105.6 dB(A). This is interesting because the longitudinal grooves that result from the tining process vary widely in depth, spacing, the amount of material displaced that protrudes from the surface, and how straight they are (often they appear to be “waves” of different wavelengths, but in other cases they are perfectly straight). Four examples of longitudinally tined sections are shown in Figure 4.5. A summary of the information for longitudinally tined sections is presented in Table 4.5.

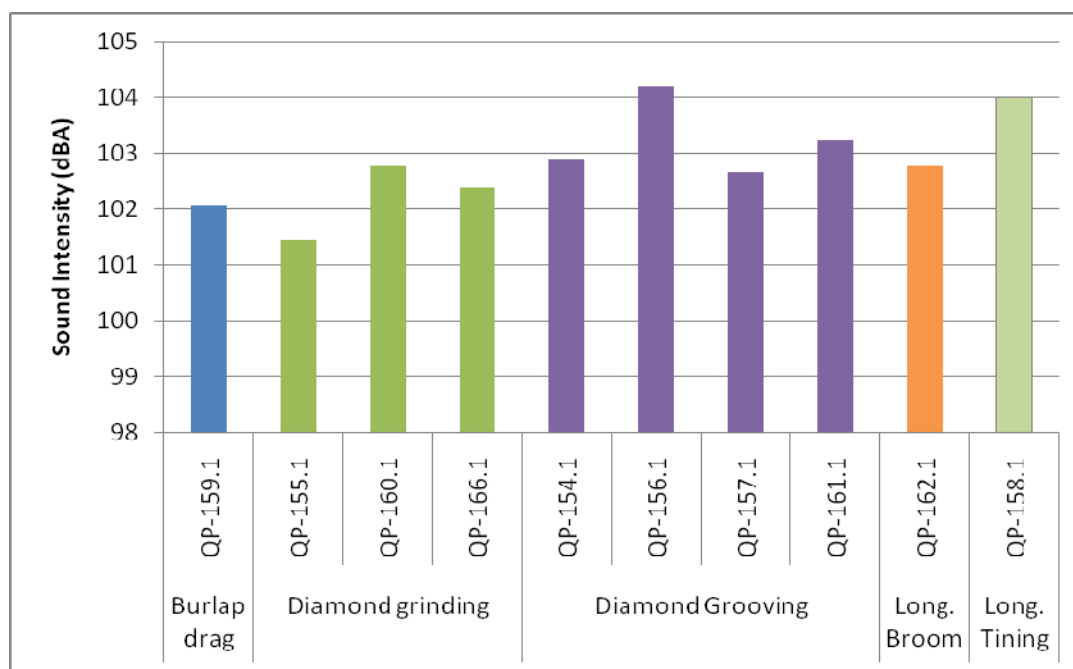
Figure 4.6: Comparison of OBSI noise levels of concrete pavement textures in Mojave sections averaged over the two years of measurement.

Table 4.6, Figure 4.6, and Figure 4.7 present the results of the pavement sections in the Mojave test site (Kern 58). The quietest sections were those with a diamond-ground surface. Figure 4.6 shows the results of the sections averaged across the two years while Figure 4.7 shows each year of measurement individually, ordered by the Year 1 OBSI measured value. The one-year change on the Mojave sections in the reported data for the corrected OBSI values ranges from 0 to 1.6 dB(A), averaging 0.7 db(A), which is greater than expected. It should be noted that the effects of the error term for the tire correction equation discussed in Chapter 2 is accentuated on a small sample such as the Mojave sections. In this case, since there are only two years of data the error term is large relative to the expected annual change (noise to signal ratio), and the error does not get averaged out well on a small sample. Additional years of data will be needed to clarify the rate of change of OBSI on these sections.

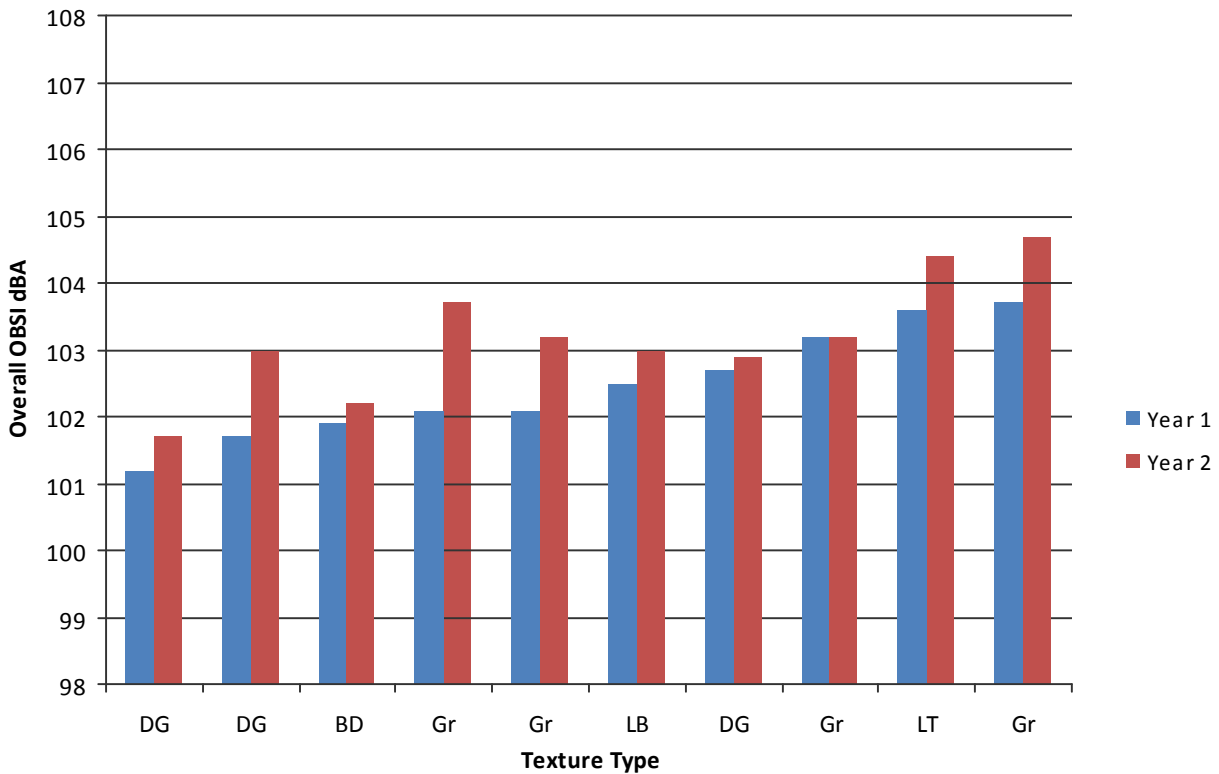
Figure 4.7: Comparison of average OBSI noise levels of concrete pavement textures in Mojave sections ranked from quietest to loudest in Year 1 (Year 1 on the left and Year 2 on the right).

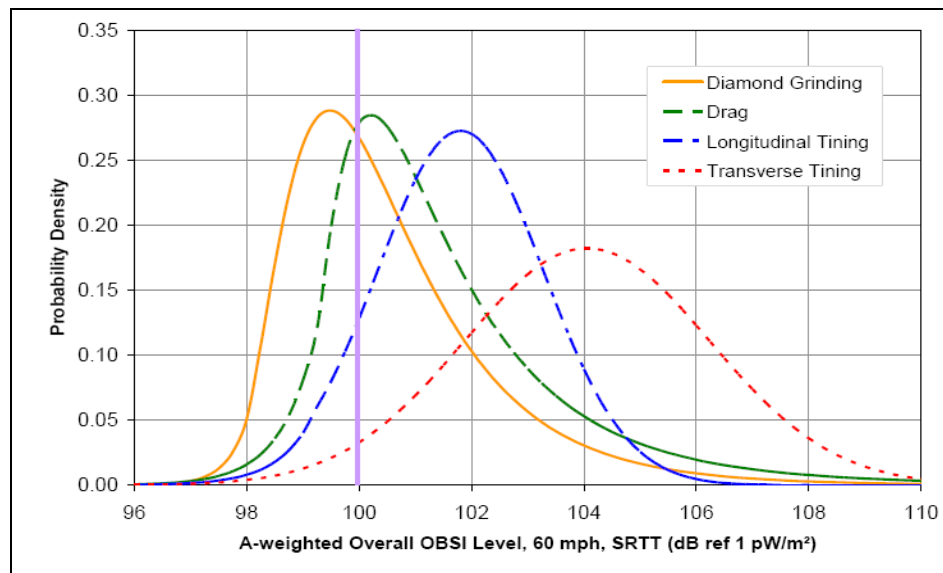
Figure 4.8: Probability distributions of OBSI noise levels for concrete pavement textures as reported by the National Concrete Pavement Technology Center (4).

Although the rankings are similar, the OBSI levels included in the 2008 NCPTC report were consistently lower than those measured in this study, as can be seen in Figure 4.8 and Figure 4.9.

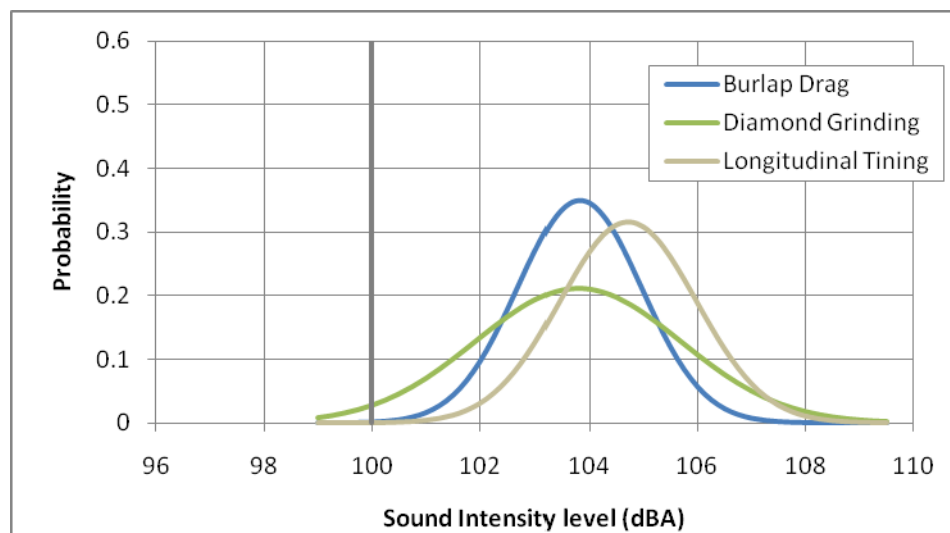
Figure 4.9: Distributions of OBSI noise levels in this study (excluding LB and Gr because of limited amount of data).
