1. REPORT NUMBER CA12-1200 A	2. GOVERNMENT ASSOCIATION NUMBER	3. RECIPIENT'S CATALOG NUMBER
4. TITLE AND SUBTITLE Quieter Pavement Research: Concrete Pavement Tire Noise	5. REPORT DATE 05/30/2011

6. PERFORMING ORGANIZATION CODE
7. AUTHOR John T. Harvey and Erwin Kohler	8. PERFORMING ORGANIZATION REPORT NO. UCPRC-RR-2010-03	
9. PERFORMING ORGANIZATION NAME AND ADDRESS University of California, Davis & Berkeley Partnered Pavement Research Center 1353 S. 46th Street, Bldg. 452 Richmond, CA 94804	10. WORK UNIT NUMBER

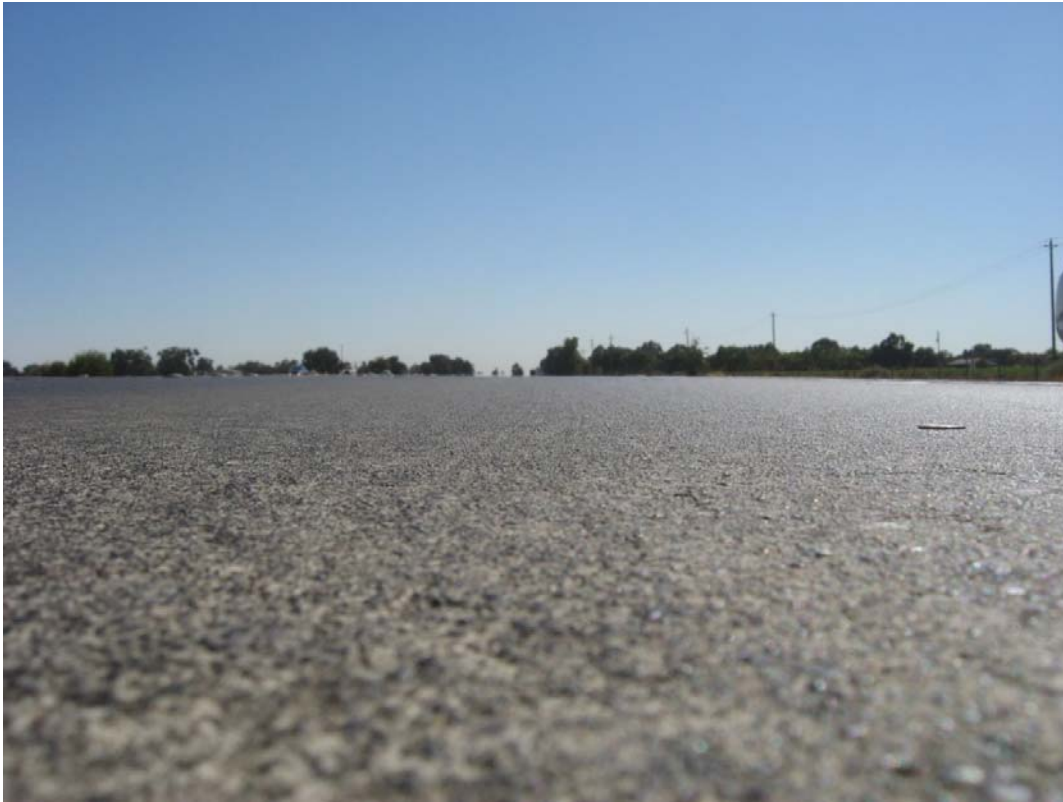
Figure A.1: Burlap drag, OBSI=103.0 dB(A) (Section QP-102.2).

Two photographs of the same texture type are shown on each page, displaying the surface texture as observed with the camera held directly on the pavement surface. The top and bottom photographs show respectively sections with low and high OBSI level. Surface type, section ID, and OBSI level are presented in the caption.

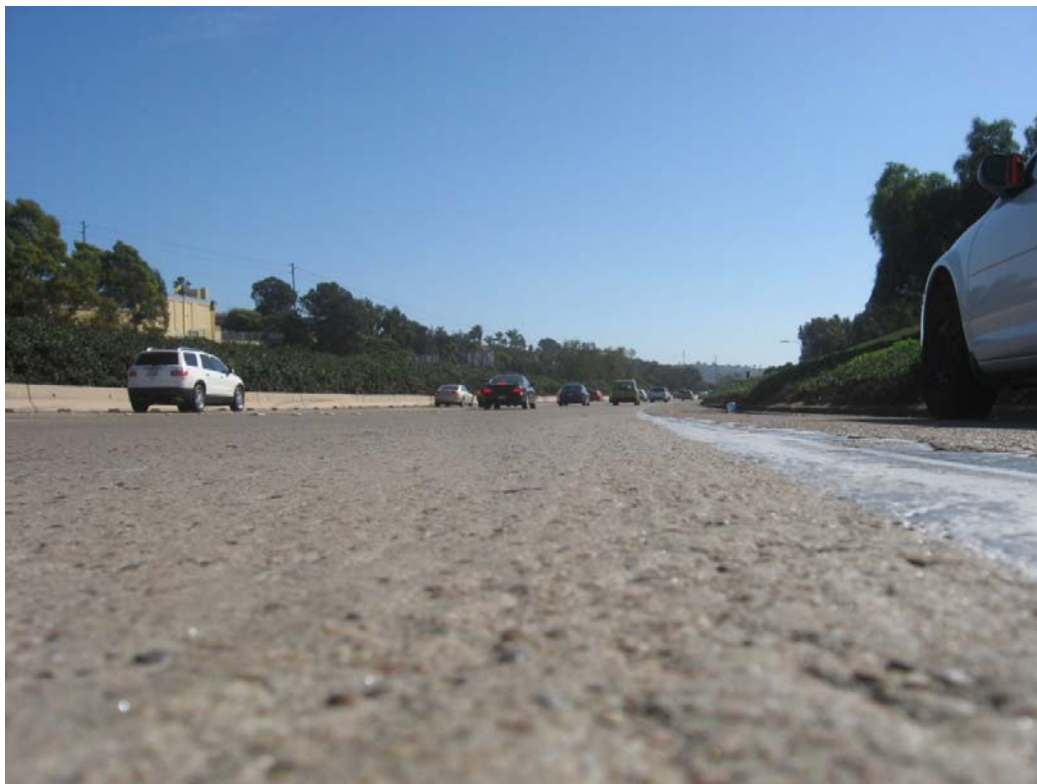
Figure A.2: Burlap drag, OBSI=107.3 dB(A) (Section QP-130.1).

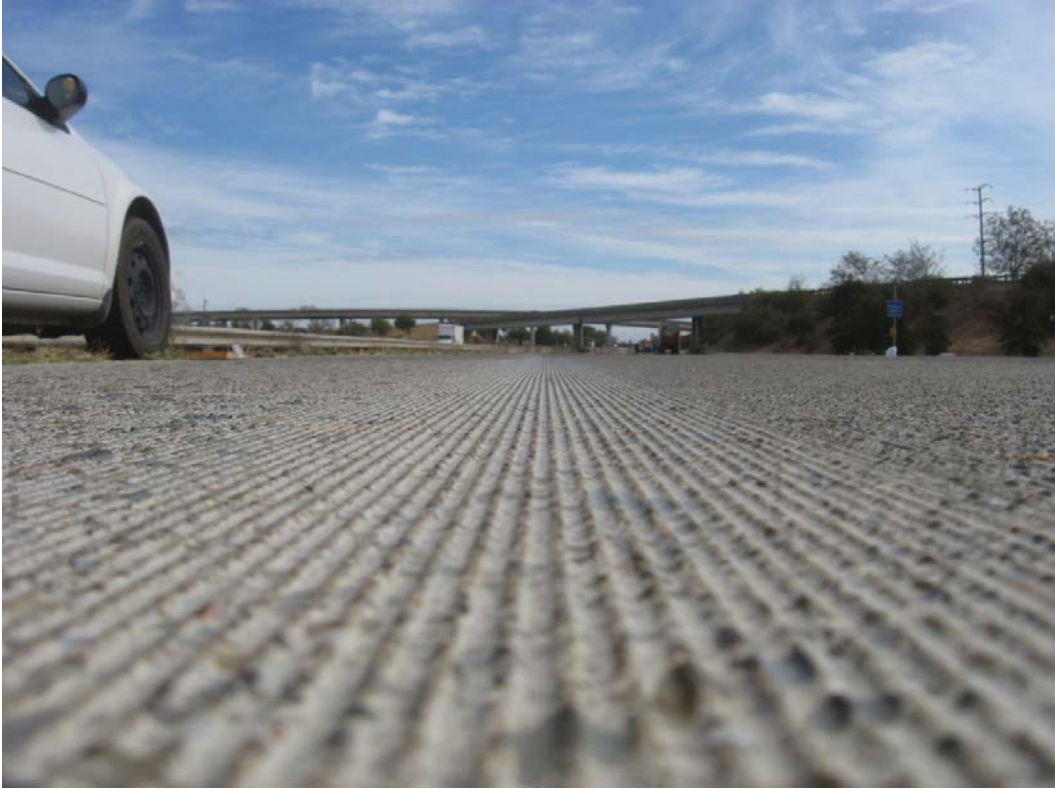
Figure A.3: Diamond ground, OBSI=99.4 dB(A) (Section QP-103.3).

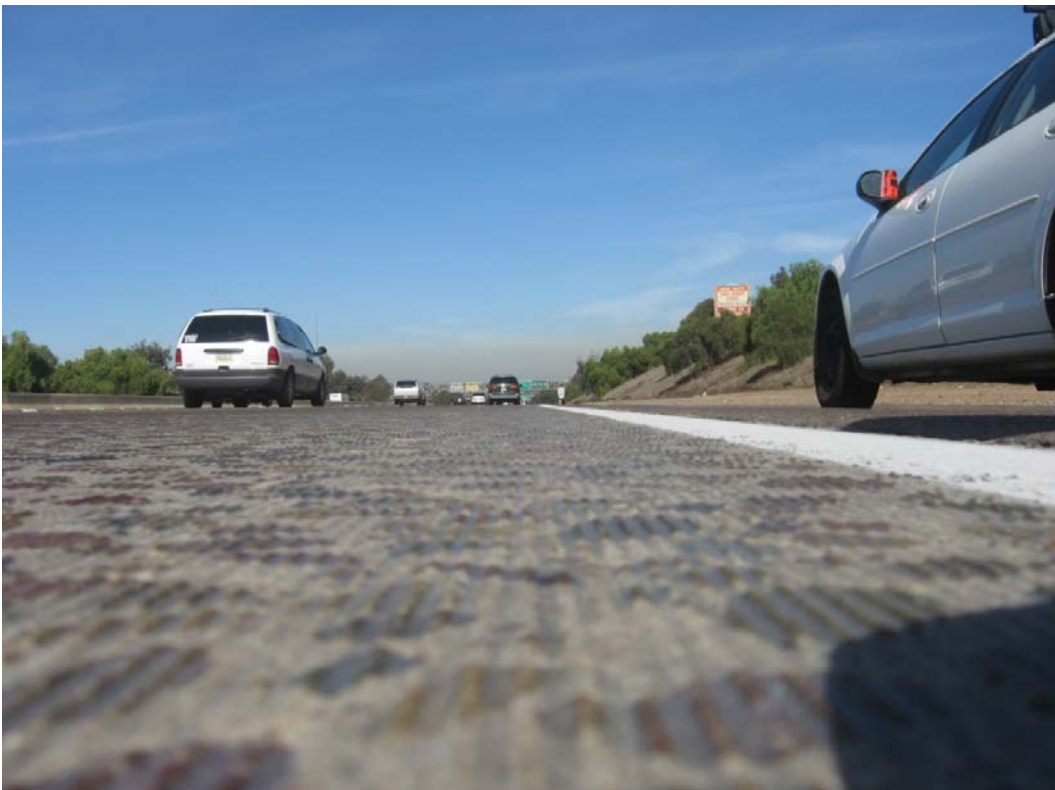
Figure A.4: Diamond ground, OBSI=107.2 dB(A) (Section QP-132.2).

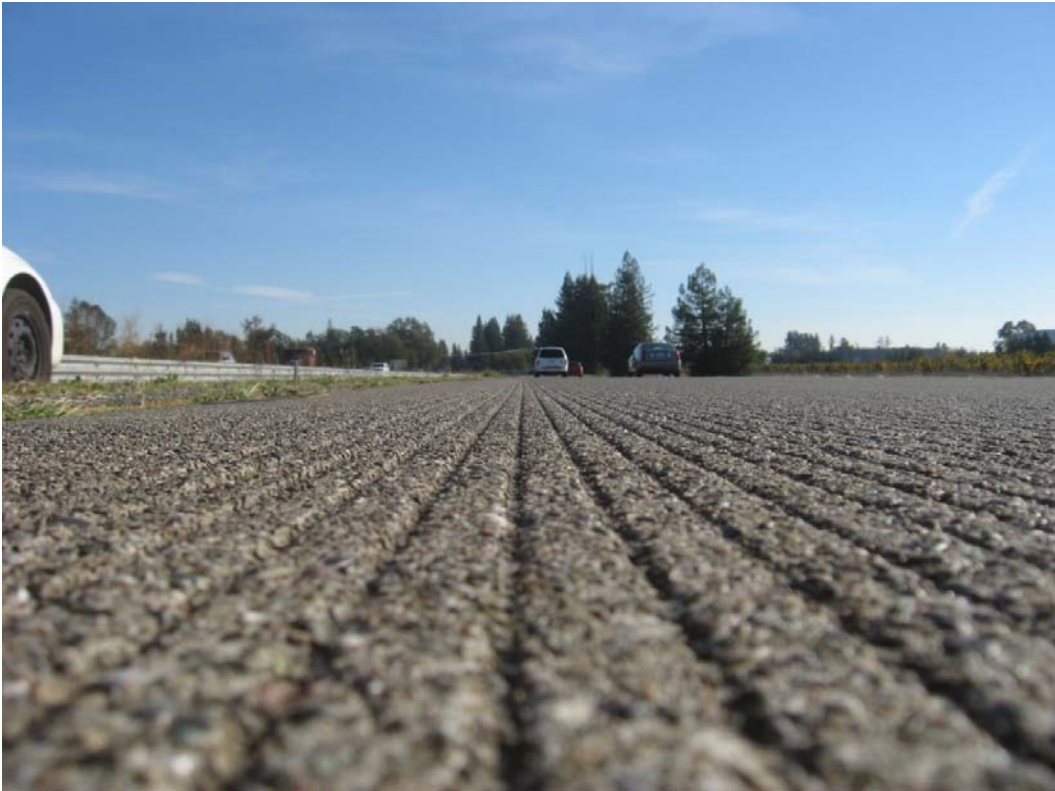
Figure A.5: Diamond grooved, OBSI=101.7 dB(A) (Section QP-138.3).

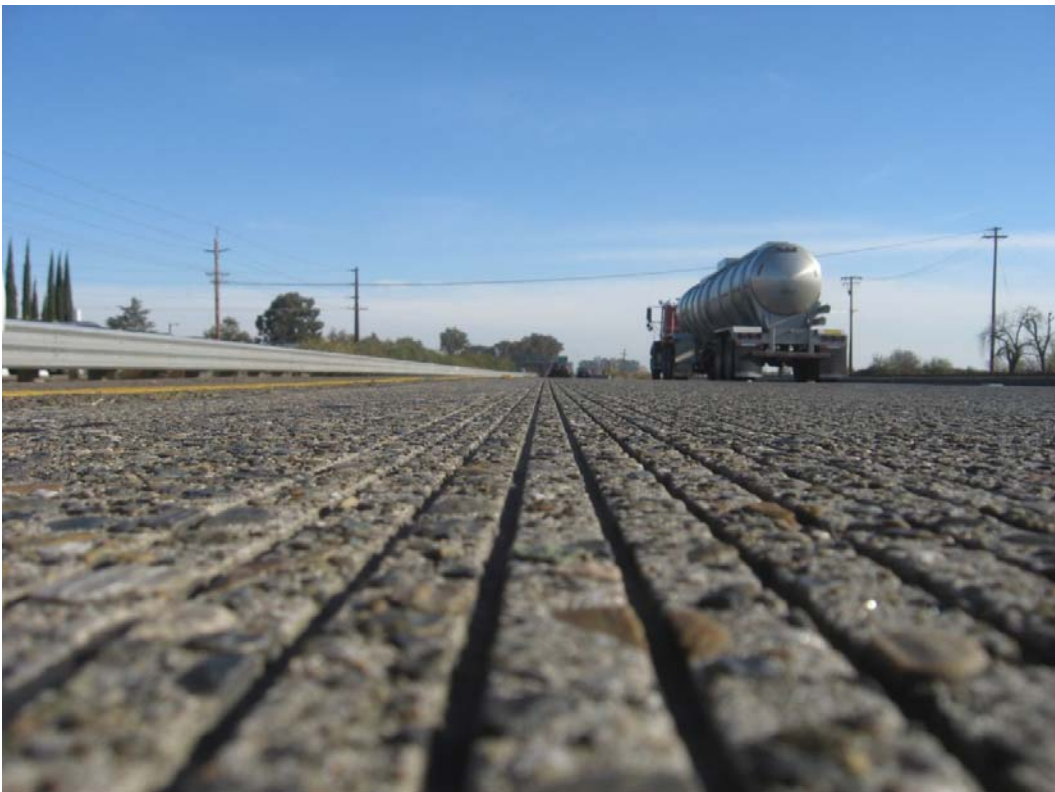
Figure A.6: Diamond grooved, OBSI=105.6 dB(A) (Section QP-153.2).

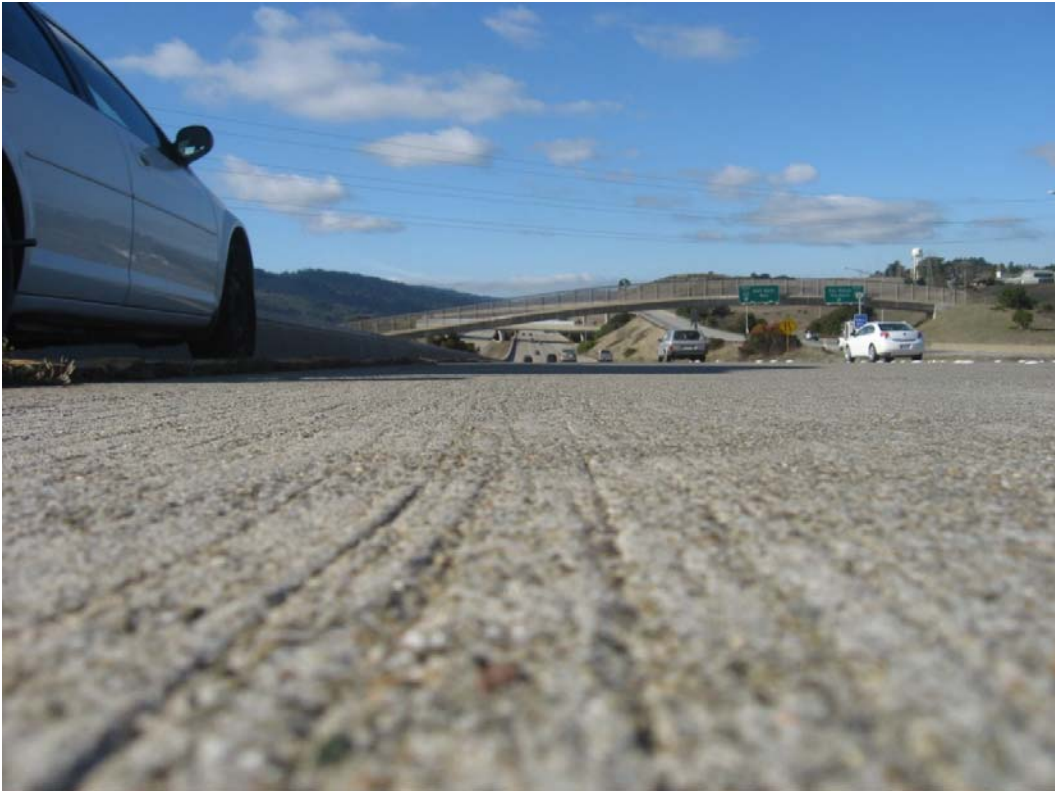
Figure A.7: Longitudinally broomed, OBSI=101.1 dB(A) (Section QP-146.3).

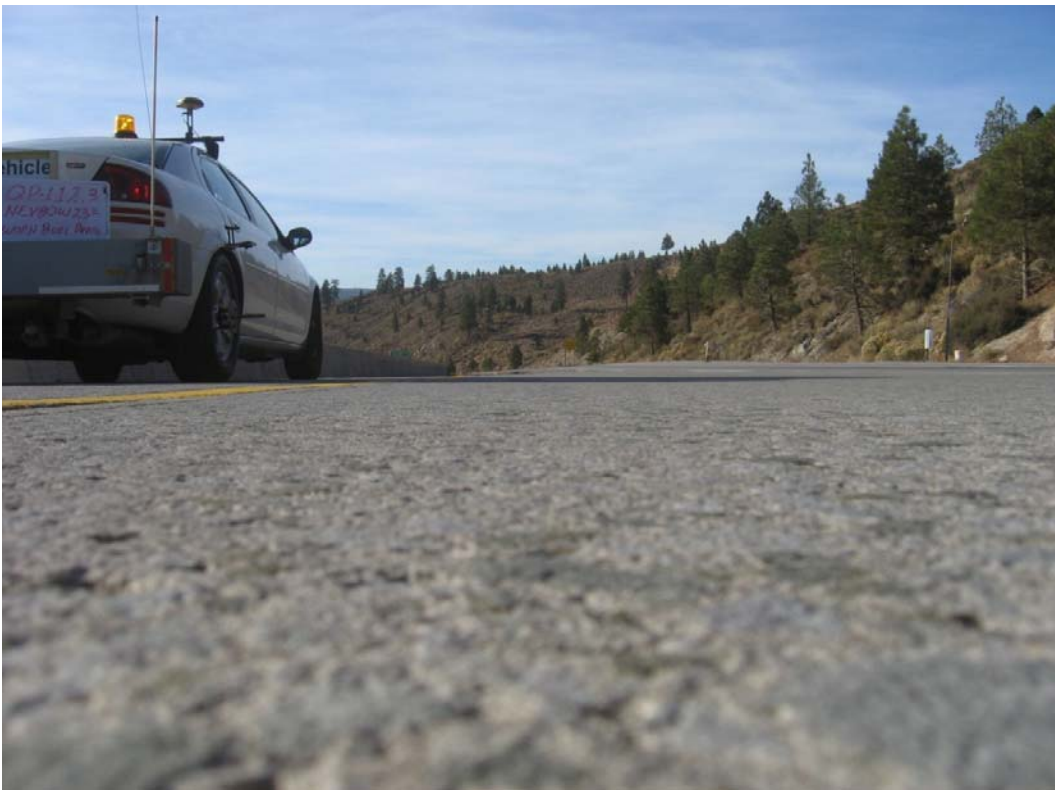
Figure A.8: Longitudinally broomed, OBSI=104.1 dB(A) (Section QP-112.3).

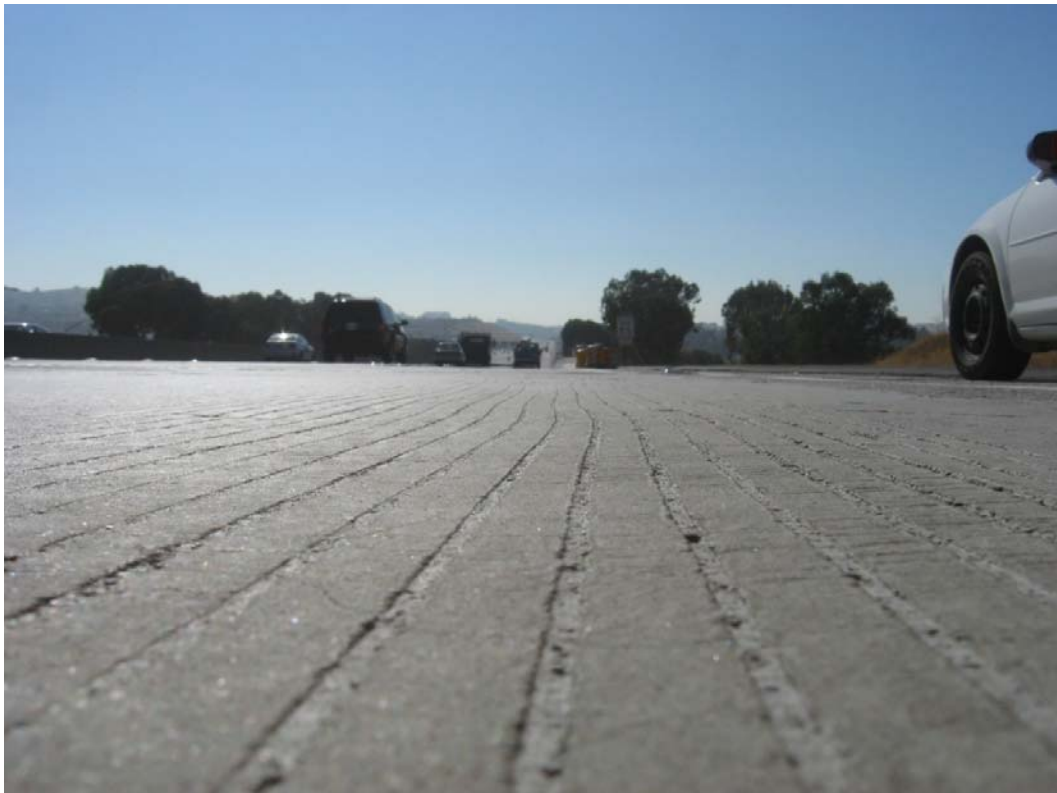
Figure A.9: Longitudinally tined, OBSI=102.7 dB(A) (Section QP-117.2).

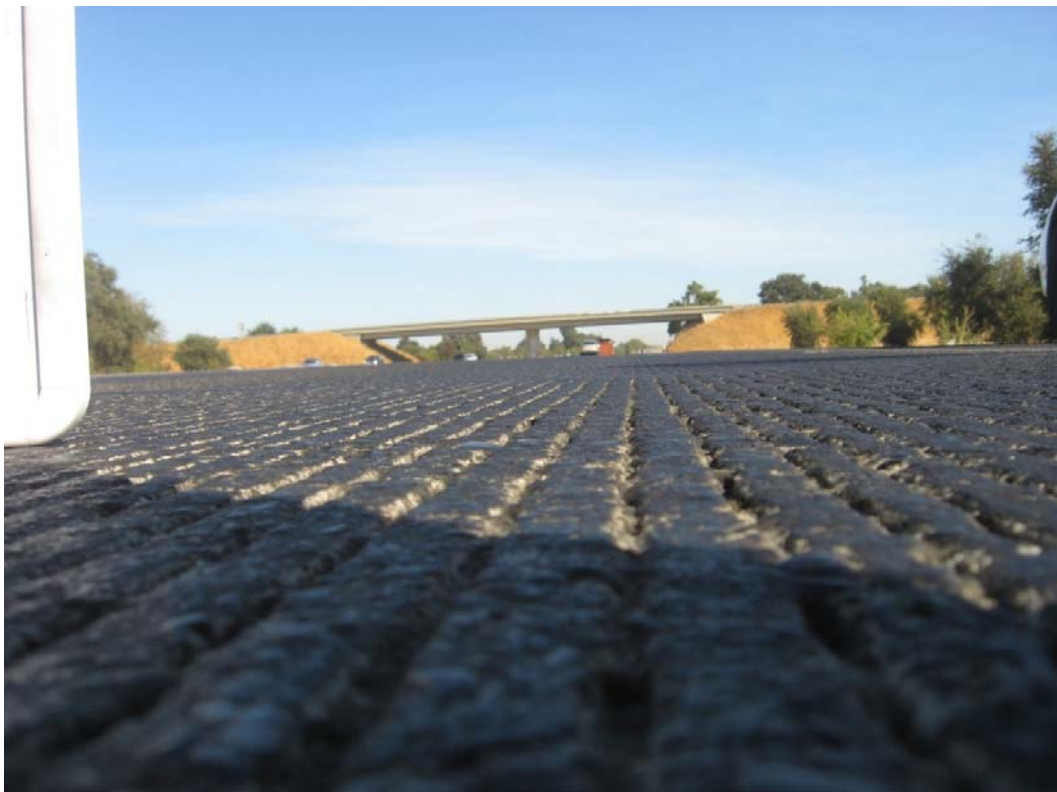
Figure A.10: Longitudinally tined, SI=105.5 dB(A) (Section QP-101.2).

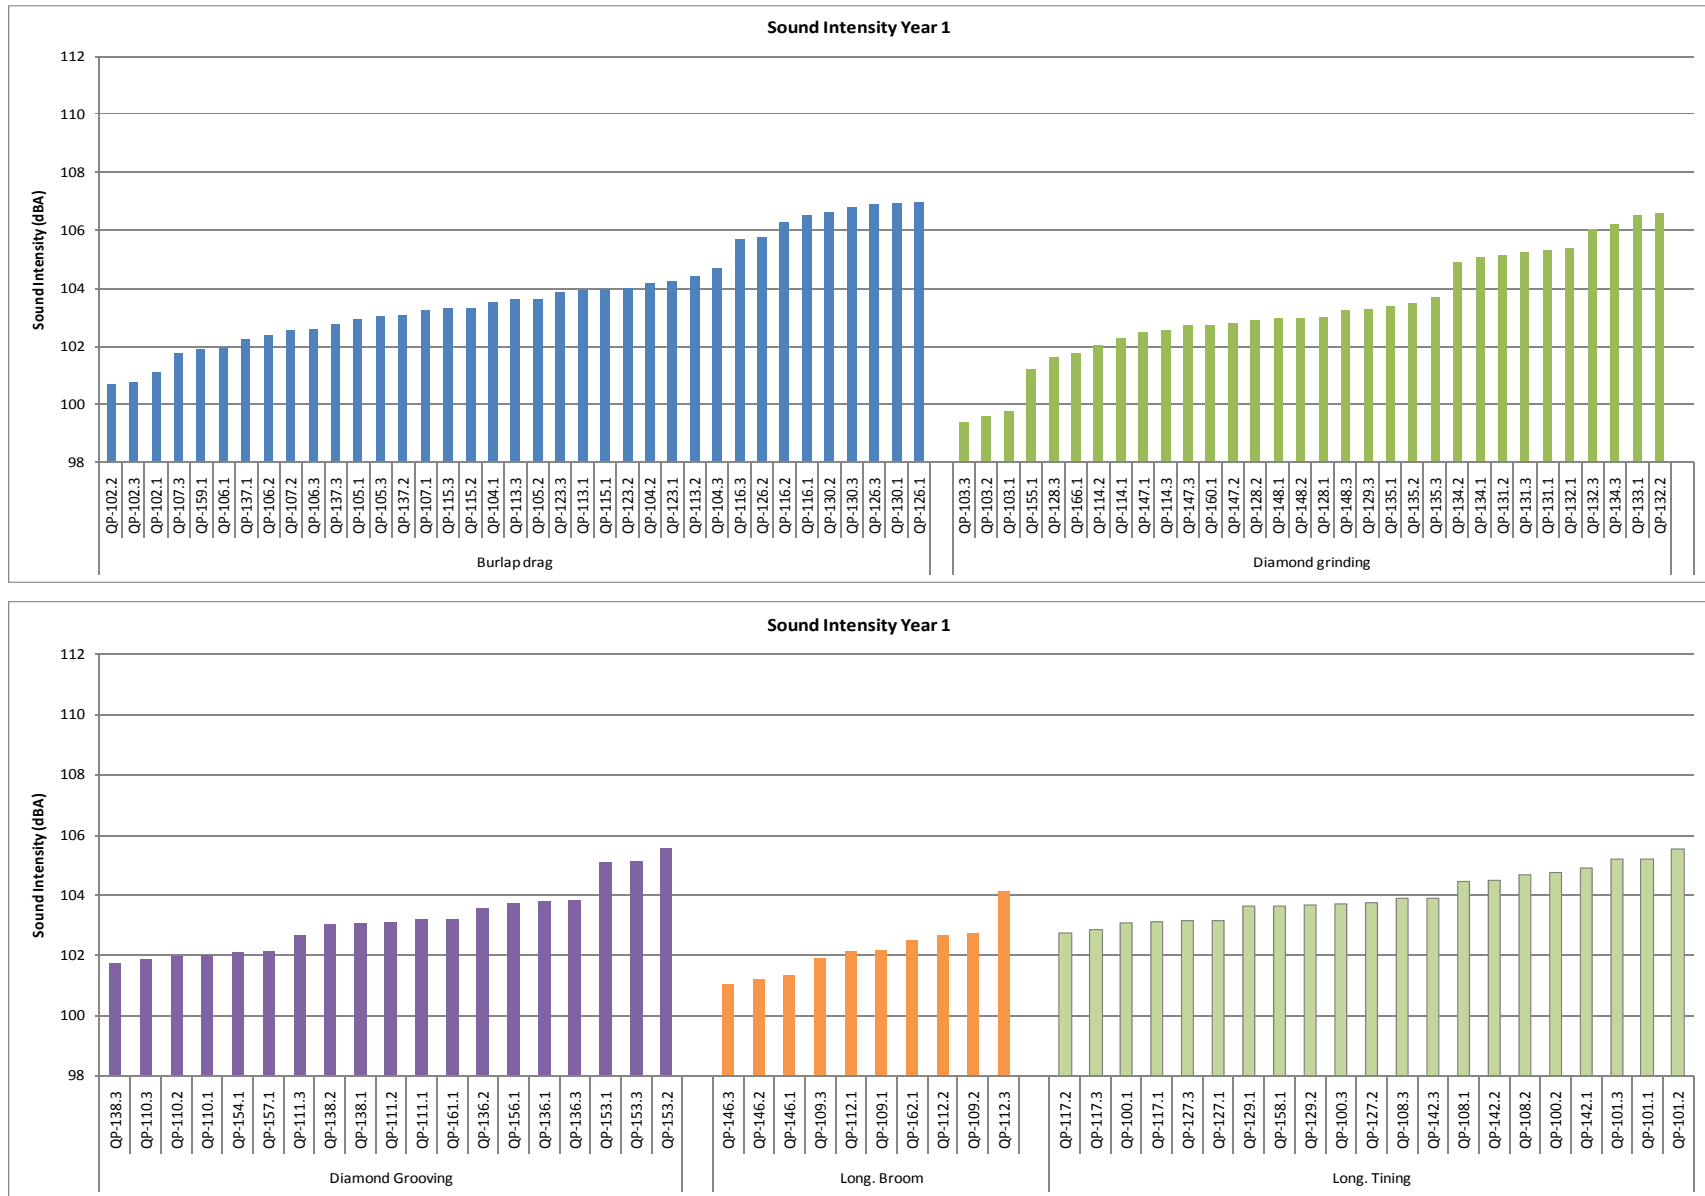
Figure B.1: On-board Sound Intensity levels of all sections as measured in Year 1.

The overall OBSI levels of each section measured in Year 1 and Year 2 are presented here.

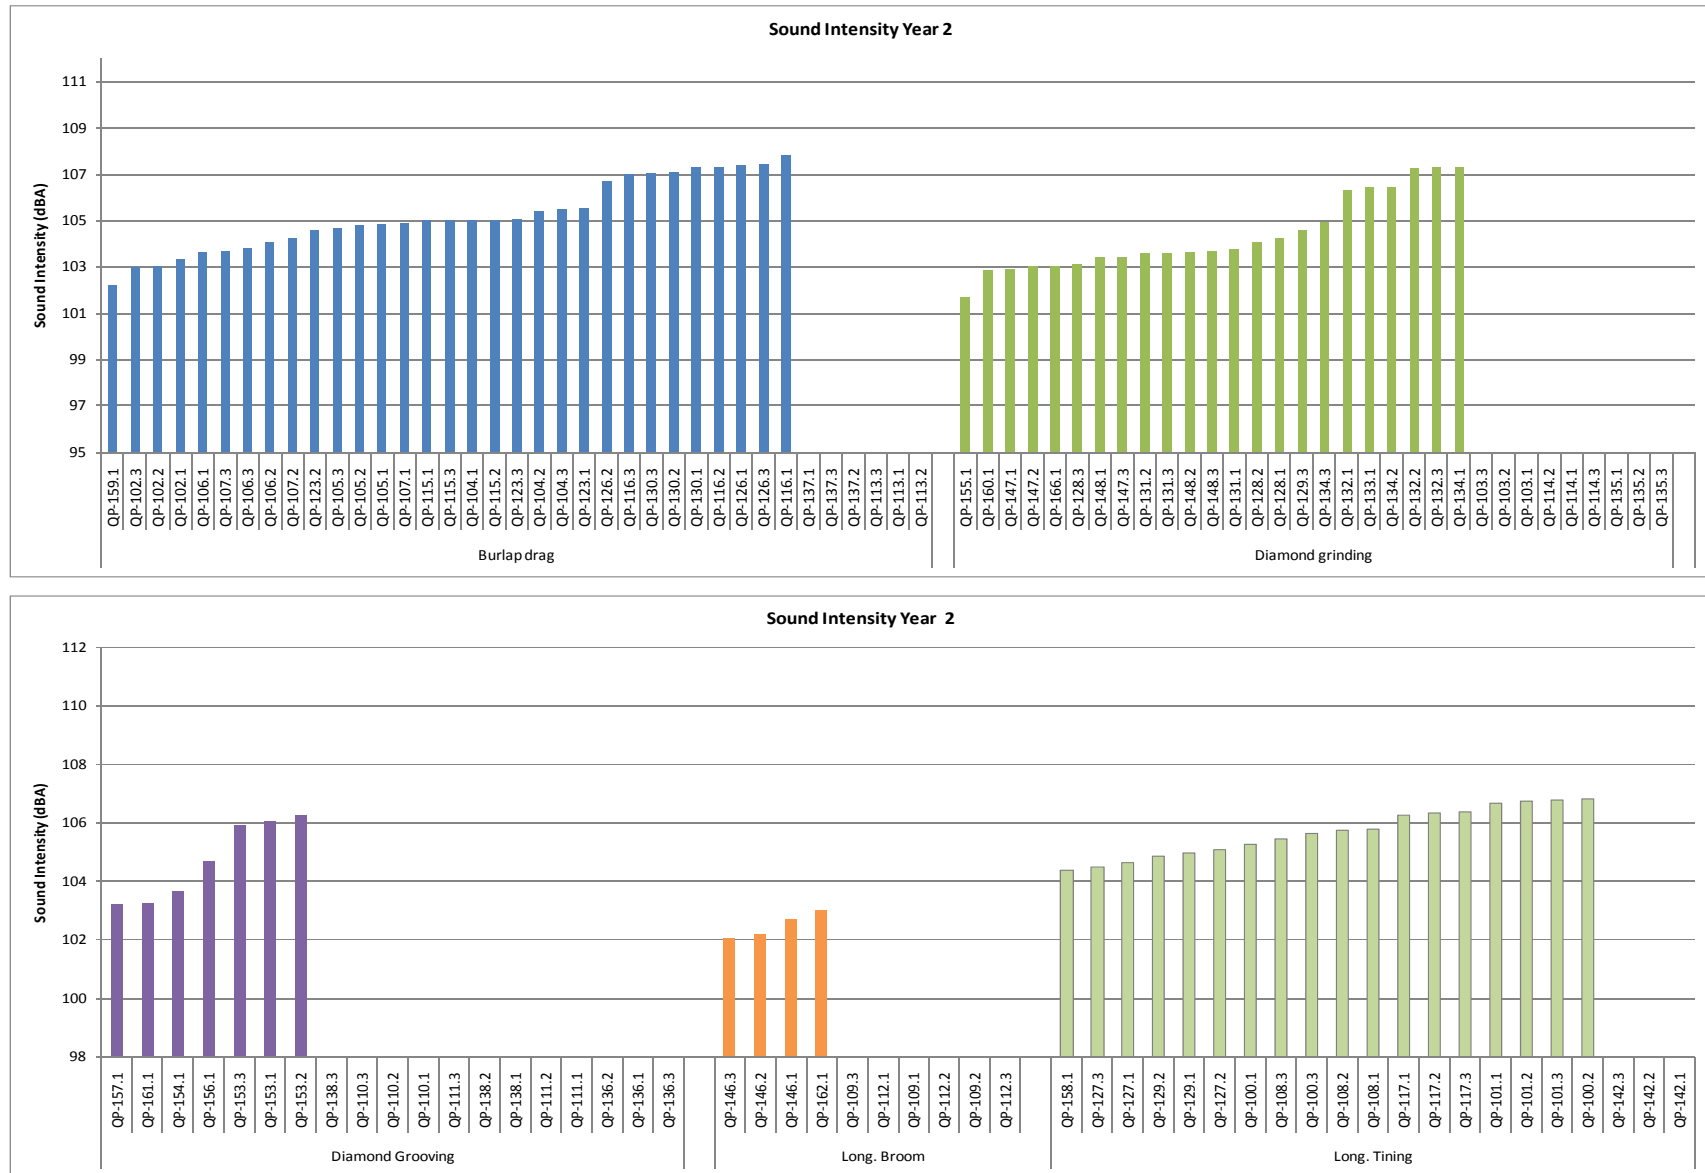
Figure B.2: On-board Sound Intensity levels of all sections as measured in Year 2.

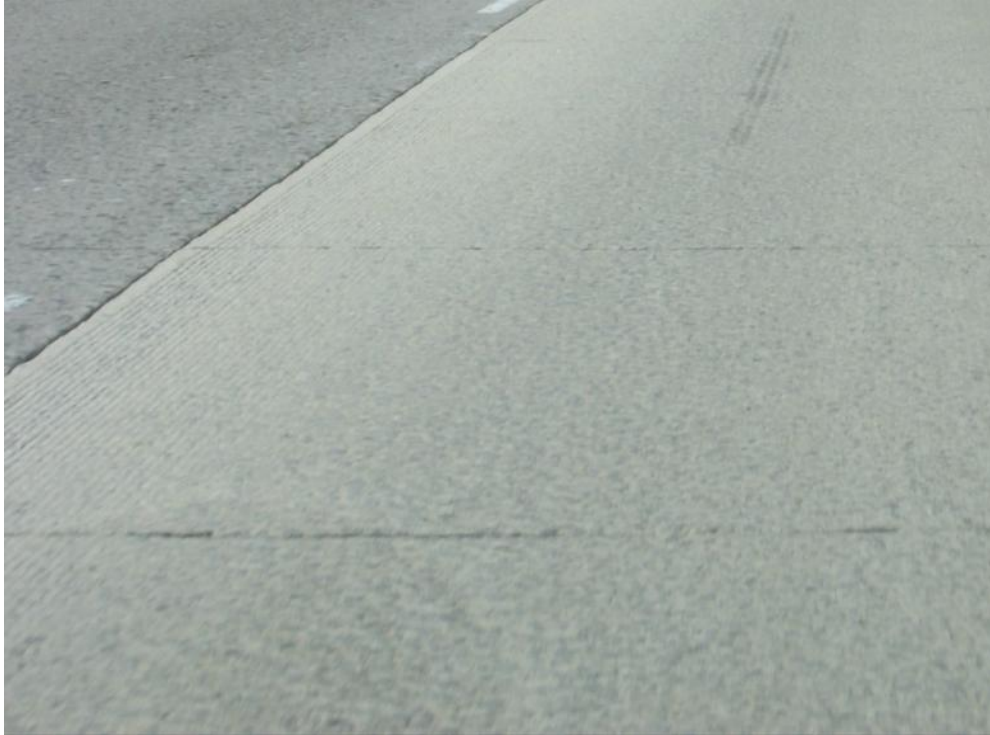
Figure C.2: Evidence of original longitudinal tines outside of the wheelpaths of Section QP-142.2 after one year of traffic.

The pavement at Sections QP-142.1, 142.2, and 142.3 all experienced a large increase in noise level from Year 1 to Year 2. The increase was due to an unusual rapid wearing of the longitudinal texture, which disappeared completely, leaving a surface where the concrete paste was recessed and the aggregates were exposed and protruding. The average OBSI values of these sections changed from 104.4 dBA (104.9, 104.5, and 103.9) to 111.8 dBA (111.4, 111.2, and 112.6), an increase of 7.4 dBA.

Images of the surface texture of Sections QP-142.1 and QP-142.3 at approximately the same spots are shown in Appendix D, with the pictures on the left taken in November 2008 and the ones on the right in September 2009. This pavement was new—it had been opened to traffic in the summer of 2008—and is located at 5,900 feet above sea level, where it was subjected to chain wear during snow season. Appendix D shows that the longitudinal tining remains outside the wheelpath, while it has been completely obliterated in the wheelpaths by the chains.

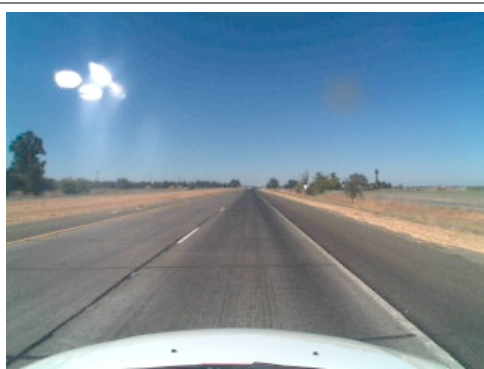
Onboard picture Year 1

Comments: Longitudinally tined. Aggressive texture, sealed joints.

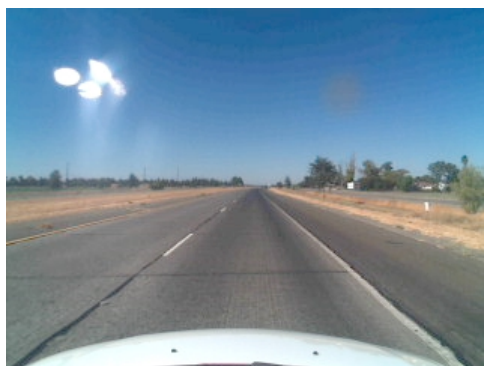
Onboard picture Year 1

Type of section: Pavement Field testing Year 1: 9/3/2008 15:59
 Location: 03Yol113N3.1 Field testing Year 2: 9/4/2009 14:24
 Comments: Longitudinally tined. Aggressive texture, sealed joints.
 Surface Year: 1976

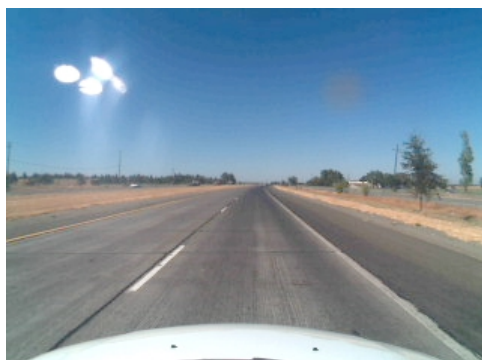
Onboard picture Year 1

Type of section: Pavement Field testing Year 1: 9/3/2008 16:10
 Location: 03Yol113N3.2 Field testing Year 2: 9/4/2009 14:40
 Comments: Longitudinally tined. Aggressive texture, sealed joints.
 Surface Year: 1976

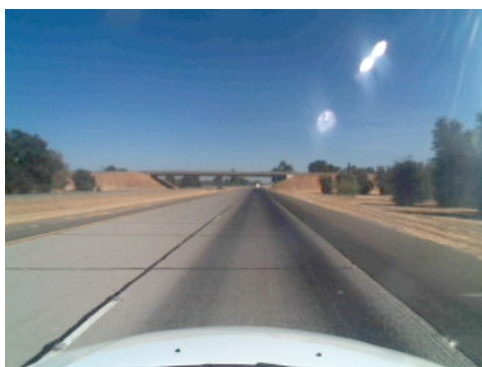
Onboard picture Year 1

Type of section: Pavement Field testing Year 1: 9/23/2008 10:42
Location: 03Yol113N6.0 Field testing Year 2: 9/4/2009 14:16
Comments: Longitudinally tined. Deep tining. Rubber built-up.
Surface Year: 1990

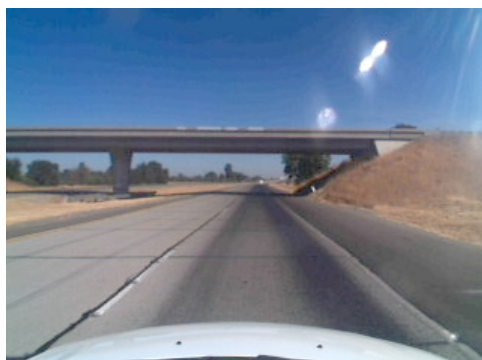
Onboard picture Year 1

Type of section: Pavement Field testing Year 1: 9/23/2008 11:00
 Location: 03Yol113N6.1 Field testing Year 2: 9/4/2009 14:29
 Comments: Longitudinally tined. Deep tines. Rubber built-up. Overcross at middle of section.
 Surface Year: 1990

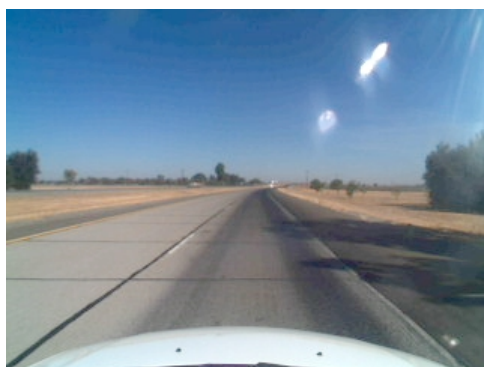
Onboard picture Year 1

Type of section: Pavement Field testing Year 1: 9/23/2008 11:09
 Location: 03Yol113N6.2 Field testing Year 2: 9/4/2009 14:46
 Comments: Longitudinally tined. Deep tines. Rubber built-up.
 Surface Year: 1990

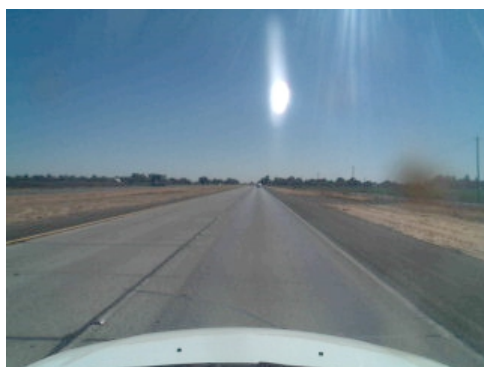
Onboard picture Year 1

Type of section: Pavement Field testing Year 1: 9/23/2008 13:12
 Location: 03Yol113S5.5 Field testing Year 2: 9/4/2009 14:20
 Comments: Burlap drag. Rubber built-up, some transverse cracks.
 Surface Year: 1976

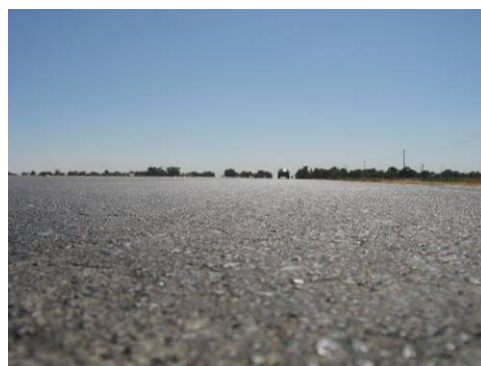
Texture detail

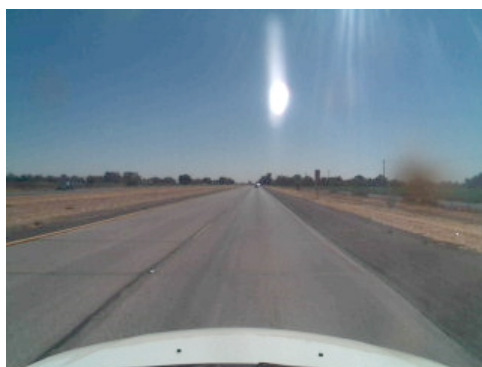
QP-102.2

Type of section: Pavement Field testing Year 1: 9/23/2008 13:46
 Location: 03Yol113S5.4 Field testing Year 2: 9/4/2009 14:49
 Comments: Burlap drag. Rubber built-up, some transverse cracks.
 Surface Year: 1976

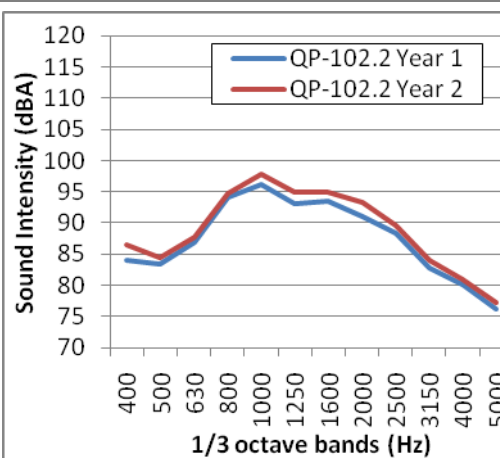
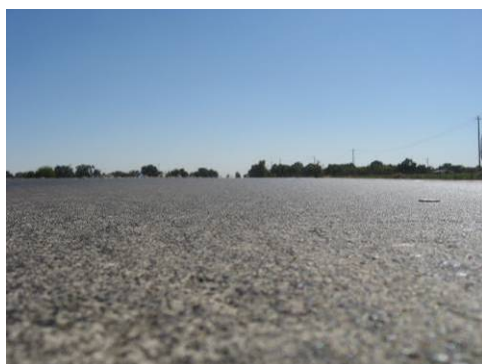
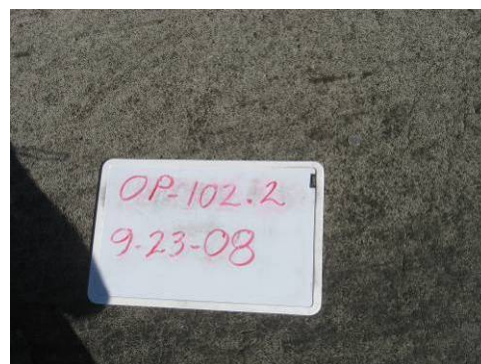
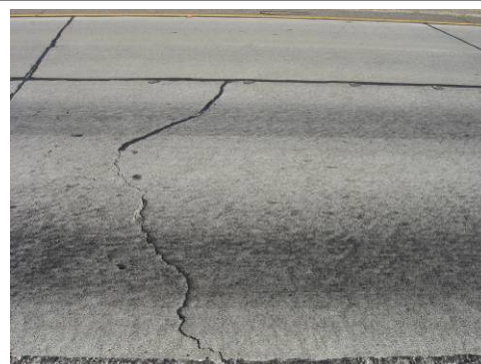
Texture detail

Joint & crack view

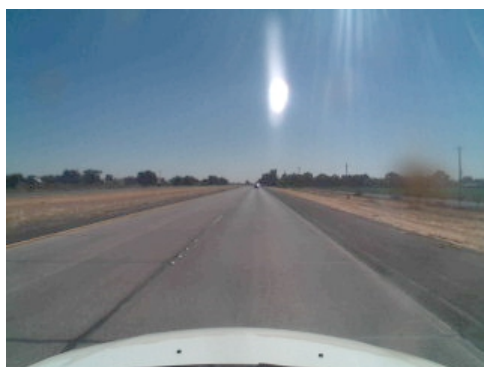
QP-102.3

Type of section: Pavement Field testing Year 1: 9/23/2008 13:58
 Location: 03Yol113S5.3 Field testing Year 2: 9/4/2009 14:49
 Comments: Burlap drag. Rubber build-up, some transverse cracks.
 Surface Year: 1976

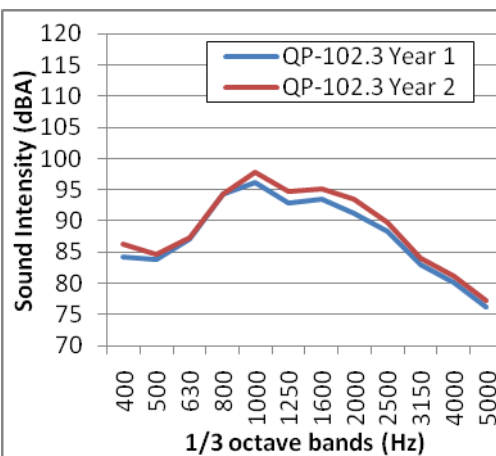
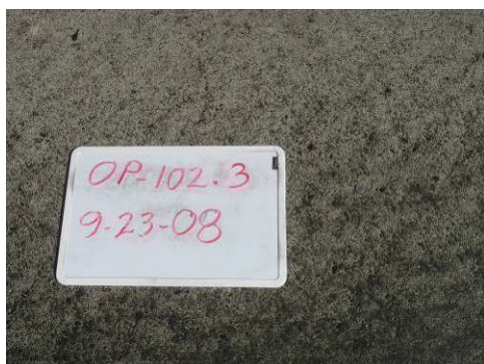
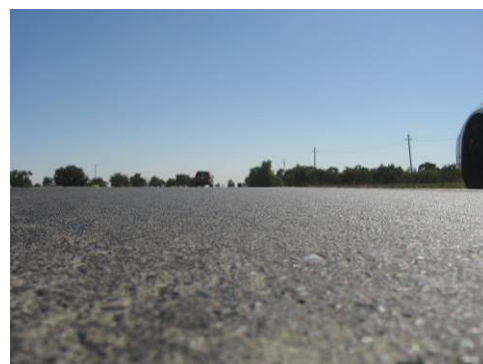
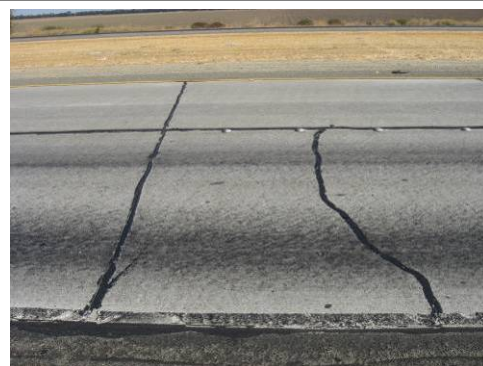
Texture detail

Joint & crack view

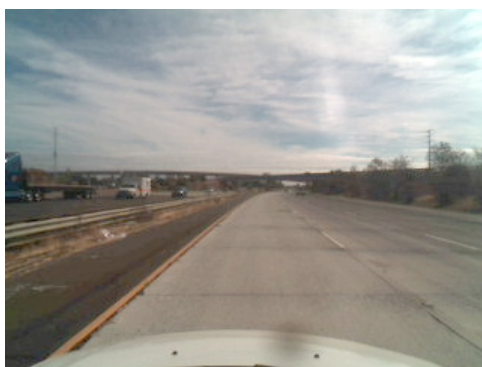
QP-103.1

Type of section: Pavement
Location: 03Yol50E0.2
Comments: Diamond ground.
Surface Year: 2005

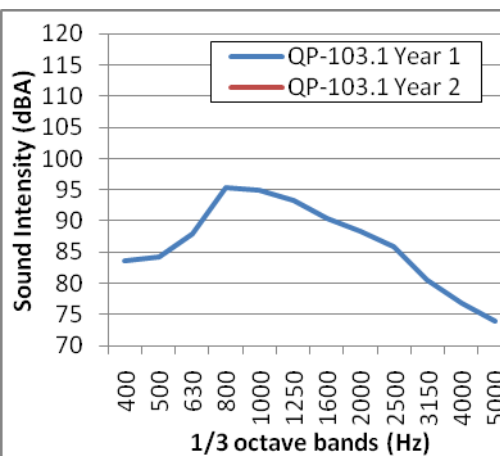
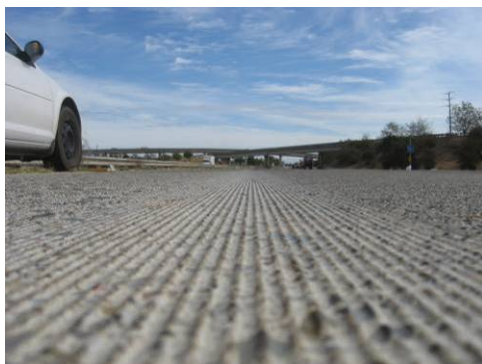
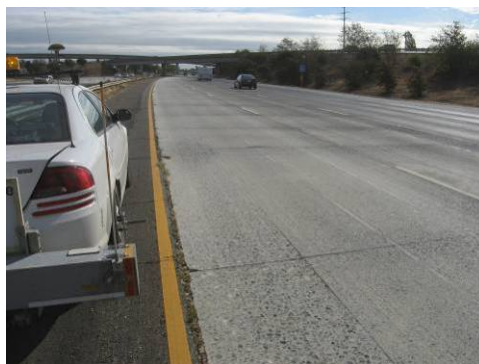
Texture detail

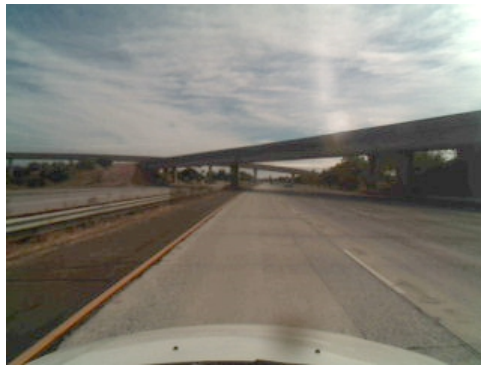
QP-103.2

Type of section: Pavement
 Location: 03Yol50E0.2
 Comments: Diamond ground.
 Surface Year: 2005

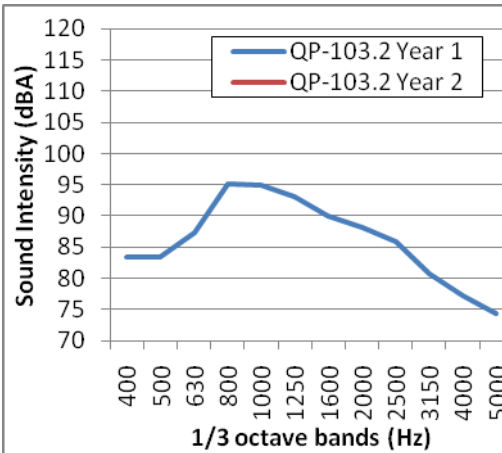
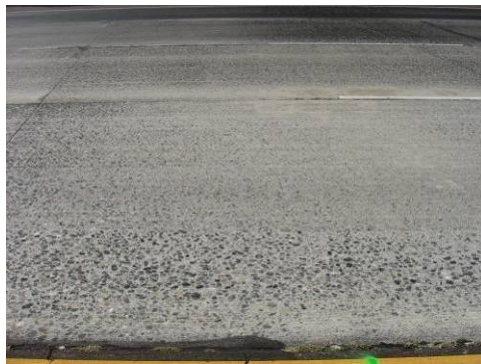
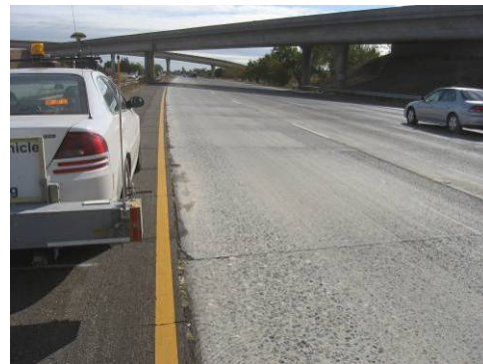
Texture detail

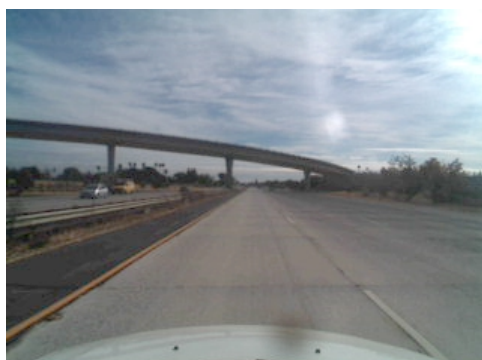
QP-103.3

Type of section: Pavement
Location: 03Yol50E0.3
Comments: Diamond ground.
Surface Year: 2005

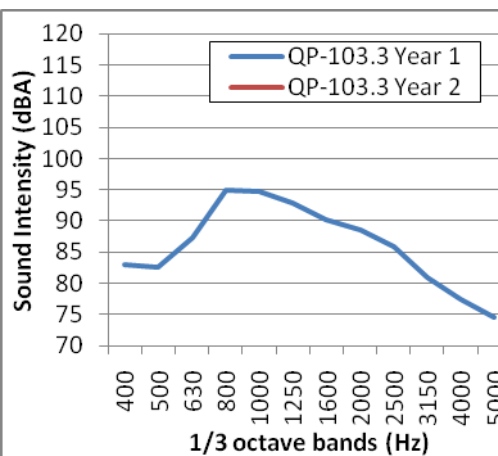
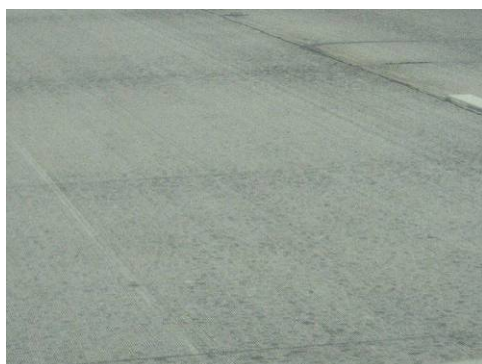
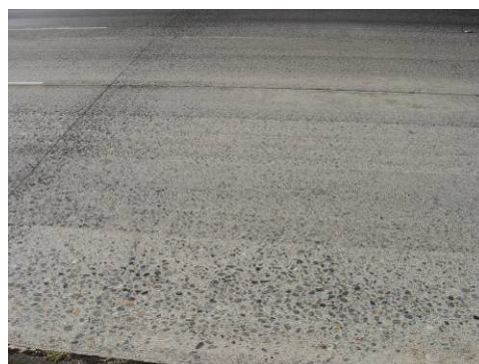
Texture detail

Texture & joint detail

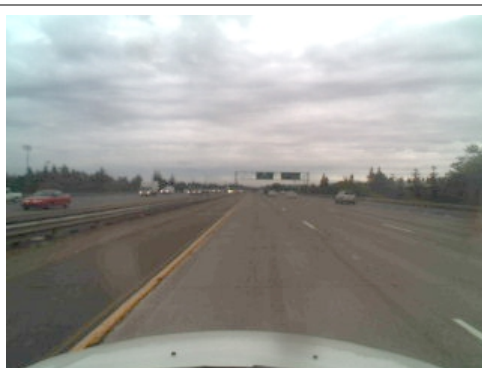
QP-104.1

Comments: Burlap drag. Worn BD.

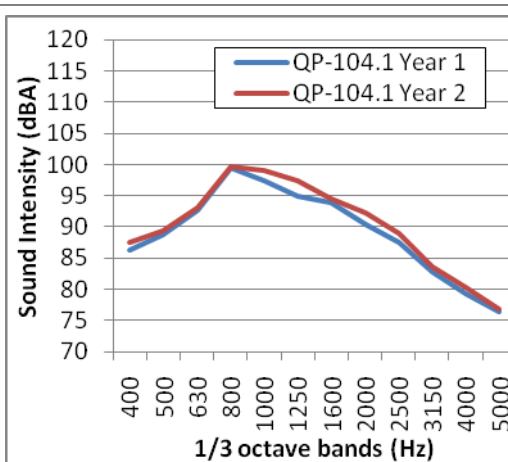
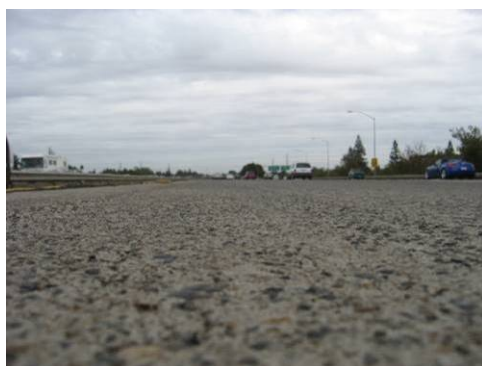
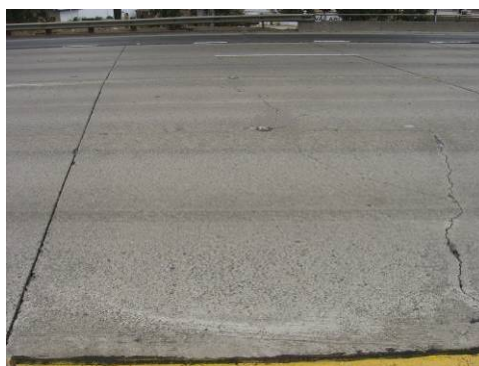
Texture detail

Joint detail

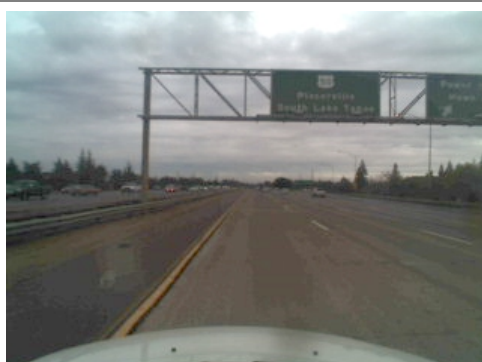
QP-104.2

Type of section: Pavement
 Location: 03Yol50E0.4
 Comments: Burlap drag.
 Surface Year: 1971

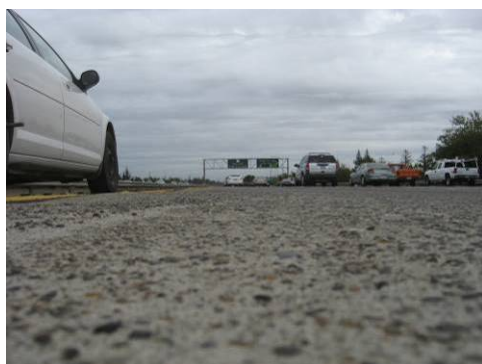
Texture detail

Type of section: Pavement Field testing Year 1: 10/3/2008 13:56
 Location: 03Sac50E3.2 Field testing Year 2: 9/11/2009 11:12
 Comments: Burlap drag. moderately worn BD.
 Surface Year: 1971

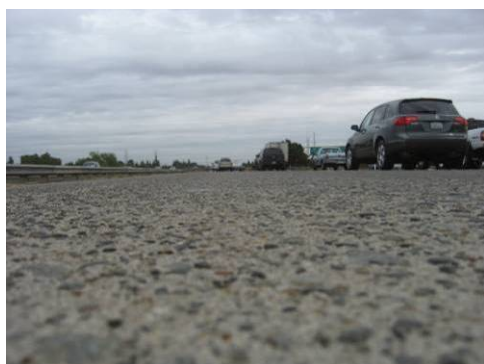
Texture detail

Type of section: Pavement Field testing Year 1: 10/3/2008 14:00
Location: 03Sac50E4.0 Field testing Year 2: 9/11/2009 11:43
Comments: Burlap drag. Worn texture, unsealed joints.
Surface Year: 1971

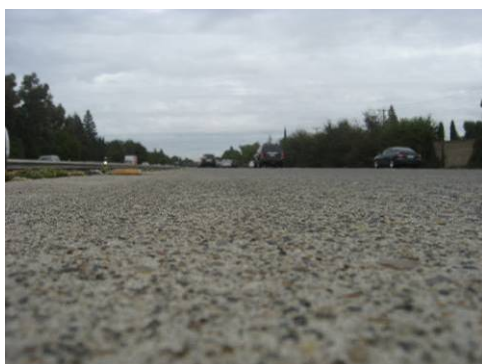
Texture detail

Comments: Burlap drag. Worn texture, unsealed joints.

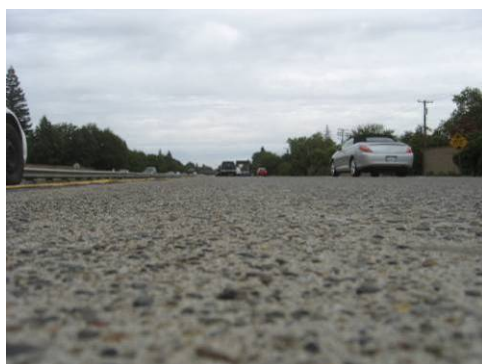
Texture detail

Type of section: Pavement Field testing Year 1: 10/3/2008 14:46
Location: 03Sac50E4.2 Field testing Year 2: 9/11/2009 12:06
Comments: Burlap drag. Worn texture, unsealed joints.
Surface Year: 1971

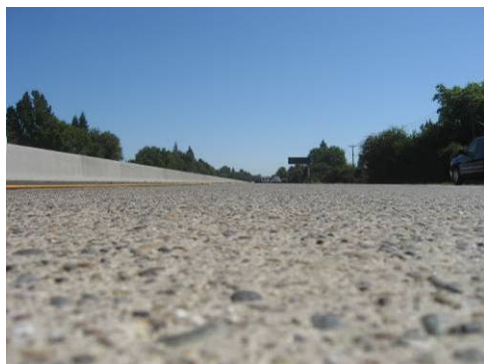
Texture detail

Comments: Burlap drag. Worn texture, unsealed joints.

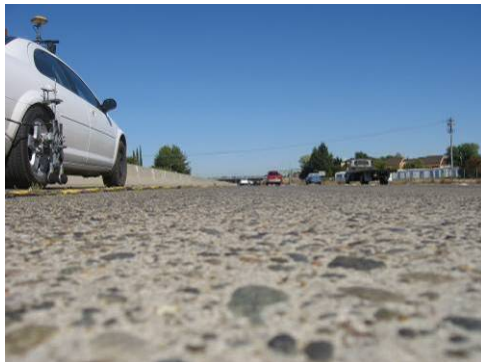
Texture detail

Type of section: Pavement Field testing Year 1: 10/13/2008 14:55
 Location: 03Sac50E10.6 Field testing Year 2: 9/11/2009 14:36
 Comments: Burlap drag. Worn texture, unsealed joints.
 Surface Year: 1973

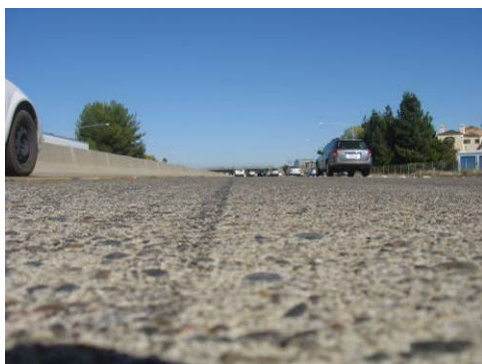
Texture detail

Type of section: Pavement Field testing Year 1: 10/13/2008 15:14
 Location: 03Sac50E10.7 Field testing Year 2: 9/11/2009 14:42
 Comments: Burlap drag. Worn texture, unsealed joints.
 Surface Year: 1973

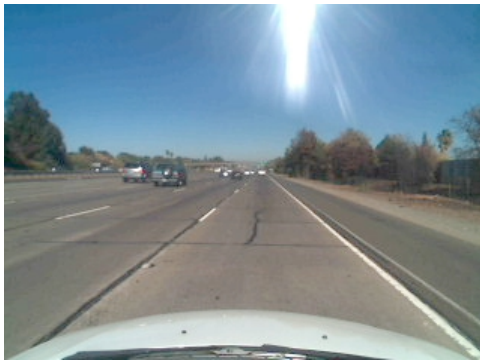
Onboard picture Year 1

Comments: Burlap drag. Shallow texture.

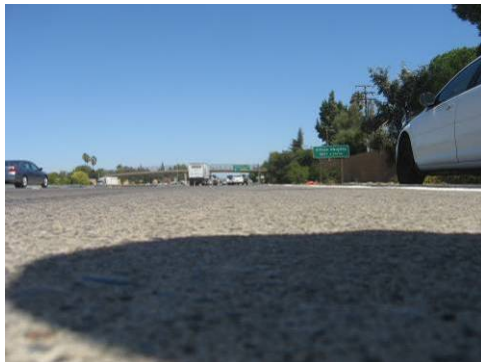
Texture detail

Comments: Burlap drag. Shallow texture.
