1. REPORT NUMBER CA12-1200 A	2. GOVERNMENT ASSOCIATION NUMBER	3. RECIPIENT'S CATALOG NUMBER
4. TITLE AND SUBTITLE Quieter Pavement Research: Concrete Pavement Tire Noise	5. REPORT DATE 05/30/2011

6. PERFORMING ORGANIZATION CODE
7. AUTHOR John T. Harvey and Erwin Kohler	8. PERFORMING ORGANIZATION REPORT NO. UCPRC-RR-2010-03	
9. PERFORMING ORGANIZATION NAME AND ADDRESS University of California, Davis & Berkeley Partnered Pavement Research Center 1353 S. 46th Street, Bldg. 452 Richmond, CA 94804	10. WORK UNIT NUMBER

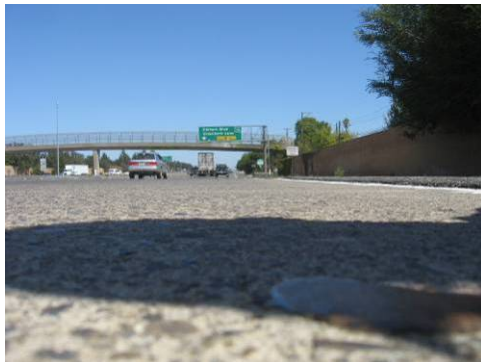
Texture detail

Comments: Burlap drag. Shallow texture.

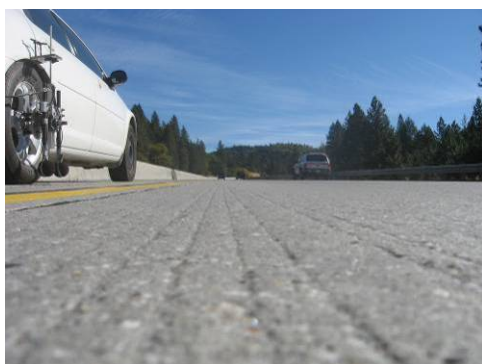
Texture detail

Comments: Longitudinally tined. Shallow texture, worn out.

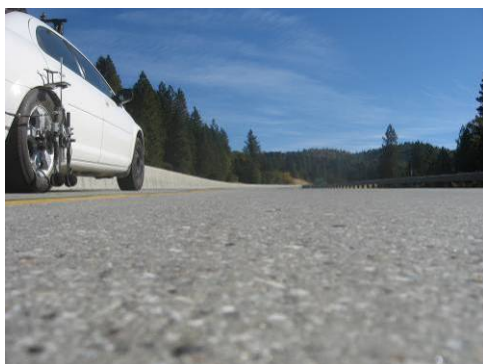
Texture detail

Type of section: Pavement Field testing Year 1: 10/21/2008 11:42
 Location: 03Pla80E45.1 Field testing Year 2: 9/16/2009 12:35
 Comments: Longitudinally tined. Texture shallower than 108.1.
 Surface Year: 2004

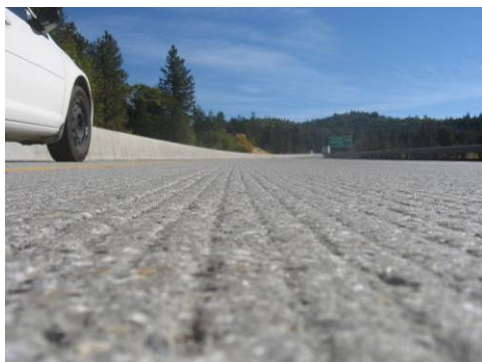
Texture detail

Type of section: Pavement Field testing Year 1: 10/21/2008 11:48
 Location: 03Pla80E45.2 Field testing Year 2: 9/16/2009 12:45
 Comments: Longitudinally tined. Texture deeper than 108.1.
 Surface Year: 2004

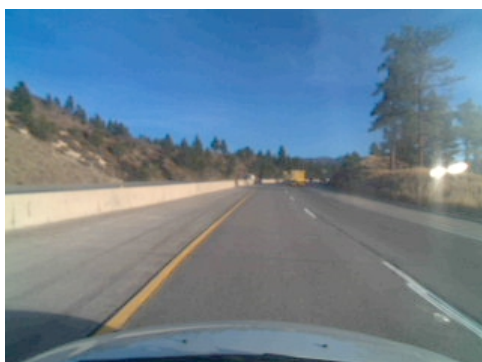
QP-109.1

Type of section: Pavement Field testing Year 1: 10/21/2008 17:02
 Location: 03Nev80E22.6 Field testing Year 2:
 Comments: Longitudinally broomed. Worn out texture.
 Surface Year: 1989

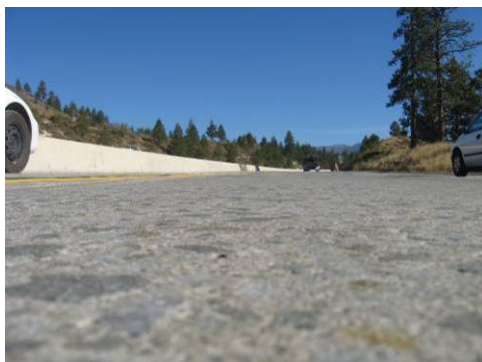
Texture detail

Type of section: Pavement Field testing Year 1: 10/21/2008 17:24
 Location: 03Nev80E22.6 Field testing Year 2:
 Comments: Longitudinally broomed. Worn out texture.
 Surface Year: 1989

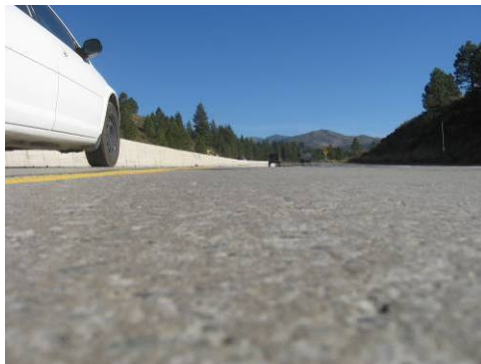
Texture detail

Type of section: Pavement Field testing Year 1: 10/21/2008 17:35
Location: 03Nev80E22.6 Field testing Year 2:
Comments: Longitudinally broomed. Worn out texture.
Surface Year: 1989

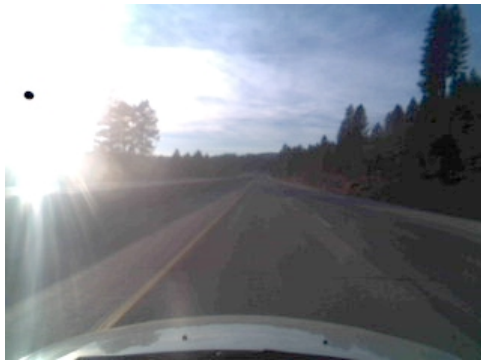
QP-111.1

Comments: Diamond grooved.

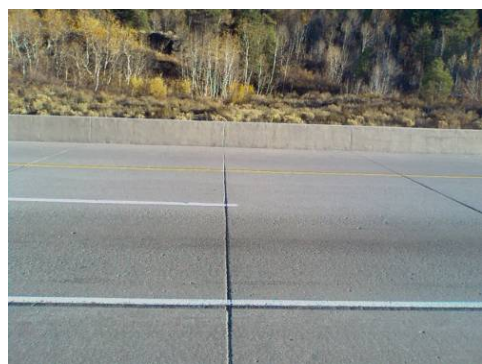
Texture detail

Comments: Longitudinally broomed. Uneven wear along section. Wide joints.

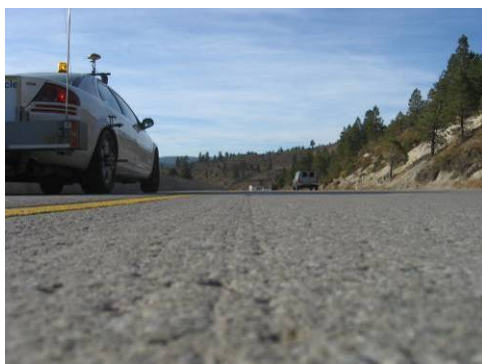
Texture detail

Comments: Longitudinally broomed. Uneven wear along section. Wide joints.

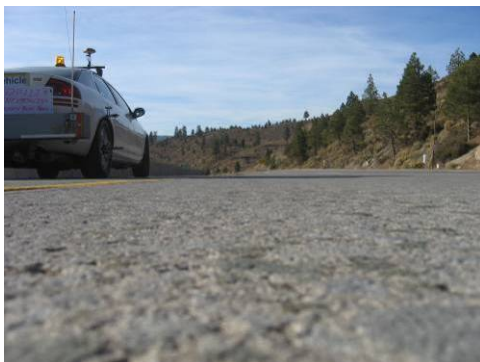
Texture detail

Comments: Longitudinally broomed. Uneven wear along section. Wide joints.

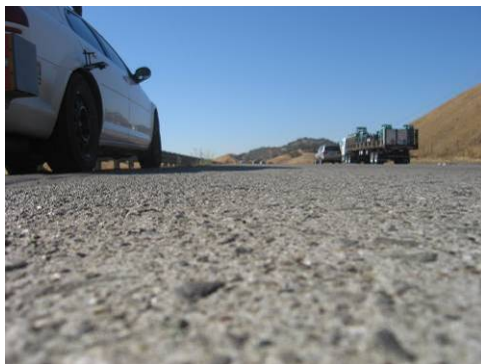
Texture detail

Comments: Burlap drag. Worn out texture.

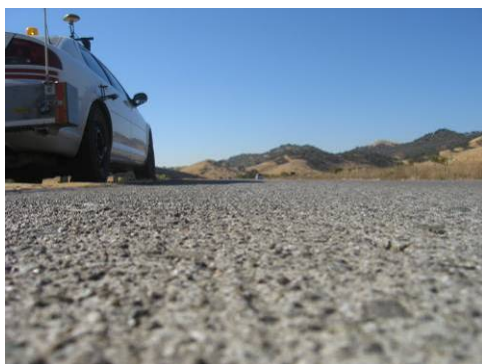
Texture detail

Comments: Burlap drag. Worn out texture.

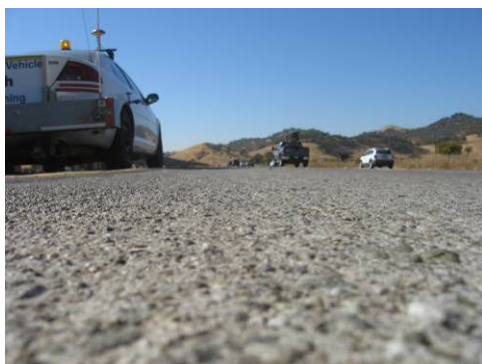
Texture detail

Type of section: Pavement Field testing Year 1: 10/23/2008 12:54
 Location: 03Yol80W22.7 Field testing Year 2:
 Comments: Burlap drag. Worn out texture.
 Surface Year: 1965

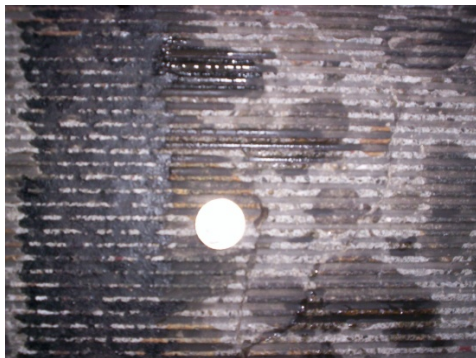
Texture detail

Comments: Diamond ground. Right wheelpath on DG CRCP.

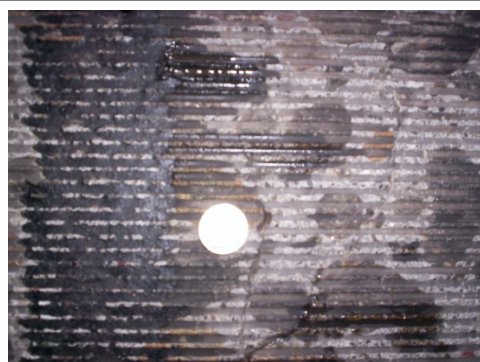
Texture detail

Comments: Diamond ground. Right wheelpath on DG CRCP.

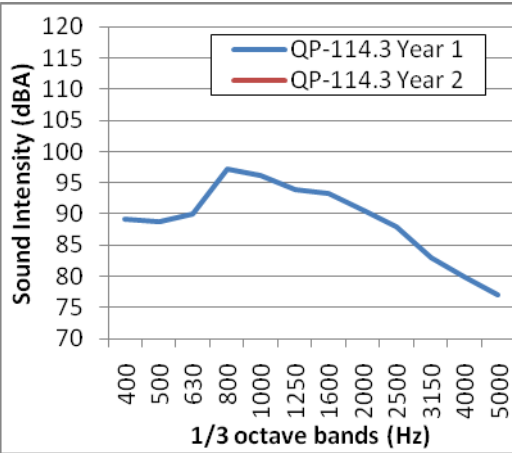
<p>Sound intensity graph showing Sound Intensity (dBA) on the Y-axis (70 to 120) versus 1/3 octave bands (Hz) on the X-axis (400 to 5000). The graph displays data for QP-114.3 Year 1 (blue line) and QP-114.3 Year 2 (red line). The Year 1 data shows a peak around 800 Hz and a general downward trend at higher frequencies.</p>

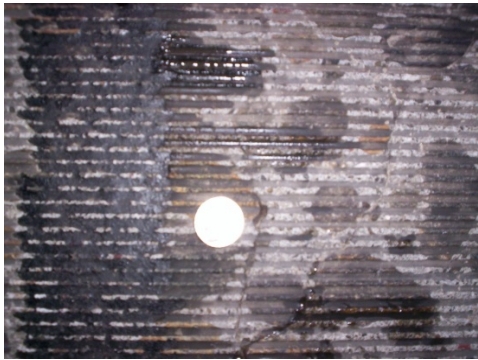
<p>Texture detail</p>

Type of section: Pavement Field testing Year 1: 10/23/2008 15:31
Location: 04Sol80W18.5 Field testing Year 2:
Comments: Diamond ground. Right wheelpath on DG CRCP.
Surface Year: 1999

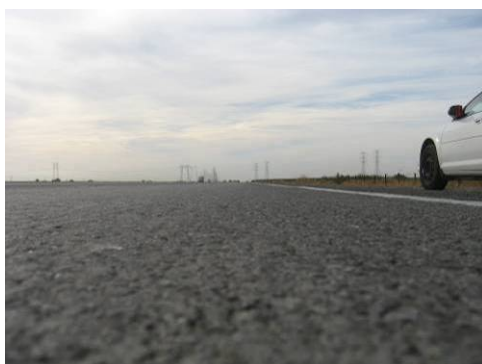
Texture detail

Type of section: Pavement
Location: 03Yol505S13.1
Comments: Burlap drag.
Surface Year: 1977

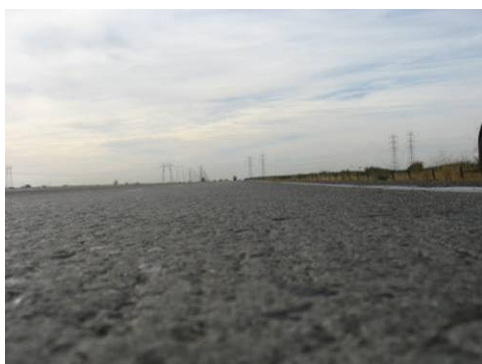
Texture detail

Type of section: Pavement
 Location: 03Yol505S13.0
 Comments: Burlap drag.
 Surface Year: 1977

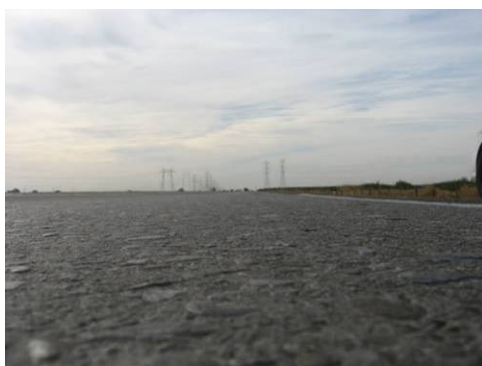
Texture detail

Type of section: Pavement
Location: 03Yol505S12.9
Comments: Burlap drag.
Surface Year: 1977

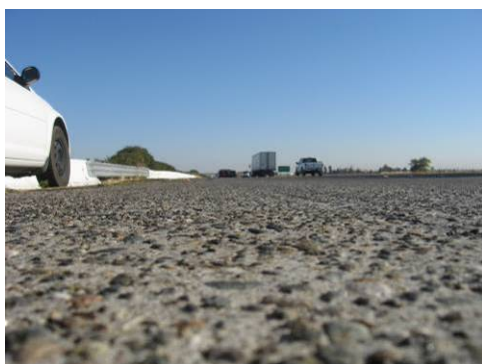
Texture detail

Comments: Burlap drag. Looks like aggressive exposed agg. Maybe no original texture.

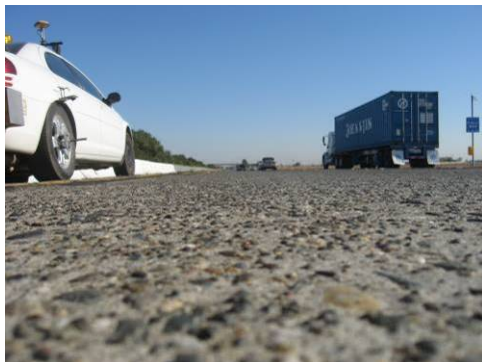
Texture detail

Comments: Burlap drag. Looks like aggressive exposed agg. Maybe no original texture.

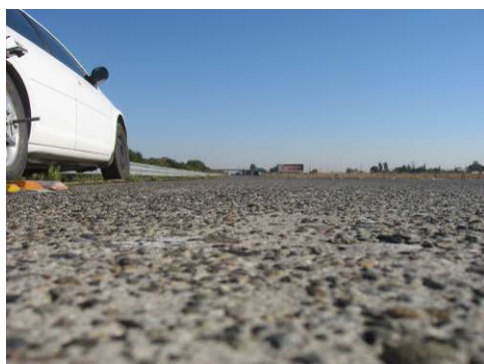
Texture detail

Comments: Burlap drag. Looks like aggressive exposed agg. Maybe no original texture.

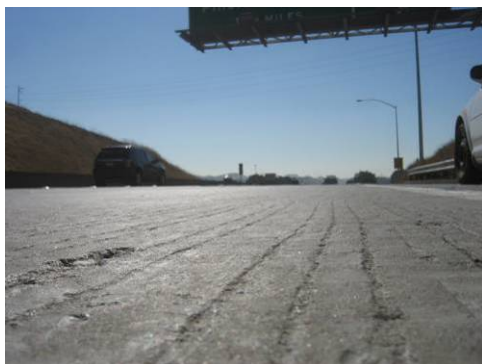
Texture detail

Type of section: Pavement Field testing Year 1: 10/28/2008 14:14
 Location: 04CC80W10.3 Field testing Year 2: 10/29/2009 14:57
 Comments: Longitudinally tined. Shallow and squiggly LT.
 Surface Year: 2007

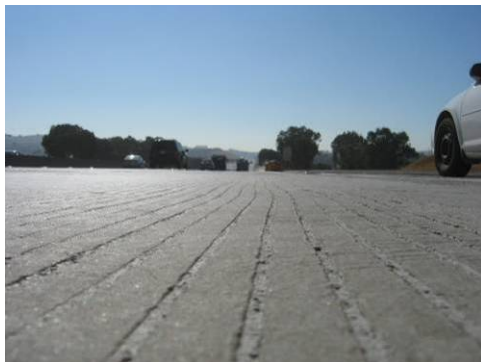
Texture detail

Comments: Longitudinally tined. Shallow and squiggly LT.

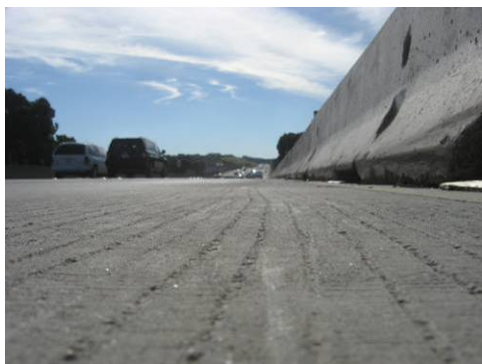
Texture detail

Type of section: Pavement Field testing Year 1: 10/28/2008 14:54
 Location: 04CC80W10.1 Field testing Year 2: 10/29/2009 15:12
 Comments: Longitudinally tined. Shallow and squiggly LT.
 Surface Year: 2007

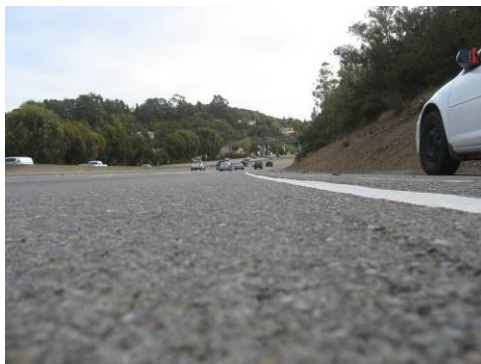
Texture detail

Type of section: Pavement
Location: 04ALA580E37.2
Comments: Burlap drag.
Surface Year: 1965

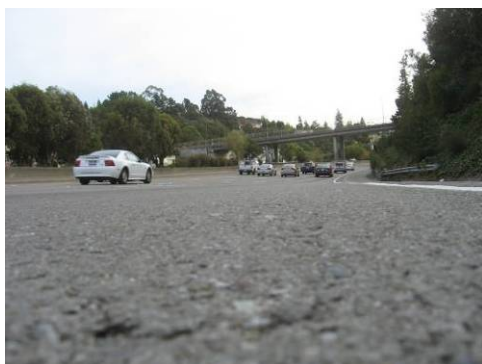
Texture detail

Type of section: Pavement
Location: 04ALA580E37.2
Comments: Burlap drag.
Surface Year: 1965

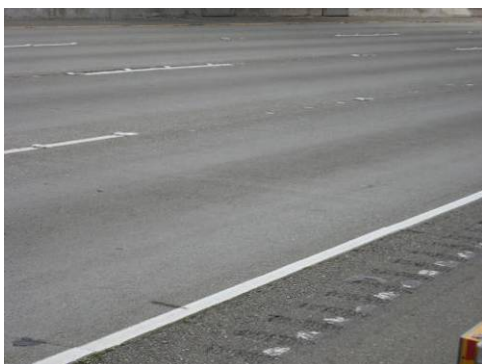
Texture detail

Type of section: Pavement
Location: 04ALA580E37.3
Comments: Burlap drag.
Surface Year: 1965

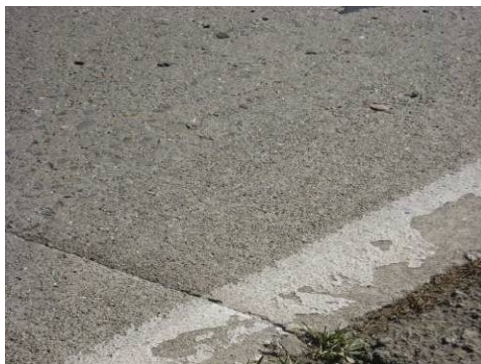
Texture detail

Type of section: Pavement
Location: 04SCL85S21.5L3
Comments: Burlap drag.
Surface Year: 1965

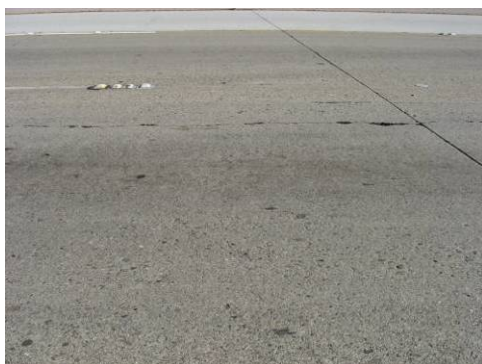
Texture detail

Type of section: Pavement
 Location: 04SCL85S21.4L3
 Comments: Burlap drag.
 Surface Year: 1965

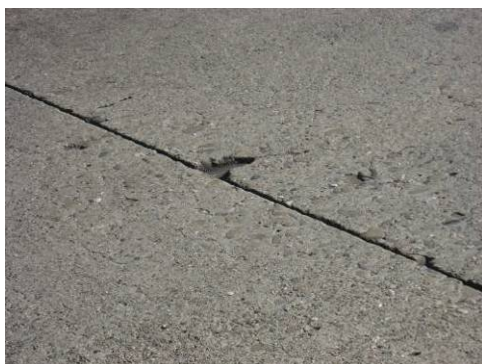
Texture detail

Type of section: Pavement
 Location: 04SCL85S21.3L3
 Comments: Burlap drag.
 Surface Year: 1965

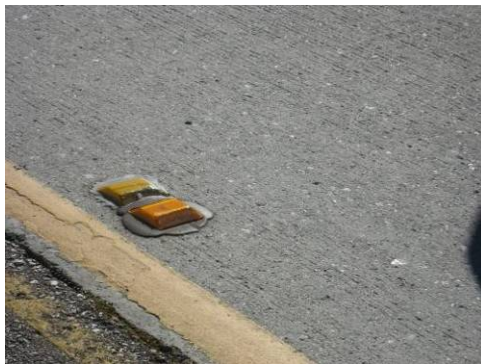
Texture detail

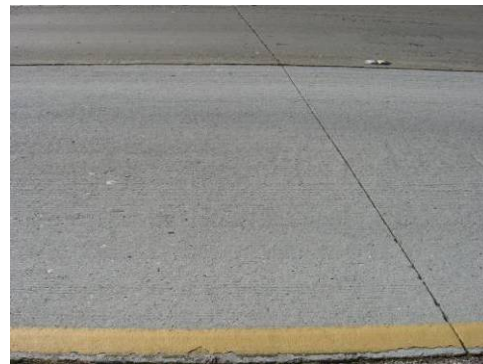
Joint detail

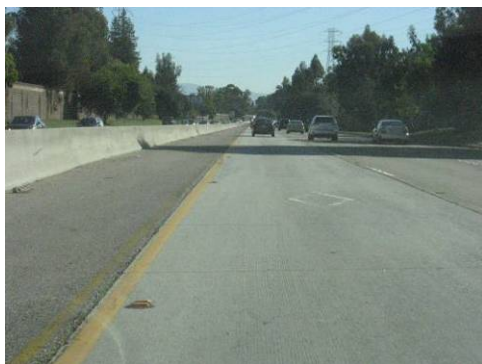
Texture detail

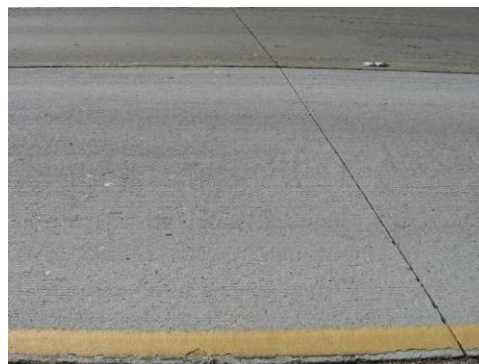
Joint detail

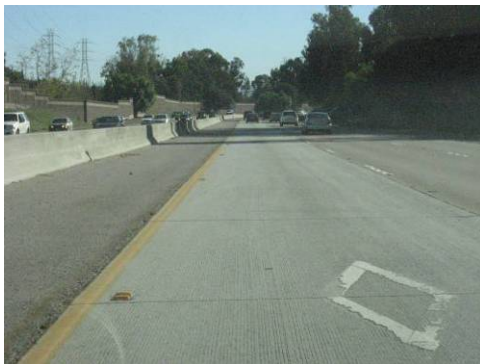
Texture detail

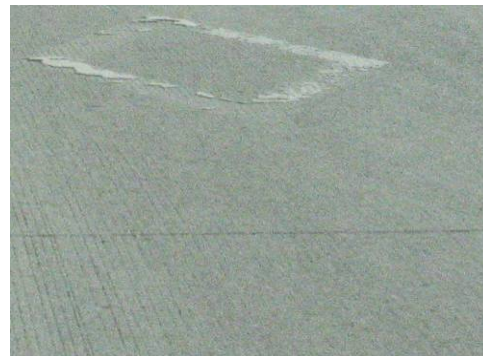
Joint detail

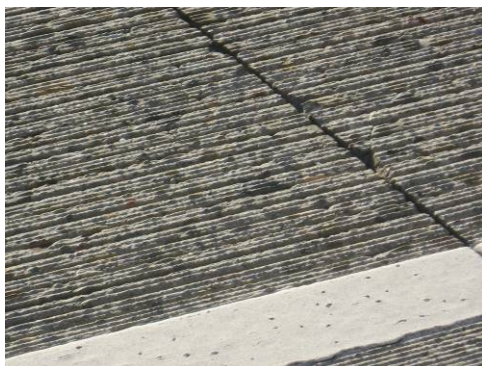
Texture detail

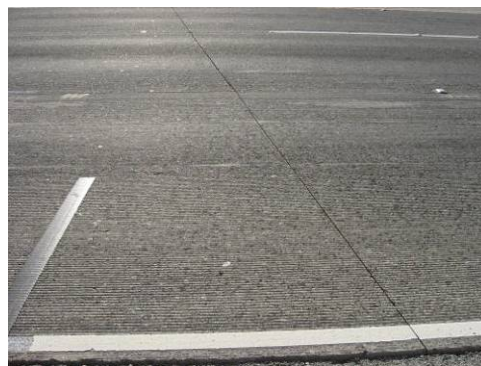
Joint detail

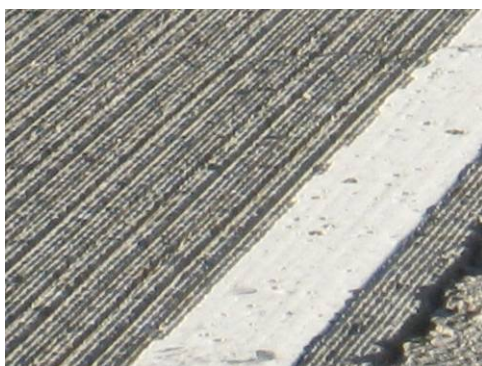
Texture detail

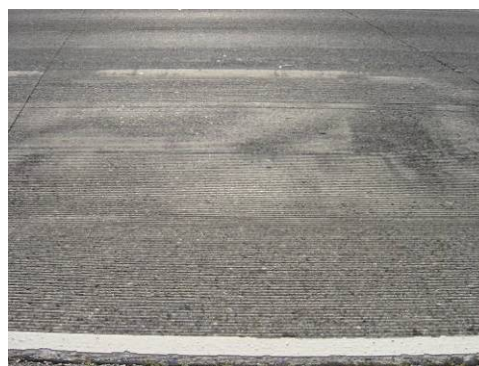
Joint detail

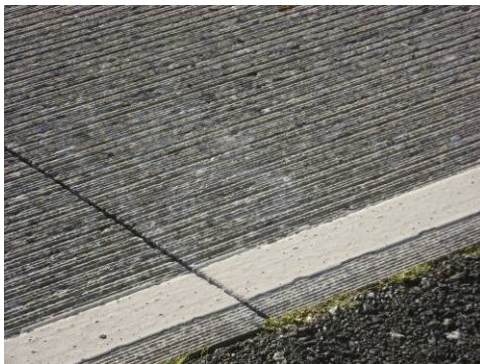
Texture and joint detail

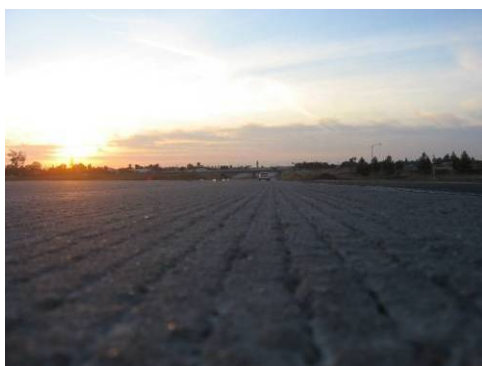
Texture detail

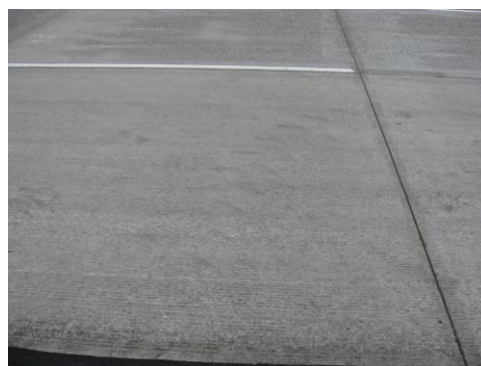
Joint detail

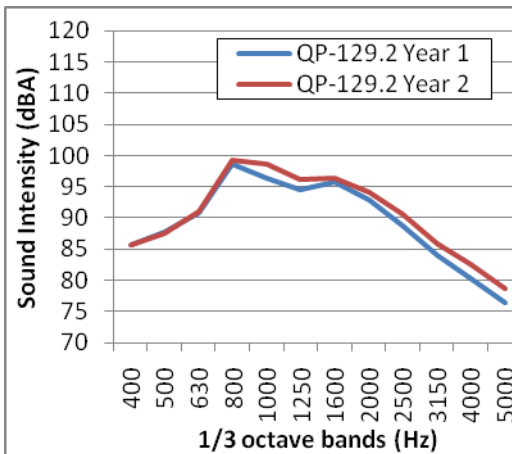
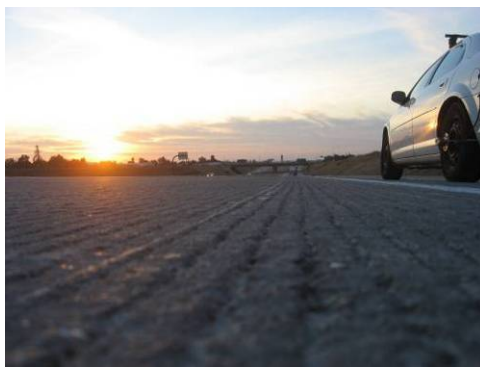
Texture detail

Comments: Longitudinally tined.

Surface Year: 2008

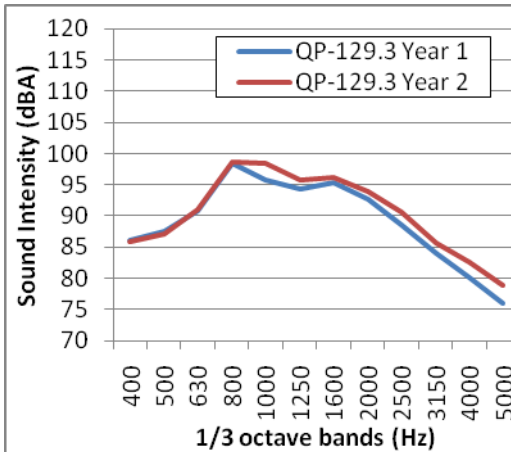
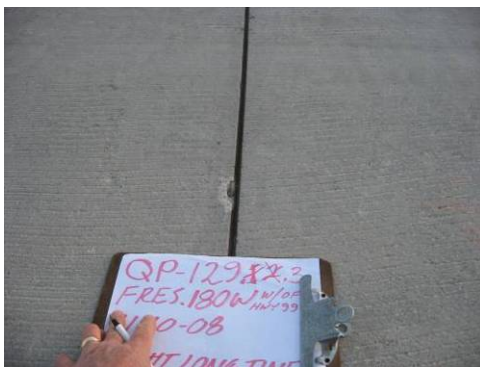
Texture detail

Type of section: Pavement Field testing Year 1: 11/10/2008 17:17
 Location: 06FRE180W55.5 Field testing Year 2: 11/13/2009 15:19
 Comments: Diamond ground. DG on LT.
 Surface Year: 2008

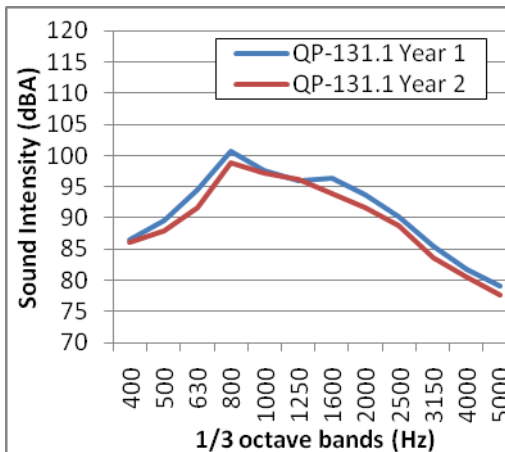
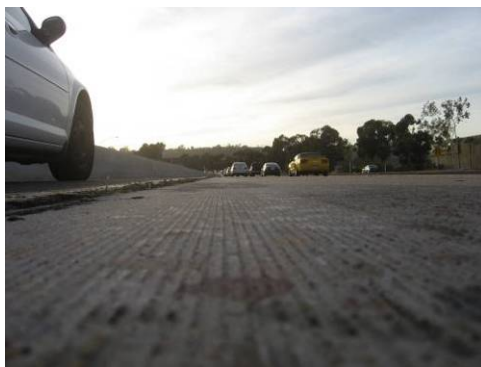
Texture detail

Type of section: Pavement Field testing Year 1: 11/11/2008 17:01
 Location: 11SD8W15.5 Field testing Year 2: 11/23/2009 9:33
 Comments: Diamond ground. DG on LT.
 Surface Year: 1997

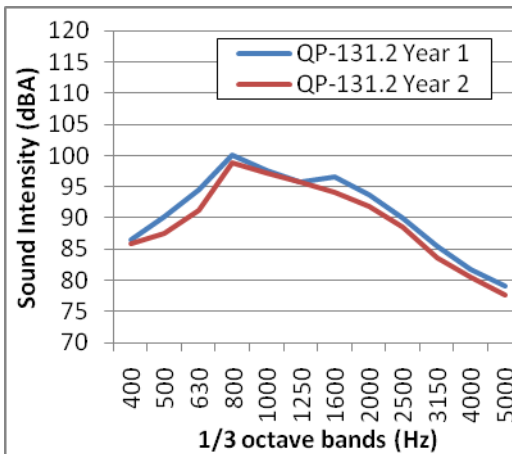
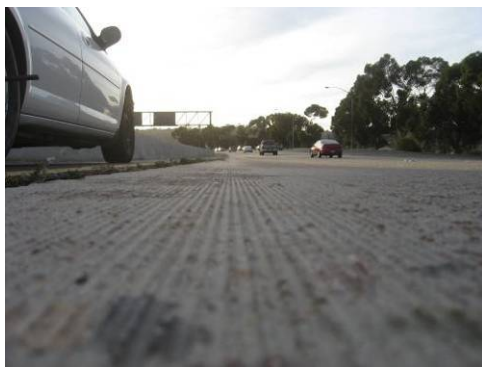
Texture detail

Type of section: Pavement
Location: 11SD8W15.6
Comments: Diamond ground.
Surface Year: 1997

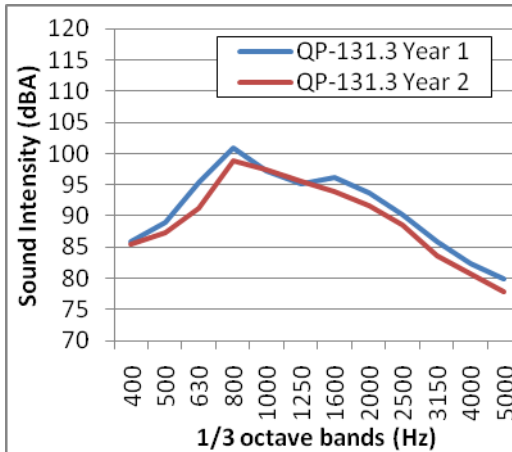
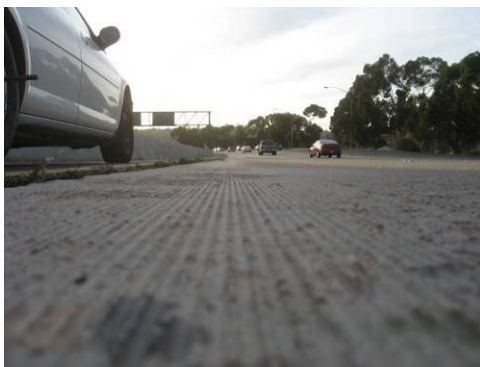
Texture detail

Type of section: Pavement
Location: 11SD8W15.7
Comments: Diamond ground.
Surface Year: 1997

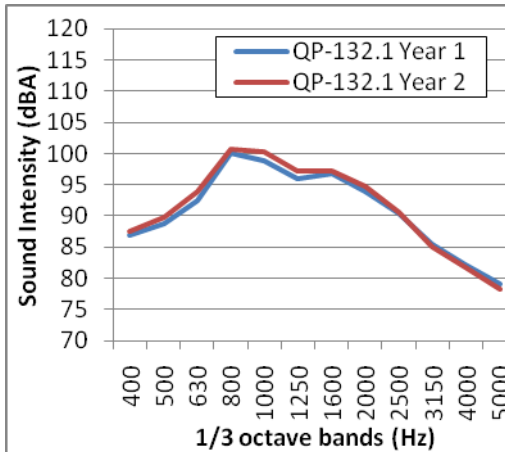
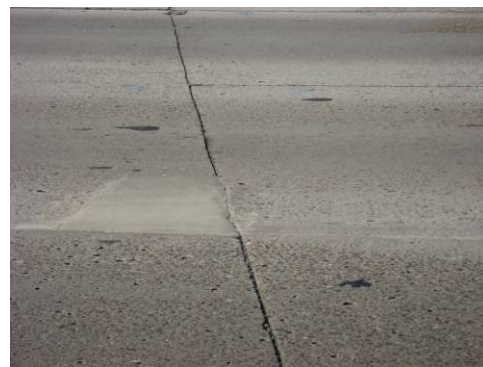
Joint detail

Type of section: Pavement Field testing Year 1: 11/12/2008 12:39
Location: 11SD805N2.1 Field testing Year 2: 11/24/2009 11:06
Comments: Diamond ground. DG on LB.
Surface Year: 1998

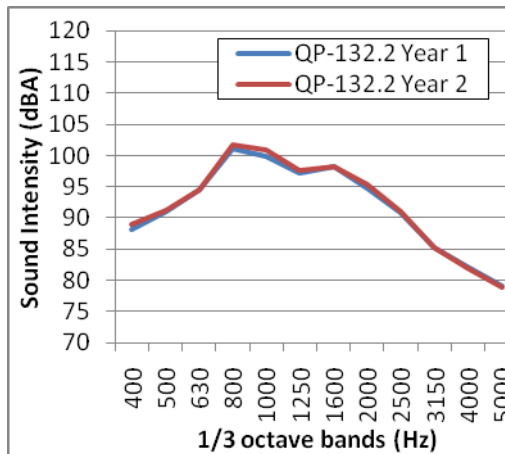
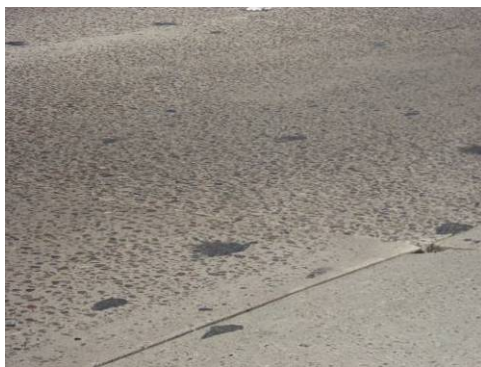
Texture detail

Type of section: Pavement
Location: 11SD805N2.2
Comments: Diamond ground.
Surface Year: 1998

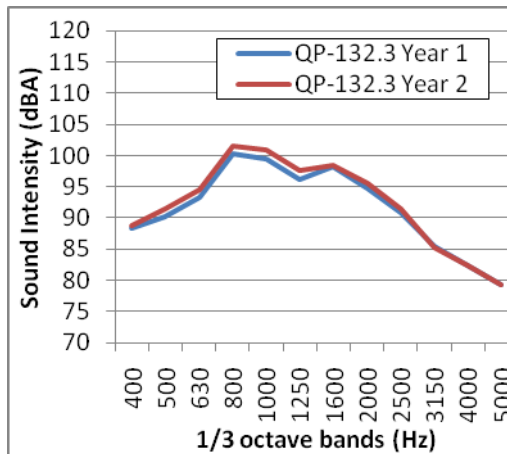
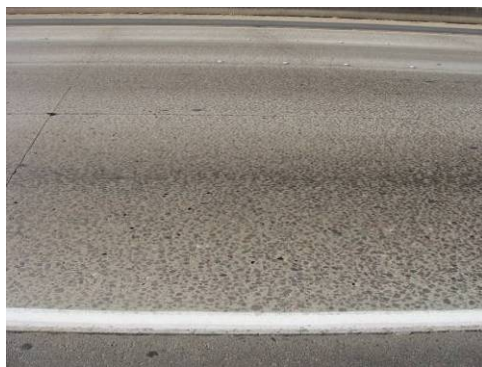
Texture detail

Type of section: Pavement
Location: 11SD805N2.3
Comments: Diamond ground.
Surface Year: 1998

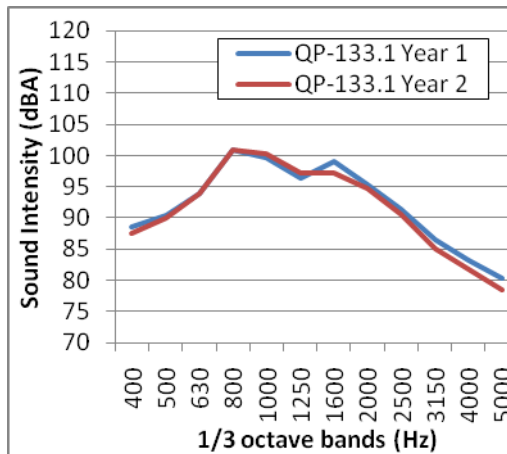
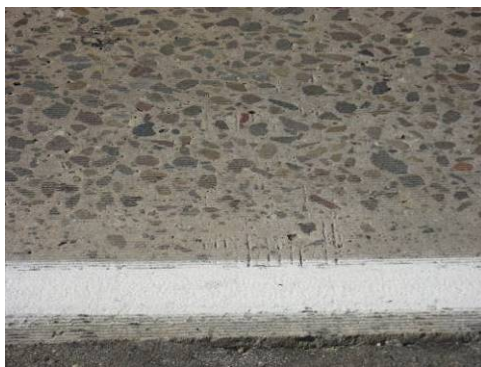
Texture detail

Type of section: Pavement Field testing Year 1: 11/12/2008 14:36
Location: 11SD805N2.3 Field testing Year 2: 11/24/2009 11:50
Comments: Diamond ground. DG on transverse tining.
Surface Year: 1998

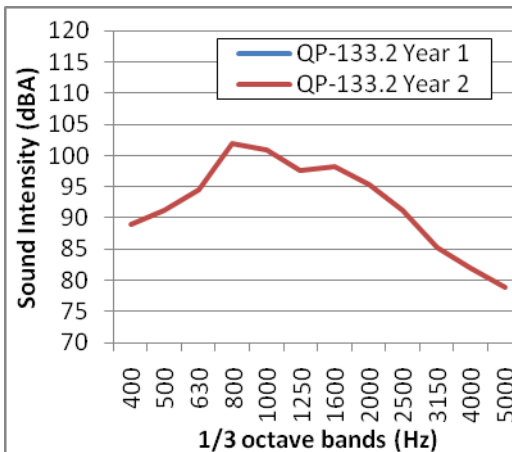
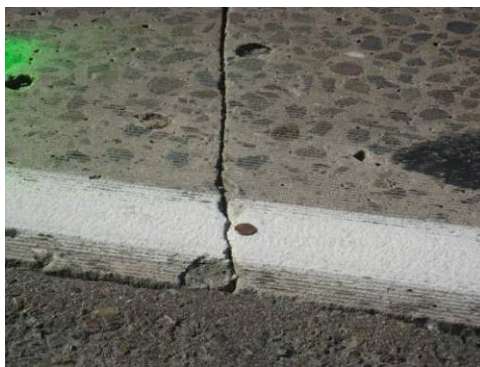
Texture detail

Type of section: Pavement
Location: 11SD805N2.4
Comments: Diamond ground.
Surface Year: 1998

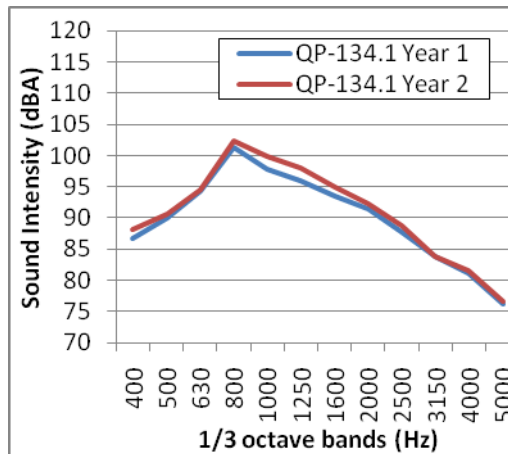
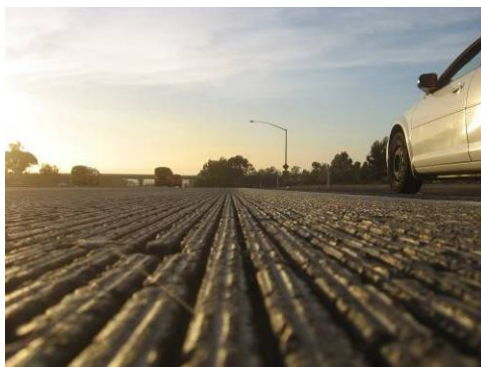
Texture detail

Type of section: Pavement Field testing Year 1: 11/12/2008 16:03
Location: 11SD905W5.2 Field testing Year 2: 11/24/2009 12:21
Comments: Diamond ground. DG on deep longitudinal tining. Off-ramp.
Surface Year: 2000

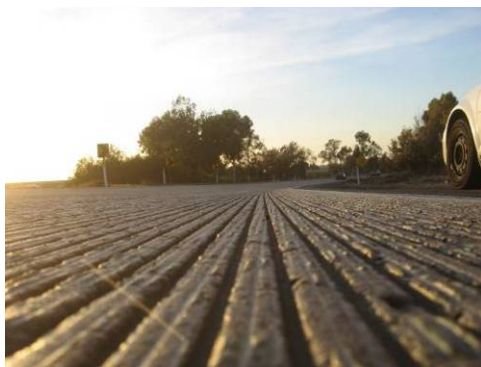
Texture detail

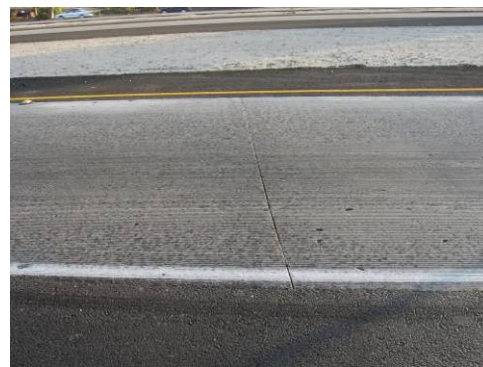
Joint detail

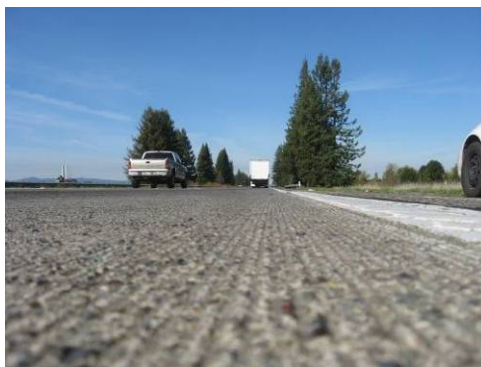
Texture detail

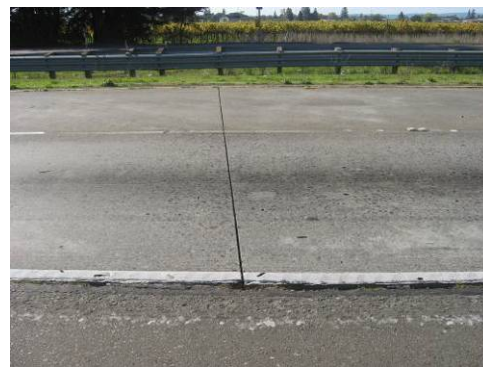
Joint detail

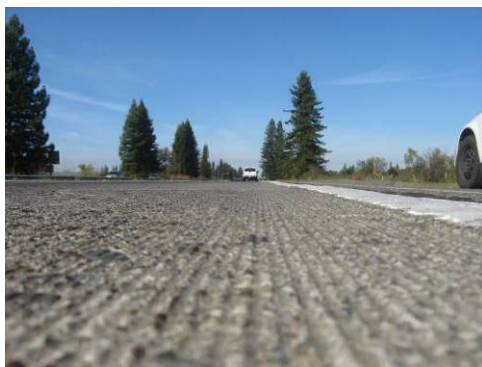
Texture detail

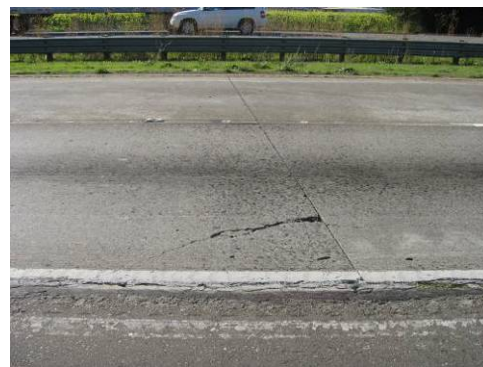
Joint detail

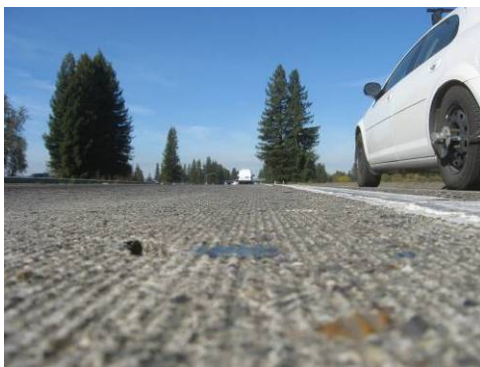
Texture detail

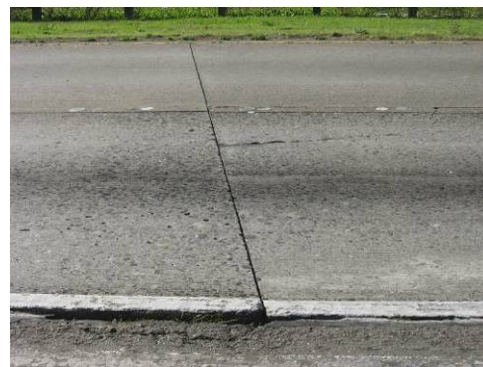
Joint detail

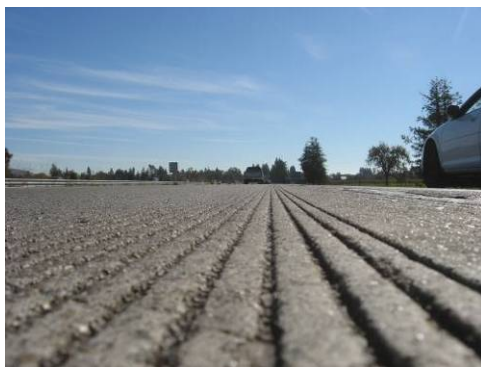
Texture detail

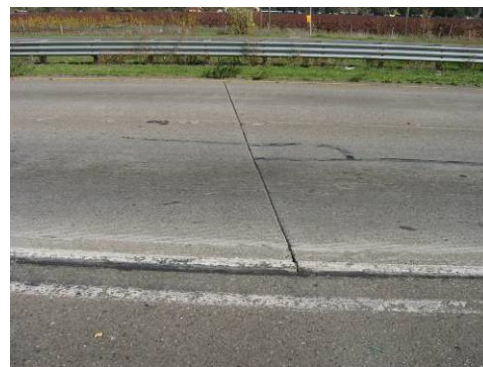
Joint detail

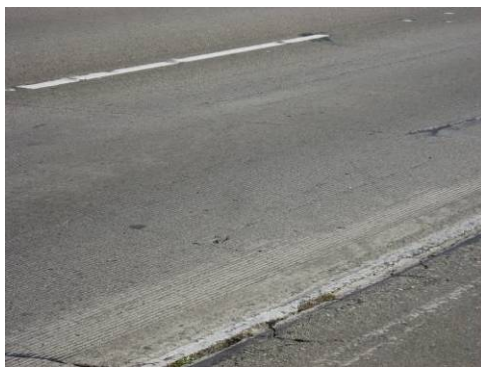
Texture detail

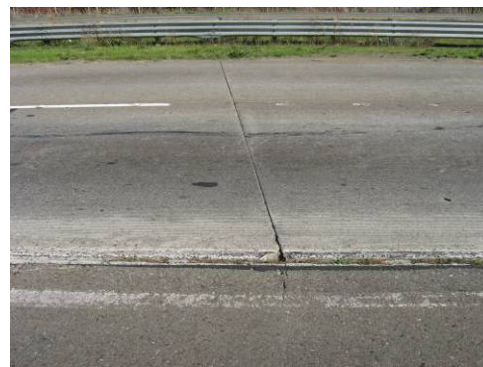
Joint detail

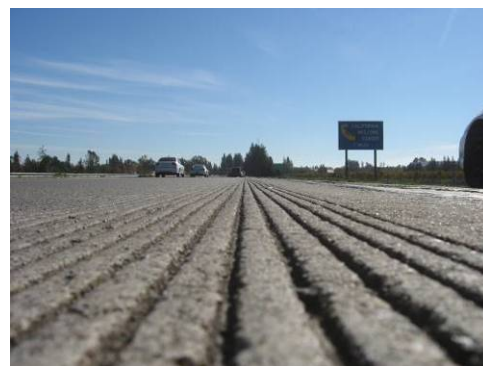
General view

Type of section: Pavement
Location: 04SON101S27.1L2
Comments: Diamond grooved.
Surface Year: 2006

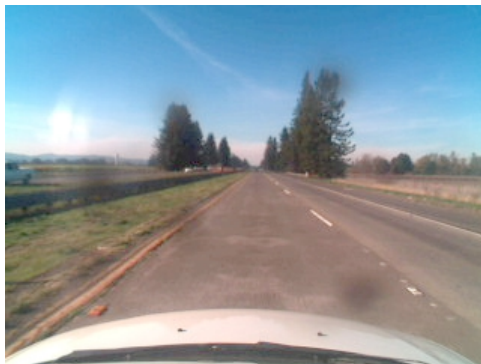
Onboard picture Year 1

Type of section: Pavement
Location: 04SON101N25.4L1
Comments: Burlap drag.
Surface Year: 1962

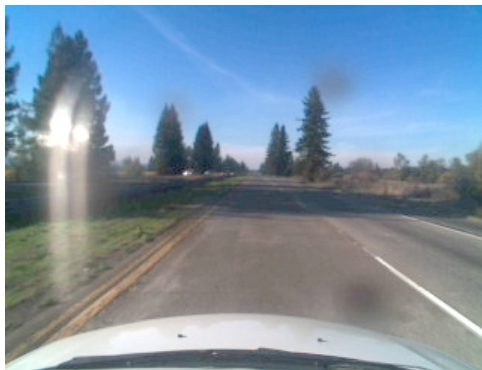
Onboard picture Year 1

Type of section: Pavement
Location: 04SON101N25.4L1
Comments: Burlap drag.
Surface Year: 1962

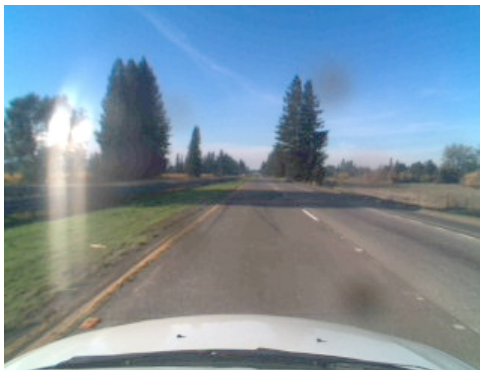
Onboard picture Year 1

Type of section: Pavement
Location: 04SON101N25.4L1
Comments: Burlap drag.
Surface Year: 1962

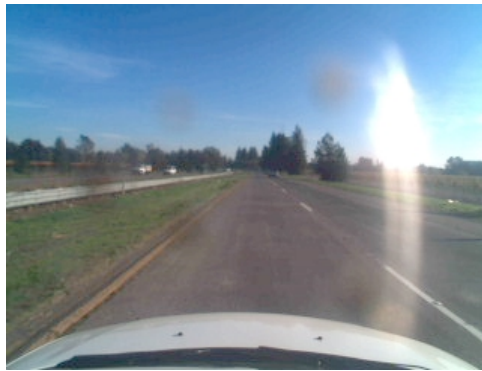
Onboard picture Year 1

Type of section: Pavement
 Location: 04SON101S27.3L1
 Comments: Diamond grooved.
 Surface Year: 2006

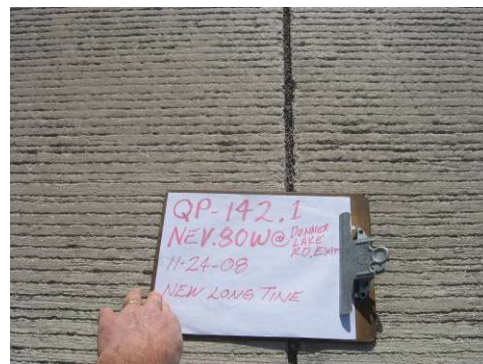
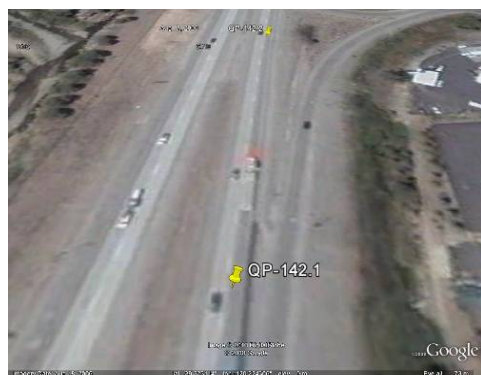
QP-142.1

Type of section: Pavement Field testing Year 1: 11/24/2008 15:10
Location: 03NEV80W1.0 Field testing Year 2: 9/17/2009 12:31
Comments: Longitudinally tined. New LT.
Surface Year: 2008

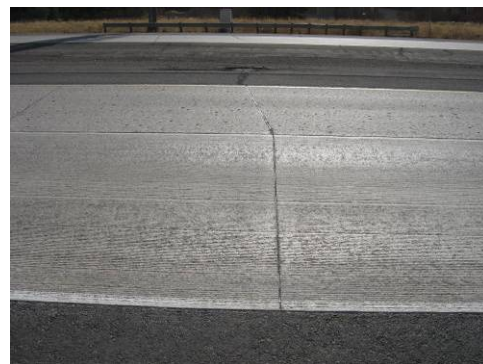
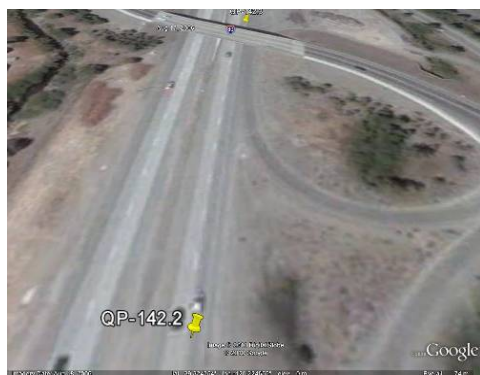
QP-142.2

Type of section: Pavement Field testing Year 1: 11/24/2008 15:16
 Location: 03NEV80W0.9 Field testing Year 2: 9/17/2009 12:49
 Comments: Longitudinally tined. New LT.
 Surface Year: 2008

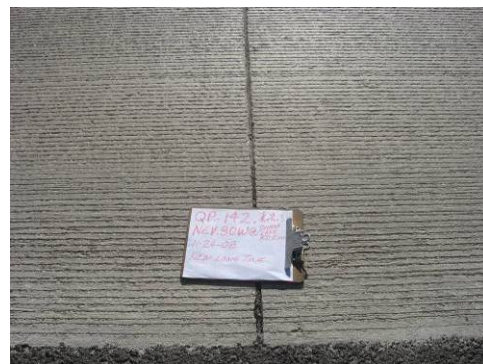
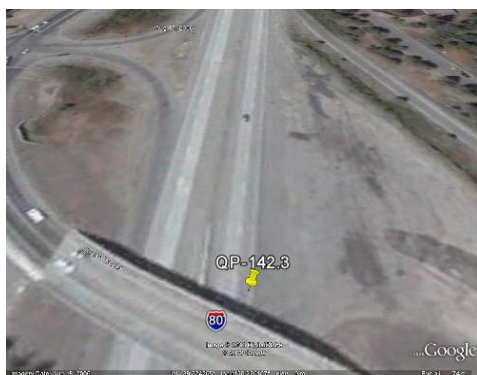
QP-142.3

Type of section: Pavement Field testing Year 1: 11/24/2008 15:19
Location: 03NEV80W0.8 Field testing Year 2: 9/17/2009 12:52
Comments: Longitudinally tined. New LT.
Surface Year: 2008

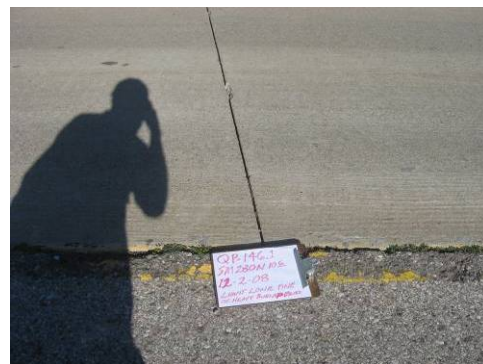
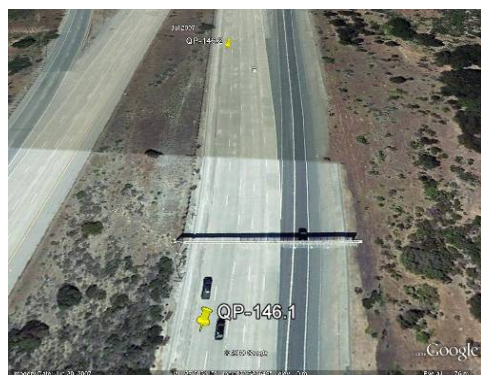
QP-146.1

Comments: Longitudinally broomed.

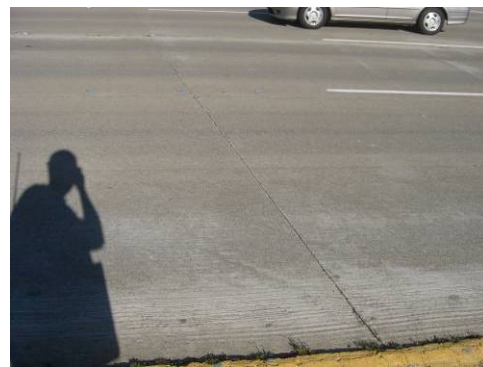
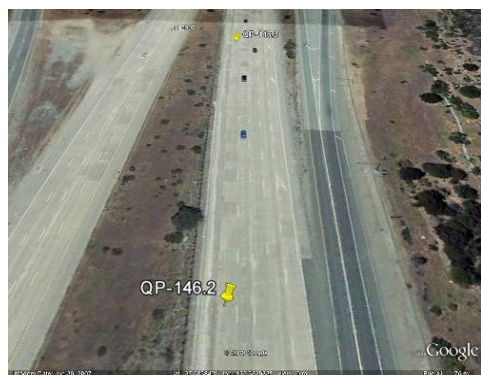
QP-146.2

Comments: Longitudinally broomed.

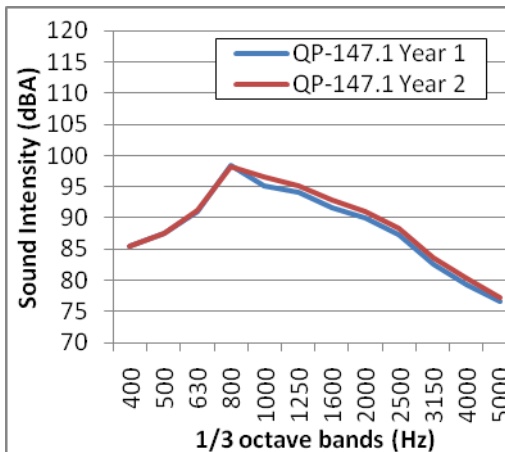
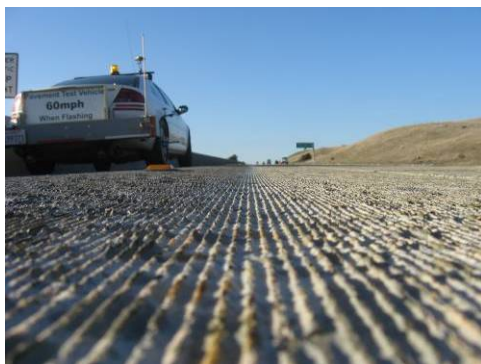
Texture detail

Type of section: Pavement
Location: 04SM280N11.6
Comments: Diamond ground.
Surface Year: 2007

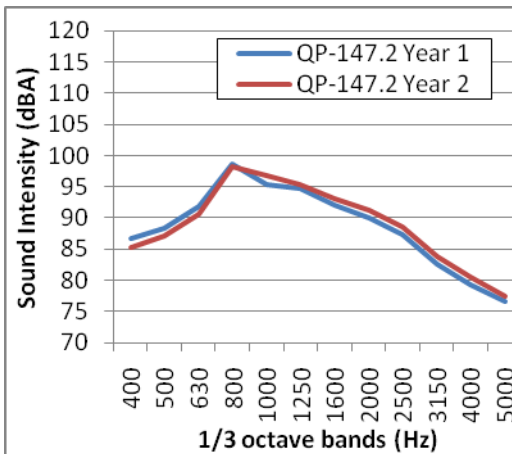
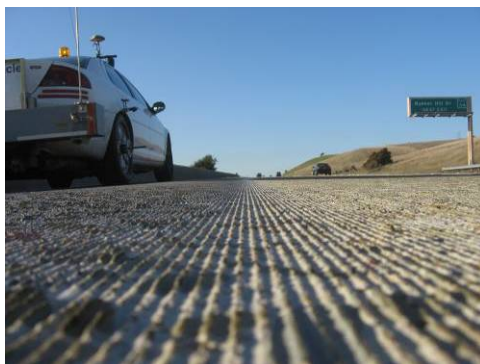
Texture detail

Type of section: Pavement
Location: 04SM280N11.7
Comments: Diamond ground.
Surface Year: 2007

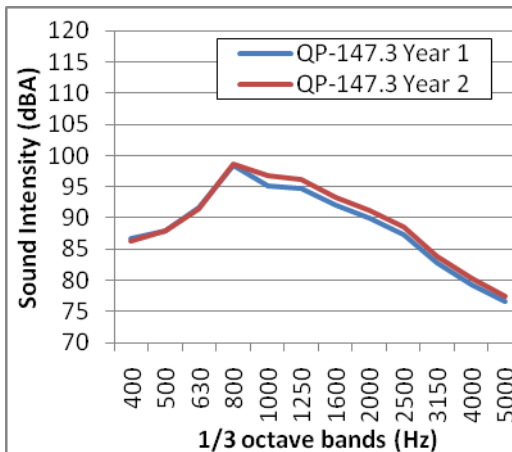
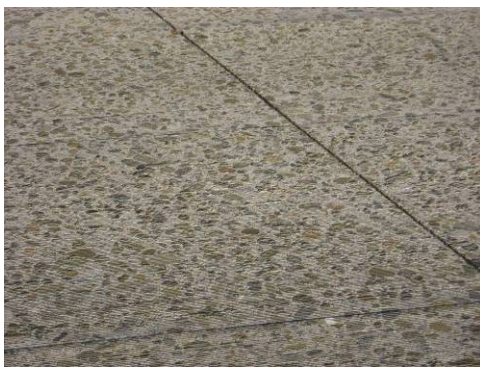
Texture detail

Type of section: Pavement
Location: 04SM280N11.8
Comments: Diamond ground.
Surface Year: 2007

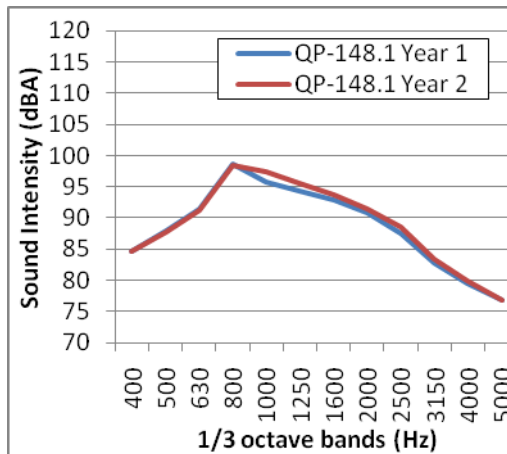
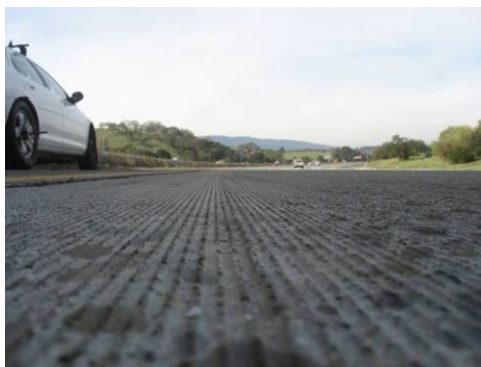
Texture detail

Comments: Diamond ground. Old DG.

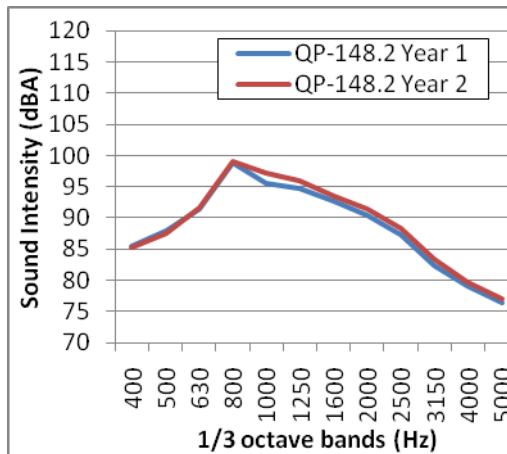
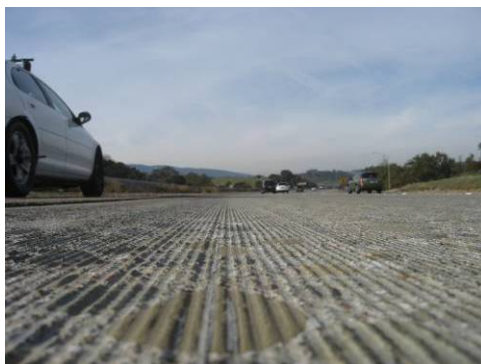
Texture detail

Comments: Diamond ground. Old DG.

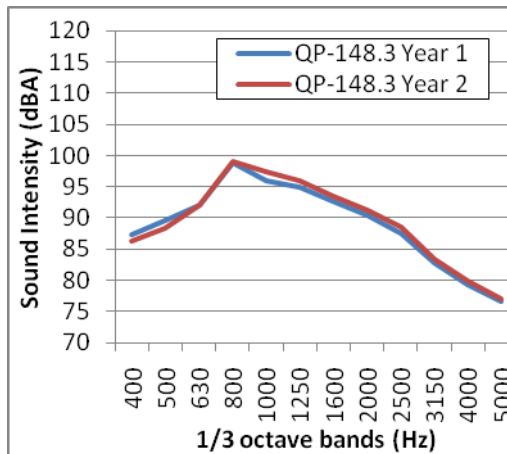
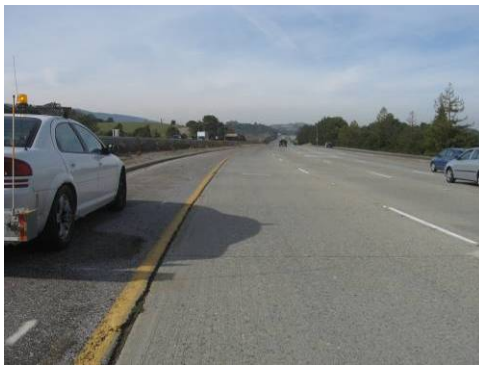
Texture detail

Comments: Diamond ground. Old DG.

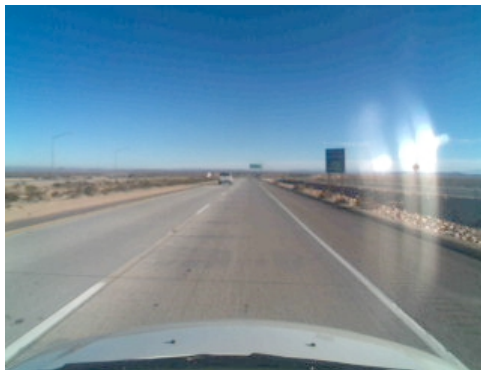
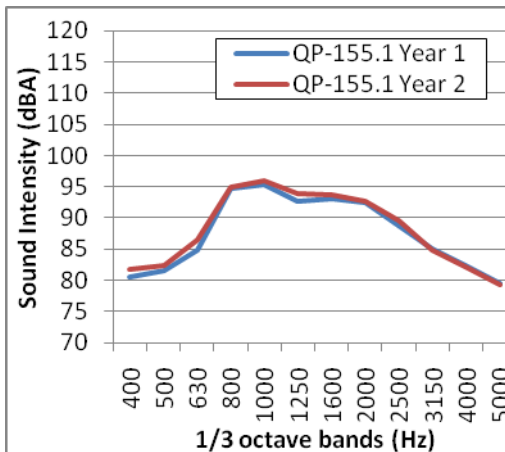
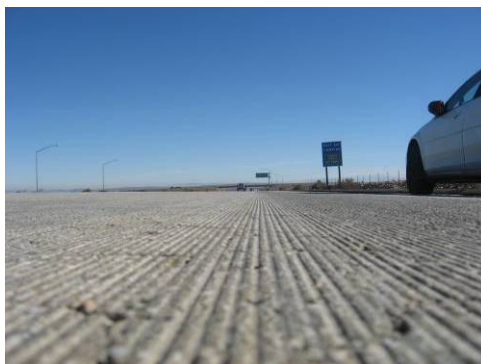
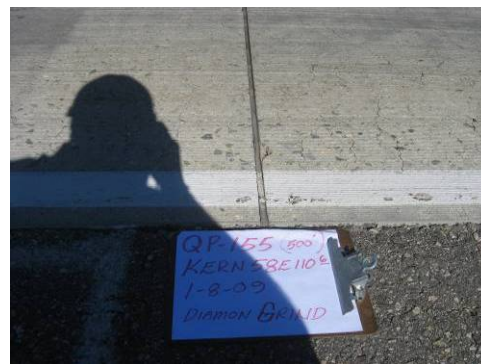
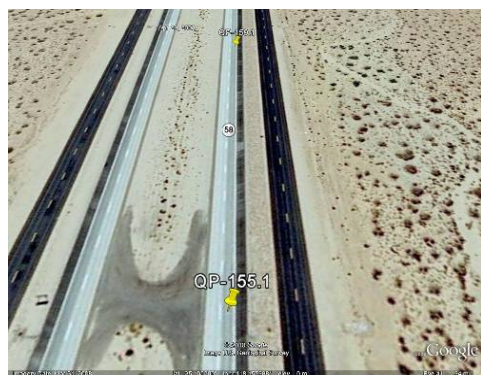
QP-155.1

Type of section: Pavement
Location: 06Ker58E110.6
Comments: Diamond ground.
Surface Year: 2006
