1. REPORT NUMBER CA12-1200 A	2. GOVERNMENT ASSOCIATION NUMBER	3. RECIPIENT'S CATALOG NUMBER
4. TITLE AND SUBTITLE Quieter Pavement Research: Concrete Pavement Tire Noise	5. REPORT DATE 05/30/2011

6. PERFORMING ORGANIZATION CODE
7. AUTHOR John T. Harvey and Erwin Kohler	8. PERFORMING ORGANIZATION REPORT NO. UCPRC-RR-2010-03	
9. PERFORMING ORGANIZATION NAME AND ADDRESS University of California, Davis & Berkeley Partnered Pavement Research Center 1353 S. 46th Street, Bldg. 452 Richmond, CA 94804	10. WORK UNIT NUMBER

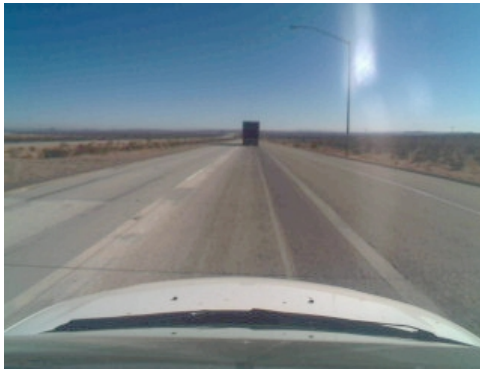
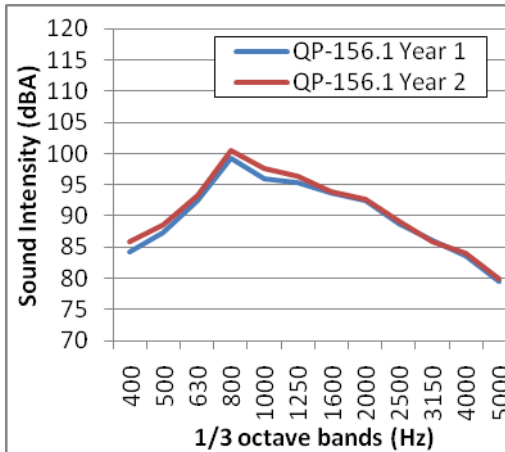
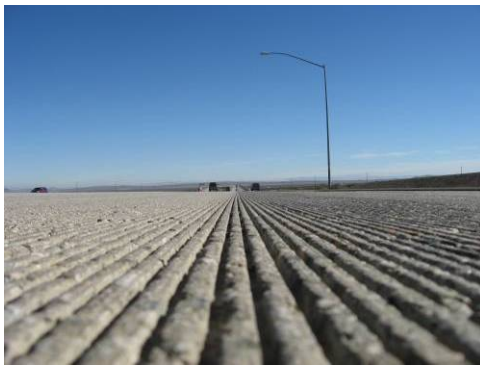
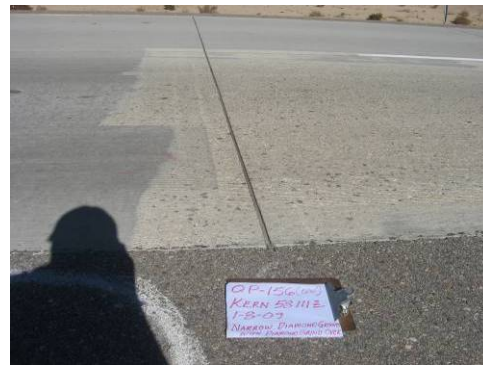
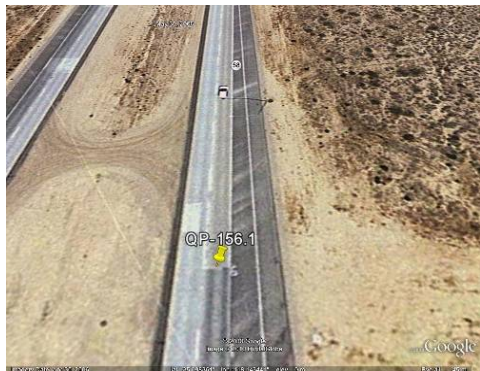
QP-156.1

Type of section: Pavement Field testing Year 1: 1/9/2009 7:57
 Location: 06Ker58E111.2 Field testing Year 2: 12/2/2009 11:43
 Comments: Diamond grooved. DG+Gr.
 Surface Year: 2006

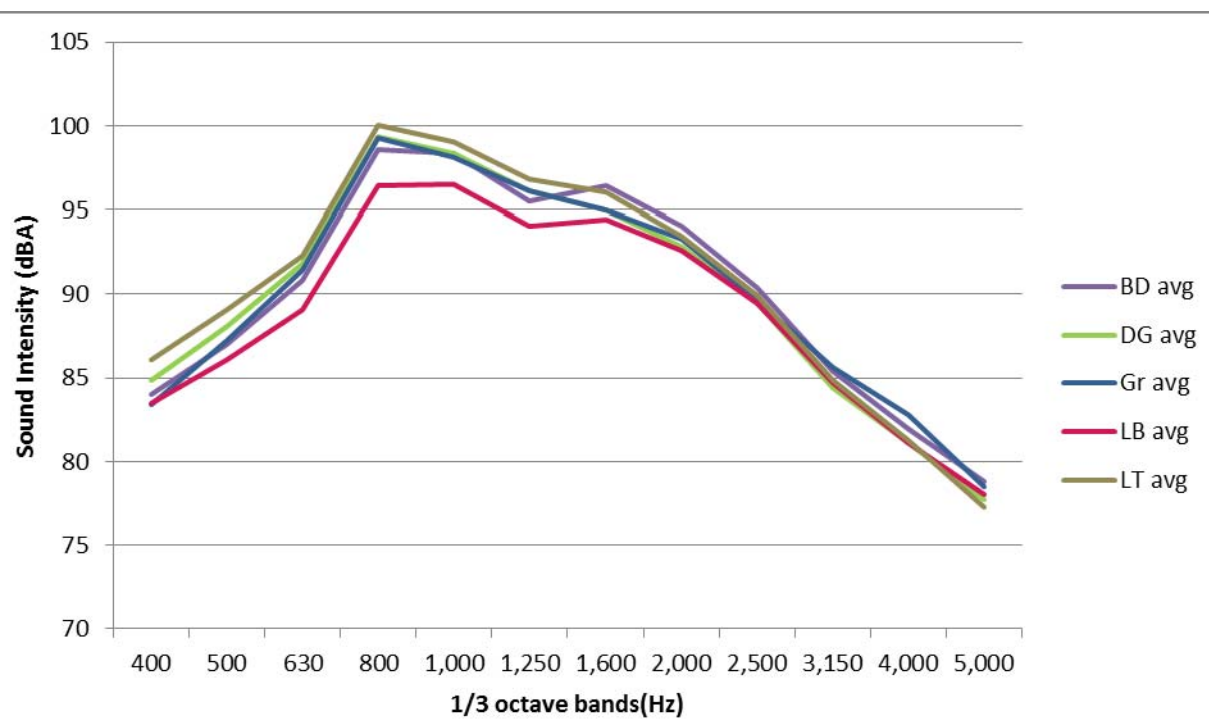
Figure E.1: Figure 3.17: Comparison of OBSI spectral content of sections with different texture types, average of sections with texture aged.

(Note: BD = burlap drag, DG=diamond ground, Gr=diamond grooved, LB=longitudinally broomed, LT=longitudinally tined.)

To begin the examination of the noise characteristics of concrete pavement surface textures in more detail, Figure 3.16 presents the one-third octave sound intensity levels, using the average for each texture type and including textures of all three conditions. The longitudinally broomed texture has markedly lower levels at frequencies below 1,250 Hz. The other surface types are difficult to distinguish from each other in terms of average OBSI spectra. Given that once the texture of a surface has disappeared, it is no longer considered to be designed, and it is more appropriate to consider only those sections with *aged* texture, as presented in Figure 3.17.

Figure 3.17: Comparison of OBSI spectral content of sections with different texture types, average of sections with texture aged.
(Note: BD = burlap drag, DG=diamond ground, Gr=diamond grooved, LB=longitudinally broomed, LT=longitudinally tined.)

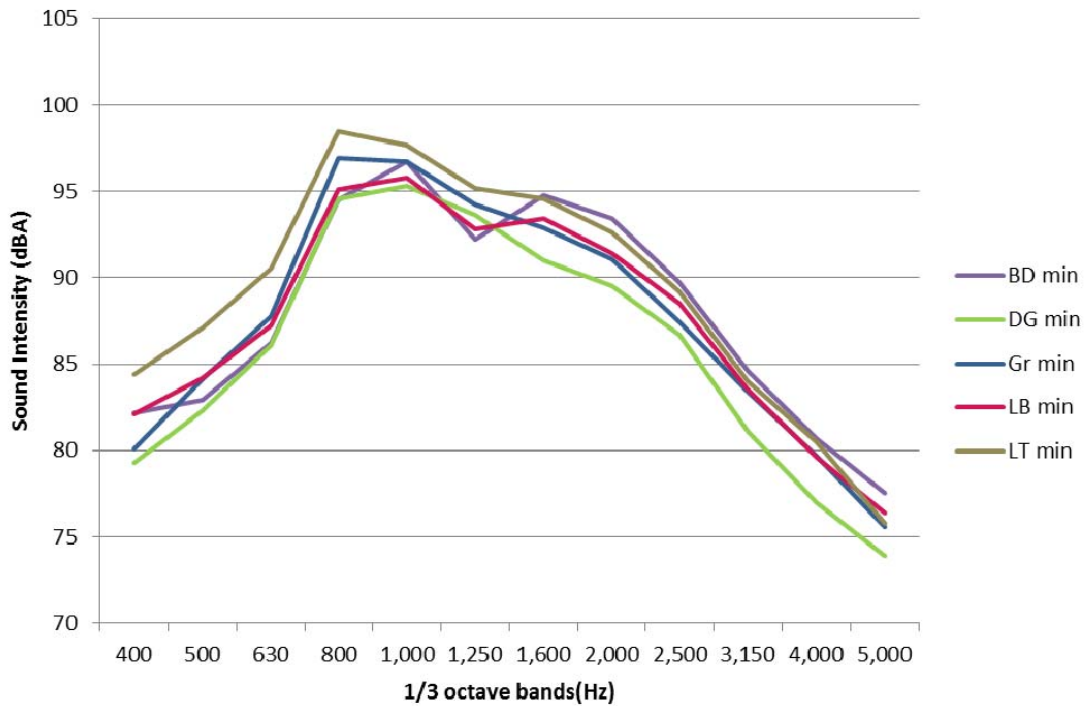
Figure E.2: Compare with Figure 3.19: Comparison of OBSI spectral content of sections with different texture types, minimum of sections with aged texture.
 (Note: BD = burlap drag, DG=diamond ground, Gr=diamond grooved, LB=longitudinally broomed, LT=longitudinally tined.)

The average spectra for all texture types and conditions was shown previously in Figure 3.16. The minimum and maximum spectra values for the one-third octaves are shown for all sections with aged texture in Figure 3.19 and Figure 3.20, respectively.

Figure 3.19: Comparison of OBSI spectral content of sections with different texture types, minimum of sections with *aged* texture.

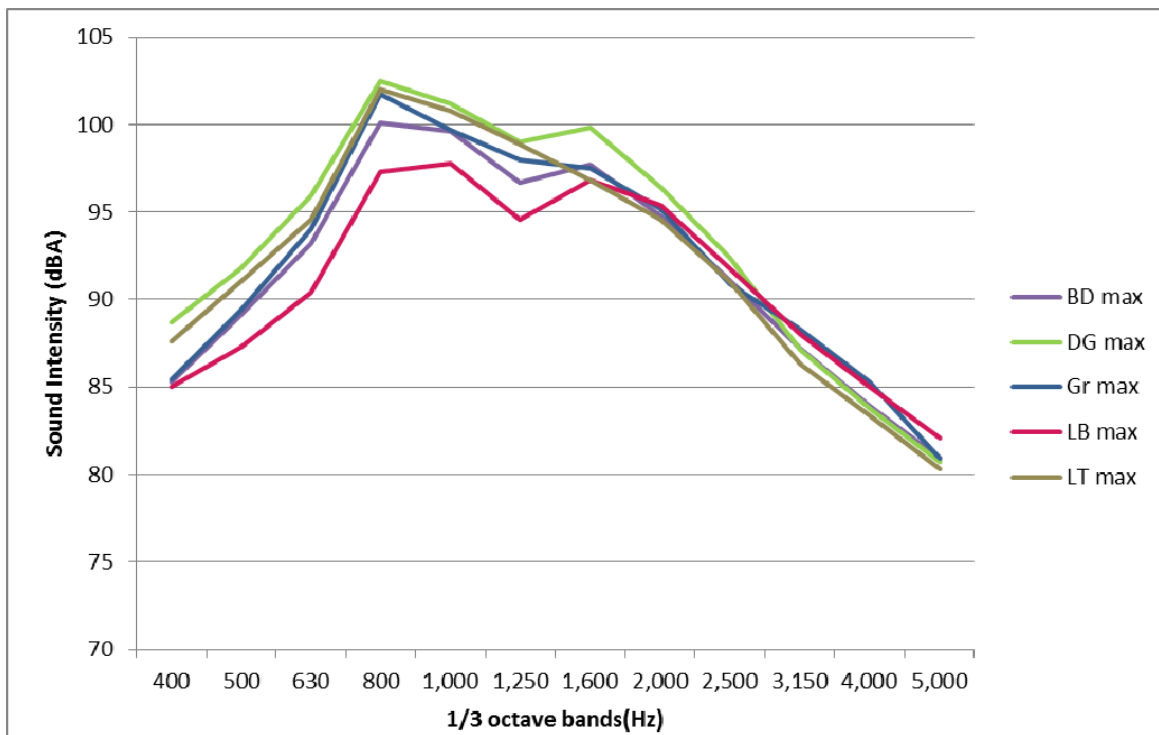
Figure E.3: Compare with Figure 3.20: Comparison of OBSI spectral content of sections with different texture types, maximum of sections with aged texture.
 (Note: BD = burlap drag, DG=diamond ground, Gr=diamond grooved, LB=longitudinally broomed, LT=longitudinally tined.)

Figure 3.20: Comparison of OBSI spectral content of sections with different texture types, maximum of sections with texture *aged*.
 (Note: BD = burlap drag, DG=diamond ground, Gr=diamond grooved, LB=longitudinally broomed, LT=longitudinally tined.)
