| 4. TITLE AND SUBTITLE Automated Safety Warning Controller Final Report | | 5. REPORT DATE March 22, 2013 |
| 7. AUTHOR Doug Galarus, Dan Richter | | 8. PERFORMING ORGANIZATION REPORT NO. |
| 9. PERFORMING ORGANIZATION NAME AND ADDRESS Western Transportation Institute P.O. Box 174250 Montana State University Bozeman, MT 59717-4250 | | 10. WORK UNIT NUMBER 65-189 |

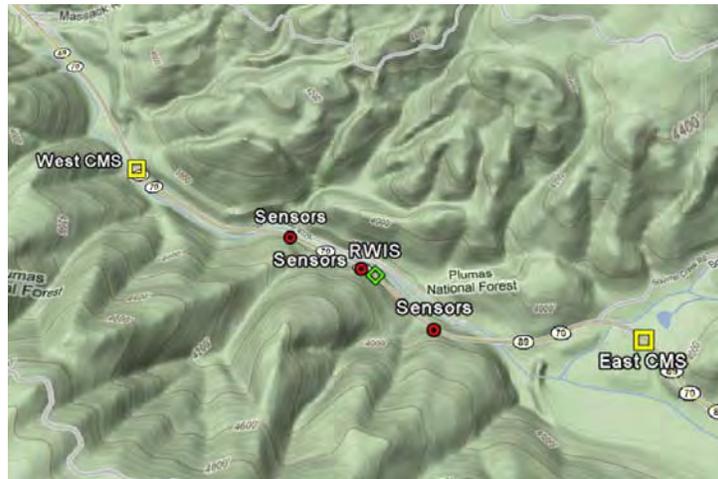
Figure 5: Spring Garden Field Element Configuration

There is an RWIS at the Spring Garden with six in-pavement surface sensors deployed at three locations spanning approximately one-half mile. The West CMS is one-half mile west of the first surface sensor and the East CMS is a little over one-half mile east of the last surface sensor.

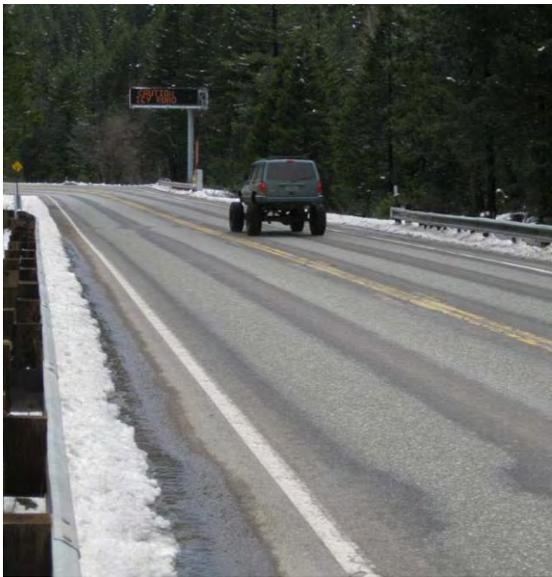
Figure 6: Eastbound CMS (photo by Ian Turnbull)

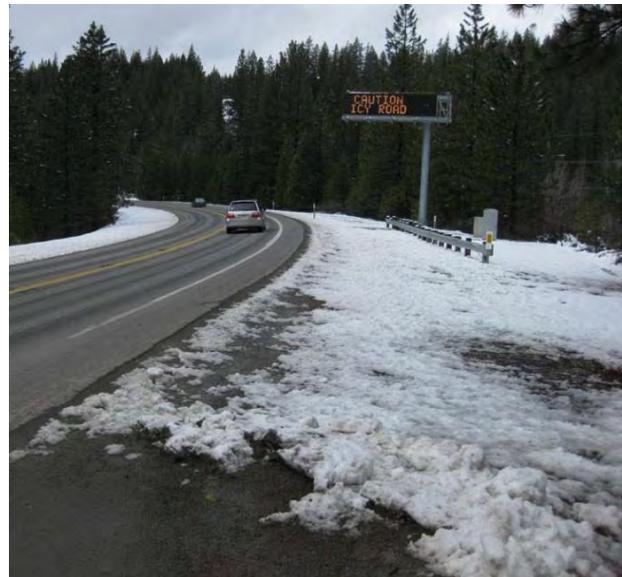
Figure 7: Westbound CMS (photo by Ian Turnbull)

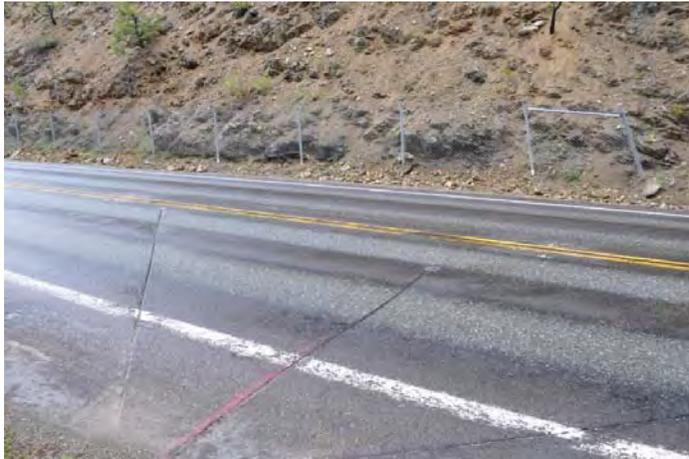
Figure 8: Pavement Surface Sensors

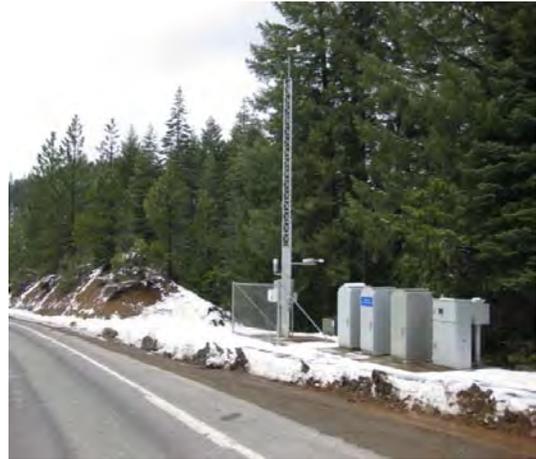
Figure 9: Spring Garden RWIS (photo by Ian Turnbull)

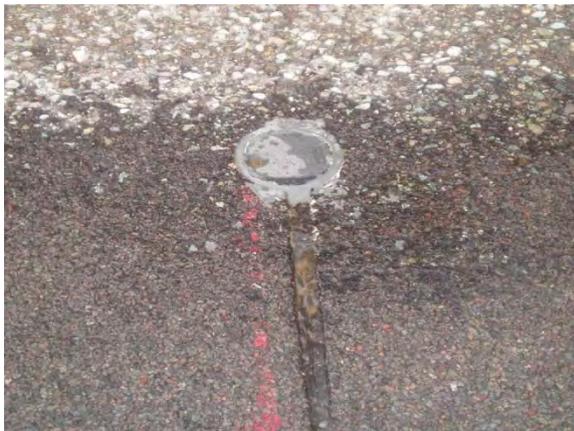
Figure 10: Pavement Surface Sensor

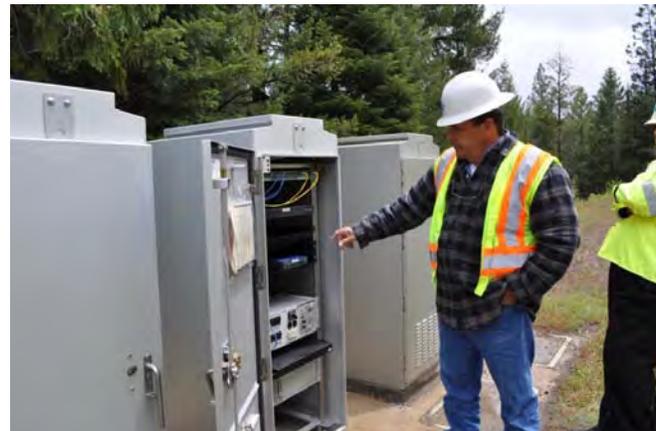
Figure 11: ASWC in Spring Garden ITS Cabinet, as shown by Ian Turnbull

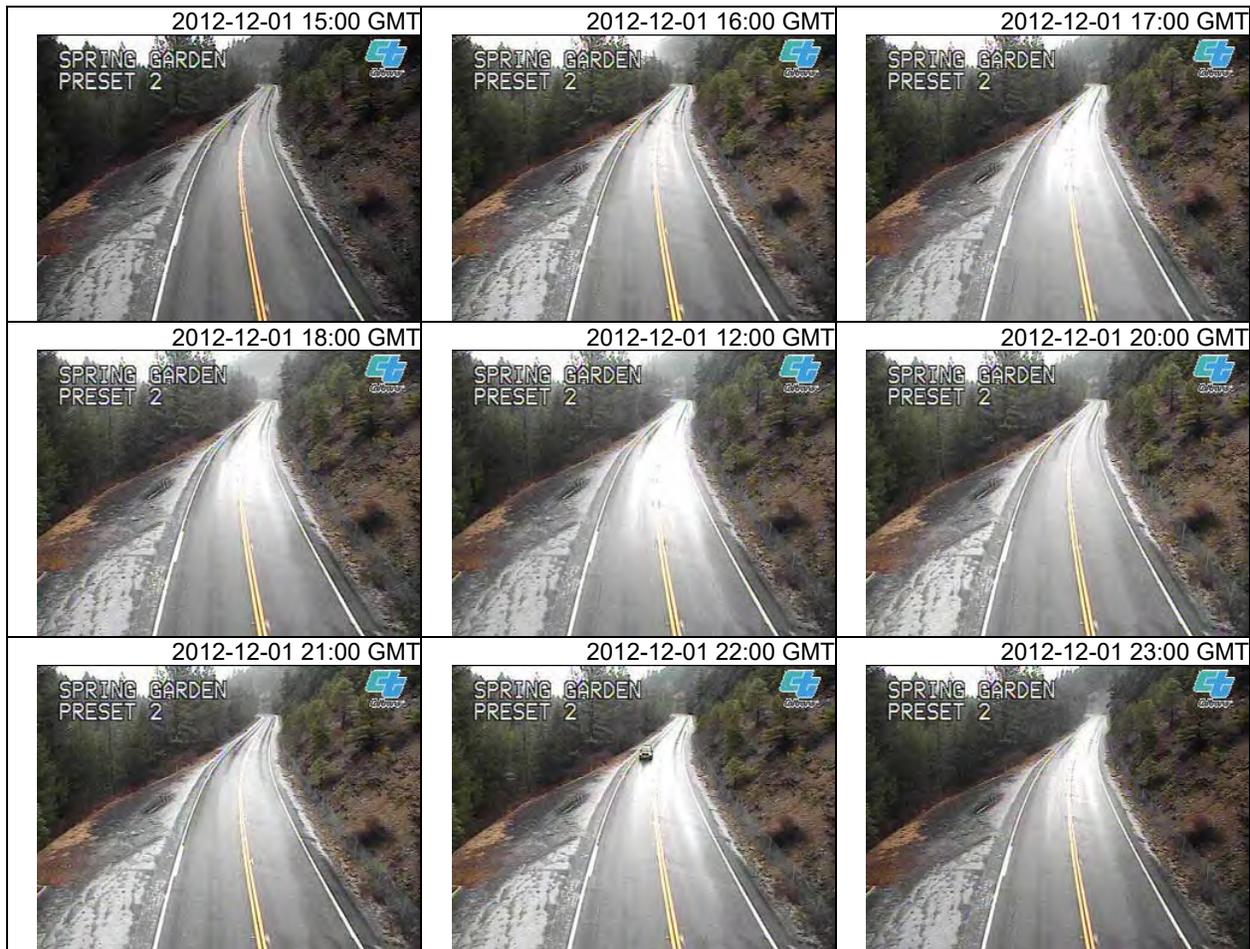
Figure 19: Conditions and Warning Status for 2012-12-01 GMT (pavement temperatures in °F, “Count” is the number of sensors reporting the given conditions)

The following CCTV images and graphs corresponding to daylight hours and allow for visual confirmation of the conditions at Spring Garden. Generally the CCTV images confirm the conditions, although it is difficult at times to determine from the images alone whether there is ice on the roadway. It is particularly interesting to observe the times in which conditions were changing from Ice to Wet and versa, including times when there is snow on the road, but ice conditions are not detected. For the latter, the additional logic used by Caltrans District 2 to represent “Snow” conditions appear to be merited, particularly during transition times which might otherwise result in no warning messages.

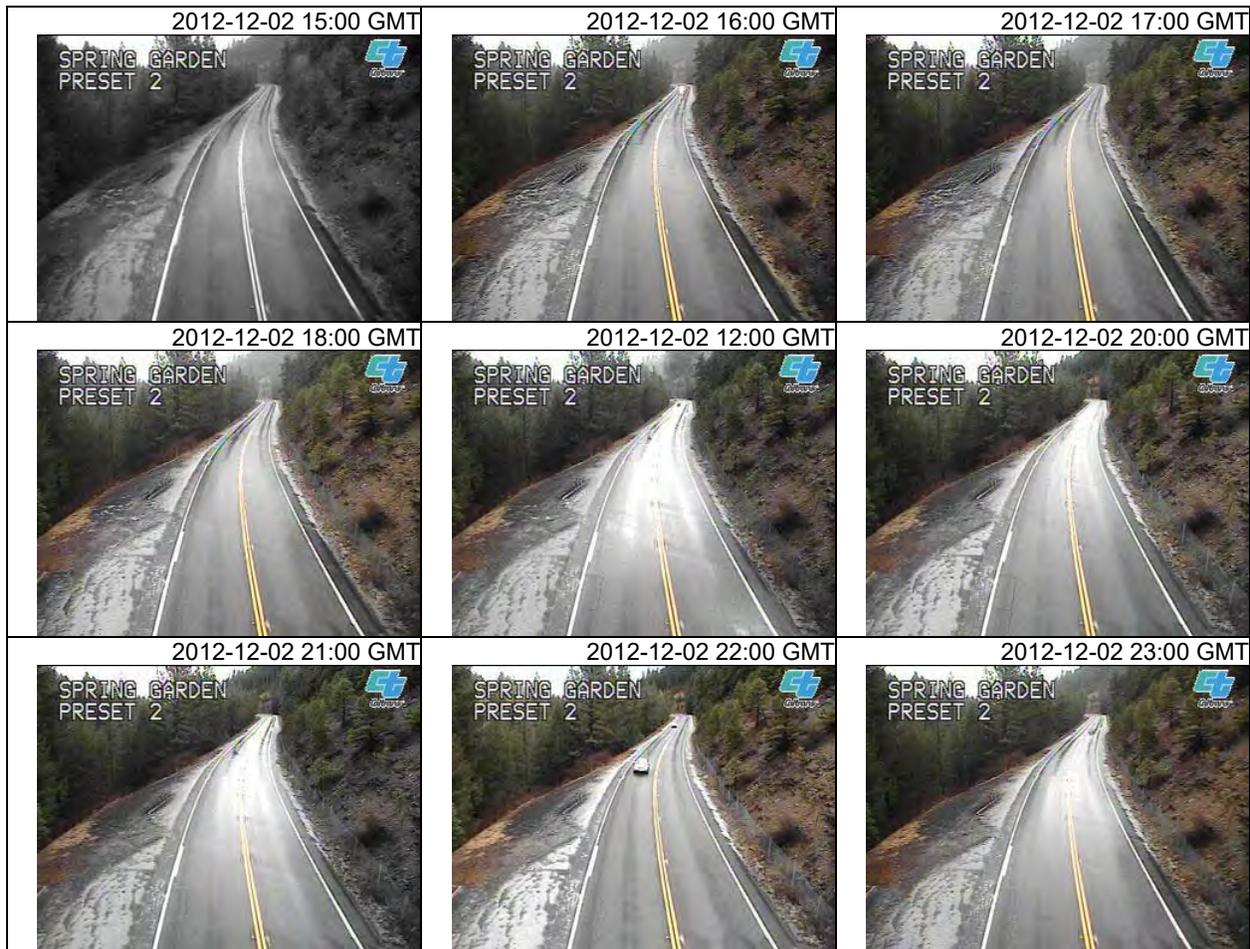
Figure 20: Conditions and Warning Status for 2012-12-02 GMT (pavement temperatures in °F, “Count” is the number of sensors reporting the given conditions)

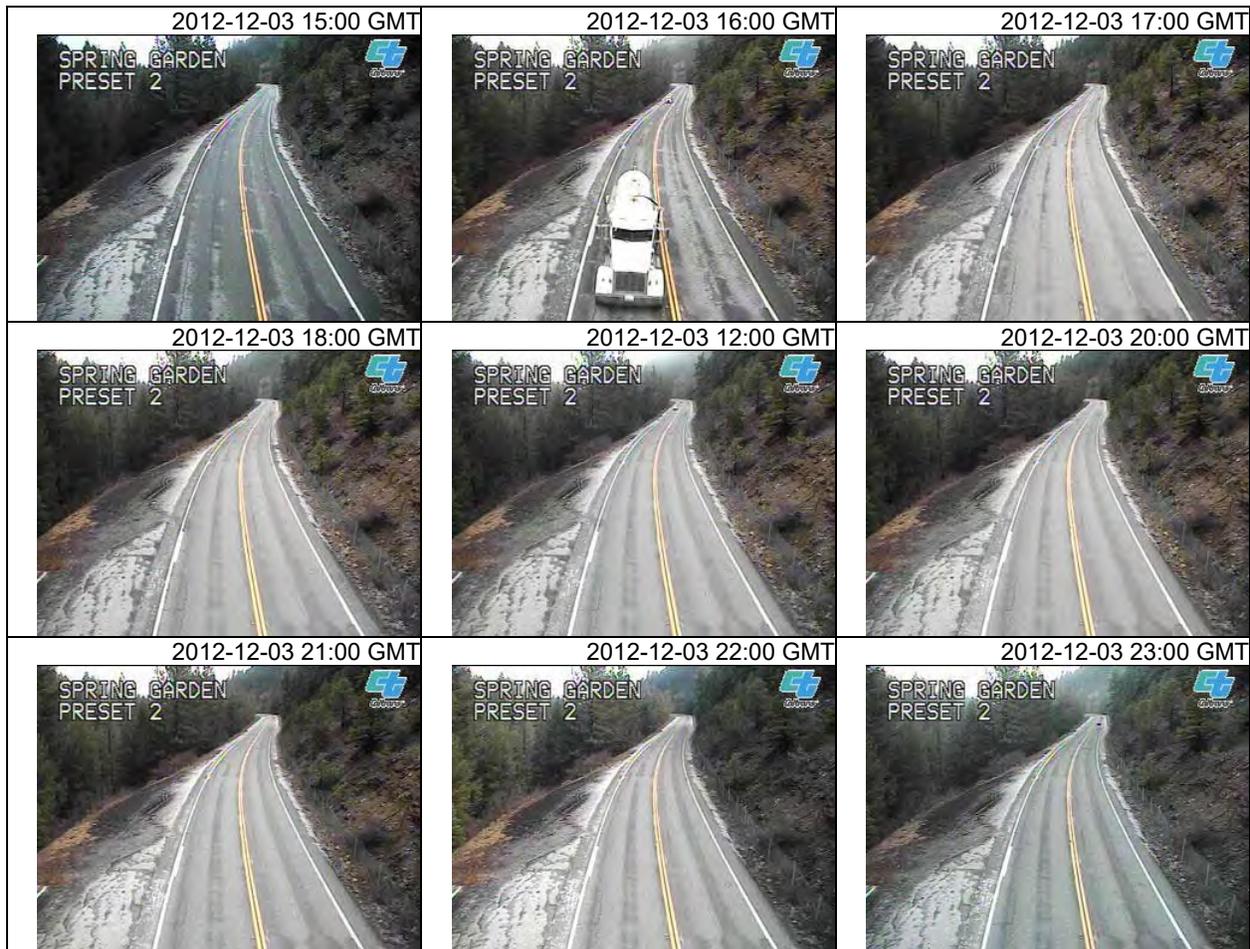
Figure 21: Conditions and Warning Status for 2012-12-03 GMT (pavement temperatures in °F, “Count” is the number of sensors reporting the given conditions)

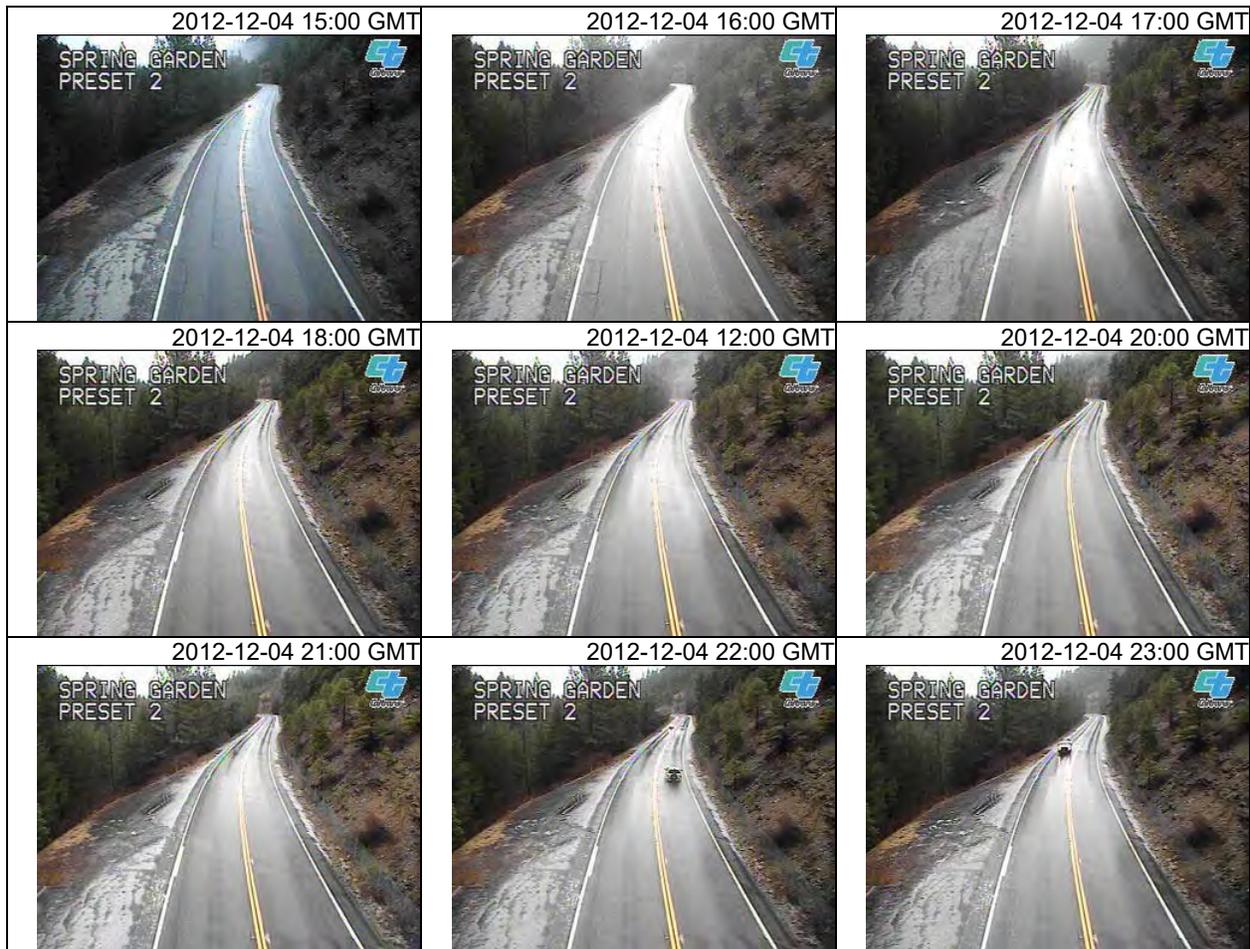
Figure 22: Conditions and Warning Status for 2012-12-04 GMT (pavement temperatures in °F, “Count” is the number of sensors reporting the given conditions)

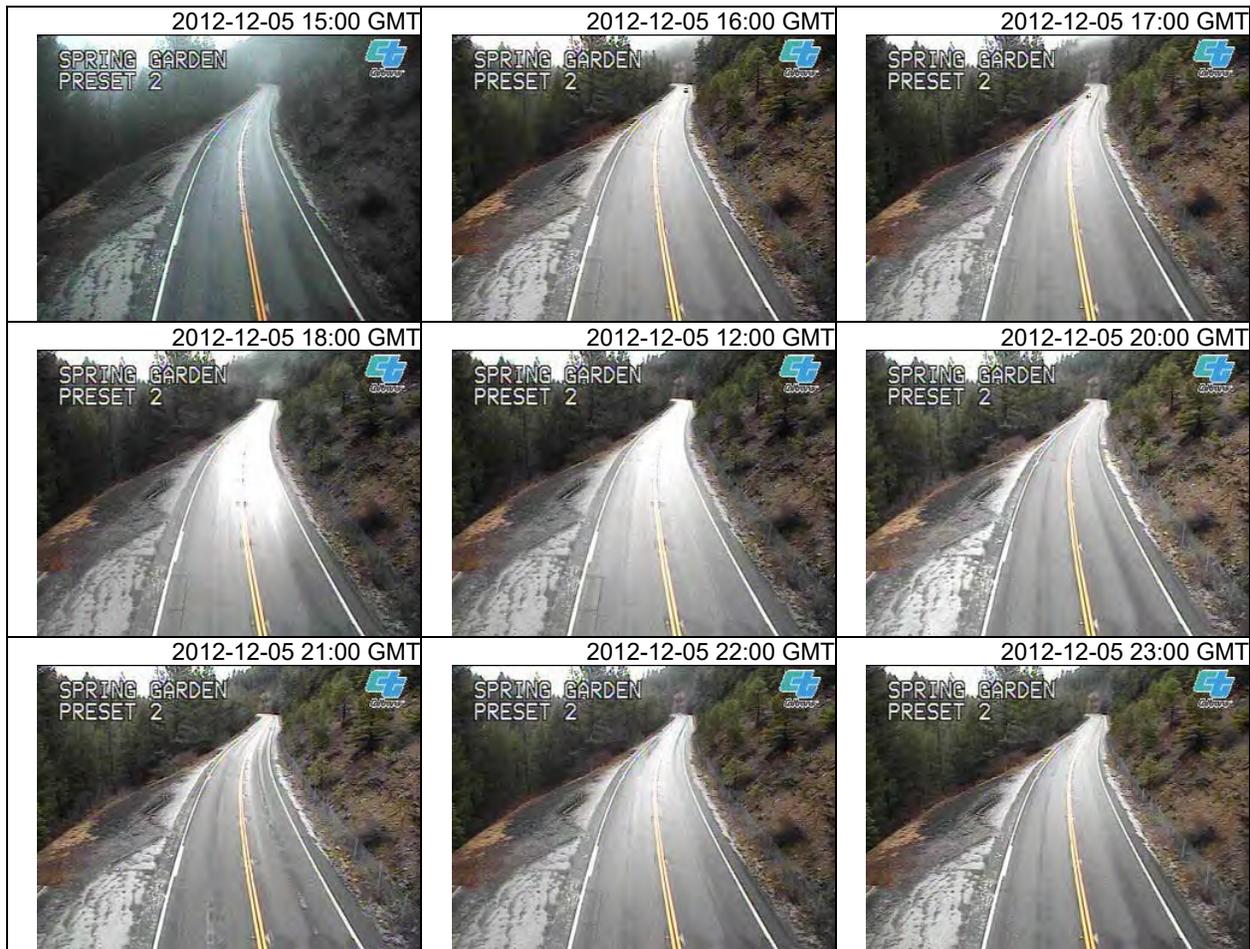
Figure 23: Conditions and Warning Status for 2012-12-05 GMT (pavement temperatures in °F, “Count” is the number of sensors reporting the given conditions)

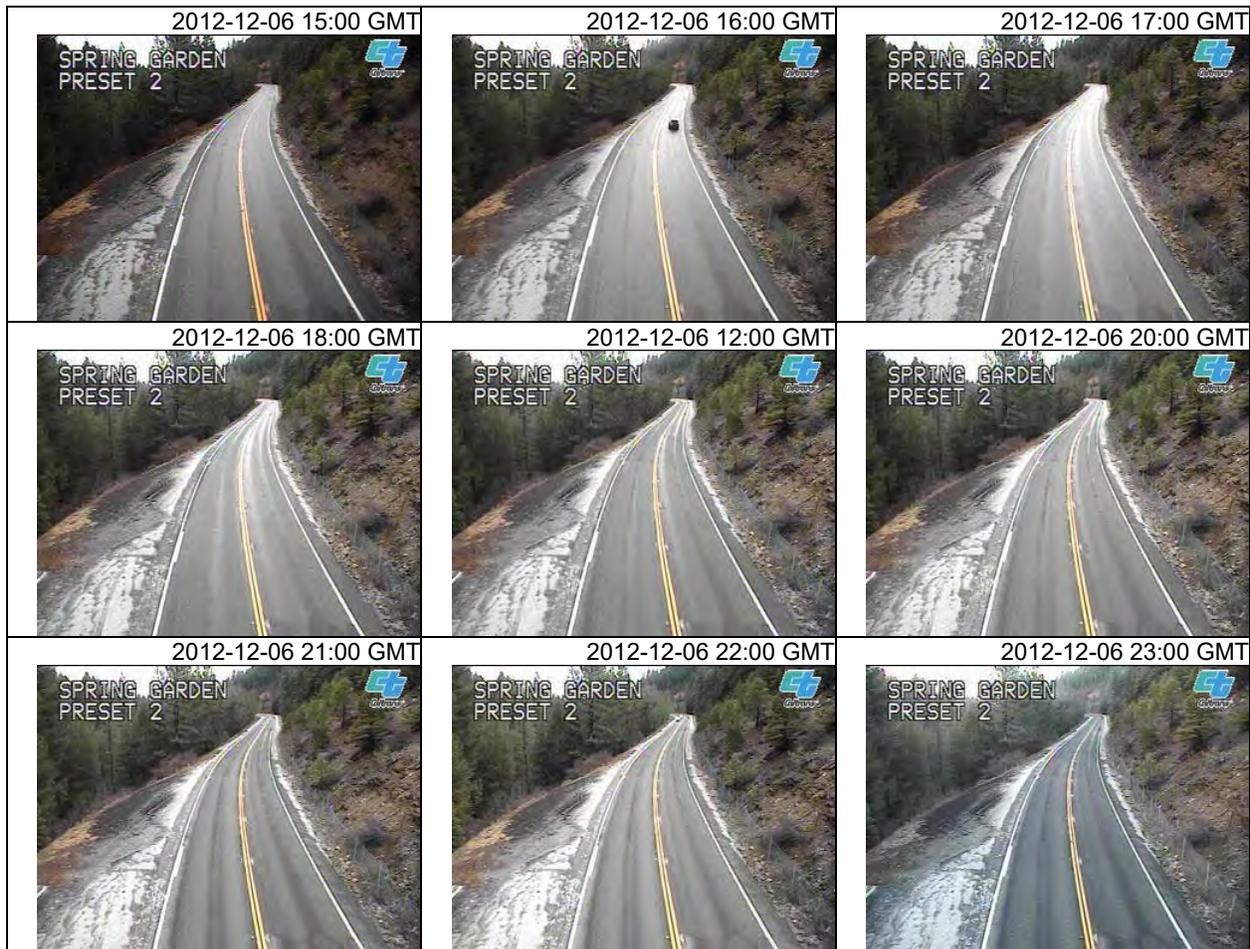
Figure 24: Conditions and Warning Status for 2012-12-06 GMT (pavement temperatures in °F, “Count” is the number of sensors reporting the given conditions)

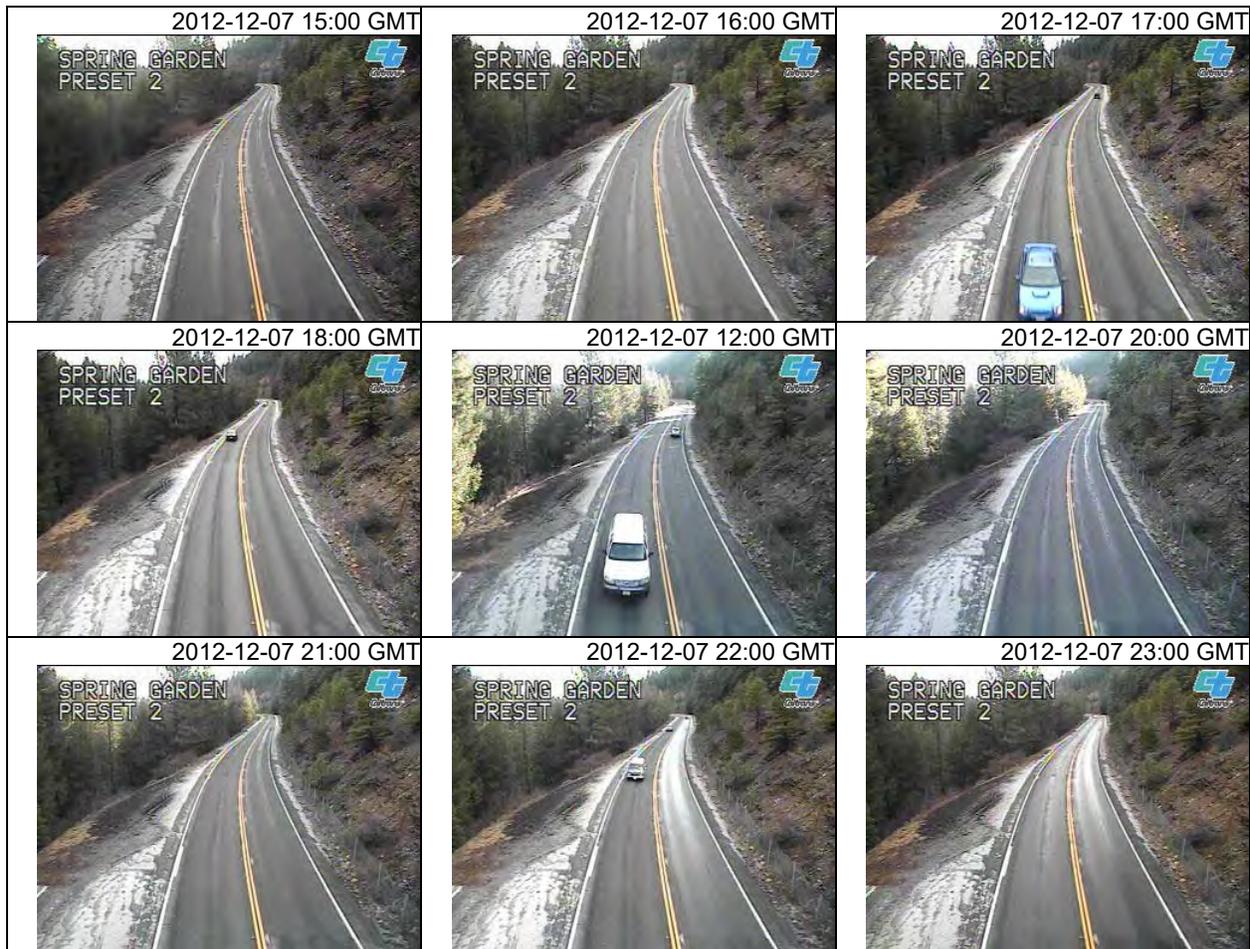
Figure 25: Conditions and Warning Status for 2012-12-07 GMT (pavement temperatures in °F, “Count” is the number of sensors reporting the given conditions)

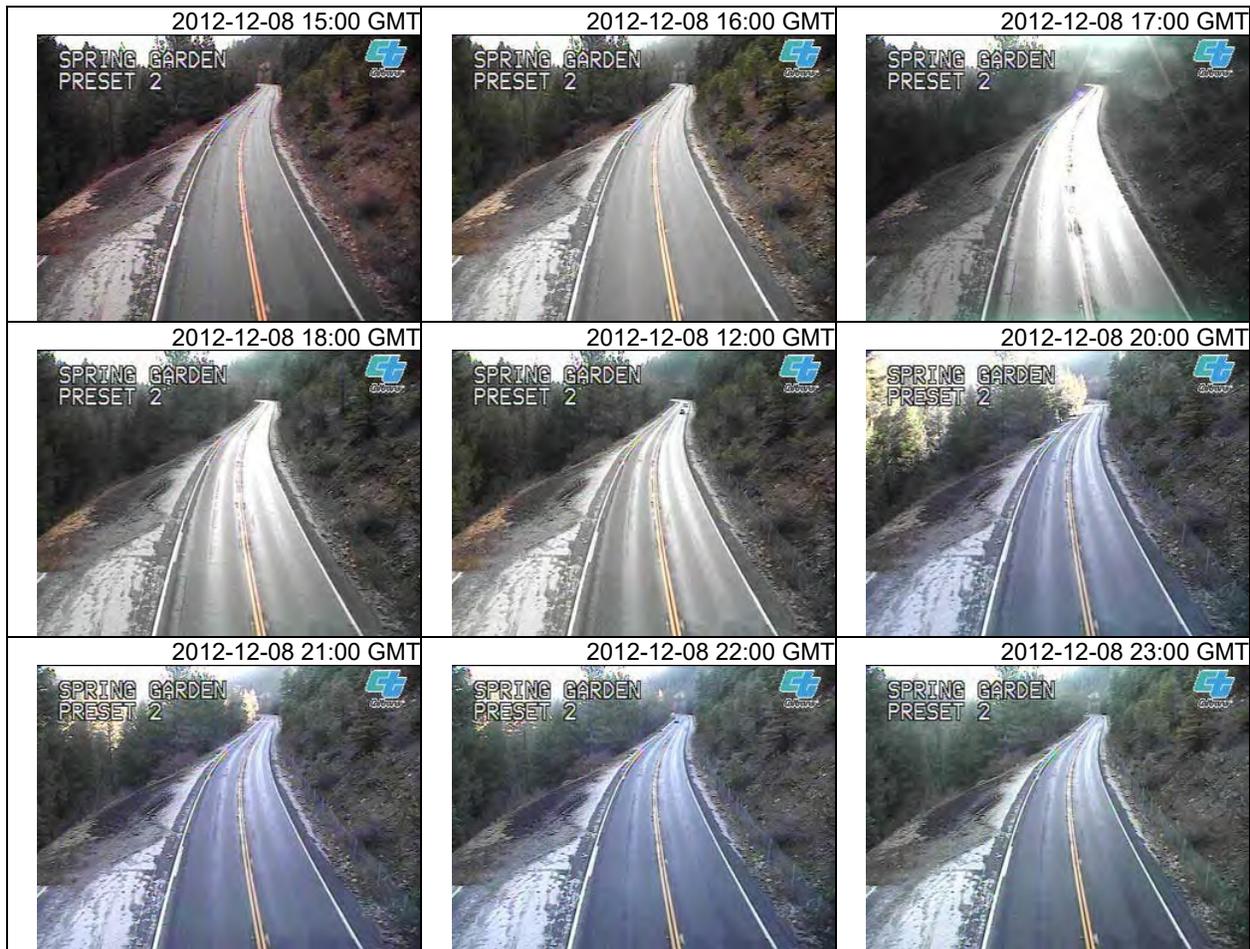
Figure 26: Conditions and Warning Status for 2012-12-08 GMT (pavement temperatures in °F, “Count” is the number of sensors reporting the given conditions)

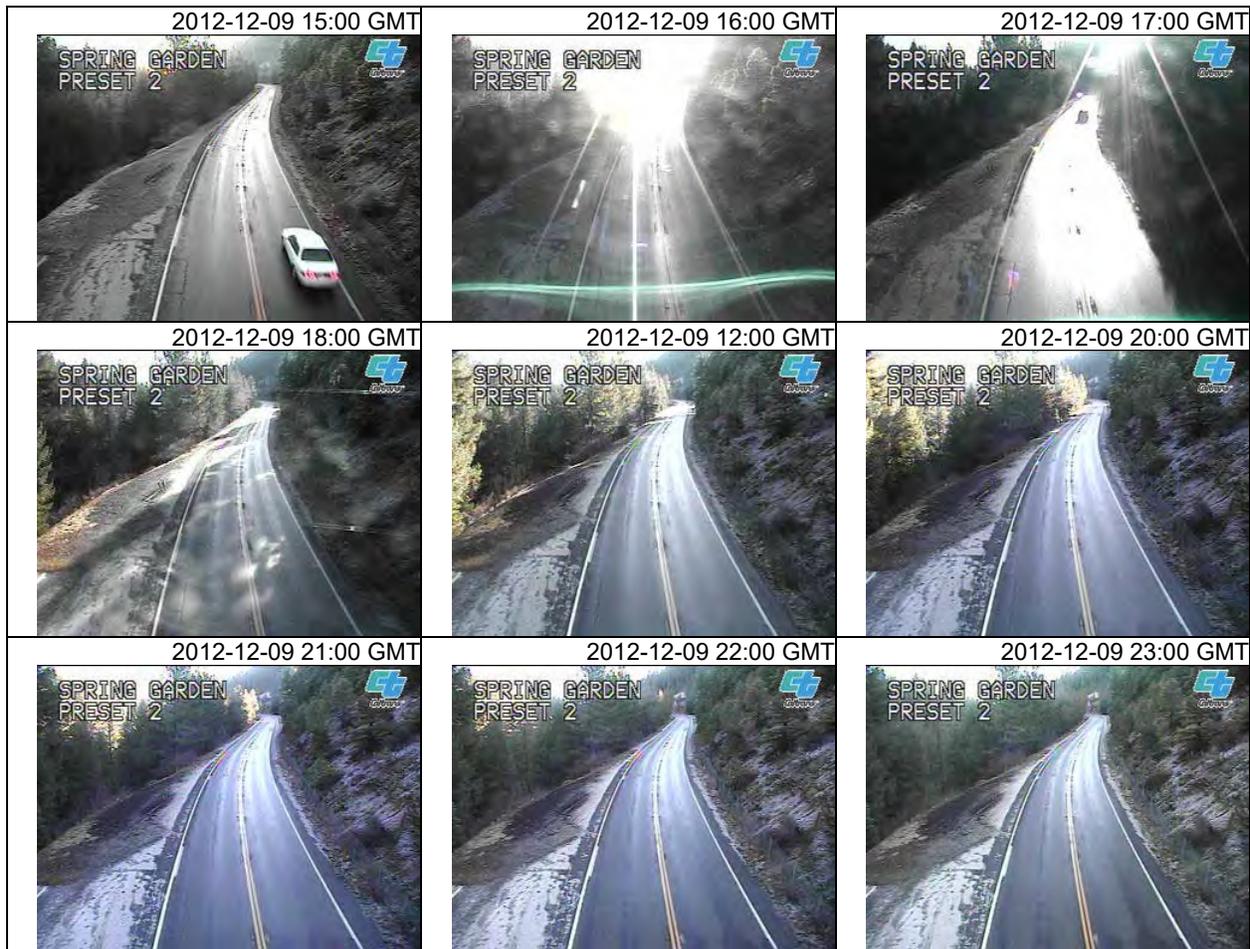
Figure 27: Conditions and Warning Status for 2012-12-09 GMT (pavement temperatures in °F, “Count” is the number of sensors reporting the given conditions)

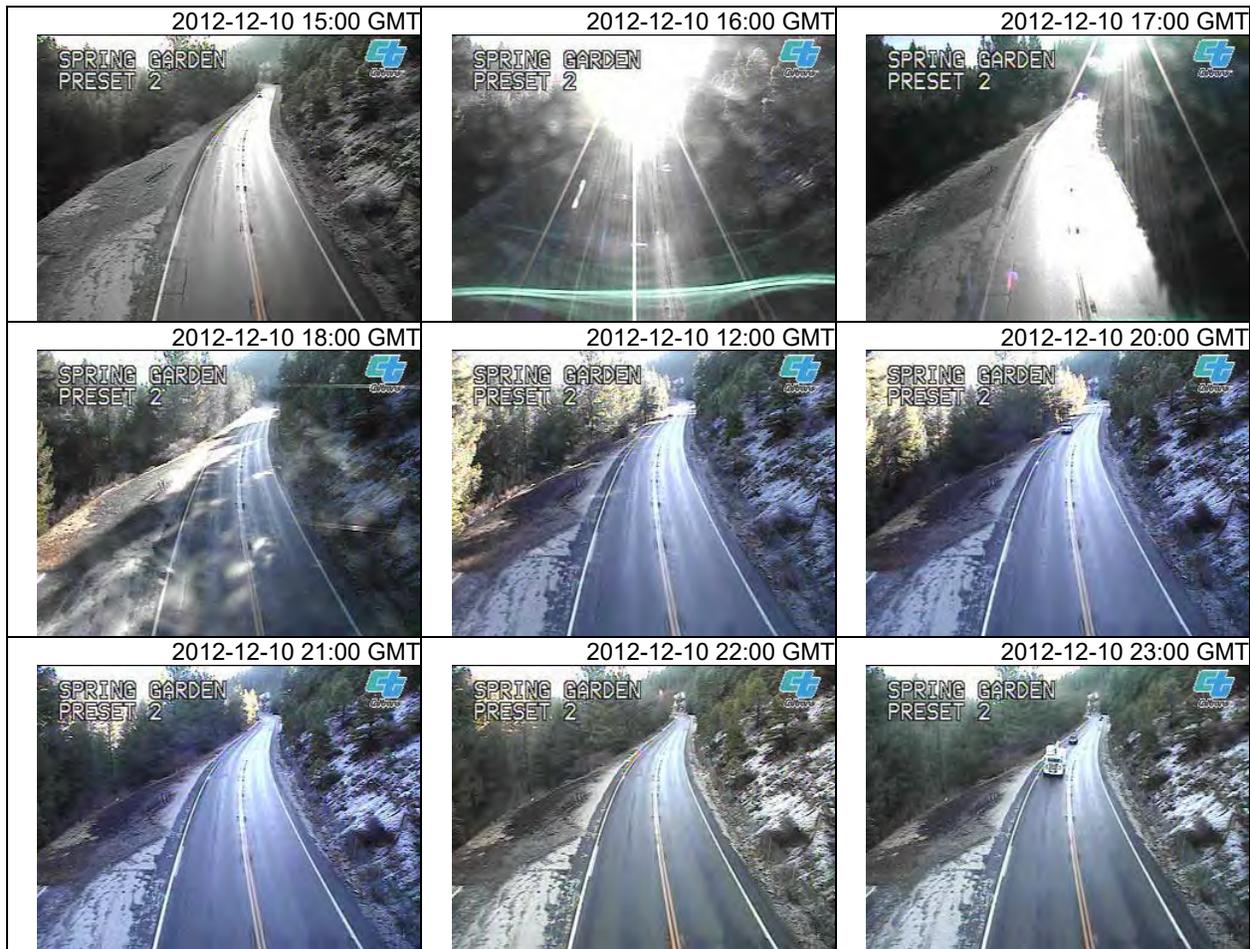
Figure 28: Conditions and Warning Status for 2012-12-10 GMT (pavement temperatures in °F, “Count” is the number of sensors reporting the given conditions)

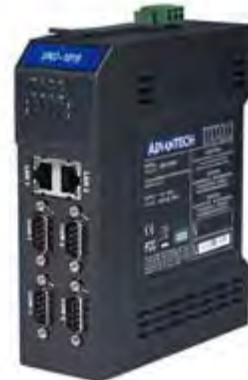
UNO-1019:

- Marvell XScale ARM-5 CPU @ 200 MHz
- 64 MB RAM
- Fanless
- **No LCD or buttons**
- Two 10/100 Mbps Ethernet
- **No USB**
- Two RS-232 serial ports, two RS-232/422/485 serial ports
- No video out port
- CompactFlash slot
- Windows CE 5.0, optional μ Clinux
- **Operating temperature: 32° to 158° F (0° to 70° C)**
- Price: \$425.00
- Source: http://downloadt.advantech.com/ProductFile/Downloadfile4/GF-X1LP/UNO-1019_DS.pdf

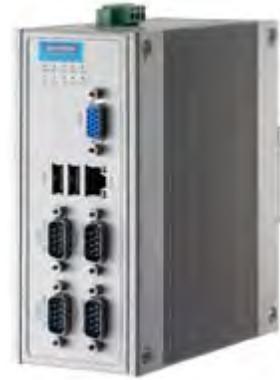
UNO-1140:

- Advantech 486SX CPU @ 150 MHz
- 64 MB RAM
- Fanless
- **No LCD or buttons**
- One 10/100 Mbps Ethernet
- Two USB ports
- Four RS-232/485 serial ports
- One VGA video out port
- CompactFlash slot
- Optional Windows CE.NET 6.0, DOS, Linux
- Operating temperature: -4° to 167° F (-20° to 75° C)
- Price: \$365
- Source: http://downloadt.advantech.com/ProductFile/PIS/UNO-1140/Product%20-%20Datasheet/UNO-1140_DS20110706140617.pdf

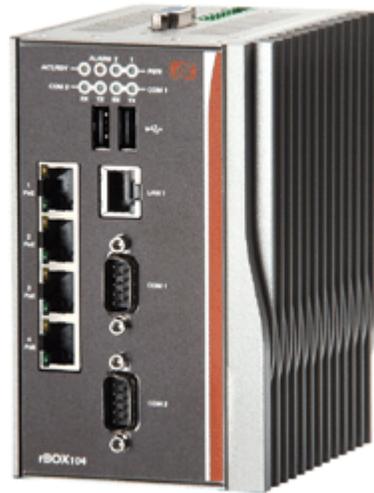
Axiomtech**rBox104:**

- Intel Atom CPU @ 1.1 GHz
- Up to 2 GB RAM
- Fanless
- **No LCD or buttons**
- One 10/100/1000 Mbps Ethernet
- Two USB ports
- Two RS-232/422/485 serial ports
- One VGA out port
- CompactFlash slot, optional SD card slot
- Two watchdog timers, alarm contact, user defined alarm LED
- Supports WinCE, Linux, Windows® 7
- Operating Temperature: -40° to 158° F (-40° to 70° C)
- Price: N/A
- Source: <http://us.axiomtek.com/Download/Spec/rbox104.pdf>

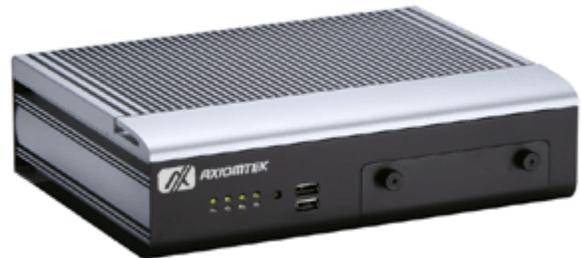
**tBox311-820-FL:**

- Intel Atom CPU @ 1.1 GHz
- Up to 2 GB RAM
- Fanless
- **No LCD or buttons**
- Two 10/100/1000 Mbps Ethernet
- Four USB ports
- No serial ports
- Two VGA video out ports
- One SATA drive bay, one CompactFlash slot
- Watchdog timer, 4 programmable LEDs
- Supports WinCE, Linux
- Operating Temperature: -40° to 149° F (-40° to 65° C)
- Price: N/A
- Source: <http://us.axiomtek.com/Download/Spec/tbox311-820-fl.pdf>

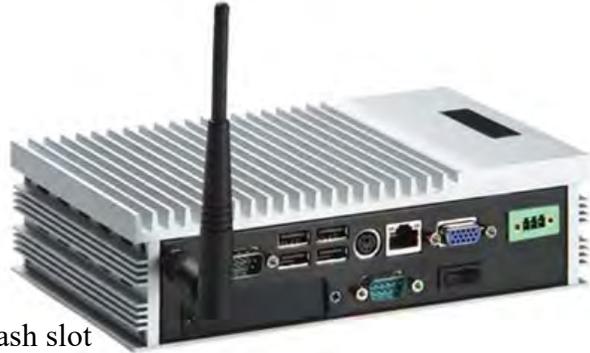
EMS6503:

- Intel Atom @ 1.1 GHz
- Up to 2 GB RAM
- Fanless
- **No LCD or buttons**
- One 10/100/1000 Mbps Ethernet
- Four USB ports
- Two RS-232 serial ports
- One VGA video out port
- One SATA drive bay, one CompactFlash slot
- Watchdog timer
- Supports Windows XPE
- Operating temperature: -4° to 149° F (-20° to 65° C)
- Price: \$805
- Source:
http://www.bsicomputer.com/new/embedded_computer/ems6503/ems6503_embedded_computer.htm

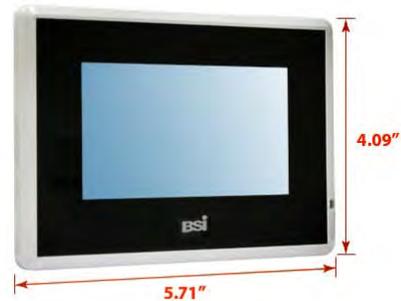
IOVU-430M:

- Intel XScale RISC CPU @ 416 MHz
- 128 MB RAM
- Fanless
- Touch sensitive LCD
- One 10/100 Mbps Ethernet
- One USB port
- One RS-232/422/485 serial port
- miniSD card slot
- Windows CE 5.0
- Operating temperature: -4° to 140° F (-20° to 60° C)
- Price: N/A
- Source:
http://www.bsicomputer.com/new/panel_PC/iovu430m/iovu430m_touch_panel_pc.htm

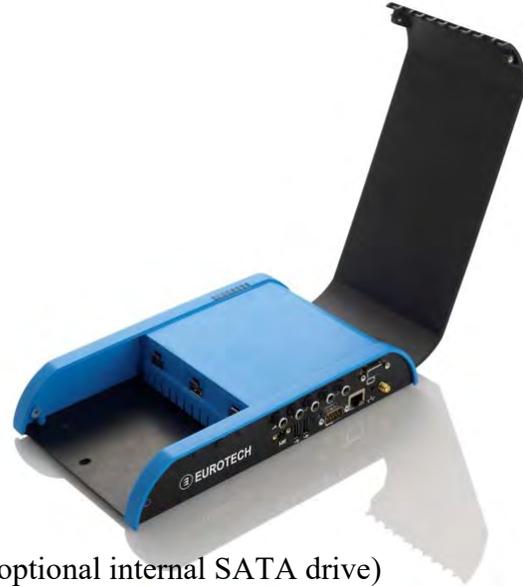
Helios:

- Intel Atom @ 1.1 GHz
- 512 MB RAM
- Fanless
- **No LCD or buttons**
- One 10/100/1000 Mbps Ethernet
- Five USB ports (3 inside bay)
- One RS-232/485 serial port
- Optional multimedia card for video out
- 2 GB CompactFlash card (optional SD card, optional internal SATA drive)
- Eight programmable LEDs, one software readable push button
- Wind River Linux 3.0, Windows CE 6.0
- Operating temperature: -40° to 185° F (-40° to 85° C)
- Price: N/A
- Source:

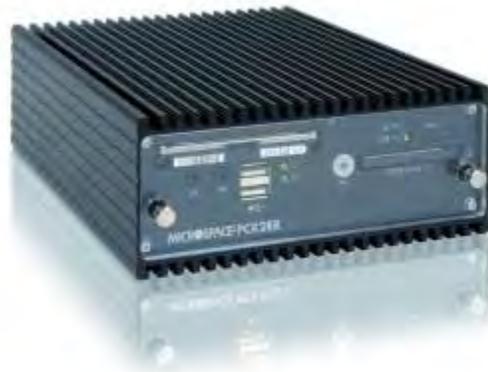
MICROSPACE MPCX28R:

- Intel Atom CPU @ 1.6 GHz
- 1 GB RAM
- Fanless
- **No LCD or buttons**
- Two 10/100 Mbps Ethernet
- Five USB ports
- Two RS-232/422/485 serial ports
- One DVI video out port, VGA optional
- One SATA bay, optional CompactFlash
- Compatible with Windows or Linux
- Operating temperature: -4° to 158° F (-25° to 70° C)
- Price: N/A
- Source:

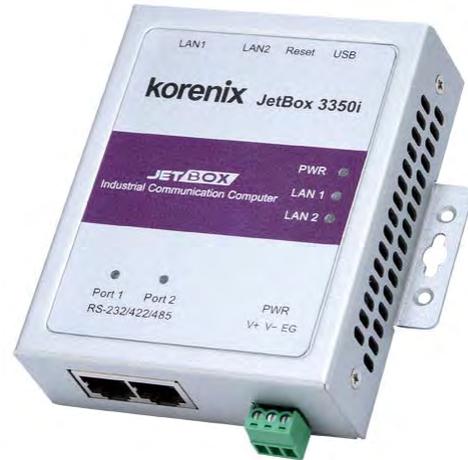
JetBox 3350i-w:

- Atmel ARM CPU @ 180 MHz
- 64 MB RAM
- Fanless
- **No LCD or buttons**
- Two 10/100 Mbps Ethernet
- Two USB ports
- Two RS-232/422/485 serial ports
- No video out port
- One microSD slot
- Watchdog timer
- Linux
- Operating temperature: -40° to 176° F (-40° to 80° C)
- Price: N/A
- Source: <http://www.korenix-usa.com/pdfs/JetBox3350i-w-low.pdf>

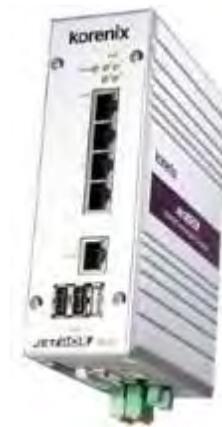
JetBox 9430-w:

- Intel XScale IXP435 RISC CPU @ 667 MHz
- 128 MB RAM
- Fanless
- **No LCD or buttons**
- Five 10/100 Mbps Ethernet
- Three USB ports
- No serial ports
- No video out port
- One SD card slot, one CompactFlash card slot
- Watchdog timer
- Linux 2.6.20
- Operating temperature: -40° to 176° F (-40° to 80° C)
- Price: N/A
- Source: <http://www.korenix-usa.com/pdfs/JetBox9430-w-low.pdf>

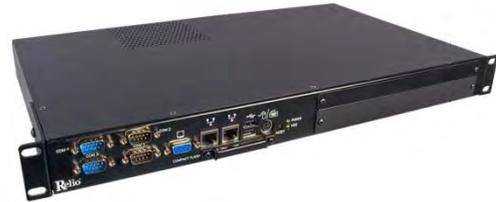
Relio R4300:

- AMD Geode CPU @ 500 MHz
- 1 GB RAM
- Fanless
- **No LCD or buttons**
- Two 10/100 Mbps Ethernet
- Two USB ports
- Two RS-232/422/485 serial ports, two RS-232 serial ports
- One VGA video out port
- One optional internal hard drive, one CompactFlash slot
- Watchdog timer
- Windows and Linux compatible
- Operating temperature: 32° to 122° F (0° - 50° C) (Extended temperature options available)
- Price: \$999
- Source: <http://www.sealevel.com/store/computing-hmi/industrial-computers/expandable-rackmount/r4300-relio-r4300-500mhz-amd-geode-lx800.html>

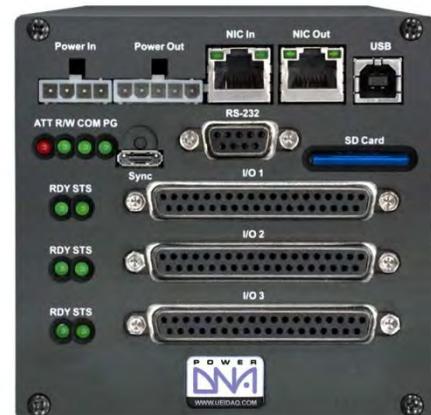
DNA-PPCx:

- Freescale MPC5200 CPU @ 400 MHz
- 128 MB RAM
- Fanless
- **No LCD or buttons**
- Two 10/100 Mbps Ethernet
- **No USB host ports**
- One RS-232 serial port
- No video out port
- 128 MB internal flash, SD card slot
- Windows and Linux compatible
- Operating temperature: -40° to 185° F (-40° to 85° C)
- Price: \$995
- Source: <http://www.ueidaq.com/media/catalog/product/pdf/datasheet/dna-ppcx.pdf>

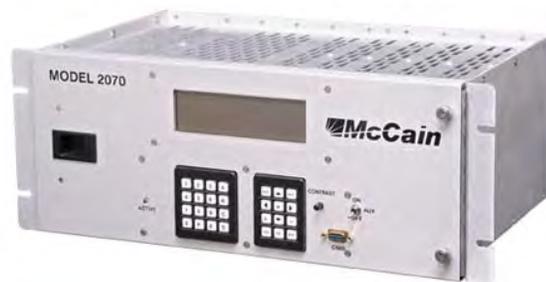
Environment: Operating Temperature: -37° C to $+74^{\circ}$ C
Humidity: 0 to 95% (non-condensing)

- 256MB DDR memory expansion
- Optional modules
- Various modems (2070 form factor)
- GPS module

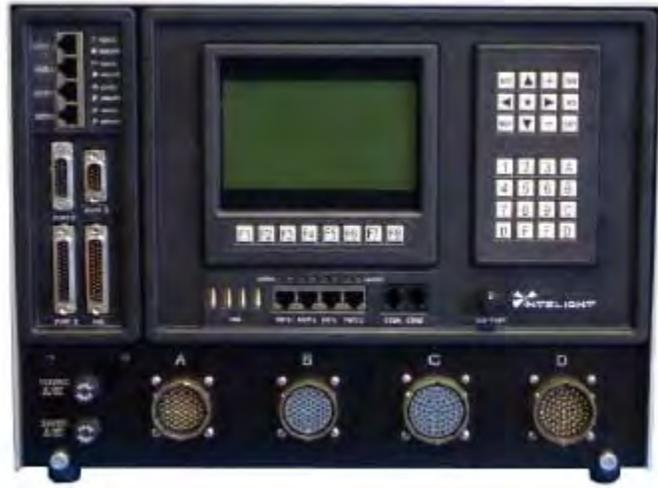
IntelightNEMA TS2 Type 1 & 2 Advanced
Transportation Controller (ATC)

- Compliant with current NEMA TS2 and ATC 5.2b standards
- Open Architecture Embedded Linux Multi-Processing Operating System
- 4 Standard 10/100 Mbit Ethernet Ports
- 2 Quad 4 Port Integral Ethernet Switches
- 4 USB Ports
- 2 Keypads & 8 Programmable Special Function Keys
- ATC 5.2b Compliant Engine Board CPU
- ATC Standard API for third party application support
- Two ATC/2070 Type Communications/Modem Slots
- 16 Line X 40 Character (240 X 120 Graphics) LCD Display
- 7 configurable Serial Ports (5 are SDLC capable)
- 14 3/4" W X 7 3/4" D X 10 1/2" H
- Power 95 - 250 VAC 50/60 Hz Auto Sensing
- -40 to +80° C operating environment
- 64MB Flash / 64MB DRAM memory / 1MB SRAM

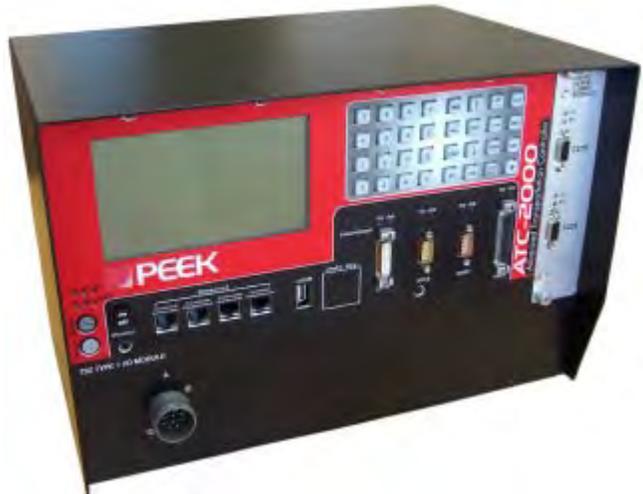
- 16MB SDRAM memory (standard)
- 32MB and 64MB available as upgrade options
- 1MB SRAM
- Dimensions: 14¾" Wide × 10½" Deep × 10¼" Tall (375mm × 267mm × 261mm)

- Power requirements 95 to 135VAC 60Hz ± 3 Hz
- Environment: -35°F to + 165°F -37°C to + 74°C
- 0-95% relative humidity

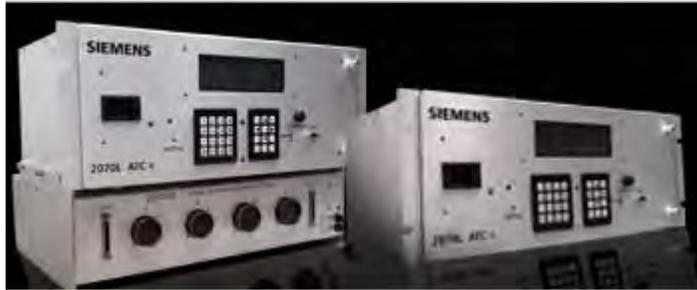
- Multitasking - each 2070ATC unit can control multiple applications
- Multiprocessing - each 2070ATC unit can accommodate multiple CPUs
- High speed serial communications to CPU

- Designed and built for unattended operation in harsh environments
- Built-in 10 Base-T Ethernet with IP address on 2070-1B (2070L models)

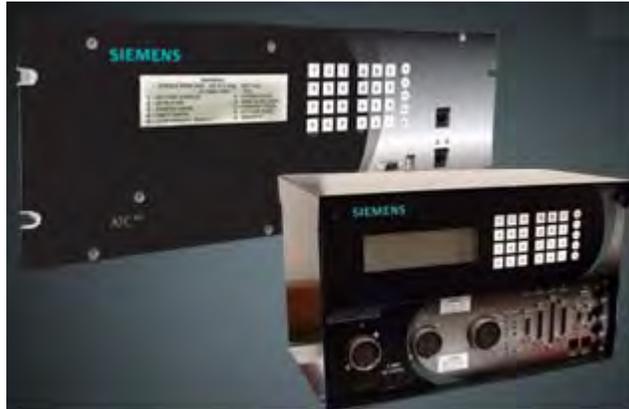
SITRAFFIC® Sphere ATC

Freescall Power Quicc II Pro microprocessor w/ e200 core, running at 500MIPs with E200 core 266 MHz processor

- 36MB flash memory
- 64 MB DRAM
- 2 MB SRAM
- Linux operating system using glibc w/ C++ support libraries
- Multi-line alpha-numeric backlit display
- Durable front coating
- Runs multiple-concurrent applications
- Lightweight, injection molded, high-impact poly-carbonate case (rack mount)
