**VEHICLE CRASH TESTS OF THE
AESTHETIC, SEE-THROUGH CONCRETE
BRIDGE RAIL WITH SIDEWALK, TYPE 80SW**

STATE OF CALIFORNIA
DEPARTMENT OF TRANSPORTATION
ENGINEERING SERVICE CENTER,
OFFICE OF MATERIALS ENGINEERING AND TESTING SERVICES

1. REPORT NO.	2. GOVERNMENT ACCESSION NO.	3. RECIPIENT'S CATALOG NO.	
4. TITLE AND SUBTITLE VEHICLE CRASH TESTS OF THE AESTHETIC, SEE-THROUGH CONCRETE BRIDGE RAIL WITH SIDEWALK, TYPE 80 SW		5. REPORT DATE August 1998, revised 8/99

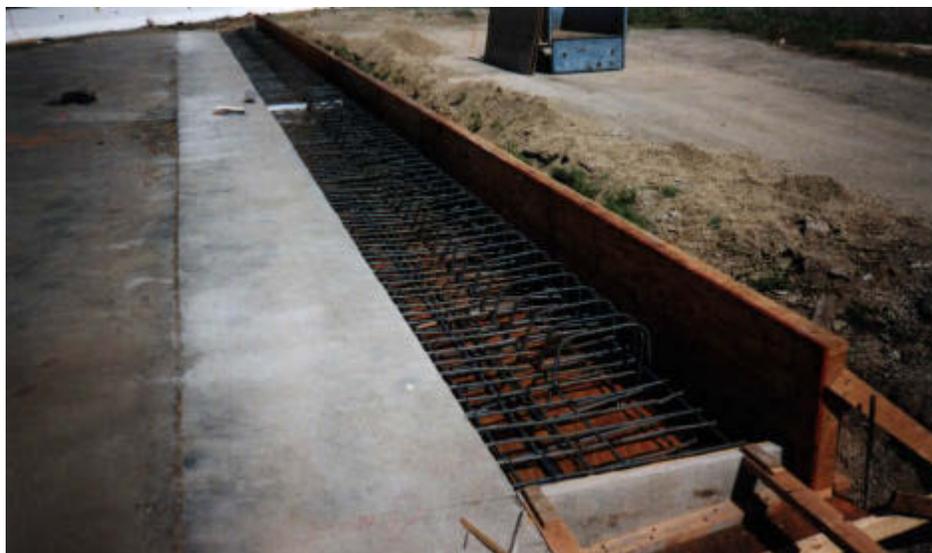
Figure 2-2 -
Concrete Anchor
Block with
Simulated Bridge
Deck Reinforcing
Steel

The bridge rail was constructed in several stages. An existing anchor block with a simulated bridge deck was utilized for the new bridge rail. The existing simulated bridge deck was demolished with the reinforcing steel retained for use in the new deck (Figure 2-2). Additional reinforcing steel was added to the steel retained including bars which looped up out of the deck approximately 200 mm above the deck surface. The forms for the new simulated deck were completed and concrete was poured level to the deck surface (Figure 2-3). To construct the sidewalk, reinforcing steel was placed over part of the anchor block and deck. Short curved bars were doweled into the anchor block at the front edge of the sidewalk to provide a positive connection. At the same time reinforcing steel for the barrier base and posts were tied into place as shown in Figure 2-4. The forms were completed and concrete poured to include the sidewalk and the base of the barrier, 200 mm above the back edge of the sidewalk (Figure 2-5).

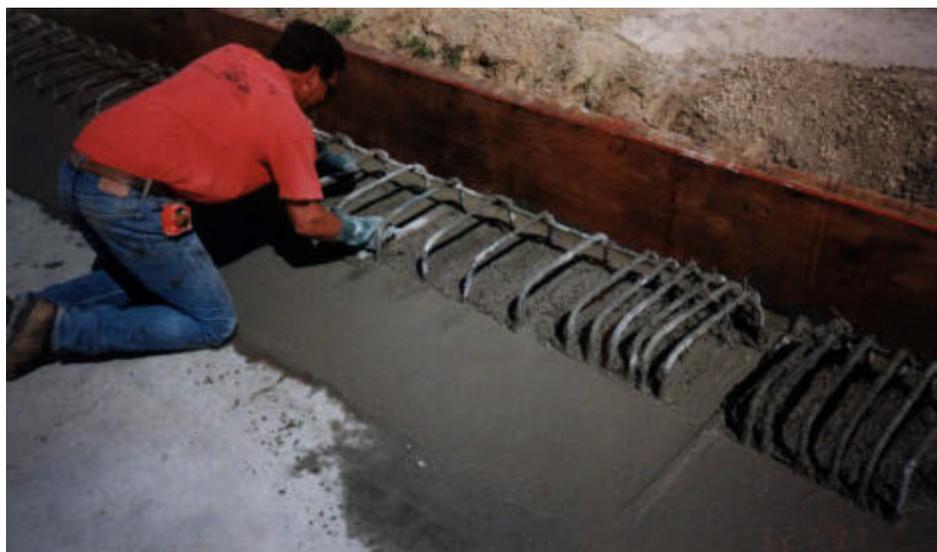
Figure 2-3 -
Simulated Bridge
Deck Construction

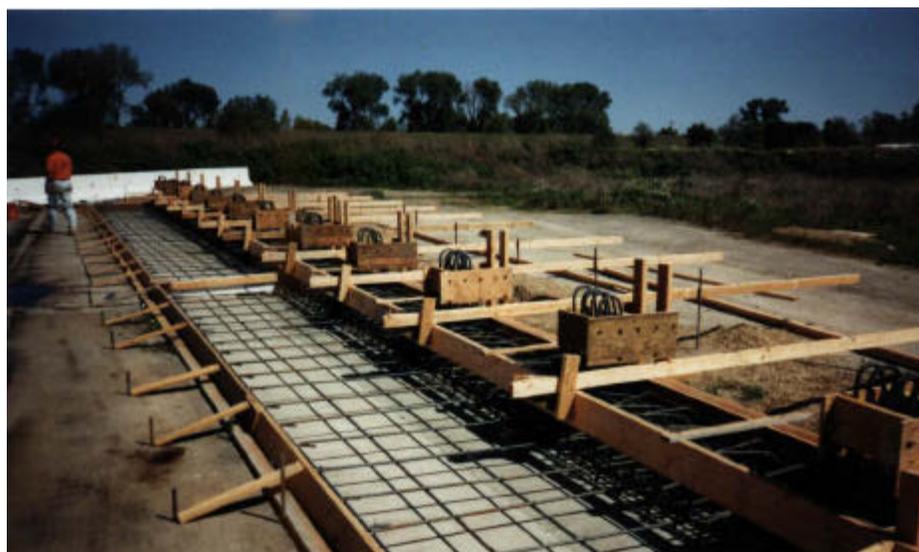
Figure 2-4 - Reinforcing Steel for
the Sidewalk and Lower Portion
of the Bridge Rail

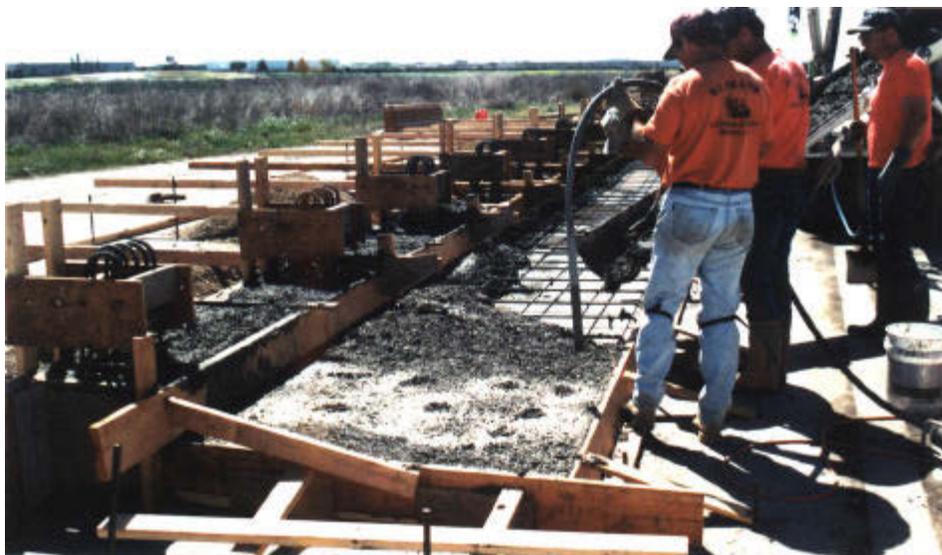
Figure 2-5 -
Concrete Pour
for Sidewalk
and Curb
Section of
Bridge Rail

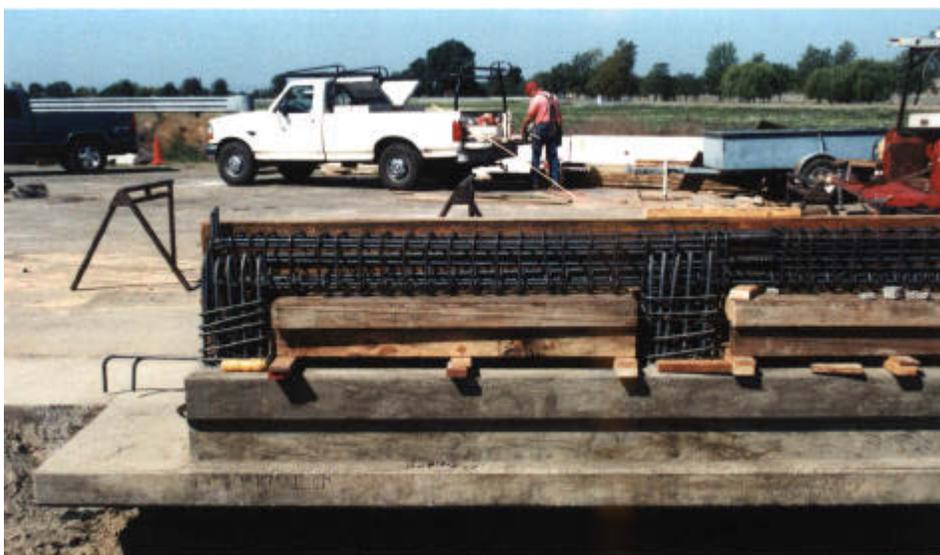
Figure 2-6 -
Reinforcing Steel
for Posts and
Beam Section of
Bridge Rail

Next, the reinforcing steel was installed for the beam section of the barrier (Figure 2-6 through Figure 2-9). The orientation of reinforcement loops and end loops for some of the bars were changed from the original plans to aid installation due to the high concentration of reinforcement. After all of the post and beam reinforcing was tied in place and the forms set, the last concrete pour was completed. The final items installed were the galvanized lower pedestrian rail and the pedestrian hand rail. The handrail was attached to the top of the beam with threaded rods on a 25 mm-high grout pad. Wood forms were used throughout and all concrete was vibrated. Figure 2-10 through Figure 2-13 show the completed barrier.

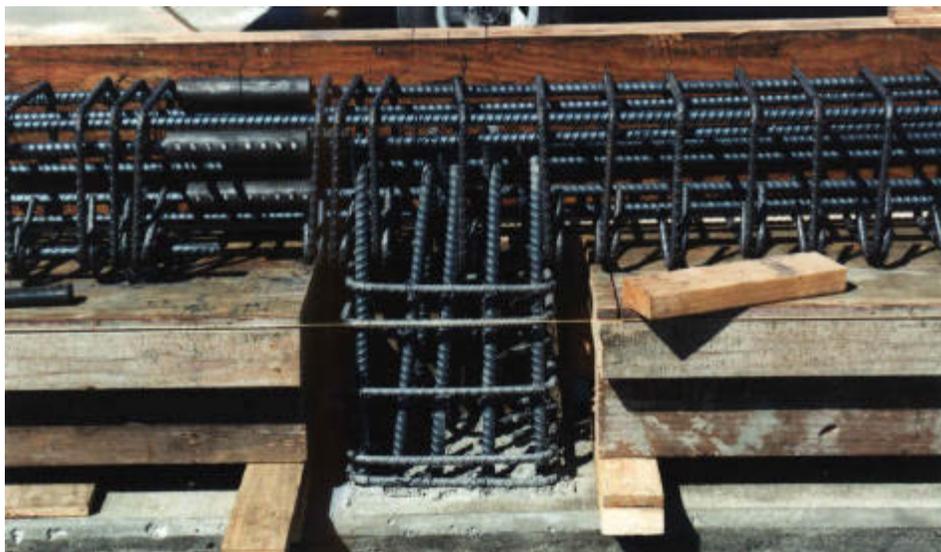
Figure 2-7 -
Close up of Post
and Beam
Reinforcing Steel,
Couplers and
Wood Forms

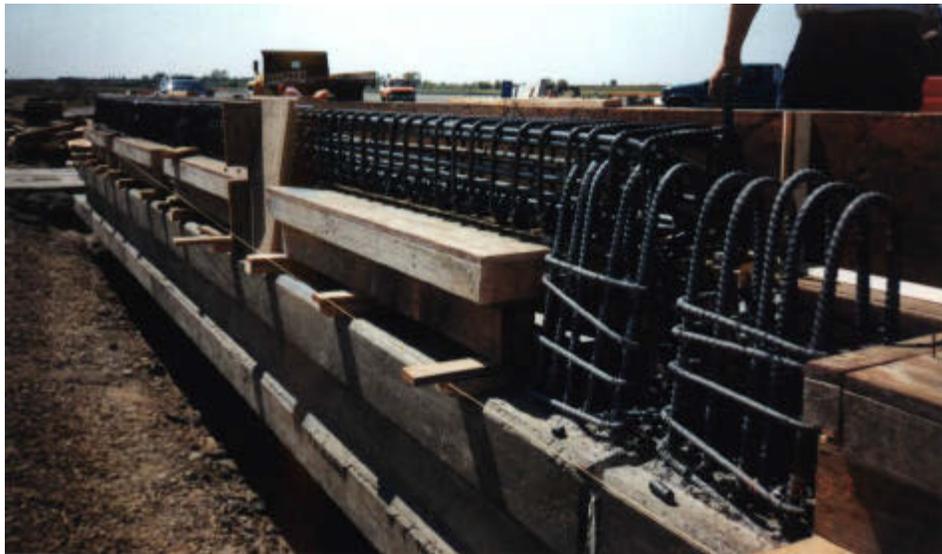
Figure 2-8 -
Expansion Joint
Post and Beam
Configuration

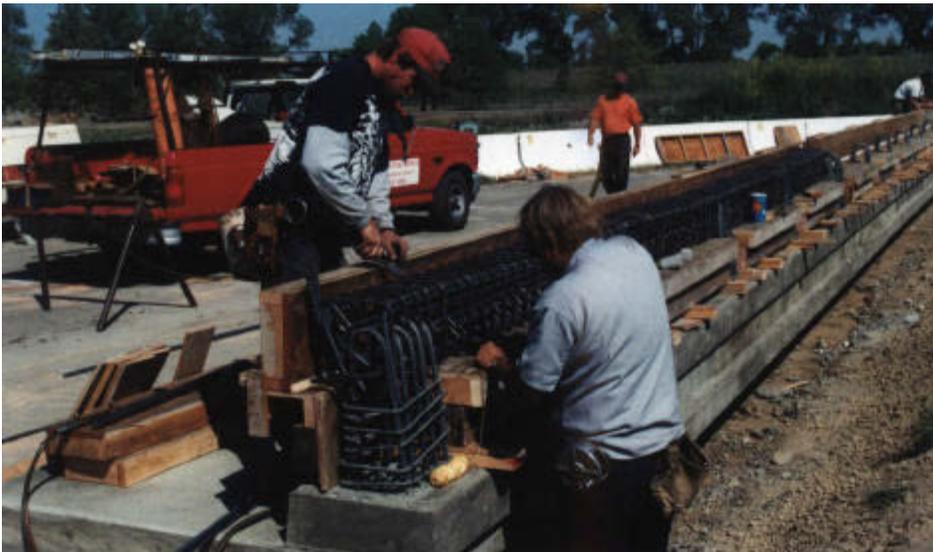
Figure 2-9 -
Reinforcing
Steel Placement
for the Post and
Beam Sections

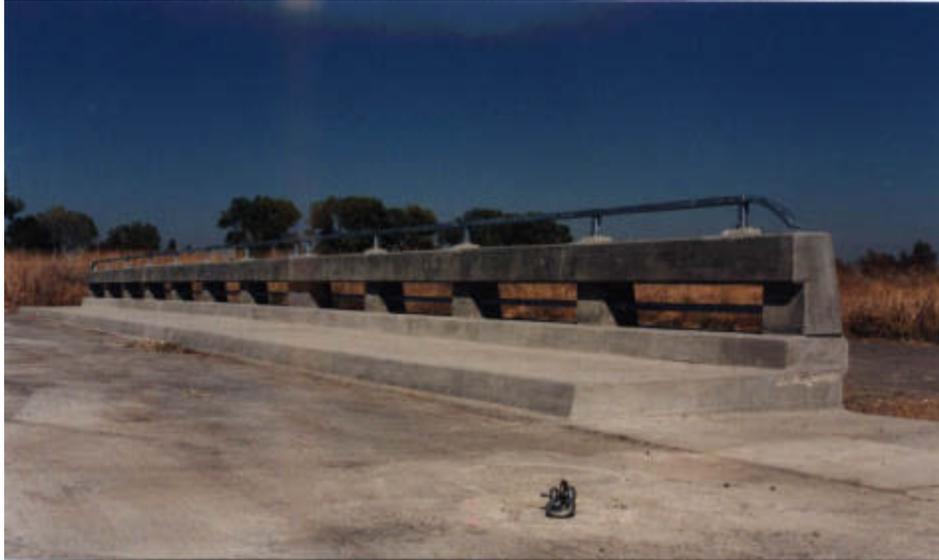
Figure 2-11 -
View of
Completed
Barrier and
Sidewalk

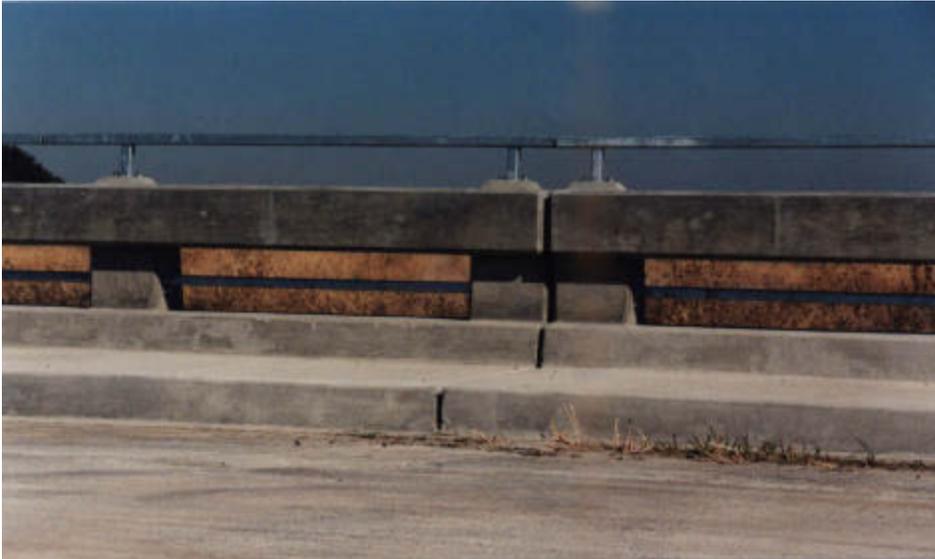
Figure 2-12 -
Completed
Expansion Joint

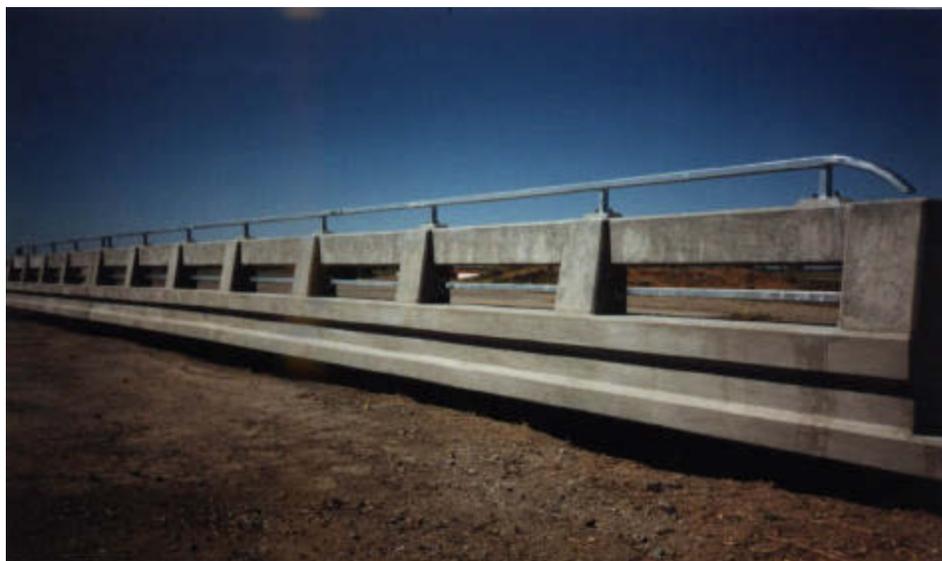
Figure 2-13 -
Backside of
Completed Bridge
Rail

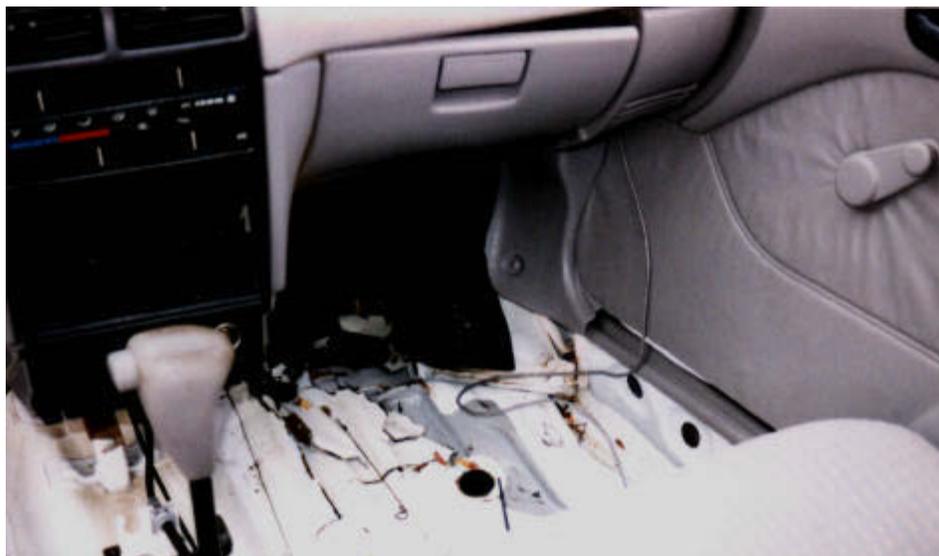
Figure 2-19 -
Post Impact
Passenger
Floorboard
Damage,
Vehicle 541

The right front section of the vehicle sustained crushing of the bumper and minor unibody frame deformation, damage to the suspension and a flat tire. Initial right front wheel damage occurred on impact with the sidewalk 0.38 m from the beginning of the bridge rail installation. The sidewalk contact caused deformation of the wheel and tire deflation. Other tires experienced minor deformation on impact with the sidewalk but remained inflated. After contacting the bridge rail the right front wheel was pushed back, forcing the wheel well area to deform (Figure 2-21).

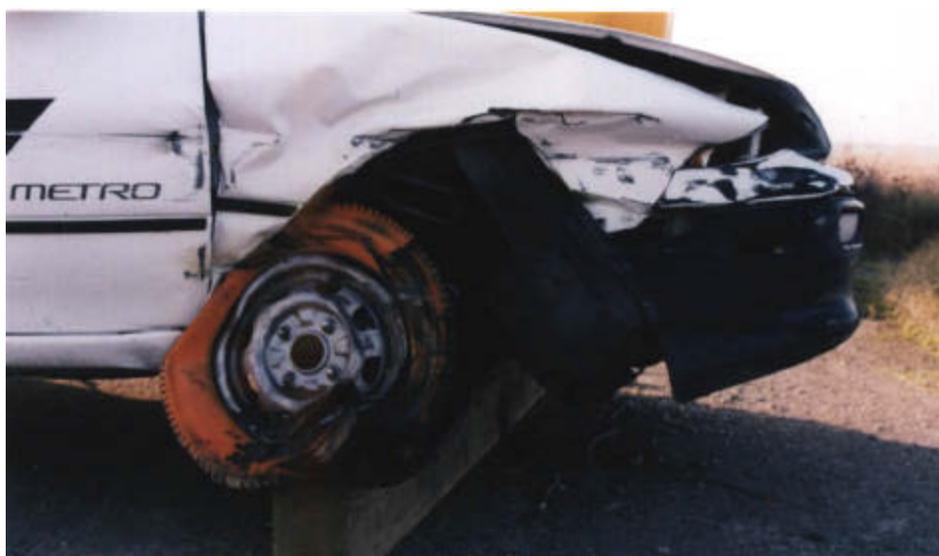
Figure 2-21 -
Close up of
Passenger Side
Front Damage,
Vehicle 541

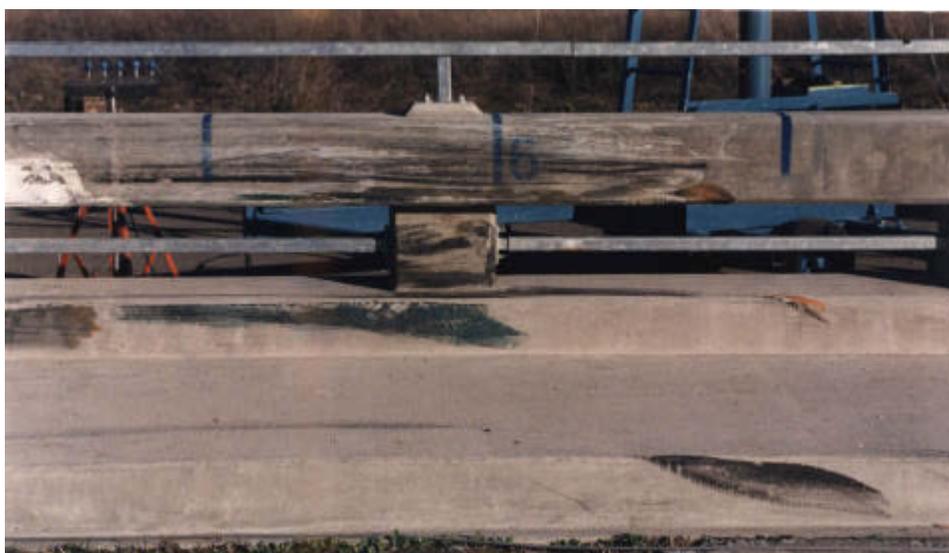
Figure 2-25 -
Close up of Post
Impact Bridge
Rail Scuff Marks

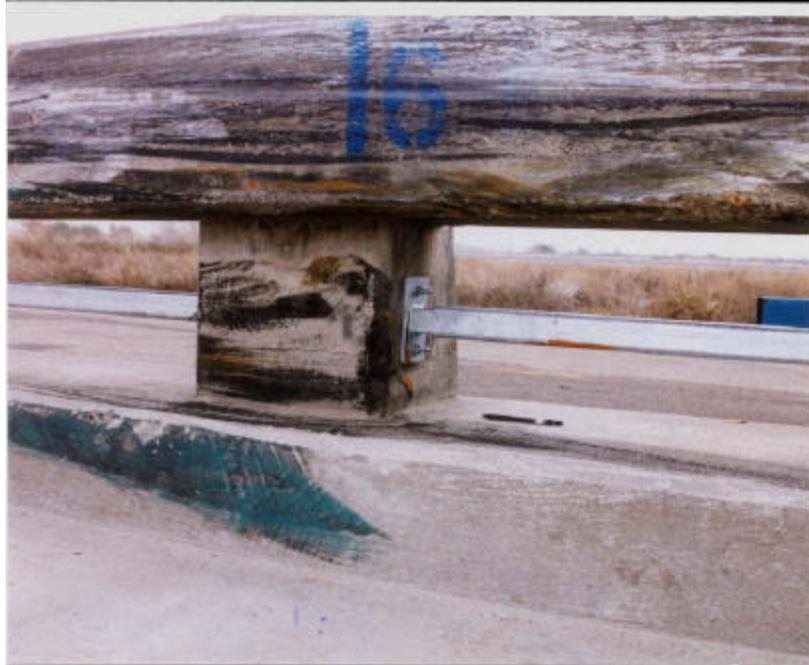
Figure 2-26 -
Wheel Rotation
Marks Around
Bridge Rail Post

The first point of contact for the constructed test article was the sidewalk. The right front passenger wheel was damaged and the tire deflated as a result of the impact with the sidewalk curb. During the examination of the impact area after the test there was evidence that the front passenger wheel had contacted and rotated around the post 6 m from the upstream end of the barrier (Figure 2-25 and Figure 2-26). The tire also contacted the pedestrian steel tube within the gap. The next post at 8 m had black tire marks along its face, but the wheel did not enter into the gap (Figure 2-23). It was the contact and rotation around post 6 and the contact with the steel tube that led to the decision to reduce the gap and re-run the 820 kg test. The retest was performed as Test 548 and is discussed starting in Section 2.2.1.11.

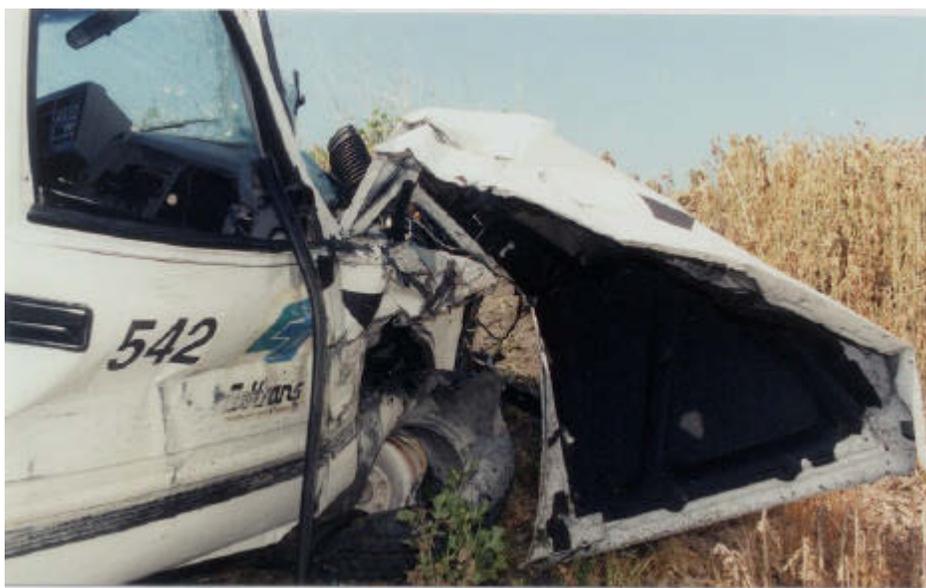
Figure 2-36 -
Close-up of
Impacting
Corner Of
Tested
Vehicle 542

The extra speed of the vehicle, 10.2 km/h over target, undoubtedly contributed to higher deformation of the impacting right corner of the vehicle than would have otherwise occurred. Figure 2-36 shows the right front wheel pushed back into the wheel well, caused by impact with the rail curb and beam face. All of the wheels stayed connected to the vehicle throughout the test. The front right shock absorber, stabilizer bar and upper and lower control arms were bent but still attached. The rear and left front suspension components were intact and appeared undamaged. There was minor deformation of the right front frame.

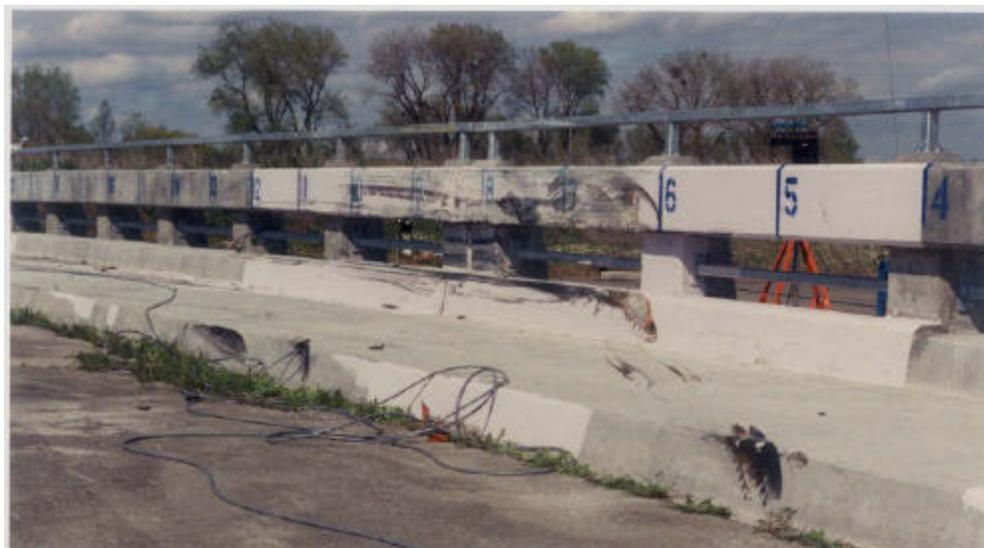
Figure 2-39 -
Bridge Rail
after Test
542-View
from
Upstream

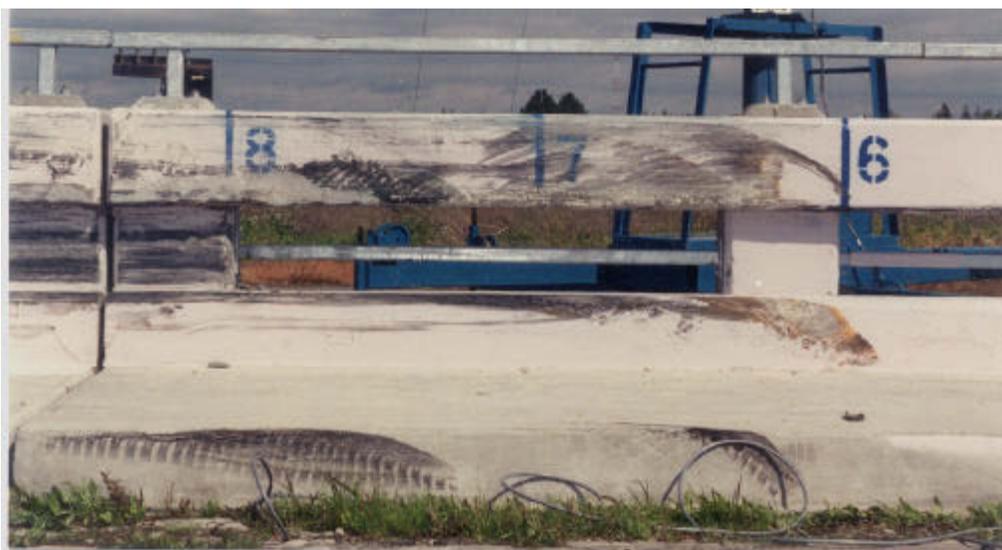
Figure 2-40 -
View
Perpendicu
lar to Point of
Impact

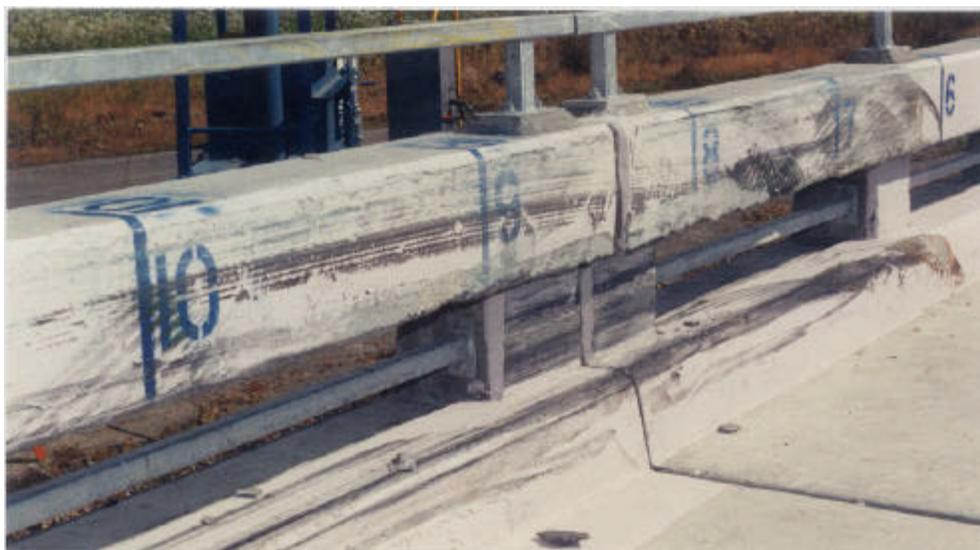
Figure 2-41 -
Impact Area
and Expansion
Joint

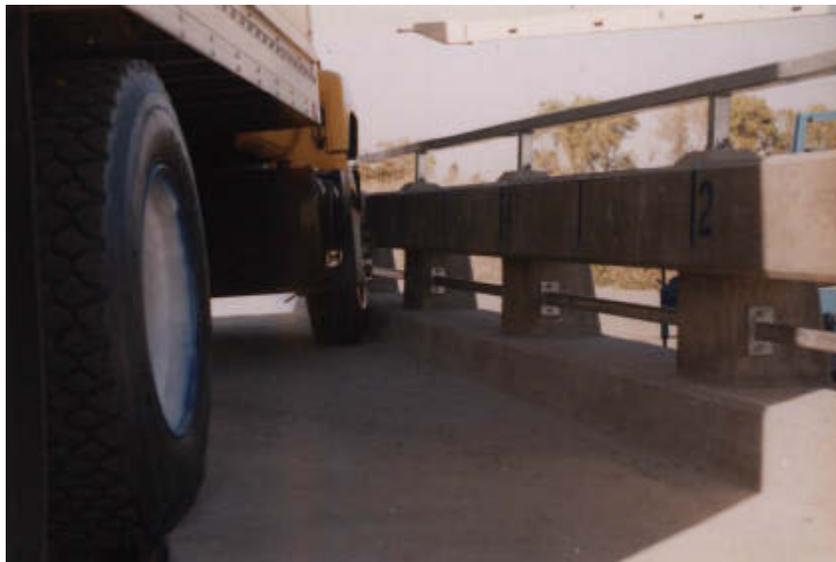
Figure 2-46 -
Impact Side of
543 Test
Vehicle

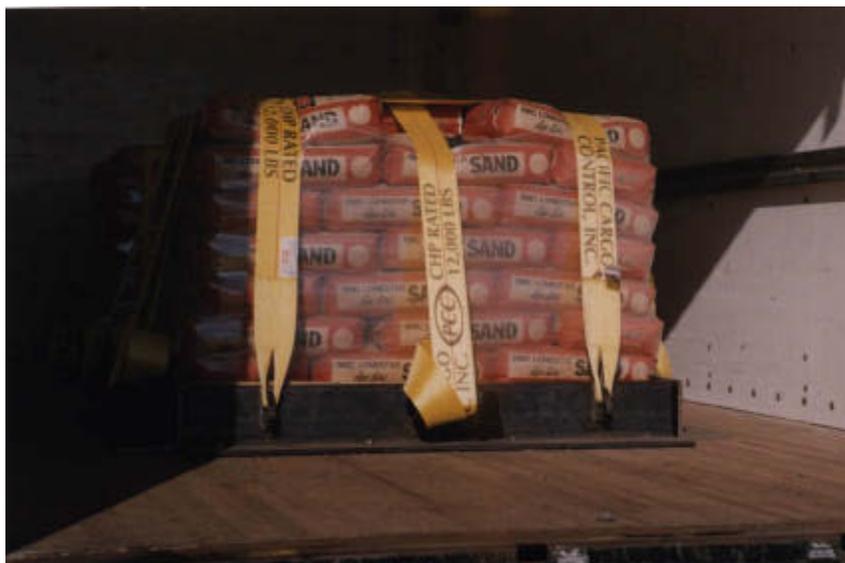
Figure 2-47 -
150 mm Angle
Irons Used To
Constrain Two
Pallets of Sand

The 2918 kg of ballast, comprised of two separate pallets of sand bags strapped down to the cargo floor. The pallets were constrained by 150 mm angle iron and the sand bags were held down by 100 mm trucking straps as shown in Figure 2-47. The sand was allowed to shift slightly but is unlikely to have affected the test. None of the sand bags broke loose during the test (Figure 2-49).

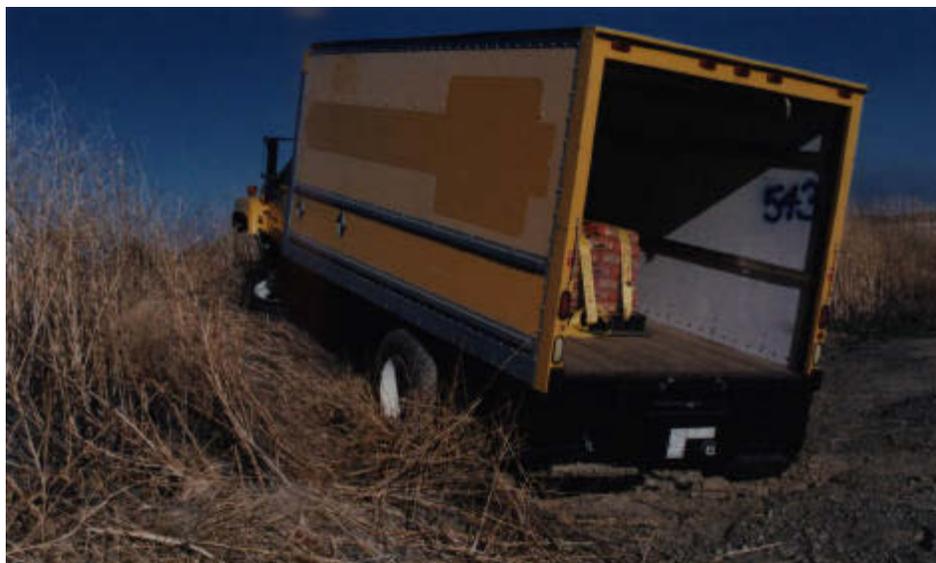
Figure 2-49 -
Impact Side
View of Vehicle
543 after Impact

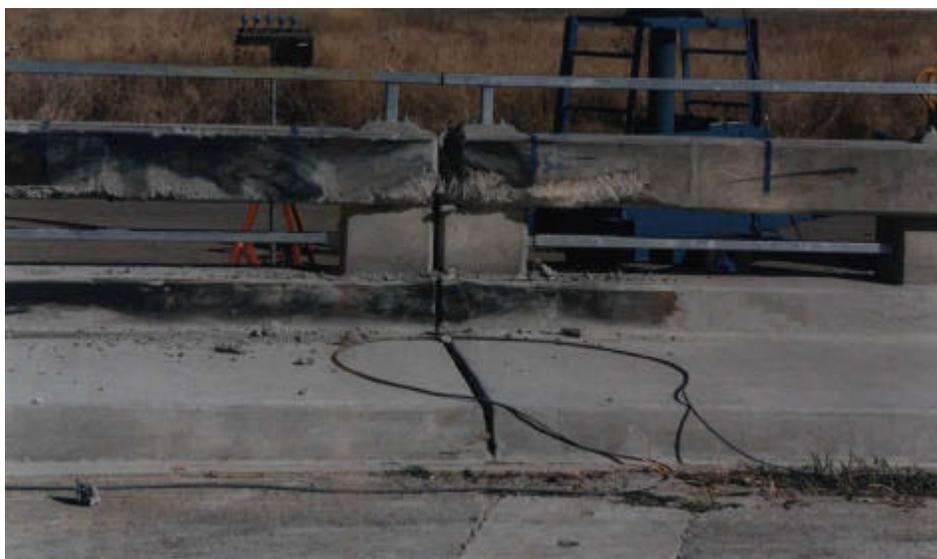
Figure 2-54 -
Impact Area for
Test 543

The barrier was scraped along the face and edges over a 3 m length. There was also spalling on the underside of the beam caused by the downward force of the rotating right front wheel lug nuts. The tire marks along the barrier were only a little longer than the scraping along the face. A concrete spall at the expansion joint was 80 mm to 100 mm deep and extended to the back face of the rail, shown in Figure 2-55 and Figure 2-56. The spall exposed the end of a piece of rebar but no structural damage was evident. The bridge rail withstood the impact from vehicle 543 well with only spall repairs necessary before subsequent tests.

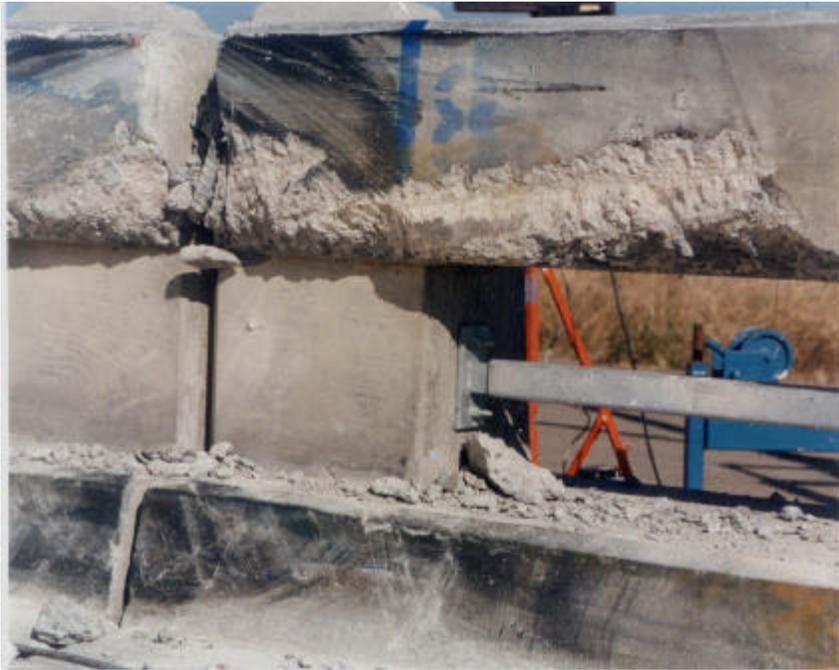
Figure 2-55 -
Close-up of
Impact Area for
Test 543

It appeared that the right front lug nuts scraped along the beam face, causing most of the concrete spalling seen in Figure 2-55. The right wheel well hit the handrail 0.028 s after initial contact with the bridge rail. Beginning 0.177 s after contact with the bridge rail, both the left front and left rear tires rose approximately 1 m off the ground and remained off the ground for 0.480 s and 0.757 s, respectively. The vehicle continued to make contact with the barrier for approximately 4.5 m. A peak roll of the vehicle box section to the right and then left was 17.5° at 0.521 s and 14.5° at 1.099 s, respectively, from the impact with the rail. These peaks were taken before the vehicle exited the end of the test article installation. Higher values may have occurred later after the brakes were applied. The vehicle continued to a point of rest on an earth berm about 43 m from the point of impact. The vehicle remained upright throughout and after the collision.

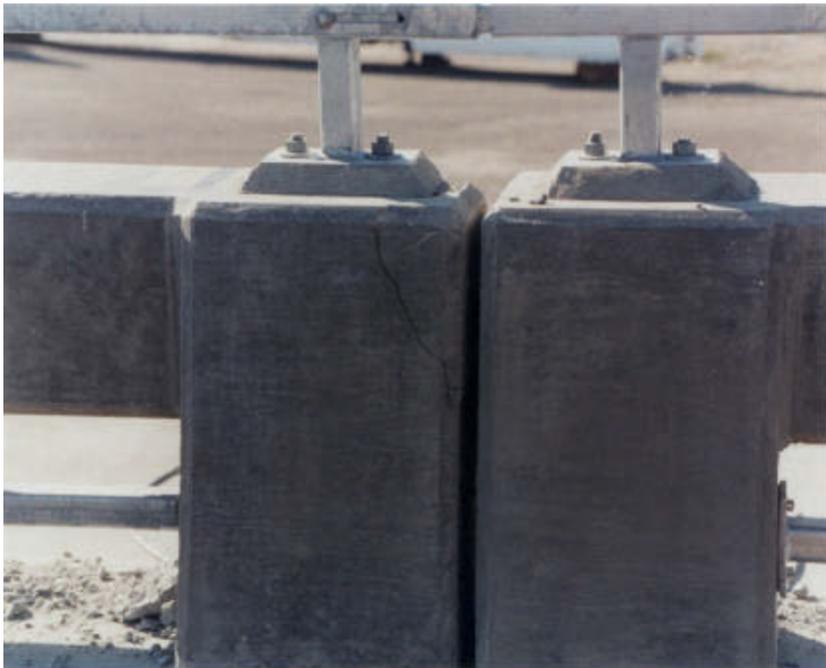
Figure 2-56 -
Backside of
Expansion Joint
Area after
Test 543

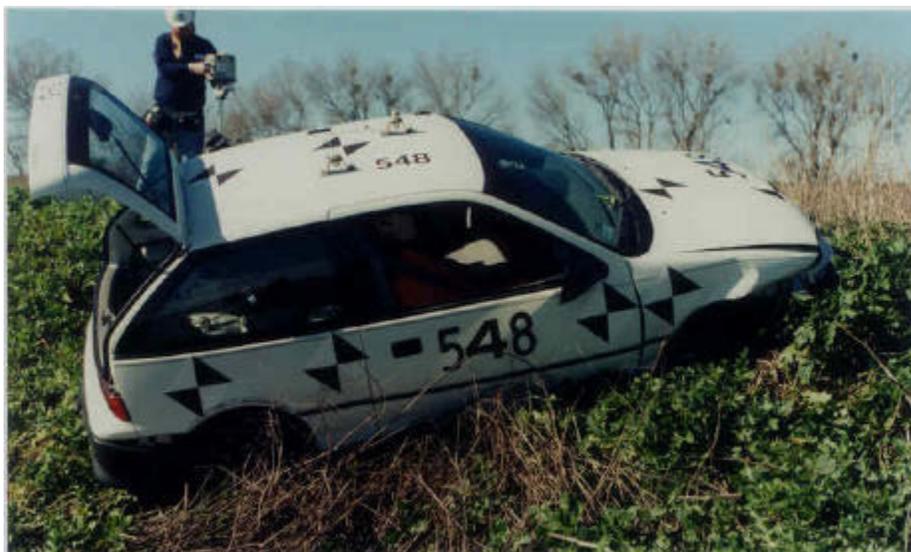
Figure 2-64 -
Final Resting
Position of
Vehicle 548

The exit speed and angle were approximately 62 km/h and 4°, respectively. The maximum roll of -14.3° occurred during the initial contact with the bridge rail and a maximum pitch of 5° was obtained as the vehicle's side came into contact with the beam section. The vehicle remained upright throughout and after the collision. Brakes were not applied and the stopping point for the vehicle was approximately 37 m from the point of last contact with the barrier. Figure 2-64 and Figure 2-67 show the vehicle in its resting position.

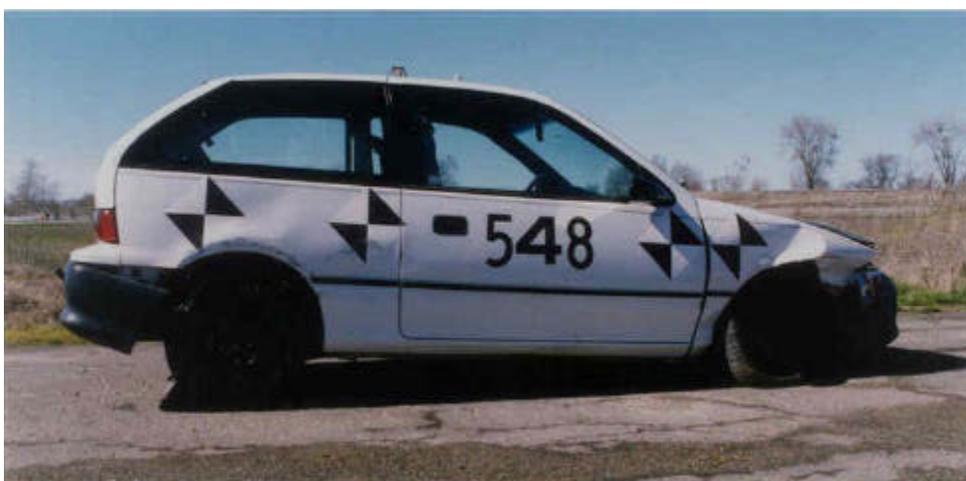
Figure 2-65 -
Right Side of
Vehicle 548
after Impact

The right front section of the vehicle sustained crushing of the bumper and right front quarter panel, damage to the suspension and a flat tire. Initial right front wheel damage occurred on impact with the sidewalk 0.4 m from the beginning of the bridge rail. The sidewalk contact caused deformation of the wheel and tire deflation. Wheel damage is shown in Figure 2-66. Other wheels were slightly deformed upon impact with the sidewalk, but the tires remained inflated. The vehicle first contacted the bridge rail on the curb section below the beam approximately 5.1 m from the beginning of the rail. After contacting the bridge rail, the right front wheel was pushed back, forcing the wheel well area to deform (Figure 2-65). The strut and axle for the right front wheel were bent, but remained attached.

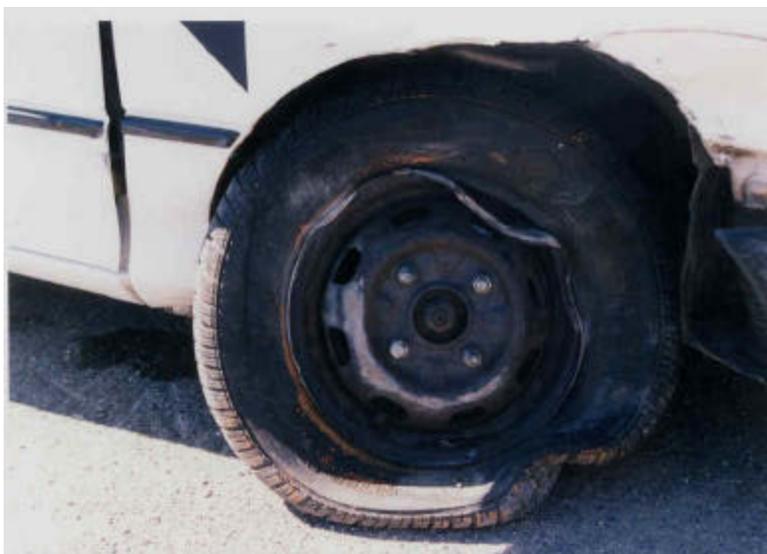
Figure 2-66 -
The Front Right
Tire of Vehicle
548 after
Impact

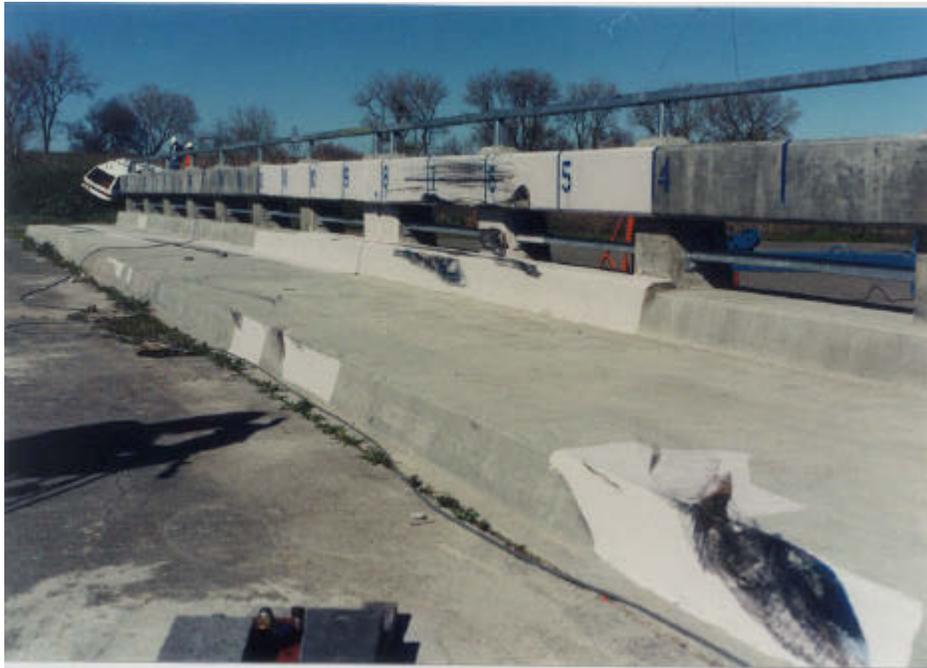
Figure 2-67 - Downstream View of Bridge Rail and Vehicle after Test 548

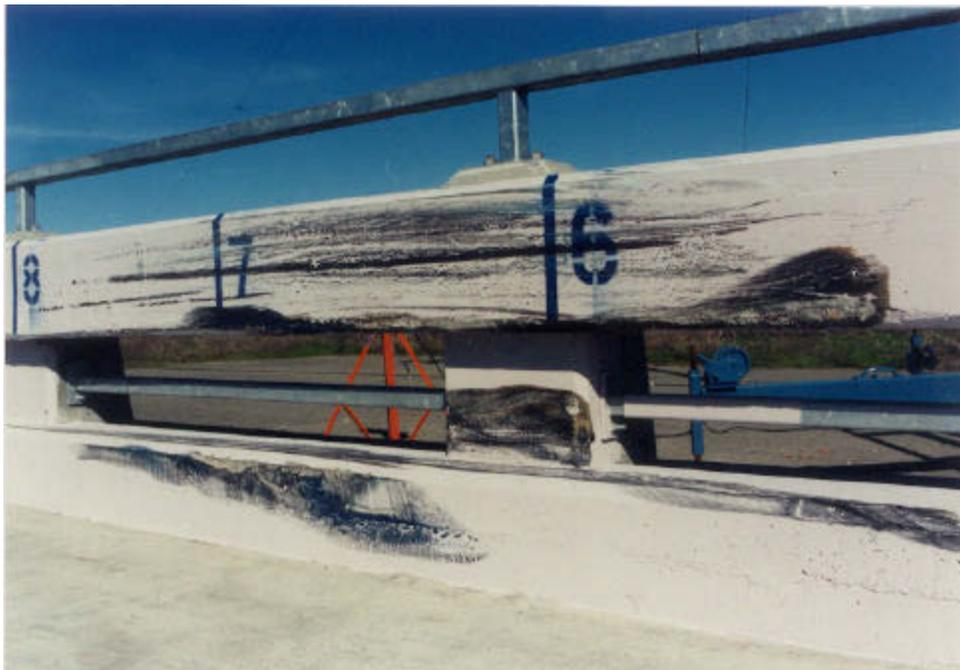
Figure 2-68 - Close-up View of Bridge Rail at Impact Point for Test 548

The right front wheel of test vehicle 548 did not show the snagging potential that was seen in Test 541. Tire marks are seen on post 6, Figure 2-68, but they do not enter the gap area to the extent they did on Test 541. It is unknown how much the lower than anticipated impact velocity affected the wheel penetration for Test 548. However, both impacts were similar, other than the speeds, and the initial concerns of wheel snagging were largely eliminated based on the results of the second test. Moreover, by reducing the bridge rail gap by 30 mm, the gap was smaller than the vehicle wheel diameter, so there should be much less chance for significant wheel snagging. There were no problems encountered for either test other than tire marks in the gap area in Test 541. For both tests the vehicle was smoothly redirected at an acceptable angle, meeting all of the criteria listed for test level 4 in NCHRP Report 350⁽¹⁾.
