CRASHWORTHINESS TESTING OF A PORTABLE MAINTENANCE WORK-ZONE BARRIER

STATE OF CALIFORNIA
DEPARTMENT OF TRANSPORTATION
DIVISION OF RESEARCH AND INNOVATION
OFFICE OF SAFETY INNOVATION AND COOPERATIVE RESEARCH

December 2008

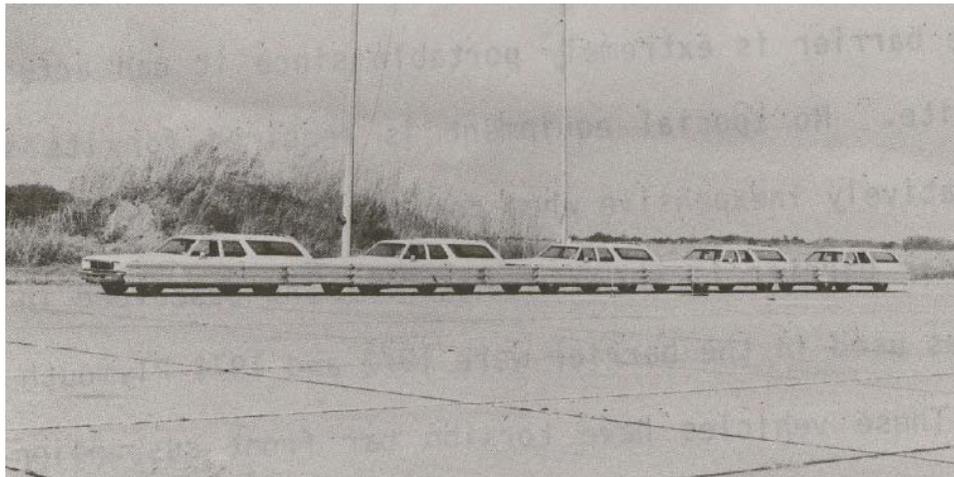
Figure 1-1 Used Car Barrier

In 1982 TTI developed a portable traffic barrier which consisted of five used station wagons closely connected by tow bars and protected on both sides by three beam rail elements² (Figure 1-1). The lead car towed the other four to the work zone. This train of vehicles formed a portable barrier 2.4 meters (94 inches) wide and 30.5 meters (100 feet) long that could shield maintenance personnel in an adjacent lane or shoulder. The trailing vehicle did not perform as an end treatment or crash cushion. It was successfully crash tested twice with a 2,041-kg (4,500-lb) sedan, impacting at 83.7 km/h (52 mph) with an angle of 7 degrees and at 77.2 km/h (48 mph) with an angle of 15 degrees. Texas DOT maintenance forces tried using the system but found it too cumbersome to deploy efficiently. The lead vehicle also suffered transmission failure during one of the trail deployments.

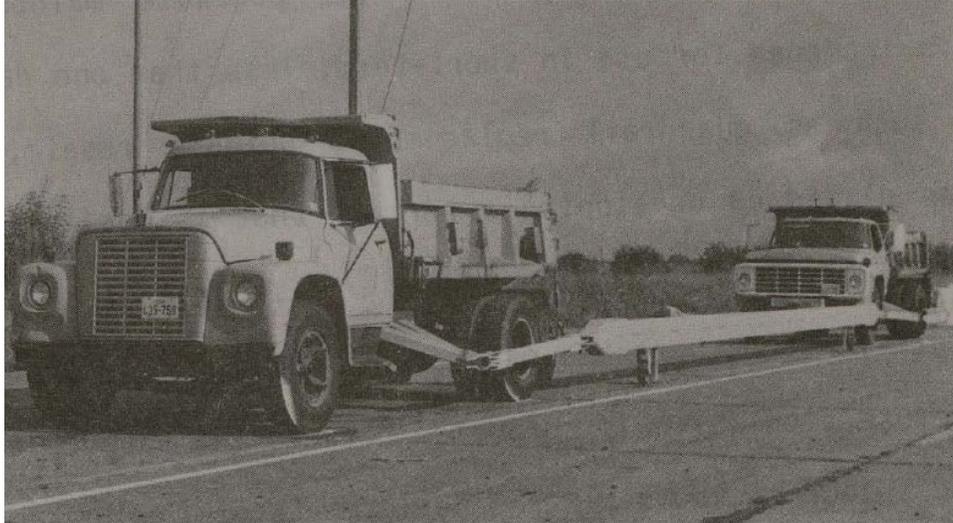
Figure 1-2 Truck-Mounted Portable Barrier

In 1984 TTI made another attempt with a truck-mounted portable maintenance barrier³ (Figure 1-2). This system consisted of a steel barrier connected between two 5 cubic yard dump trucks. The 13.4-m (44-ft) barrier was attached to hitch and support assemblies fixed to the sides and rear or front of the trucks. The barrier was towed behind one of the vehicles with a tow dolly and then assembled between the two trucks along the traffic side at the work location. It took two men 15 minutes to set up the barrier. This provided a 9.1-m (30-ft) work zone and 4.3-m (14-ft) buffer zone between the two trucks. The lead vehicle could tow the barrier and trailing vehicle in this configuration at 24.1 km/h (15 mph). It was successfully crash tested twice with a 2,041-kg (4,500-lb) sedan, impacting at 82.1 km/h (51 mph) with an angle of 7.3 degrees and at

80.5 km/h (50 mph) with an angle 15 degrees. It also passed a crash test with an 800.6-kg (1765-lb) vehicle impacting at 82.1 km/h (50 mph) with an angle of 14 degrees. Texas DOT used the system for several short-term maintenance operations, but found it too cumbersome to operate.

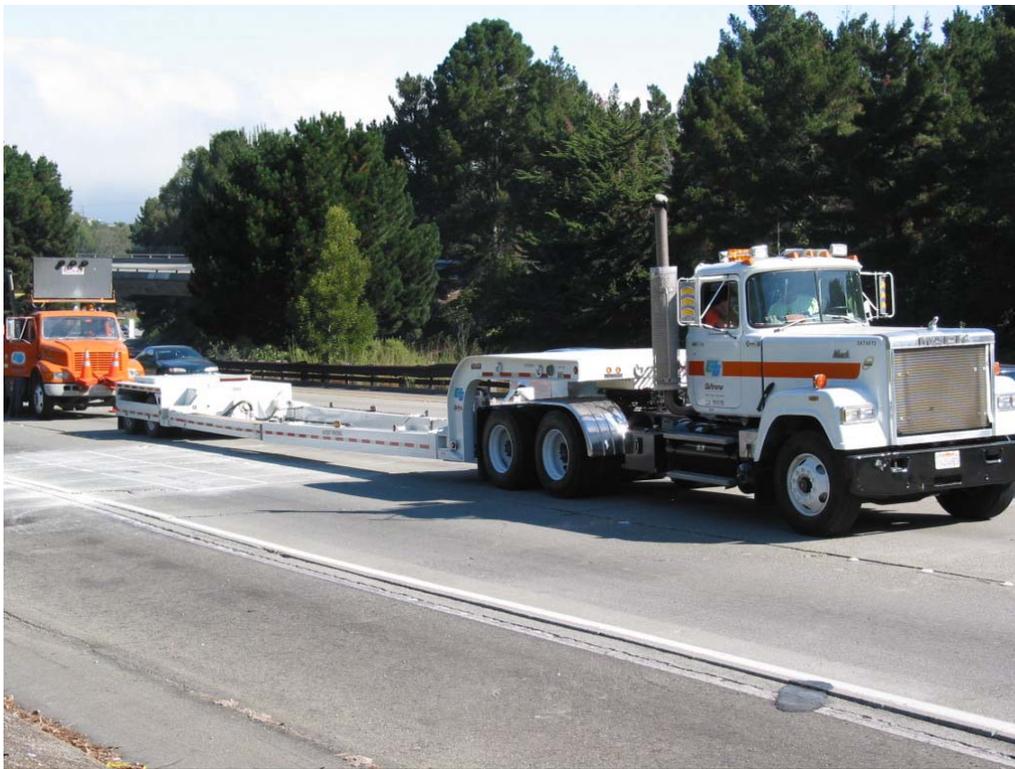
Figure 2-1 Balsi Beam Deployment 1

The Caltrans Portable Maintenance Work-Zone Barrier (PMWB) is commonly referred to as the Balsi Beam in honor of a Caltrans maintenance employee who was seriously injured while performing his assigned duties. The Balsi Beam consists of a modified tractor truck and trailer. The trailer has two telescoping box beams, one on each side, that connect the front and back of the trailer. To create a positive workspace, one of the beams rotates onto the other beam to create a double beam barrier. The trailer can then be extended to provide 9.1 m (30 ft) of protected workspace. The beams can both be rotated to protect either side of the trailer so that work can be done on median or shoulder areas. The trailer is controlled from inside the cab of the tractor truck.

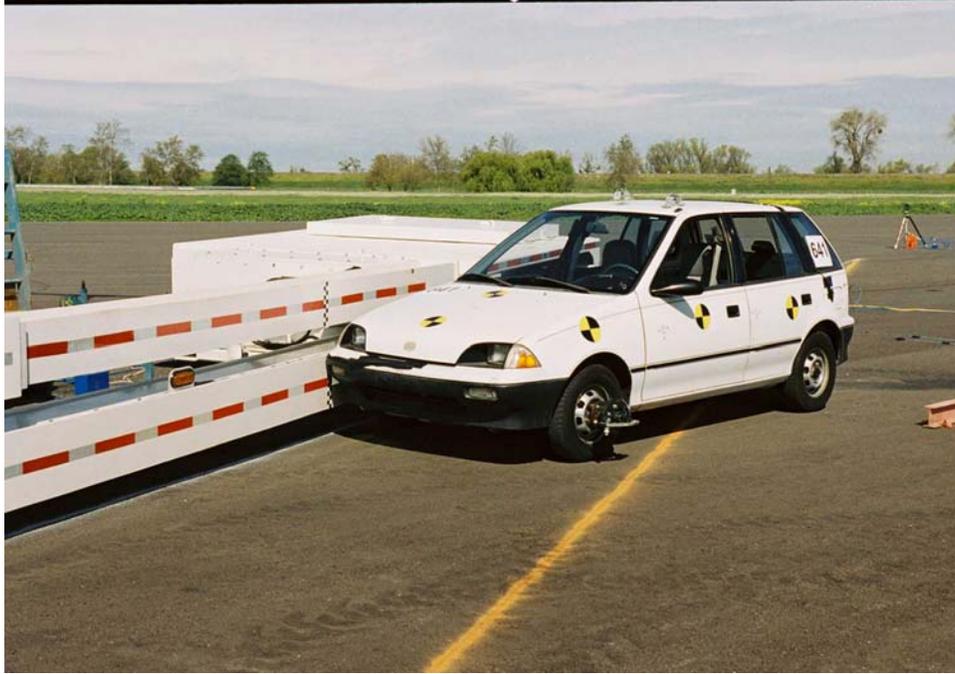
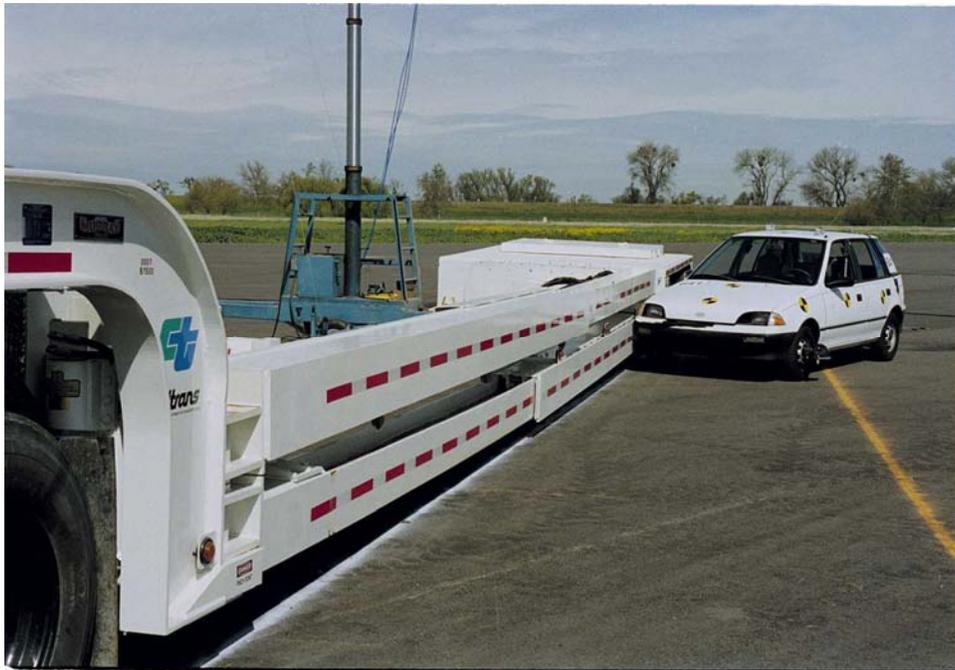
Figure 2-7 Impact Area Prior to Test 641

Figure 2-8 Impact Area Prior to Test 641

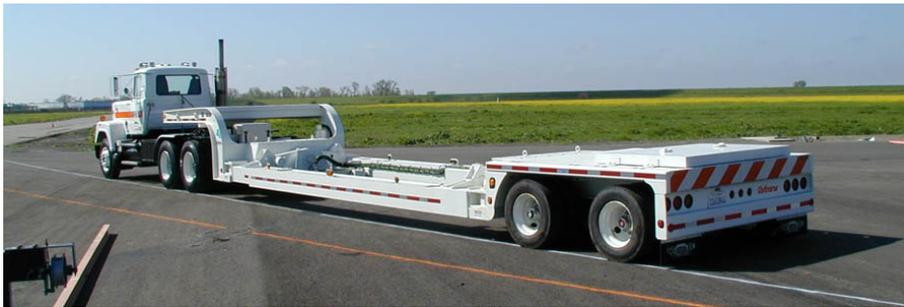
Figure 2-10 Trailer Prior to Being Deployed for Test 641

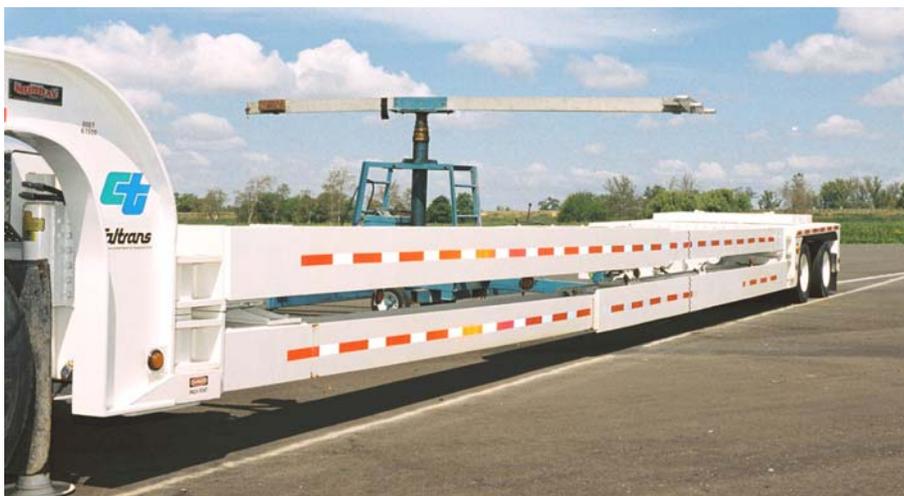
Figure 2-11 Trailer in Barrier Mode for Test 641

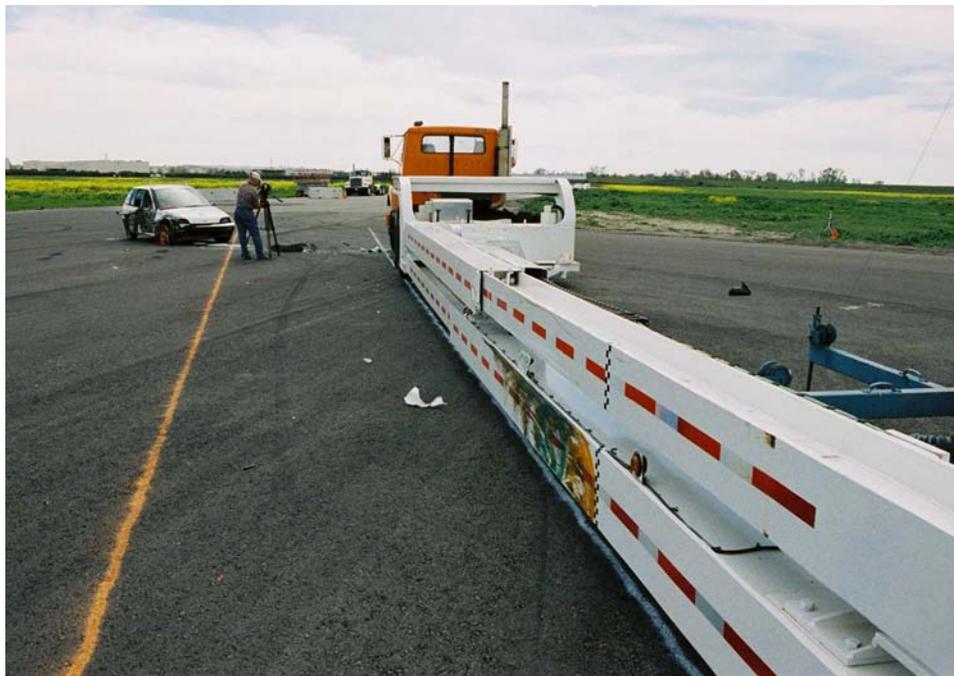
Figure 2-13 Impact Area After Test 641

The barrier suffered minor scrapes and scratches from the impact with the vehicle. Sheet metal from the vehicle was lodged in-between the overlapping in the beams. During the impact with the vehicle, the barrier deflected dynamically by 100 mm (3.94 in) and had a final static deflection of 23-mm (0.91-in). The PMWB did not move from its initial location. The tractor truck had minor damage to the left side. The front bumper was push forward away from the truck slightly.

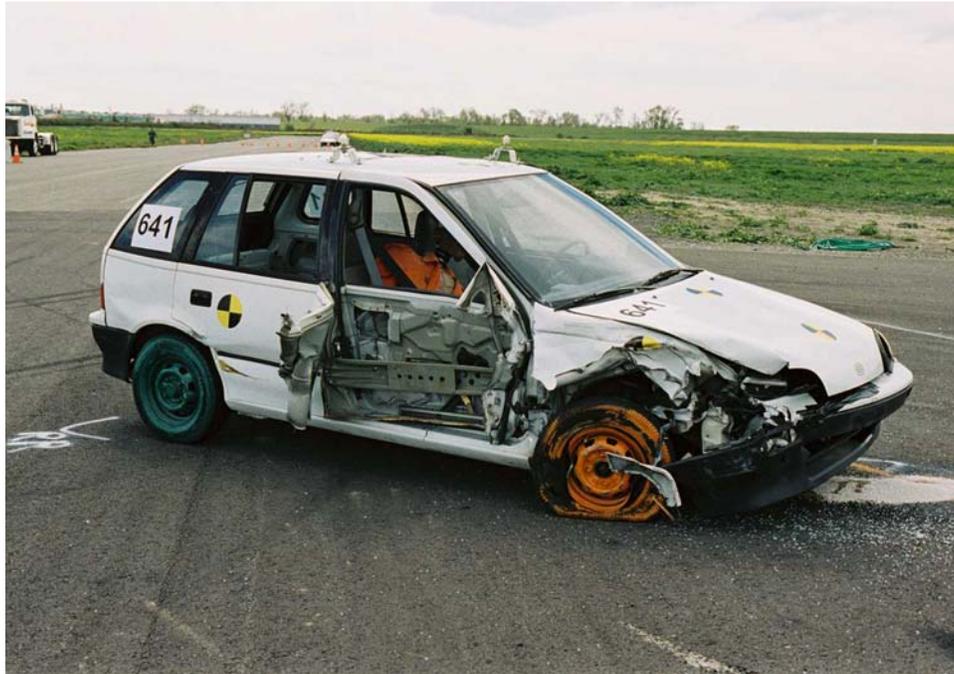
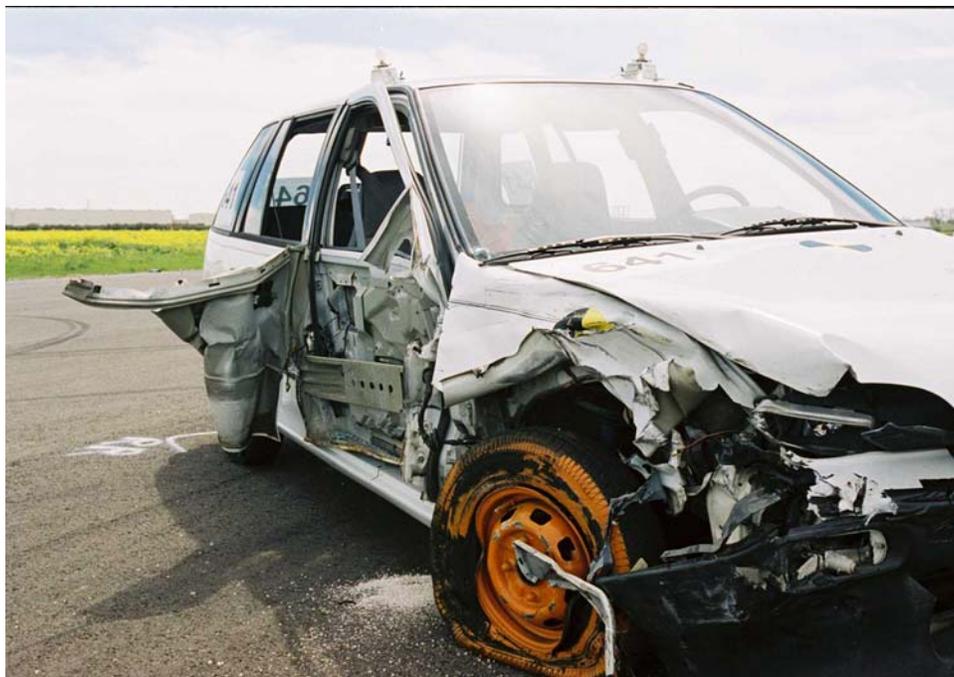
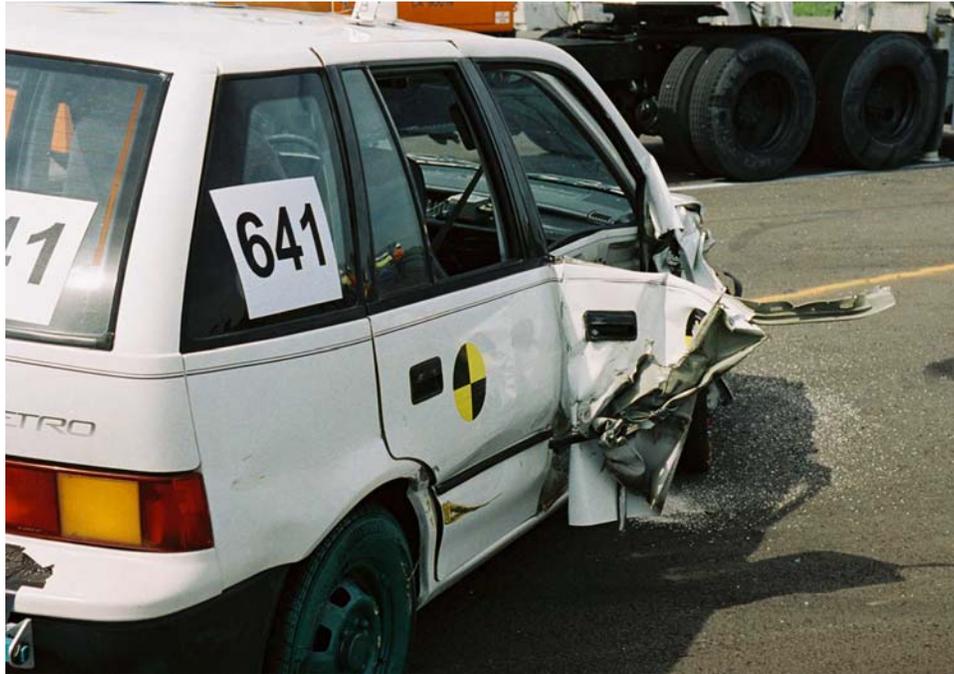
Figure 2-14 Test Vehicle After Test 641

Figure 2-15 Test Vehicle After Test 641

Figure 2-16 Test Vehicle After Test 641

The right front corner of the vehicle sustained minor damage from the initial impact with the barrier. The amount of damage increased as the vehicle impacted the point where the box beams overlap each other. The sheet metal over the right front tire was crumpled inward and the tire deflated. The sheet metal over the passenger door was completely pulled away and the internal portion of the door was pushed inward. The final impact with the bumper on the tractor truck pushed the right front bumper of the test vehicle backward. The right front tire was also pushed back in the wheel well. Inspection of the occupant compartment revealed that there had been little to no deformation to the floorboard and firewall.

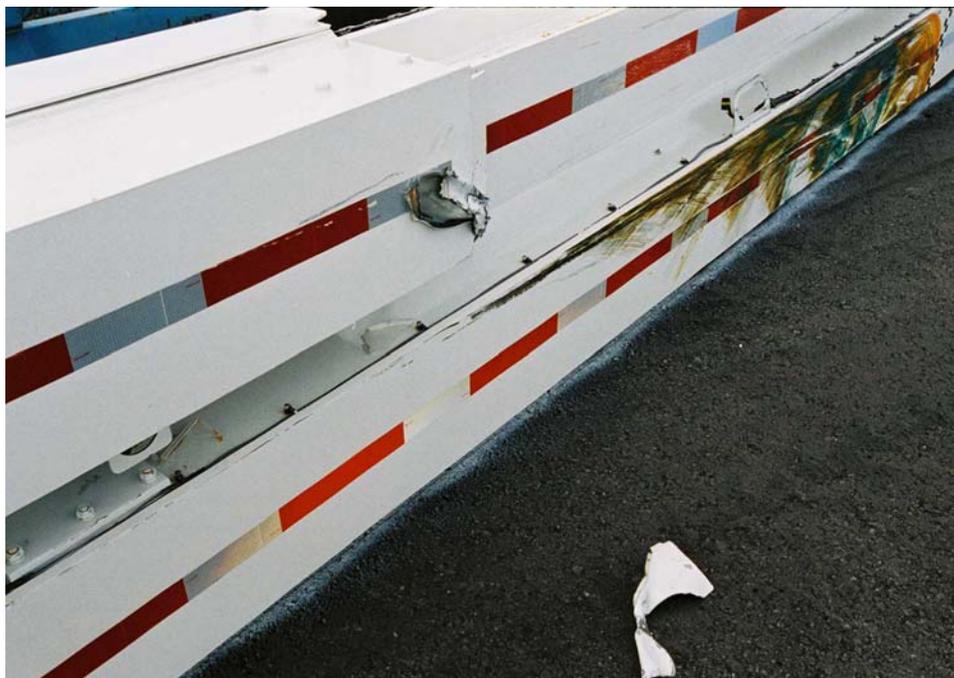
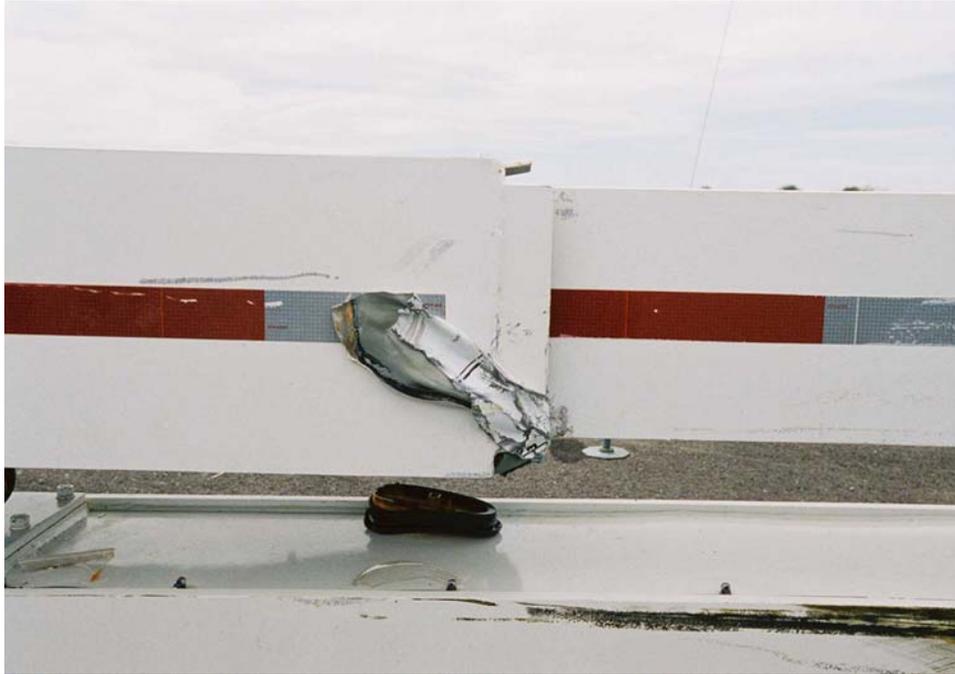
Figure 2-17 Barrier After Test 641

Figure 2-18 Barrier After Test 641

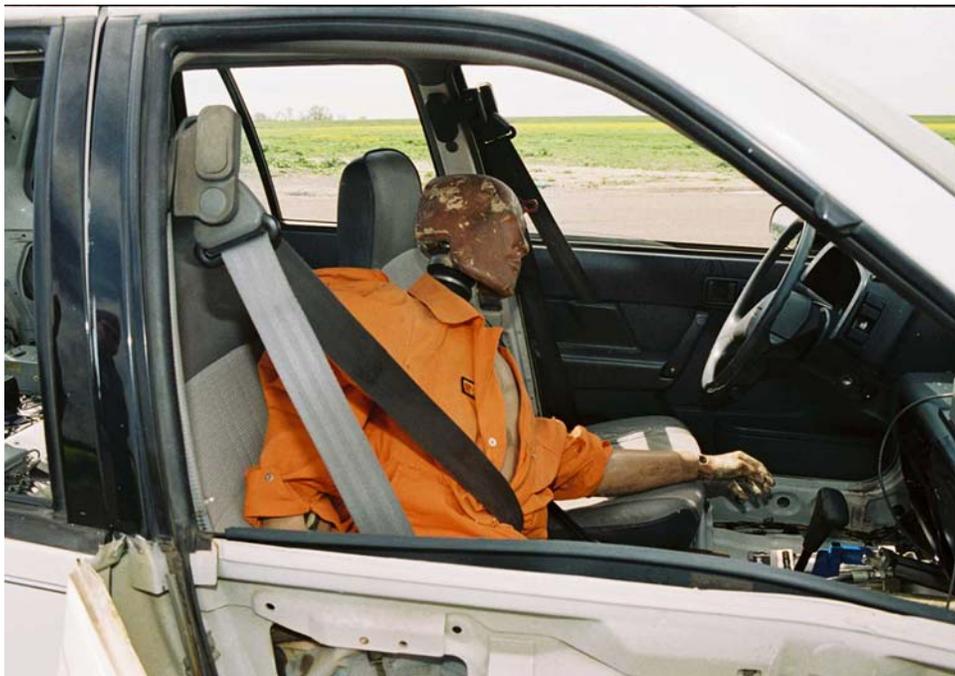
Figure 2-19 Final Resting Place of Test Dummy

The test dummy was strapped into the right front seat with both a lap and shoulder belt. The dummy's head never moved out of the passenger's side window. There was no contact between the dummy and the face of the barrier. The dummy remained upright and secure during the test. The final resting position of the dummy was leaning slightly to the left, but was still belted into the passenger's seat.

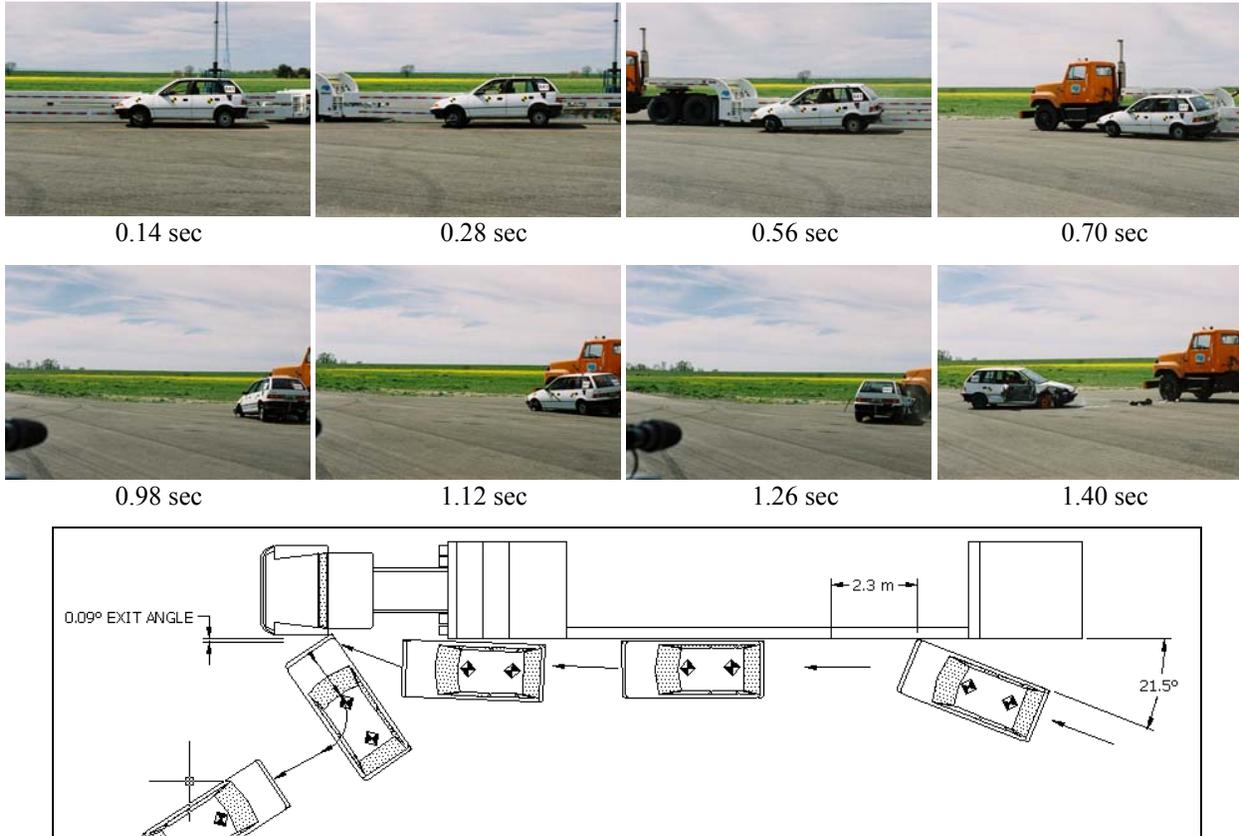
Figure 2-20 Test 641 Impact Sequence and Diagram

After the initial impact the vehicle was smoothly redirected until the front end hit the overlap of the two box beams at 122 ms after impact. At this point the sheet metal began to snag in the overlap. The snagged sheet metal accumulated at the overlap and pushed the passenger door inward at 174 ms after impact. The vehicle lost contact with the barrier at 264 ms. The exit angle was 0.9° and the exit velocity was 57.7 km/h (35.9 mph). The right front tire was damaged during the initial impact, causing the vehicle to steer back toward the tractor truck. Roughly 380 ms after the initial impact the vehicle hit the backside of front bumper on the tractor truck. At this point the vehicle yawed to the right about its right front corner by approximately 110° before coming to a rest.

The barrier had minor scratches from the impact. A piece of the Metro's sheet metal was lodged in the area where the box beams overlap. The tractor truck had minor damage to the front end due to a secondary impact with the vehicle.

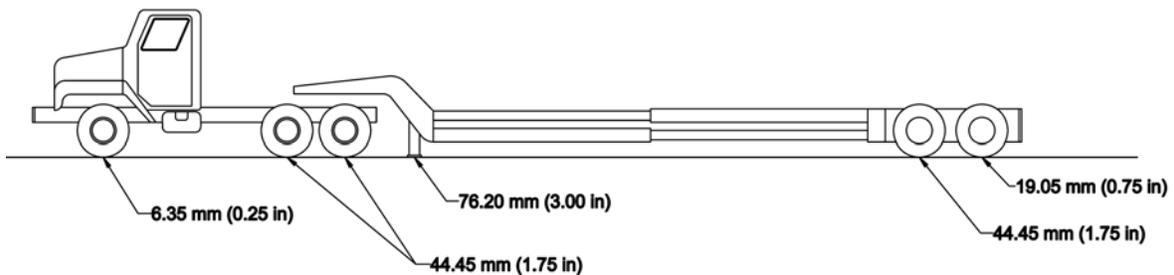
Figure 2-21 Later Displacement of the Tractor Truck and Trailer to Test 642

During the impact with the vehicle, the barrier had a lateral dynamical deflection of 200 mm (7.87 in) and had a final static deflection of 142 mm (5.59 in). Both the tractor truck and trailer were pushed away from the impact area (to the right/passenger side of the tractor truck and trailer). Figure 2-21 shows the amount of displacement of the tractor truck tires, trailer tires, and trailer brace.

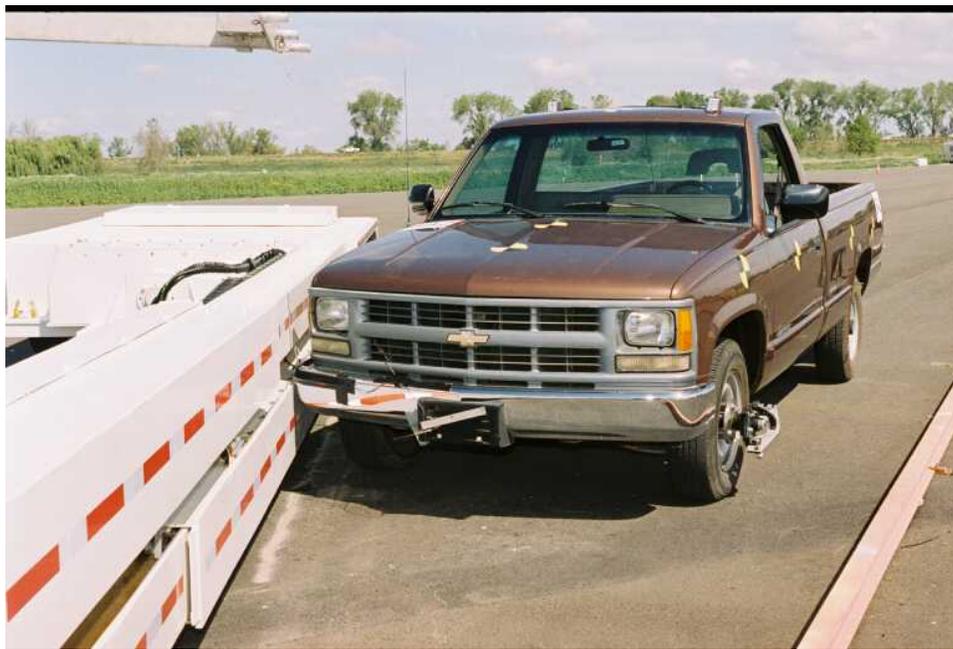
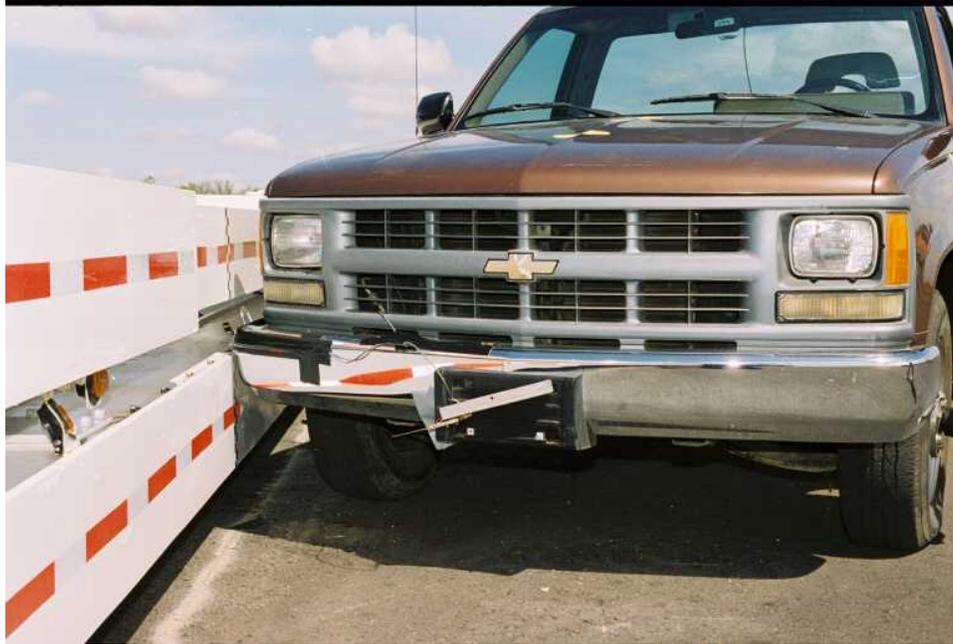
Figure 2-22 Impact Area Prior to Test 642

Figure 2-23 Close-up of Impact Area Prior to Test 642

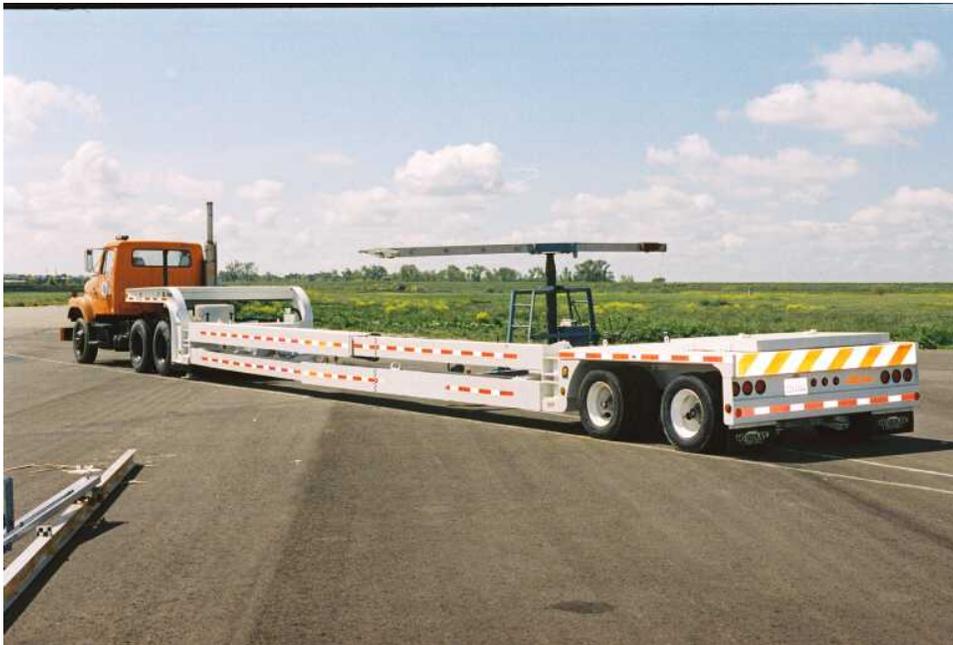
Figure 2-26 Barrier Prior to Test 642

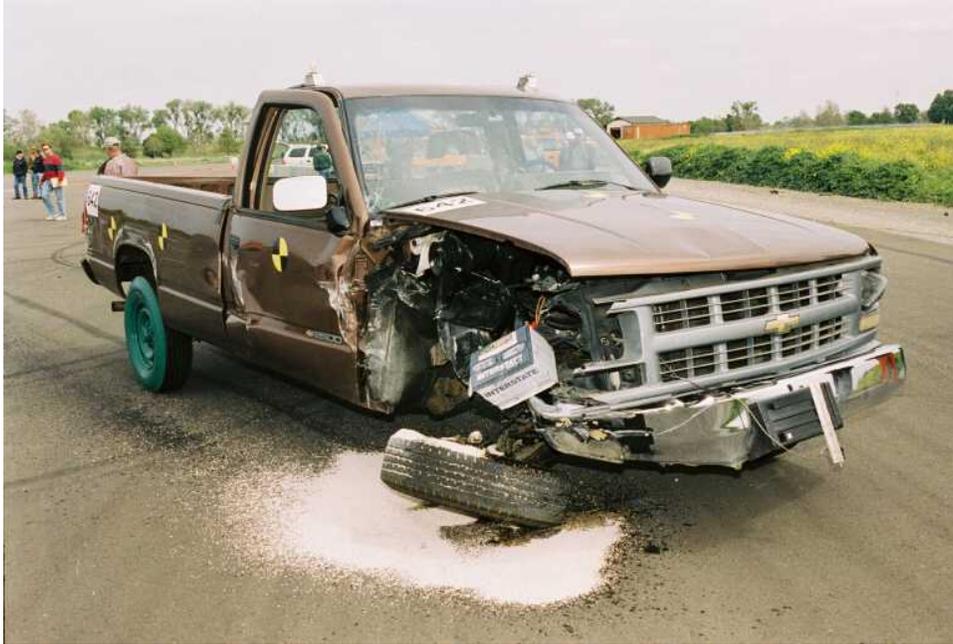
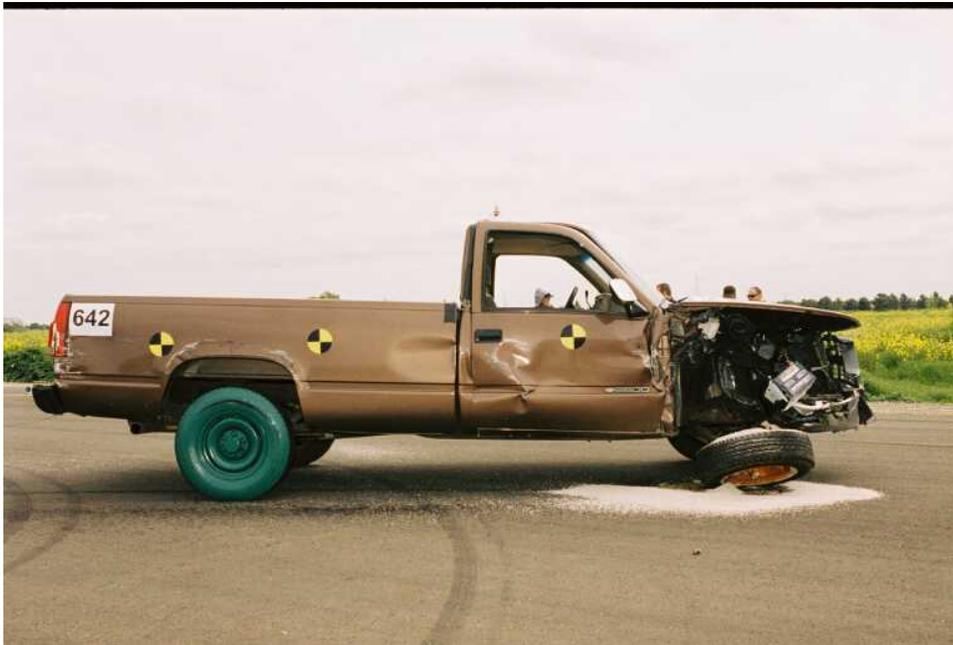
Figure 2-27 Vehicle After Test 642

Figure 2-28 Vehicle After Test 642

The right front corner of the vehicle sustained significant damage due to the impact with the box beam overlap. Only the lower control arm was still attached to the front wheel hub assembly. All of the sheet metal that covered the right corner of the vehicle was torn away. The battery was exposed and only supported by its wiring. The right half of the front bumper was folded backward. The top of the passenger door was bent outward and the steel metal was crumpled inward.

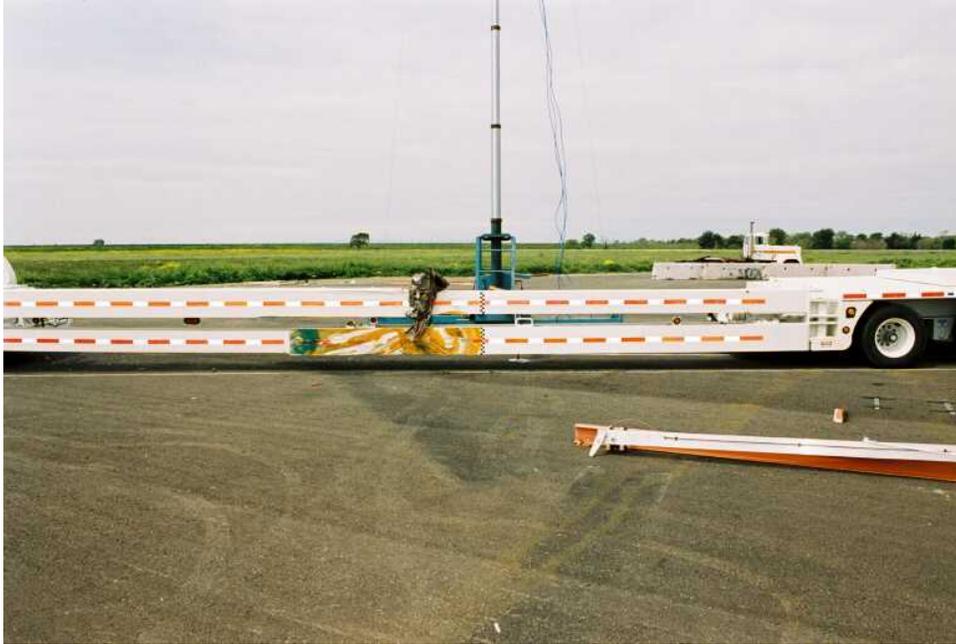
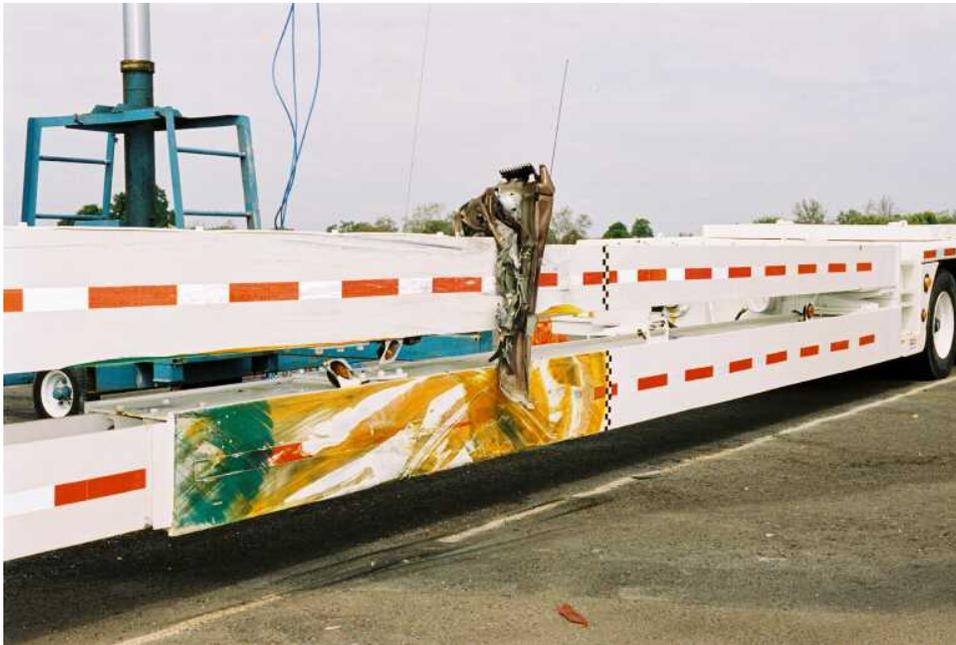
Figure 2-29 Barrier After Test 642

Figure 2-30 Barrier After Test 642

The barrier appears to have suffered only minor damage and scraping. There was a large amount of the test vehicle's sheet metal lodged into the overlapping joint of the barrier's box beams.

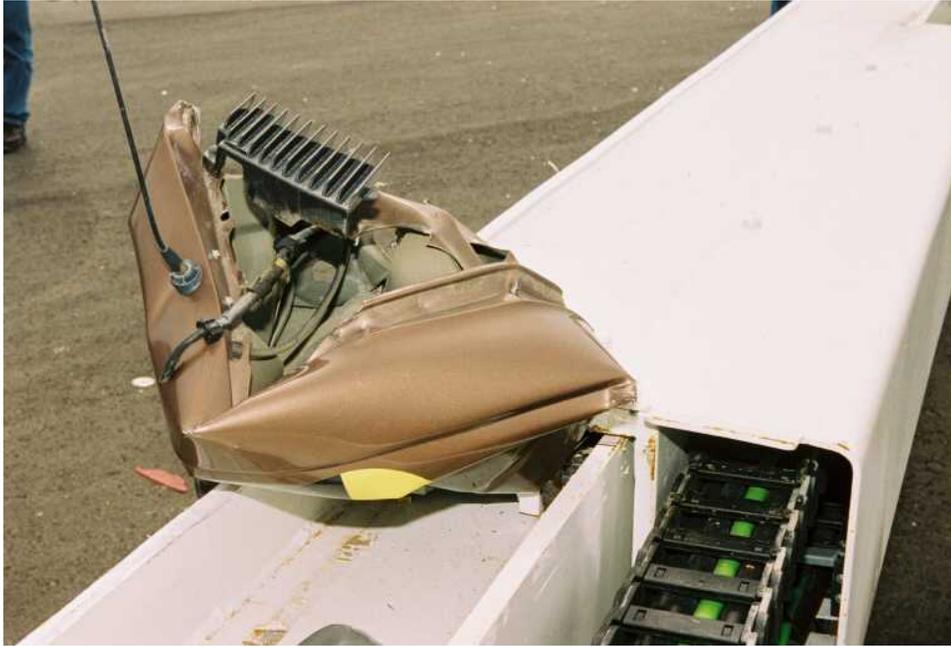
Figure 2-31 Close-up of the Vehicle's Sheet Metal in Test 642

Each of the two tests conducted involved significant sheet metal damage. This was expected considering the reversed lap connection in the barrier elements for the top beam. The snagging of the sheet metal can probably be lessened if each of the beam elements were made to lap in the appropriate direction. However, this change would make a reverse hit even more damaging to the impacting vehicle.

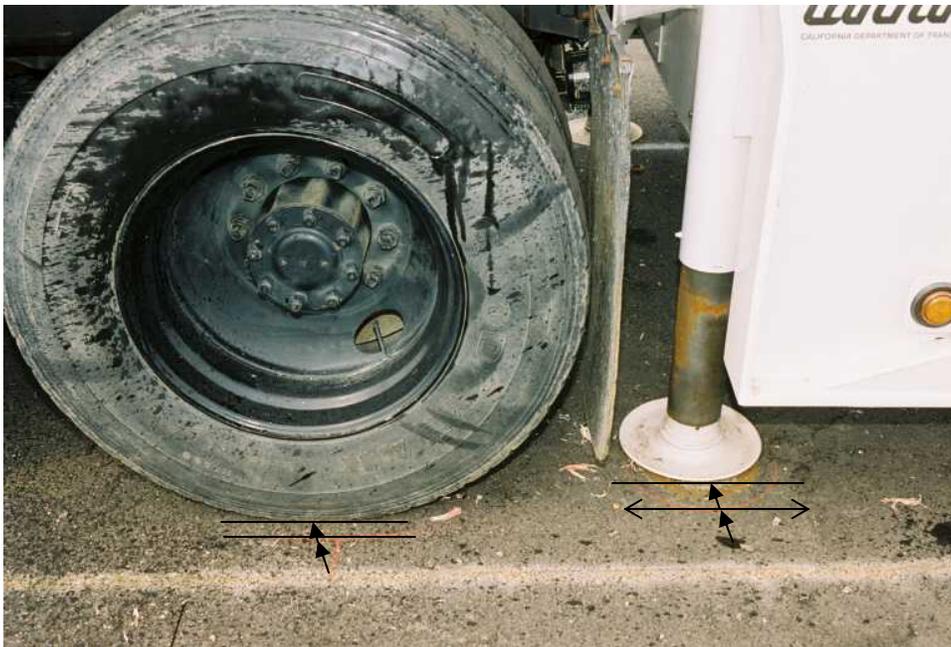
Figure 2-32 Trailer Tire and Brace Displacement in Test 642

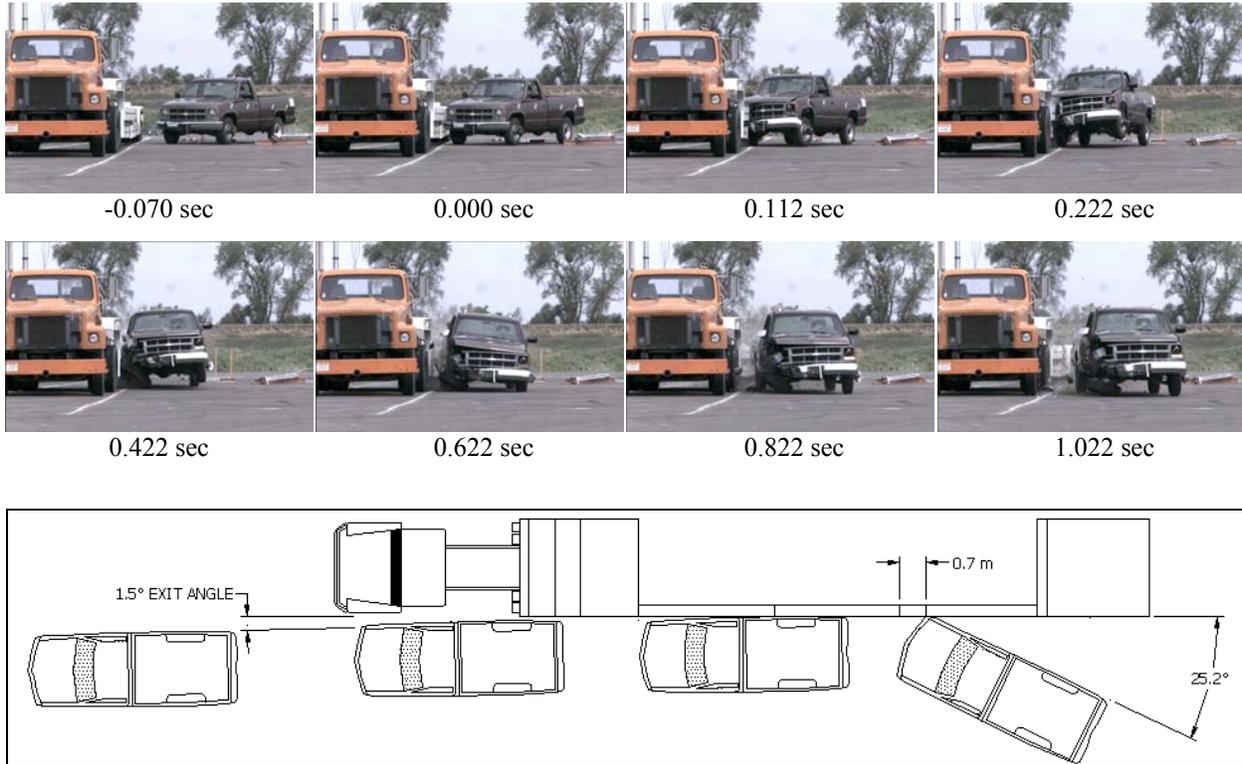
Figure 2-33 Test 642 Impact Sequence and Diagram

The initial impact with the barrier caused the right front corner of the vehicle to deform inward and the hood to overlap the front face of the barrier. 30 ms later the vehicle impacted the overlap of the two beams. The hood of the vehicle continued to override the top of the barrier but the sheet metal covering the right front wheel well snagged on the overlap and was pulled away from the vehicle. At 132 ms much of right front corner panel was accumulated at the beam overlap and had completely torn away from the vehicle. Also, the sheet metal from the passenger door had pulled away from the vehicle. The hood of the vehicle overlapped the front face of the barrier 387 mm (15.4 in) and did not penetrate the back face of the barrier. The vehicle lost contact with the barrier at 448 ms after the initial impact. At this point the vehicle exited at an angle of 1.5° and a velocity of 45.9 km/h (28.5 mph).

The barrier suffered minor scratches caused by the vehicle. The tractor-trailer was pushed backwards slightly. A large section of sheet metal from the vehicle was wedged in-between the overlap in the box beams.

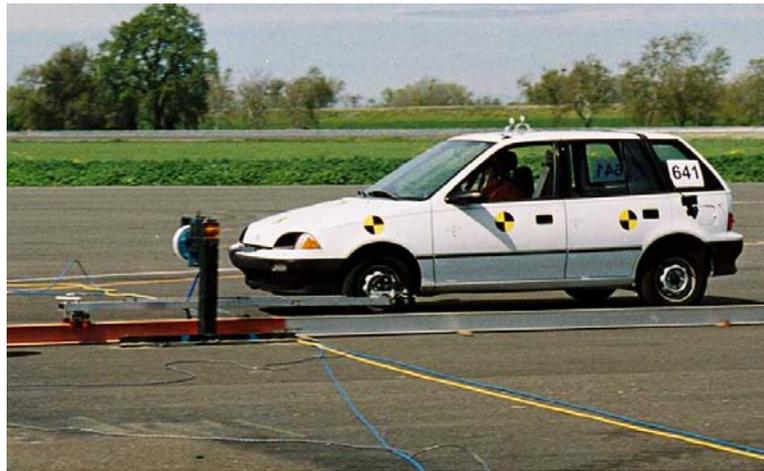
Figure 7-1 Vehicle Guidance System

A rail guidance system directed the vehicles into the barrier. The guidance rail, anchored at 3.8 m (12.5 ft) intervals along its length, was used to guide a mechanical arm that is attached to the front driver side wheel of the each of the vehicles. A 10-mm (0.375-in) nylon rope was used to trigger the release mechanism on the guidance arm, thereby releasing the vehicle from the guidance system before impact, see Figure 7-1.

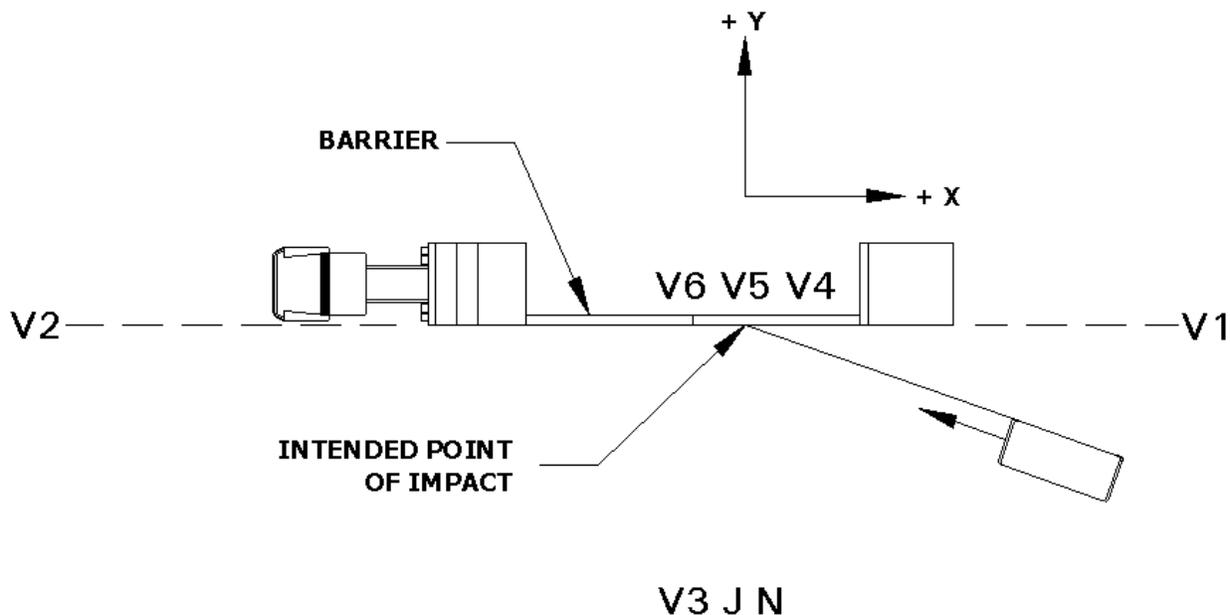
Figure 7-2 Camera Locations Test 641 (Not to Scale)

Several high-speed movie cameras recorded the impact during the crash tests. The types of cameras and their locations are shown in Table 7-3 and Figure 7-2. All of these cameras were mounted on tripods except the three that were mounted on a 10.7-m (35.1-ft) high tower directly over the impact location.

Note:
*X, Y, and Z distances are relative to the impact point.

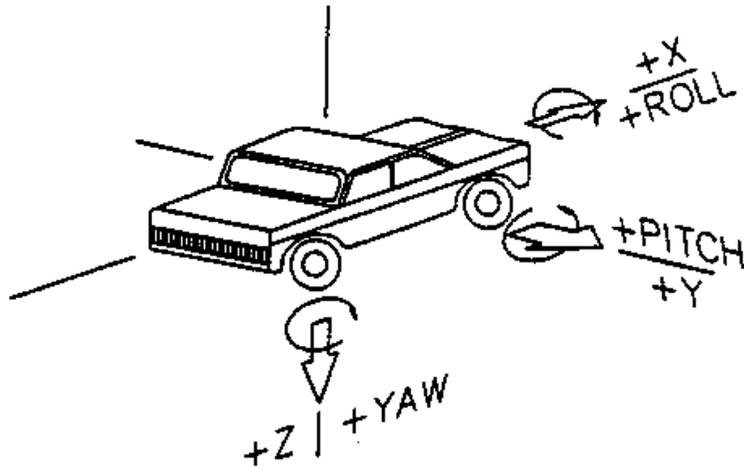
Figure 7-3 Vehicle Accelerometer Sign Convention

Accelerometer and gyro specifications are shown in Table 7-4. The vehicle accelerometer sign convention used throughout this report is the same that is described in NCHRP Report 350 and is shown on Figure 7-3.

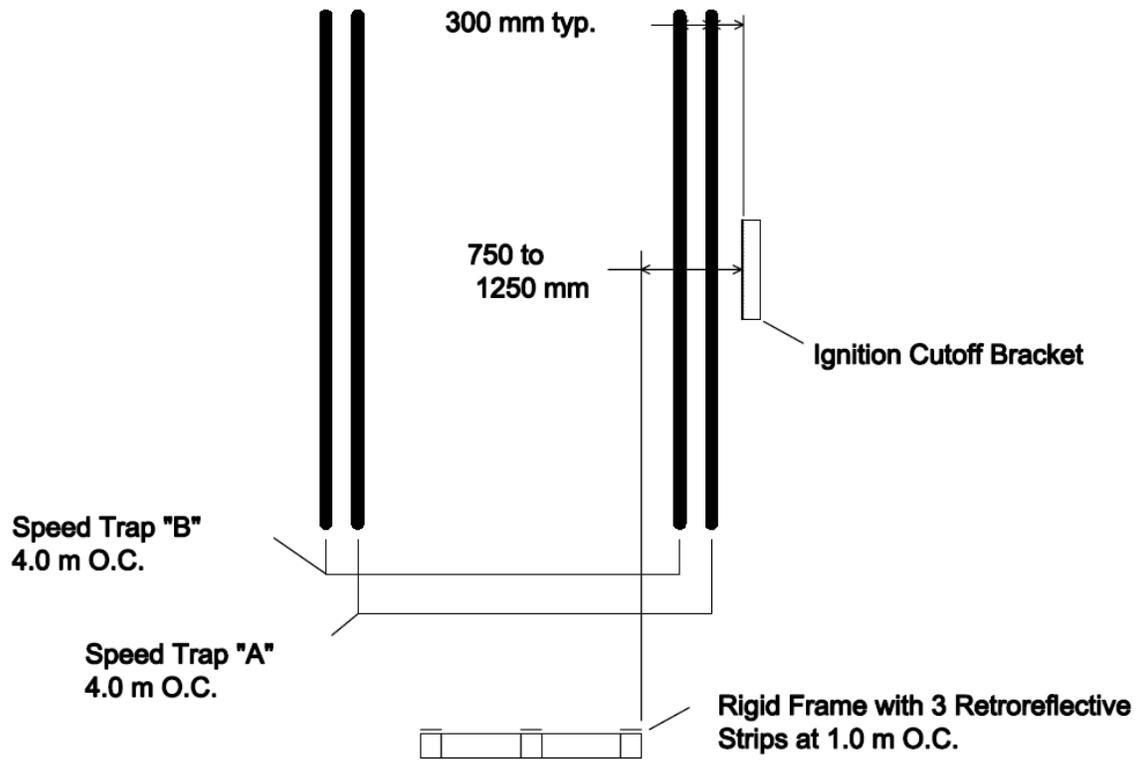
Figure 7-4 Event Switch Layout

A rigid stand with three retro reflective 90° polarizing tape strips was placed on the ground near the test article and alongside the path of the test vehicles, Figure 7-4. The strips were spaced at carefully measured intervals of 1.0 m (3.28 ft). The test vehicles had an onboard optical sensor that produced sequential impulses or "event blips" that were recorded concurrently with the accelerometer signals on the TDR, serving as "event markers". The impact velocity of the vehicles could be determined from these sensor impulses and timing cycles and the known distance between the tape strips. A pressure sensitive tape switch on the front bumper of the vehicles closed at the instant of impact and triggered two events: 1) an "event marker" was added

to the recorded data, and 2) a flashbulb mounted on the top of the vehicles were activated. Two other pressure sensitive tape switches, connected to a speed trap, were placed 4.0 m (13.1 ft) apart just upstream of the test article specifically to establish the impact speed of the test vehicles. The layout for all of the pressure sensitive tape switches is shown in Figure 7-4.
