CRASHWORTHINESS TESTING OF A PORTABLE MAINTENANCE WORK-ZONE BARRIER

STATE OF CALIFORNIA
DEPARTMENT OF TRANSPORTATION
DIVISION OF RESEARCH AND INNOVATION
OFFICE OF SAFETY INNOVATION AND COOPERATIVE RESEARCH

December 2008

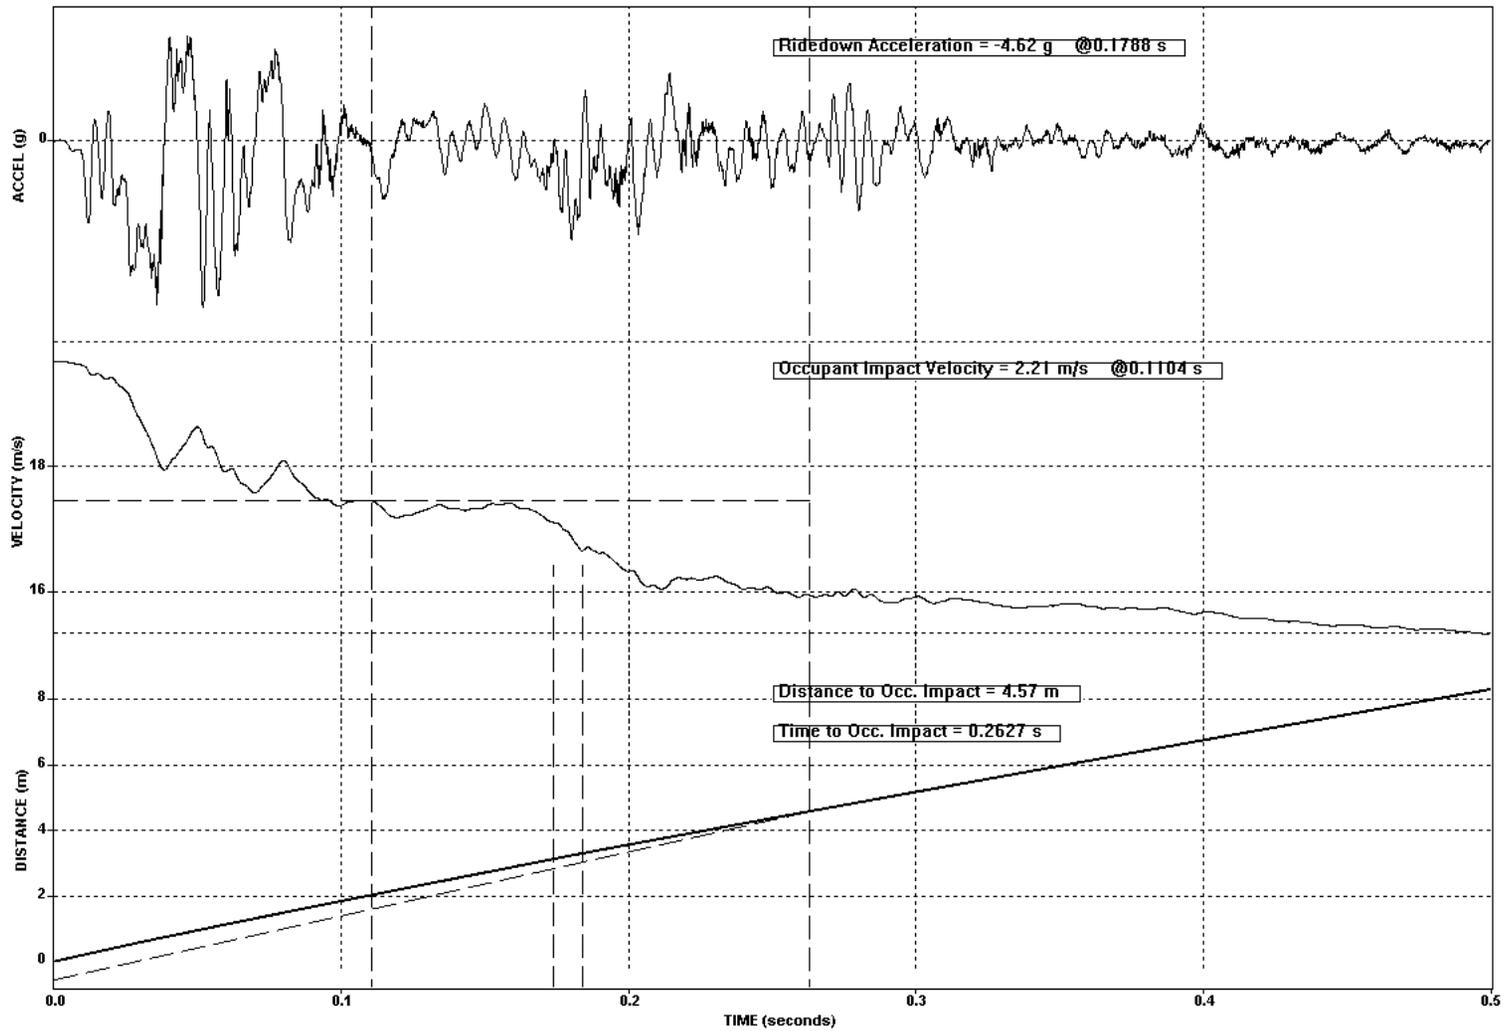
Figure 7-5 Test 641 Vehicle Longitudinal Acceleration, Velocity, and Distance -Vs- Time

The data curves are shown in Figure 7-5 through Figure 7-12 and include the accelerometer and rate gyro records from the test vehicles. They also show the velocity and displacement curves for the longitudinal and lateral components. These plots were needed to calculate the occupant impact velocity defined in NCHRP Report 350. All data were analyzed using software written by DADiSP and modified by Caltrans.

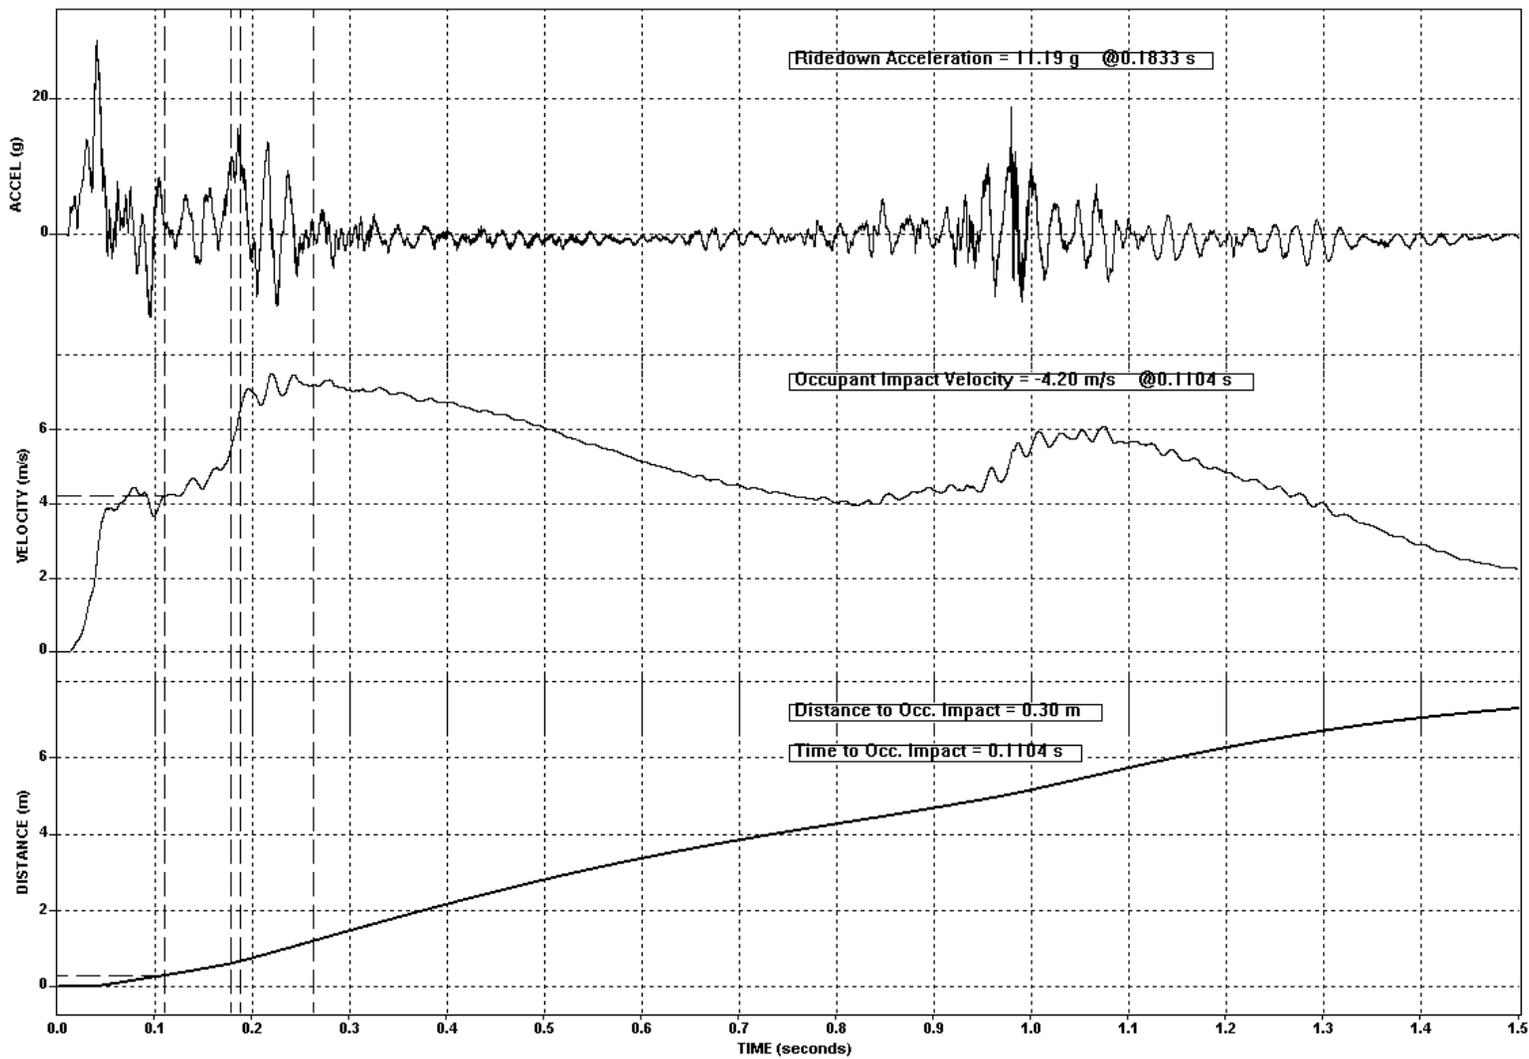
Figure 7-6 Test 641 Vehicle Lateral Acceleration, Velocity, and Distance -Vs- Time

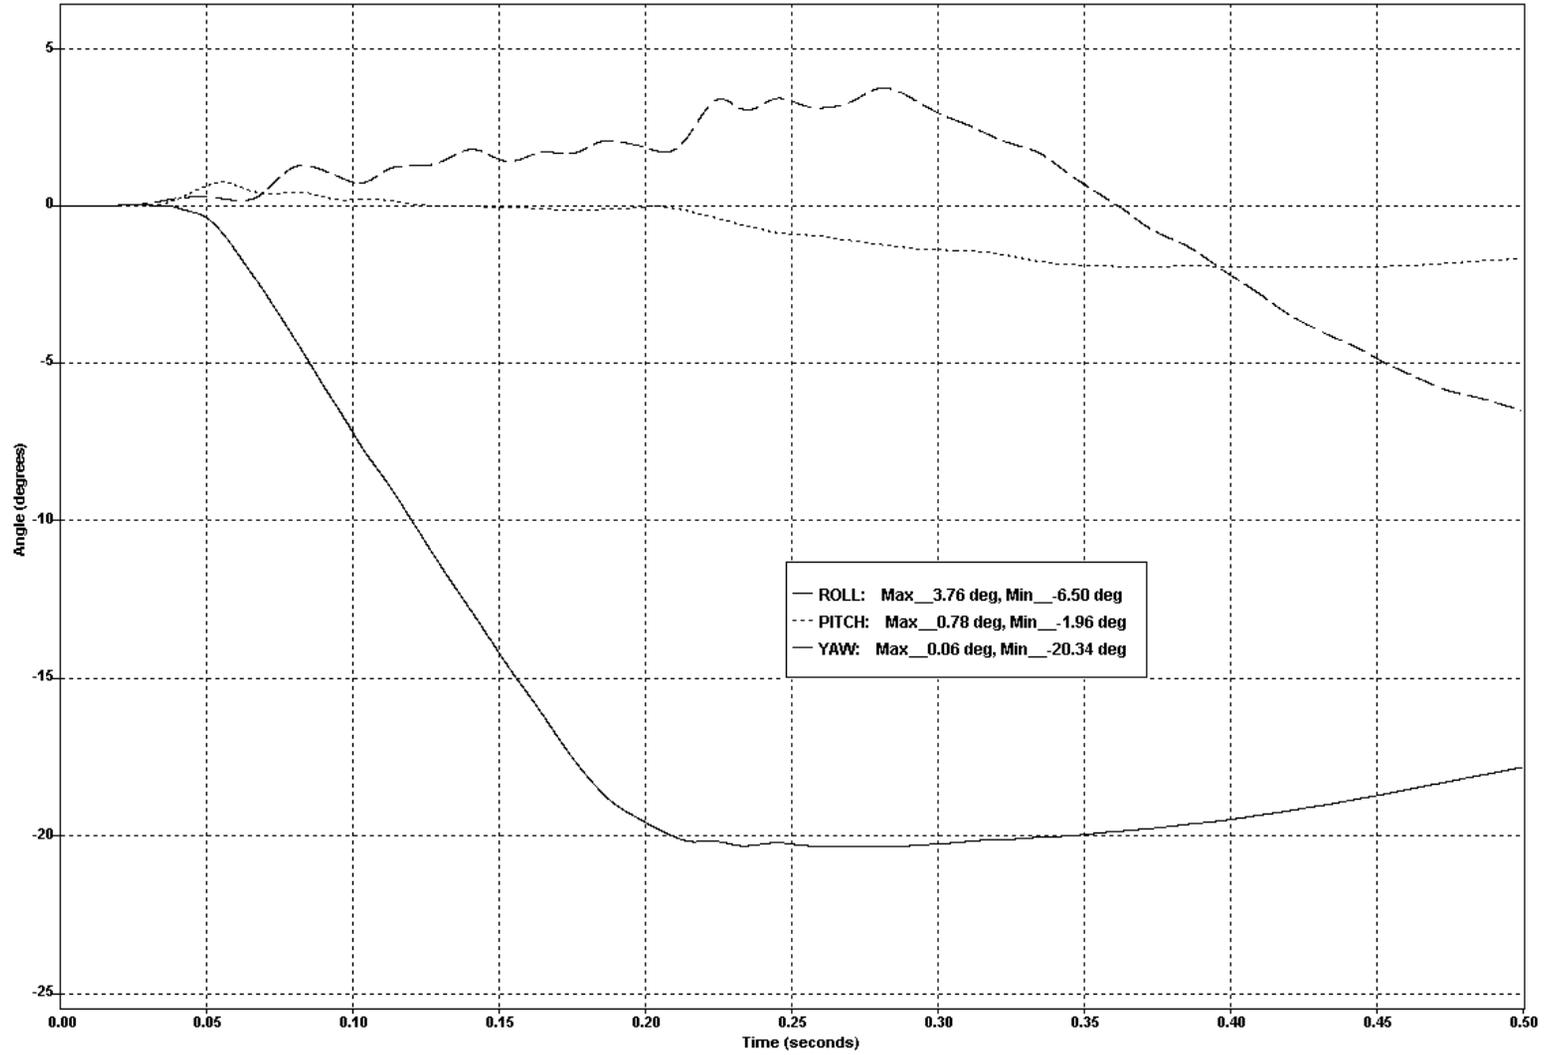
Figure 7-7 Test 641 Vehicle Roll, Pitch, and Yaw -Vs- Time

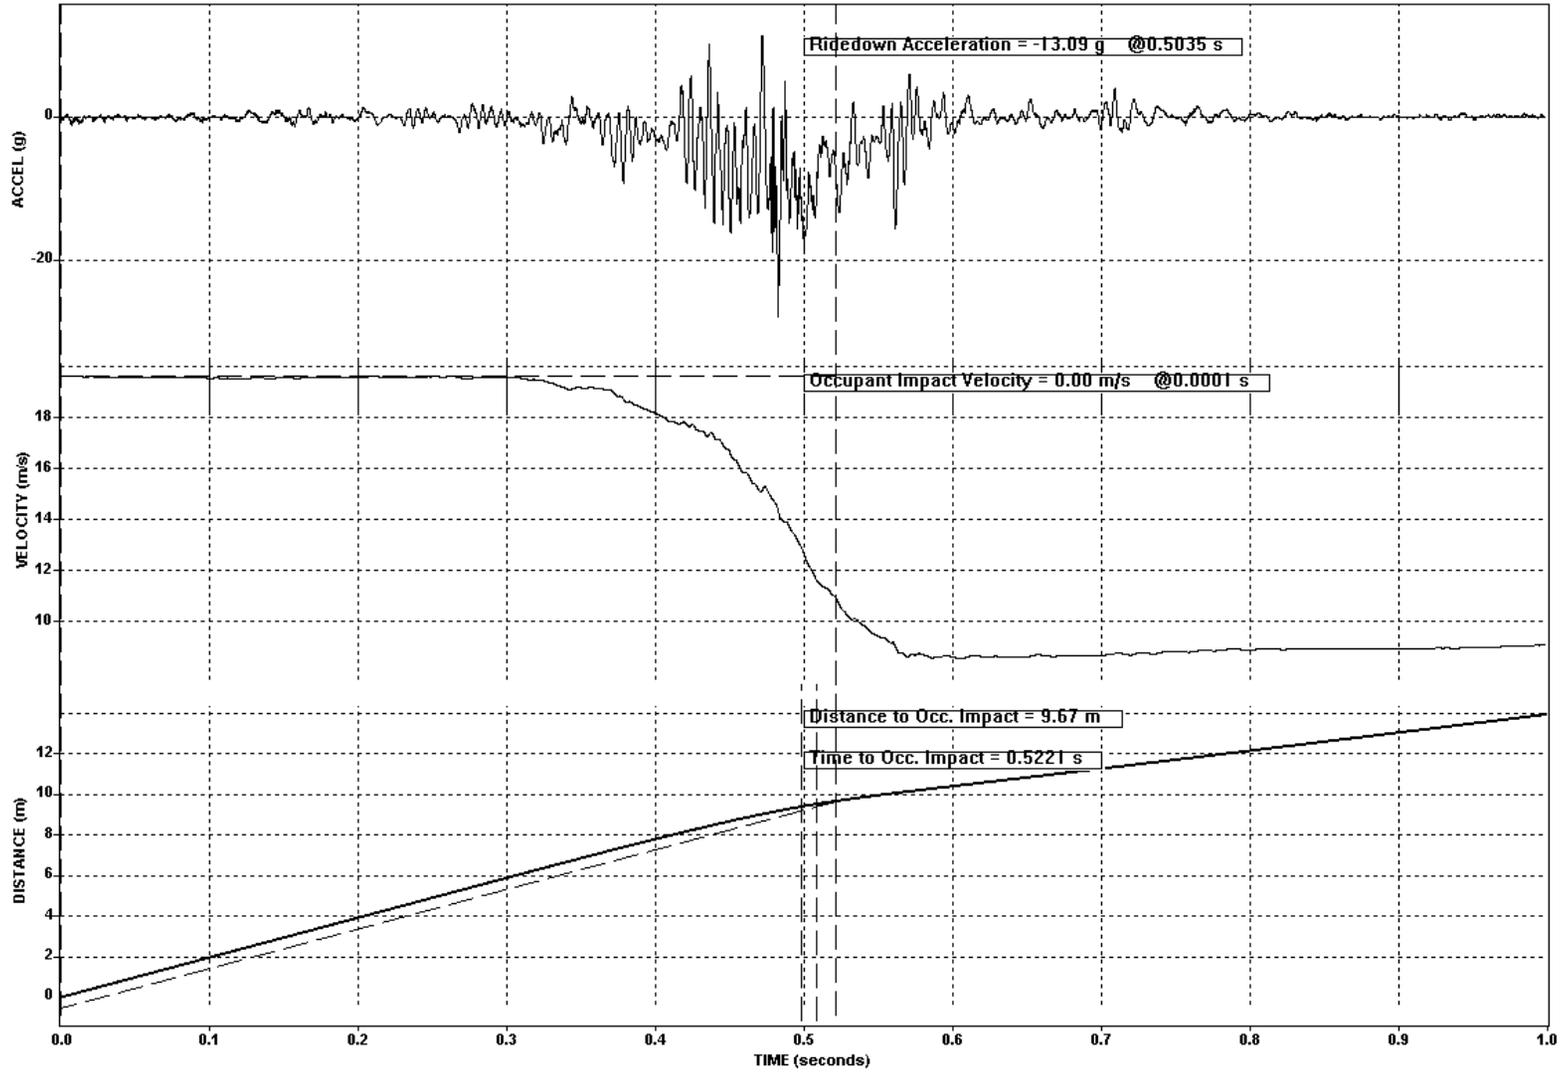
Figure 7-8 Test 641 Second Impact Vehicle Longitudinal Acceleration, Velocity, and Distance -Vs- Time

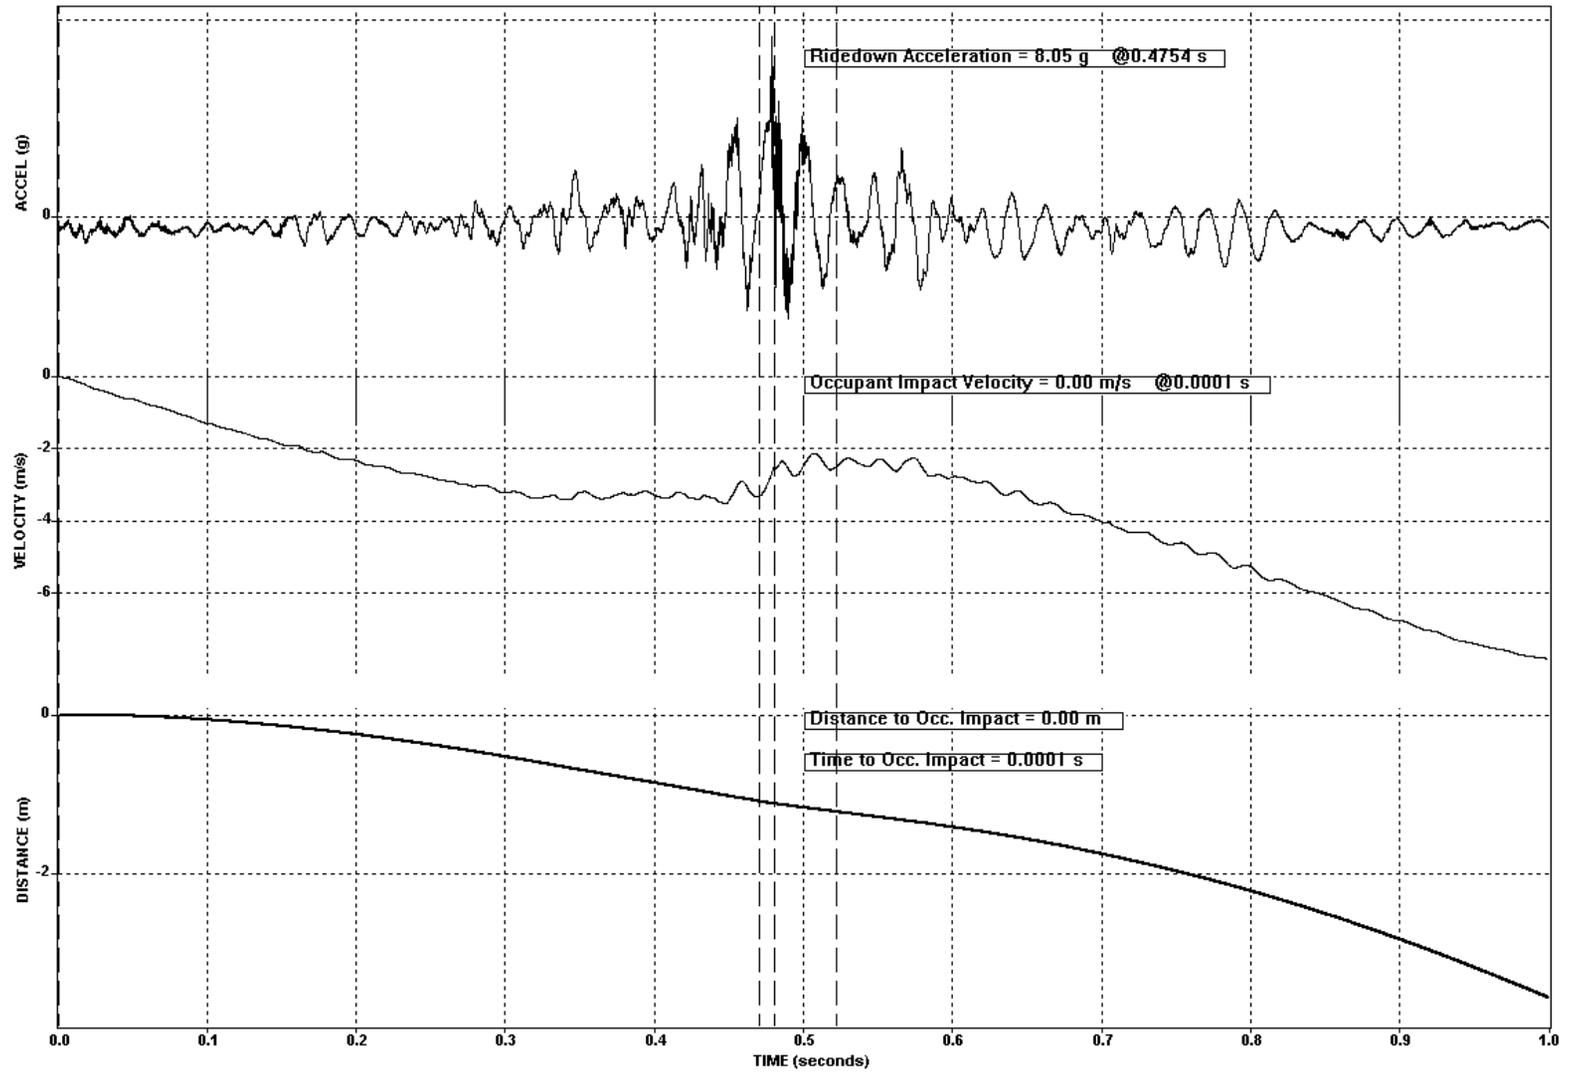
Figure 7-9 Test 641 Second Impact Vehicle Lateral Acceleration, Velocity, and Distance -Vs- Time

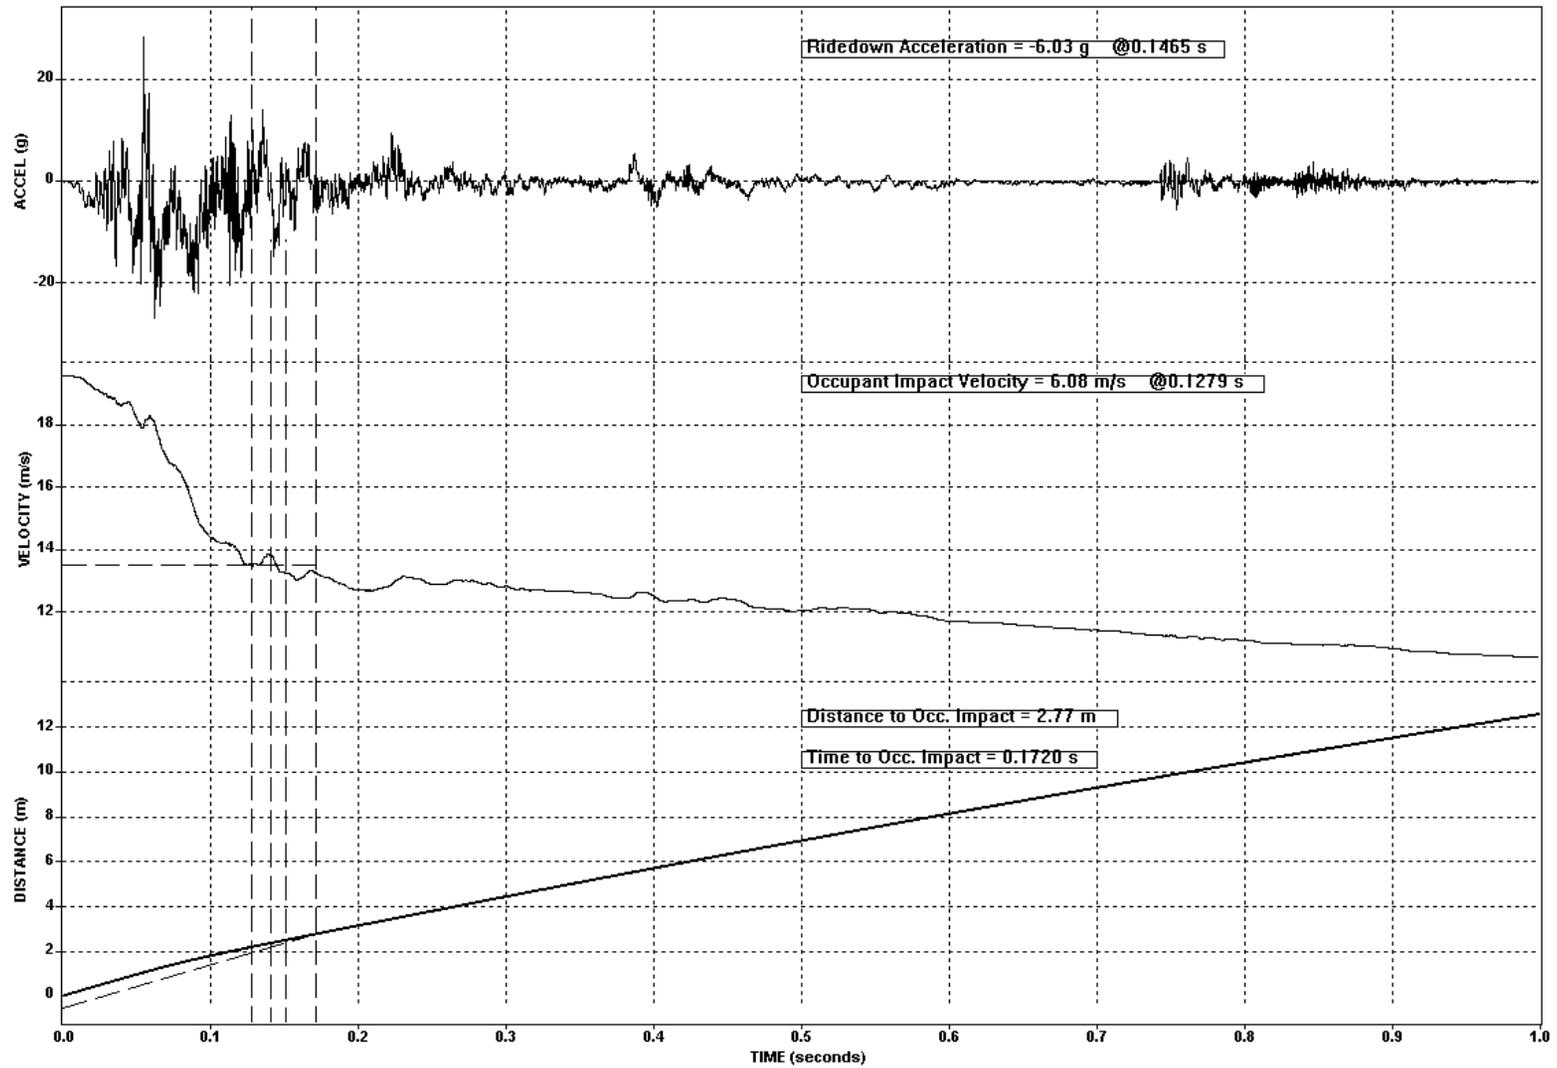
Figure 7-10 Test 642 Vehicle Longitudinal Acceleration, Velocity, and Distance -Vs- Time

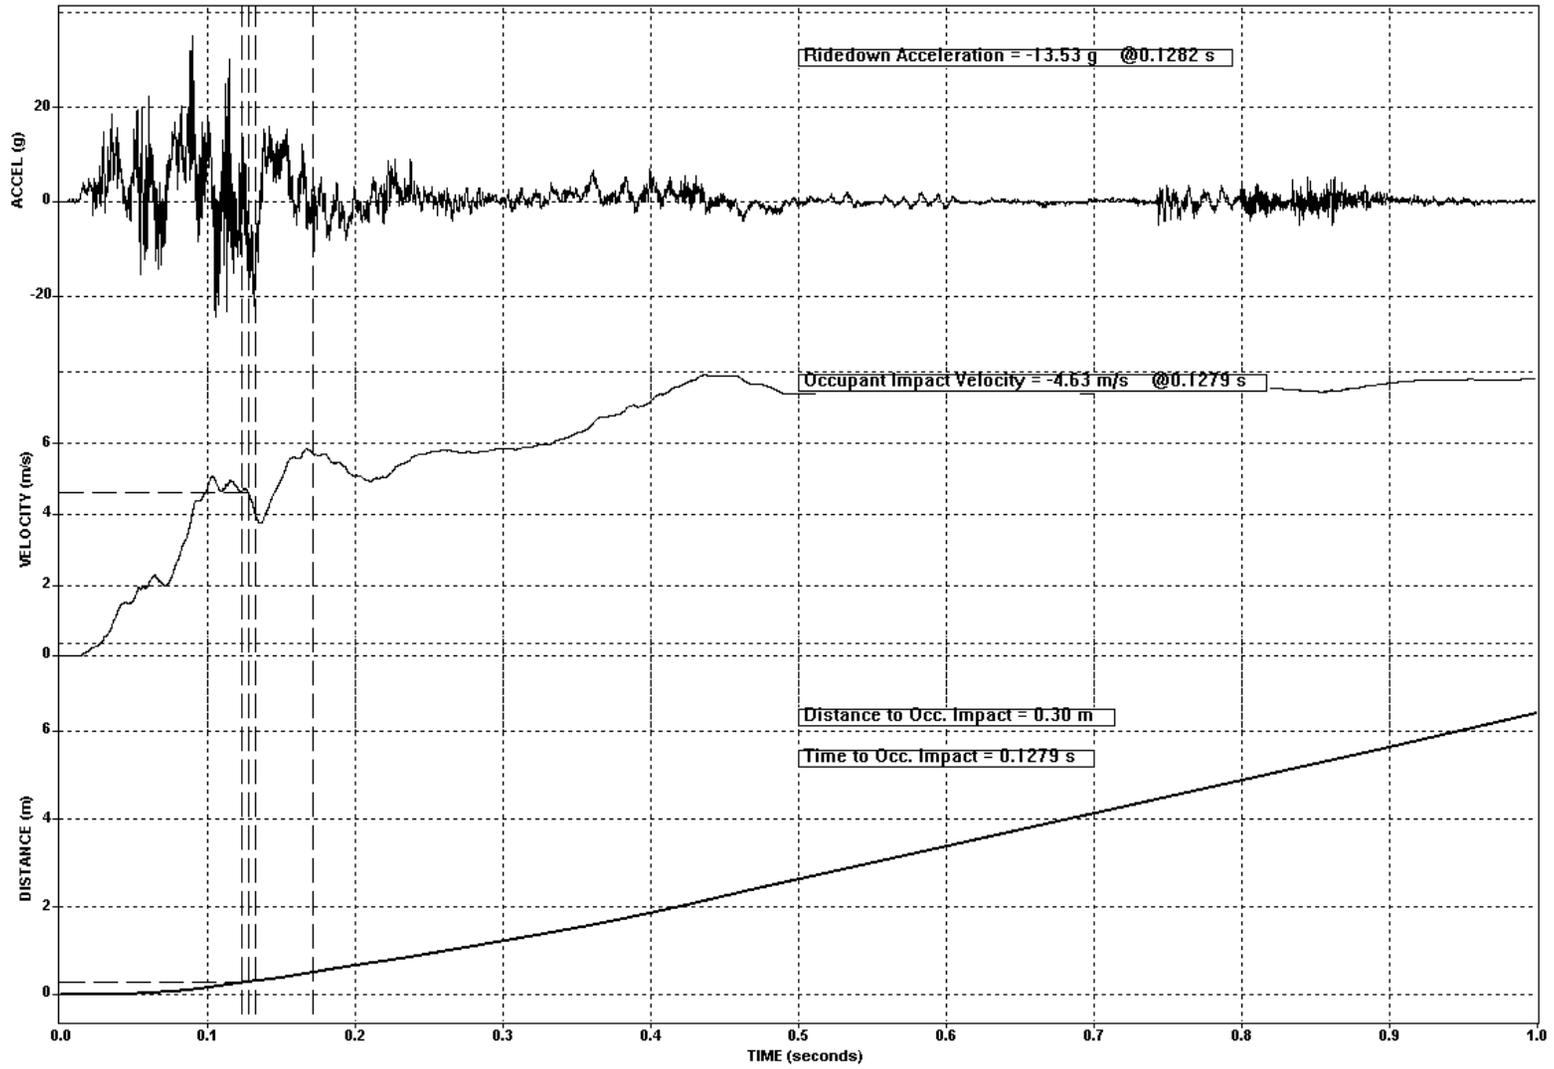
Figure 7-11 Test 642 Vehicle Lateral Acceleration, Velocity, and Distance -Vs- Time

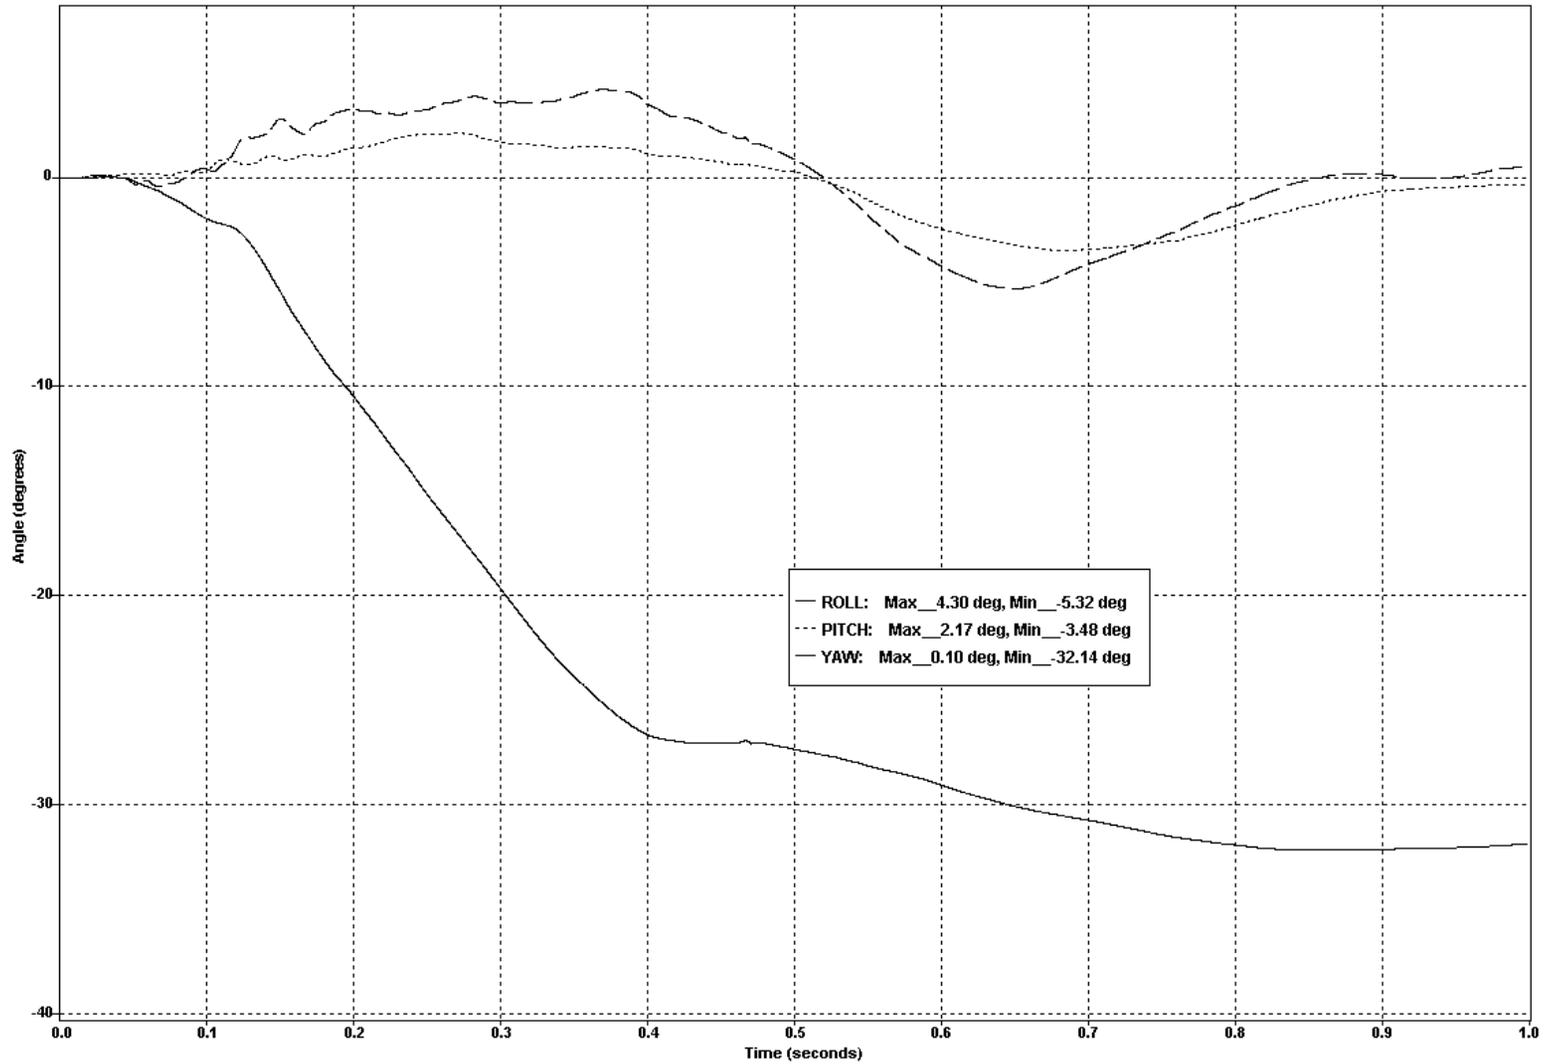
Figure 7-12 Test 642 Vehicle Roll, Pitch, and Yaw -Vs- Time

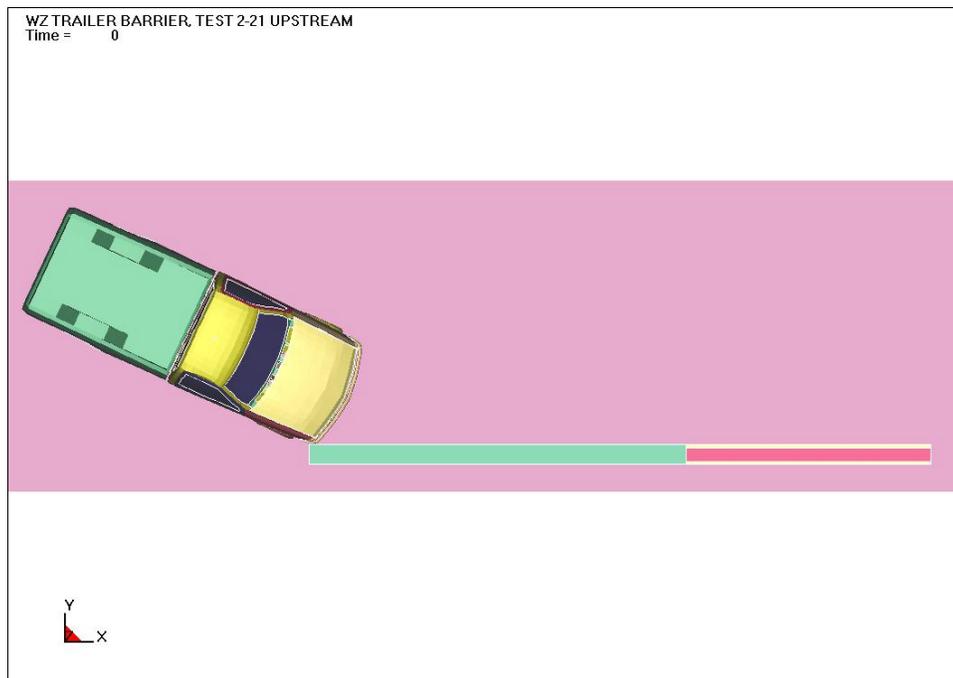
Figure 7-13 Initial Orientation in Plan View for the Upstream Impact Simulation

The crash test simulation at the upstream support ran with no apparent numerical analysis problems. Figure 7-13 shows initial orientation of the crash test simulation. Global energy totals seem realistic, with hourglass energy (HE) less than 10% of the internal energy (IE). Some individual parts registered very high HE with respect to IE, but these are small parts in the truck, and insignificant. The pickup truck was contained and redirected without penetration, overriding or underriding the barrier, see Figure 7-14. The maximum dynamic lateral deflection of the barrier was just less than 70 mm. The vehicle showed no precarious instability after impact. The

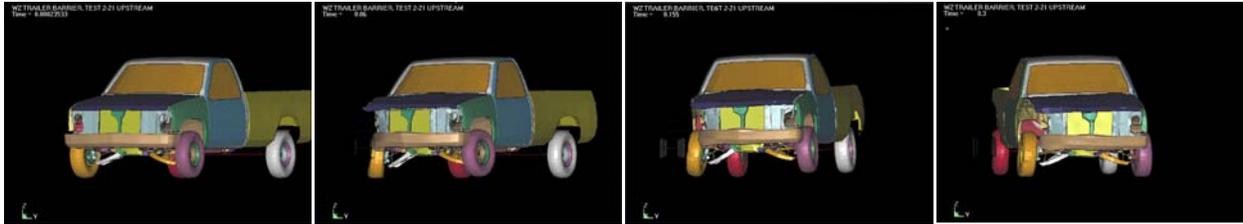
Figure 7-14 Upstream Impact Simulation Impact Sequence

simulation was only run for 400 ms due to the long CPU run time, but initial redirection angle of the vehicle appeared to be satisfactory. The longitudinal occupant impact velocity (OIV) was 4-m/s and the lateral OIV was less than 1 m/s, both well below the limit of 12-m/s. The longitudinal ridedown acceleration was 9.1 g's and the lateral was 16.2 g's, both below the limit of 20 g's.

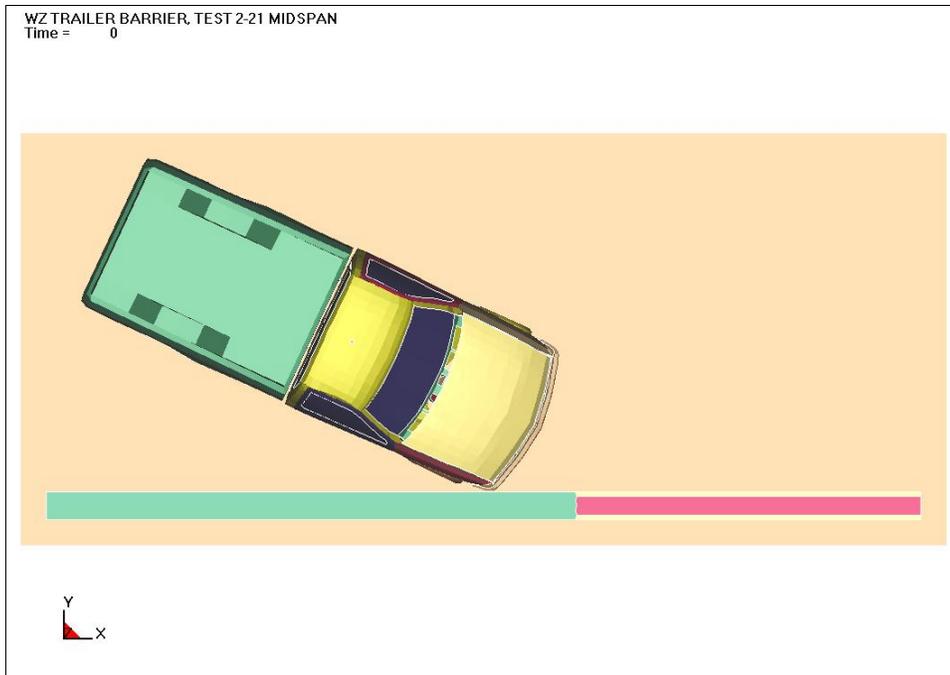
Figure 7-15 Initial Orientation in Plan View for the Mid-Span Impact Simulation

This crash test simulation at mid-span ran with no apparent numerical analysis problems. Figure 7-15 shows initial orientation of the crash test simulation. Global energy totals seem realistic, with HGE less than 10% of IE. Some individual parts registered very high HGE with respect to IE, but these are small parts in the truck, and insignificant. The pickup truck was contained and redirected without penetration, overriding or underriding the barrier, see Figure 7-16. The maximum dynamic lateral deflection of the barrier was about 190 mm. The vehicle showed no precarious instability after impact. The simulation was only run for 400 ms due to the long CPU run time, but initial redirection angle of the vehicle appeared to be satisfactory. The longitudinal OIV was 4.3 m/s and the lateral OIV was 1.06 m/s, both well below the limit of 12-m/s. The longitudinal ridedown acceleration was 4.5 g's and the lateral was 10.2 g's, both below the limit of 20-g's.

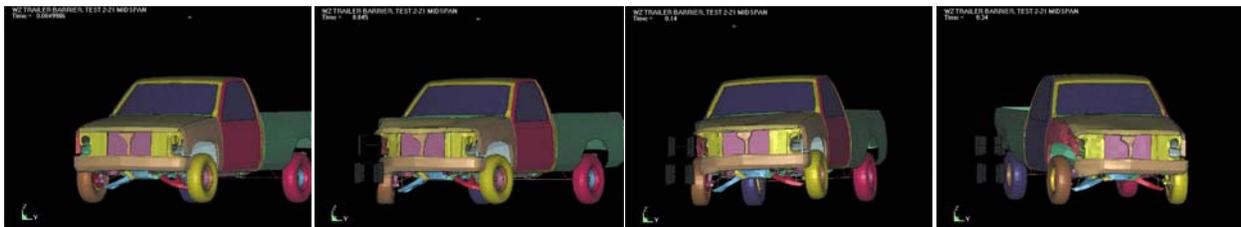
Figure 7-16 Mid-Span Impact Simulation Impact Sequence

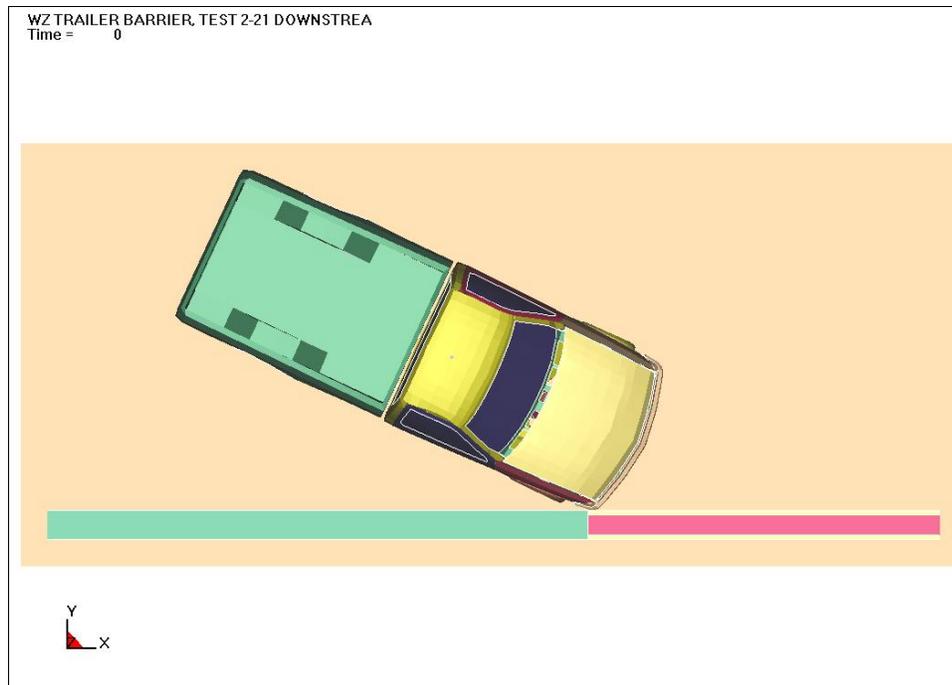
Figure 7-17 Initial Orientation in Plan View for the Downstream Impact Simulation

This crash test simulation with impact just downstream from the overlap section ran with no apparent numerical analysis problems. Figure 7-17 shows initial orientation of the crash test simulation. Global energy totals seem realistic, with HGE less than 10% of IE. Some individual parts registered very high HGE with respect to IE, but these are small parts in the truck, and insignificant. The pickup truck was contained and redirected without penetration, overriding or underriding the barrier, see Figure 7-18. The maximum dynamic lateral deflection of the barrier was about 185 mm. The vehicle showed no precarious instability after impact. The simulation was only run for 400 ms due to the long CPU run time, but initial redirection angle of the vehicle appeared to be satisfactory. The longitudinal OIV was 4.1 m/s and the lateral OIV was 0.868-

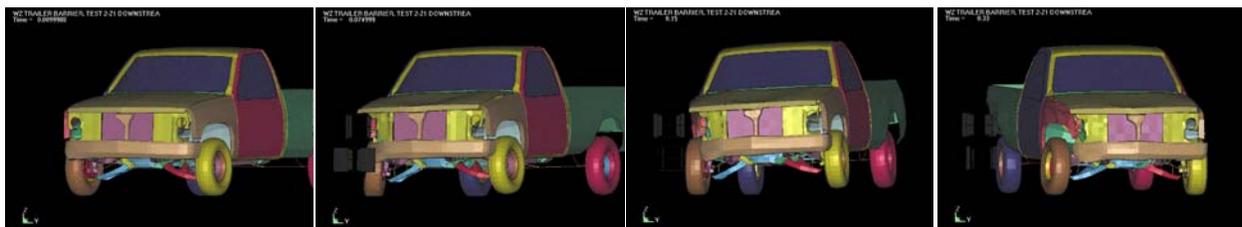
Figure 7-18 Downstream Impact Simulation Impact Sequence
