Freeway Exit Gore Signage: A Survey of State Practice and Related Research

Donald E. Howe, PE, Signs Functional Manager, Caltrans Division of Traffic Operations

December 12, 2013

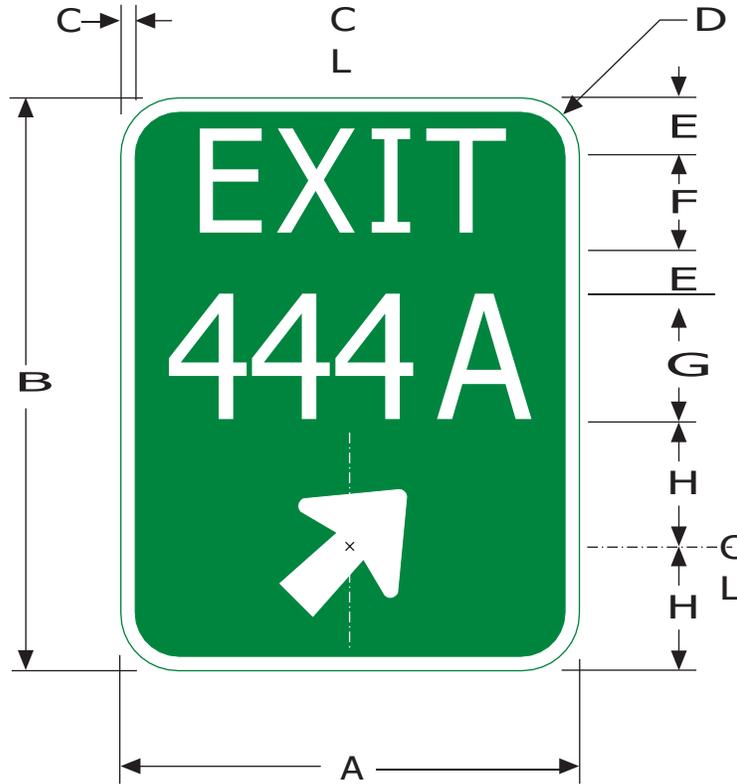
G84-3 (CA)

Use when an Exit Number/Suffix has 3 to 4 numbers or letters.

For arrow dimensions, see Figure 2D-2 (CA) of the CA MUTCD. Arrow angle can vary, specify angle or order unapplied.

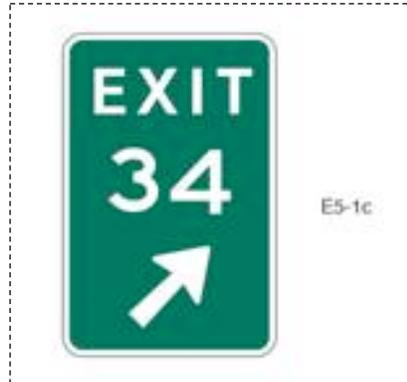
E5-1c, Narrow Exit Gore Sign

Excerpt from Figure 2E-28, Exit Gore Signs

See [Appendix E](#) for Figure 2E-28, Exit Gore Signs, which provides a thumbnail example of the E5-1c narrow exit gore sign. This thumbnail representation of the E5-1c sign appears on page 231 of the Texas MUTCD (see page 43 of the PDF), and does not appear in the 2009 MUTCD or the 2012 CA MUTCD.
