Roadway Departure Technical Brief No. 2 Drive - by Inspection of Safety Hardware

CATEGORY: Maintenance

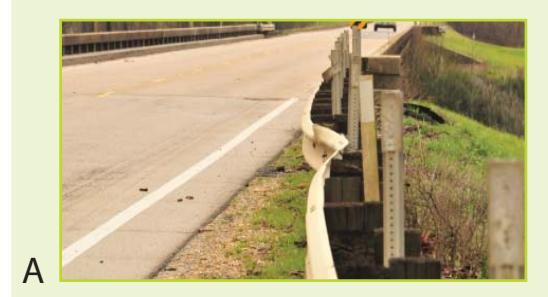
- More than 9 inches of deflection over a 25-foot span (Photograph A).
- Top of rail two or more inches below original height
- Two or more posts missing or detached from rail.

W-Beam Guardrail: The following types of damage can be easily seen and may significantly reduce the capacity of the barrier if not repaired:

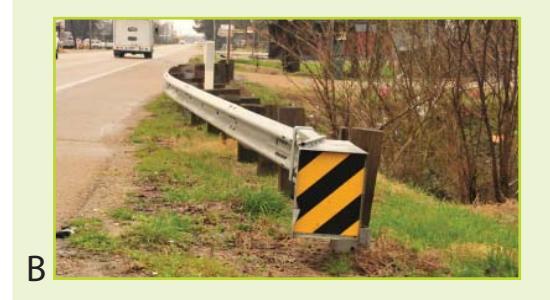
- The cable must be in place and tight. The terminal head in **Photogragh B** is separated from the end post and the cable is missing.
- The steel bearing plate must be in place and set with the longer dimension facing up.
- The end post must be intact with the extruder head firmly in place. The end post in Photograph C has split, causing the head to drop. The terminal may not function properly in a end-on hit.

These terminals must function as an anchor for barrier impacts immediately downstream from the end. Therefore:

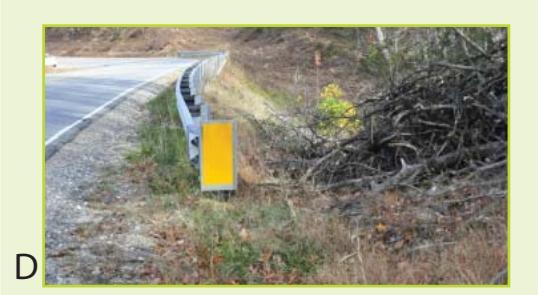
- The w-beam rail must be fully inserted into the impact head to prevent spearing in a head-on crash (**Photograph D**).
- Any energy absorbing head must be properly aligned with the w-beam.
- The first 50 feet of w-beam must be straight (not a curved section) and undamaged so the rail can extrude without kinking.
- An energy absorbing terminal must have a reasonably clear runout area behind and beyond the terminal nose.
- For non-energy absorbing terminals, a longer runout area is needed because an impacting vehicle will not be significantly slowed on impact.

For end-on hits, extruder type terminals must act as an energy-absorbing device when hit directly and allow a vehicle to pass behind it when struck at an angle on the nose. Therefore:
