# Investigation of Tire/Pavement Noise for Concrete Pavement Surfaces: Summary of Four Years of Measurements

**Authors:**  
A. Rezaei and J. Harvey

Work Conducted as Part of Partnered Pavement Research Center Strategic Plan Element No. 4.39:  
Field and HVS Evaluation of Noise Benefits of Open-Graded and Other Quieter Surfaces

University of California  
Pavement Research Center  
Davis and Berkeley

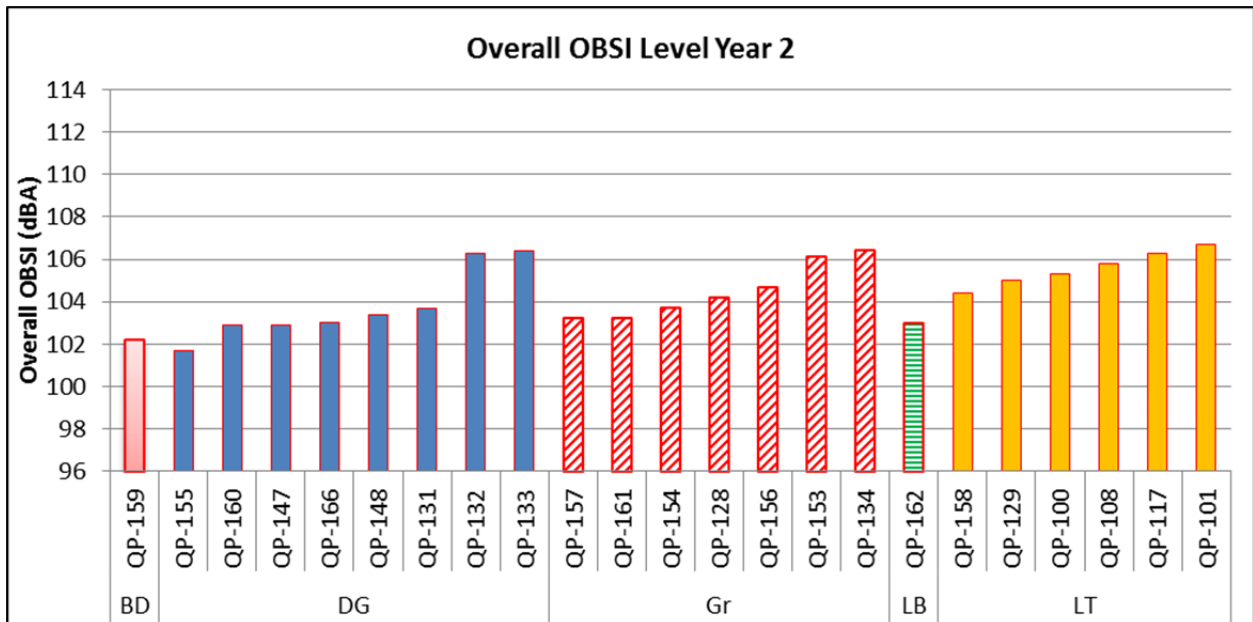
Figure C.2: OBSI for each section measured in Year 2 sorted by texture type and OBSI level, for sections with fourth year measurements.
