OPTIMIZING RUBBERIZED OPEN- GRADED FRICTION COURSE (RHMA-O) MIX DESIGNS FOR WATER QUALITY BENEFITS PHASE I: LITERATURE REVIEW

Partnered Pavement Research Center (PPRC) Strategic Plan Element 2.7 under Caltrans Contract 65A0628

1. REPORT NUMBER UCPRC-RR-2019-03	2. GOVERNMENT ASSOCIATION NUMBER	3. RECIPIENT'S CATALOG NUMBER
4. TITLE AND SUBTITLE Optimizing Rubberized Open-graded Friction Course (RHMA-O) Mix Designs for Water Quality Benefits: Phase I: Literature Review		5. REPORT PUBLICATION DATE September 2020

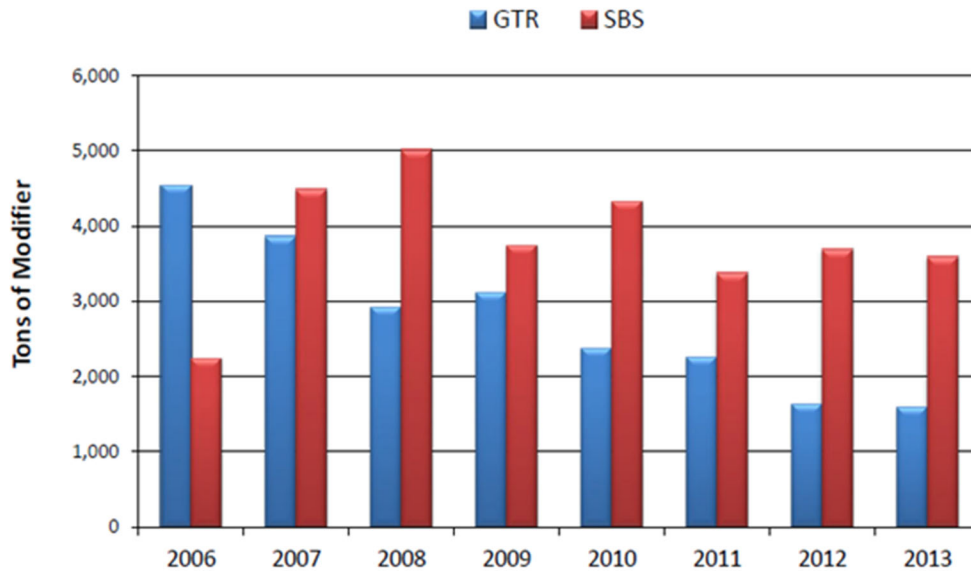
Figure 2.9: Usage of polymer and rubber-modified binder in Florida.
(Source: FDOT)

(Figure 2.9) clearly shows the gradual decrease in rubber-modified binder usage in the state. According to one study (Moseley 2019), the use of rubberized binder during fiscal year 2018 fell to less than 3 percent of the state’s total binder use.

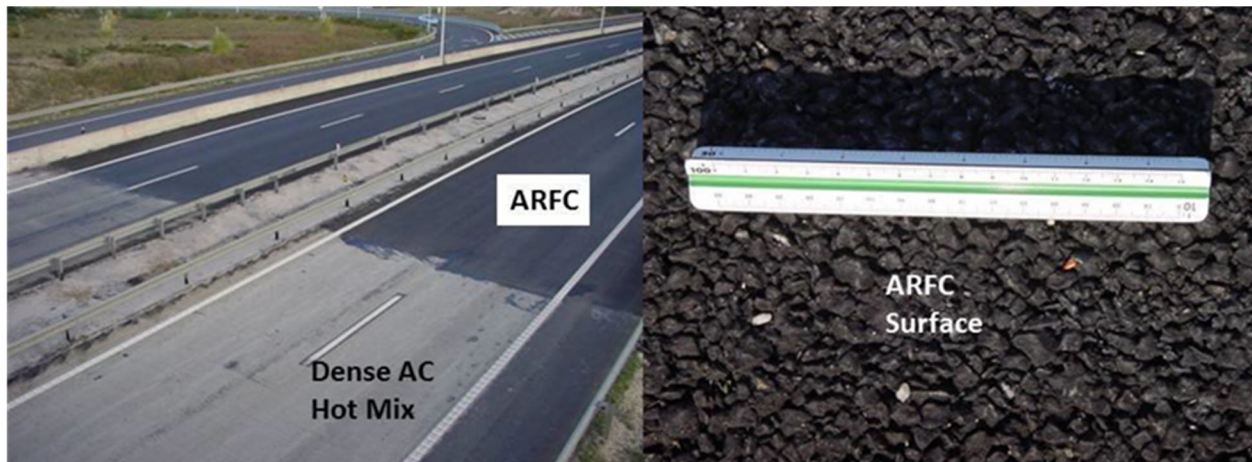
Figure 2.10: Dense-graded asphalt cement (AC) hot mix and asphalt rubber open-graded friction course (ARFC) surfaces in Portugal.

Portugal began to use RHMA-O surfaces in 2003 to provide a smooth riding surface, good wet-weather skid resistance, and less tire-pavement noise (see Figure 2.10). The RHMA-O was reported to have a noise level 5 to 6 dBA lower than a typical dense-graded hot mix asphalt and 8 to 10 dBA lower than a typical concrete surface (Way et al. 2012).

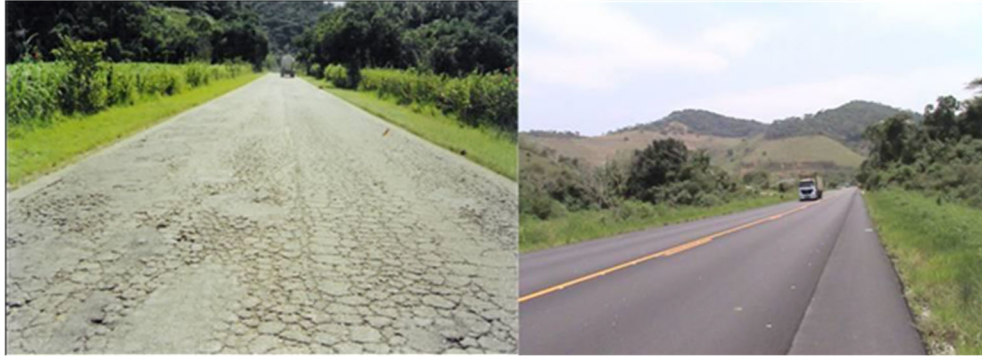
Figure 2.12: Highway RJ-122 pavement in Brazil before and after overlay placement with an ARFC surface.

and uncomfortable (see Figure 2.12). This highway’s traffic volume was high and composed mainly of heavy trucks, and therefore the pavement needed to be rehabilitated to handle heavy loads. As a result, a rubberized pavement mix design was selected for the Highway RJ-122 overlay project (Pinto and Sousa 2012).

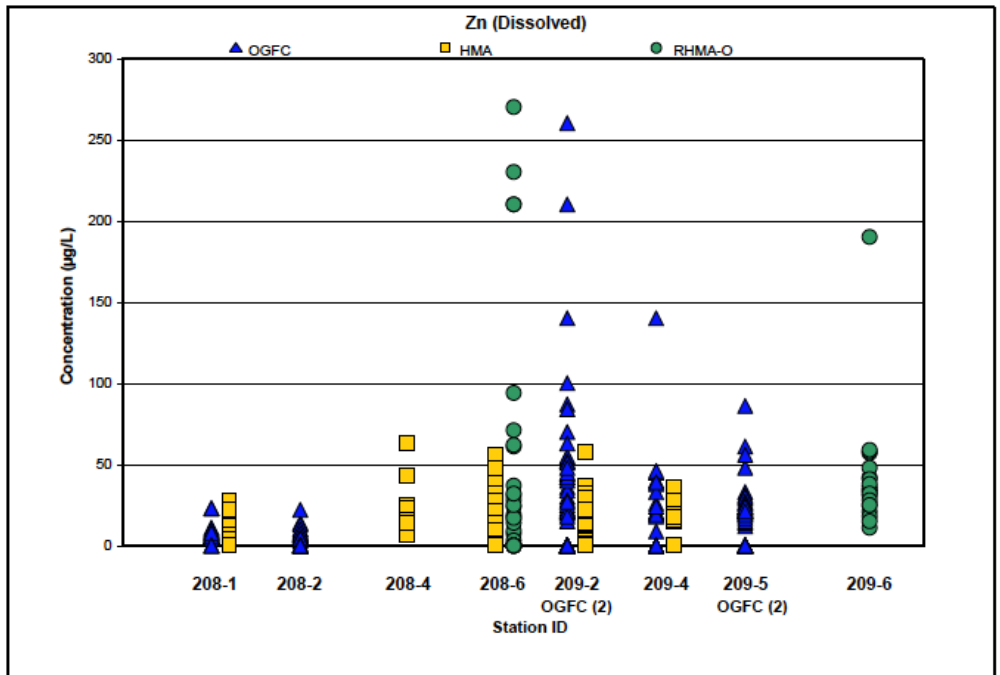
(a) Total Zn

(b) Dissolved Zn

Figure 4.1: Concentration of total and dissolved Zn from rubberized and non-rubberized OGFC compared with conventional impervious HMA sites monitored during from 2007 to 2011. (Note: the concentration of total and dissolved Zn for runoff generated from conventional HMA impervious surface is generally lower compared OGFC and RHMA-O overlays.)
