# Rapid Response

## Caltrans Rebuilds I-10 Bridge after 1,000-Year flood

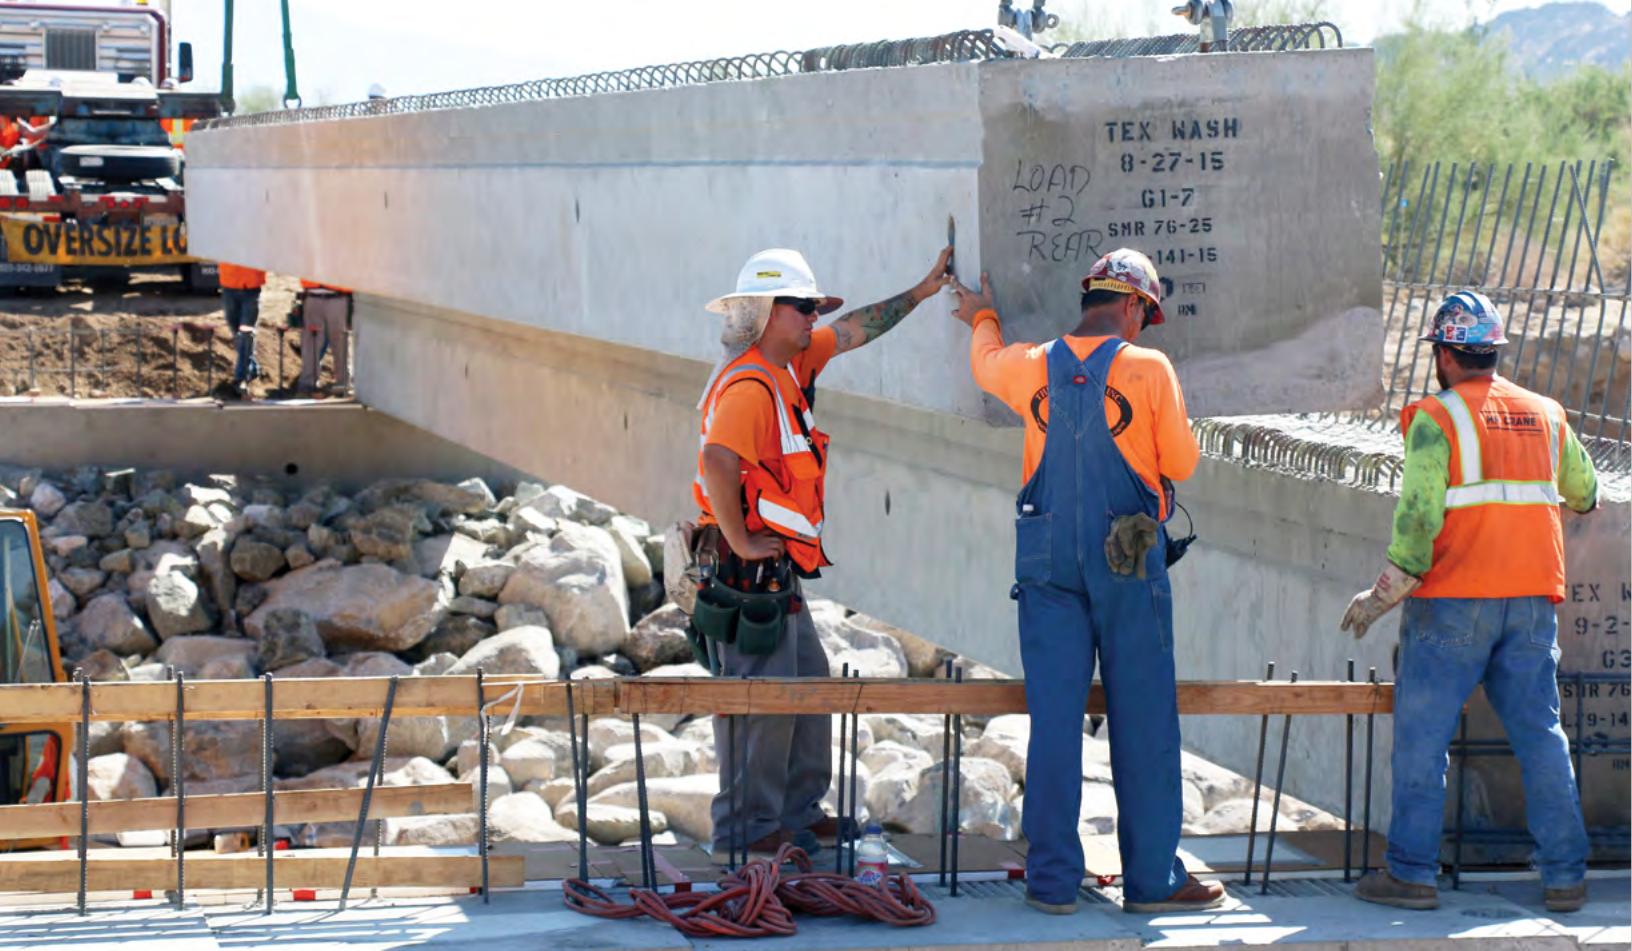
Workers guide one of 10 girders, each weighing 55 tons, during construction of the new Tex Wash Bridge.

The new bridge has a much deeper foundation than the 1967 original. Engineers included piles 48 inches in diameter extending 52 feet below ground for the footing. The existing westbound bridge received two 48-inch supports extending 23 feet deep.

Engineers also redesigned the eastbound bridge to current standards, using one span. Using Accelerated Bridge Construction methods — meaning building many portions offsite to reduce time and minimize road closures and traffic disruptions — 10 girders, each weighing 55 tons, were built offsite by Oldcastle Precast, 130 miles away in Perris, south of Riverside. Likewise, the abutments, made up of 240 cubic yards of concrete, were also made in Perris.
