| 4. TITLE AND SUBTITLE Seismic Performance of Precast Girder-to-Cap Connections for Accelerated Bridge Construction of Integral Bridges | 5. REPORT DATE July 2015 | |
| 7. AUTHOR Justin Vander Werff, Robert Pegg, Zhao Cheng, and Sri Sritharan | 8. PERFORMING ORGANIZATION REPORT NO. | |
| 9. PERFORMING ORGANIZATION NAME AND ADDRESS Department of Civil, Construction and Environmental Engineering Iowa State University | 10. WORK UNIT NUMBER | |
| 13. TYPE OF REPORT AND PERIOD COVERED Final Report January 2011-July 2015 | | 14. SPONSORING AGENCY CODE 913 |

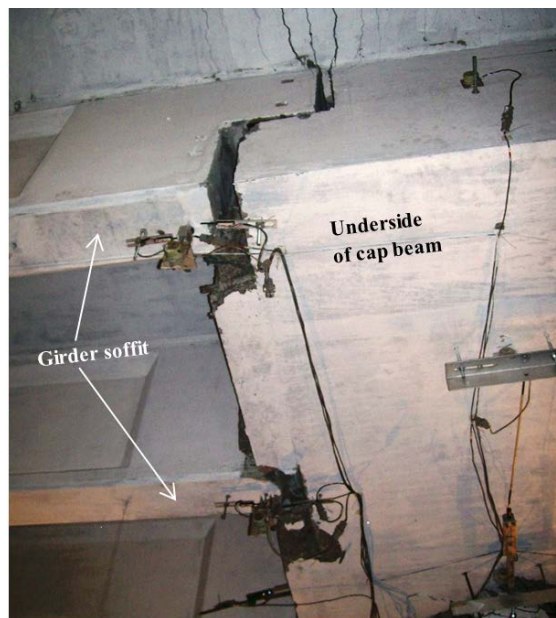
Figure 2.1: Opening of as-built connection under large positive-moment load

The loss of tension resistance for the positive moment direction resulted in the superstructure behaving essentially as if the as-built connection region was a pin, with limited rotational resistance when subjected to large positive moments. This type of behavior is schematically illustrated in Figure 2.2. The deterioration of the rotational resistance in the as-built connection in the positive-moment direction resulted in diminished ability to generate large positive moment action in the improved connection, since additional vertical displacement at the girder ends would

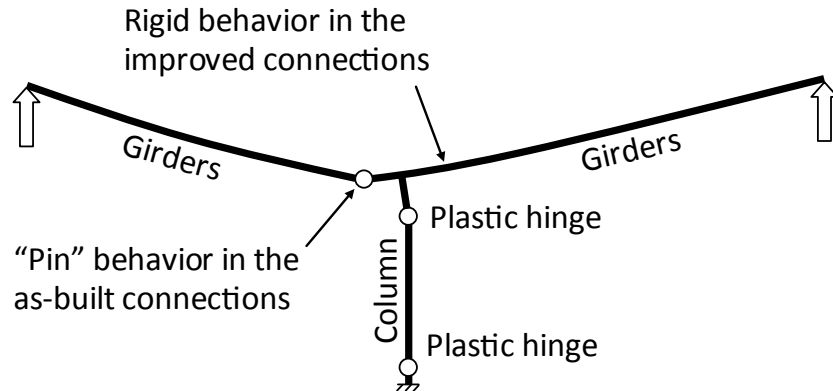
Figure 2.2: Schematic of system test superstructure behavior with girders subjected to large upward vertical displacements

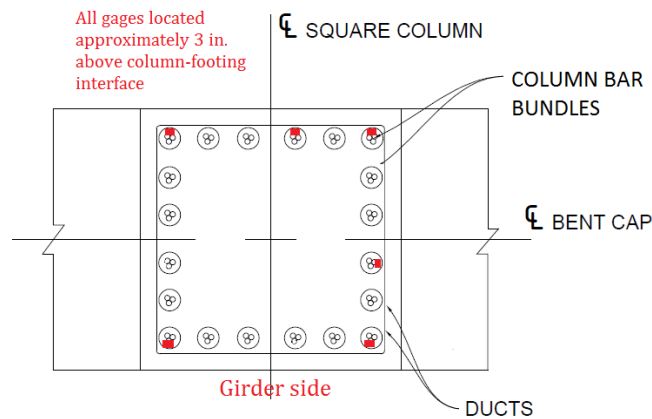
Figure 3.5: Column strain gages

Figure 3.5 shows the locations of the strain gages on the column longitudinal bars. The column was designed to remain elastic throughout the connection test, acting as a fixture in the test unit and not as prototype-modeling component. Therefore, the strain gages were included on the column reinforcement simply to monitor the column condition and ensure that it was not being overstressed during the connection tests. Gages were located on the corner bars to monitor strains from moment about either axis, and bars nearer the neutral axis were gaged to monitor strains related to axial loading.

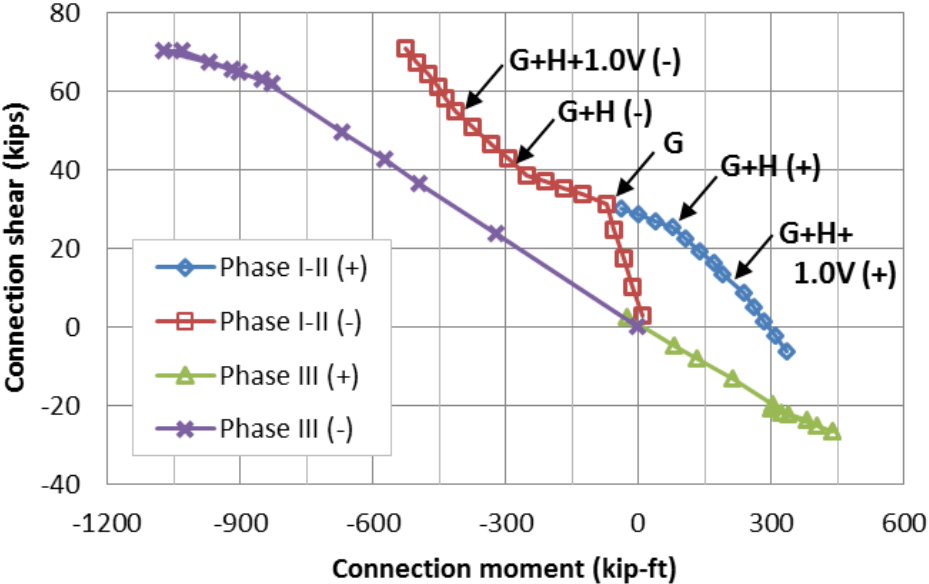
Figure 3.18: Connection shear resistance in GUSC

Figure 3.18 shows the connection shear at the first load/displacement peaks during the GUSC test (a very similar pattern was used for the LUSC test) plotted as a function of connection moment. The initial portion of the boxed pattern shows the load incrementally advancing to the full gravity condition. Then the remainder of the boxed pattern extending to higher shear values and larger negative moment values shows the negative shear and moment conditions advancing

through horizontal seismic and into large vertical acceleration simulations. The diamond patterns show the conditions associated with positive moment during the horizontal seismic simulation initially and concluding with the larger vertical acceleration simulations. The “x” and triangle patterns show the large force/displacement conditions that were not simulations of any specific prototype conditions but rather were intended to fully exercise and quantify the connection behavior.

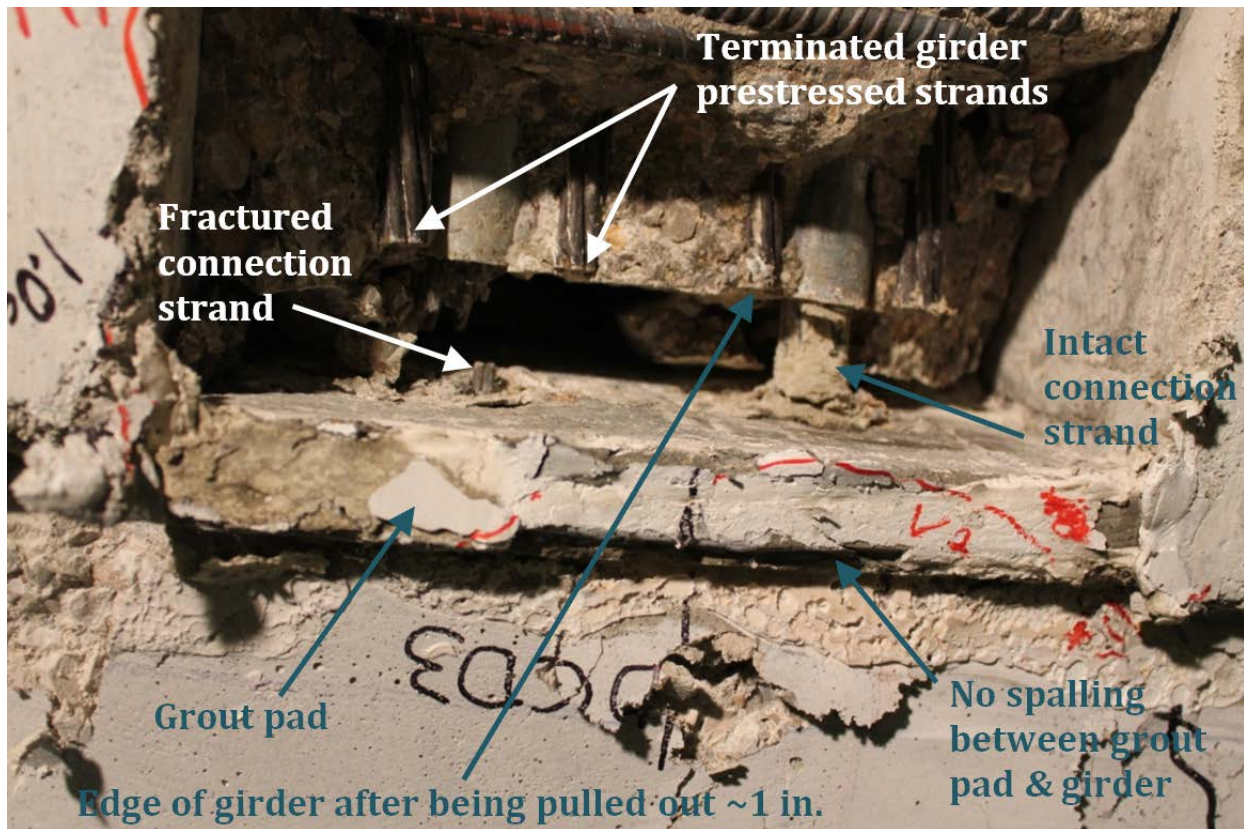
Figure 3.19: GUSC girder-cap interface during peak positive-moment displacement (looking up)

The concrete in the connection region of the GUSC detail remained largely intact for the duration of testing. The primary failure mechanism of the connection was the fracture of one of the connection strands. Figure 3.19 provides a view looking straight up into the connection region at the girder-to-cap interface under the maximum positive moment displacement. The strand on the right in the photograph is seen to have remained intact, while the strand on the left fractured. The photograph also shows that, even at this extreme stage of the test, the grout pad between the girder vertical face and the cap beam girder face remained in place, held by the unstressed strand.

Fracture of the strand as the primary failure mechanism is significant for a couple of reasons. First, its fracture indicated that the grout on both sides of the interface (in the cap beam as well as in the girder bottom flange) provided sufficient anchorage to fully develop the strength of the strand. As mentioned earlier, a load cell was used to monitor the behavior of the strand at the back side of the cap beam. This monitoring revealed that, for the duration of the test, no load was transferred at the strand's anchorage point; thus, the grout/strand bond in the cap beam was sufficient to completely anchor the strand. Second, the fracture of the strand under positive moment loading indicated that the strand played a significant frictional role in providing positive moment connection capacity, as per the design intent.

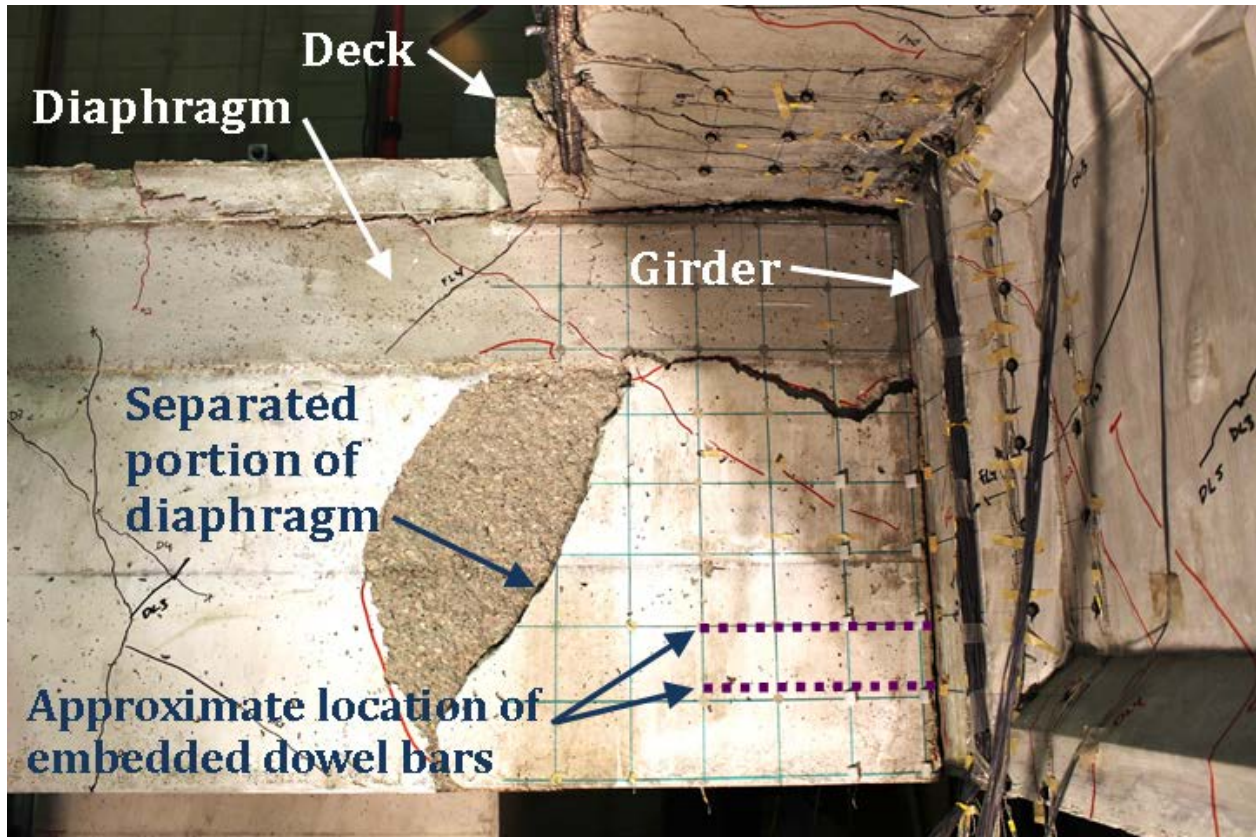
Figure 3.20: Condition of the diaphragm of LUSC detail at peak positive (upward) girder displacement of 4.5 in. at Actuator 2

The positive moment failure mechanism in the LUSC detail was not as straightforward as the GUSC detail. Observations at the conclusion of the LUSC test indicated that the failure of the connection under positive moment loading was related to the interaction of the diaphragm concrete, the looped strands, and the dowel bars. At the highest displacement cycles of Phase III loading, a clearly defined crack and separation of the diaphragm around the dowel bars was observed, as shown in Figure 3.20.

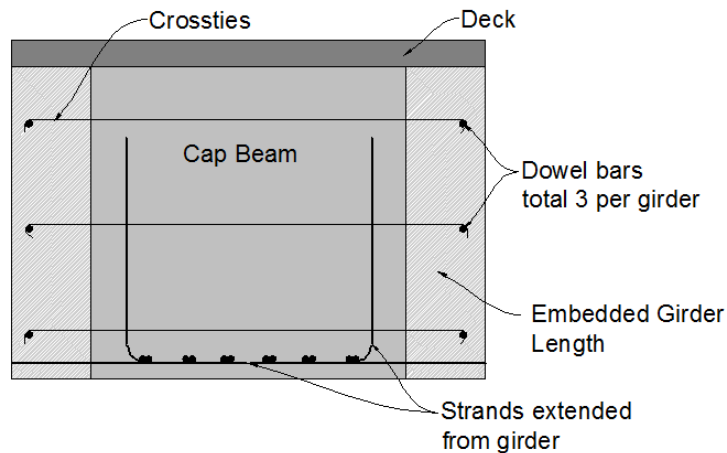
Figure 4.2: ESBF connection schematic

The first bulb-tee connection design was labeled as the Extended Strand Bent with Free end (ESBF) connection, and is shown in Figure 4.2. The connection utilizes extended strands bent at 90 degrees, three grouted bars placed through the girder web, and crossies which connect the dowel bars on each side of the cap beam.

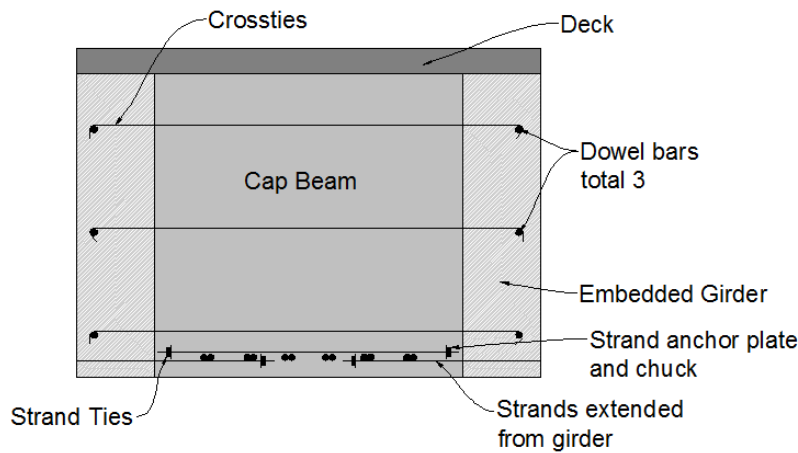
Figure 4.3: ESSP connection schematic

The second connection, known as the Extended Strand with Splice and end Plate (ESSP) connection, is shown in Figure 4.3. The extended strands and addition of strand ties in this connection were designed according to details used by the Washington Department of Transportation (WSDOT) (Khaleghi, 2012).

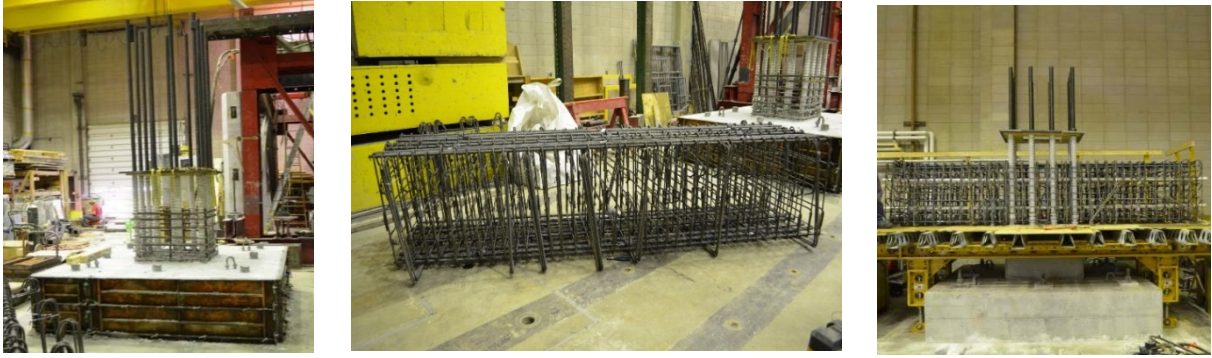
Figure 4.12: Footing and column pour (left); cap beam reinforcement cage (center); cap beam on platform (right)

The cap beam was constructed following the completion of the footing. Most of the reinforcement cage was tied on the floor (Figure 4.12) with ducts set in place for both the column and longitudinal post-tensioning. A platform was constructed around the cap beam and the cap was then lifted and lowered into place over the column post-tensioning bars (Figure 4.12). Strain gages were attached at specific locations on the cap and a portion of the cap steel was left unfinished until the girders were set in place.

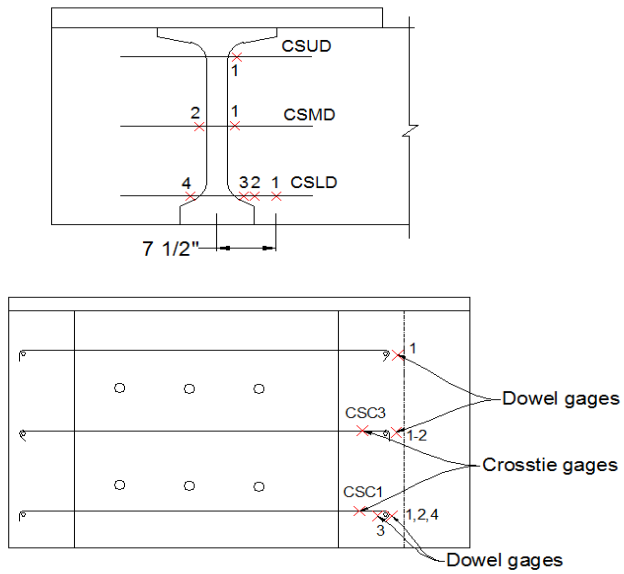
Figure 4.21: Dowel and crosstie gages

For both connections gages were also placed on the dowel bars and crossties as shown Figure 4.21. Gage labels are only shown for the ESBF connection (indicated by “CS” in label name) but gages were placed in the same locations for the ESSP connection. Three crosstie gages (CSC1-CSC3) were added with CSC1 and CSC3 placed on the column side of the connection and CSC2 placed on the lowest crosstie at the outside of the connection. A larger number of gages were placed on the lower dowel bars to better quantify the dowel resistance for positive moments.

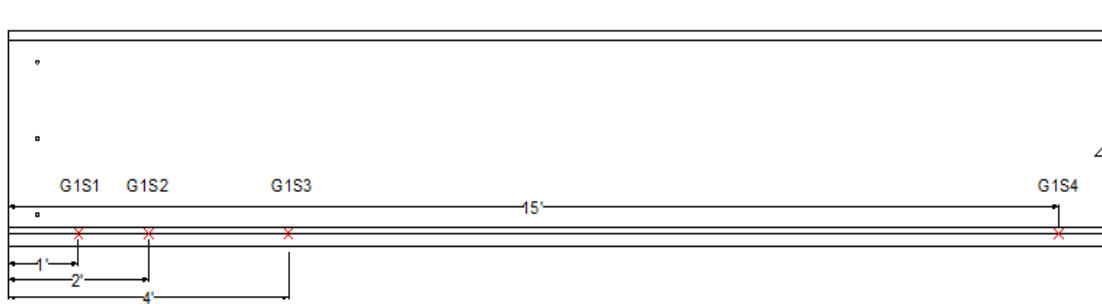
Figure 4.22: Girder strand gages

Gages were also placed on the prestressing strands inside the girders as shown in Figure 4.22. The gages were attached after the strands were pulled to the proper prestressing force but before the girder concrete was cast. Strands were placed 1, 2, 4, and 15 feet from end of the girder and were located on the center strand noted in Figure 4.23. These gages would monitor the length of strain penetration into the girder caused by tension forces under positive moments. Gages were also placed on the top layer of deck steel to monitor the deck reinforcement strains under negative moments as shown in Figure 4.24.

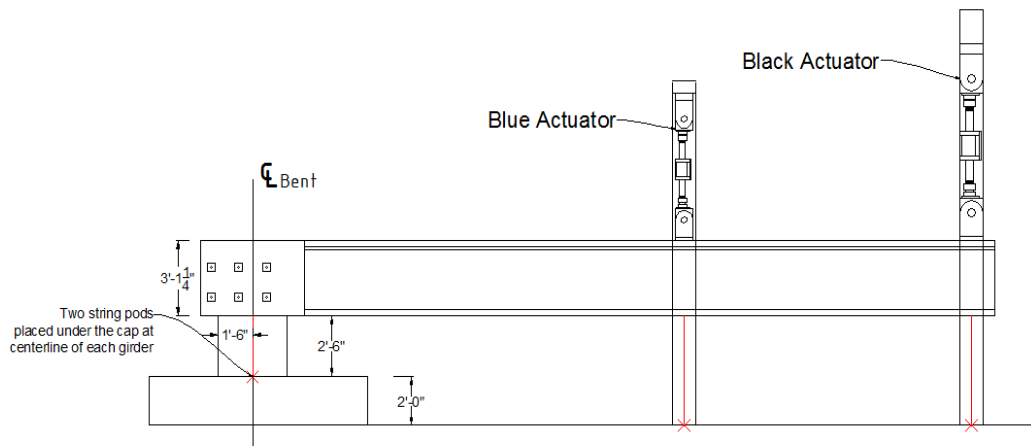
Figure 4.27: Location of vertical string pots

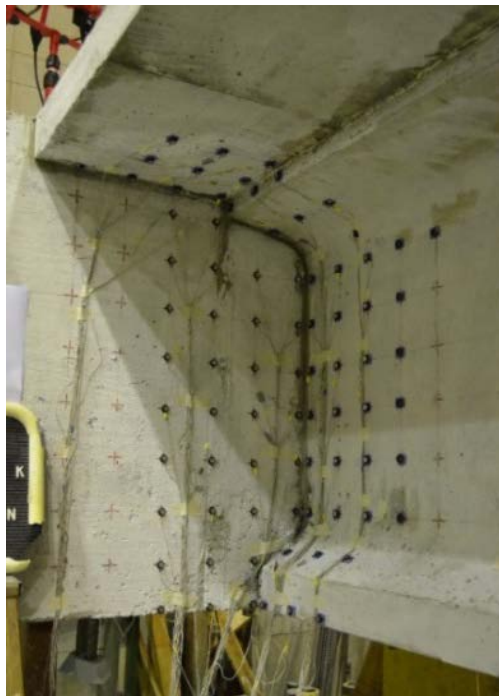
Figure 4.28: LED configuration at connection region

An Optotrak camera system was used to record 3-dimensional movement on the surface of the connection region. LED sensors were glued to the inside region of each connection as shown in Figure 4.28. During the testing of each connection, the Optotrak camera recorded the movement of the LED's which would allow surface displacements and cracking to be measured.

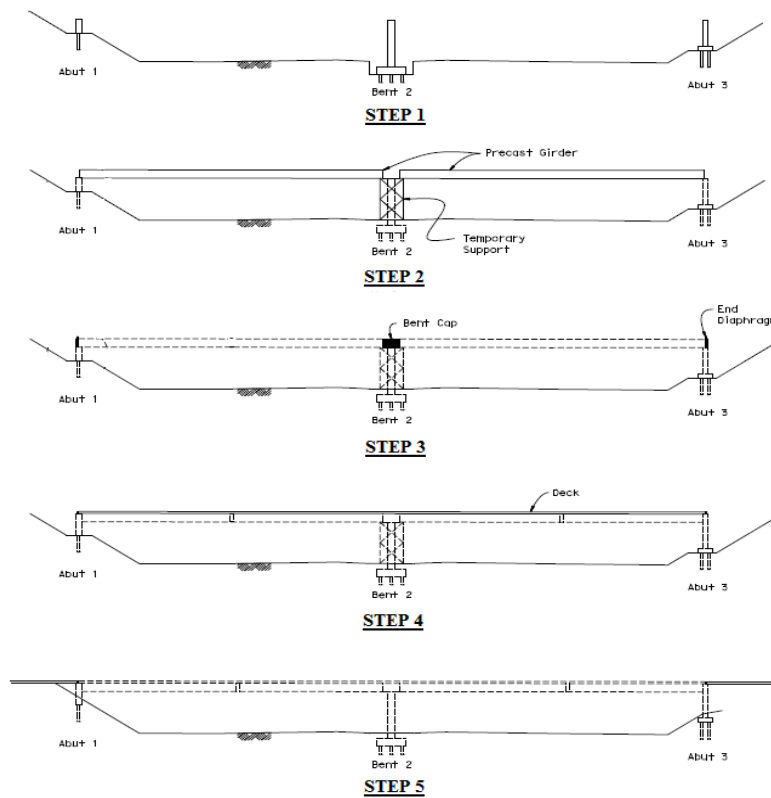
Figure 4.30: Construction sequence (Caltrans, 2013)

The construction process for a cast-in-place cap is similar to that of the precast girder with the exception that falsework is used at the bent cap location to support the girder throughout the construction process as shown in Figure 4.30.

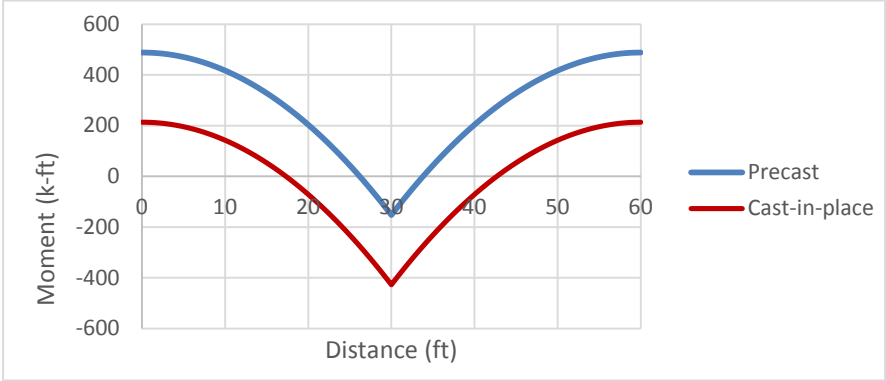
Figure 4.31: Moment difference between precast and cast-in-place cap beam

The gravity moment generated by the two types of cap are different, however, it is important to note that for both bent caps the shear at the connection is the same due to an equal shear transfer in both cap types. A test unit moment diagram showing the difference in gravity moment for the two bent caps is shown in Figure 4.31 with the girder to cap connection occurring at 30 ft.

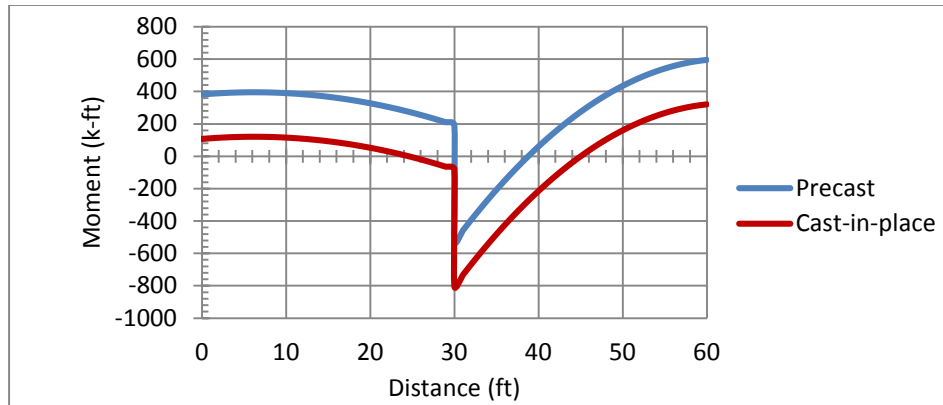
Figure 4.32: Moment difference at gravity + horizontal seismic + 0.5gV

Due to the difference in gravity load, the effects of seismic forces on the girder to cap connection are also different. Horizontal and vertical ground acceleration due to seismic activity cause both positive and negative moments, these moments are added to the gravity moment of the structure with negative moments acting in the same direction as the gravity moment and positive moments acting in the opposite direction. The addition of positive and negative moments to a precast cap results in the connection being subject to higher positive moments and lower negative moments than the cast-in-place cap as shown in Figure 4.32. The difference in the connection moment stems from the larger gravity moment of the cast-in-place cap which must be overcome for the connection to experience a net positive moment.

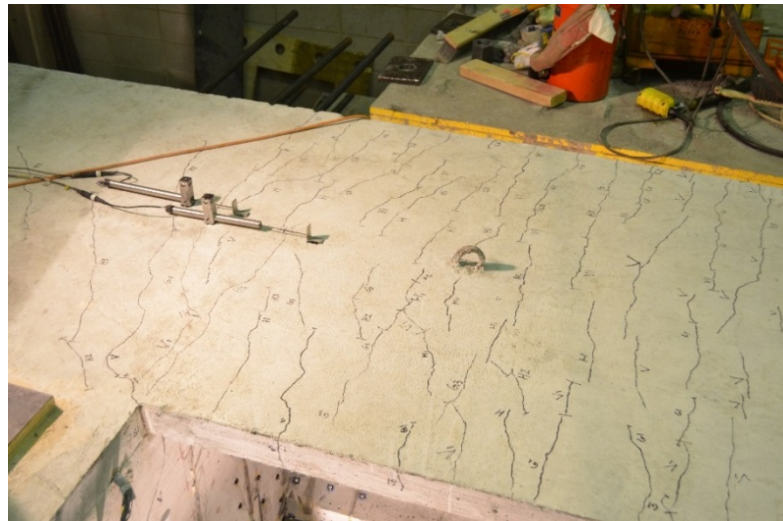
Figure 4.39: Girder cracking due to negative moment

The ESBF connection was loaded following the previously outlined loading protocol. Damage was limited to small cracks on the deck for load steps up to the gravity (G) + horizontal seismic load (H). The girder was then loaded to (G)+(H)+0.5g vertical acceleration (0.5gV). Girder cracking began to occur near the connection region due to application of negative moment at the load G+H+0.1gV. At G+H+0.5gV multiple cracks were present in the deck and girder as shown in Figure 4.39. Under positive moment, a 1/16 in. gap opened between the bottom of the girder and the cap beam at G+H+0.5gV. There was also a small amount of cracking on the side of the cap beam near the girder interface as shown in Figure 4.40. After reaching 0.5gV, the cap was post-tensioned to provide higher torsional capacity before increasing the loads to G+H+1.0gV. More damage occurred in the connection region as loading increased above 0.5gV. Under negative moment cracking continued to increase on the bridge deck and girder. The gap between the girder and cap beam due to positive moment widened throughout the loading cycle reaching a maximum opening of 3/32 in at G+H+1.0gV.

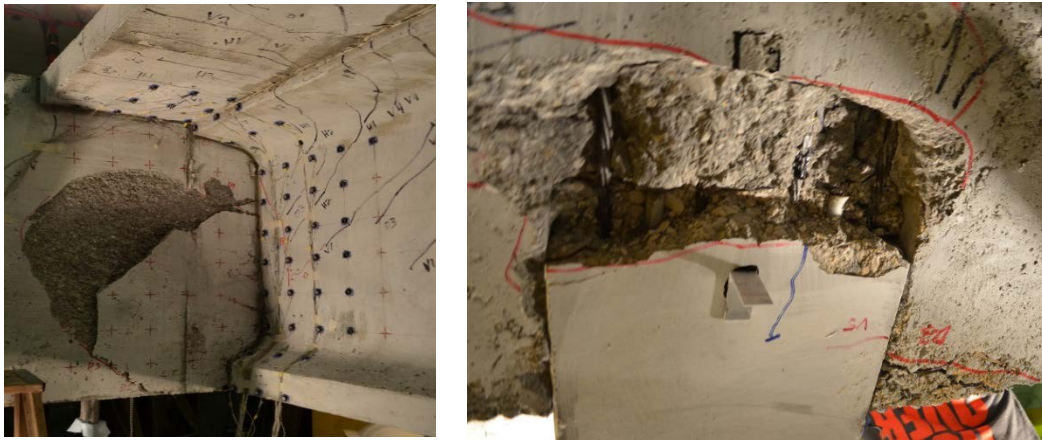
Figure 4.41: Spalling of cap and girder cover concrete

After the load of $G+G+1.0gV$ was reached, the test unit actuators were placed in displacement control since the connection was beginning to exhibit inelastic behavior. Controlling the actuators by displacement allowed the capacity of the connection to be fully quantified. The connection was cycled through a series of load steps for the displacement cycle as outlined in the loading protocol (Figure 4.37). Positive values of displacement corresponded to downward movement of the girder and negative moments while negative values of displacement corresponded to upward movement of the girder and positive moments. The blue actuator was held at a constant force value in each loading direction in order to apply a consistent shear at the connection interface. For the displacement cycles, the values of girder displacement measured at the black actuator location began at +2 in./-1 in. and were gradually increased until the ultimate displacements of +15 in./-7.5 in. were reached. As the displacement cycles were increased, cracking continued in the deck and girder due to negative moments. The girder also began to pull away from the deck as damage to the cap beam increased. A large amount of cap cover concrete began to spall due to the rotation of the dowel bars under positive and negative moments as shown in Figure 4.41. Concrete also began to spall at the bottom of the girder to cap connection as shown in Figure 4.41. Under positive moment the gap between the girder and cap widened and exposed the extended strands (Figure 4.41). During the displacement cycles the DCDT's at the column to cap connection were monitored to prevent decompression of the column post-tensioning bars. No movement was observed at the column to cap interface.

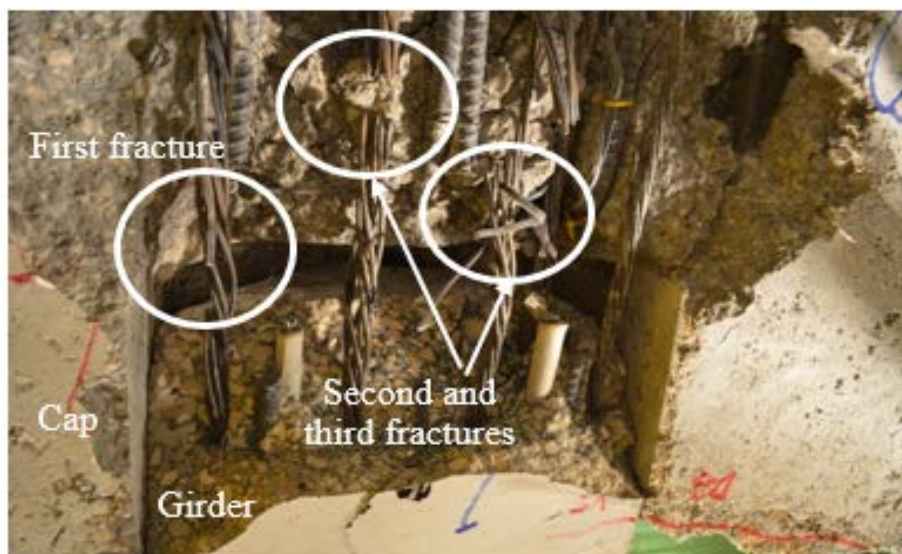
Figure 4.42: Fracture of extended strands

During the displacement cycles one of the extended strands fractured which decreased the positive moment capacity of the connection. At the ultimate displacement of +15 in./-7.5 in. two more of the extended strands fractured as shown in Figure 4.42. After strand fracture, the positive moment capacity of the connection greatly decreased and testing of the connection was ended. The final condition of the connection is shown in Figure 4.43.

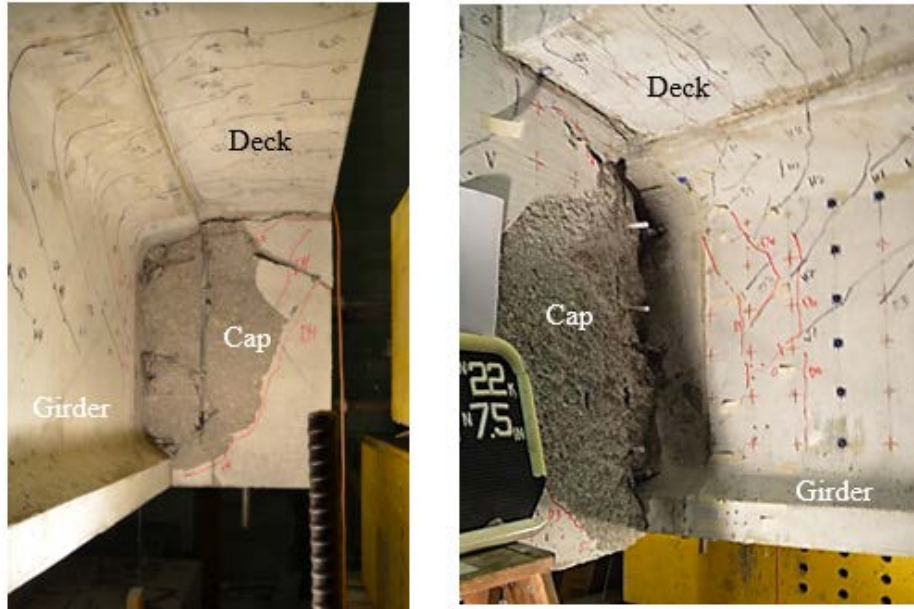
Figure 4.43: Final condition of connection region

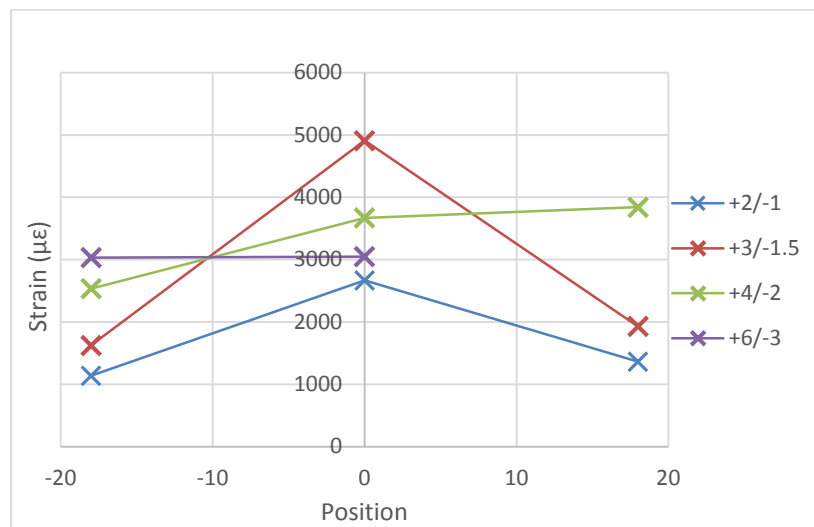
Figure 4.45: Strain profile of deck steel

The ultimate capacity of the connection in the negative direction was less than originally expected. The yield moment for the deck steel was originally calculated to be -940 k-ft, however, the yield moment of the test was around -615 k-ft. The predicted yield moment of -940 k-ft assumed that all the deck steel yielded simultaneously. The strains recorded in the deck steel during the test indicated that the rebar in the center of the deck reached yield sooner than rebar closer to the edge of the deck as shown in Figure 4.45 where zero position represents the center of the deck. The rebar in the middle of the deck began to exhibit inelastic behavior before yielding of the outer deck steel which caused the connection to behave in an inelastic manner at a lower than predicted moment value of -615 k-ft.

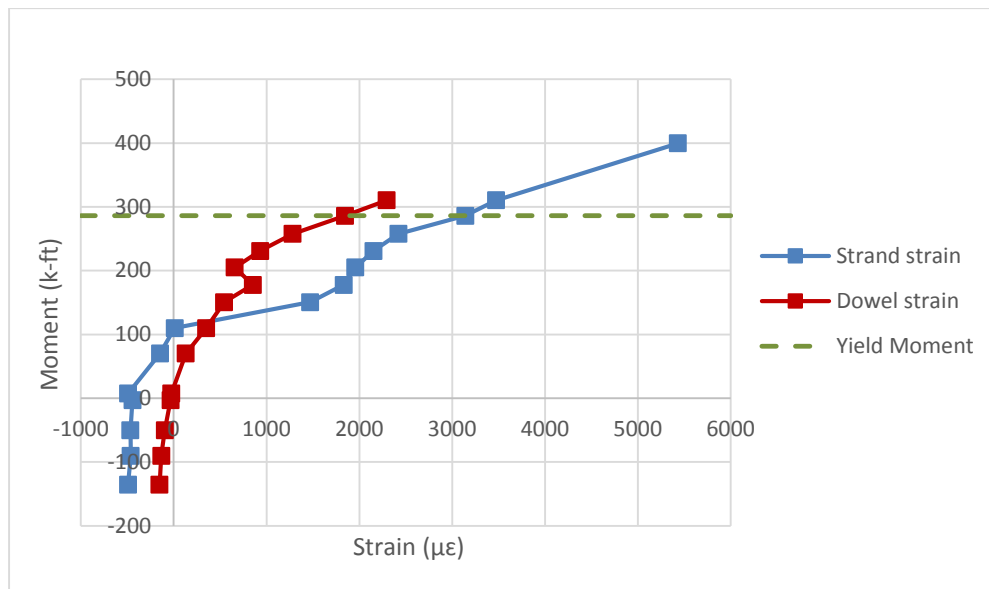
Figure 4.46: Strand and dowel bar strains

The response of the extended strands and dowel action was examined to further understand the behavior of the connection during positive moments. The positive yield moment of the connection was defined as the moment at which inelastic behavior began and was found to be 286 k-ft. At this moment value, the strain in the extended strands at the connection interface was 3100 $\mu\epsilon$ and the dowel bar strain was 1800 $\mu\epsilon$ as shown in Figure 4.46. These strain values were then converted to stresses and moment resistance using an equivalent stress block approach. It was found at the yielding of the connection that the moment resistance of the strands was 111 k-ft and the moment resistance due to dowel action was 175 k-ft.

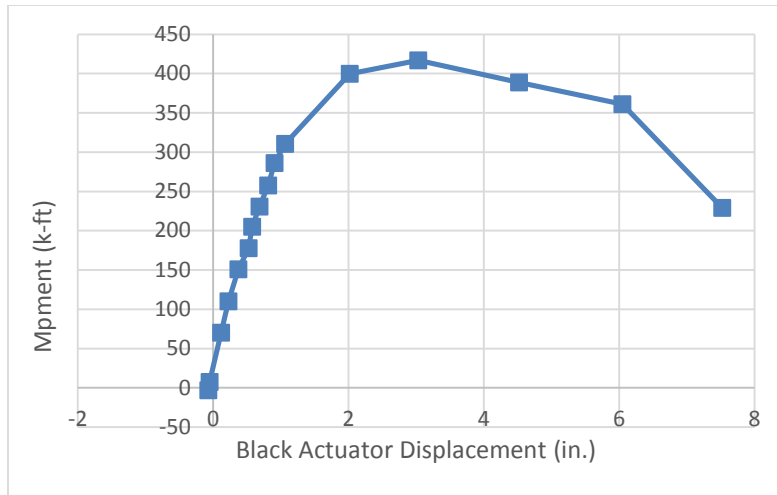
Figure 4.47: Moment decrease in ESBF connection

The ESBF connection reached ultimate condition in the positive direction with a displacement at the black actuator of -3 inches. The girder was then cycled through displacement of -4.5, 6, and -7.5 inches. The strand strain continued to increase and the concrete adjacent to the girders began to spall. At each displacement cycle beyond -3 in. the positive moment capacity of the girder decreased as shown in Figure 4.47. The decrease in moment at the displacement of -4.5 in. occurred due to cracking of the concrete adjacent to the girder around the lower dowel bar as well as the partial fracture of one of the extended strands. At -6 in. of displacement the moment loss was due to the continued loss of concrete adjacent to the girder which caused the moment capacity of the dowel bars and concrete friction to decrease. At a displacement of -7.5 inches a large drop in capacity was caused by the fracture of a second and third strands.

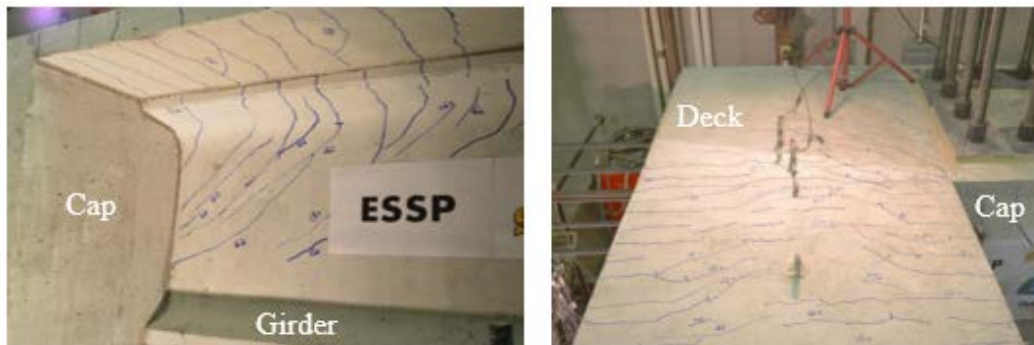
Figure 4.49: Cracking caused by overloading

the testing was stopped due to the concern that too large of forces were being input into the connection since little to no cracking should have occurred at such a low load level.

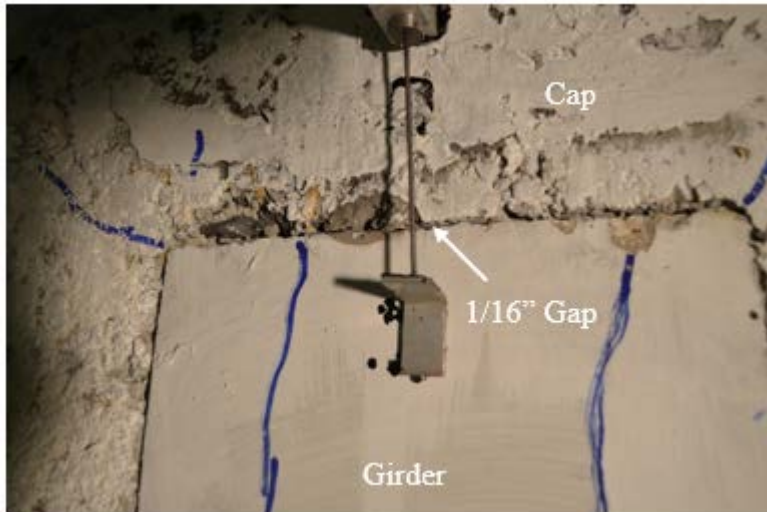
Figure 4.50: Girder to cap gap opening

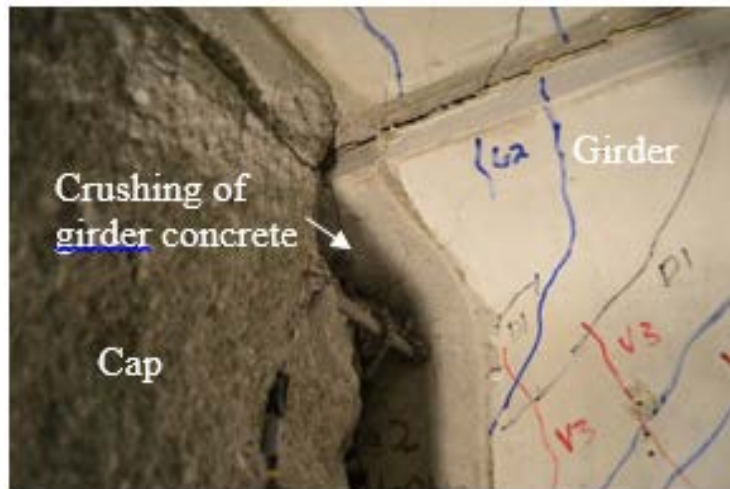
Figure 4.53: Crushing of girder concrete

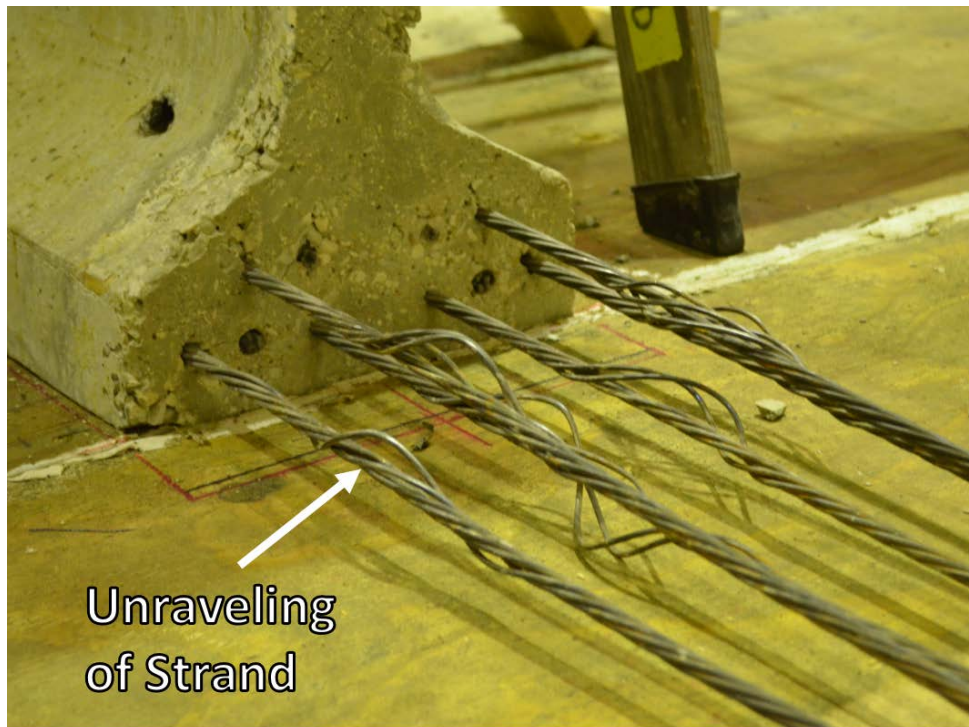
Figure 5.10: Unraveling of portion of unstressed strands

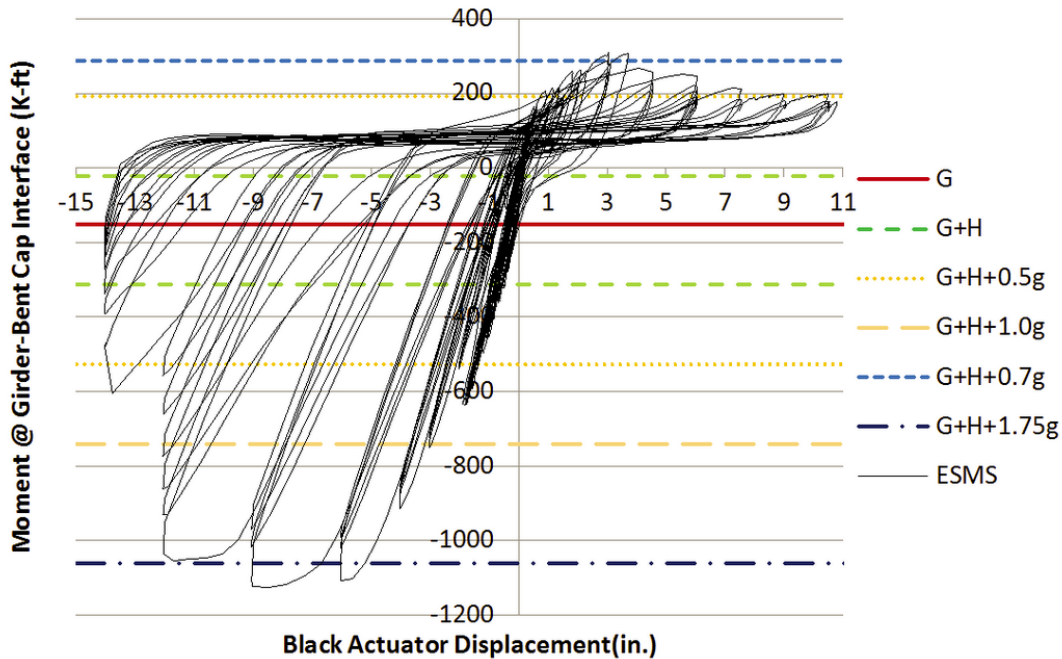
Figure 5.20: The measured moment resistance versus black actuator displacement for the ESMS connection

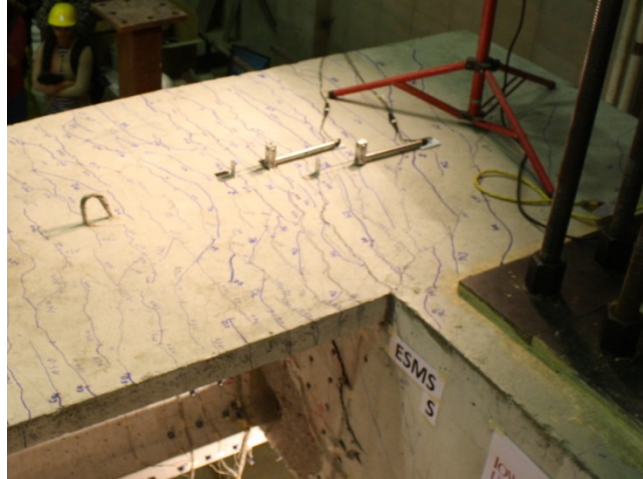
Figure 5.21: Flexural cracks formed on the deck of the ESMS Connection

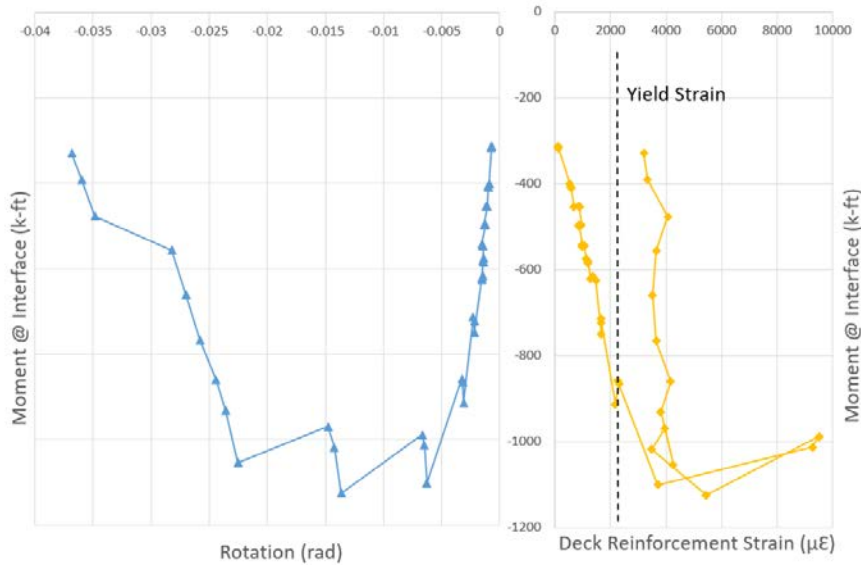
Figure 5.24: Negative moment versus rotation and negative moment versus deck reinforcement strain for the ESMS connection

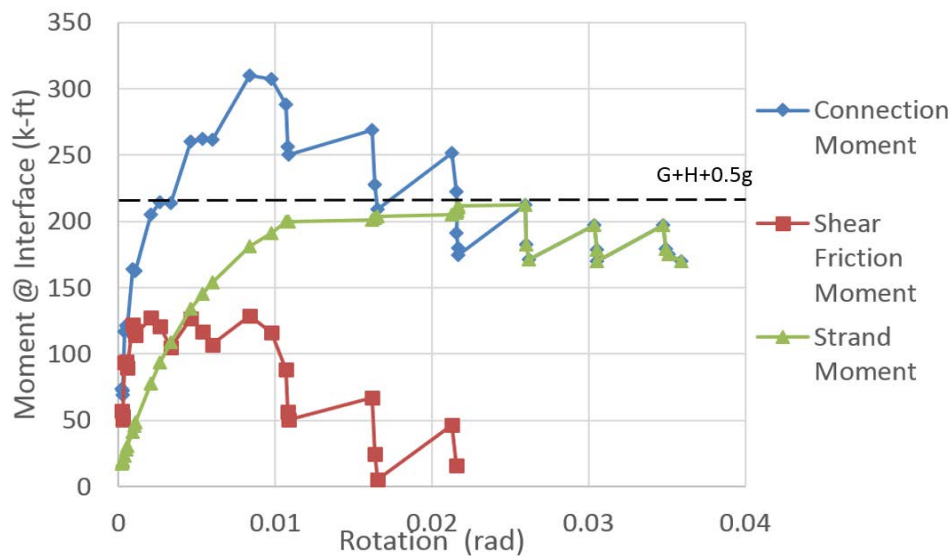
Figure 5.26: Estimating the contribution of the positive moment resistance in the ESMS connection

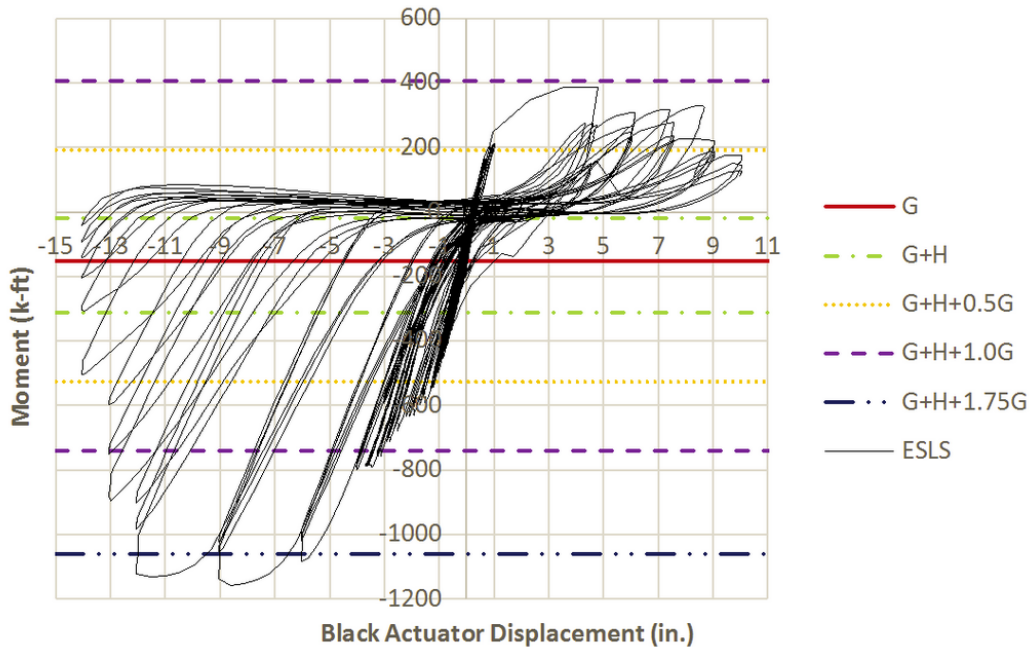
Figure 5.28: The measured moment resistance versus the black actuator displacement for the ESLS connection

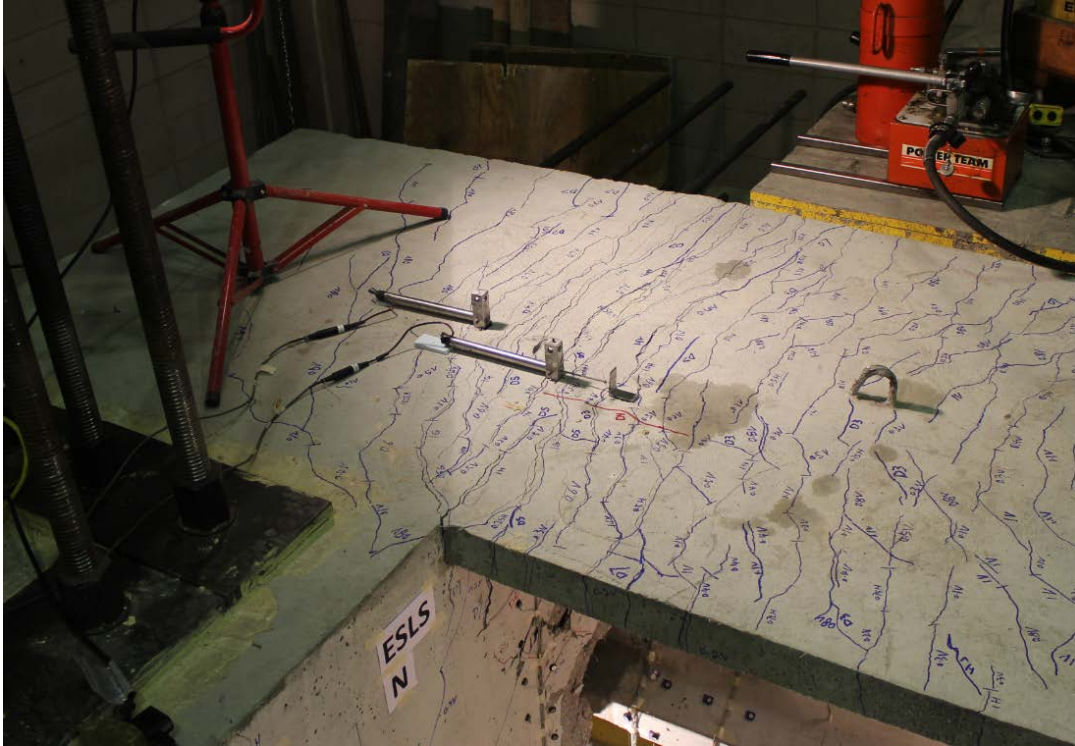
Figure 5.29 Cracks on Deck of the ESLS Connection

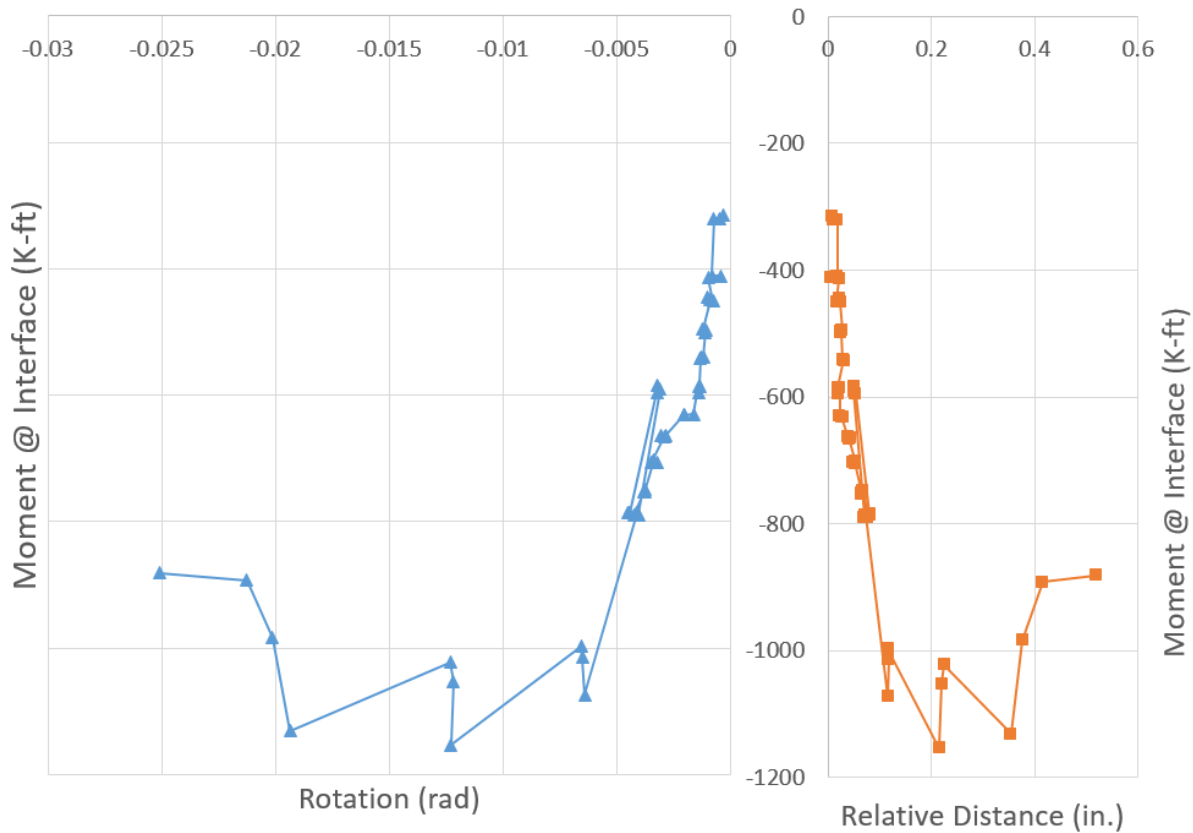
Figure 5.32: Negative moment versus rotation and negative moment versus relative displacement between girder end and bent cap for the ESLS connection

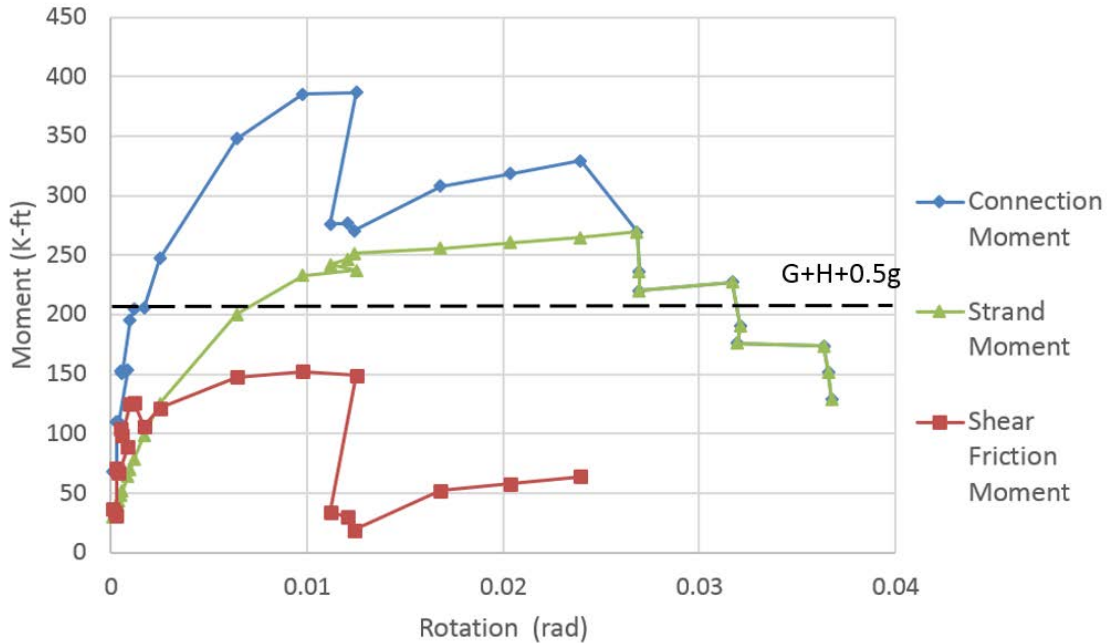
Figure 5.33: Positive moment versus rotation for the ESLS connection
