| 4. TITLE AND SUBTITLE Seismic Performance of Precast Girder-to-Cap Connections for Accelerated Bridge Construction of Integral Bridges | 5. REPORT DATE July 2015 | |
| 7. AUTHOR Justin Vander Werff, Robert Pegg, Zhao Cheng, and Sri Sritharan | 8. PERFORMING ORGANIZATION REPORT NO. | |
| 9. PERFORMING ORGANIZATION NAME AND ADDRESS Department of Civil, Construction and Environmental Engineering Iowa State University | 10. WORK UNIT NUMBER | |
| 13. TYPE OF REPORT AND PERIOD COVERED Final Report January 2011-July 2015 | | 14. SPONSORING AGENCY CODE 913 |

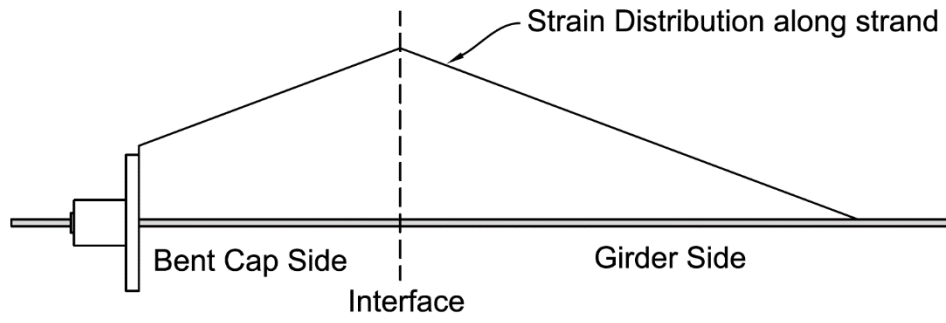
Figure 5.34: Strain distribution along strand in the ESLS connection

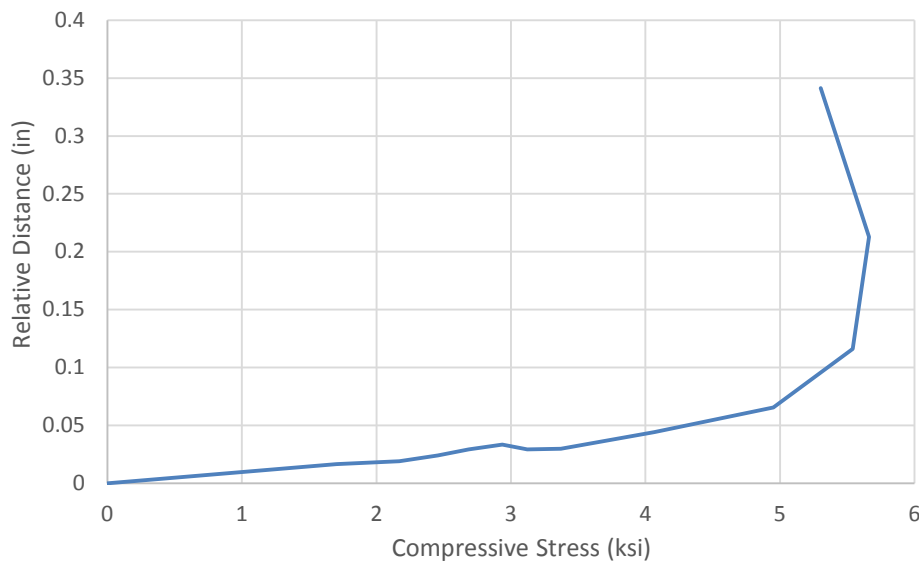
Figure 6.3: Experimental measured relative distance between bulb-tee girder end and bent cap

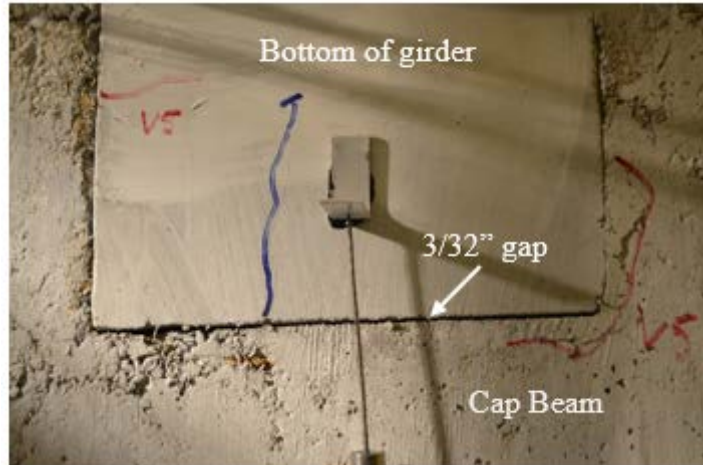
Figure 6.10: Gap observed between cap beam and bottom of girder

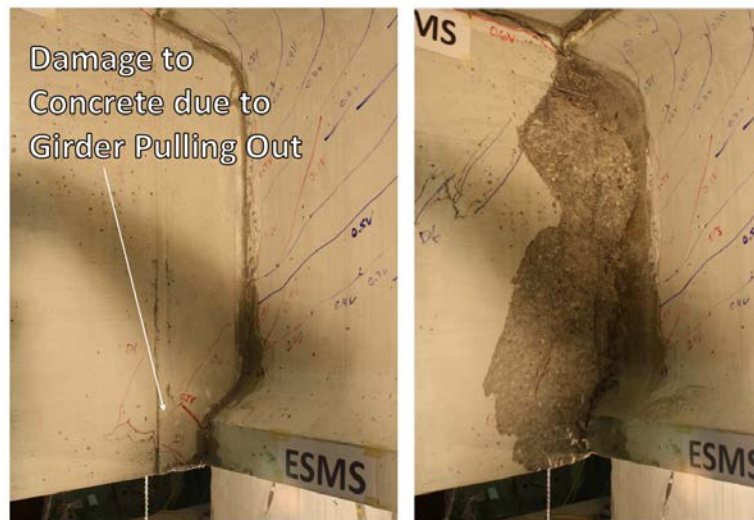
Figure 6.11: Damage to concrete due to girder pulling out on the diaphragm adjacent to the girder

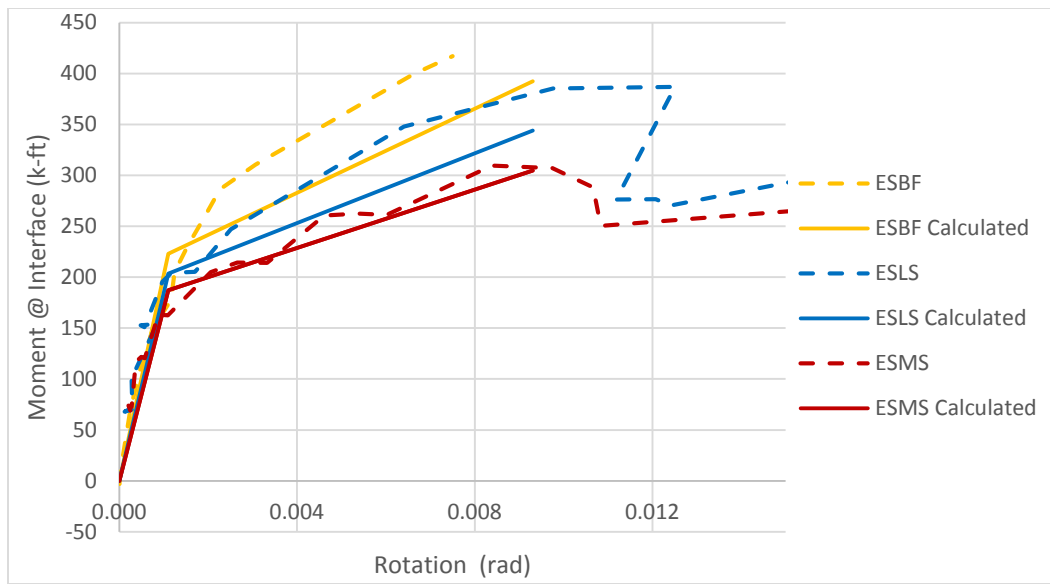
Figure 6.15: Comparison between calculated and the experimental positive moment to rotation response

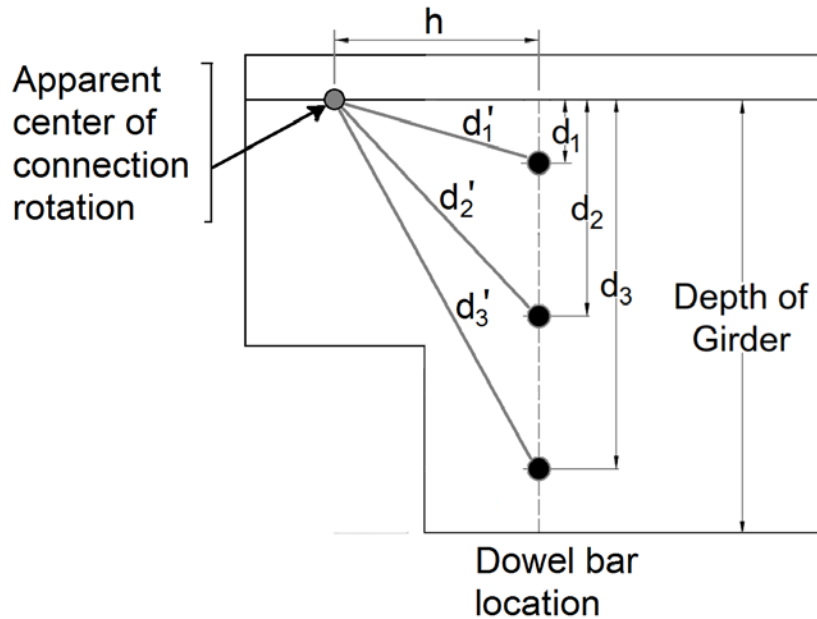
Figure 6.16: Modification to dowel bar distances about the girder rotation point for calculating the positive moment resistance for girder with dapped end

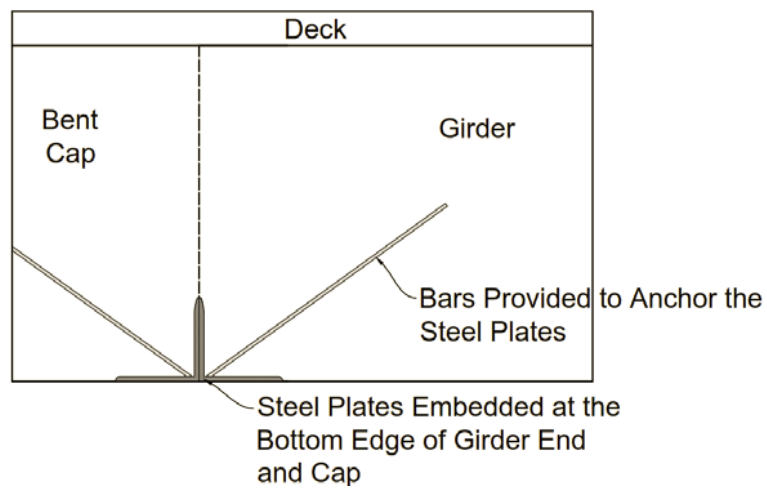
Figure 6.17: Location of steel angles in girder and cap beam

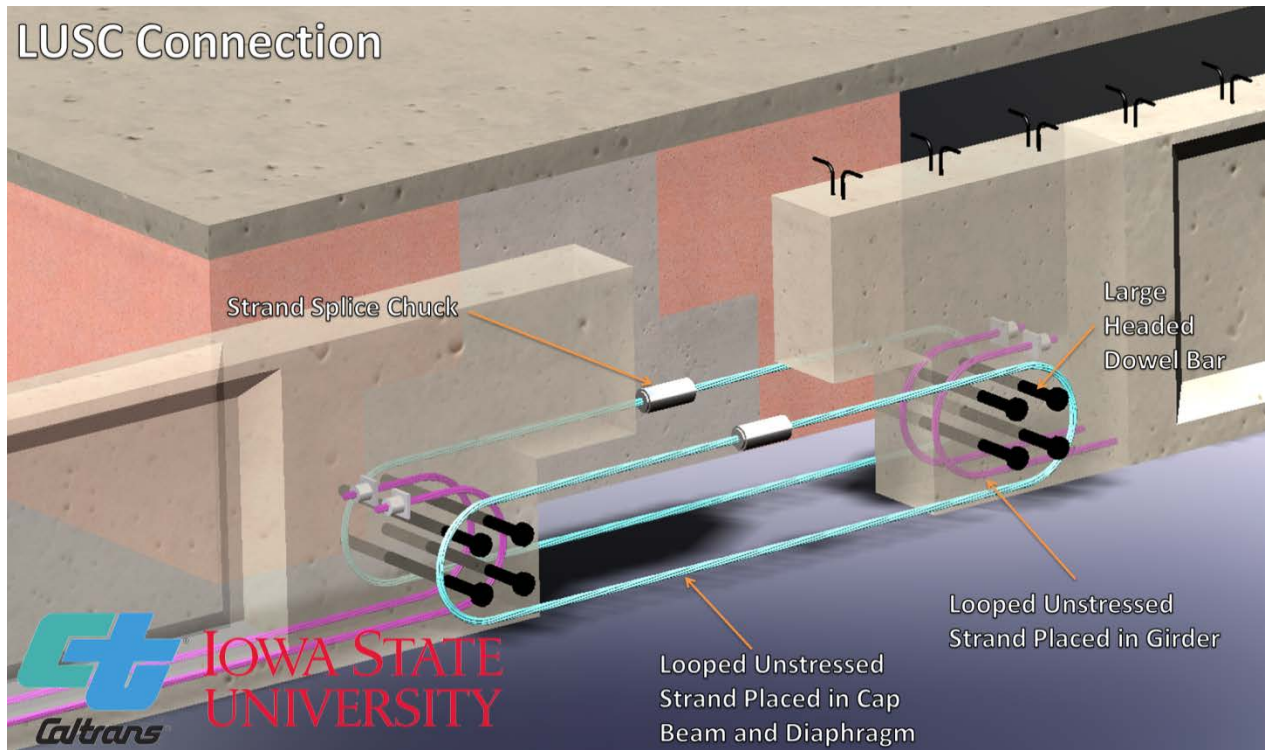
Figure 7.2: LUSC Connection Detail

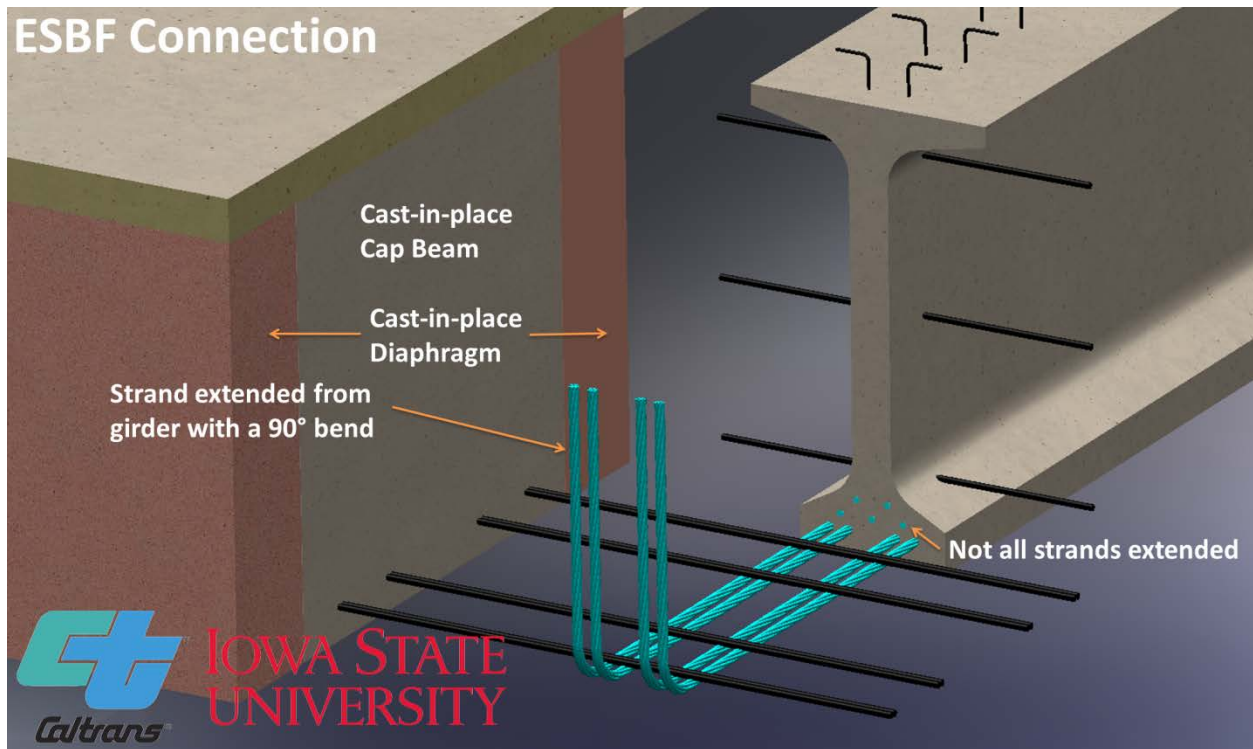
Figure 7.3: ESBF Connection Detail

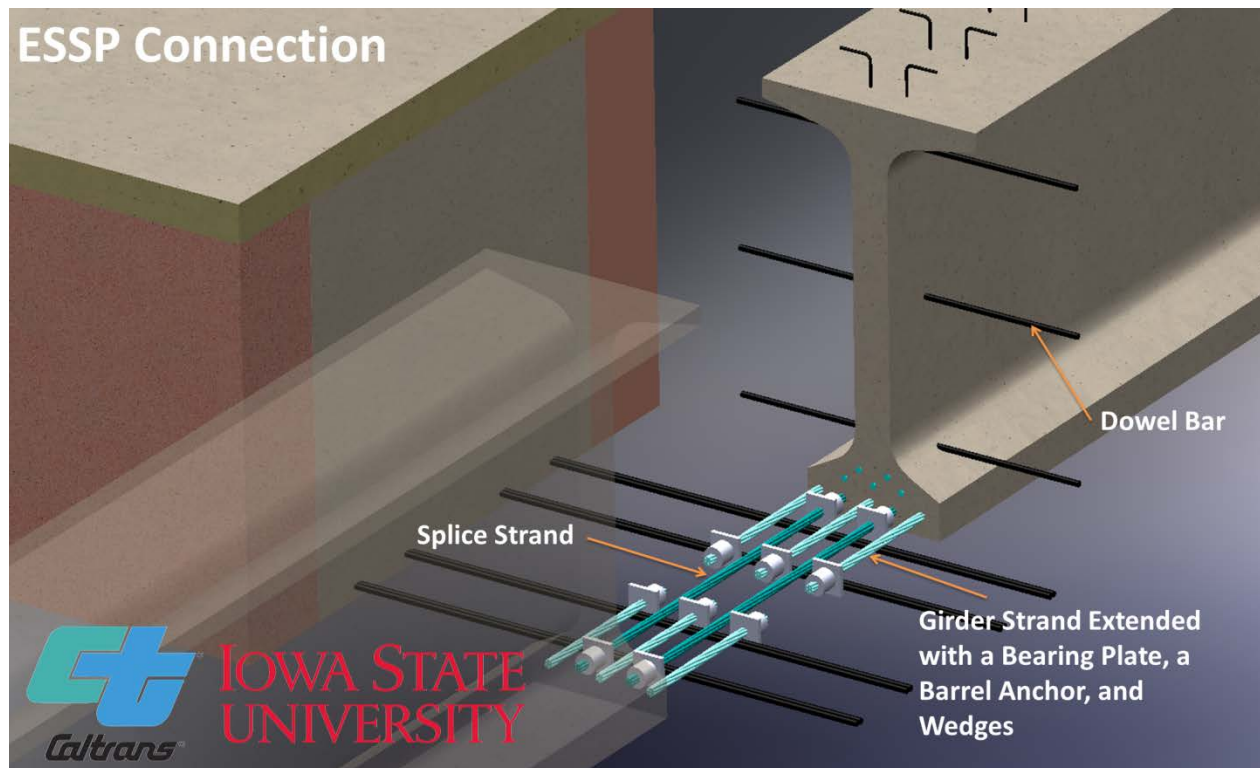
Figure 7.4: ESSP Connection Detail

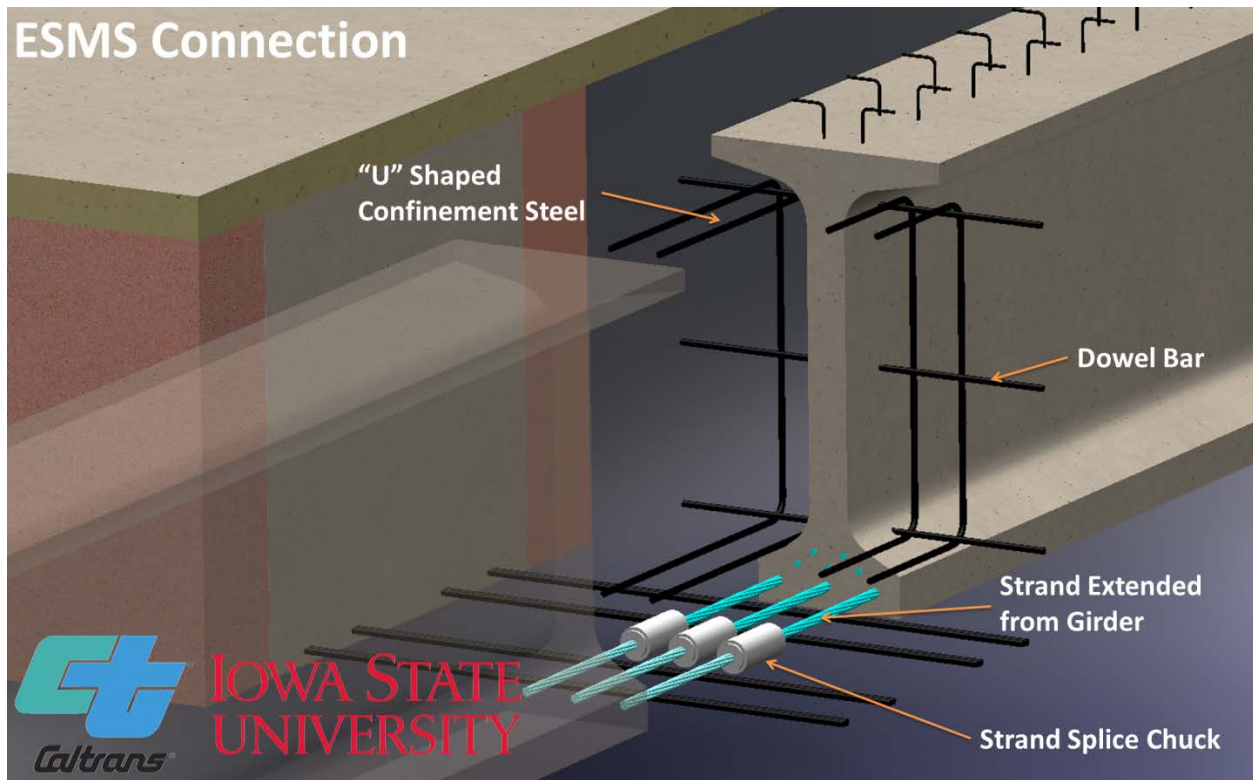
Figure 7.5: ESMS Connection Detail

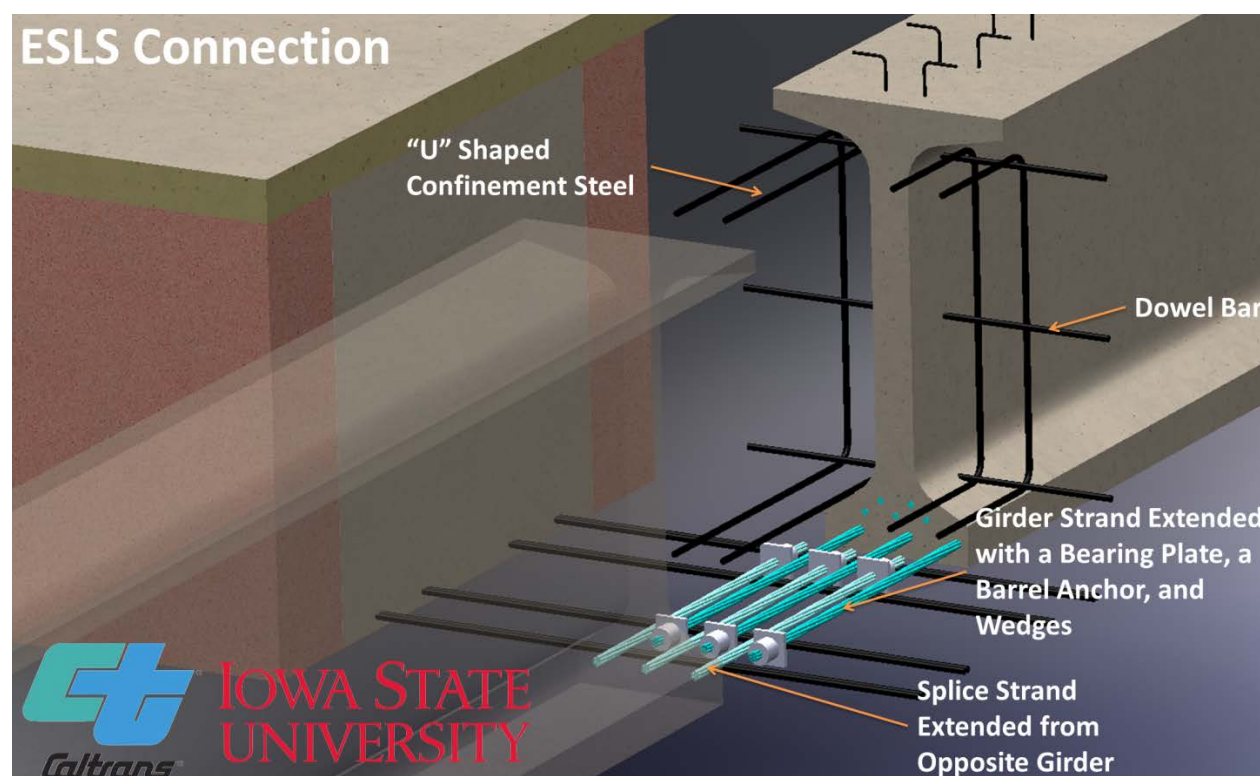
Figure 7.6: ESLS Connection Detail

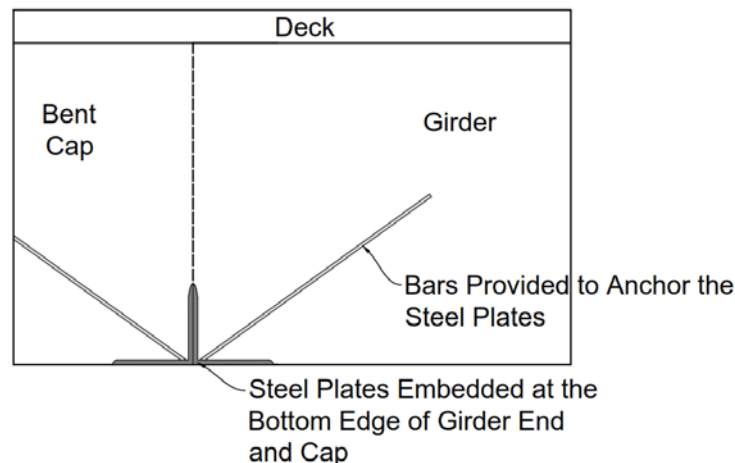
Figure 7.7: Location of steel angles in girder and cap beam

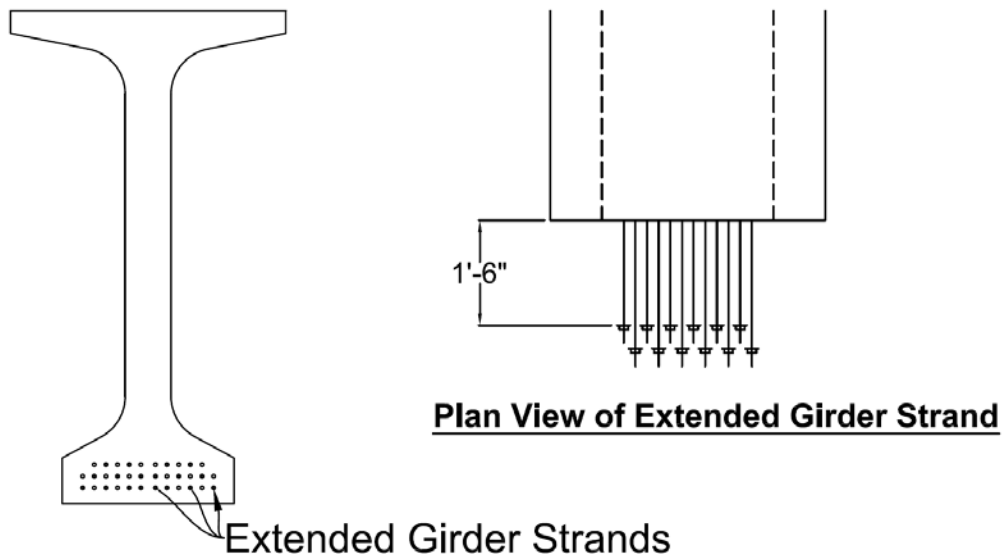
Figure E2: Extended girder strand details
