1. REPORT NUMBER CA11-1863A	2. GOVERNMENT ASSOCIATION NUMBER	3. RECIPIENT'S CATALOG NUMBER
4. TITLE AND SUBTITLE An Evaluation of Crack, Seat and Overlay in California (Phase II)	5. REPORT DATE January 18, 2011	
	6. PERFORMING ORGANIZATION CODE	
7. AUTHOR(S) Rahim, Ashraf and Fiegel, Gregg	8. PERFORMING ORGANIZATION REPORT NO.	
9. PERFORMING ORGANIZATION NAME AND ADDRESS California Polytechnic State University Department of Civil and Environmental Engineering San Luis Obispo, CA 93407	10. WORK UNIT NUMBER	
	11. CONTRACT OR GRANT NUMBER 65A0305	
12. SPONSORING AGENCY AND ADDRESS California Department of Transportation Division of Research and Innovation, MS-83 1227 O Street Sacramento CA 95814	13. TYPE OF REPORT AND PERIOD COVERED Final-April 2008 to November 2010	
	14. SPONSORING AGENCY CODE	
15. SUPPLEMENTAL NOTES

**AN EVALUATION OF THE CRACK, SEAT AND OVERLAY METHOD IN
CALIFORNIA**

Final Report

Department of Civil and Environmental Engineering
California Polytechnic State University
San Luis Obispo, CA 93407

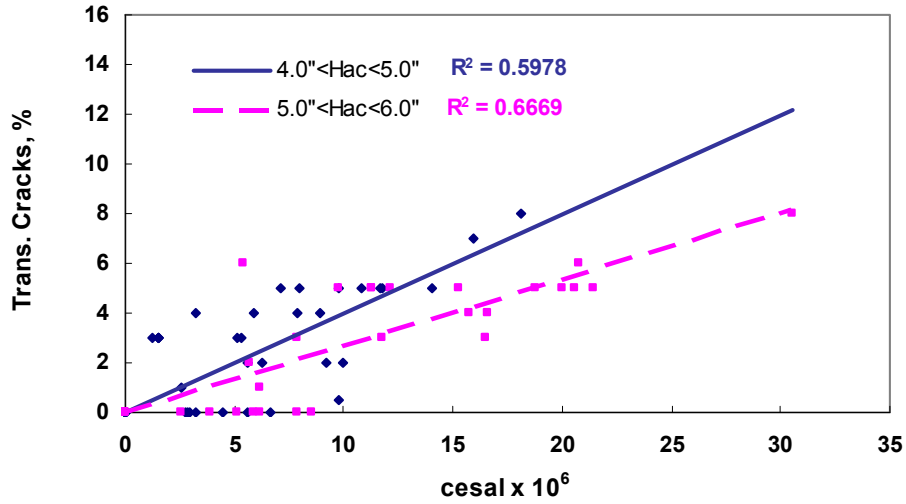
Figure 2.1 Transverse cracks for sections with different overlay thicknesses in the Central Valley.

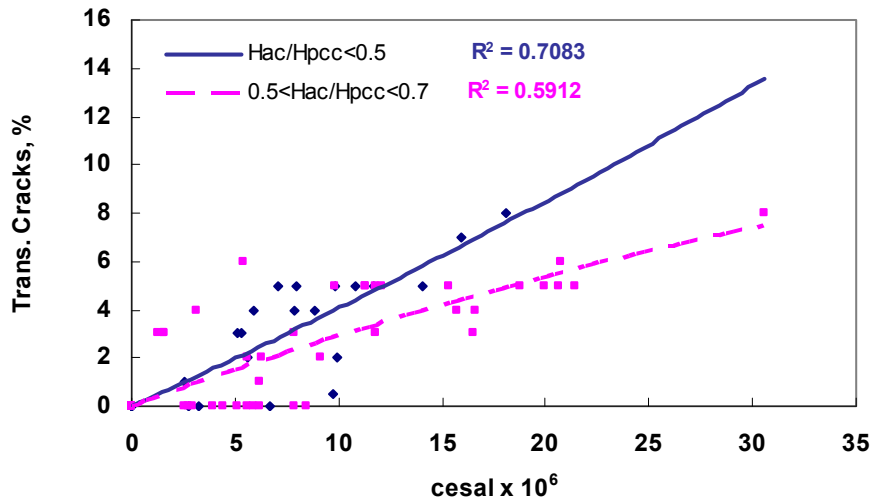
Figure 2.2 Transverse cracks for sections with different thickness ratios in the Central Valley.

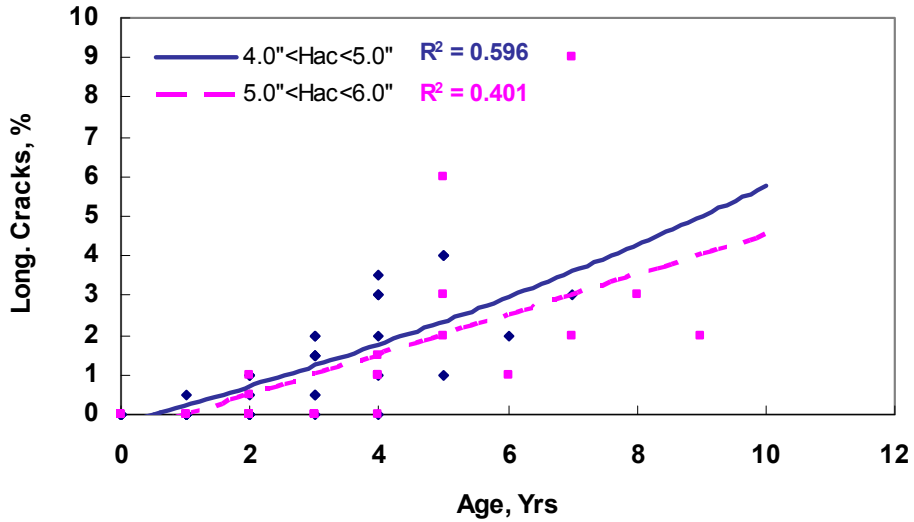
Figure 2.3 Longitudinal cracks for sections with different overlay thicknesses in the Central Valley.

2.3.4.3 Longitudinal Cracks: From the trend lines shown in Figures 2.3 and 2.4, the longitudinal cracks start at approximately the same time for the two overlay thickness and thickness ratio ranges, respectively. Overlays with thicknesses ranging from about 5 to 6 inches slightly reduced the percentage of longitudinal cracks over those with overlay

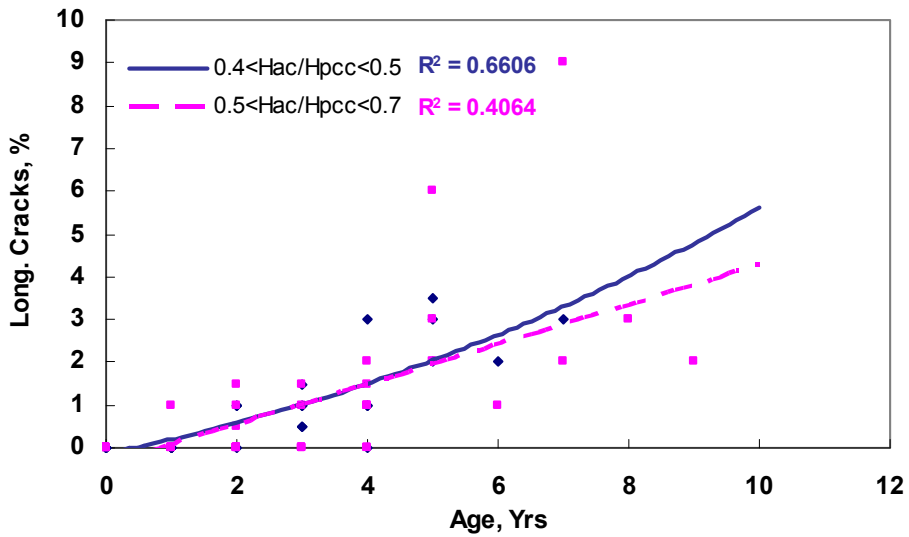
Figure 2.4 Longitudinal cracks for sections with different thickness ratios in the Central Valley.

thicknesses ranging from 4 to 5 inches. Similar trends are evident in Figure 2.4 for overlays with different thickness ratios.

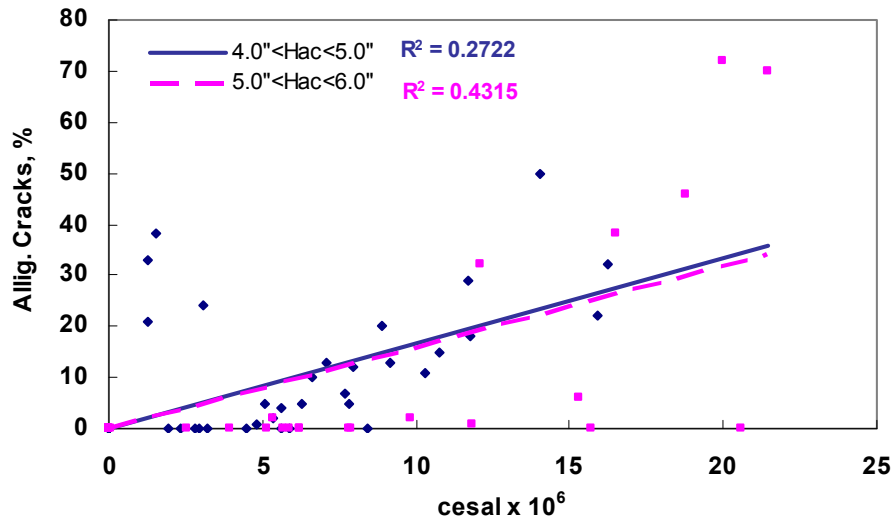
Figure 2.5 Alligator cracks for sections with different overlay thicknesses in the Central Valley.

2.3.4.4 Alligator Cracks 'A' and 'B': For the range of data available and from the trend lines in Figures 2.5 and 2.6, it can be seen that overlay thickness ratio has a more

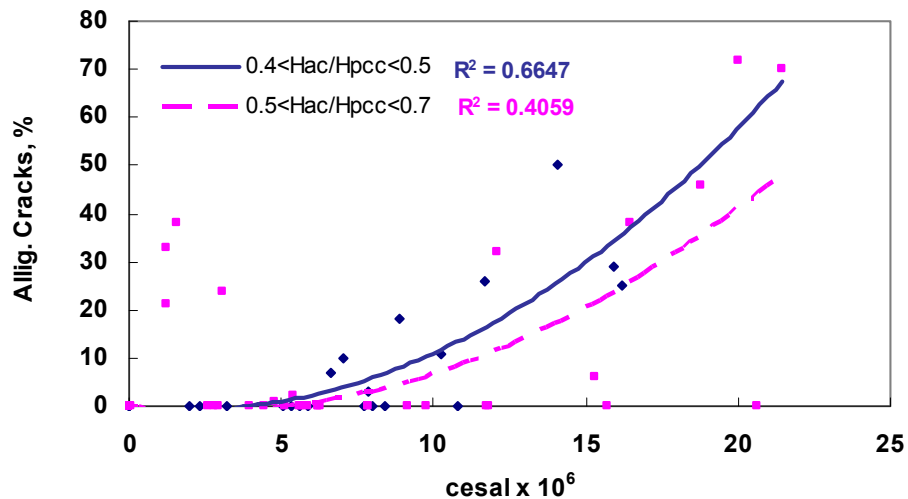
Figure 2.6 Alligator cracks for sections with different thickness ratios in the Central Valley.

significant effect on alligator cracking than the thickness of overlay itself, especially at high cumulative traffic levels. For the same cumulative ESAL, pavement sections with thickness ratios in the range of 0.5 to 0.7 outperformed sections with thickness ratios in the range of 0.4 to 0.5, as shown in Figure 2.6.

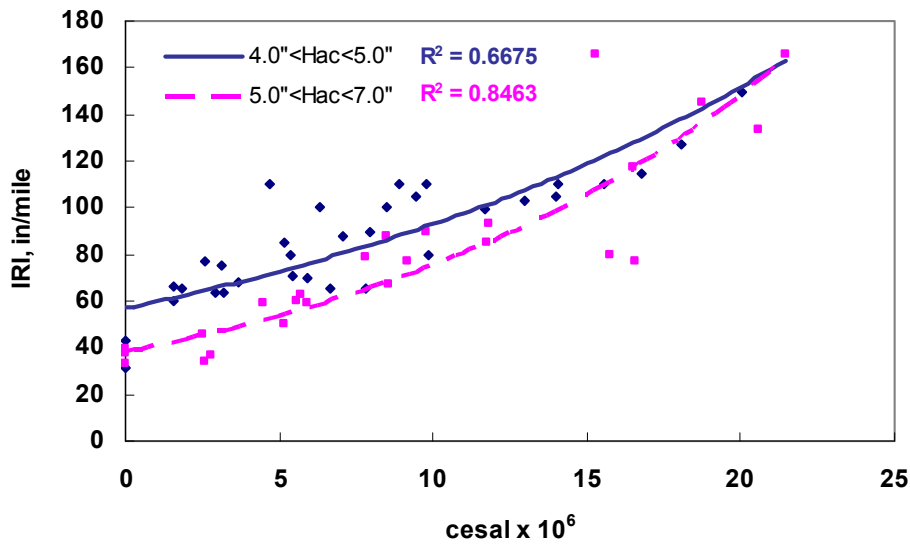
Figure 2.7 IRI for sections with different overlay thicknesses in the Central Valley.

2.3.4.5 IRI: The effect of overlay thickness and thickness ratio on IRI values for CS&O sections in the Central Valley is presented in Figures 2.7 and 2.8, respectively. The trend lines seen in Figure 2.7 suggest that sections with overlay thicknesses in the range of 5 to 7 inches exhibited lower initial IRI values than sections with overlay thicknesses in the range of 4 to 5 inches. As the cumulative traffic increases, IRI for the two thickness groups increases. At cumulative traffic levels equal to approximately 20 million repetitions, sections within the two thickness ranges exhibit the same IRI value. A similar trend can be seen in Figure 2.8 for the effect of thickness ratio.

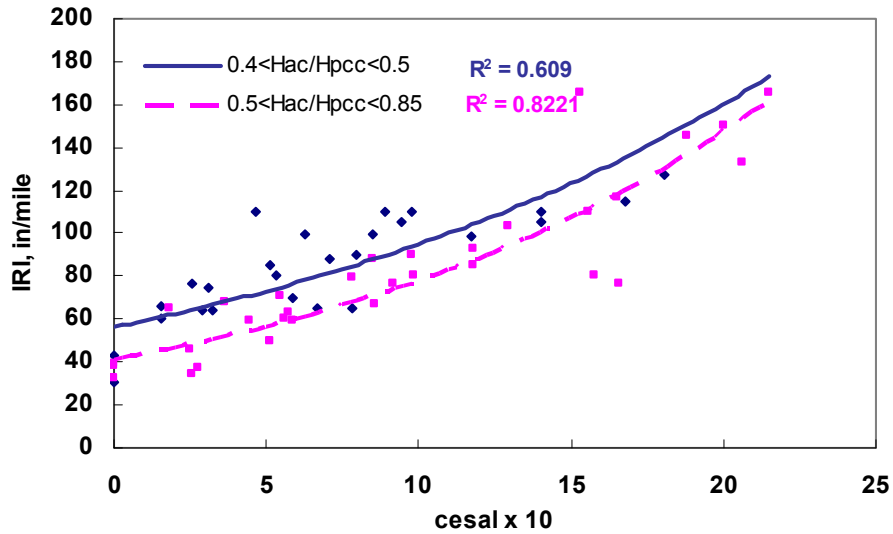
Figure 2.8 IRI for sections with different thickness ratios in the Central Valley.

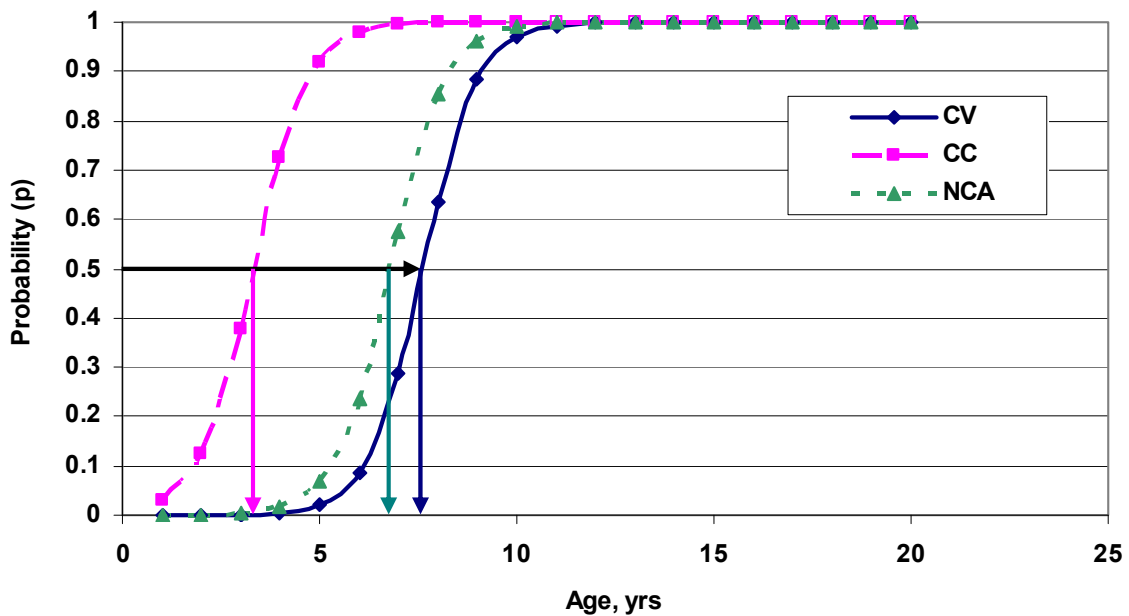
Figure 3.1 Probability of alligator cracks occurrence vs. time.

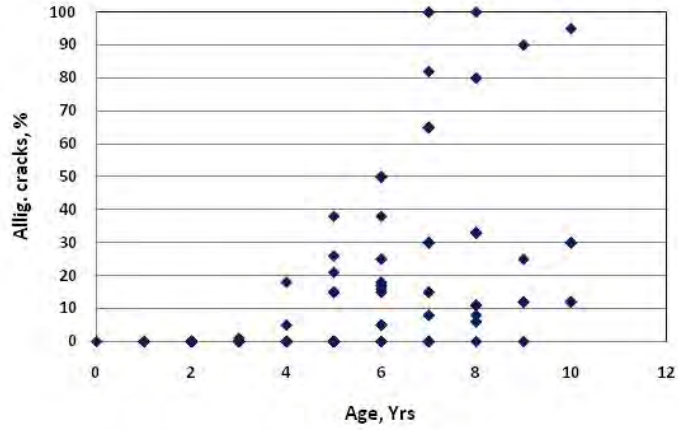
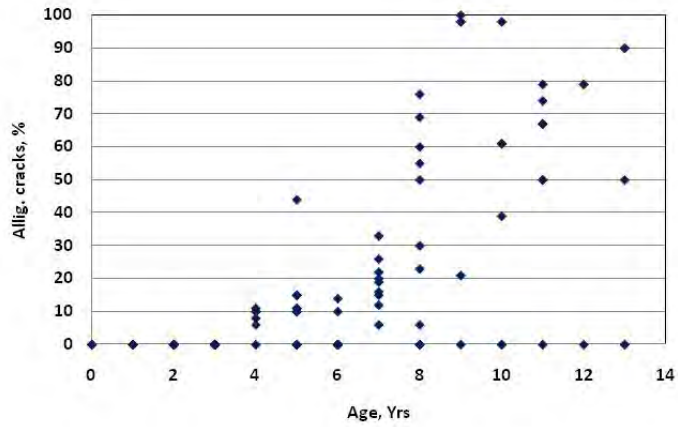
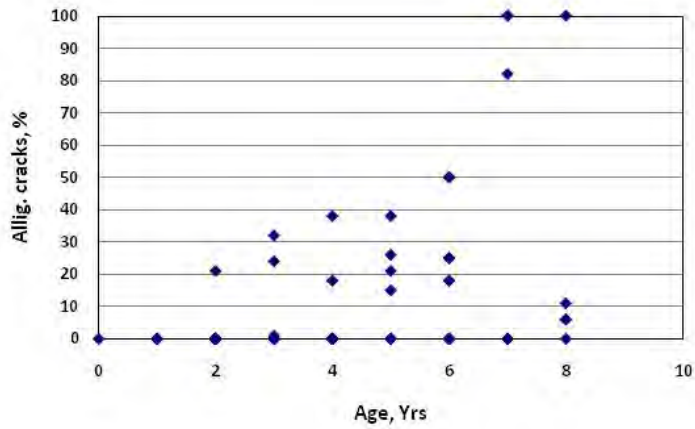
Figure 3.2 Actual percentages of alligator cracks vs. age for CV, NCA and CC region sections.

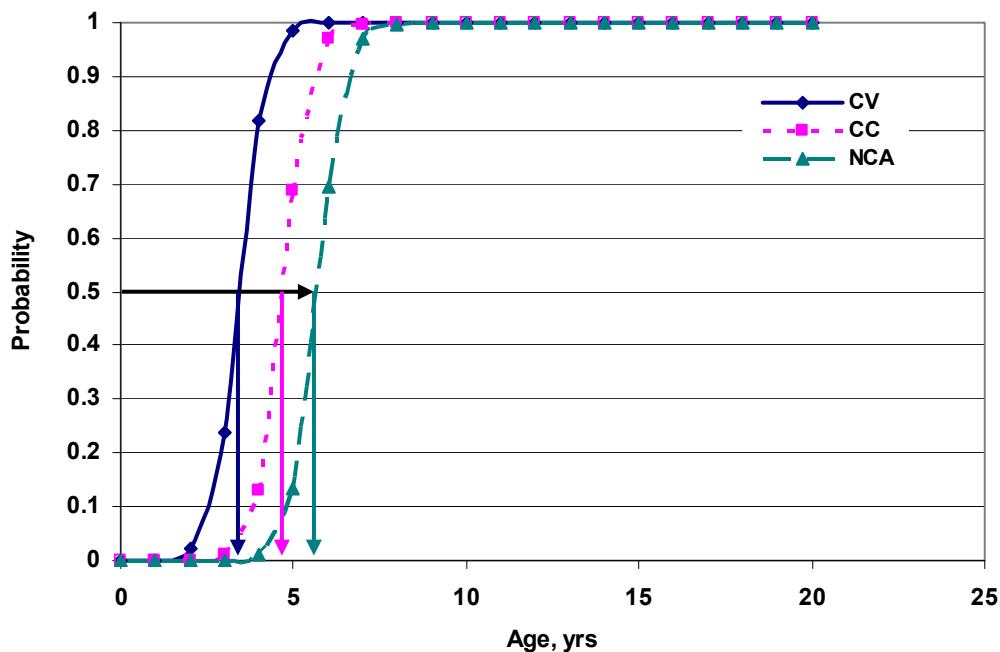
Figure 3.3 Probability of transverse cracks occurrence vs. time.

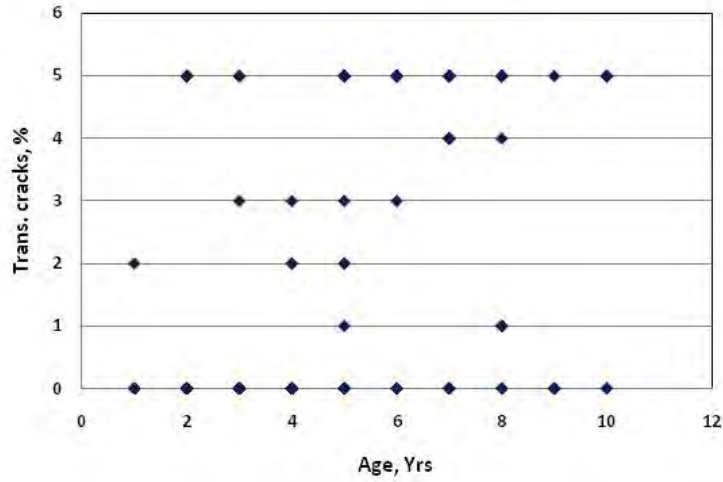
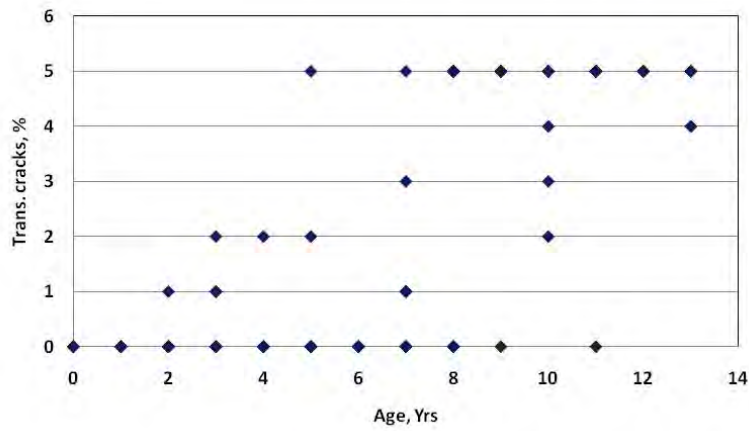
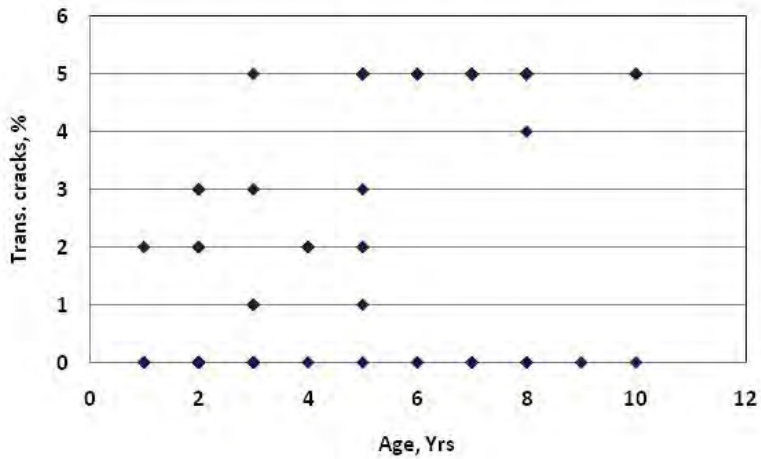
Figure 3.4 Actual percentages of transverse cracks vs. age for CV, NCA and CC region sections.

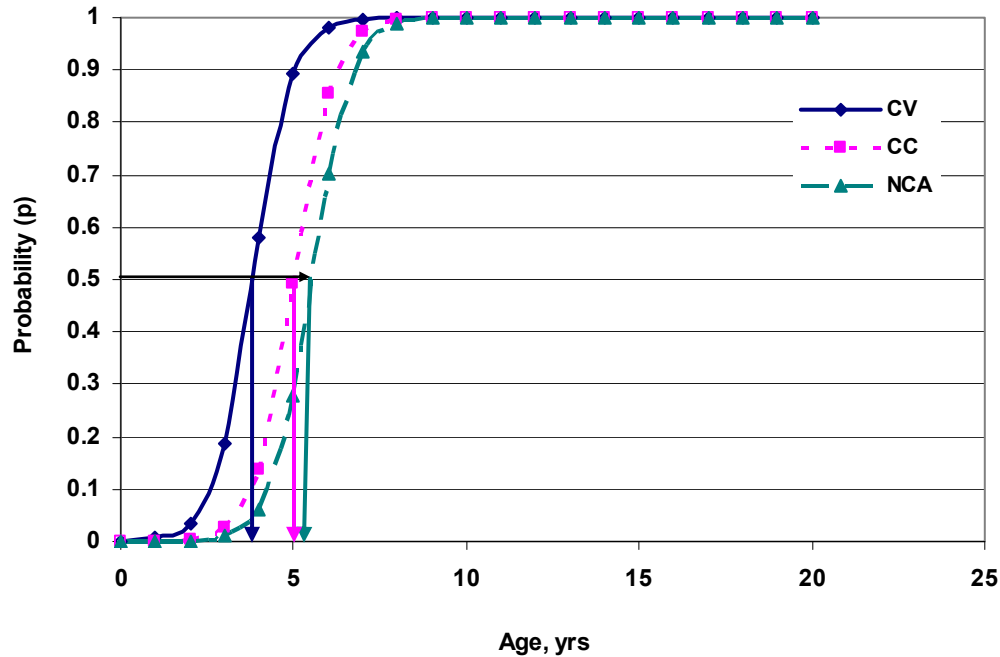
Figure 3.5 Probability of longitudinal cracks occurrence vs. time.

From Figure 3.3 it is noted that longitudinal cracks are expected to develop after about 4.0, 5.0, and 5.0 years for same section structure built in CV, CC and NCA region, respectively. Actual percentages of longitudinal cracks for sections in the three regions are presented in Figure 3.6.

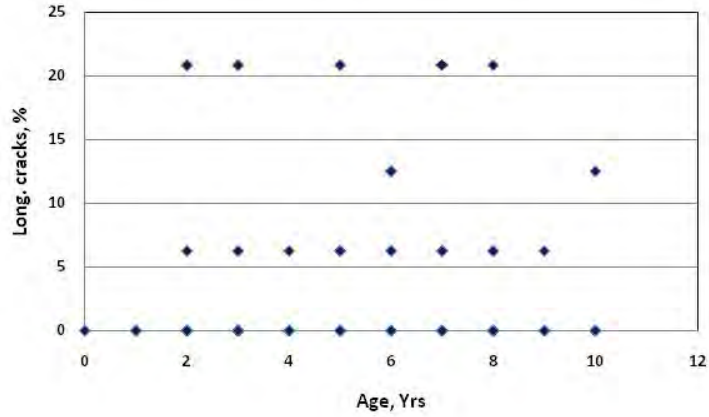
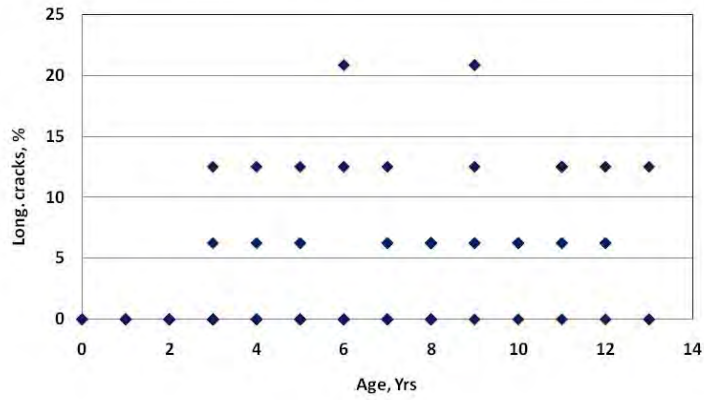
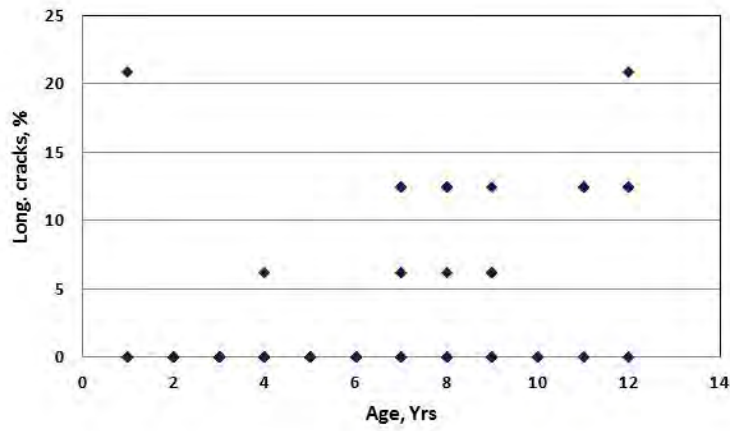
Figure 3.6 Actual percentages of longitudinal cracks vs. age for CV, NCA and CC regions sections.

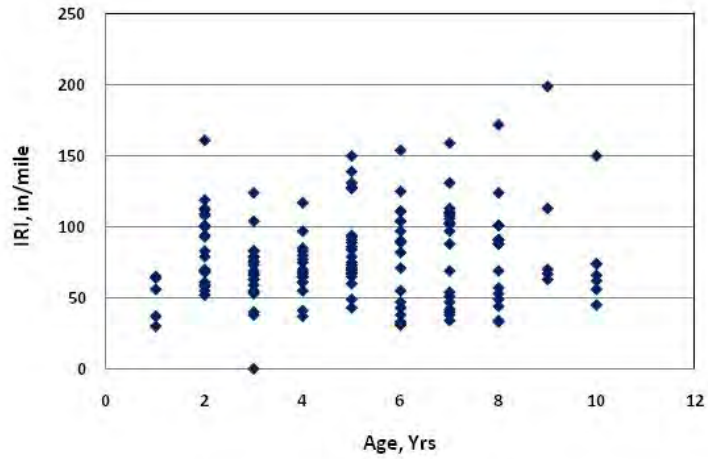
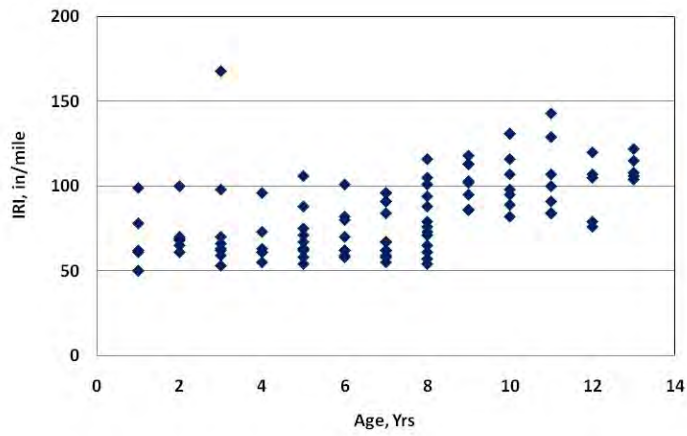
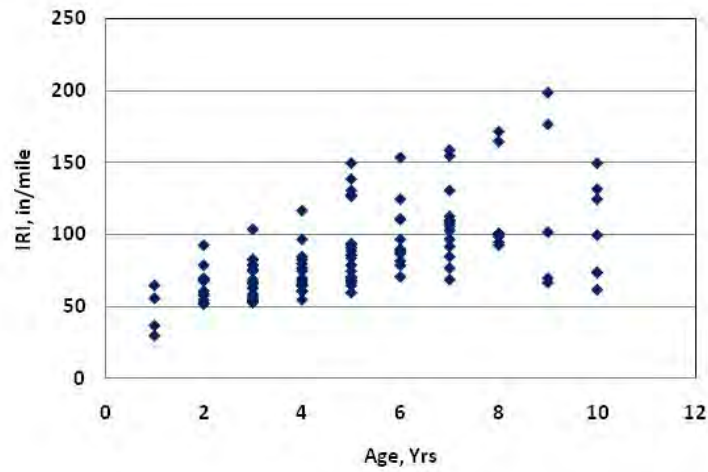
Figure 3.7 Actual IRI vs. age for CV, NCA and CC region sections.

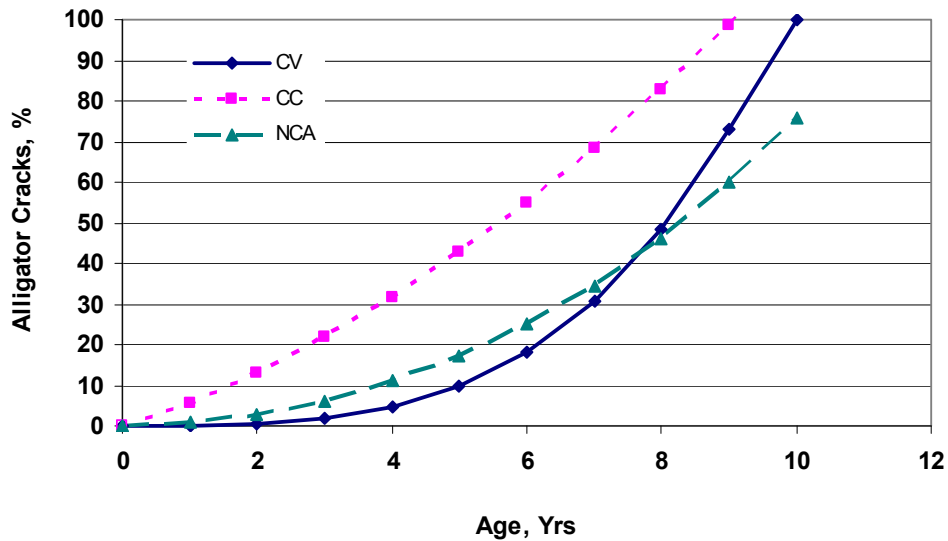
Figure 4.1 Variation of alligator cracks with time for a 10-year design life.

Figure 4.1 shows the predicted development of alligator cracks in CS&O sections in the CV, CC and NCA regions. It is noted from this figure that sections in the CV and NCA regions outperform those in CC region throughout the pavement service life. This trend agrees with the results from the logistic regression model analysis covered in Chapter 3. As mentioned in Chapter 3, the trend could be attributed to the type and condition of subgrade soils, especially for those coastal sections in Santa Barbara County.

In addition, sections in the CV region slightly outperform those in the NCA region until year eight, when the trend reverses. This reverse in the trend could be attributed to continued hardening of asphalt binder coupled with the high traffic level on those sections. Data concerning the type and properties of asphalt binder were not available for investigation in this study.

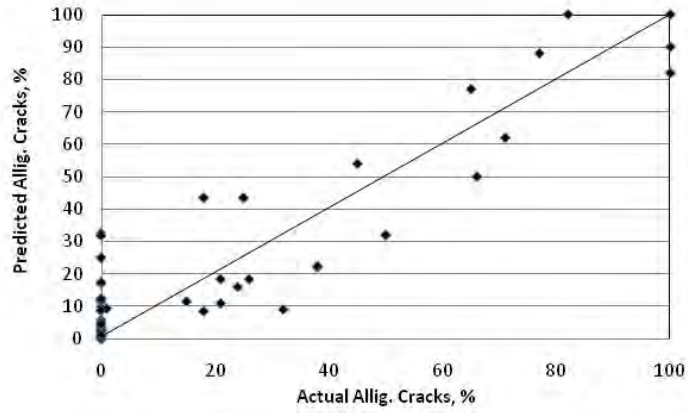
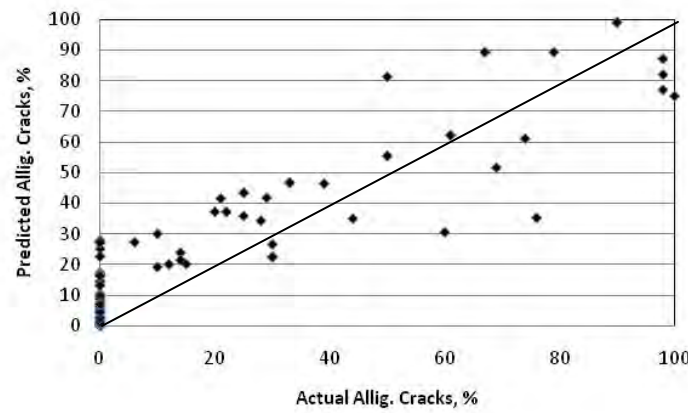
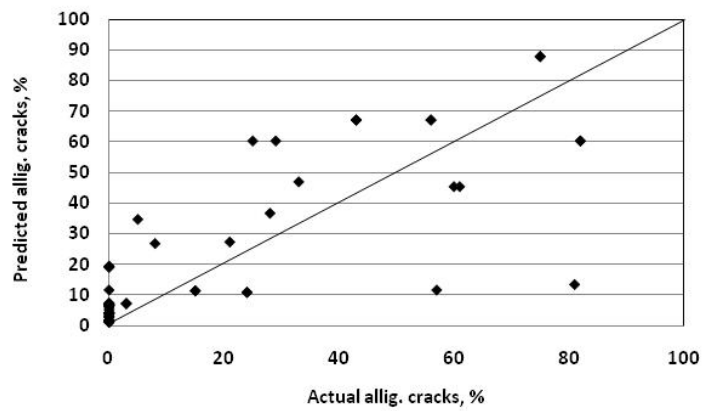
Figure 4.2 Actual alligator cracks vs. predicted for three regions

The actual alligator cracks percentages were plotted against the predicted values calculated from the regression models for each region (see Figure 4.2). The points clustering along line of equality is an indication of the satisfactory prediction capabilities.

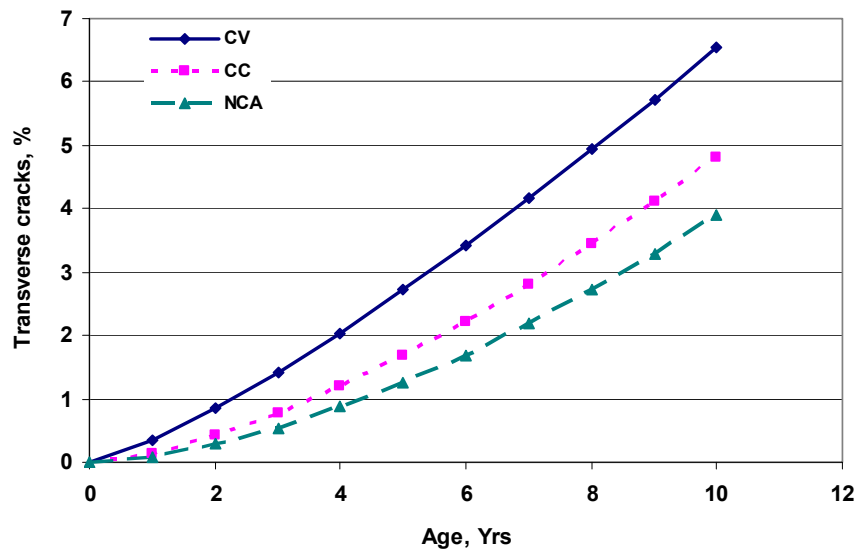
Figure 4.3 Variation of transverse cracks with time for a 10-year design life.

Comparisons of transverse crack development are presented in Figure 4.3. The models predict that CS&O sections in the CV region will develop more transverse cracks at a higher rate (especially for the first five years) when compared with sections in both the

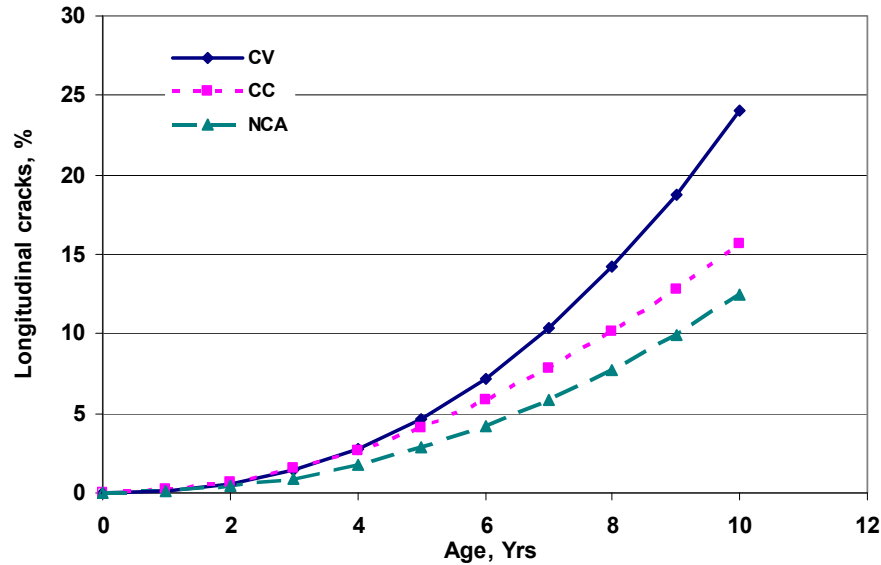
Figure 4.4 Variation of longitudinal cracks with time for a 10-year design life.

CC and NCA regions. Figure 4.4 compares the development of longitudinal cracks for the three regions. A trend similar to that for transverse cracks is observed in this figure.

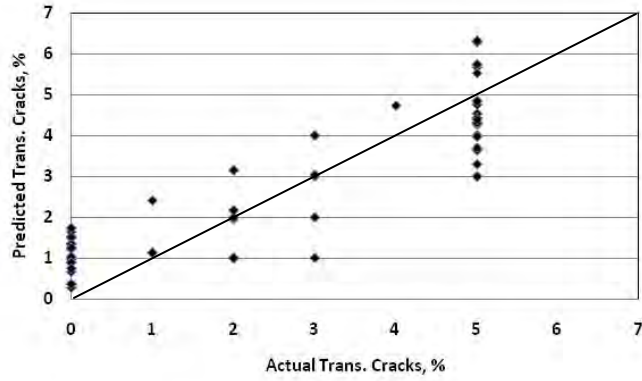
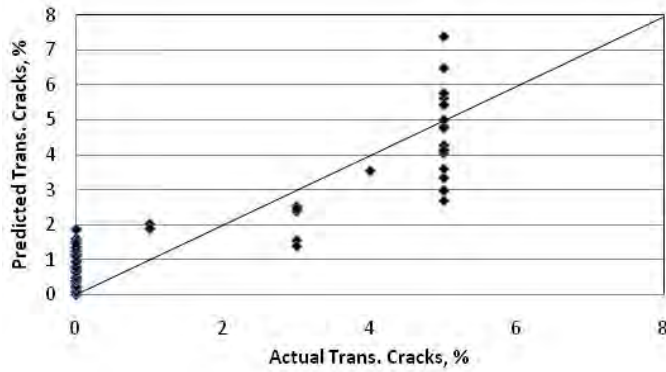
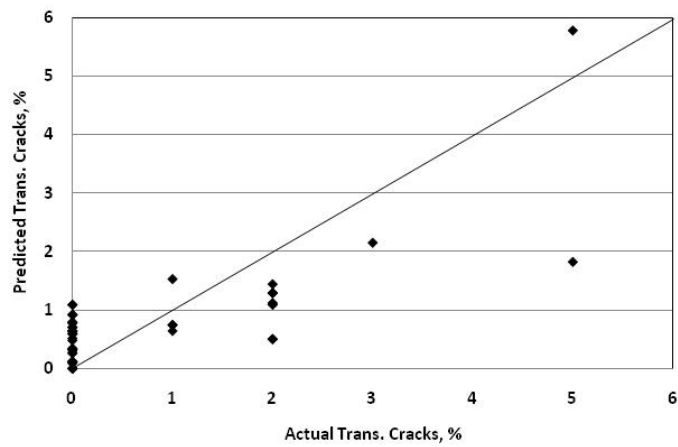
Figure 4.5 Actual transverse cracks vs. predicted for three regions.

Transverse and longitudinal cracks are primarily reflection cracks from the underlying cracked concrete slabs. Thermal expansion/contraction coupled with the rocking of unstable concrete pieces are considered the primary causes of reflection cracks. Sections in the CV region received the highest traffic repetitions, as compared with sections in the other two regions. Also, the extreme hot summer and cold winter in the CV region could trigger excessive cracks movement in the underlying concrete, which would eventually propagate through HMA overlay. The actual percentages of transverse and longitudinal cracks are plotted against the predicted values and are shown in Figures 4.5 and 4.6, for transverse and longitudinal cracks, respectively

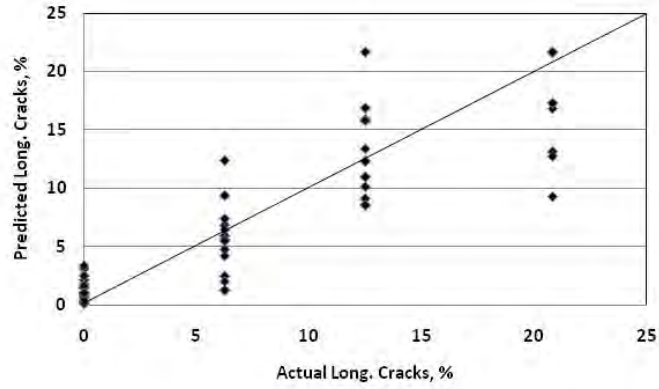
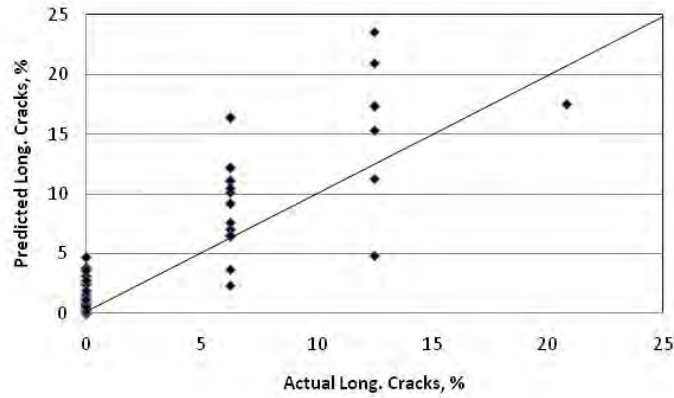
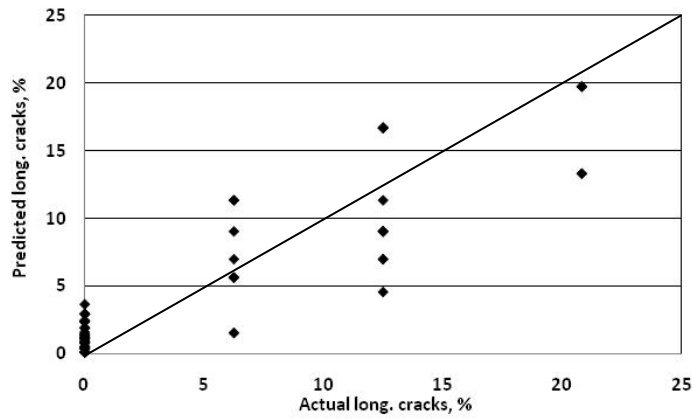
Figure 4.6 Actual longitudinal cracks vs. predicted for three regions.

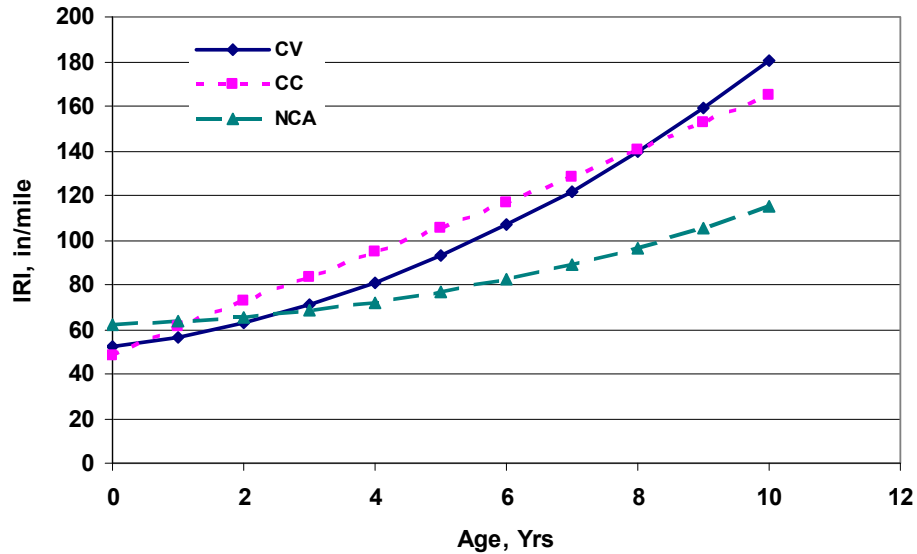
Figure 4.7 Variations of IRI with time for 10-year design life.

The variation of IRI with time for CS&O sections in the CV, CC, and NCA regions is presented in Figure 4.7. Even though sections in NCA started with an initial IRI higher than those for the CV and CC regions sections, the rate of increase in IRI for the NCA region outperformed that for both the CV and CC regions. Sections in the CV region slightly outperformed those in the CC region during the first eight years of service. However, the trend reversed afterward presumably due to the higher traffic volume experienced by the CV sections. The IRI-models predict that CS&O sections in the CV region would exceed the threshold of 170 in/mile after 10 years of service (see the Caltrans Highway Design Manual (HDM), Chapter 630), as compared with 165 in/mile and 115 in/mile for the CC and NCA regions, respectively.

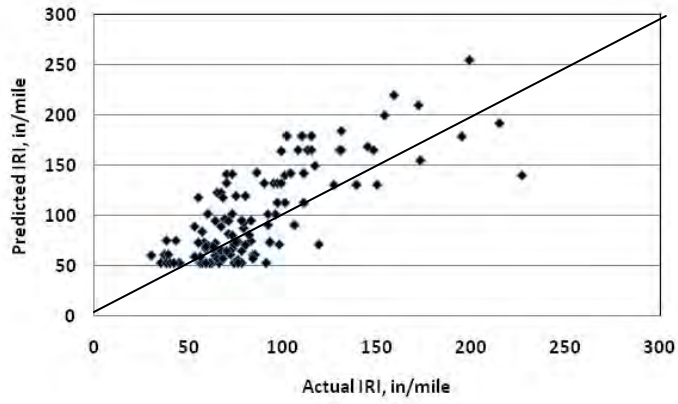
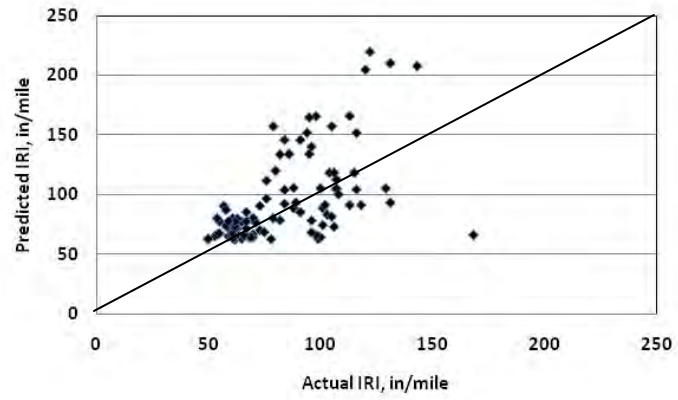
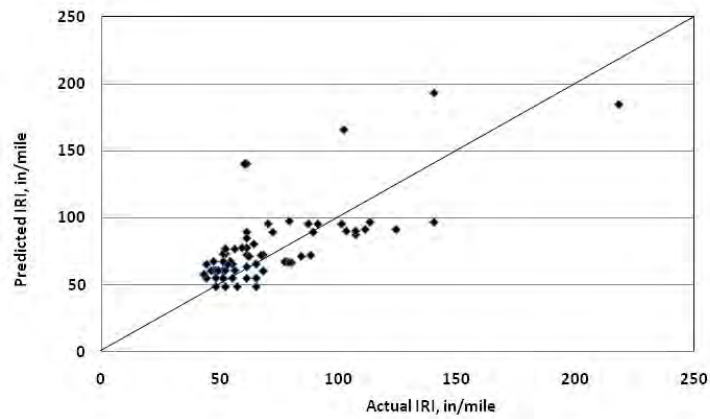
Figure 4.8 Actual IRI vs. predicted values for three regions.

The actual IRI are plotted against predicted IRI values for all three regions (see Figure 4.8)

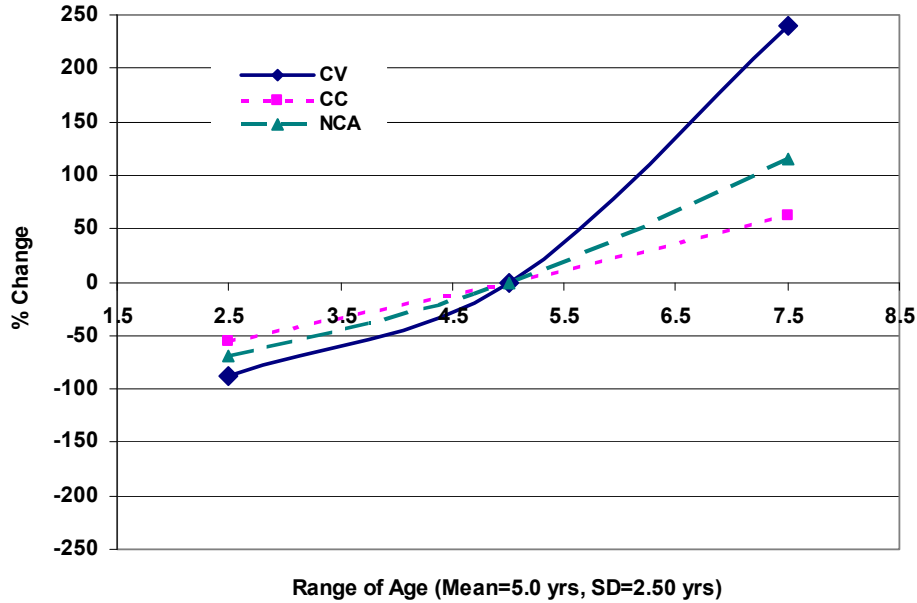
Figure 4.9 Percent change in alligator cracks with age.

Figure 4.9 presents the percent change in alligator cracks as the age of the sections deviates above and below the average. The steepness of lines slope in all three plots indicates that each of the models are sensitive, to various extents, to a change in age. The model developed for sections in the CC region is the least sensitive as compared with those developed for sections in the CV and NCA regions. This could be attributed to the relatively mild climatic/temperature changes during the year, when compared with the CV and NCA regions. The extreme changes in pavement temperature accelerate asphalt hardening, which makes both the binder and asphalt mix stiffer and more brittle. Also, sections in both the CV and NCA regions experienced higher traffic levels than sections in the CC region. This will result in cumulative traffic over the sections in the CV and NCA region higher than that over the CC sections, therefore developing more alligator (fatigue) cracks in a faster rate. This is also supported by the trend in Figure 4.9, where the percent change in alligator cracks is significantly higher as pavement sections in both the CV and NCA regions grow older.

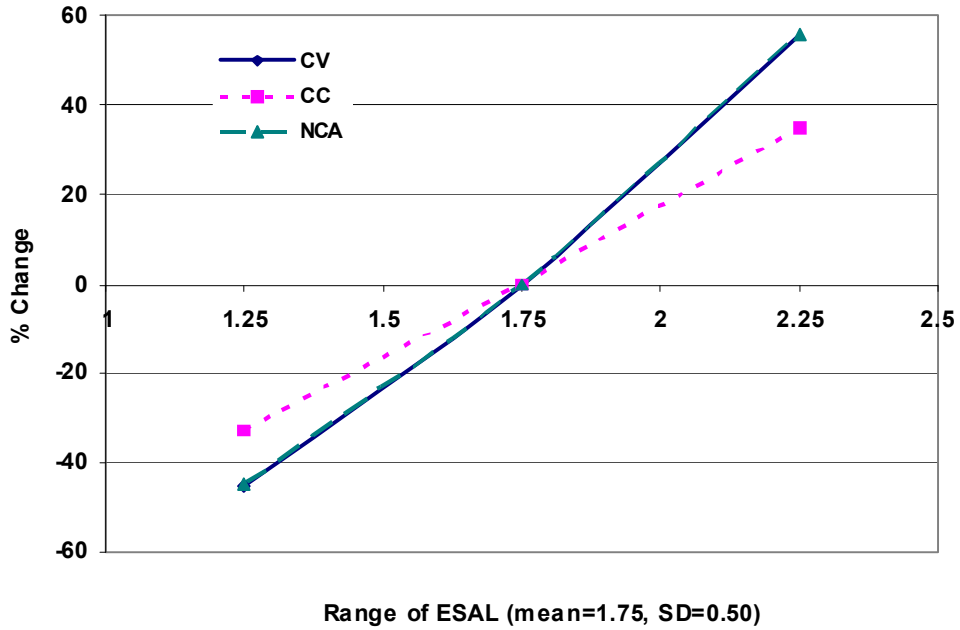
Figure 4.10 Percent change in alligator cracks with traffic (ESAL).

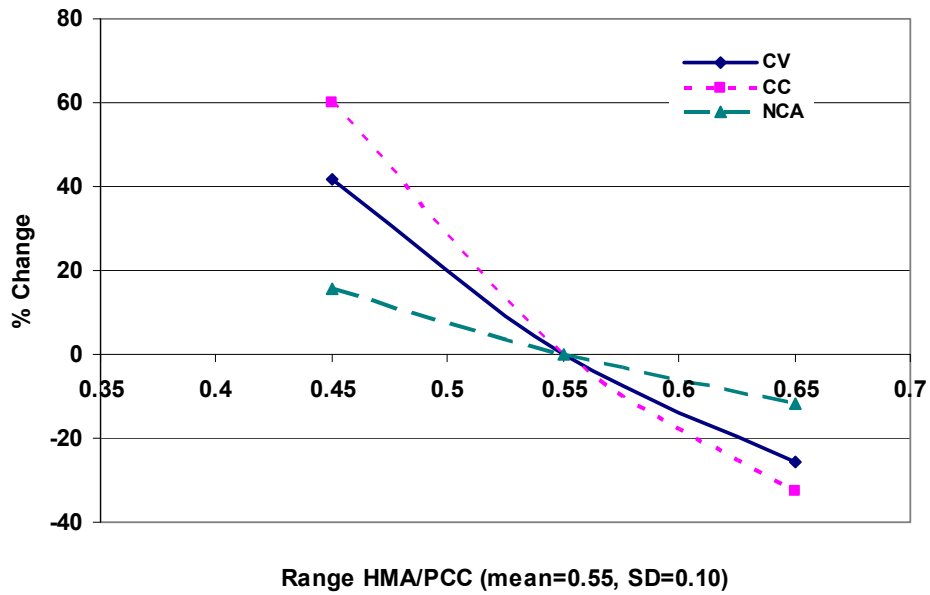
Figure 4.11 Percent change in alligator cracks with thickness ratio (HMA/PCC).

Figure 4.11 presents the change in alligator cracks as the thickness ratio (HMA/PCC) varies around the mean. The three performance models are sensitive to changes in thickness ratio, especially for values below the mean. The percent change is higher for the CC model, which could be attributed to the effect of subgrade type and drainage issues. These issues were discussed in sections 3.4.2.1.2 and 4.4.1.

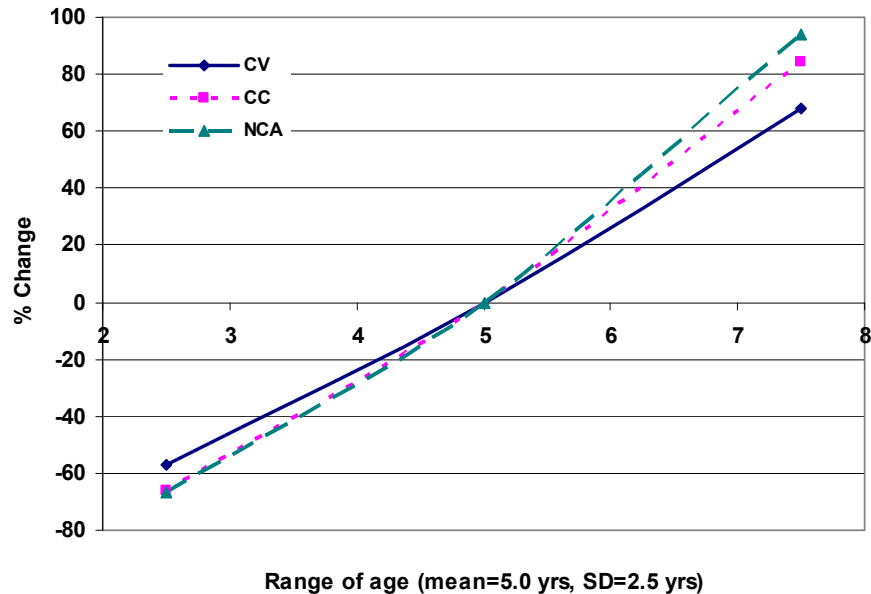
Figure 4.12 Percent change in transverse cracks with age.

Sensitivity analyses for transverse and longitudinal cracks, as a function of pavement age, are presented in Figures 4.12 and 4.13, respectively. It is evident from these figures that the models for the three regions exhibit approximately similar trends. The percent change and the rate of the change both increase as pavement sections grow older. Older pavements are expected to receive more traffic in addition to more thermal change cycles, which leads to the formation of reflective cracks.

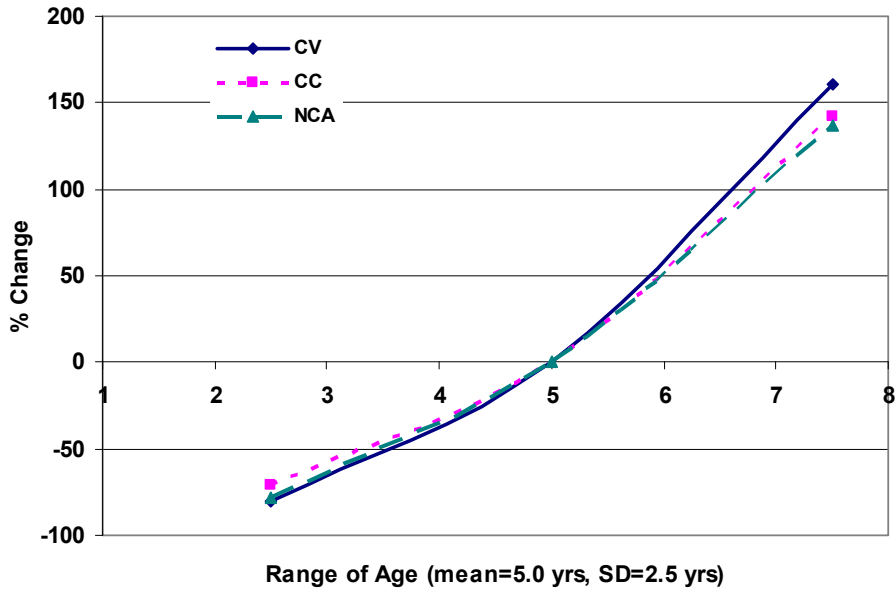
Figure 4.13 Percent change in longitudinal cracks with age

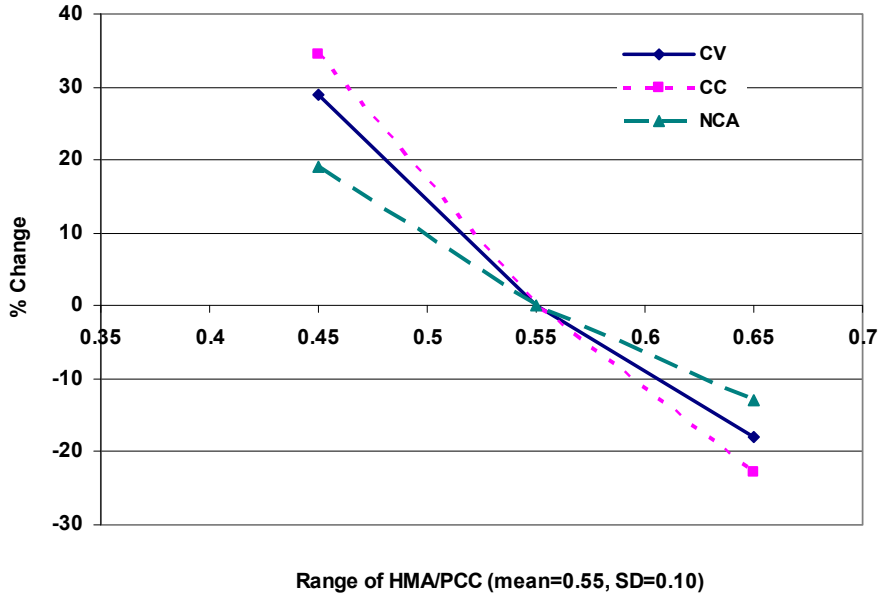
Figure 4.14 Percent change in transverse cracks with thickness ratio (HMA/PCC).

The plots for the sensitivity of reflective cracks to the changes in thickness ratio are presented in Figures 4.14 and 4.15. As noticed in the figures, both the percent change and the rate of the change increase as thickness ratio decreases. In general, a higher thickness ratio would mean thicker HMA overlay, assuming uniform PCC thickness was originally used in the construction of rigid concrete pavements. A thick HMA overlay helps retard the development of reflective cracking and also reduces the rate of crack formation. Since concrete slab thicknesses are not uniform (as evident from comparing section cores with the as-built data), it is recommended that PCC pavements be cored for slab thickness verification before employing CS&O to make sure that adequate thickness ratio (HMA/PCC) is used.

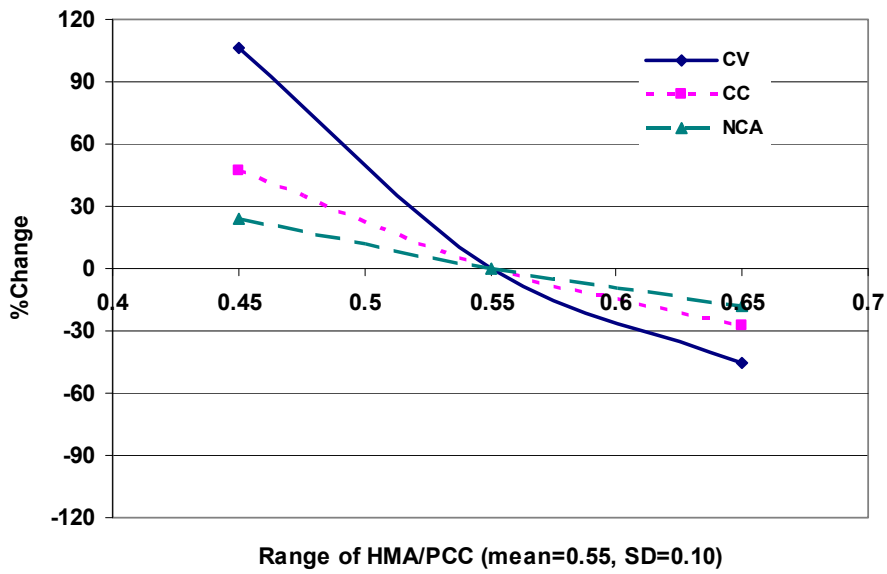
Figure 4.15 Percent change in longitudinal cracks with thickness ratio (HMA/PCC).

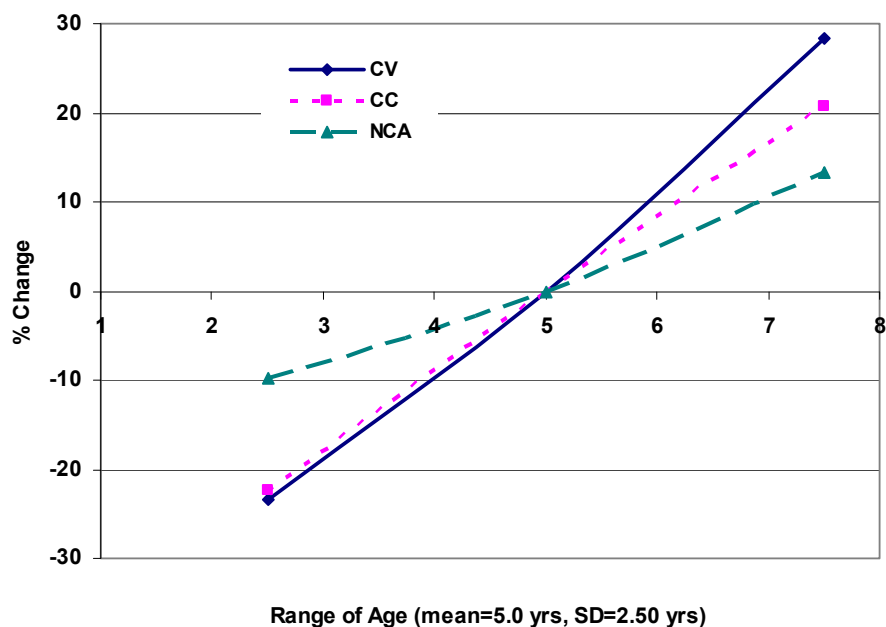
Figure 4.16 Percent change in IRI with age.

Figure 4.16 presents the changes in IRI with age, as predicted from the three performance models developed for the CV, CC and NCA regions. The models predict a similar trend for sections in the three regions. However, the model for the NCA sections exhibits smaller changes and slower rate of change when compared with models for the CV and CC regions, even though the NCA sections receive higher traffic (ESAL) than those in the CC region (see Table 3.11). This trend could be attributed to construction practices, subgrade, and subsurface drainage issues that were not investigated as part of this study.
