1. REPORT NUMBER CA11-1863A	2. GOVERNMENT ASSOCIATION NUMBER	3. RECIPIENT'S CATALOG NUMBER
4. TITLE AND SUBTITLE An Evaluation of Crack, Seat and Overlay in California (Phase II)	5. REPORT DATE January 18, 2011	
	6. PERFORMING ORGANIZATION CODE	
7. AUTHOR(S) Rahim, Ashraf and Fiegel, Gregg	8. PERFORMING ORGANIZATION REPORT NO.	
9. PERFORMING ORGANIZATION NAME AND ADDRESS California Polytechnic State University Department of Civil and Environmental Engineering San Luis Obispo, CA 93407	10. WORK UNIT NUMBER	
	11. CONTRACT OR GRANT NUMBER 65A0305	
12. SPONSORING AGENCY AND ADDRESS California Department of Transportation Division of Research and Innovation, MS-83 1227 O Street Sacramento CA 95814	13. TYPE OF REPORT AND PERIOD COVERED Final-April 2008 to November 2010	
	14. SPONSORING AGENCY CODE	
15. SUPPLEMENTAL NOTES

**AN EVALUATION OF THE CRACK, SEAT AND OVERLAY METHOD IN
CALIFORNIA**

Final Report

Department of Civil and Environmental Engineering
California Polytechnic State University
San Luis Obispo, CA 93407

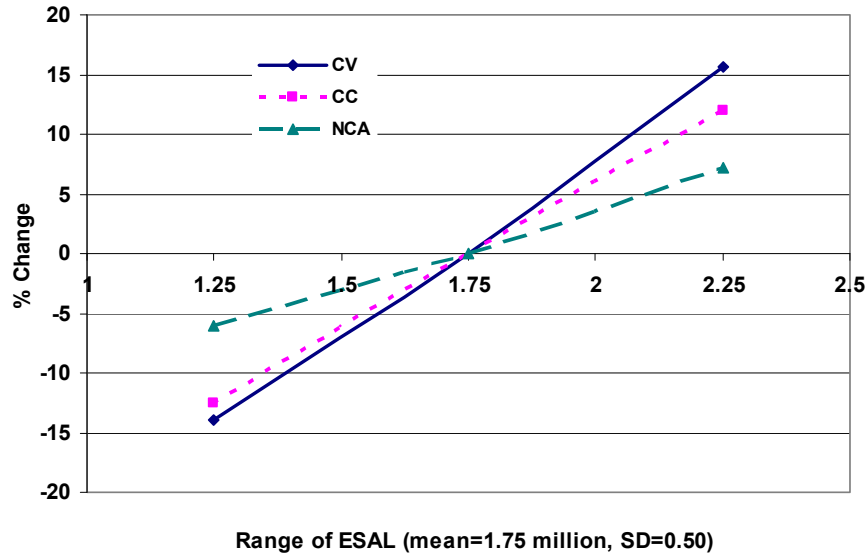
Figure 4.17 Percent change in IRI with ESAL.

Performance model results as ESAL varies around the mean value are presented in Figure 4.17. Trends similar to those observed in Figure 4.16 are evident, which could be attributed to the same factors mentioned in section 4.5.3.1.

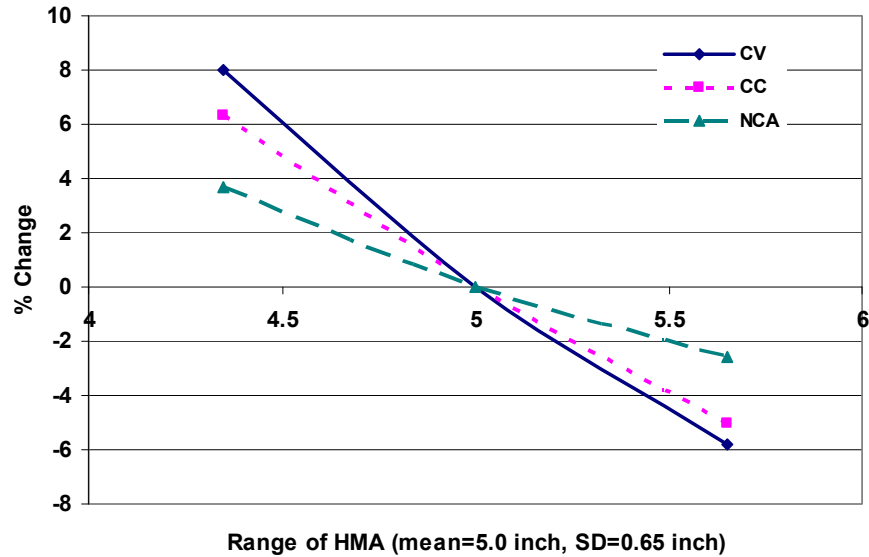
Figure 4.18 Percent change in IRI with HMA thickness.

The sensitivity of the IRI models to the changes in HMA thickness is summarized in Figure 4.18. As evident in this figure, sections in all three regions are expected to experience higher IRI for thinner HMA overlays and lower IRI for thicker HMA overlays. The rate of change is approximately the same for both the thinner and thicker overlays. For the three regions, the percent change in IRI as result of overlay thickness variations is much lower than that resulting from variations in age and ESAL (see Figures 4.16 and 4.17).

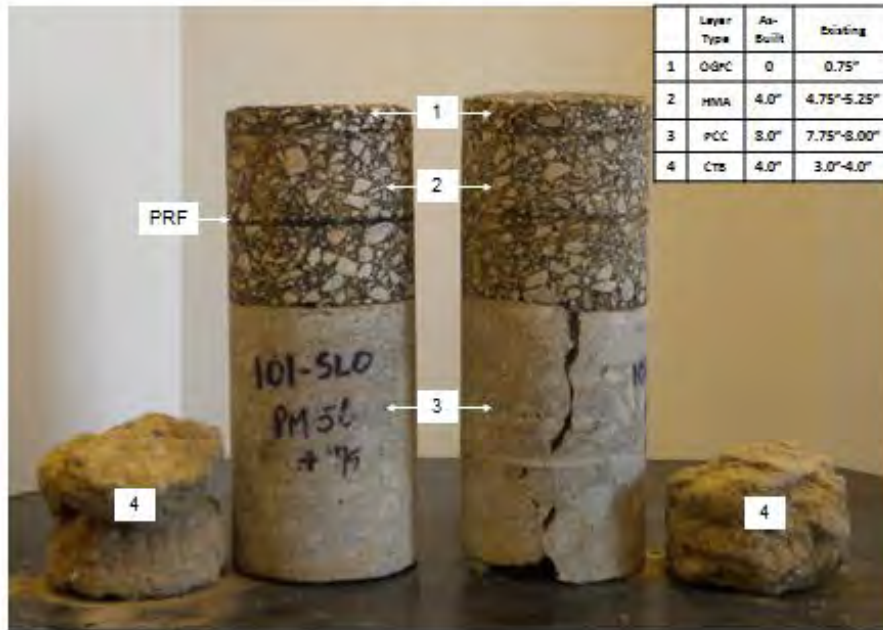
Figure A.1 Cores extracted from Section SLO_101N_56.06

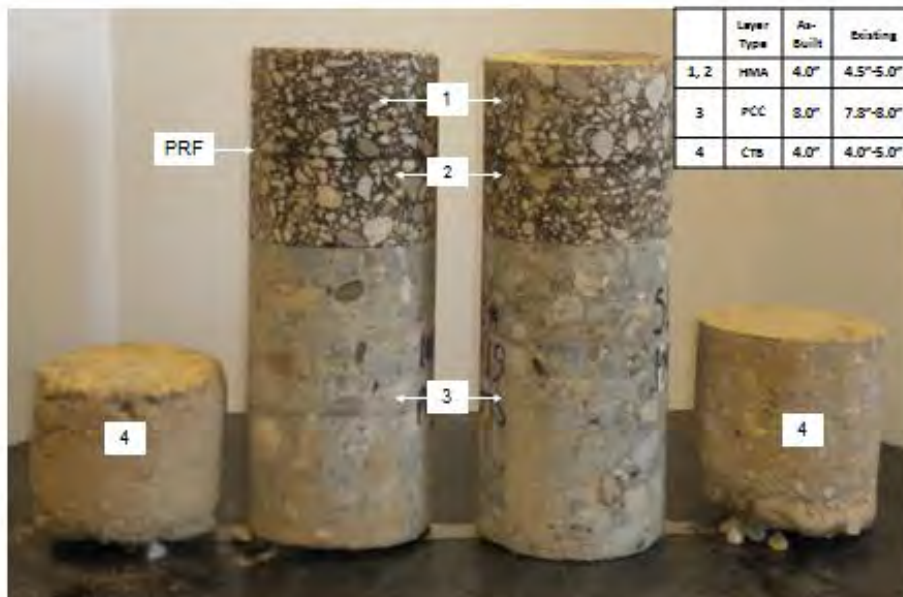
Figure A.2 Cores extracted from Section SLO_101N_60.98

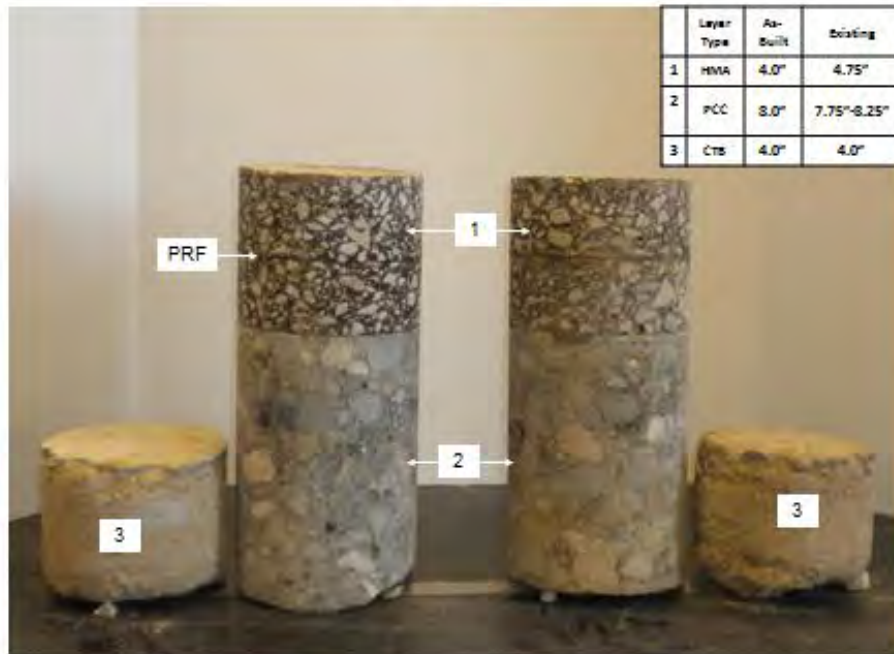
Figure A.3 Cores extracted from Section SLO_101S_61.00

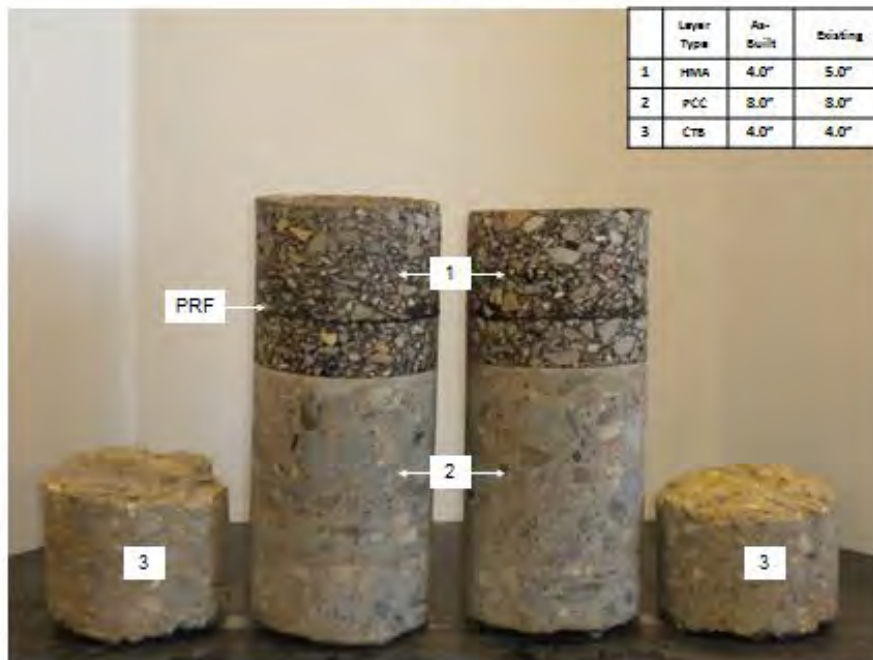
Figure A.4 Cores extracted from Section SB_101N_90.06

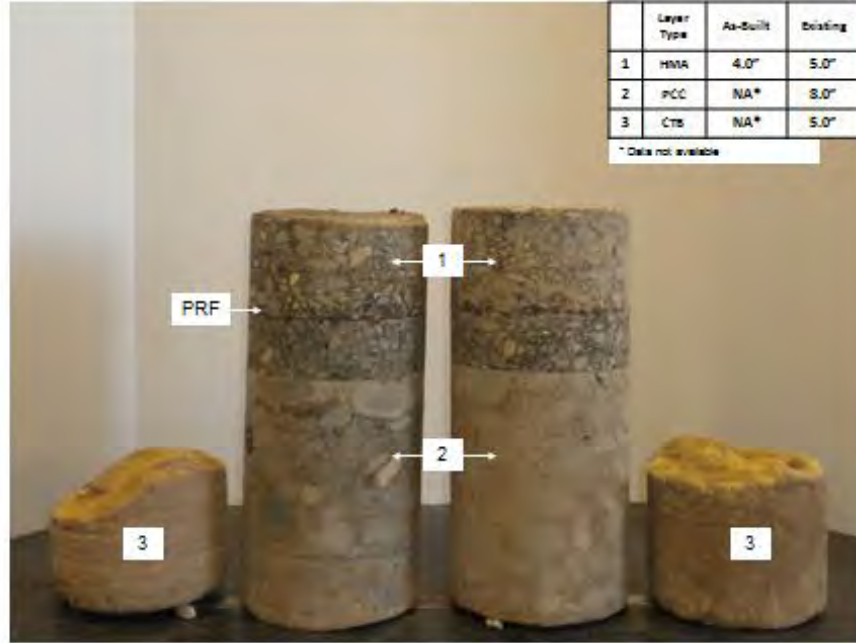
Figure A.5 Cores extracted from Section SB_101N_82.85

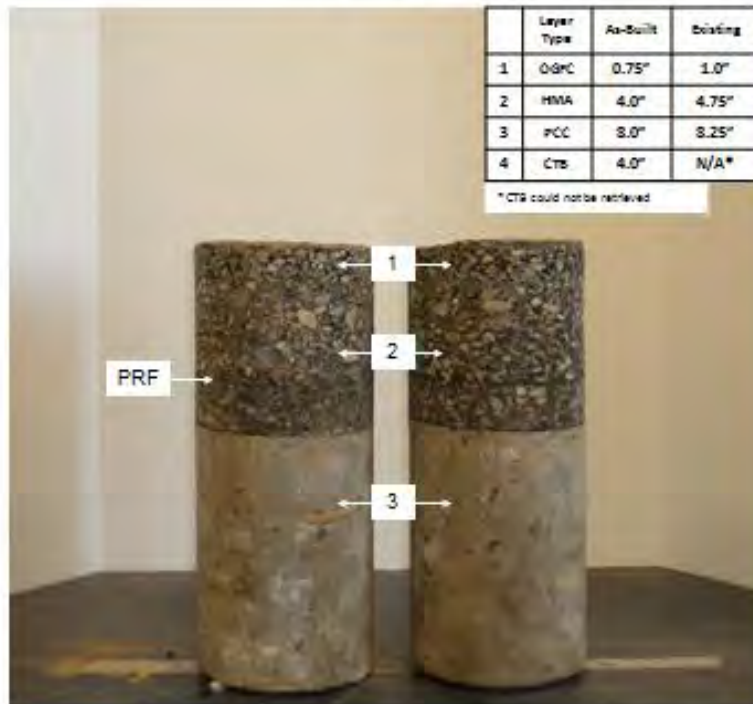
Figure A.6 Cores extracted from Section SB_101N_27.59

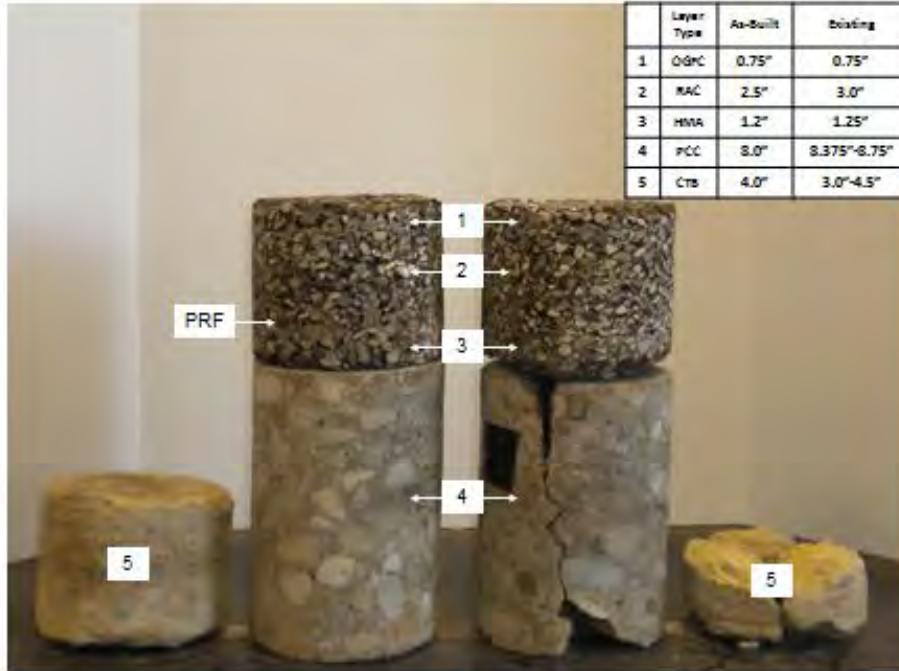
Figure A.7 Cores extracted from Section SB_101N_21.66

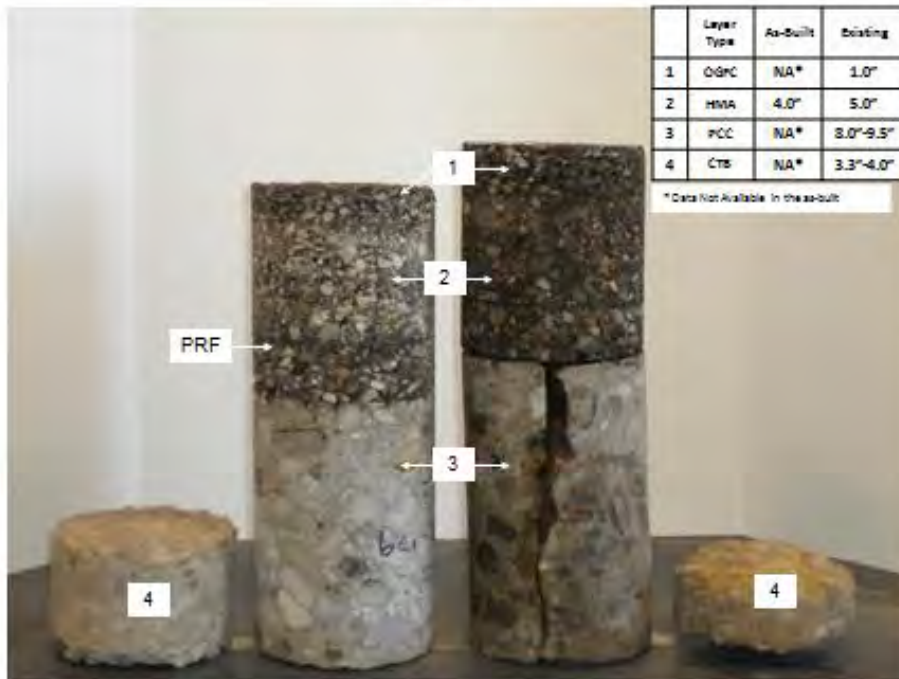
Figure A.8 Cores extracted from Section SB_101N_15.24

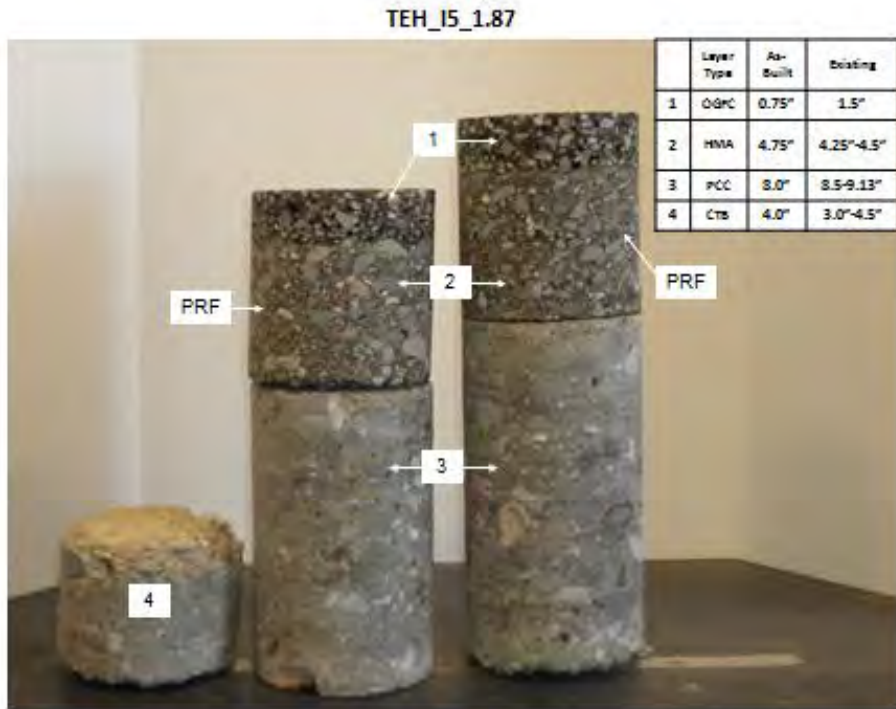
Figure A.9 Cores extracted from Section TEH_I5N_1.87

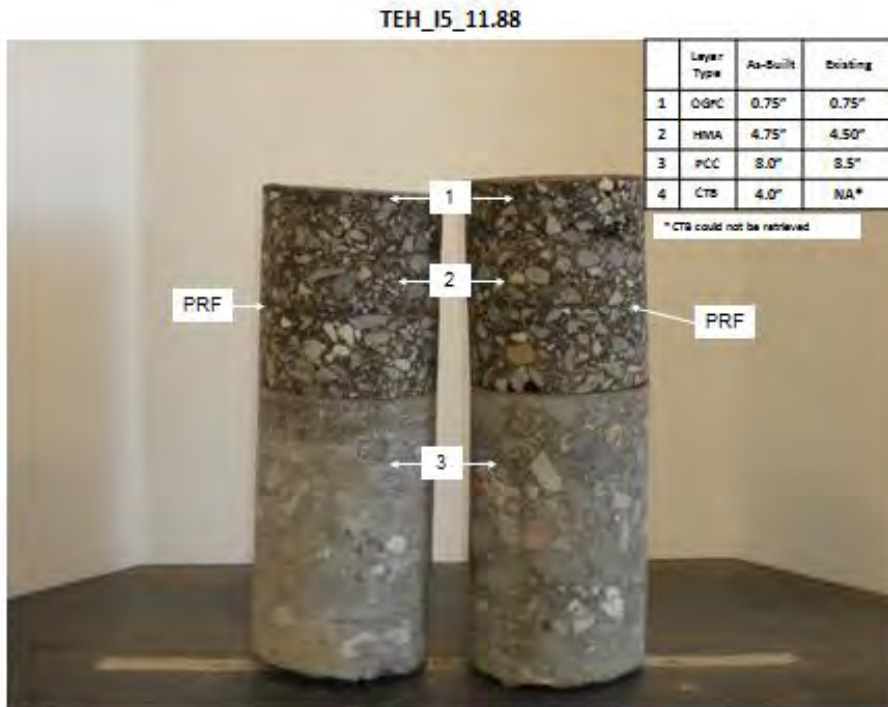
Figure A.10 Cores extracted from Section TEH_I5N_11.88

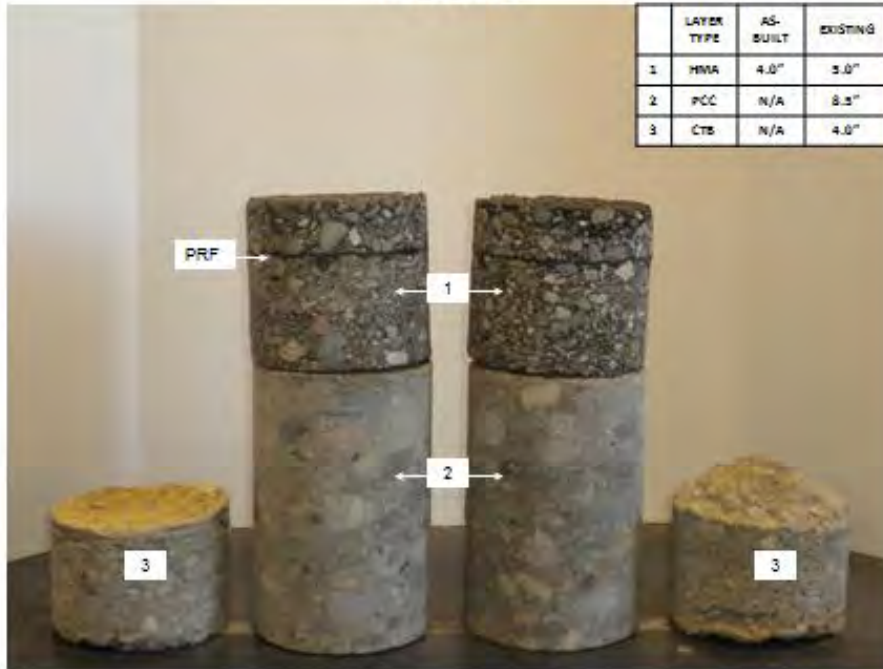
TEH_I5_27.53

Figure A.11 Cores extracted from Section TEH_I5N_27.53

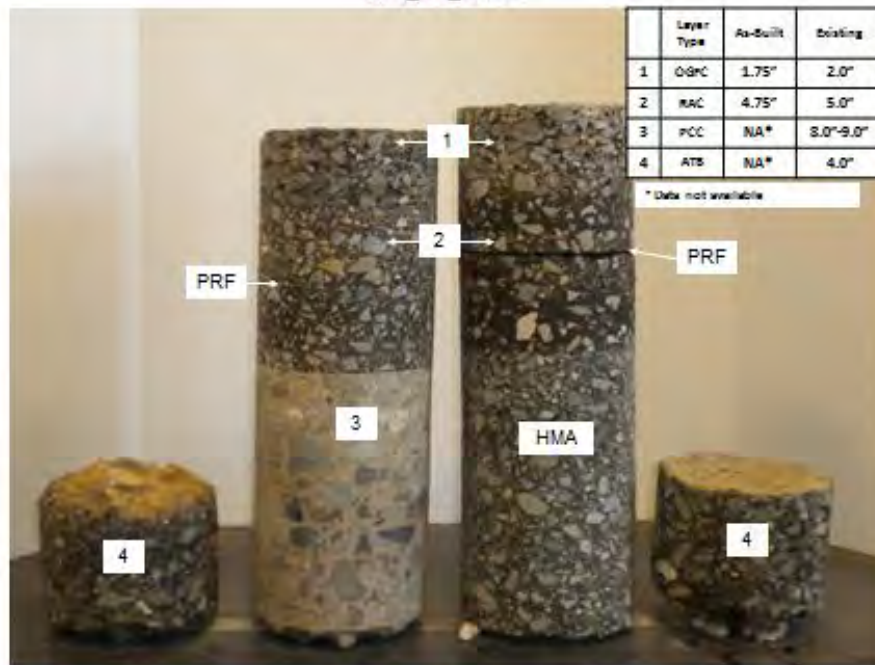
SHA_5N_19.45

Figure A.12 Cores extracted from Section SHA_I5N_19.45

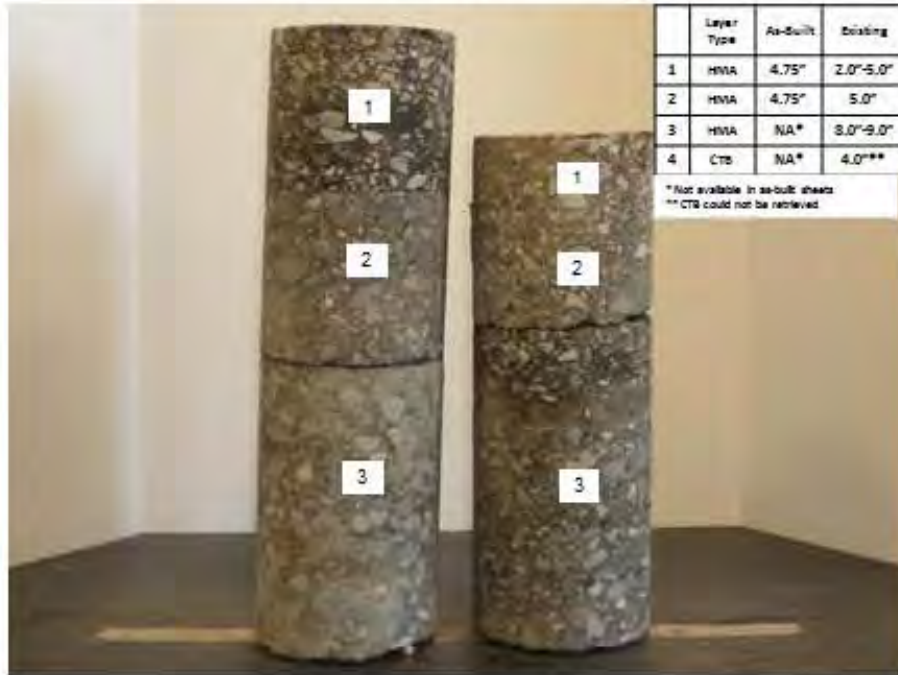
Figure A.13 Cores extracted from Section SHA_I5N_39.50

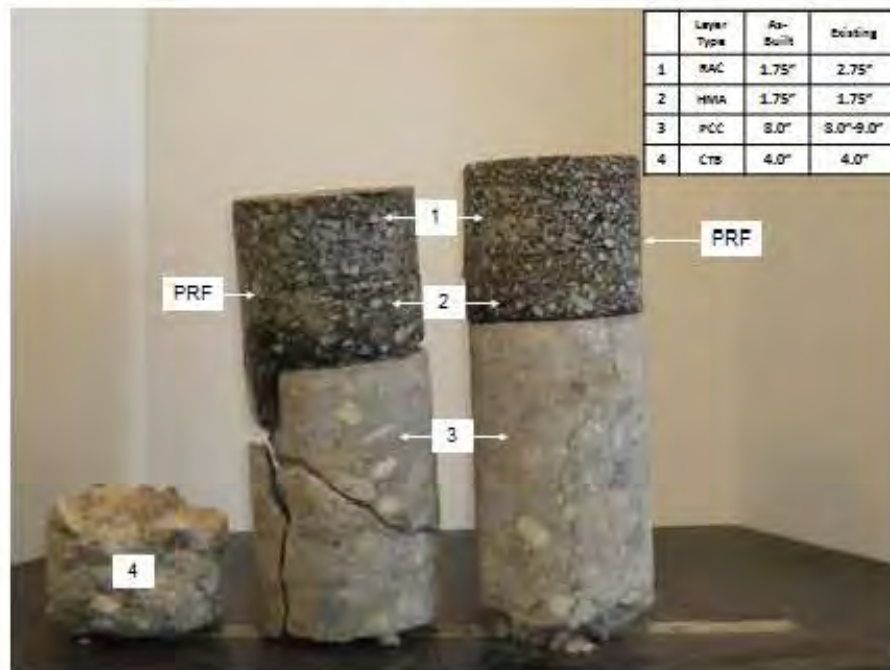
Figure A.14 Cores extracted from Section SHA_I5N_60.04

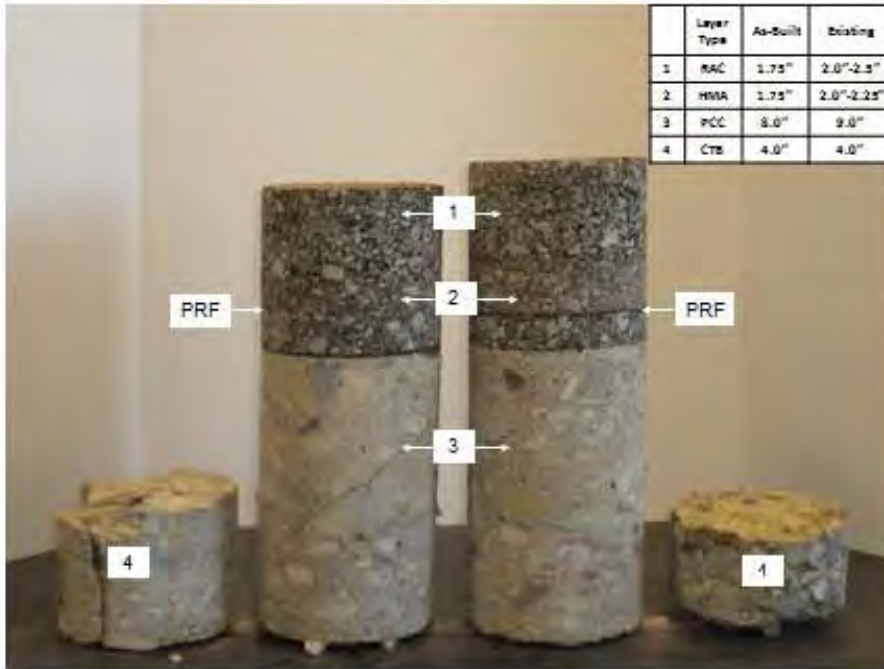
Figure A.15 Cores extracted from Section SHA_I5N_60.57

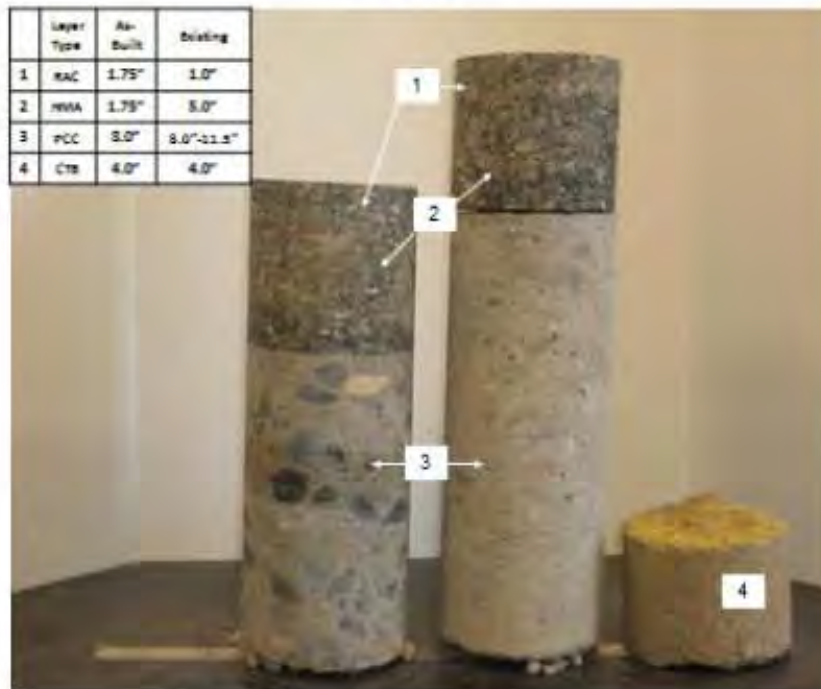
Figure A.16 Cores extracted from Section SIS_I5N_42.60

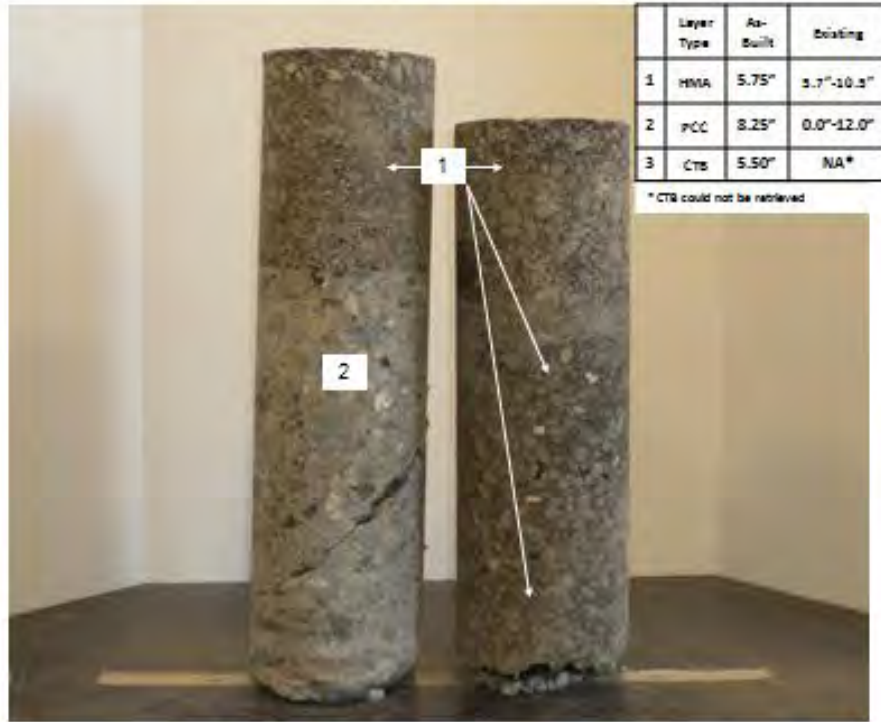
Figure A.17 Cores extracted from Section SIS_I5N_60.29
