**Federal Highway
Administration**

Refer to: HSA-10/B-110

In late September, you sent me one copy of a California Department of Transportation test report dated September 2002 entitled "Crash Testing of Various Textured Barriers" and one set of videotapes showing each of the tests you conducted. Based on the results of these tests, you developed general guidelines for the architectural treatment of single-slope barriers and requested formal acceptance of these guidelines.

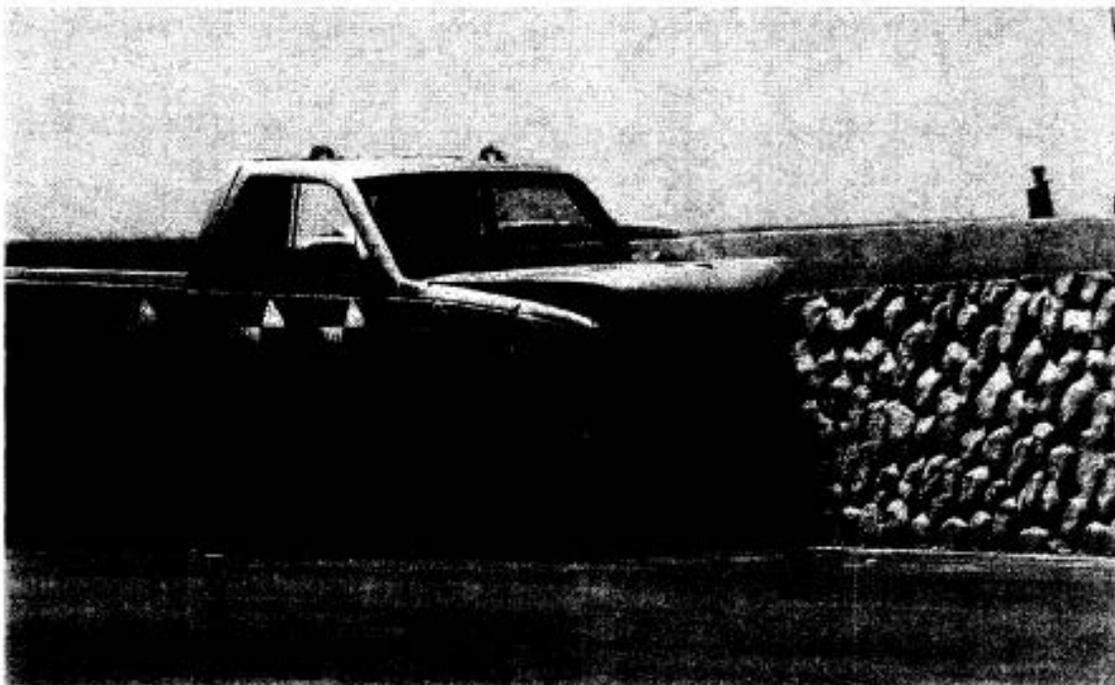
ENCLOSURE 1

- Deep Cobblestone design (Enclosure 1) – not acceptable, due to excessive occupant compartment intrusion (2000P vehicle)
- Fluted Rib at 45 degrees (Enclosure 2) – not acceptable, due to rollover (820C vehicle)
- Mission Arch (Enclosure 3) – acceptable performance when tested with 820C vehicle. 2000P test waived
- Deep Cobblestone Reveal (Enclosure 4) – acceptable performance with 2000P vehicle. 820C test waived
- Drystack (Enclosure 5) – acceptable performance with 2000P vehicle. 820C test waived
- Fractured Granite (Enclosure 6) – acceptable performance with 2000P vehicle. 820C test waived
- Shallow Cobblestone (Enclosure 7) – deemed not acceptable due to 2000P vehicle driveshaft separation in crash. Report 350 evaluation criteria were met, however
