Bridging the Gap

August 2024

Scaling California's Mountain Ranges

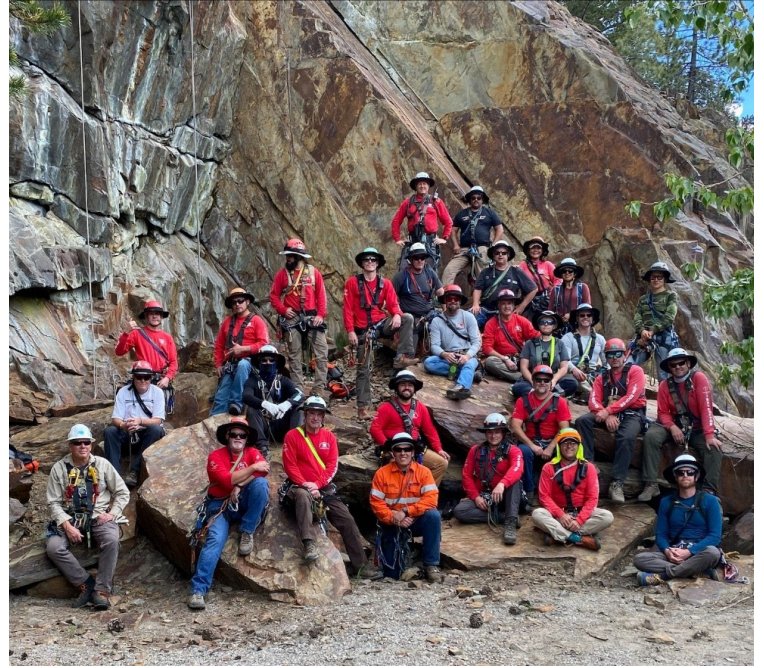
A project that Geotechnical Design recently completed was a slope on San Bernardino State Route 18 that had very active rockfall.

The climbing team planned a job to blast the brow of the slope, eliminating an overhang, and then scale the remaining loose rock. The amount of rock removed during this job was approximately 15,000 yards.
