# Nine Proven Safety Countermeasures

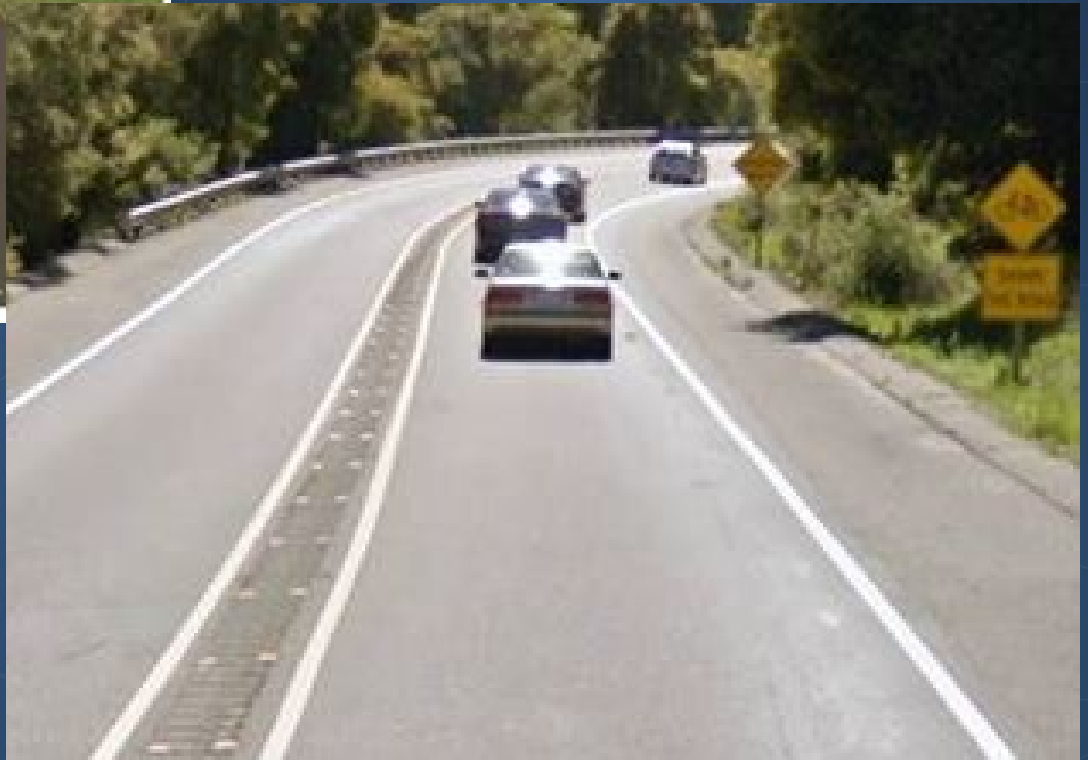
Shoulder Rumble Stripe

SR 84 in bay area  
Courtesy of Google

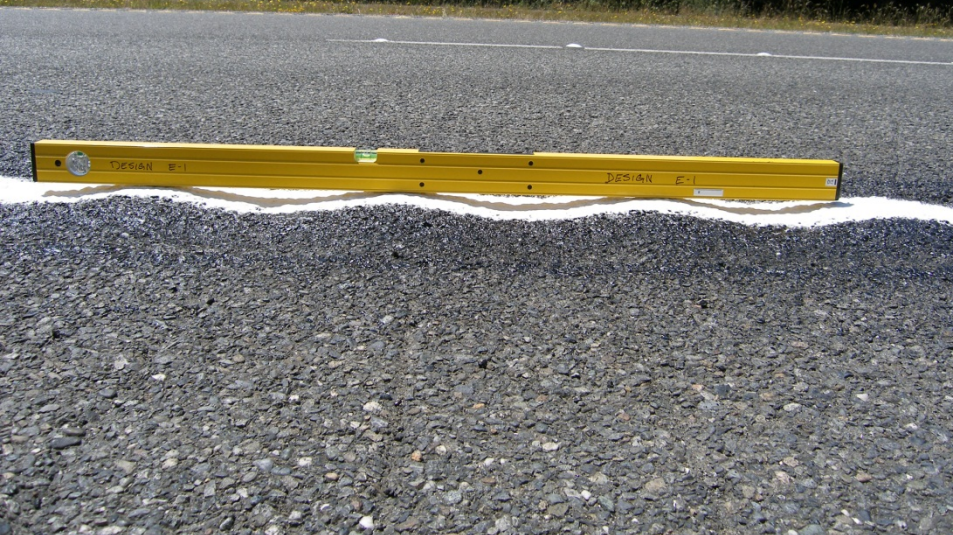
"Mumble" strip: 14" O.C., sinusoidal profile, p-p depth 5/16"

- Rumble strips can help reduce sideswipe, head-on collisions, and run-off-road crashes
- Caltrans mumble strips achieved goals
  - Lower exterior dB A-weighted levels
  - Provide sufficient driver warning input
- Interior noise & vibration response varied with vehicle type

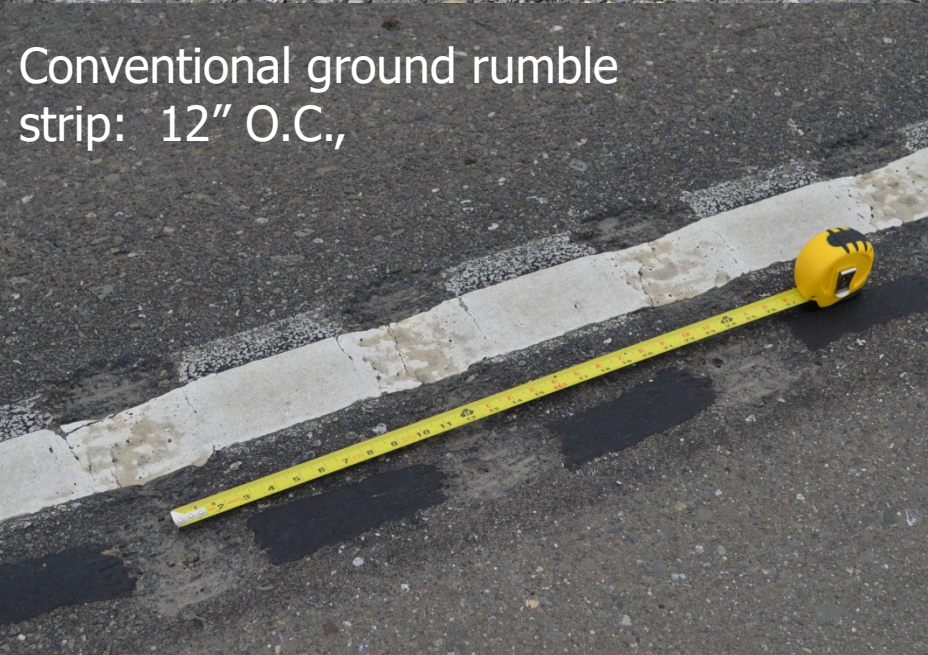
Conventional ground rumble strip: 12" O.C.,

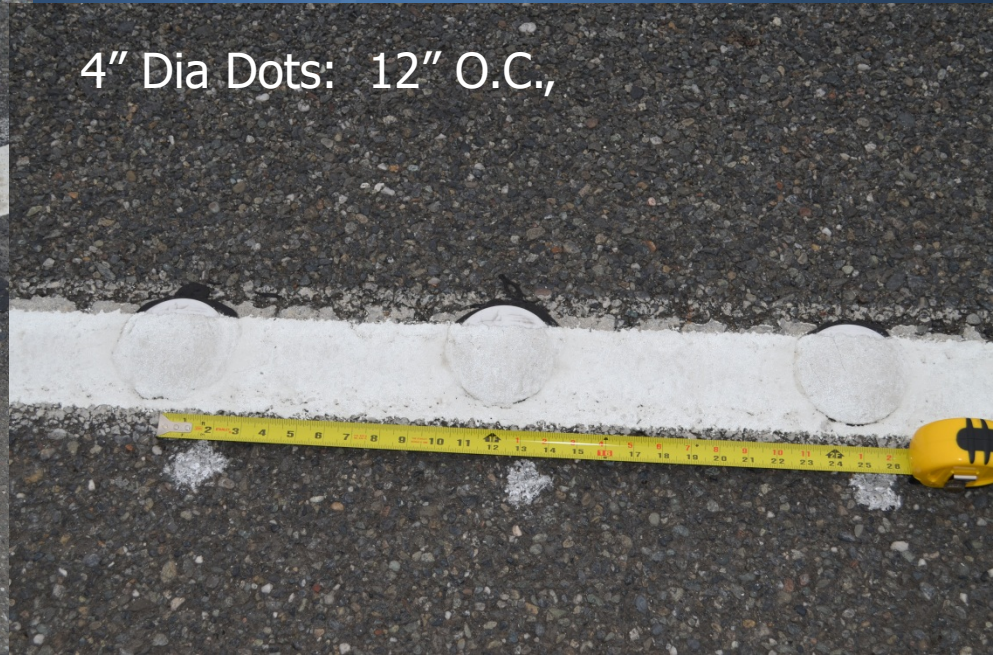
4" Dia Dots: 12" O.C.,

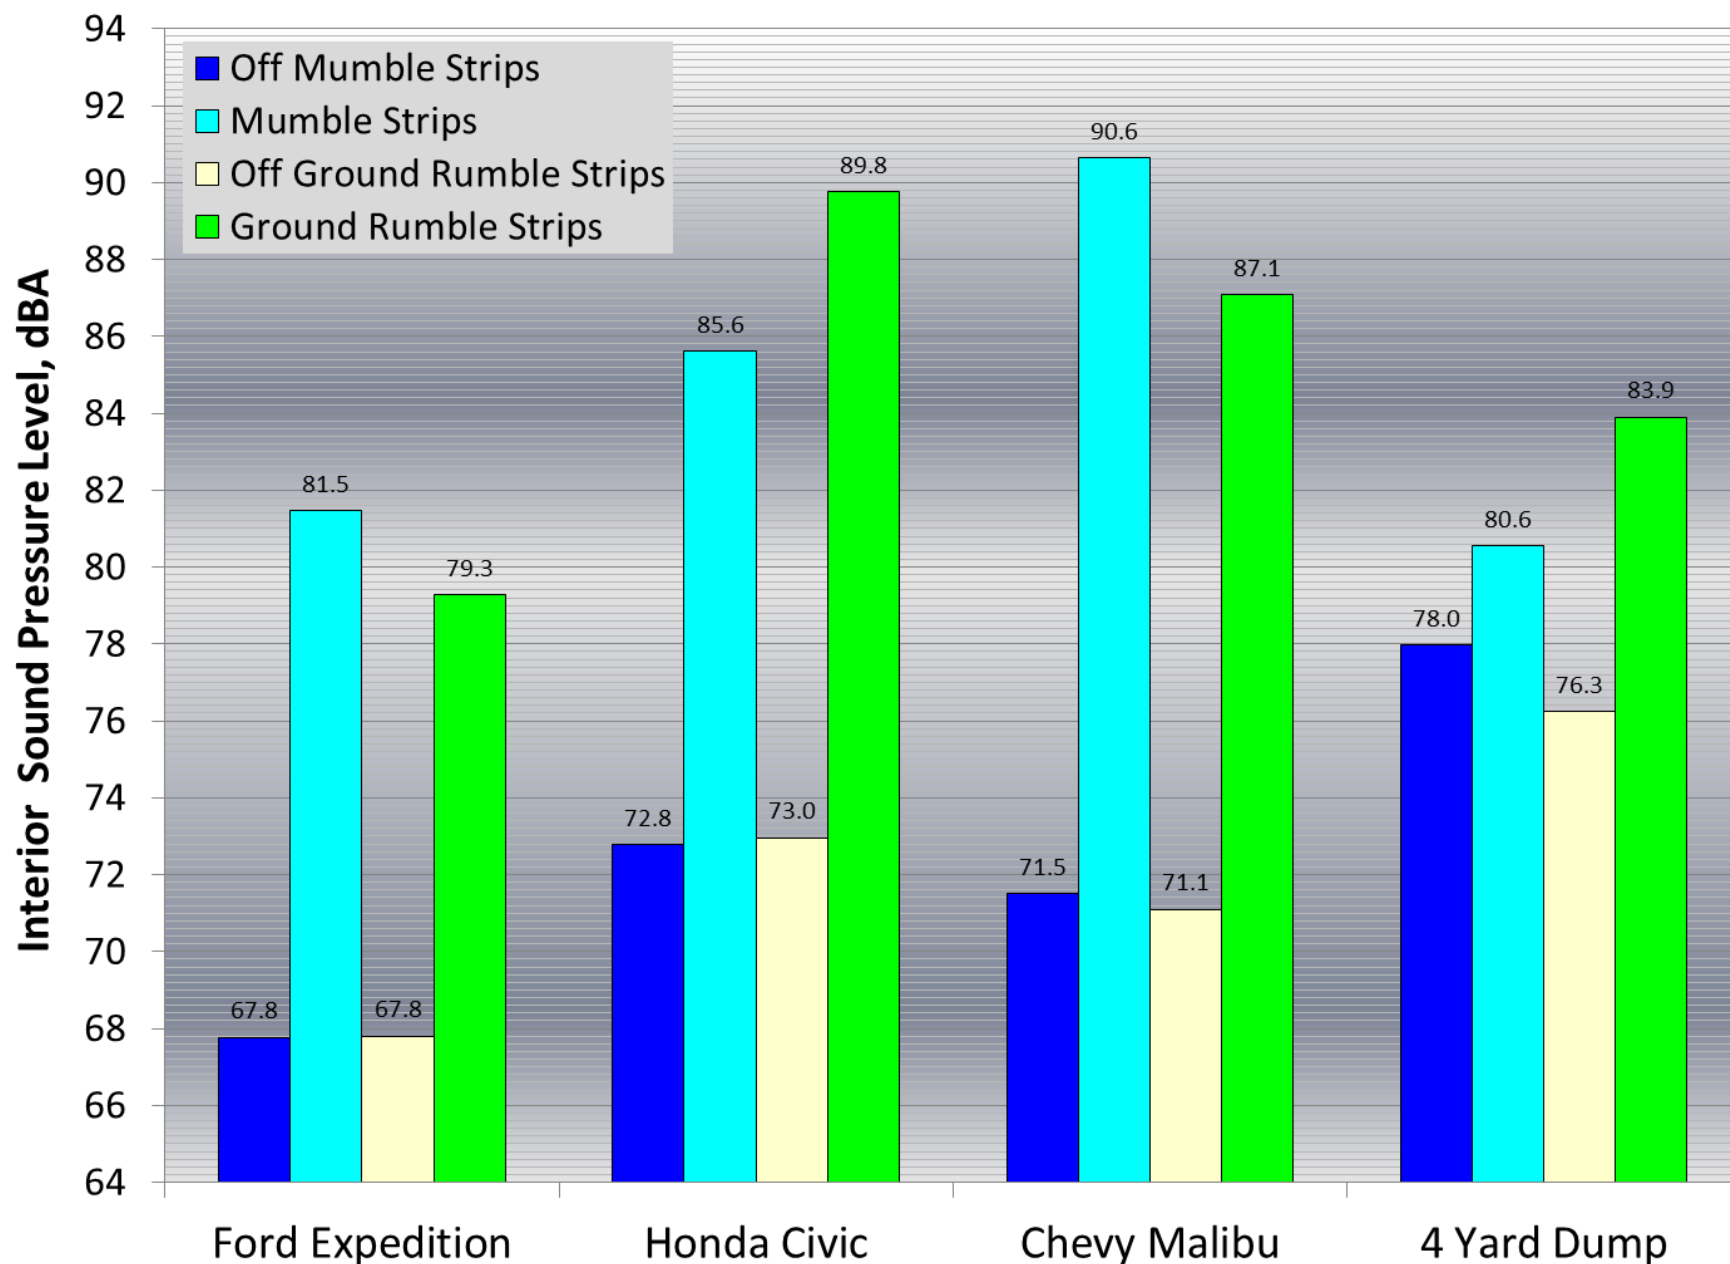
# Overall Interior Noise Levels

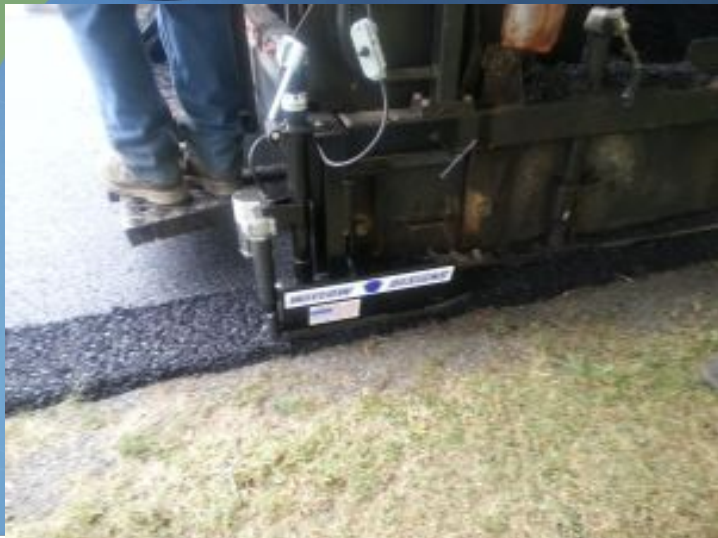
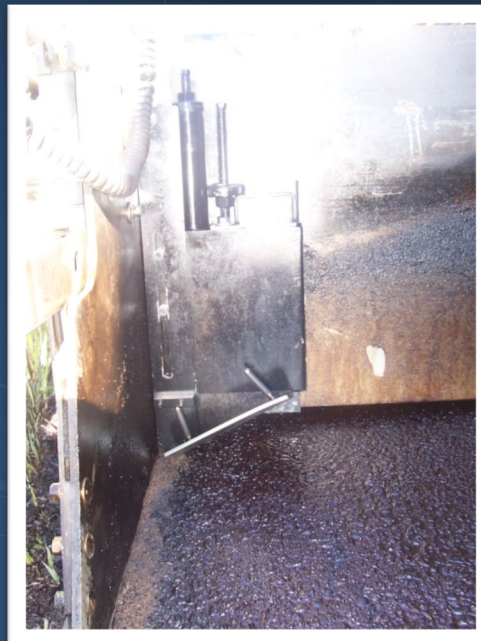
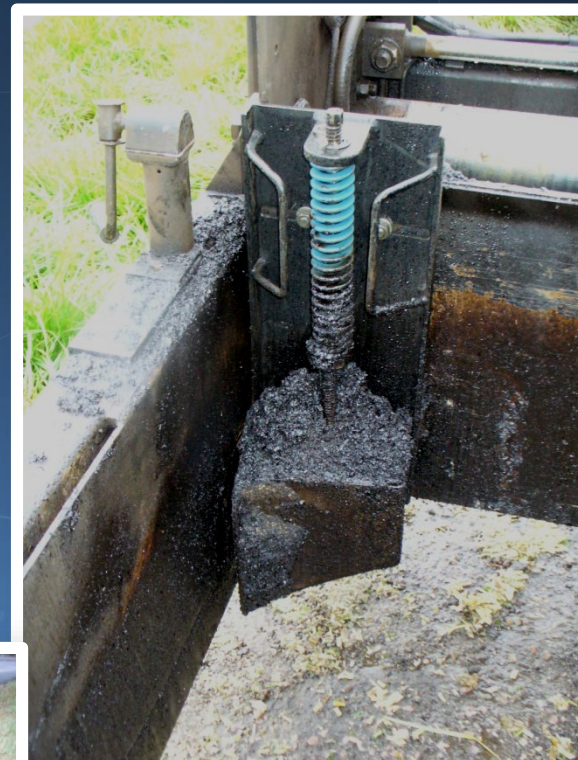
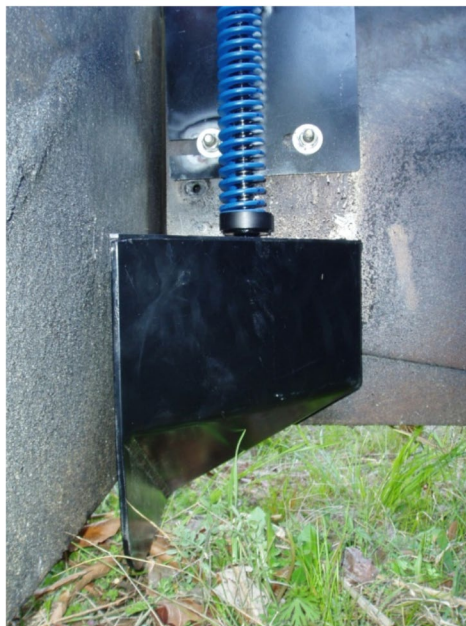
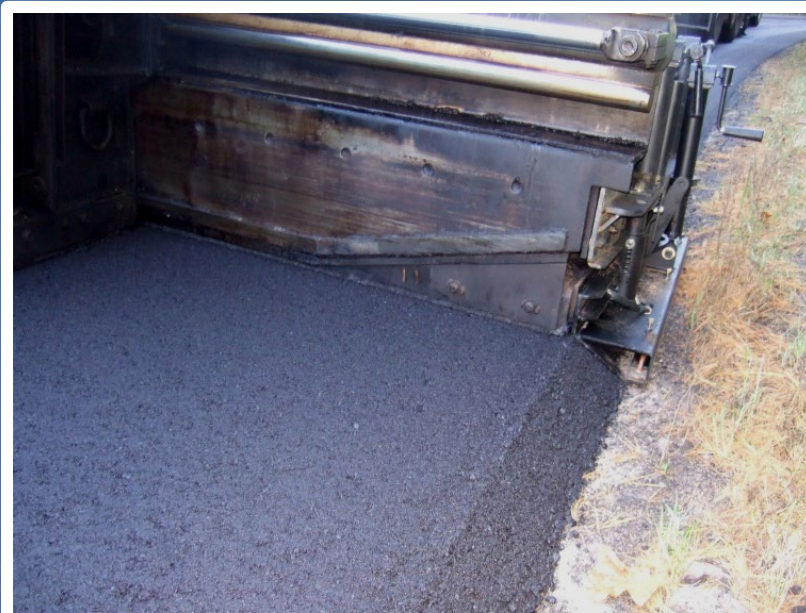
# The Hardware

- Hardware
  - Approximately \$1400-\$4500 per device
  - Reusable
- Material
  - Minor additional asphalt (depends on shoulder condition)
- Paving Process
  - No change in paving speed or rolling patterns
  - No additional operation
  - Minimal monitoring
- Surface Details
  - No change in smoothness/ride quality

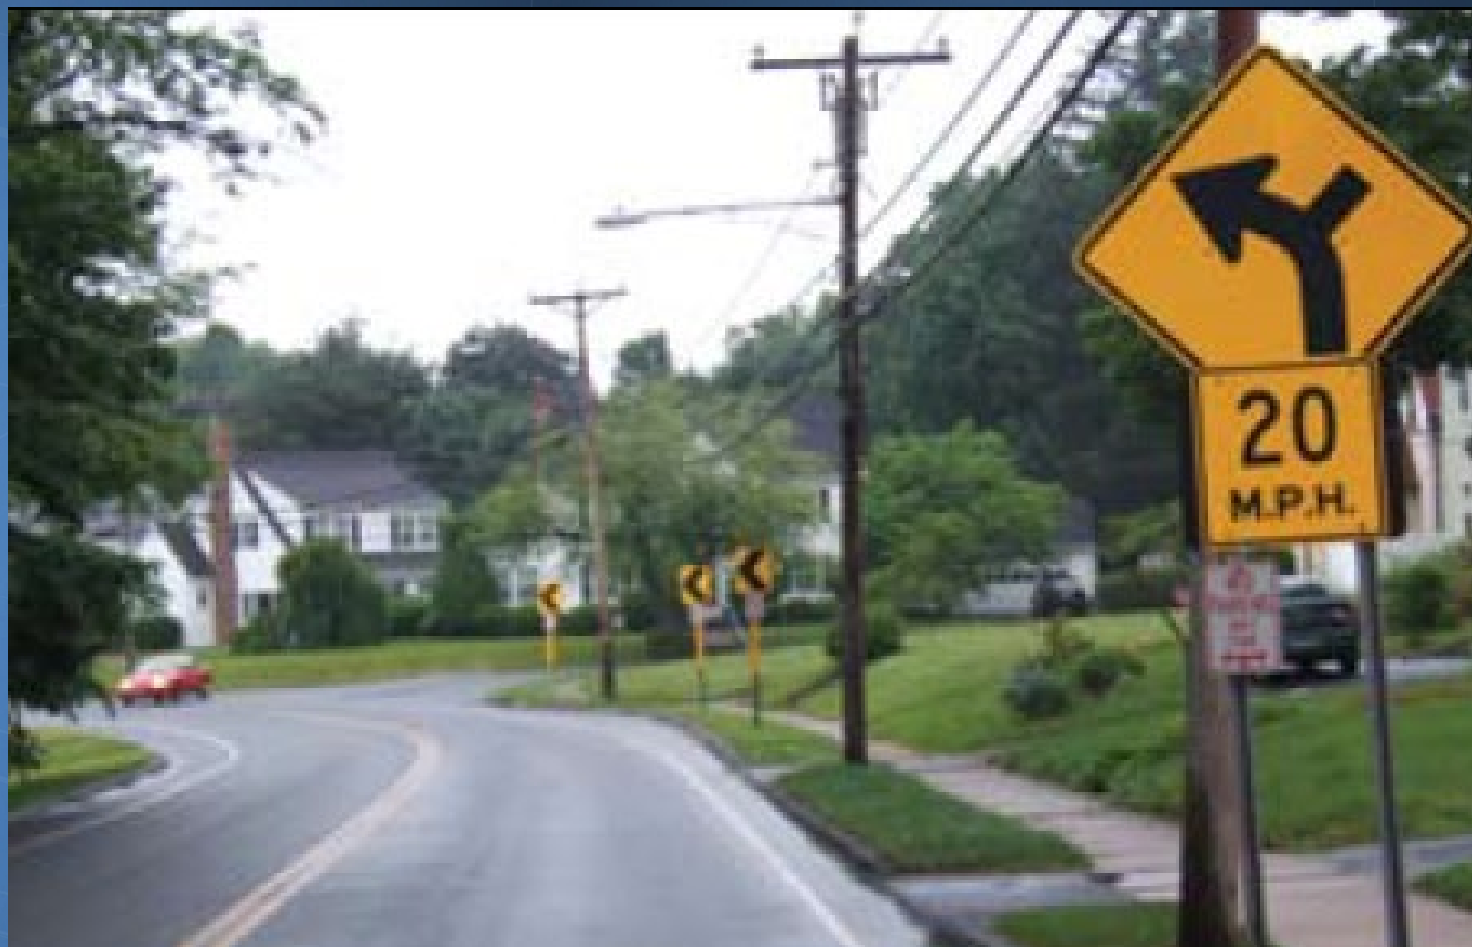
# Example of Enhanced Delineation

\* Improving curve delineation with signing improvements, is a very cost-effective treatment with a B/C exceeding 8:1. The greatest enhancements can be seen at locations with more hazardous roadsides, higher volumes and smaller curve radii.

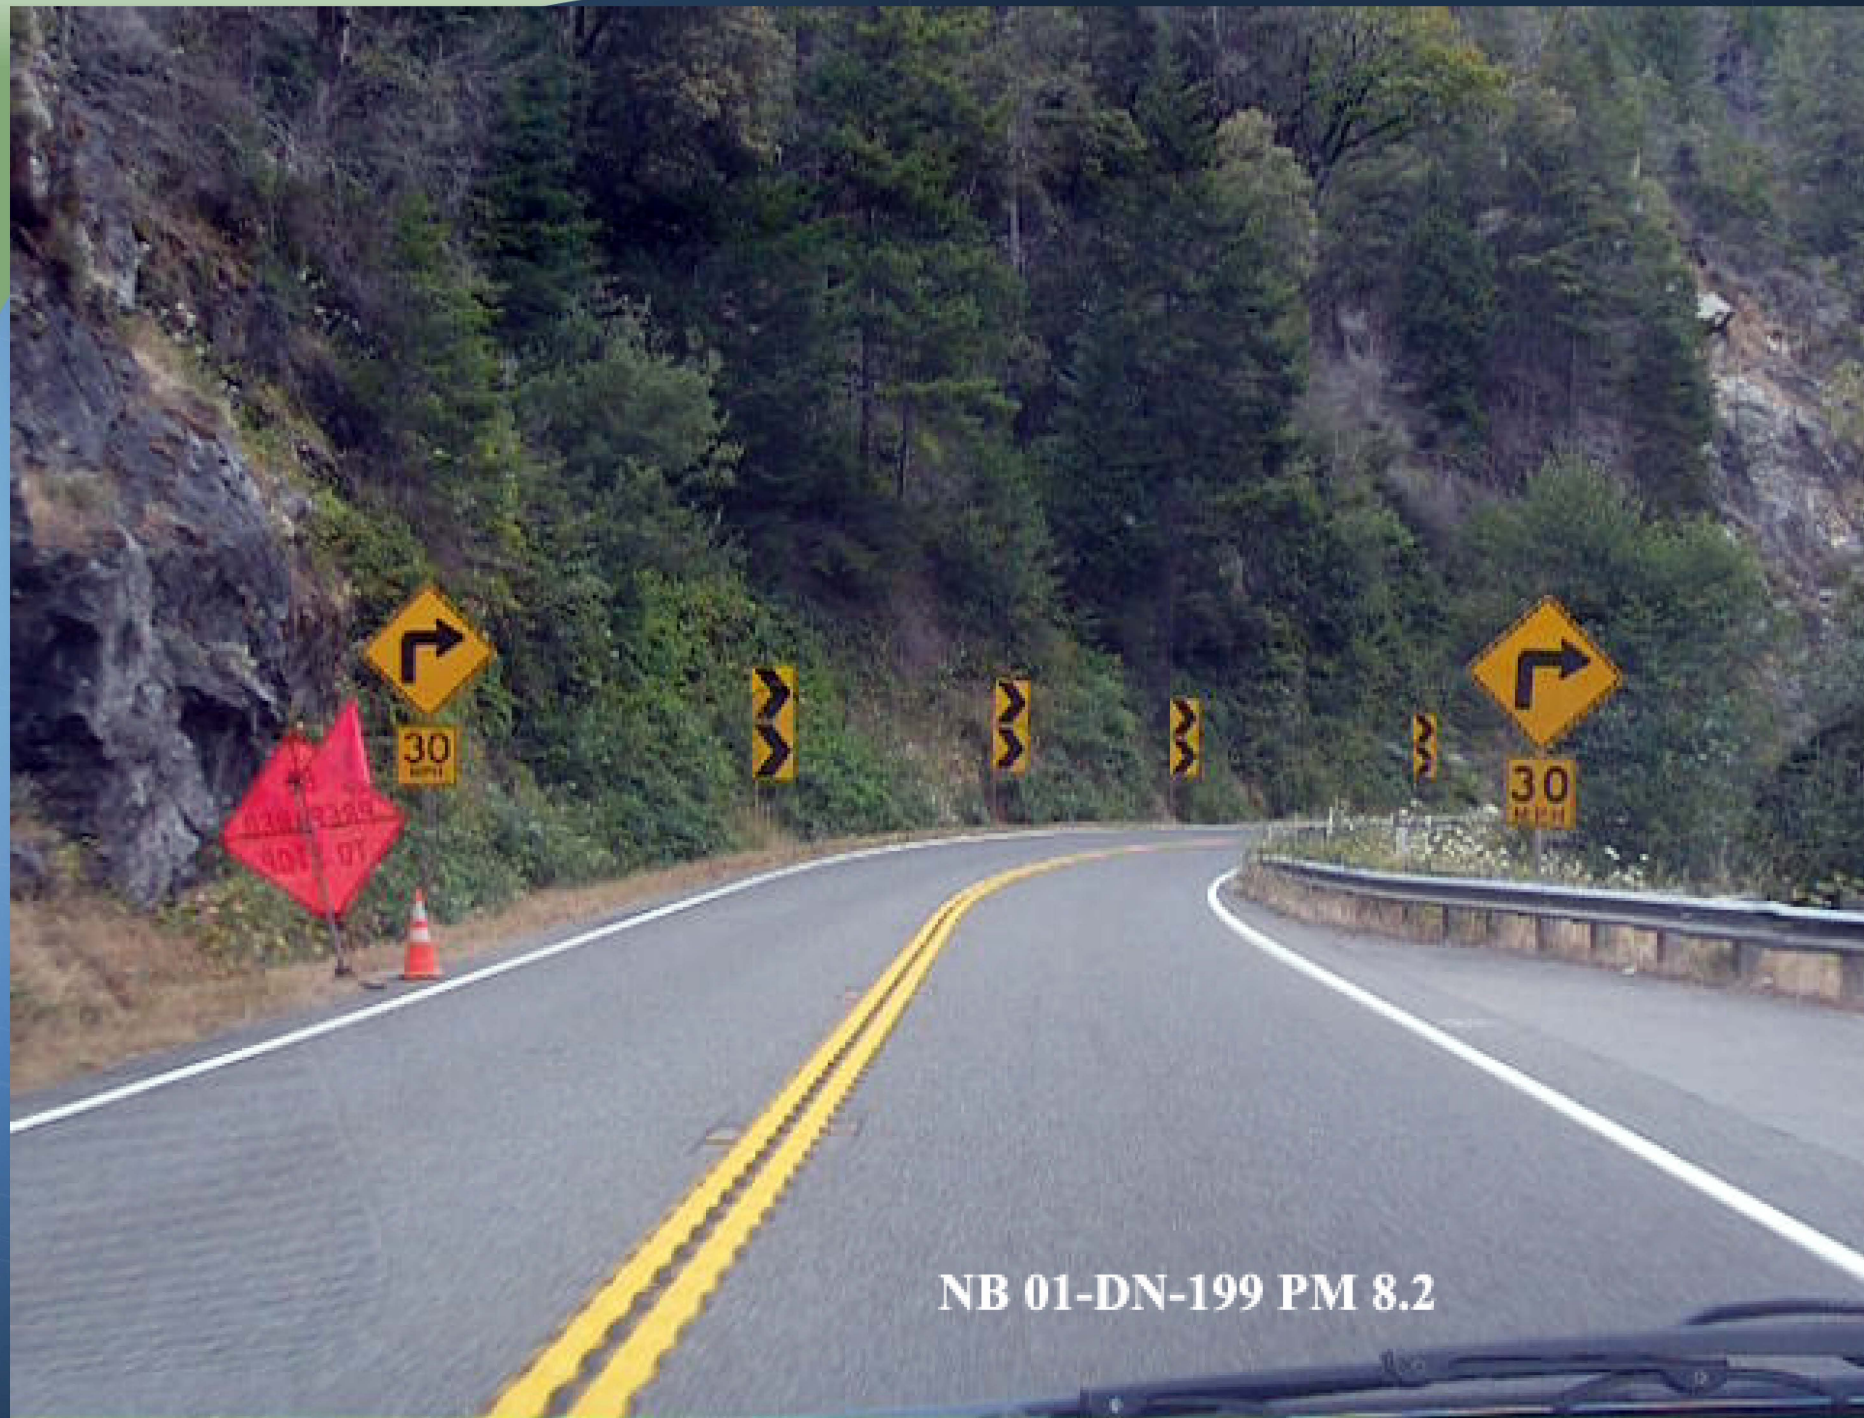
NB 01-DN-199 PM 8.2

- All 28 collisions in 3 years occurred under wet pavement conditions.
- District had used many low cost countermeasures with little change in collision pattern.
- District proposed curve realignment.

- Initial proposed project was to realign curve
  - \$14 M project; approx. 5 years for environmental, design and construction
- Realignment project put on hold to install HFST
  - \$250 K project; approx. 6 months for environmental, design and construction
- No crashes since installation (Summer 2012)

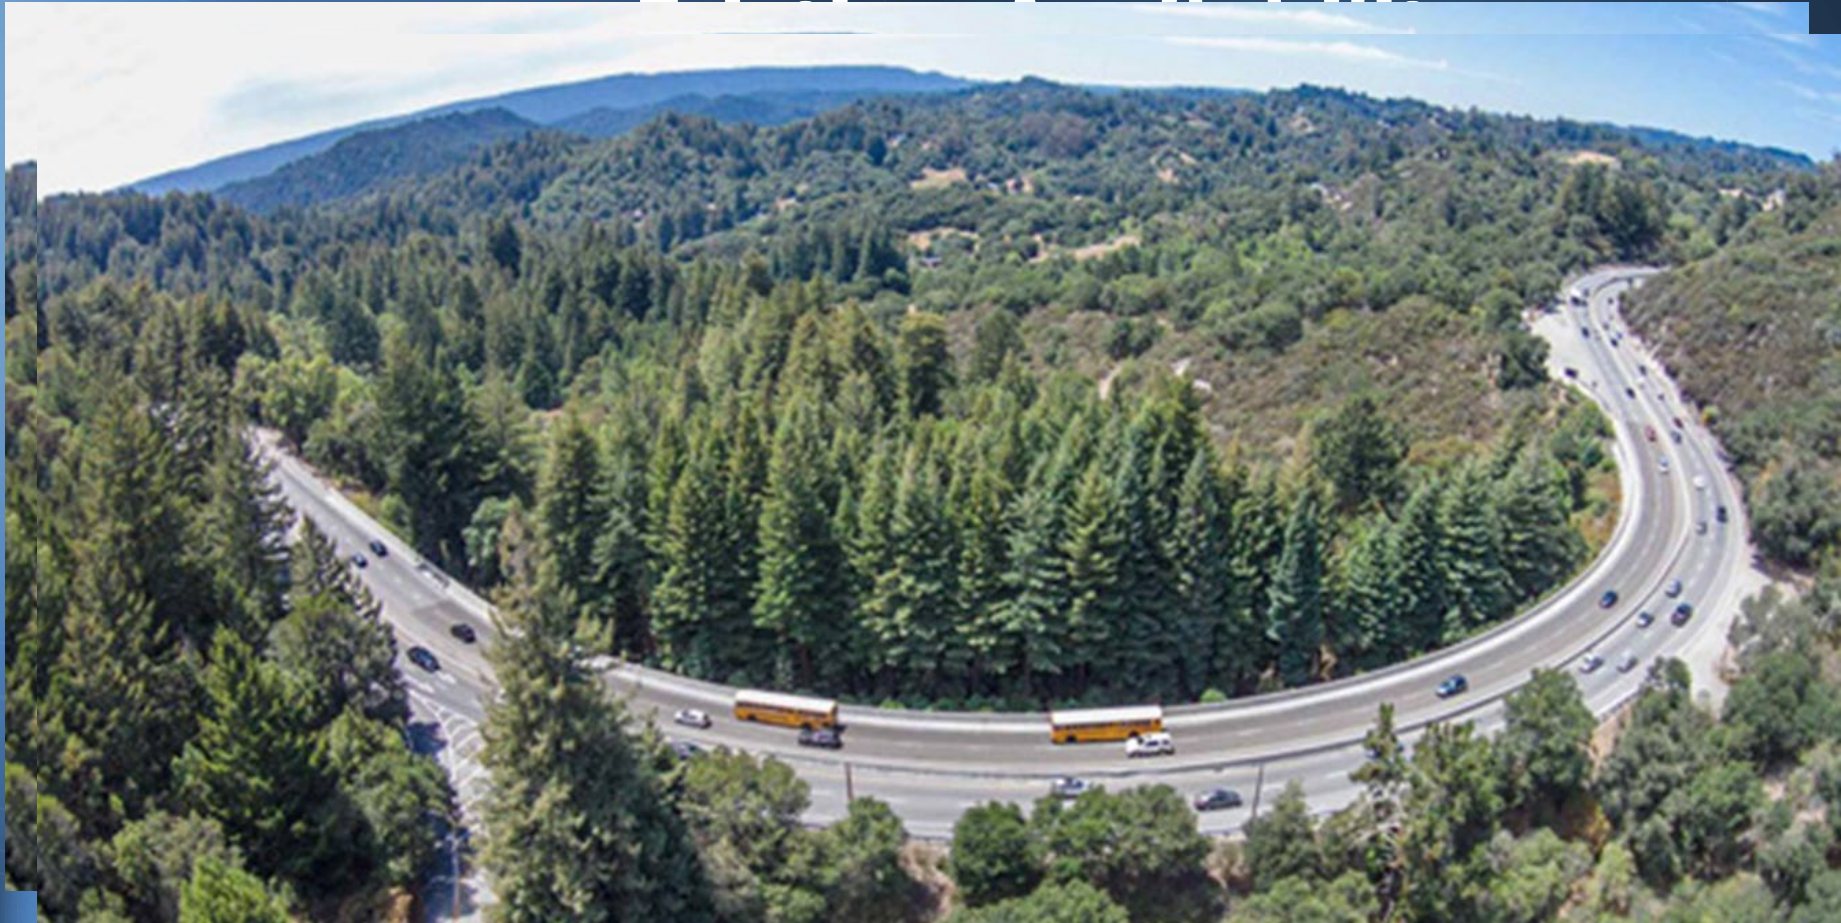
# Conceptual Relationship Between Friction Demand, Speed and
