Roadway Departure Technical Brief No. 4
Roadside Safety Systems
Pre-Installation Field Review Check List

California Local Roads

CATEGORY: Design

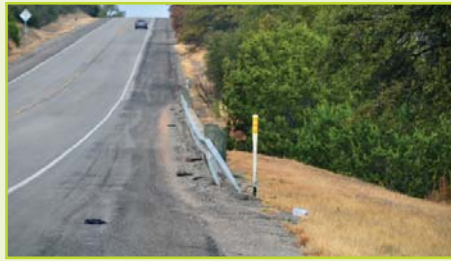
J

Although the turned down terminal is no longer used by most DOTs, existing installations remain in place. Such terminals should be delineated, as in **Photograph J**, until they can be upgraded. This terminal in **Photograph K** would not prevent an errant motorist from striking the bridge pier or intruding into opposing traffic. Locations where impacts could result in severe crashes should be identified and systematically upgraded.

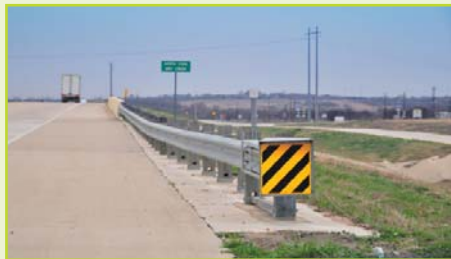
L

A terminal struck by a stable vehicle, i.e., a vehicle that has its suspension neither compressed nor extended and has minimal roll, pitch, and yaw angles, will result in the best terminal performance possible. The roadway approaches to virtually all terminals should be as flat and traversable as practical, as shown in **Photograph L**.

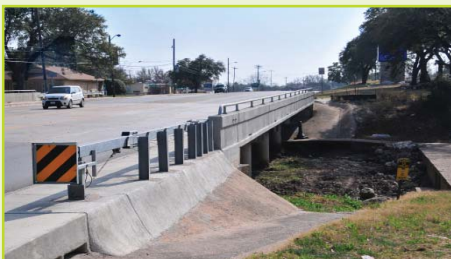
M

Impacting a terminal, even when it is installed on flat ground, induces some instability in most vehicles. When the area immediately behind a terminal is steep or non-traversable, a vehicle can overturn after breaking through the terminal. A minimal traversable runout area behind the terminal is an essential part of good barrier design. A field check to determine if a minimal runout area exists is to see if a passenger-type vehicle can be safely driven and parked behind the terminal, parallel to the barrier. If so, one may assume that a minimal runout area is available. Another check is to observe whether or not the area behind the terminal is at least as clear and unobstructed as the unshielded area immediately upstream of the terminal. If not, extending the barrier a greater distance may be warranted. In **Photograph M**, the area beyond the terminal is too steep and the barrier LON is too short. Any vehicle impacting the terminal at an angle would likely reach the river below.

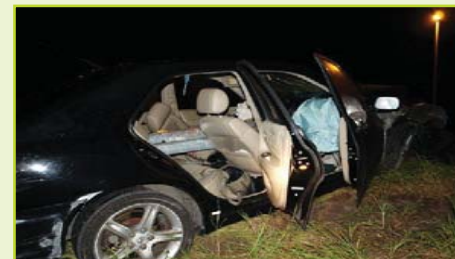
A

Installing and maintaining roadside barriers can be costly and, if installed incorrectly, they can become an additional hazard in a serious crash, as shown in **Photograph A**. If running off the roadway at a specific location is clearly less hazardous than striking a guardrail, or if the hazardous feature can be removed, relocated, or redesigned, barrier should not be used. Be certain there is a clear and justifiable barrier warrant before installing guardrail.

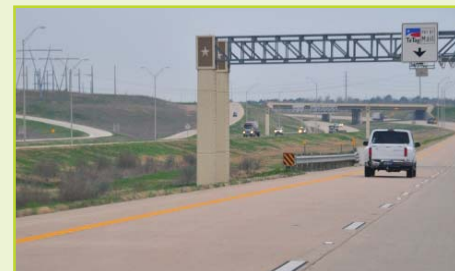
B

The clear zone distances for low and high volume roadways used by most DOTs to determine if a hazard warrants shielding are minimum distances based on relatively limited data. While there are hazards adjacent to virtually every roadway, special attention should be given to man-made fixed objects such as bridge piers, culverts, and large sign or light supports. Such fixed objects may be considered for shielding if there is a reasonable expectation that an errant motorist may strike them even if they are outside the design clear zone. While the barrier in **Photograph B** does shield the end of the bridge, the steep median slope leaves the massive truss support in a vulnerable location - especially on a high speed freeway. Extending the metal beam guardrail to shield the support would be desirable.

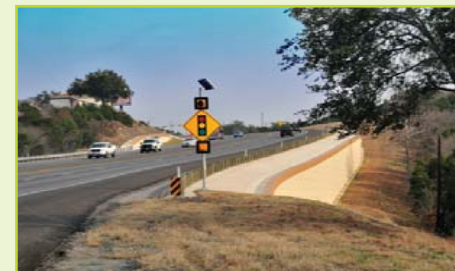
C

To check the barrier length of need (LON) in the field, one need only pace off the appropriate runout distance (starting on the shoulder opposite the upstream edge of the hazard), then turn and look at the back of the hazard. If the barrier intersects this line of sight the LON is probably adequate. The barrier shown in **Photograph C** is too short to prevent a vehicle from reaching the steep slope/retaining walls directly behind the terminal.

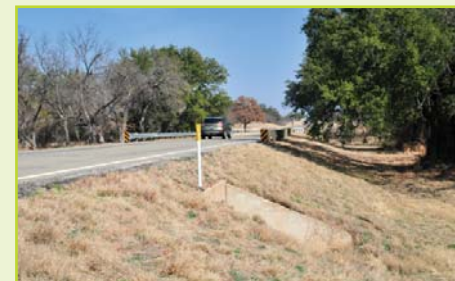
D

When verifying the correct LON required to shield a primary hazard, one must note other significant hazards immediately in the vicinity of the barrier terminal that could be effectively shielded by extending the barrier. While such secondary hazards (such as the concrete culvert in **Photograph D**) may not normally warrant shielding on their own, it is best to avoid a situation where a motorist runs off the road in advance of the metal beam guardrail and is then seriously injured in a collision with a secondary hazard that could easily have been shielded. Judgment must be used where these secondary hazards (such as a solid line of trees, which would not normally be shielded) extend a significant distance upstream from the primary hazard.

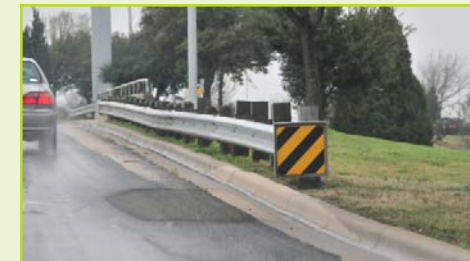
F

Installing barrier behind curbs creates a concern similar to installing barrier on a slope. Because curbs do not have significant redirection capabilities, tire impact with a curb tends to raise a vehicle's bumper height, again resulting in a higher-than-normal impact into a metal beam guardrail. If the barrier is installed with its face directly above the curb and is stiffened to limit its deflection when struck, a curb/barrier combination poses only a slight risk of an override. However, installing a W-beam metal beam guardrail slightly beyond a 6-inch concrete curb, as shown in **Photograph F**, is an invitation to an override.

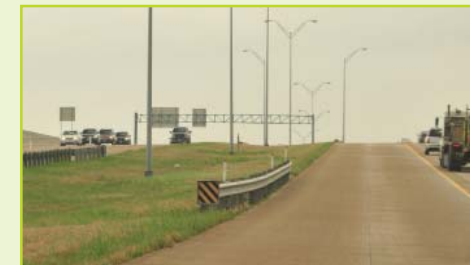
G

As noted above, barrier is also a fixed object and should be used only when it is able to result in a less severe crash that would occur if it were not present. The "need" for barrier in **Photograph G** is questionable.

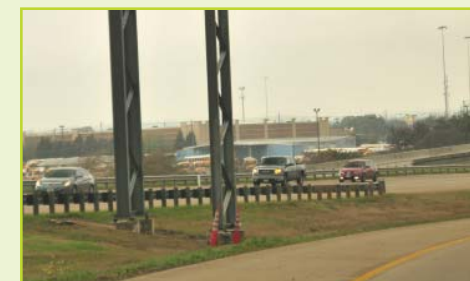
Photograph H shows a metal beam guardrail shielding the steel post in one direction of traffic but the supports on the near side of the curve remain unshielded. Similarly, the bridge piers in **Photograph I**, while beyond the 30-ft clear zone, are in a very vulnerable location on the outside of the curve along this high-speed, high volume freeway.
