Nine Proven Safety Countermeasures

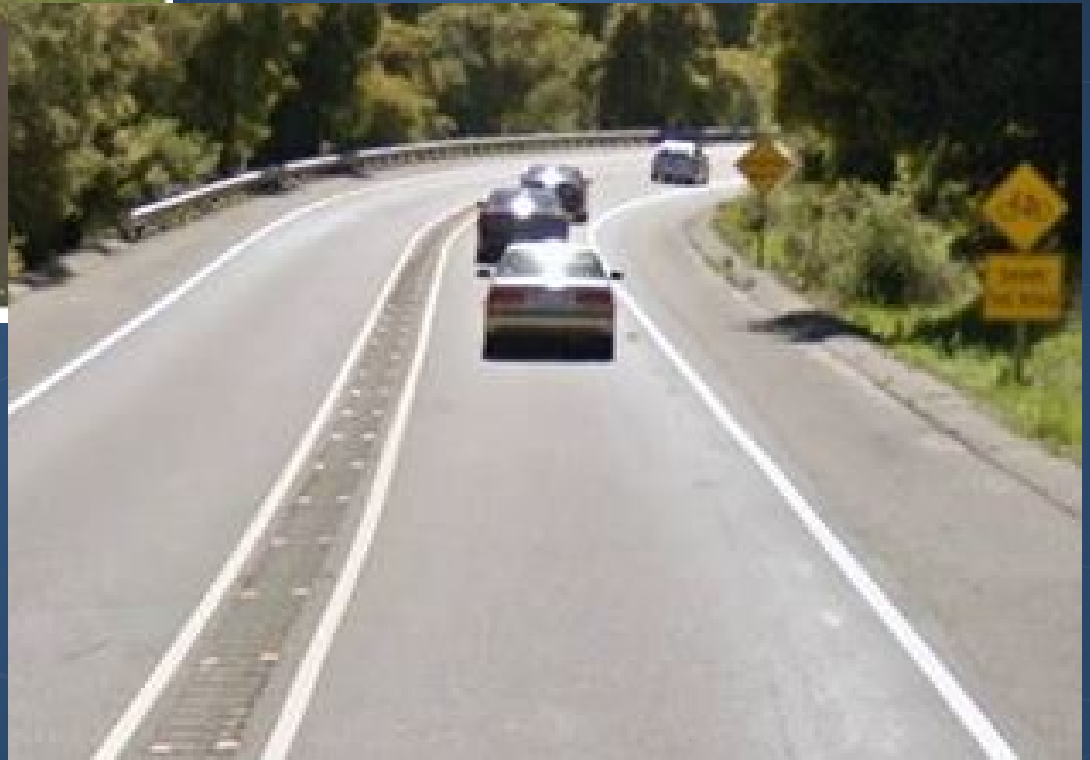
Shoulder Rumble Stripe

**SR 84 in bay area
Courtesy of Google**

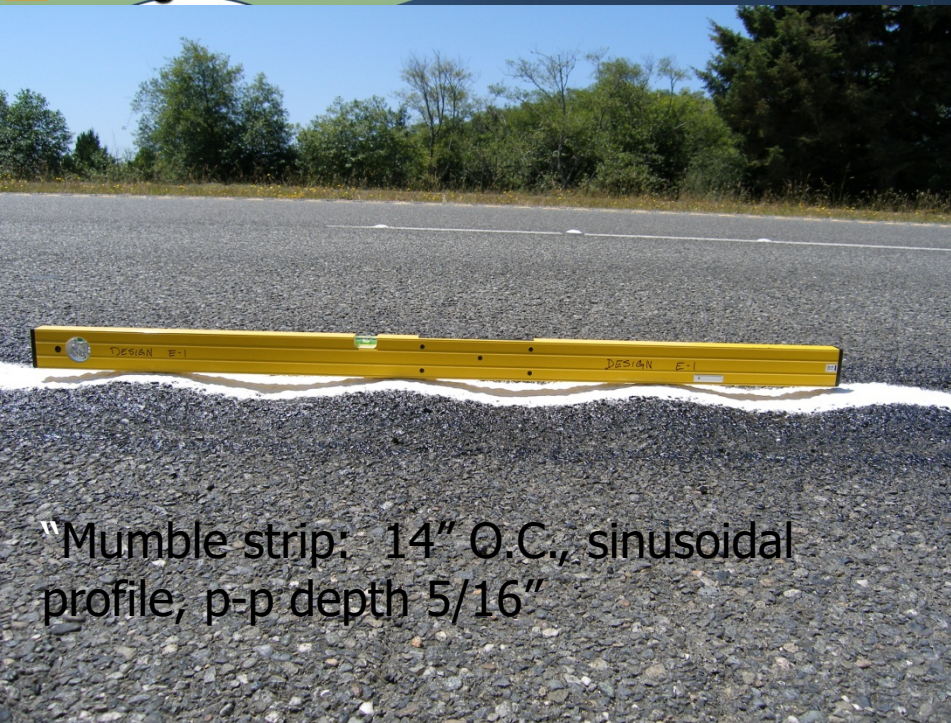
"Mumble strip: 14" O.C., sinusoidal profile, p-p depth 5/16"

Caltrans Sinusoidal Rumble Strip (aka mumble strip)

- Rumble strips can help reduce sideswipe, head-on collisions, and run-off-road crashes
- Caltrans mumble strips achieved goals
 - Lower exterior dB A-weighted levels
 - Provide sufficient driver warning input
- Interior noise & vibration response varied with vehicle type

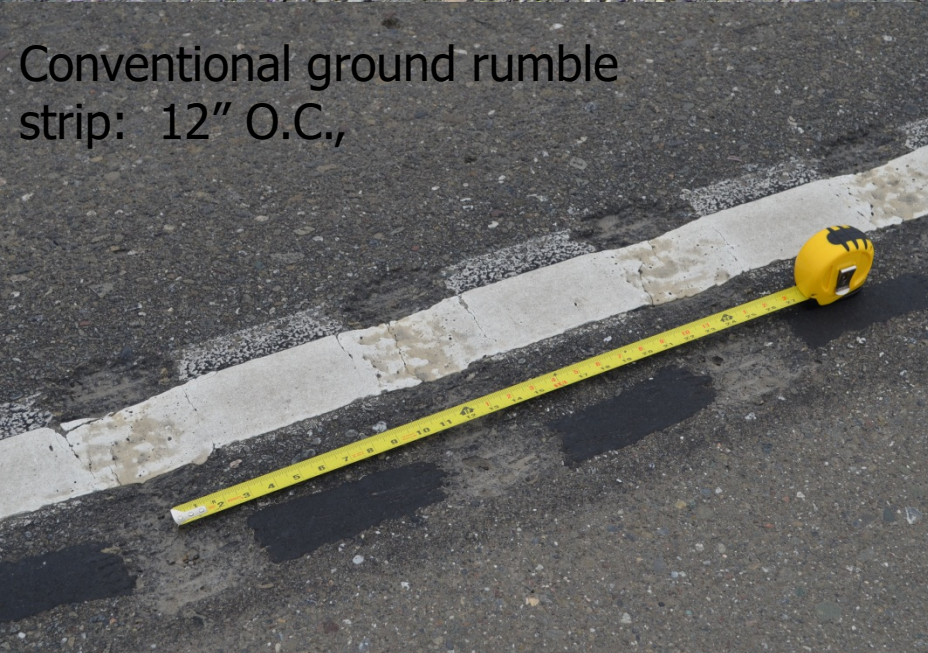
Conventional ground rumble strip: 12" O.C.,

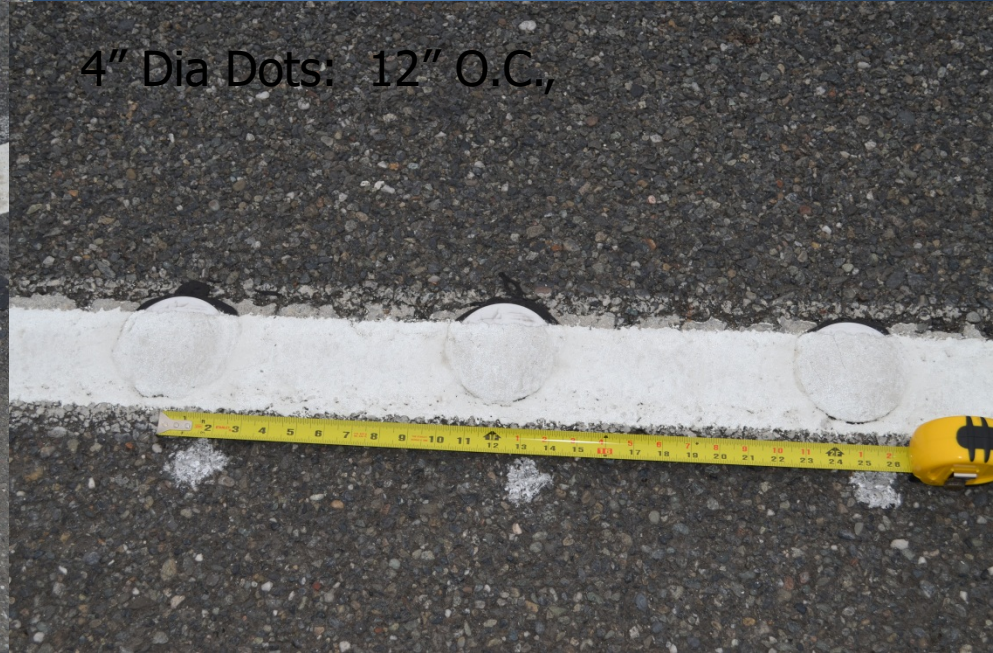
4" Dia Dots: 12" O.C.,

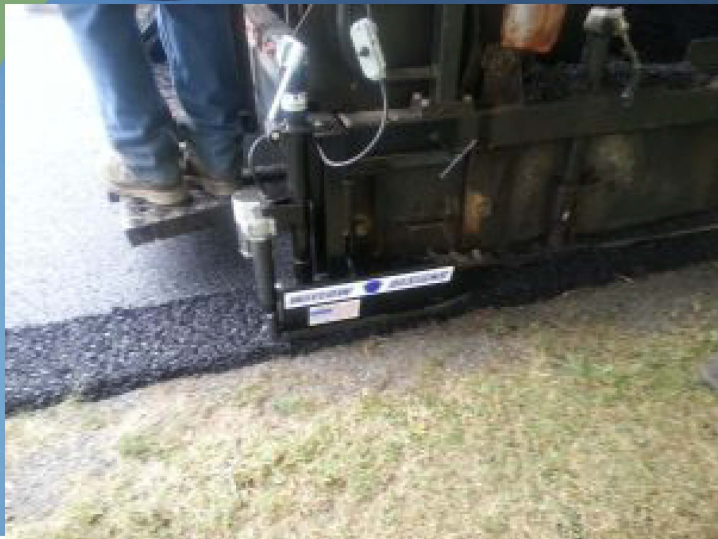
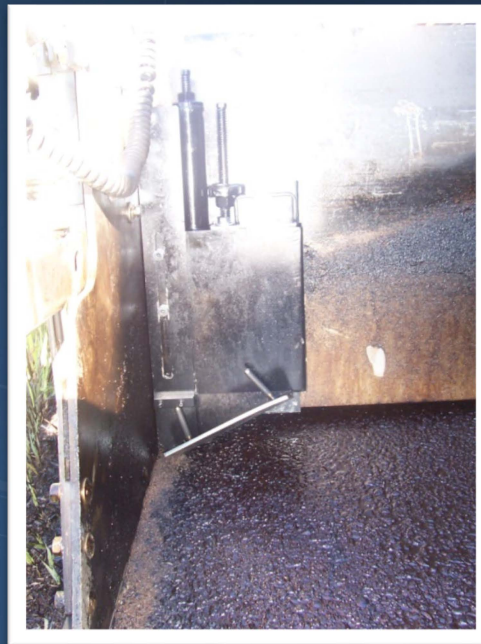
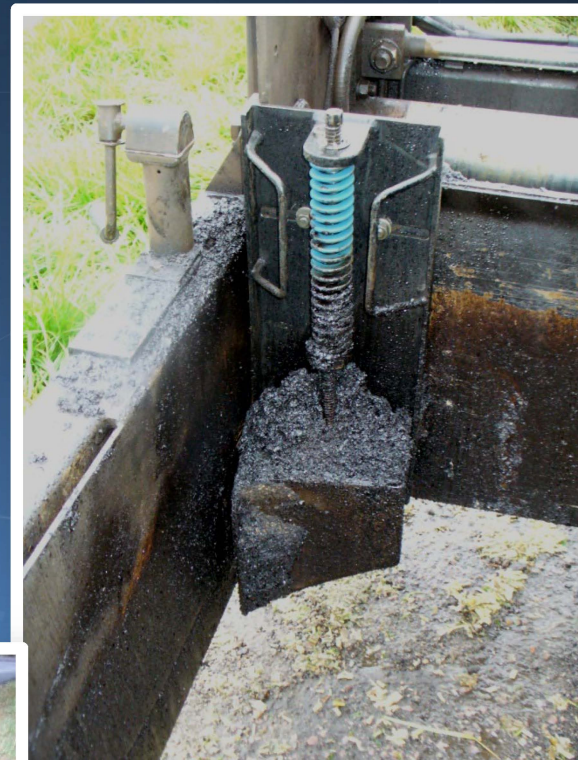
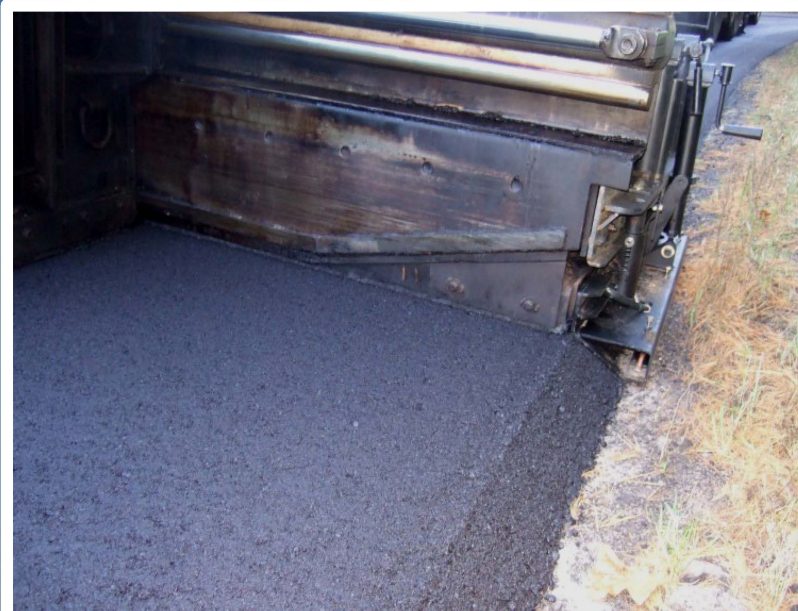
The Hardware

- Hardware
 - Approximately \$1400-\$4500 per device
 - Reusable
- Material
 - Minor additional asphalt (depends on shoulder condition)
- Paving Process
 - No change in paving speed or rolling patterns
 - No additional operation
 - Minimal monitoring
- Surface Details
 - No change in smoothness/ride quality

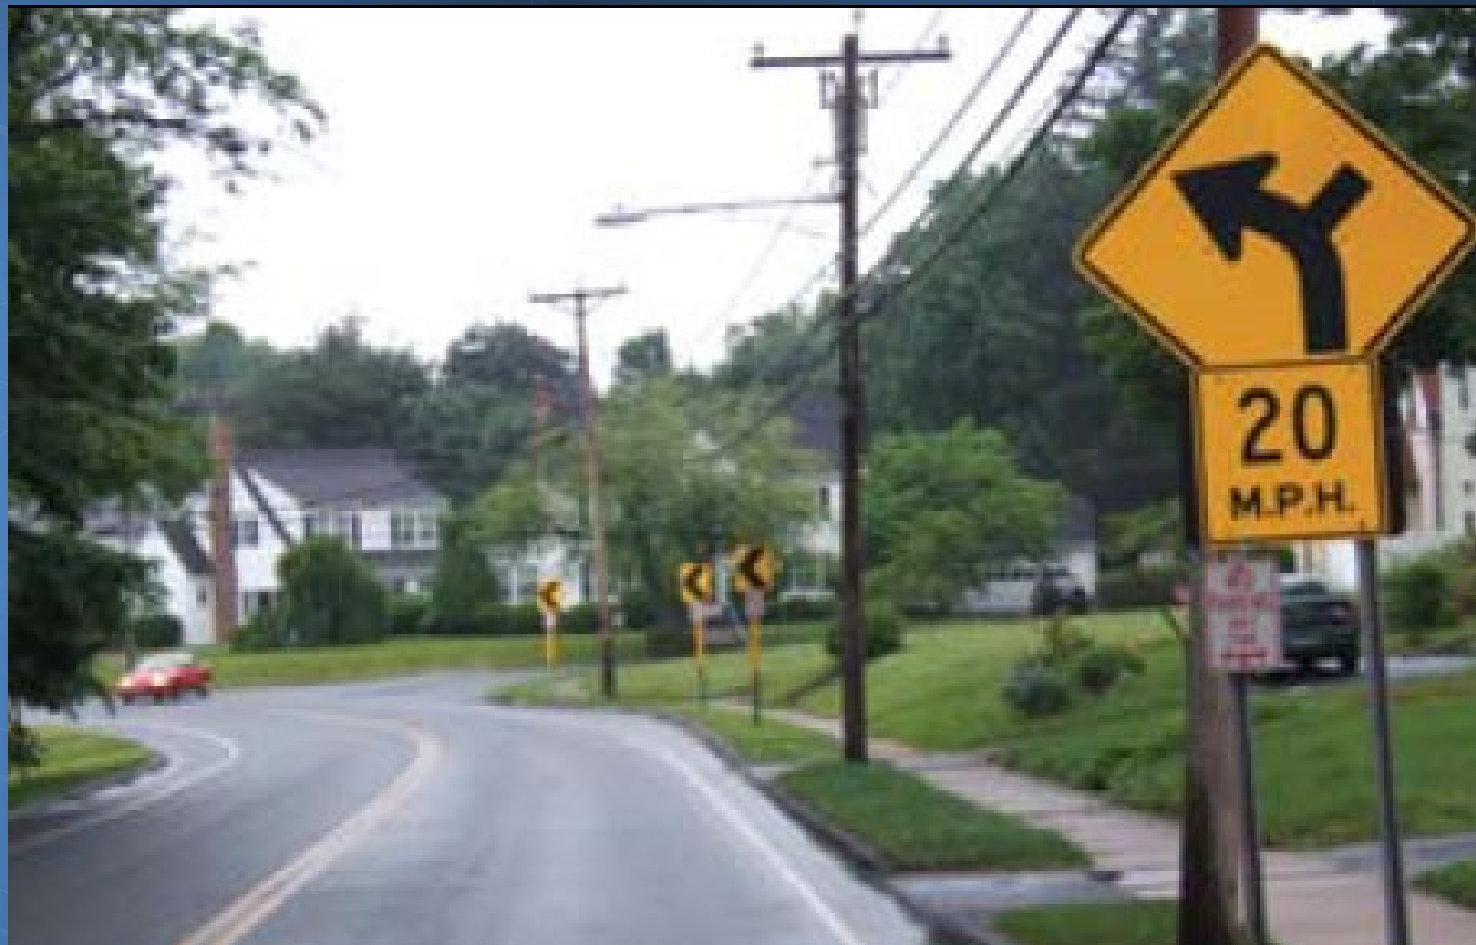
Example of Enhanced Delineation

- Data collected from states of Connecticut and Washington
- Delineation improvements for horizontal curves on two-lane rural roads
- 117 mile/years of before and after data (228 sites total)
- Chevron, curve ahead, horizontal or suggested speed limit signs
- Fluorescent sheeting, increased size or additional signs

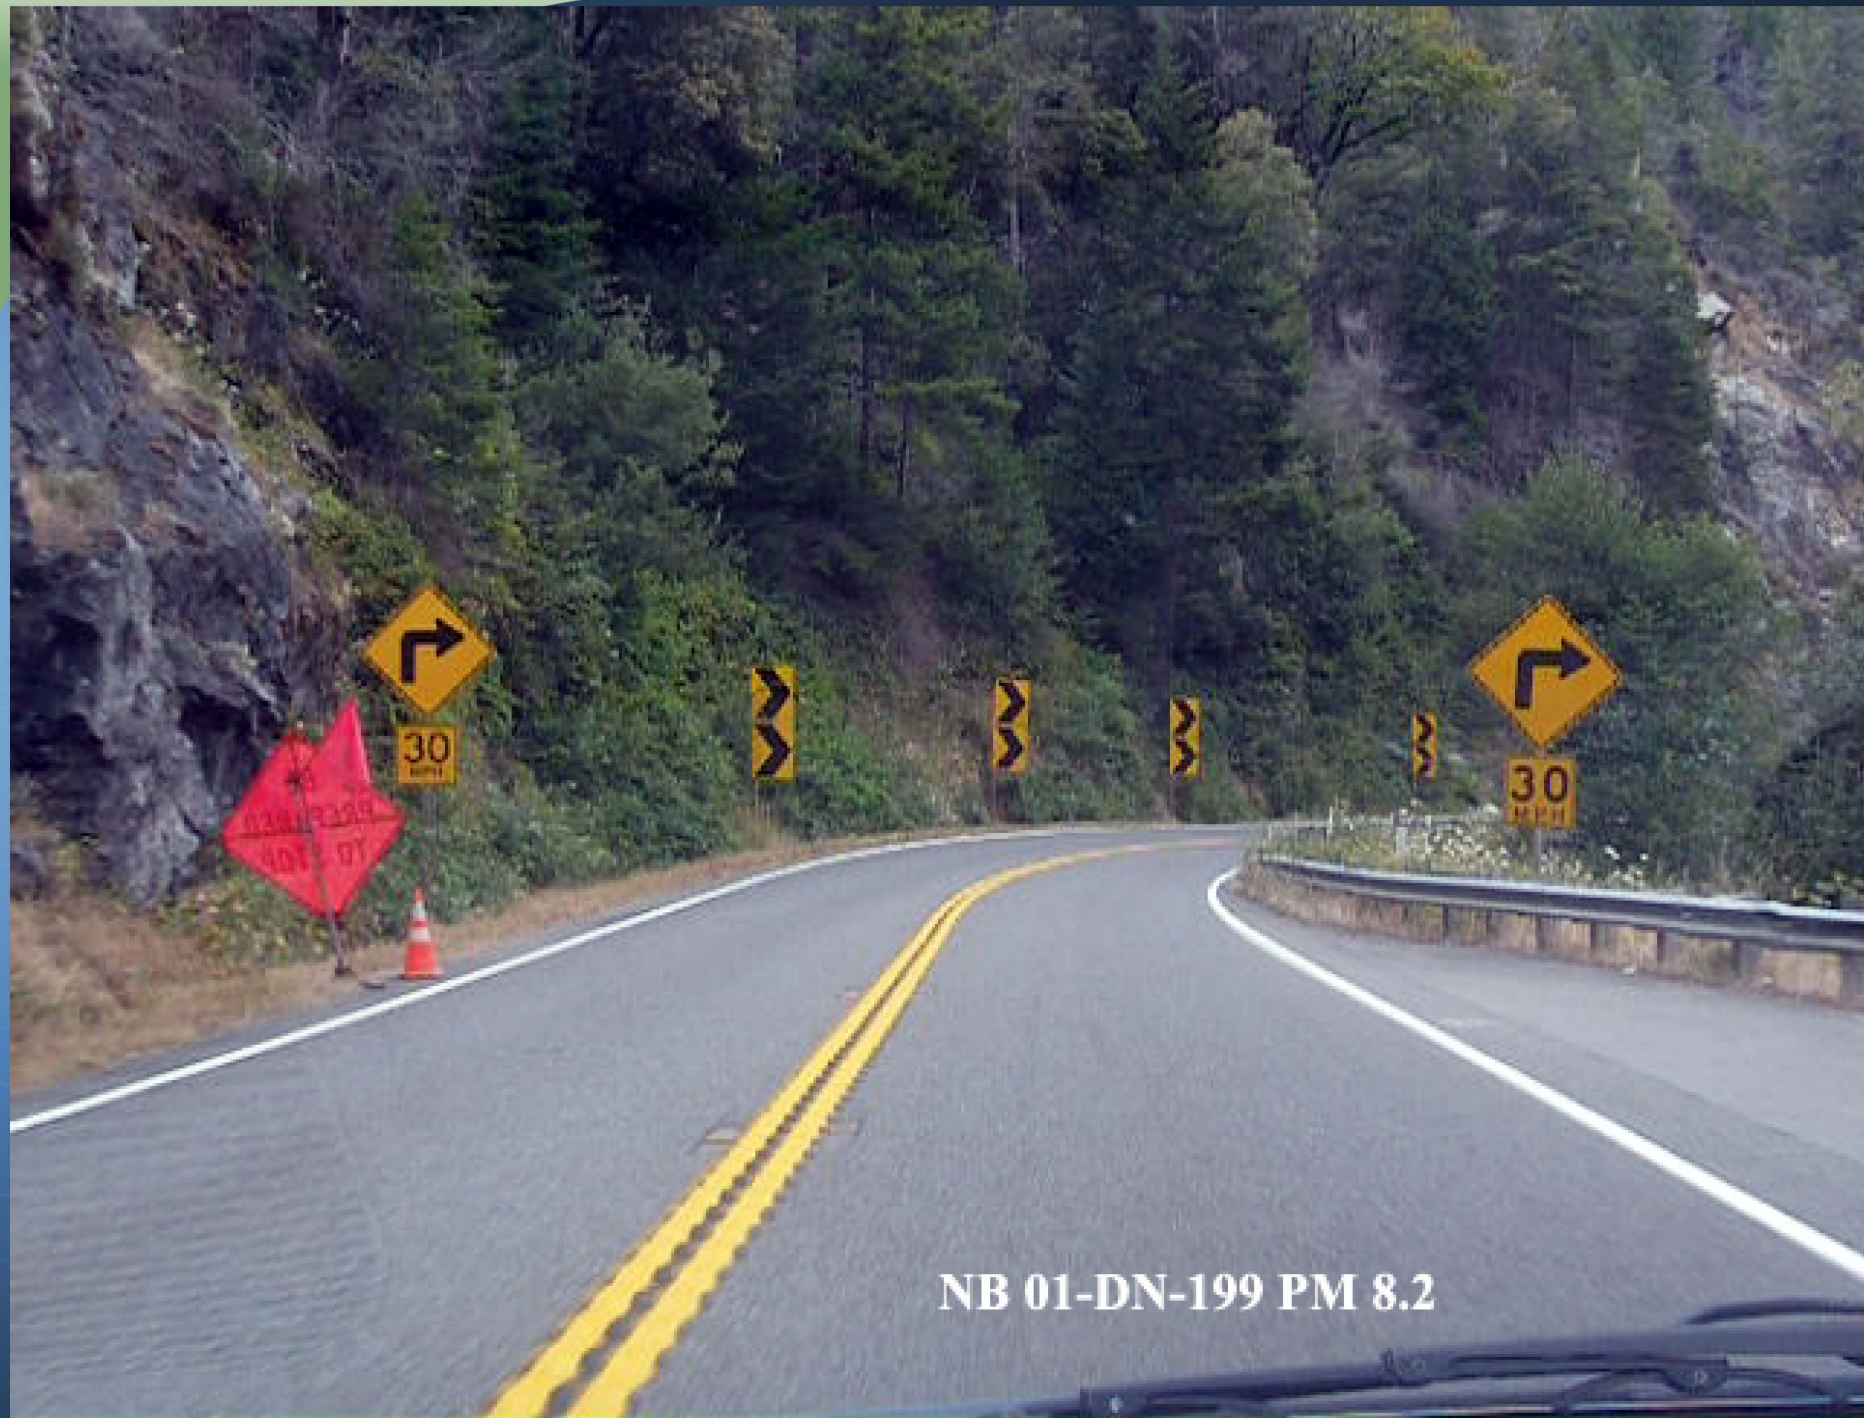
NB 01-DN-199 PM 8.2

- All 28 collisions in 3 years occurred under wet pavement conditions.
- District had used many low cost countermeasures with little change in collision pattern.
- District proposed curve realignment.

- Initial proposed project was to realign curve
 - \$14 M project; approx. 5 years for environmental, design and construction
- Realignment project put on hold to install HFST
 - \$250 K project; approx. 6 months for environmental, design and construction
- No crashes since installation (Summer 2012)

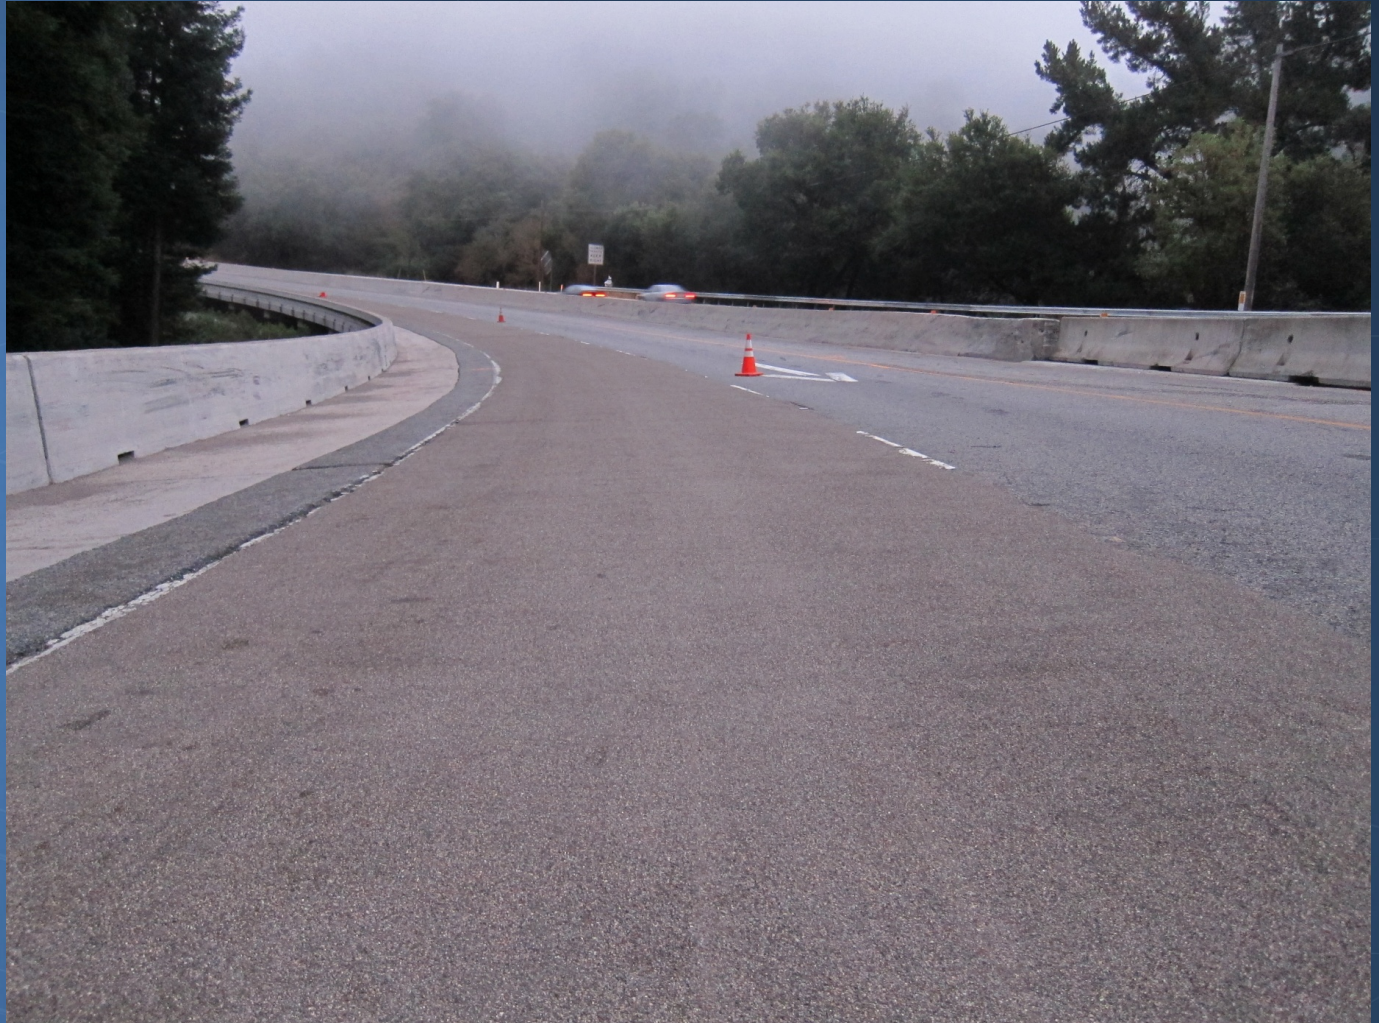
SR-17, Laurel Curve near Santa Cruz (July 2012)
