METHODS FOR EXCLUDING CLIFF SWALLOWS FROM NESTING ON HIGHWAY STRUCTURES

Final Report CA05-0926
August 24, 2009

Prepared for:
State of California
Department of Transportation
Division of Research and Innovation
Office of Materials and Infrastructure Research
1101 R Street
Sacramento, CA 95811

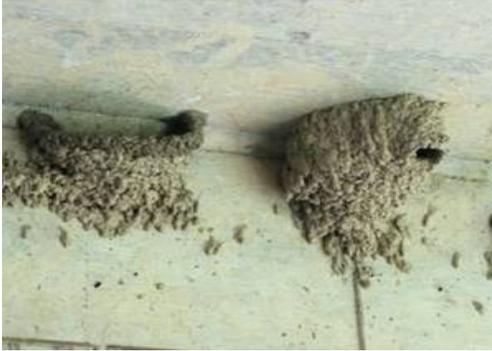
Figure 1. Partial and completed cliff swallow nests on underside of highway structure.

Cliff swallows (*Petrochelidon pyrrhonota*) are protected by the Migratory Bird Treaty Act (MBTA) of 1918. Completed nests cannot be disturbed during the breeding season, which is defined by the California Department of Fish and Game to be February 15 – September 1. Cliff swallows nest in colonies that often contain 200 to 400 nests or more (Brown and Brown 1995). The original nesting habitat of cliff swallows was on rocky cliffs (Emlen 1954), but their range has expanded in North America over the last half century due to the availability of suitable habitat from bridges, culverts, and buildings, which serve as surrogates for cliffs (Figure 1).

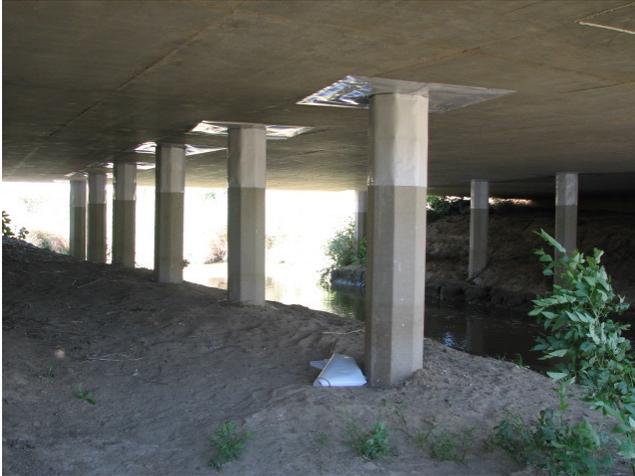
Figure 3. Highway structures with PTFE surface modification.

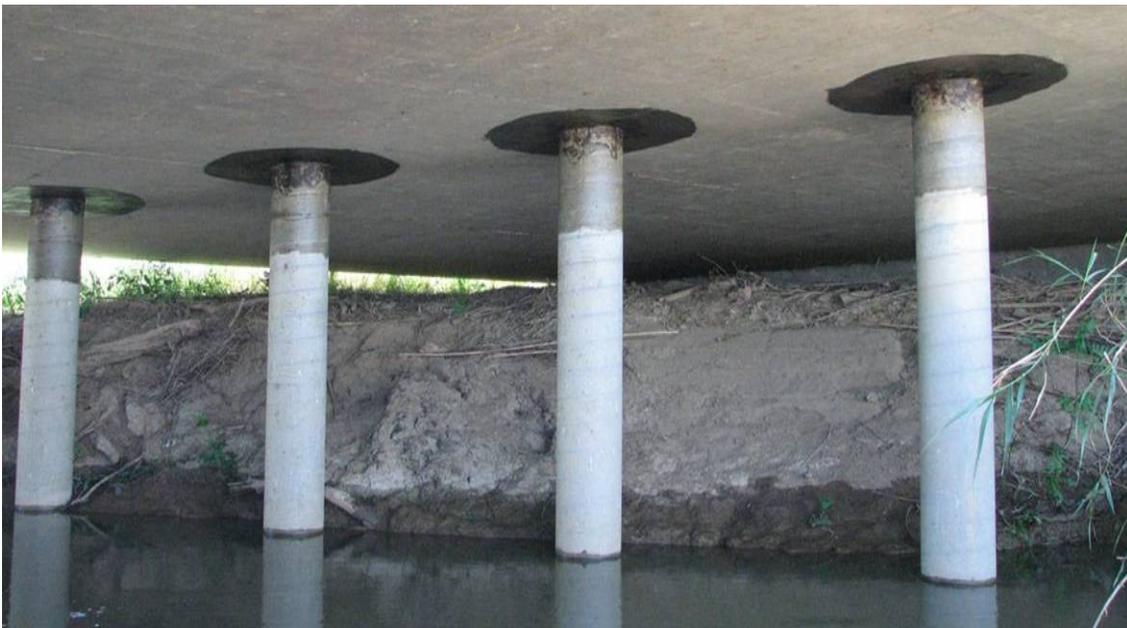
Figure 4. Highway structures with paint surface modification.

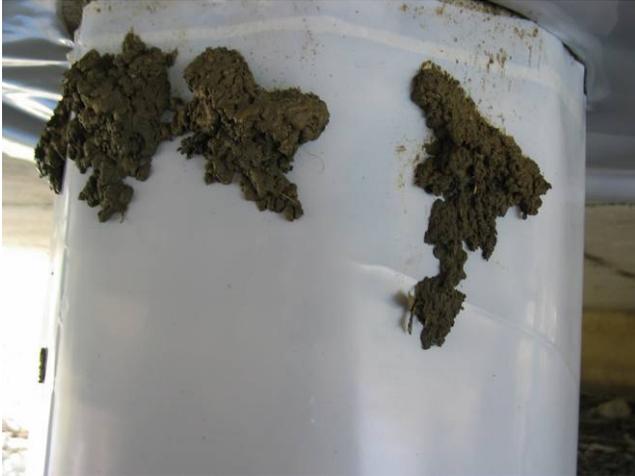
Figure 7. Mud sliding down surface of PTFE surface modification on column.

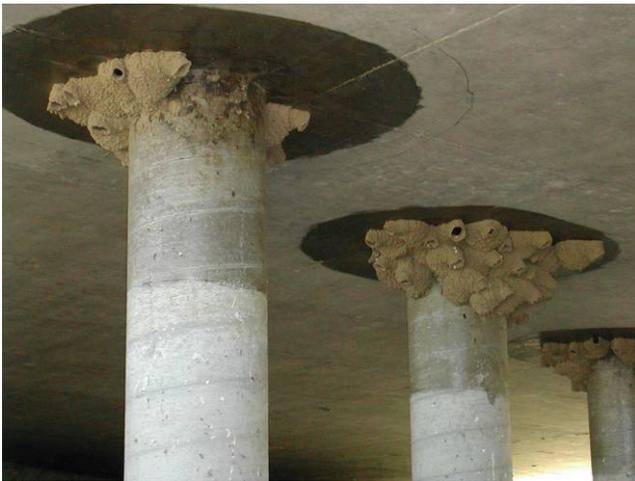
Figure 8. Completed nests on columns and overhead surfaces treated with silicone paint.

of our preliminary test results, mud did stick to the painted surfaces and allowed nest completion. The reason for this discrepancy is not fully known, but there are several factors that could be responsible, including differences in mud composition, pellets formation by birds versus our hand, paint thickness or adhesion to the bridge surface versus the concrete block used in preliminary tests, and surface alteration by the birds (e.g., scratching or dirtying the painted surface with repeated nest building attempts). These results were similar to those of HDPE in 2006 and we felt silicone paint did not warrant further consideration. PTFE performed well in the 2007 study. No nests were completed on the PTFE sheets, though several attempts were made by birds. The only completed nests in the study were found on an abutment with no evidence of nesting in prior years. This prompted us to treat abutments in our 2008 study. A total of 9 PTFE sheets detached from the bridge surfaces in last few weeks of the 2007 study. At the time, we felt this would not be a major problem for the 2008 study, though this ultimately proved to be untrue.

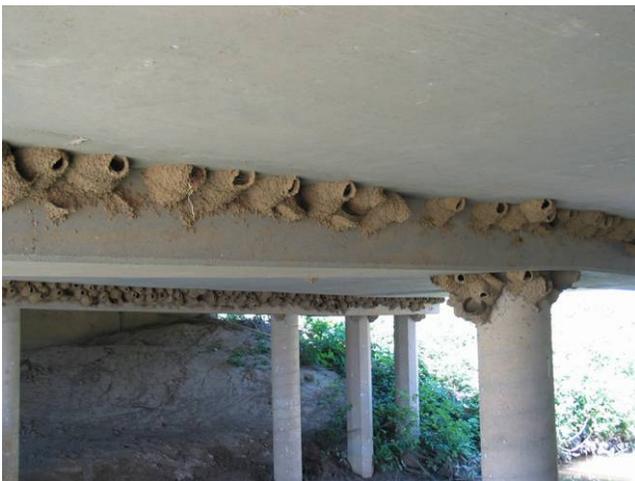
Figure 9. Completed nests at a control site.

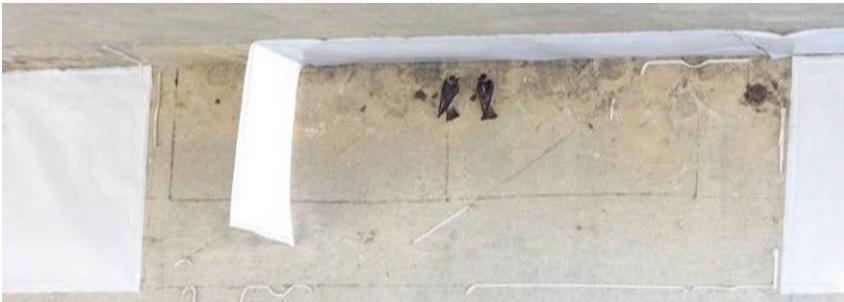
Figure 15. PTFE sheets detaching from the highway structure surfaces and cliff swallows building nests.

Analysis of the 2008 field study showed that only PTFE+BC treatment differed from the control treatment. However, we believe both PTFE and PTFE+BC treatments would have been more equally effective if not for problems with PTFE sheet adhesion to the bridge surface. We estimate that 192 sheets detached from the bridge surfaces (about 29% of all sheet installed) in 2008 (Figure 15). Most of these sheets (176) were installed overhead such that the weight of the sheet pulled directly away from the bridge surface. We do not believe vandalism contributed to this problem. Vandalism was clear on only one occasion, but this was for a broadcast call unit, which was smashed and partially stolen. We replaced missing sheets as quickly as possible during the first 7 weeks of study, but were soon overwhelmed by the rate of failure and stopped replacing sheets. At some sites, we were unable to replace PTFE sheets before the birds had built nests at that location. These nests were part of those counted during the study and therefore do not reflect the ability of PTFE to deter nesting (assuming it is properly attached to the surface). We were unable to determine whether the butyl adhesion failed first on the concrete bridge surface or PTFE sheet surface. Butyl detached from the concrete in half the cases and from the PTFE in half the cases. This indicates that butyl sealant is not adequate for reliable surface modification treatments as conducted in this study. Thinner or smaller sheets, or additional strips of butyl adhesive might prevent detachment from the bridge surface, but we feel that a better solution would be to find an alternative attachment method. Mechanical fasteners or semi-permanent epoxy adhesives could be used by Caltrans if not constrained by the same permit limitations encountered in our study.

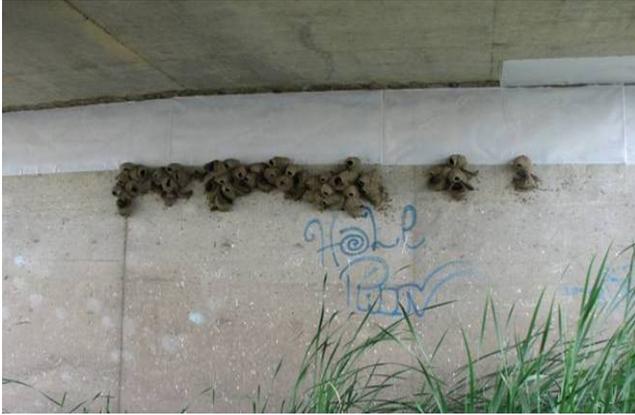
Figure 16. Completed nests below the bottom edge of PTFE treatments on a pier wall.

Sheet attachment failure was not the only reason for completed nests at PTFE treated sites, however. We also noted that several nests were started at unusual locations on the bridges. Completed nests were found on the vertical surfaces below the edge of PTFE sheets (Figure 16) and on the overhead surfaces along seams in the concrete (Figure 17). These nests were also counted and do reflect the true ability (or lack of ability) of PTFE to deter cliff swallow nesting when used only at typical nesting locations. No nests were completed wholly on PTFE sheets at any site.

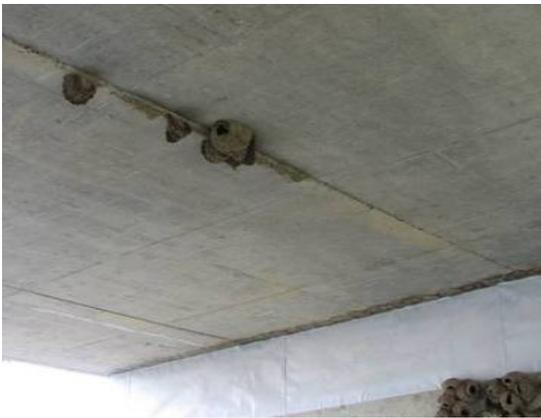
Figure 17. Completed nests on an overhead concrete seam at a PTFE-treated site.

of the ground (level at which birds would be concerned about predators) would provide more effective deterrence. Lastly, unusual surface features such as seams, cracks, lumps, bolts, and brackets should be treated for even greater deterrence. Only complete coverage of a bridge surface with PTFE and reliable attachment methods would likely be 100% effective.
