1. REPORT NUMBER CA14-2338	2. GOVERNMENT ASSOCIATION NUMBER	3. RECIPIENT'S CATALOG NUMBER
4. TITLE AND SUBTITLE Continued Evaluation of Pothole Patching Equipment, Materials, and Processes		5. REPORT DATE 06/14/2014

7. AUTHOR Duane Bennett, Steven A. Velinsky		6. PERFORMING ORGANIZATION CODE
9. PERFORMING ORGANIZATION NAME AND ADDRESS Advanced Highway Maintenance and Construction Technology (AHMCT) Research Center Department of Mechanical & Aerospace Engineering University of California, Davis Davis, California 95616-5294		8. PERFORMING ORGANIZATION REPORT NO. UCD-ARR-14-06-30-03

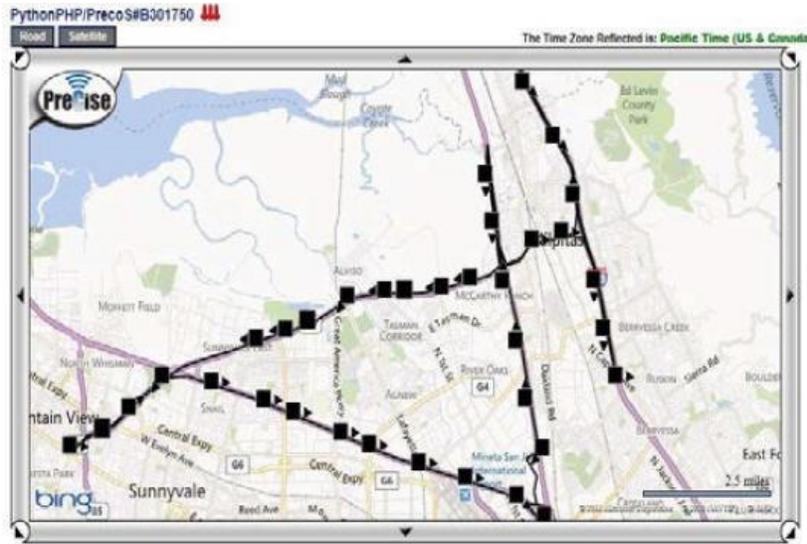
Figure 5. Caltrans District 4 Single Day's Python PHP Patching Data Log

In these highway trials, the District 4 deployment strategy consisted of the semi-automated patching machine traversing the district once or twice a week depending on the demand. Area supervisors would contact the machine’s base of operation, the Caltrans San Jose maintenance station, with patching requests and their priority levels. For urgent requests, the patching machine was routed immediately; less critical patching requests were combined with others in the vicinity along a planned, larger-area, high-production route. With the Caltrans crews in the destination area providing all necessary traffic control resources, the dedicated operator could drive the semi-automated patching machine anywhere in the district in a single day.

operations. Some of the data on these summary reports comes directly from the PreCise data logger. The data generated from the PreCise data logger includes maps displaying the Python PHP machine's patching routes as well as illustrations of the overall lane miles patched at two lanes per pass while patching all pavement potholes encountered. Besides the information from the PreCise data logger, the summaries also contain additional information, including observatory and operational notes, the number of potholes/spalls filled on some of the latter summary reports, and IMMS work order references.

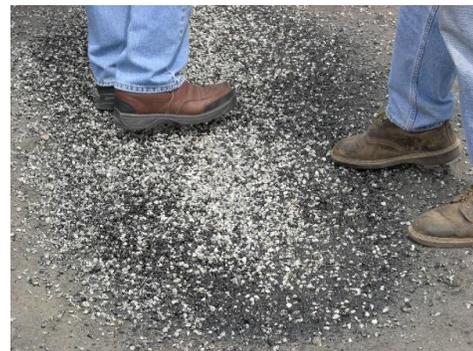
Figure 6. Spray Patch

The semi-automated spray patch method involves filling the pothole with an incompressible mixture of small gravel and liquid emulsion binder. Figure 6 displays a photograph of a spray patch pothole repair. The spray patch process utilizes the following modified four-step method to patch potholes:

- 1) Clean pothole with a compressed air blast
- 2) Apply tack spray
- 3) Spray patch mixture into the pothole
- 4) Apply a no-tack top coat

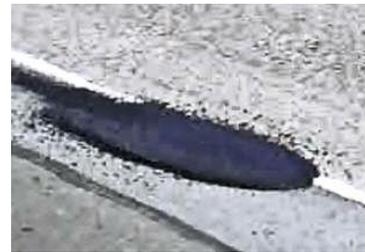
Figure 8. Hot Asphalt Patch

- 1) Clean pothole with air jet blast
- 2) Apply tack oil spray
- 3) Fill the pothole with hot asphalt
- 4) Compact the patch with the compaction roller

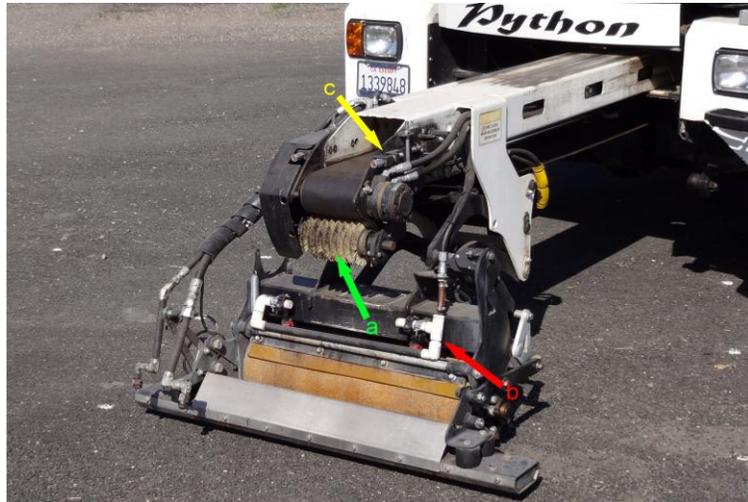
Figure 10. AHMCT Belt Tensioner

The AHMCT Research Center worked with Python Mfg. to develop a spiral brush attachment at the end of the conveyor (location a in Figure 10) that physically scrubs the belt clean to prevent sticking asphalt from building up on the belt or getting pulled back into the machine. The spiral brush is chain-driven off of the conveyer drive roller shaft and geared up such that the brush spins faster than the belt. The Python PHP machine was returned to UC-Davis for the brush modification, which also involved the modification of the compaction roller water spray heads (location b in Figure 10). The modified Python PHP machine was then returned to the D4 San Jose maintenance station for testing on the highway. The successful conveyor brush development completely prevented asphalt from building up on the material belt and the patching head.

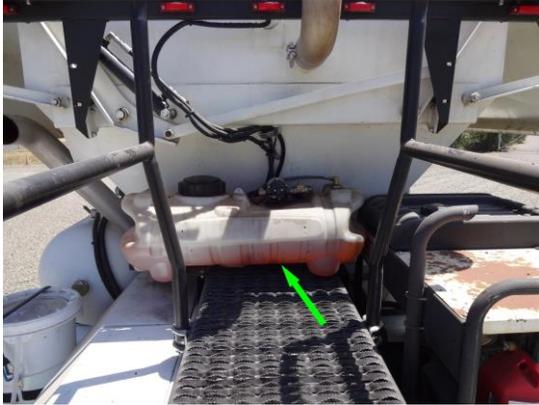
Figure 11. Citrus Cleaner System

The standard Python PHP cleaner, and the most commonly utilized asphalt cleaning fluid, is diesel fuel. Caltrans favors the use of an environmentally safe alternative fluid for asphalt clean-up operations. The AHMCT Research Center purchased the Python PHP machine modified to operate with concentrated citrus solvent instead of diesel fuel, as shown in Figure 11. Unfortunately, Python Mfg. used their standard diesel seals and hose materials, which dissolved over a short period of time. AHMCT Research Center personnel identified new materials that are chemically resistant to the citrus cleaner and replaced the machine's cleaning system hoses and an all Viton seals fluid pump. The level of difficulty involved in changing the rubber hose in the spring return mechanical reel led to the decision to replace the hose reel at regularly scheduled intervals, as needed.

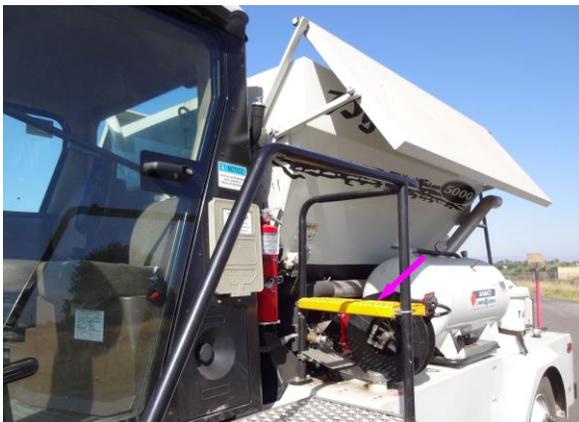
Figure 13. Hopper Viewing Footstep

Python Mfg. provides a slide-out stairway up the rear of their machine for the operator to gain access to the hopper, which is mostly useful for soaping the hopper walls prior to loading asphalt and for post-operational cleaning. However, sometimes during highway patching operations, the operator may want to quickly look in the hopper to examine the state of the remaining hot asphalt. The rear step is not readily accessible on the highway in moving closure operations. AHMCT Research Center personnel added a step adjacent to the cab access door, such that the operator can step out the door and onto the gangway and then step up on the footstep to safely look into the hopper while out on the highway (Figure 13).

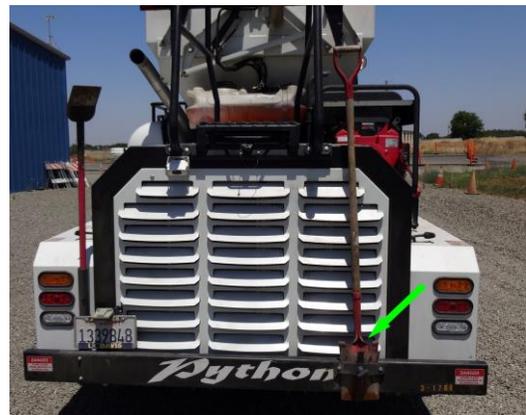
Figure 14. Hopper Shovel

head. The pole scraper's lack of reach limits this tool's usefulness in the hopper. The AHMCT Research Center fabricated a long-reach shovel scraper, which enables the operator to reach into the hopper from the rear gangway and chip loose any remaining clumps of stuck asphalt so it falls into the auger during the machine's post-operational cleaning (Figure 14). The shovel scraper contains a perpendicular end grip to maximize the power and reach of the shovel. AHMCT Research Center personnel designed a spring-clamp mounting, which stores the shovel scraper securely on the Python PHP rear bumper and can be released with the pull of a single T-pin.

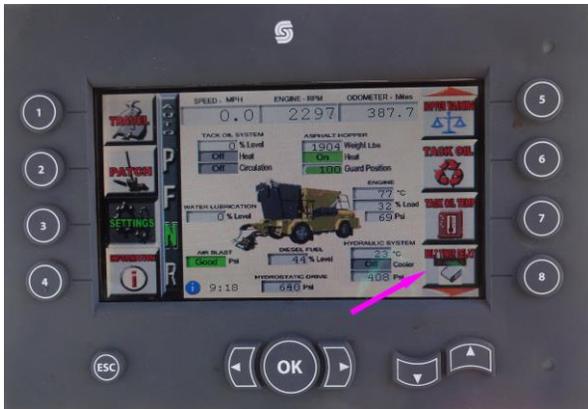
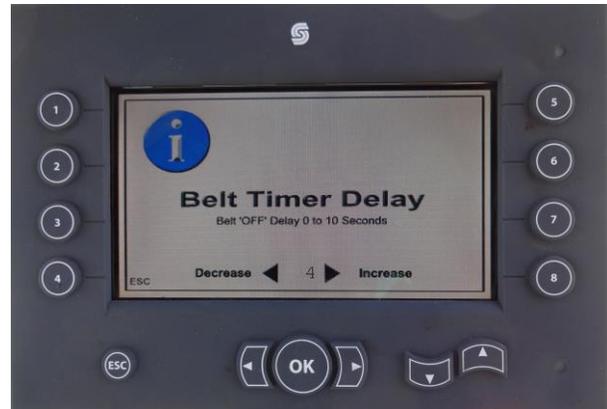
Figure 15. Settings Screen – Belt Delay

enhancement eliminates the initial material delivery delay and the asphalt stop delay time to shave roughly twenty seconds off the Python PHP machine's patch application time. This practice proves especially effective with potholes spaced minutes apart on the highway such that the asphalt on the conveyor remains appreciably heated. For longer distances of travel, the operator can choose to clear the asphalt off the conveyor in a pothole or off the side of the highway away from traffic.

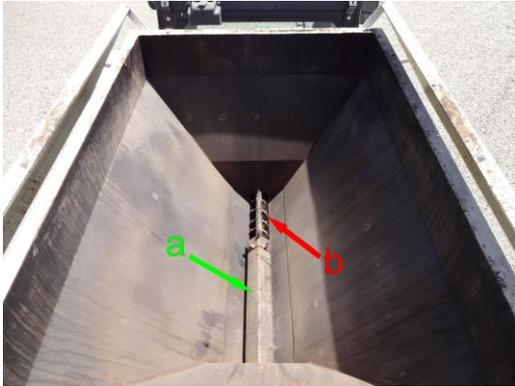
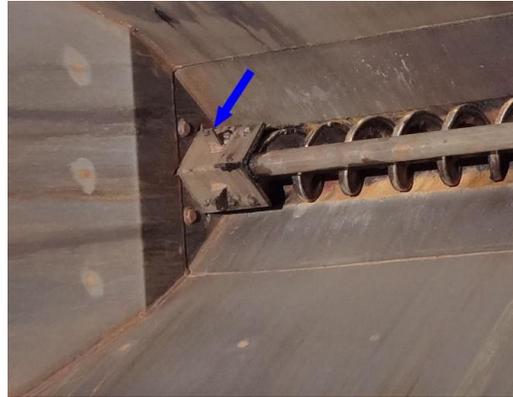
Figure 17. Python PHP Hopper with Guard Closed

An auger screw drive in the bottom of the Python PHP V-shaped hopper feeds hot asphalt forward toward a chute, which discharges over the material conveyor belt. When the operator presses the asphalt feed button on the command joystick, the auger rotates and asphalt drops onto the conveyor belt and then moves forward to the end roller, where the asphalt falls off into the pothole (location b in Figure 17). The auger is incapable of spinning with the weight of a full load of sticky asphalt pressing against the auger in the hopper. The Python PHP design relies on a retractable guard riding along a support pipe to partially cover the auger and thereby reduce the dead weight pressing against the auger (location a in Figure 17). On the leading edge of the guard resides a set of three fins (Figure 18), which breaks up asphalt chunks or frees the auger should it jam by hydraulically driving the guard back and forth over the auger. The Python PHP machine's standard operating procedure permits the operator to periodically retract the guard as the asphalt discharges from the hopper, ensuring at least a couple of feet of auger stays covered with hot asphalt. In practice, however, the operator retracts the guard only after noticing the asphalt beginning to thin out unexpectedly or stop coming off the conveyor altogether.

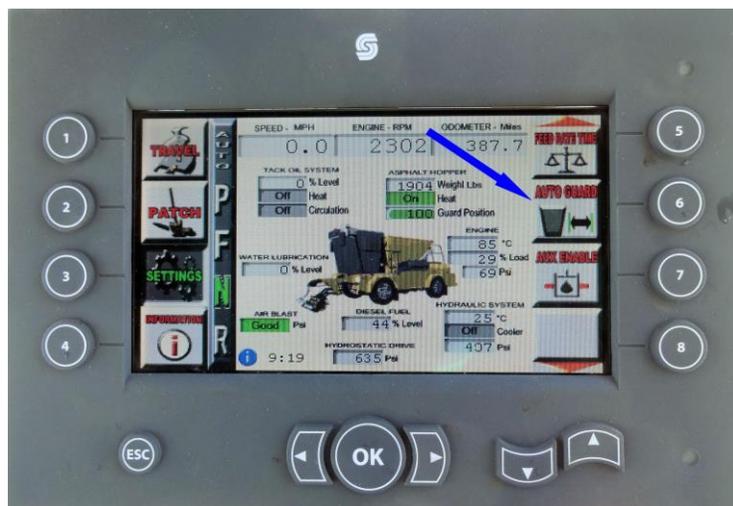
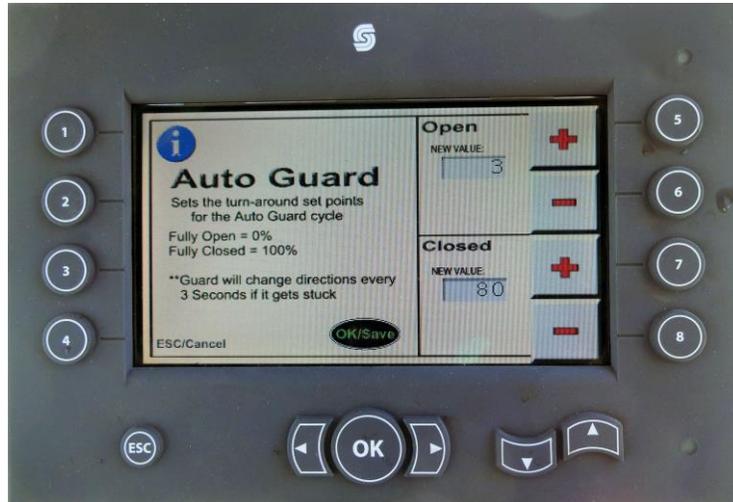
Figure 19. Settings Screen - Auto Guard

The quick delivery of hot asphalt material to potholes without any delays remains an essential aspect for Caltrans mainline moving closure patching operations. The operator does not have time to access the guard settings when stopped at a pothole or while driving along the highway between potholes. Therefore, the AHMCT Research Center collaborated with Python Mfg. to add an automated guard control function to the control program. Based on the weight of the asphalt in the hopper, the controller opens the guard as the asphalt depletes from the hopper. The Auto Guard program settings can be accessed through the **SETTINGS** tab on the control panel (Figure 19). Selecting the **AUTO GUARD** button displays the auto guard adjustment screen, where the desired end positions of the guard can be entered (Figure 20). The initial set-up process required the use of this adjustment; however, the operator unlikely would ever need to access this setting under normal operating conditions.

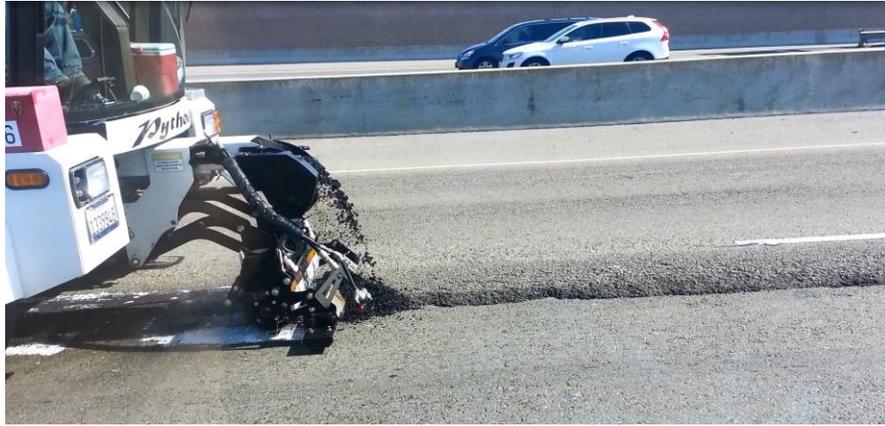
Figure 21. Linear Pavement Gap Patching

By definition, potholes primarily represent a single, finite hole, as opposed to the linear, unbounded gaps often found along longitudinal asphalt concrete/ Portland Cement Concrete (AC)/ (PCC) transitions and ramp transitions. Semi-automated pothole patching application heads are designed to apply finite area patches. However, patching an unbounded linear pavement gap can be accomplished by applying a series of spot patches as the machine moves along the linear gap. This patching approach is feasible for short segments, but it quickly becomes infeasible in a moving lane closure as the length of a linear pavement gap stretches past three or four patches (Figure 21). The strategy towards solving this problem involved developing a continuous, linear hot asphalt patching process, which would improve the quality and efficiency of linear gap patching. The new capability would serve as an add-on to the existing patching capability and should be easily selectable by the operator in the cab.

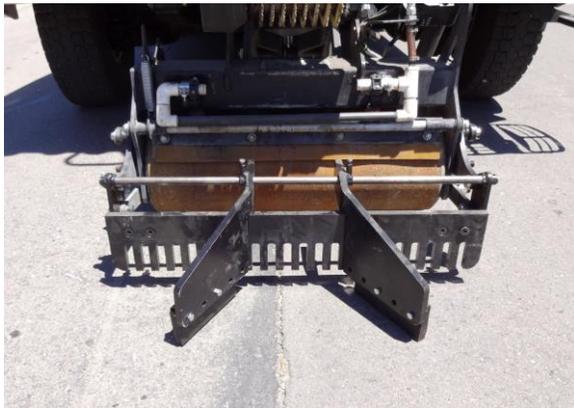
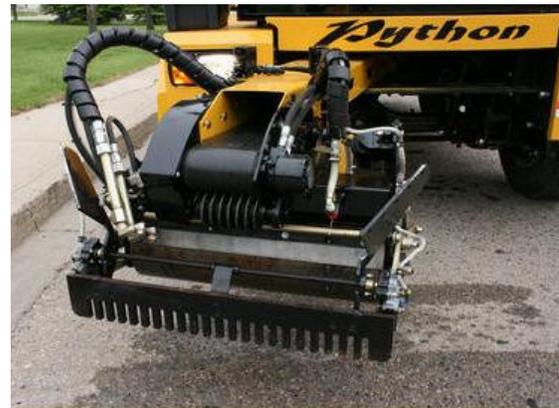
Figure 22. Python PHP Rake & Funnel Attachment

rake (Figure 23). Both of these modifications greatly benefitted patch quality by enabling the operator to effectively move and evenly distribute the asphalt around the pothole.

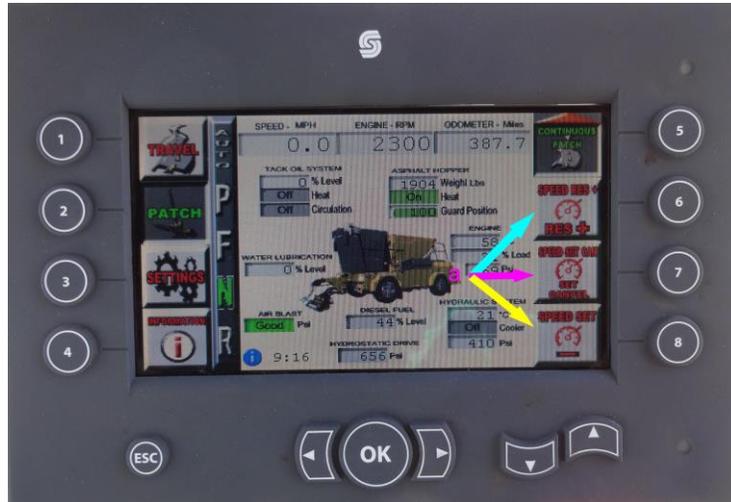
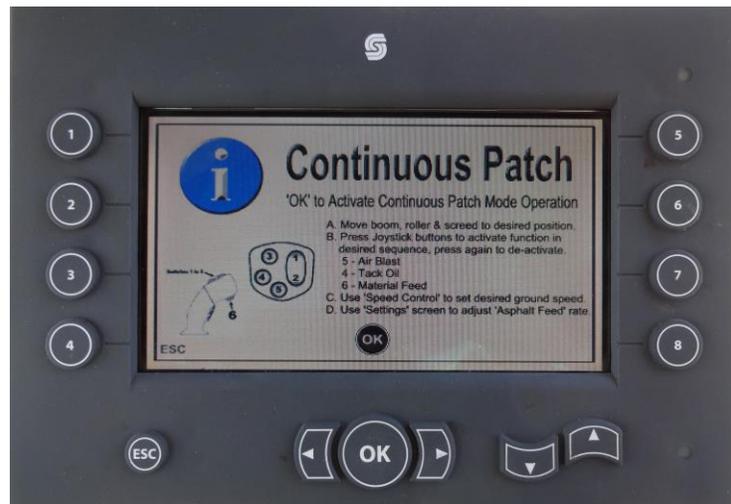
Figure 24. Continuous Mode

The addition of continuous patching capability required minor modifications to the Python PHP machine control program. AHMCT Research Center personnel added a **CONTINUOUS PATCH** mode selection on the control panel, which configures the Python PHP machine for continuous patching operation (Figure 24). Upon selection, a second screen appears showing the operator how the machine controls transform to accommodate continuous patching mode operation (Figure 25). The operator can adjust two interdependent machine settings on the control panel prior to running in continuous patching mode to produce the desired patch. The asphalt delivery rate can be adjusted in the control **SETTINGS** screen (Figure 26) and relates to both the machine speed and the size of the pavement gap. The machine speed setting essentially acts as a low-speed cruise control that drives the Python PHP machine at a continuous but adjustable speed, which is set for each specific application. The operator drives the Python PHP machine at the desired speed and presses the **SPEED SET** button, which holds that speed. The operator can then make fine speed adjustments by pressing the **SPEED RES +** button or cancel the setting with the **SPEED SET CAN/ SET CANCEL** button (location a in Figure 24).

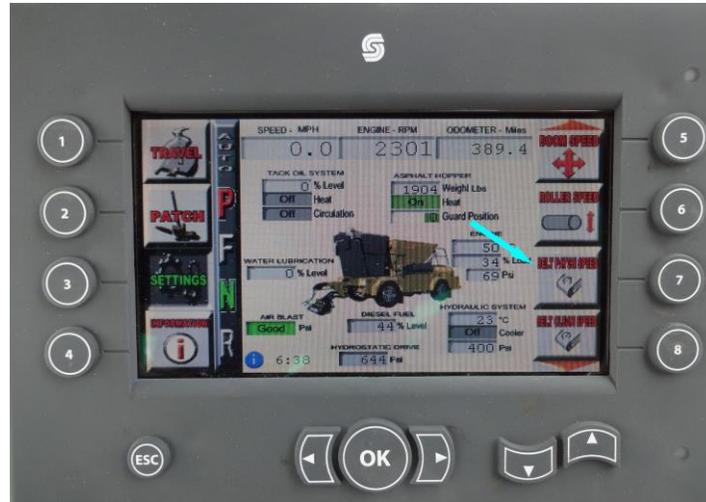
Figure 26. Asphalt Delivery Rate Setting

Once the operator configures the continuous mode, he or she can quickly switch the Python PHP machine between the normal pothole patching mode and the continuous mode as needed in the moving closure operation. Switching into continuous mode on the Python PHP machine changes the buttons on the joystick from momentary to on/off toggle controls for the air blast, tack oil, and material feed functions. The operator initiates the continuous patching process, which the machine automatically continues. With the machine operating in continuous mode, the operator only needs to steer the machine, remaining centered on the linear pavement gap. The AHMCT Research Center verified that the continuous patch functionality on the Python PHP machine correctly functioned in trials at UC-Davis, but it has yet to be utilized on the mainline highway in a Caltrans moving closure patching operation.

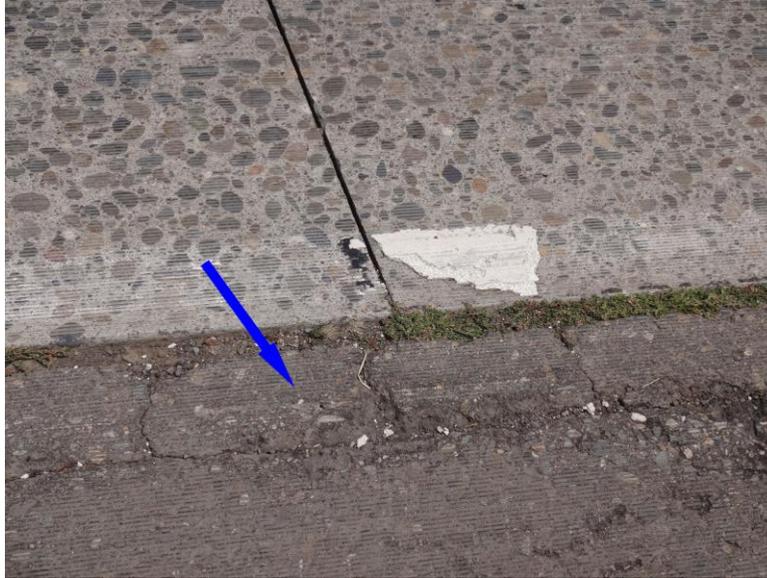
Figure 27. Edge Drain Pavement Failure

During deployment testing with Caltrans, maintenance personnel identified an innovative application of the continuous patching function. In the 1990s, Caltrans retrofitted many miles of highway shoulder edge drains to reduce damage occurring in existing PCC pavements [5]. The process involved cutting a four-inch wide trench in the asphalt shoulder along the PCC edge, installing a drainage pipe, backfilling with aggregate, and then patching with asphalt. These retrofits are extremely susceptible to block cracking and are difficult to crack seal, leading to quick deterioration of the retrofit edge drain pavement (Figure 27). The block cracking eventually loosens, allowing chunks to be dislodged by traffic impacts until the retrofit edge drain pavement resembles a linear series of small potholes. Caltrans maintenance expressed strong interest in utilizing the Python PHP machine to patch these failures. Adapting the Python PHP machine's continuous patching mode to patch these failures would be especially beneficial when pavement deterioration reaches an advanced stage; e.g., when there is a significant amount of dislodged pavement blocks.

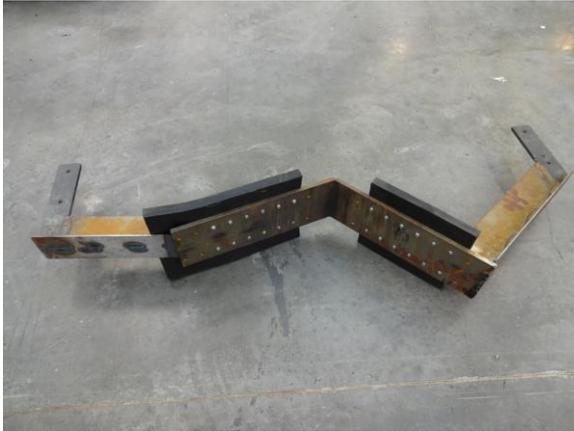
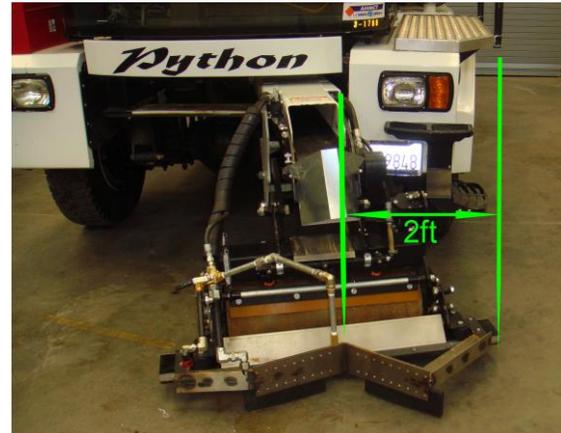
Figure 28. Edge Drain Attachment

for this offset (Figure 28). Utilizing the edge drain attachment limits the machine's encroachment into the traffic lane to approximately two feet (Figure 29). The edge drain attachment simply bolts onto the flat rake and can be flipped for either left or right side patching operations. Similar to the Python PHP funnel attachment wings, thick rubber edge strips form the sides of the funnel, and their width dictates the asphalt mound height.

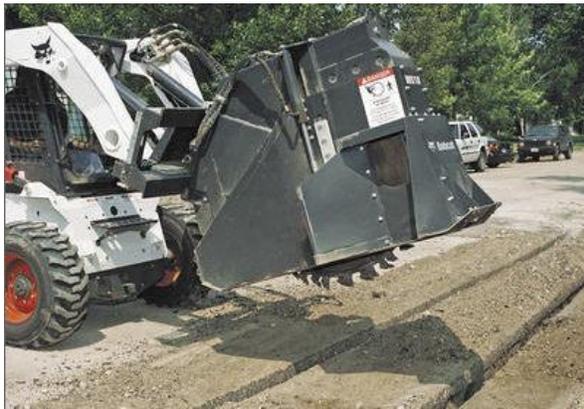
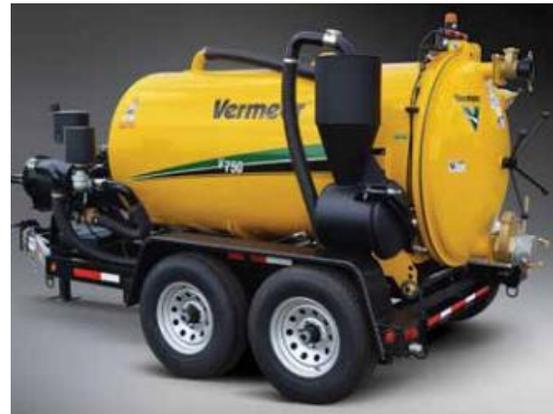
Figure 30. Bobcat Wheel Saw Attachment

Asphalt cutting or routing, which far surpasses all other types of passive cleaning methods like wire brushing and compressed air either separately or in combination, remains the most consistent and cost-effective method of clearing pavement gaps. This clearing technique especially applies in the case of patching edge drains where the relatively large asphalt chunks must be removed in order to enable the new asphalt patch to properly adhere to the intact pavement sidewalls. Commercially available pavement cutters like the Bobcat Wheel Saw attachment (Figure 30) would be a suitable cutter in the development of a high production routing machine.

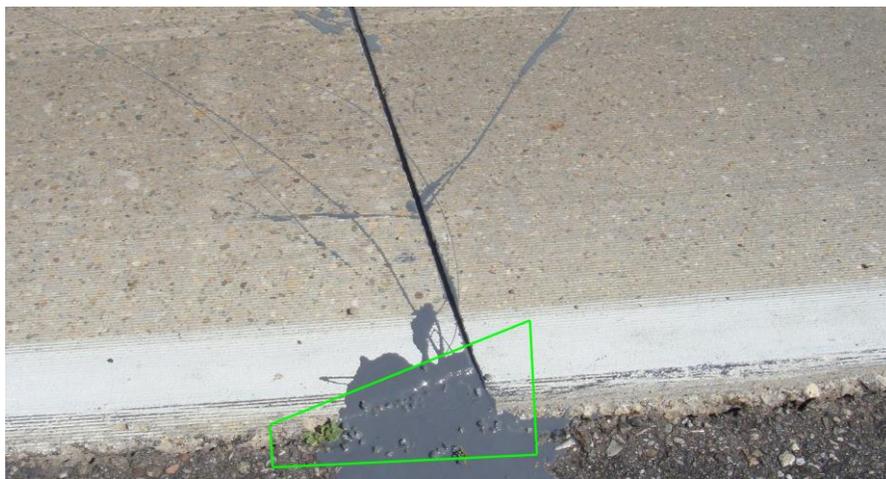
Figure 32. Caltrans Urethane and Gravel Spall Patch – Interstate 8

Once Caltrans makes the investment in establishing a mainline stationary lane closure to repair a spall, the focus is on creating a long-lasting patch by taking the time necessary to make a quality repair. Therefore, Caltrans crews are instructed to remove all damaged concrete in the repair area and cut or chip vertical faces and square corners in the pavement around the spall to guarantee a maximum strength repair. Removing all loose dust and debris helps ensure a clean and dry spall before applying the patch to promote optimum adhesion. Then, coating the spall with an epoxy resin material before adding pea gravel (i.e., the incompressible filler material) ensures consistency. Next, adding additional epoxy resin such that the gravel stays completely immersed in the epoxy and brought up to grade completes the patch application. Generally dispensed with a 20-minute set time, the two-part epoxy gravel repair patch should not be subject to traffic until the epoxy fully hardens (Figure 32). A two-part epoxy gravel patch installed within these guidelines will generally remain intact indefinitely while exposed to mainline highway traffic.

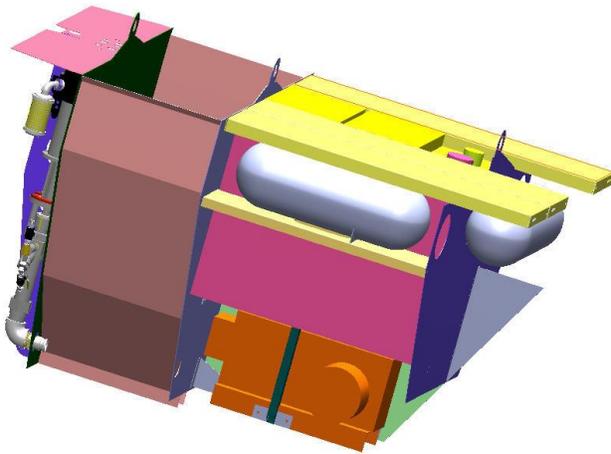
Figure 35. Python PHP Urethane Module

The urethane module contains the resin and catalyst tanks, the air compressor, the material pumps, and the pea gravel filler (Figure 35). The design of the urethane module permits it to slip down flush into the Python PHP asphalt hopper. This design allows the hopper doors to be closed, leaving a six-inch gap to maintain an exit passage for the umbilical. Due to the angular positioning of the Python PHP hopper, the urethane module must share the same shape, which leaves the module unstable when standing alone out of the hopper. Therefore, a module stand is required to stabilize the module when it is out of the hopper for maintenance and storage (Figure 36). Ideally, Caltrans would use standard forklifts or loaders normally found in Caltrans maintenance yards to load the urethane module into the Python PHP hopper. The greatest vertical height measured in the San Jose maintenance station occurred with their loader with bucket fork attachments, which clear approximately thirteen feet (Figure 37). Since the top rim of the Python PHP hopper measures approximately twelve feet high, the loader must be able to attach to the bottom of the urethane module to attain the necessary height for insertion. However, in order to lower the module down into the hopper, the urethane module must be hung from the top. Therefore, the design of the module stand also must allow the stand to act as a mechanism to facilitate the insertion of the urethane module into the hopper using an ordinary Caltrans bucket loader.

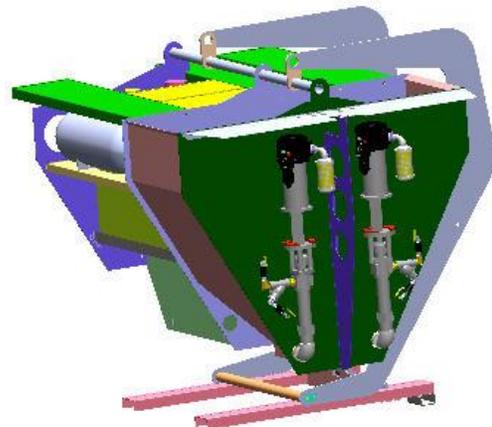
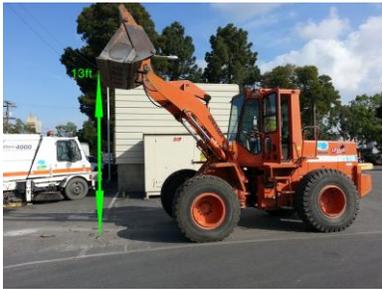
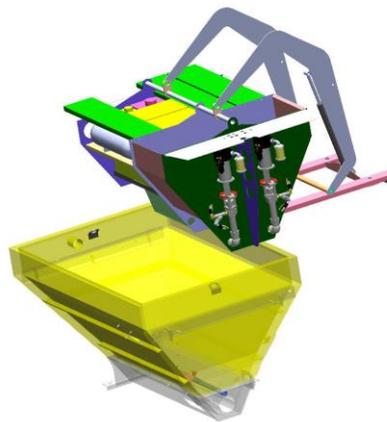
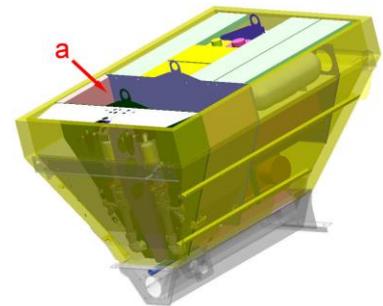
Figure 36. Urethane Module Stand

Current Voltage (Vdc) hydraulic pump unit mounted on the stand's base and controlled by a wireless remote controller. Inserting the urethane module inside the Python PHP hopper involves lifting the module unit to a preset position above and adjacent to the Python PHP hopper. Then, the operator extends the hydraulic lift cylinder that lowers the module down into the hopper (Figure 38). The lifting pipe slides out and disconnects the hopper stand. Connecting the umbilical and plugging the air compressor's electrical power into the generator fully links the urethane module to the Python PHP machine. The module contains a specific compartment for the management of the pea gravel, which stays open to the material feed auger screw on the bottom (location "a" in Figure 39). The standard Python PHP asphalt feed system feeds the pea gravel to the urethane patch. Since the partition stays open on the bottom, the gravel must be emptied via the material belt before removing the urethane module from the hopper. The pea gravel used in urethane gravel is specially graded and washed, so the aggregate should be collected and reused in a custom designed bucket insert, which also assists with the loading of the aggregate when using conventional bucket loaders.

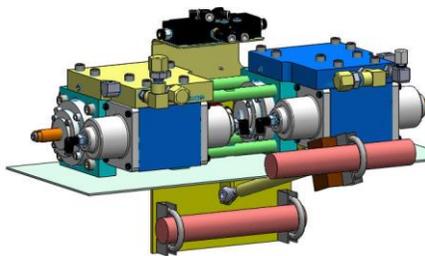
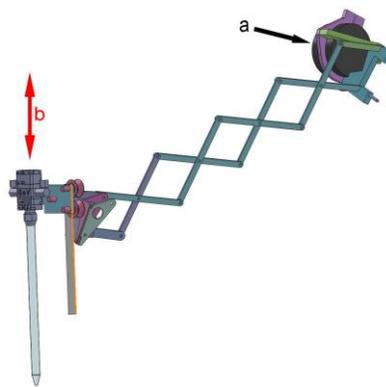
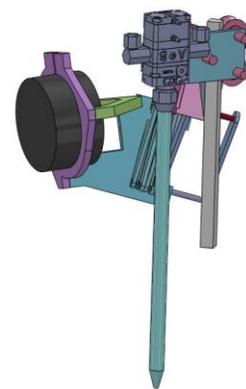
Figure 40. Metering Block

dispensing head, a simple on/off valve, controls the urethane's flow through the attached mixing nozzle. The mixing head and nozzle mount to the end of the injection linkage, which provides both positional extension and a vertical translation for the nozzle. The preliminary design of the injection linkage simply clamps over the case of the Python PHP material belt drive hydraulic motor (location a in Figure 41). Note that Figure 41 displays this partial model, with the second scissor mechanism hidden to improve visibility and clarity. The scissor mechanism design extends the urethane applicator assembly out and down to a spot two feet out from the center of the material belt and four inches above the pavement. This area approximates where the pea gravel rolls off the material belt and lands on the pavement. Applying the urethane binder and aggregate matrix at this common spot promotes a natural blending of these two components in the spall. In addition, the nozzle can be moved vertically six inches, enabling the urethane to inject directly into the patch matrix as needed (location b in Figure 41). In the retracted position, the applicator assembly closes into a compact position out of the way of the Python PHP material belt (Figure 42). Mounted below the nozzle in the retracted position, a disposable spoils bucket catches the urethane expelled during the nozzle refreshment stage.

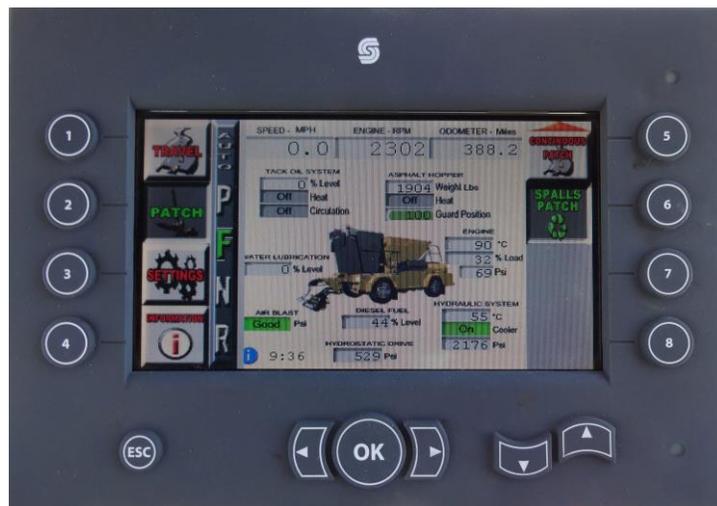
Figure 43. Spall Repair Screen

configured and loaded for urethane patching operations, it can be parked on stand-by, ready to be deployed at short notice to patch spalls. To patch, the dedicated operator drives the Python PHP machine to a safe location near the beginning of the work site and installs a fresh mixing nozzle. In the cab, the operator selects the **SPALL PATCH** mode on the control panel (Figure 43). The control panel displays an informational screen describing how the Python PHP operational control changes when dispensing urethane (Figure 44). In this example, the **#3-EPOXY ON/OFF BUTTON** on the joystick controller activates the pumping of urethane through the nozzle. After the establishment of urethane flow through the mixing nozzle, the Python PHP controller automatically purges the mixing nozzle at regular intervals with new urethane to prevent clogging. Now, the Python PHP machine is ready to be driven out on the highway to begin patching operations. The patching crew and traffic control personnel establish the moving closure, and the operator drives the Python PHP machine into the closed lanes and patrols for spalls. The Python PHP machine and the traffic control vehicles can accelerate up to and travel at near highway speeds on the mainline between repairs.

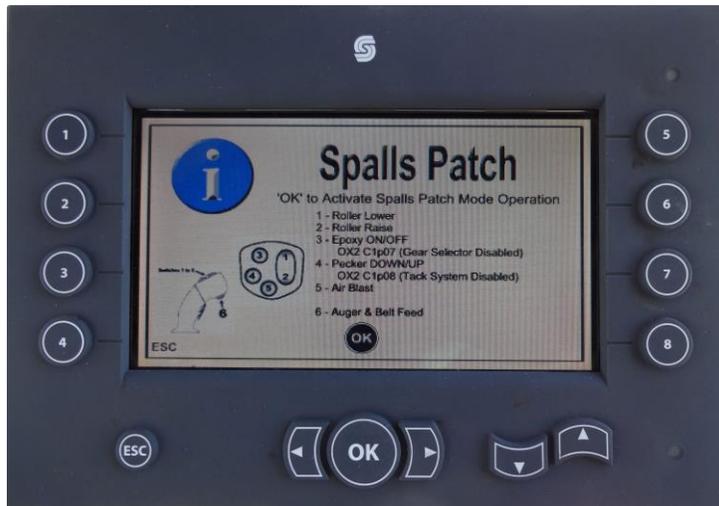
Figure 44. Spall Controls Screen

telescoping boom. Using the joystick, the operator moves the applicator around the spall and applies an even coating of primer. After a set time, the dedicated operator similarly applies the urethane as a coating in the spall before adding the pea gravel matrix. For maximum patch strength and adhesion, mixing the gravel and the urethane uniformly is important. The method to accomplish this is to apply urethane at the bottom of the spall, urethane on top of the gravel filler, and then inject urethane directly into the gravel filler by randomly poking the nozzle into the gravel patch. To apply pea gravel, the operator presses the **#6-AUGER & BELT FEED BUTTON** on the joystick, which runs gravel off the material belt and into the spall. The operator works the urethane nozzle and gravel filling in concert to fill the spall, striving to ensure the pea gravel remains immersed in urethane. The urethane nozzle may also be driven down into the gravel with the **#4-PECKER BUTTON** on the joystick to inject urethane directly into pockets of dry pea gravel. A plastic cover on the rake provides the operator with a means of tooling the surface of the patch if necessary. The Python PHP machine and all traffic control vehicles avoid driving over the fresh patch to provide an undisturbed set time before being exposed to the trailing highway traffic.
