## **Evaluation of Pothole Patching Equipment and Processes**

Report Number: CA12-1738

AHMCT Research Report: UCD-ARR-12-06-30-05

Final Report of: IA 65A0275, Task ID 1738

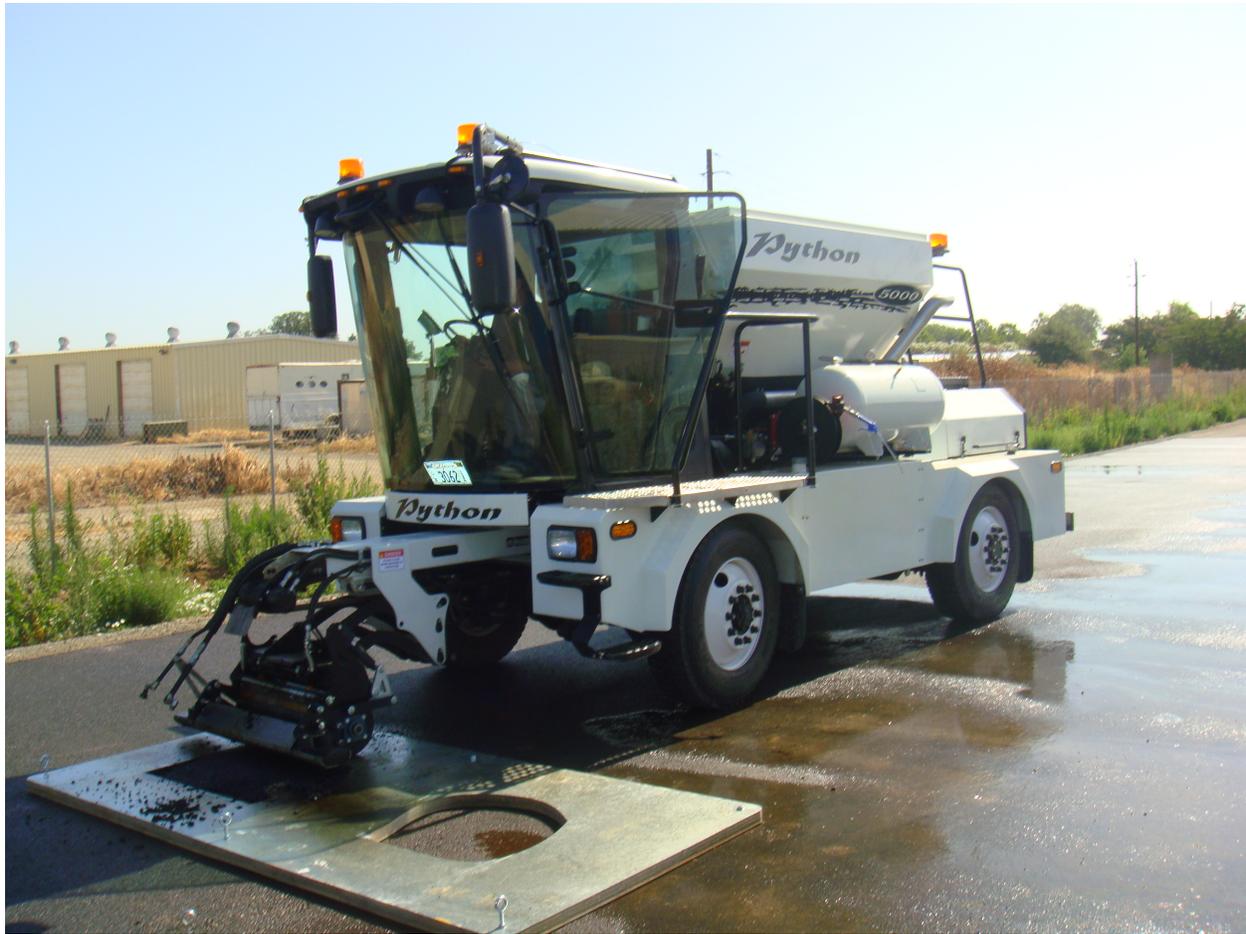
**Figure 1. Python PHP 5000 Pothole Patcher During Testing at ATIRC**

The Python Pothole Patcher (PHP) was selected as the commercially available machine that matches Caltrans requirements. It automates the traditional hot asphalt patch process: 1) air jet blast pothole clean, 2) tack oil spray, 3) hot asphalt fill, and 4) high pressure roller compaction of the patch. The quality of the resulting patch can range from long-term to permanent, depending primarily on pothole preparation and cleaning. The goal is to conduct the majority of pothole patching operations without the establishment of fixed lane closures in order to maximize the benefit of the automated machine. The patch can be applied very quickly within a moving closure operation or a very high quality patch is possible when more time is available for blowing out the hole and applying a tack coat. The machine can be easily configured for different types of patching requirements and it is simple to clean. Several features of the PHP are as follows:

AHMCT staff was responsible for providing training, training materials, related training consumables, addressing maintenance issues and arranging heavy transport services to facilitate long distance moving of the Python Pothole Patcher (PHP) (see Figure 1) between Caltrans districts. AHMCT staff also acted as a liaison between Python Manufacturing, Caltrans and warranty service providers. The PHP spent a good portion of this research task deployed to Caltrans District 3 Rancho Cordova and District 4 Foster City, CA when operable.

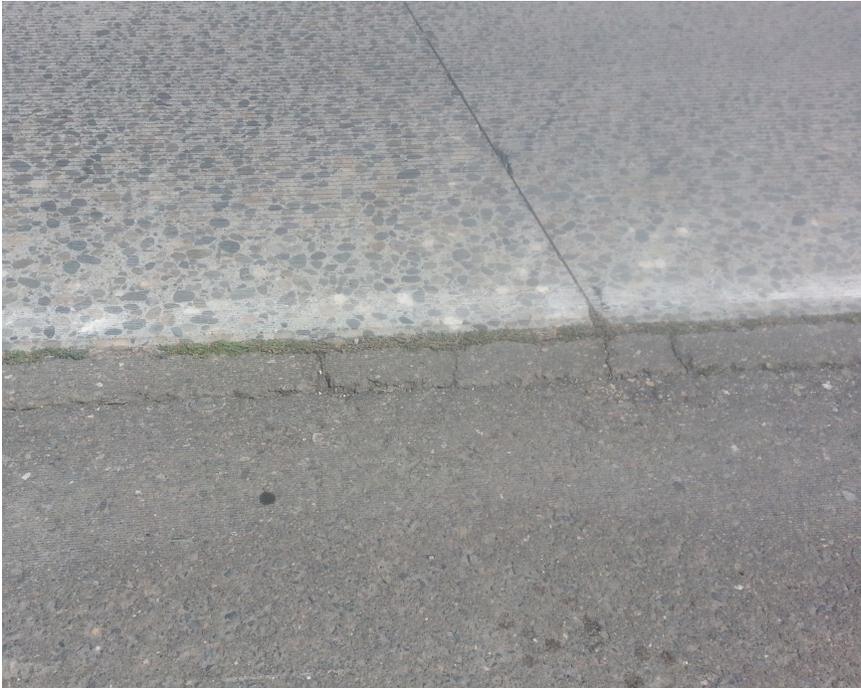
**Figure 2. Example of an Edge Drain**

Python Manufacturing was very receptive to suggestions that could potentially make the PHP more useful to Caltrans maintenance crews tasked with roadway surface repairs such as edge drain patching for example (see Figure 2). Python fabricated boom attachments that would control the dispensing and application of hot mix. Python also modified software options for the operator while in patch mode at AHMCT's request to facilitate slow rolling continuous patching consistent with linear edge drain repairs.

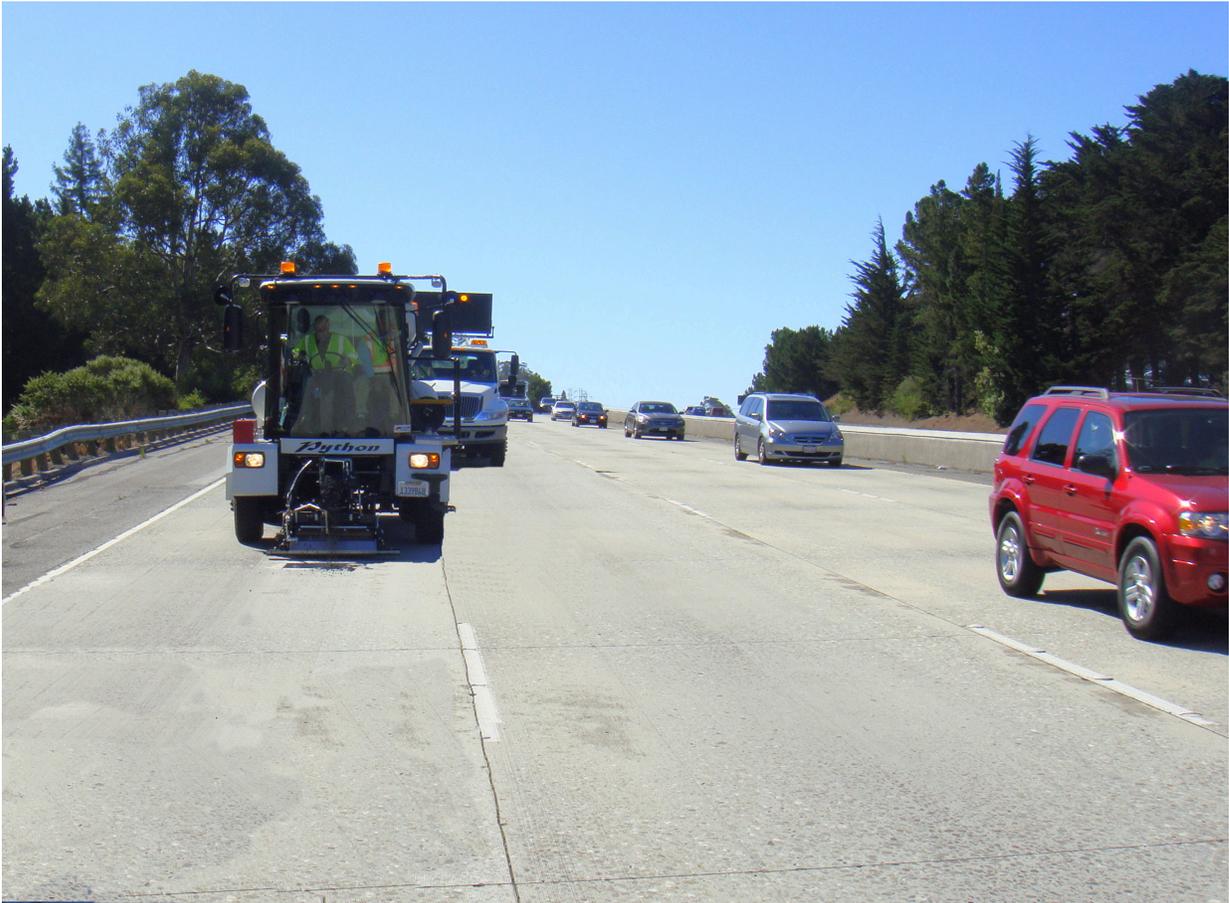
**Figure 3. Python PHP Filling Potholes in Concrete Pavement N.B. I-280 Millbrae, CA**

The PHP is currently deployed to Caltrans District 4 San Jose, CA and performing as designed. Figure 3 shows the PHP at work in Millbrae, CA. Maintenance crews and management have provided positive feedback regarding the PHP and its contribution to making roadway pothole patching safer, more effective and productive.
