Tire-Noise Performance of Selected Montana Highway Pavements: On-Board Sound Intensity (OBSI) Measurements

The Department of Transportation
Helena, Montana

ILLINGWORTH & RODKIN, INC.
//// Acoustics • Air Quality ///

505 Petaluma Boulevard South
Petaluma, California 94952
March 29, 2010

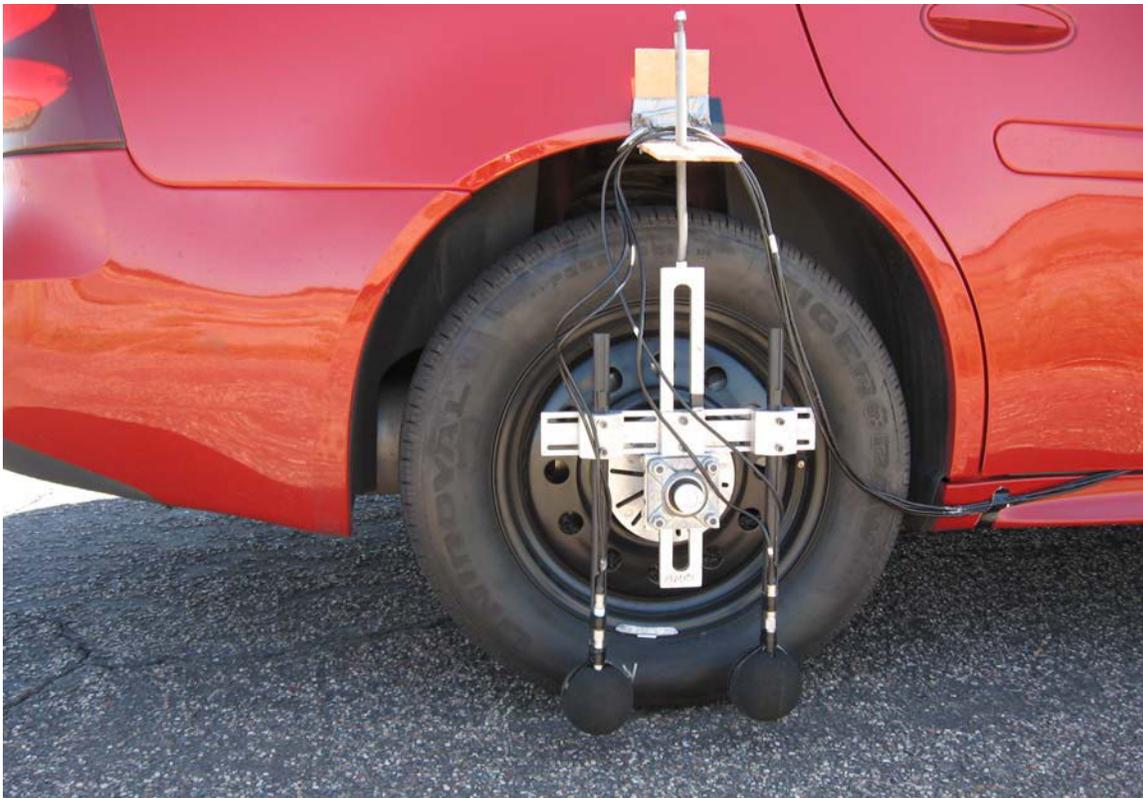
Figure 1. OBSI Equipment Installed on a Test Vehicle

On-vehicle OBSI testing was conducted following the provisional American Association of State Highway and Transportation Officials (AASHTO) Standard Method of Test TP 76-10. This was accomplished using a dual-probe sound-intensity fixture with attached microphones. This fixture assembly was connected to and supported by the test vehicle in free space, allowing for measurement positions close to the leading and trailing edges of the tire contact patch. The dual-probe sound-intensity fixture allows the leading and trailing edge positions to be measured simultaneously. Each probe consisted of two ½-inch G.R.A.S phased-matched condenser microphones, installed on ½-inch G.R.A.S 26AK microphone preamplifiers, attached to a plastic probe holder at a spacing of 0.63-inches (16-mm) in a side-by-side configuration, and fitted with spherical windscreens. The probe was positioned 3-inches (75-mm) from the pavement surface and 4-inches (100-mm) from the face of the tire, at locations opposite the leading and trailing contact patch of the tire, and were oriented such that the sensitive axis was directed toward the tire. See Figure 1 for a picture of the setup as installed on the vehicle. Data from the leading and trailing edge positions are acquired separately for the same section of pavement and averaged together during post-analysis. Three or more passes were made

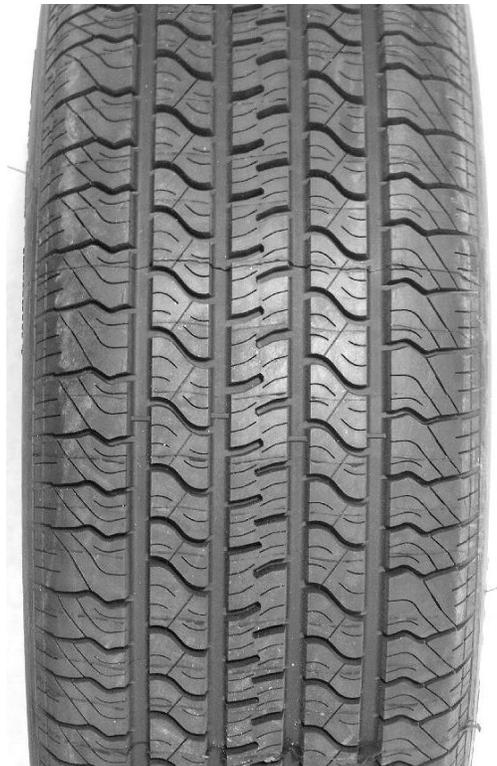
Figure 2. Photograph of Uniroyal SRTT

The measurements were taken at the end of September 2009 using a Chevrolet Impala test vehicle. A Uniroyal Standard Reference Test Tire (SRTT) was used for all measurements under free flow traffic conditions and a load of two people plus OBSI instrumentation. Prior to the sound intensity measurements, the test tire hardness was measured by means of the Durometer Hardness Test¹. The hardness was averaged across the tire at the Tiger Paw “T” and the Uniroyal “U” and was recorded to be 67 and 65, respectively. Figure 2 shows the SRTT tire. For all roadways with multiple lanes of traffic, testing took place in the right through travel lane, and where possible, in the left through lane as well. A constant vehicle speed of 60 mph (97 km/h) was used with a ‘cold’ tire inflation pressure of 30 psi.

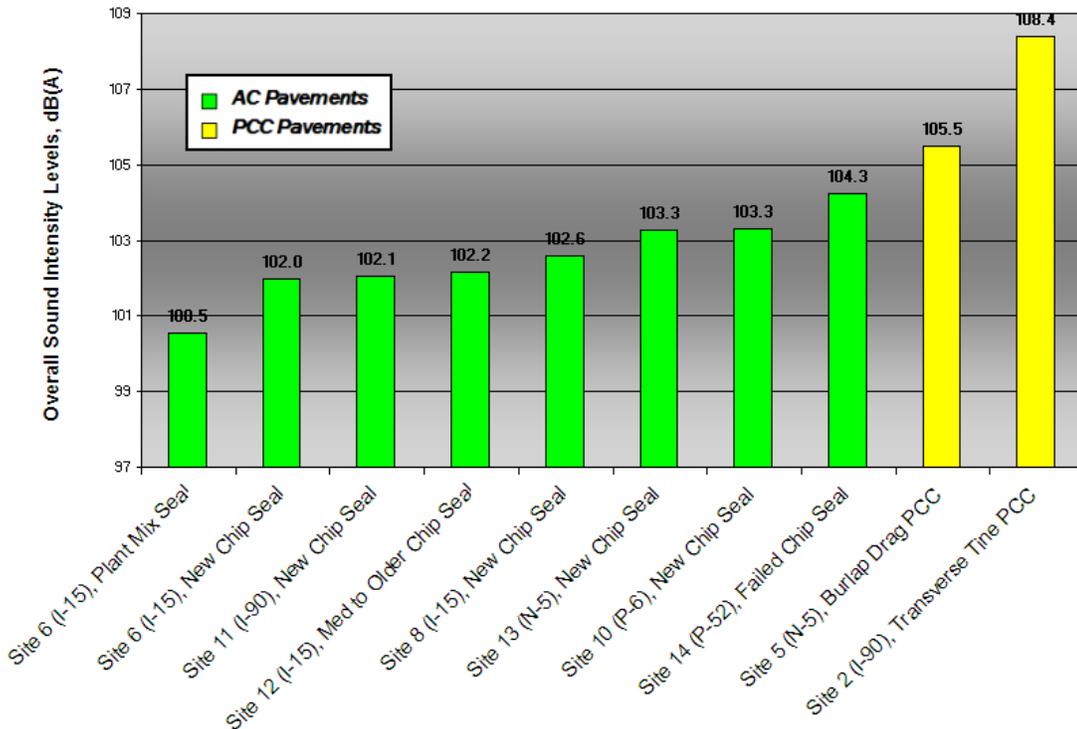
Figure 4. A-Weighted Tire/Pavement Sound Intensity Levels

Table 2 shows a summary of the test sites and the resultant overall A-weighted sound intensity levels for each site. Averages, by pavement type, are also summarized in Table 2. A comparison of the overall A-weighted sound intensity levels for each test site is shown in Figure 4.

As indicated in Table 2 and Figure 4, the PCC sections were on average 6.4 dBA higher than the Plant Mix section and 4.1 dBA higher than the Chip Seal sections. The transverse tine PCC segment along Site 2 (I-90) resulted in the highest overall level of

Test Track in California, which was 104.1 dBA, and quieter than the Chip Seal pavement along SR 521 in Ohio, which was 104.4 dBA. The Plant Mix Seal falls approximately in the middle of the DGAC pavements and is about 2.0 dBA lower in level than the average of the Chip Seal pavements.

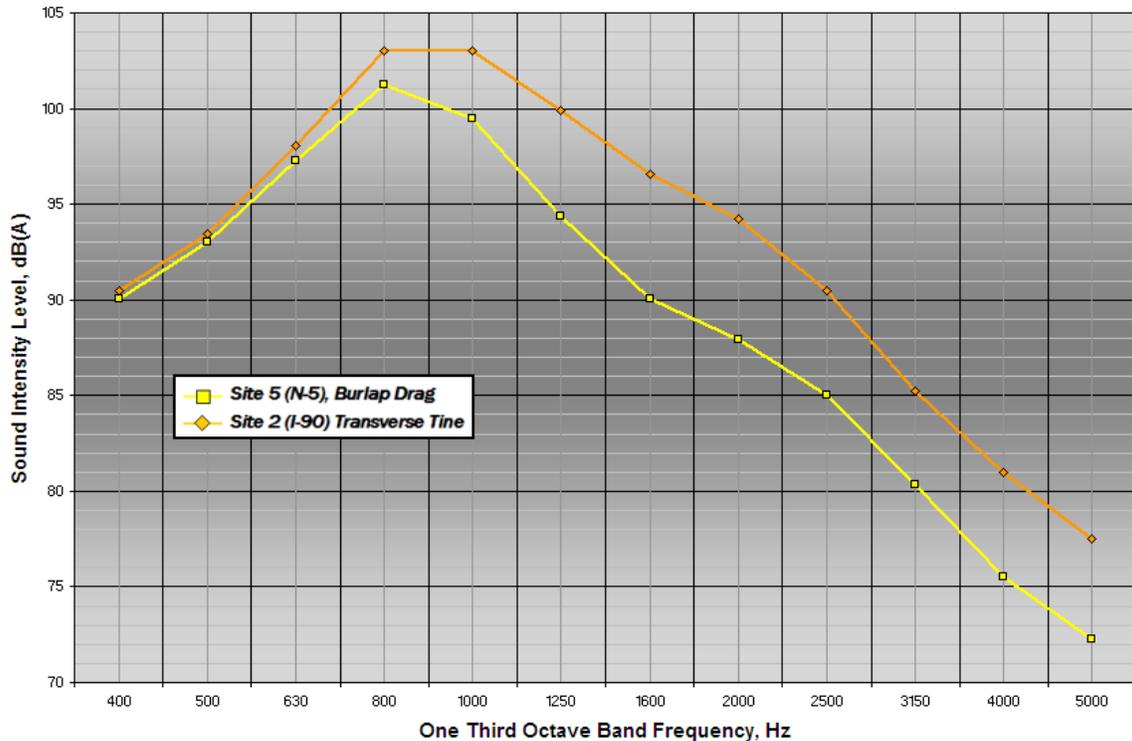
Figure 7. One-Third Octave Band Levels for PCC Pavements

Figure 7 shows the spectra for both of the PCC pavements measured at sites Site 5 (N-5) and Site 2 (I-90). As shown by the overall levels above, the PCC pavements were, on average, higher than the Chip Seal pavements by approximately 4.1 dBA. The segment for Site 5 (N-5) shows similarities to Site 2 (I-90) in the lower frequency range but has significantly lower levels at frequencies above 800 Hz. In these frequencies, both pavements are about 10 dB higher in level than typical burlap drag or ground surfaces re-enforcing the conclusion that stud/chain damage and the resultant increase in surface roughness is a major factor in the performance of these pavements. Above 800 Hz, the levels for Site 2 (I-90) become 3 to 6 dB higher than Site 5 (N-5). The magnitude and range in the levels between these two pavements is similar to that observed for the range of pavements in the OBSI data base and maybe be due aging effects for the much older Site 2 (I-90) pavement.

9. At frequencies below 800 Hz, Site 2 (I-90) is an average 0.6 dBA higher than Site 5 (N-5), but at frequencies above 800 Hz, the average difference is 5 dBA. In comparison to other PCC surfaces, higher levels in the lower frequencies for both pavements is likely due to increased roughness, presumably due to studded snow tire and snow chain usage. The higher frequency differences may be due to the relative age of the two surfaces.

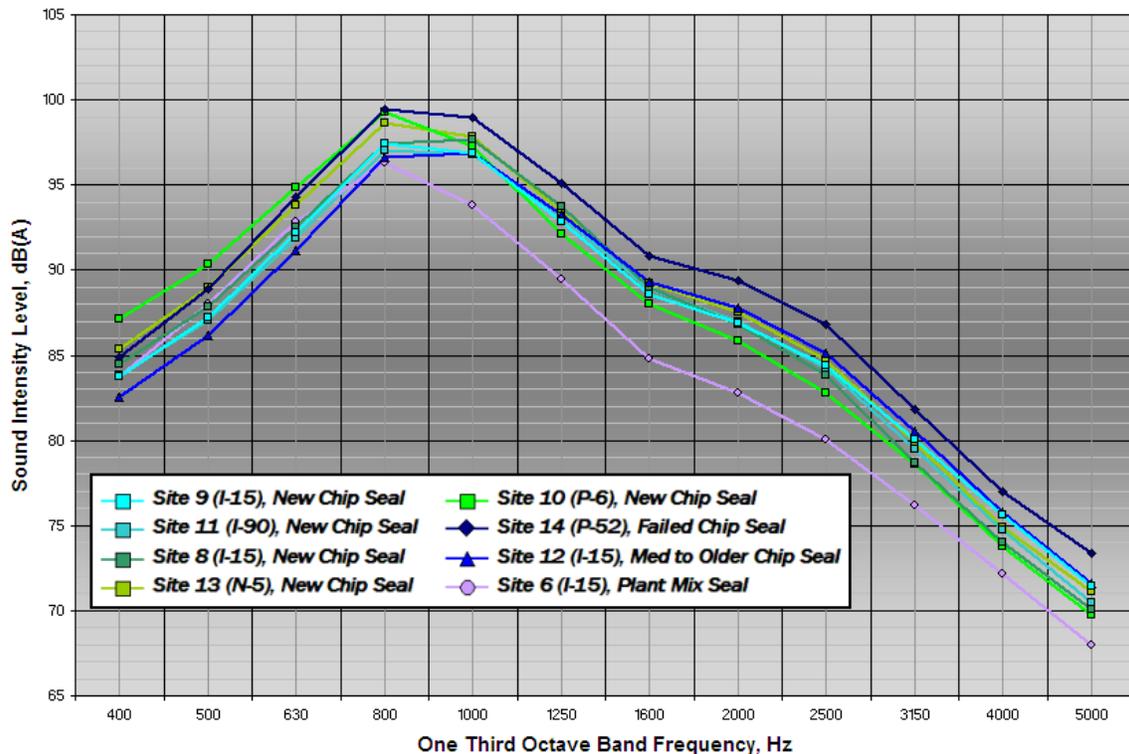
Figure 8. One-Third Octave Band Levels for AC Pavements

The spectra for all the chip seal AC pavements and the plant mix seal pavement are shown in Figure 8. The plant mix seal segment is in the low to mid-range of spectral levels at frequency bands below 800 Hz and is the quietest pavement at frequency bands above 800 Hz, averaging approximately 3.3 dBA quieter than the chip seal pavements. For each test segment with chip seal pavement, raised levels exist in the range from 800

to 1000 Hz. The peak levels are at 800 Hz for the following chip seal segments: Site 9 (I-15), Site 11 (I-90), Site 10 (P-6), and Site 14 (P-52). For the segments along Site 8 (I-15) and Site 12 (I-15), the peak levels are at 1000 Hz. The failed chip seal segment, which is Site 14 (P-52), is in the mid- to high range of spectra for frequency bands below 800 Hz, but above 800 Hz, Site 14 (P-52) shows the highest levels, averaging approximately 2.2 dBA higher than the other chip seal segments. The quietest segment at the lower frequencies is the medium to older chip seal pavement Site 12 (I-15). Site 12 (I-15) averages approximately 1.9 dBA quieter in this frequency range than the new chip seal pavements and is 2.7 dBA quieter than the failed chip seal. At the higher frequencies, however, Site 12 (I-15) is among the segments with the highest spectral levels, being an average 0.7 dBA higher than the new chip seal pavements and 1.6 dBA quieter than Site 14 (P-52). On average, the new chip seal segments fall within the mid-range of spectral levels throughout Figure 8. However, at the lower frequencies, Site 10 (P-6) and Site 13 (N-5) are slightly higher than the other new chip seal pavements, with a standard deviation of 1.2 dBA; at frequencies above 1000 Hz, all the new chip seal segments remain within 0.6 dBA of each other.

5. The plant mix seal, which is denoted as Site 6 (I-15), has spectral levels that fall within the lower to mid-range of AC pavements for frequencies below 800 Hz. Above 800 Hz, however, the plant mix seal averages approximately 3.6 dBA lower than all other AC segments.

6. On average, the new chip seal pavements are within the mid-range of spectral levels throughout the frequency band range. However, the standard deviation of 0.6 dBA at the frequency bands greater than 800 Hz is significantly better than the standard deviation of 1.2 dBA at the frequency bands below 800 Hz.

7. The spectrum for the medium to older chip seal pavement, as compared to the other AC segments, has the lowest levels for frequency bands less than 800 Hz. From 1250 Hz and greater, the medium to older chip seal pavement is among the highest segments.

8. For frequency bands less than 800 Hz, the failed chip seal segment, which is Site 14 (P-52), is in the mid- to upper spectral level range. Above 800 Hz, however, Site 14 (P-52) has the highest spectral levels, averaging approximately 2.2 dBA higher than the other chip seal segments.

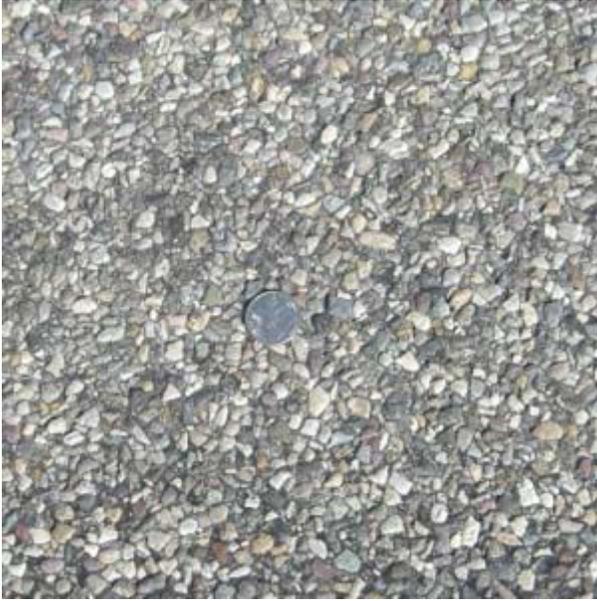
(a) Site 12 (I-15), Medium to Older Chip Seal

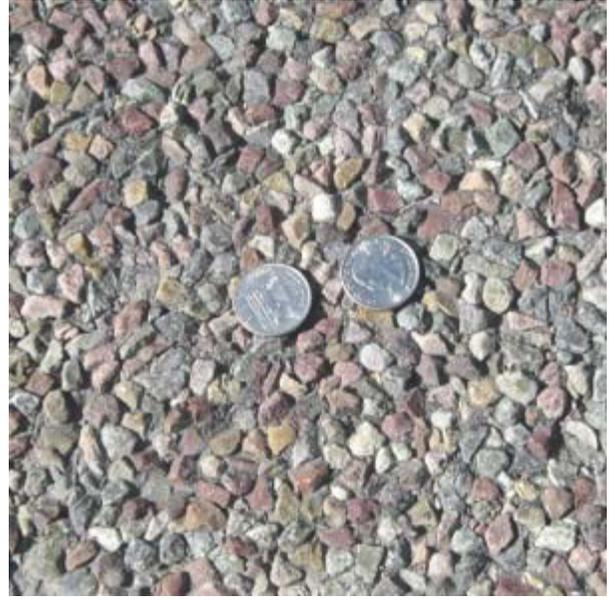
(b) Site 13 (N-5), New Chip Seal

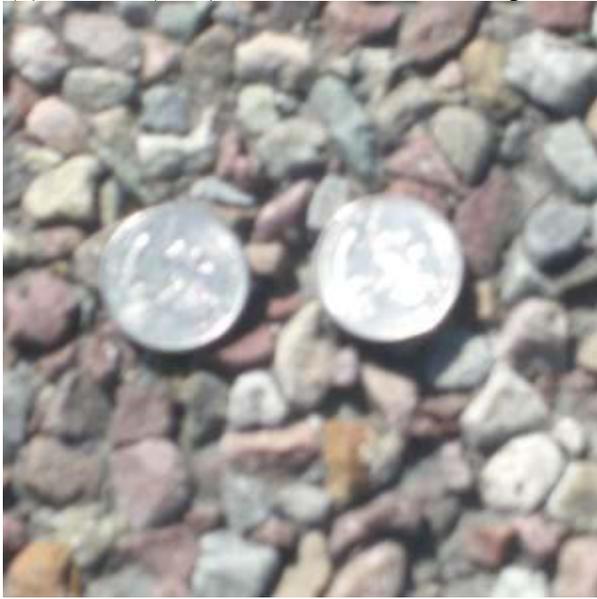
(c) Site 14 (P-52), Failed Chip Seal

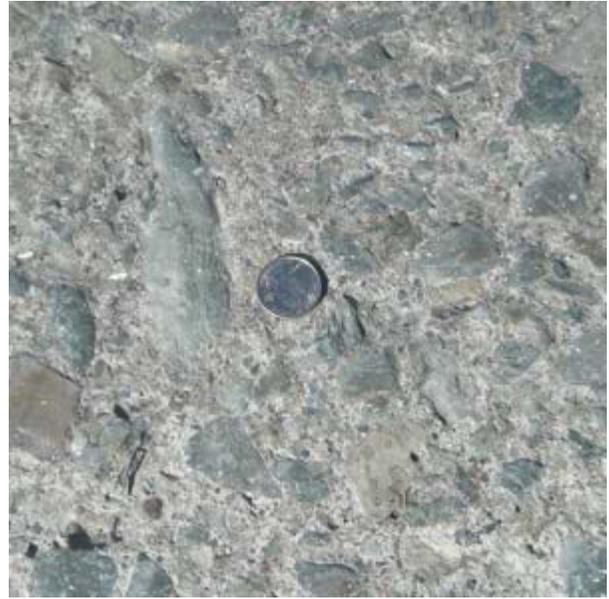
(d) Site 2 (I-90), Transverse Tine PCC

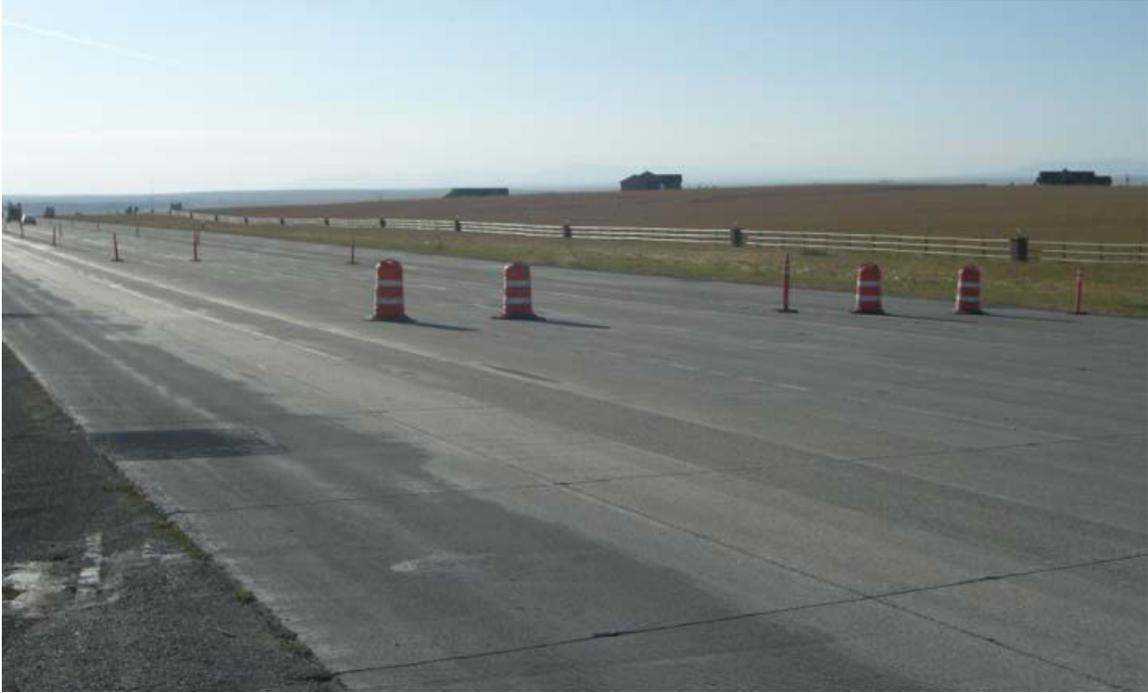
(a) Roadway Construction

Figure A-2 shows the construction existing at Site 15 at the time of testing.

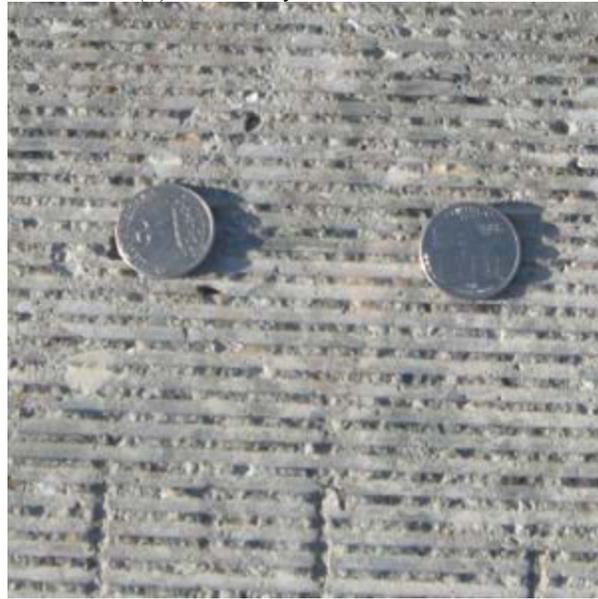
(b) Existing Pavement
