## Geotechnical/ Structures

**Project Title:** MASH 2016  
Compliance of Roadside Safety  
Features

**Task Number:** 3169

## Development of a replacement for breakaway supports for large roadside signs and crash testing to MASH 2016 Test Level 3

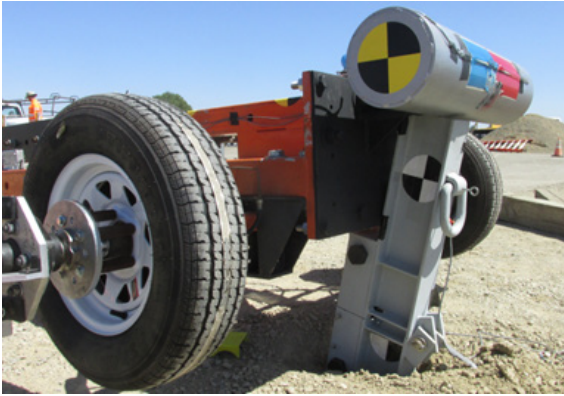
**Image 1:** Test 610MASH0B24-01: Dynamic Bogie Test

Three dynamic bogie tests were conducted in the soil pit, but the tests failed to meet the MASH soil strength requirements. The first test failed with the measured load too high due the soil being

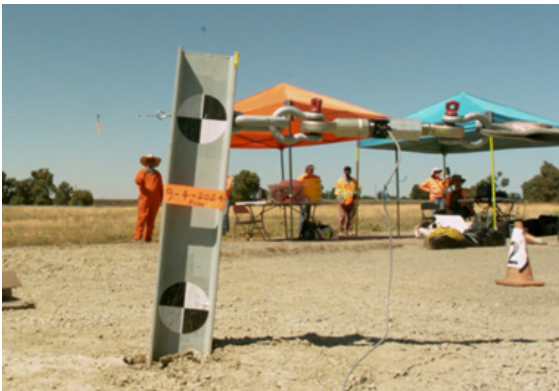
**Image 2:** Test 610MASH0B24-01: Static Test

over compacted. A series of compaction and static tests were conducted until a compaction method was developed that was believed would provide a successful force-deflection curve during a dynamic bogie test. This compaction method was then used on the next two tests. The second test failed with a low force-deflection curve due to frequent rain the prior months increasing the height of the ground water table, the surrounding water seeped into the installation and weakened the soil. The third test's force-deflection curve was just below what is required and failed due to the soil not having enough compaction. Therefore, the chosen compaction method needs to be modified to increase the force-deflection curve.

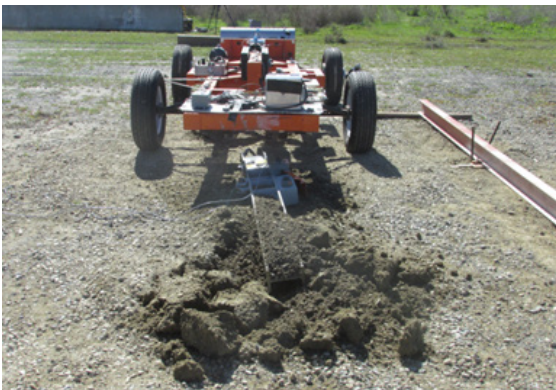
**Image 3:** Test 610MASH0B25-01: Dynamic Bogie Test

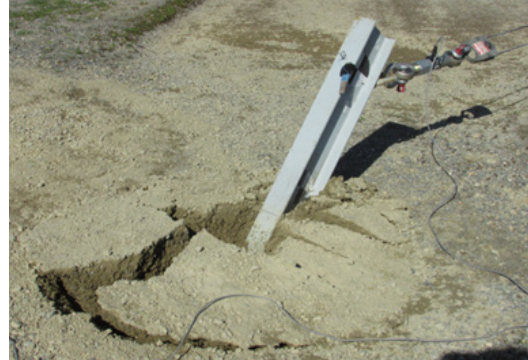
**Image 4:** Test 610MASH0B25-01: Static Test

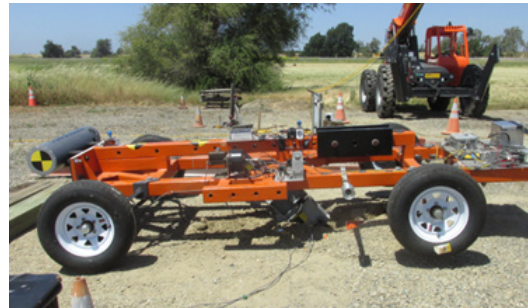
**Image 5:** Test 610MASH0B25-02: Dynamic Bogie Test

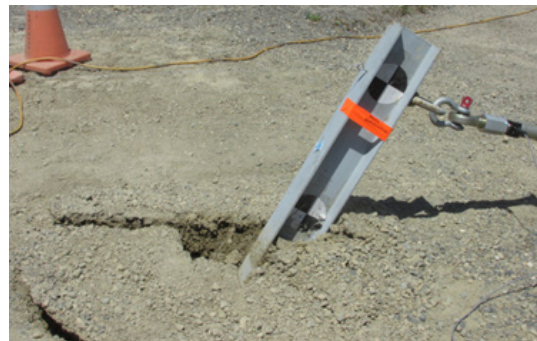
**Image 6:** Test 610MASH0B25-02: Static Test
